Fundão Tailings Dam Review Panel

Report on the Immediate Causes of the Failure of the Fundão Dam

EXECUTIVE SUMMARY

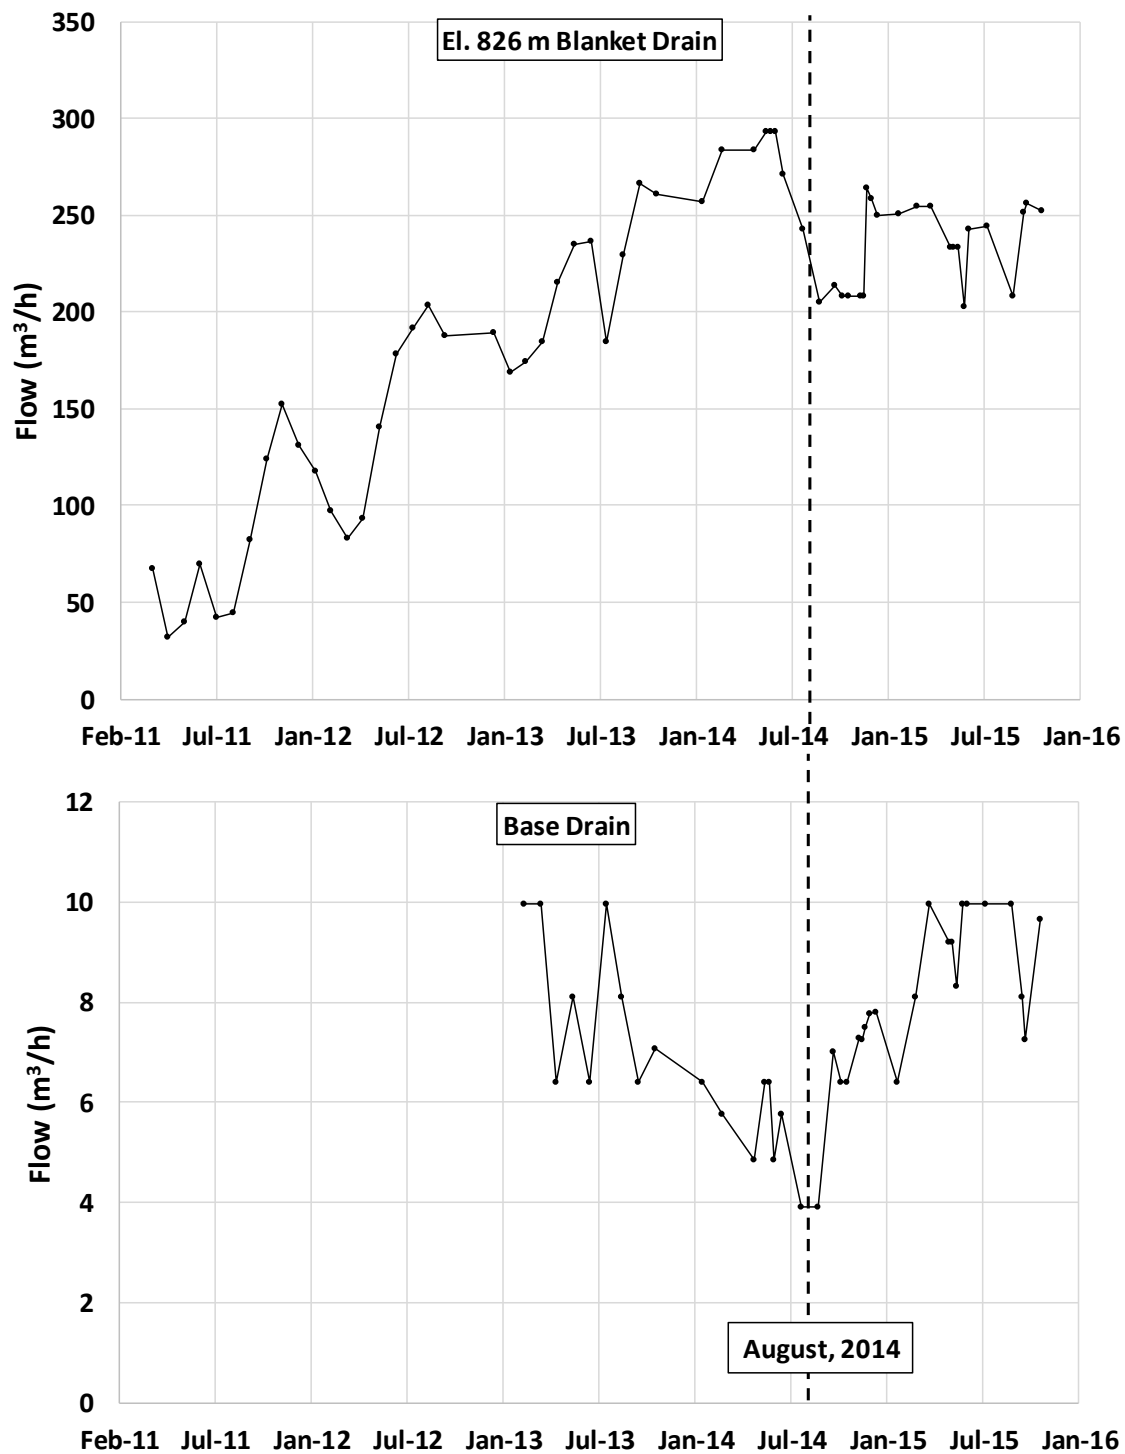
Figure 4-10 Measured flows from El. 826 m blanket drain and Starter Dam base drain

An explanation consistent with these events is that the El. 826 m blanket drain with its Kananet® outlet pipes reached its maximum capacity. With the drain unable to divert additional seepage, saturation on the right abutment increased, breaking out in July at El. 855 m. At the same time, the diminished effectiveness of the blanket drain caused base drain flow to reverse its previous trend and begin increasing, while related increase in flow into the foundation caused artesian conditions to appear at the Starter Dam toe. And, as discussed subsequently in detail, all of these things were accompanied by the shallow saturation and unprecedented cracking of the left abutment that also occurred in August, 2014.

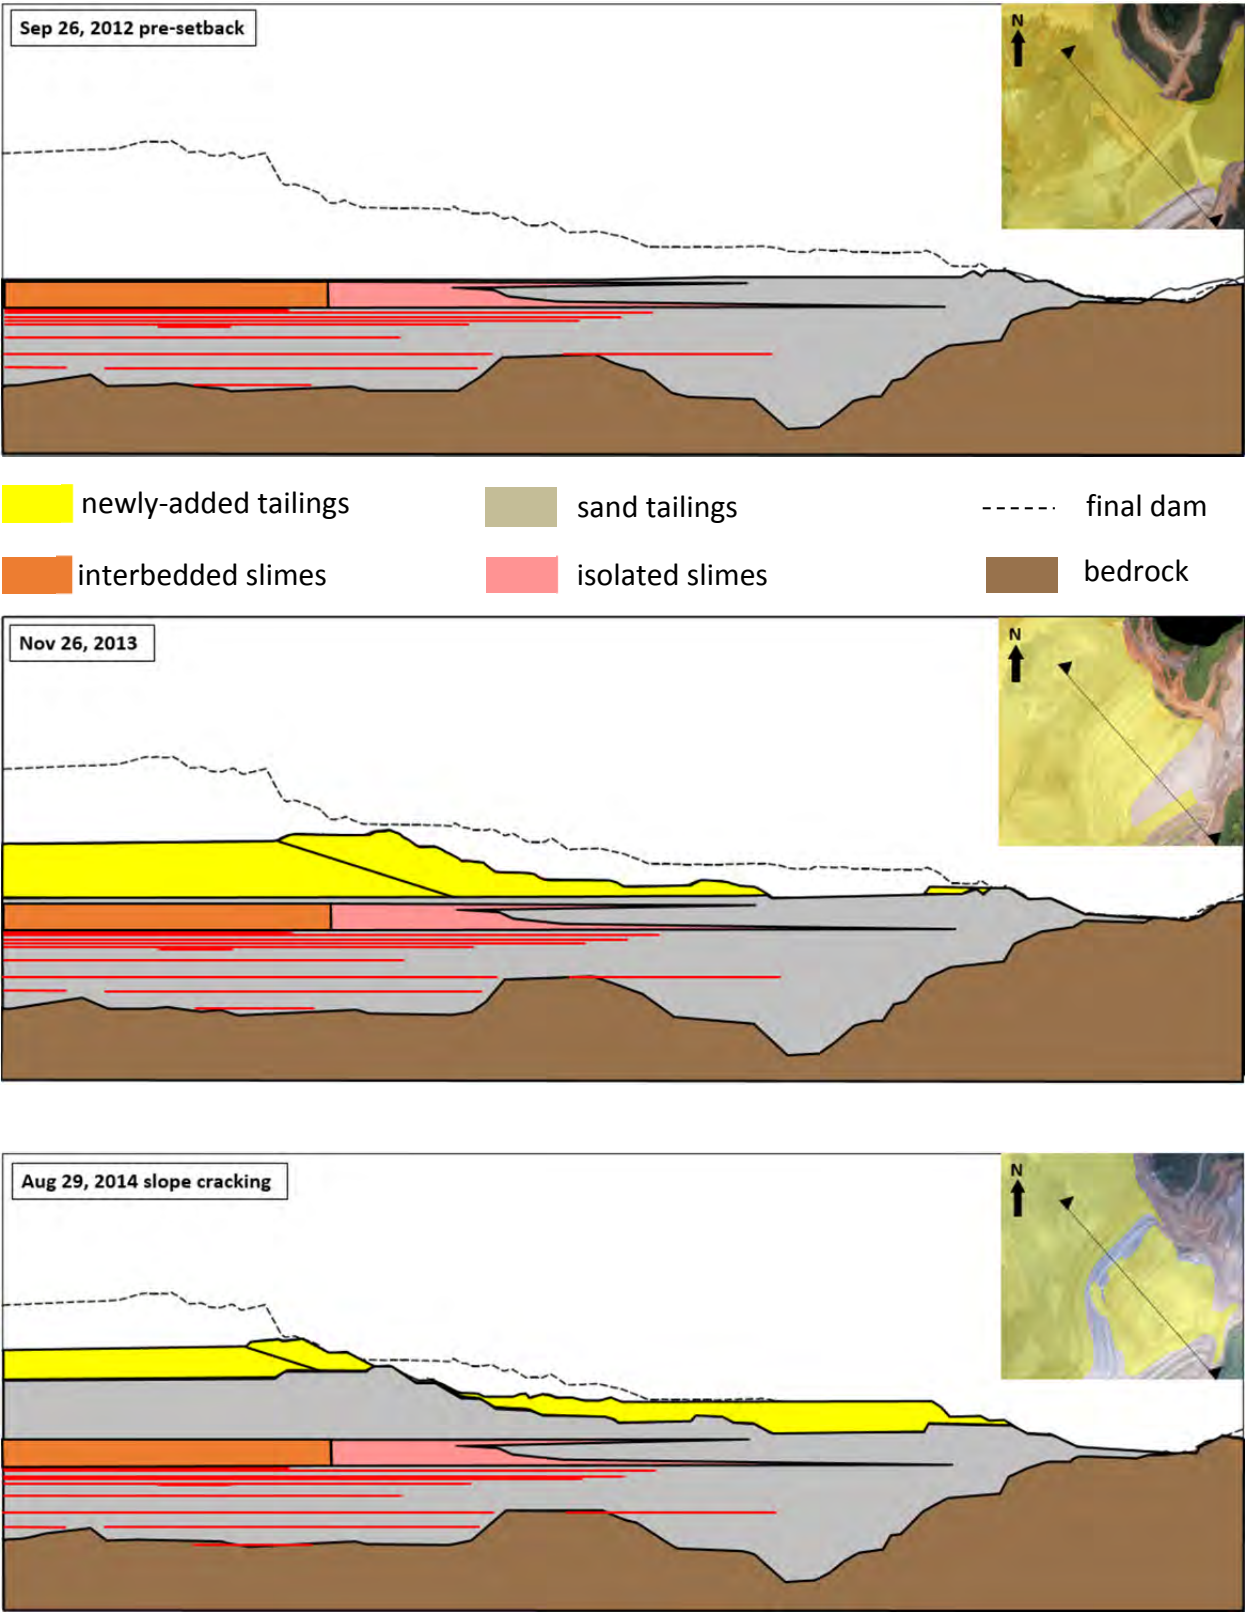
Figure 5-10 shows that the alignment setback caused all or most of the embankment to be constructed over slimes. In addition, as the embankment became higher and its crest moved upstream, more of the embankment slope became underlain by the higher proportion of slimes in the interbedded region.

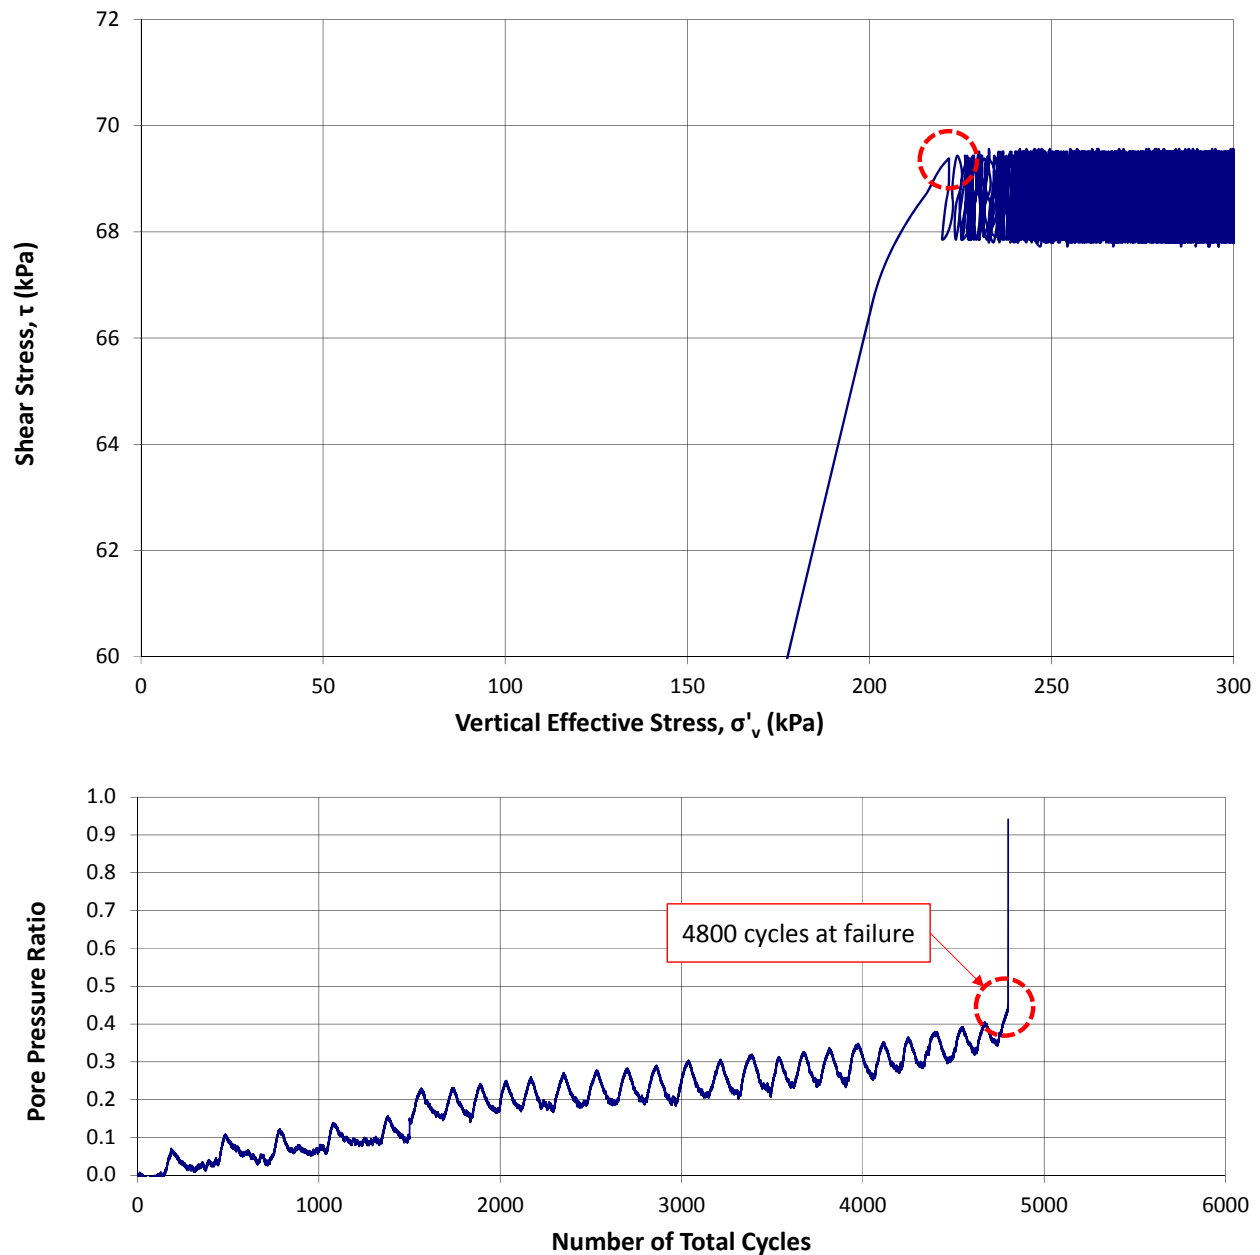
Figure 6-2 Stress path during cyclic loading

Testing is also of value in understanding the role of cyclic loading from earthquakes leading to liquefaction. This is illustrated on Figure 6-2.

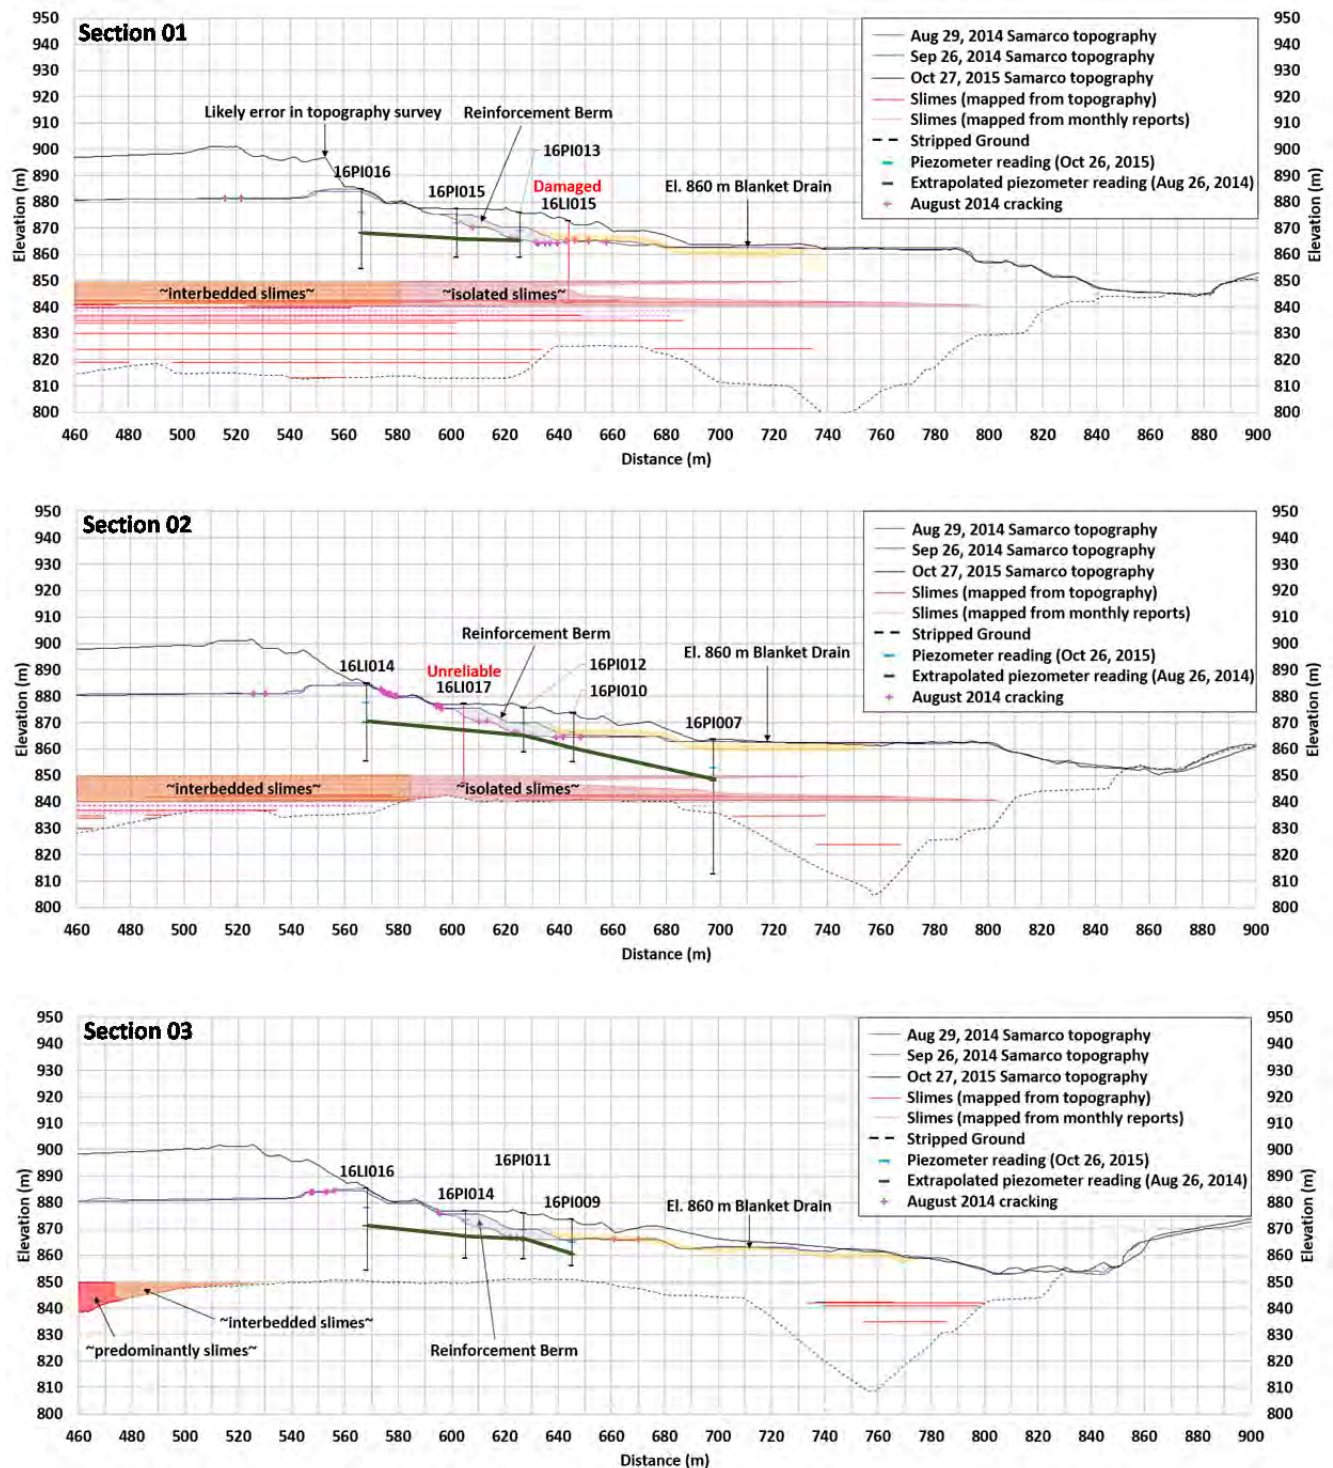
Figure B8-2 August, 2014 data compilation for Section 01, 02, 03

The left abutment setback geometry, the back extrapolated piezometric surface and the location of cracks are shown on Figure B8-2.

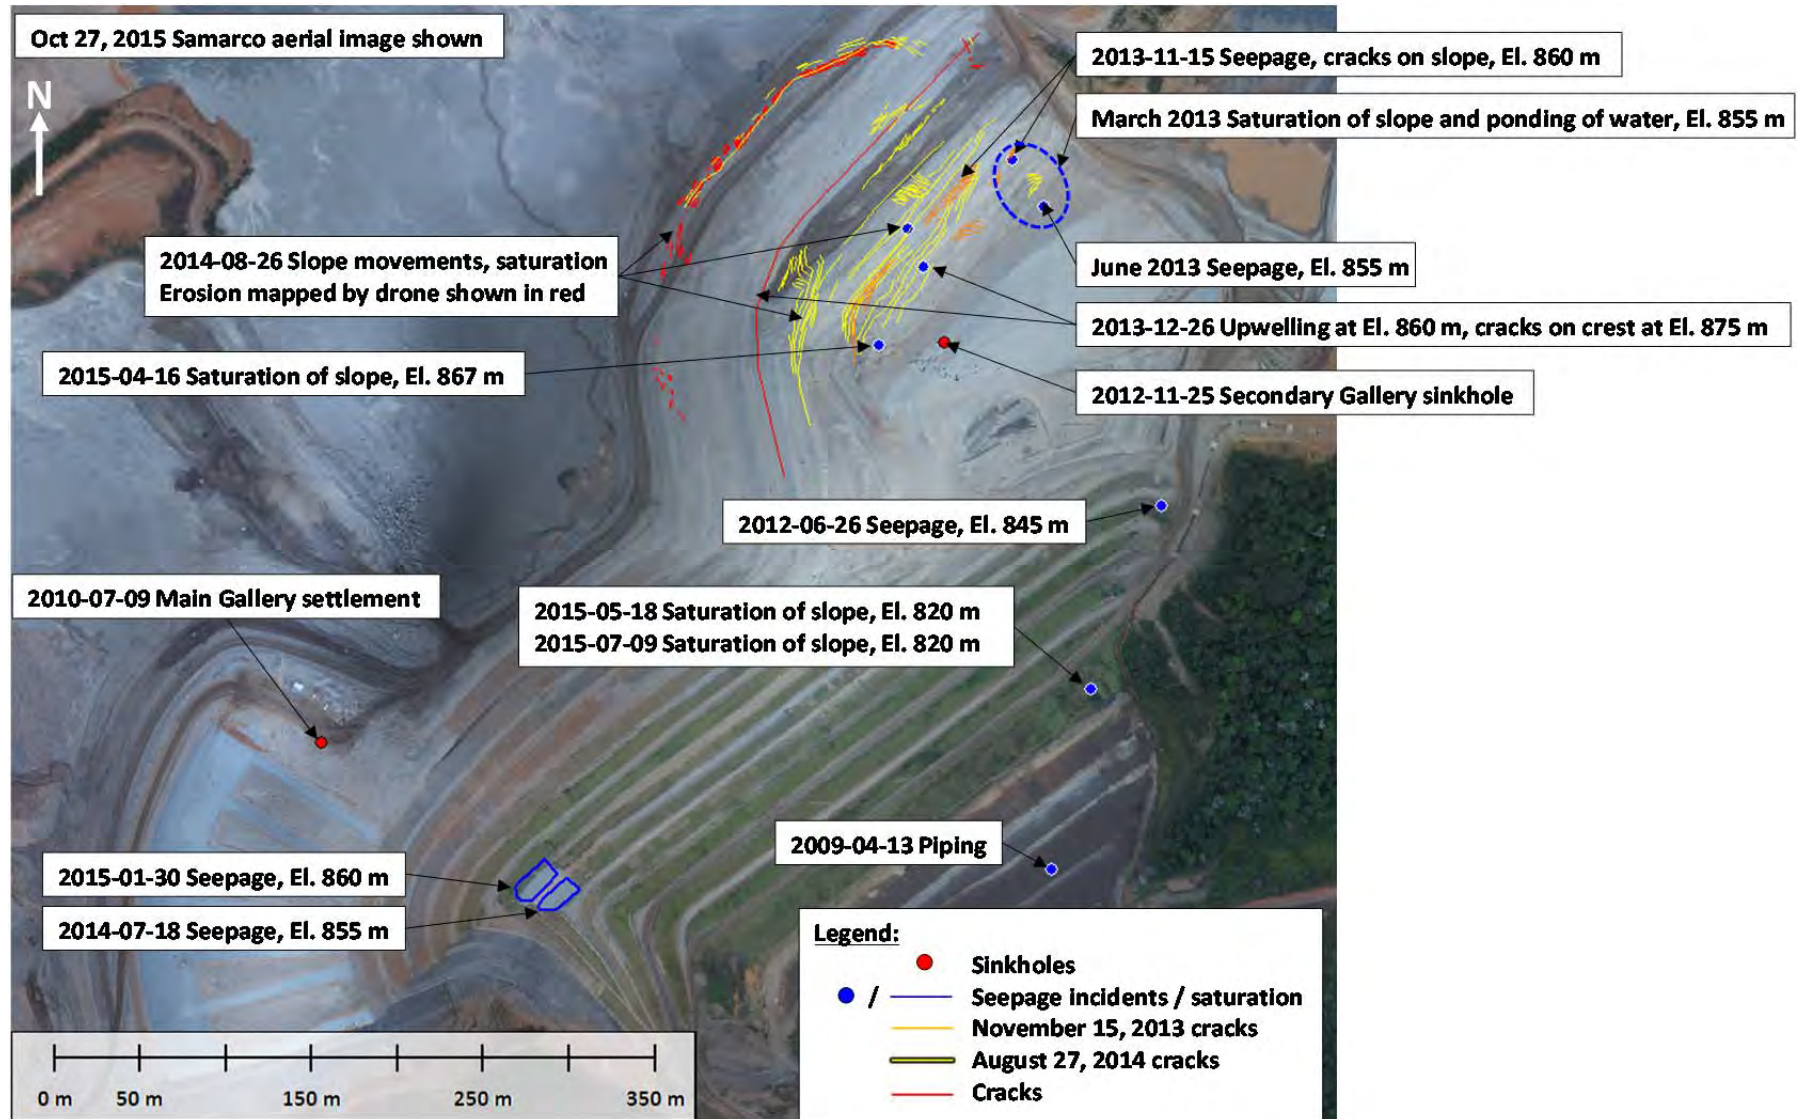
Figure B.B8-1 Incidents at Fundão shown in plan

Abutment	Date	Elevation	Incident Type
-	April 13, 2009	-	Piping
Right	July 9, 2010	-	Main Gallery settlement
Left	June 26, 2012	845 m	Seepage
Left	November 25, 2012	-	Secondary Gallery sinkhole
Left	March, 2013	855 m	Saturation of slope and ponding of water
Left	June, 2013	855 m	Seepage
Left	November 15, 2013	860 m	Seepage, cracks on slope
Left	December 26, 2013	860 m	Upwelling at El. 860 m, cracks on crest
Right	July 18, 2014	855 m	Seepage
Left	August 26, 2014	-	Slope movements, saturation
Right	January 30, 2015	860 m	Seepage
Left	April 16, 2015	867 m	Saturation of slope
Left	May 18, 2015	820 m	Saturation of slope
Left	July 9, 2015	820 m	Saturation of slope

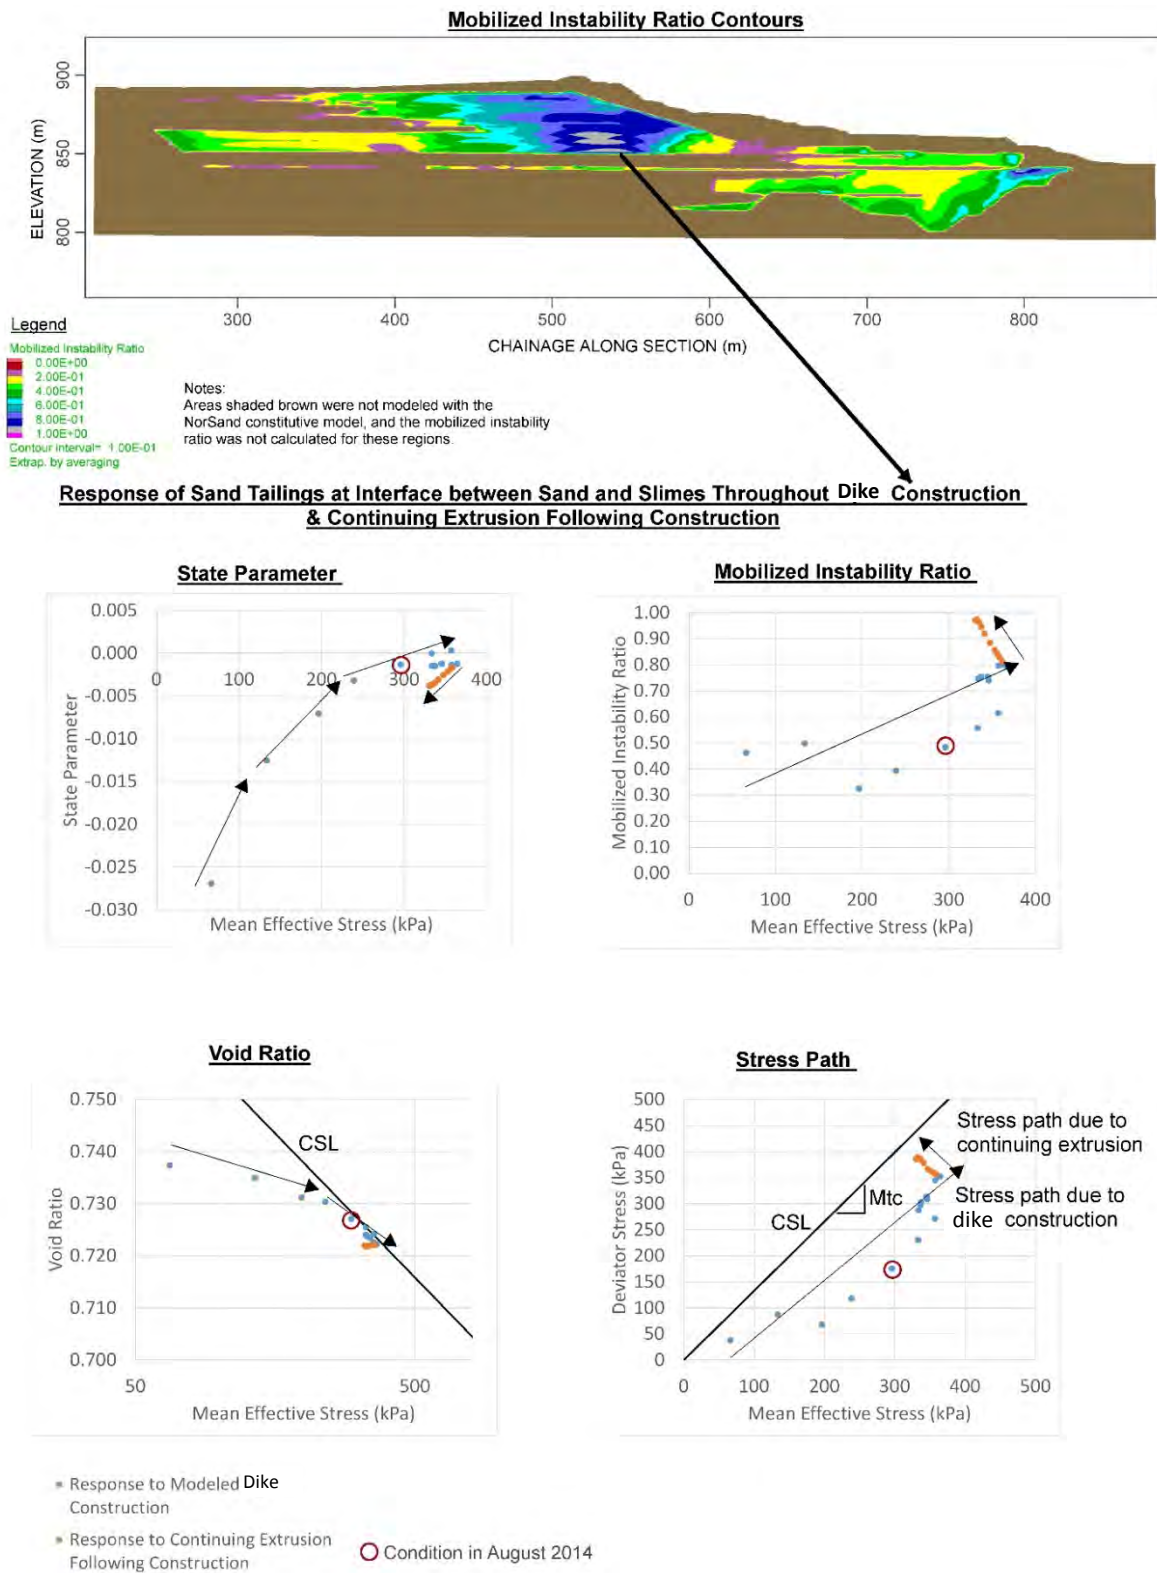
Figure I3-29 Mobilized instability ratio and stress path due to continuing extrusion of slimes – reduced strength continuous interbedded slimes model
