# MOUNT POLLEY MINING CORPORATION POST-EVENT ENVIRONMENTAL IMPACT ASSESSMENT REPORT – KEY FINDINGS REPORT

JUNE 5, 2015

Golder Associates Ltd.  
Suite 200 - 2920 Virtual Way,  
Vancouver, BC, V5M 0C4

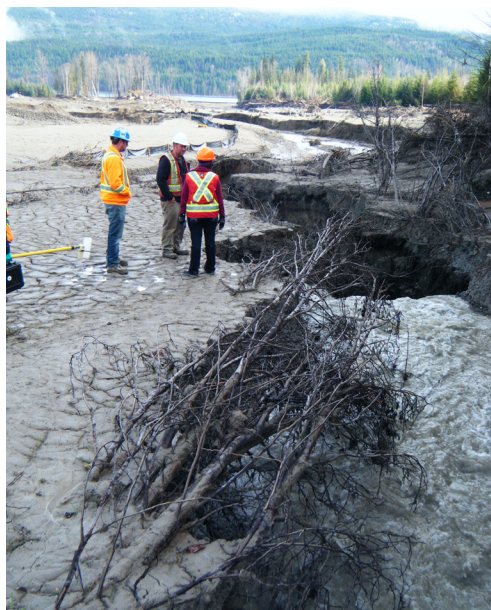
Hazeltine and Edney Creeks converge prior to discharge to Quesnel Lake. The mouth of Edney Creek was scoured during the debris flow to allow fish passage between Quesnel Lake and Edney Creek, a new channel was constructed.

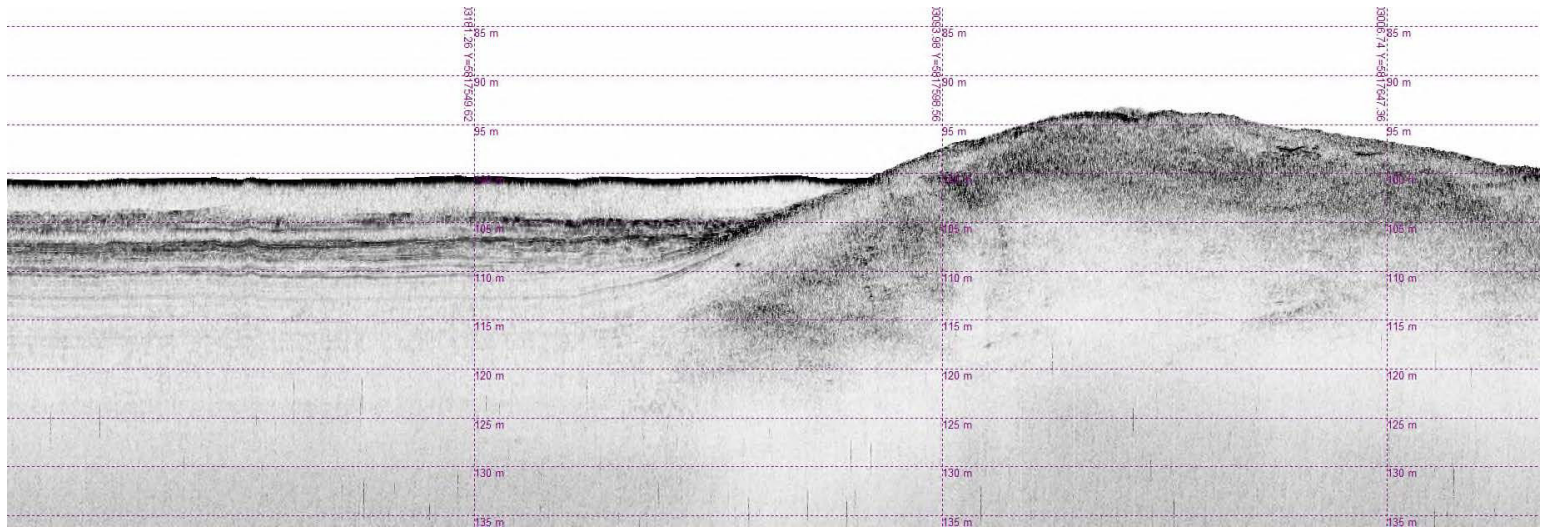
Figure 7: A sub-bottom profile image of Quesnel Lake showing fine-grained sediments on the lake bed along the flat section of the image and showing an underwater lake sideslope on the rise to the right of the image.

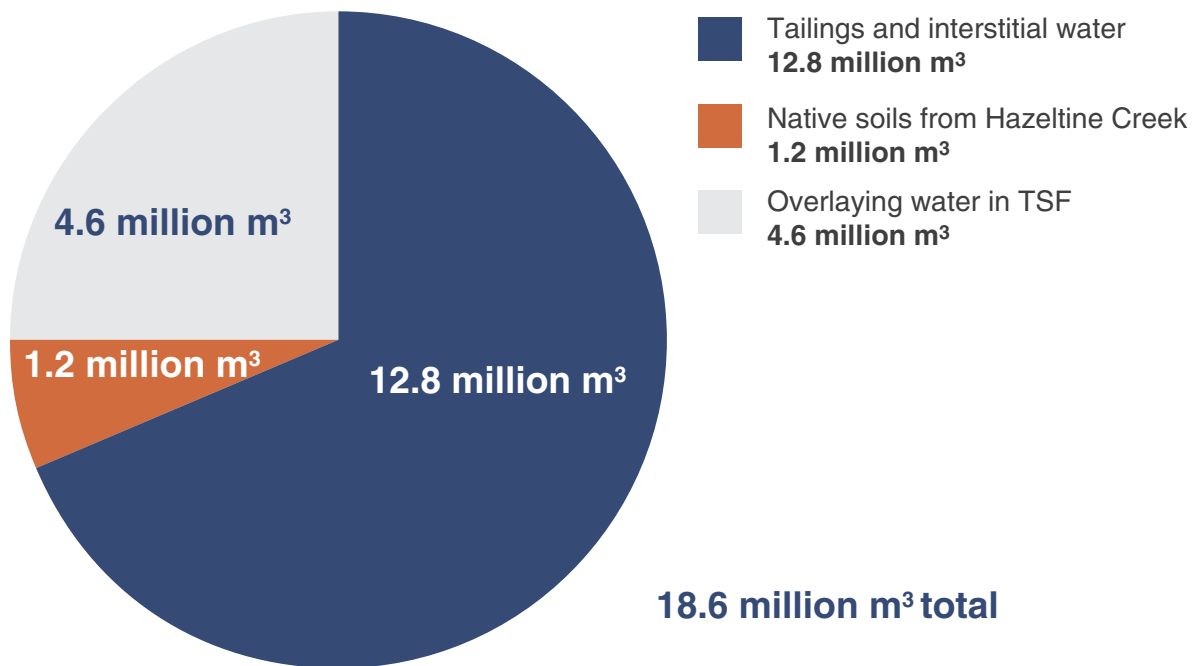
Figure 9: Sediment into Quesnel Lake

Using this information, Tetra Tech EBA estimated that  $18.6 \pm 1.4$  million m<sup>3</sup> entered Quesnel Lake. The breakdown of that material is shown in Figure 9. Most of this material deposited deep in the West Basin, below 100 m depth. The area of that deposit was estimated to be approximately 1.81 km<sup>2</sup>. In some places the deposited material was estimated to be up to 10 m thick; however, those estimates were done soon after the spill and that depth is expected to decrease as the sediments consolidate/dewater/compact with time. For Polley Lake, the pre-tailings dam failure data does not allow an interpretation of post breach data.

This material on the lake bed resulted in a change in the lake bottom habitat and a disruption in the community of small animals that live in the deep lake bed. This impact is part of ongoing studies but early sampling suggests that some recovery of those organisms may have already begun. Sampling of those bottom-dwelling organisms following that deposition and settling of the sediments is necessary to verify expectations that the sediments will recover their function.

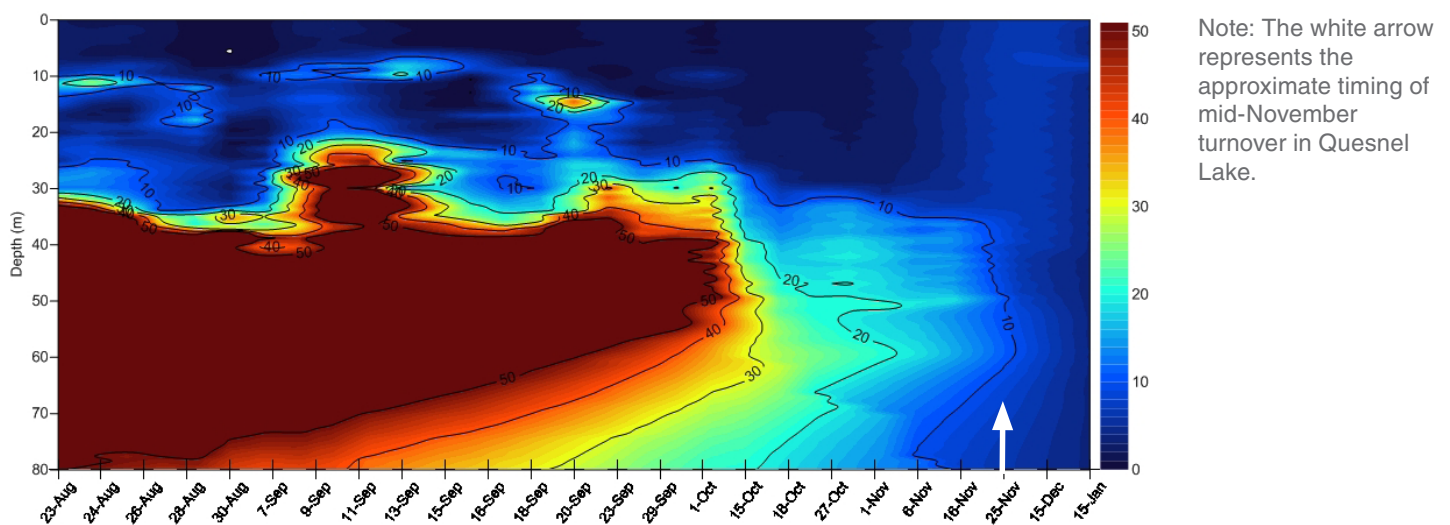
Figure 11: Turbidity measurements of Quesnel Lake water from the surface to the bottom of Quesnel Lake at a station adjacent to the mouth of Hazeltine Creek, showing the clearing of turbid water that happened over time

The water in Hazeltine Creek is now running clear and the turbidity of the main body of Quesnel Lake is in the range of pre-event conditions. There is still a slight increase in turbidity near the bottom of Quesnel Lake and that is expected to clear, but the main body of the lake has returned to normal conditions and is expected to stay that way into the future.

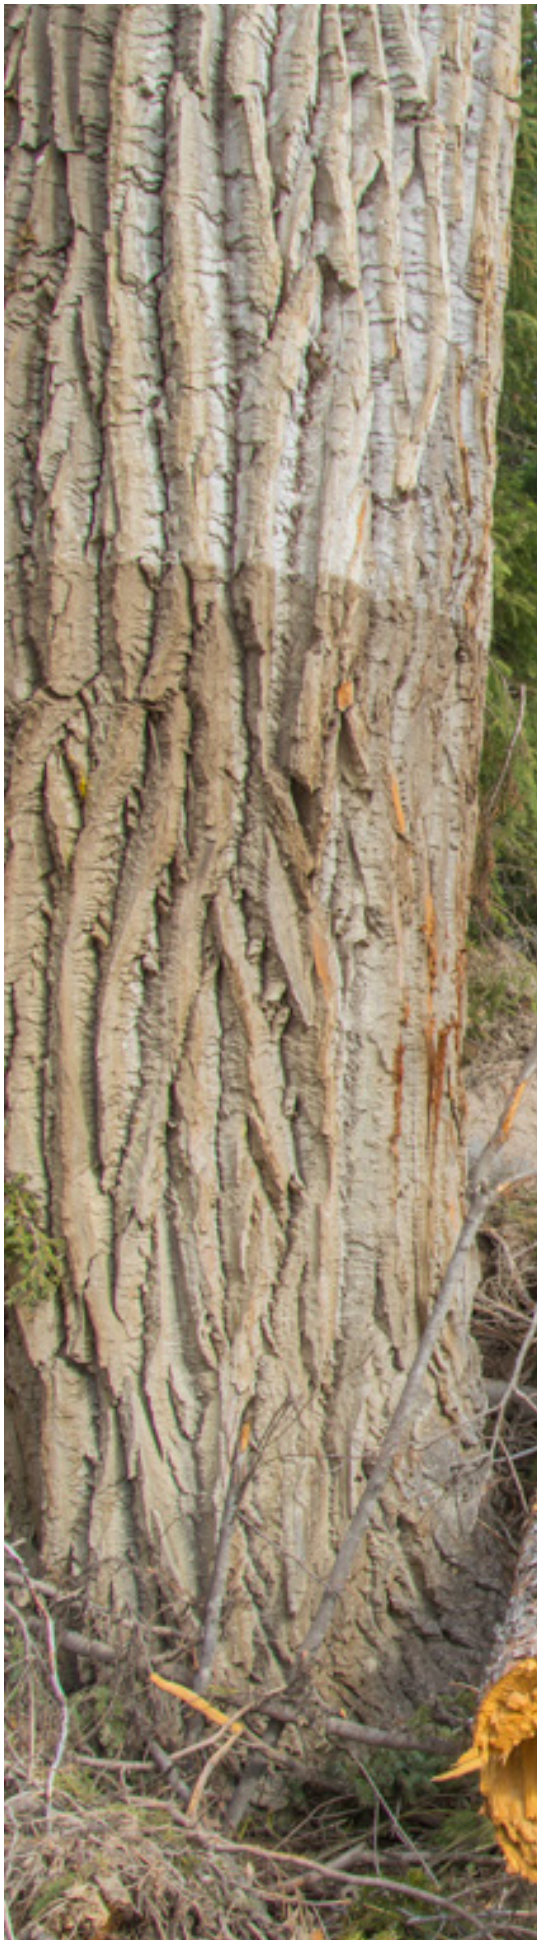
Old growth cottonwood showing the height of debris flow

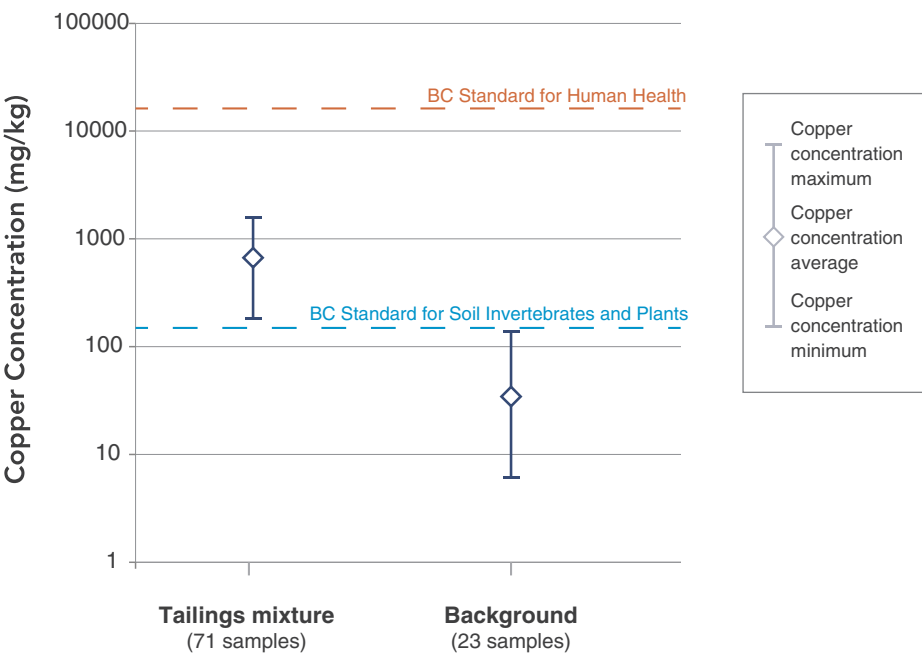
Figure 12: Copper concentrations in the tailings mixture from Hazeltine Creek area compared to background soil

Eighty-eight samples of the tailings soil mixture and twenty-three background soil samples were collected from 18 transects along the Hazeltine Creek channel to evaluate the quality of the tailings mixture in the soil impact assessment. Consistent with the mineral mixture of the tailings discussed previously, the concentrations of copper in the tailings mixture are higher than in the native soil alone, and higher than the BC Soil Standard for the protection of soil invertebrates and plants. The copper concentration in soil is far below the standard for the protection of human health meaning that the tailings mixture is safe for direct human contact.

Based on these studies, the data indicate that the quality of the mixture of tailings and soil deposited in the Hazeltine Creek flood plain and surrounding forest has changed from pre-dam failure conditions. The copper concentrations are higher, the soil pH is higher, the deposited mixture is layered in some areas based on the sand and silt content, and the nutrient content of tailings mixture is lower.

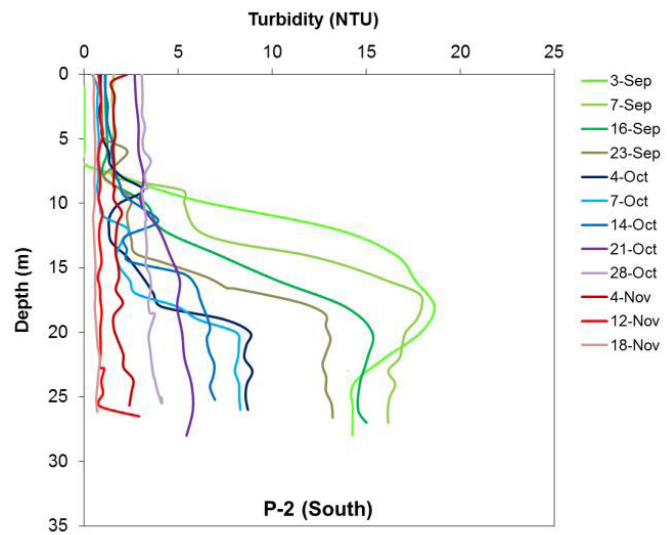
Figure 14: Post-event turbidity measurements with depth in Polley Lake showing the turbid water at depths of greater than 7 m below the surface

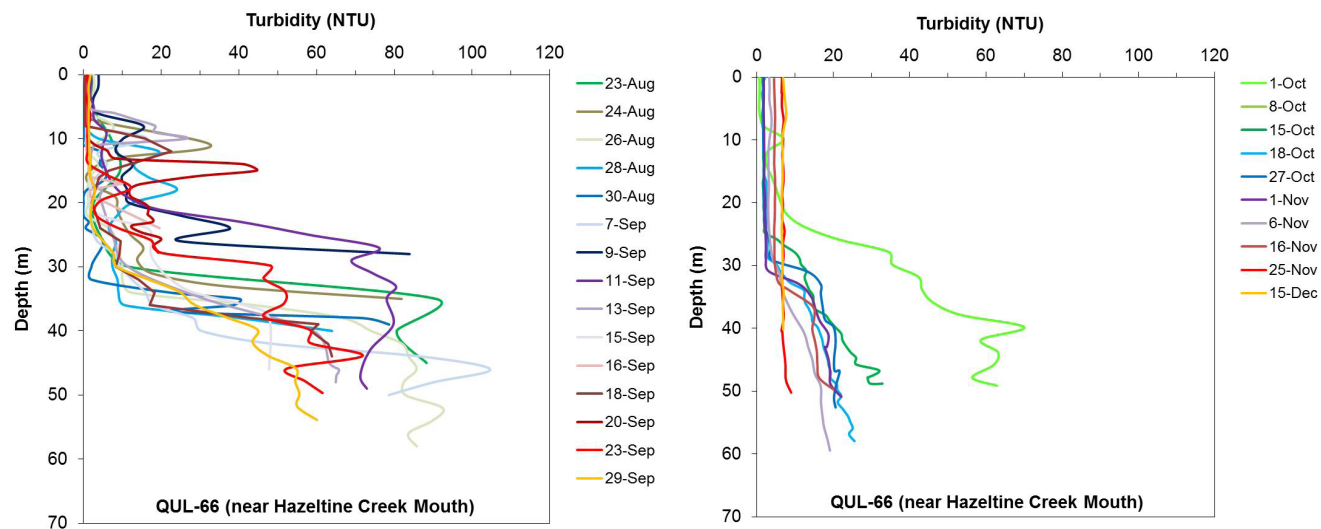
A similar chain of events occurred in Quesnel Lake, except the lake ‘turn over’ event occurred in mid-November. The mixture of displaced material that entered Quesnel Lake following the dam failure was more dense (“heavier”) than Quesnel Lake water and so caused turbid water at depths ranging from 10 to 25 m and beyond (Figure 15).

Figure 15: Turbidity measurements in Quesnel Lake near Hazeltilde Creek over time. The results show the higher turbidity measurements with depth.

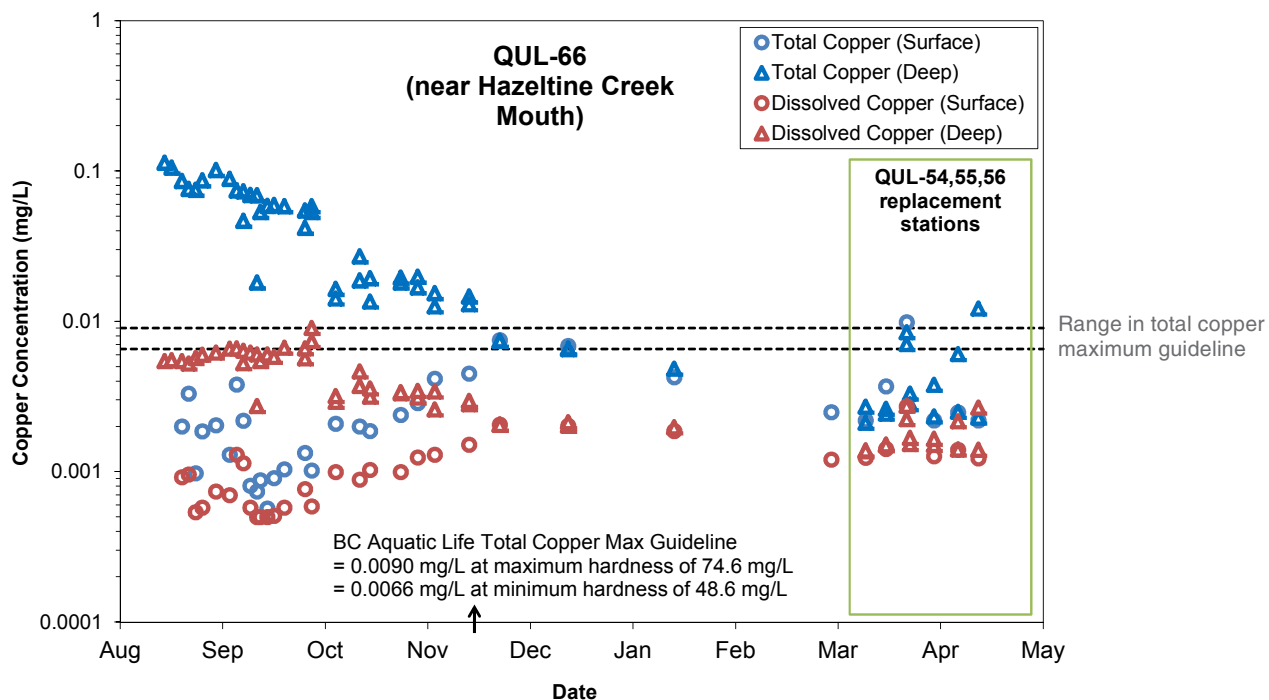
Figure 16: Post-event measurements of total and dissolved copper in Quesnel Lake near Hazeltn Creek

With the increase in turbidity at depth, there was an associated increase in the concentrations of total copper at depth. The concentrations of total copper were above the BC Water Quality Maximum Guideline between August and November of 2014, and were generally below the guideline since then (Figure 16). The concentrations of dissolved copper were below the water quality guideline even at depth where the turbid water was located, providing confirmation of the geochemistry results that found the copper in the tailings soil mixture was not leachable.

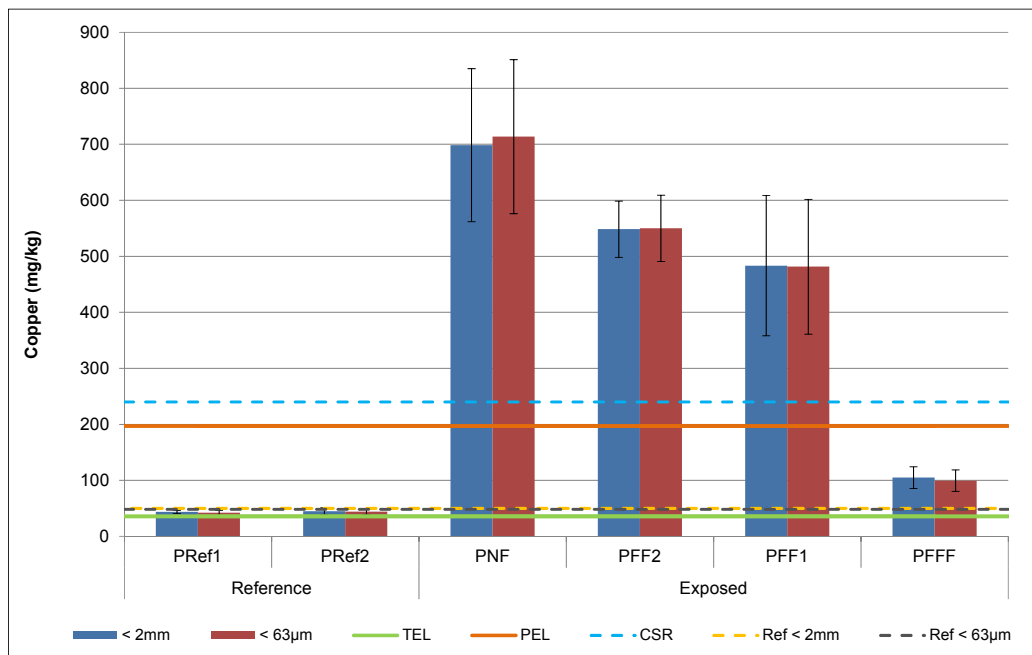
Figure 17: Mean copper concentrations ( $\pm t^*SE$ ) in sediment from profundal sampling areas in Quesnel Lake, Mount Polley Mine, 2014

As expected, the sediment locations closest to the dam failure had higher concentrations of copper than samples taken more distant from the TSF. Sediments in Quesnel Lake near Hazeltine Creek had concentrations of copper (Figure 17) that exceeded the provincial sediment quality guidelines and are higher than background concentrations. Consistent with the findings of the soil quality assessment, the sediments also exhibited low nutrient content and low concentrations of organic carbon content. Several studies conducted in collaboration with the geochemical assessment indicated low potential for bioavailability of metals (including copper) to benthic-dwelling organisms in the lakes and river. Therefore, although copper concentrations in sediment exceed provincial guidelines, the copper and other associated metals are not expected to be harmful.
