MOUNT POLLEY MINE **TAILINGS STORAGE** **FACILITY BREACH**

August 4, 2014

Investigation Report
of the Chief Inspector of Mines

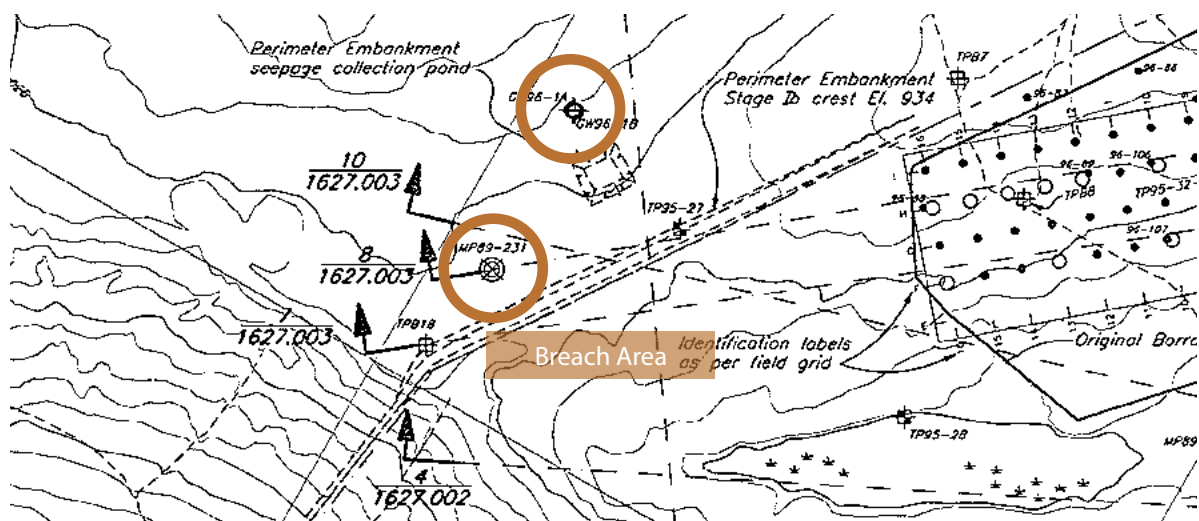
The test holes located in the vicinity of the area of the breach included: MP89-231 (condemnation drill hole), and GW96-1A (groundwater monitoring well), which are shown in plan on Fig 6.7 and in section on Fig. 6.8. The highlighted section represents a lower-strength clay unit.

Figure 6.7 Location of Borehole MP89-231 and GW96-1A
Knight Piésold (1995d) Dwg. 1627-001

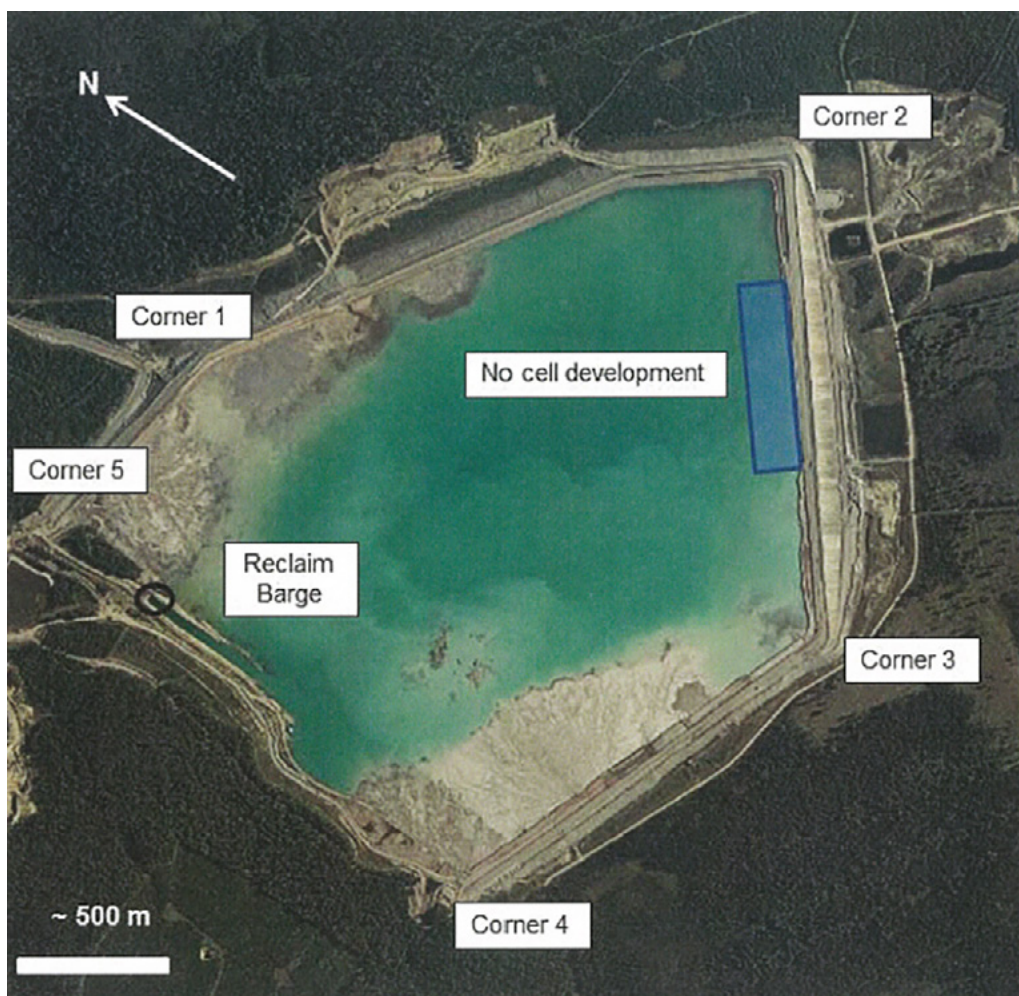
BGC’s assessment noted, “given the orientation of the gravity-fed tailings line, insufficient tailings line pressure prevented cell [Zone U] construction along the central portion of the Main Embankment... The tailings delivery line is currently being redesigned with the expectation that the new alignment will allow for upstream tailings cell construction to take place along the Main Embankment in 2013.”¹¹⁵ The limited cell development (and lack of beaches) can be seen in Figure 6.20.

1.9.1, 2.1.1	Within 30 days, ensure local exhaust ventilation captures contaminants from hydraulic hose cutting.
4.2.1.1	Within 14 days, update power distribution drawings to accurately show current configuration.

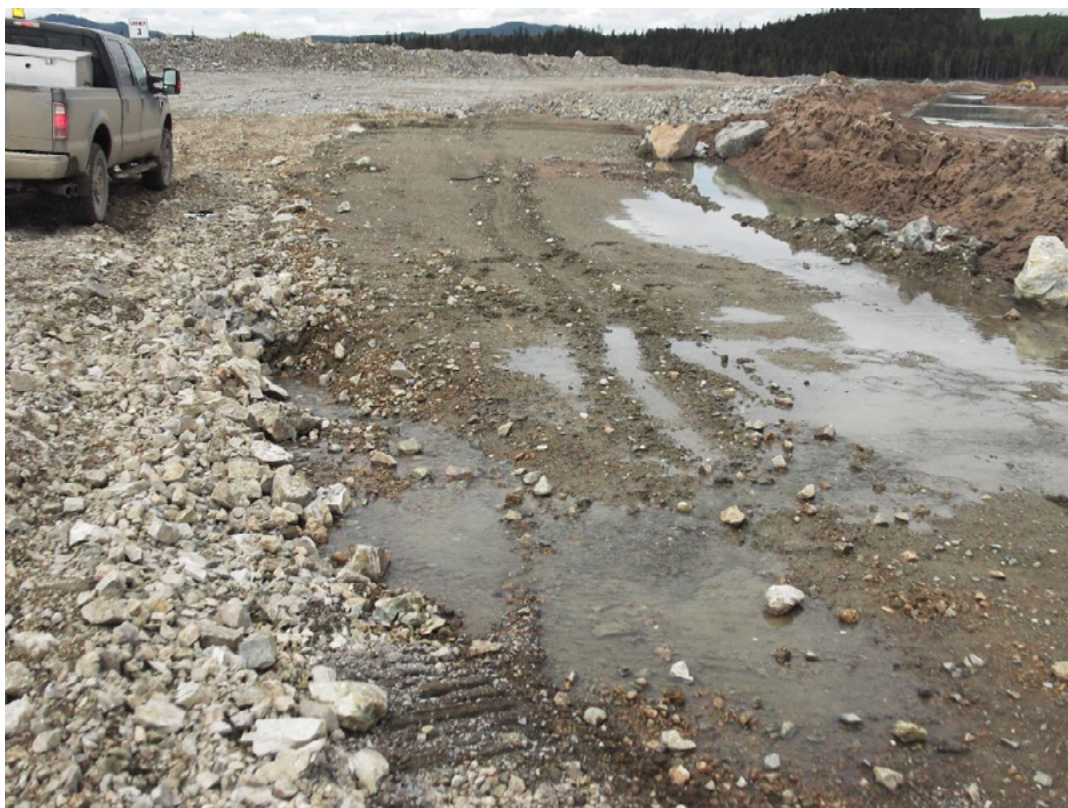
The incident was described in AMEC’s daily report as: “water is seeping through the U zone and ending up on top of our till which then flows into the filter due to the water elevation in the sand cell being 0.2 m higher than the top of the till at Corner 3.” MPMC initiated response actions by constructing a temporary berm at Corner 3, consisting of random fill (Zone U) over the sand cell and glacial till. The berm was subsequently placed upstream of the core to contain the water. The pond water elevation at the time of this incident was 966.5 m.¹³⁵

Figure 6.25 *Water Overtopping Embankment Core and Entering Filter Zone, Station 1+530 on SE, May 24, 2014 AMEC (2014d) p. 5*

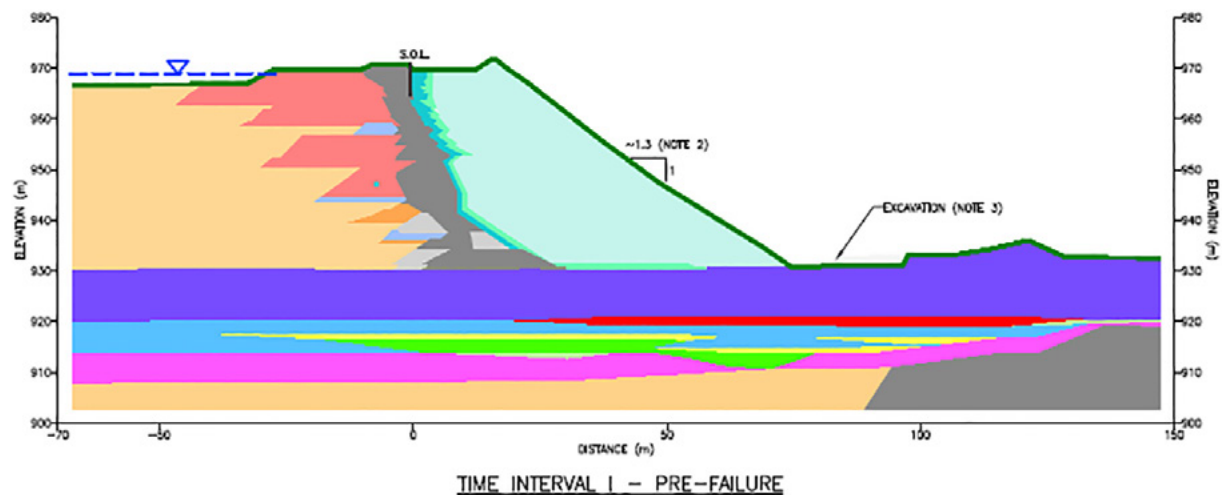
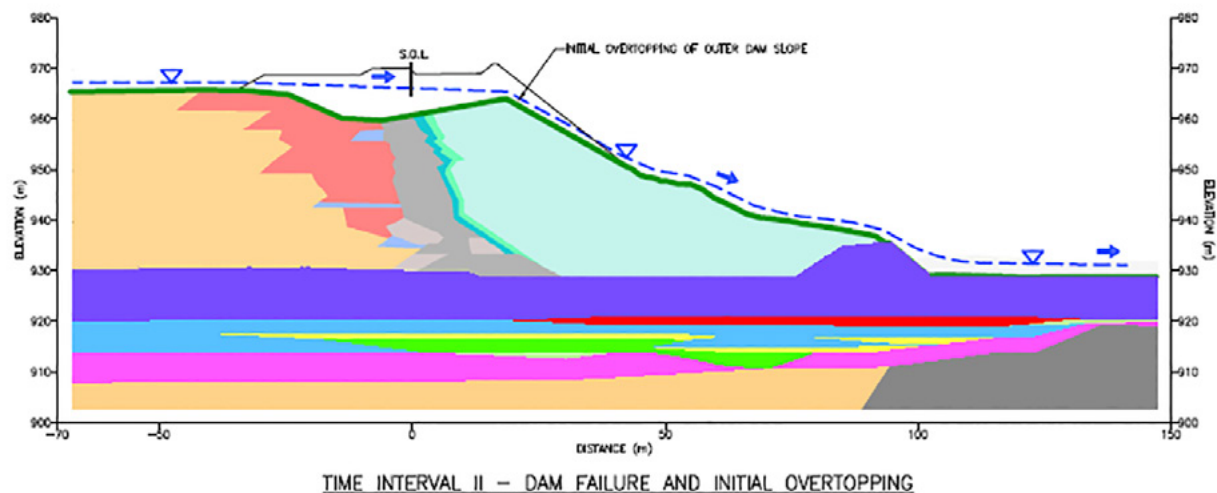
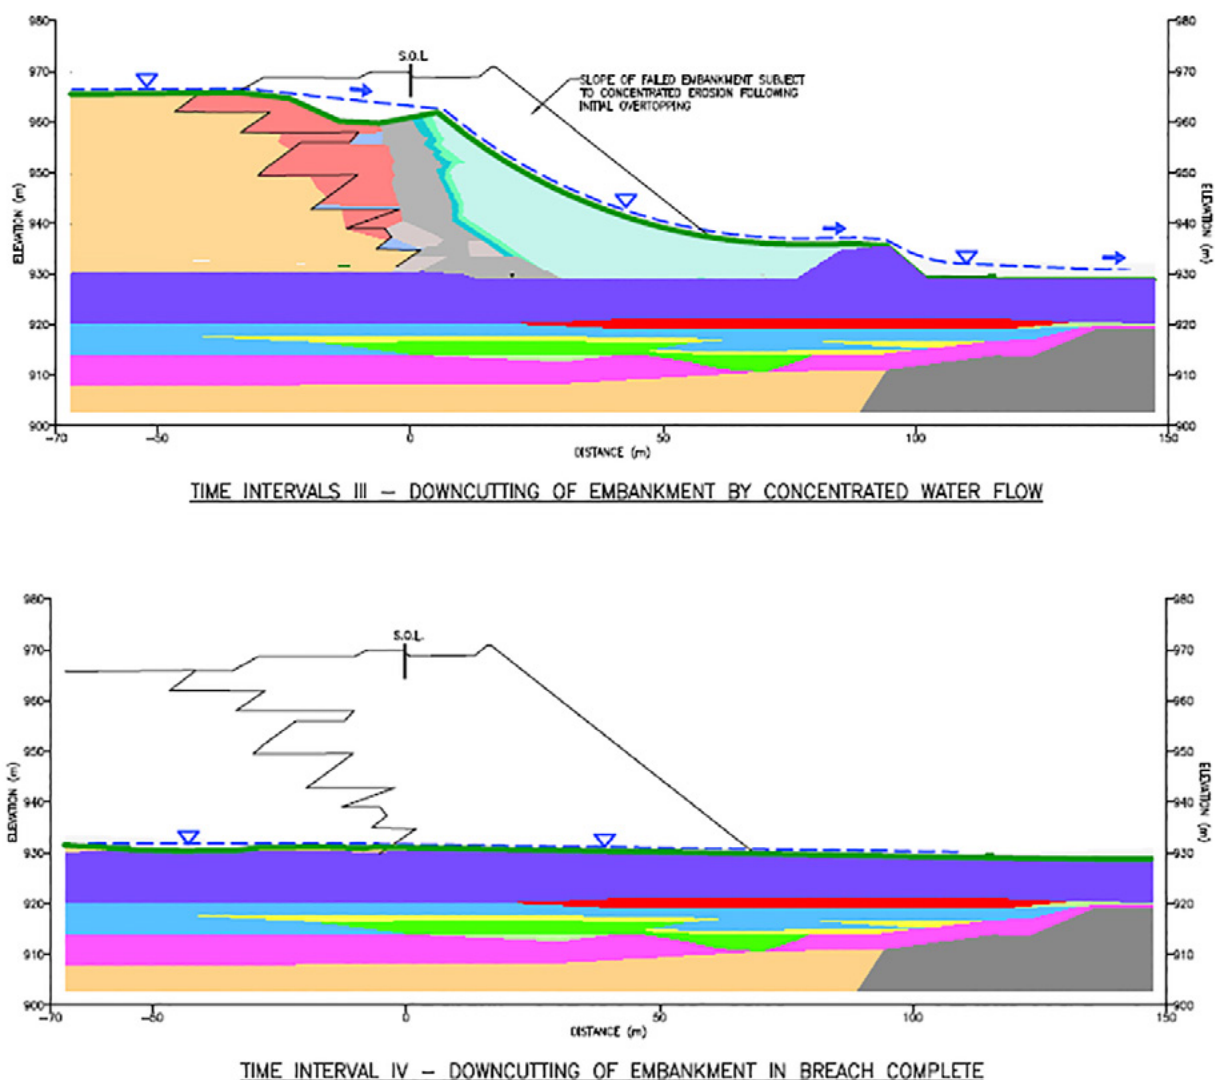
Figure 9.4 Hypothesized Embankment Breach Sequence
Appendix 2, Fig. 3-12

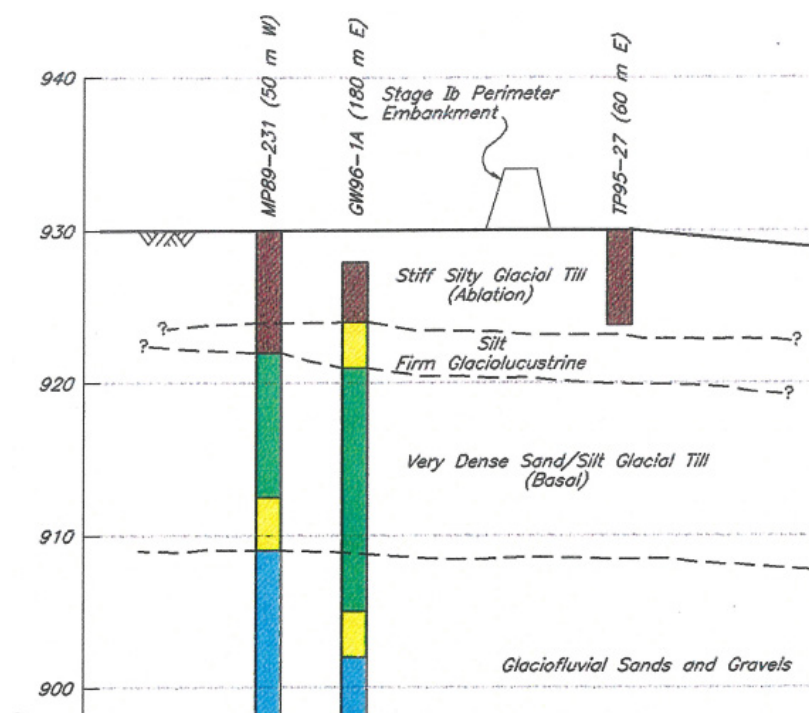
Figure 10.2 Detail of UGLU
Knight Piésold (1997c) Dwg 1627.011

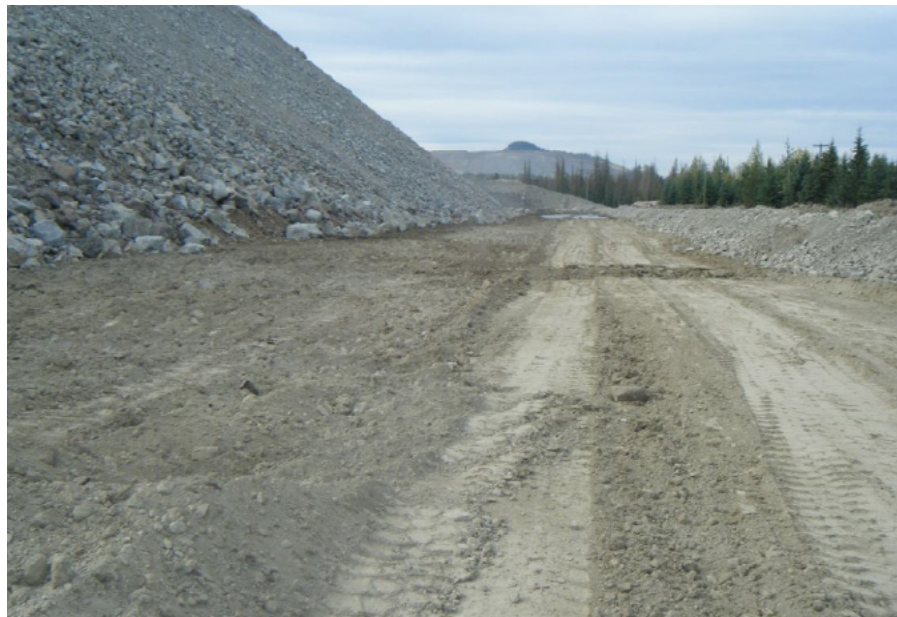
Figure 10.3 Typical Buttress Subexcavation
AMEC Environment and Infrastructure (2014a) Appendix A)
