Report of the Expert Panel on the Technical Causes of the Failure of Feijão Dam I

December 12, 2019

EXECUTIVE SUMMARY

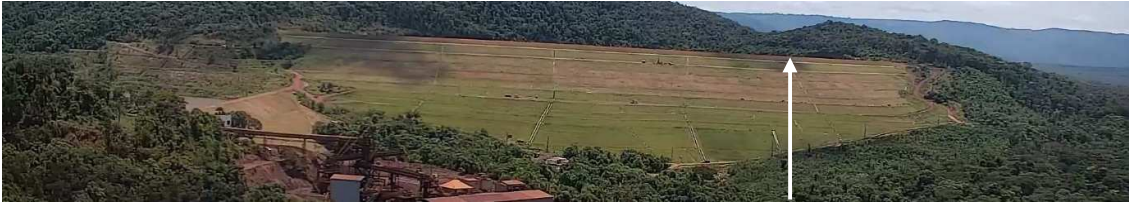
Figure 5: Observed Initial Deformation of the Central Part of Crest

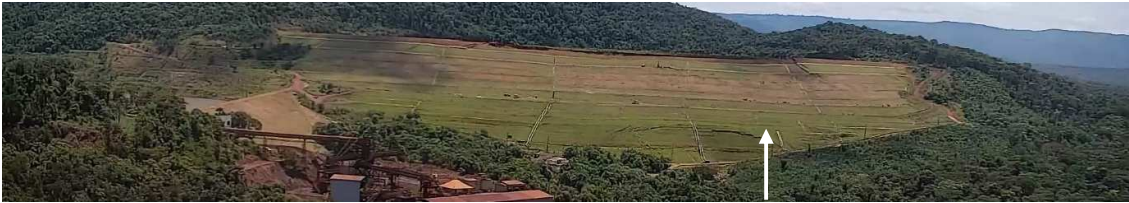
Figure 6: Bulging Above the Toe of the Dam Approximately One-Third in from the Left Abutment (Right Side of Photograph), Initiated About 0.2 s After the First Observed Deformation at Crest

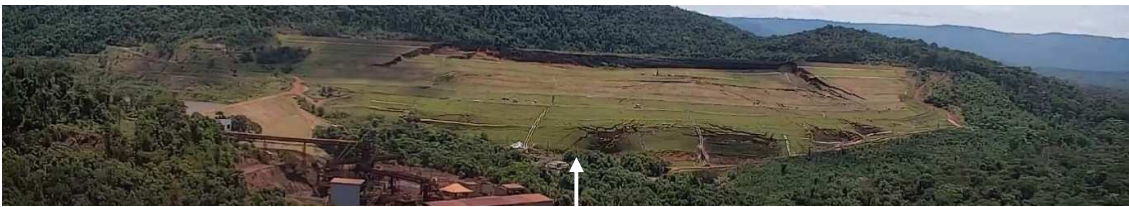
Figure 7: Continued Settlement of the Crest and Bulging Above the Toe with Water Erupting Above the Toe Toward the Right Abutment (Left Side of Photograph) About 5.5 s After the First Observed Deformation at Crest

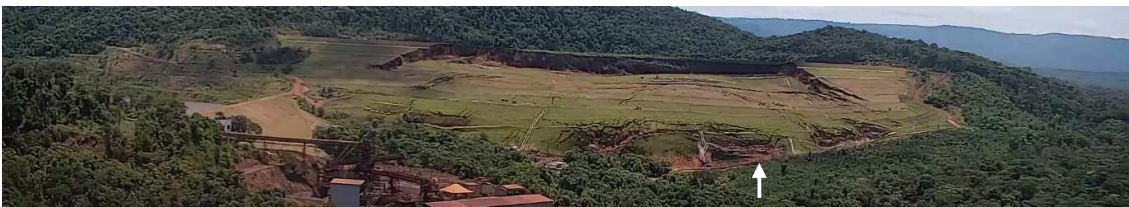
About 5 s after the first observed deformation at the crest, further crest settlement and bulging above the toe occurred and water appears to erupt from the toe region of the dam about one-third in from the right abutment (Figure 7). A second, more turbid, water spout erupted from the toe area, as the surface of the dam in the region of the bulge began to break apart (Figure 8).

Figure 8: Extensive Settlement of the Crest and Bulging Above Toe with a Second Water Spout in the Region of Bulge About 5.8 s After the First Observed Deformation at Crest

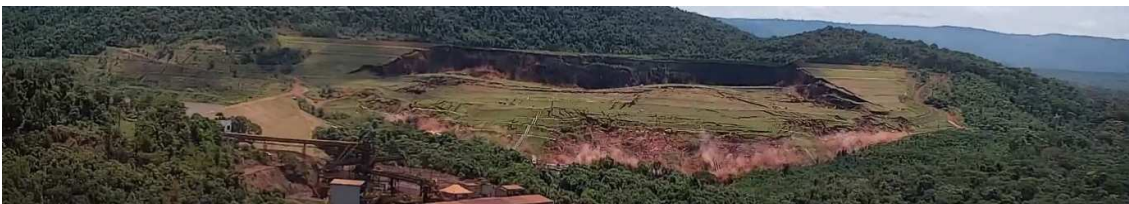
Figure 9: Full Development of Slope Failure with Failed Mass Moving out Beyond the Toe at About 6.7 s After the First Observed Deformation at Crest

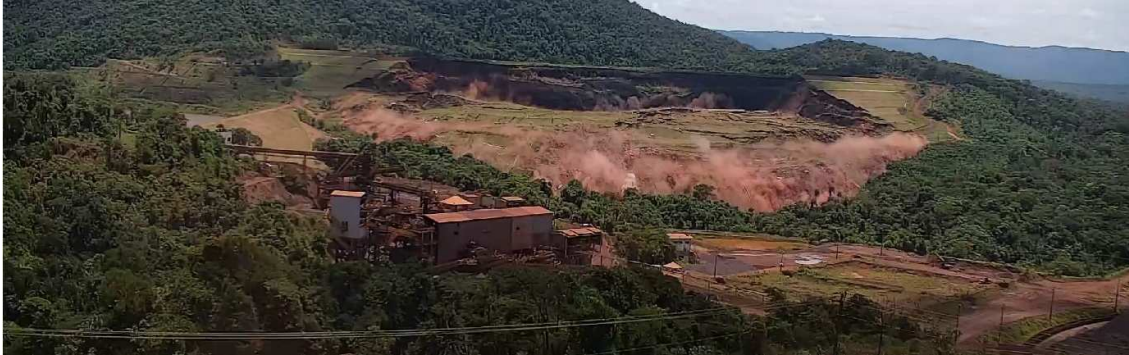
As the failed mass progressed downstream, the failure regressed into the stored tailings as a series of rapid slips, leaving near-vertical back scarps, as shown in Figures 10 through 12. The capture of further progression of the failure by CAM1 became obscured by the dust and mist that rose above the failing mass.

Figure 10: Regression of the Failure 11 s After the First Observed Deformation, as Captured by CAM1

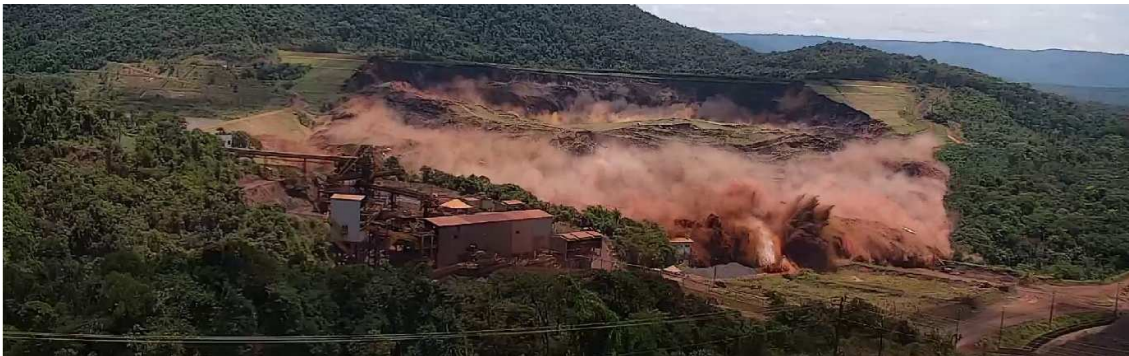
Figure 11: Regression of the Failure 18 s After the First Observed Deformation, as Captured by CAM1

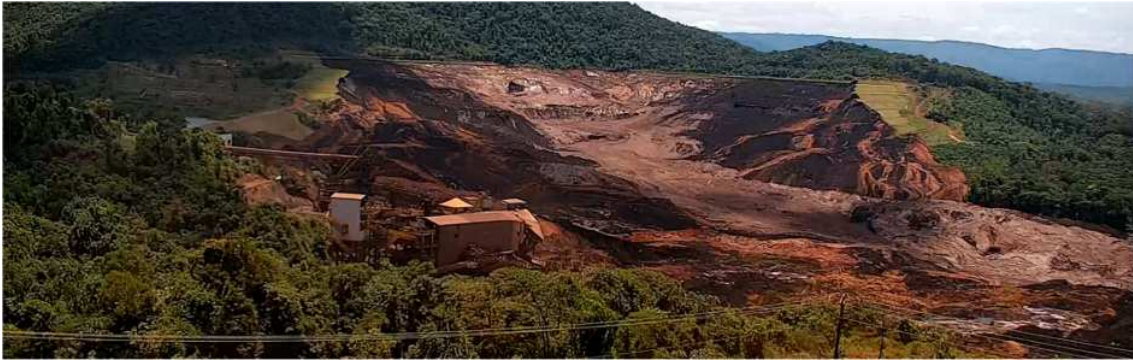
Figure 12: Final Regression of the Failure 6 min and 25 s After the First Observed Deformation, as Captured by CAM1

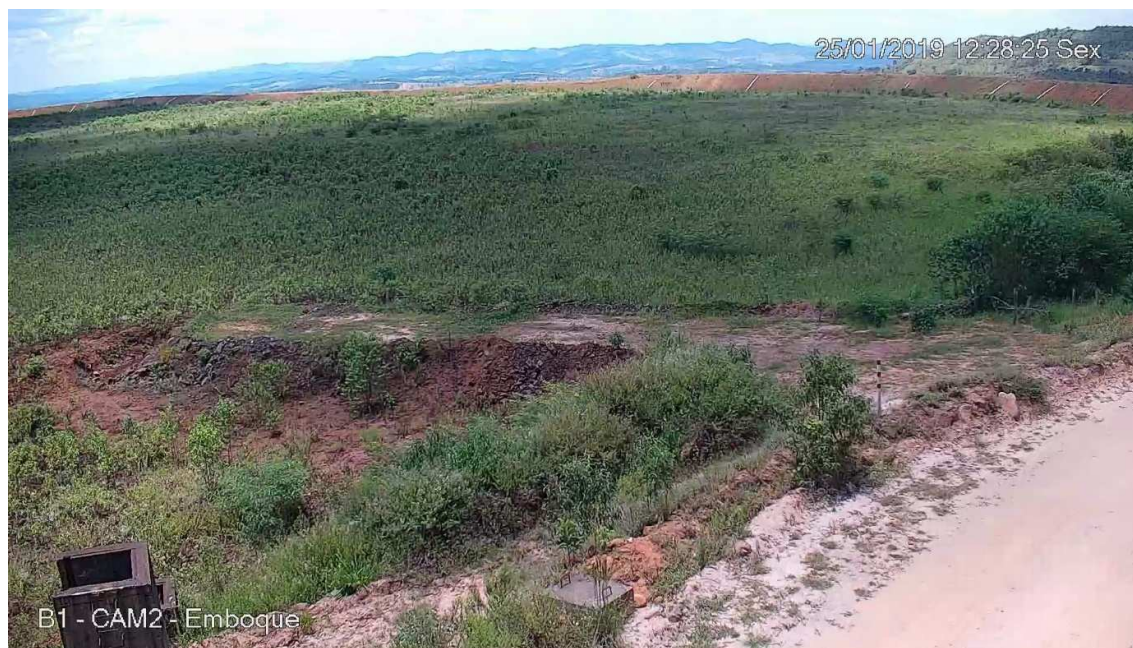
CAM2 confirmed that the initial failure was relatively shallow and started just behind the crest. CAM2 also clearly shows the regression of the failure into the stored tailings, eventually stopping close to natural ground, as seen in Figures 13 through 17. CAM2 also shows that after each failure slice, the failed material appears to become a heavy liquid.

Figure 14: Initial Settlement of the Central Part of Crest, as Captured by CAM2

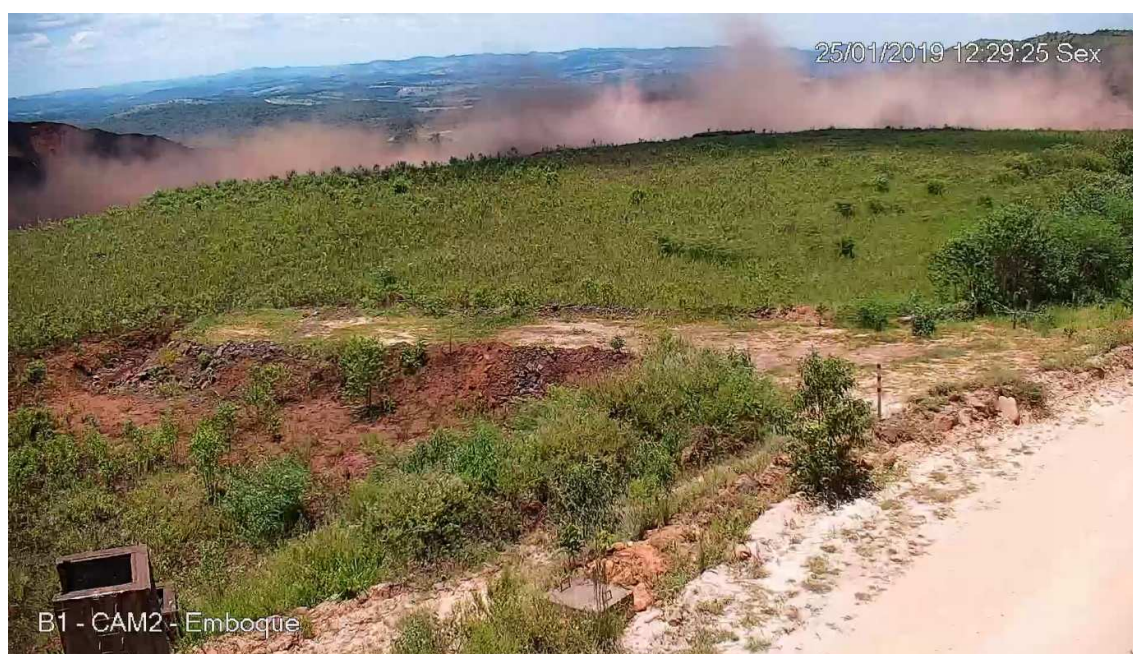
Figure 15: Regression of Liquefaction Failure at 60 s After the First Observed Deformation, as Captured by CAM2

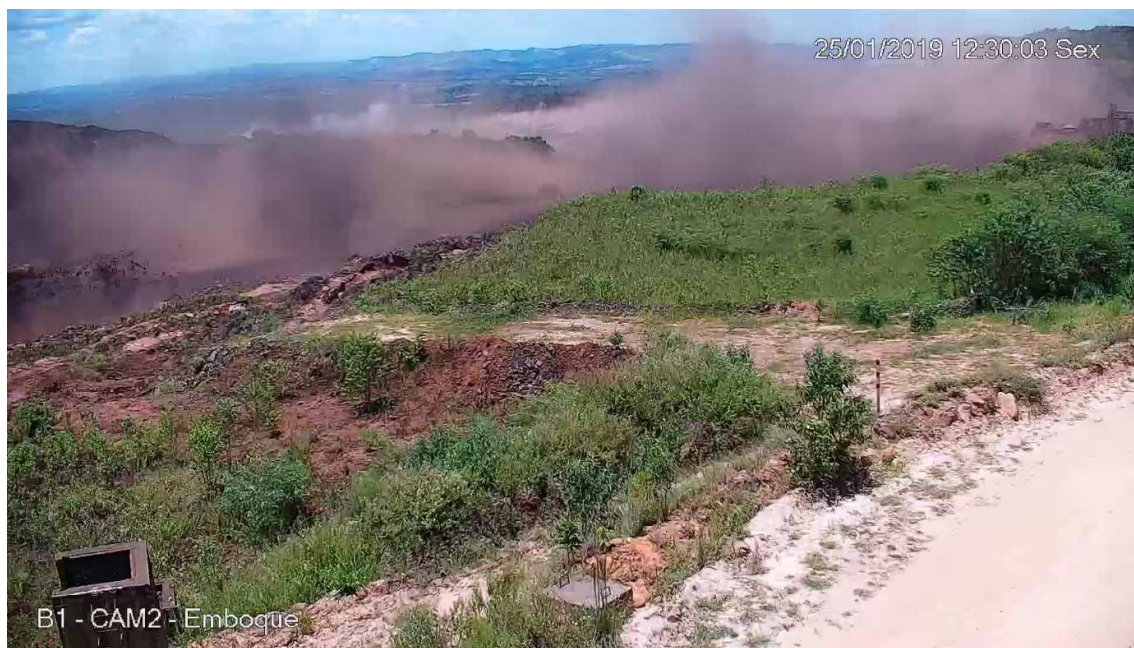
Figure 16: Regression of Liquefaction Failure at 98 s After the First Observed Deformation at the Crest, as Captured by CAM2

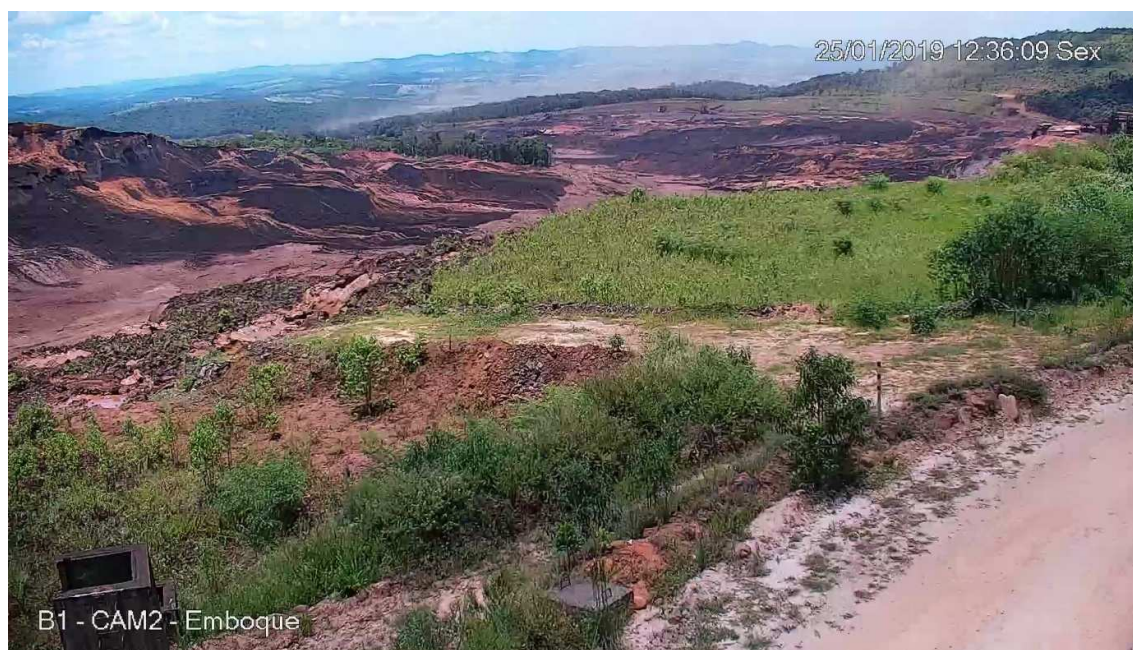
Figure 17: Final Regression of Liquefaction Failure 7 min and 44 s After the First Observed Deformation Initiation of Failure, as Captured by CAM2

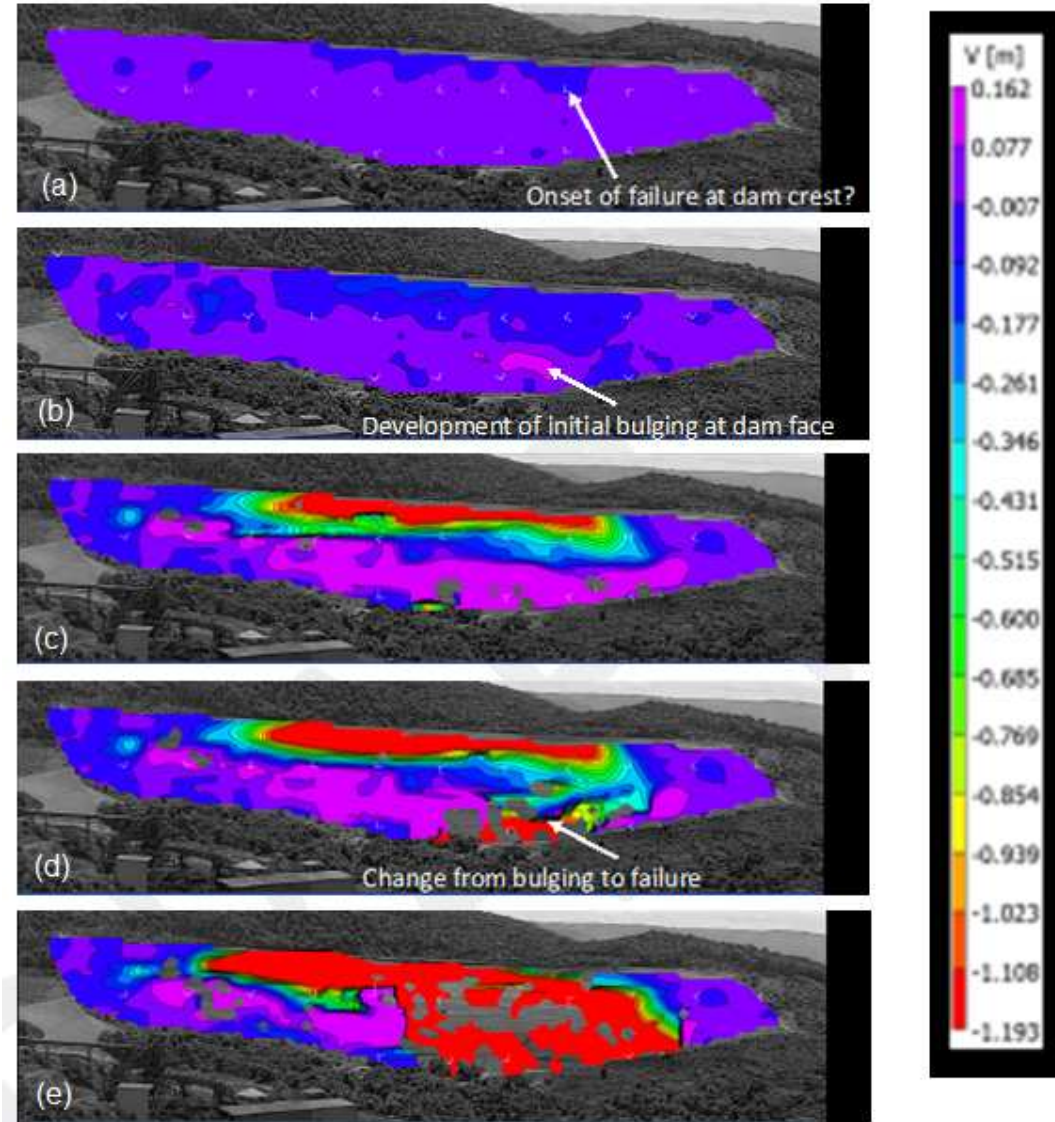
by initially upward deformation of the area just above the toe that rapidly changed to downward deformation as the crest continued to drop vertically. The slope shows signs of complete failure after about 4 s.

Figure 18: Failure of Dam I: (a) Observed Initiation at the Center of the Crest; (b) 0.2 s After the Observed Initiation, Showing Initial Bulging of the Face; (c) 1.4 s After the Observed Initiation, Showing Escalation; (d) 2.4 s After the Observed Initiation, Showing the Widening Collapse of the Crest and Increased Bulging of the Face; (e) 2.6 s After Observed Initiation; and (f) 3.6 s After Observed Initiation When the Crest and Bulging Join in Failure

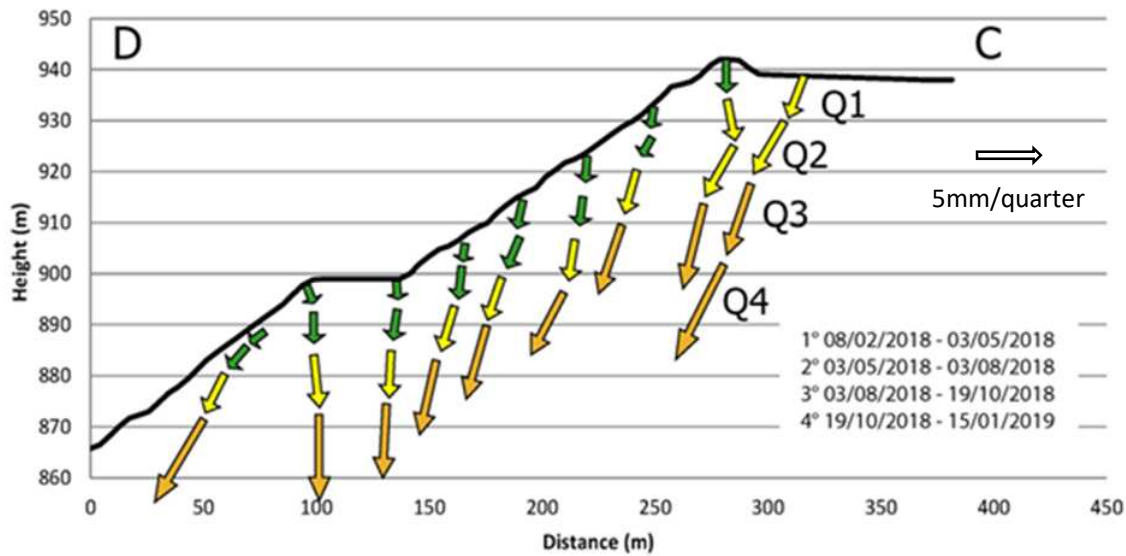
The Panel obtained and used InSAR data to evaluate deformations of the dam and impounded tailings in the one-year period prior to failure. The InSAR images provide about an order of magnitude higher precision than the ground-based radar, since the radar wavelength used for InSAR is longer, making the results less sensitive to moisture, and hence generating less noise. The analysis of the InSAR data indicates small downward deformations near the crest and mid-height of the dam of no more than 30 mm/year. In the lower parts of the dam in the central region, the analysis indicates small deformations of up to 36 mm/year, mostly in the downward direction. Figure 20 shows the quarterly velocities of deformation in the 12 months before the failure in the central region of the dam. It also shows that the deformations near the crest are mostly vertical, while closer to the toe of the dam the deformations have a slight horizontal outwards component. The horizontal deformations (in the east-west (E-W) direction) near the toe of the dam were mostly less than 10 mm/year over that period, but included some small areas with up to 30 mm/year. The deformation vectors inferred from InSAR do not include the north-south (N-S) component since the LOS of both ascending and descending orbits were almost perpendicular to that direction and, hence, likely to be an unreliable estimate of the actual deformations. A comparison between the InSAR and rainfall data indicates a correlation where deformations tend to increase slightly during the wet season. The observed deformations from the InSAR were too small and slow to be reliably detected by the survey, inclinometers, and ground-based radar methods used. The CPTu data show that the tailings within the dam were fully consolidated. Hence, such deformations in the dam are consistent with slow, long-term settlement of the dam, likely the result of ongoing internal creep, and are not indicative of a precursor to failure.

Figure 20: Cross-section Showing Deformation Vectors for the Four Quarters Prior to Failure

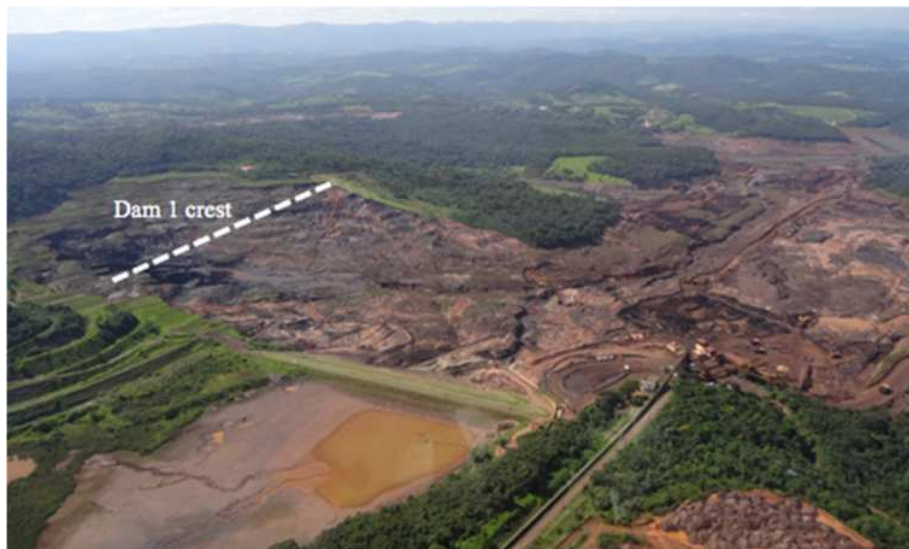
Figure 25: Aerial View of Failed Dam I, Looking Approximately South-East, Photographed on March 28, 2019

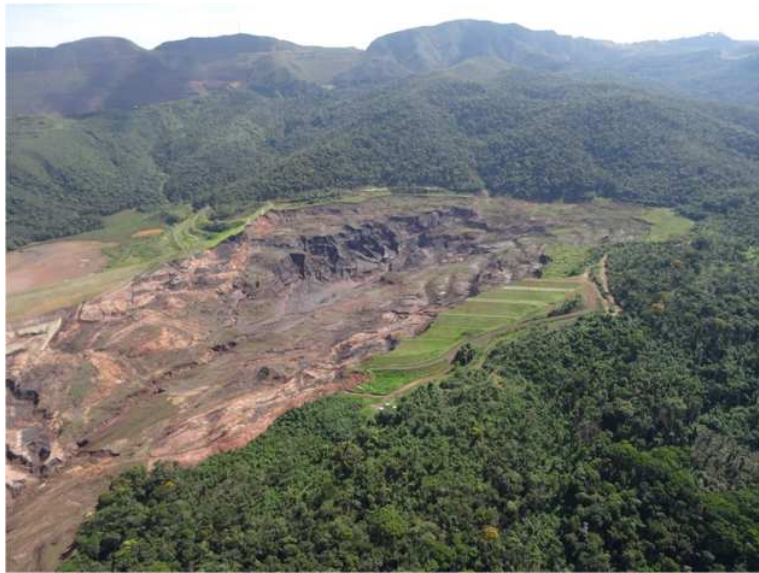
Figure 26: Aerial View of Failed Dam I, Looking North, Photographed on March 28, 2019

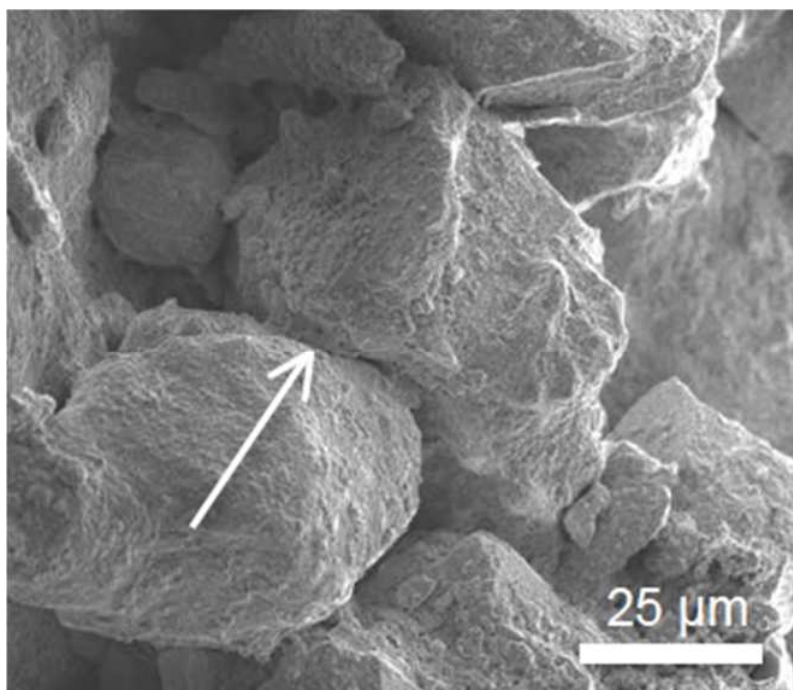
Scanning electron microscope (SEM) images were taken of samples of coarse tailings and slimes from the June 2019 field program to qualitatively assess particle structure, angularity, and other parameters at the microscopic level. Example images are shown in Figures 31 (coarse tailings) and 32 (slimes). The SEM images confirm the high iron content and show that the particle shape is similar for both materials and that the grains are typically sub-angular to angular with rough, often pitted surfaces. Additional SEM images were taken to study the interaction between particles and showed evidence of bonding between particles, shown in Figures 33 and 34. The nodules shown in Figure 33, and highlighted in Figure 34, are composed of iron oxide. The bonding appears to be derived from clay-size iron oxide. It appears that oxidation of the iron produces bonding between particles.

Figure 34: SEM Image of Coarse Tailings (Detail of Box Shown in Figure 33).
Region Highlighted with Arrow Shows Bonding Between Particles

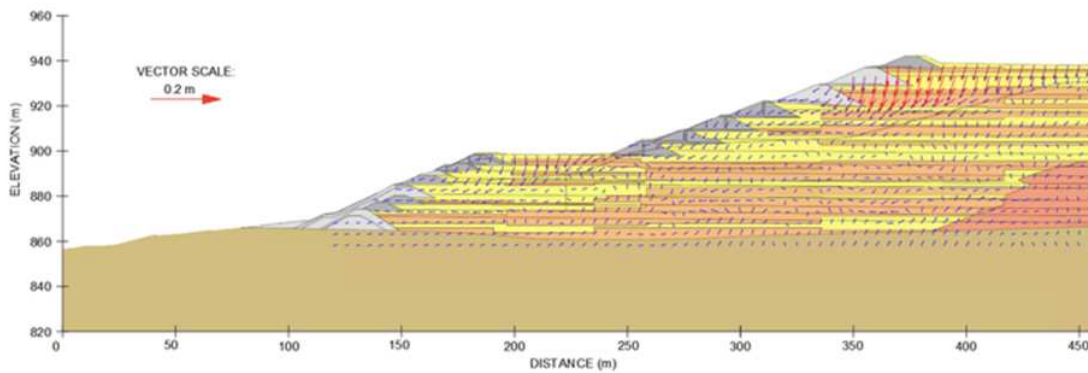
Figure 50: Cross-section 3-3 Showing Calculated Pre-failure Deformations Due to Creep Combined With a 15 kPa Strength Reduction From Loss of Suction from 3D Computer Simulations

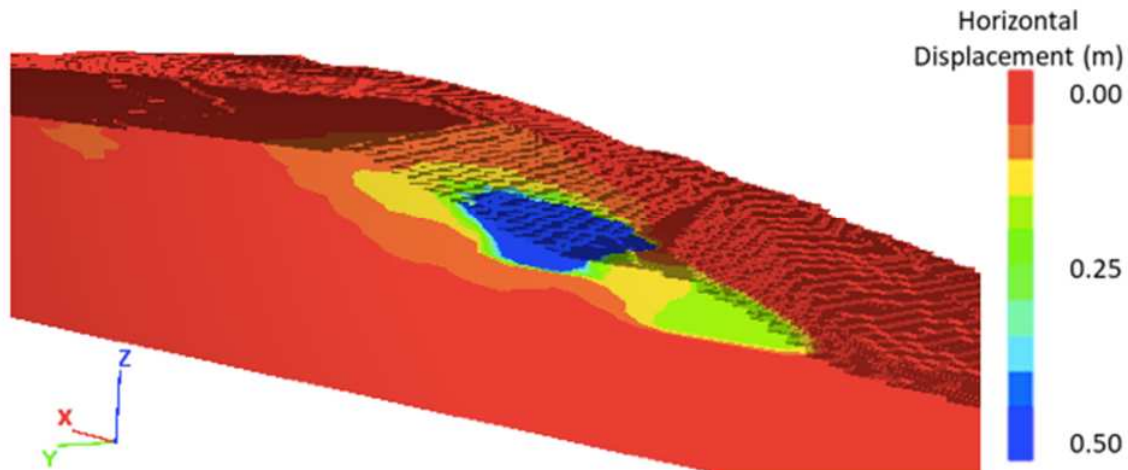
Figure 51: Cross-section 3-3 Showing Calculated Deformations at Failure Due to Creep Combined With a 15 kPa Strength Reduction From Loss of Suction from 3D Computer Simulations
