November 13, 2017

RESOLUTION
C O P P E R

2017 Oak Flat Surface Water Monitoring Program

Pinal County, Arizona

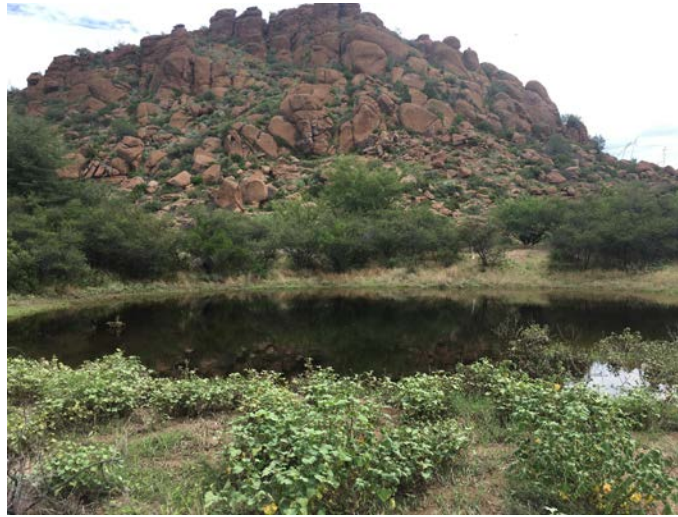
The Rancho Rio pond is a stock tank excavated from naturally-occurring alluvium, just west of the fault, approximately 1 mile from the confluence with Devil's Canyon (**Photo 1**). The main stream channel flows into the north end of the pond and pools in the depressed, stock tank feature. A pressure transducer was buried at the base of the alluvium on March 22, 2017. The transducer was installed in this location to monitor the storage of surface water in the alluvium, upstream from Rancho Rio Canyon. The thickness of the alluvium at the monitoring site is about 44 inches to bedrock at the center of the tank.

Photo 1. Rancho Rio pond, August 3, 2017

At the time of the transducer installation in March, the surface of the pond was dry. A hole was dug down to underlying bedrock and water was measured at 15.5 inches below land surface (bls), or 28.5 inches above the installation depth. The transducer was placed on the bedrock surface and re-buried under the alluvium.

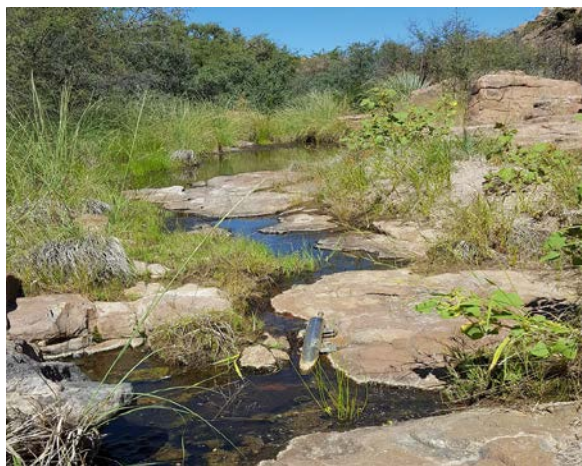
The Aqua TROLL 200 (S/N 459725) is installed in a bedrock channel of Rancho Rio Canyon, approximately 120 feet downstream from Rancho Rio pond (**Photo 2**). The transducer was installed in 2011 to monitor surface flow in the canyon as part of the RC baseline surface water studies. A Baro TROLL logger is positioned in the shade on the east bank of the wash to atmospheric pressure and temperature in the region. Flow leaving the Rancho Rio pond alluvium is monitored by the RR 1.5 C Aqua TROLL.

Photo 2. Rancho Rio Aqua TROLL (RR 1.5 C), September 21, 2017

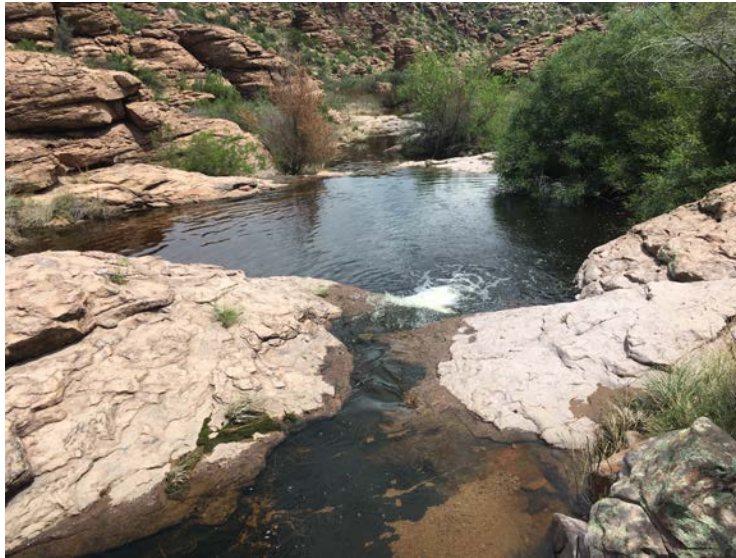
The Rancho Rio Tinajas site consists of three bedrock pools (upper, middle, and lower) located approximately 0.3 miles (650 feet) downstream from RR 1.5 C (**Photo 3**). A trail camera is set up on a tree above the middle tinaja to the west, facing downstream. The placement of the camera was designated to capture flow into and out of the largest tinaja (middle). Flow entering the tinaja from the stream channel is monitored by the RR 1.5 C datasonde. The camera is set up to record hourly photographs during daylight hours only.

Photo 3. Rancho Rio Middle Tinaja from camera location, August 3, 2017

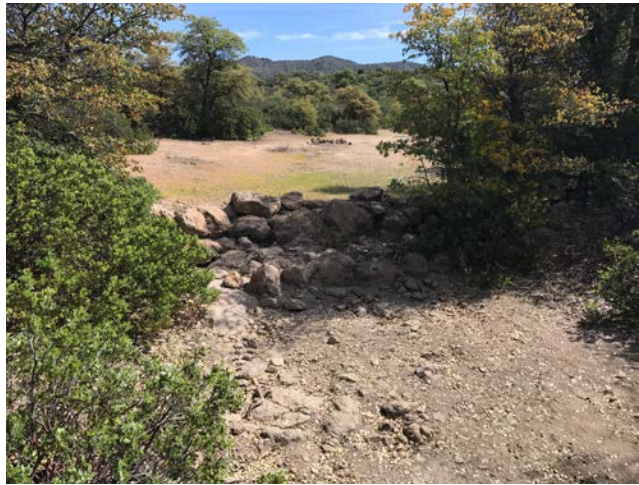
Photo 4. FS 2438 Check Dam observed dry, April 17, 2017

During the March 23 installation visit to Oak Flat, no flowing or pooled water, or moist soil was observed (**Tables 3a**). The alluvial veneer above the dam was dry and the vegetation was healthy and green. From March through mid-July, the site remained dry and surrounding foliage further dried out.

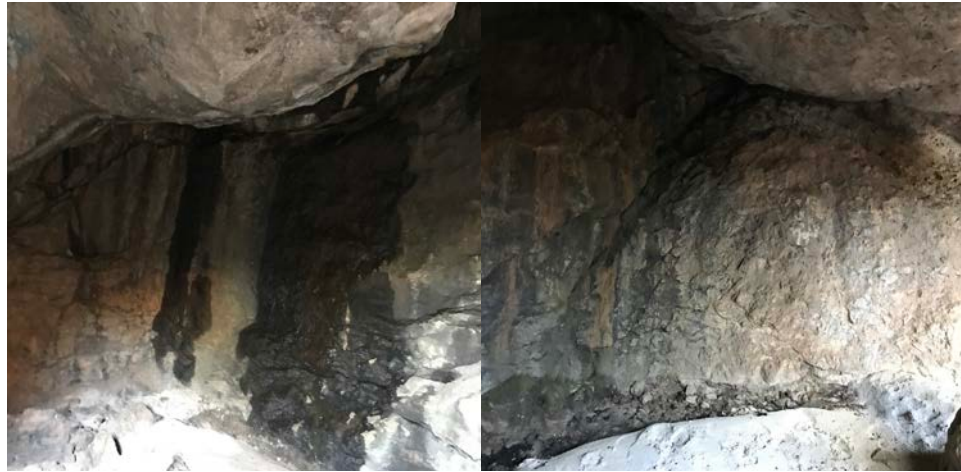
The eastern bedrock face of the Grotto is the discharge location of the seepage through the upstream alluvium (**Photo 5**). This natural alcove seepage is known as the “Grotto” spring. The total area percentage of moisture coverage on the wall face has been monitored and directly correlates with the availability of water retained above the Grotto.

Photo 5. Grotto Wall with estimated 25% moisture coverage, August 24, 2017

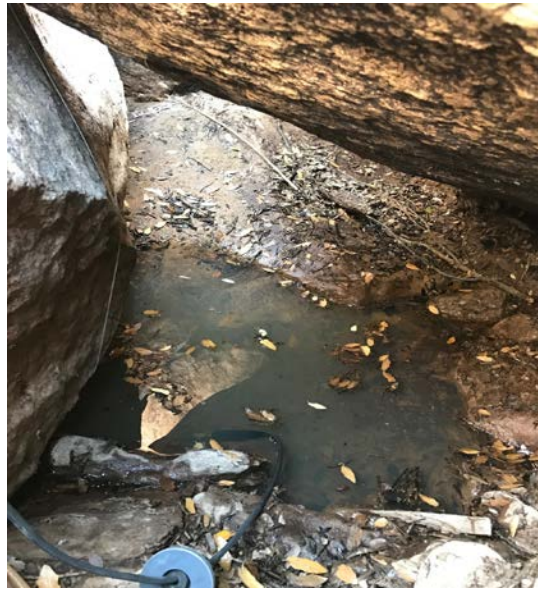
A transducer was installed in one of the alluvial pools directly above the Grotto seep to monitor the collection, retainment, and infiltration of runoff from the natural dam of accumulated colluvium (**Photo 6**).

Photo 6. “Above Grotto” monitoring location. Transducer is hung on braided steel cable between pinch point of two boulders and on top of sandy bottom

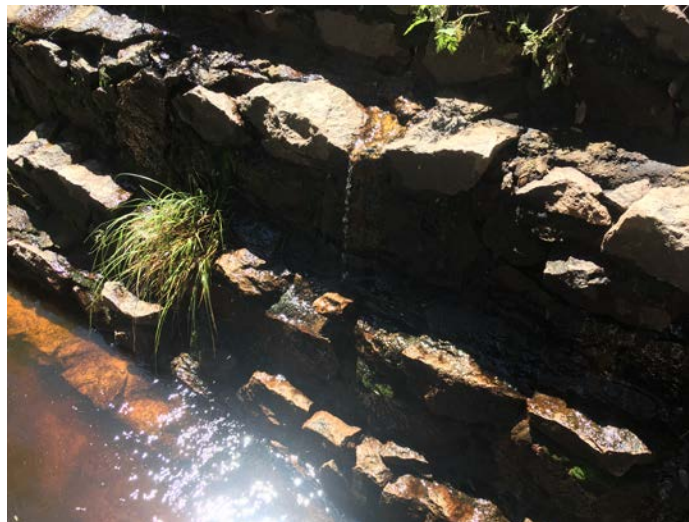
Water is retained in the alluvial sediments behind the dam and seeps through the cemented wall (**Photo 7**). During high flow events, water also flows over the dam. A transducer was placed in a pool at the base of the dam on the downstream side. The pool dries out during the arid summer months, and may have over 1 foot of ponding during wet periods.

Photo 7. Water seeping through KP Dam. Transducer is set in pool below dam

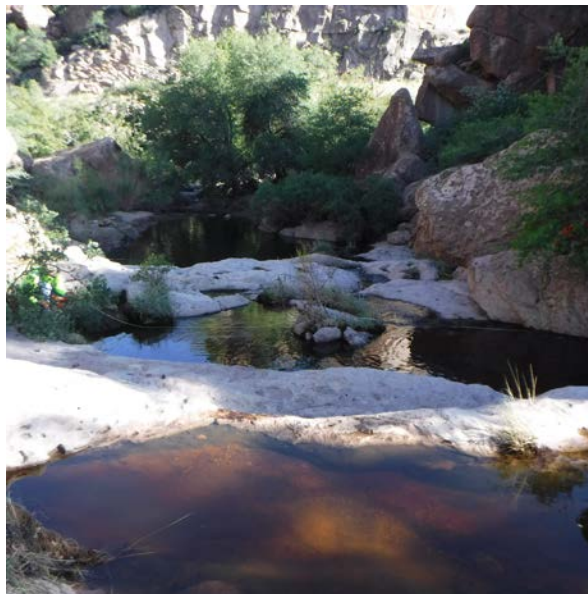
The Number 9 Wash Tinajas are located 50-100 feet upstream from the confluence of Number 9 Wash and Queen Creek (**Figure 1**). The feature contains a series of three pools carved into the Tal bedrock, before dropping into the alluvial channel of Queen Creek Canyon (**Photo 8**). No continuous monitoring instrumentation was installed at this location.

Photo 8. Number 9 Wash Tinajas, looking downstream, August 3, 2017

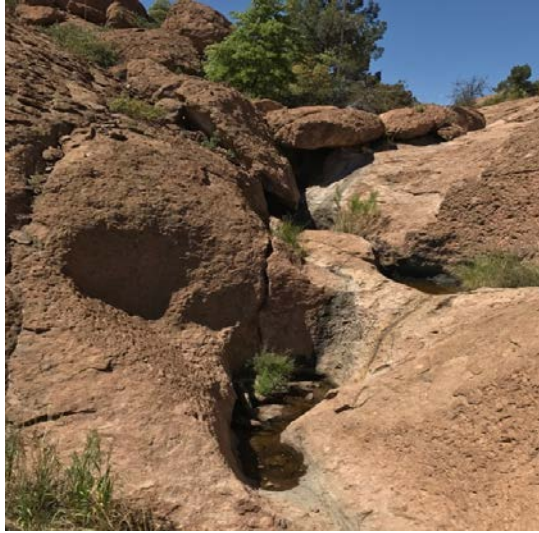
The site has been equipped with a south facing (upstream) trail camera to record flow events through the channel (**Photo 9**). The photos from June 5 through July 14, were lost because the camera malfunctioned due to excessive heat. The camera was replaced and

Photo 9. SS-1 tinajas, from trail camera location, September 21, 2017

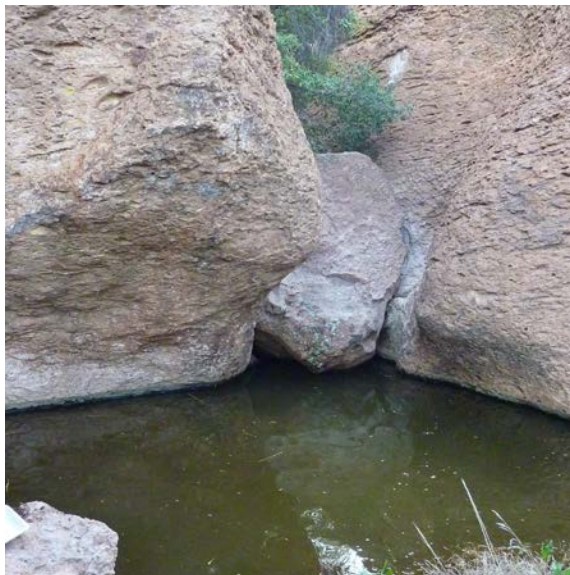
Oak Flat Tinaja is a large bedrock pool located in the first major drainage east of the RC East Plant site (**Figure 1**). This drainage is a tributary of the Number 9 wash drainage basin. The tinaja is located in the unnamed drainage approximately 620 feet northwest from RC exploration core hole RES-006, and 120 vertical feet down from the access road. The canyon is steep and is shaded from the exposure of the sun most of the day (**Photo 10**).

Photo 10. Oak Flat Tinaja, March 23, 2017

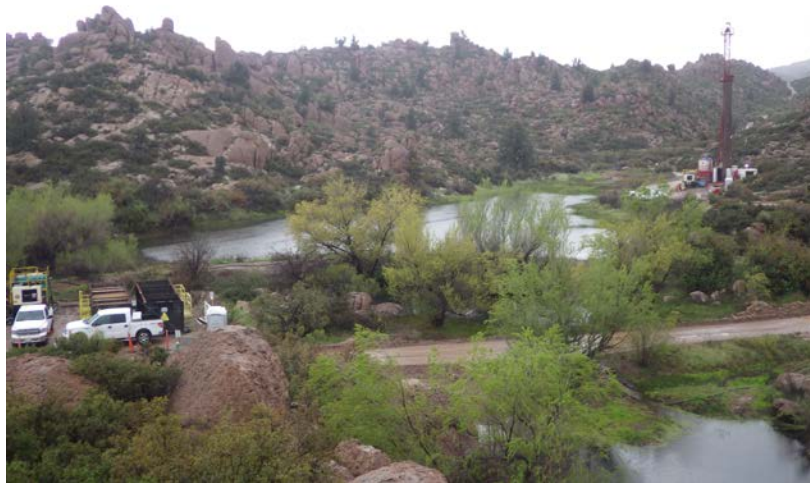
naturally flat lying area, south of the Number 9 wash drainage (**Photo 11**). The source of water in the pond is runoff from rain events and seepage from the jointed and fractured Tal topography above the pond. The watershed contributing to the pond encompasses 0.6 square miles of area to the south and southwest towards the Tal escarpment. The retention of water is most likely due to the construction of Magma Mine Road over the natural drainage direction. Water flows under the road in a culvert when the pond fills up beyond its storage capacity.

Photo 11. View of Anxiety Fault Pond from Magma Mine Road, May 4, 2017

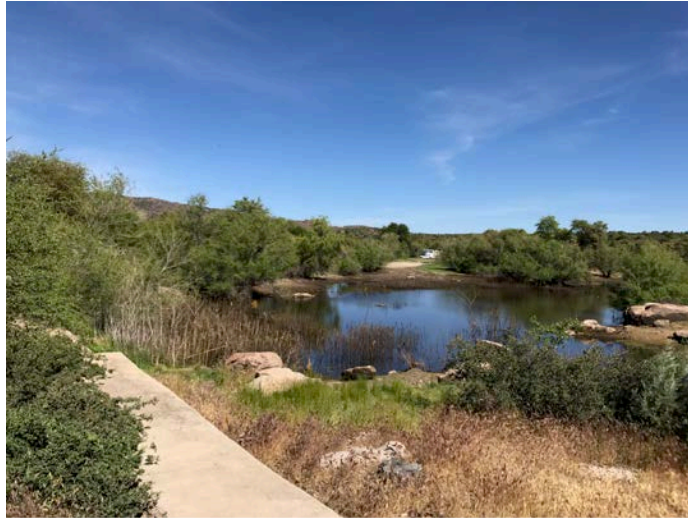
Photo 12. Oak Flat Reservoir, April 26, 2017

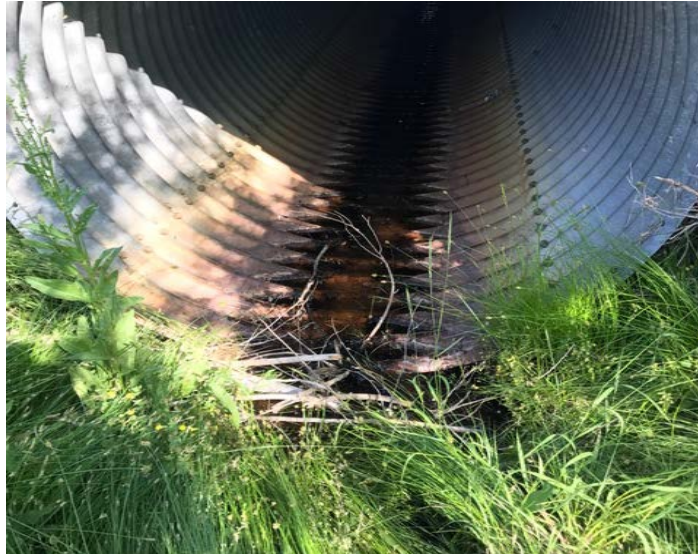
Below the dam is a flat lying, marshland funneling flow to a culvert that passes under Magma Mine Road towards Queen Creek. A pressure transducer was installed below the galvanized steel casing of the culvert just upon entering the underpass, secured by a braided steel cable attached to a hole in the casing (**Photo 13**). The installed depth of the

Photo 13. Oak Flat Reservoir Culvert, transducer location, April 26, 2017

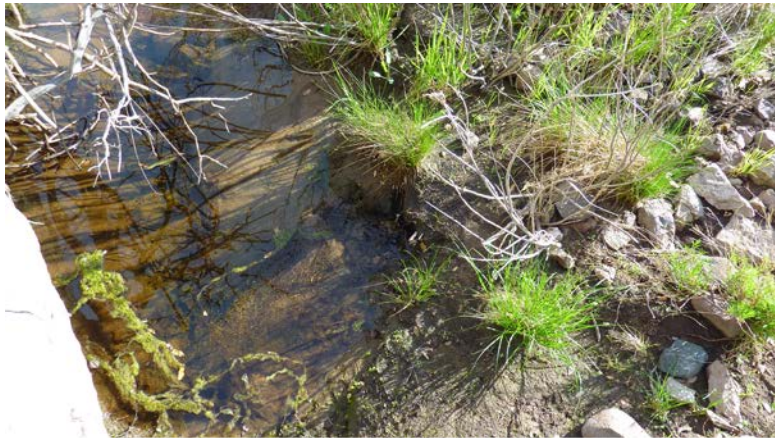
Photo 14. Gibson Spring, March 21, 2017

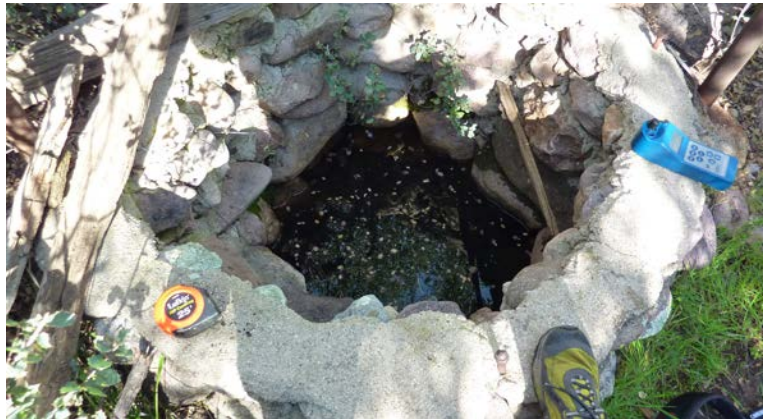
A pressure transducer was installed at the bottom of Gibson Well to monitor the groundwater level within the local alluvium (**Photo 15**). No continuous monitoring equipment was installed at Gibson Spring.

Photo 15. Gibson Well, transducer location, March 21, 2017
