Failure Modes and Effects Analysis
2020 Workshop
Resolution Copper Environmental Impact Statement
Proposed Skunk Camp Tailings Storage Facility

October 2020

Prepared for:
BGC Engineering

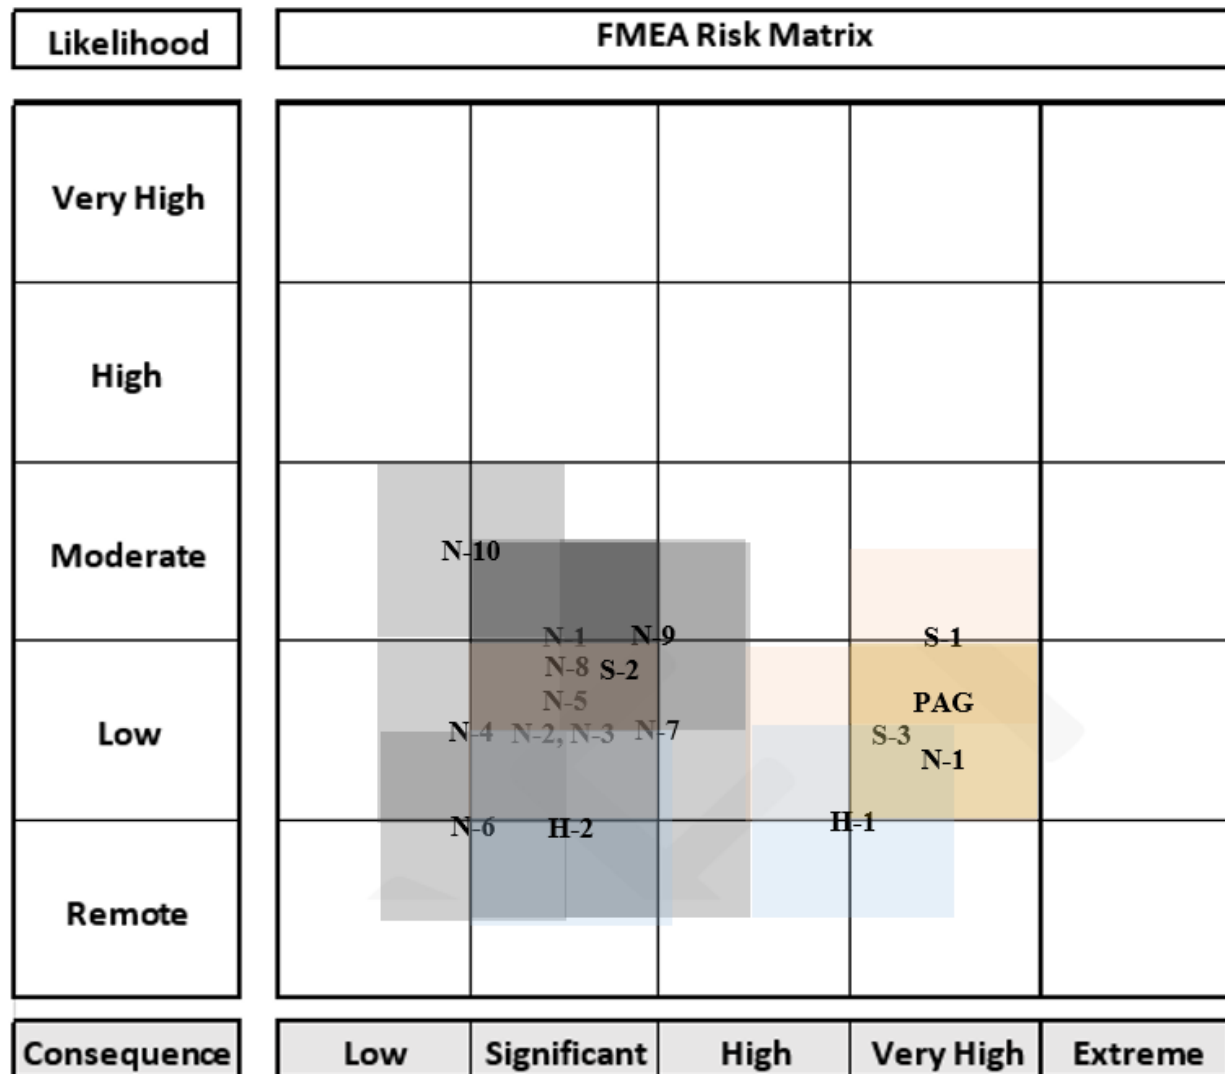
Figure 20: Summary of Results on Risk Matrix

Figure 4 presents a summary of the 2020 Skunk Camp TSF PFMs plotted on the risk matrix. The majority of the PFMs plot on the lower left of the risk matrix. Of the sixteen potential PFMs developed during the FMEA workshop, no unmanageable risks were identified. The risk assessment of the PFMs indicated that risks generally fall within acceptable societal risk levels. Those PFMs that plot towards the right on the chart are considered higher risk and reflect more fluid tailings behavior with higher runout and consequences. This plot location indicates that a better understanding of the failure modes is needed to assess the likelihood and tailings runout behavior under these scenarios and to assess the consequences. In general, the risk matrix indicates that the proposed Skunk Camp TSF design evaluated during the risk assessment is robust and addresses the potential PFMs through design, mitigation measures or planned operating procedures.

Note: The location ranges of the failure modes are approximate and intended to provide a relative location of the risk for all the failure modes discussed during the workshop. For the specific classification of each PFM, please refer to that PFM in Section 2.4 of the report. PFMs N-5, N-7, S-3 were classified over a range of categories and are plotted near the center of the range on this matrix.
