Resolution Copper Project

Near West Tailings Storage Facility

Geotechnical Site Characterization Report

Volume 3 of 4 – Appendices III, IV, V, VI and VIII

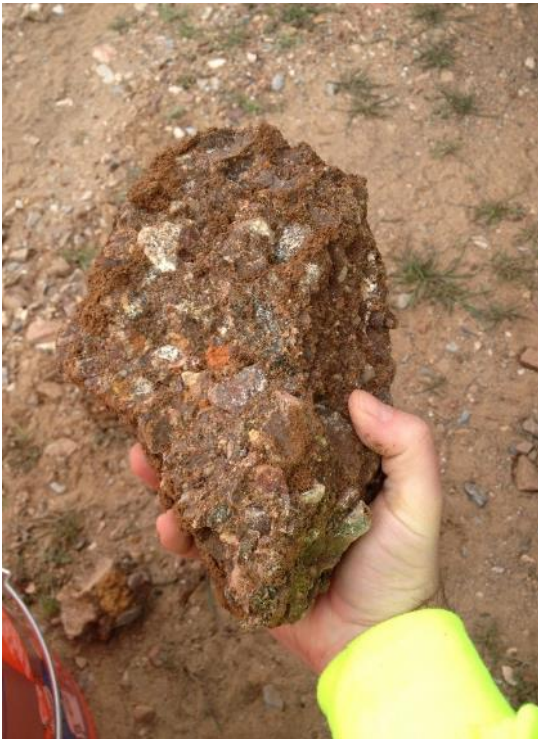
Photo II-7 TP17-32 - Cemented fragment of moderately weathered Gila Conglomerate from 2 ft depth. (Feb. 27, 2017)

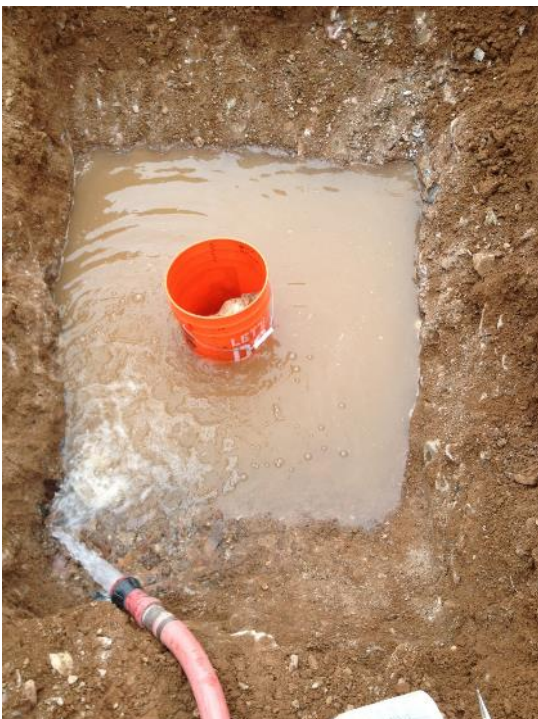
Photo II-8 TP17-32 - Infiltration test in test trench. (Feb. 27, 2017)

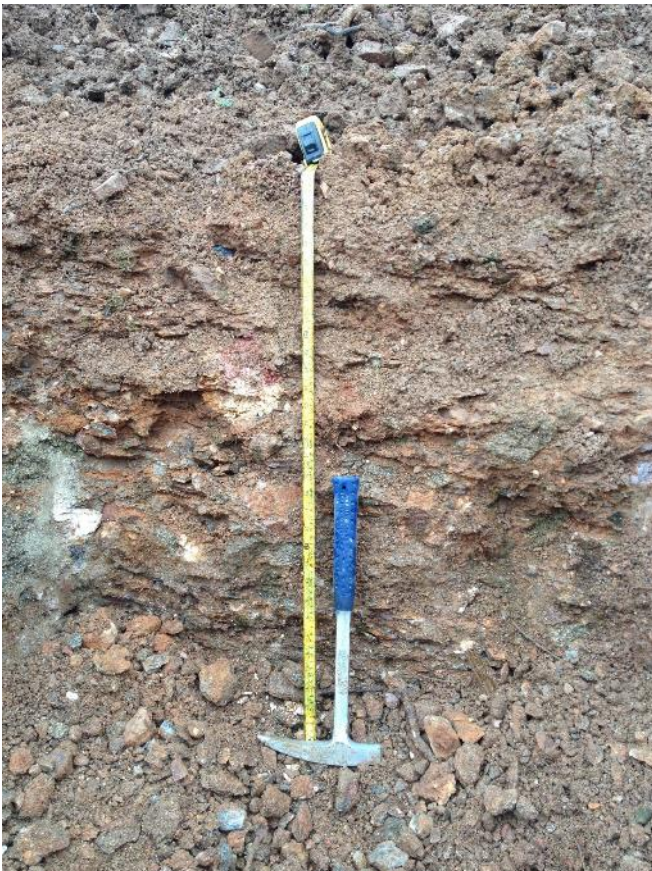
Photo II-10 TP17-33 - 1 ft of compact residual soil overlying highly weathered Gila Conglomerate with rusty mottling. (Feb. 28, 2017)

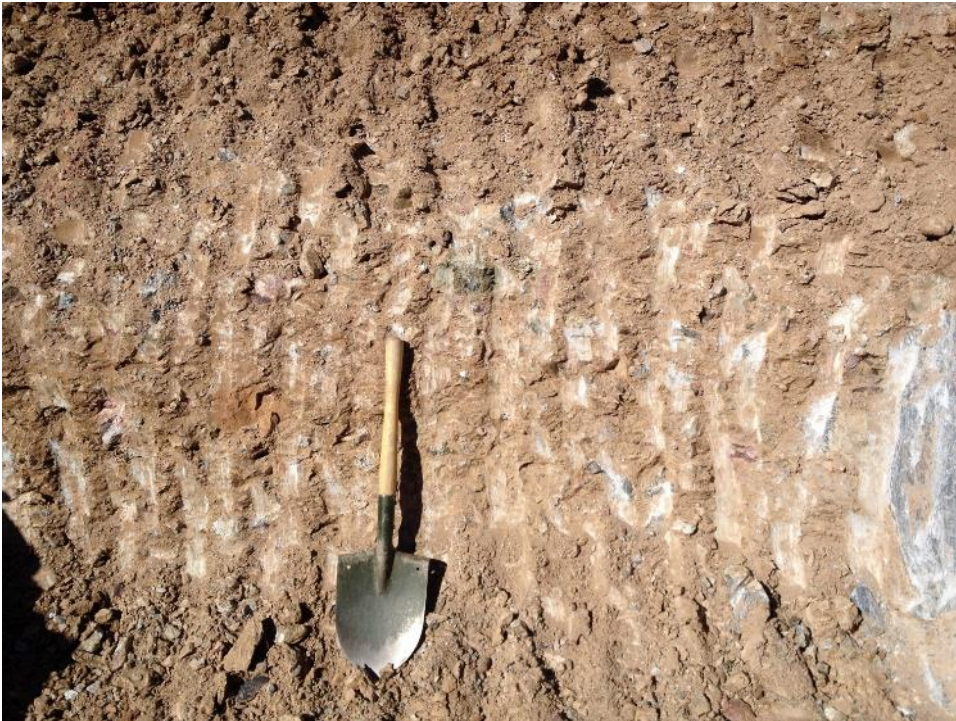
Photo II-25 TP17-36 - Close up of face excavated in Gila Conglomerate. (Mar. 1, 2017)

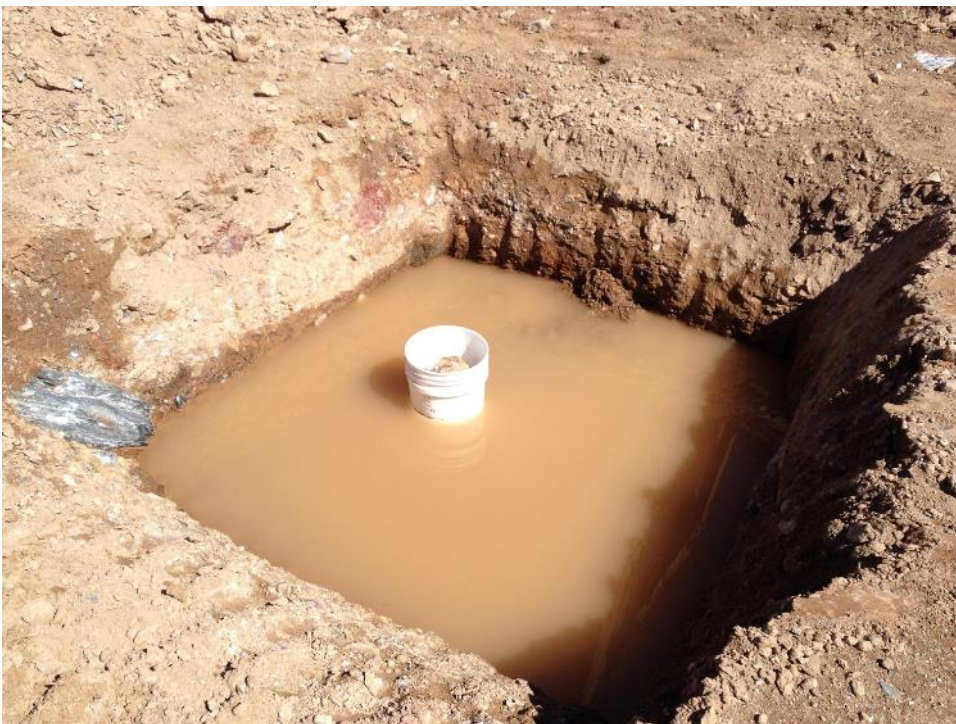
Photo II-26 TP17-36 - Infiltration test in test trench. (Mar. 1, 2017)

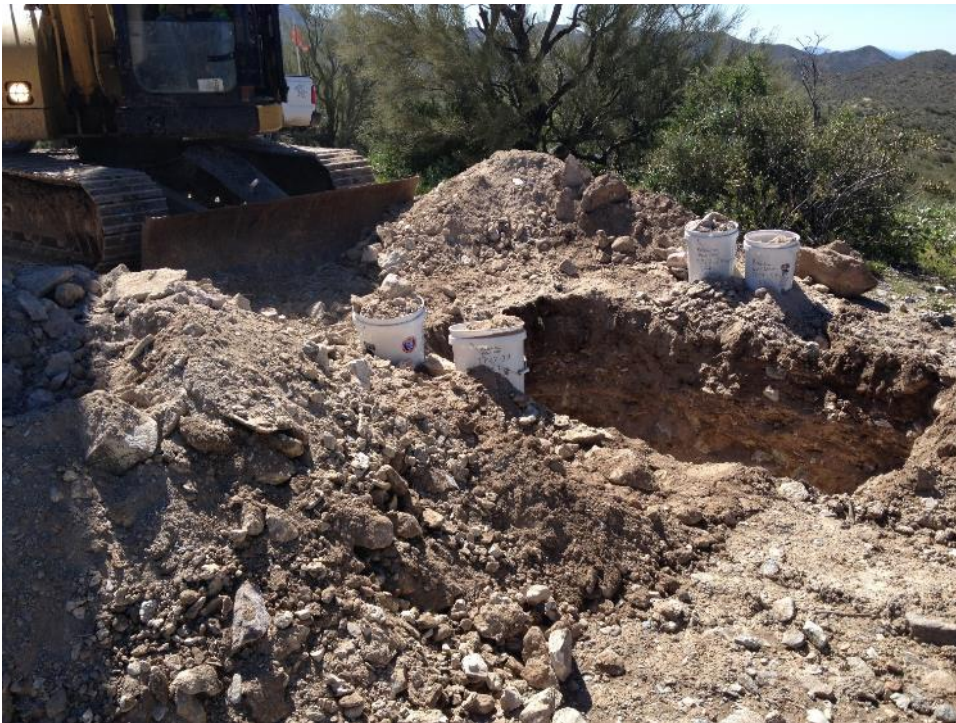
Photo II-31 TP17-37 - Material excavated from test trench. (Mar. 1, 2017)

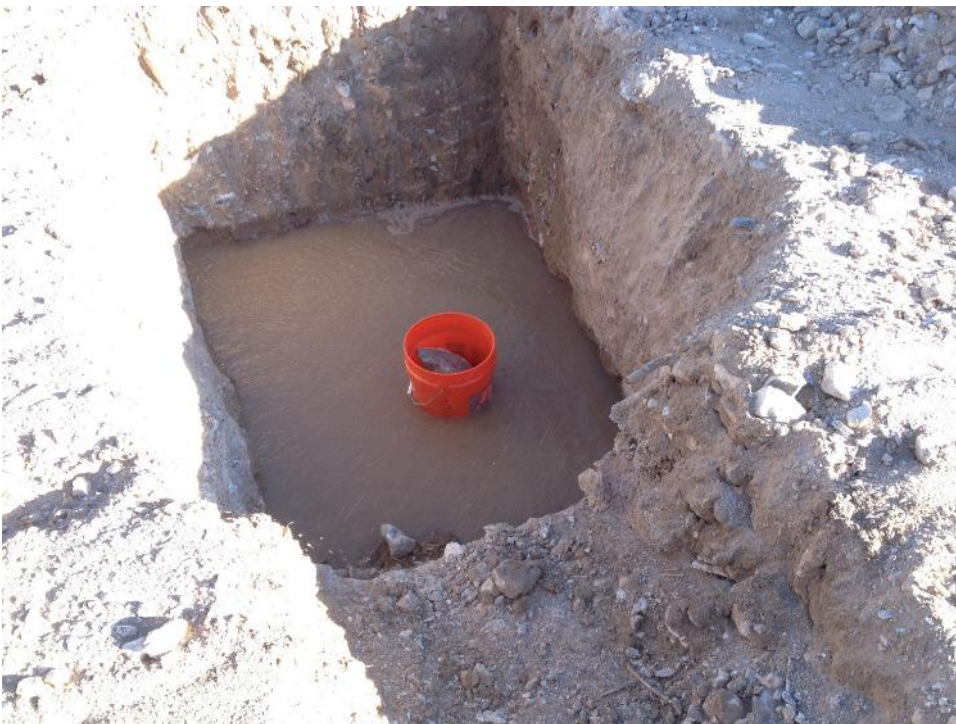
Photo II-32 TP17-37 - Infiltration test in test trench. (Mar. 2, 2017)
