## APPENDIX I-E

### Traverse #5

PROJECT  
RESOLUTION PROJECT  
2013 NEAR WEST SITE INVESTIGATION

TITLE  
CREEK TRAVERSE #5

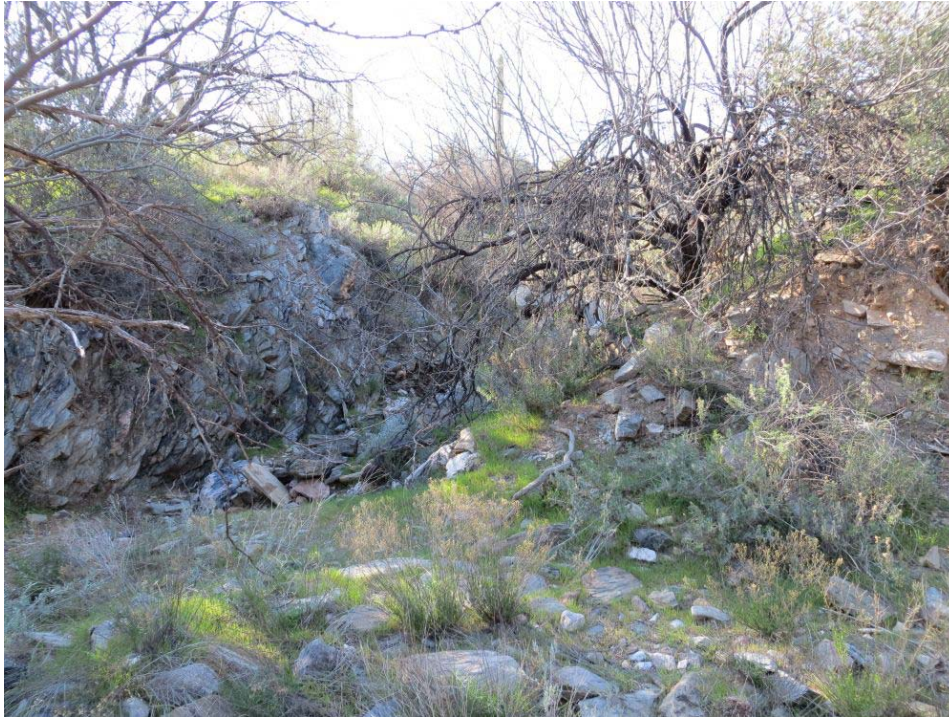
### OBS35

Short erosional gully terminating perpendicular to the main channel. Intact schist exposed on gully sides. Fractured schist particles “floating” in weakly cemented well graded clayey sand exposed in left channel bank near mouth of gully.

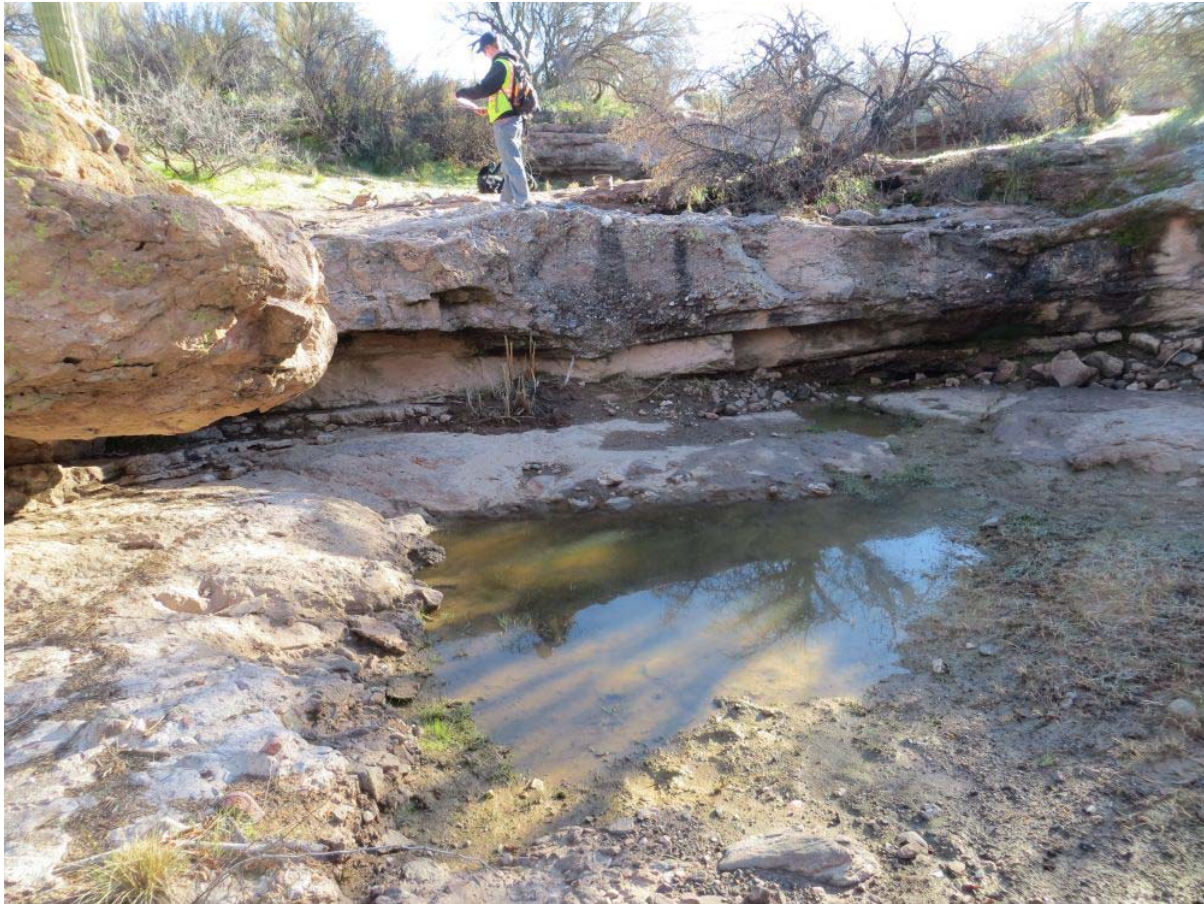
Orientation of beds on left channel bank: **015/11**

Orientation of beds on right channel bank: **320/02**

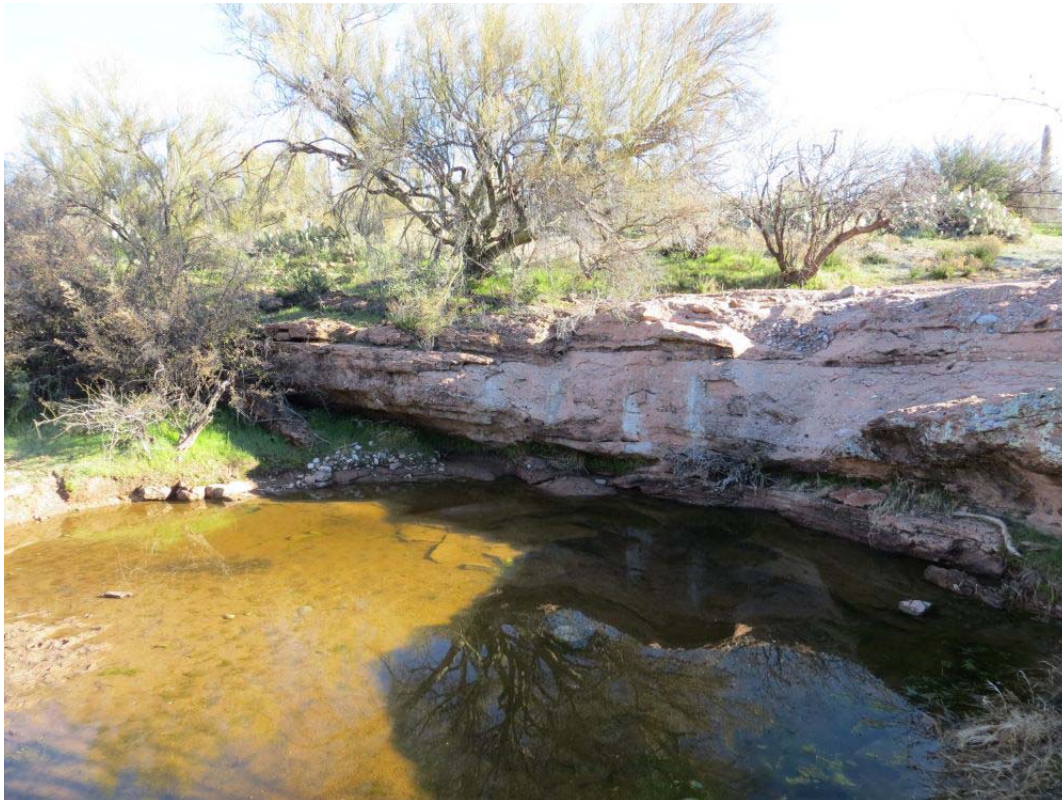
**OBS38**

Contact between conglomerate and basalt. Basalt now exposed in both channel banks.

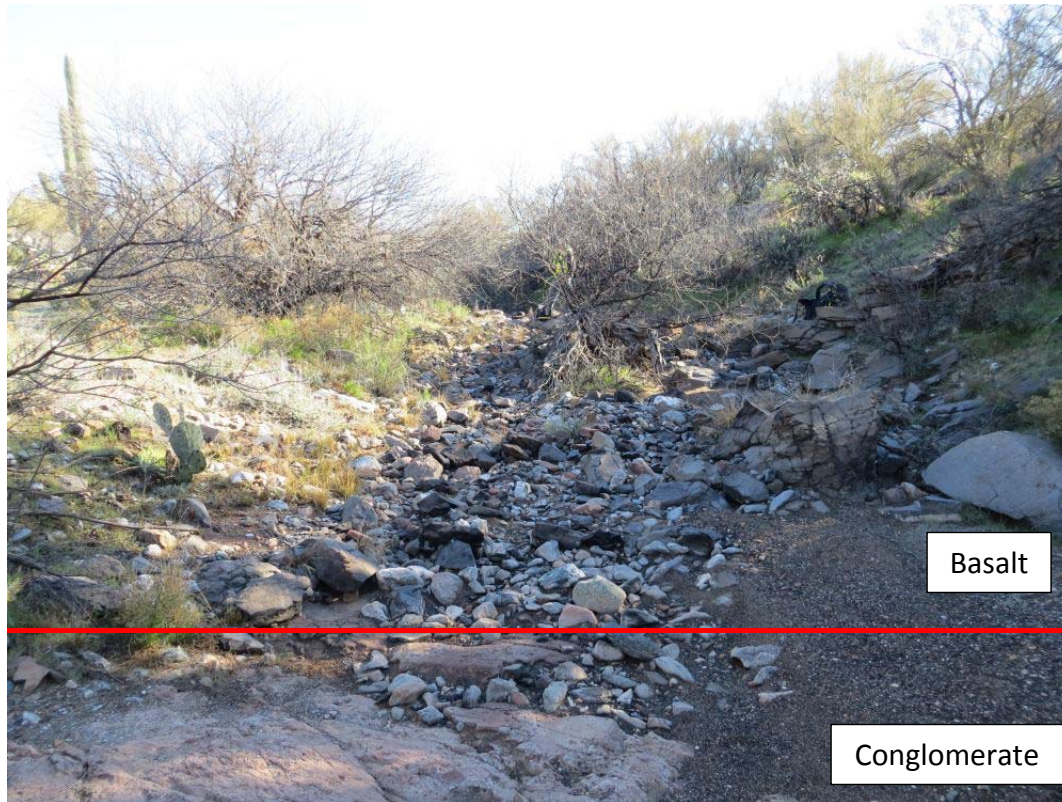
### OBS39

Basalt outcrop in left channel bank, fresh to slightly weathered, R6, flatly dipping (approx. 20 deg.) joints with 5cm – 15 cm (1.97 – 5.91 inches) spacing, closed to open (max. aperture = 1 mm (0.04 inches)), either no infilling or calcite infilling. A fracture zone is exposed next to the basalt outcrop with calcite filled veins and clayey sand infilling in some larger fractures.

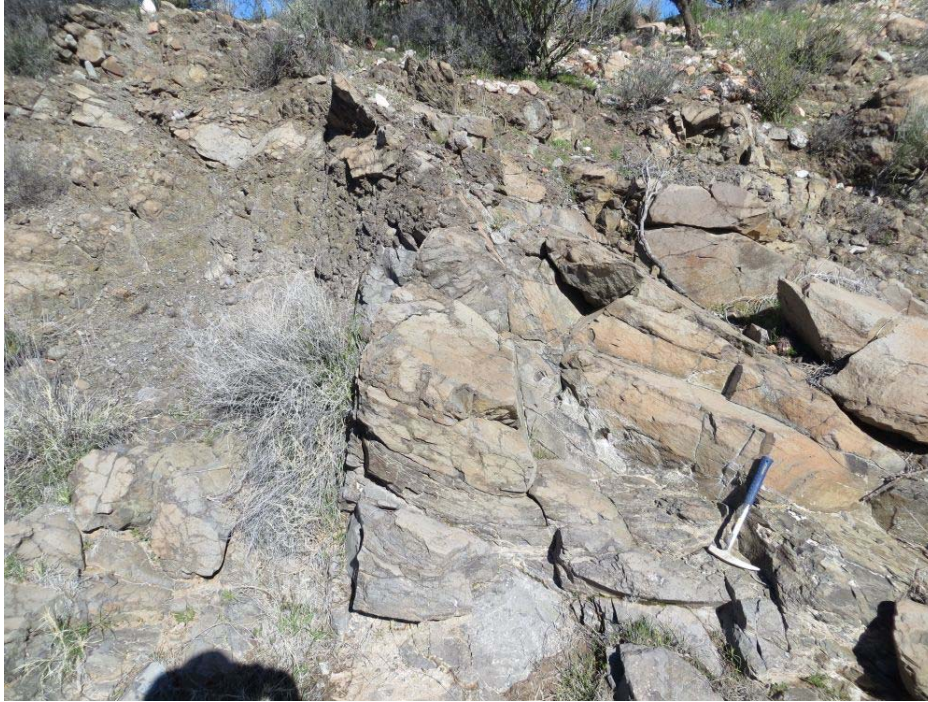
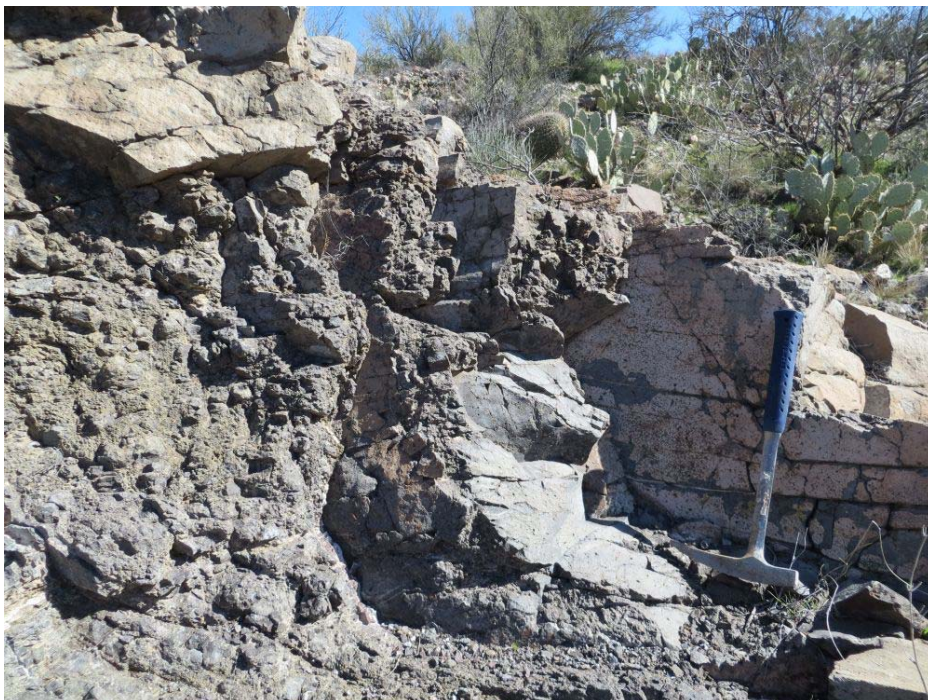
**OBS40**

Sub-horizontal conglomerate bed outcropped in right channel bank

Orientation of bed: **355/07**

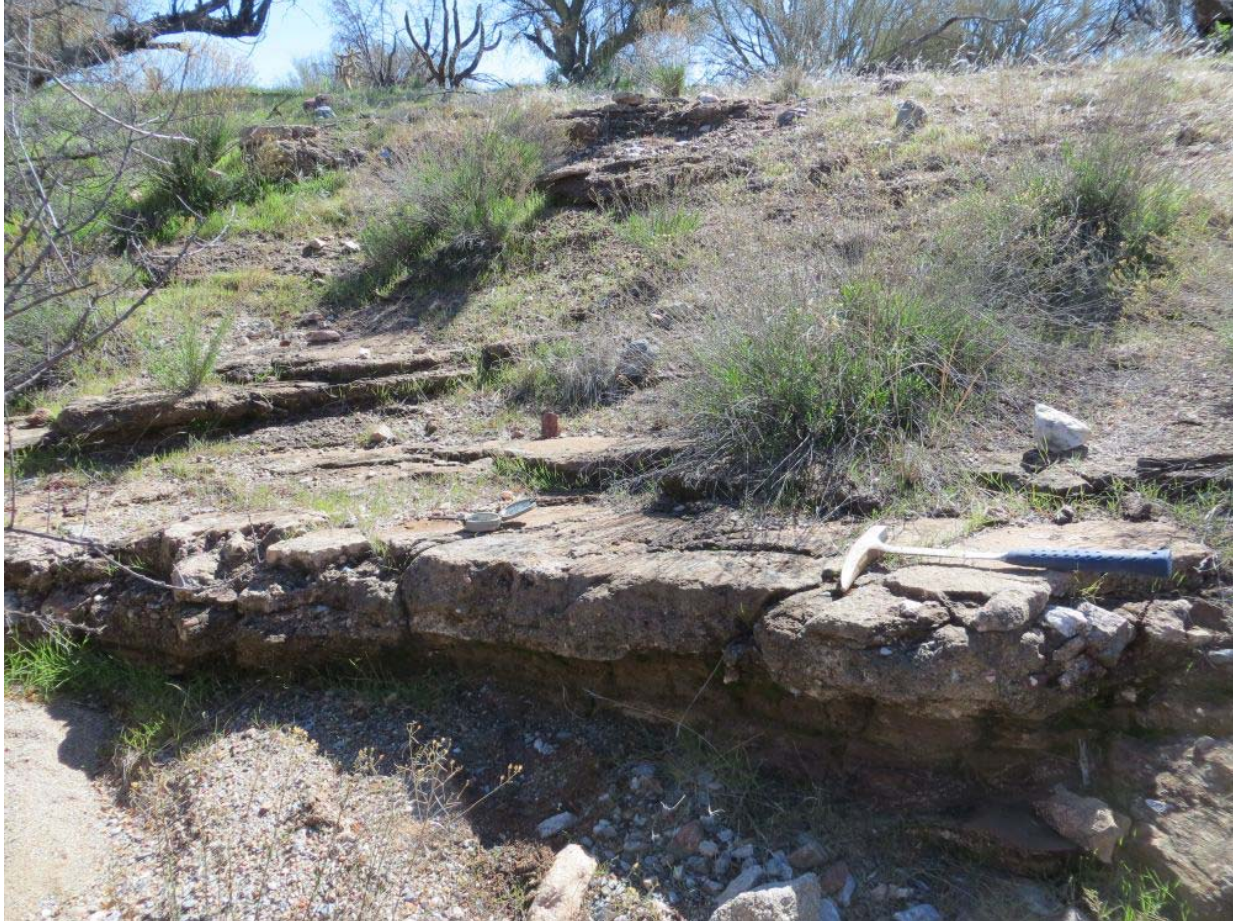
**OBS41**

Dipping conglomerate bed in left channel bank

Orientation of bed: **000/14**

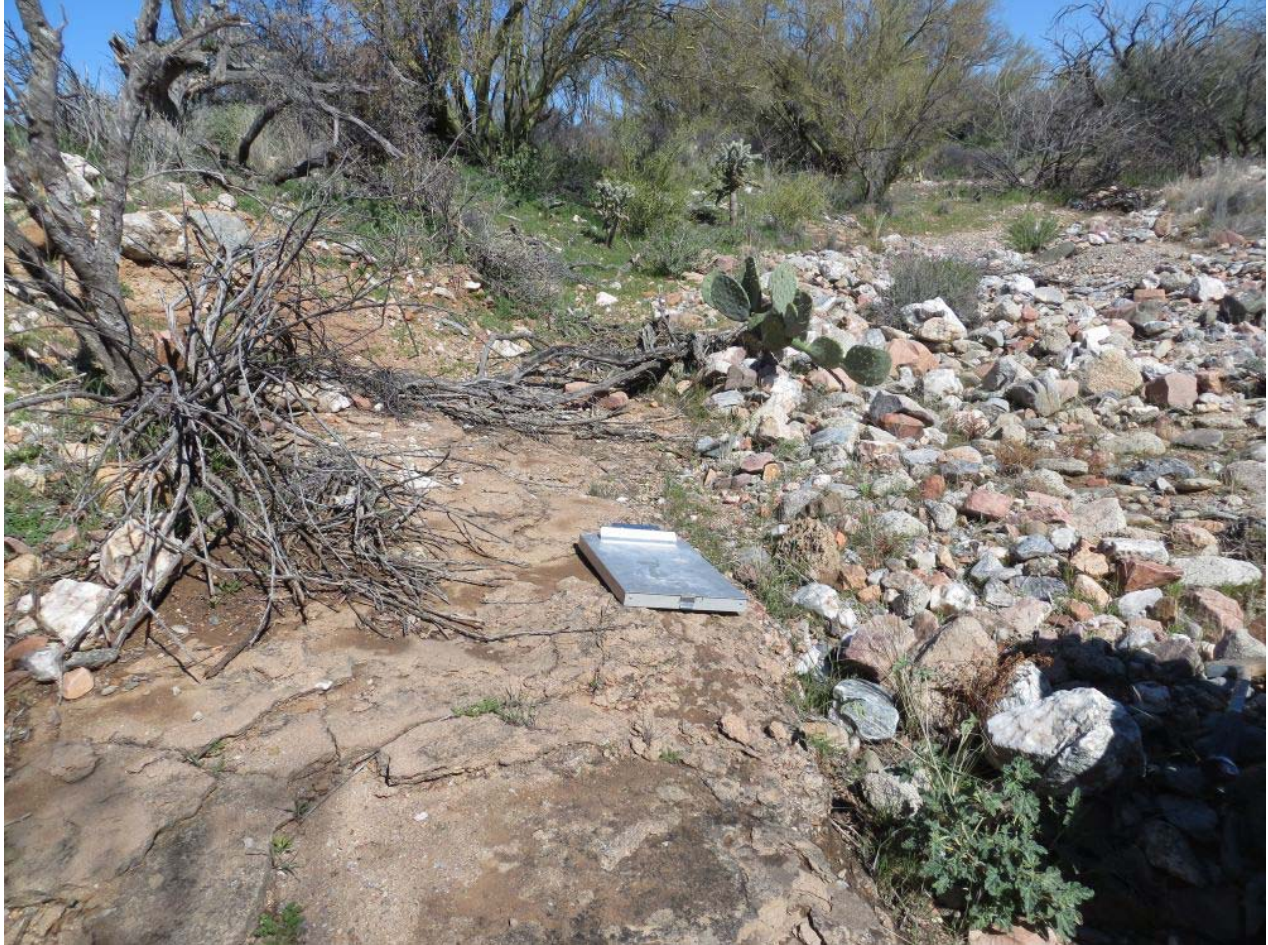
**OBS42**

Sub-horizontal conglomerate bed outcropped in left channel bank.

Orientation of bed: **000/06**

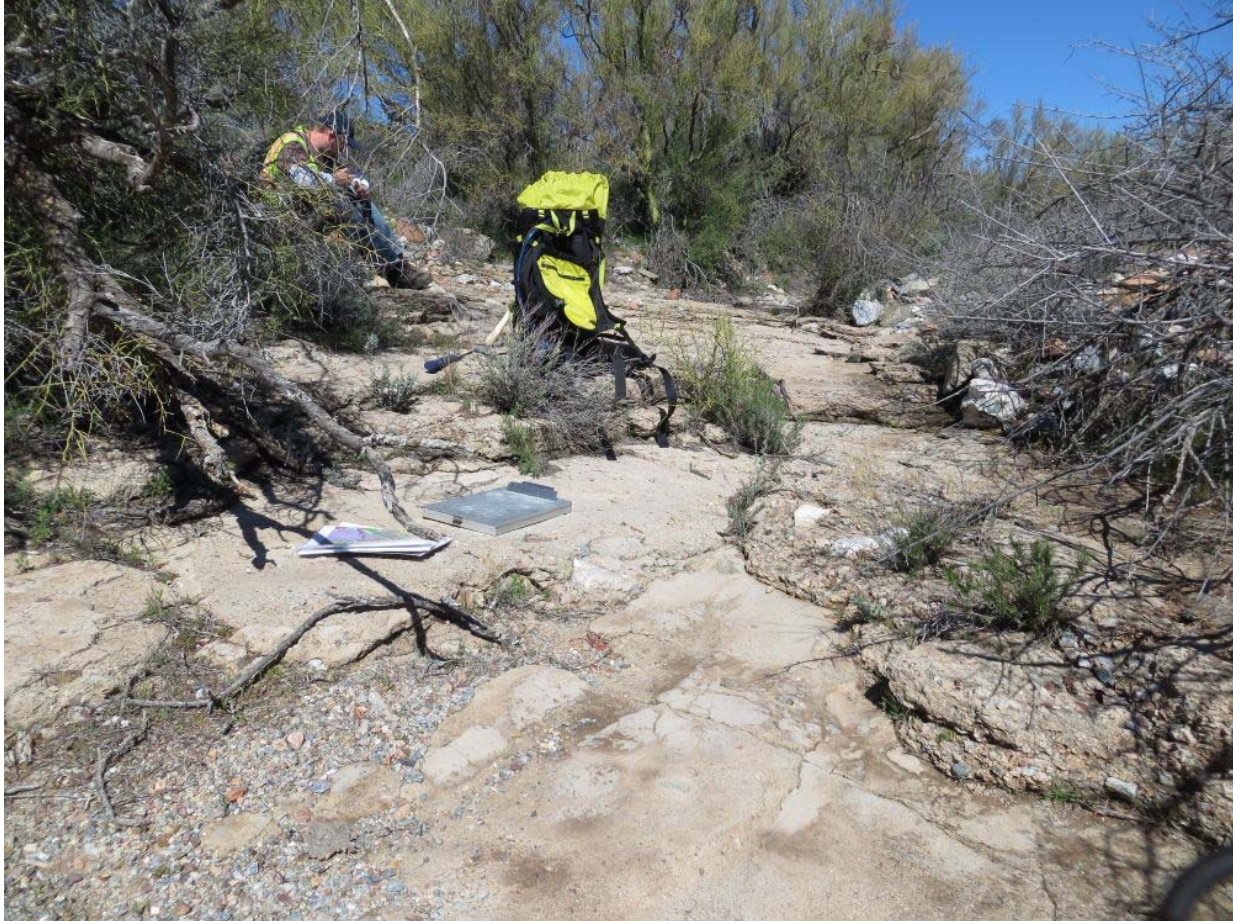
**OBS43**

Fluvial deposits in the channel invert end and bare conglomerate surface exposed in channel invert.

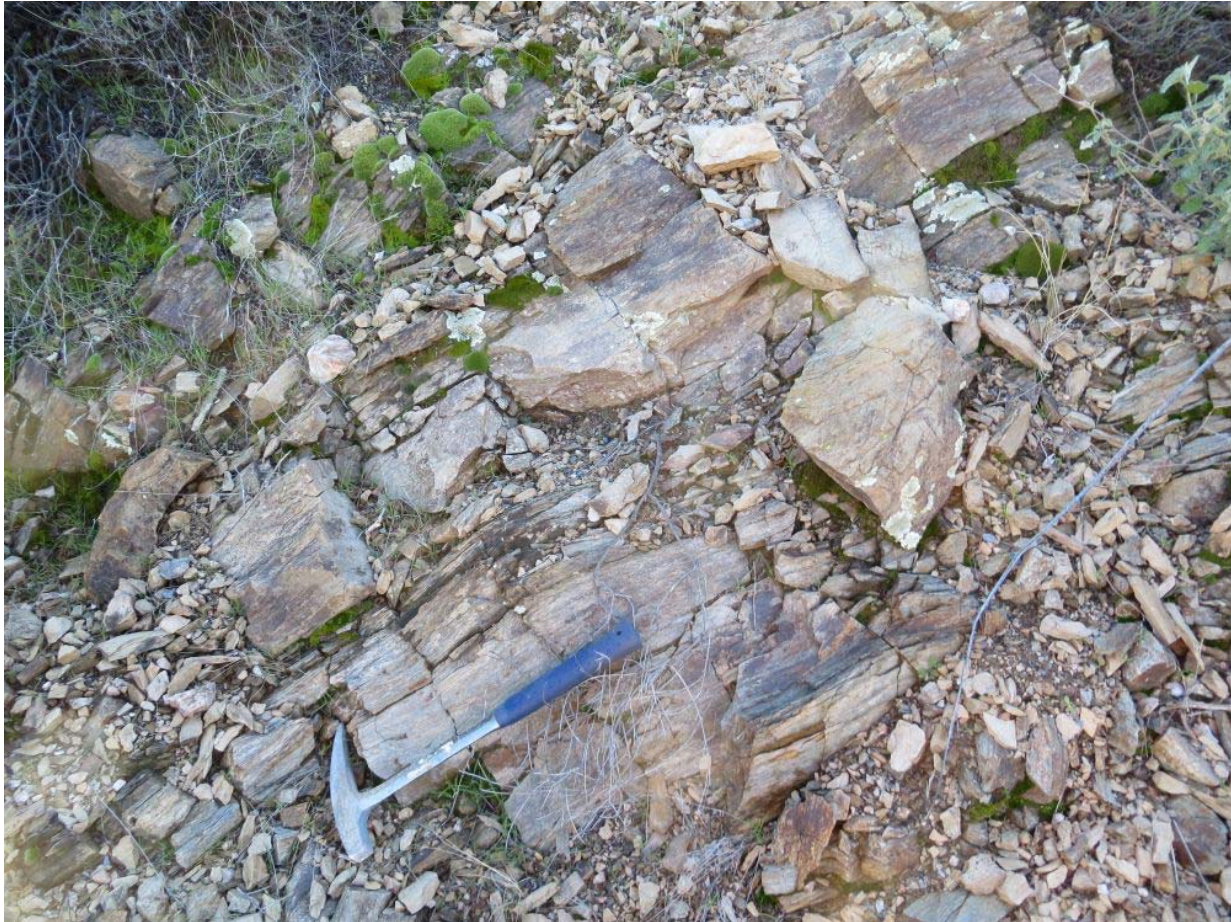
Joint set visible in schist outcrop. R4 rock, 10 cm to 20 cm (*3.94 inches to 7.87 inches*) joint spacing, closed aperture.

Orientation of joint set: 194/38

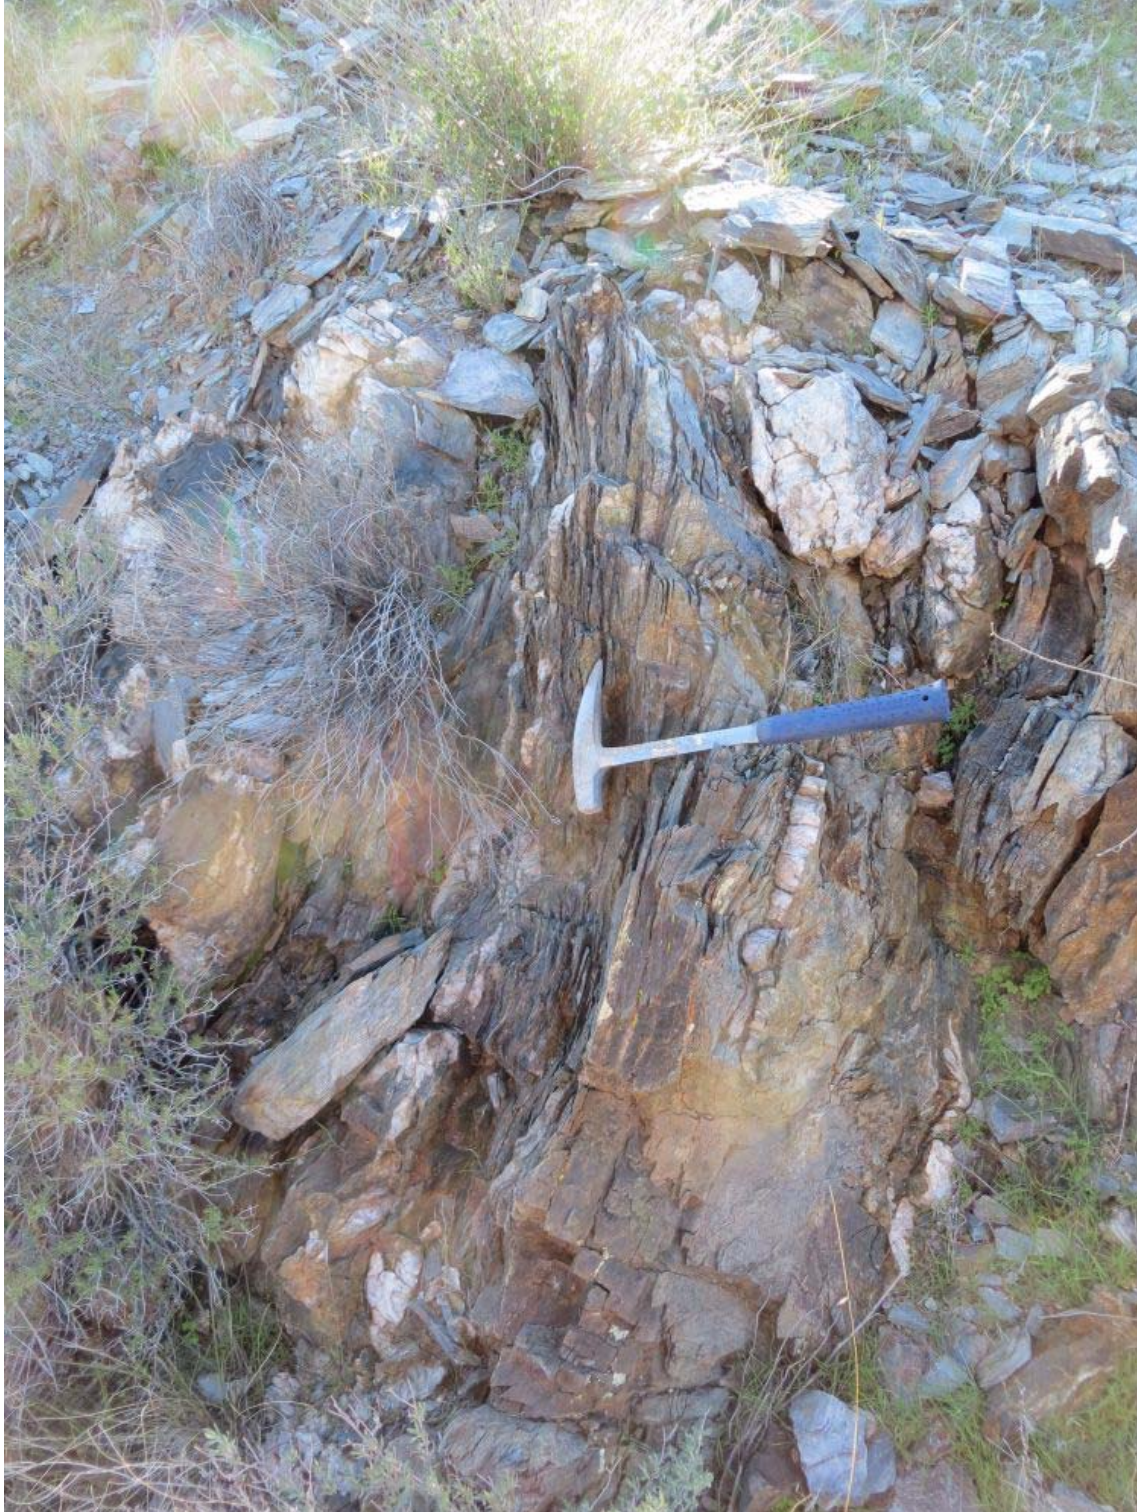
**OBS45**

Gently folded, near vertical foliation cleavage in schist outcrop. Millimeter scale spacing between foliation planes.

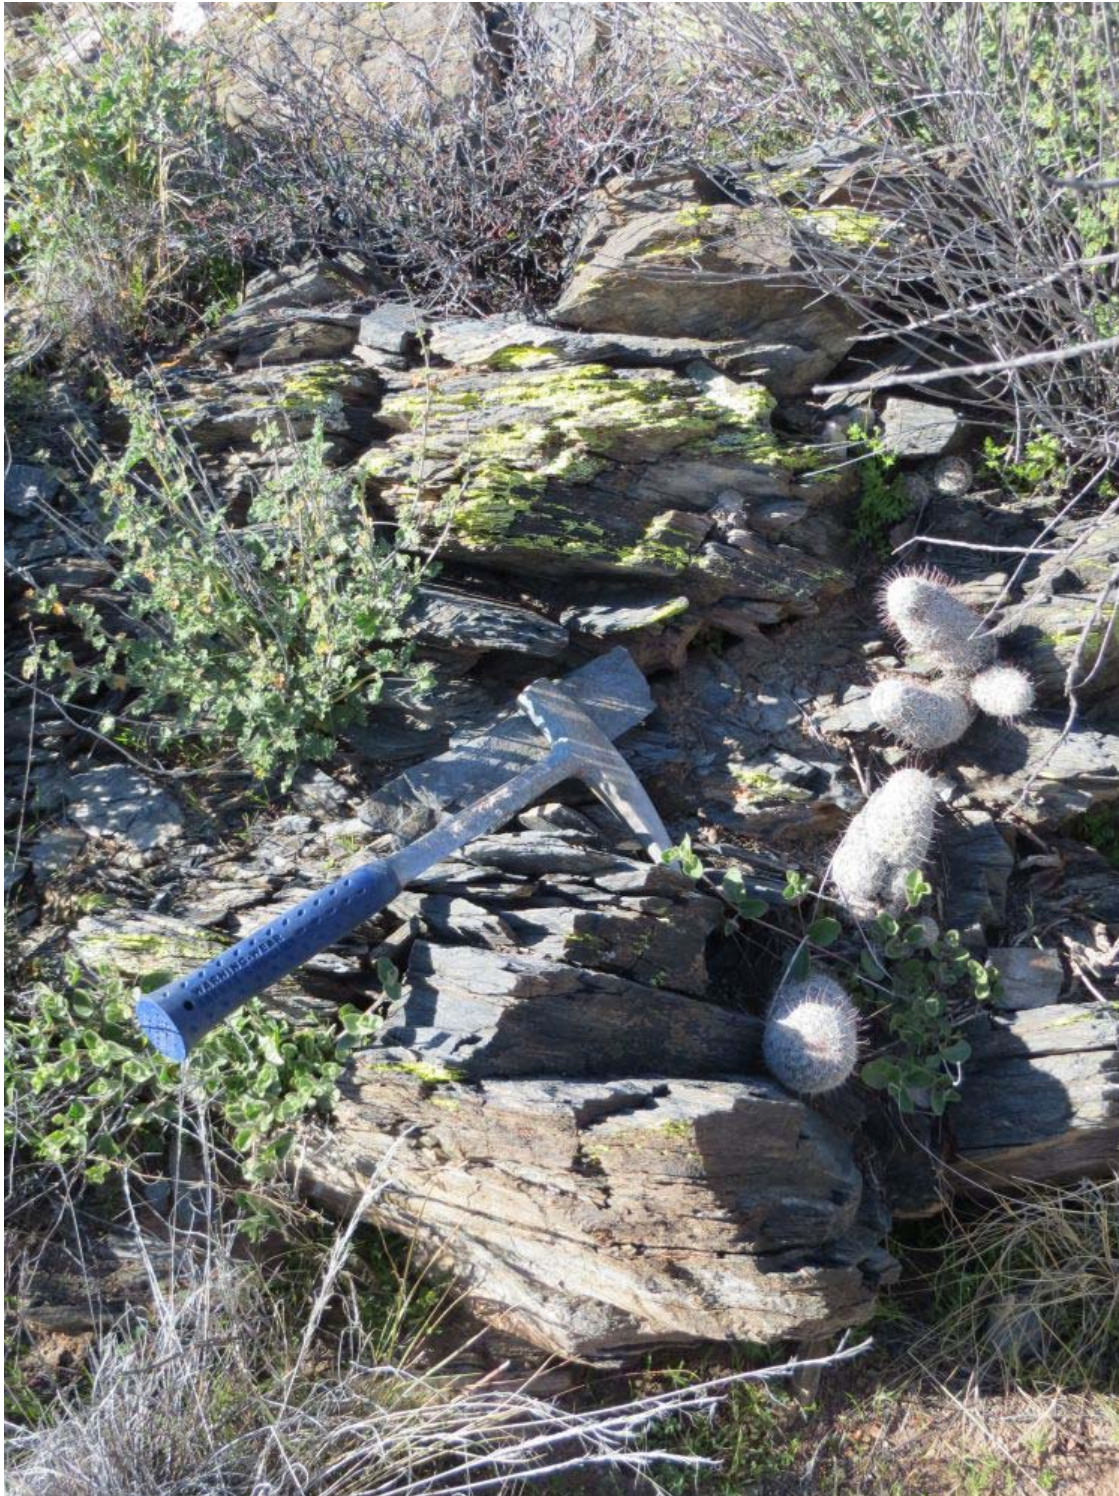
**OBS47**

Poorly welded tuff (Tt) outcrops in channel banks. Contact between schist and tuff. Tuff is massive, R2, some low angle "bedding" observed.

Orientation of bedding structure: **353/07**

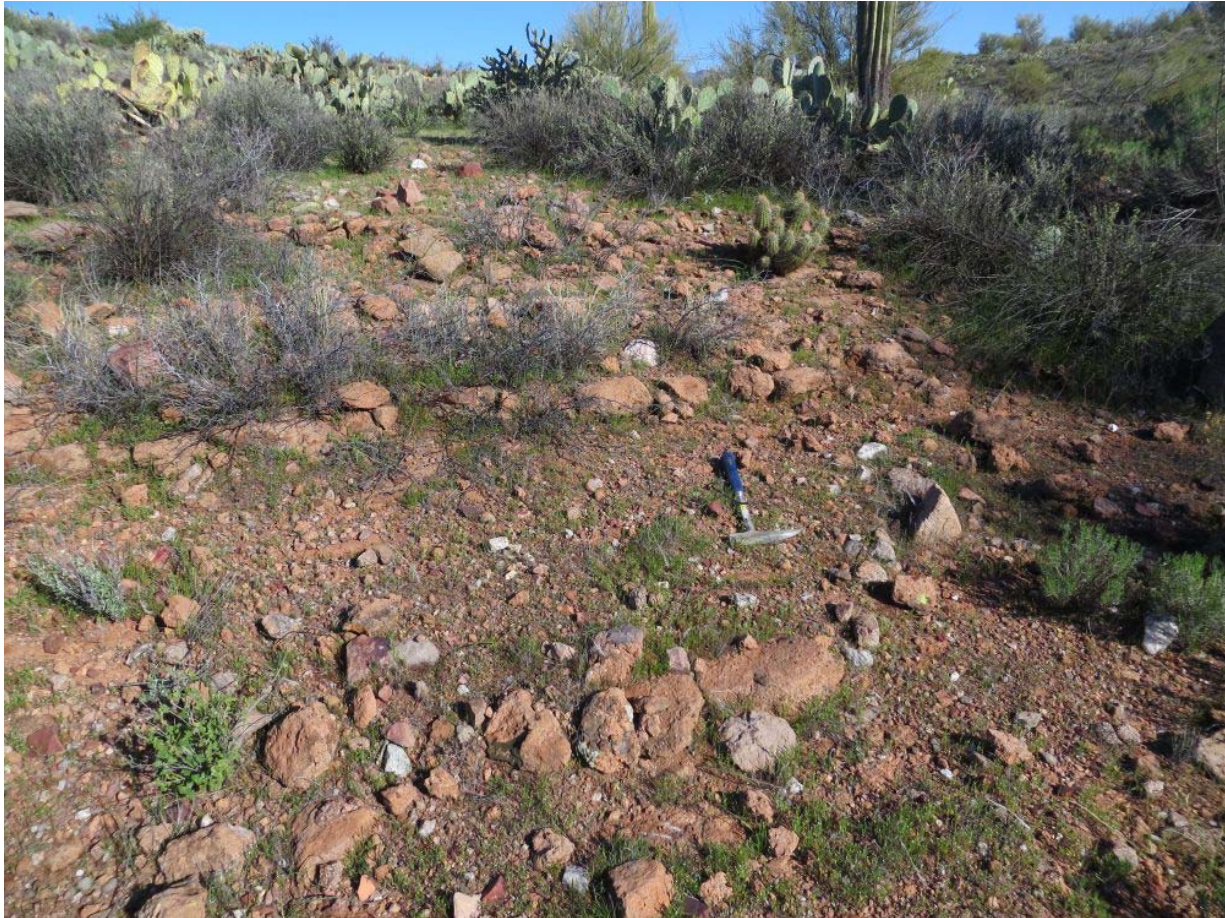
**OBS48**

Contact between tuff (Tt) and basalt (Tb). Small depression along contact line.

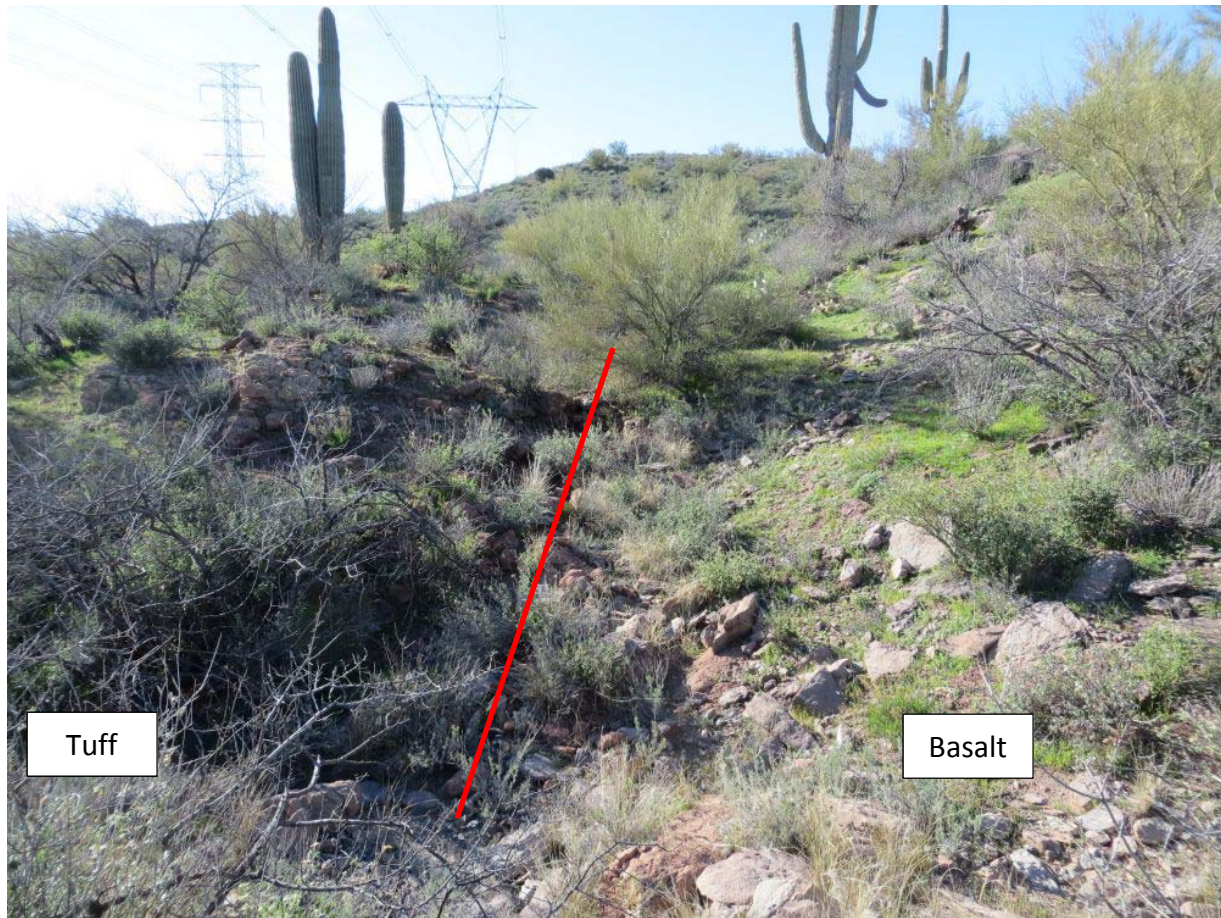
#### OBS49

Elevation drop of approximately 2 m (6.56 ft) in channel invert over tuff outcrop. Tuff is fresh, R2, massive with some randomly oriented closed to tight fractures. Reactive to acid on some but not all fresh surfaces.

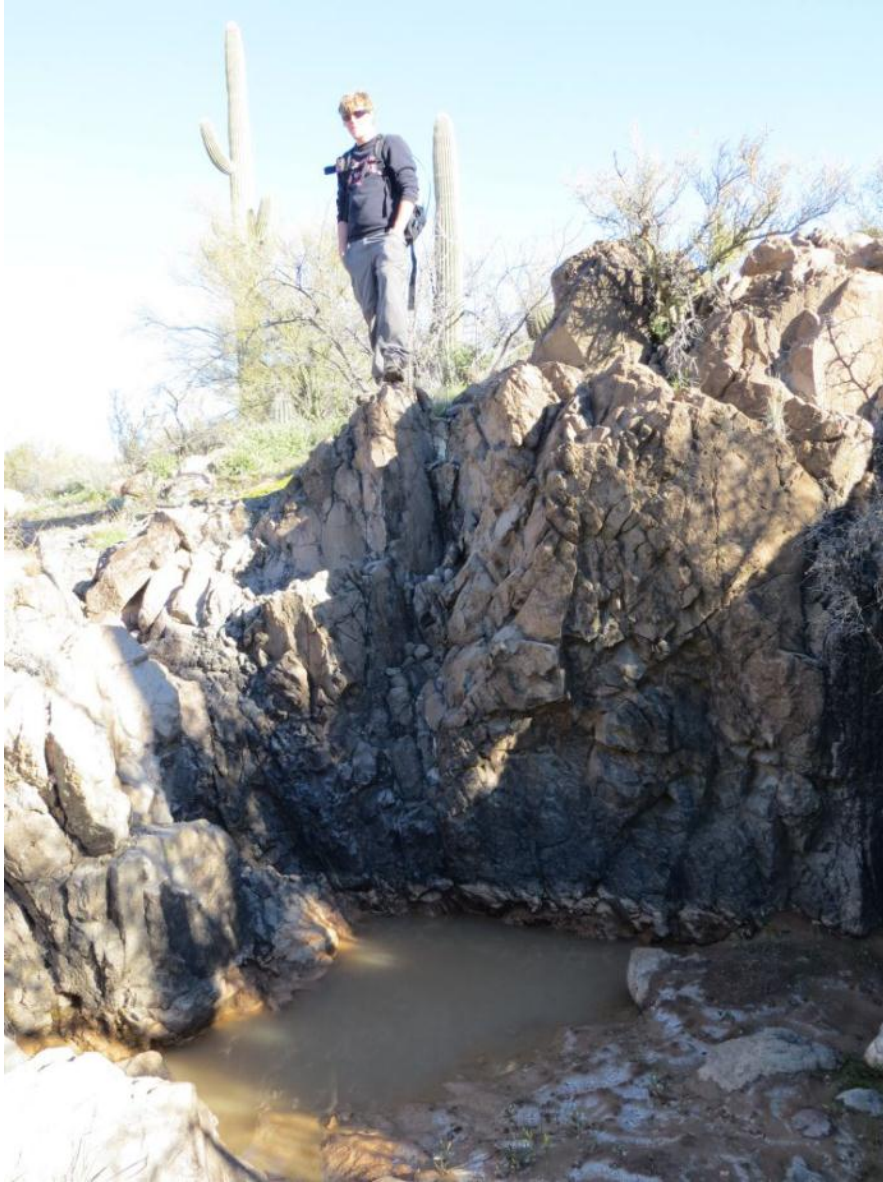
### OBS50

Elevation drop in channel invert of 2.5 m (8.20 ft) over basalt outcrop where small drainage terminates at Potts Canyon. Basalt is fresh, R5/R6, very blocky with a number of joint sets, max. joint aperture = 2 cm (0.79 inches) but closed at 30 cm (11.8 inches) depth, no infilling, smooth and planar joint surfaces. High water mark 15 cm (5.91 inches) above channel invert.

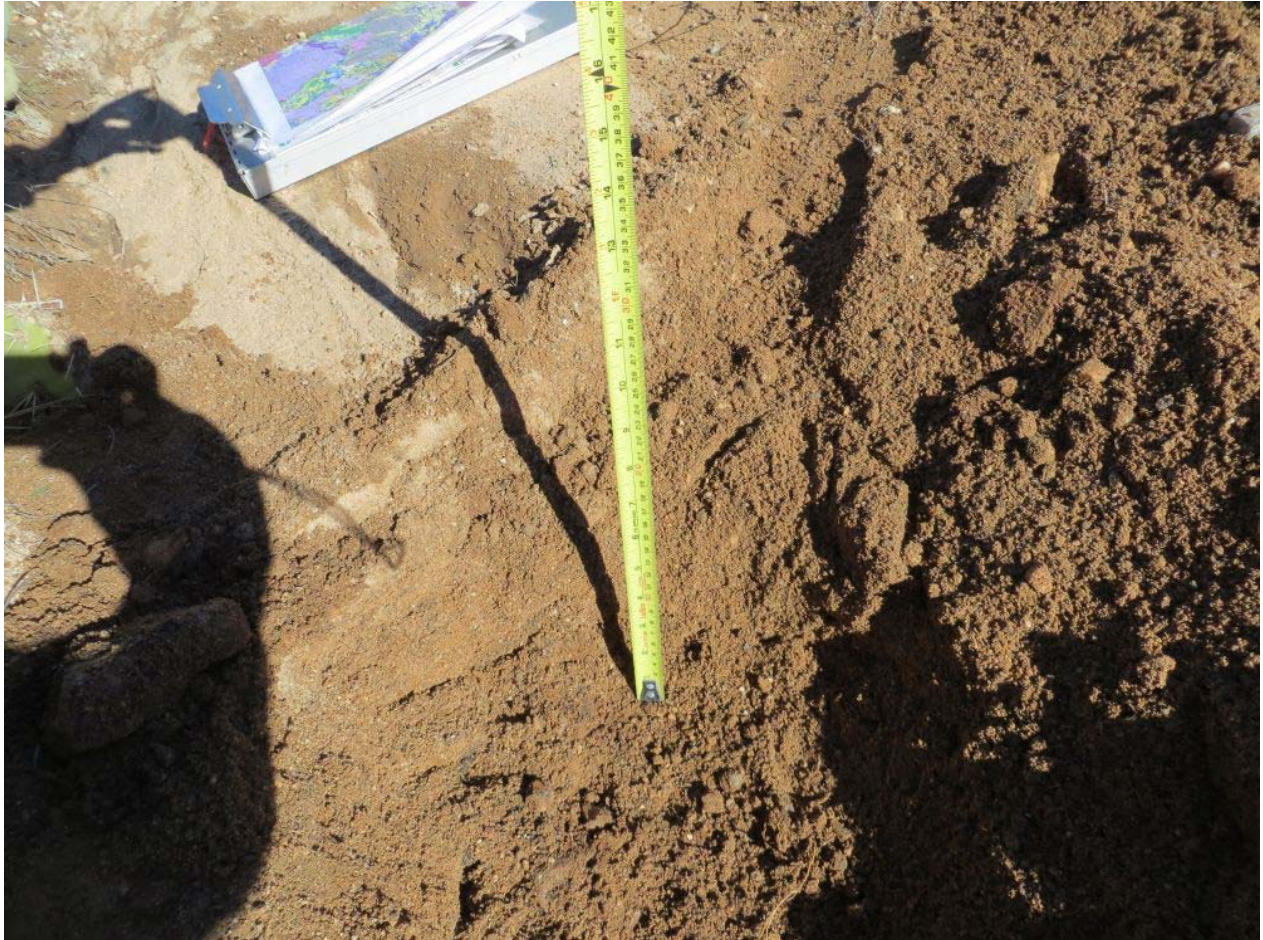
**OBS53**

Sub-horizontal sandstone bed outcropping in left channel bank.

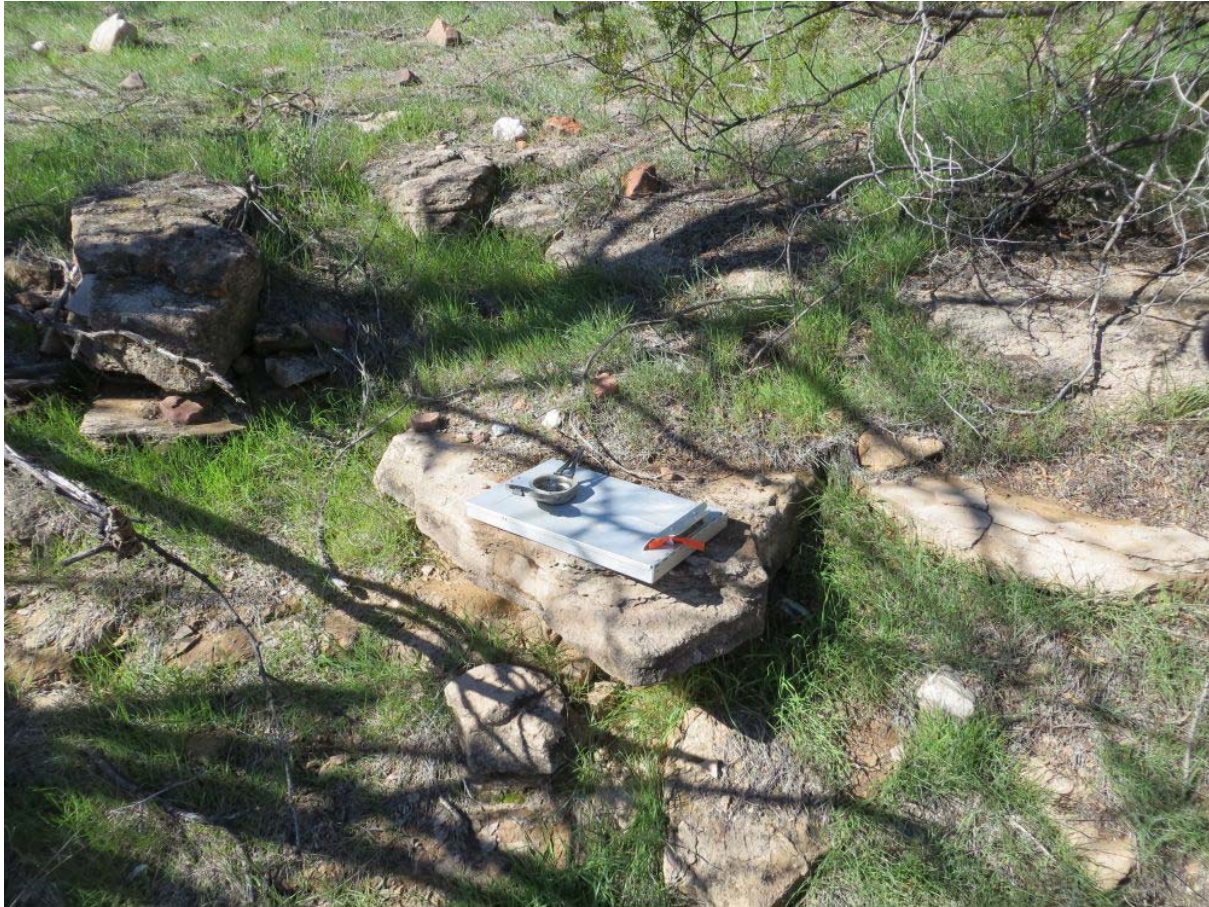
Orientation of bed: **298/05**

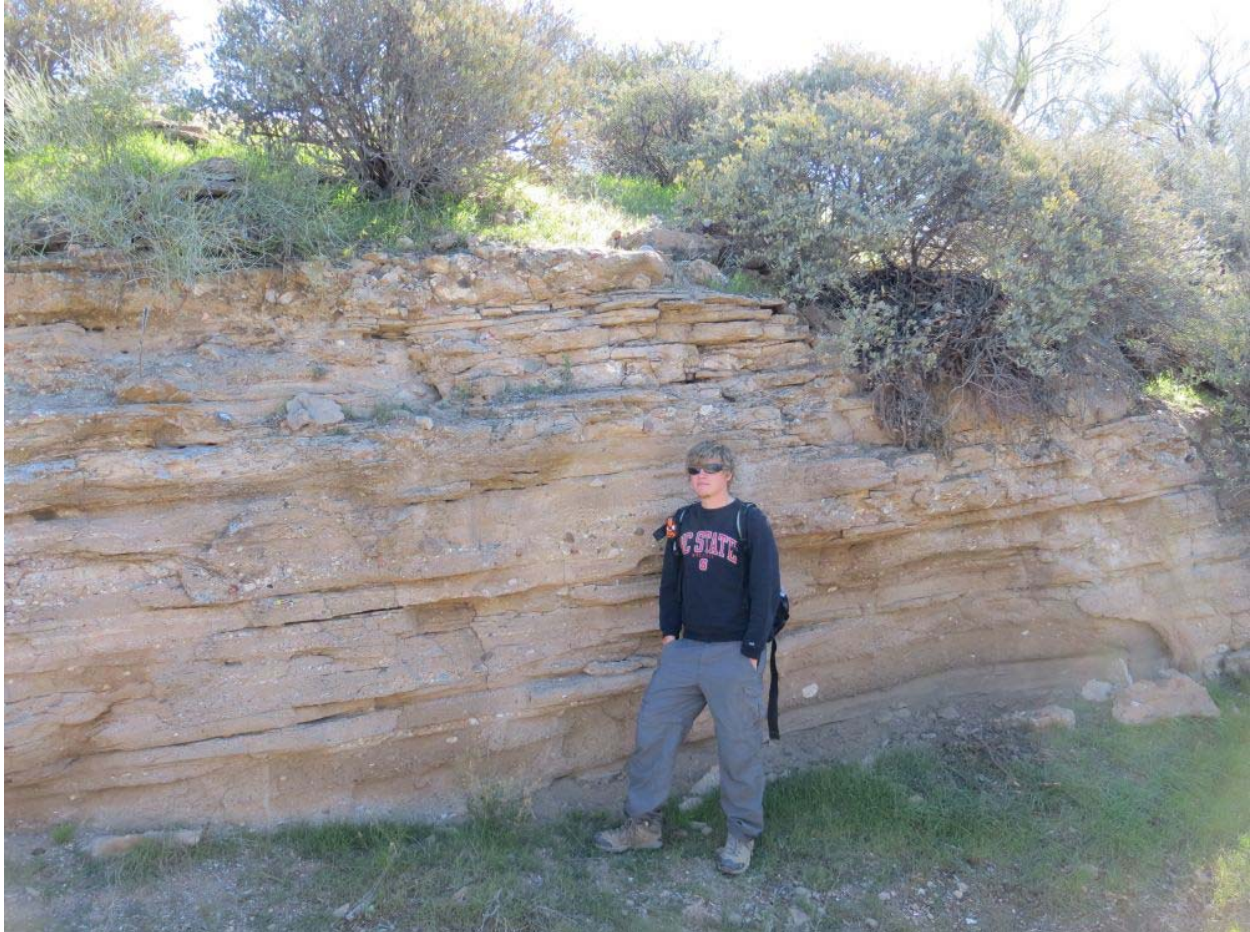
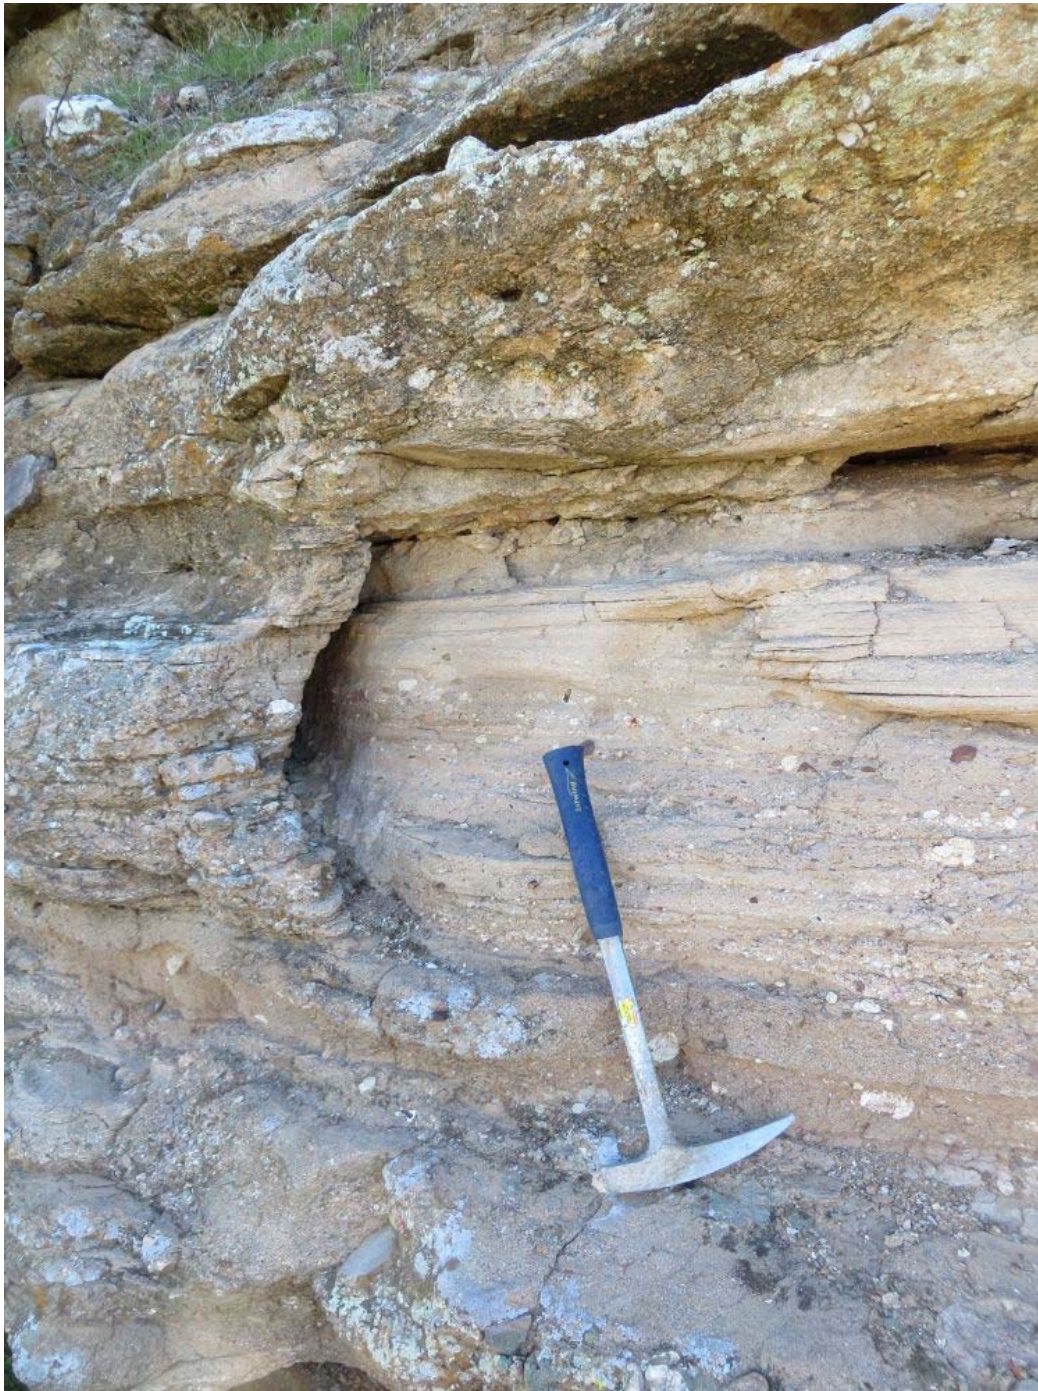
#### OBS54

3 m to 4 m (9.84 to 13.1 ft) high Tss (Tertiary Sandstone) outcrop on right channel bank. Fresh, R2, sub-horizontal beds, bed thickness ranges from thin laminations (mm scale) to massive beds up to 20 cm (7.87 inches) thick, range of particle sizes (max. = 15 cm (5.91 inches)), various clast lithology, reactive to acid, differential weathering of finer beds.

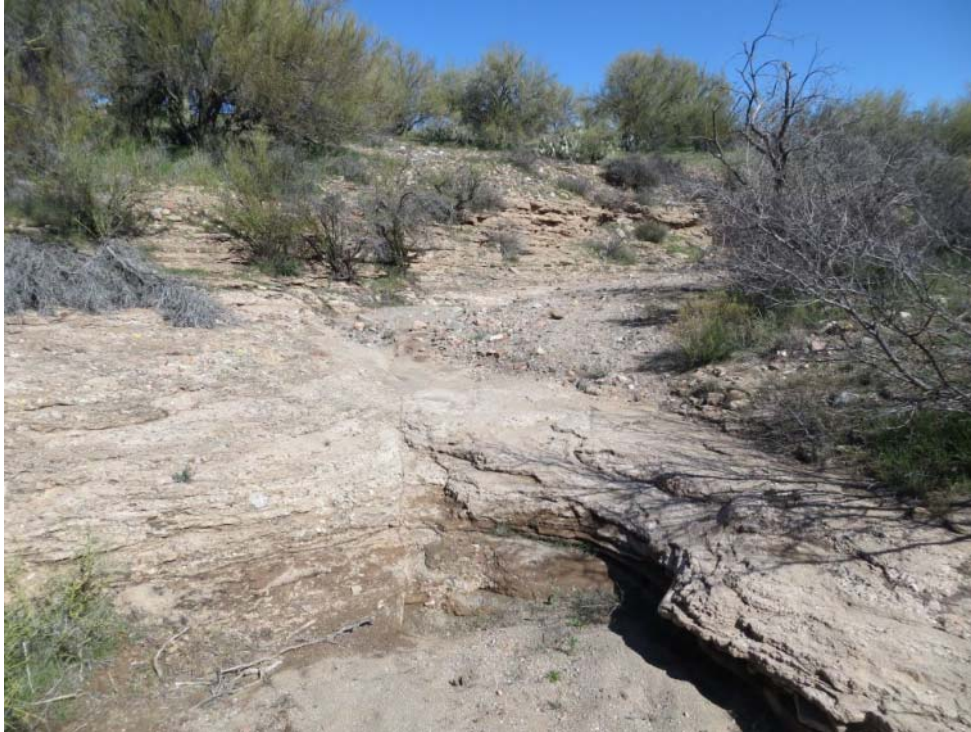
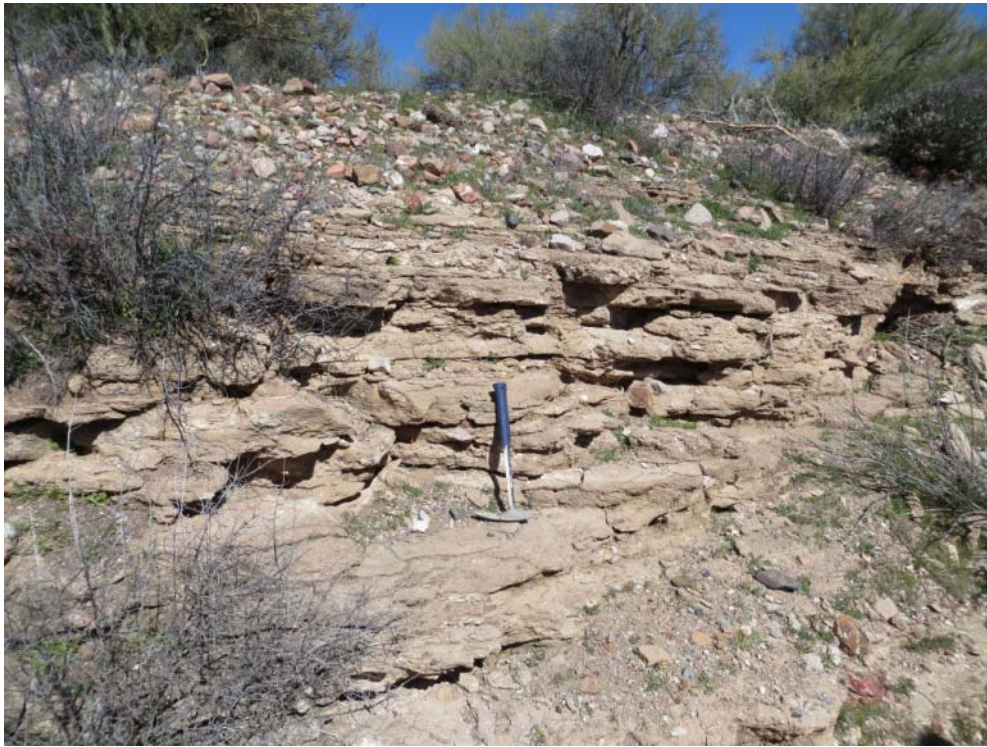
**OBS55**

40 cm (*15.75 inches*) elevation drop in channel invert over sandstone “ledge”. Moist sand at bottom of drop.

Orientation of beds: **327/04**
