## APPENDIX I-E

### Traverse #5

PROJECT  
RESOLUTION PROJECT  
2013 NEAR WEST SITE INVESTIGATION

TITLE  
CREEK TRAVERSE #5

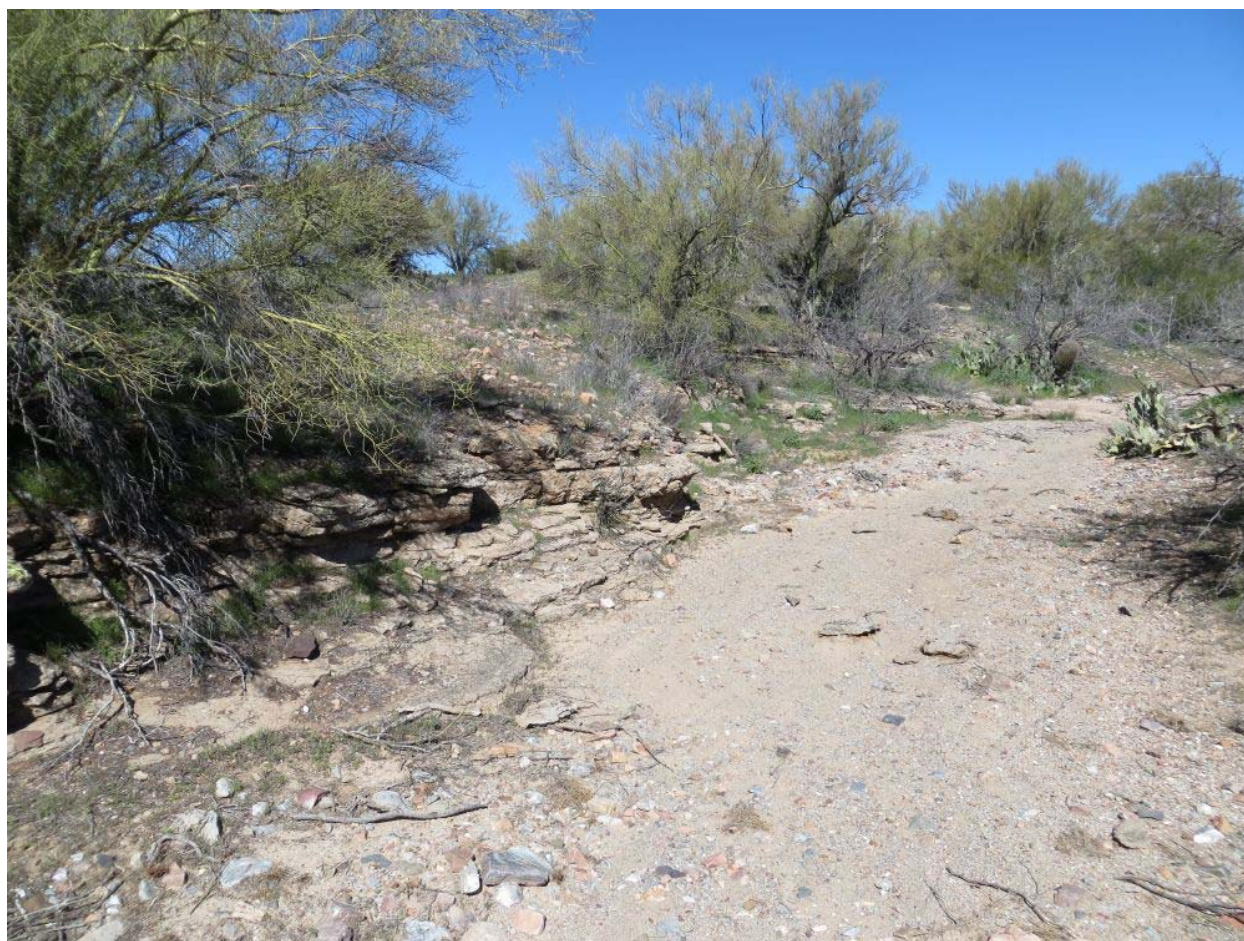
Sub-horizontal Tss beds exposed in left channel bank.

Orientation of beds: **033/11**

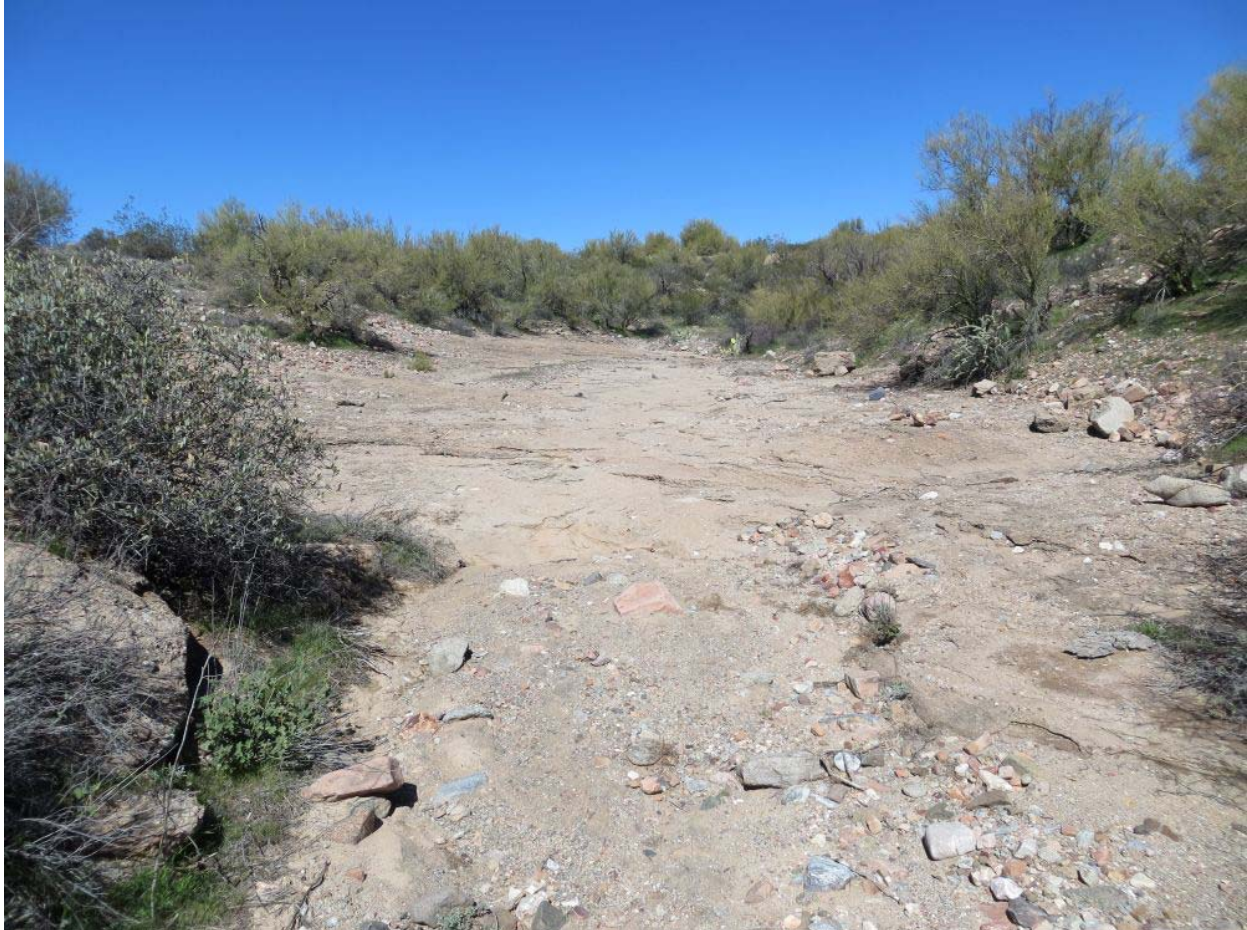
**OBS58**

Large sub-horizontal surface of conglomerate spanning channel invert (~10 m (32.8 ft) across) with thin fluvial soil cover in some areas.

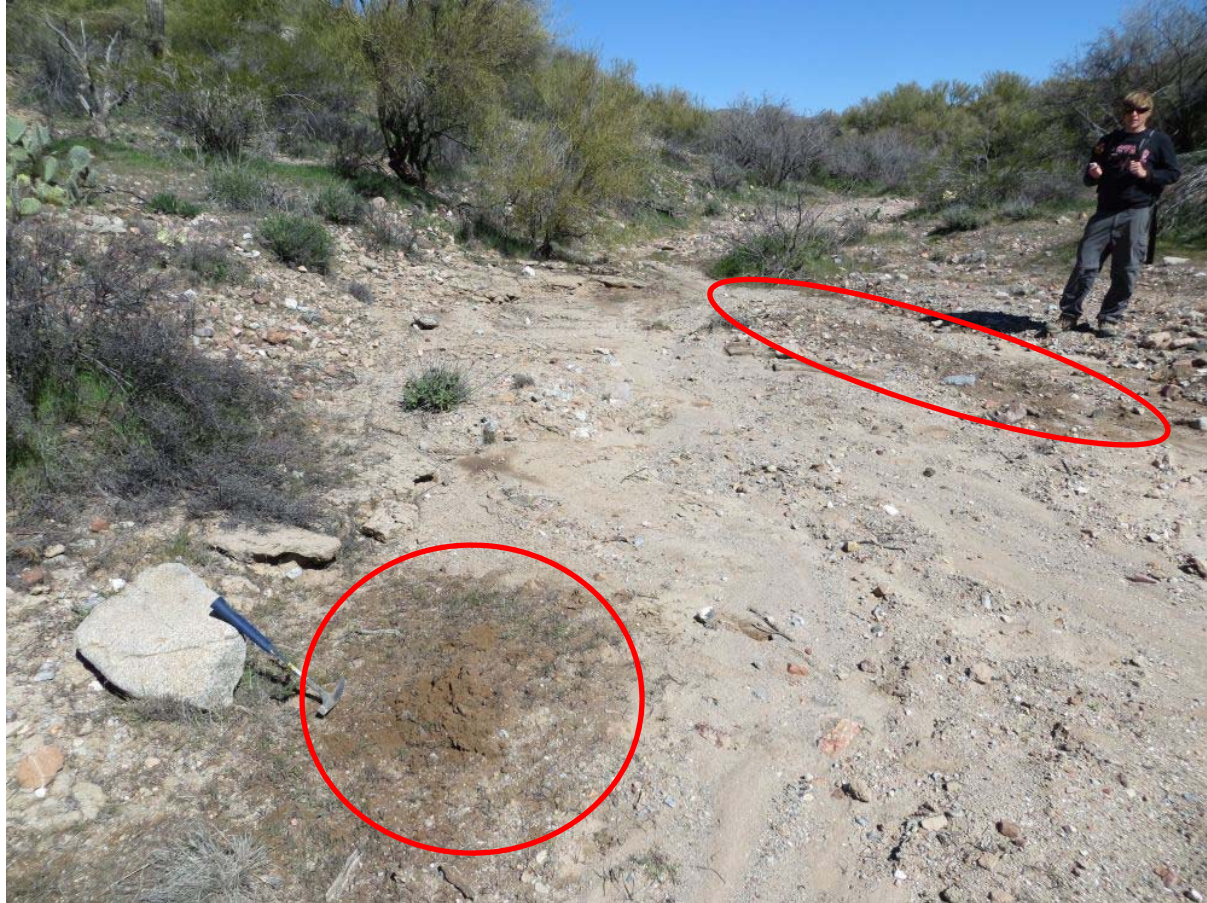
**OBS59**

Localized wetting of thin (~15 cm (5.91 inches) thick) fluvial sediments deposited on top of sub-horizontal conglomerate surface. Wet spots concentrated along channel edges.

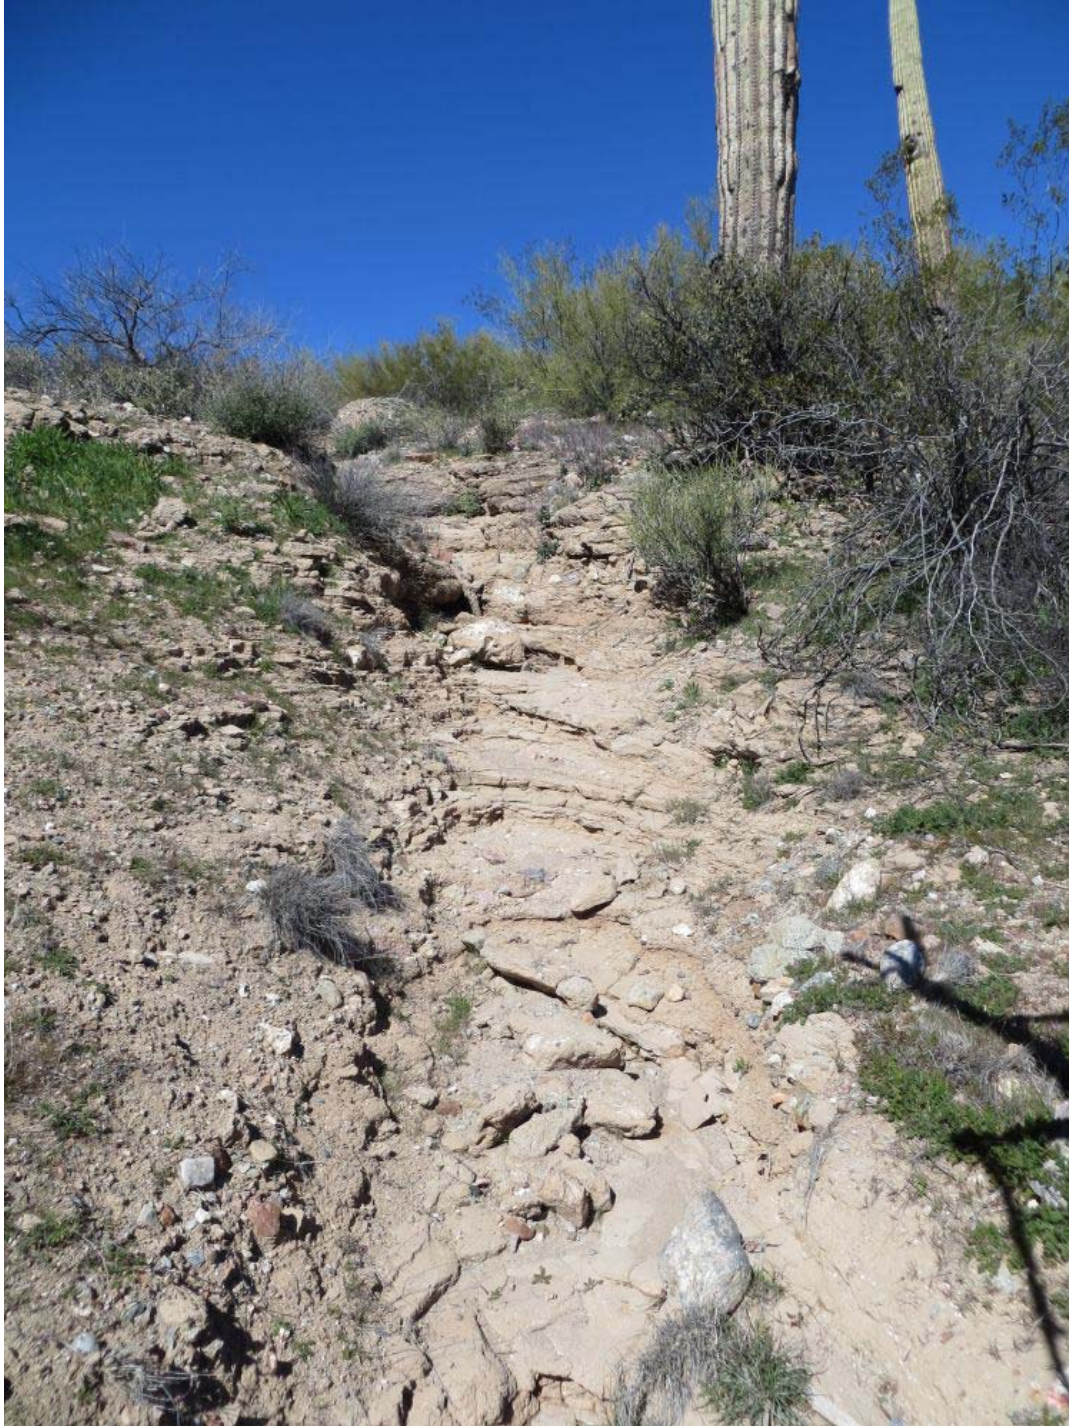
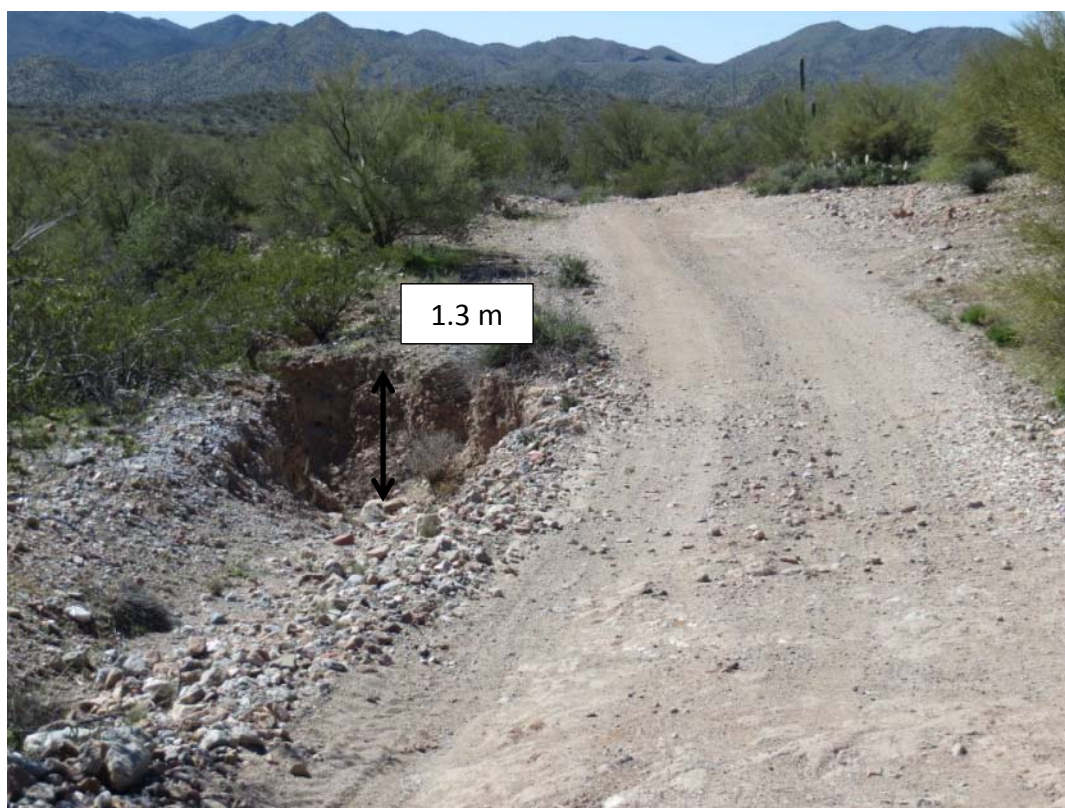
### OBS60

Erosional gully (~1.5 m (4.9 ft) wide) perpendicular to right channel bank. Soil-like exposure ~ 1.3 m (4.3 ft) thick and reactive to acid. Could be weathered conglomerate or reworked material from road construction (berm). Gully looks to have been formed by runoff collected in a low spot on the road.

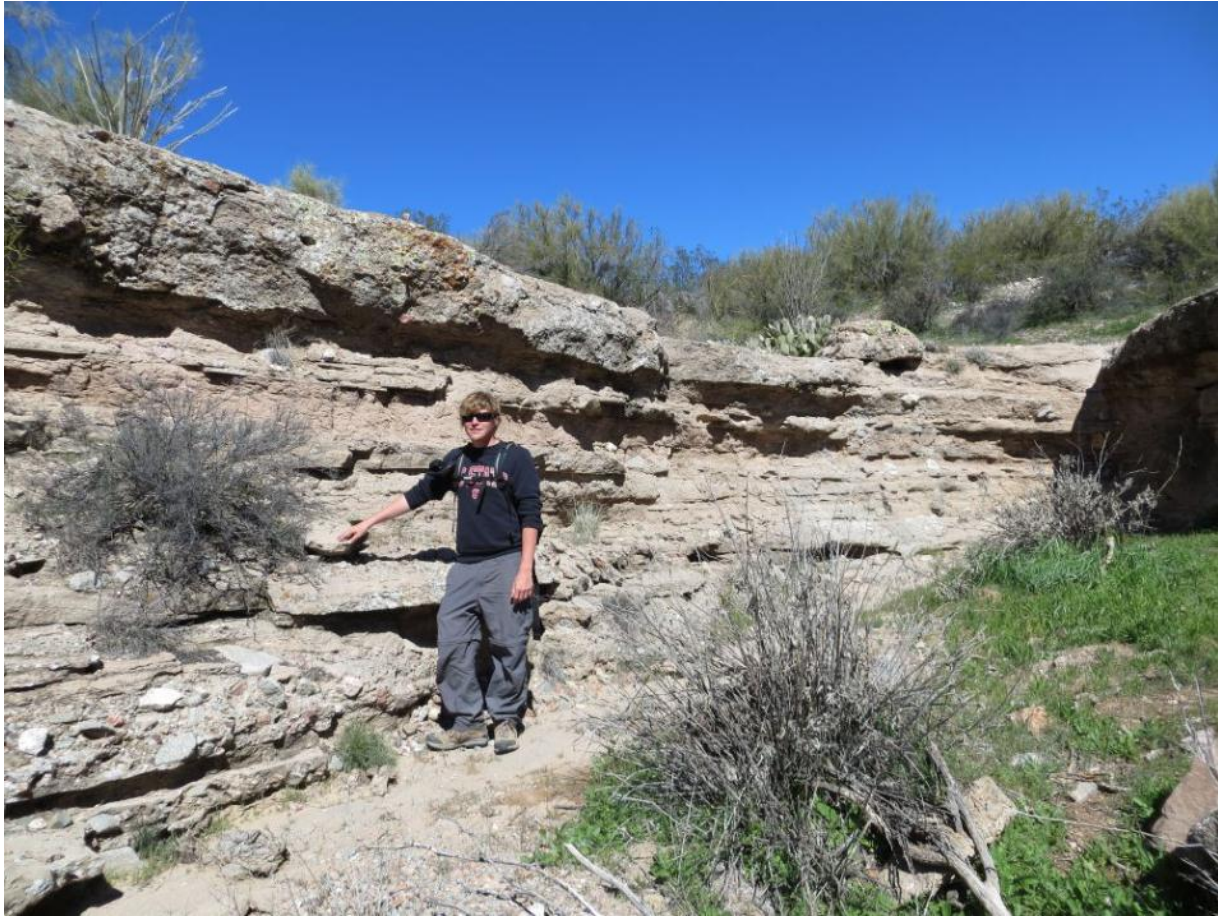
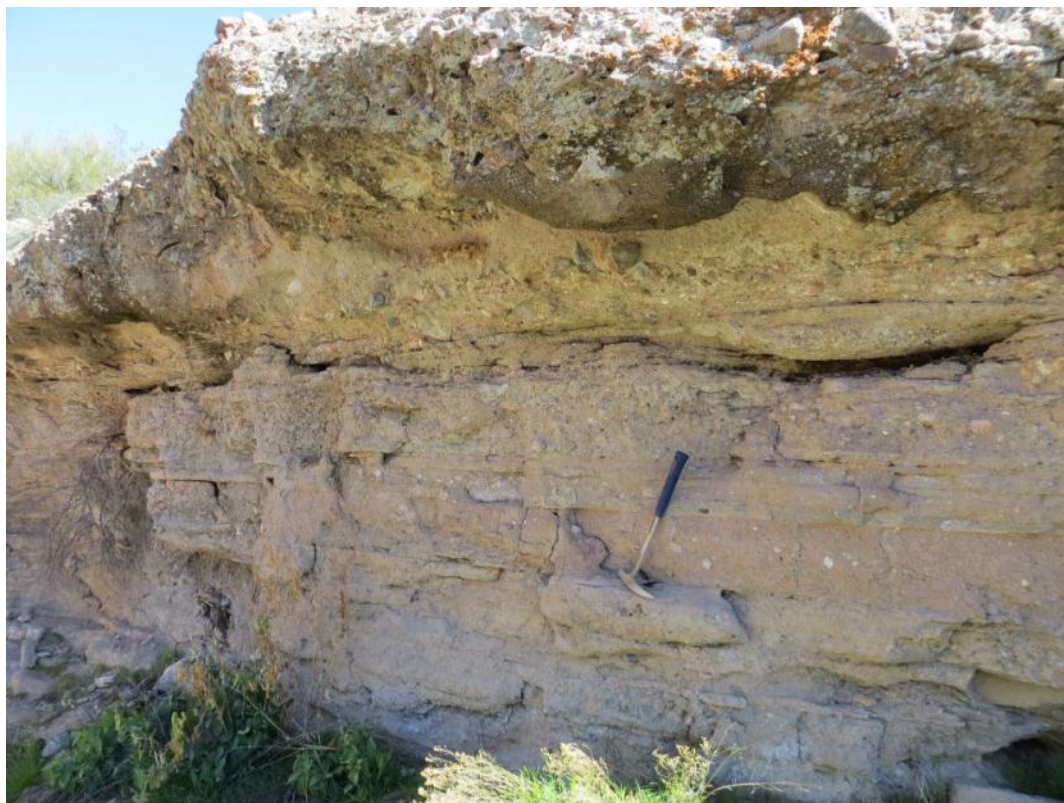
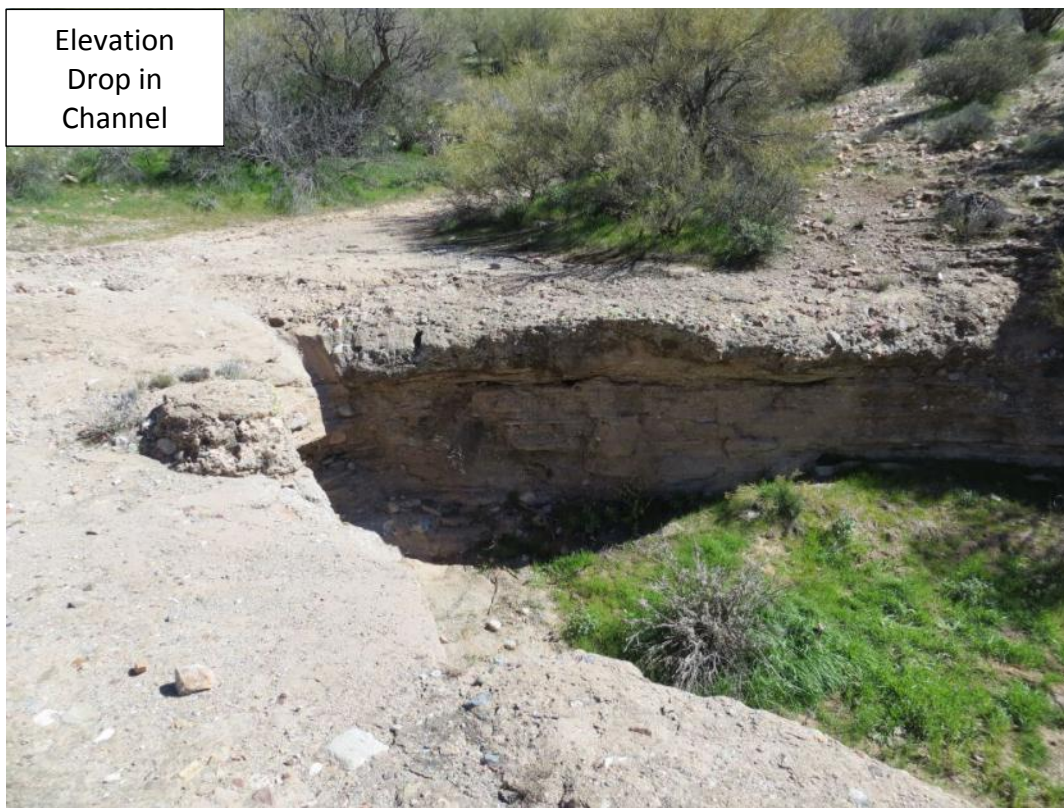
### OBS61

2.8 m (9.2 ft) elevation drop in channel invert large conglomerate exposure. CONGLOMERATE, fresh, R2/R3, sub-horizontal bedding ranging from 2 cm to 60 cm (0.79 to 23.6 inches) thick, max. particle size = 30 cm (11.8 inches), range of particle shapes (rounded to angular) and lithology, reactive to acid, differential erosion of finer beds, topmost bed is hardest, coarsest and most erosion resistant, some vertical cracks that terminate at lift interfaces.

Elevation  
Drop in  
Channel

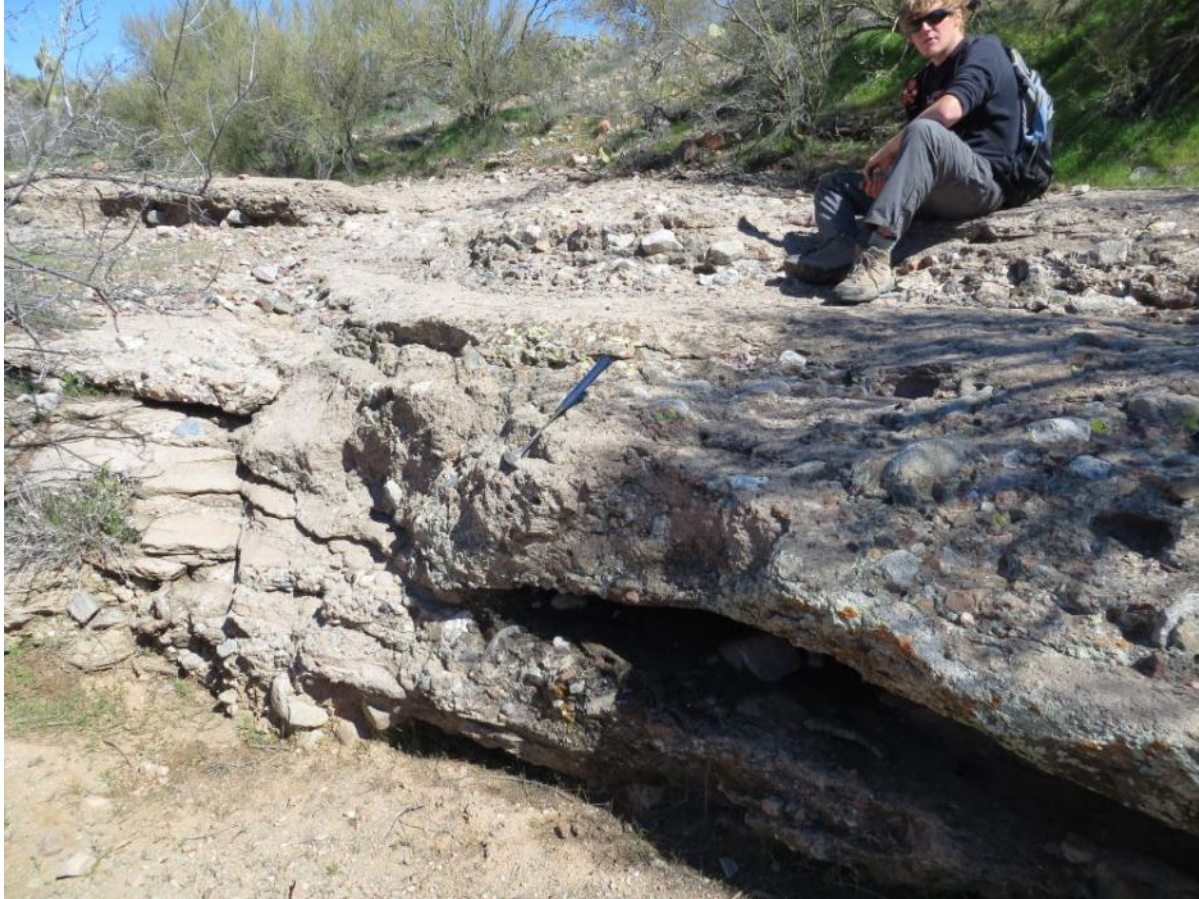
**OBS63**

Conglomerate exposure. Moist at surface. Well graded sand with gravel and cobble clasts. Very weak and “soil-like” rock with strength R0 to R1.

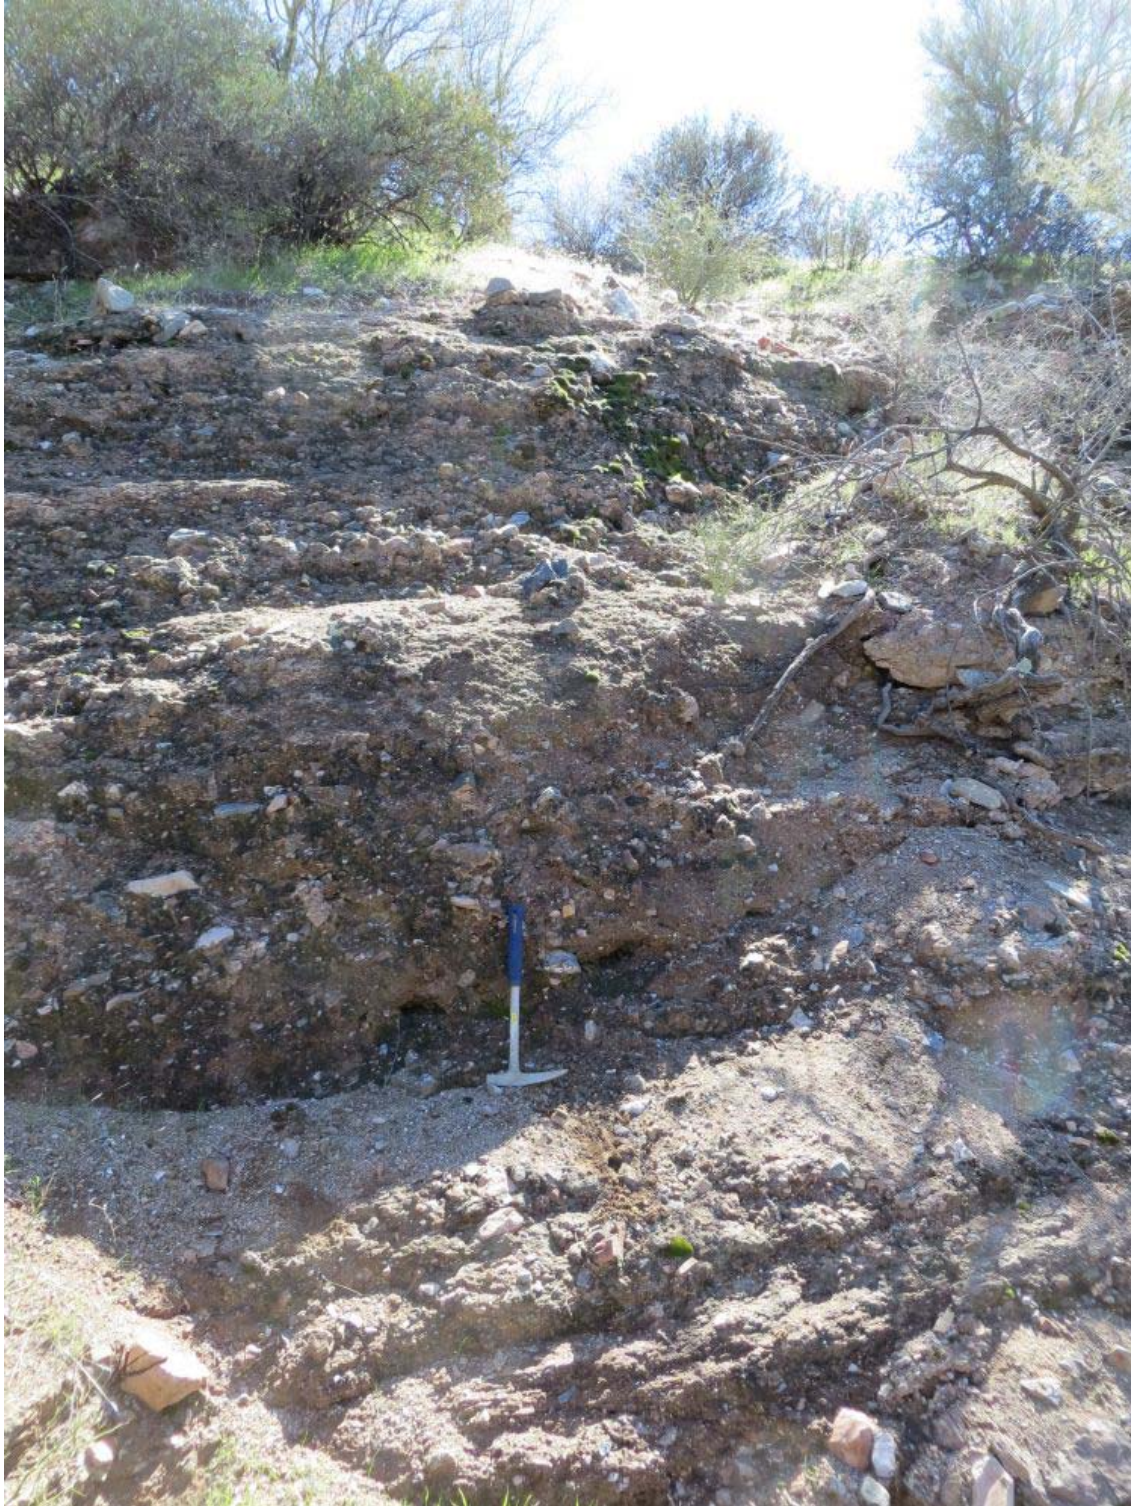
**OBS64**

2.5 m (8.2 ft) high conglomerate exposure. Massive with no apparent bedding, R1, max. clast size of 15 cm (5.91 inches).

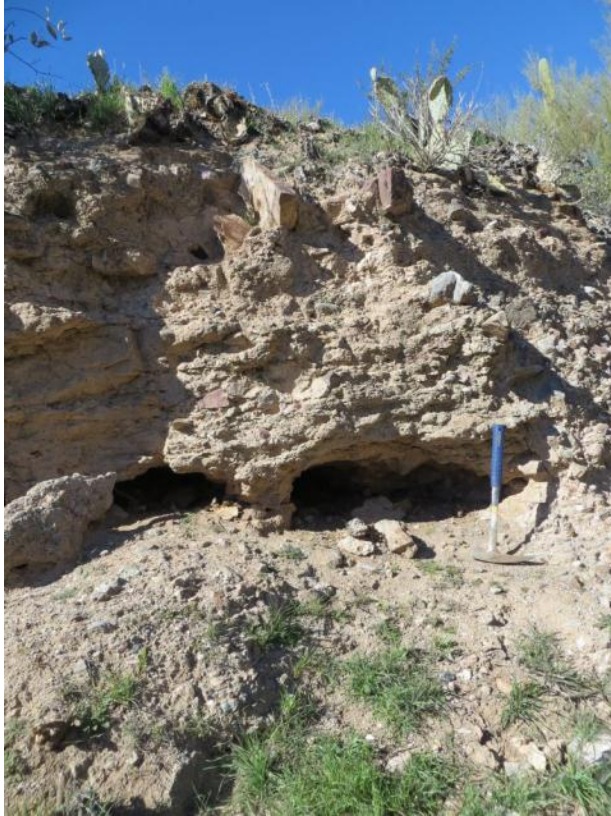
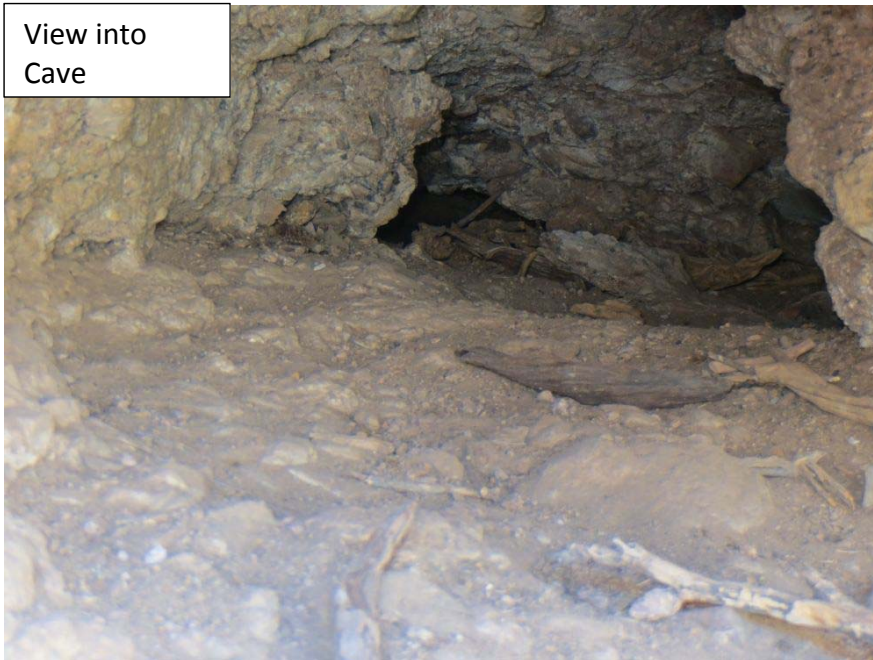
**OBS65**

“Cave” hollowed out into base of conglomerate exposure. Cave penetrates at least 2.2 m (7.2 ft) deep into exposure. Strength of conglomerate = R2.

View into  
Cave

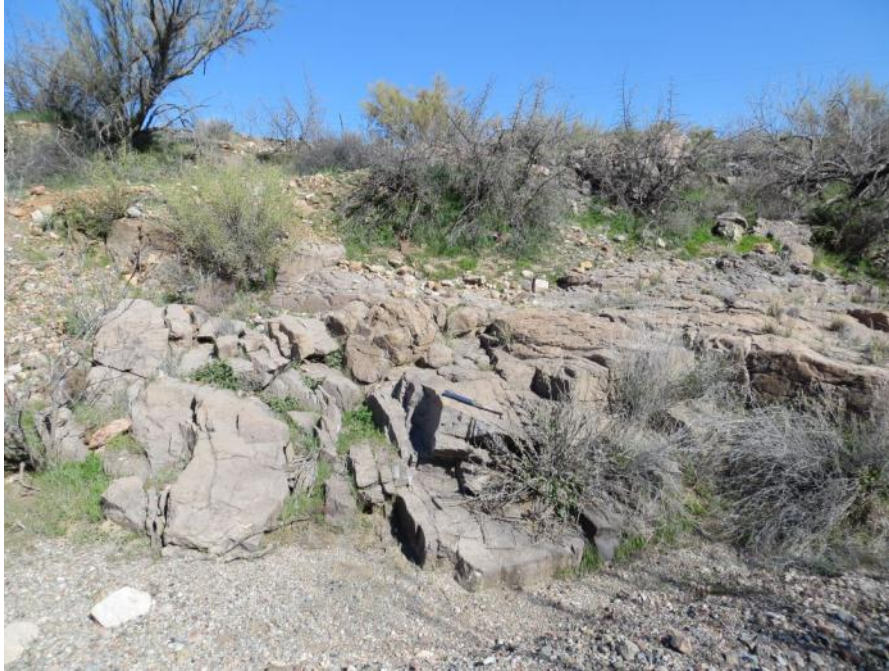
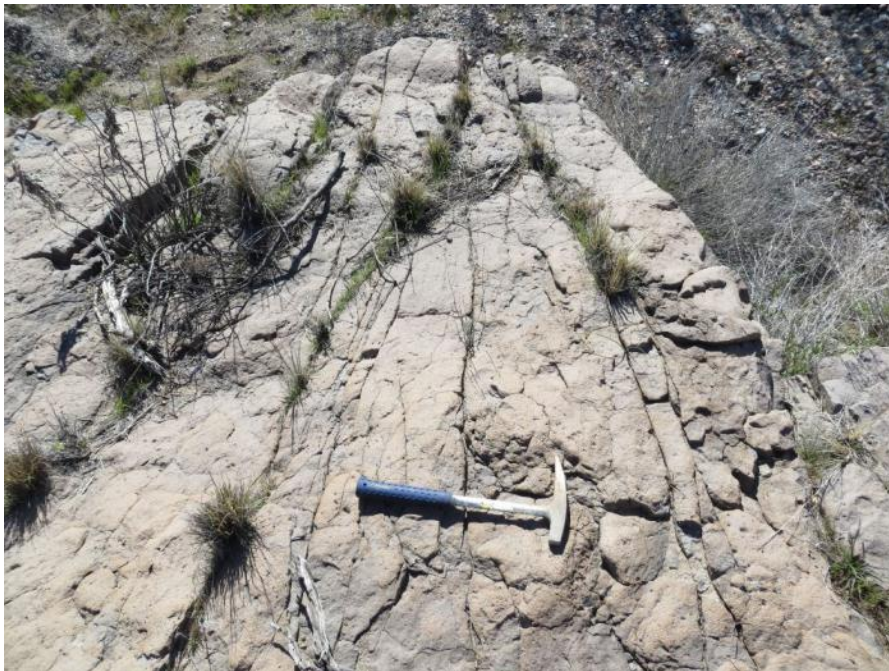
Basalt outcrop in channel. Fresh, R5 to R6, some vertical parallel joints with average spacing of 10 cm (3.94 inches), closed to open (max. aperture = 1 cm (0.39 inches)), planar surfaces.

Orientation of joint set: **133/90**

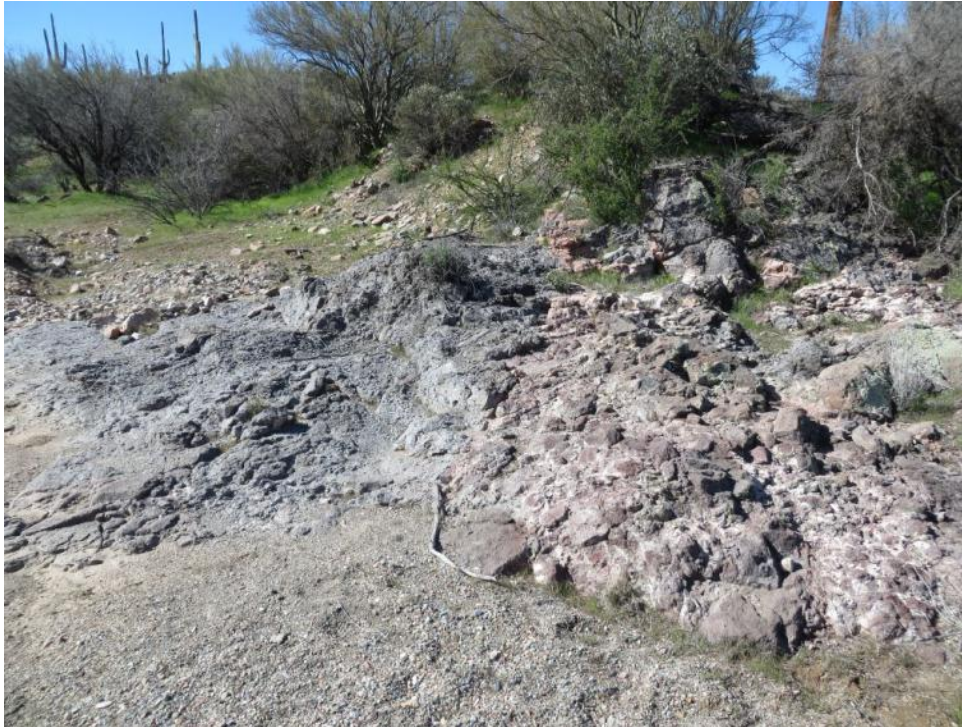
### OBS67

Basalt outcrop in channel. Disturbed rock mass. Half of the exposure weathering to a different colour however both sides appear to be the same rock type. Abundance of calcite (some large crystals) on basalt surface and infilling voids.

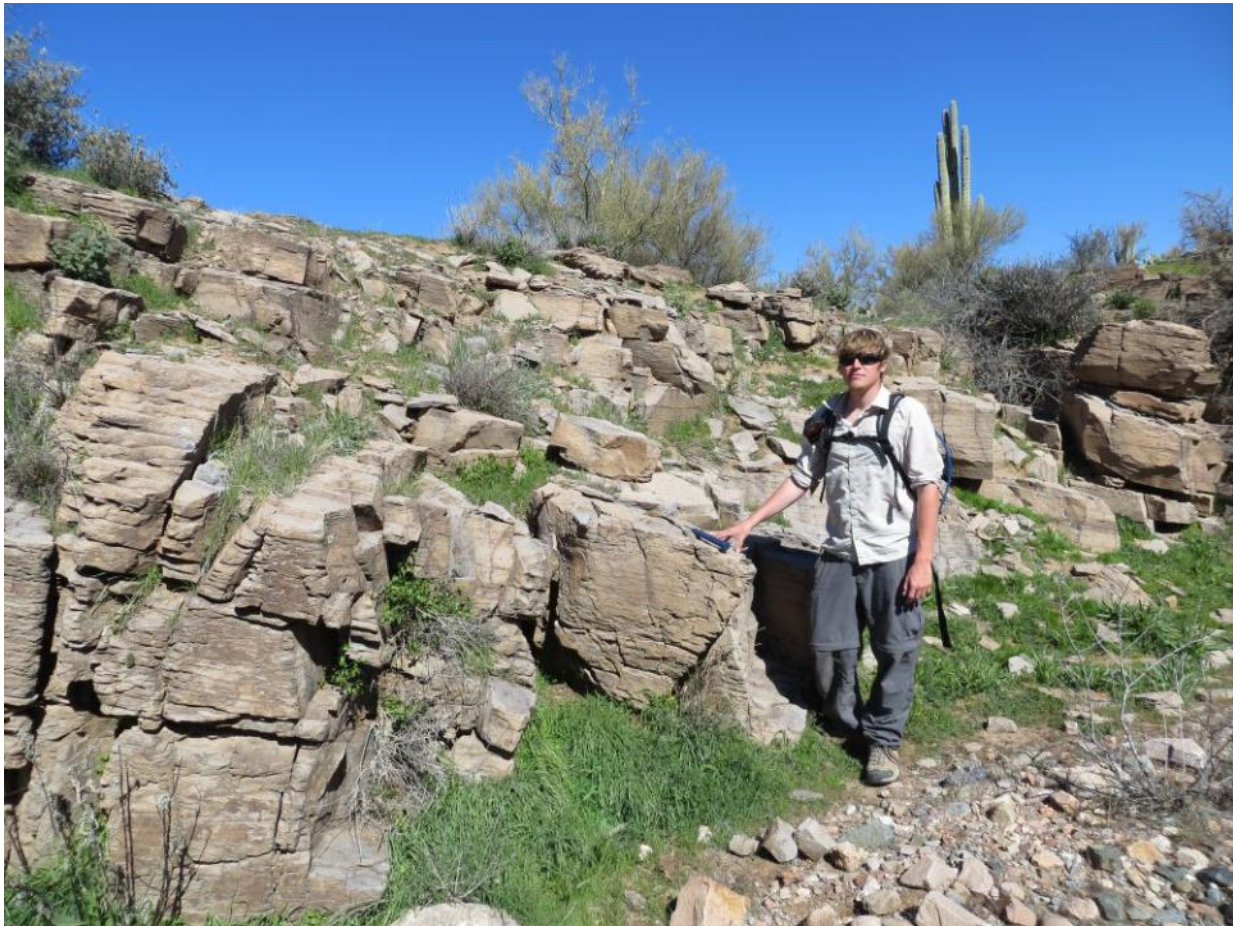
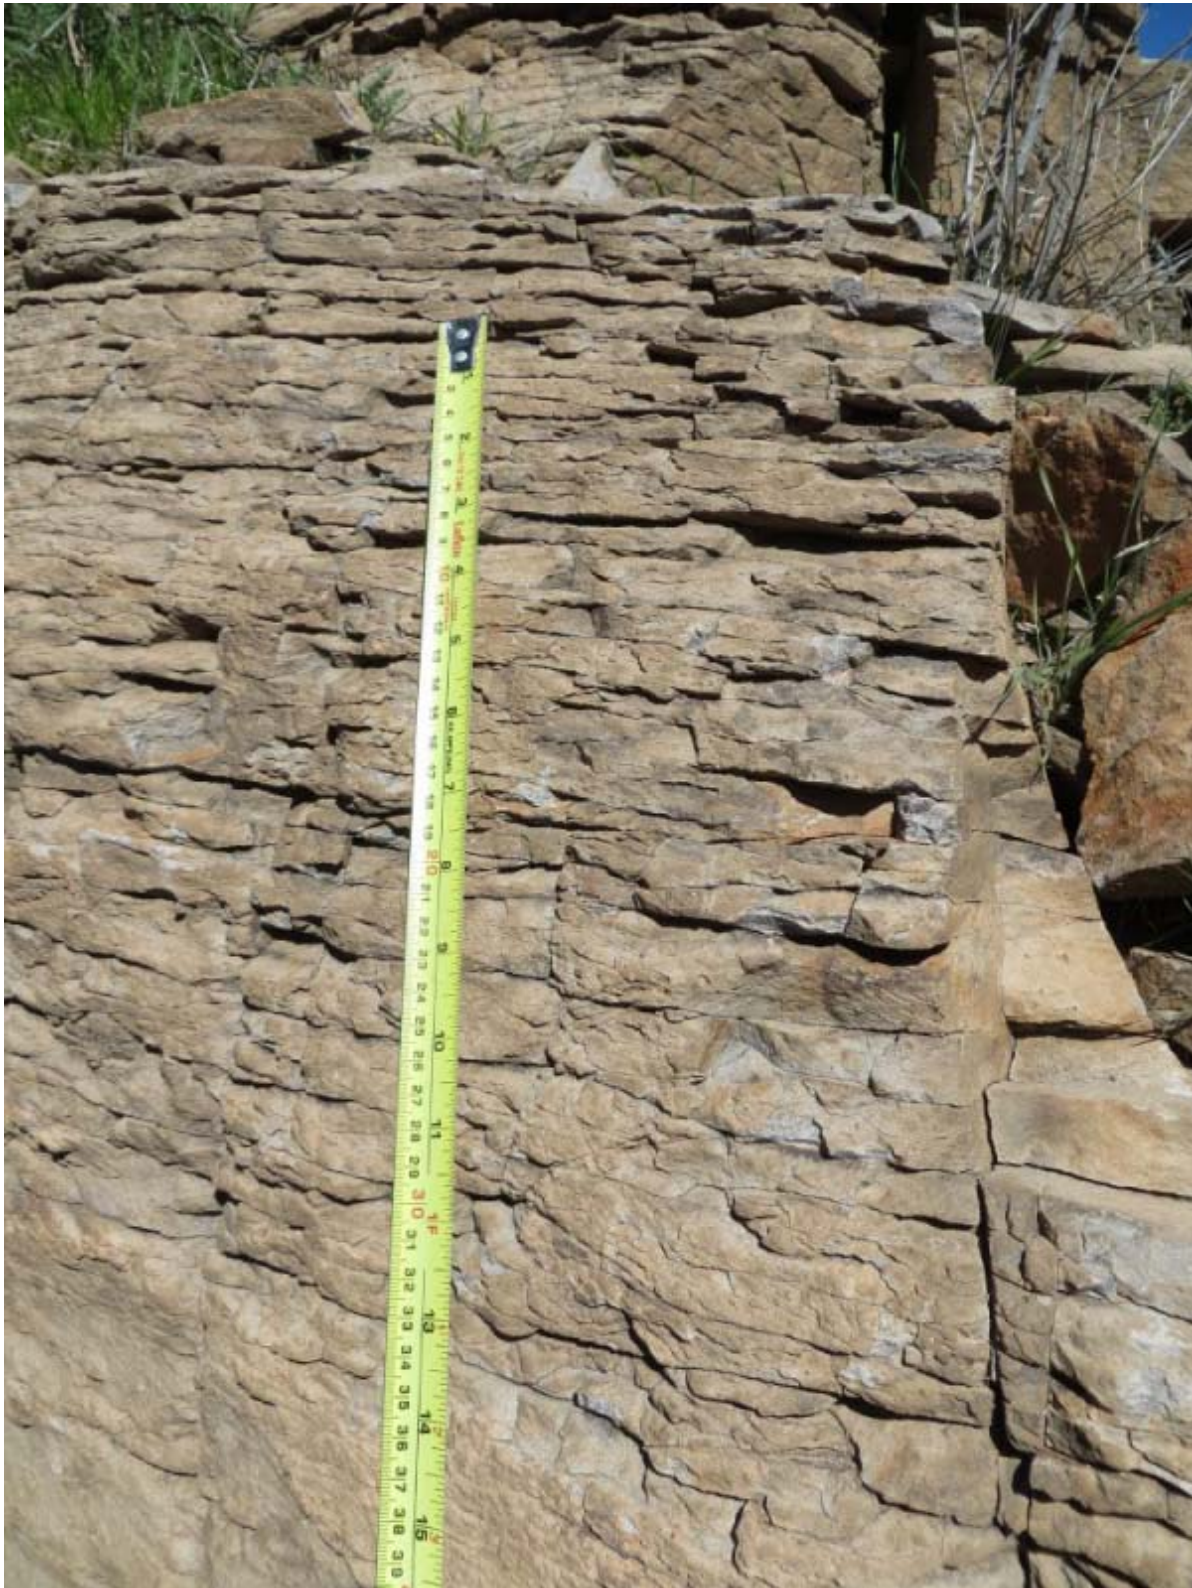
### OBS68

Exposure of phyllitic facies schist (Xpp). Fresh to slightly weathered, R5, very strong parallel foliation cleavage surfaces avg. 1 cm (*0.39 inches*) apart, closed, some other randomly oriented fractures cross cutting foliation planes, one large open vertical joint penetrating 60 cm (*23.6 inches*) into outcrop, foliation cleavage surfaces planar to undulating with “grainy” surface texture

Orientation of foliation cleavage: **355/15**

Orientation of large vertical joint: **350/90**

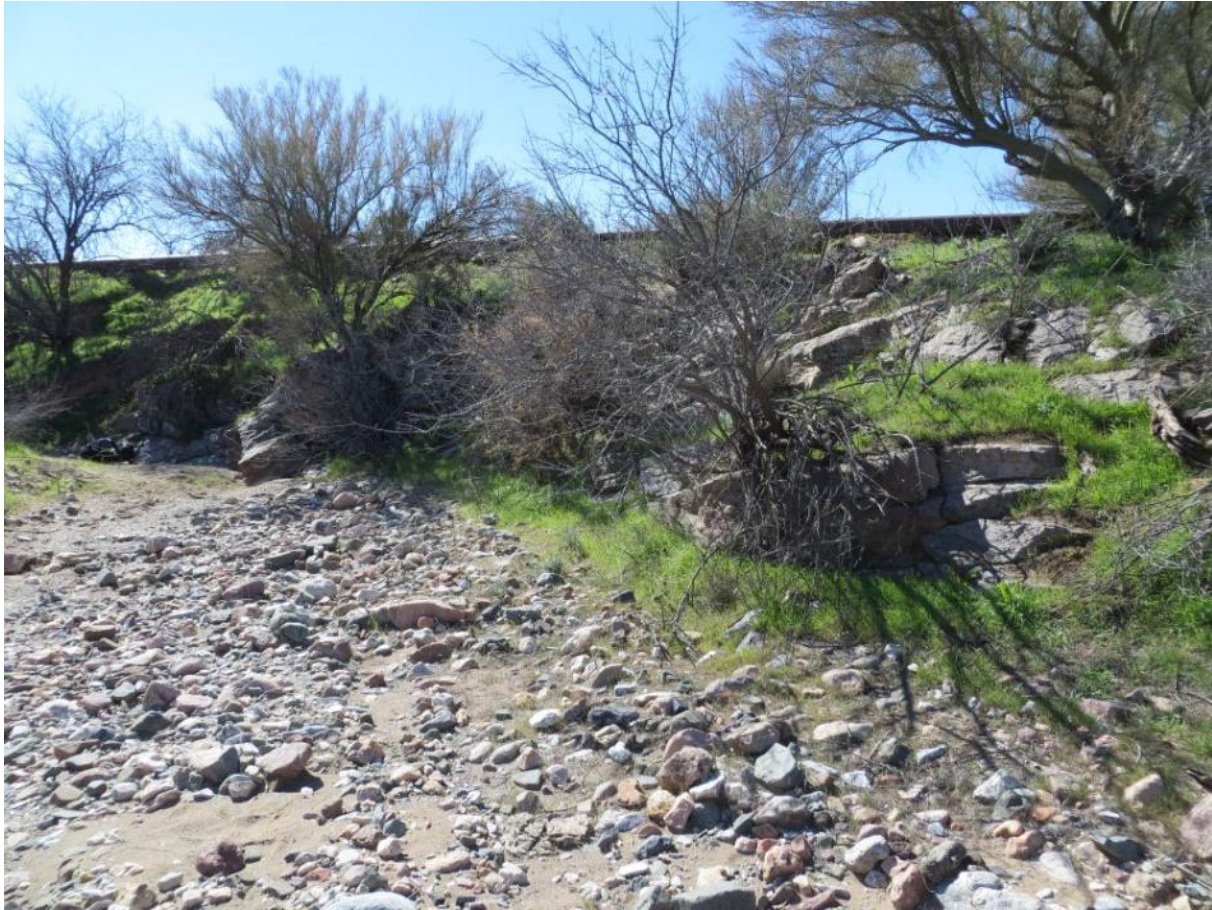
**OBS69**

Basalt exposure on right channel bank.

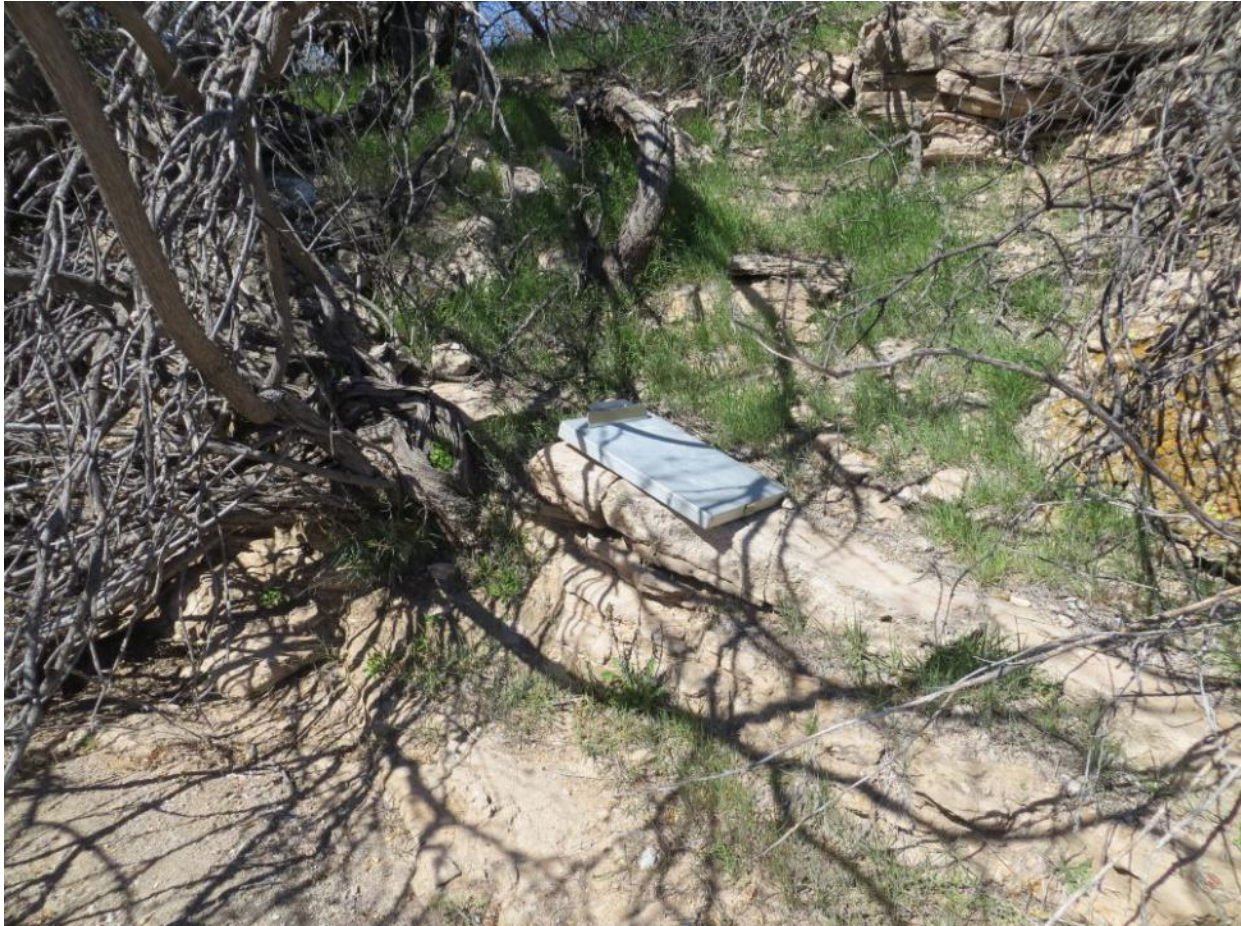
**OBS70**

Dipping cemented silty sand bed in left bank (Tss).

Orientation of bed: **346/17**
