## APPENDIX I-E

### Traverse #5

PROJECT  
RESOLUTION PROJECT  
2013 NEAR WEST SITE INVESTIGATION

TITLE  
CREEK TRAVERSE #5

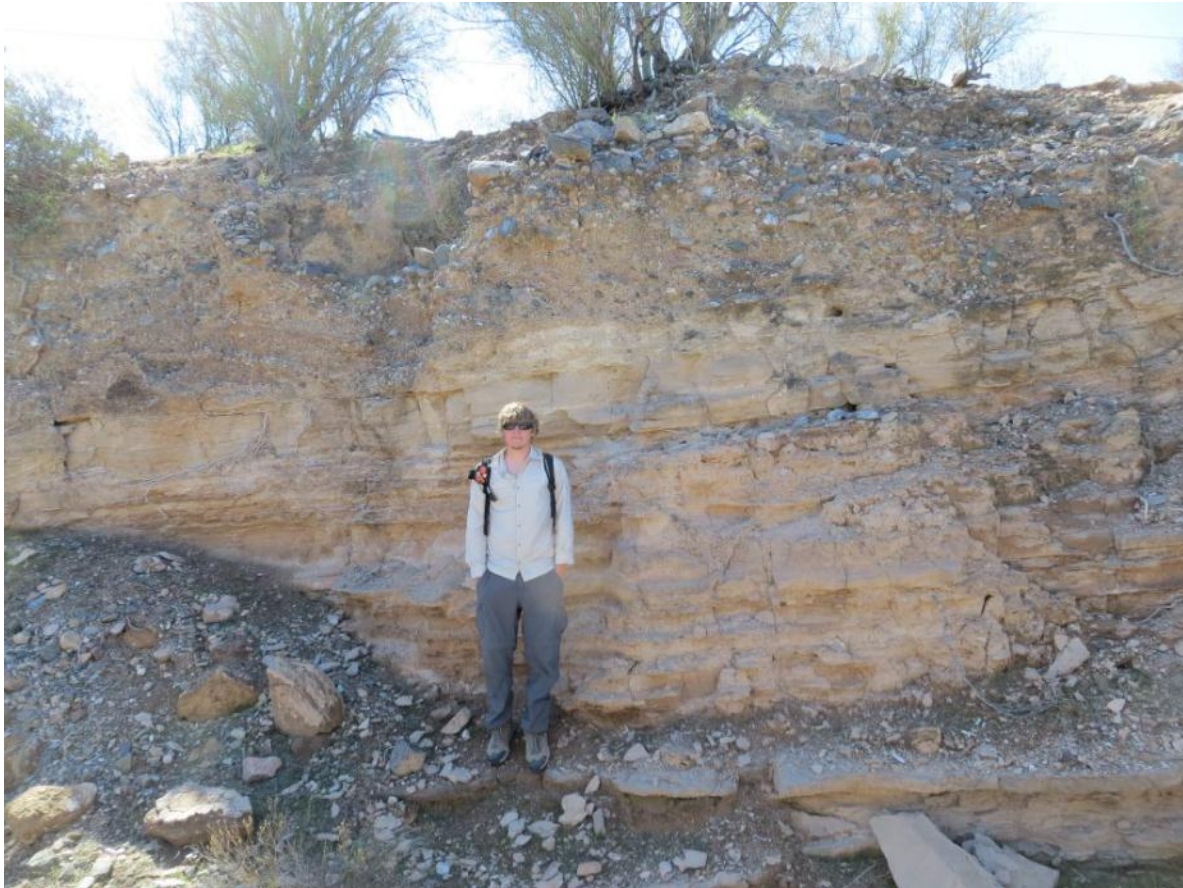
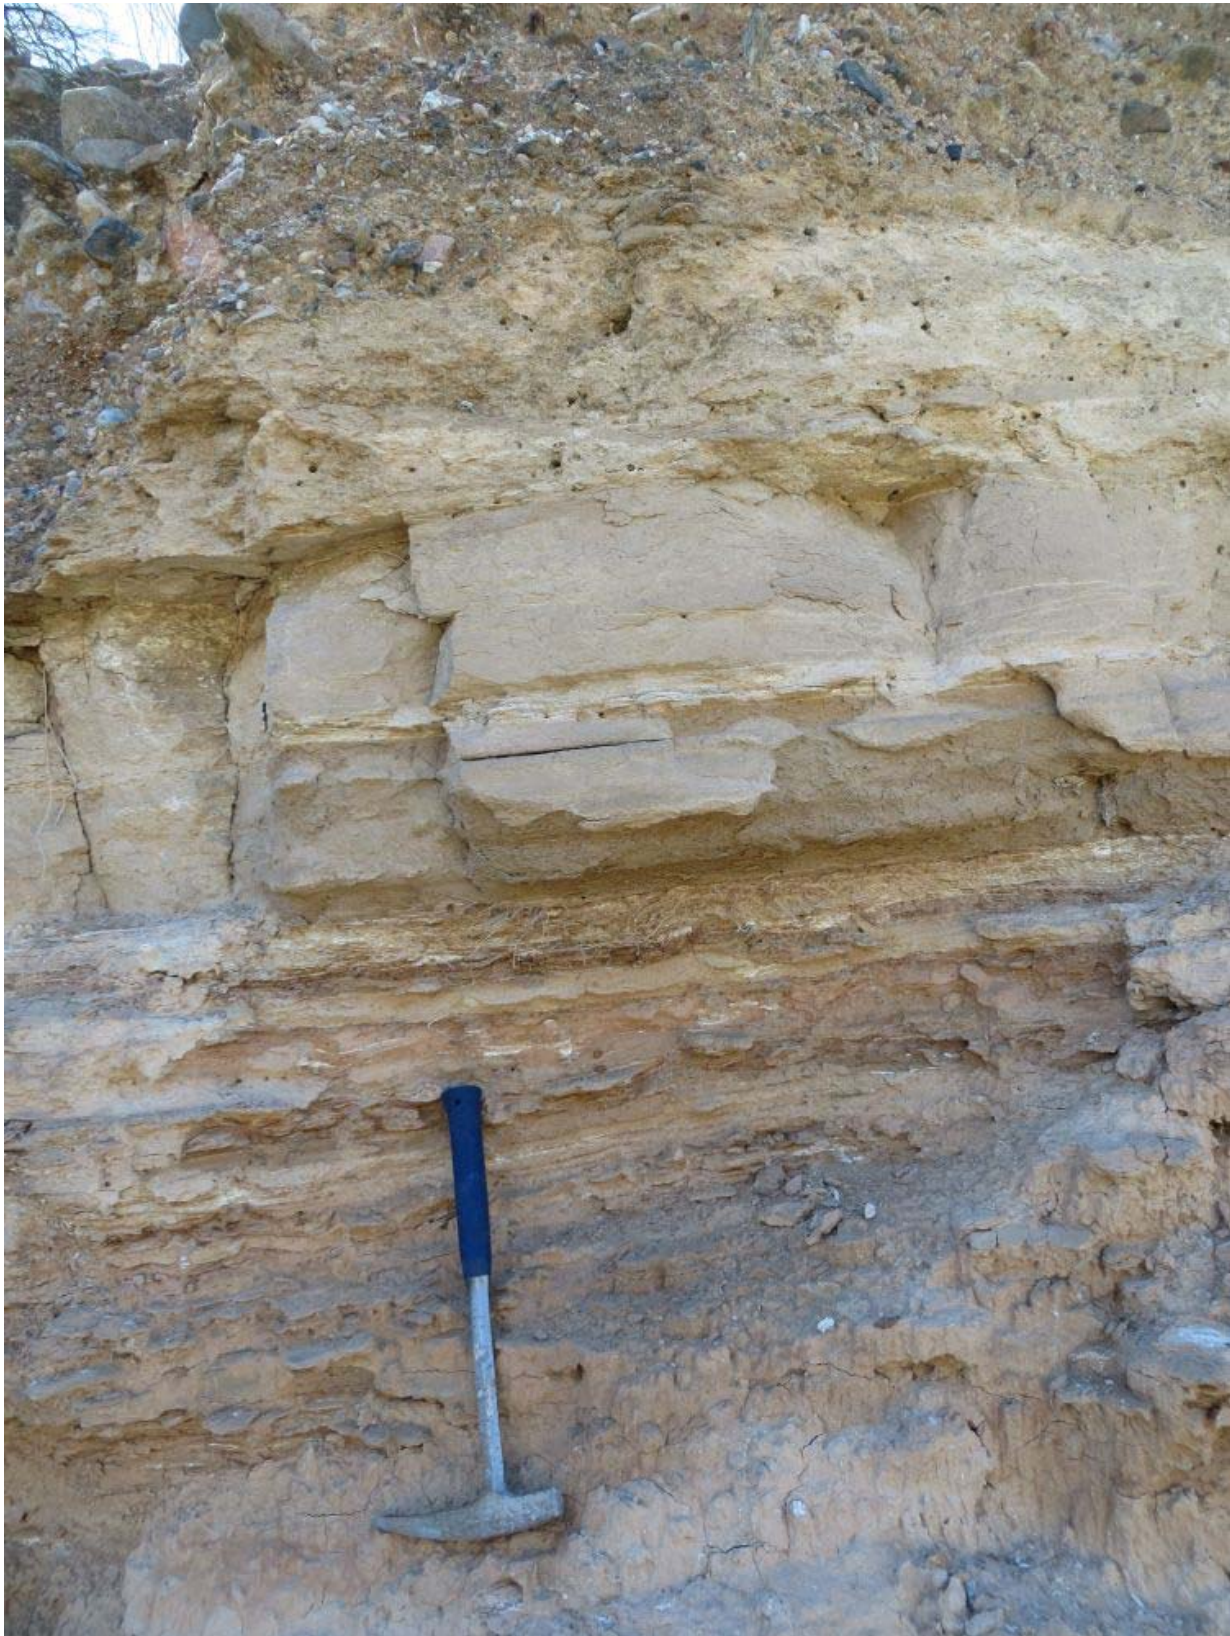
**OBS71**

2.5 m (8.2 ft) high exposure of parallel bedded silt and sand (Tss). Bed thickness ranges from scale of millimeters up to 20 cm (7.87 inches) thick. Cemented.

Orientation of bedding: **350/10**

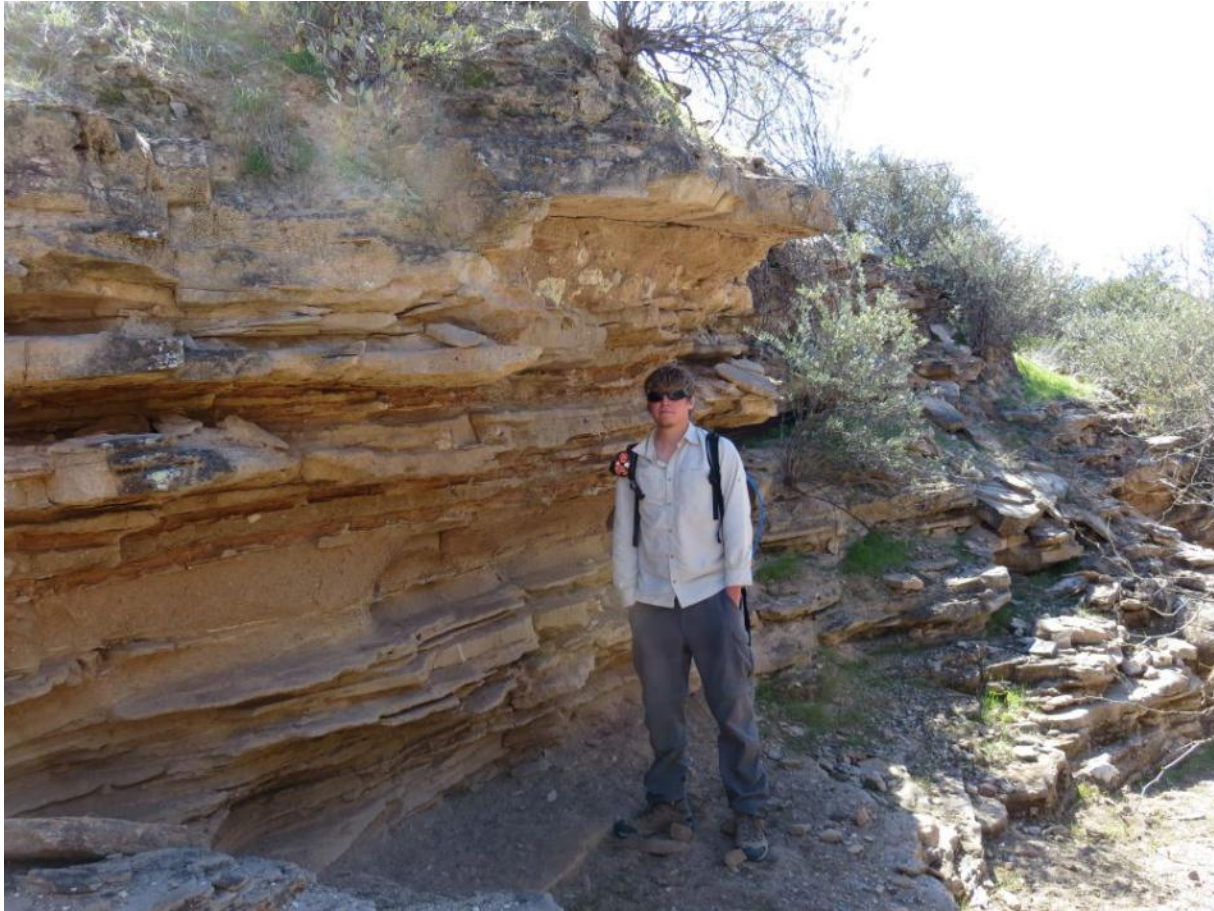
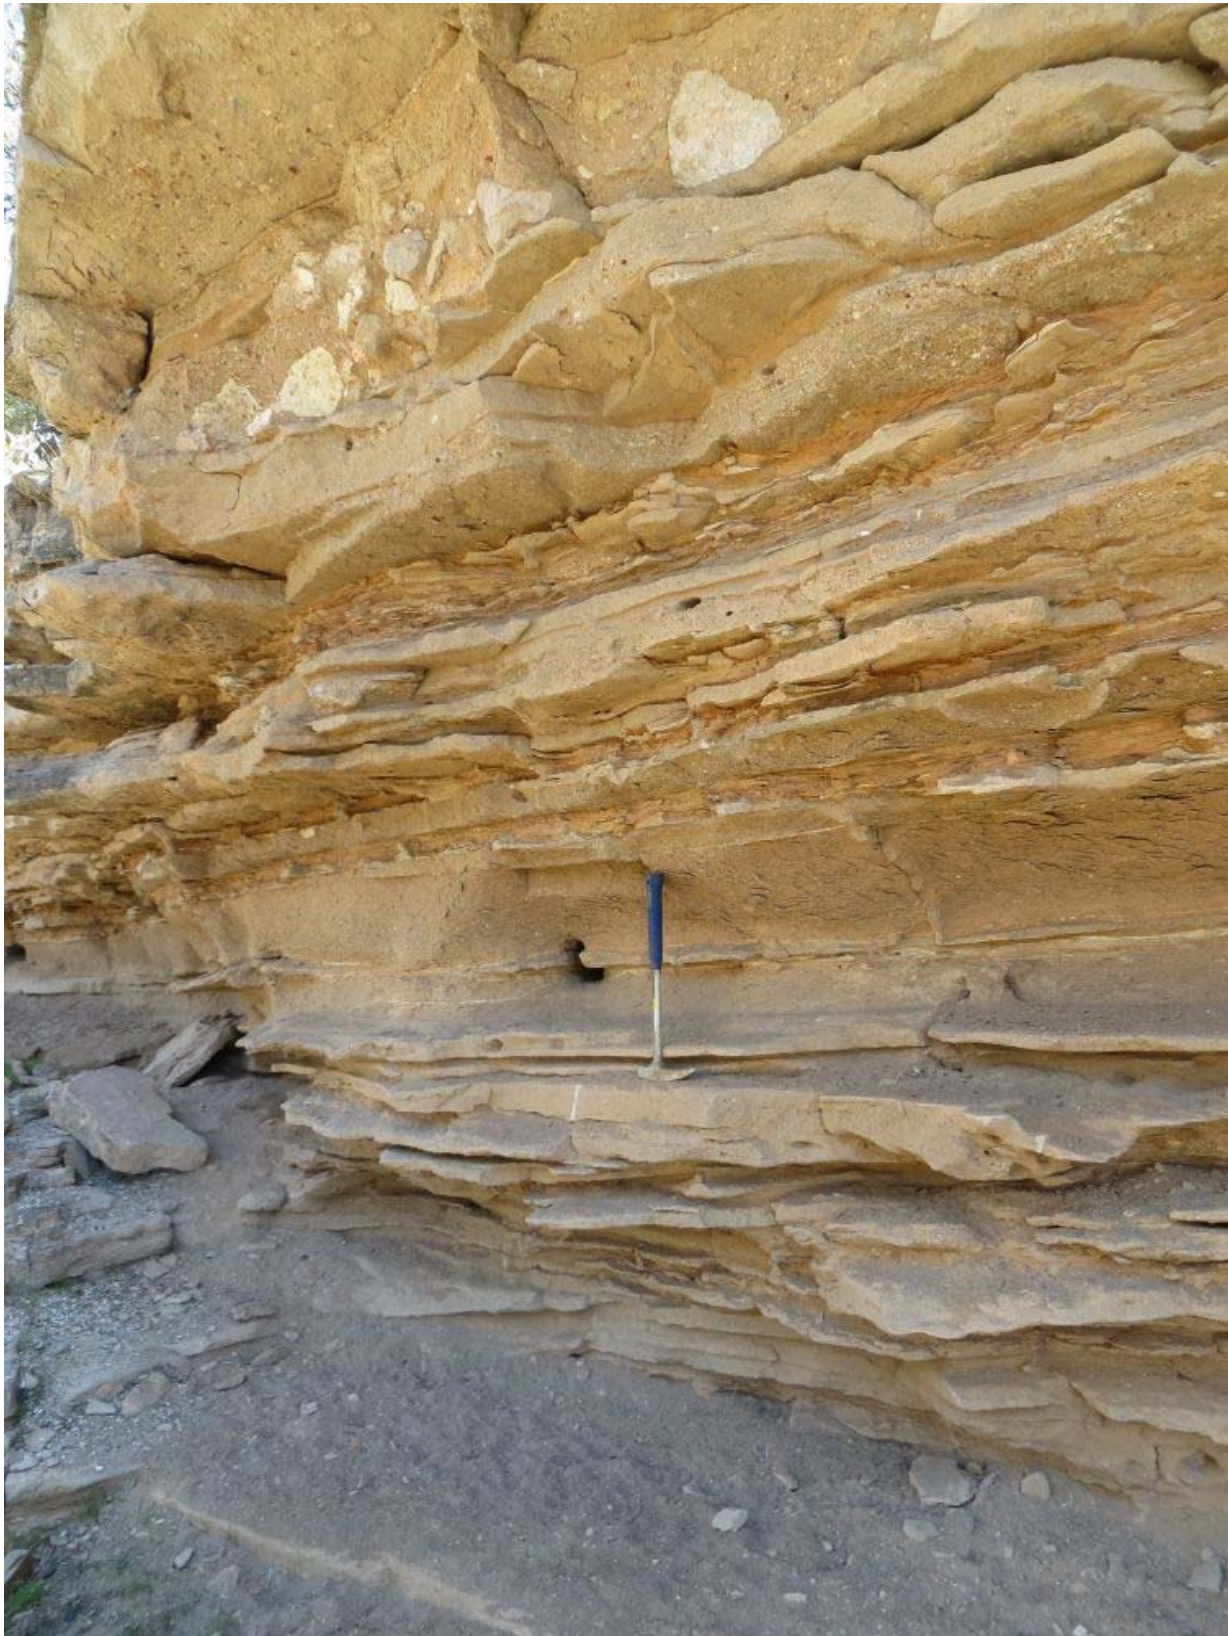
**OBS72**

Bedded Tss. Cemented silt to well graded sand, gravel and cobbles. Beds range from >1 mm to 20 cm (>0.04 to 7.87 inches) thick. Differential weathering of finer beds. Fine, silty beds = R0 (soil) and coarser beds = R2/R3.

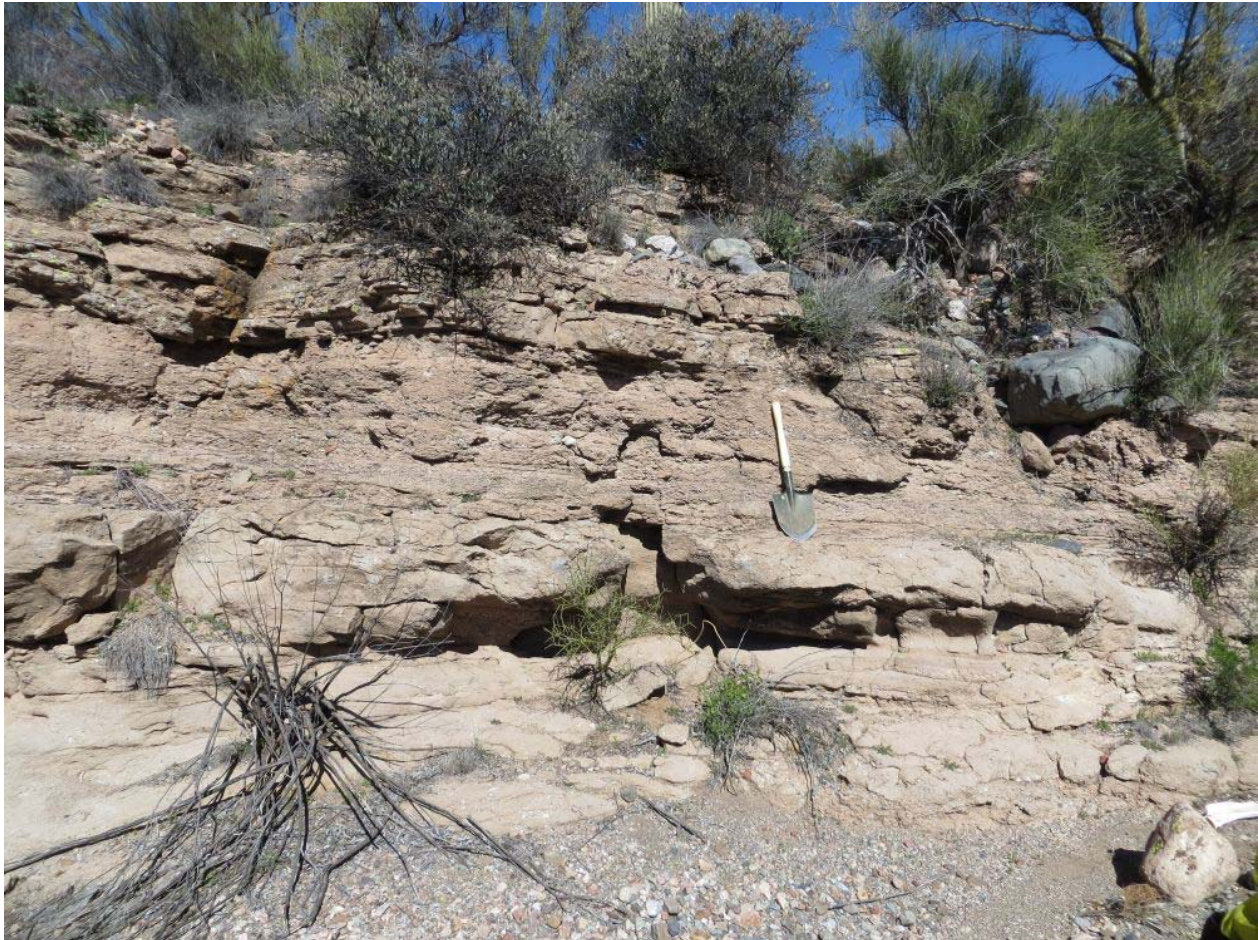
**OBS73**

Potential contact between sandstone (Tss) and conglomerate (Tcg). Outcrops become coarser and more massive (bedding less apparent).

Orientation of bedding: **348/07**

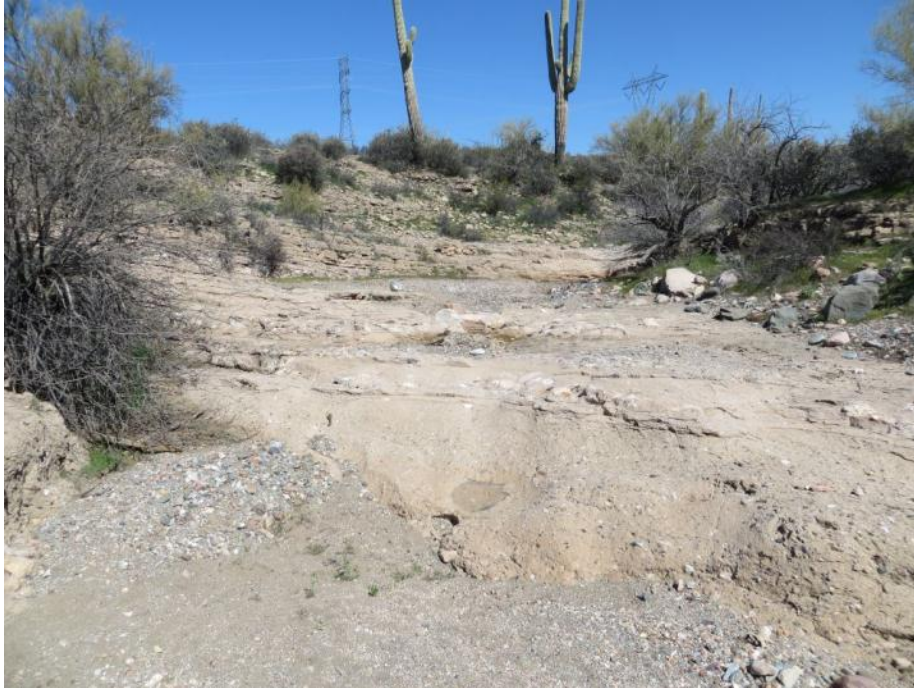
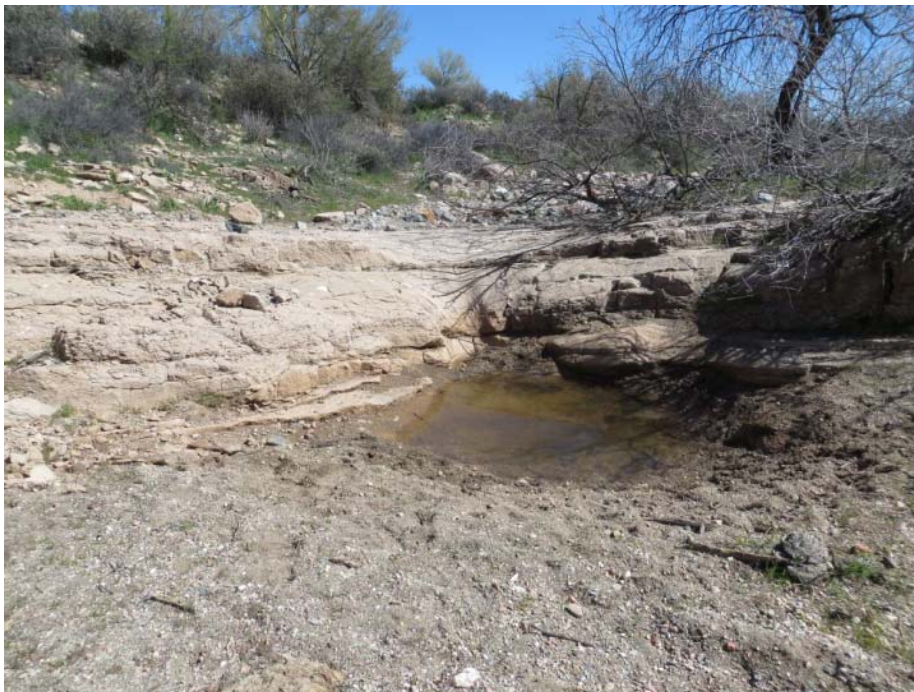
**OBS74**

Two 1 m (3.3 ft) elevation drops in channel over conglomerate outcrops spanning the channel invert. Water ponding at the base of the first (upstream) ledge.

Orientation of bedding: **331/08**

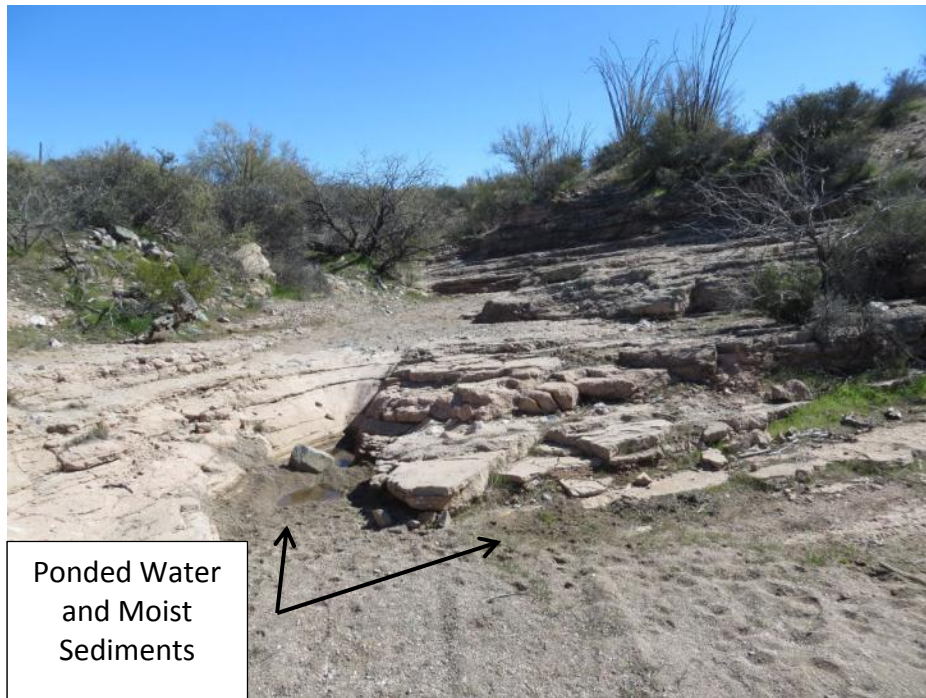
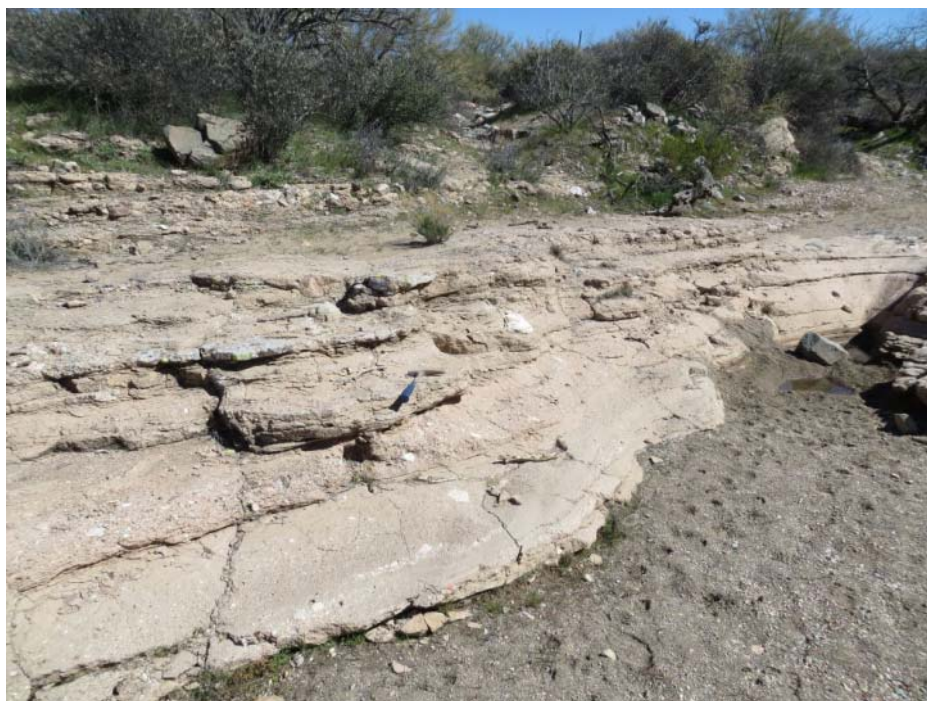
### OBS75

Two 1 m (3.3 ft) elevation drops in channel over conglomerate outcrops spanning the channel invert. Water ponding at foot of ledges. Stream makes a 90 degree bend at this location. Steep conglomerate exposure on the outside of bend is coarse and massive (R4).

Orientation of bedding: **306/08**

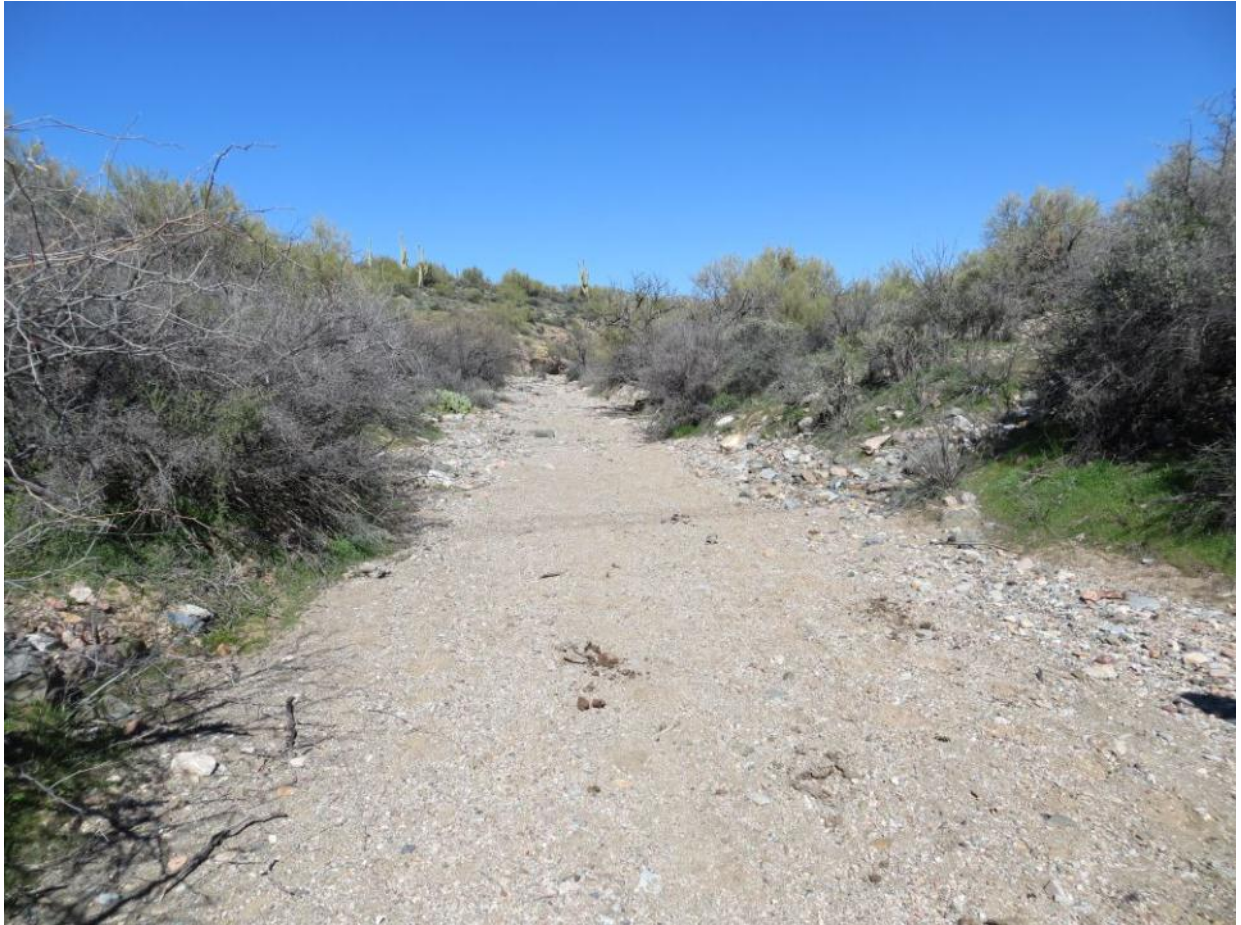
**OBS76**

Channel width = 6 m (19.7 ft).

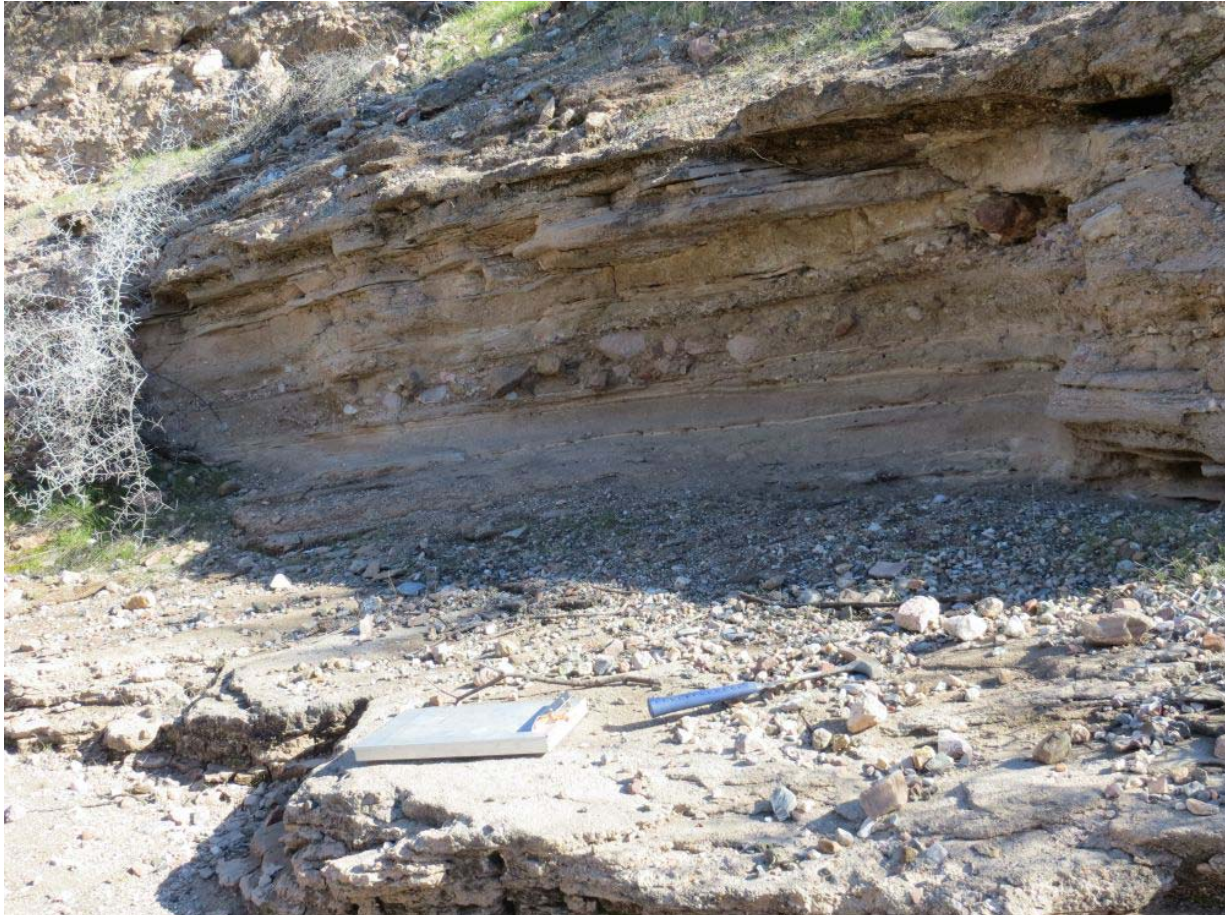
**OBS78**

1 m (3.3 ft) elevation drop in channel over sub-horizontal conglomerate ledge spanning channel invert. Moist sand at base of drop.

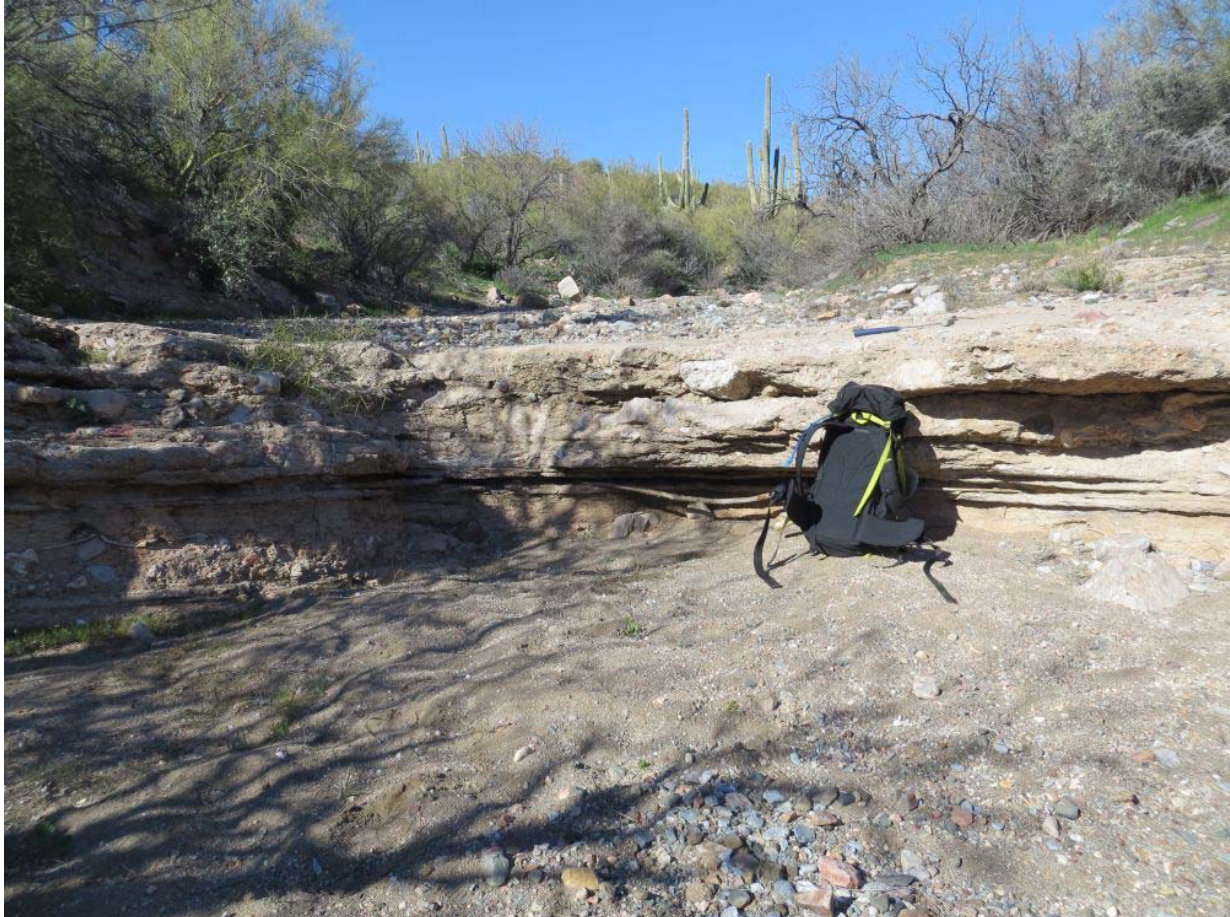
**OBS79**

Conglomerate exposure on outside of channel bend. Massive with some large clasts (>1 m (>3.3 ft)), cemented, rock strength controlled by strength of large clasts.

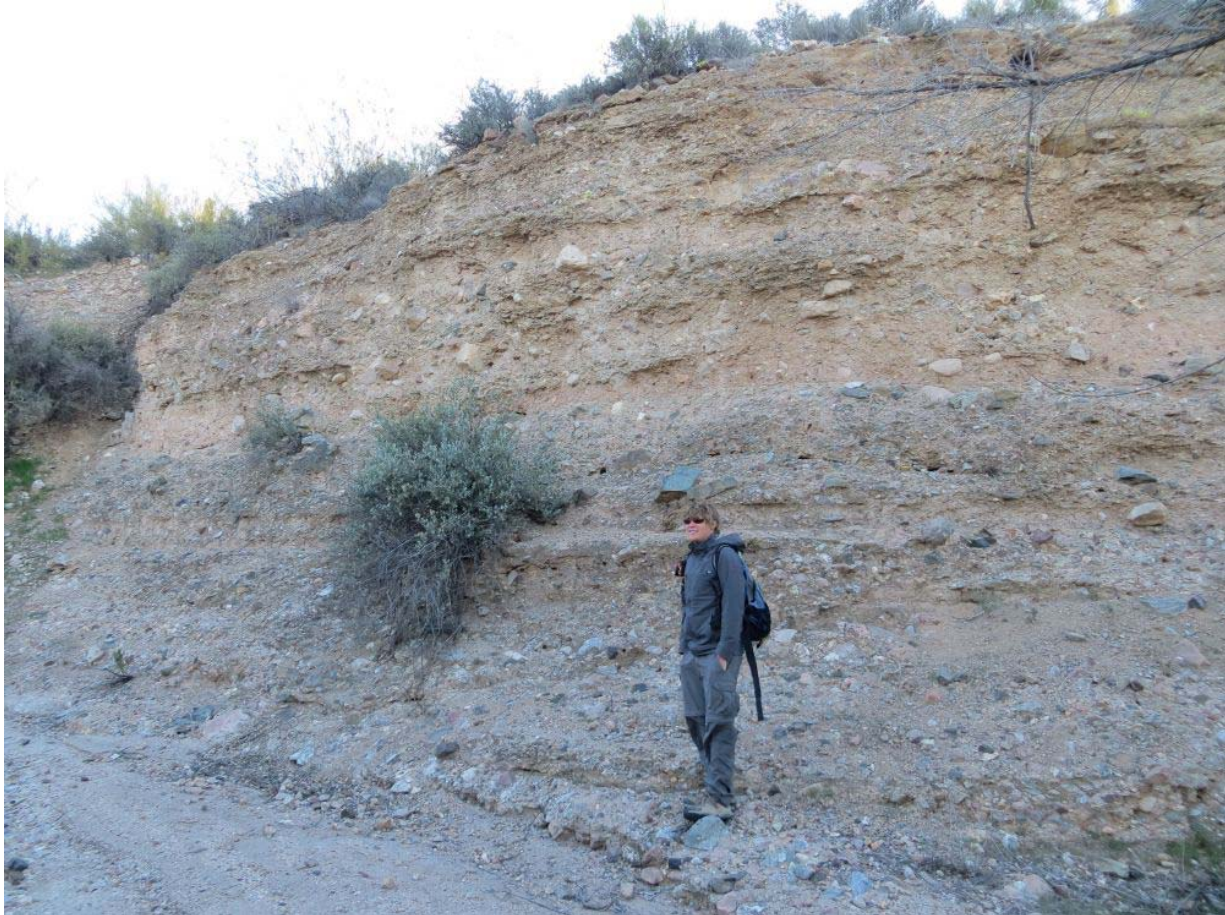
**OBS81**

Conglomerate (~ 1.5 m (~4.9 ft) thick, R3) overlain by either weathered and weakened conglomerate or old alluvium (R1 to R0). Softer material is moist at surface, reactive to acid and has the same clast lithology and size as the more cemented unit below.

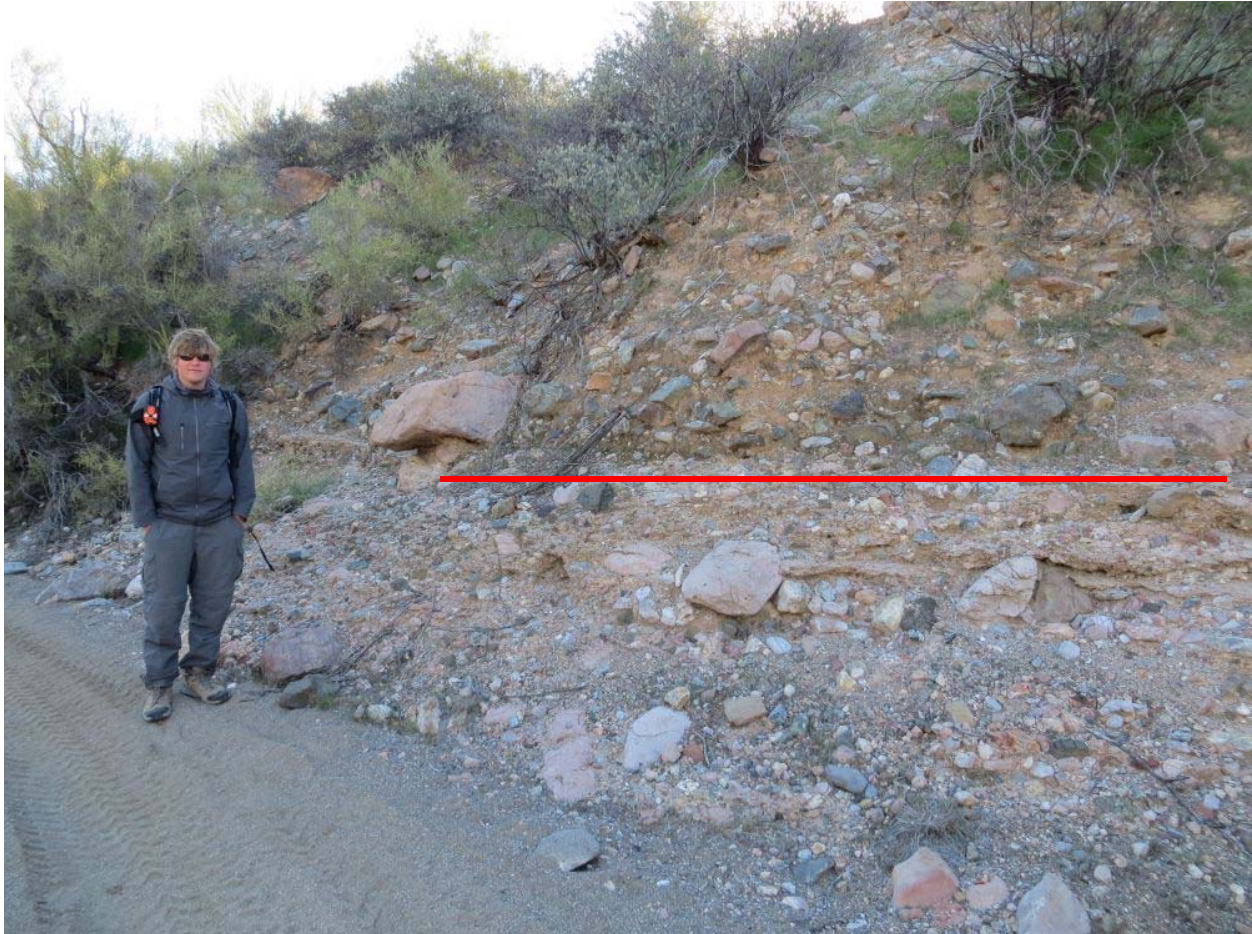
**OBS82**

0.6 m (1.97 ft) high overhang carved out of base of conglomerate exposure on outside of gradual channel bend. Rock strength = R3.

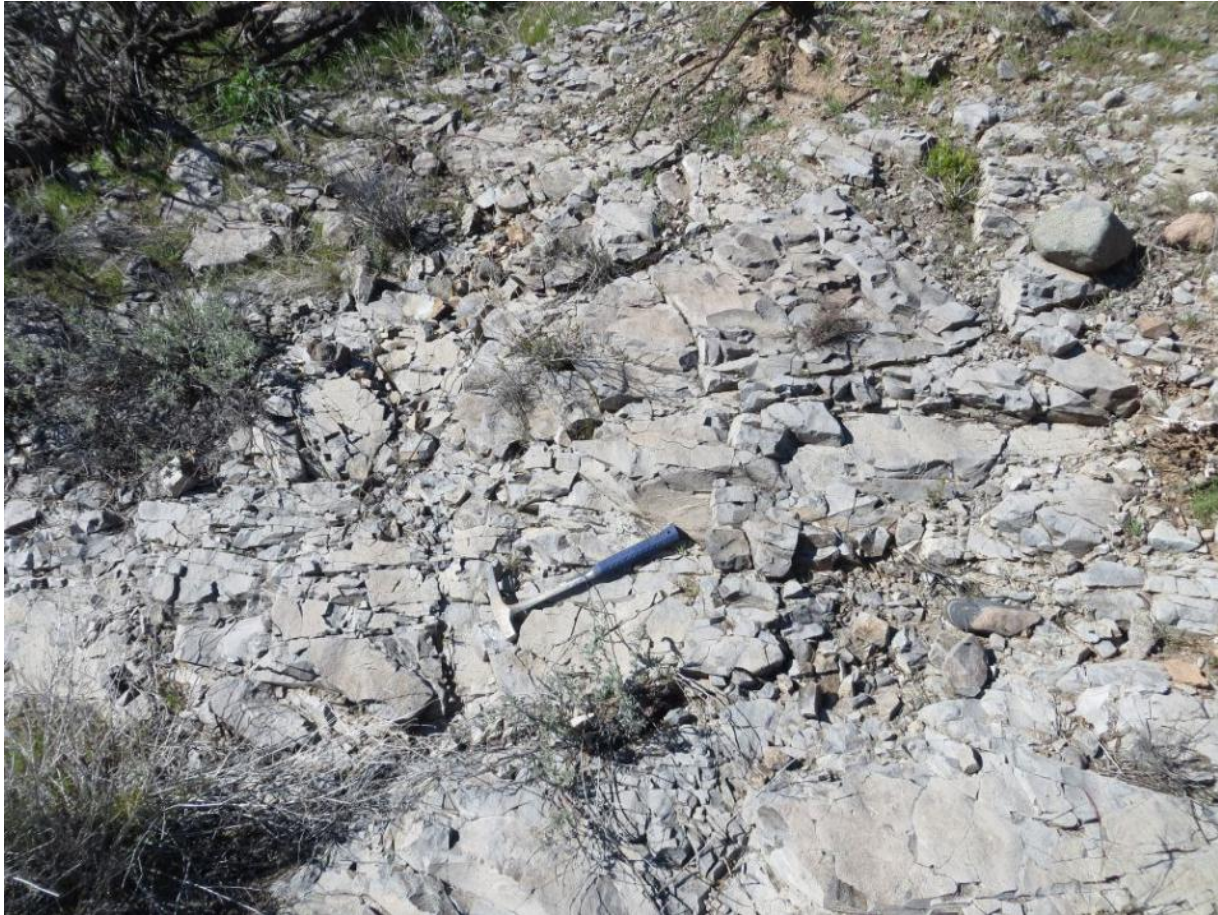
**OBS83**

Basalt exposure on left channel bank. Fresh, R4, disturbed rock mass with randomly oriented fractures. One joint set observed with spacing ranging from 10 cm to 0.5 cm (*3.94 inches to 0.20 inches*), closed with smooth/planar surfaces.

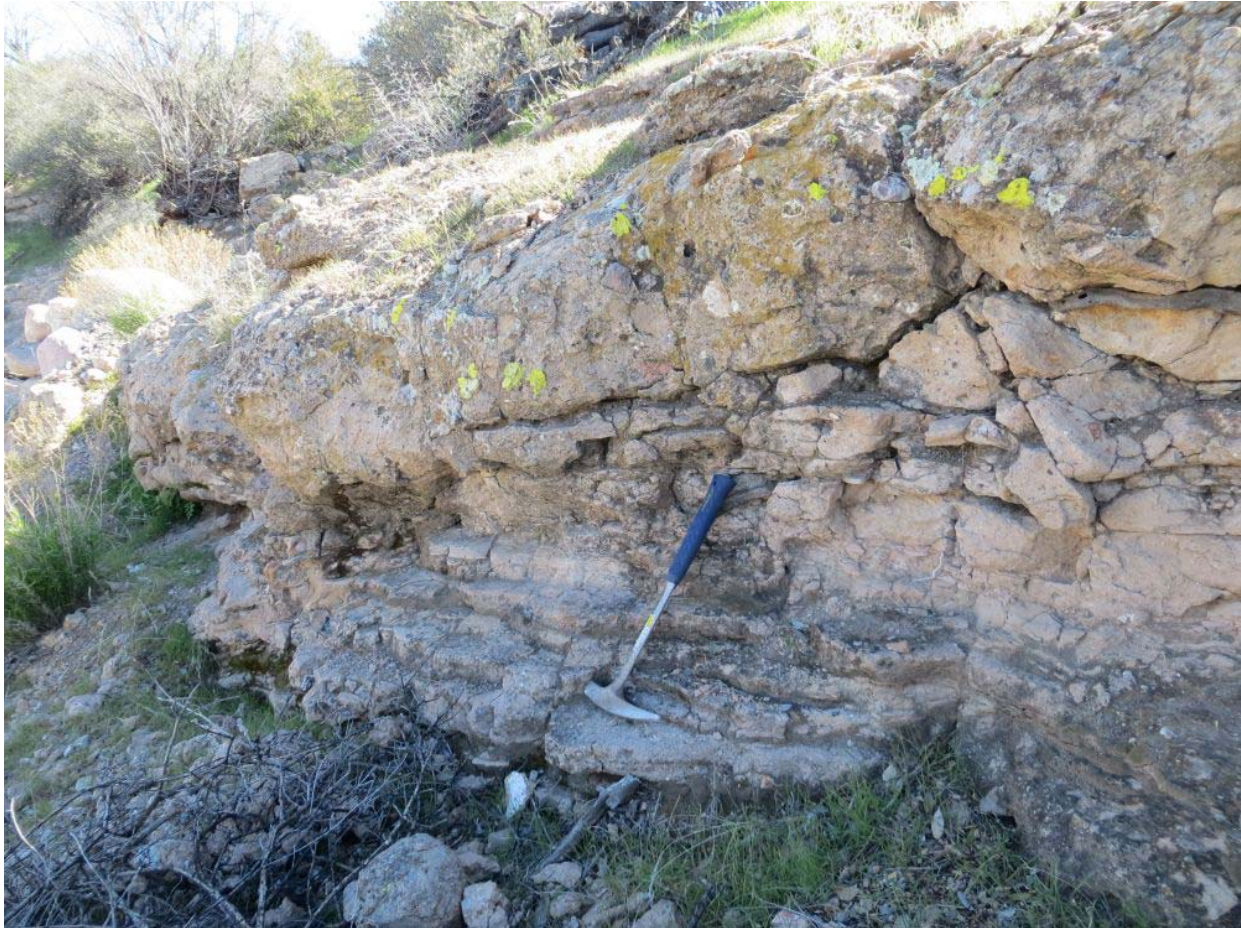
#### OBS84

Exposure of Tertiary Sandstone (Tss). Cemented well graded gravelly sand, R4, max. particle size = 5 cm (1.97 inches), sub-angular to angular grains, bed thickness ranges from 70 cm (27.6 inches) to mm scale, differential weathering of finer, siltier beds.

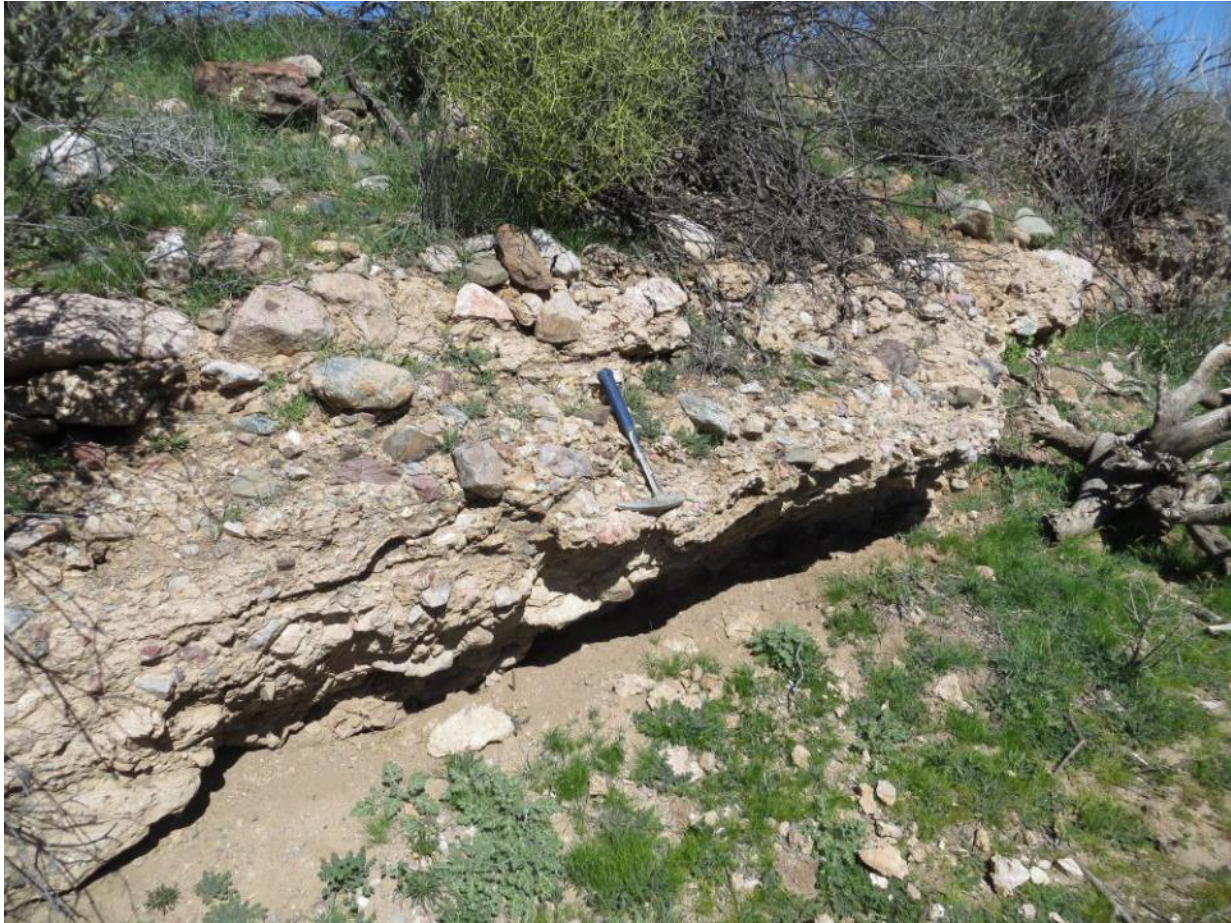
**OBS86**

1.5 m (4.9 ft) high massive conglomerate outcrop in left channel bank, R3.

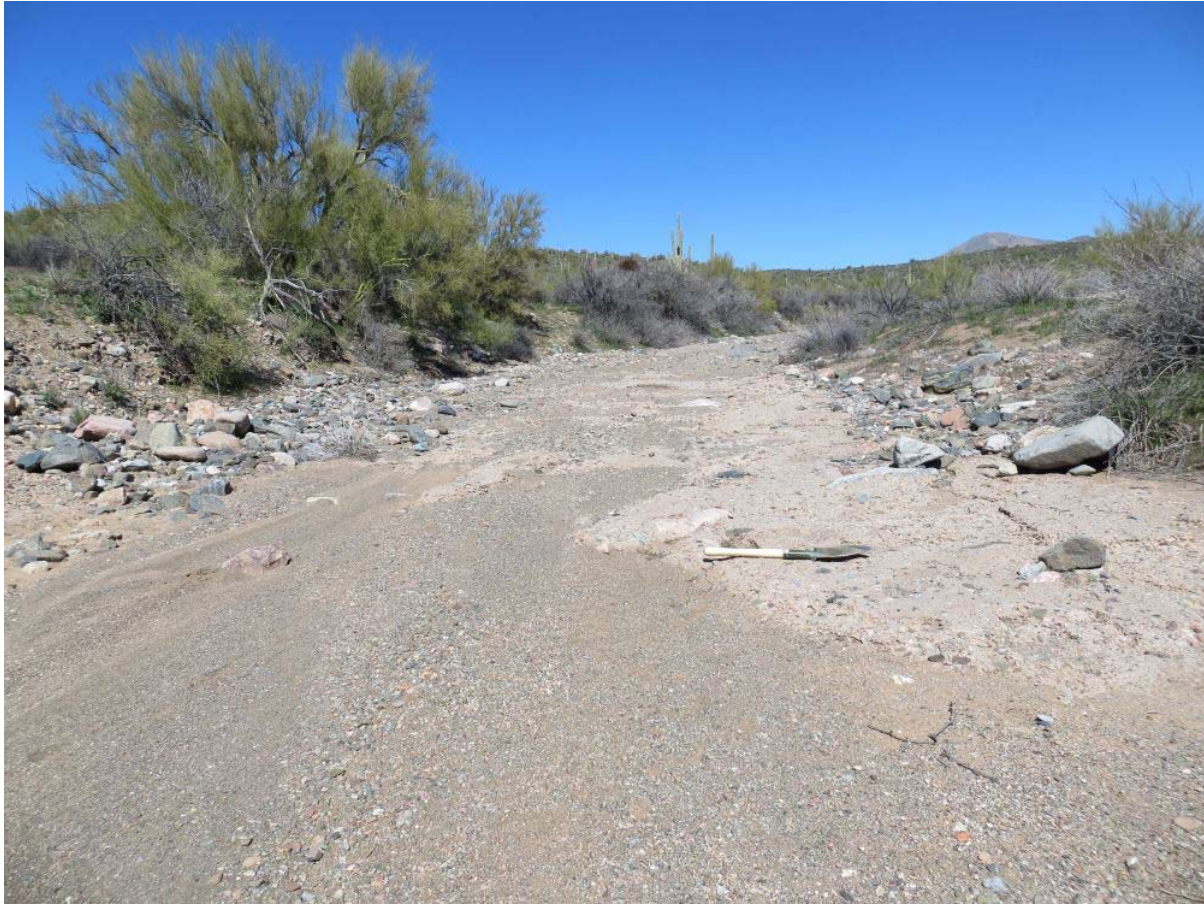
**OBS87**

Horizontal conglomerate beds spanning the channel invert.

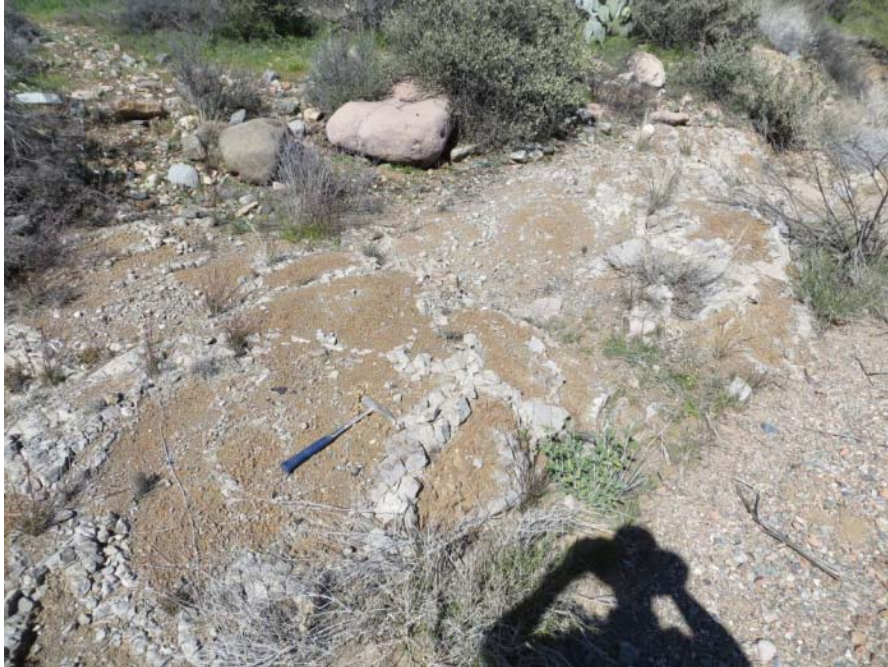
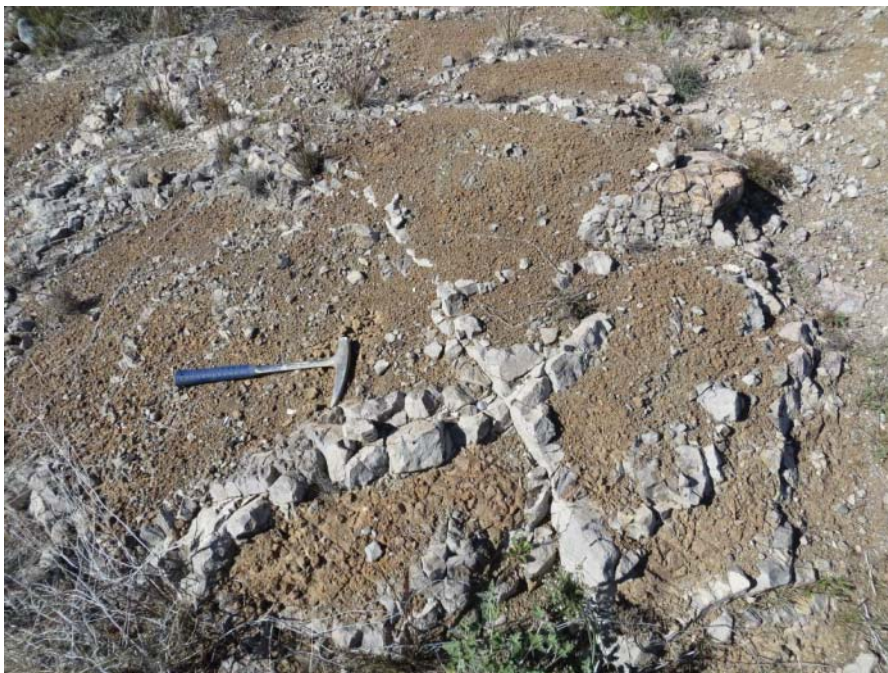
**OBS88**

Differential weathering of disturbed basalt surface on left channel bank. Basalt along strike of vertical joints less weathered than surrounding rock.

Orientation of two joint sets: **310/90 and 225/90**
