## APPENDIX I-E

### Traverse #5

PROJECT  
RESOLUTION PROJECT  
2013 NEAR WEST SITE INVESTIGATION

TITLE  
CREEK TRAVERSE #5

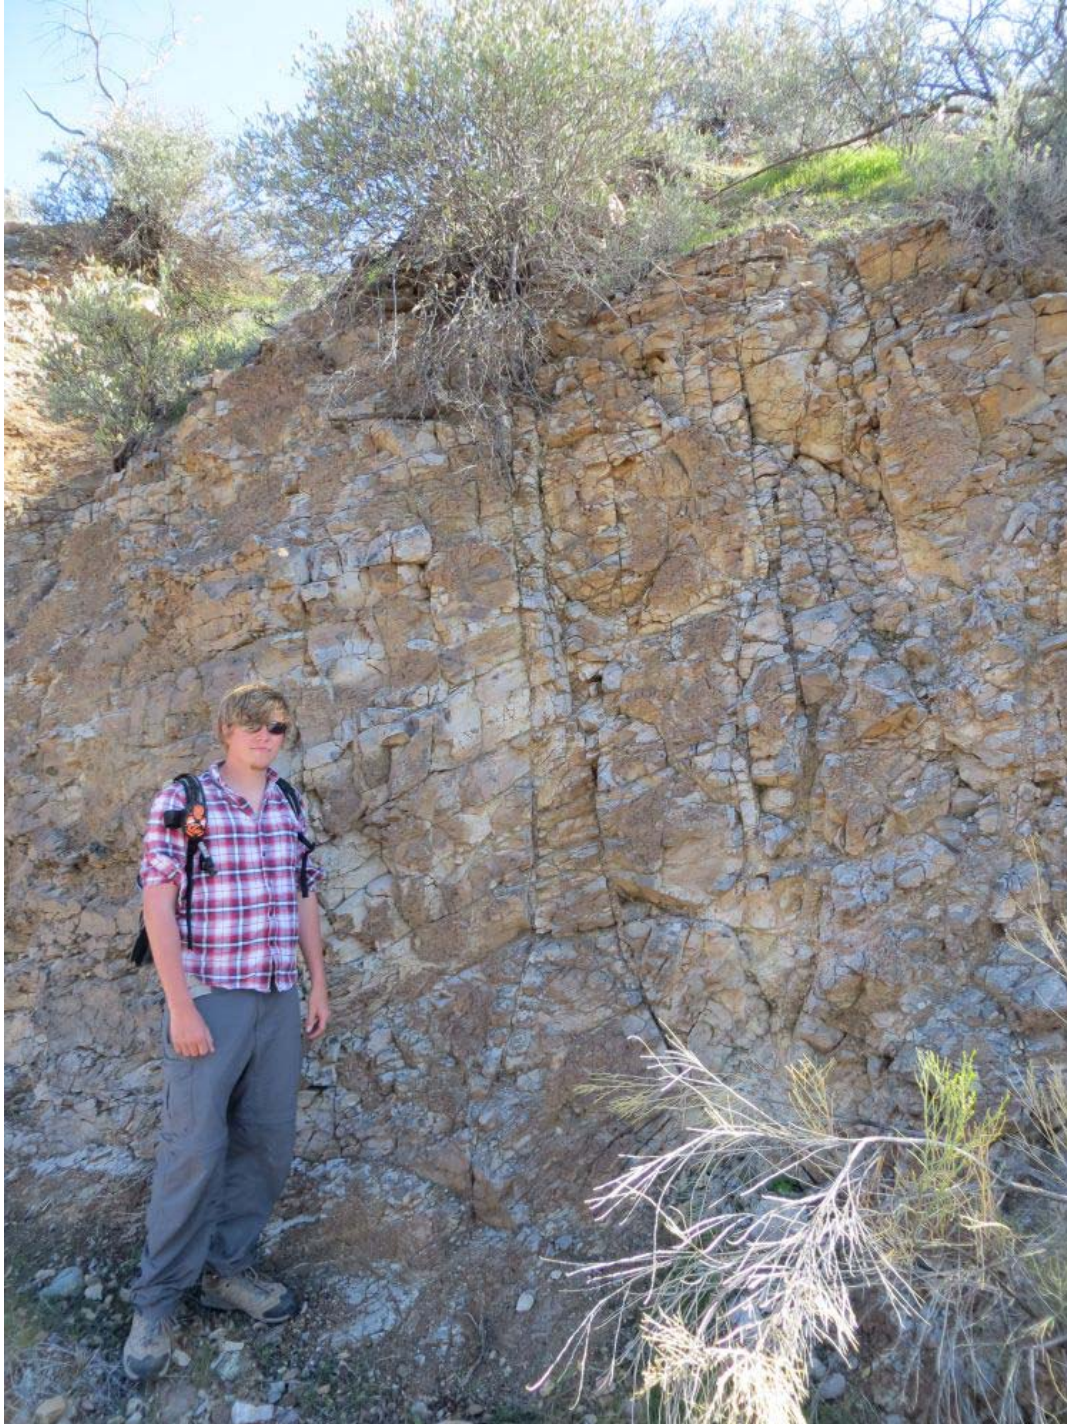
**OBS90**

High water marks caused by calcite staining on the surface of cobbles in the river channel. Calcite staining extends 8 cm (3.15 inches) above channel invert.

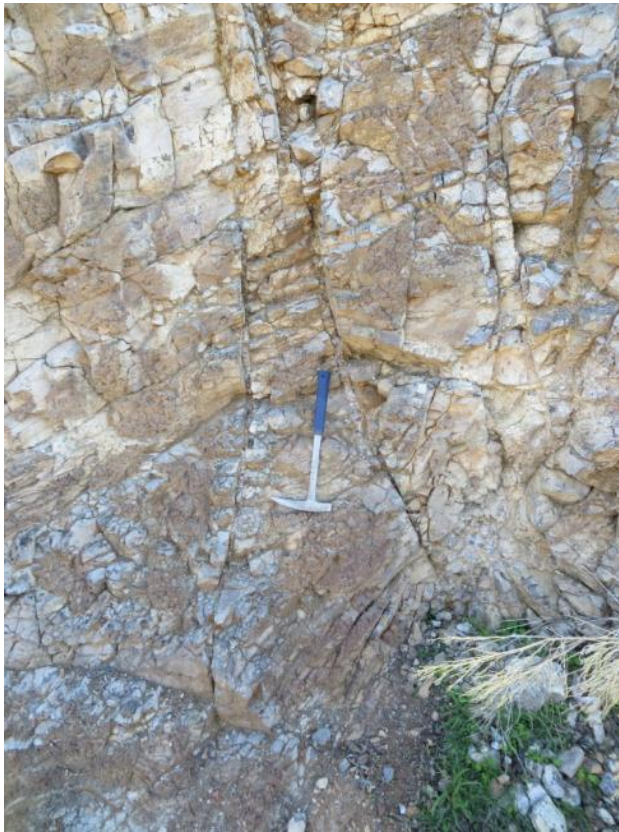
### OBS89

Fractured/disturbed basalt. Two continuous vertical fractures observed running the length of the outcrop. One wide (70 cm (27.6 inches)), vertical, heavily fractured zone that forms a depression in the outcrop face and along the ridge above the outcrop. Fractured zone infilled with well graded sand and fractured basalt. Rock mass strength R3 to R4.

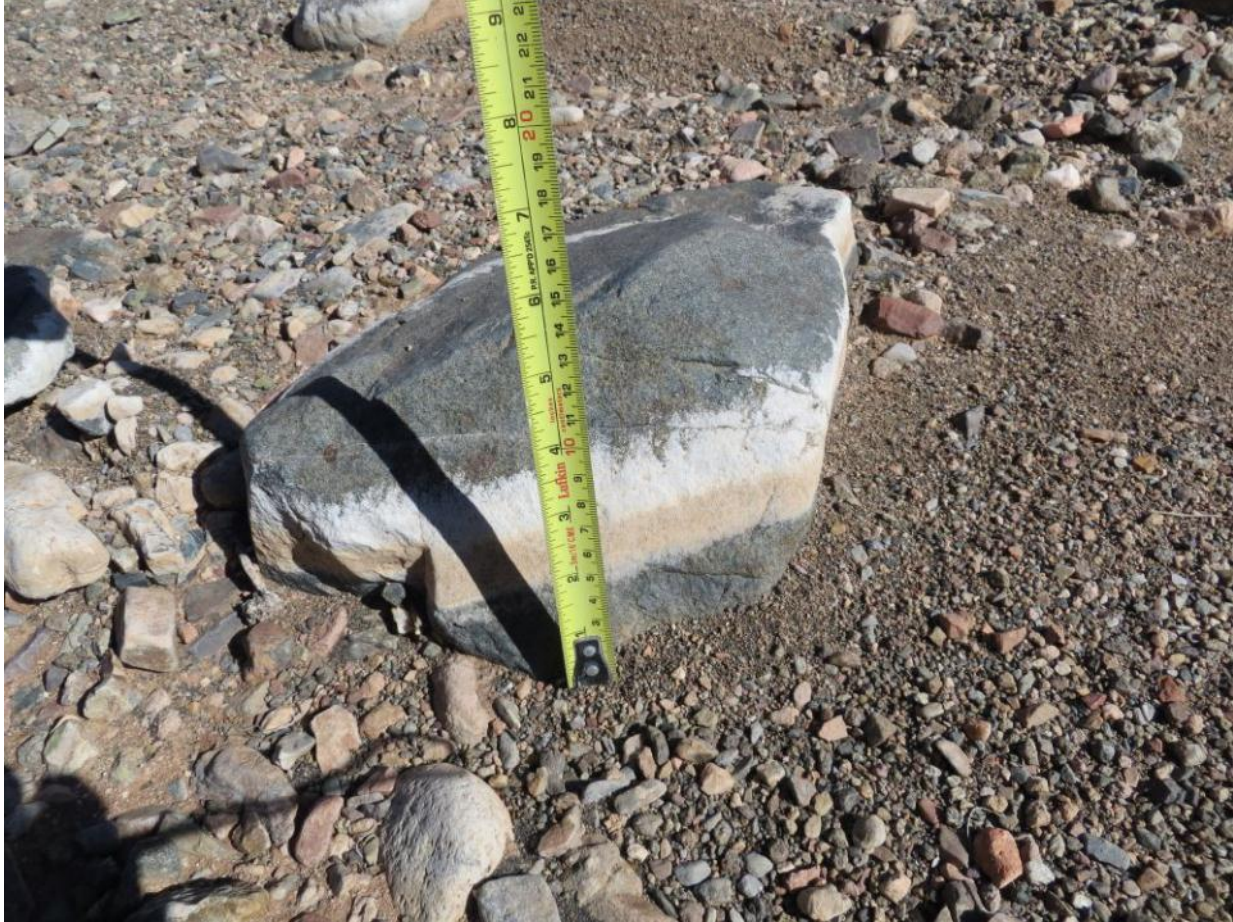
**OBS91**

Welded tuff with basalt inclusions outcropped on left channel bank. Large calcite crystals formed in voids within the basalt.

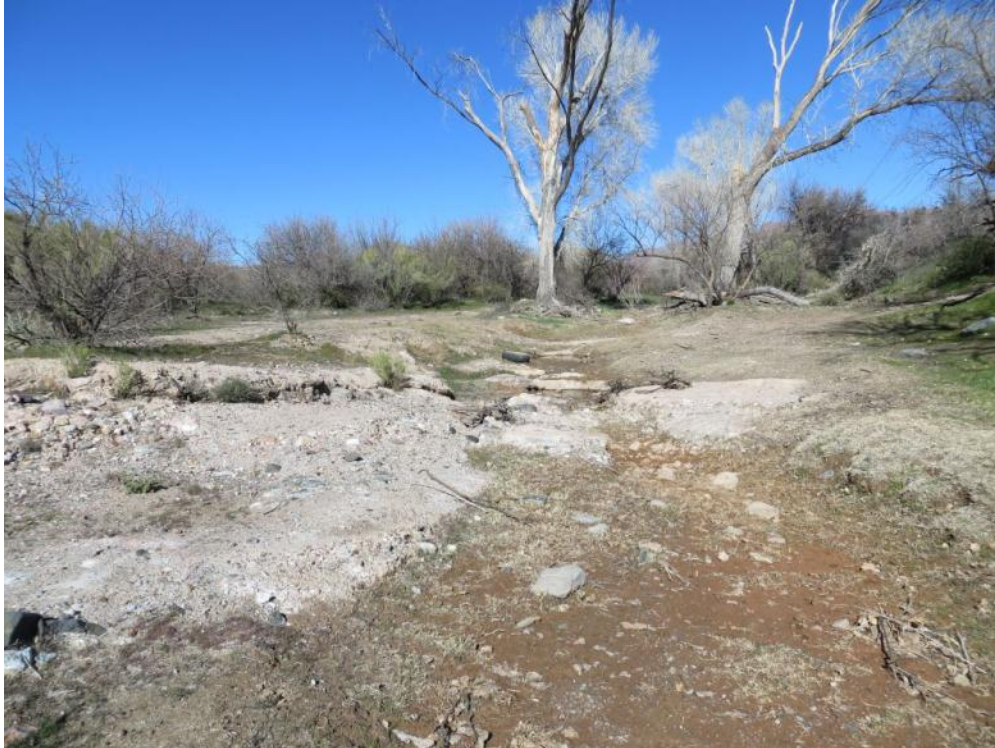
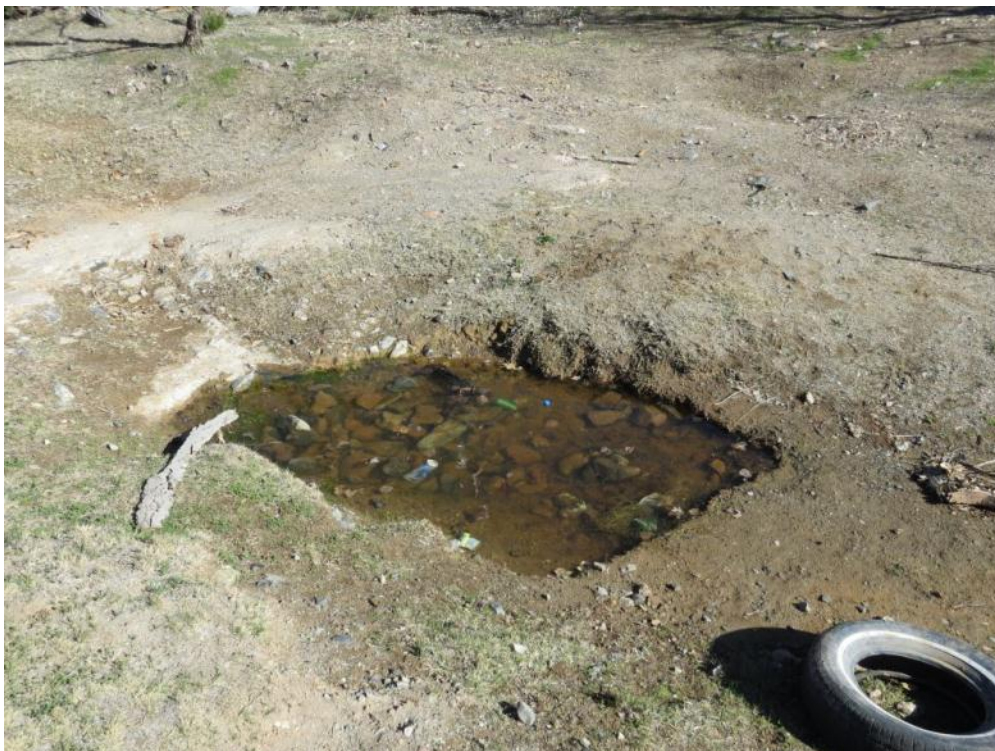
**OBS92**

Water ponding in channel invert where flatly dipping beds of conglomerate span channel invert. Large trees growing in channel centre.

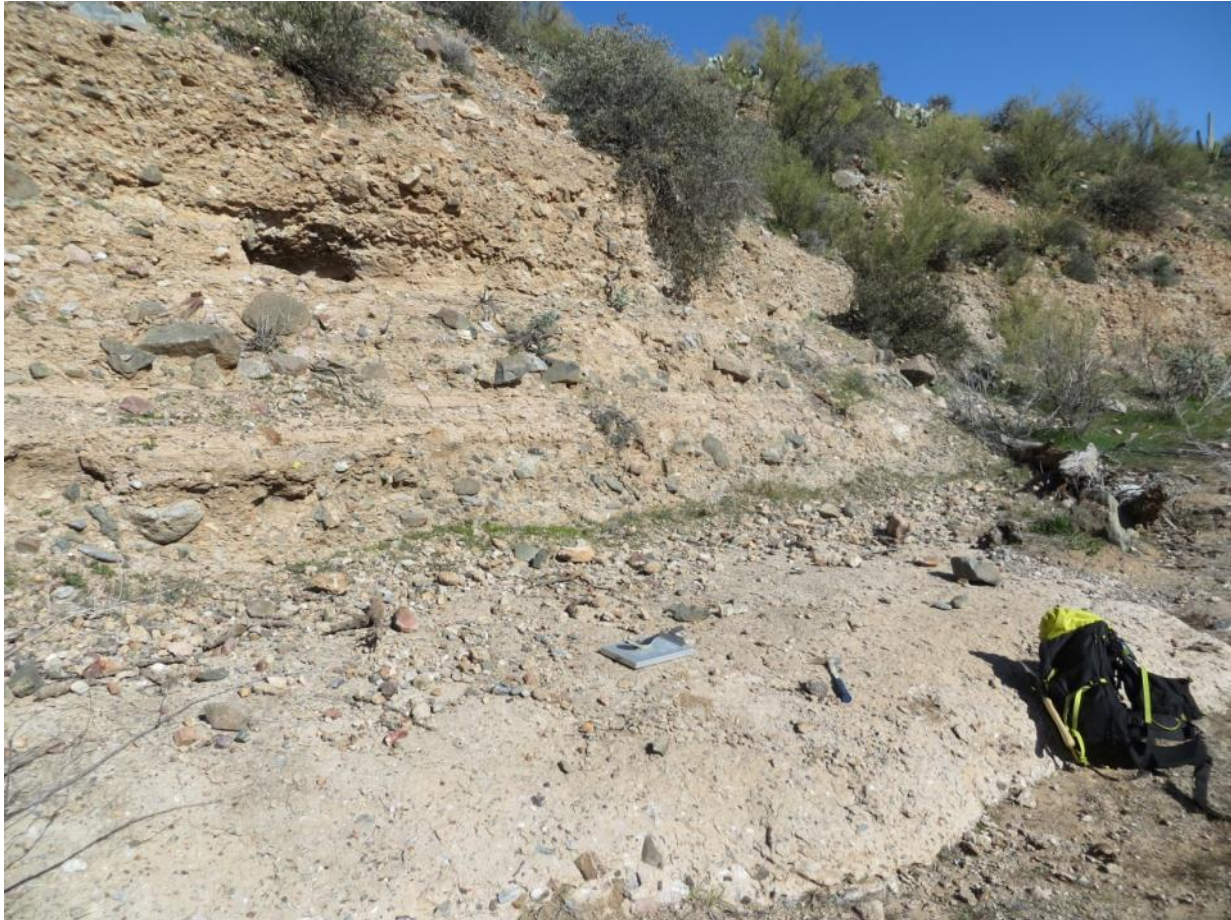
**OBS94**

30 cm (11.8 inches) elevation drop in channel over sub-horizontal conglomerate bed spanning the channel invert. Sand at foot of drop moist just below surface.

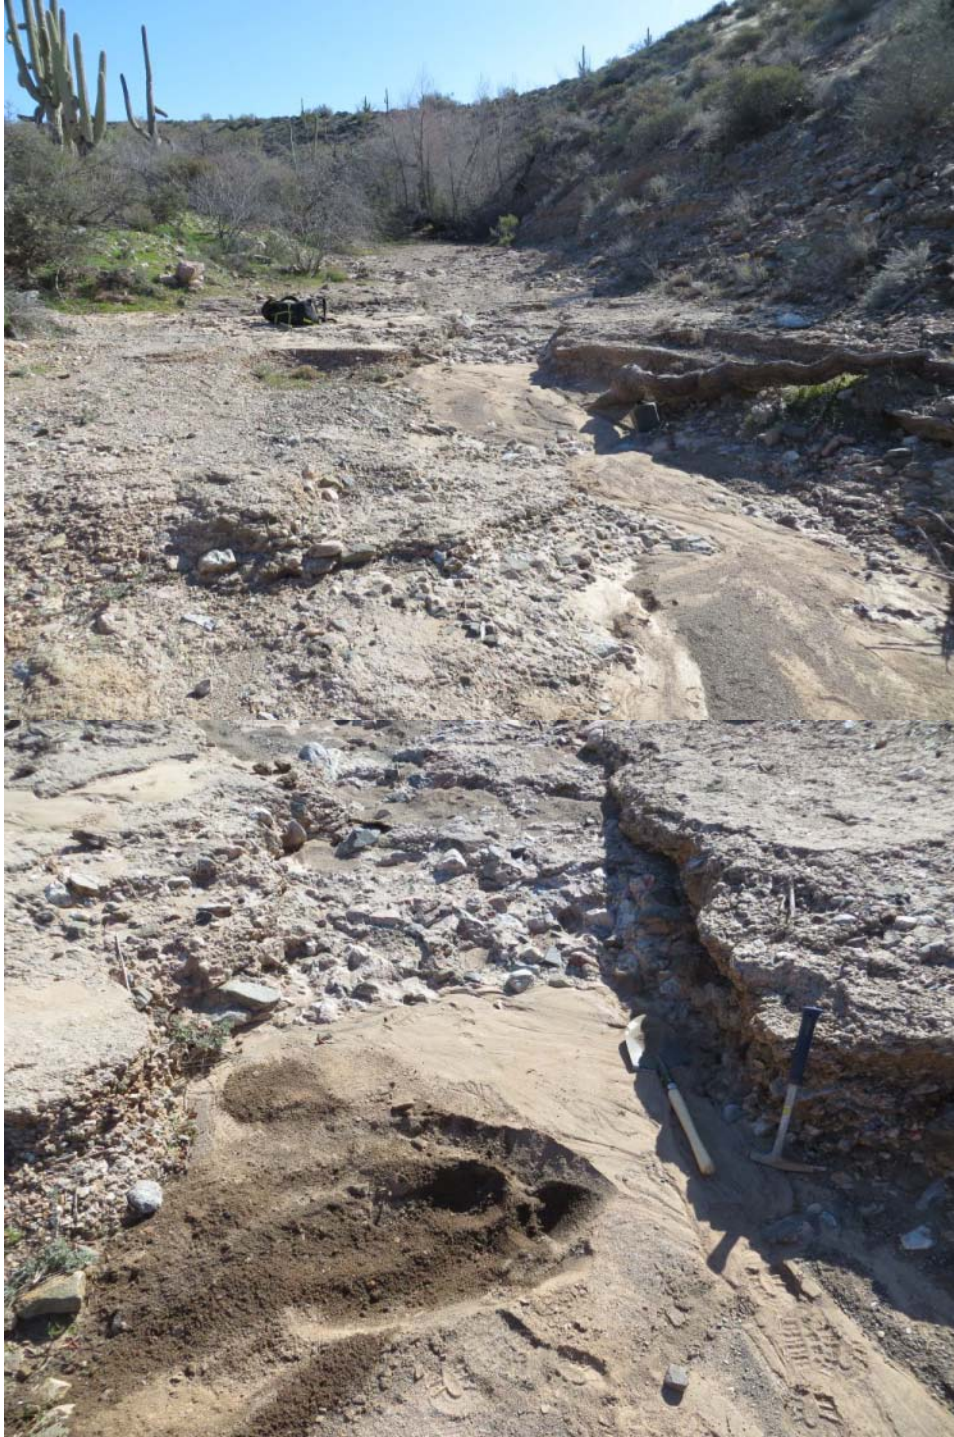
### OBS95

Large well cemented conglomerate exposure on outside of sharp channel bend. Range of clast sizes up to 70 cm (27.6 inches), range of clast lithology and shape. Overhang running along the base of the exposure cut approximately 1 m (3.3 ft) above the channel invert. Moist sand with grass below the overhang. Differential weathering of a finer bed at the base of the exposure may be due to fluvial erosion. Moderate acid reaction on the conglomerate surface consistent across exposure.

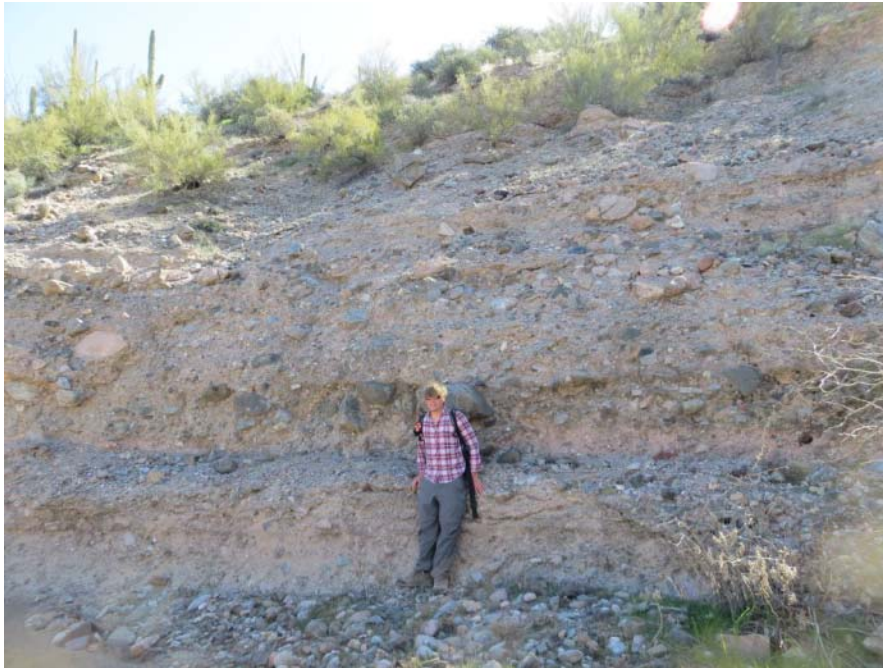
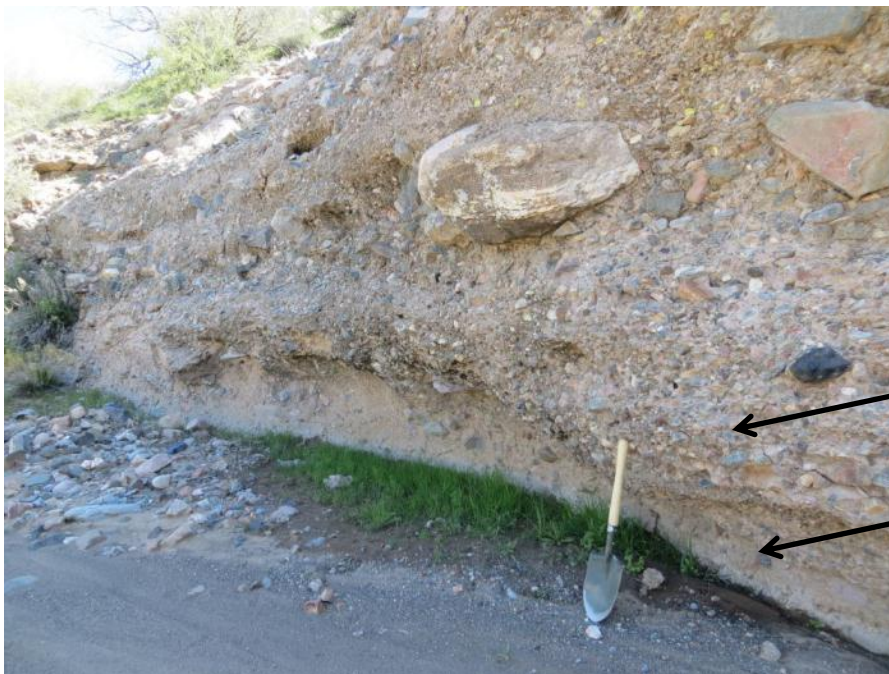
Overhang

Finest Bed

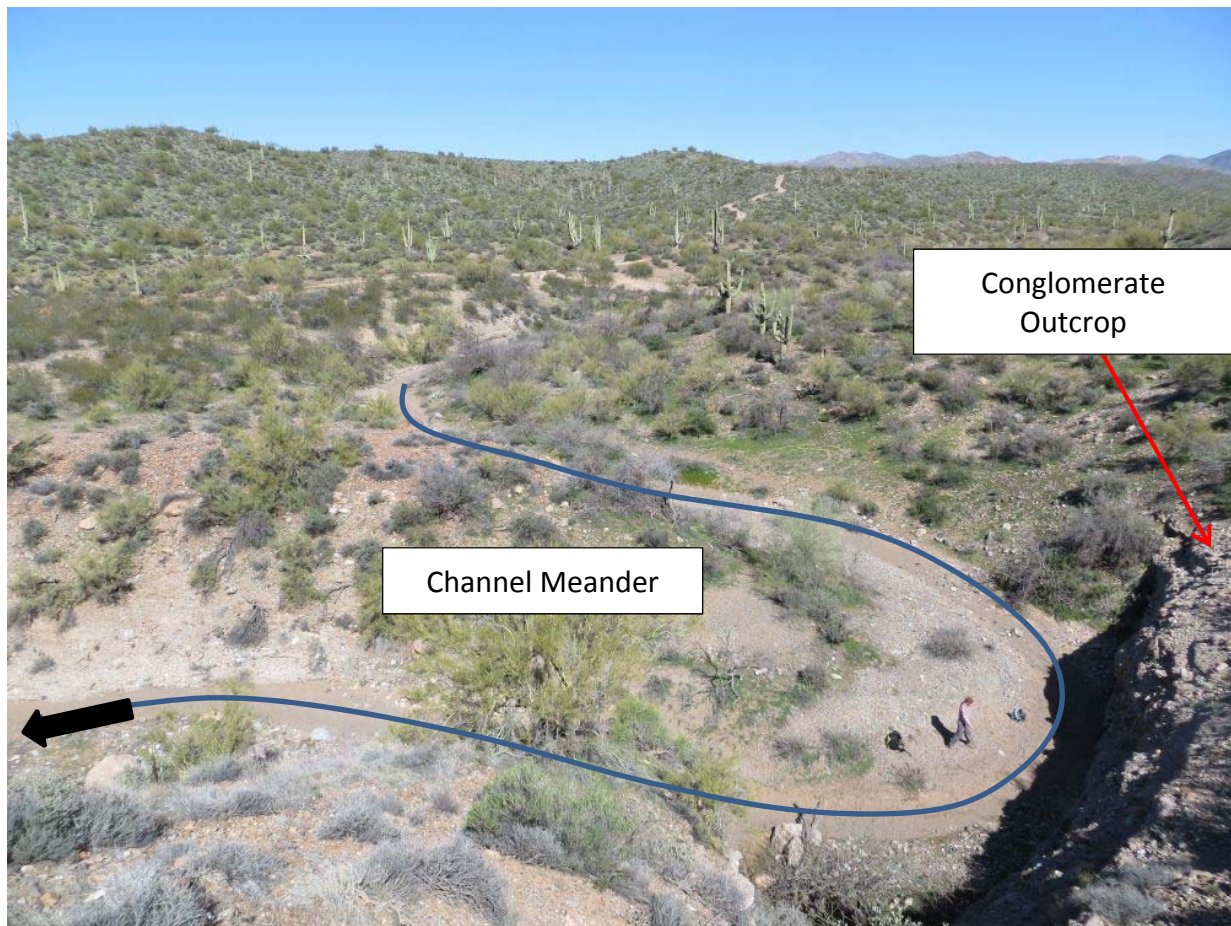
**OBS96**

Extremely hard (R6) calcite stained rock exposed in channel invert (chert?). Strong acid reaction on surface. Likely an exposed clast from conglomerate underlying the channel invert.

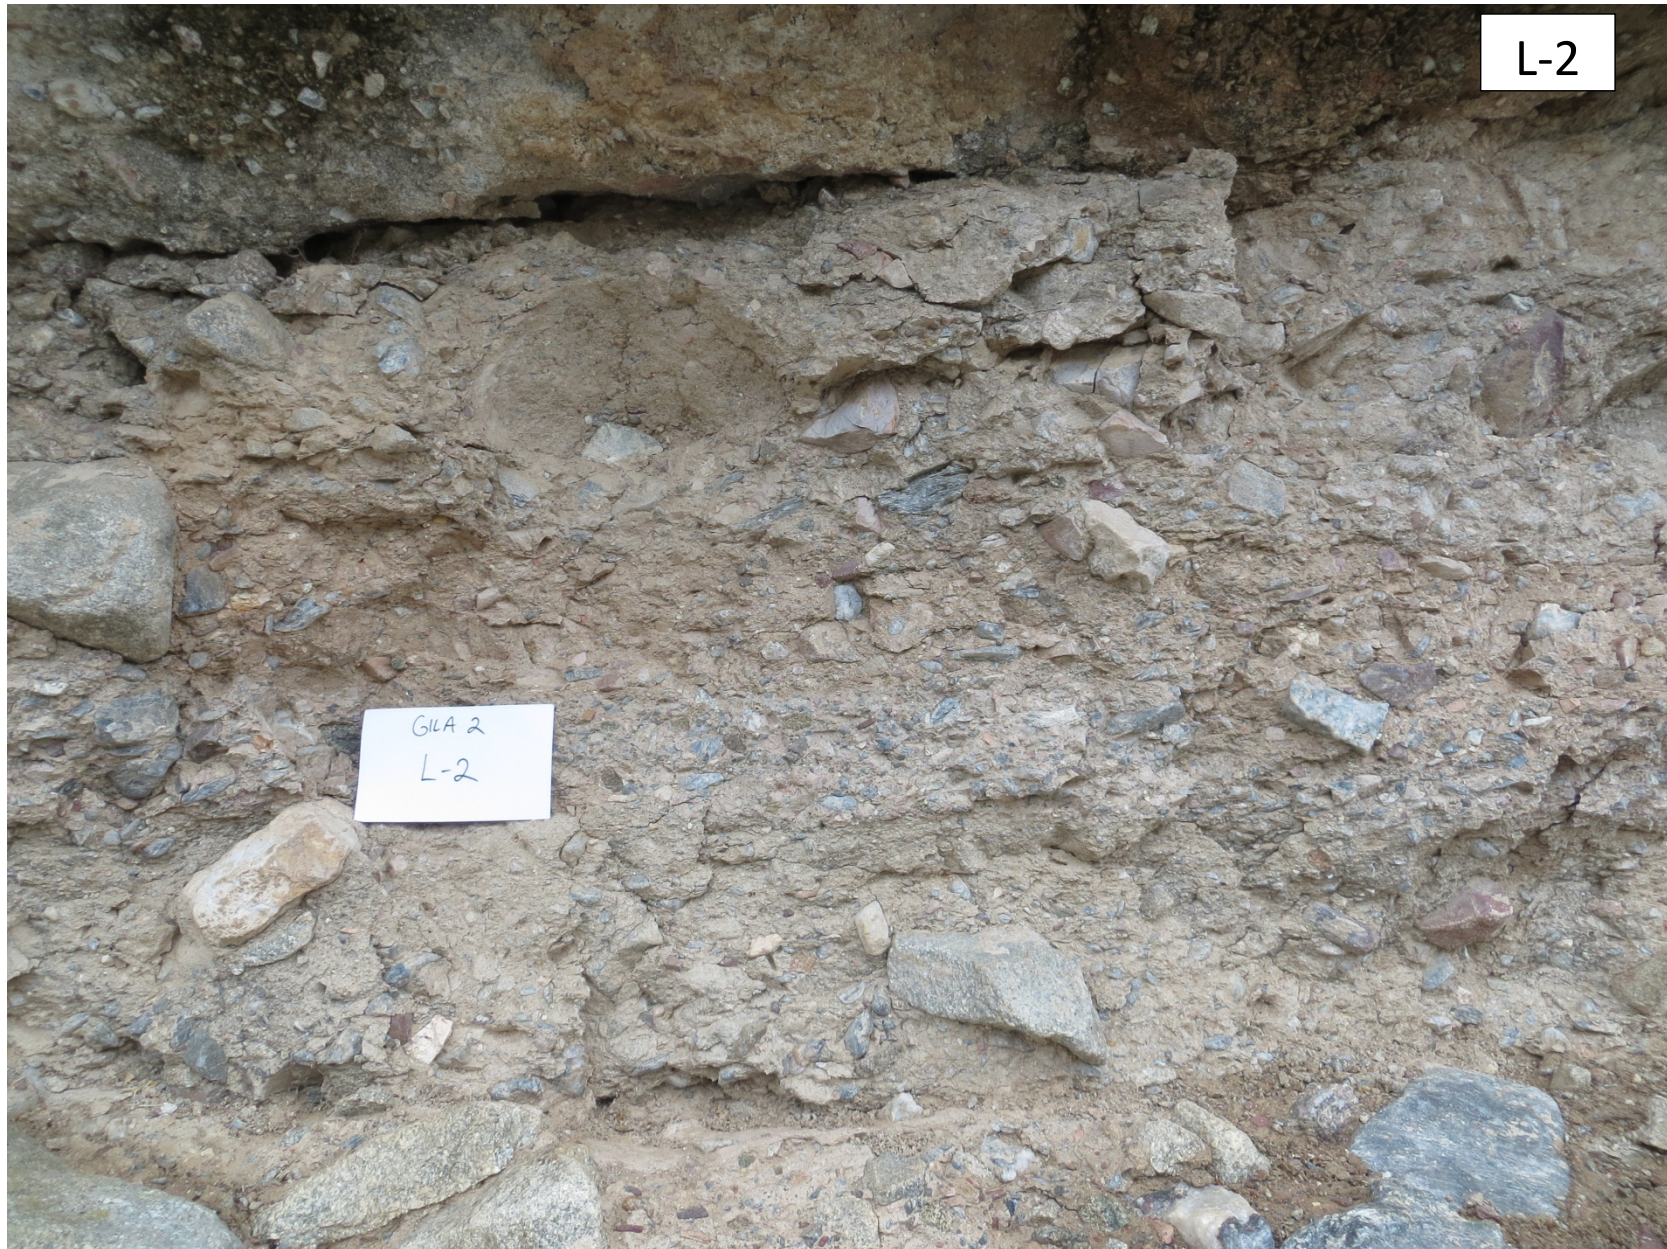
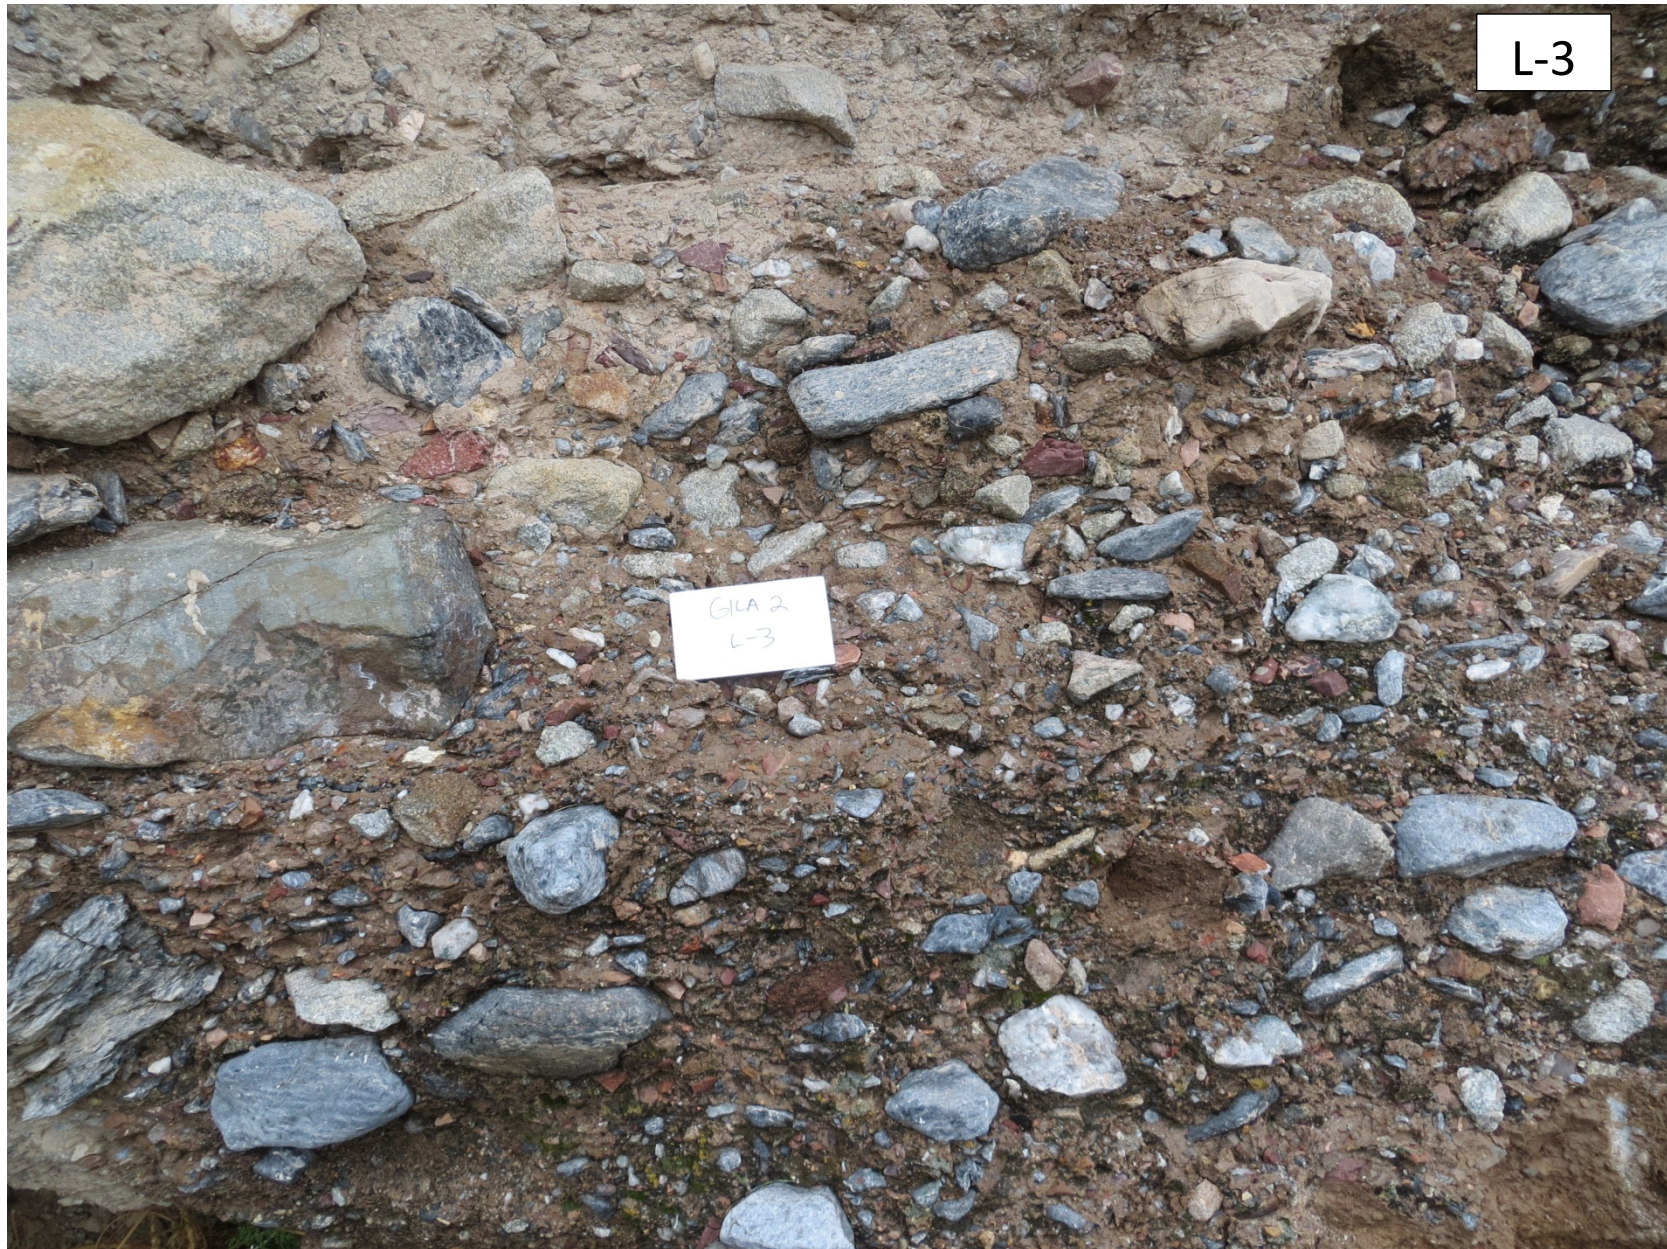
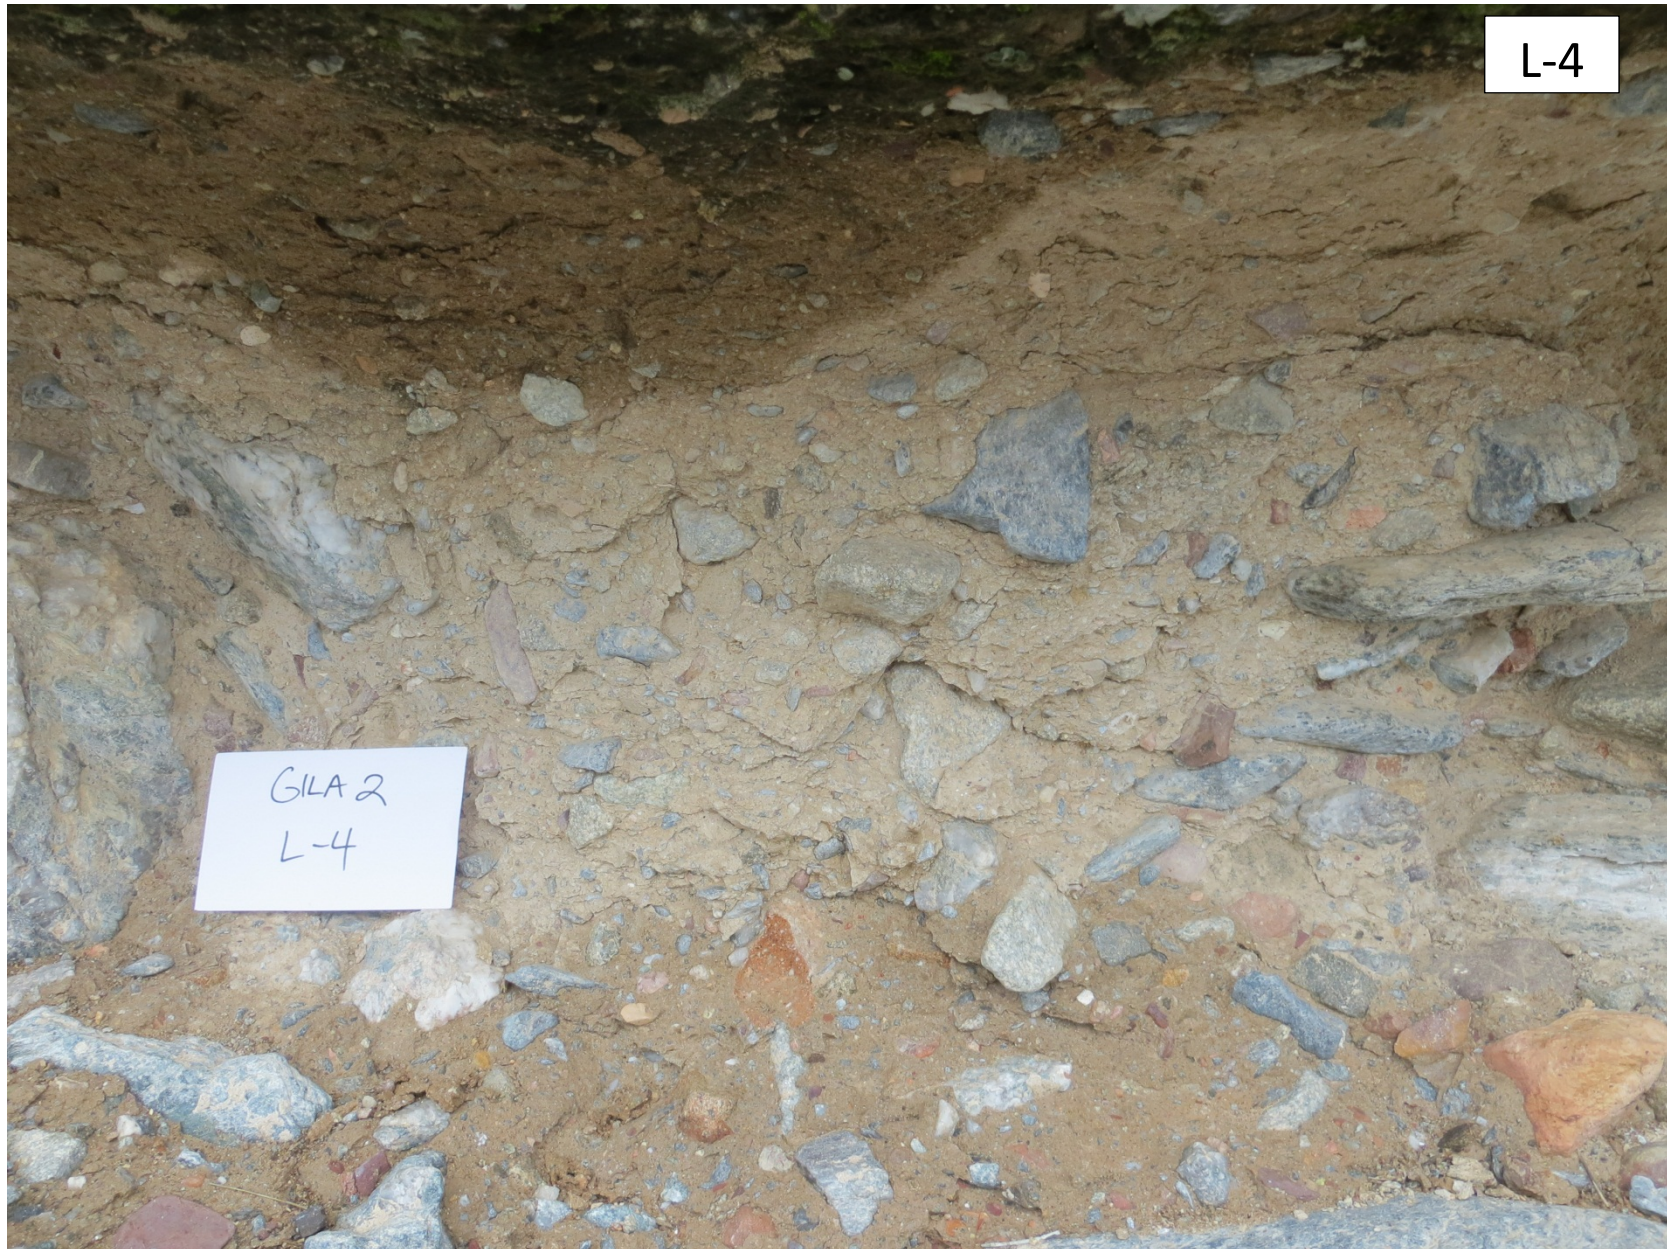
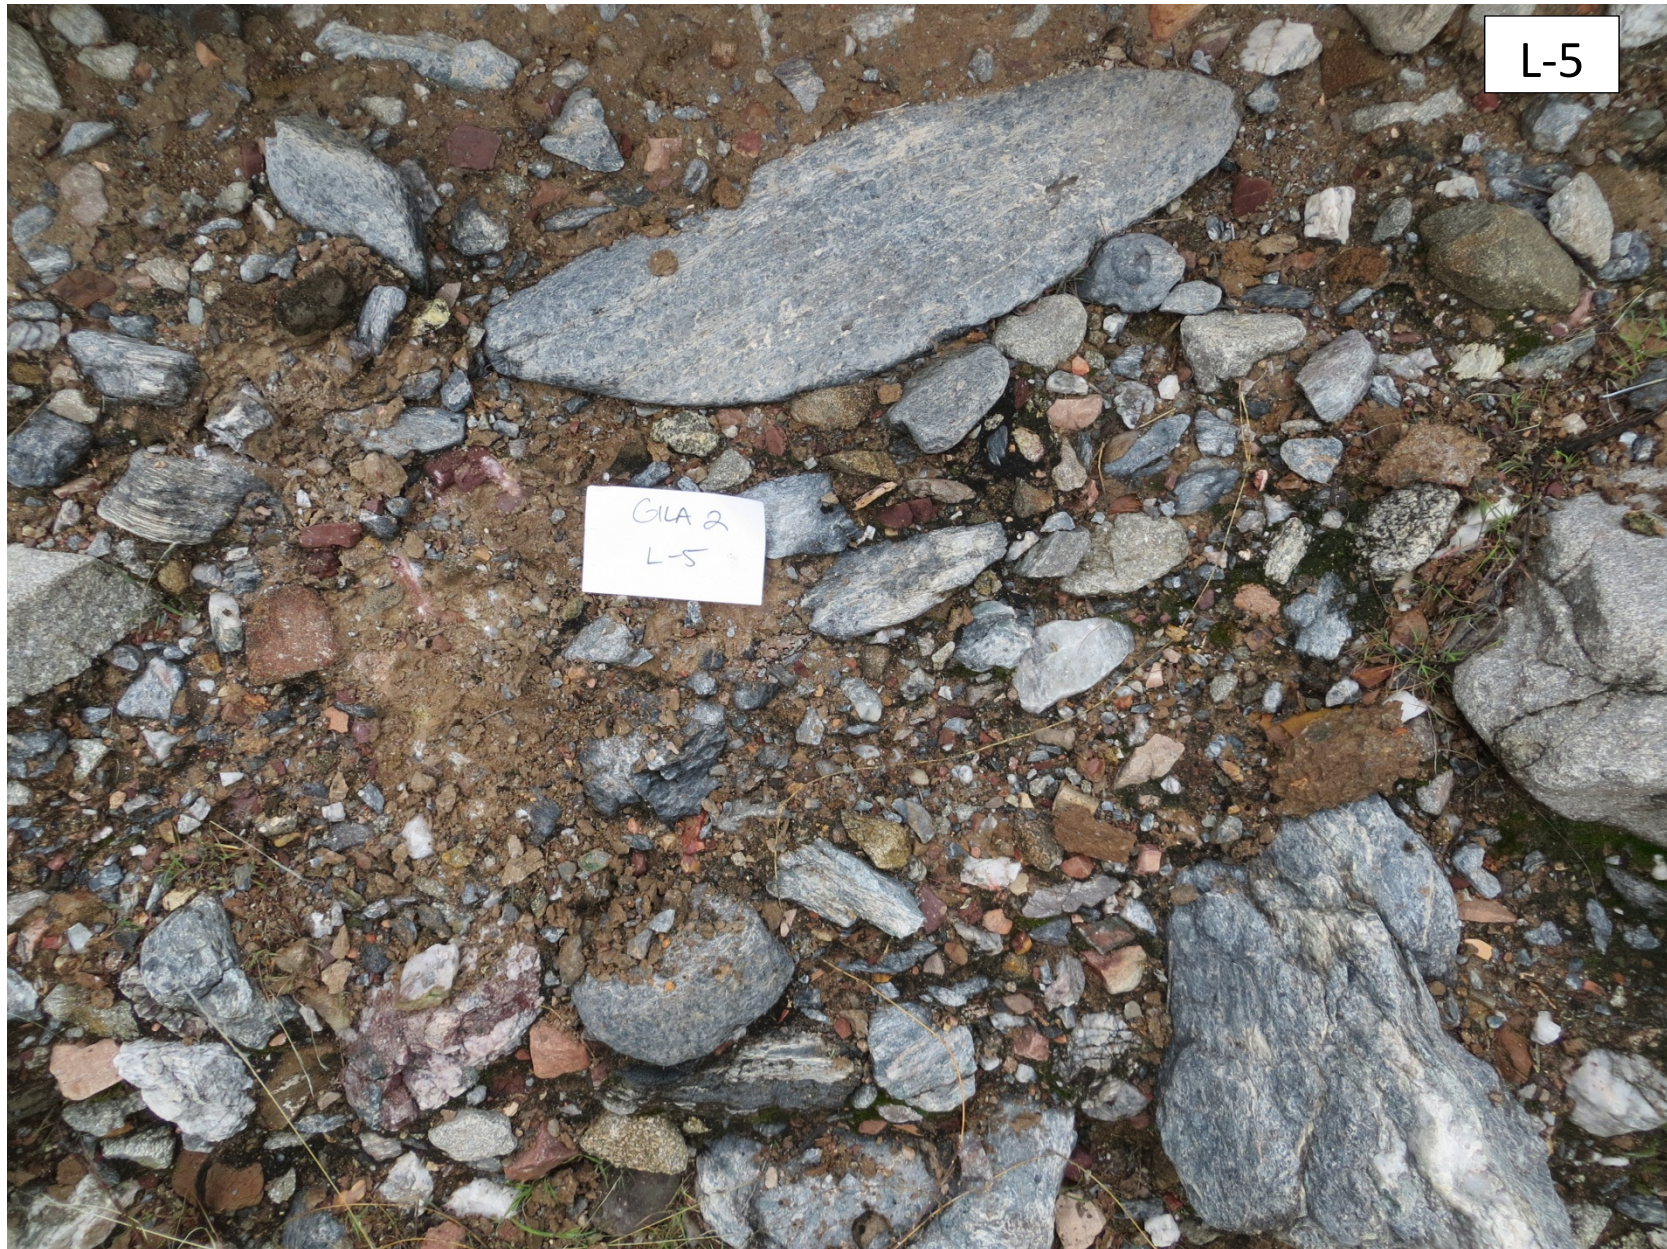
Date Mapped	Mapping Point	Northing* (m)	Easting* (m)	Layer Described	From (m) (ft)	To (m) (ft)	Description (Top to Bottom)	Acid Reaction**	Rock Strength	Relative Weathering	Soak Test	Laboratory Testing			Outcrop Notes
												Moisture Content (%)	Soluble Salts (ppm)	Soluble Salts (%)	
9-Mar-13	GILA3	3686534	482631	L-1	0 (0)	1.6 (5.3)	SAND, GRAVEL and COBBLES, fine to coarse, trace boulders, some to trace clay, well graded, max. particle size = 30 cm, sub-rounded to angular, light brown, various lithology (schist, quartz, granodiorite, quartz sandstone, siltstone, quartzite), matrix supported, massive	weak to moderate	R3 (exposure face) R1 (hand sample)	Stronger, forms overhang	No slaking - moderate strength loss	2.4 1.8	140 170	.014 .017	Moist at time of sampling 2 samples taken
				L-2	1.6 (5.3)	3.1 (10.2)	Silty SAND, GRAVEL and COBBLES, fine to coarse, some boulders, well graded, max. particle size = 1.6 m (schist boulder), angular to sub-angular, light brown, various lithology (as L-1), clast supported, massive	weak to moderate	R1	Weaker, forms undercut	Significant slaking - total strength loss	0.7	1750	0.18	Two samples taken

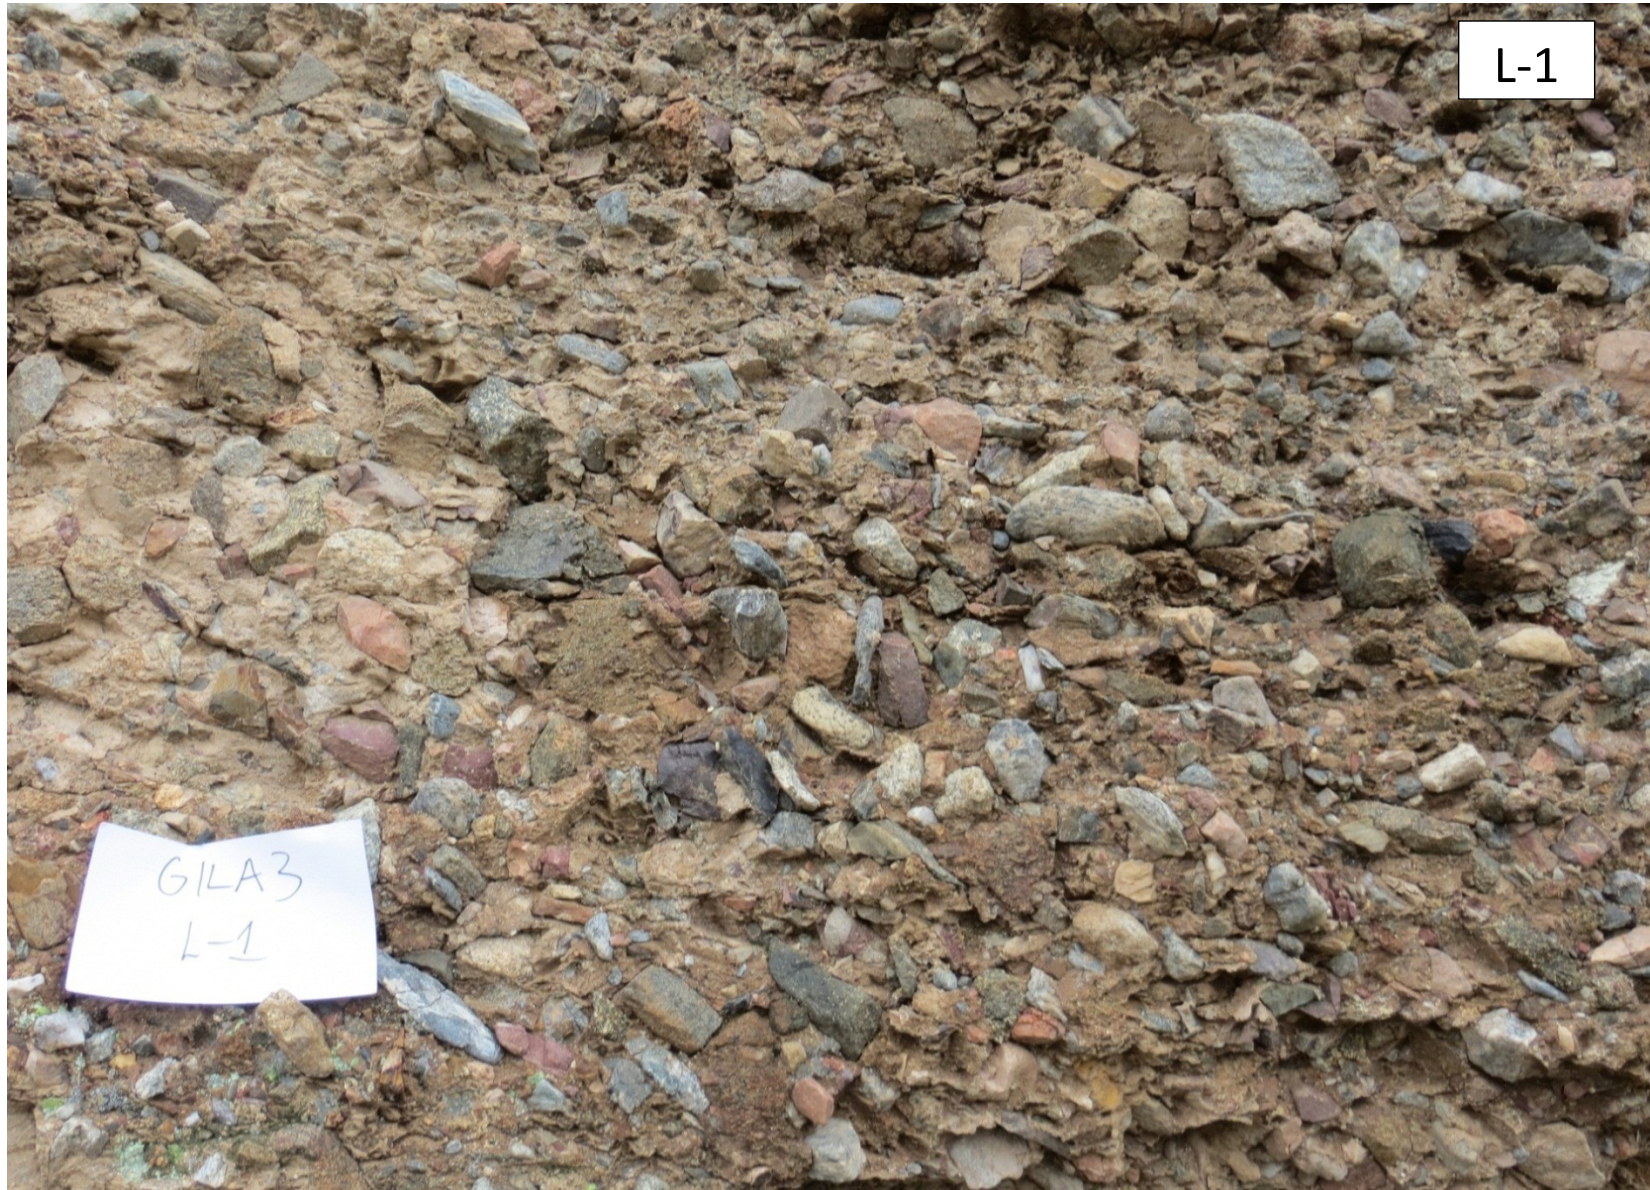
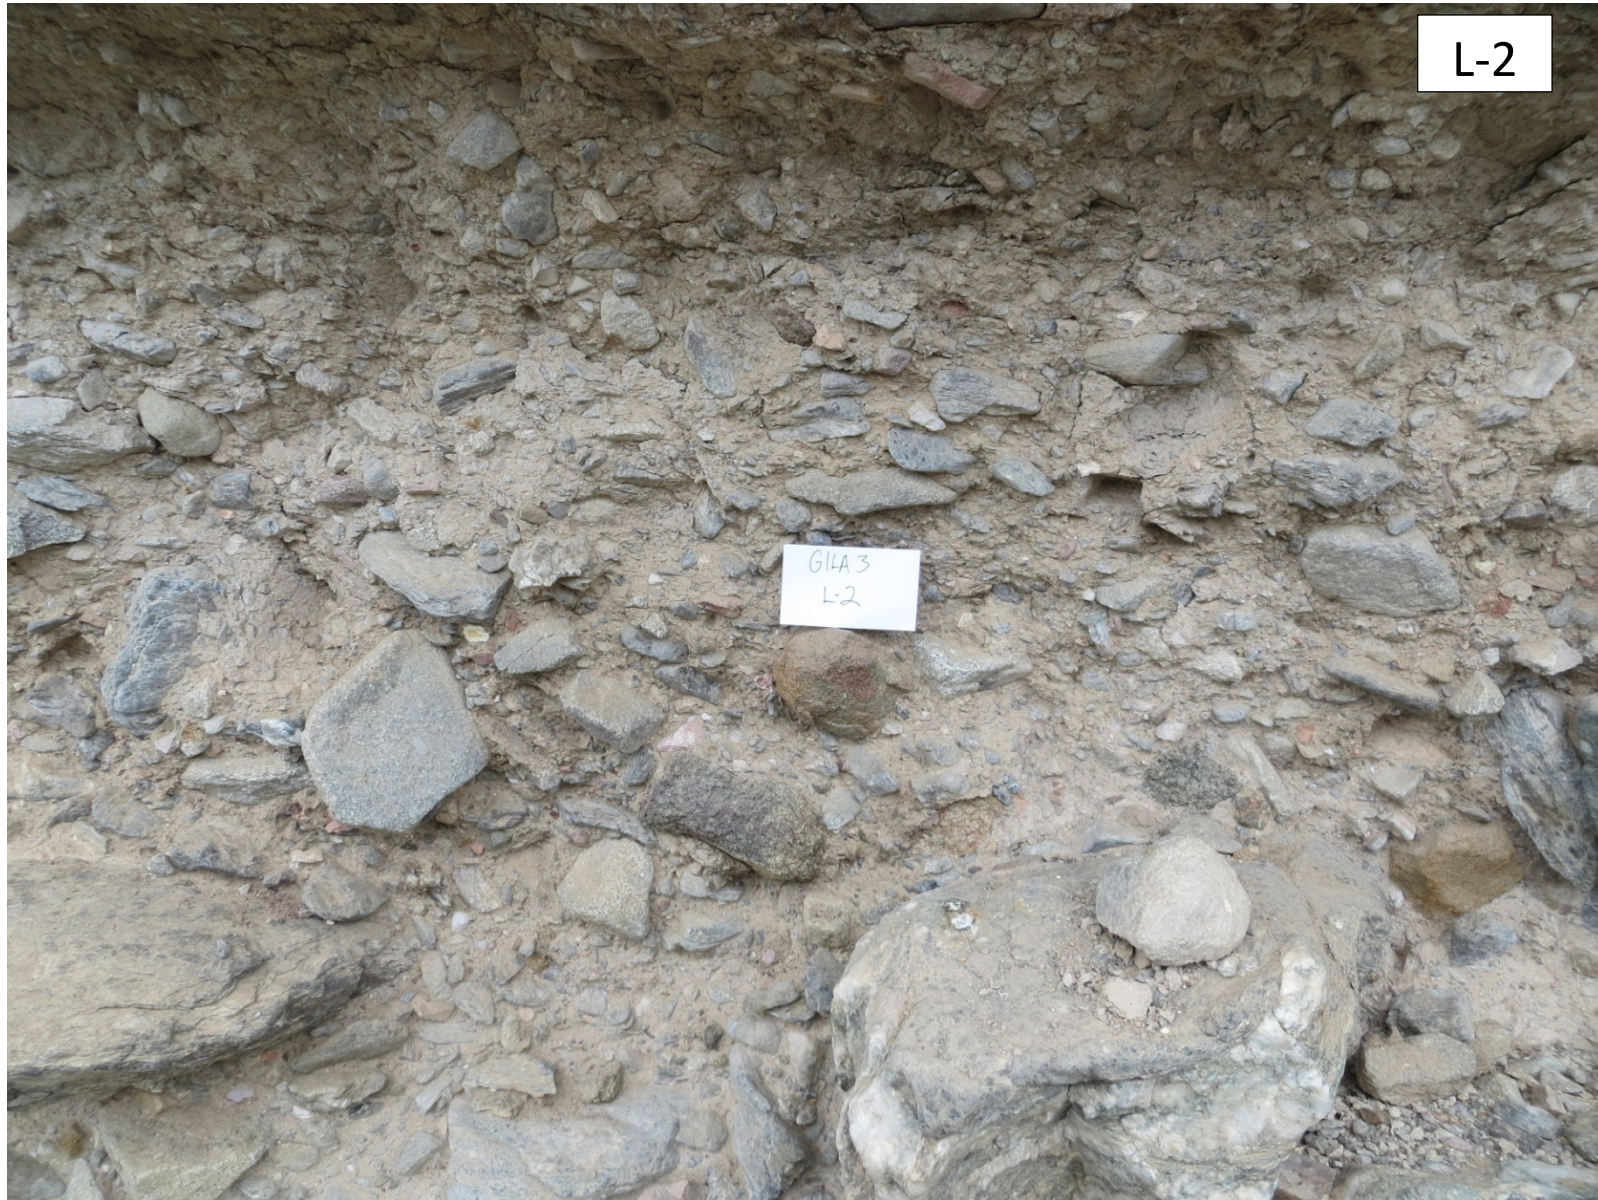
Date Mapped	Mapping Point	Northing* (m)	Easting* (m)	Layer Described	From (m) (ft)	To (m) (ft)	Description (Top to Bottom)	Acid Reaction**	Rock Strength	Relative Weathering	Soak Test	Laboratory Testing			Outcrop Notes
												Moisture Content (%)	Soluble Salts (ppm)	Soluble Salts (%)	
9-Mar-13	GILA4	3687033	483112	L-1	0 (0)	0.8 (2.6)	SAND and GRAVEL, fine to coarse, some cobbles to cobbly, some clay, well graded, max. particle size = 10 cm, angular to sub-angular, reddish brown, various lithology (schist, quartzite, tuff, quartz), clast supported, massive	none to moderate	R1	Both layers the same	No slaking - moderate strength loss	11.6	180	0.018	Moist at time of sampling, very similar to L-1 in GILA3
				L-2	0.8 (2.6)	1.6 (5.3)	SAND, GRAVEL and COBBLES, some clay, well graded, max. particle size = 35 cm, sub-angular to angular, brown, various lithology (as L-1), clast supported, massive	weak to moderate	R1	Both layers the same	No slaking - moderate strength loss	5.4	1370	0.137	Very similar to L-1 in GILA3
