## APPENDIX I-E

### Traverse #5

PROJECT  
RESOLUTION PROJECT  
2013 NEAR WEST SITE INVESTIGATION

TITLE  
CREEK TRAVERSE #5

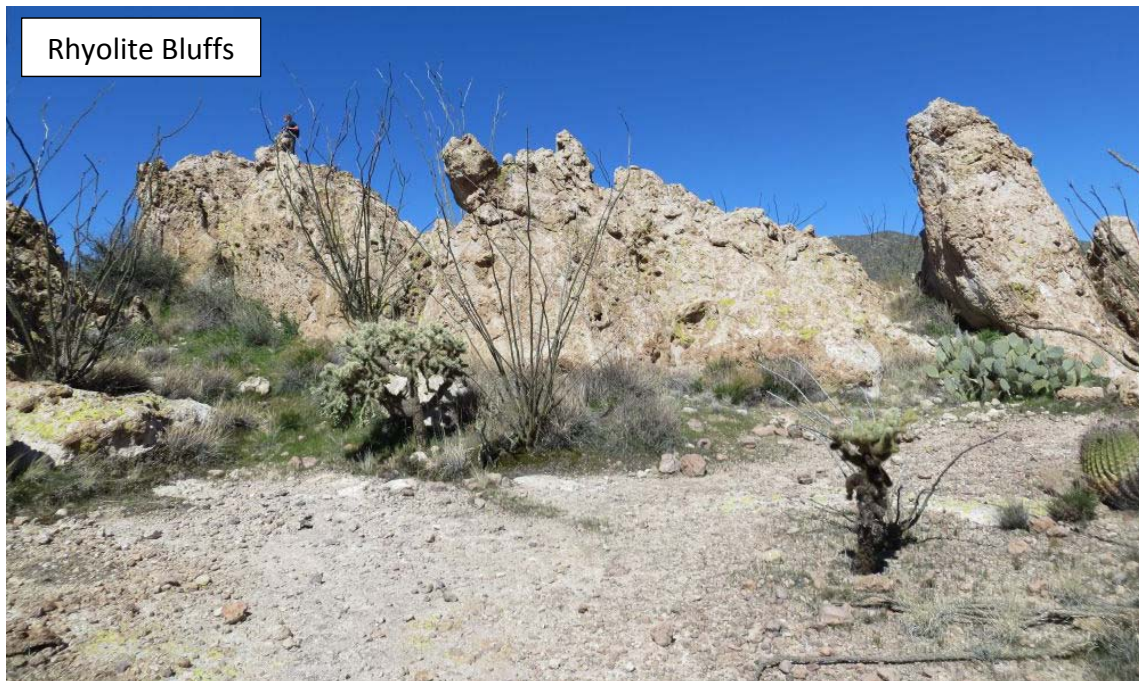
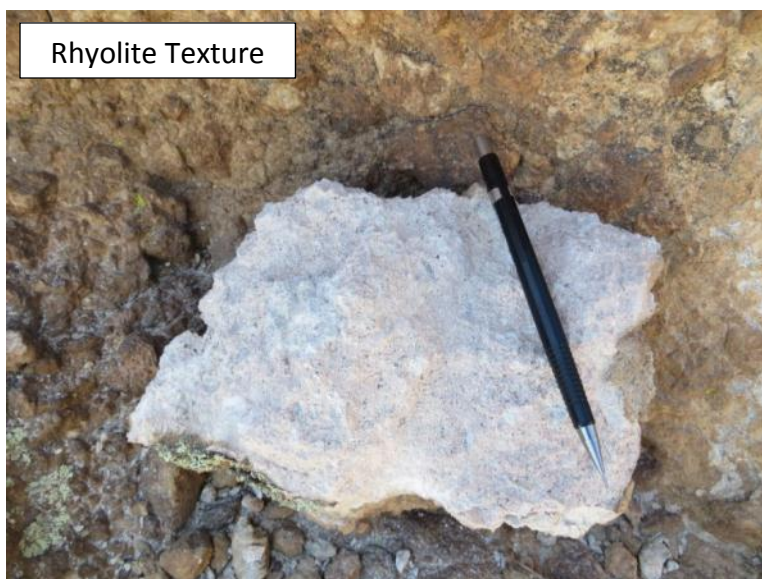
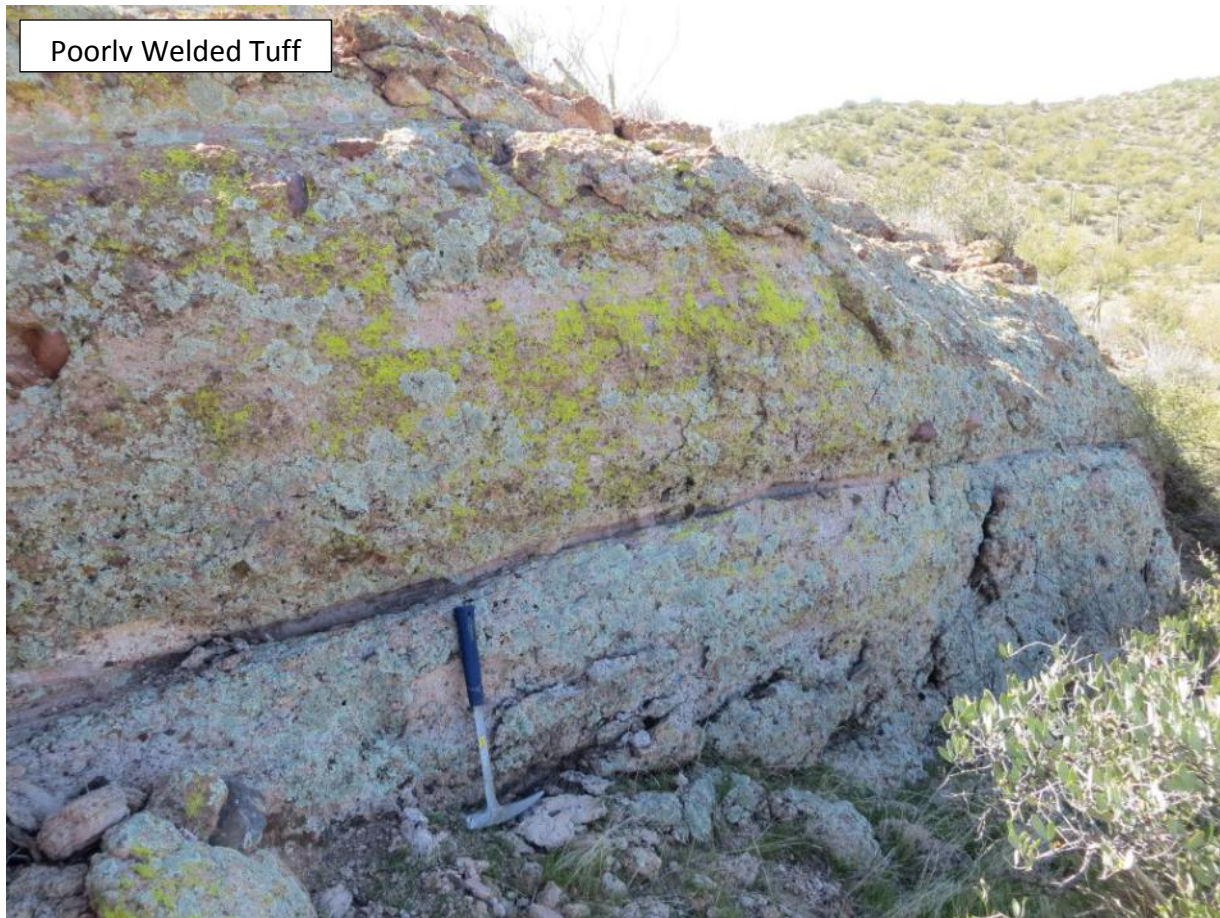
Contact area between perlite/rhyolite and poorly welded tuff (Tt). Rhyolite forms steep bluffs; R2 to R3, white powdery texture with perlite inclusions, surface of exposure is covered with thin, discolored hardened “crust”.

Directly behind rhyolite bluffs is gently dipping layers of tuff. R4, angular to sub-angular coarse particles in very fine grained felsic matrix, sub-horizontal layers with thickness ranging from 100 cm to 5 cm (*39.37 inches to 1.97 inches*), discontinuities along layer interfaces generally closed down section in the outcrop but open up near the ground surface.

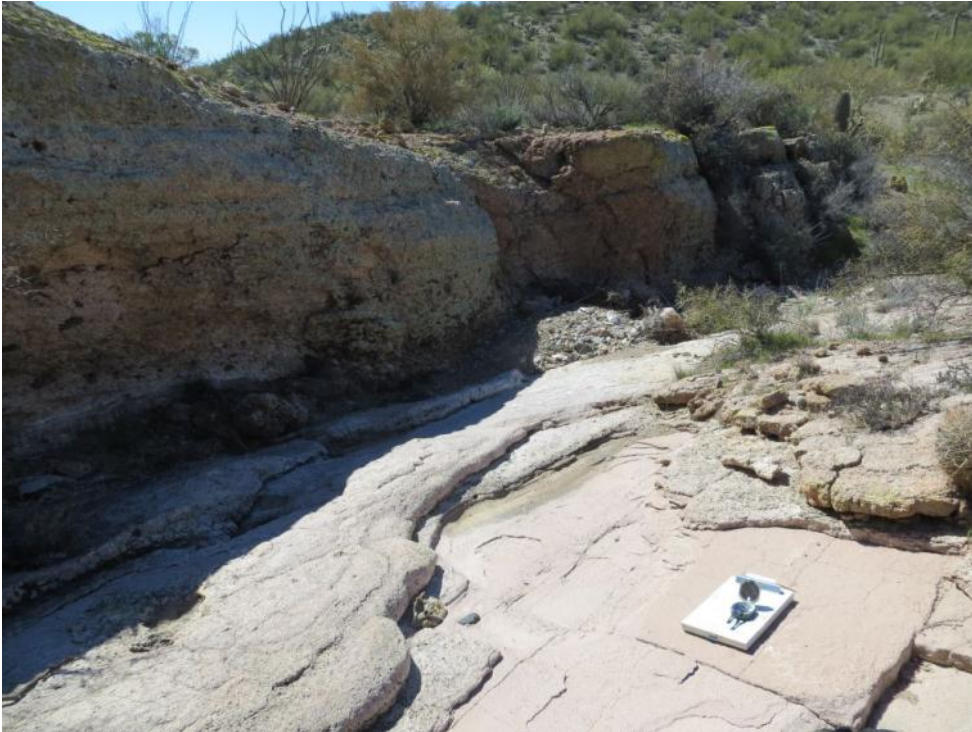
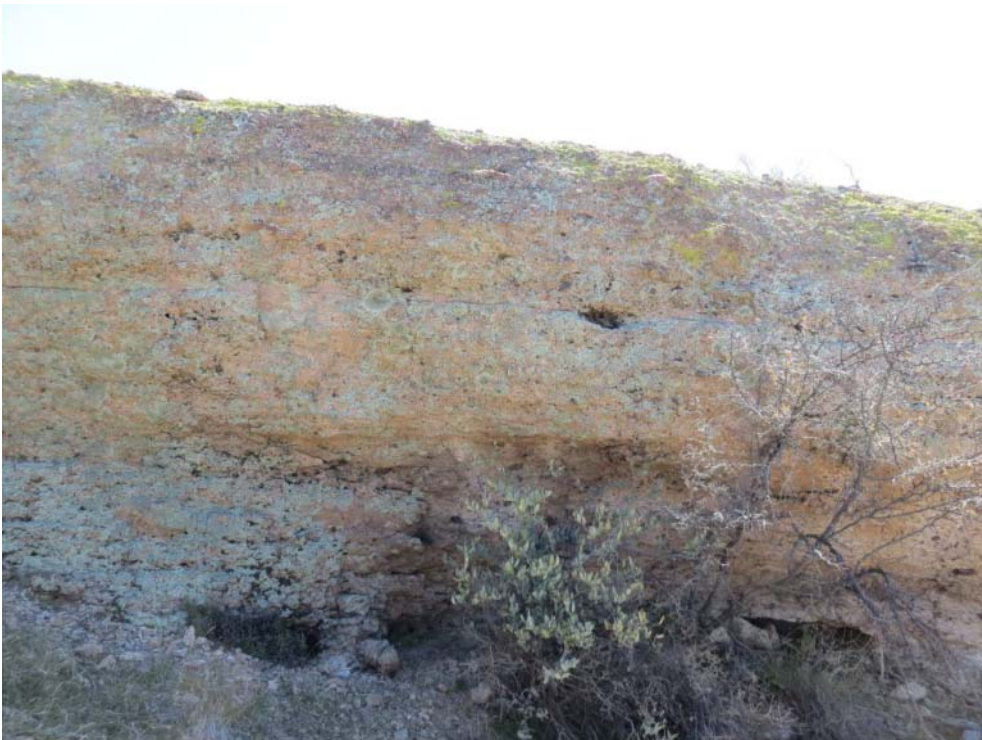
**Tt2**

Flatly dipping tuff layers exposed in small wash. Large, massive layers exposed on the channel banks.

Orientation of tuff layers: **115/11**

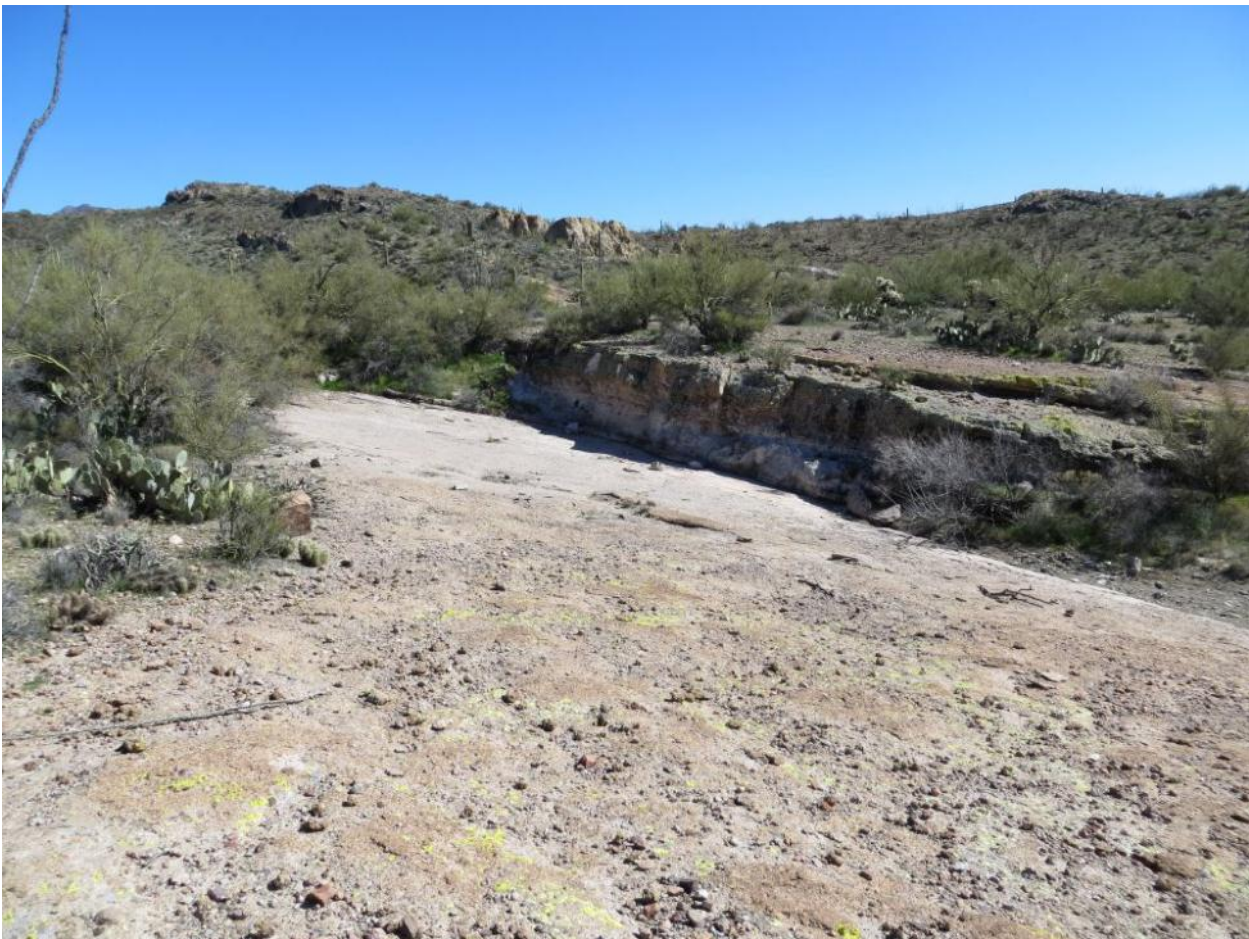
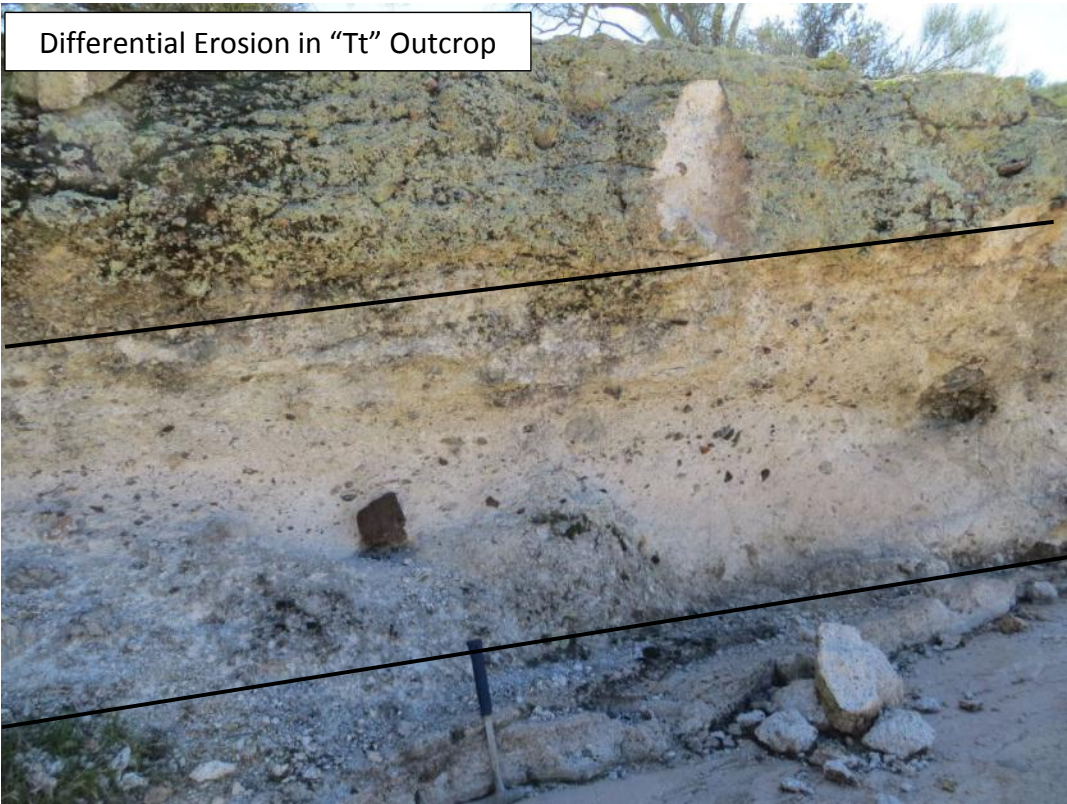
### Tt3

Open area with flatly dipping tuff exposed at the intersection of two washes. Layered tuff exposed in the bank showing differential weathering.

More eroded layer. Tuff (Tt), R2, angular to sub-rounded gravel clasts in white powdery matrix, no jointing or fracturing (massive).

Orientation of dipping tuff in invert (see photo below): **265/11**

Orientation of dipping tuff on opposite bank (see photo below): **050/05**

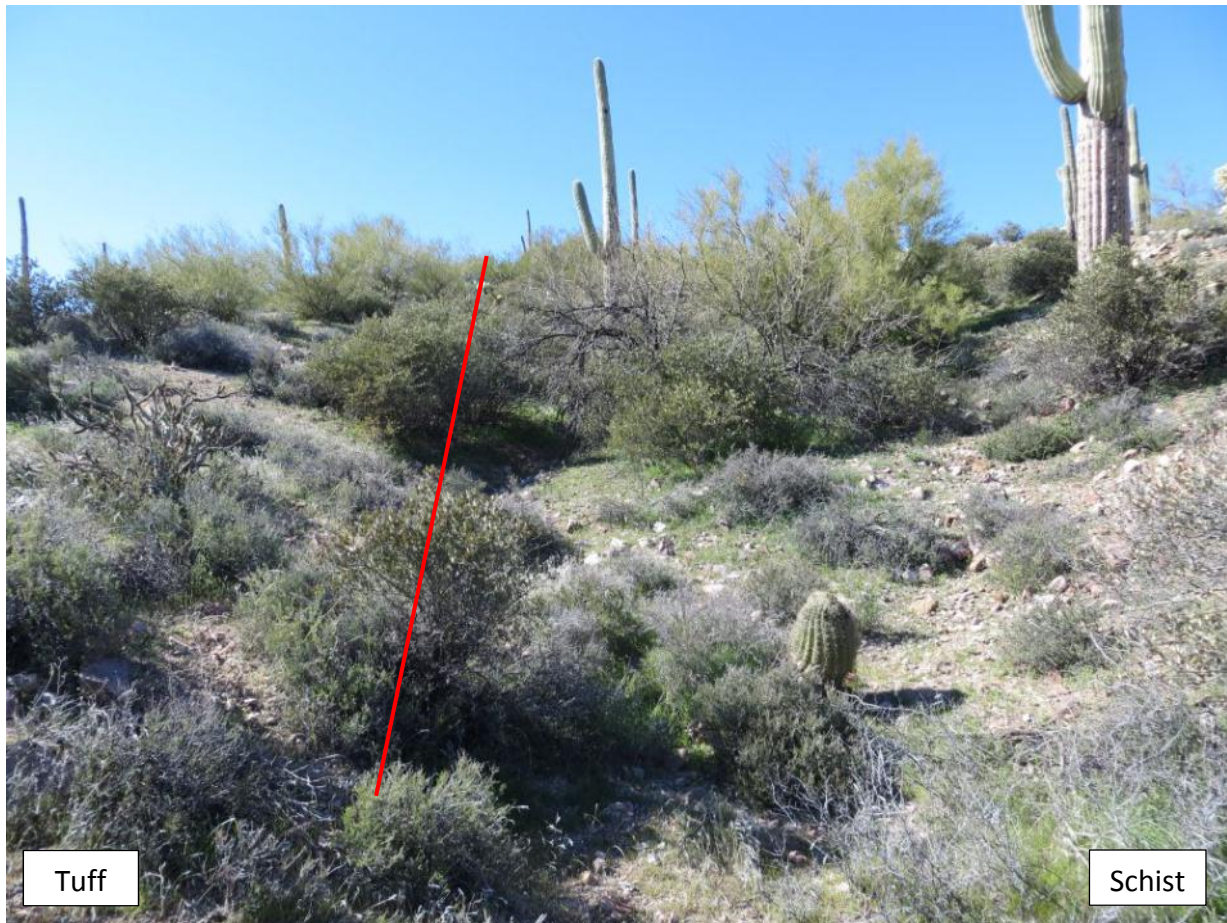
Tt4

Contact between poorly welded tuff (Tt) and Pinal schist (Xpm).

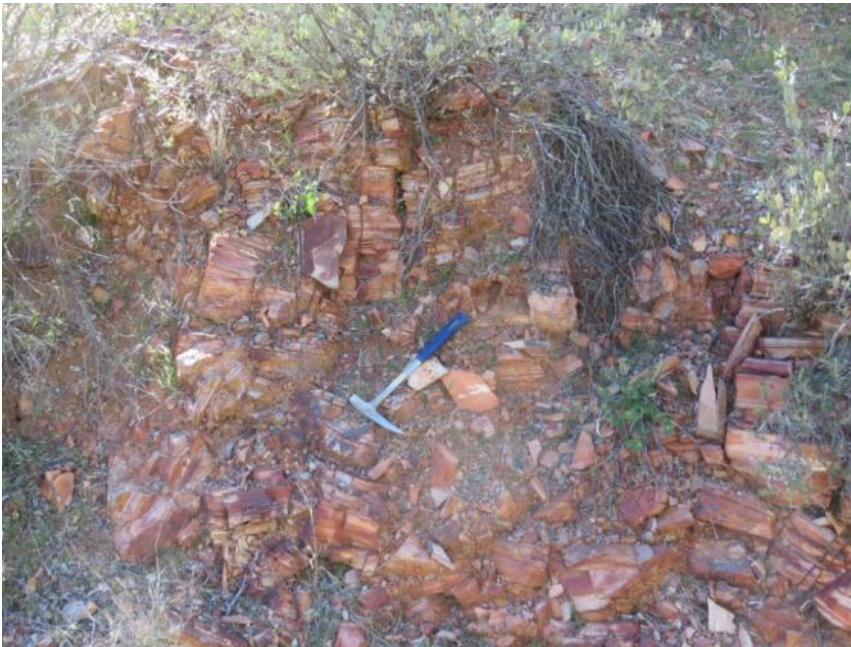
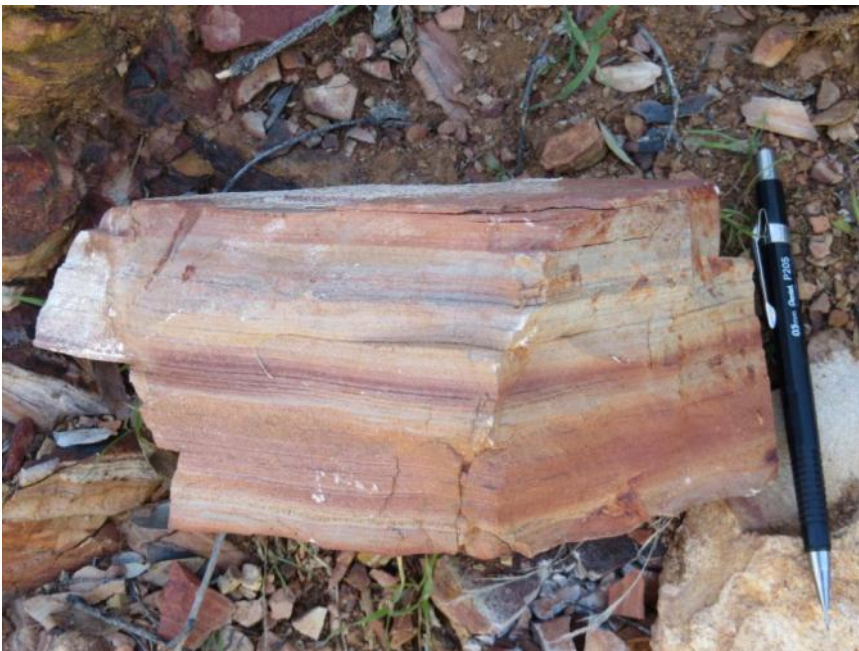
### Yds1

Disturbed outcrop of dripping springs quartzite (Yds) in narrow wash invert. Tuff outcrops are visible just upstream/uphill of the quartzite.

Yds fresh, R4 (breaks preferentially along bedding planes), red, white and grey fine grained quartz beds (rock is quartz arenite, not quartzite), bedding at mm scale.

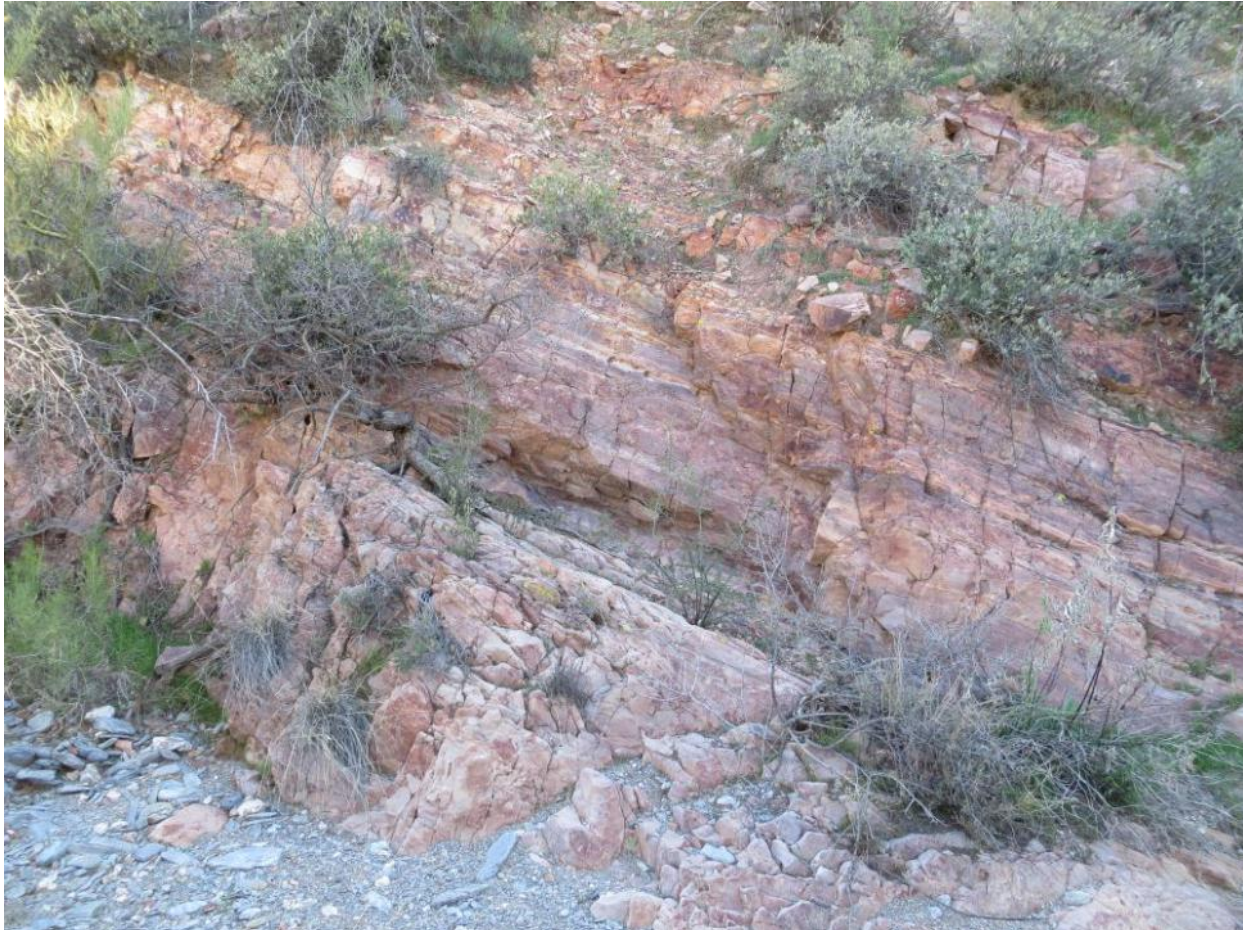
Bedded quartz arenite, fresh, R5, fractures along bedding planes with other fractures cross cutting bedding planes, one joint set running parallel with the face of the outcrop, joints spaced 2 cm to 30 cm (*0.79 inches to 11.81 inches*) apart, 0.5 cm (*0.20 inches*) (max.) joint aperture to closed, planar joint surfaces with rough “grainy” surface texture.

Orientation of joint set: **155/54**

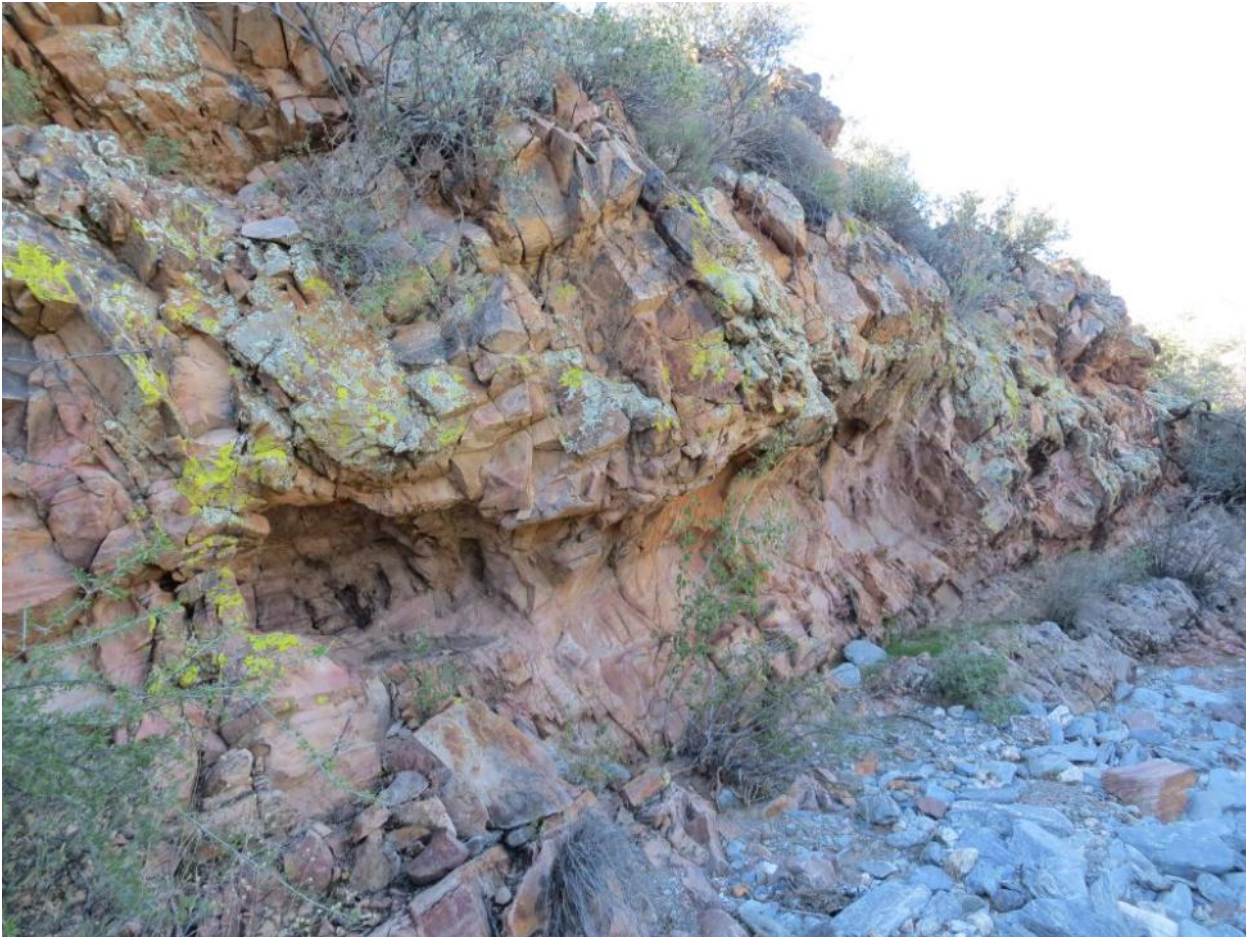
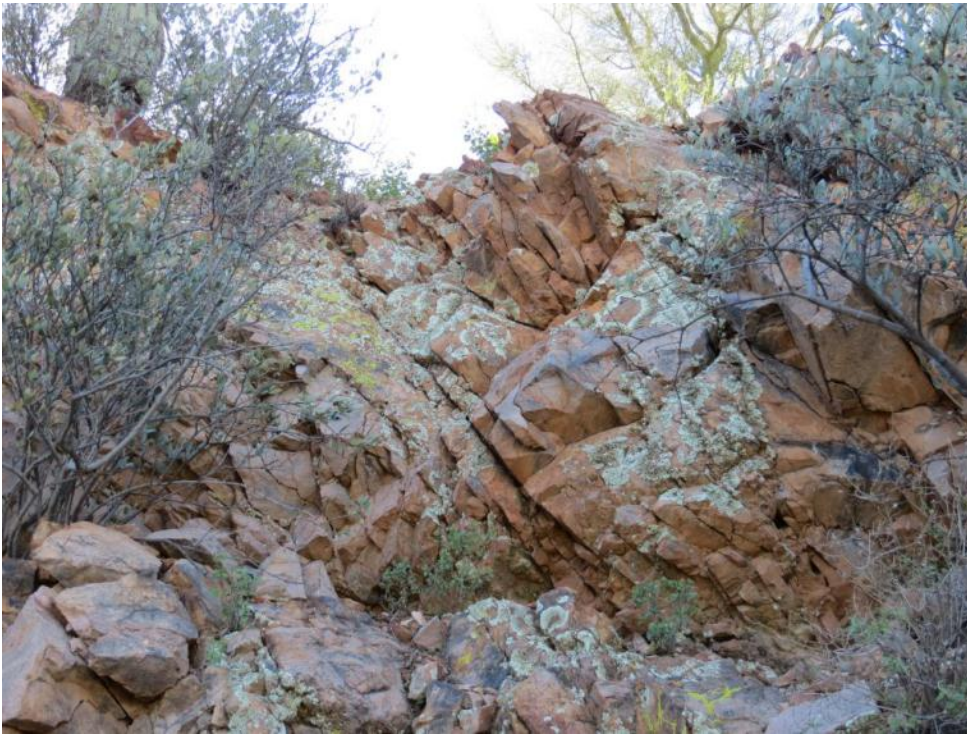
#### Yds4

Heavily jointed/blocky quartz arenite. Eroded overhang 1.5 m (4.9 ft) above channel invert. Two dominant joint sets:

Orientation of Joint Set #1: **048/39**

Orientation of Joint Set #2: **160/50**

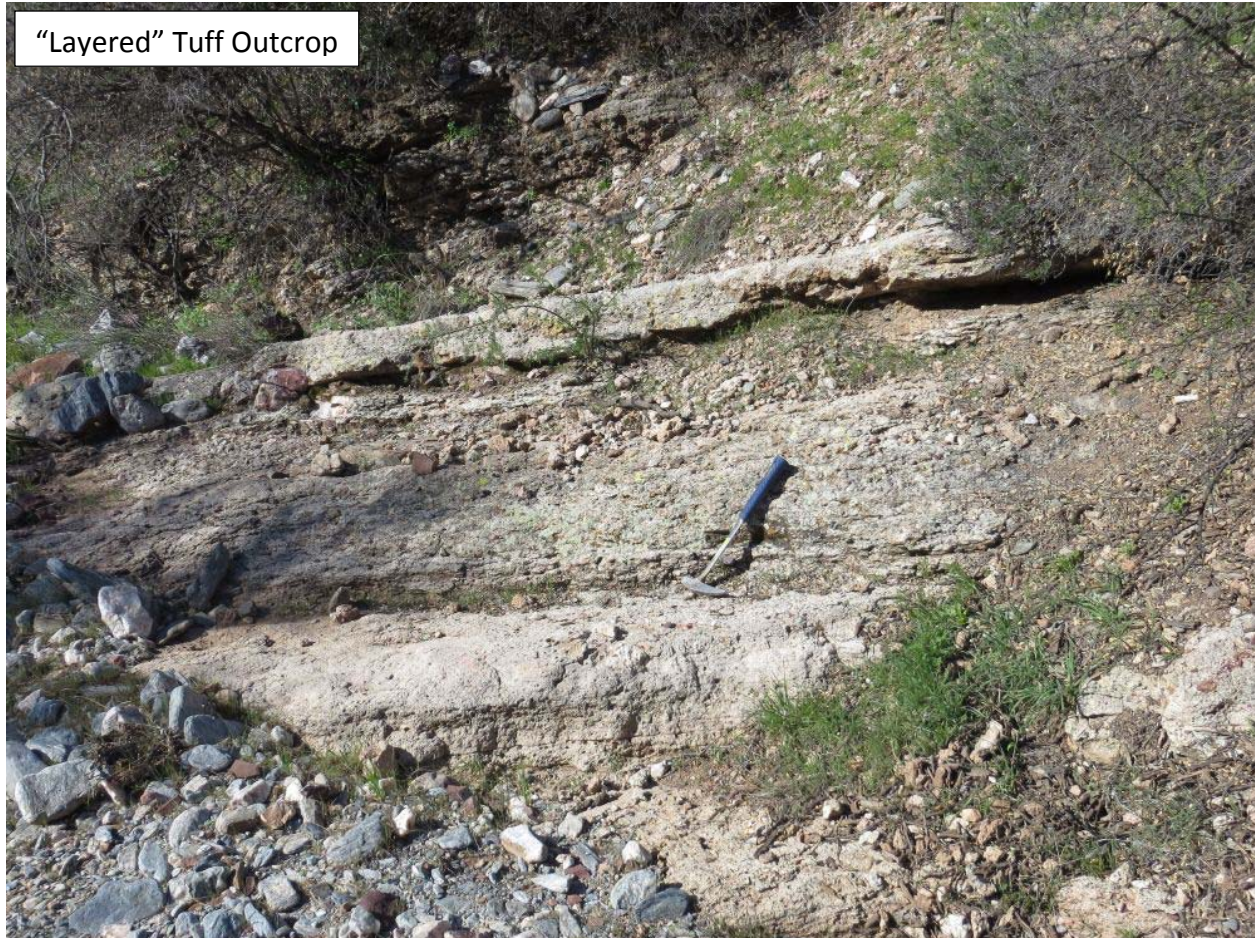
### CONTACT1

Point of contact between dripping springs quartzite and poorly welded tuff (Tt). Layered tuff outcrop just downstream of observation point

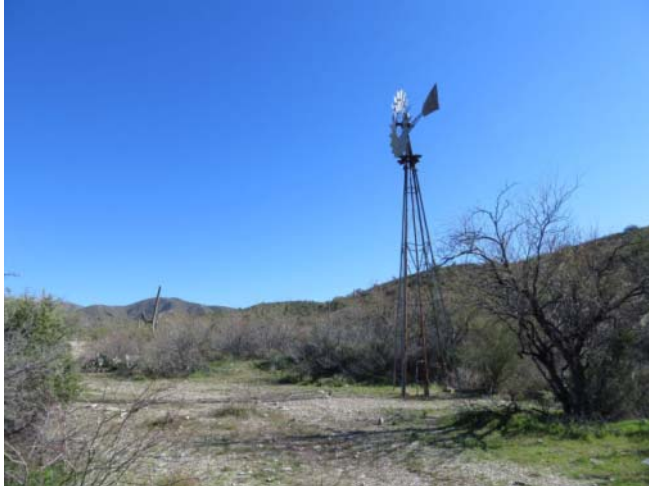
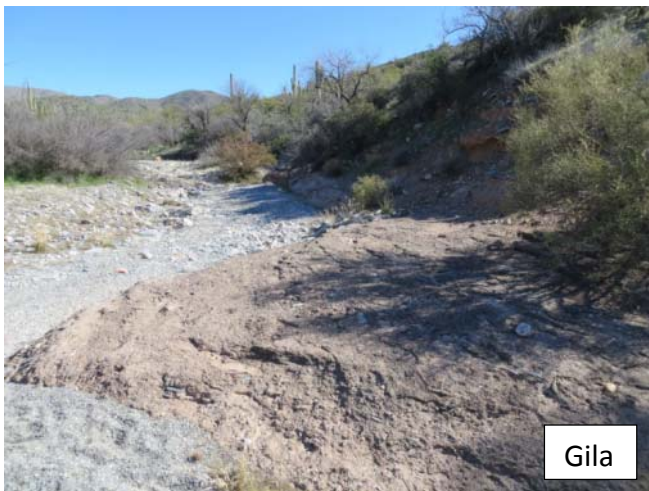
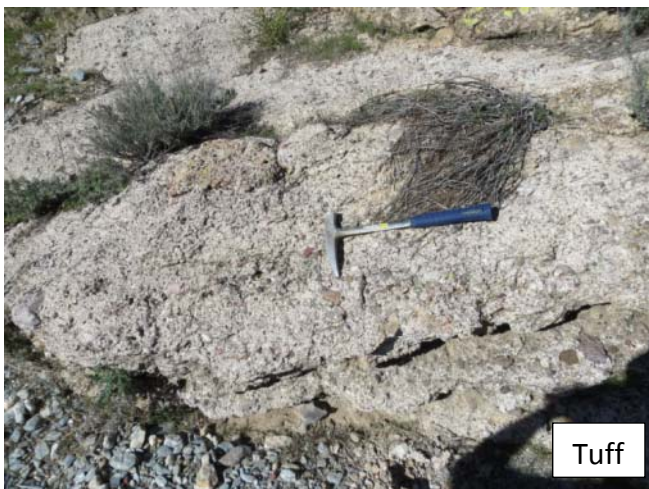
### REBELTANK

Well installation location in elevated bar of undivided surficial sediments (Qs). Gila conglomerate outcrops on channel banks directly adjacent to the windmill. Tuff exposed just upstream of the Gila.

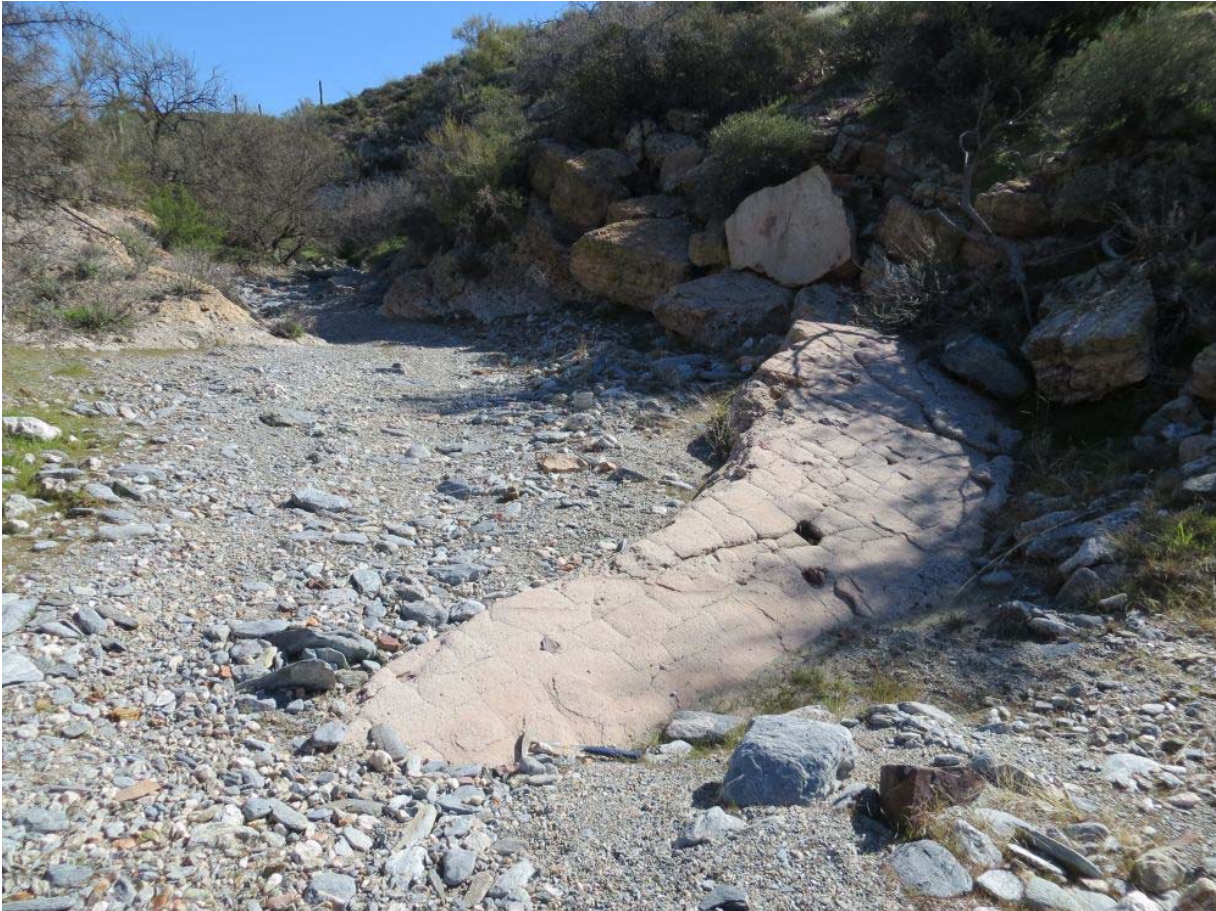
**Tt5**

Dipping tuff layer exposed in creek invert just upstream of REBELTANK.

Orientation of dipping tuff layer: **126/20**

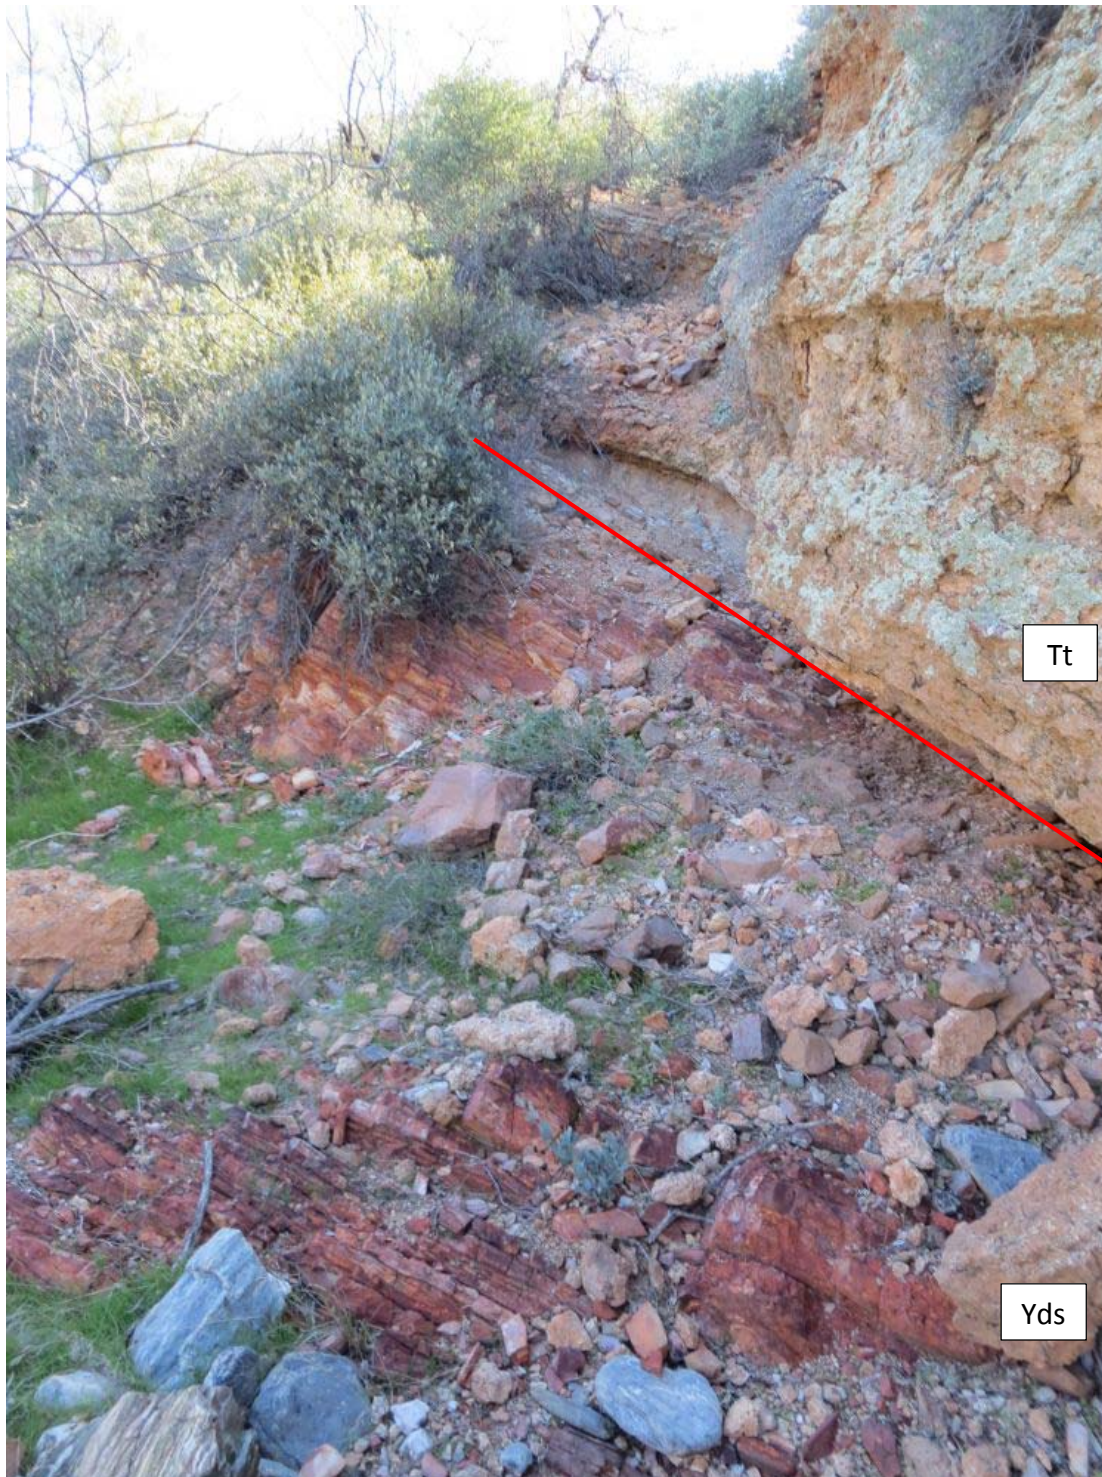
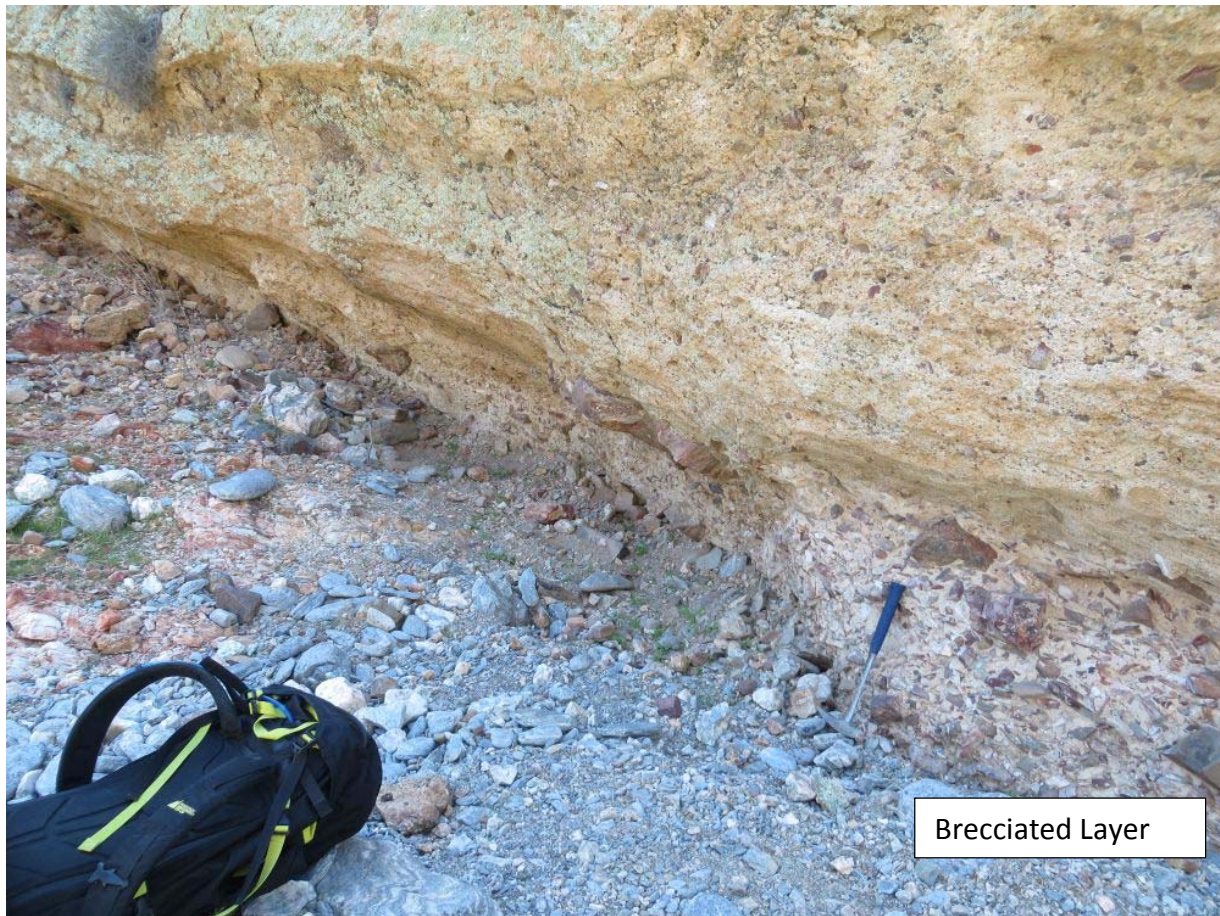
## CONTACT2

Line of contact between poorly welded tuff (Tt) and dripping springs quartzite (Yds). Quartzite appears to be “diving below” the tuff. Layer of brecciated tuff with Yds clasts at the bottom of the tuff exposure.

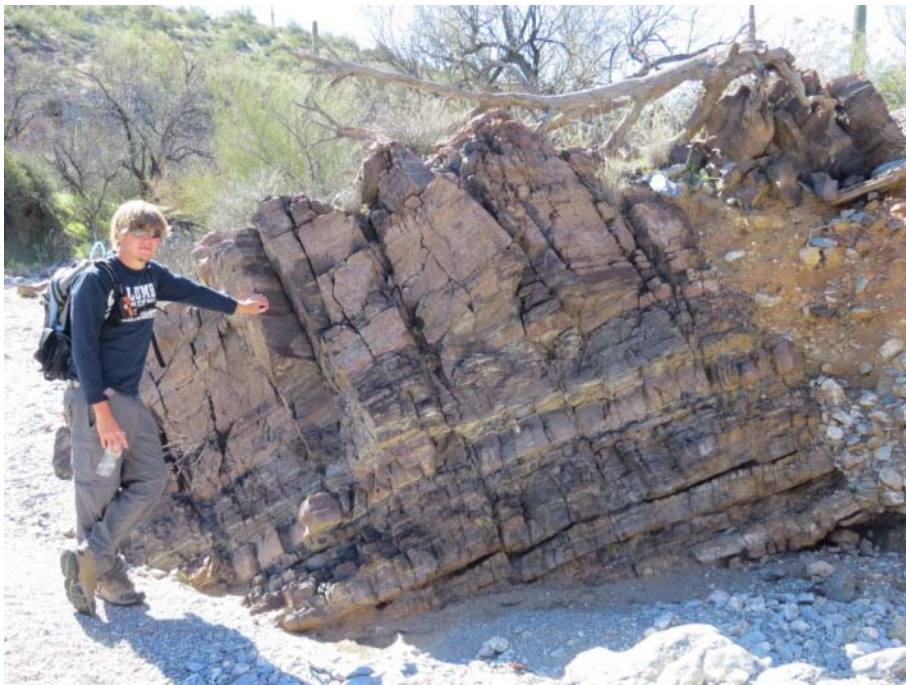
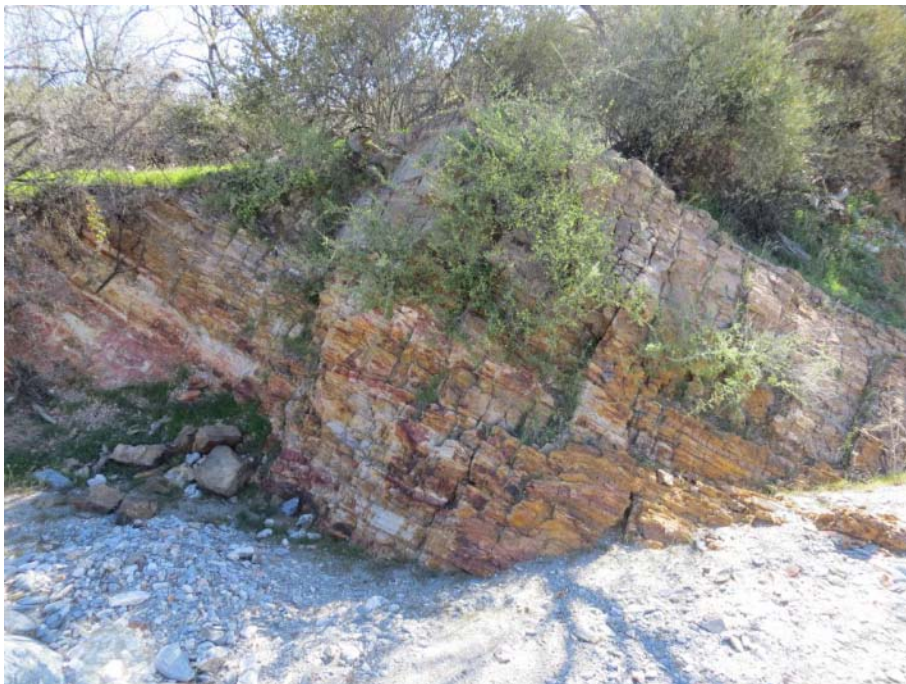
### Yp1

Outcrop of Pioneer shale with strong parallel fracturing parallel to bedding planes, fractures <1 mm to 20 cm (<0.04 inches to 7.9 inches) apart, smooth planar surfaces, darker coloured beds are weaker and very fine grained (shale), lighter coloured beds are fine grained quartz arenite.

Orientation of bedding: **049/44**

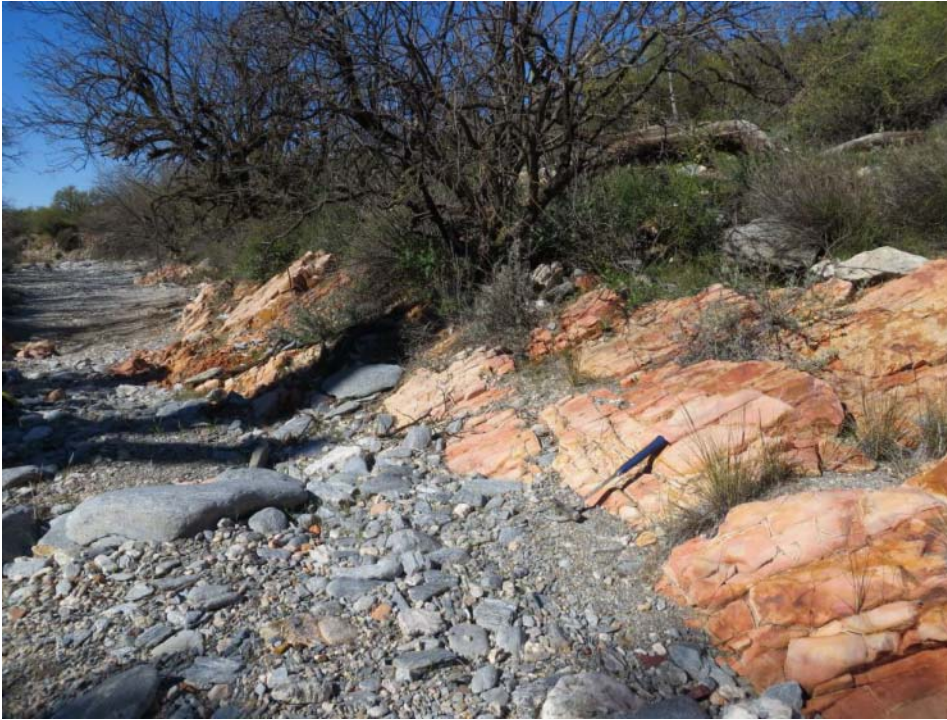
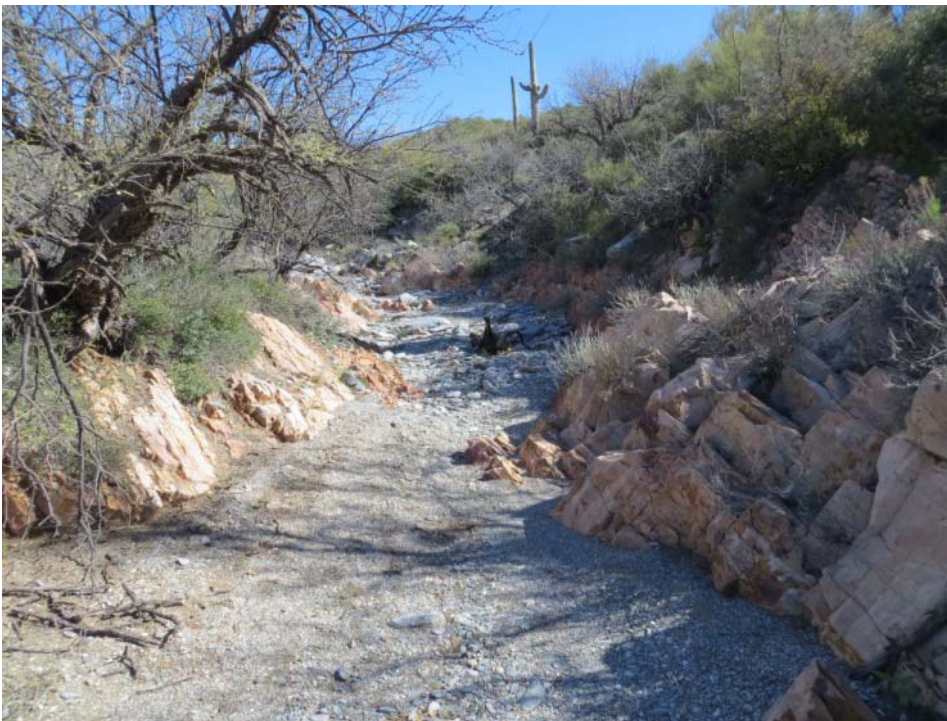
Yp2

As Yp1. Orientation of bedding/fracturing: **047/36**
