## APPENDIX I-E

### Traverse #5

PROJECT  
RESOLUTION PROJECT  
2013 NEAR WEST SITE INVESTIGATION

TITLE  
CREEK TRAVERSE #5

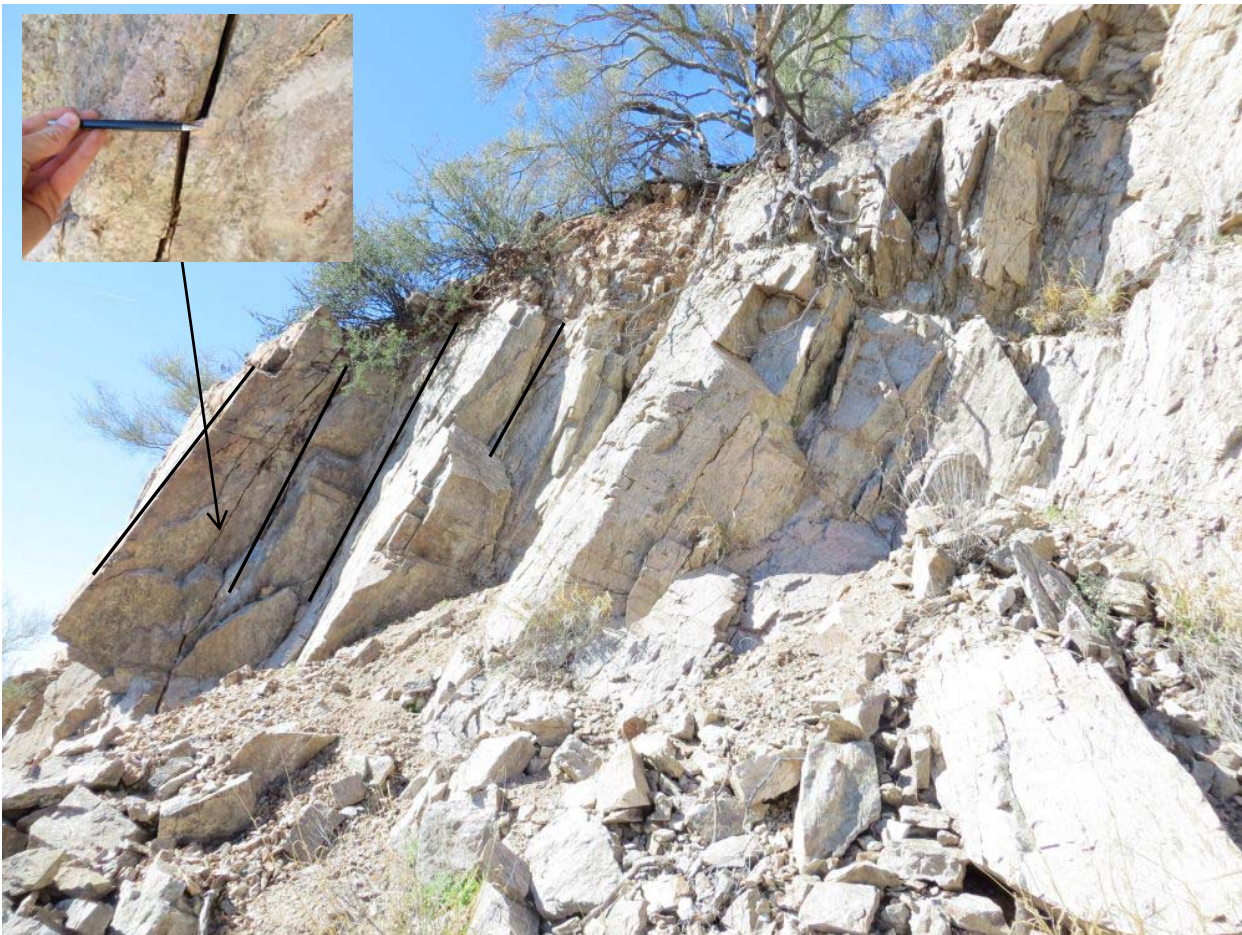
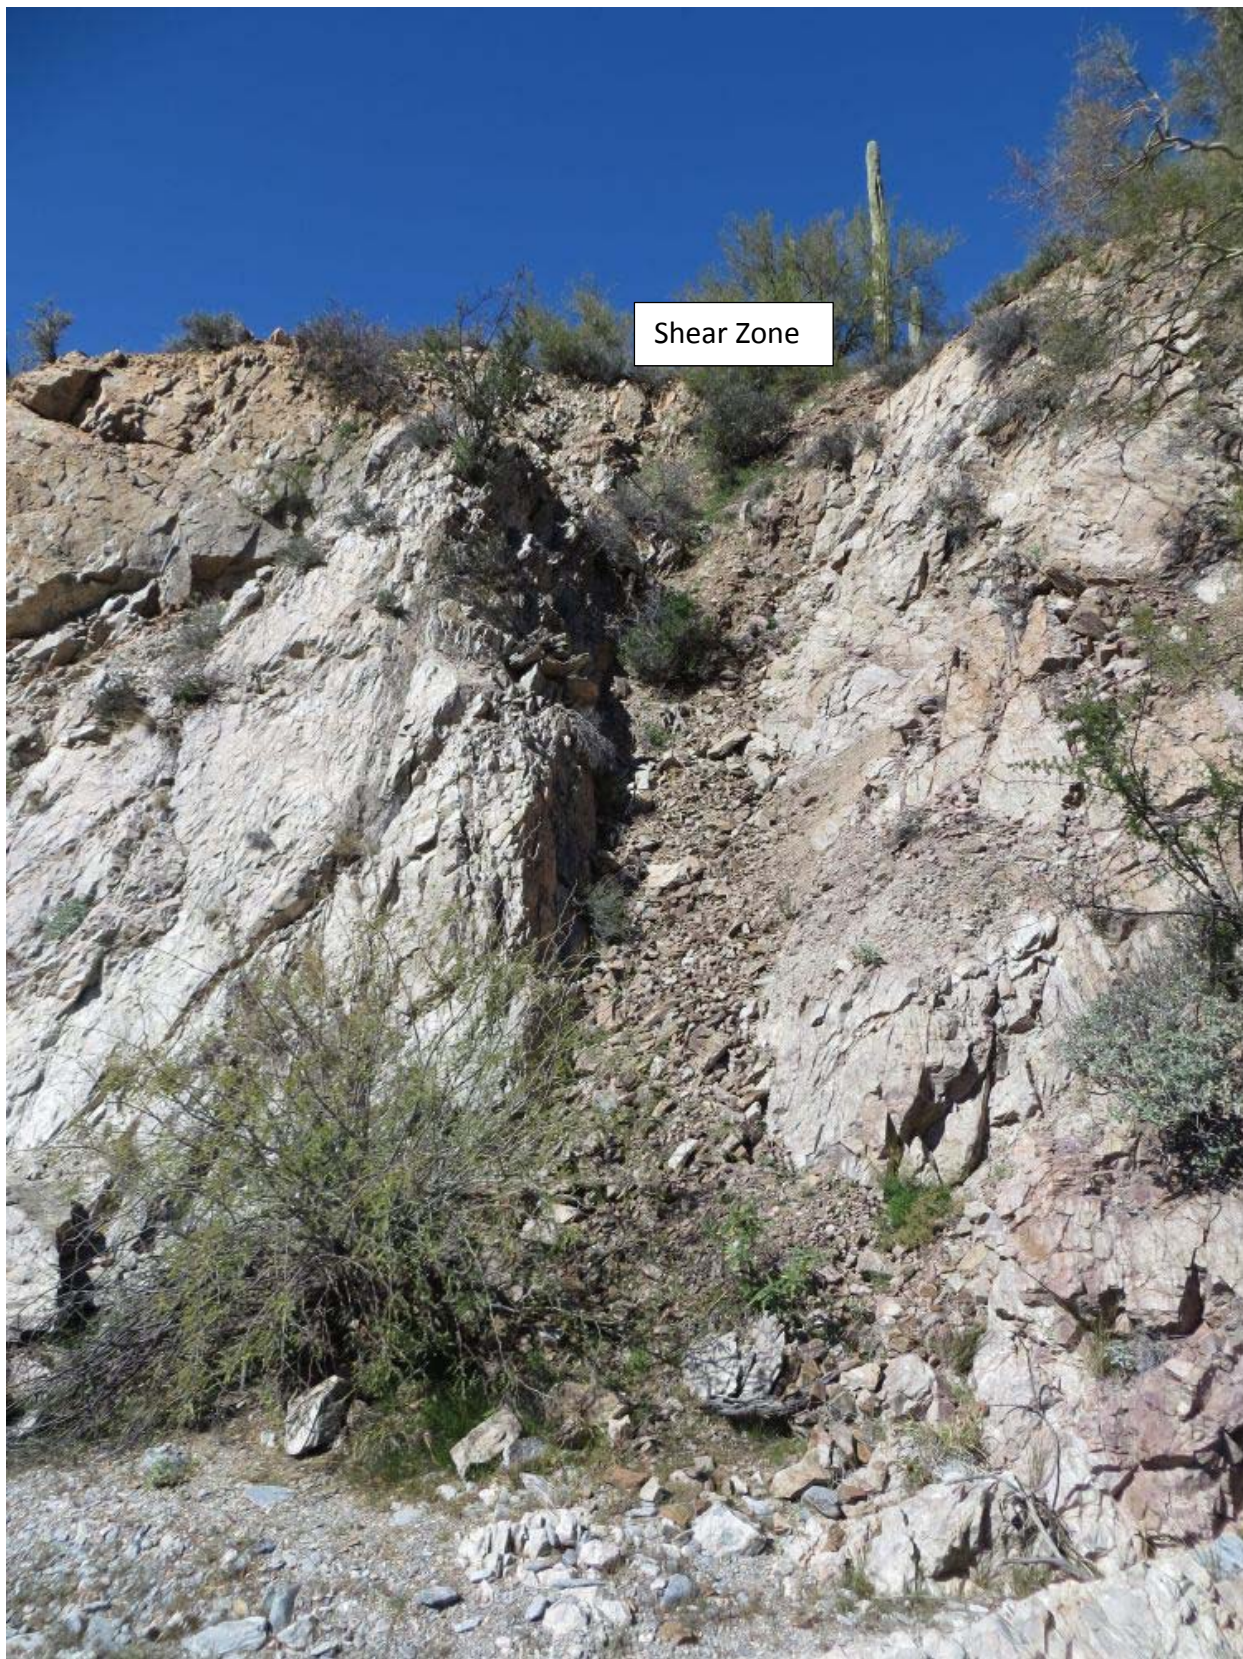
Foliation Cleavage in Fresh  
Schist adjacent to Shear  
Zone

Shear zone cutting vertically up through exposure filled with fractured schist. Rock exposed on either side of shear zone is fresh. Strong parallel cleavage foliation with < 1 mm (0.04 inches) spacing observed in rock on right side of shear zone.

Orientation of foliation cleavage in rock on right side of shear zone: **065/63**

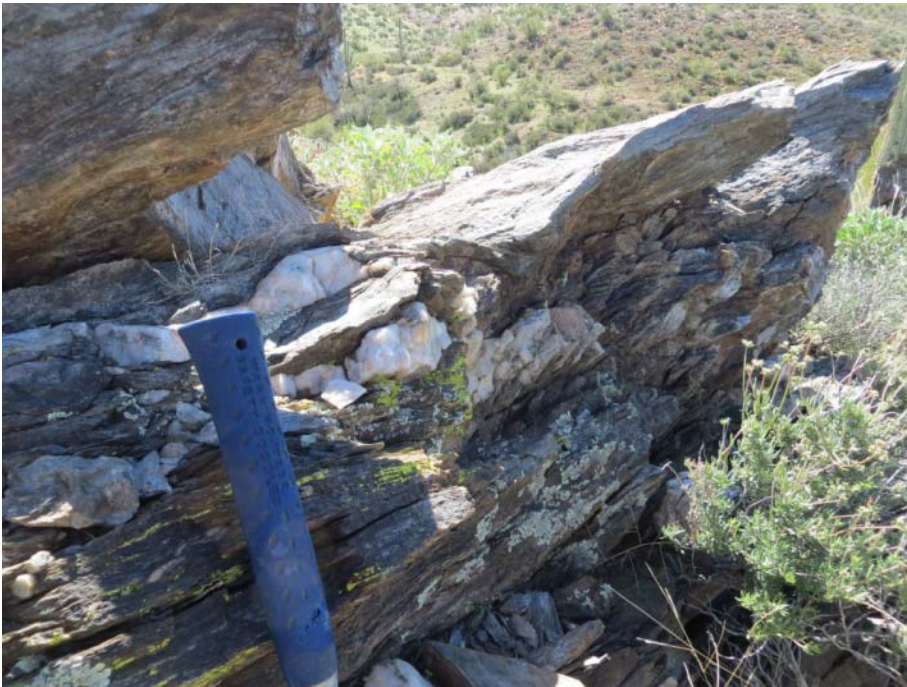
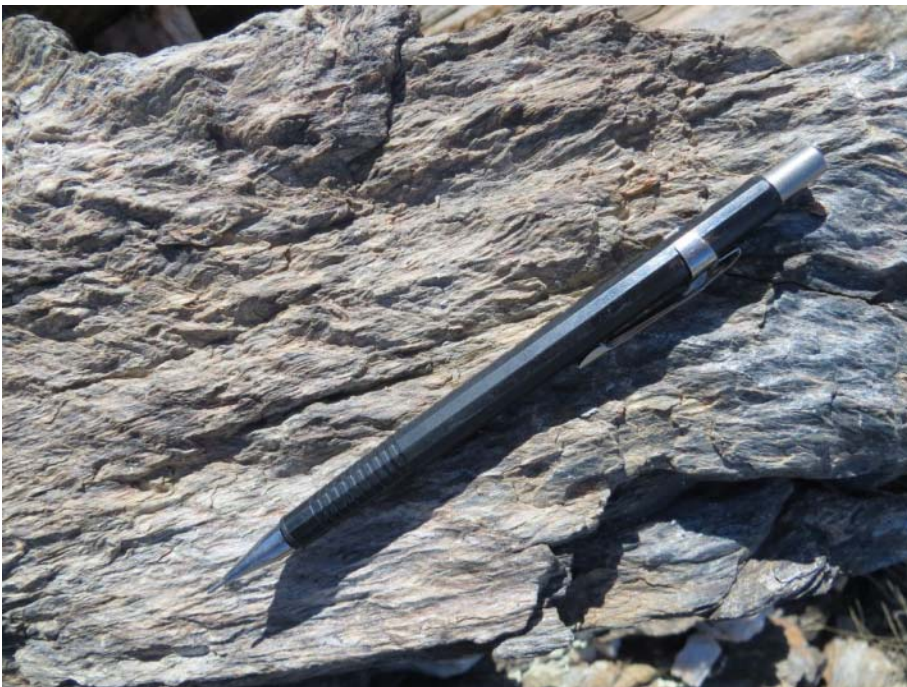
Small outcrop of Xpc facies schist. Very similar in structure to typical Xpm shale. Fresh, R4, strong foliation cleavage spaced in mm scale with some evidence of folding, some quartz veining and infilling, cleavage planes are undulating with smooth, shiny surfaces.

Foliation cleavage orientation      **077/61**

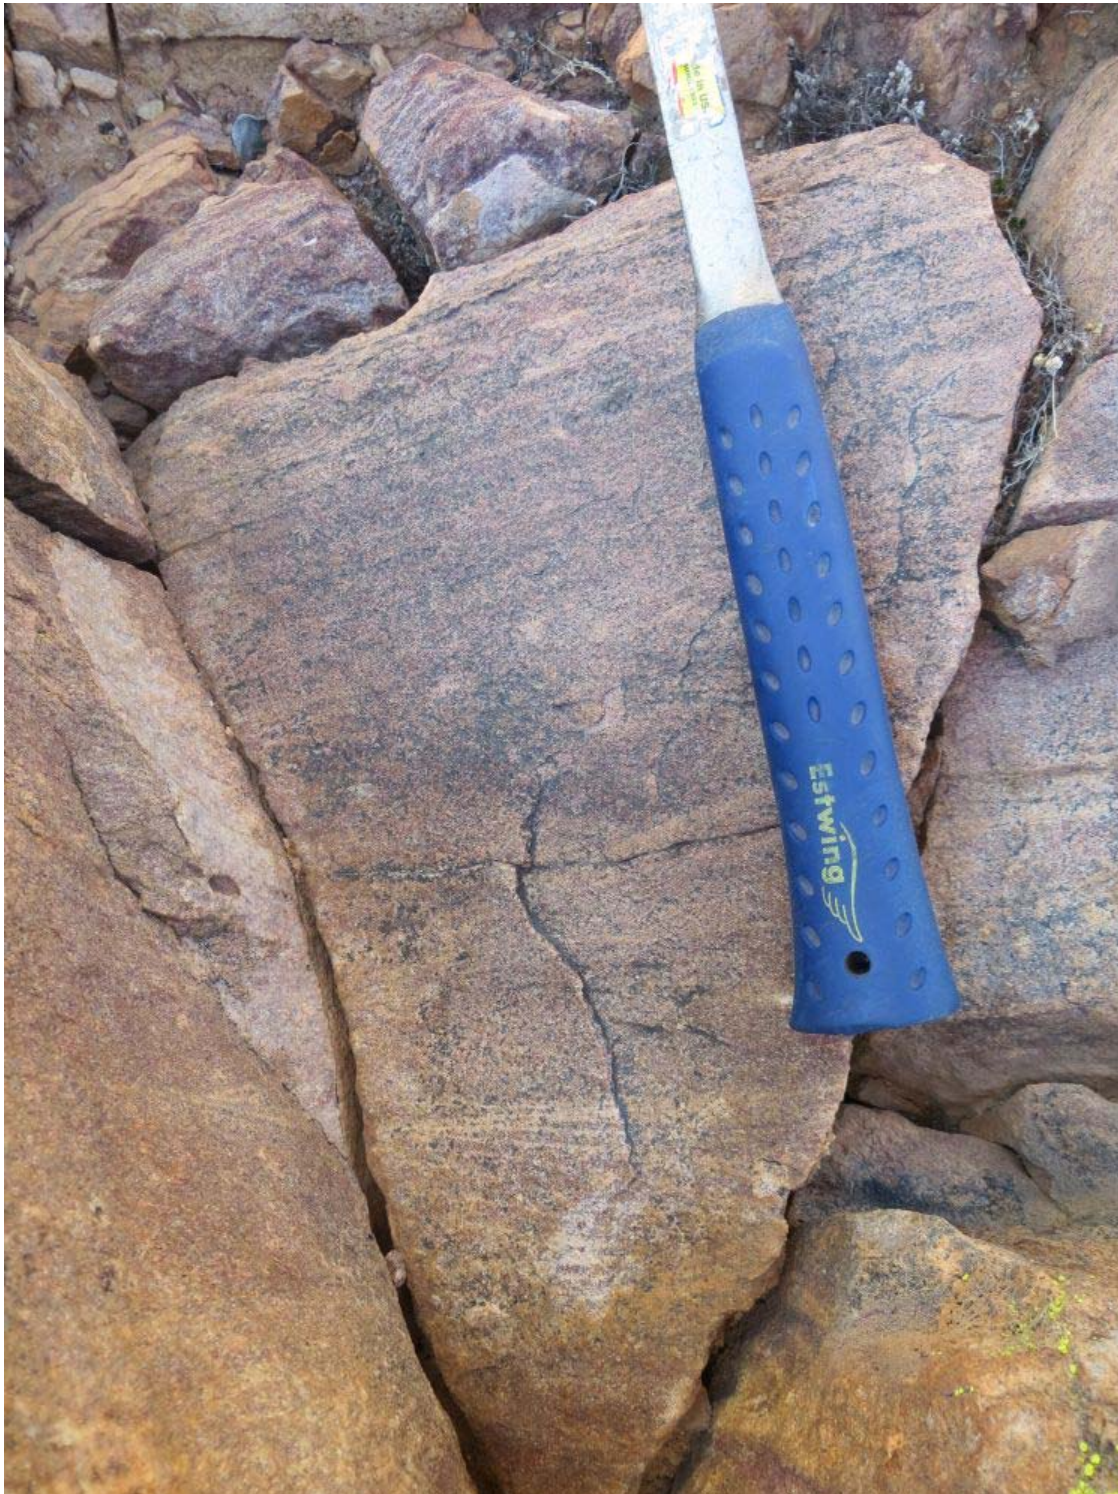
### Yp3

Exposure of Pioneer Shale in channel invert below the Yds unit. Fresh, R4 to R5, bedded, some parallel fractures perpendicular to bedding orientation, average fracture spacing 5 cm to 10 cm (*1.97 inches to 3.94 inches*), closed to max. aperture of 1 mm (*0.04 inches*), no infilling or silty sand infilling with some grass growth, smooth planar surfaces.

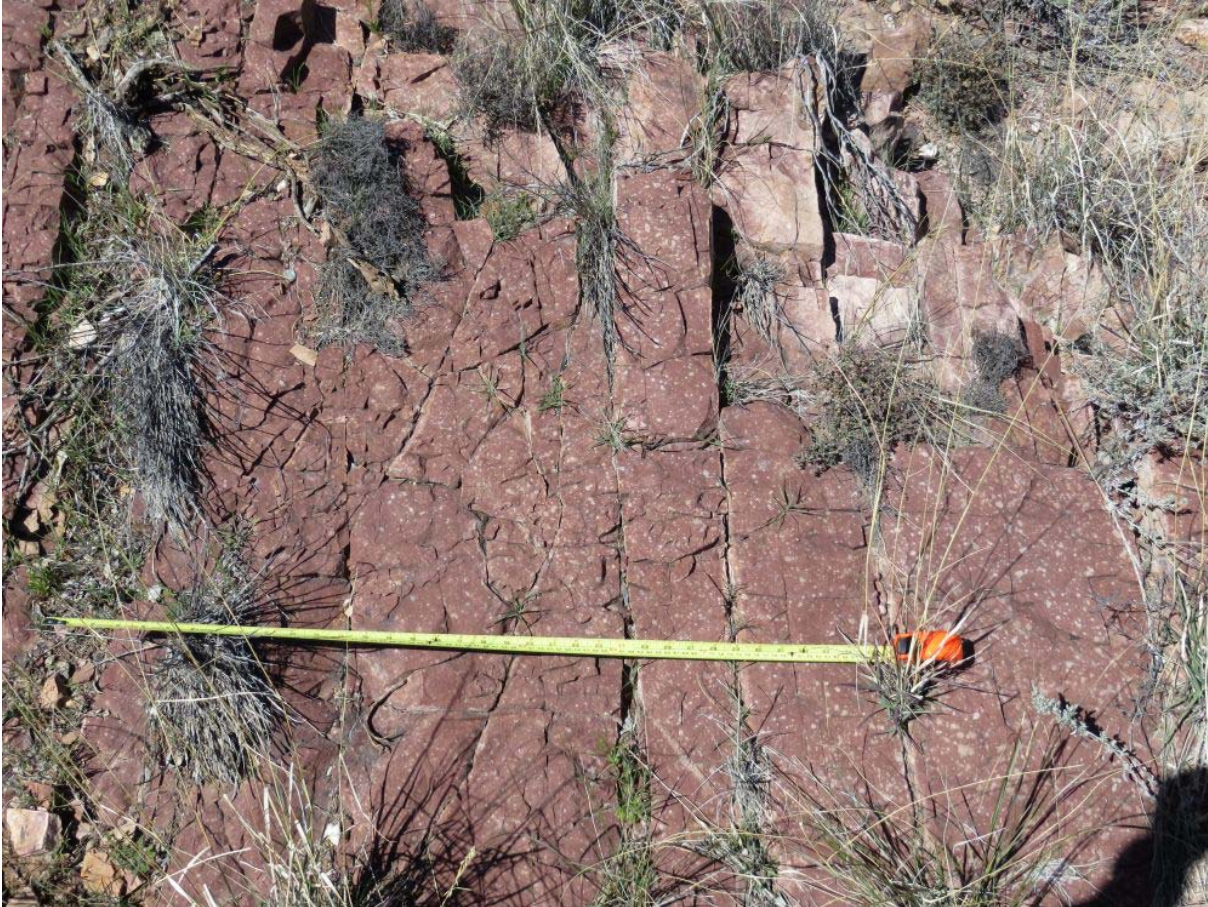
Yd1

Typical surface exposure of diabase. Flat lying area without outcrops visible, only oxidized (rust coloured) gravel sized particles of diabase at surface.

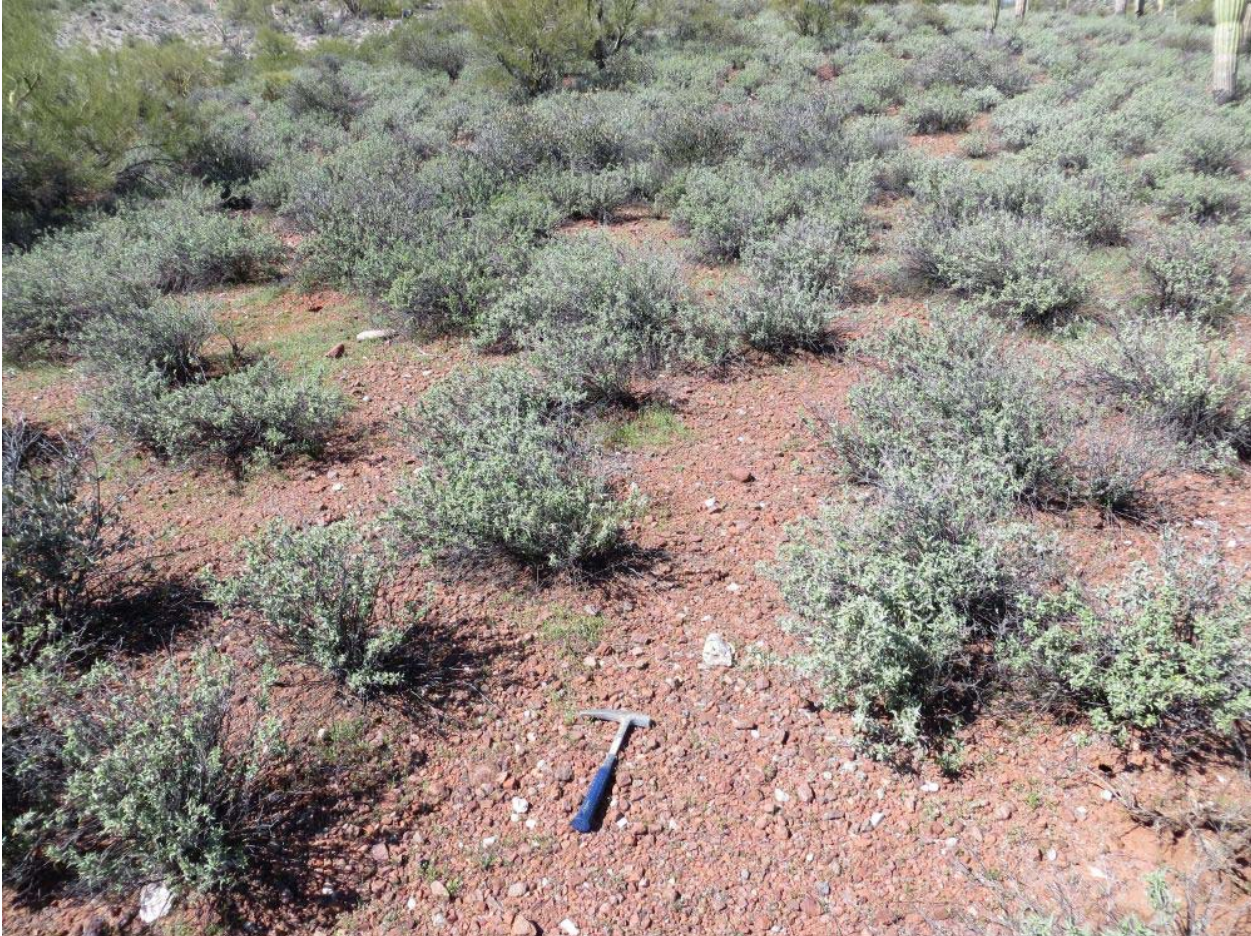
## Yd2

Disintegrated (extremely fractured) diabase exposed along small wash with limestone above. Rock strength R3 (breaks along fractures), one exposure in wash showing two sets of tightly spaced (~ 3 cm (*1.18 inches*)) perpendicular fractures, closed with some fractures calcite infilled, calcite crystals on the exposed diabase surface.

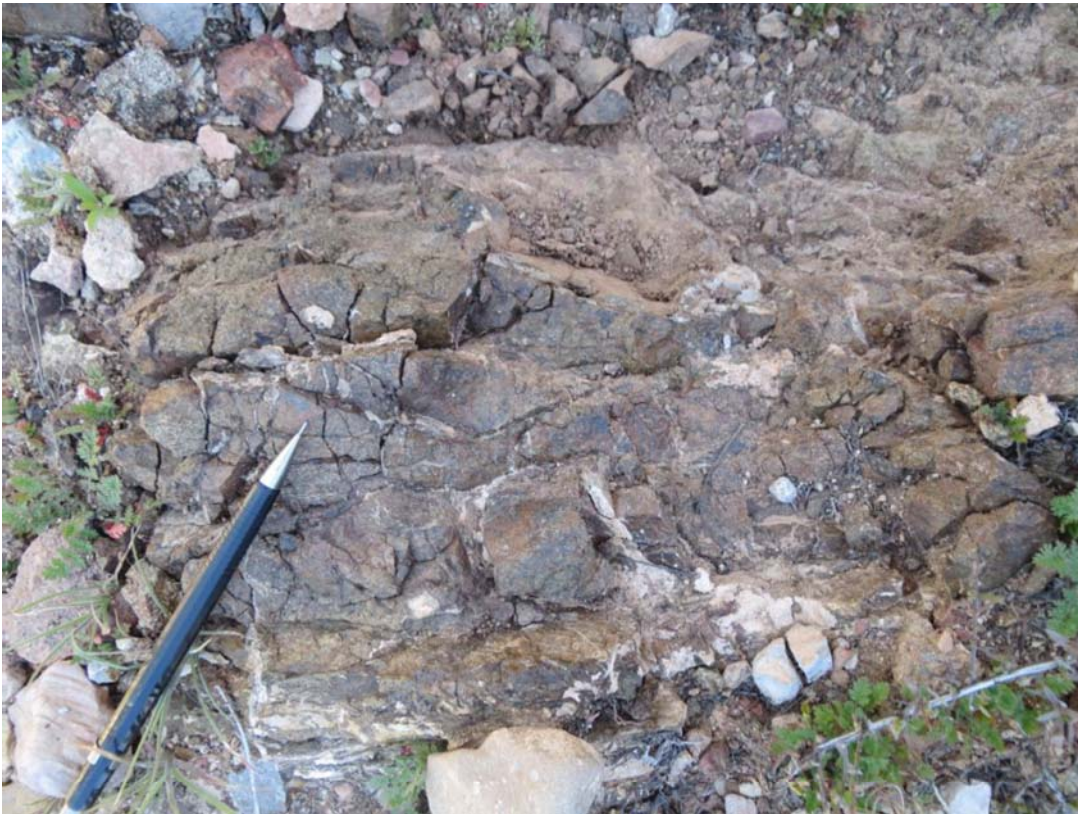
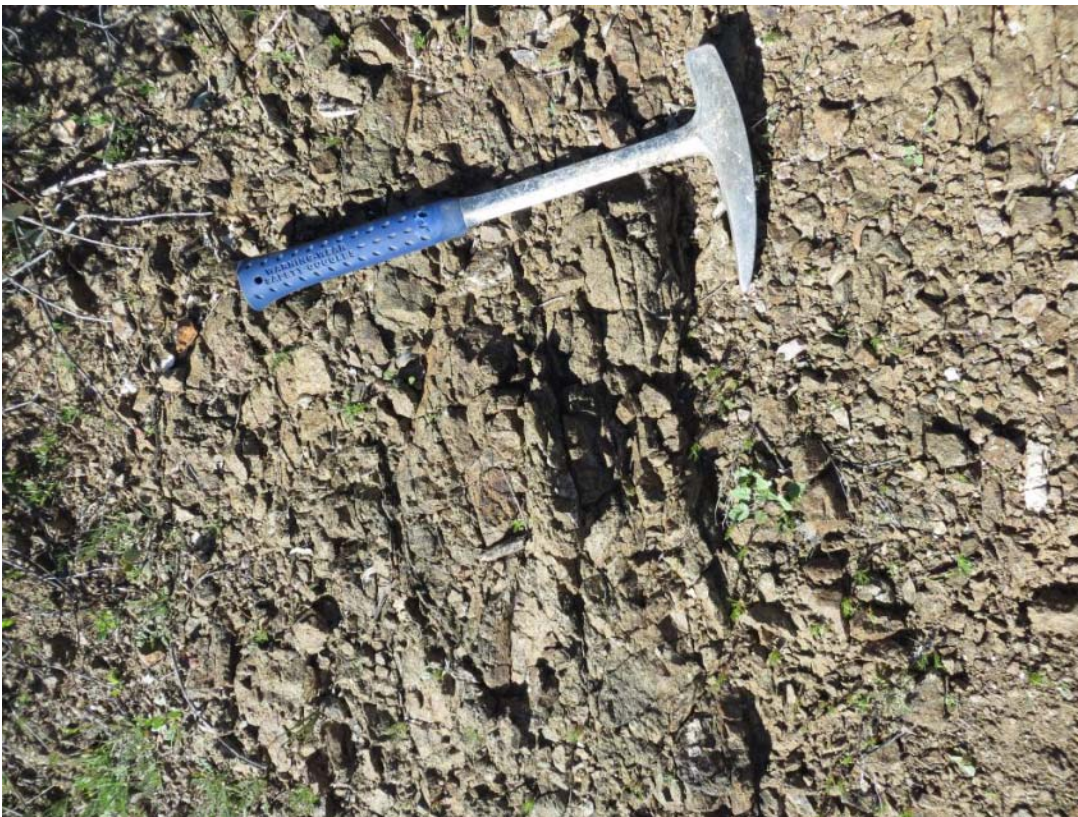
### Dm1

Limestone conglomerate exposure on left side of steep ravine. Fresh, R4 (strength of massive, fine grained intact blocks) to R3 (strength of conglomerate), gravel to cobble fine grained fossiliferous limestone clasts in fine grained calcareous matrix, massive with randomly oriented joints (largest aperture = 3 cm (1.18 inches)) and void space, calcite crystals forming along some areas of the outcrop in void space

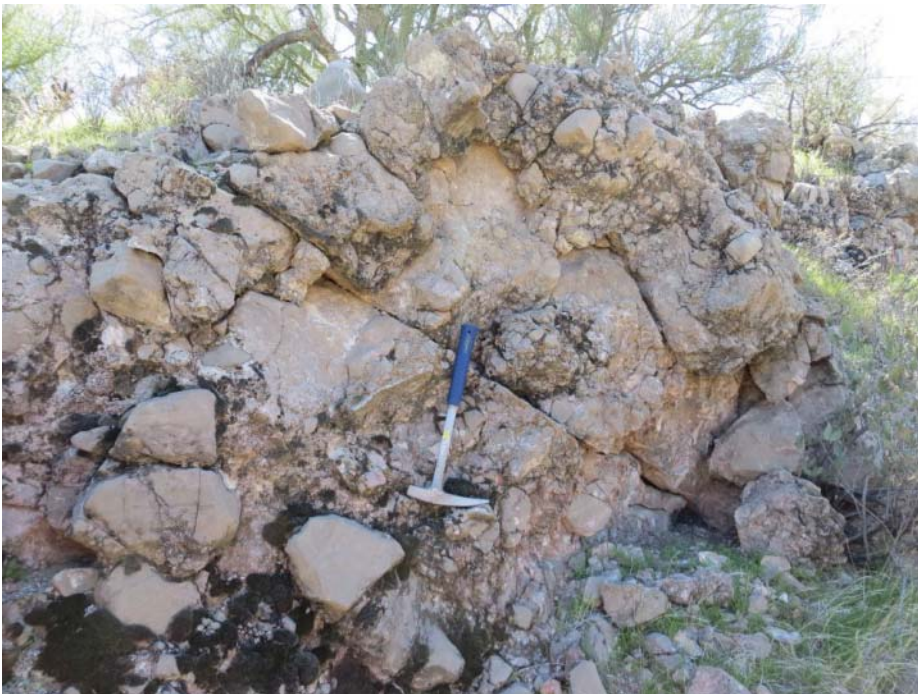
Dm2

Fresh, R4, light grey very fine limestone (calcareous siltstone?), massive with randomly oriented fractures, pitting on surface

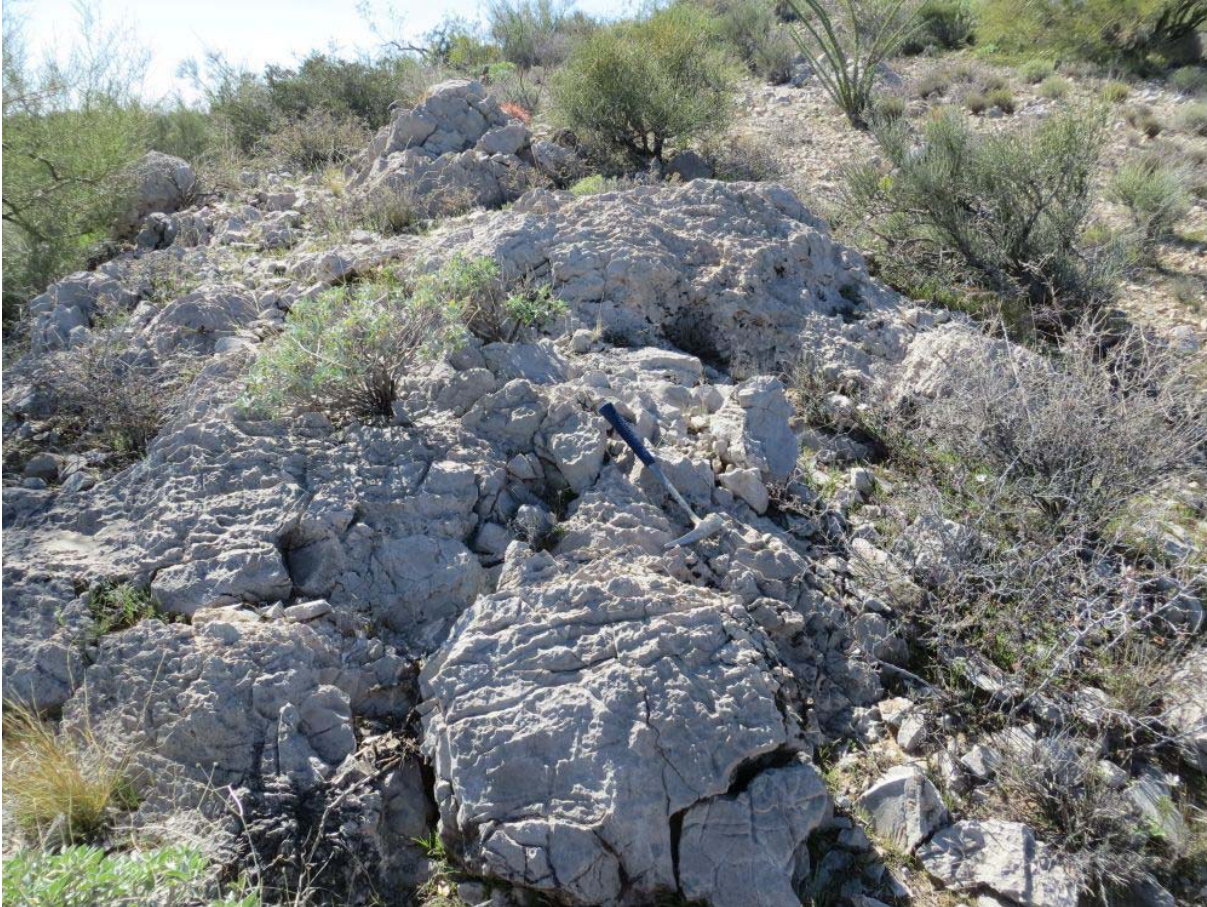
### Dm3

Fresh, R3, fine to medium grained fossiliferous calcareous sandstone, bedded, some joints spaced 2 cm to 10 cm (*0.79 inches to 3.94 inches*) apart, closed near the ground surface but open up at the surface of the outcrop, rough planar surfaces.

Orientation of beds: **103/32**

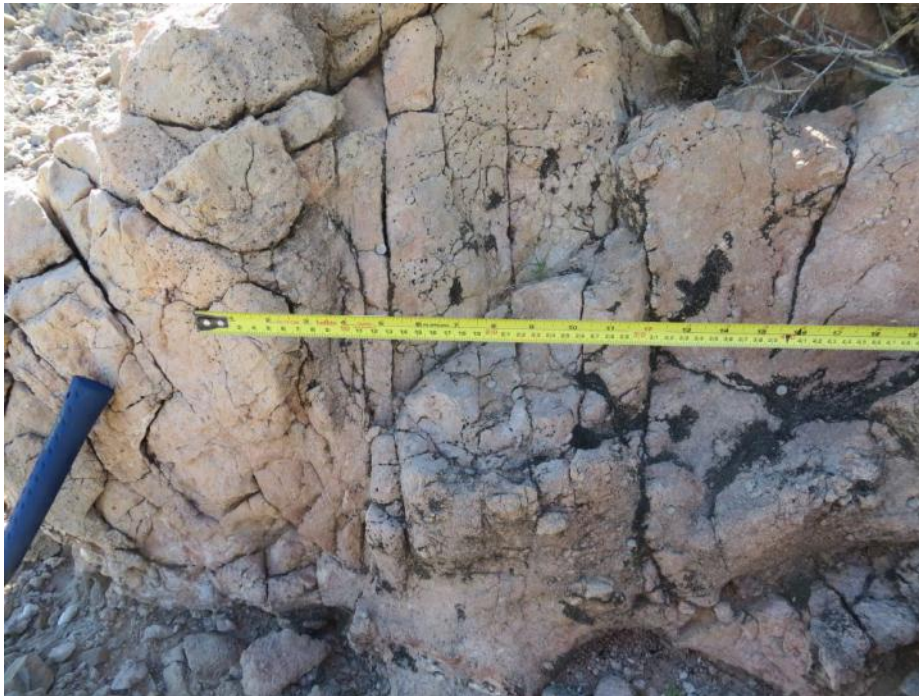
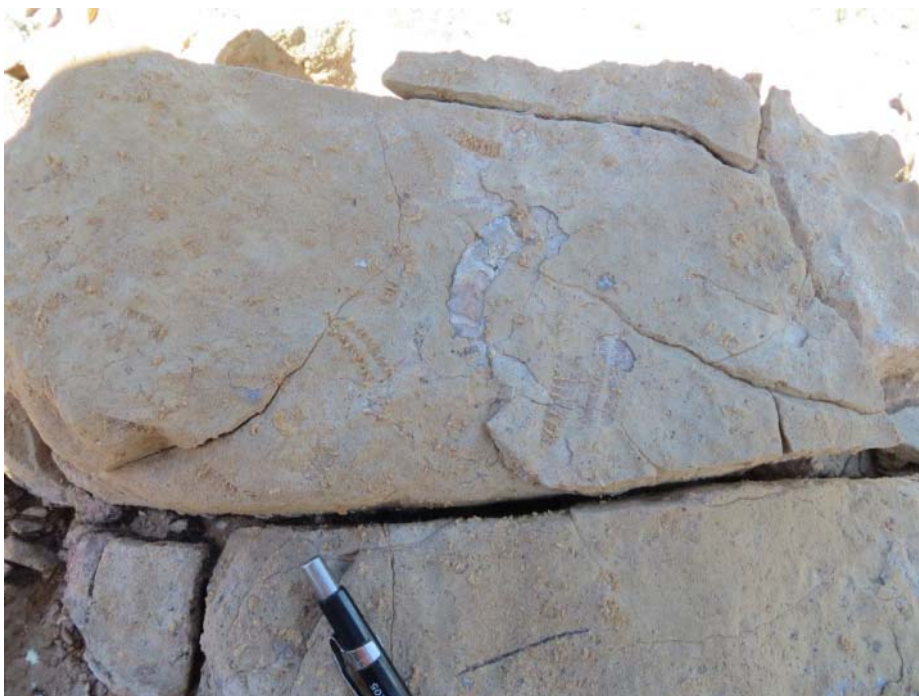
**Cb1**

Bolsa quartzite cobbles and boulders at surface. Slightly weathered (rusty oxidized surfaces), R5, bedded well graded quartz arenite, preferentially breaks along bedding planes.

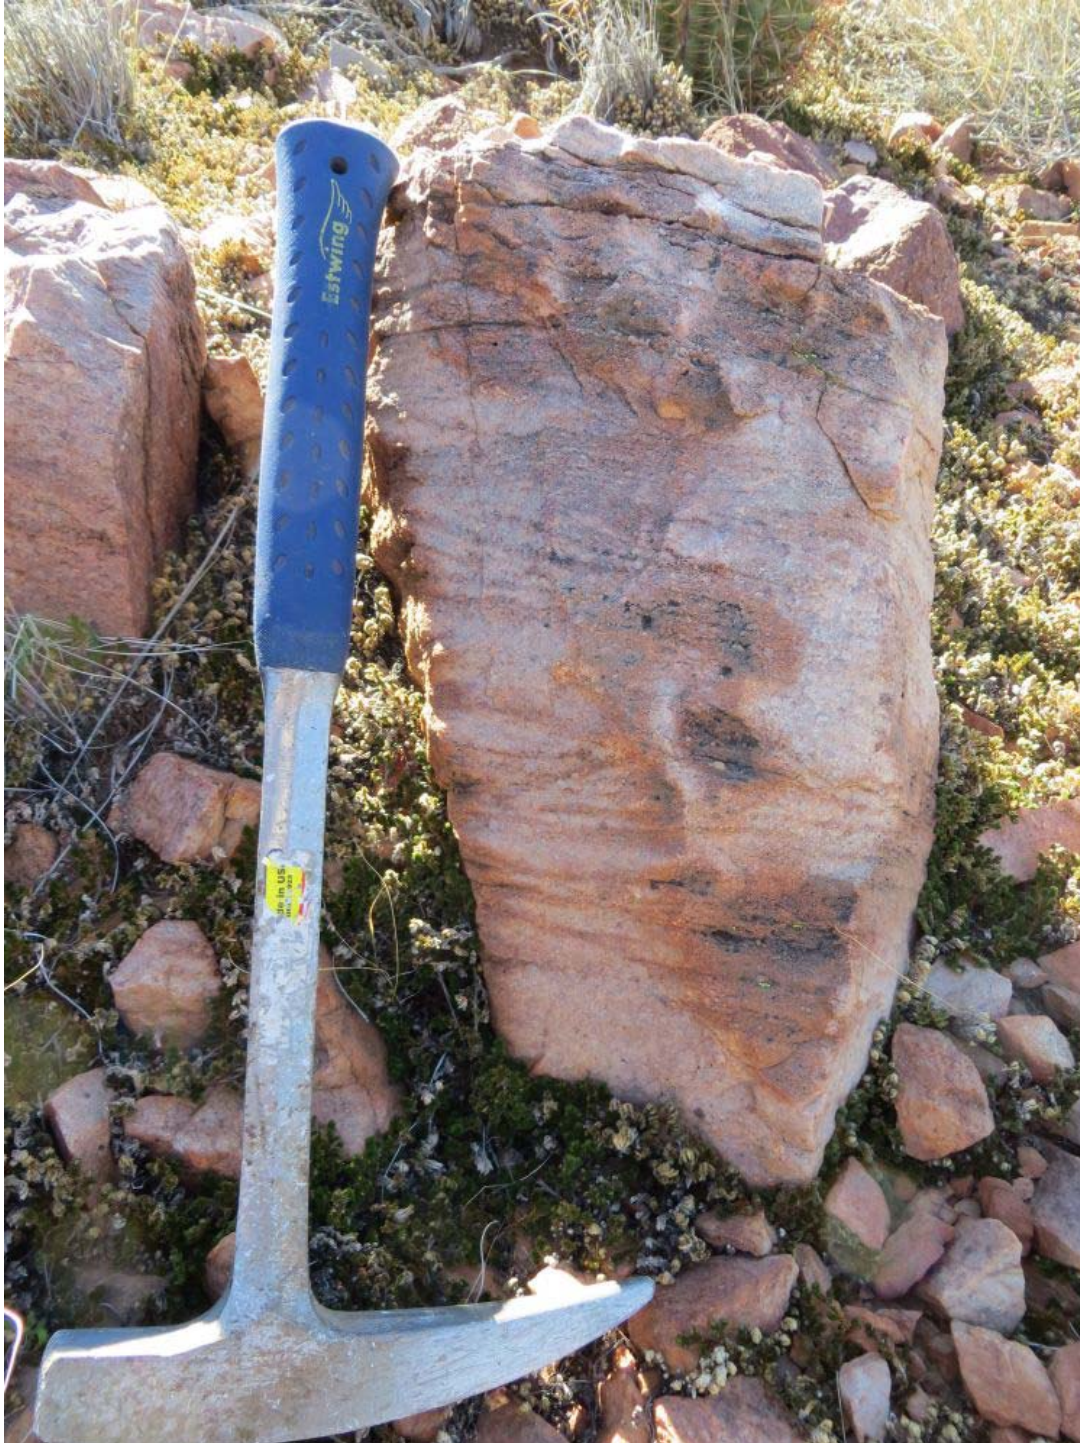
## Cb2

Weathered (jagged and massive) exposure of Bolsa quartzite. R5, quartzite, some areas of exposure appear to be brecciated with angular pieces of quartzite in siliceous fine grained matrix.

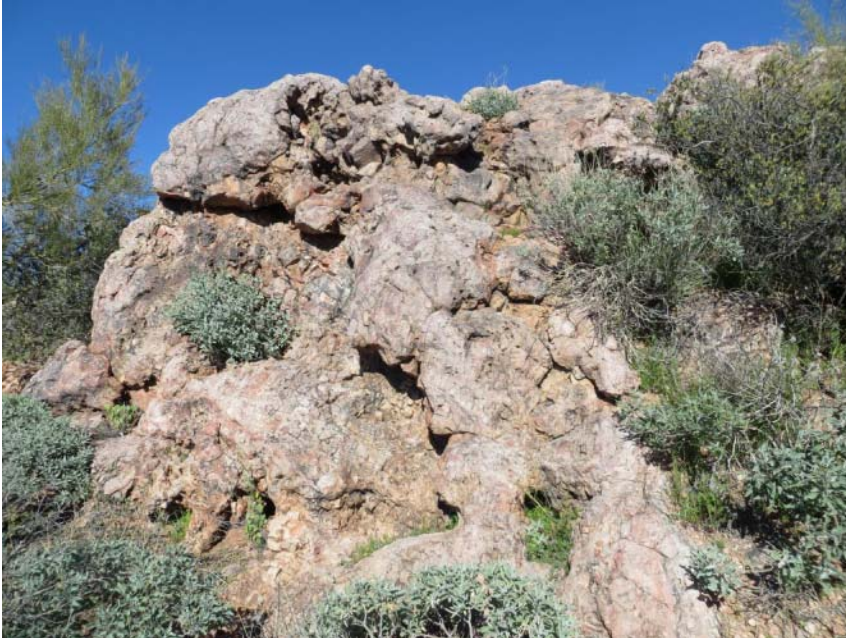
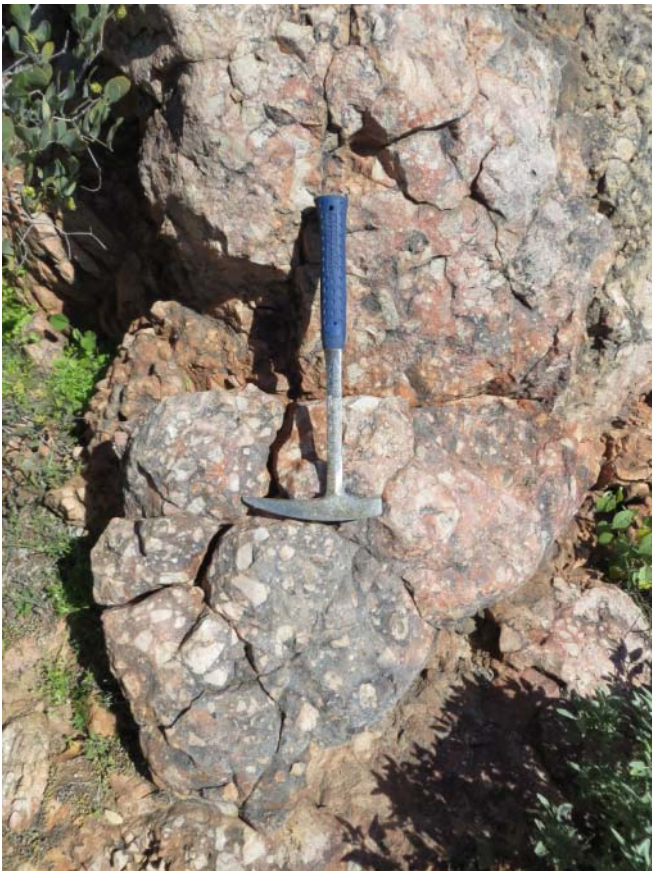
### Tt6

Tuff, 1.2 m (3.9 ft) of harder pink tuff (R3) underlying ~0.6 m (~2.0 ft) of white, weaker (R2) and lower density tuff, random fracture orientation, fractures closed just below surface of outcrop, rough, planar fracture surfaces.

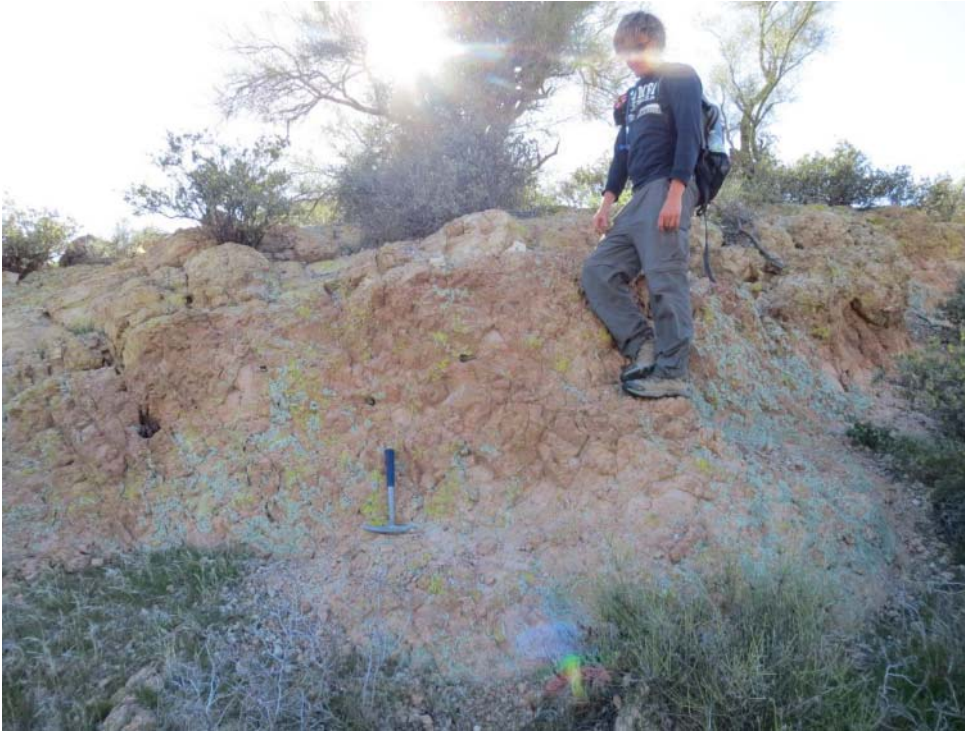
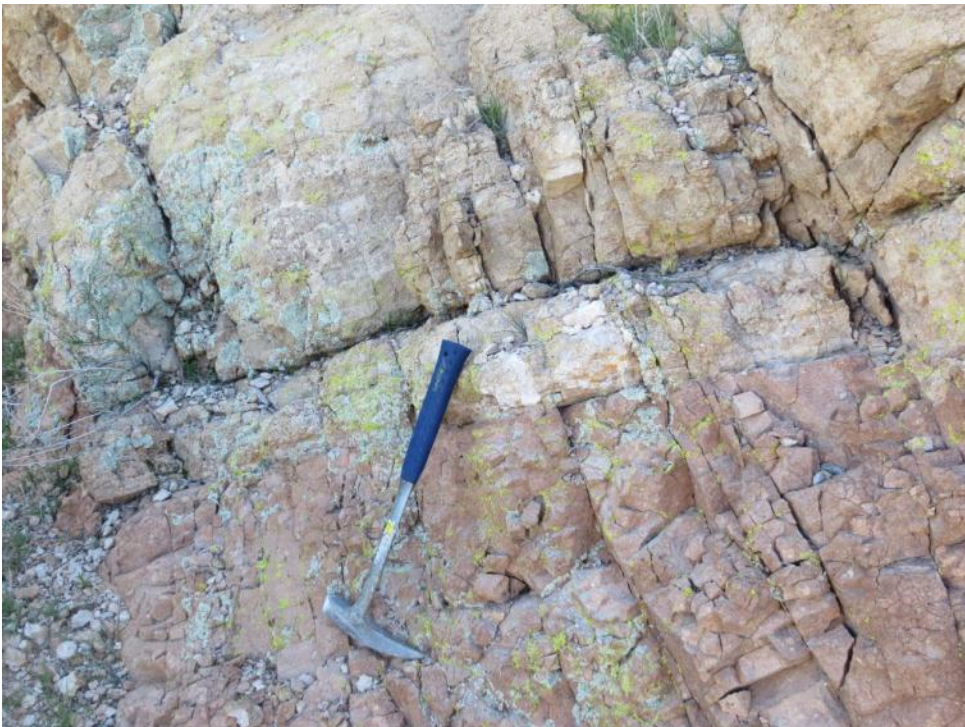
#### Dm4

Fresh limestone, R5 (coarse sandy beds) to R3 (finer siltstone beds), interbedded calcareous sandstone and siltstone, bed thickness ranges from cm scale to metres thick, wide openings between interbedded units appear to be caused by differential erosion of the finer beds.

Orientation of dominant bedding planes in the outcrop: **055/20**

Orientation of dominant bedding planes in channel invert: **065/12**

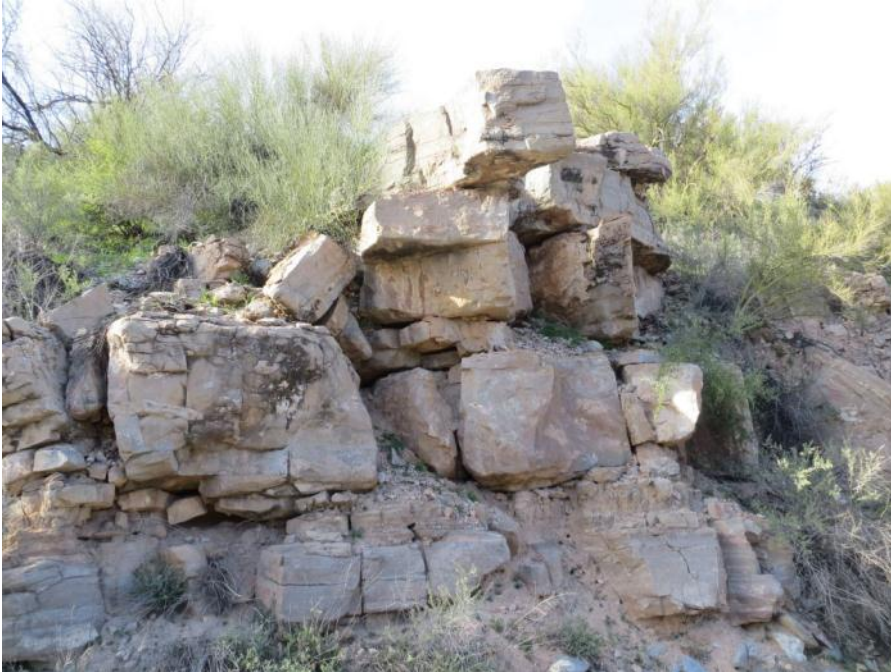
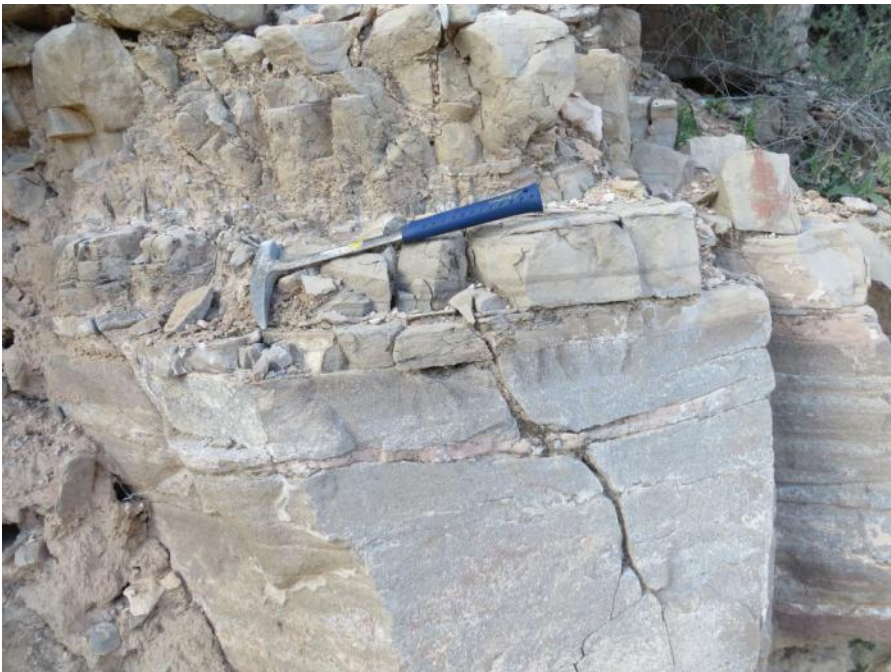
### Me1

Fresh limestone, R5, massive, light grey fine grained calcareous siltstone(?), many discontinuous and randomly oriented fractures, pitted surface, calcite infilling in the wider fractures.

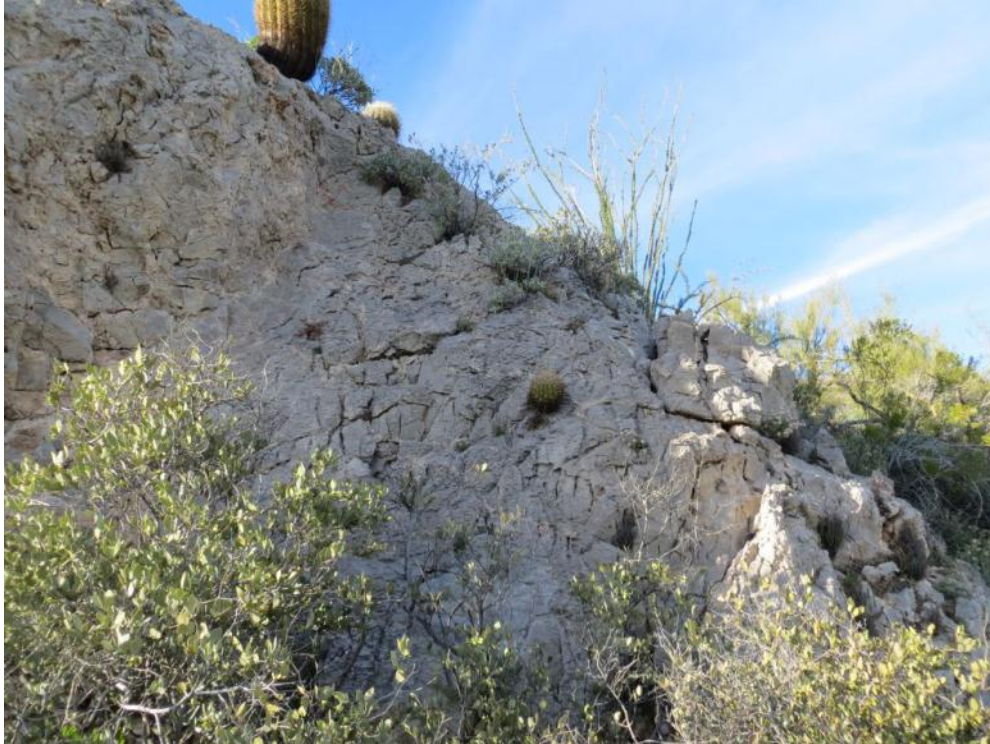
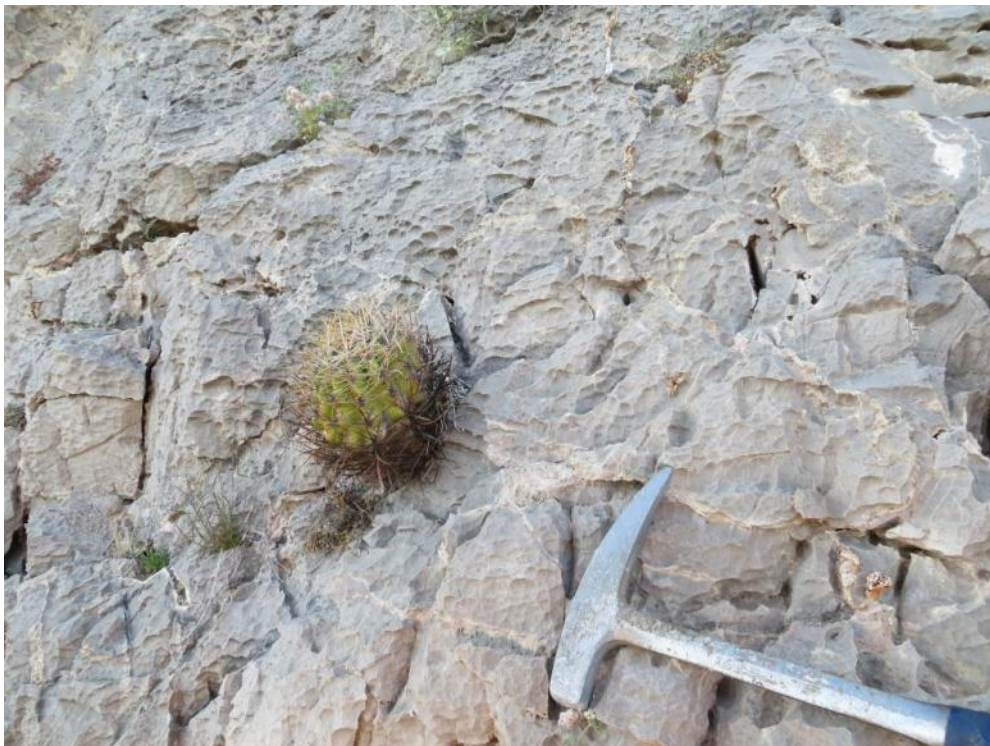
### Dm5

Exposure of limestone in small wash invert. R4 to R5, randomly oriented fractures all filled with calcite, fracture aperture ranging from closed to ~ 2 cm (0.79 inches) but all well healed with calcite.

Orientation of limestone beds in channel bank:

061/21

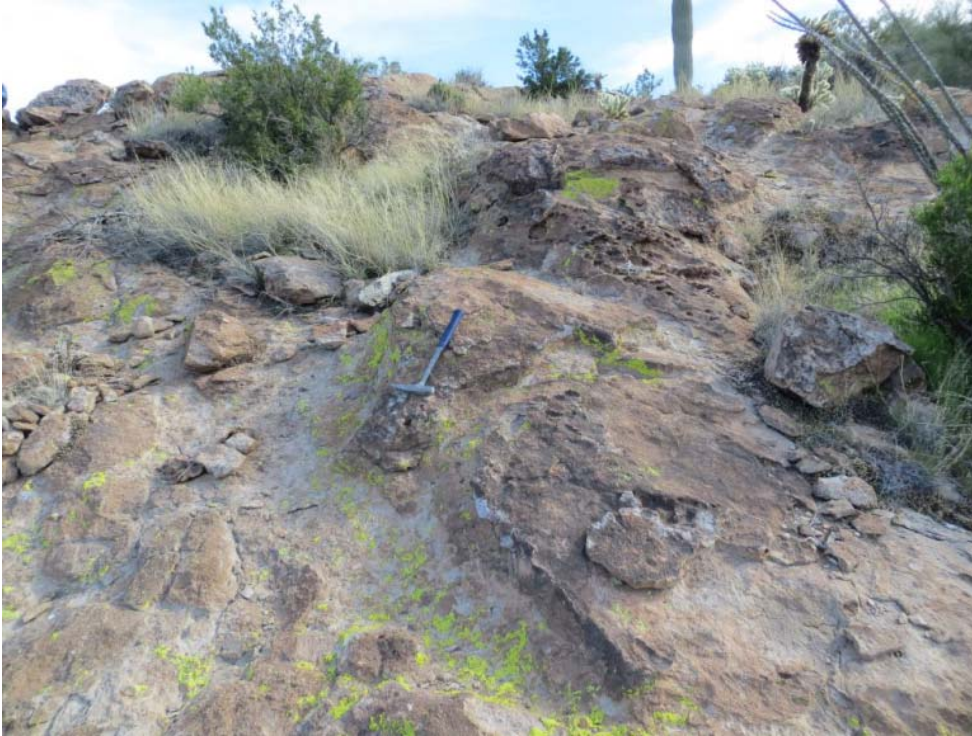
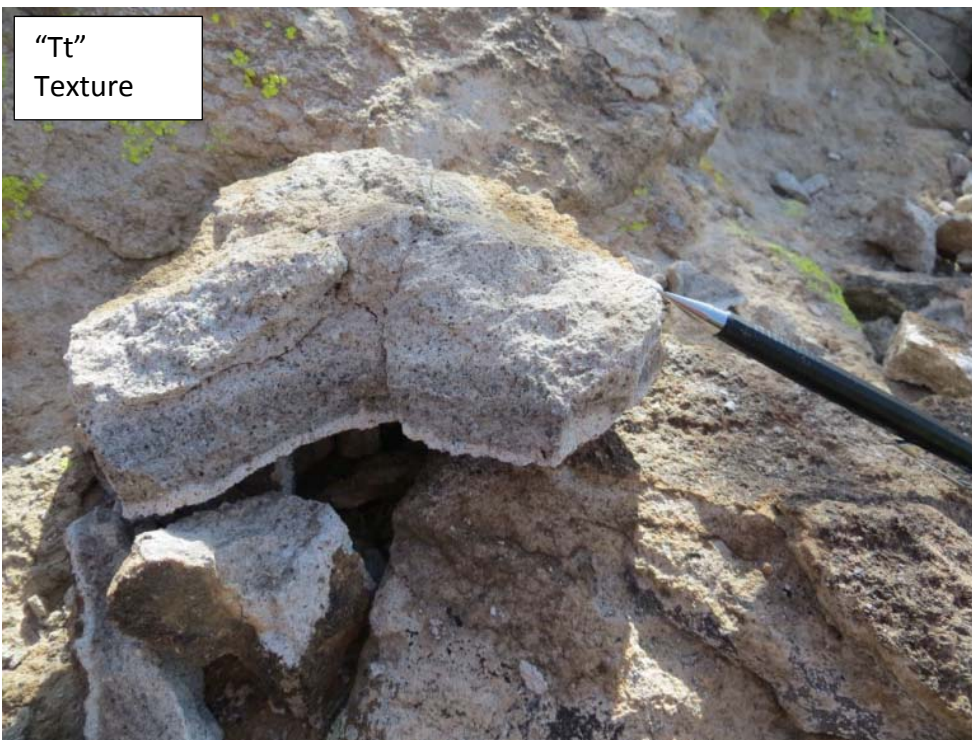
### Tt7

Large tuff exposure near Tt and Tcg (Gila conglomerate) contact. Massive with no joints visible, fresh, R3, white very fine felsic matrix with biotite grains visible.

"Tt"  
Texture
