## APPENDIX I-E

### Traverse #5

PROJECT  
RESOLUTION PROJECT  
2013 NEAR WEST SITE INVESTIGATION

TITLE  
CREEK TRAVERSE #5

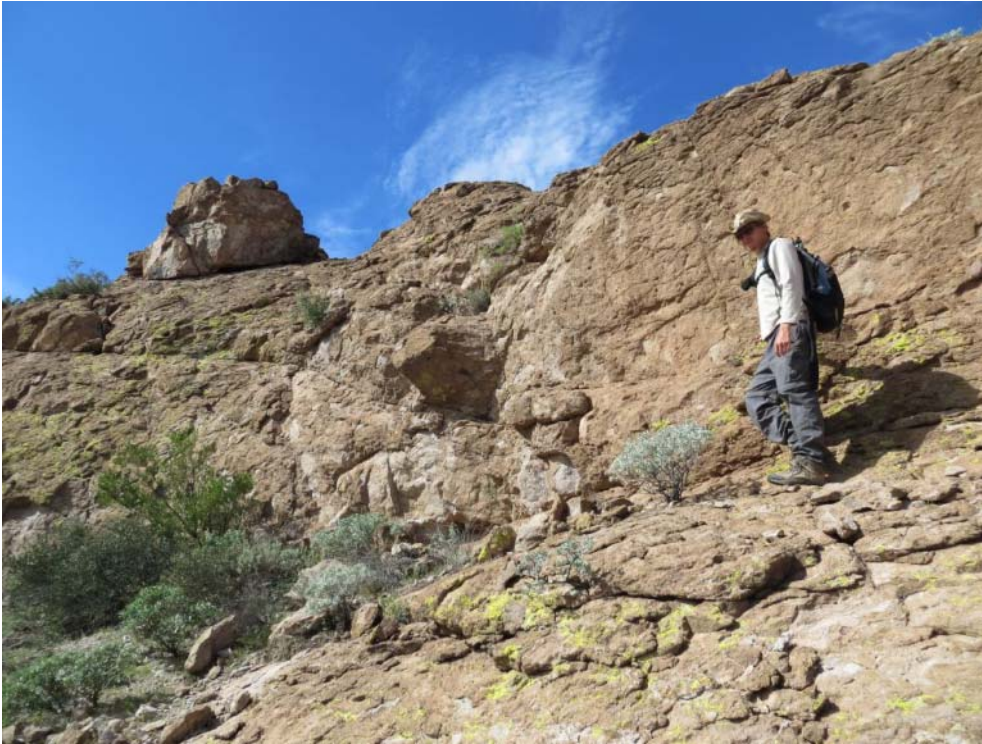
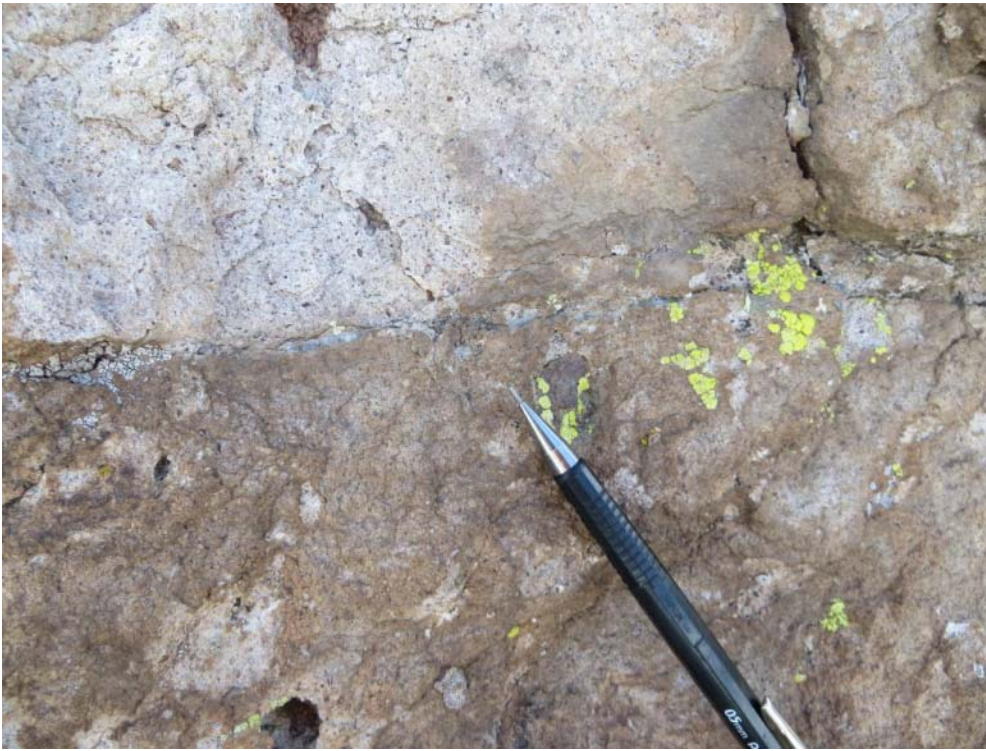
### Tt8

Large tuff exposure, fresh, R4, massive with some randomly oriented fractures, calcite infilling of some thin (<1 mm (*0.04 inches*) aperture) fractures, white very fine felsic matrix with biotite grains visible.

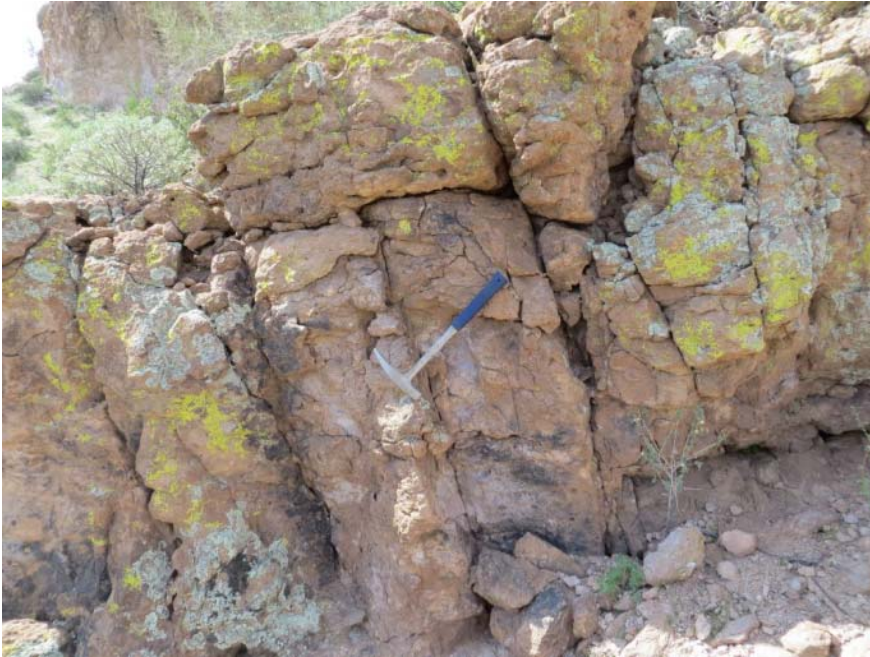
**Tt9**

2 m (6.6 ft) high exposure of tuff, R4, parallel vertical joints spaced ~ 40 cm (15.7 inches) apart. Some more tightly spaced joints on sub-horizontal tuff exposure below, spaced 5 cm (2.0 inches) below. Joints can be wide open on the exposure surface but close off quickly, rough and stepped joint surfaces.

Orientation of joint set: **040/90**

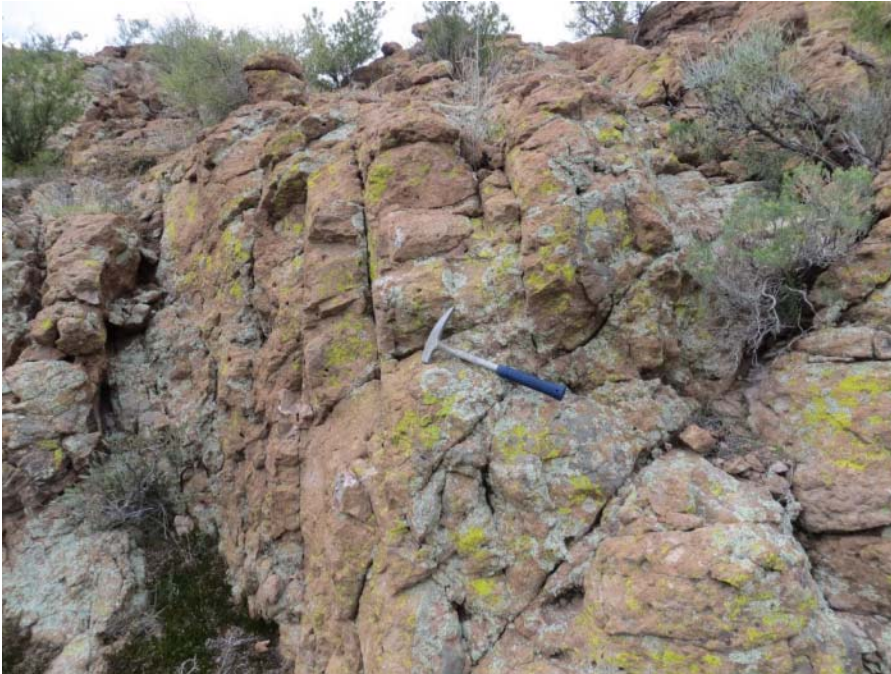
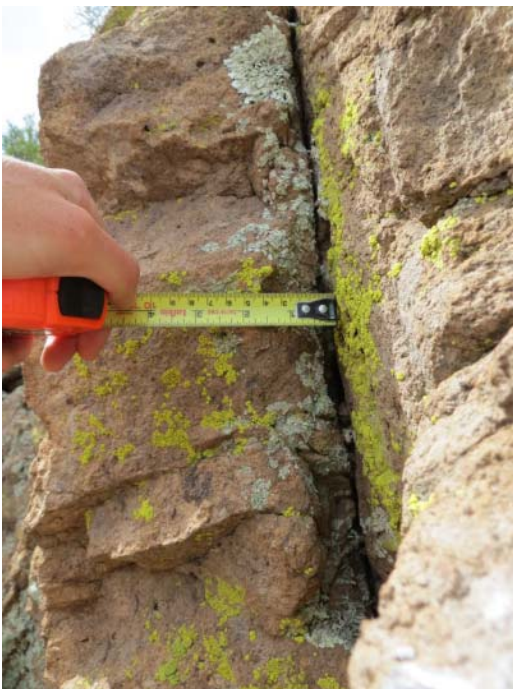
### Tt10

Tuff, fresh, R4, parallel vertical joints with avg. spacing of ~30 cm (*11.8 inches*), closed to moderately wide aperture (max. 5 mm (*0.2 inches*)) but appear to close off below the outcrop surface, rough and stepped joint surfaces. Second set of flatly dipping joints with 40 cm (*15.7 inches*) spacing and closed just below surface.

Orientation of joint set: **031/90**

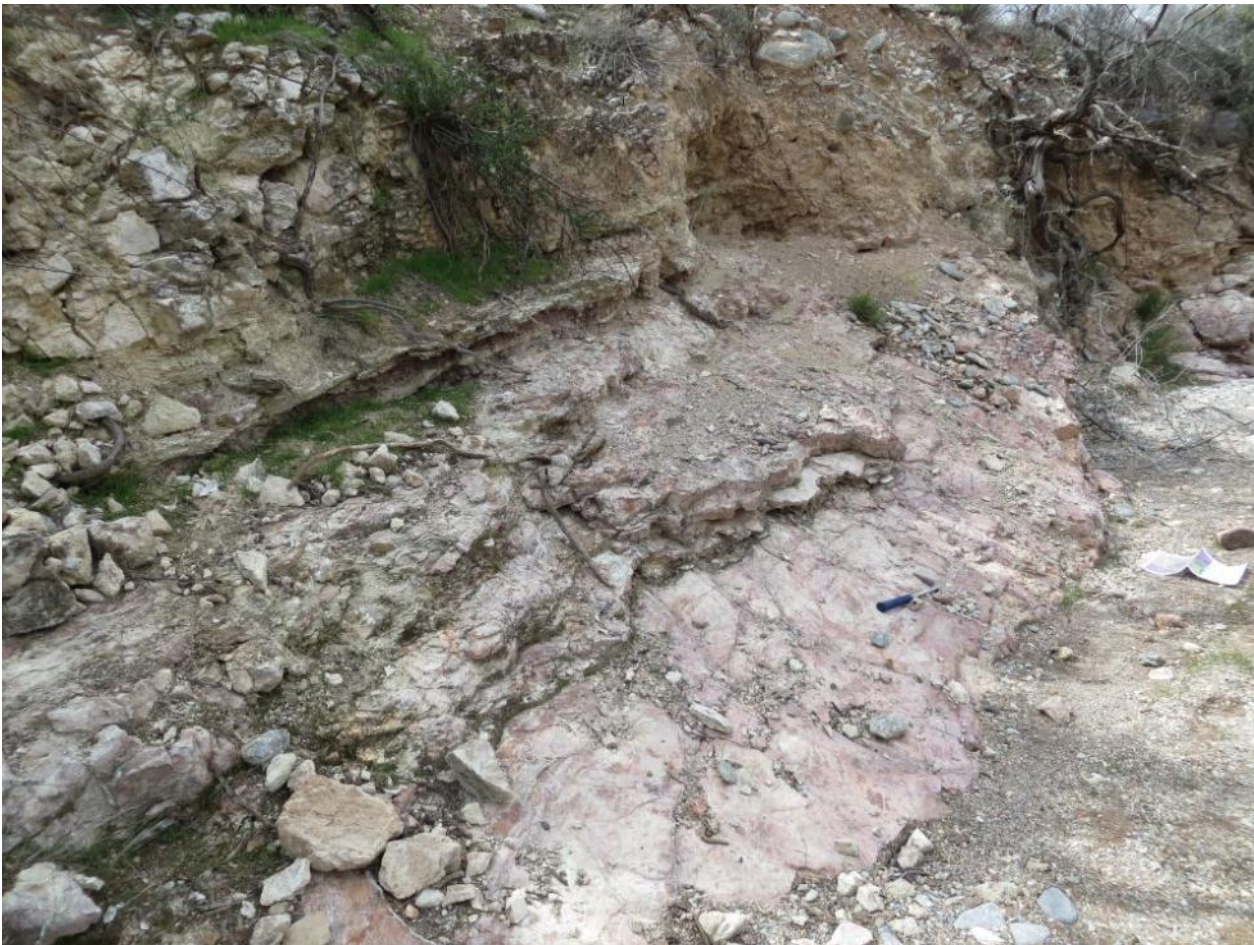
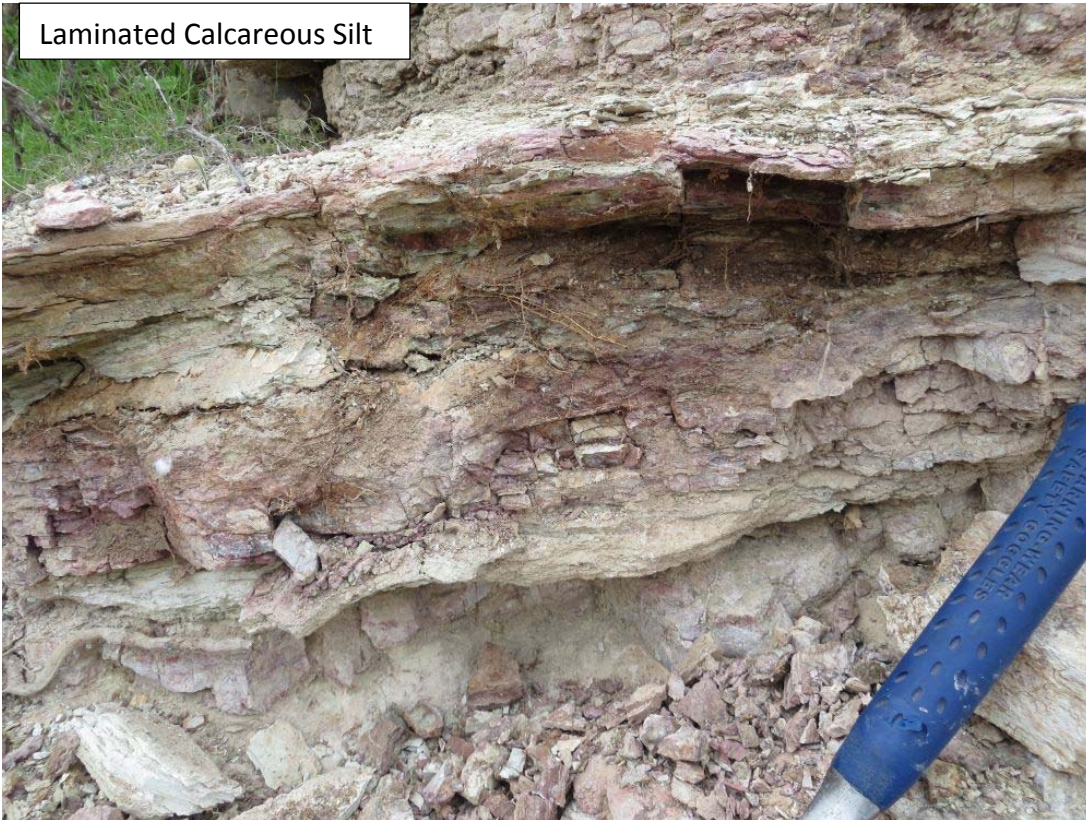
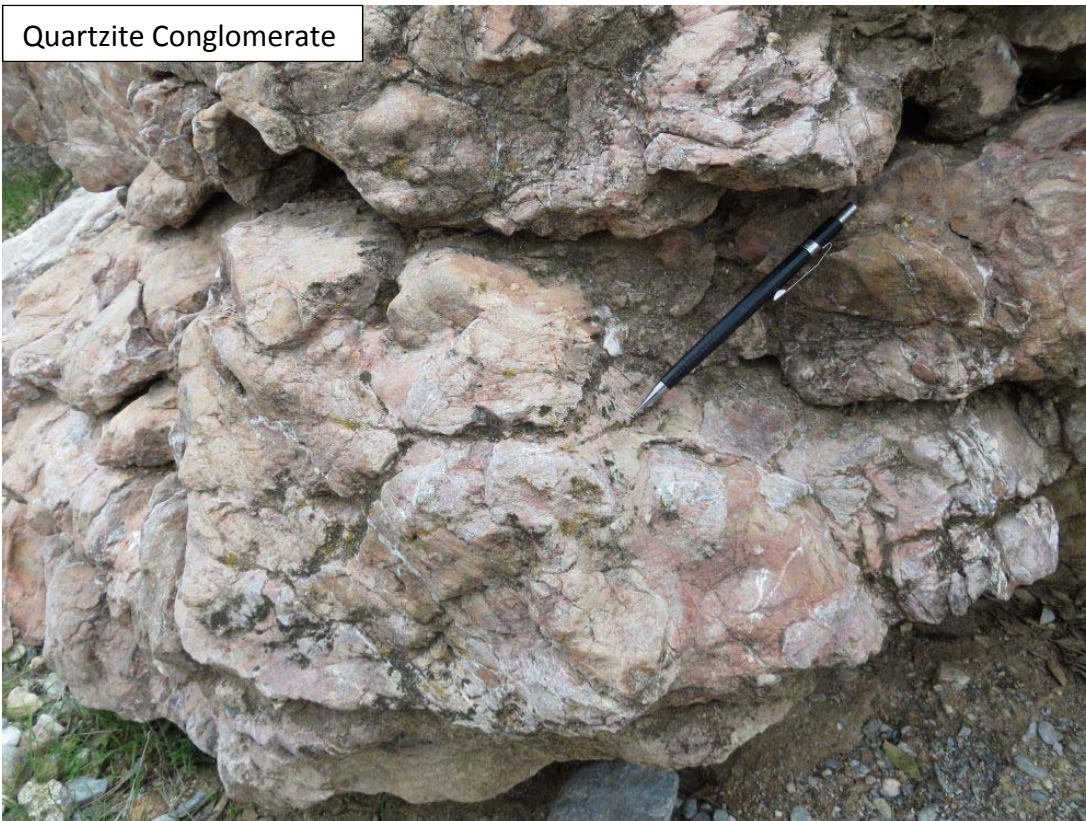
### Ym1

Mescal Limestone overtop of Dripping Springs Quartzite (Yds) in channel bank.

Ym – Calcareous shale, laminated, R1 (powdery, laminations can be pulled apart and crushed by hand), weakest along bedding laminations, numerous other tightly spaced fractures cross cutting laminations.

Yds – Conglomerate with rounded quartzite particles in fine grained siliceous matrix, R5, numerous randomly oriented fractures with aperture up to 2 cm (*0.79 inches*), all fractures infilled and well healed with calcite.

Orientation of Ym laminations: **309/16**

Orientation of Yds bed in channel invert: **279/23**

Laminated Calcareous Silt

Quartzite Conglomerate

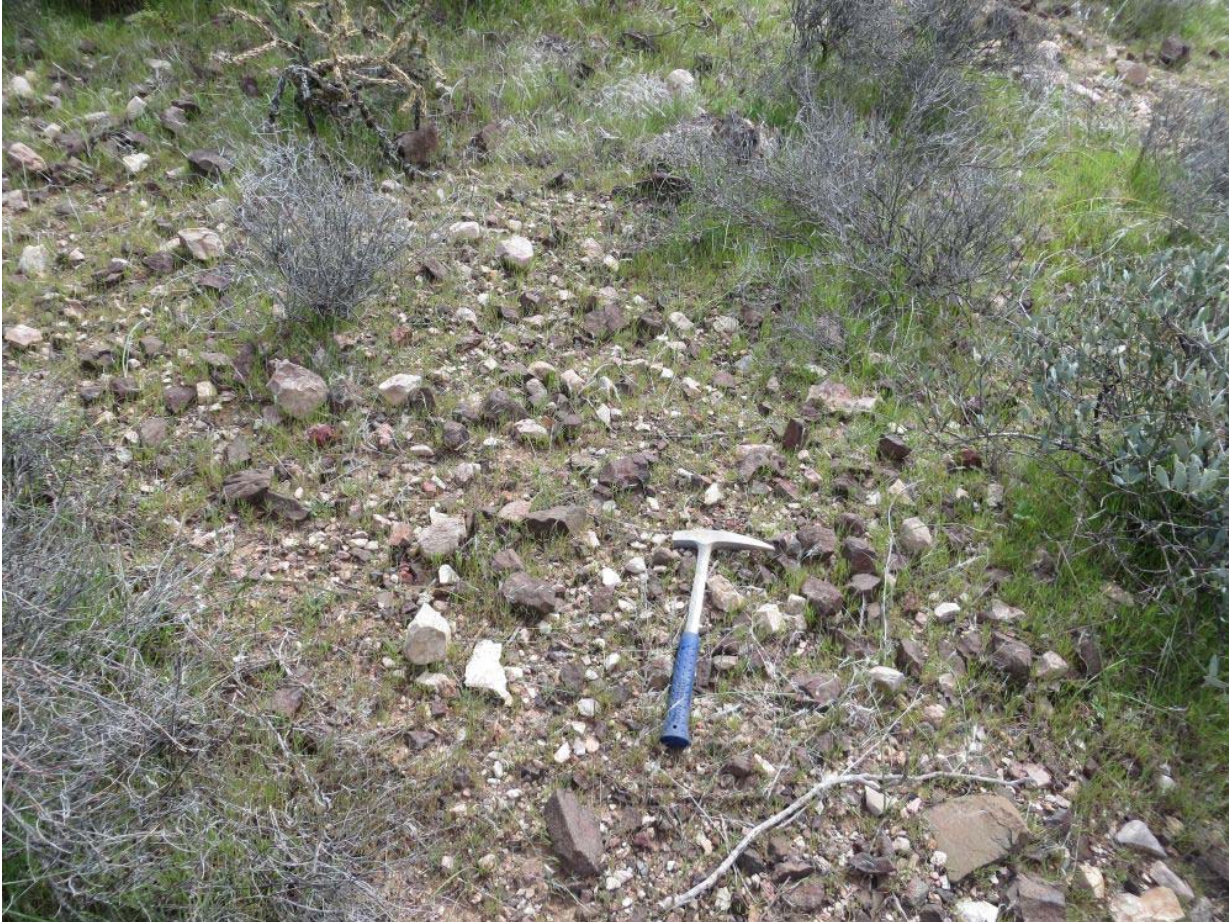
Yd4

Diabase and Mescal Limestone cobbles exposed at surface. Some very small diabase outcrops at surface.

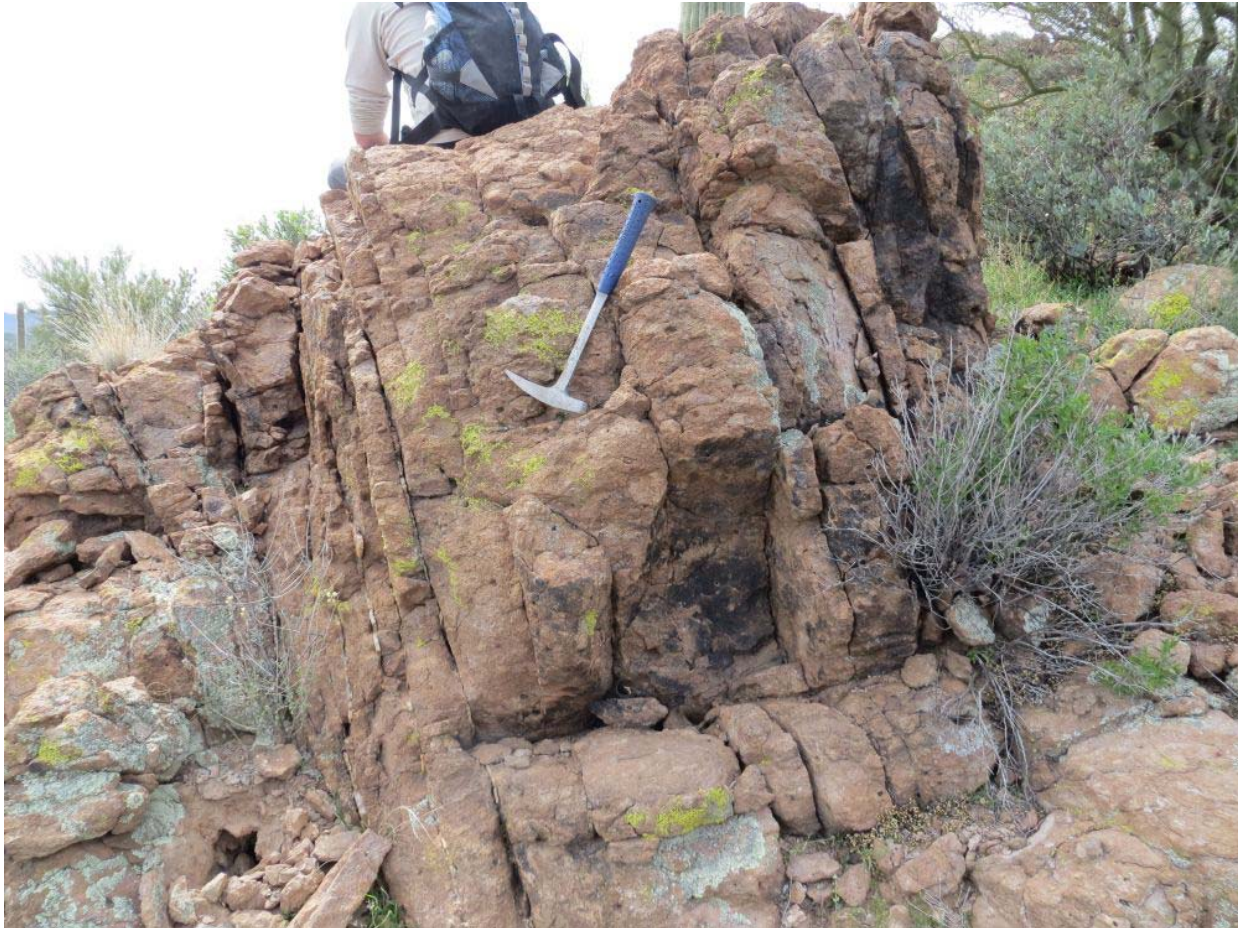
### Tal1

Exposure of Apache Leap Tuff near the contact with Yd. Fresh, R4, very fine grained felsic rock, some steeply dipping parallel joints with spacing ranging from 5 to 25 cm (*1.97 to 9.74 inches*), aperture closed to very wide (max. 5cm (*1.97 inches*)), quartz infilling of larger joints, stepped and rough joint surfaces

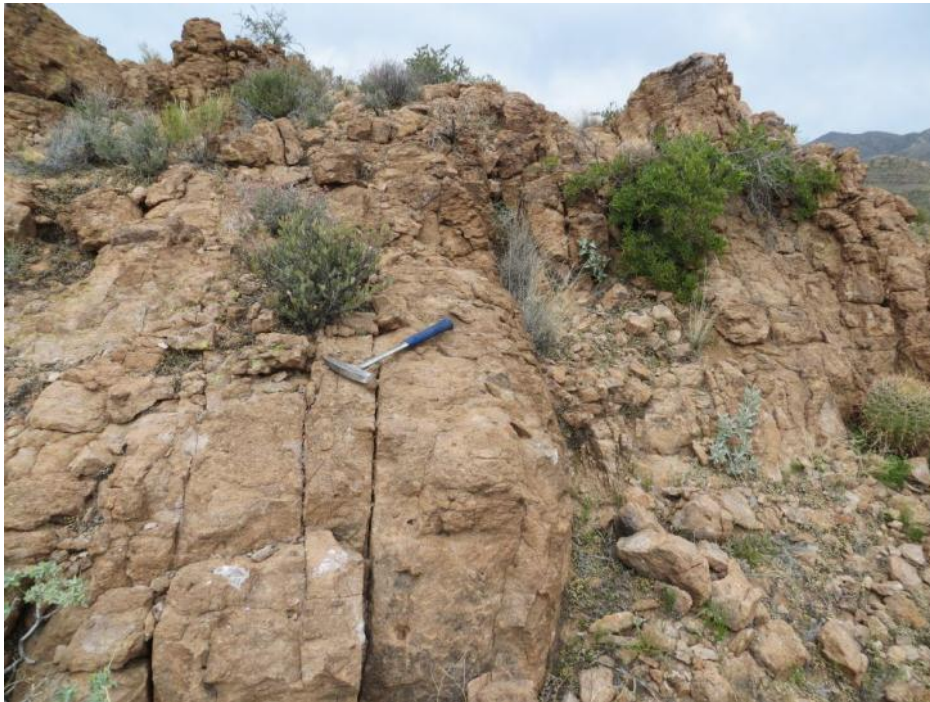
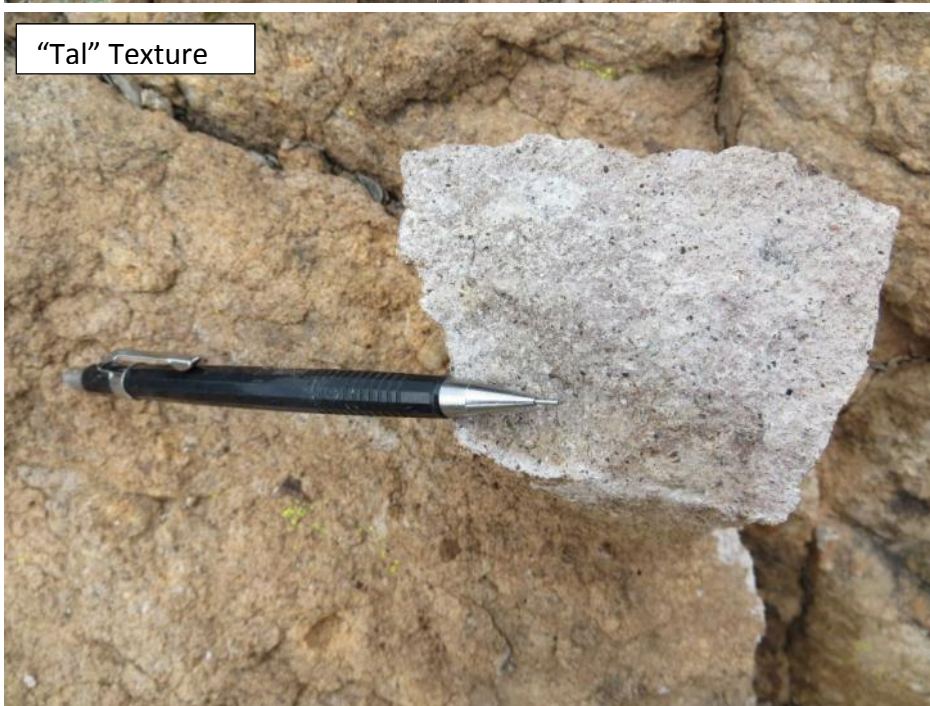
## Tal2

Fresh, R5, fine grained felsic matrix with some visible quartz/biotite/feldspar crystals, parallel joints with range of spacing from 0.5 cm (*0.20 inches*) up to 30 cm (*11.81 inches*), joint aperture closed to moderately wide (max. 5 mm (*0.20 inches*)), joint faces undulating to stepped and rough.

Orientation of joint set: **190/81**

"Tal" Texture

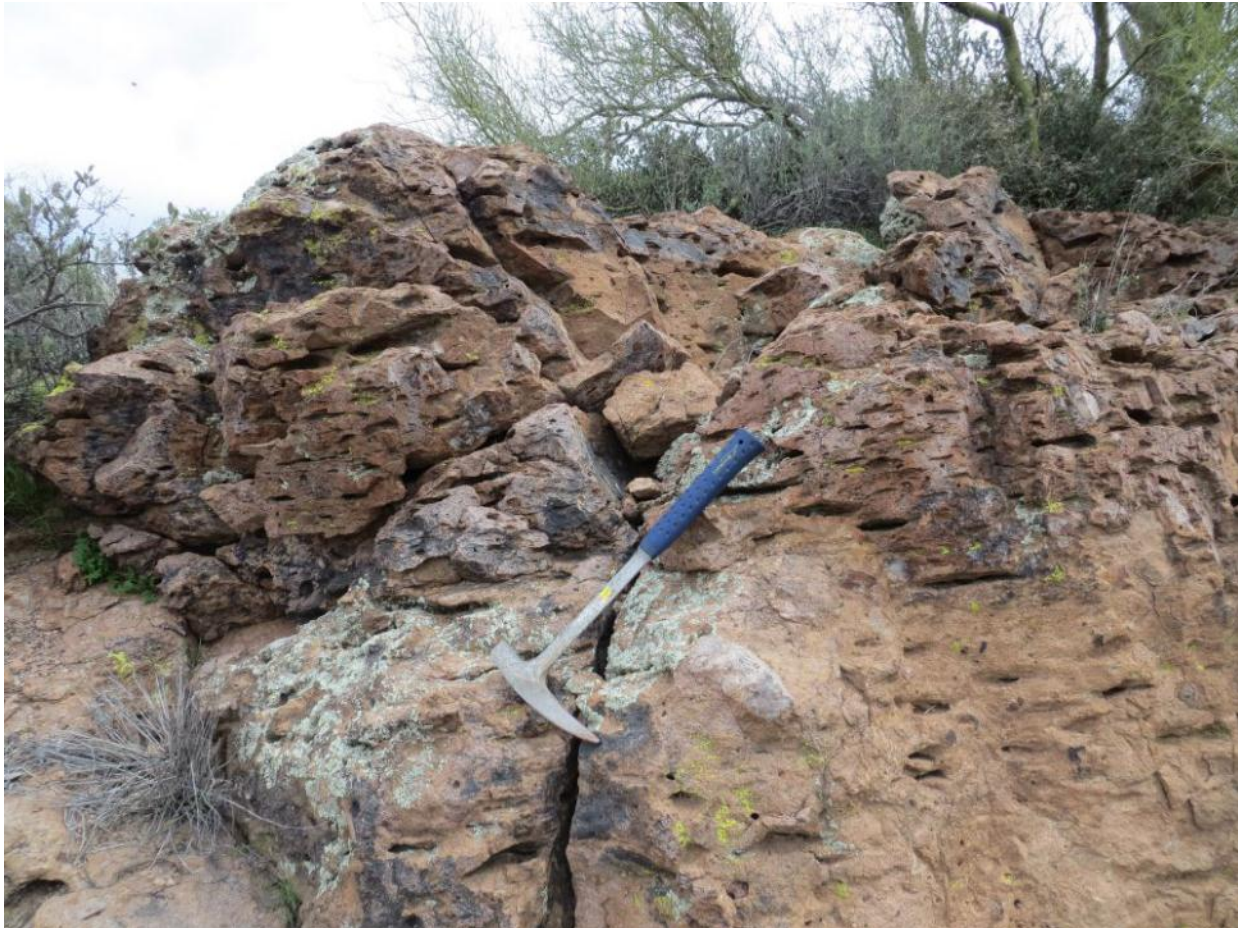
### Tal3

Tuff with open voids in surface outcropped near bottom of gully just uphill of the diabase and Mescal Limestone. Voids in surface are elliptical and can be as wide as 10 cm (*3.94 inches*), voids penetrate <5 cm (*1.97 inches*) into unit. Rock strength and behavior same as other Tal (R5) with no visible joint sets.

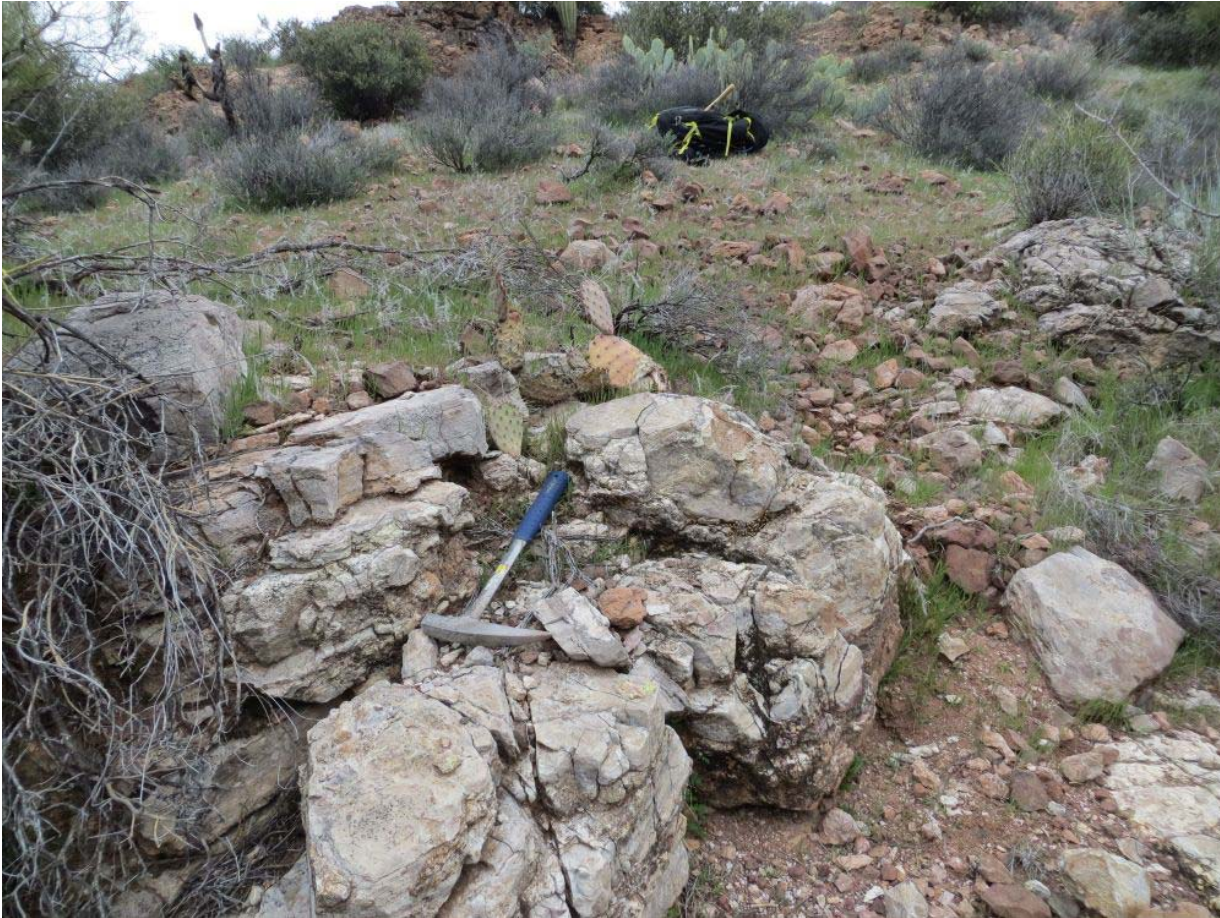
Ym2

Outcrops of Mescal Limestone exposed directly below diabase and Apache Leap Tuff (see Tal3).

Orientation of bedding: **202/26**

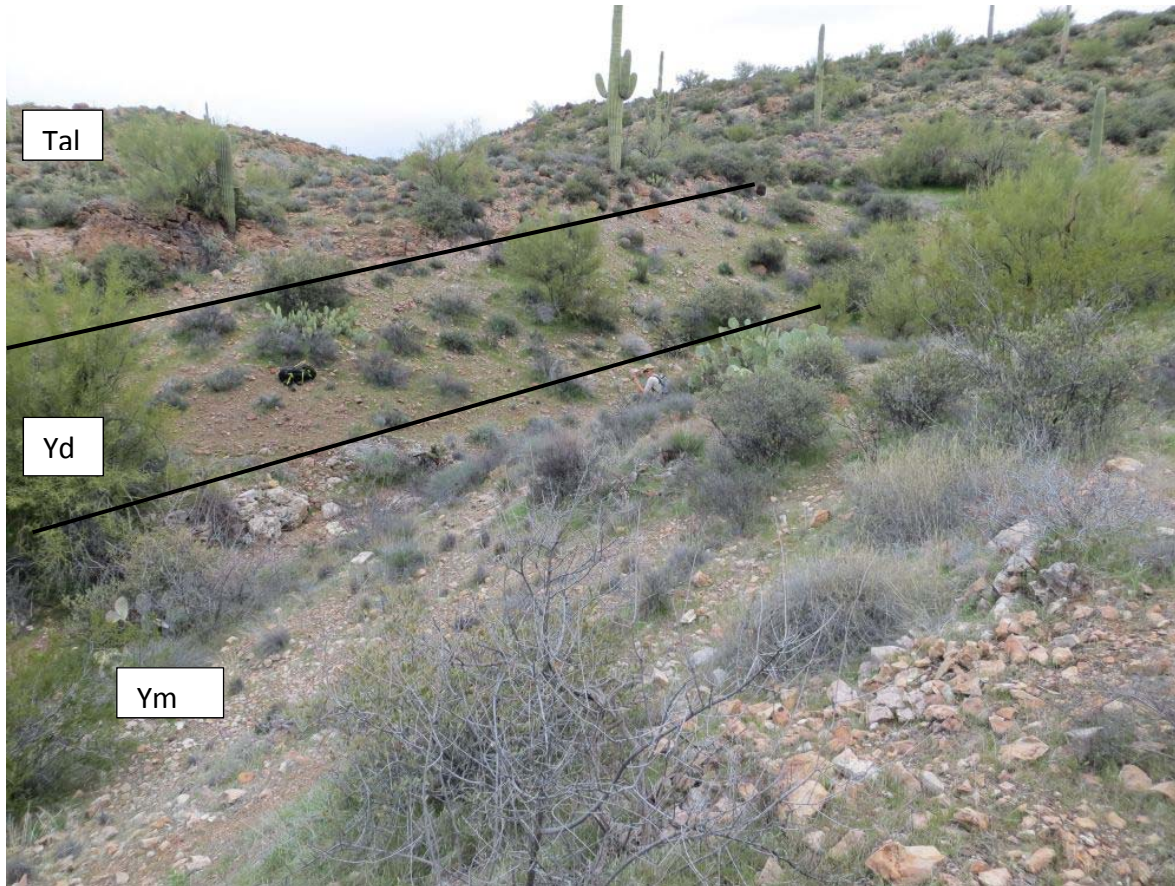
### CONTACT3

Point of contact in gully between Apache Leap Tuff (Tal), diabase (Yd) and Mescal Limestone (Ym).

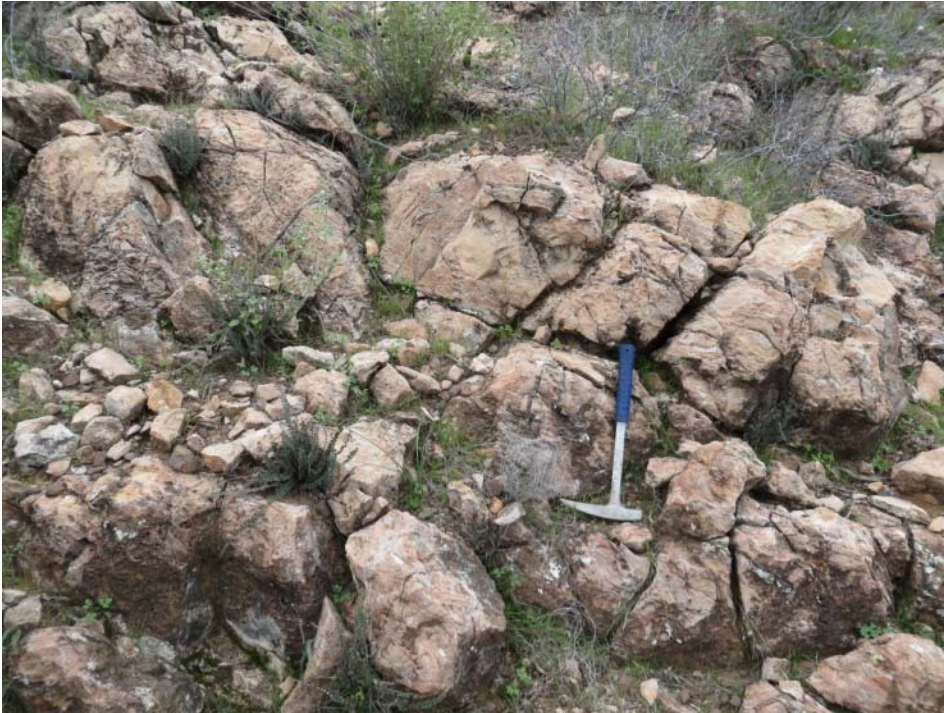
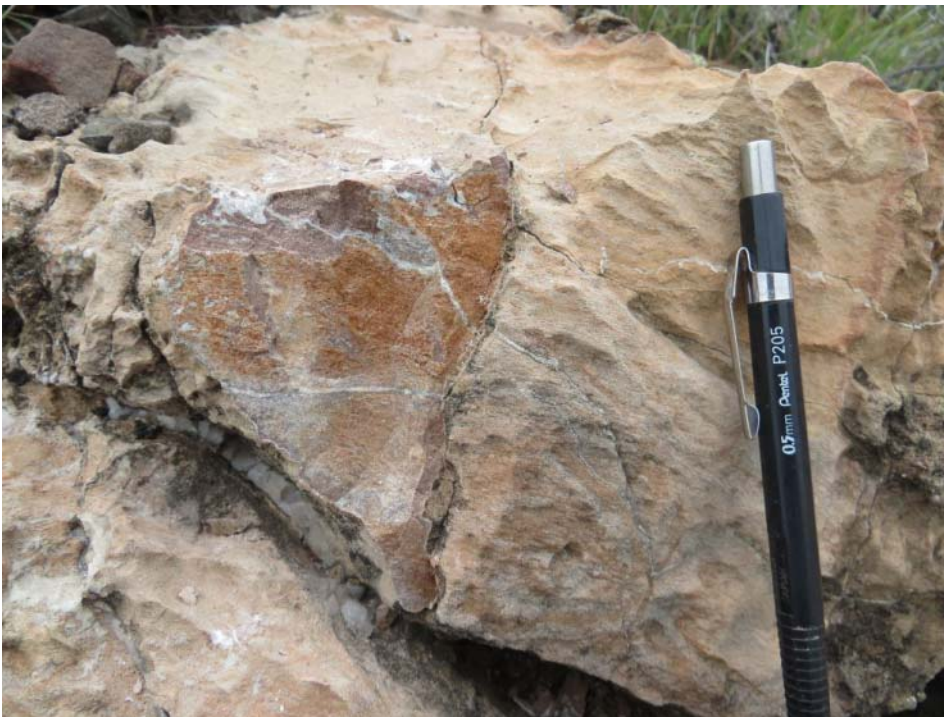
### Yds8

Outcrop of hard (R5) very fine grained quartz arenite, joint structures not visible in small outcrop, randomly oriented fractures fill with calcite, reactive to acid. May be coarse component of the Mescal Limestone, not dripping springs quartzite.

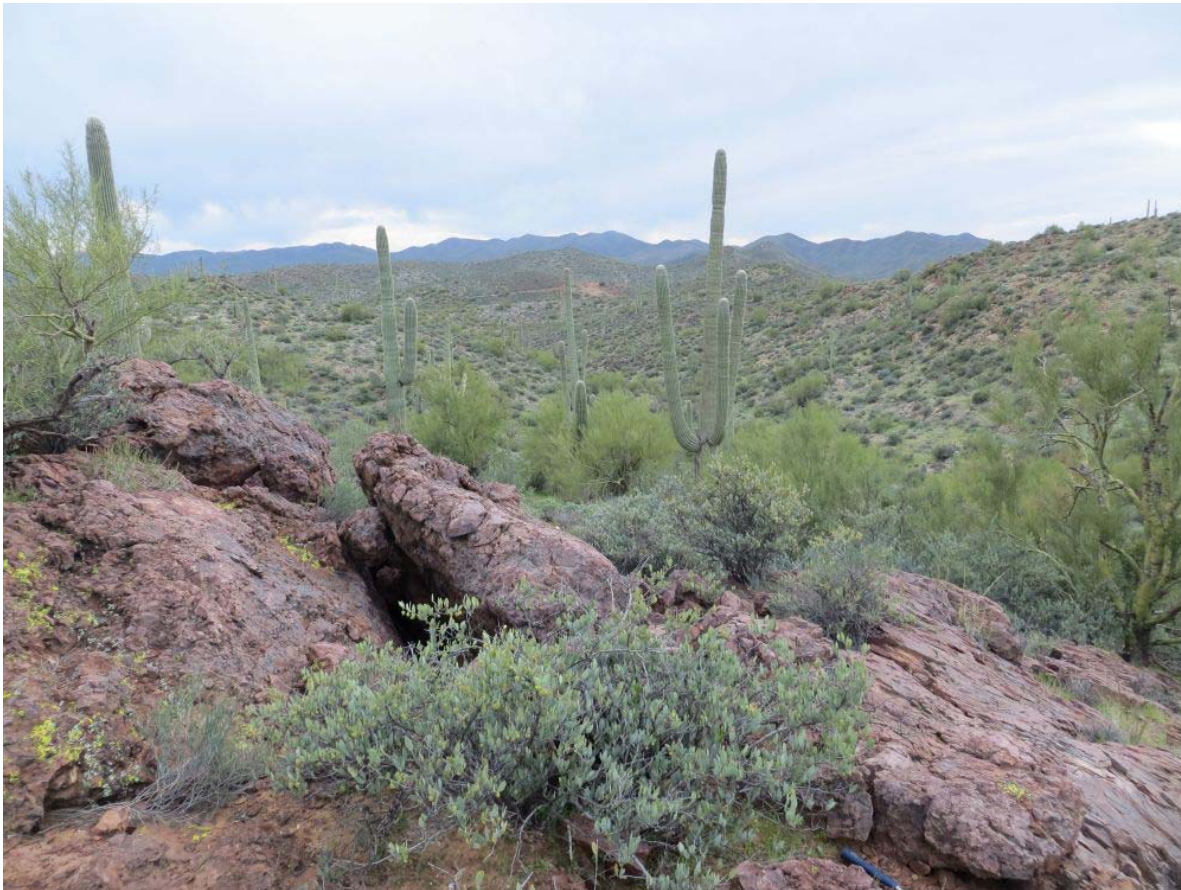
**Ydsu1**

Slightly weathered (oxidized/rust colored surfaces), R5, fine grained quartz arenite or quartzite, very blocky/heavily fractured rock mass, rock breaks along oxidized pre-existing fracture planes, some “clasts” of finely bedded quartz arenite cobbles. Fault Breccia(?)

Orientation of dipping layer: **181/24**

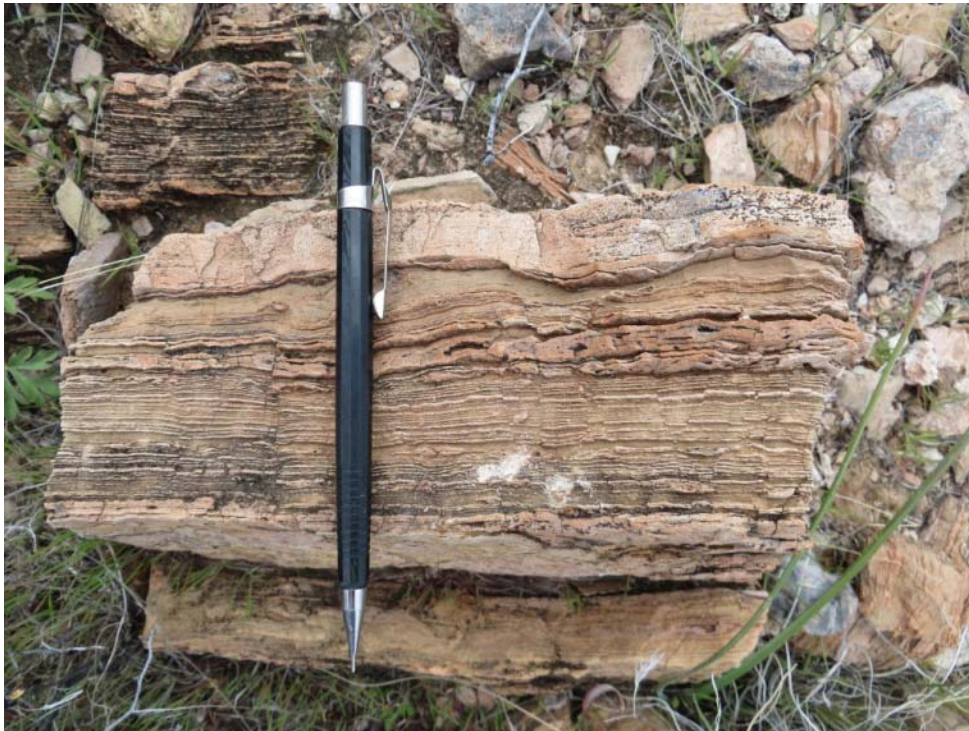
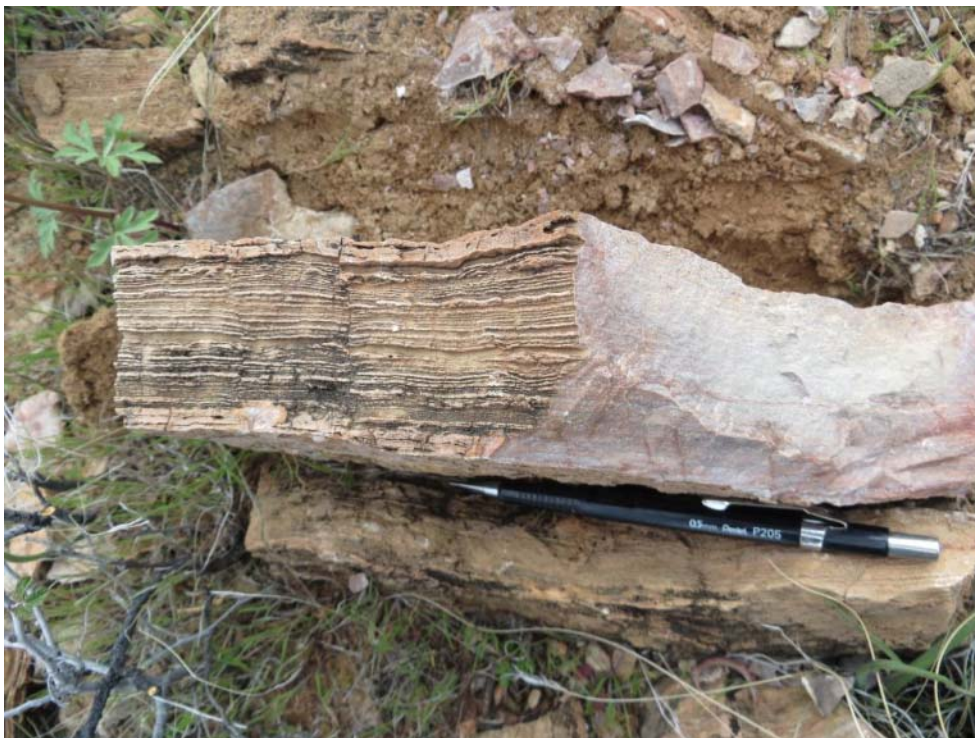
### Ydsu3

Cobbles of Dripping Springs Quartzite (Upper) on top of hill. Cobbles slightly weathered, R4, laminated (5 mm (0.20 inches)) siltstone/sandy siltstone with some hard siliceous beds, breaks preferentially along laminations.

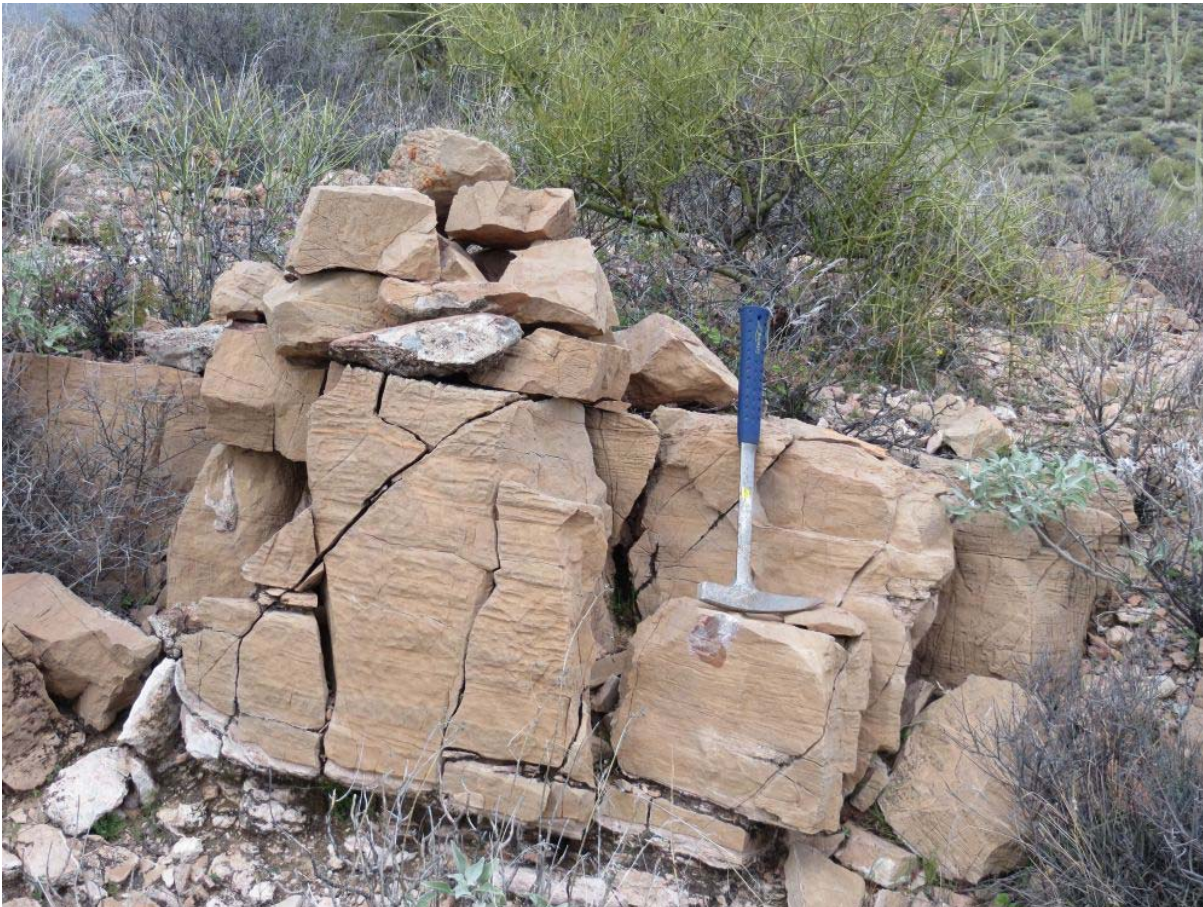
Ydsu outcrop below tuff (Tal) bluff, R4 to R5, very thin laminations visible (mm scale), fine grained quartz rich siltstone or quartzite laminations, fractures preferentially along bedding laminations, exposed laminations planar and smooth, some open joints but no joint sets identified.

Orientation of laminations: **000/21**

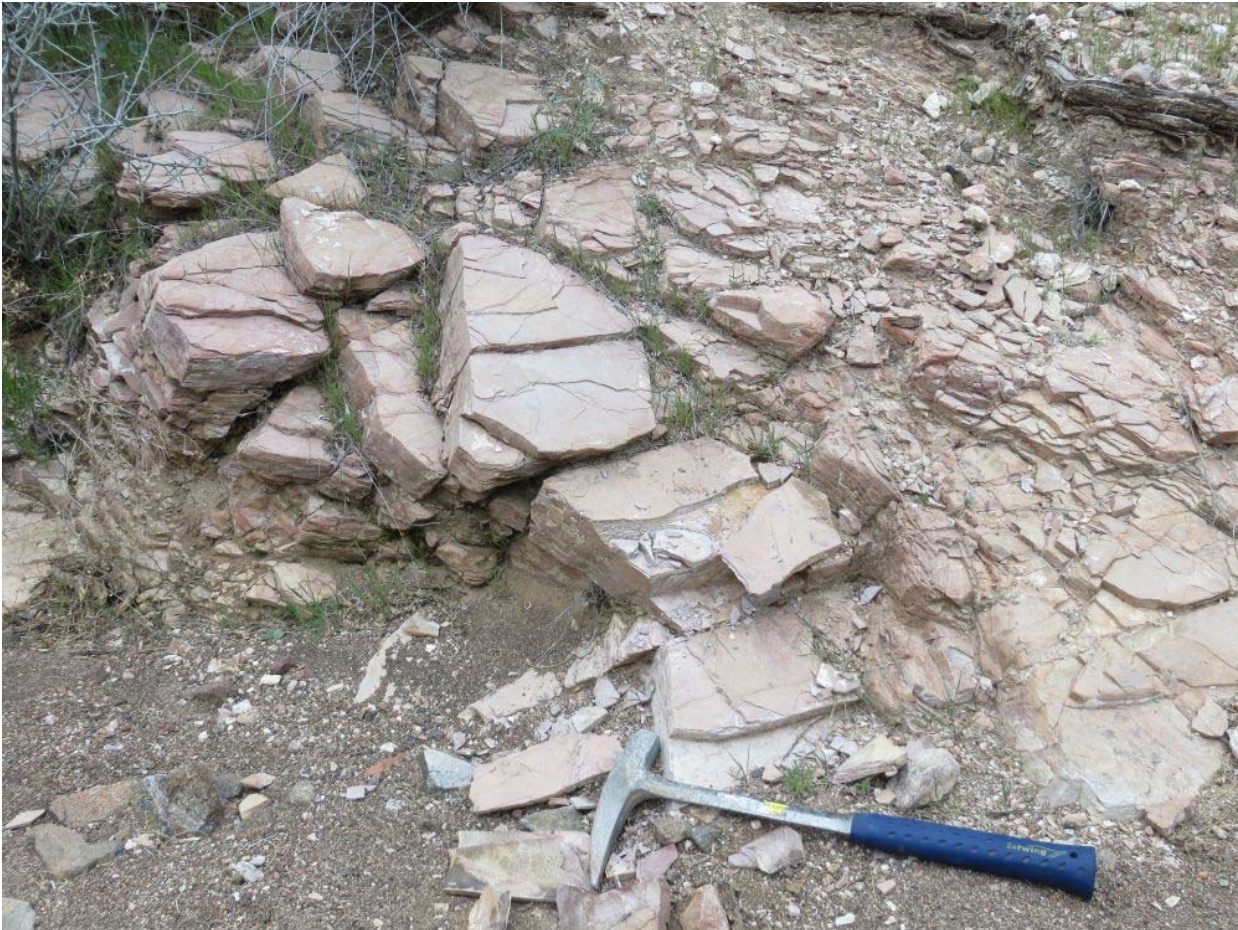
### Ym3

Small outcrop of calcareous siltstone in bank of small wash at foot of Ydsu hill, R3, preferentially fractures along very thin (<0.5 mm (*0.02 inches*)) planar laminations, strong reaction to acid.

Orientation of laminations: **336/22**
