## APPENDIX I-E

### Traverse #5

PROJECT  
RESOLUTION PROJECT  
2013 NEAR WEST SITE INVESTIGATION

TITLE  
CREEK TRAVERSE #5

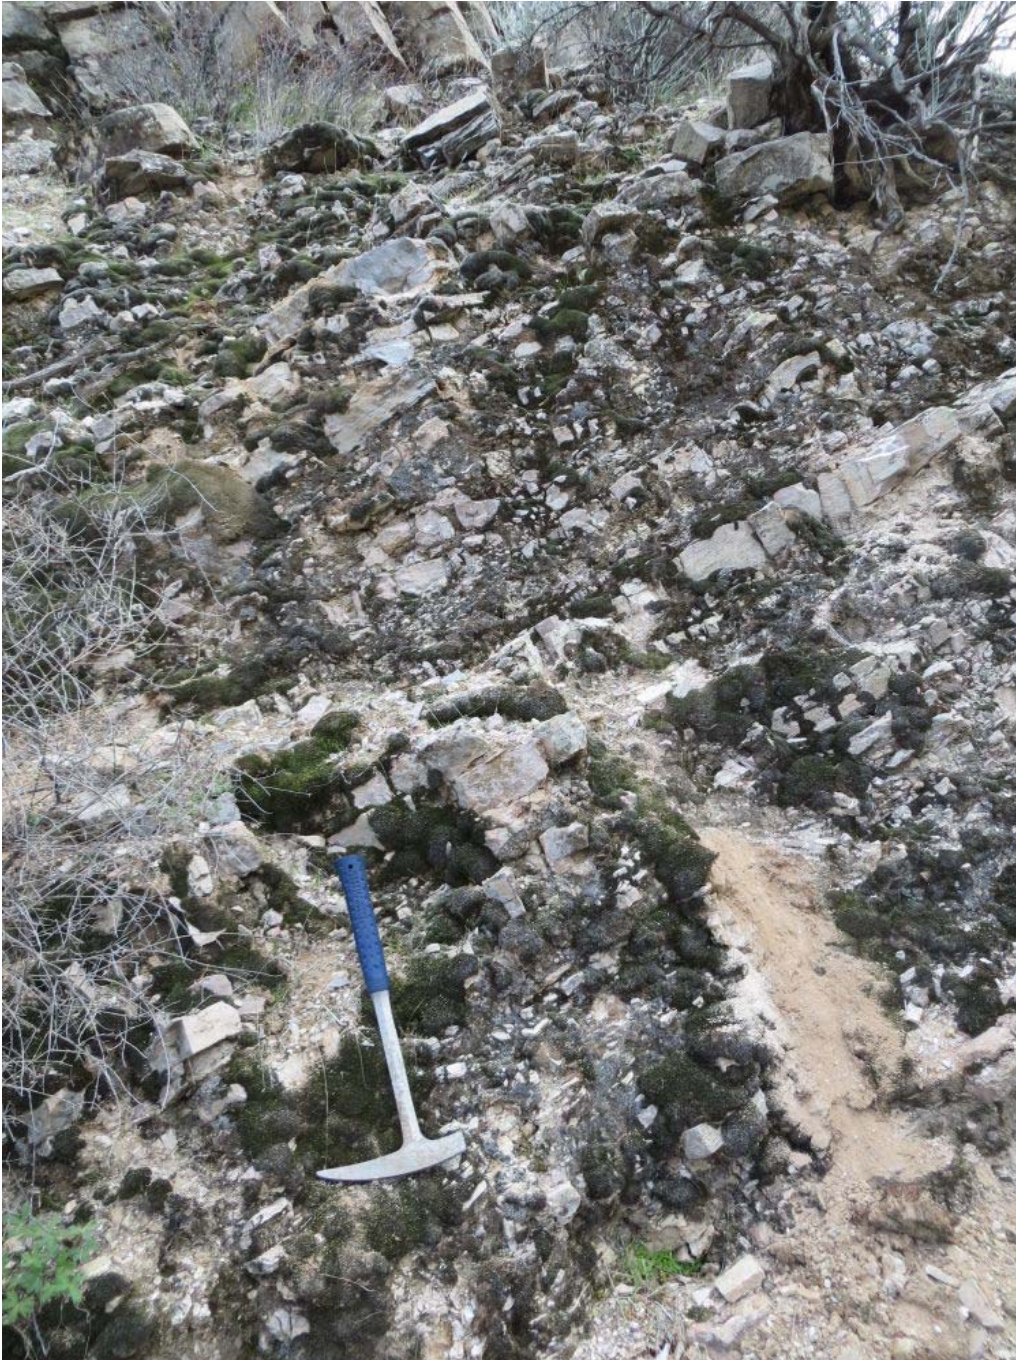
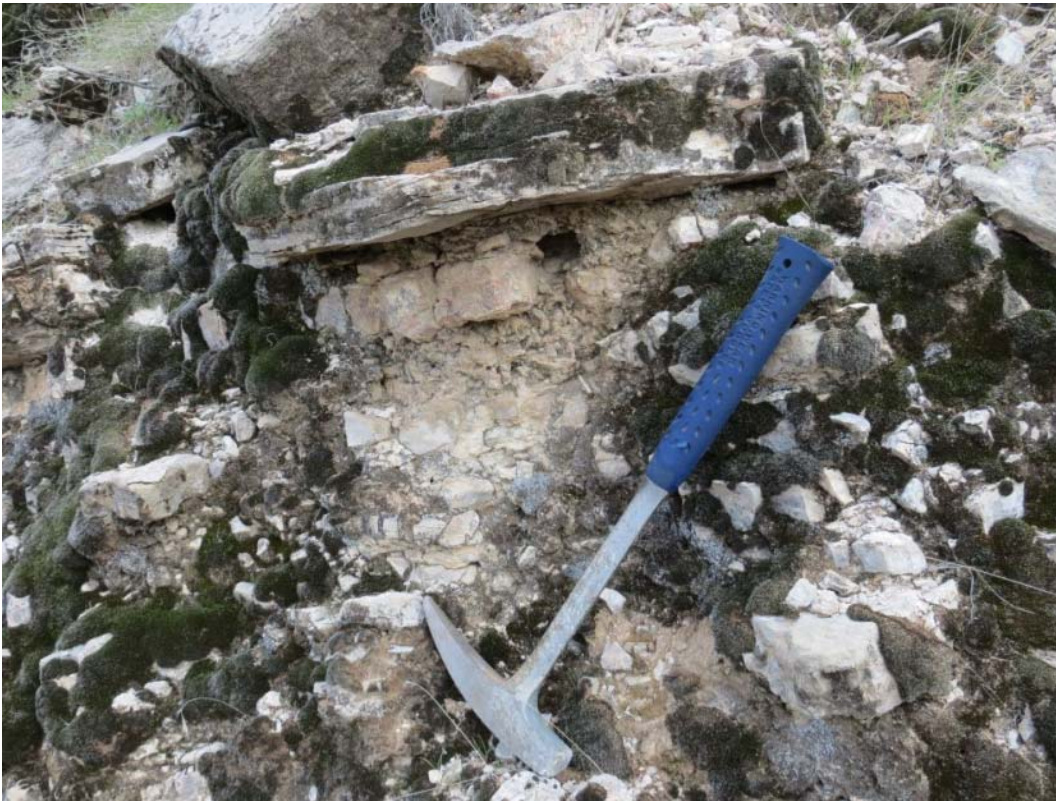
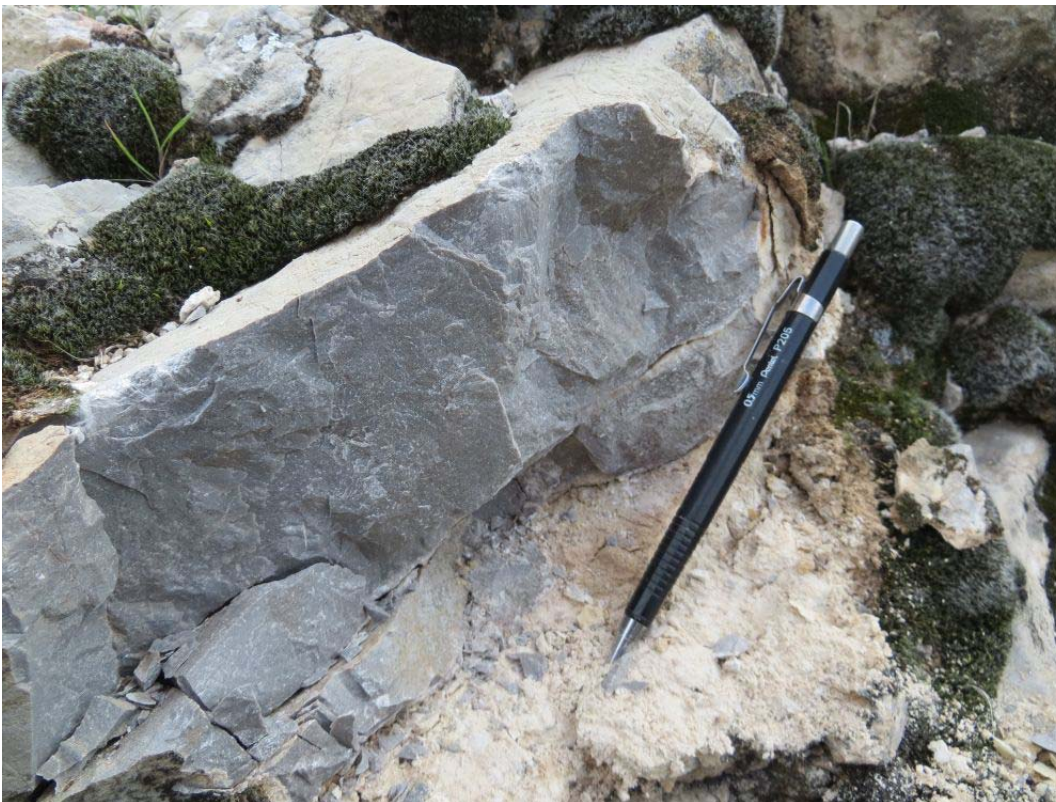
Ym4

Fresh, fine grained light grey beds of calcareous siltstone interbedded with calcareous shale (?), siltstone beds are dark grey, R3 to R4. Shale beds are laminated, white, powdery and very weak (breaks apart in hands). Differential weathering of shaley beds between the more competent dark grey siltstone resulting in large “blocks” in outcrop.

Orientation of bedding: **028/24**

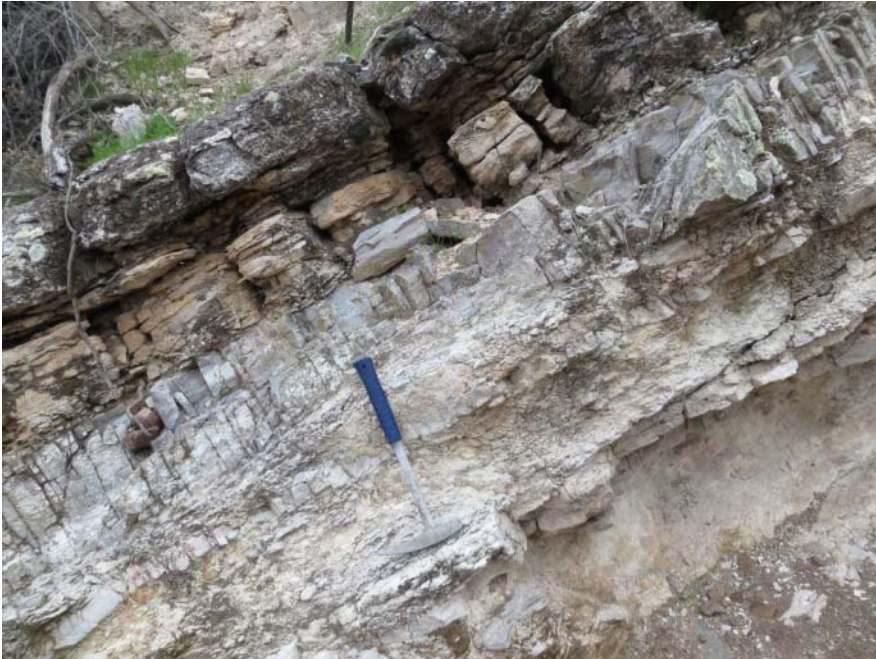
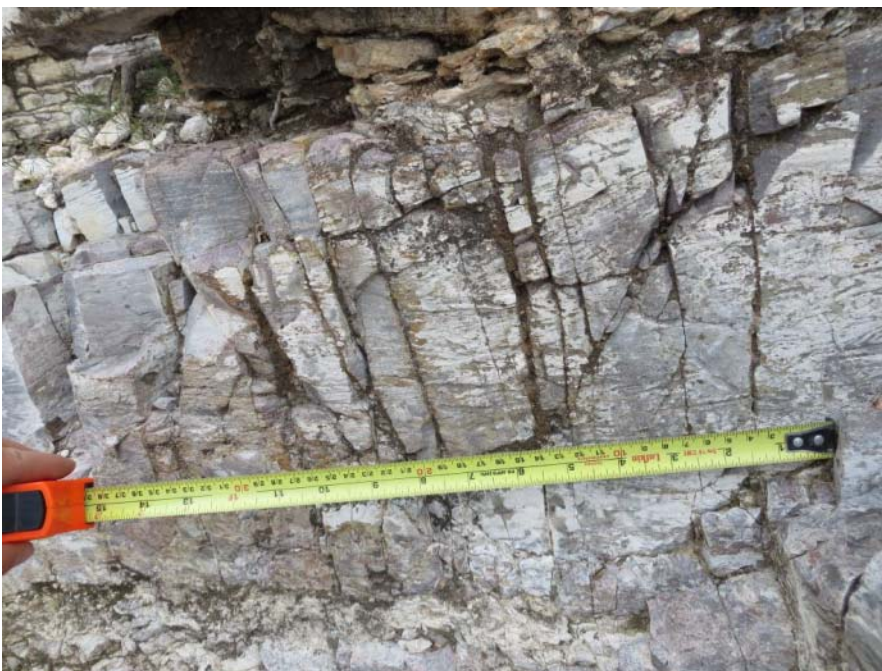
### Ym5

Very weak, white, powdery laminated material interbedded with harder (R3 to R4) dark grey calcareous siltstone, some vertical joints perpendicular to bedding planes, closed to moderately wide aperture (max. 5 mm (0.20 inches)), silty sand infilling, smooth and planar joint surfaces, differential weathering of white powdery beds.

Orientation of bedding: **001/36**

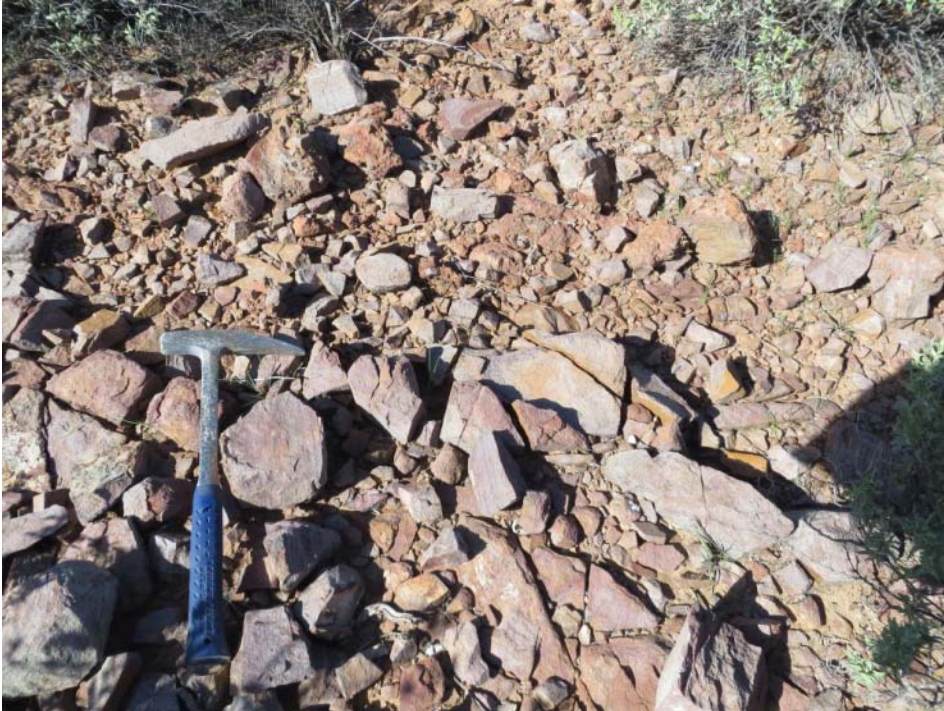
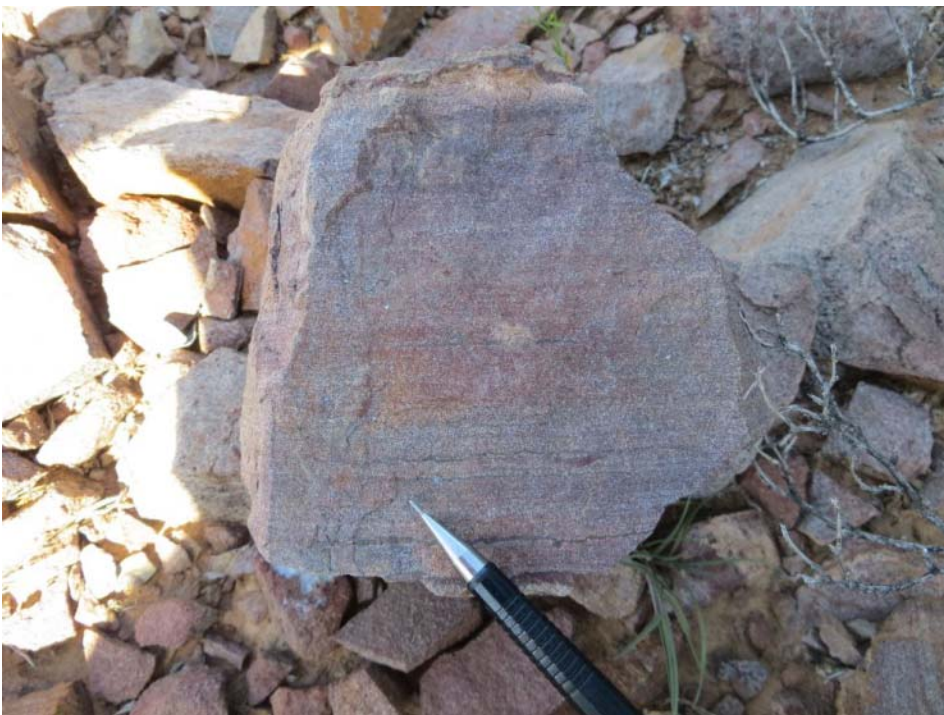
Ydsu5

Cobbles of Ydsu exposed on top of hill. Laminated (mm scale) fine grained quartz arenite, oxidized surfaces, R5.

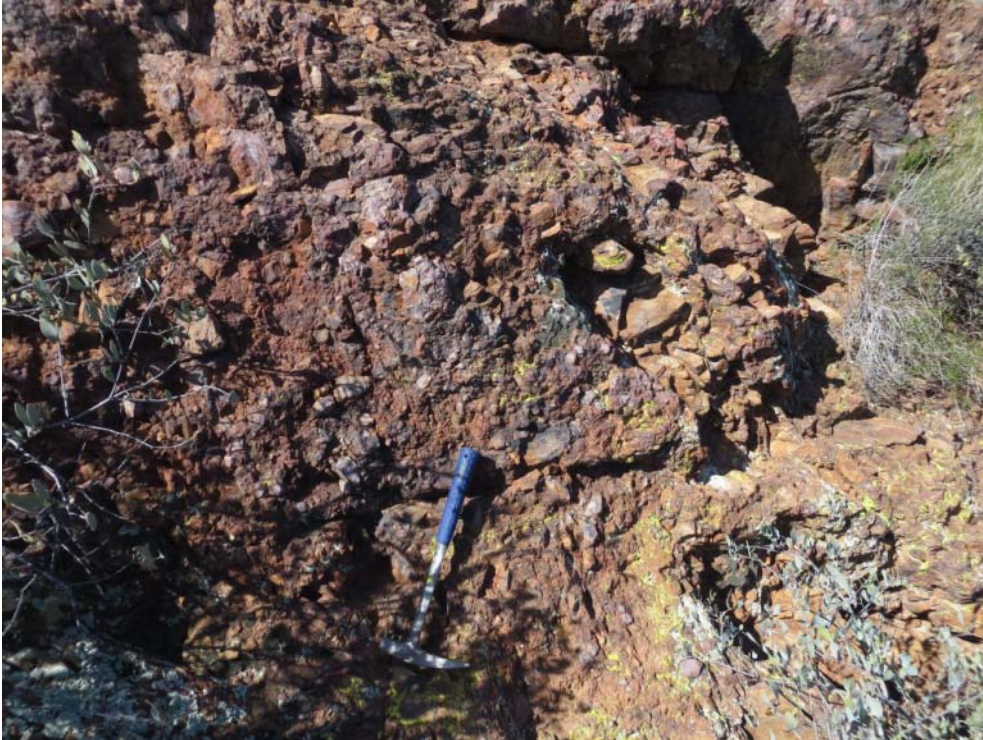
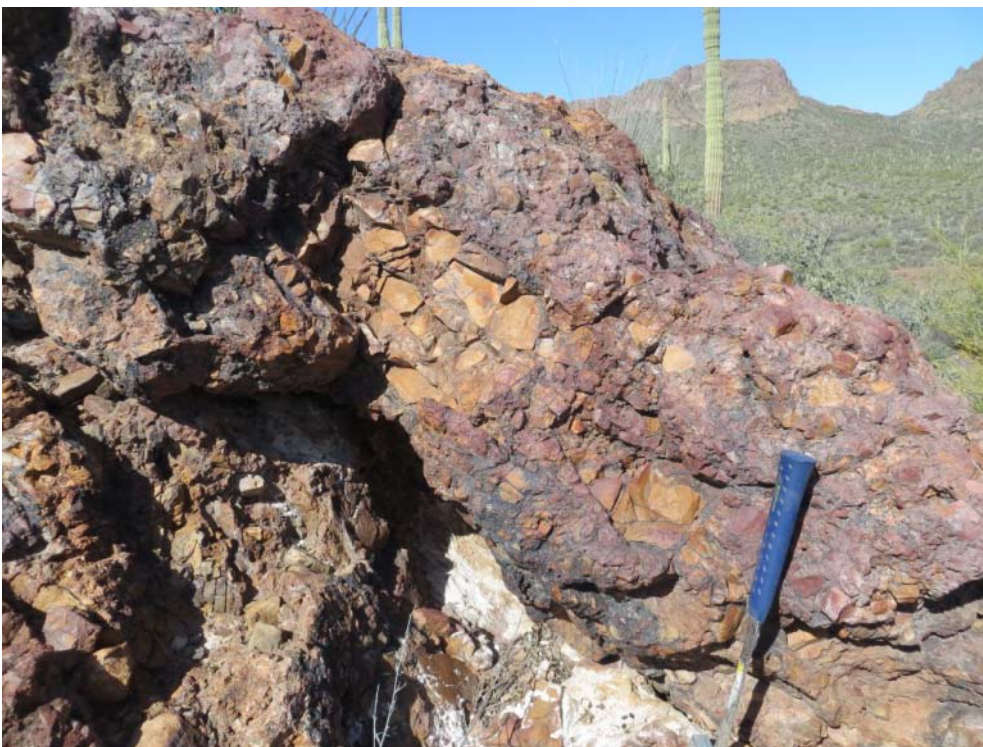
Ydsu6

Brecciated dripping springs quartzite. Oxidized (rusty colored), R5, clasts of laminated quartz arenite in fine siliceous matrix, rock fractures preferentially around arenite clasts.

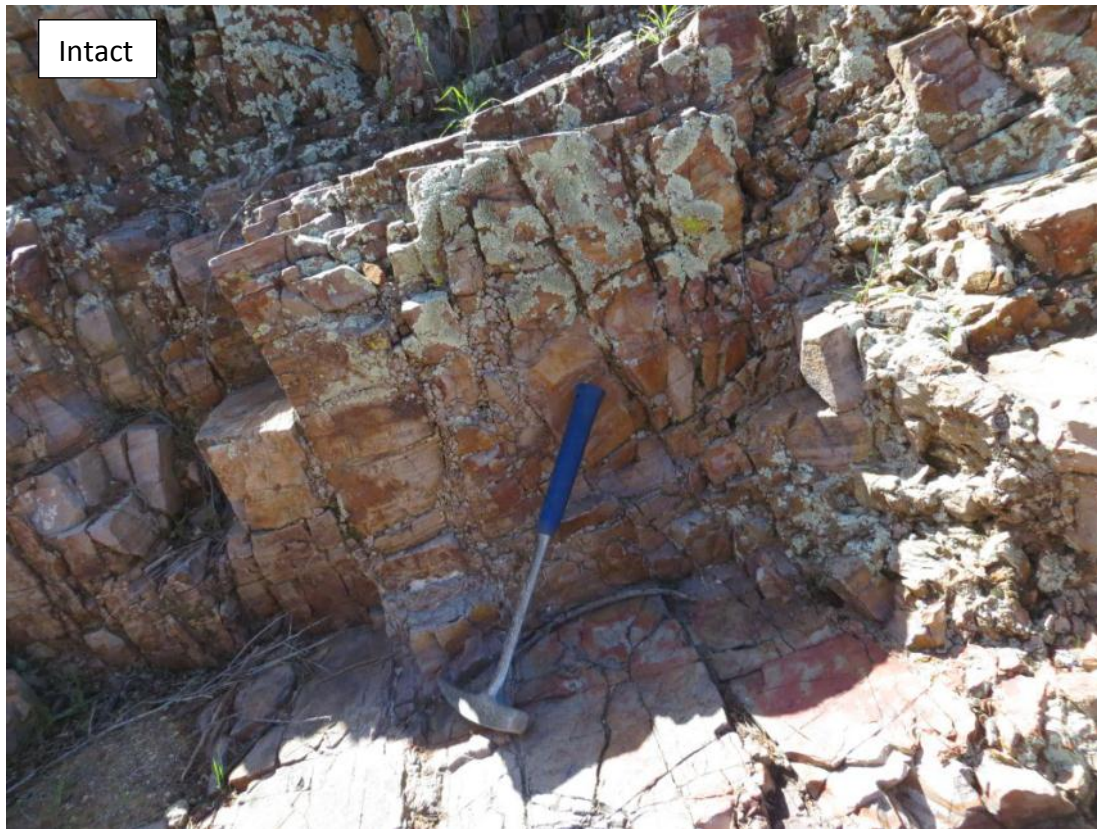
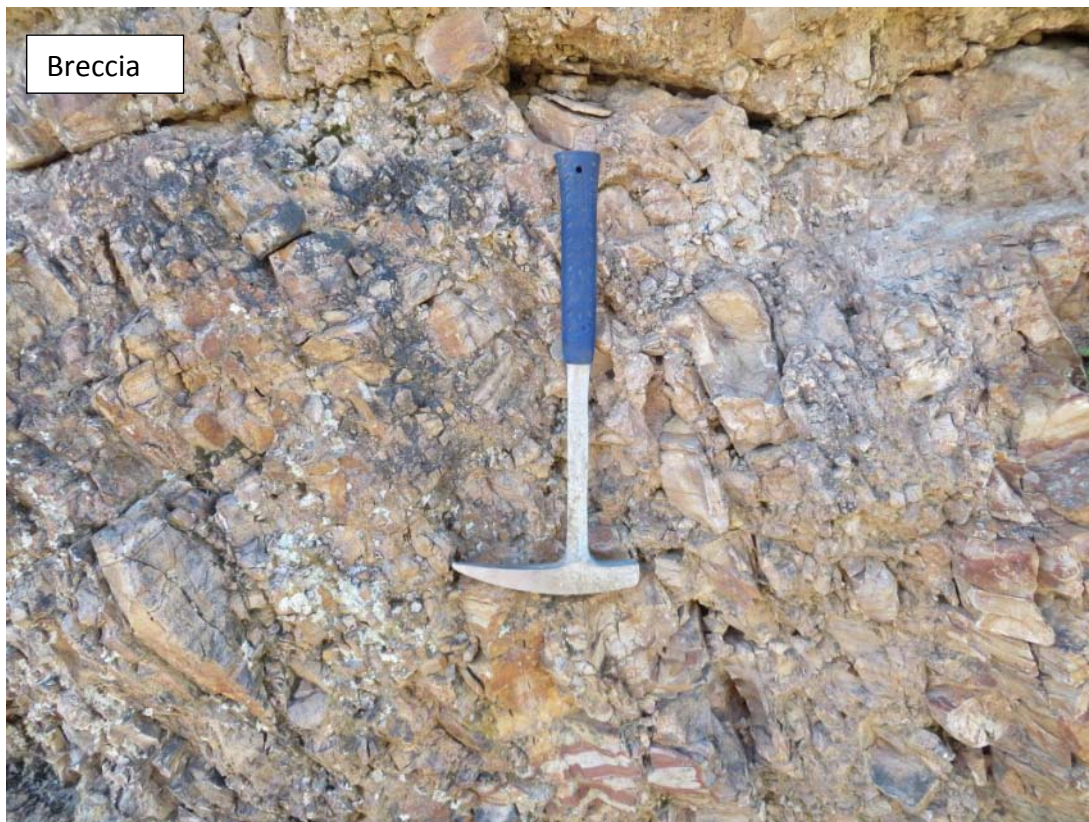
### Ydsu7

Intact and brecciated Ydsu exposed in channel bank.

Intact Portion: Fresh to slightly weathered (oxidized), R5, fine grained laminated quartz arenite or quartzite, preferentially fractures along bedding planes with other fractures cutting perpendicular and obliquely to bedding planes, fractures closed to open with open fractures being well healed with calcite.

Brecciated Portion: R5, breaks around clasts, angular clasts of laminated quartz arenite in siliceous matrix, carbonate cement present on some exposed surfaces and around some clasts, one open discontinuous sub-horizontal void in the exposure face.

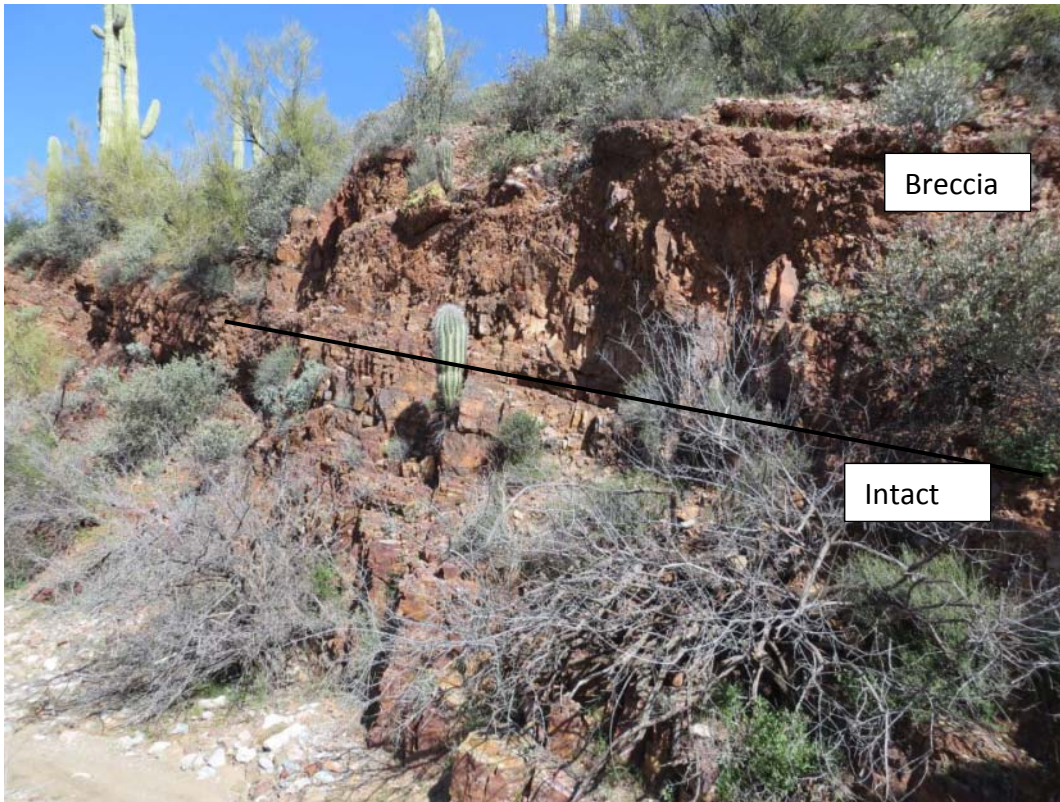
**Ydsu8**

Exposure of intact Ydsu with overlaid by breccia. Similar to Ydsu7 but on the opposite bank of the creek.

Orientation of bedding: **013/22**

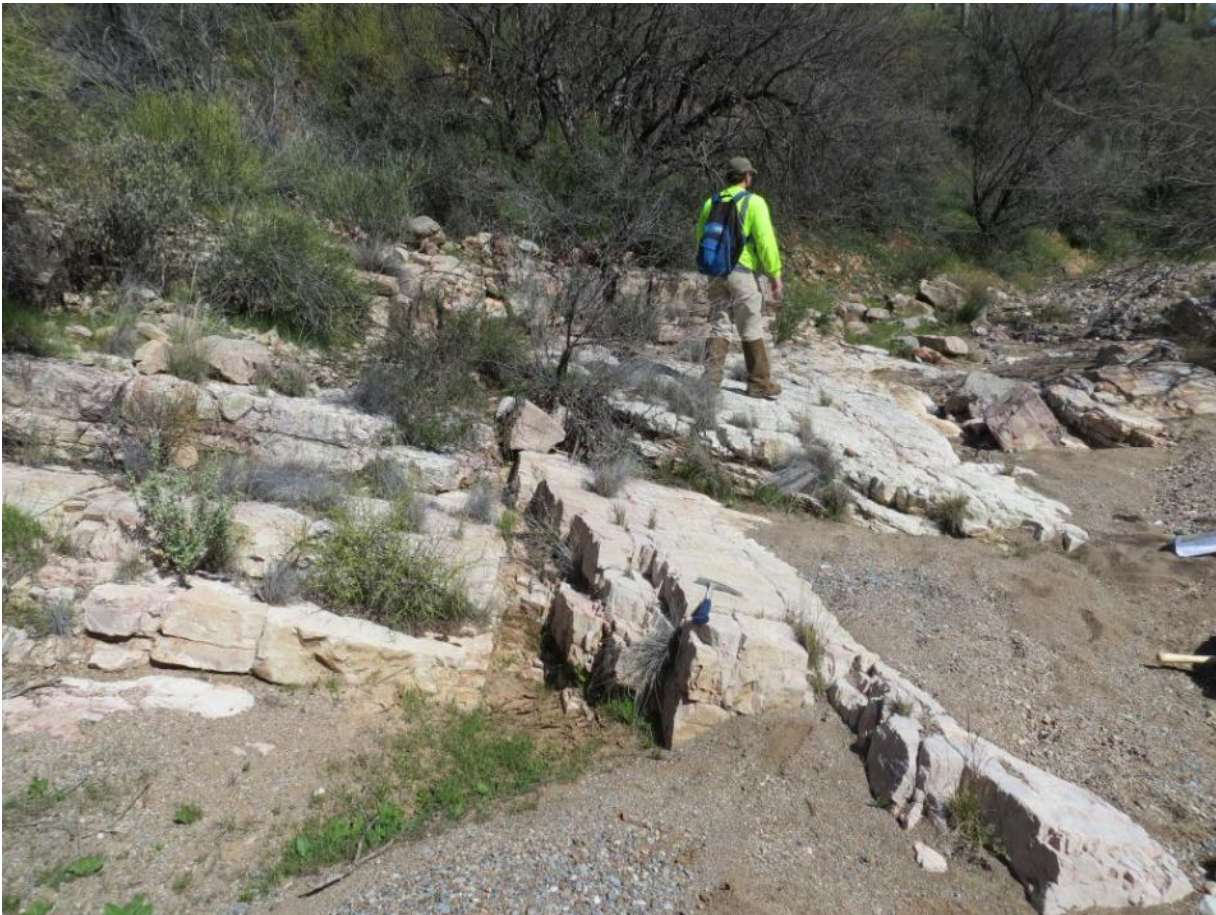
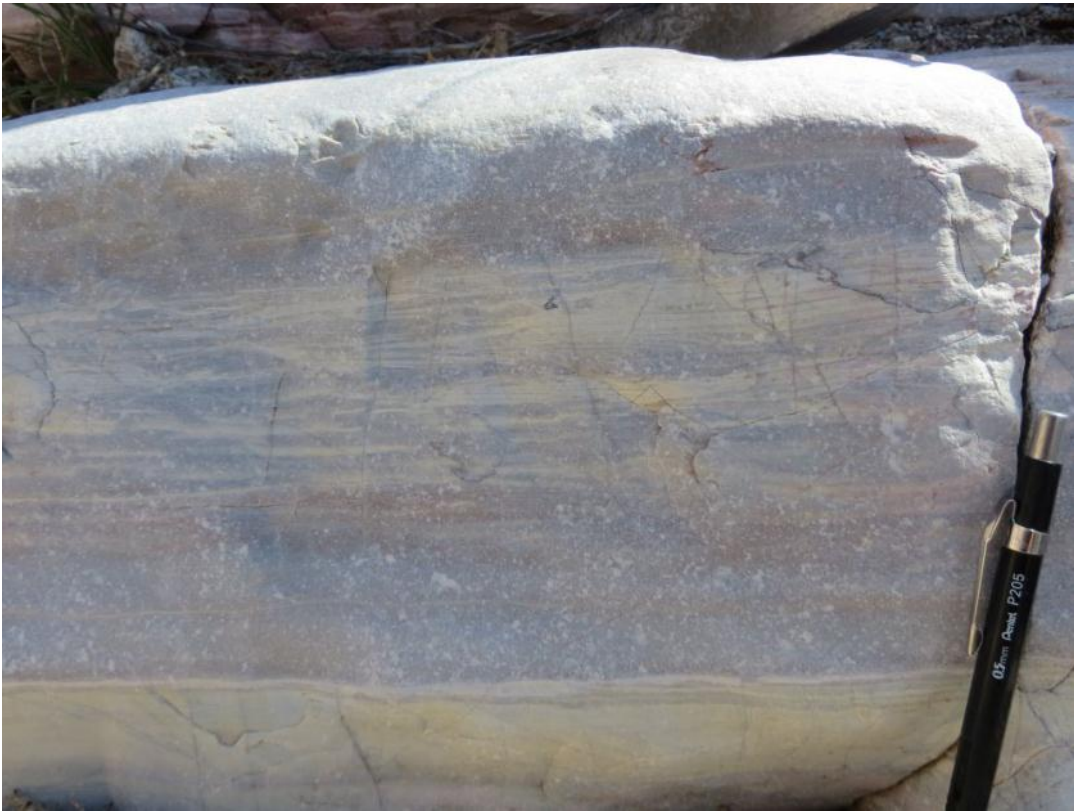
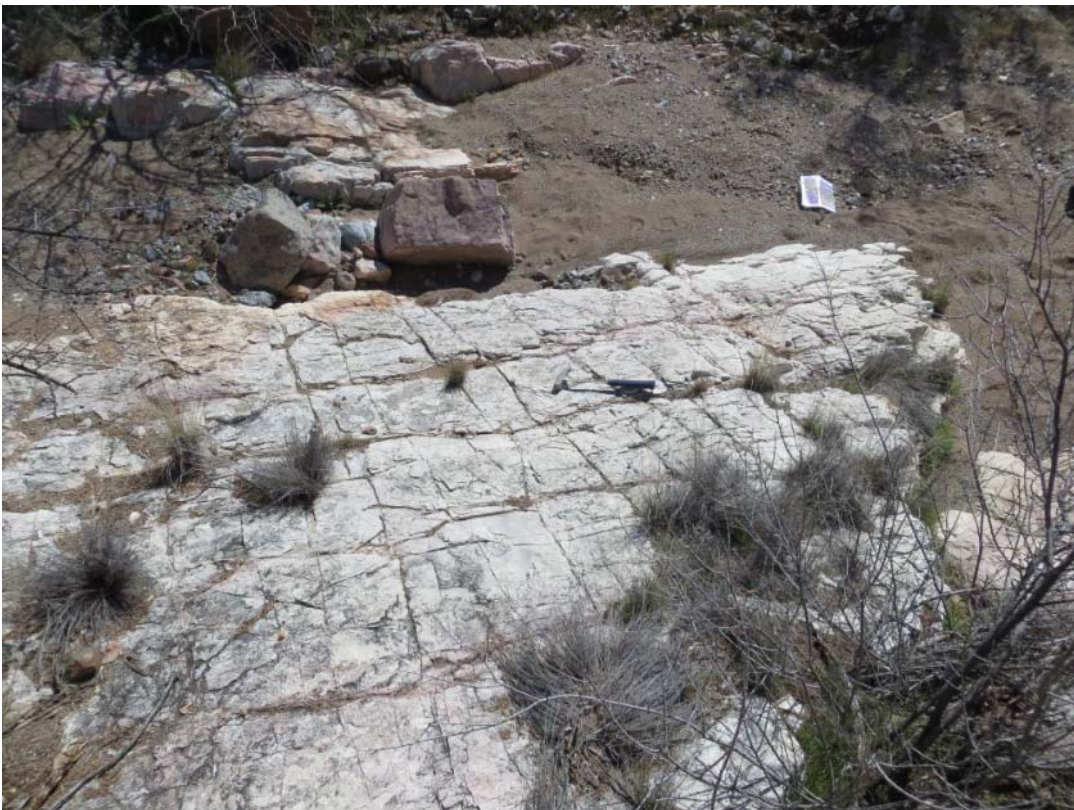
### Ym6

Exposure of limestone in channel banks and invert. Fresh, R5, light grey to pink finely laminated calcareous siltstone, “whispy” laminations < 1mm (*0.04 inches*) thick, large separated blocks in outcrop, two orthogonal joint sets with joints typically spaced 10 – 30 cm (*3.94 – 11.81 inches*) apart, closed to moderately wide aperture (max. 5 mm (*0.20 inches*)), calcite or silty sand infilling.

Orientation of Joint Set #1: **269/90**

Orientation of Joint Set #2: **015/90**

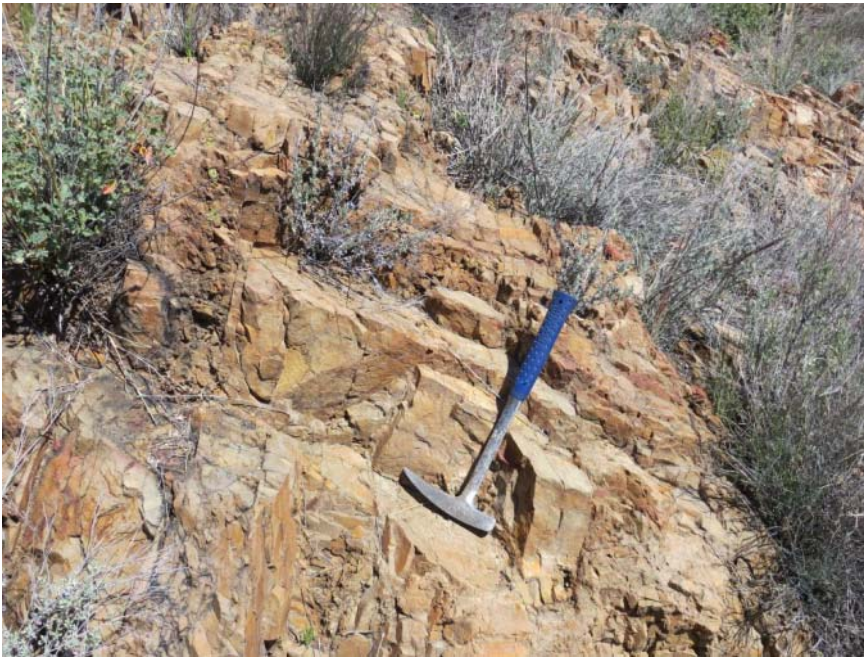
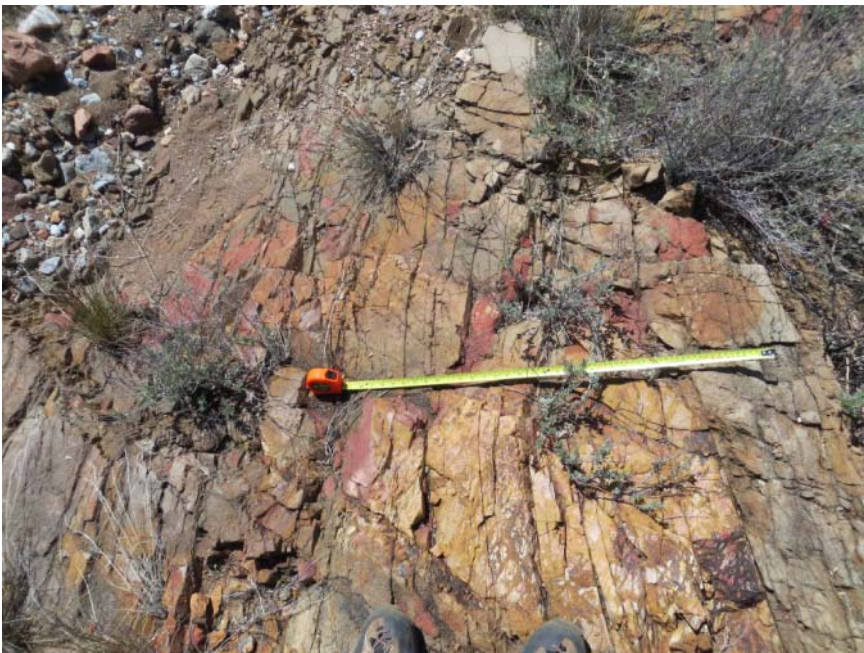
### Yd5

Diabase outcrop in channel bank and invert. Oxidized surfaces, R5 to R6, blocky with numerous tightly spaced (2 – 3 cm (*0.79 – 1.18 inches*) avg.) parallel joints (Set #1), closed. Another flatly dipping joint set (Set #2) identified with wider spacing (10 – 15 cm (*3.94 – 5.91 inches*), closed, only visible in two locations.

Orientation of Joint Set #1: **200/71**

Orientation of Joint Set #2: **052/26**

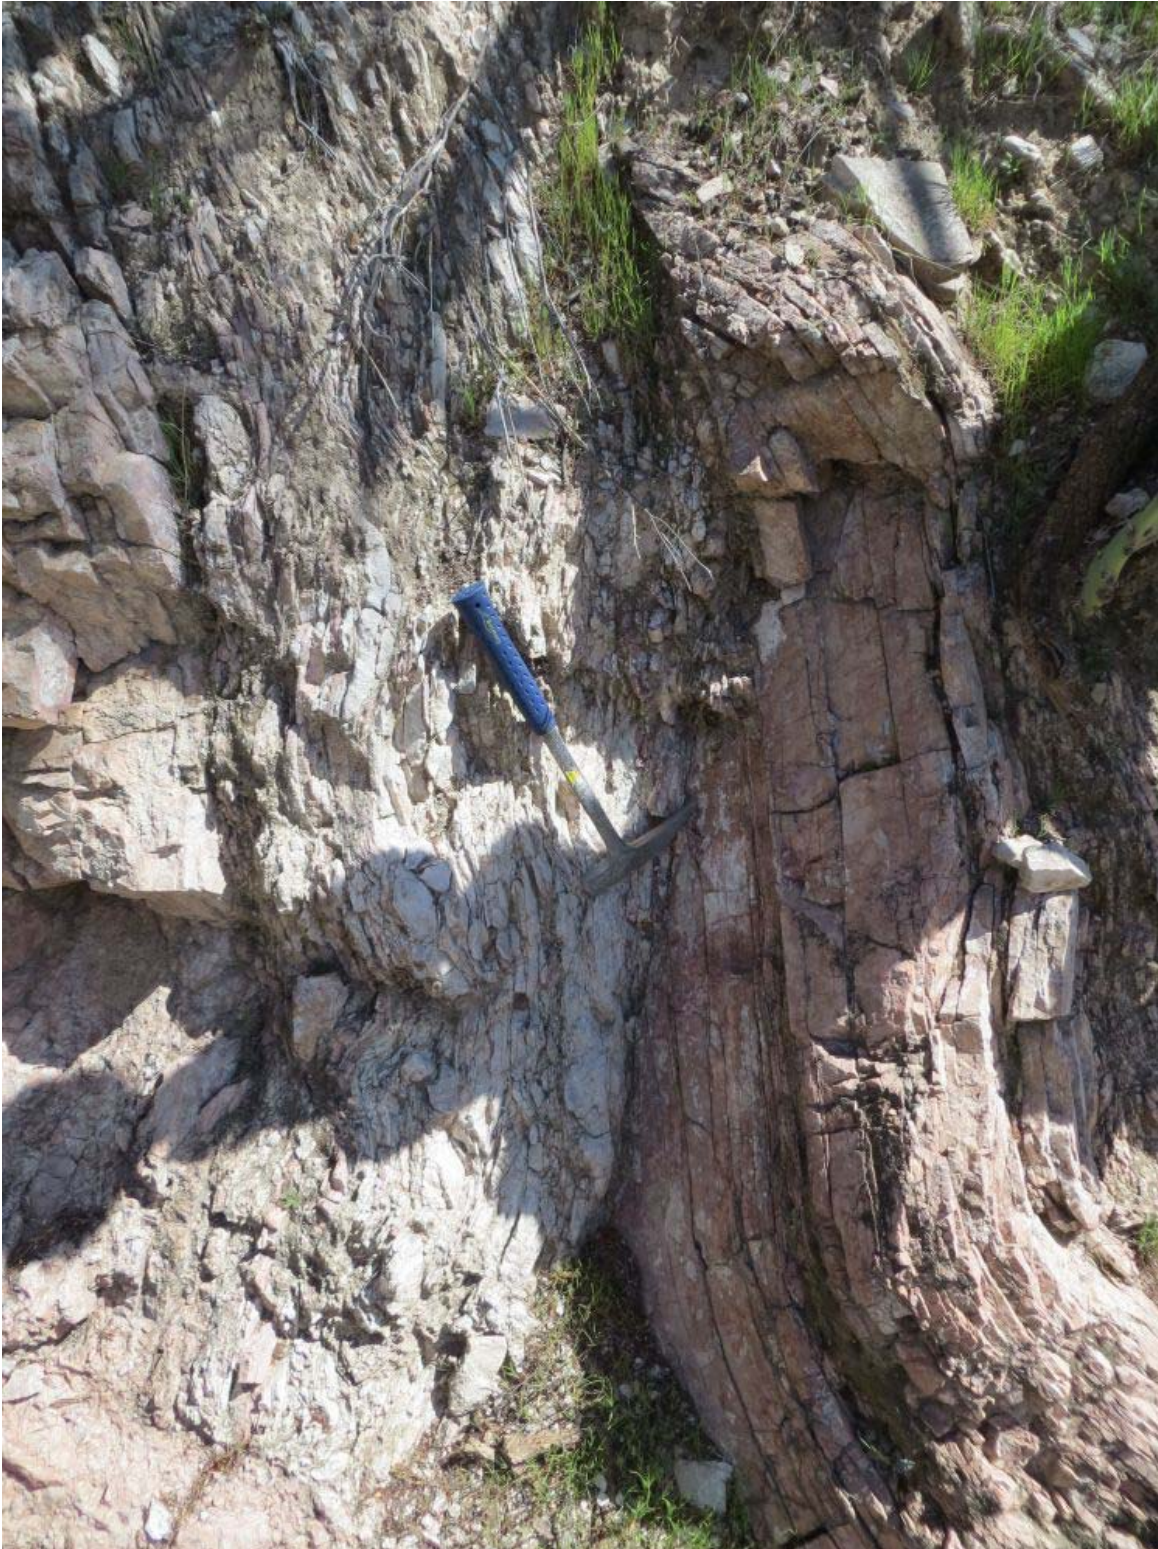
Ym7

Folded sub-vertical limestone beds near diabase exposure.

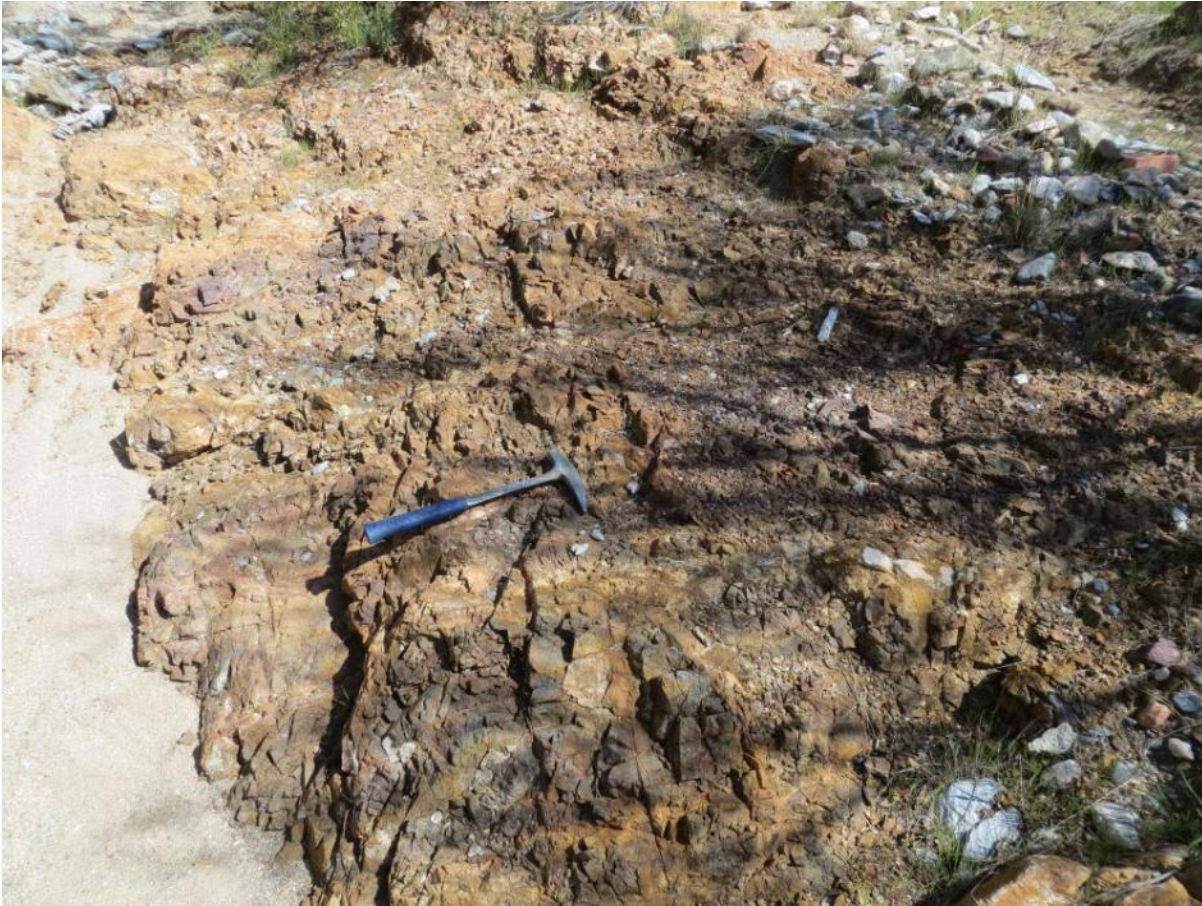
Yd6

Heavily fractured diabase exposed in channel invert. Calcite infilling of some fractures.

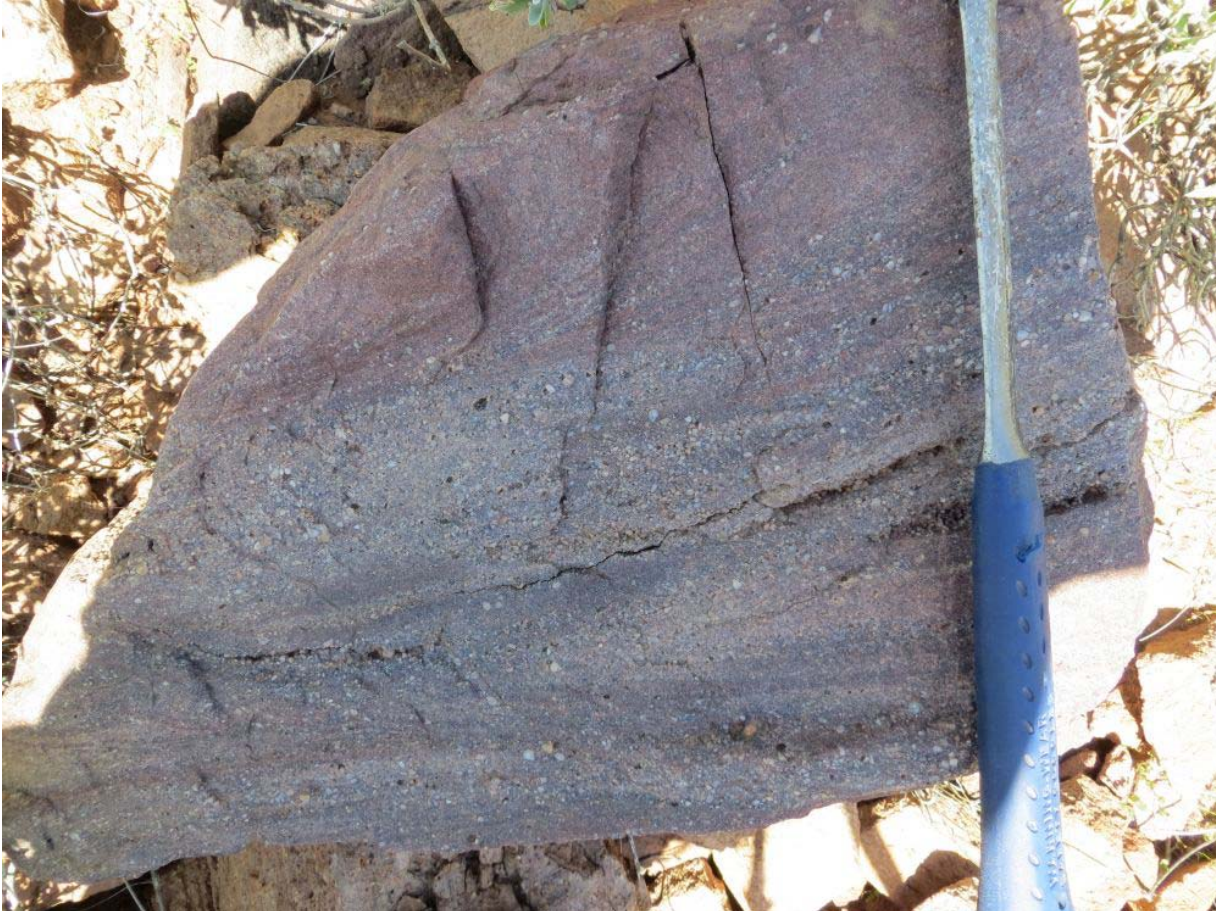
### Cb3

Bolsa Quartzite boulders and cobbles exposed on hill slope surface. Fresh, reddish purple, R6, well graded quartz sandstone (arenite) with cross bedding and parallel bedding.

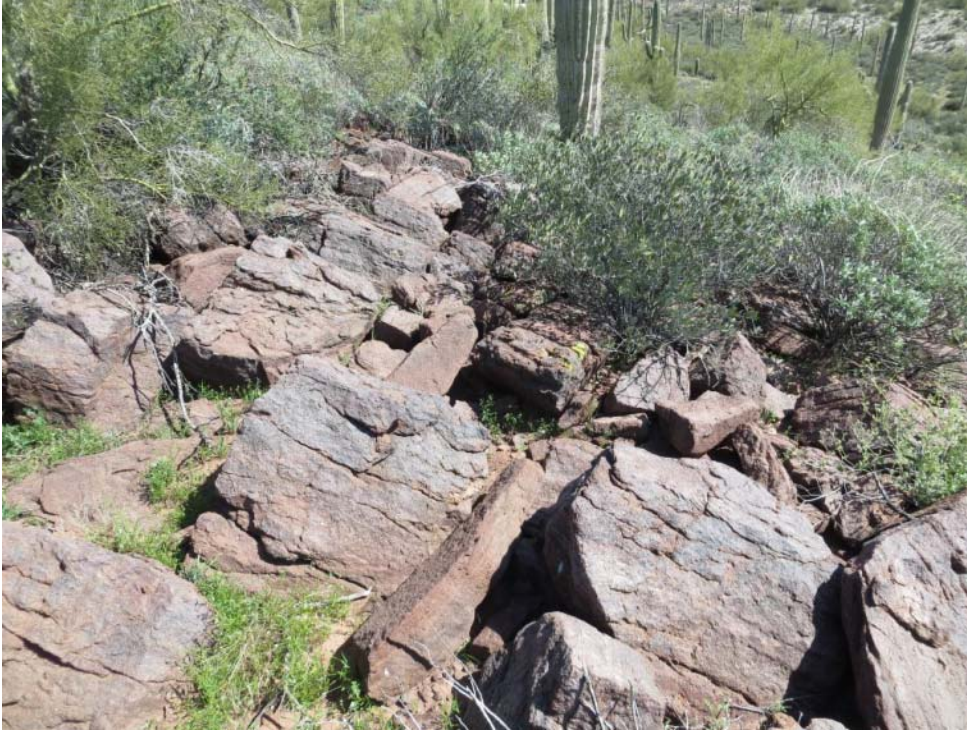
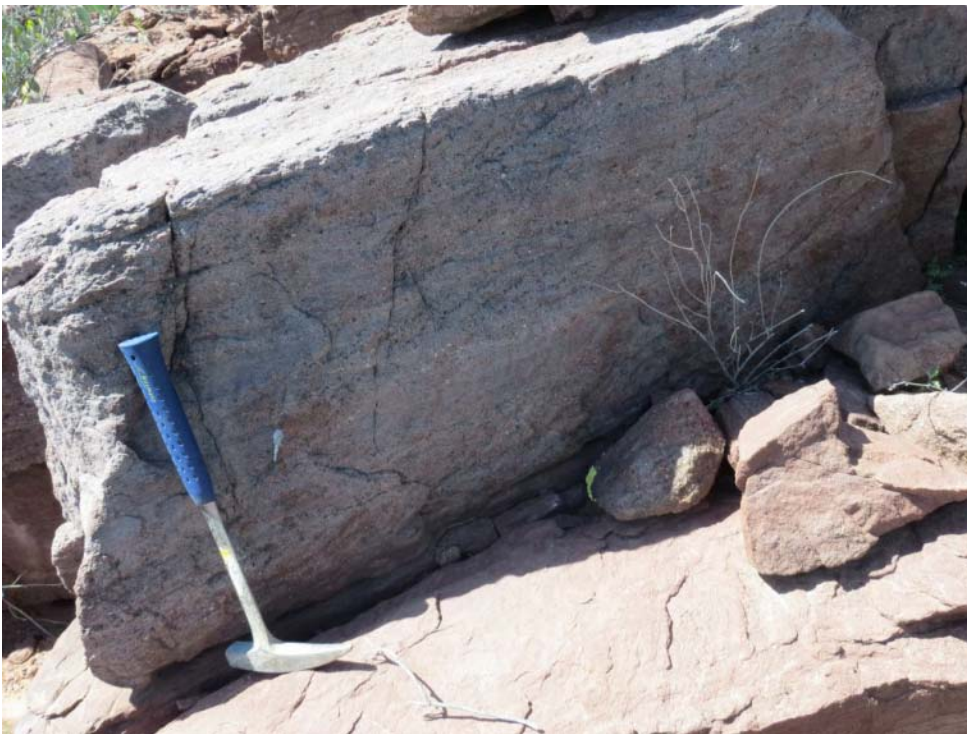
**Cb4**

Massive outcrop of Bolsa Quartzite on top of hill. Fresh, R6, separated blocks of well graded bedded quartz arenite.

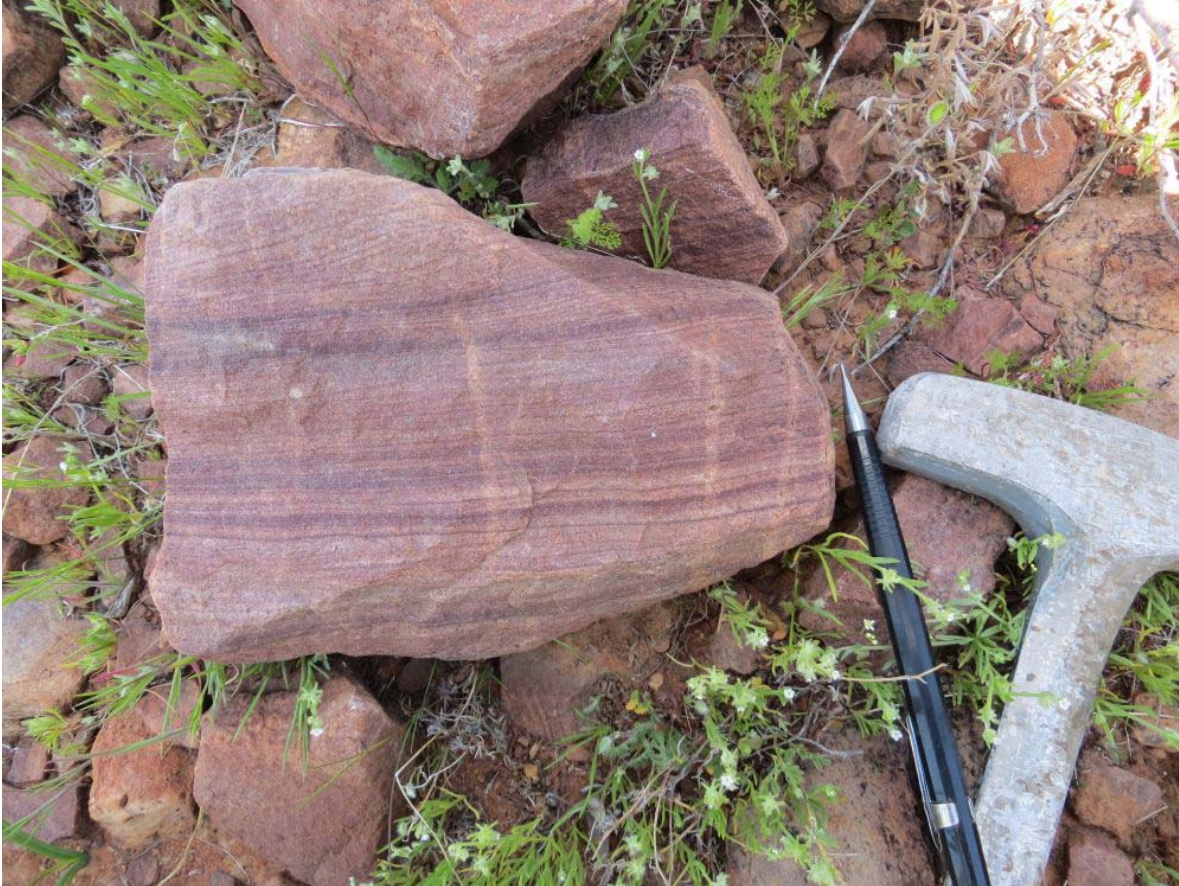
### CONTACT6

Contact near top of hill between Martin Limestone (Dm) and Bolsa Quartzite (Cb). No gullies or topographic depressions noted along line of contact.

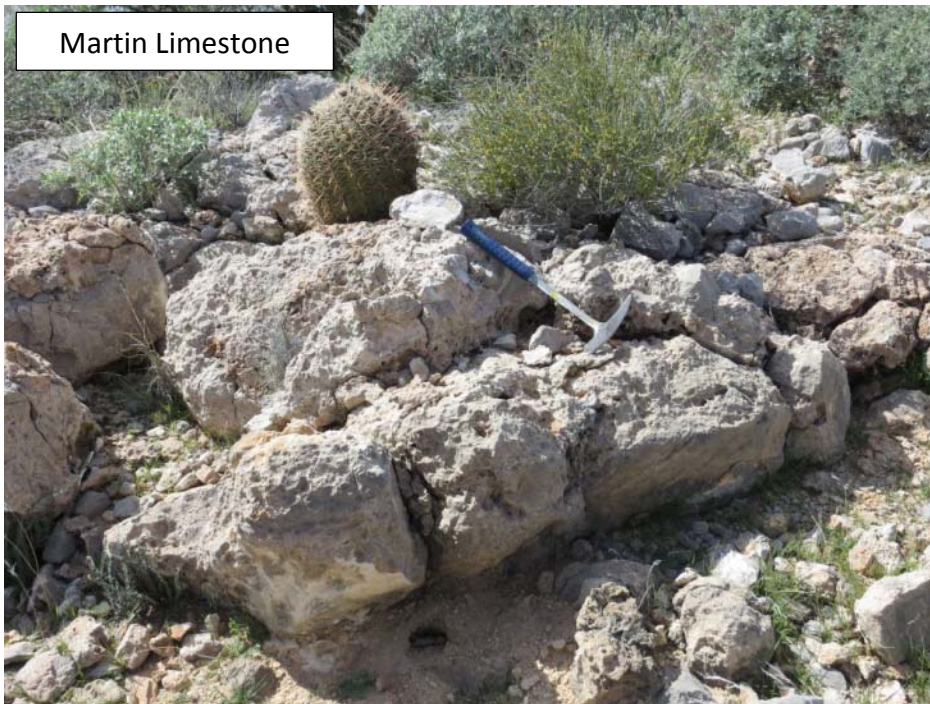
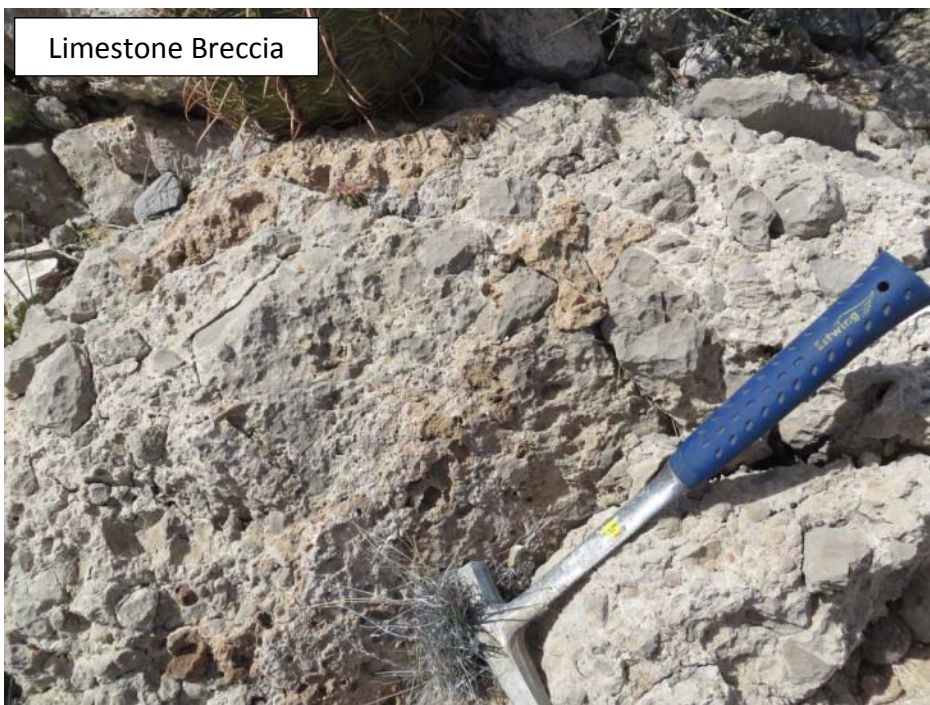
### Dm6

Small outcrop of Martin limestone on top of hill. Fresh, R4 to R5, massive grey calcareous siltstone with randomly oriented fractures well healed with calcite.

Outcrop of limestone conglomerate as well with blocks of grey calcareous siltstone in fine carbonate matrix. Both rock types display “pitted” surface texture.
