## APPENDIX I-E

### Traverse #5

PROJECT  
RESOLUTION PROJECT  
2013 NEAR WEST SITE INVESTIGATION

TITLE  
CREEK TRAVERSE #5

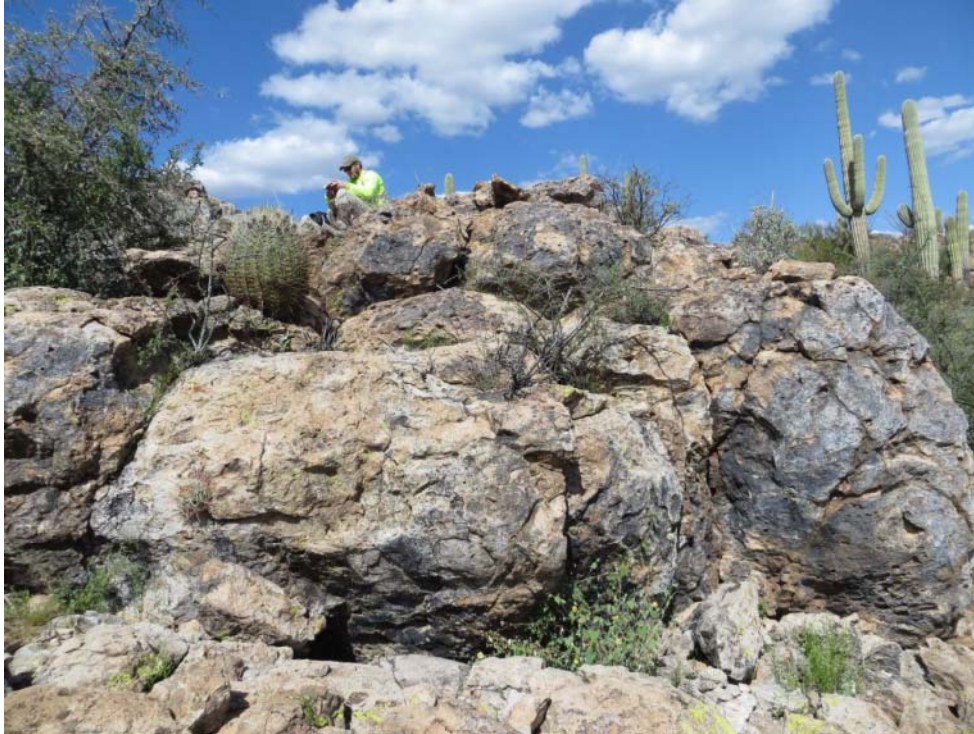
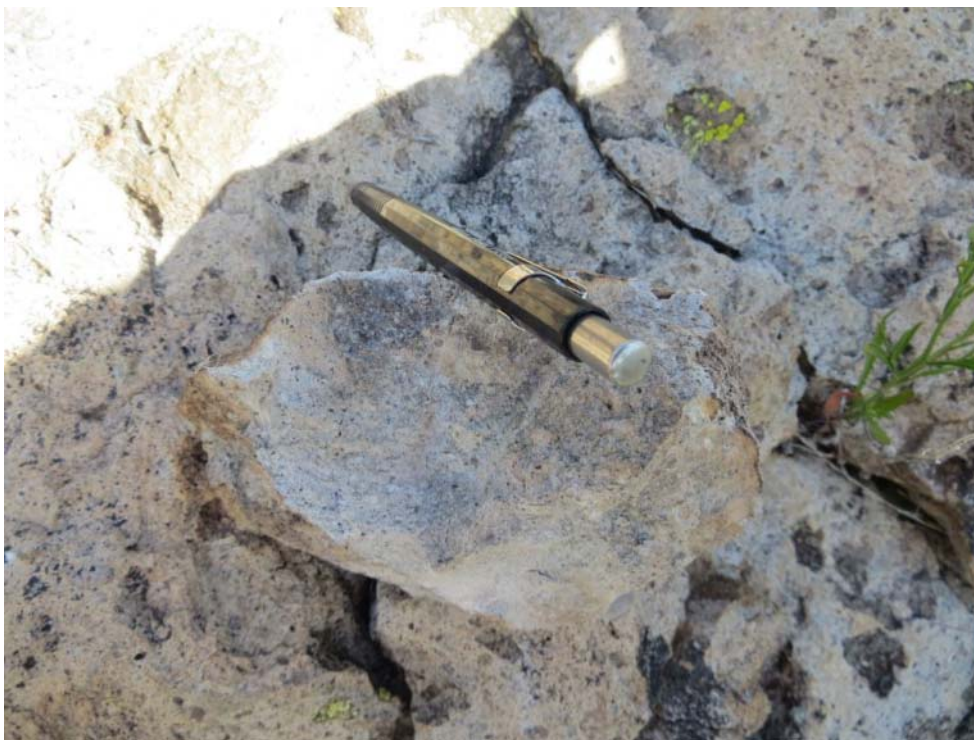
#### Tal4

Massive tuff outcrop exposed in small gully between Cb and Dm. Fresh, R5, massive, fine grained white felsic matric with quartz/feldspar/biotite grains.

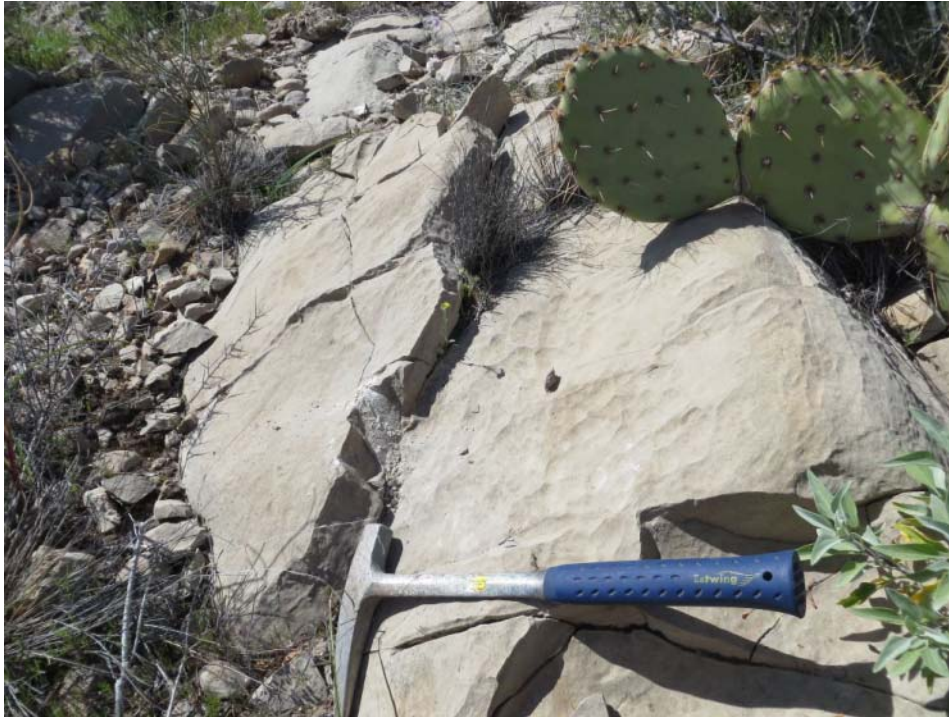
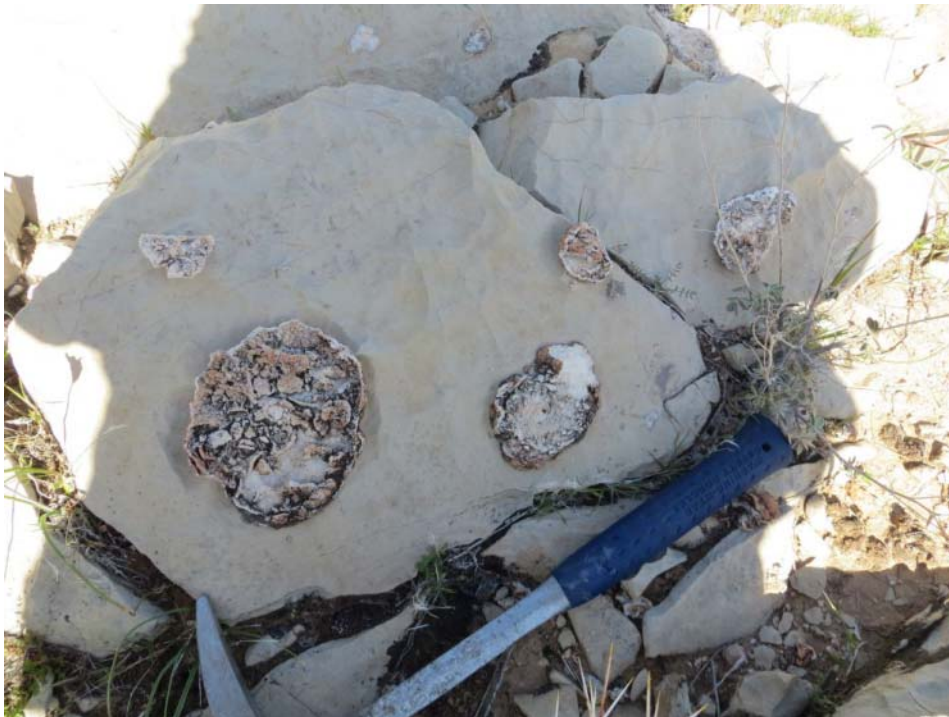
**Dm7**

Fresh, R5, light grey calcareous siltstone, dipping beds with pitted surface texture, some circular “growths” of calcite crystals.

Orientation of bedding: **076/33**

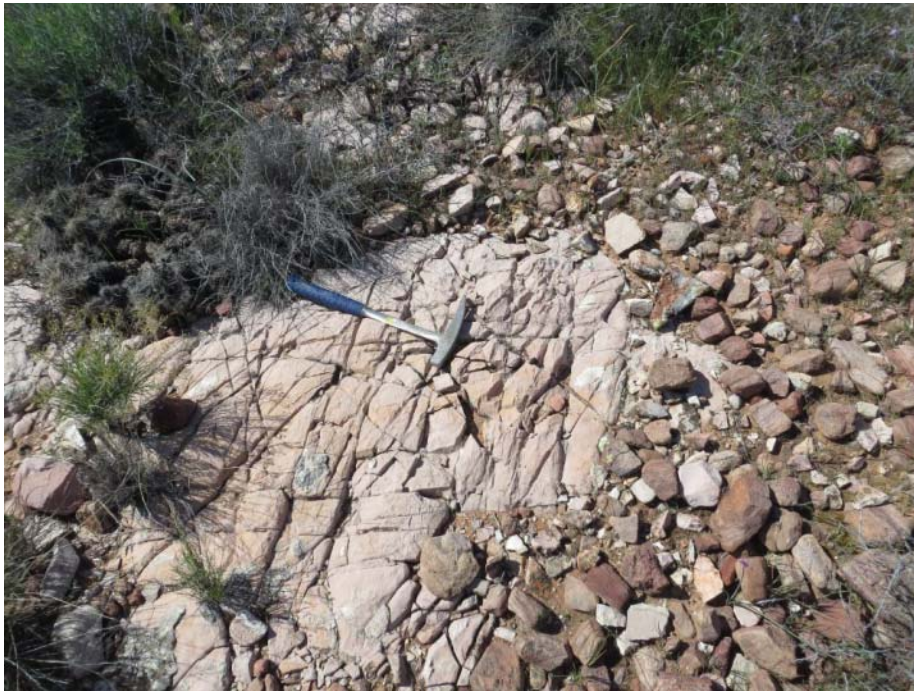
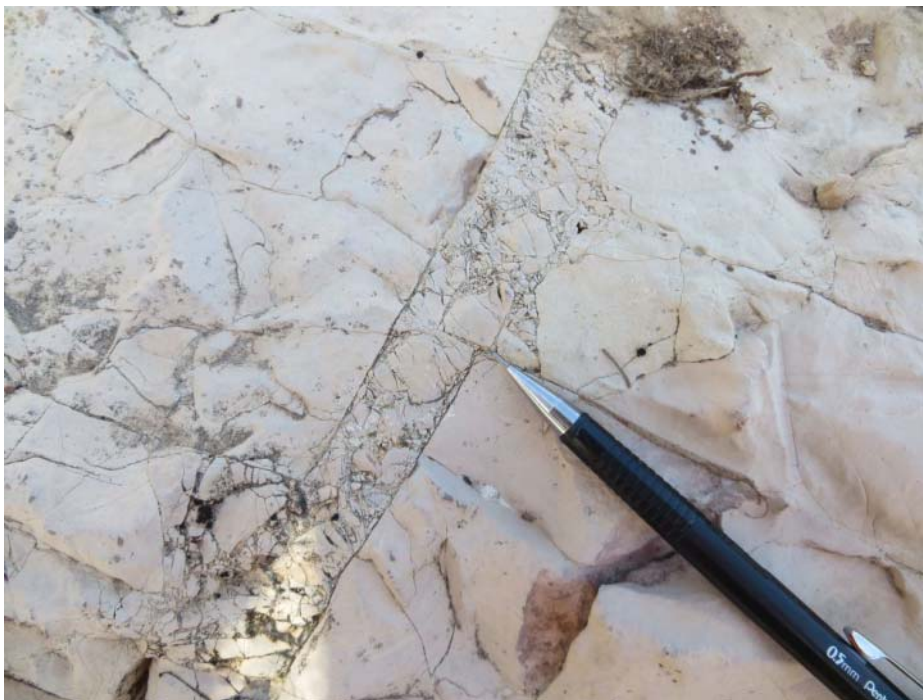
**Dm8**

Sub-horizontal exposure of greyish white calcareous siltstone in small wash near the Cb contact. Fresh, R3 to R4, numerous fractures on surface but are closed or well healed with calcite, one fracture tightly filled with brecciated limestone.

Orientation of bedding (flat surface exposed in channel bank)

**302/04**

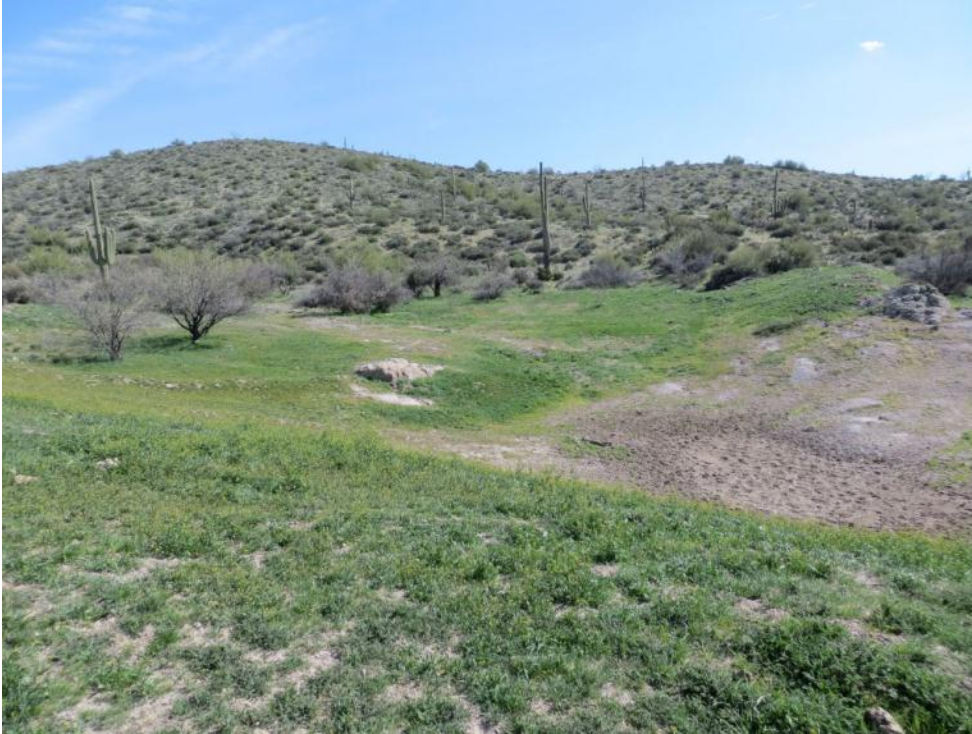
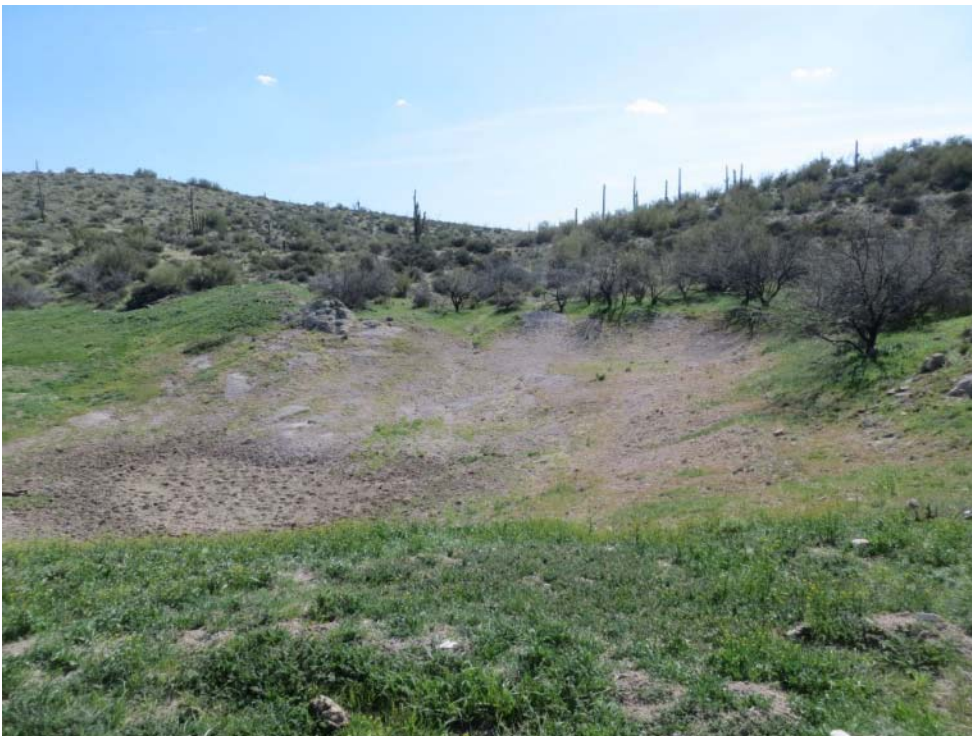
### DAM

Embankment made of carbonate rich sand blocking the end of a small drainage. No standing water in impounded area.

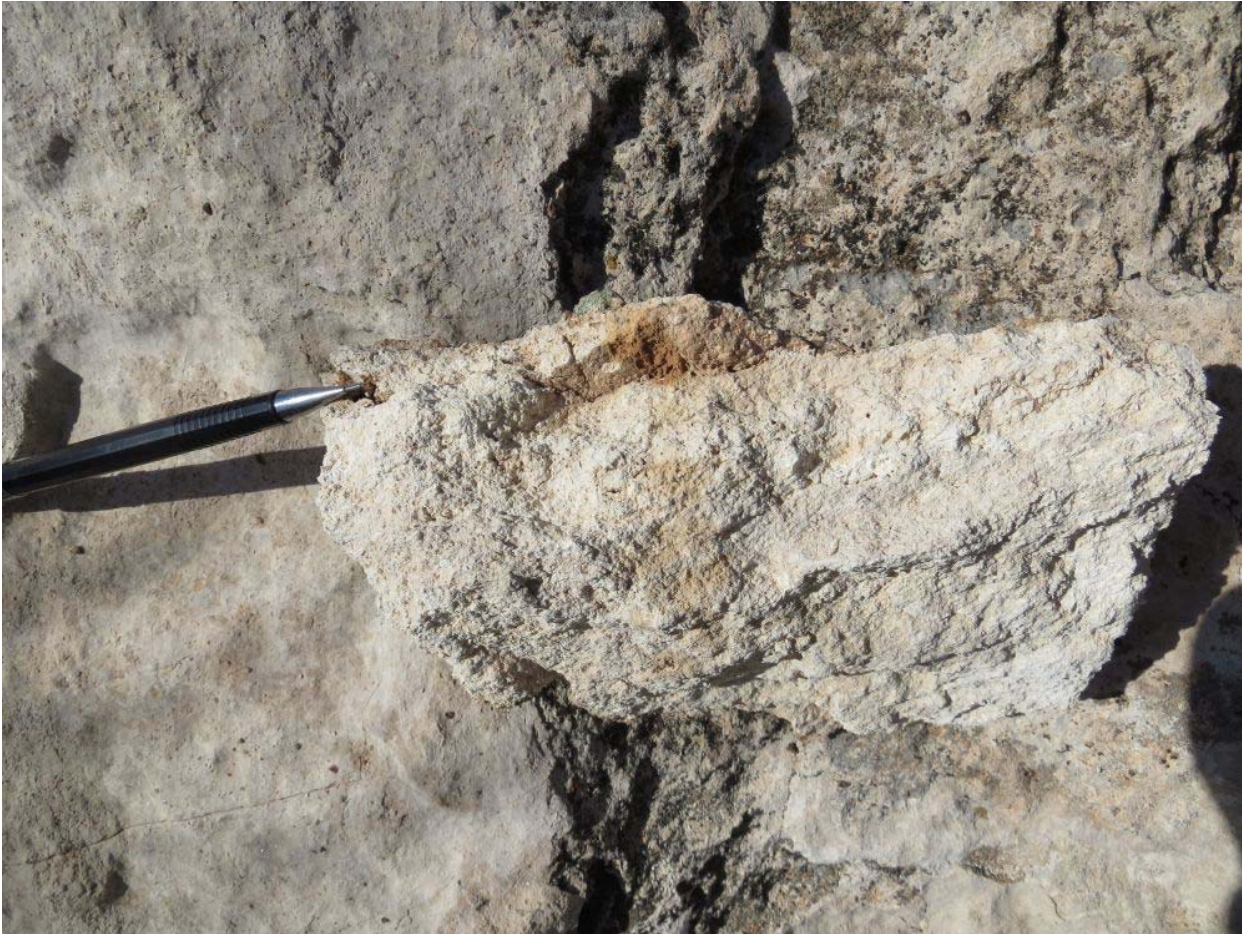
### Dm9

Outcrop of very weak (R1) very fine grained white silty/powdery limestone but more likely cemented overbank deposits since material directly below contains sub-rounded clasts of Cb and is likely old alluvium.

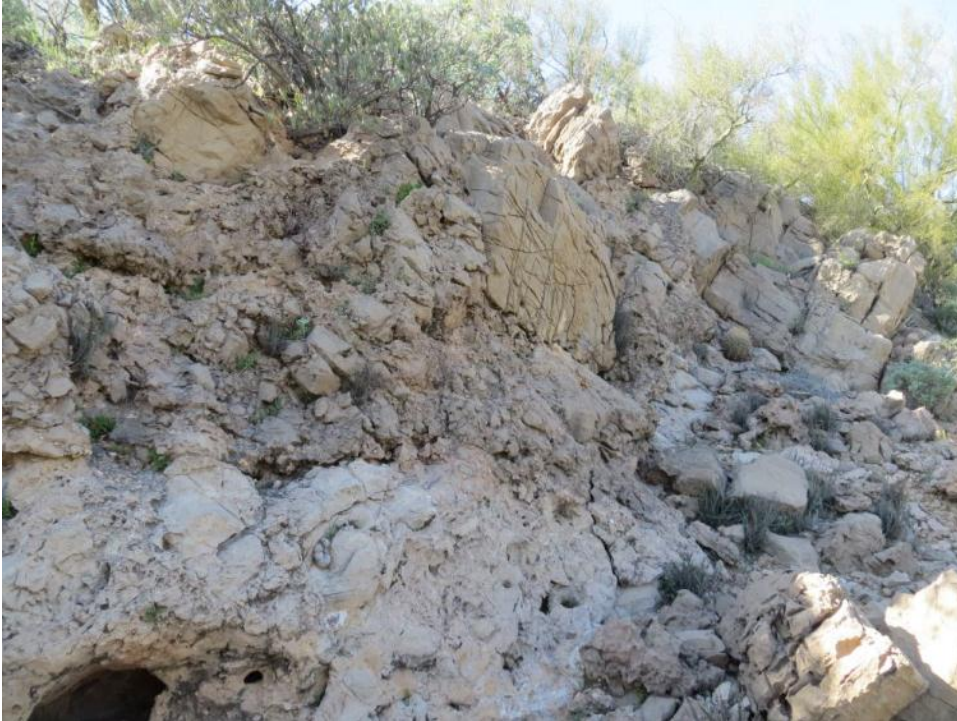
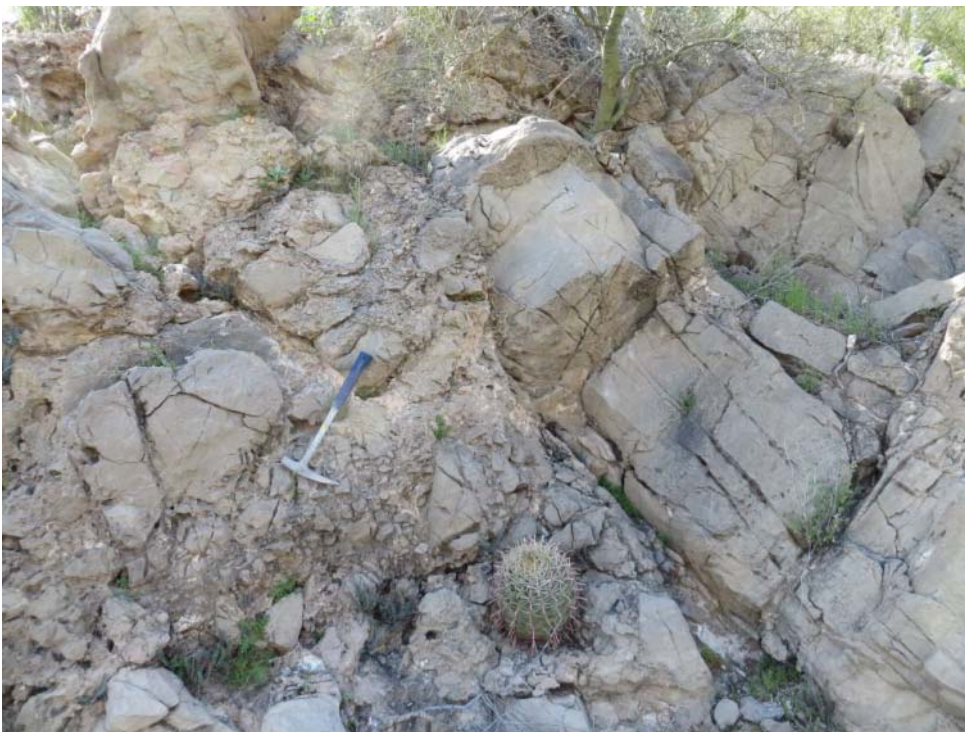
**Dm10**

Brecciated limestone outcrop. Fresh, R5, clast size ranges from large (1m) intact massive boulders of calcareous siltstone to sand size, carbonate cement, many voids in exposure face.

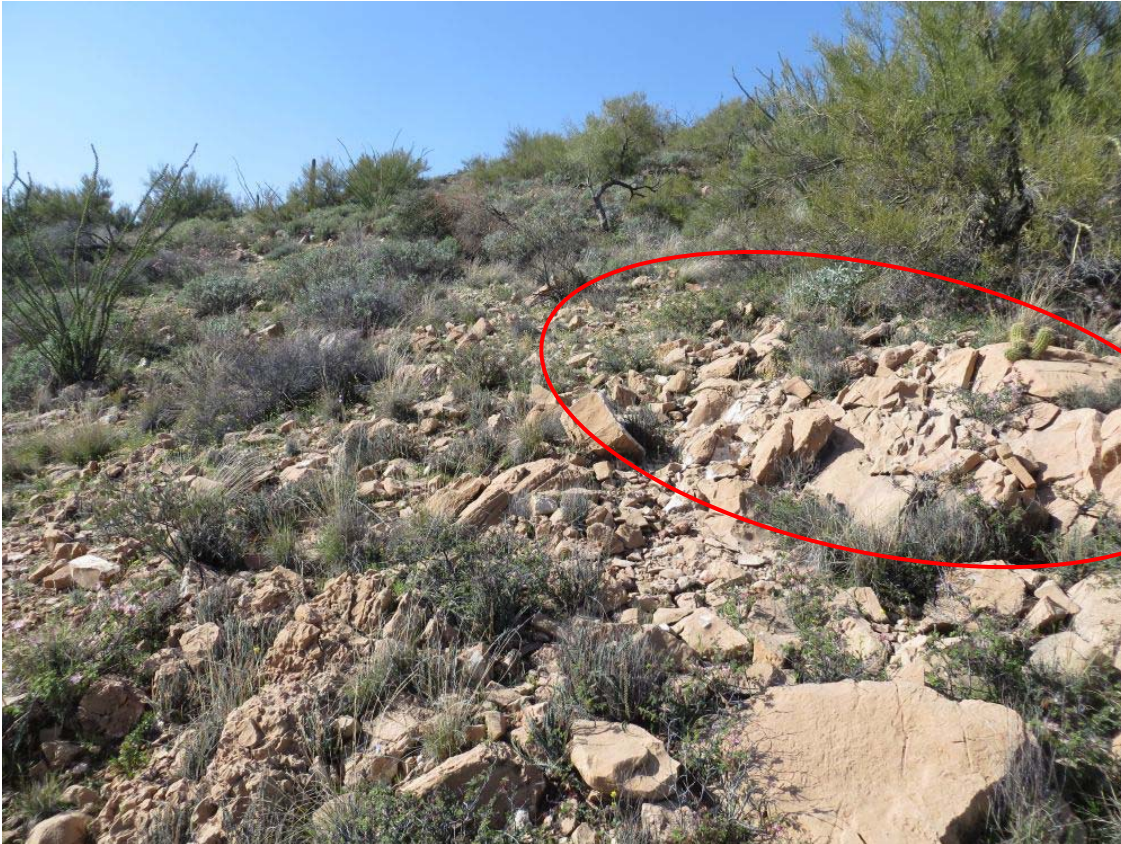
**Dm11**

Small bedded limestone exposure on hill slope amongst limestone cobbles and boulders.

Orientation of bedding: **095/17**

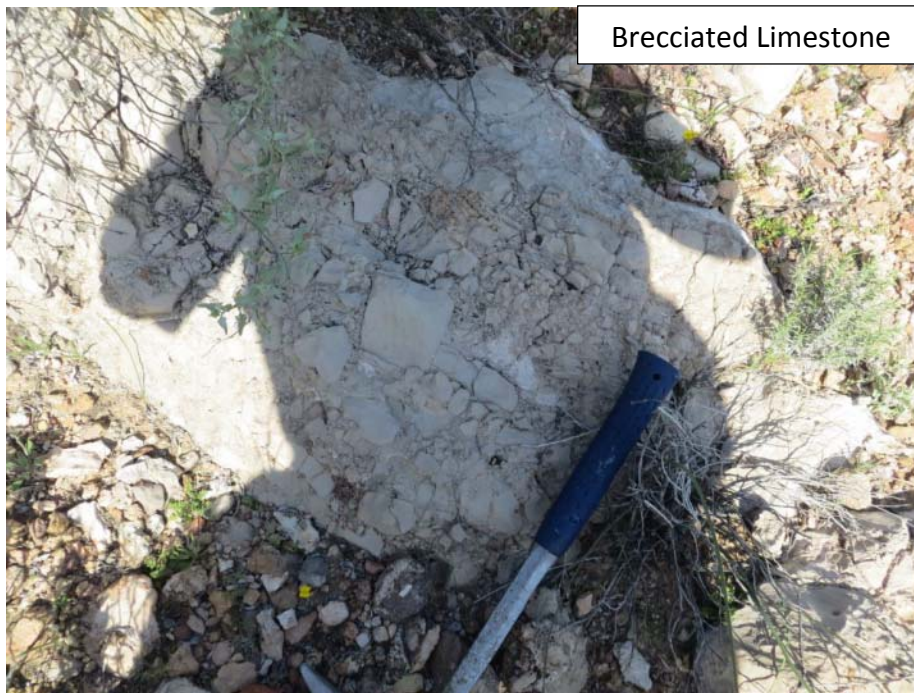
### CONTACT7

Contact between Dm and Cb along small depression. Brecciated limestone (R5) on one side of contact line and brecciated quartzite (Cb) (R5 to R6) on the other. Cobbles and gravel of both units in depression invert.

Strike of line of contact: **009**

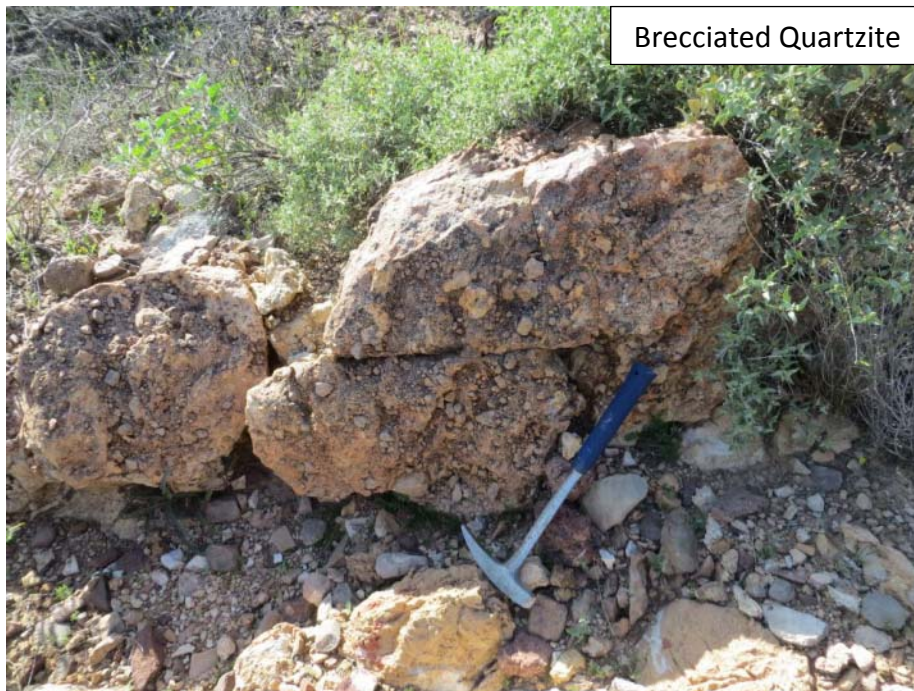
Brecciated Quartzite

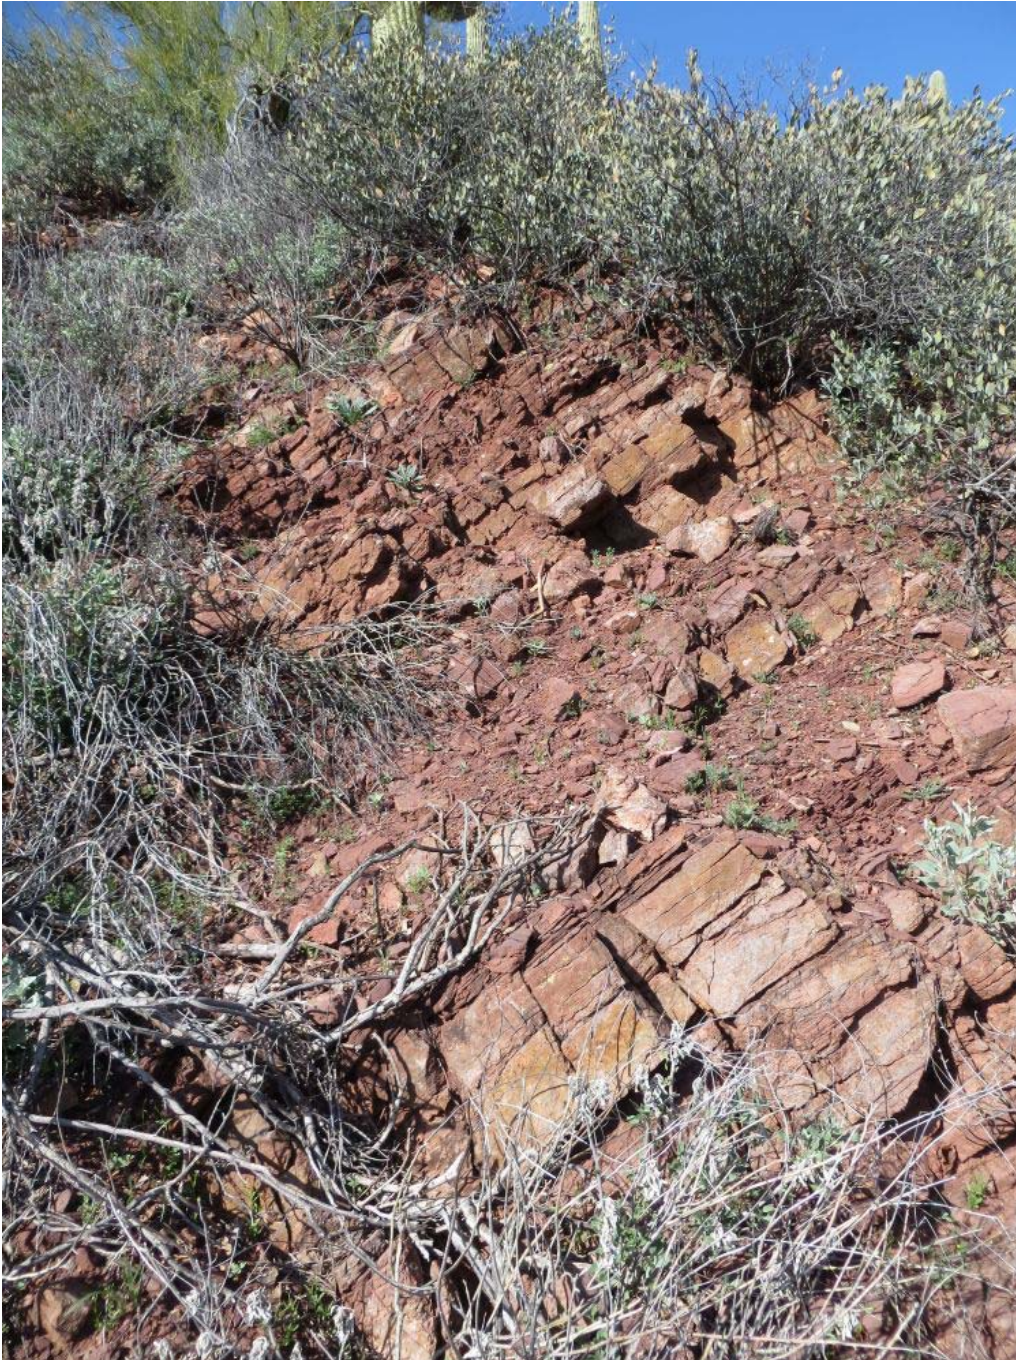
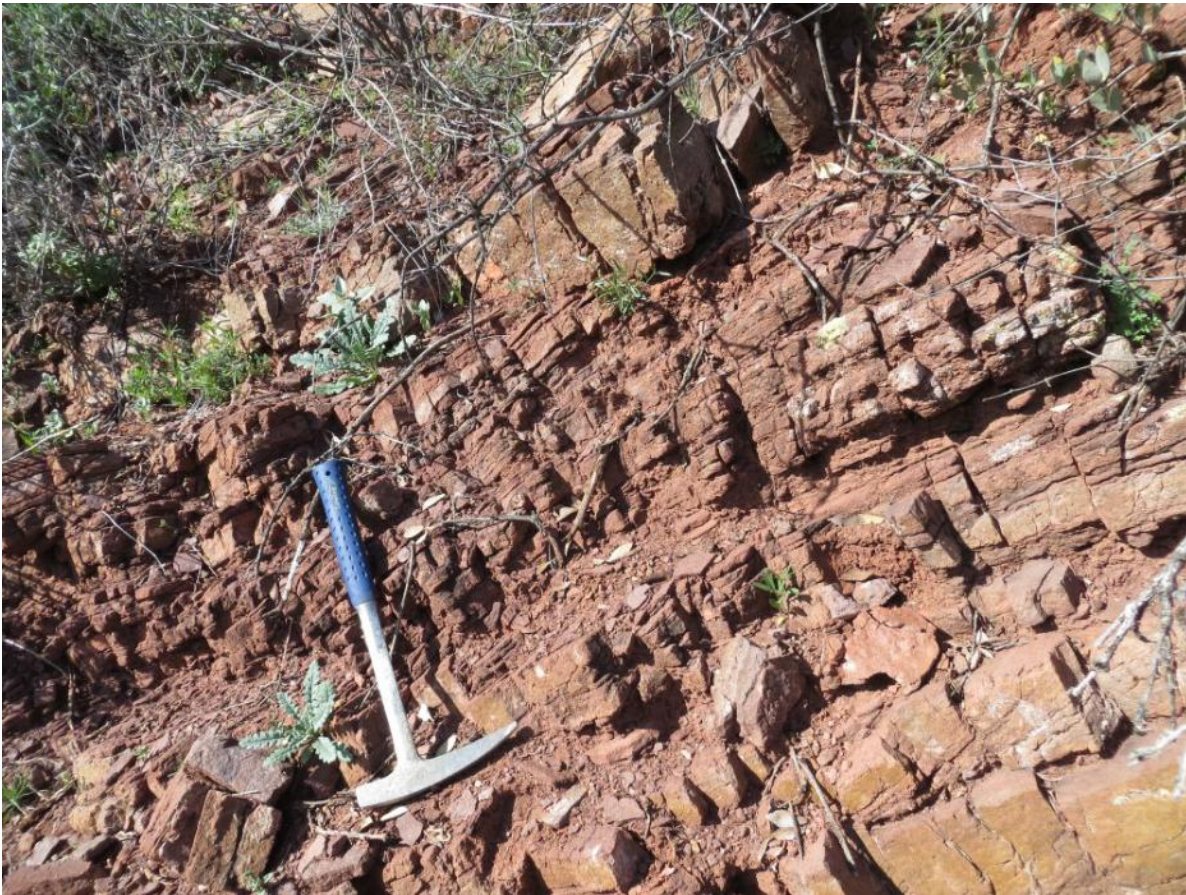
### Cb6

Oxidized, R3 to R4 (fractures along pre-existing (?) oxidized planes), interbedded fine to coarse grained quartz arenite, bed thickness ranges from mm scale laminations up to ~ 8 cm (*3.15 inches*) beds, fractures cutting perpendicular to bedding planes, fracture aperture not measurable in blocky exposure.

Orientation of bedding: **184/26**

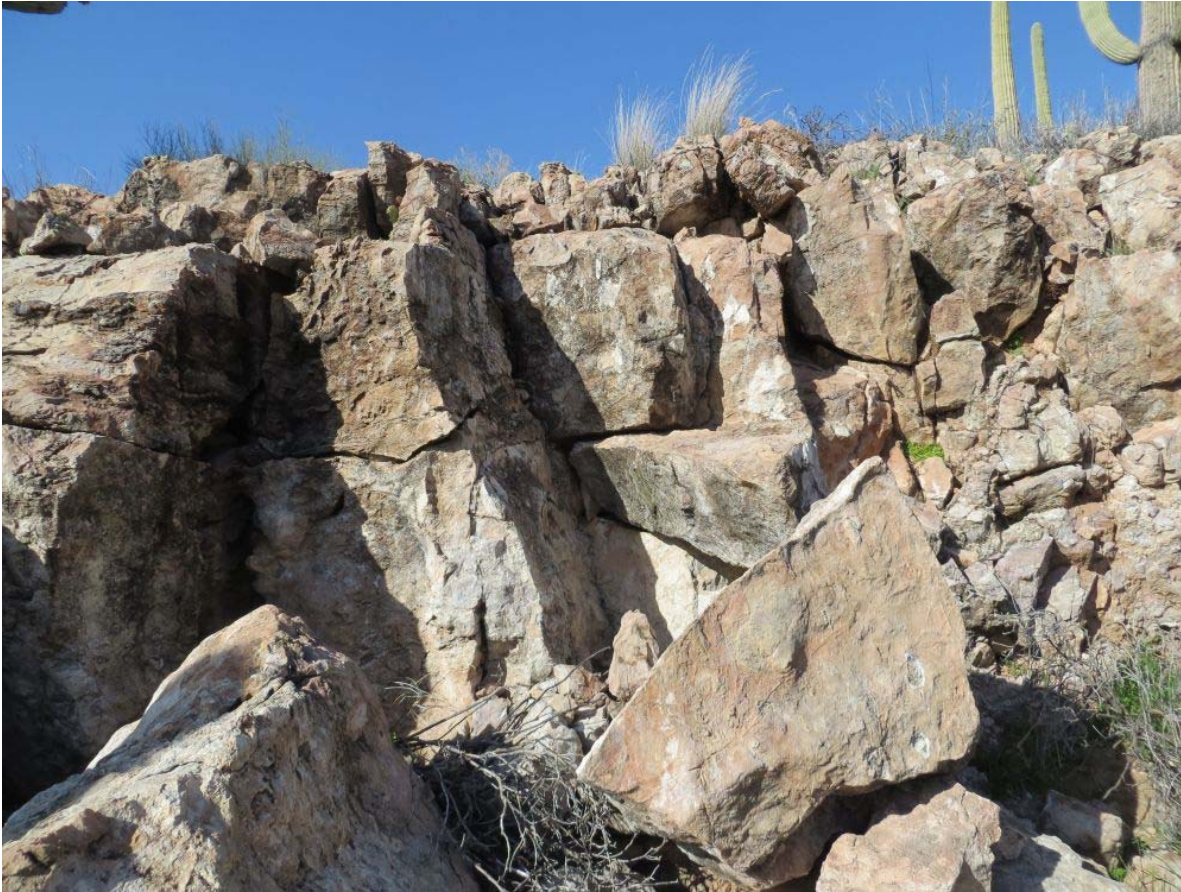
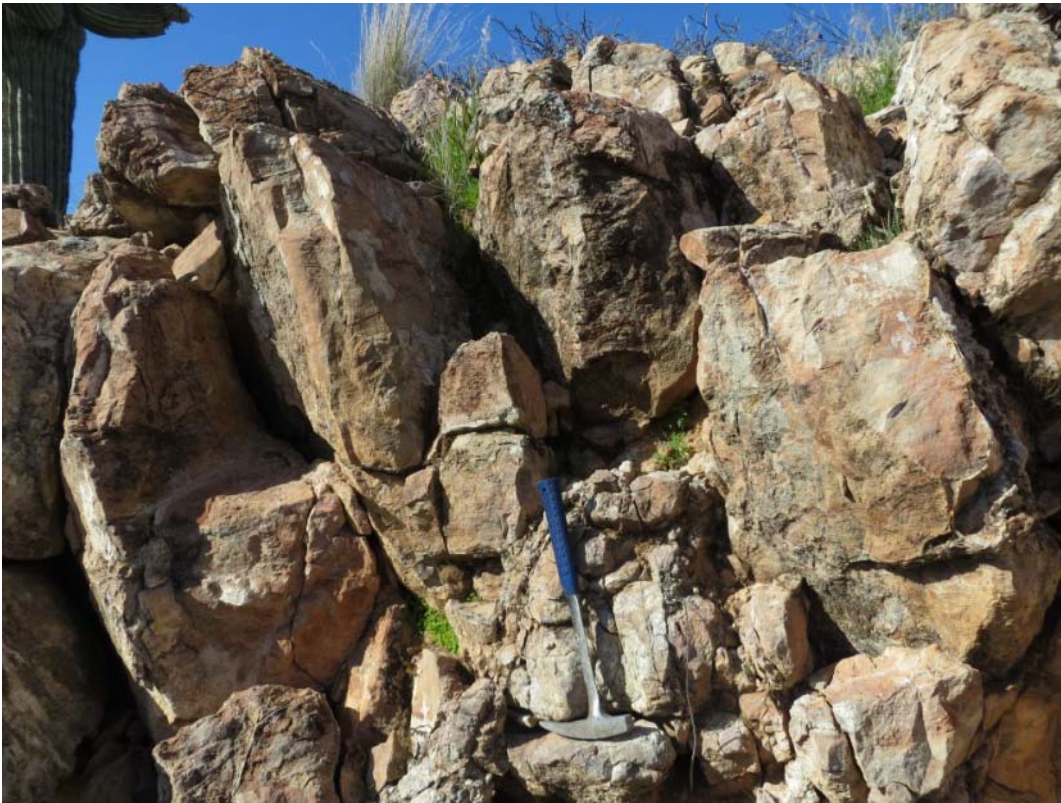
### Ym8

2 m (6.6 ft) high exposure of jointed limestone. Fresh, R5, very fine grained calcareous siltstone, sub-vertical jointing, blocks out turned and not possible to estimate joint spacing or aperture, smooth and planar joint surfaces on overturned blocks, large calcite crystals forming on exposed block faces.

Calcite Crystal Growth  
on Exposed Surface

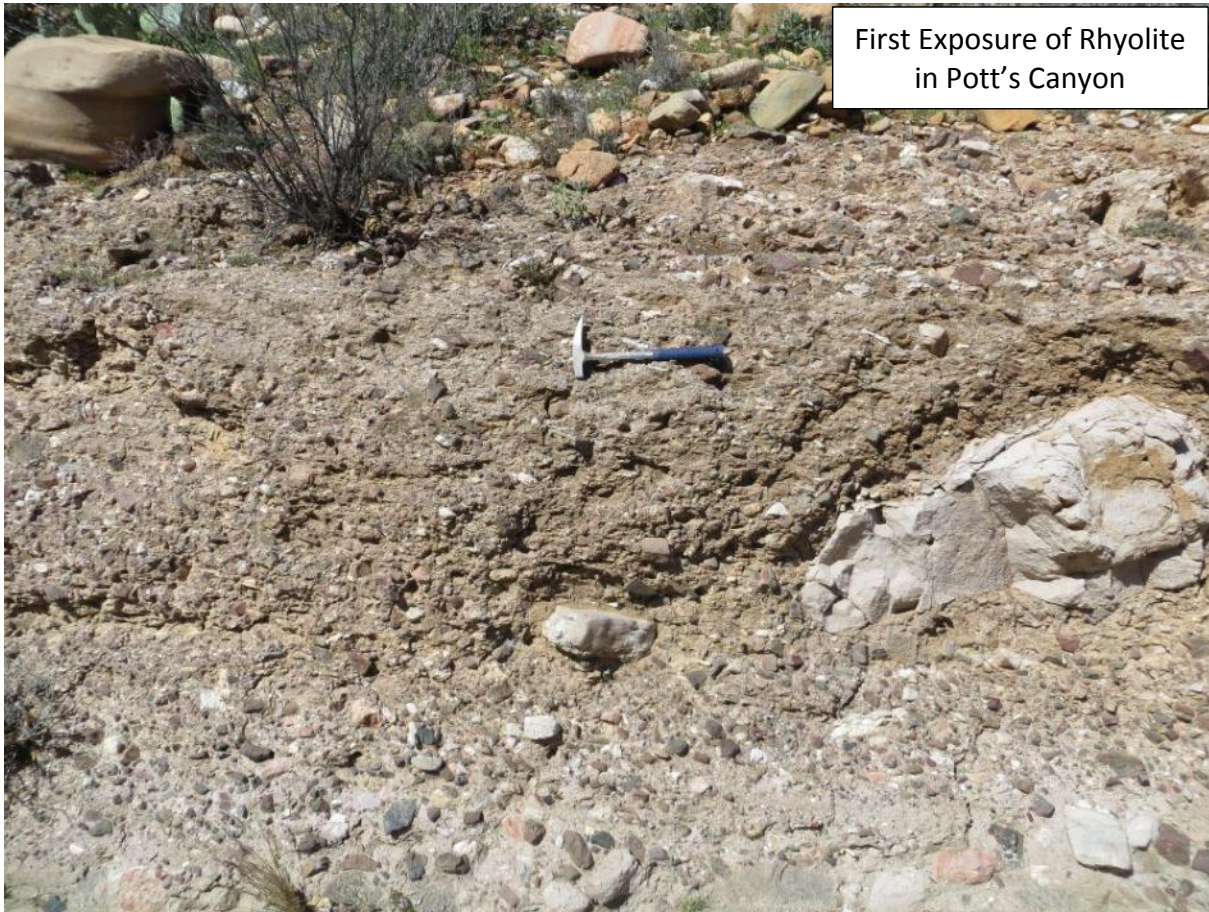
**PRL1**

Contact between conglomerate and rhyolite in Pott's Canyon.

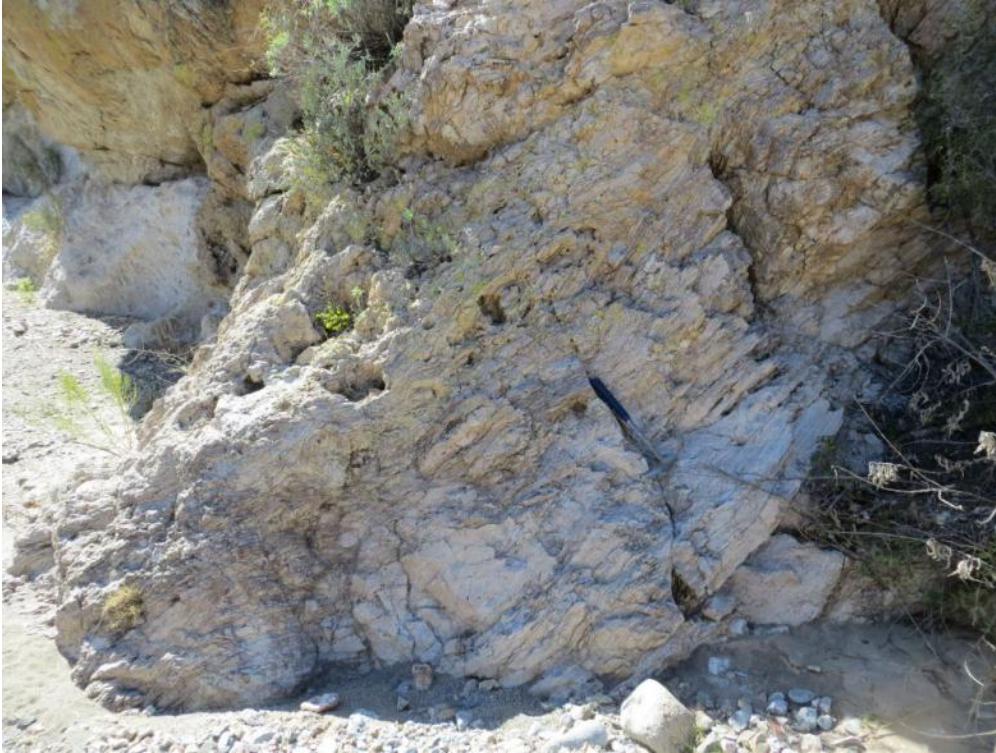
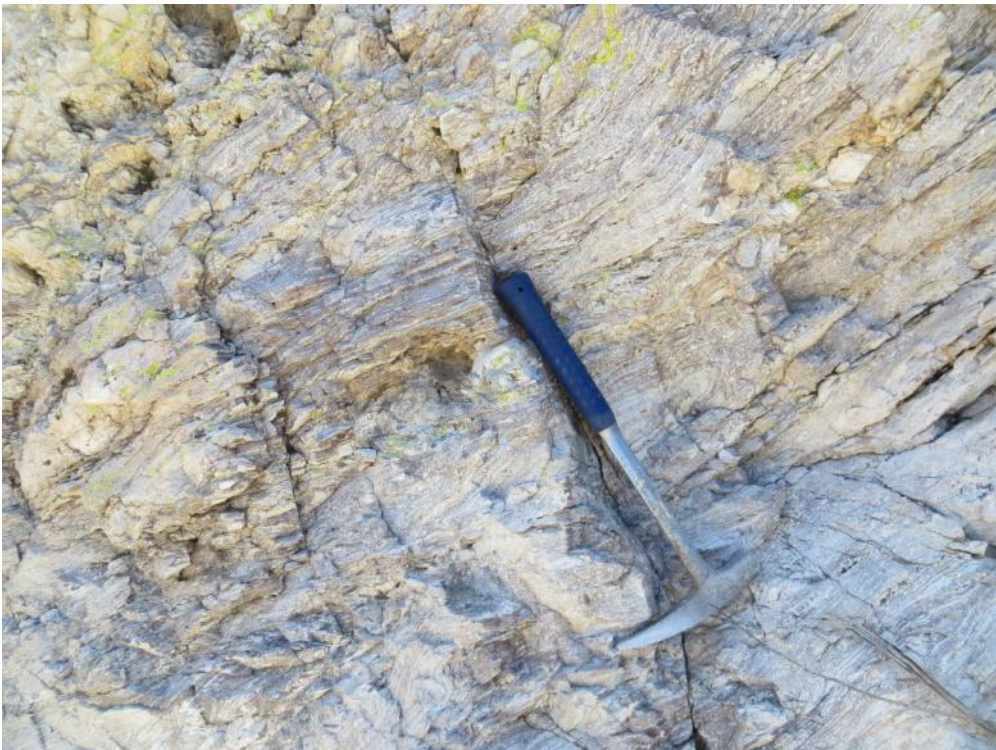
## PRL2

Rhyolite exposure on left channel bank. Millimeter scale folded bands of chalcedony. Very hard and fissile; rock fractures along bands. R5.

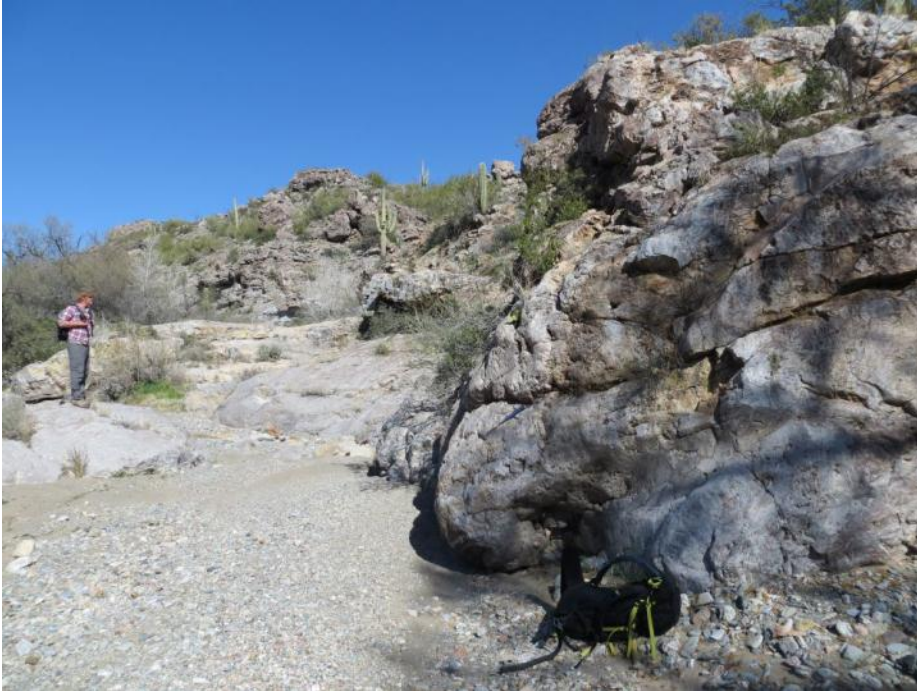
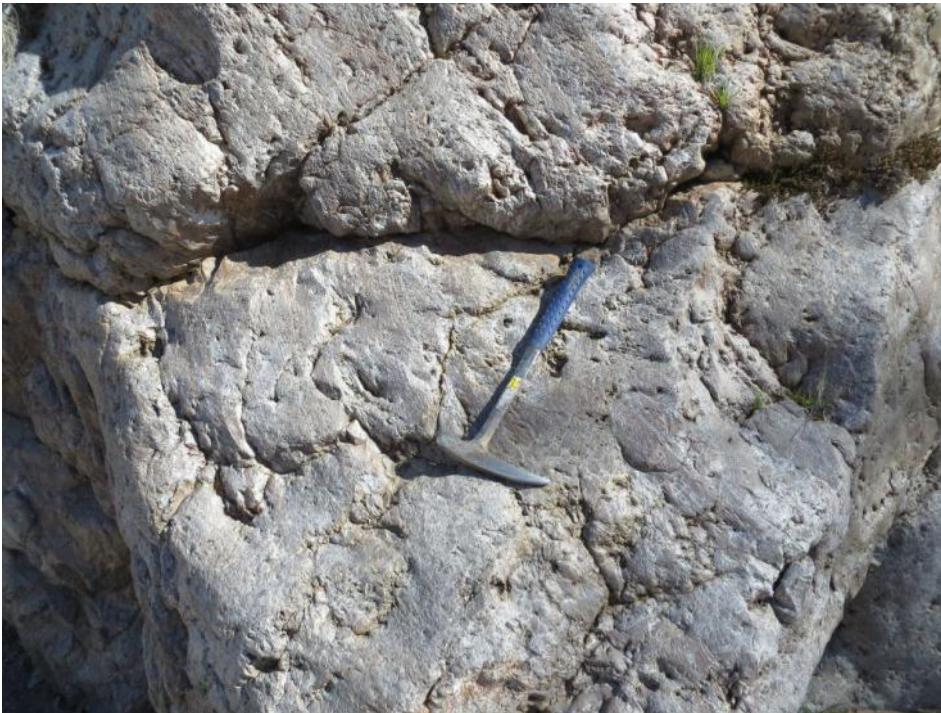
### PRL3

Exposure of massive rhyolite. Generally randomly oriented closed fractures with some closed parallel fractures exposed on one outcrop with 30 cm to 50 cm (11.81 inch to 19.69 inch) spacing. Composed of mostly microcrystalline quartz (chalcedony) (very hard, R5 to R6) with shiny lustrous surfaces. Some pink and grey banding.

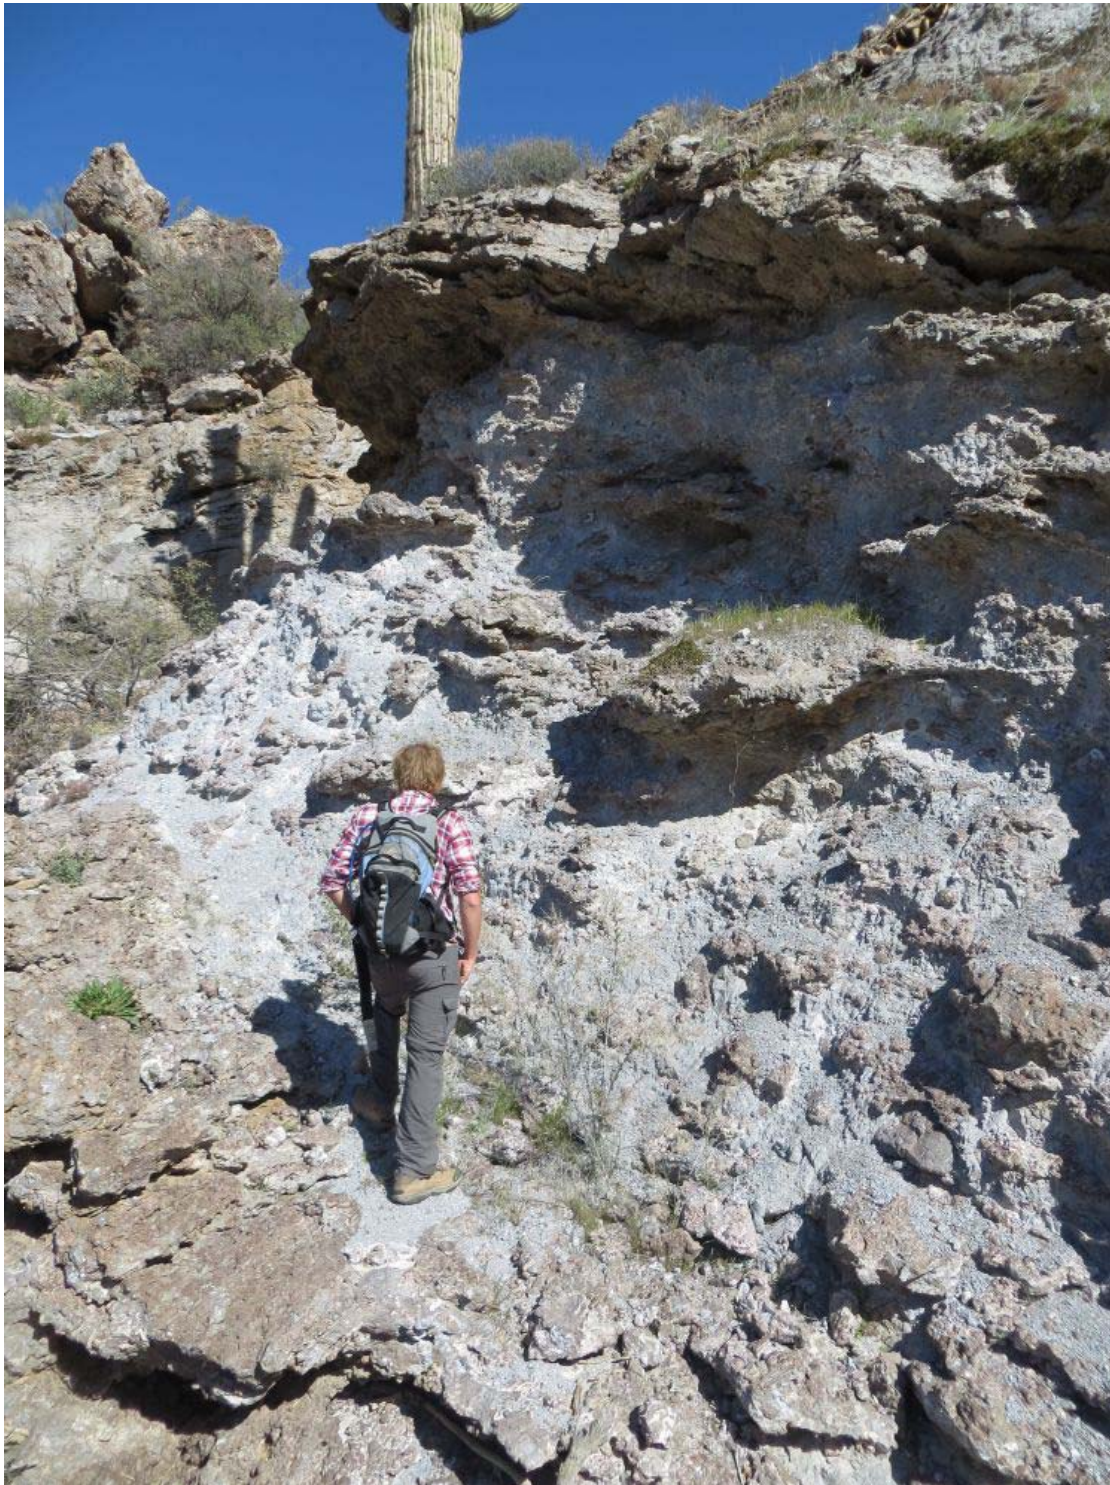
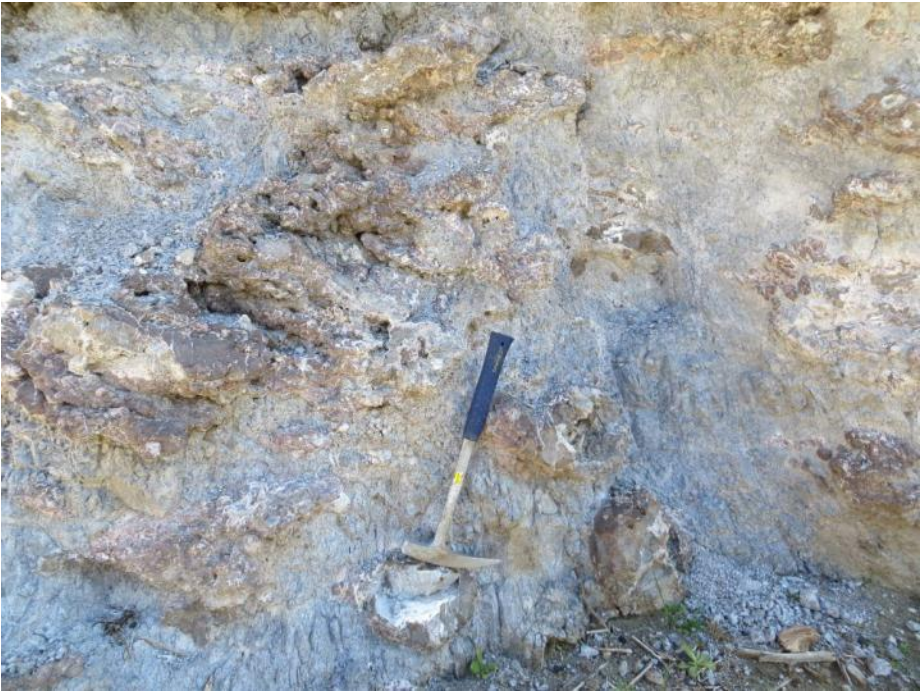
#### PRL4

5 m (16.4 ft) thick layer of perlite between two layers of microcrystalline siliceous rock. Perlite is heavily fractured with geodes (“thunder eggs”) and lenses of microcrystalline silica (chalcedony) floating in the unit. Rhyolite beds are very hard (R5 to R6) with numerous air voids.
