## APPENDIX I-E

### Traverse #5

PROJECT  
RESOLUTION PROJECT  
2013 NEAR WEST SITE INVESTIGATION

TITLE  
CREEK TRAVERSE #5

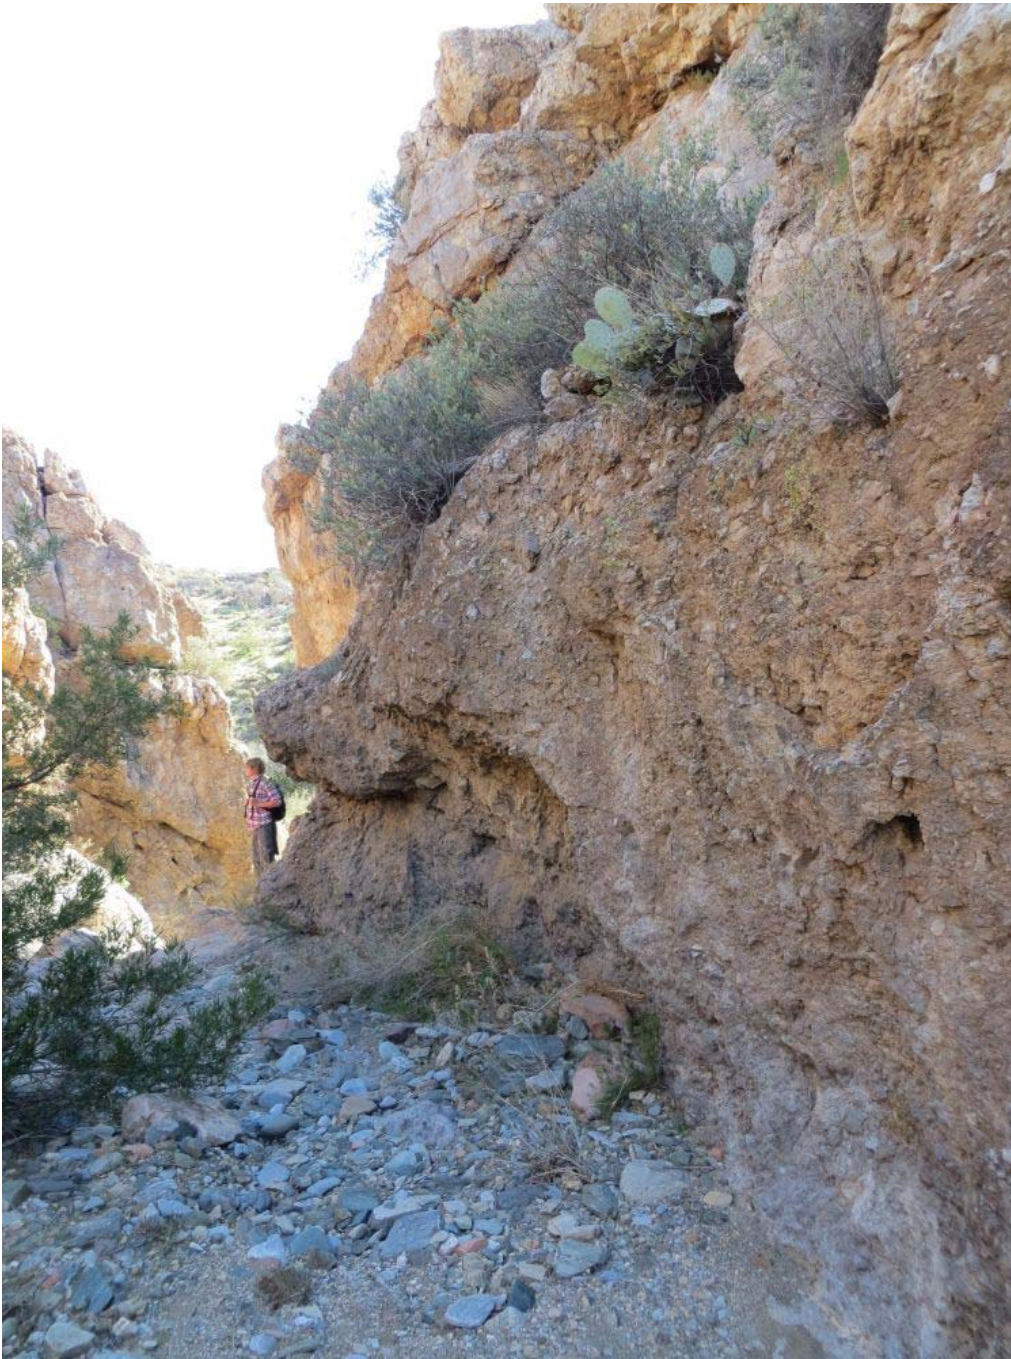
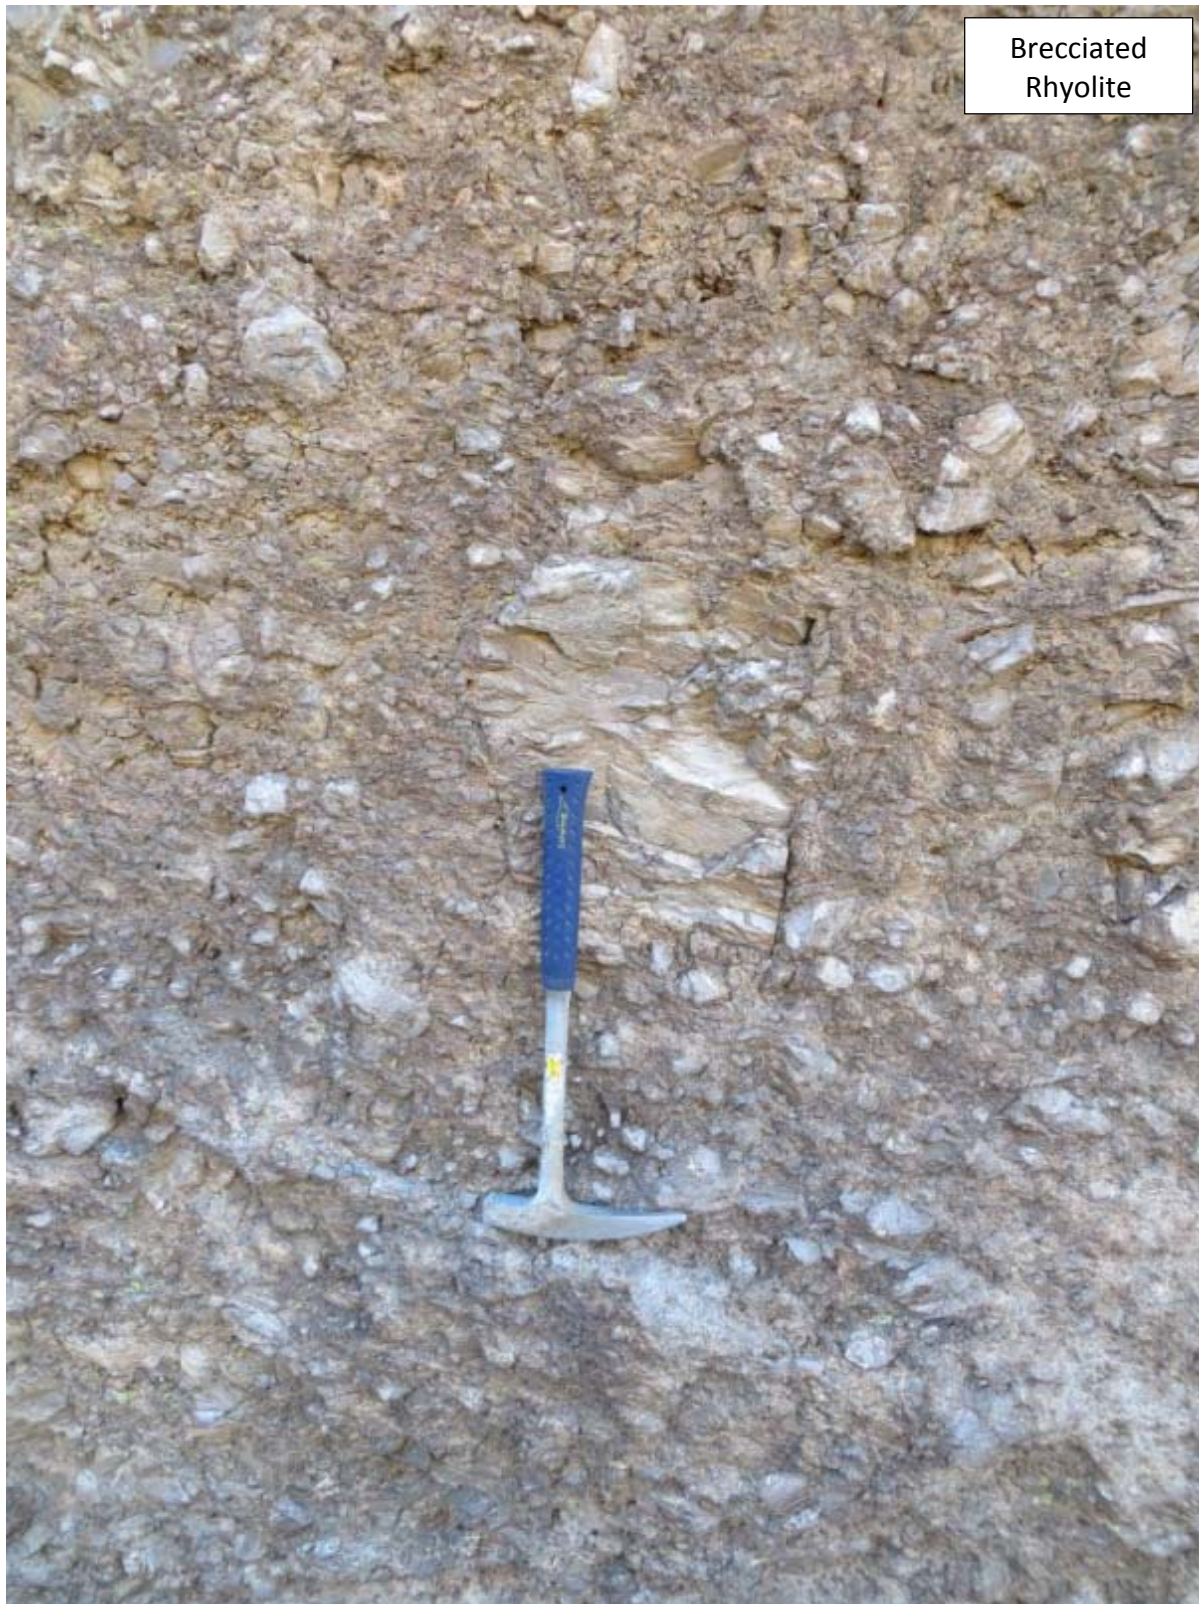
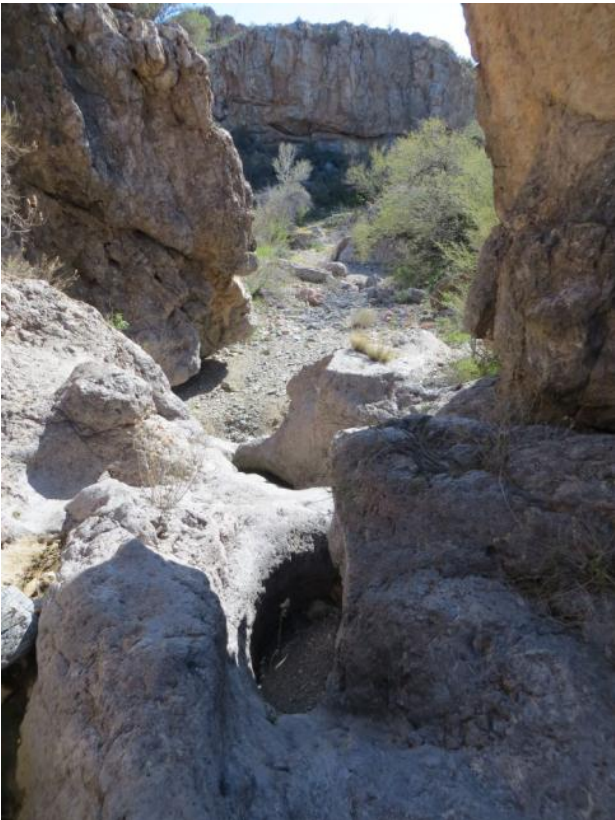
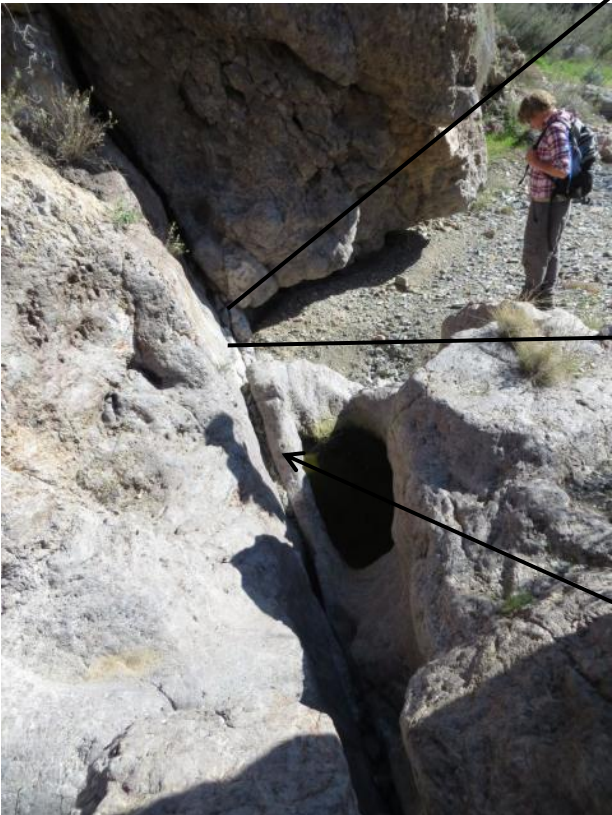
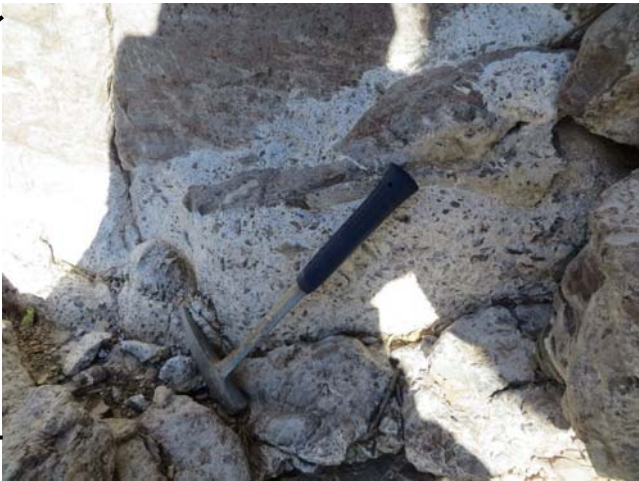
### PRL5

Steep sided gully with ponding water in invert. Brecciated rhyolite forms gully walls (angular clasts of banded rhyolite in very hard (R6) rhyolitic groundmass. One 10 cm (3.94 inches) wide vertical fault cutting across gully filled with very hard, non-acid reactive brecciated gouge.

Orientation of fault/joint: **335/90**

Fault/joint with  
brecciated gouge

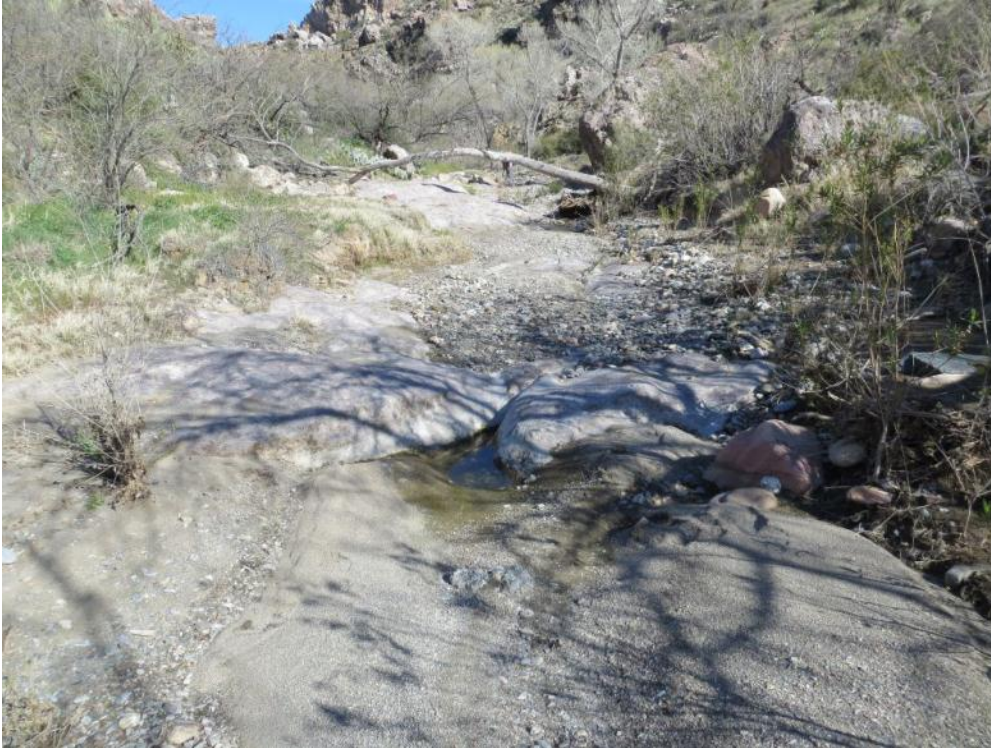
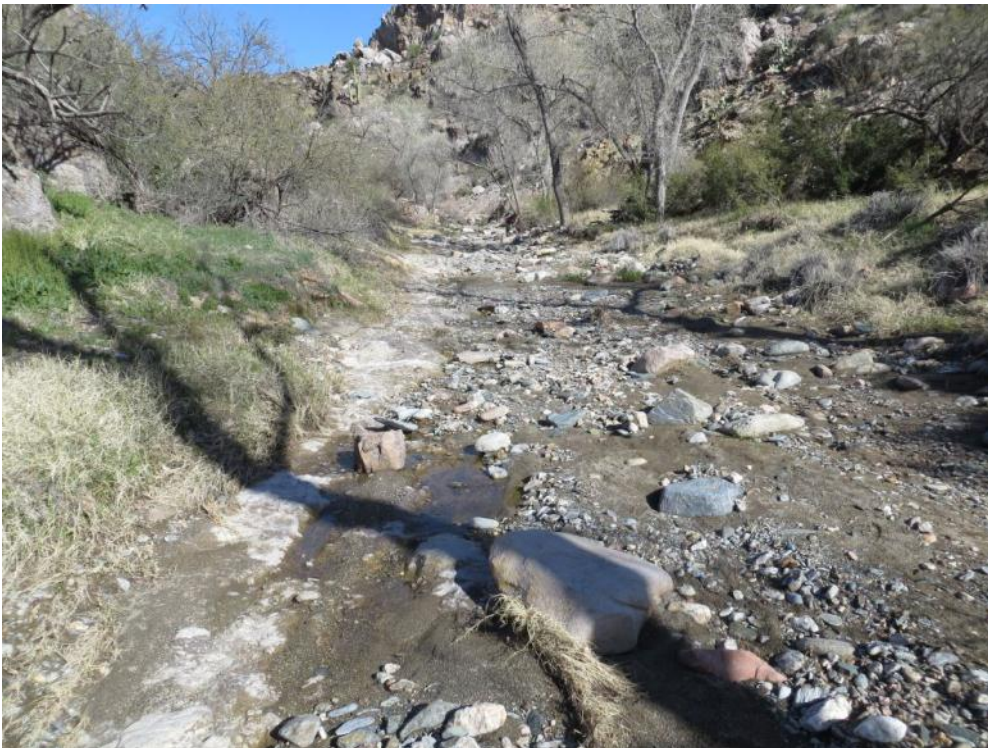
**PRL6**

Water ponding and moist sand at surface on rhyolite surface in channel invert. Trees growing in channel. Calcite staining on exposed rock surfaces.

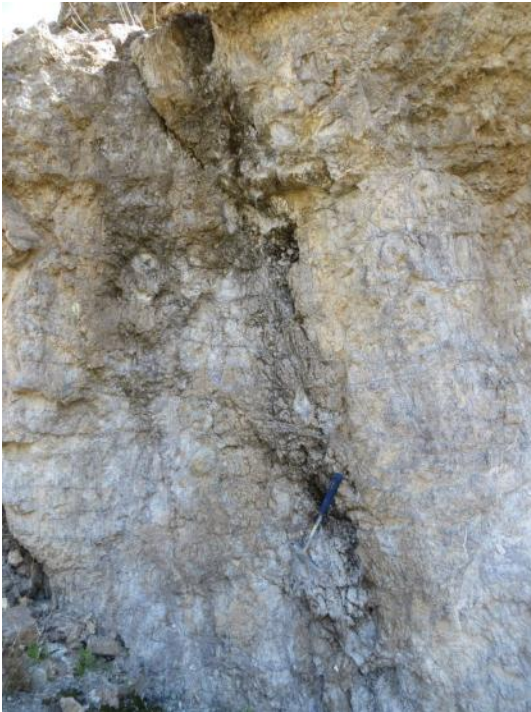
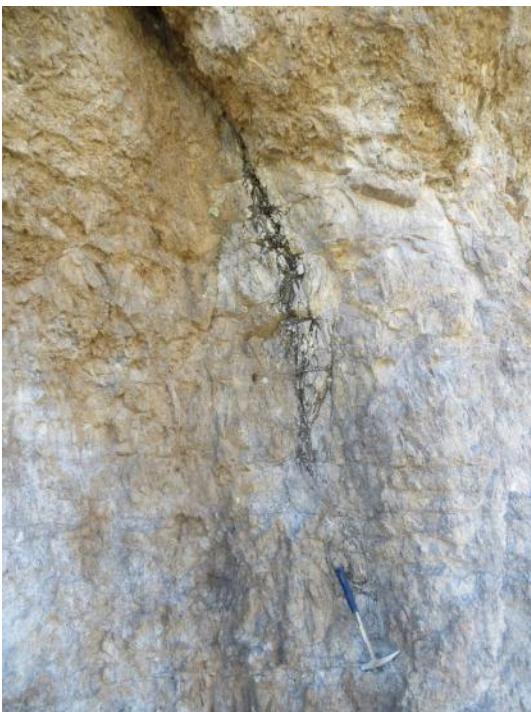
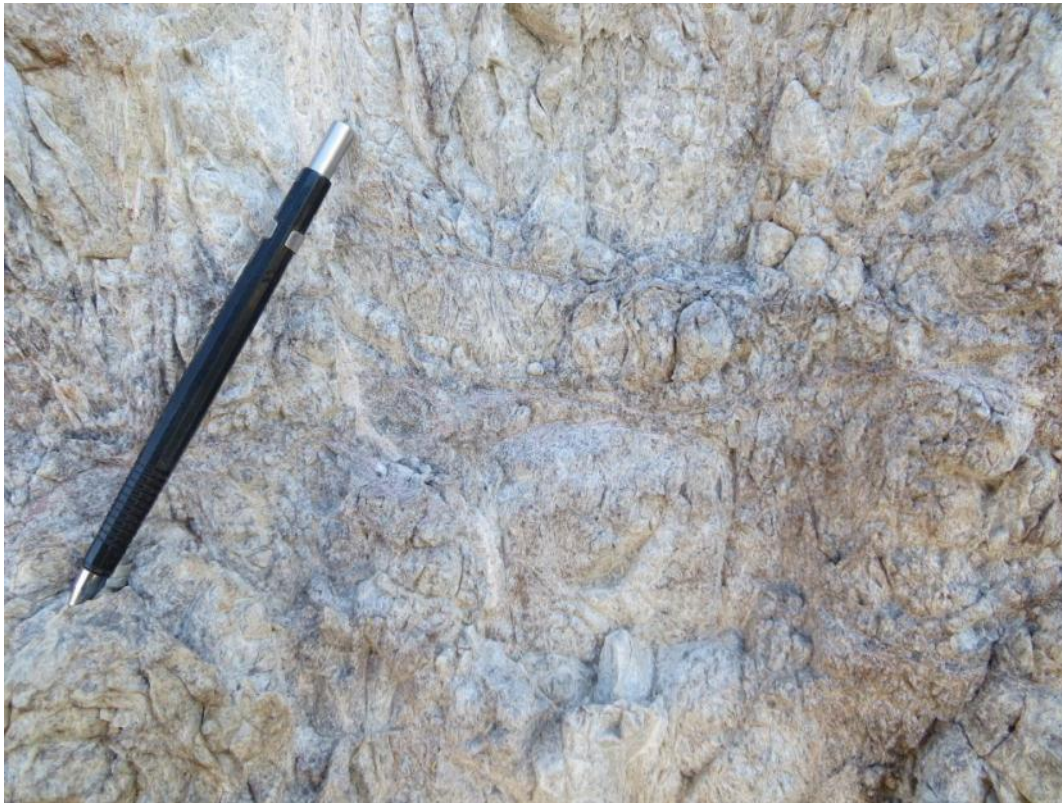
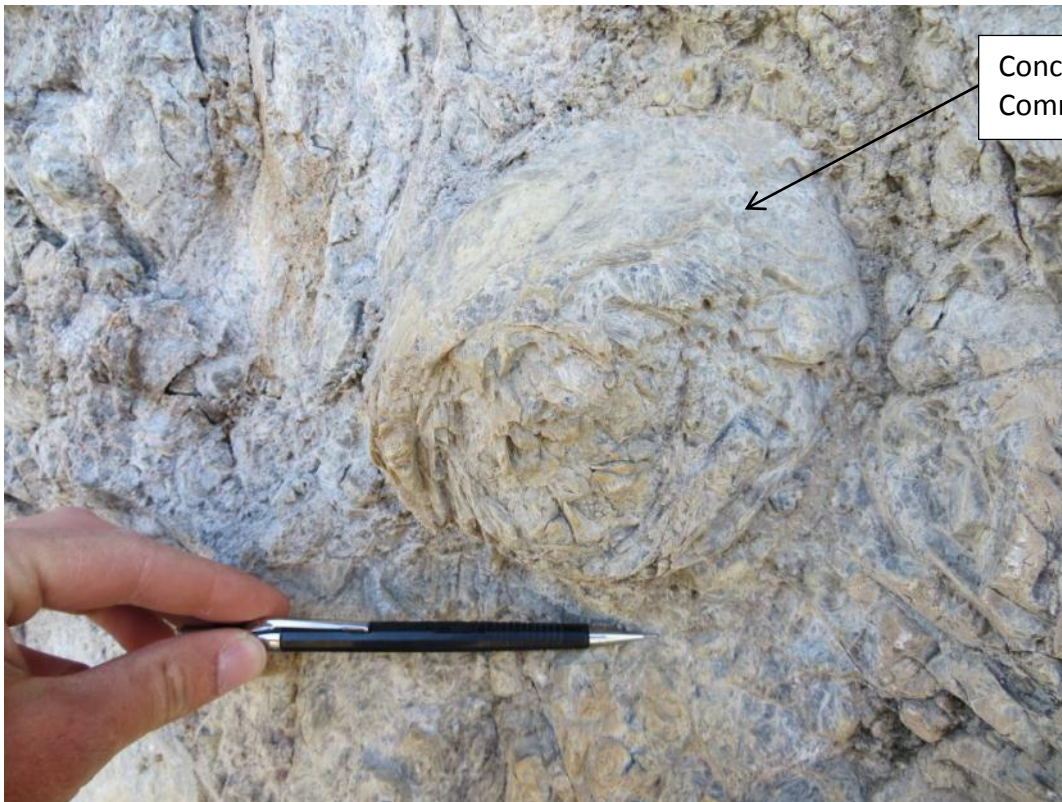
### PRL7

Vertical exposure of perlite. Heavily fractured/disturbed. Some sub-mm scale horizontal banding spaced 15 cm to 30 cm (*5.91 inches to 11.81 inches*) apart. Two vertical shear or fracture zones. Presence of a hardened and discoloured “crust” on the perlite surface. Fresh perlite is easily fractured with one light blow with hammer pick.

Concentric Fracturing  
Common in Glassy Perlite

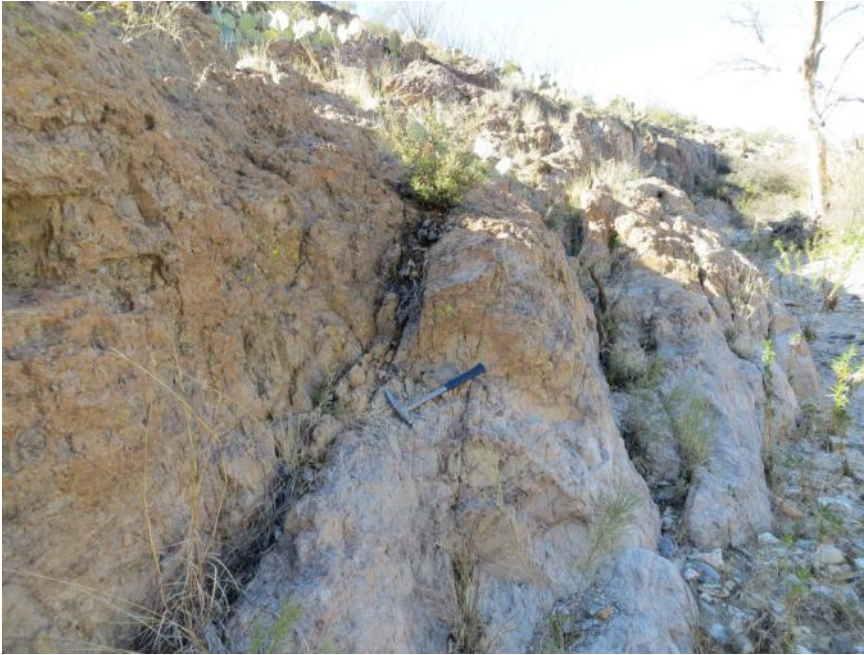
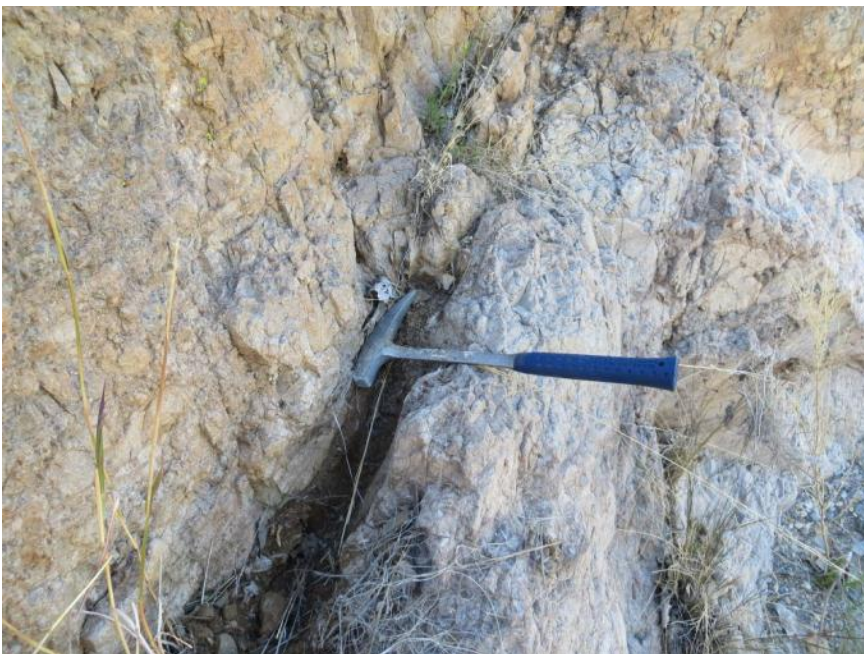
### PRL8

Exposure of brecciated rhyolite on left channel bank. R5, angular rhyolite clasts in rhyolitic groundmass with some perlite inclusions. Parallel vertical joints running ~parallel to exposure face, 20 cm to 60 cm (7.87 inches to 23.62 inch) spacing between joints, closed to very wide aperture (max. 10 cm (3.94 inches)) with silty sand and gravel infilling in widest joints.

Orientation of joints: **335/90**

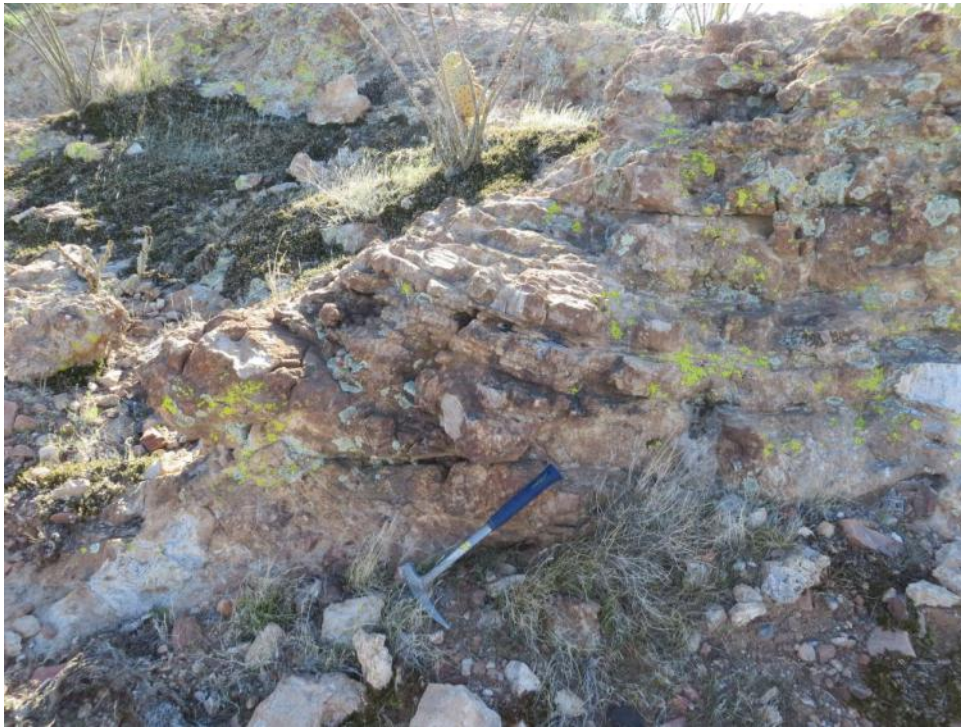
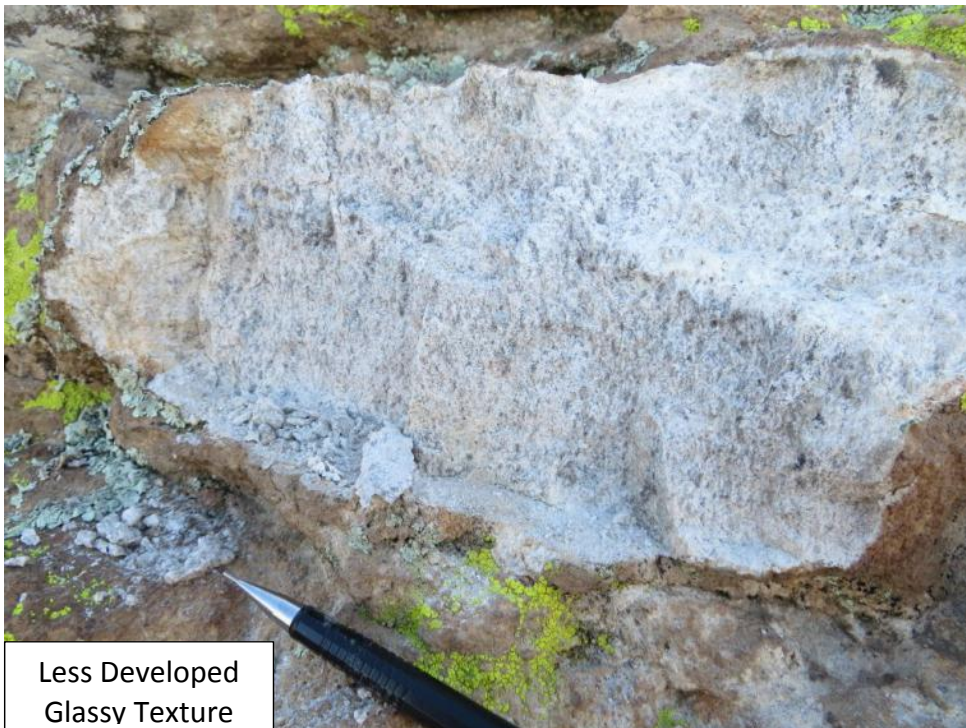
### PRL9

Perlite exposure near the top of a conglomerate (Tcg) capped hill. Harder than perlite observed at previous observation points (R4). “Glassy” texture is less developed and rock does not display the same degree of concentric fracturing. Some low angle closed parallel fractures.

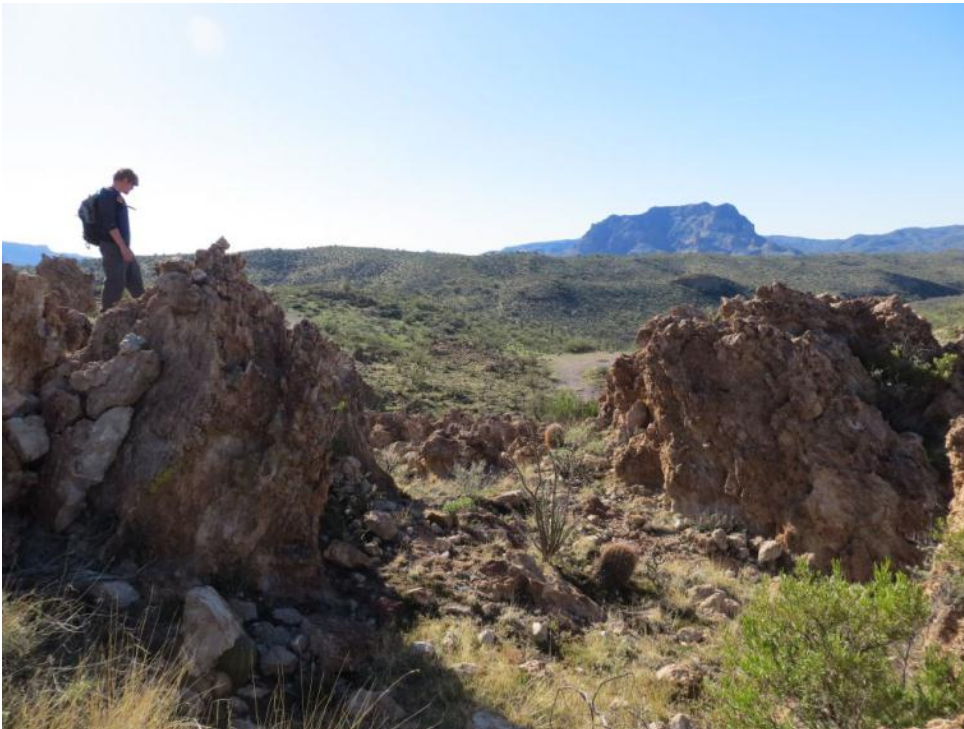
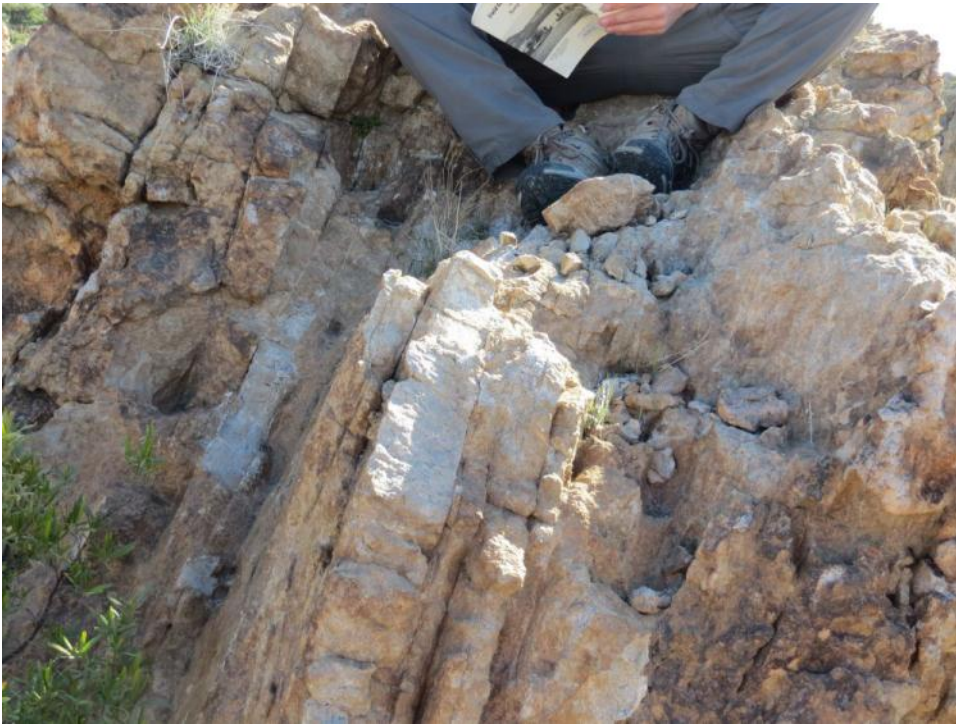
### PRL10

“Jagged” outcrops of perlite with parallel layers spaced <1 cm to 20 cm (*<0.39 inches to 7.87 inches*) apart. Typically closed. Layers interfaces are planar to stepped with a rough surface texture. R3 to R4 rock strength.

Orientation of layers: **256/63**

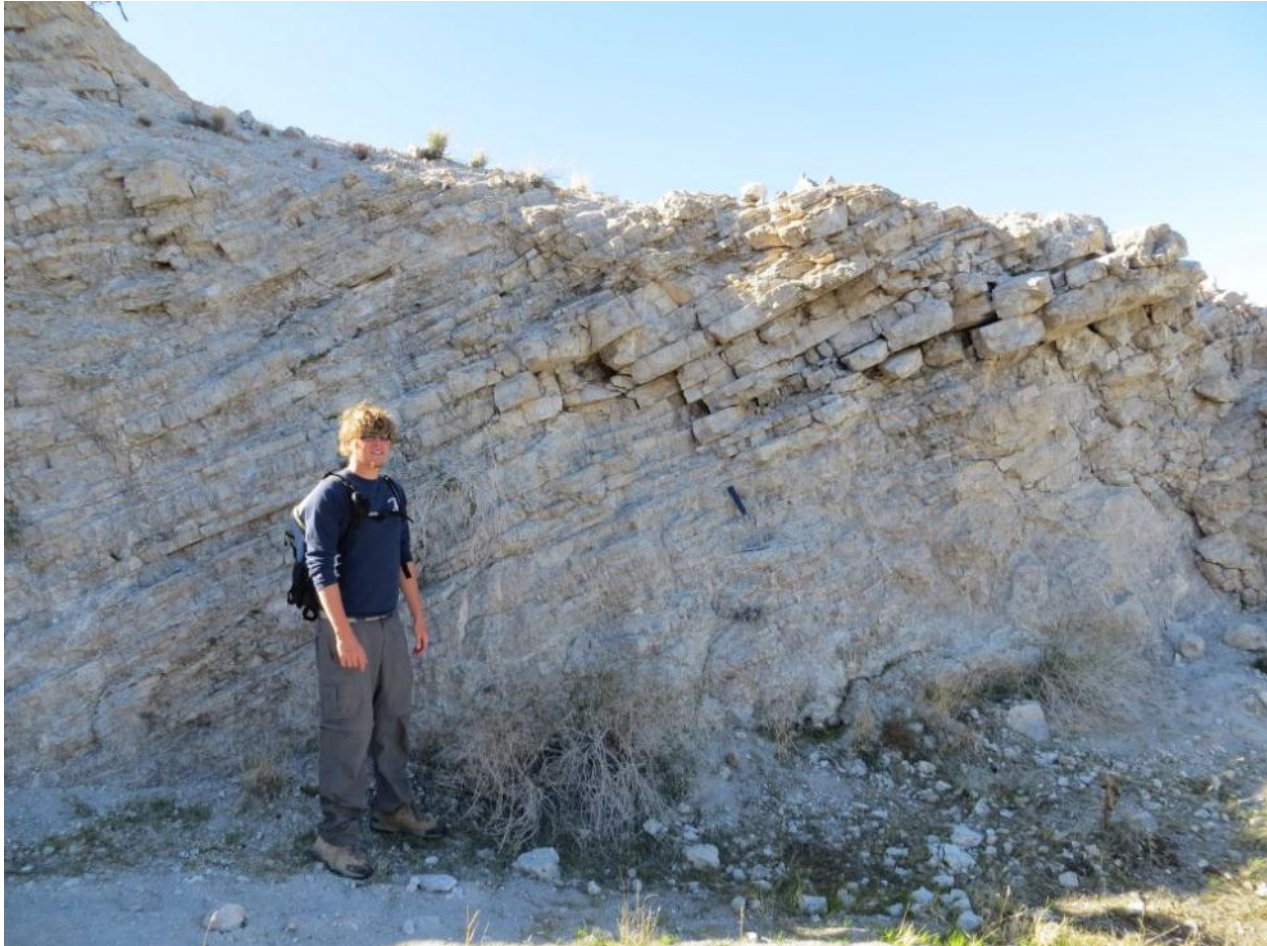
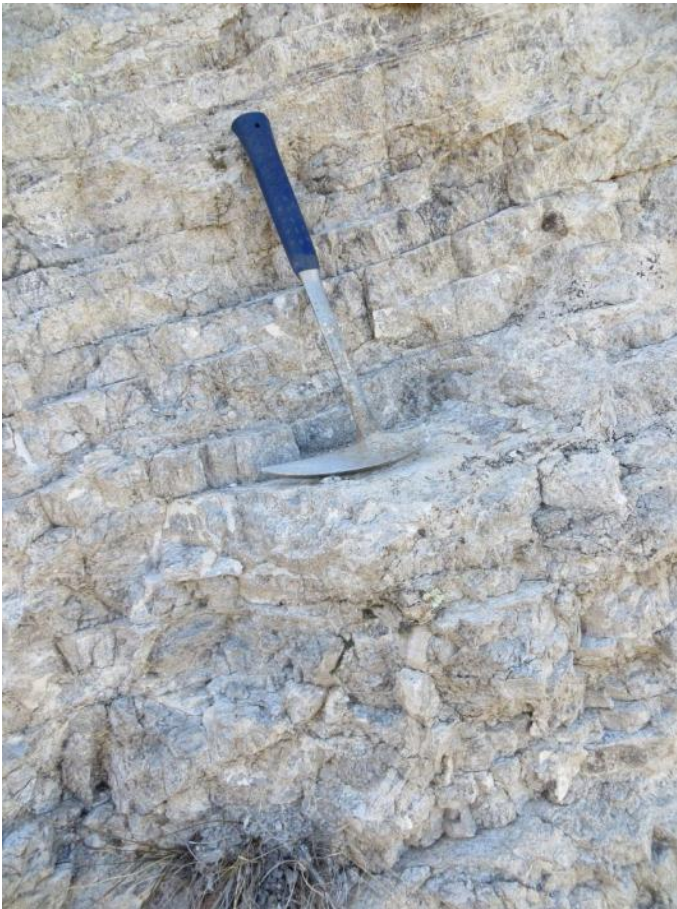
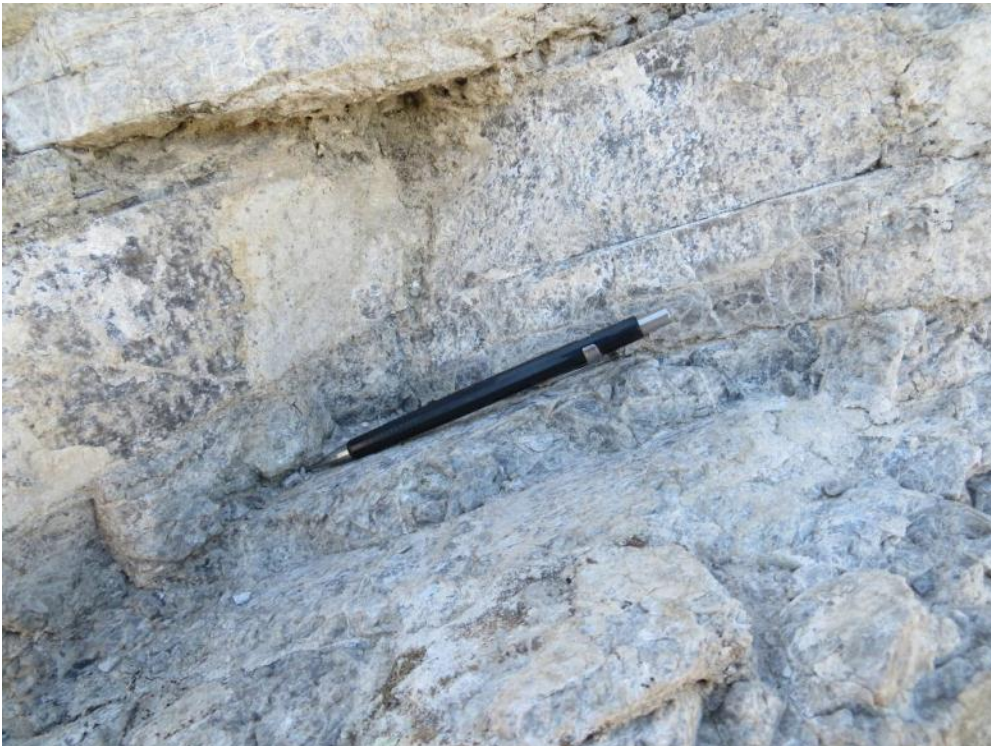
### PRL11

“Glassy” perlite exposed in quarry area. R3 strength with blunt end of hammer but noticeably weaker when struck with the point of pick. Strong parallel layering with closed interfaces between layers. Some exposed layer interfaces are smooth, glossy and planar. Average layer spacing = 5 cm (1.97 inches). Some other randomly orientated fracturing perpendicular to layer interfaces.

Orientation of parallel layers: **007/24**

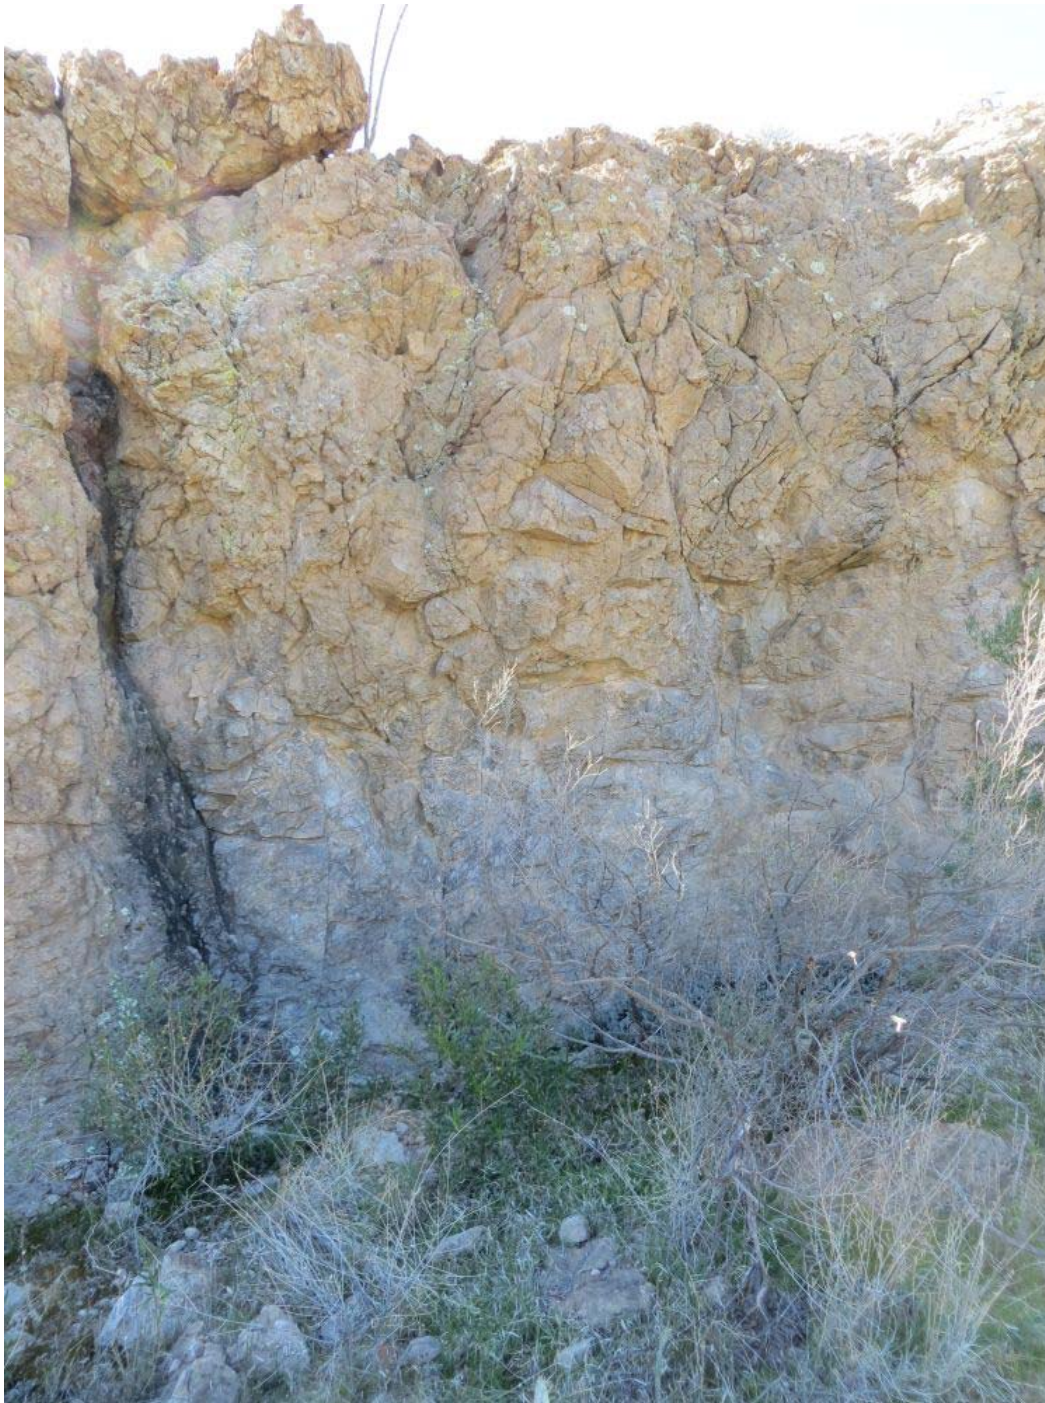
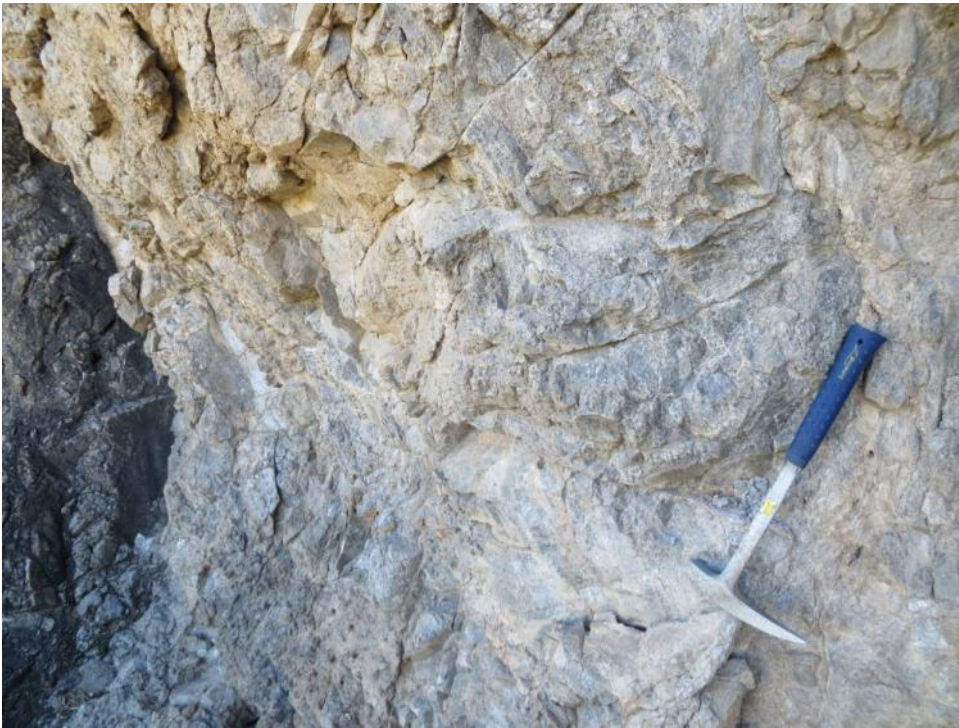
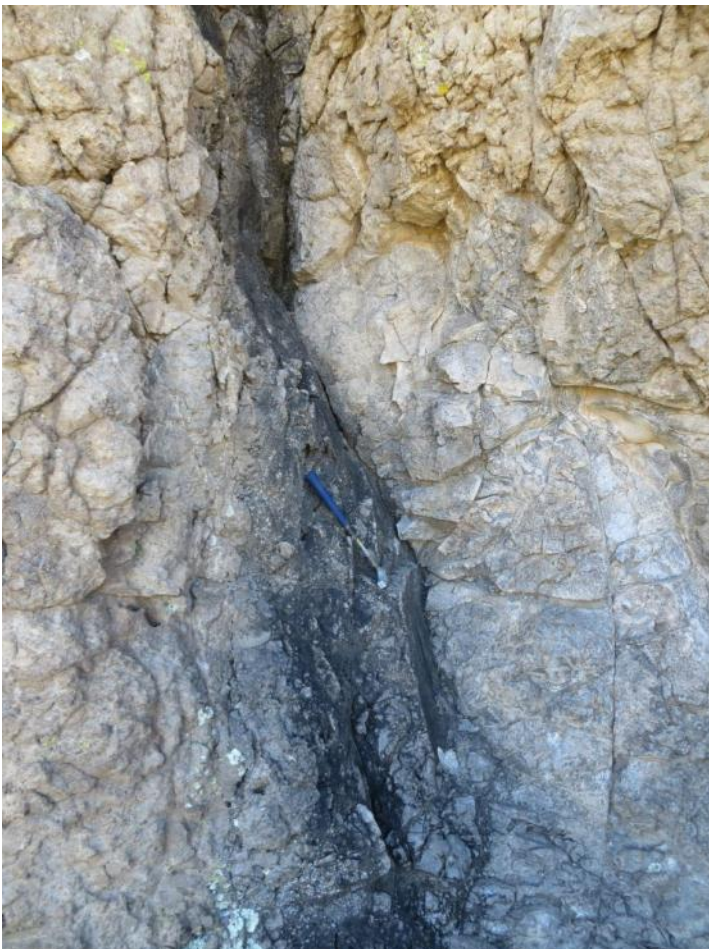
### PRL12

Vertical exposure of perlite. Disturbed rock mass with numerous randomly oriented fractures. Some vertical widely spaced (minimum 0.6 m (2.0 ft) spacing) joints extending through the full height of the exposure. R3 to R4 rock strength but weaker when struck with pick. Glassy cleavage surfaces – preferentially breaks along concentric planes. One large vertical fracture with discoloration; closed.

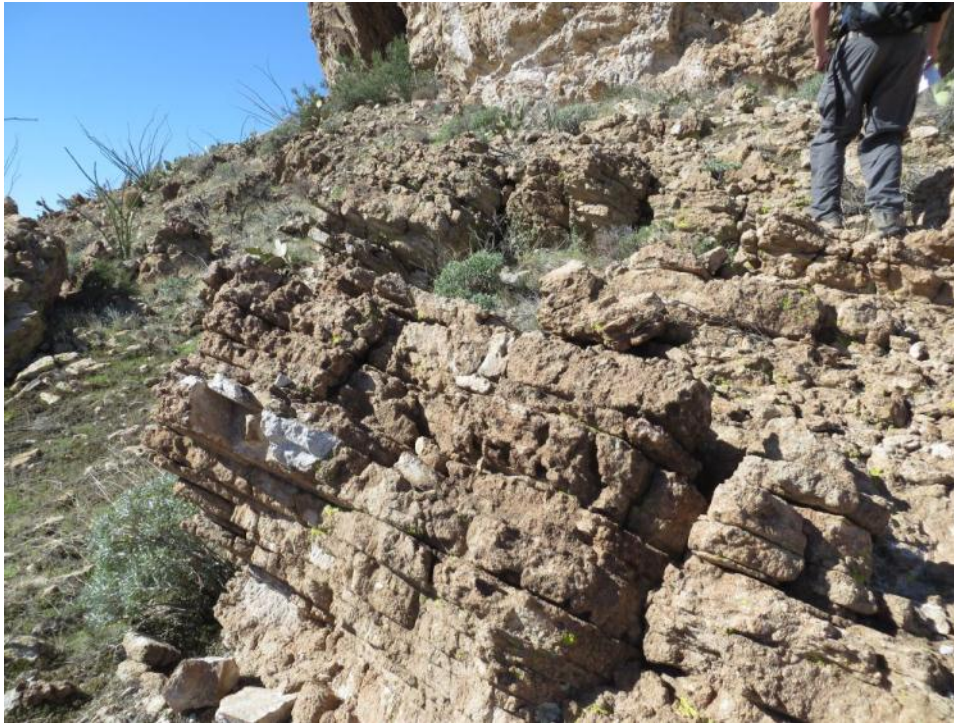
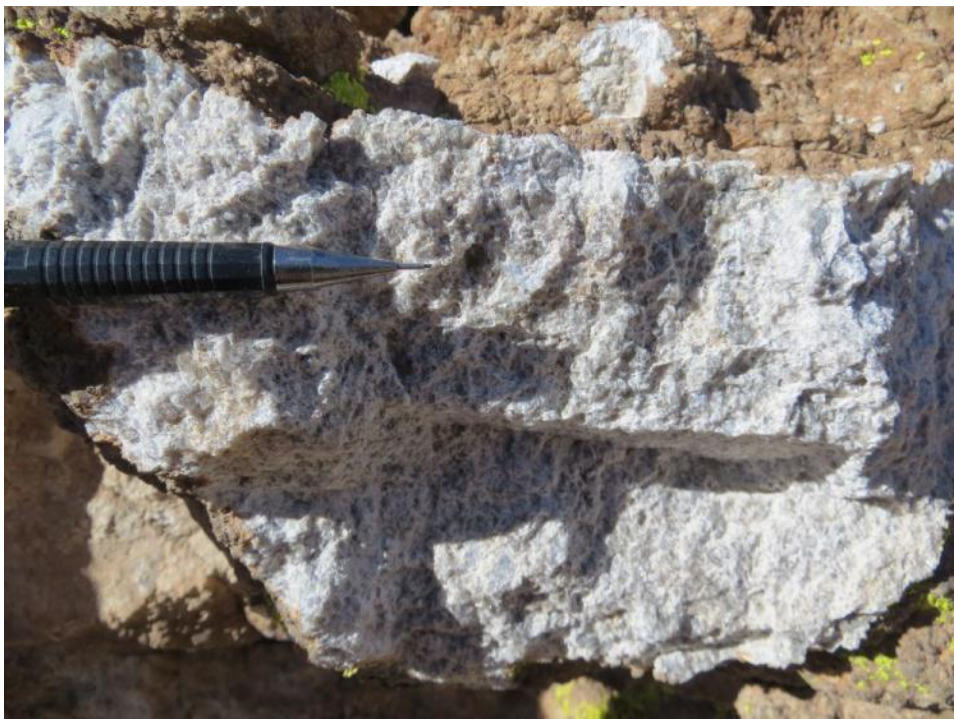
**PRL13**

Outcrop of perlite with parallel “layers”. Similar properties to the material seen at PRL9. R3 to R4 strength with relatively small glass “grains”.

Orientation of “layers”: **188/37**

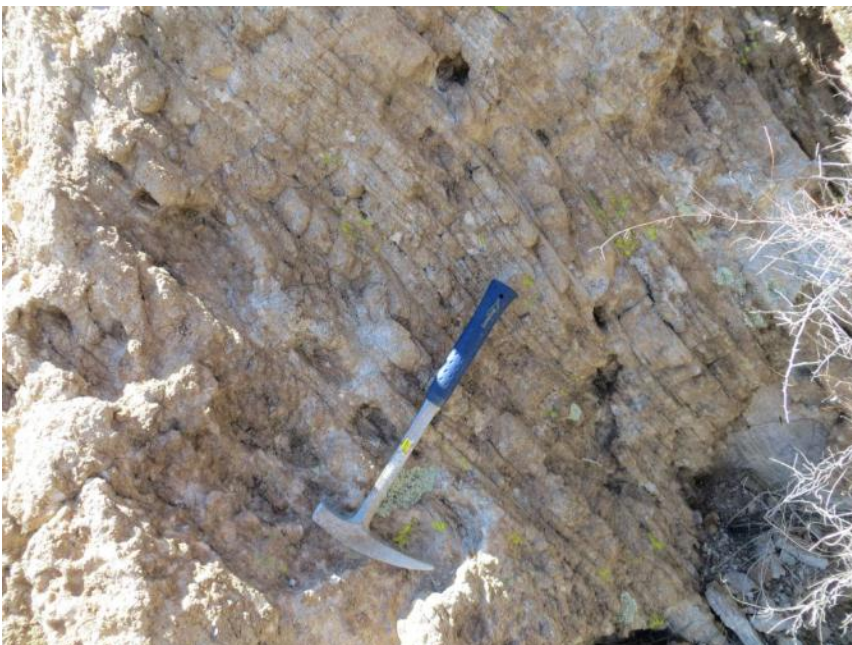
**PRL14**

Parallel jointing in perlite outcrop. Joint spacing 0.5 cm up to 10 cm (*0.20 inches to 3.94 inches*), planar exposed joint surfaces, closed. Rock strength R3 to R4.

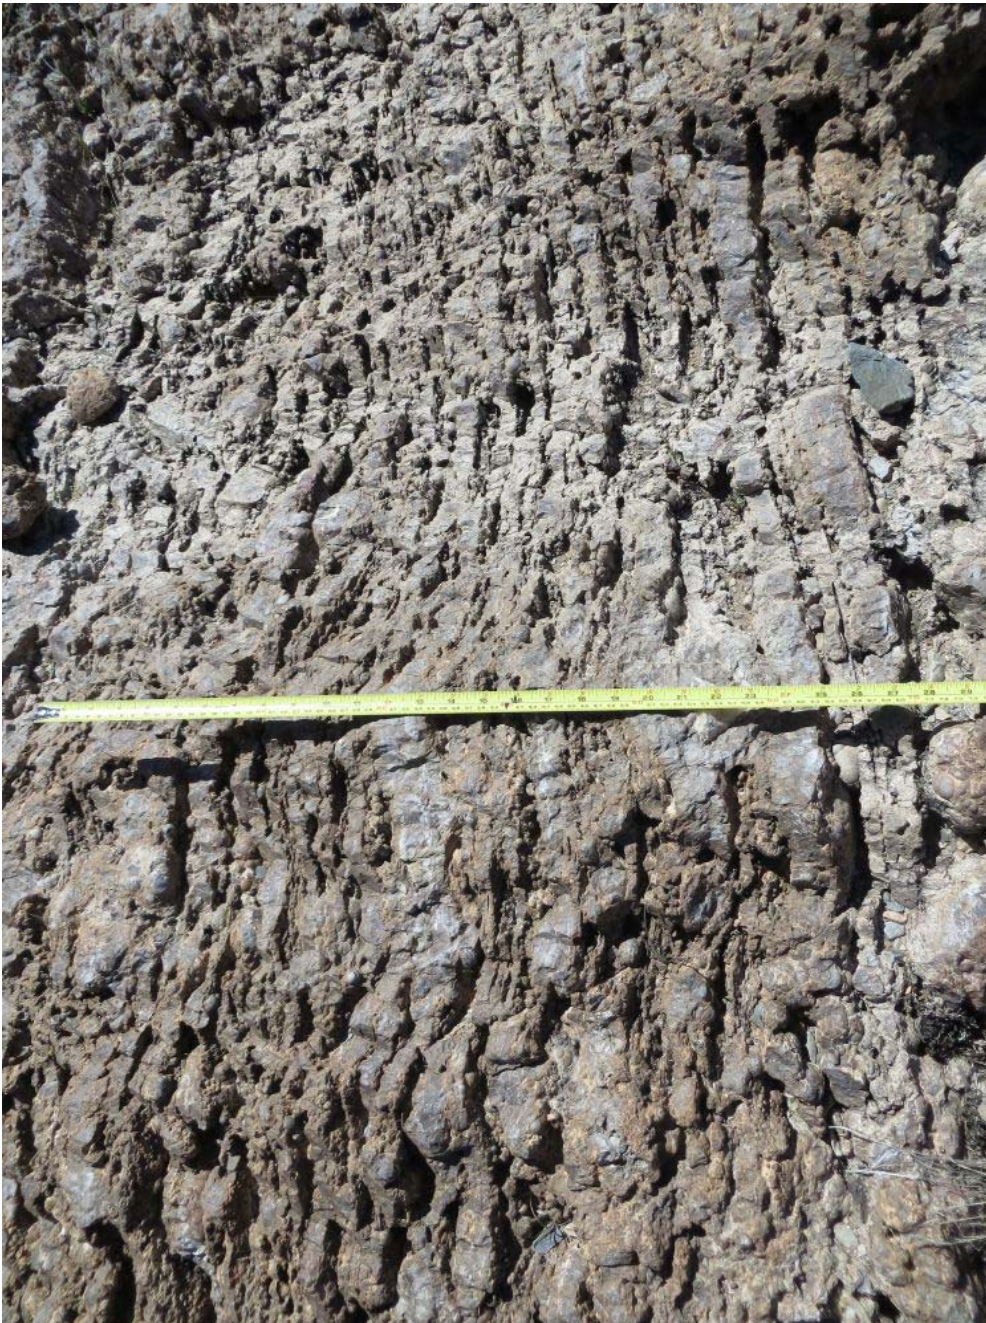
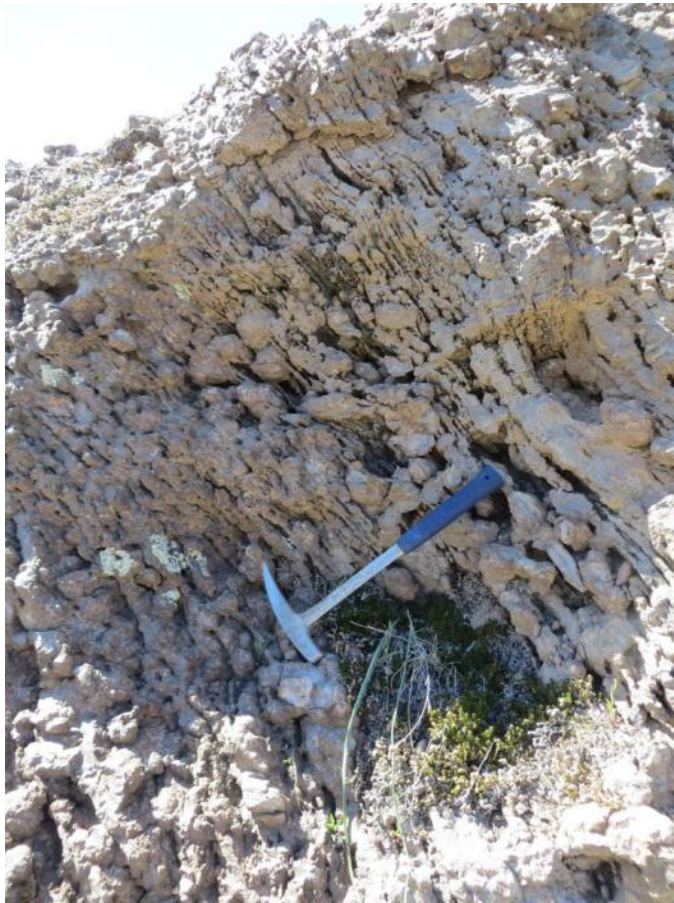
### PRL15

Outcrop of rhyolite in left bank of creek channel. Fresh R5 to R6, parallel gently folded “banding” with irregularly shaped voids between bands. Mean spacing between bands is 1 cm to 2 cm (*0.39 inches to 0.79 inches*), void space between bands is variable but can be as wide as 2 cm (*0.79 inches*), penetration of voids into the rock mass appears to be shallow (voids close off at depth). Spherical chalcedony geodes common throughout. Trace “inclusions” of glassy perlite. Based on subsequent observations (**see PRL26**) void space between rhyolite bands is likely caused by differential erosion of previously existing perlite bands.
