## APPENDIX I-E

### Traverse #5

PROJECT  
RESOLUTION PROJECT  
2013 NEAR WEST SITE INVESTIGATION

TITLE  
CREEK TRAVERSE #5

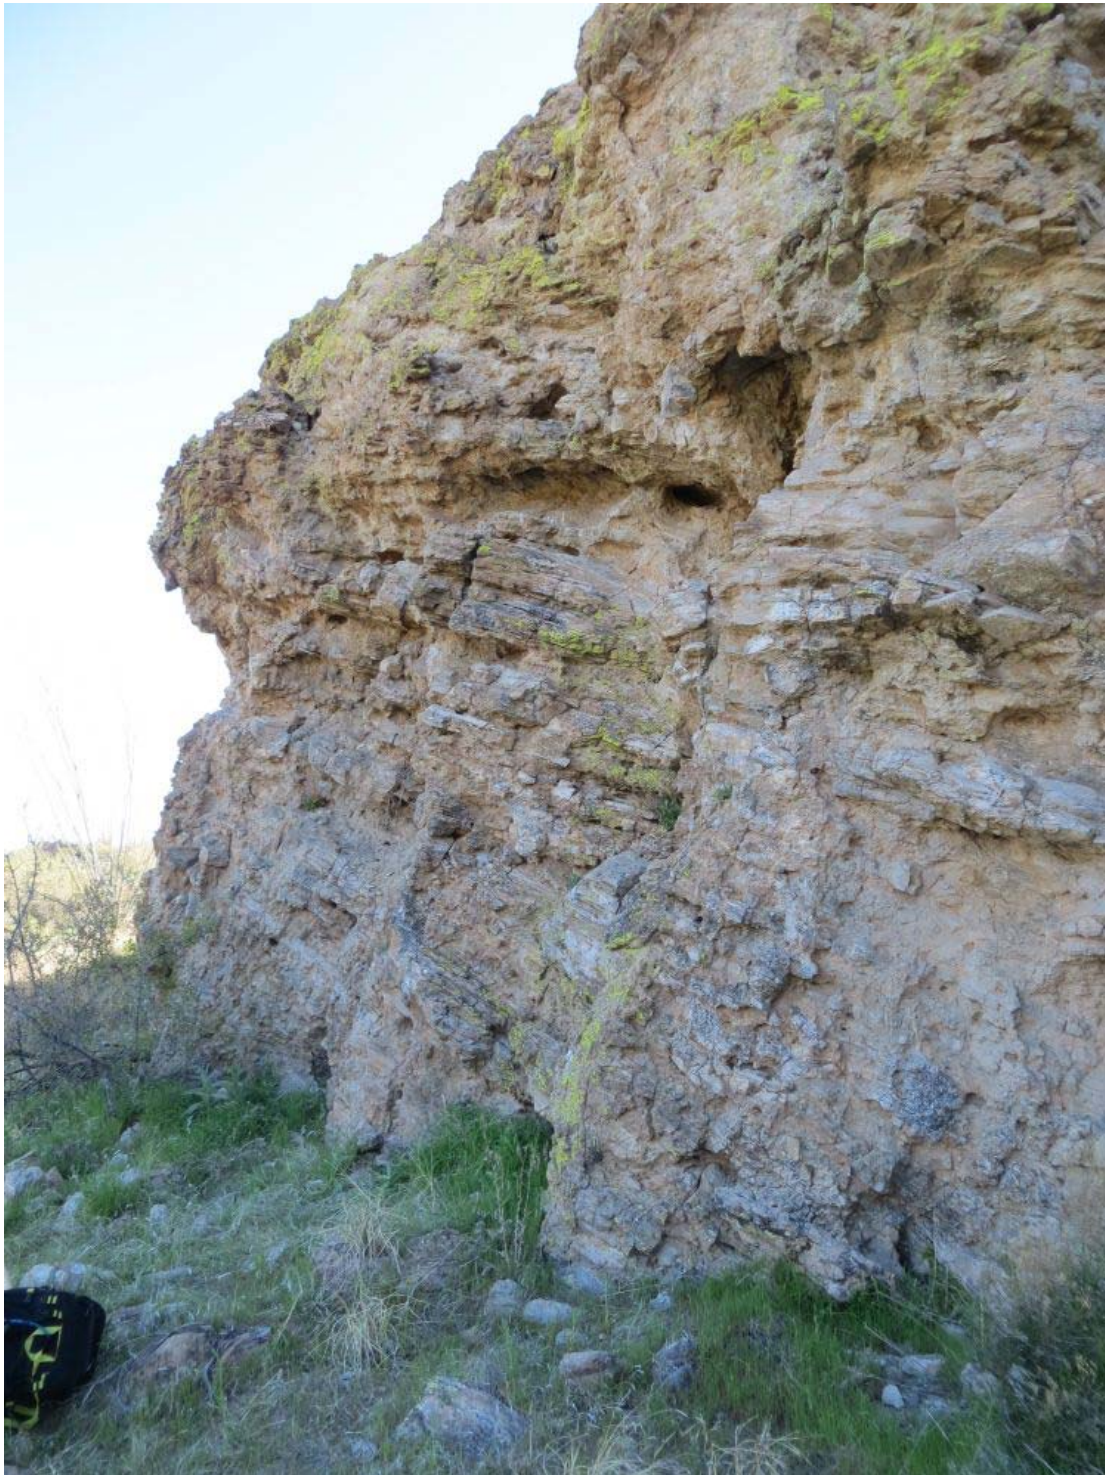
### PRL17

Perlite with areas of brecciation. Perlite, R3 to R4, “banded” with light grey and dark grey laminations, differential weathering of some bands, massive, some areas of the exposure have a brecciated appearance with clasts of banded perlite in massive perlite matrix.

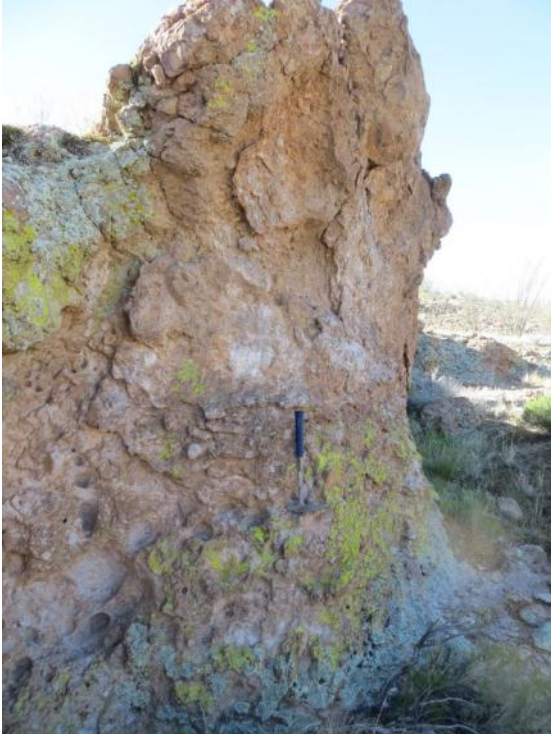
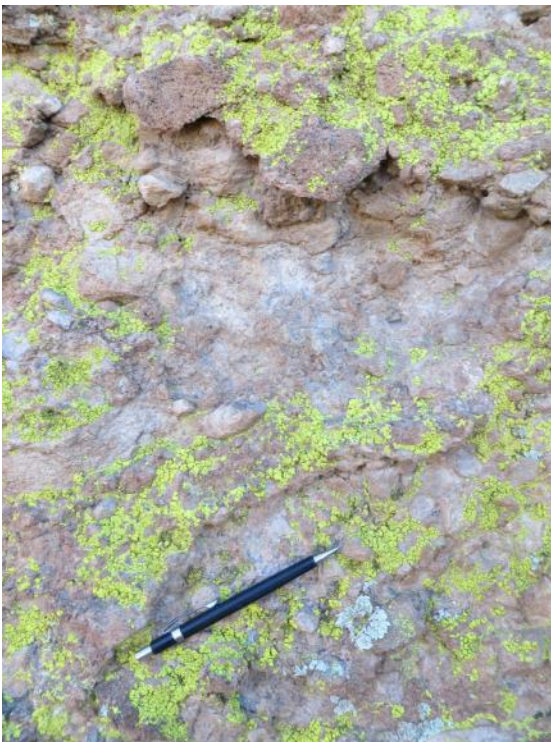
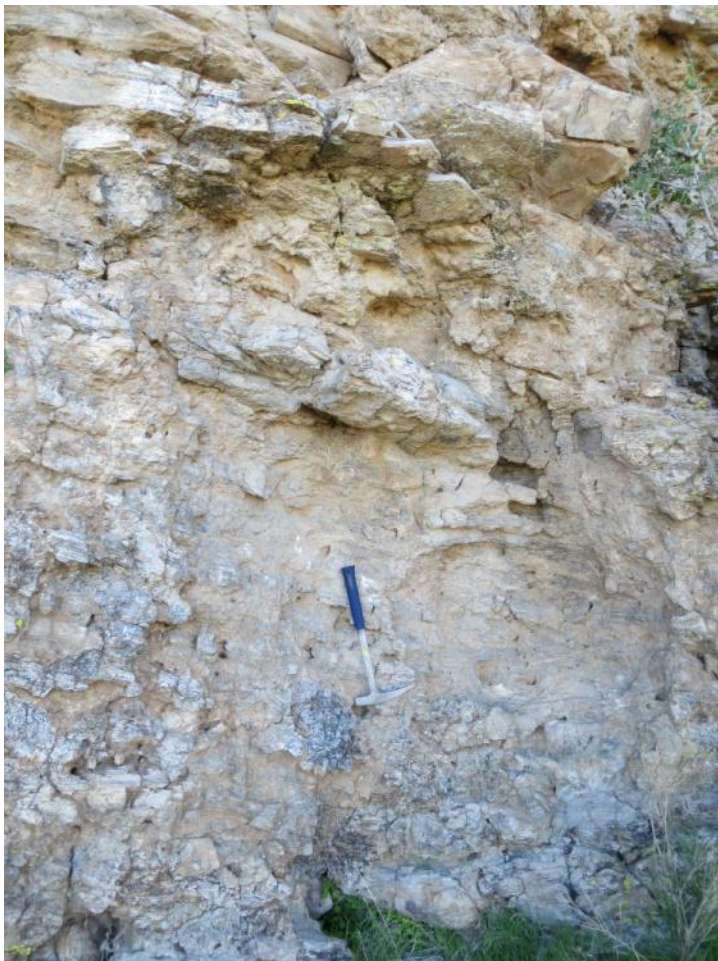
**PRL18**

Jagged surface outcrops of perlite tuff. Fresh, R3 to R4 (with intact “crust”), gravel sized clasts of grey perlite in fine grained porous pink felsic matrix, massive.

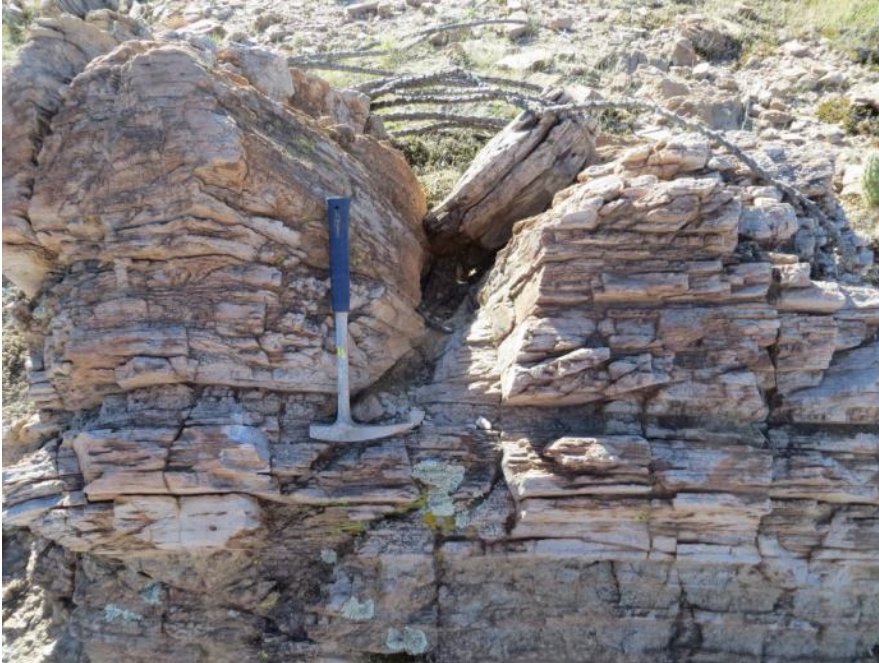
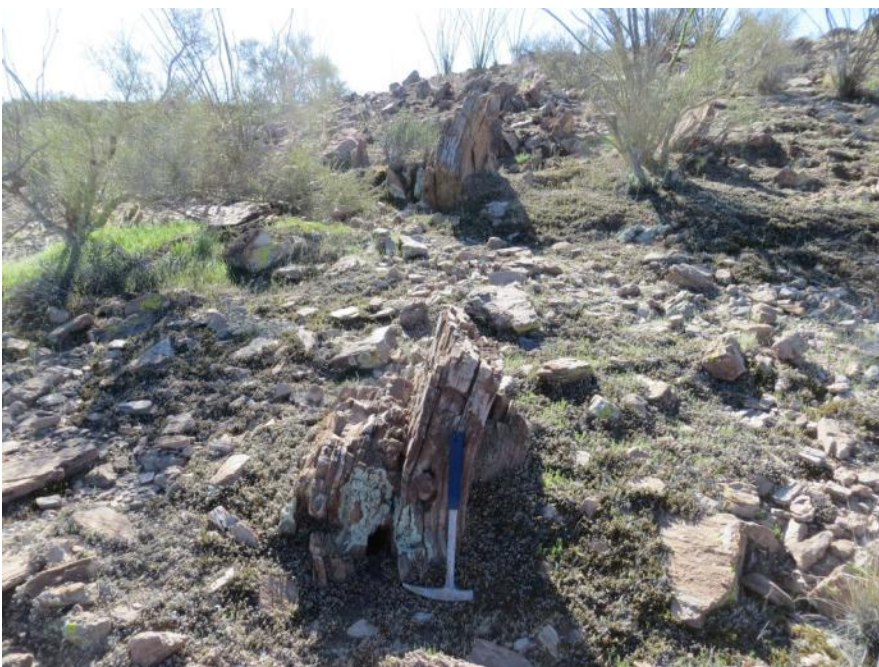
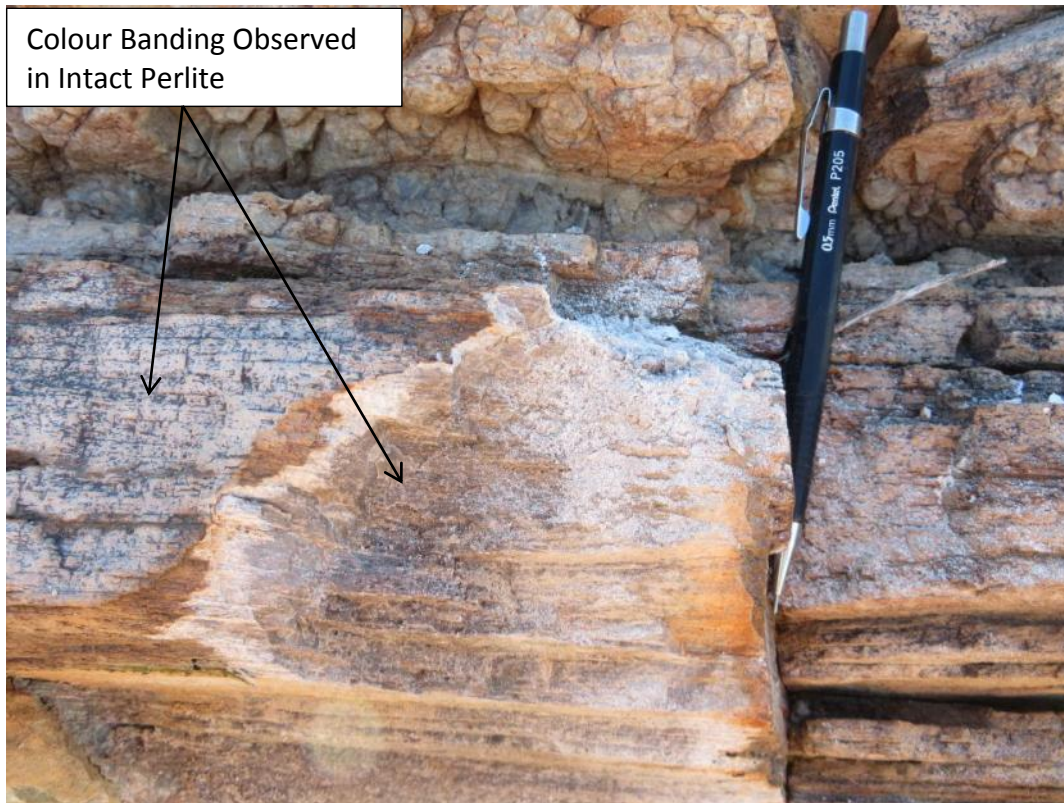
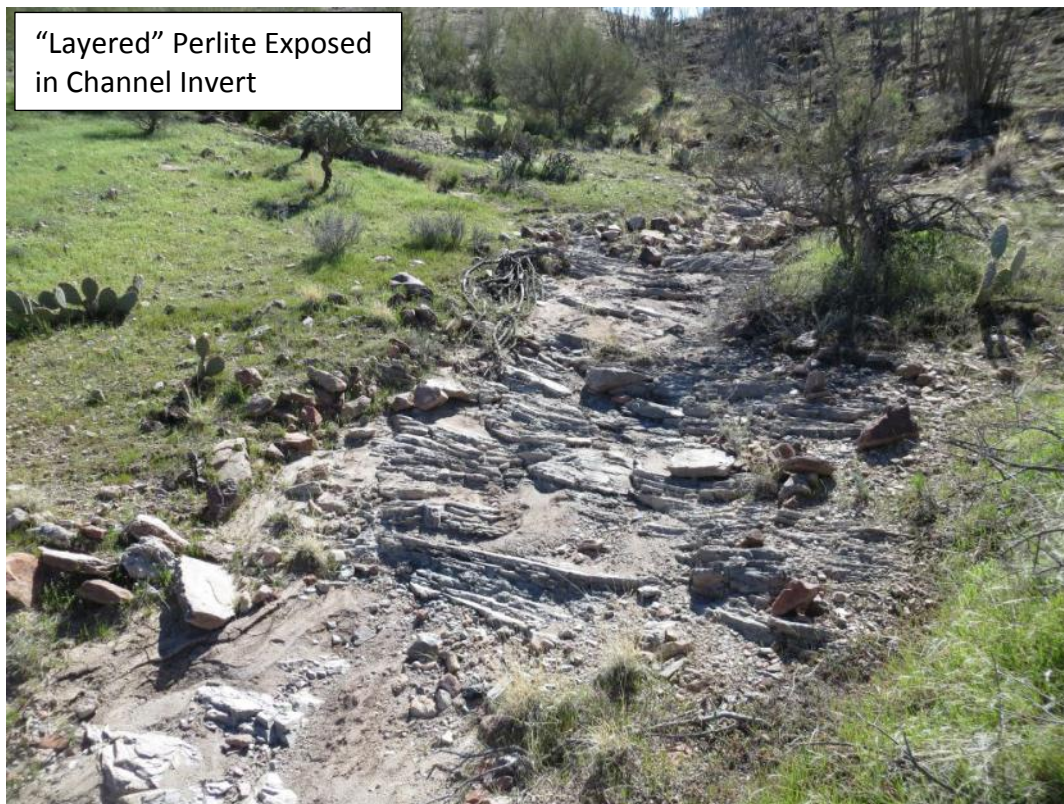
**PRL19**

Tilted “blocks” of perlite showing strong parallel layering. Fresh, R3, layer spacing from mm scale to 1 cm (*0.40 inches*), spacing between parallel color banding seen on fresh perlite surfaces is < 1 mm (*0.04 inches*), some closed fractures perpendicular to layers.

Orientation of perlite layers:               **070/28** (on side of hill)  
                                                         **033/31**(in channel invert)

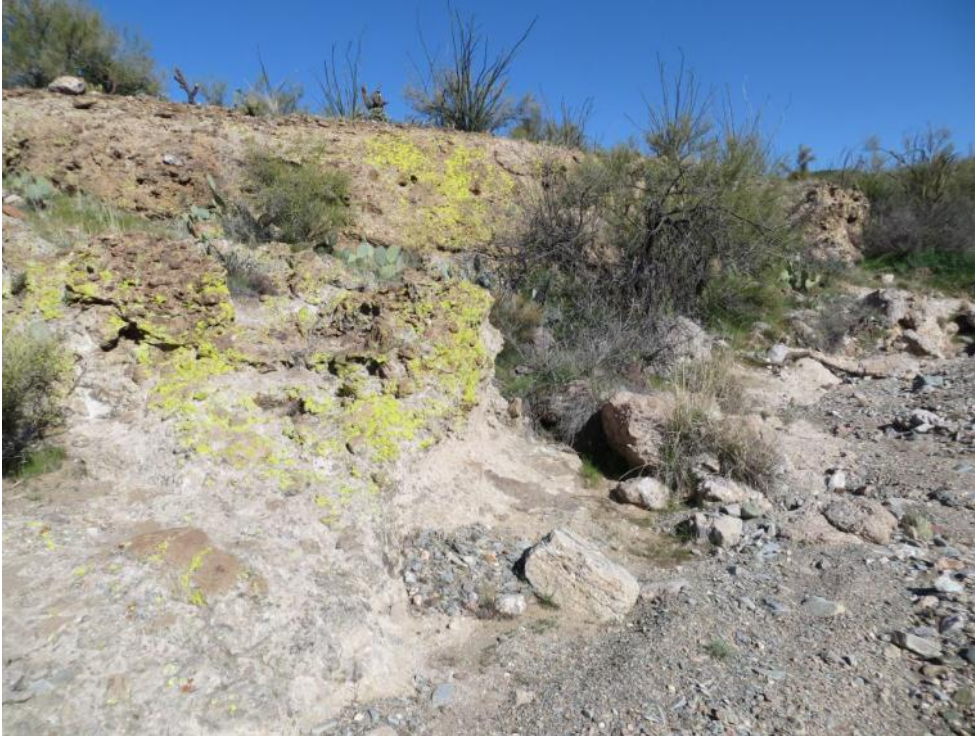
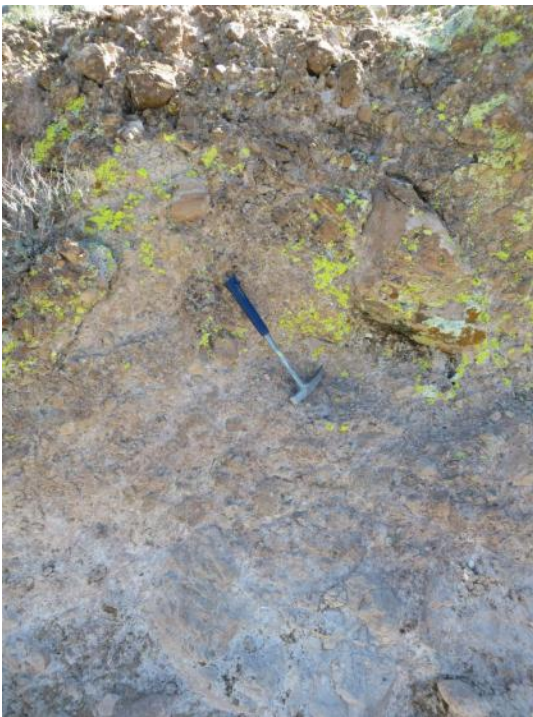
**PRL20**

Exposure of perlite “tuff” in channel invert and banks. Gravel to cobble sized angular perlite clasts floating in fine grained pink felsic matrix, R3 to R4, massive.

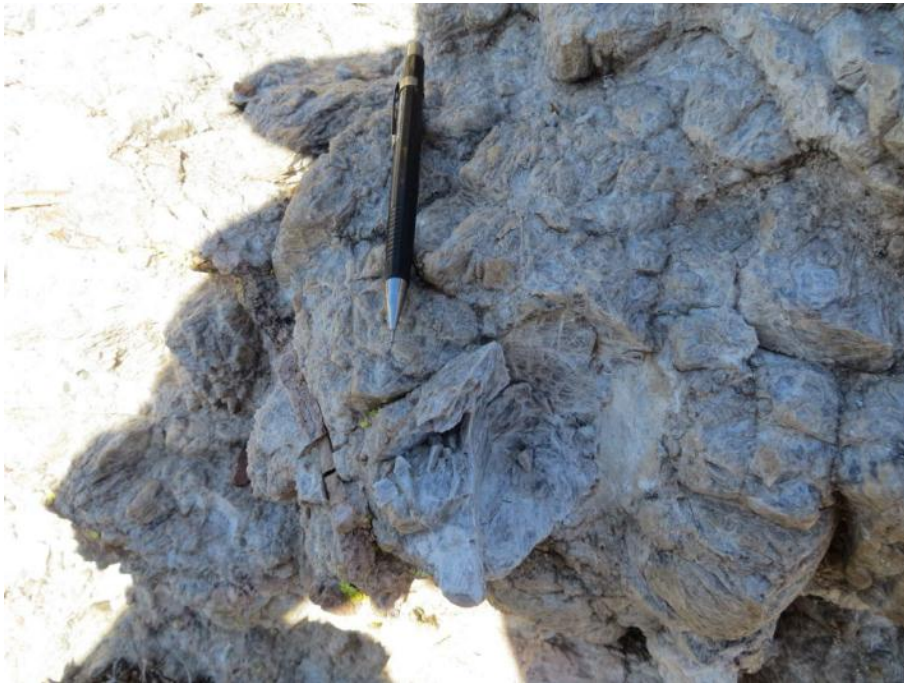
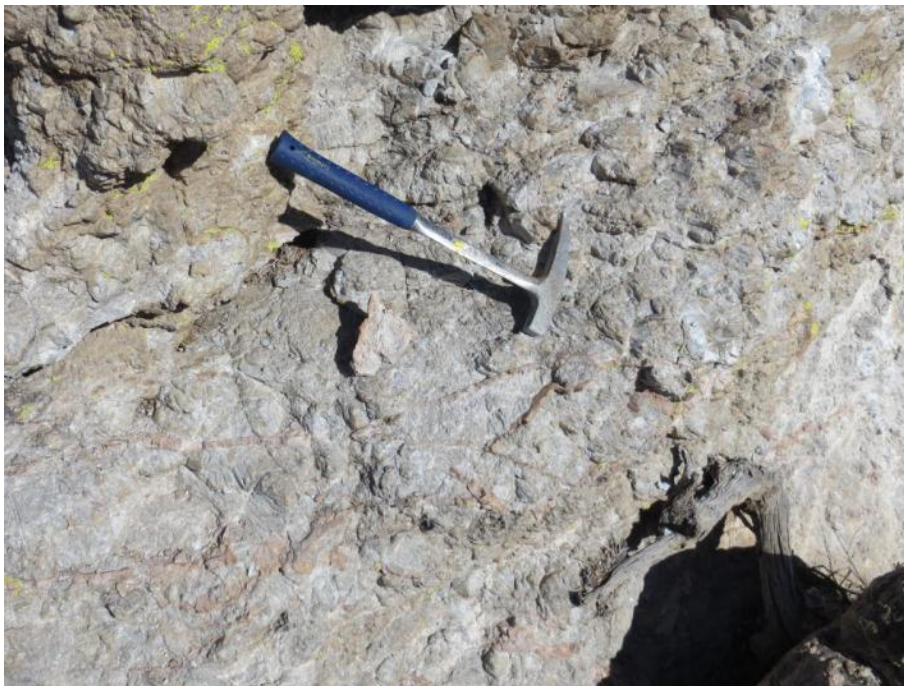
### PRL21

Rock exposures become perlite with well developed “glassy” texture moving upstream out of tuff. Fresh, R3 (weaker when struck with pick of hammer), fractures along irregular glassy surfaces, massive with no joints visible, cross cut by some pink felsic “bands”.

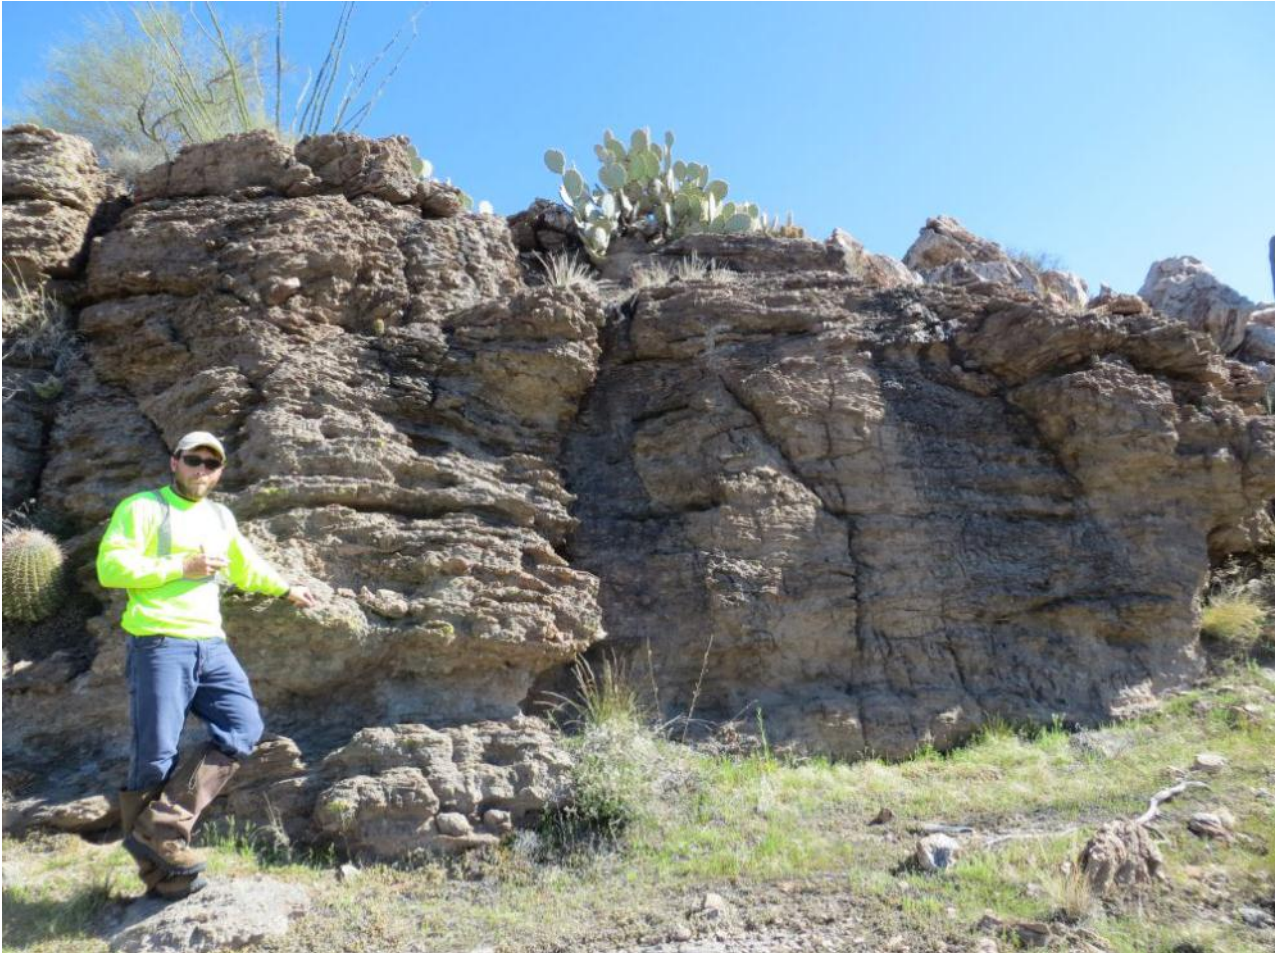
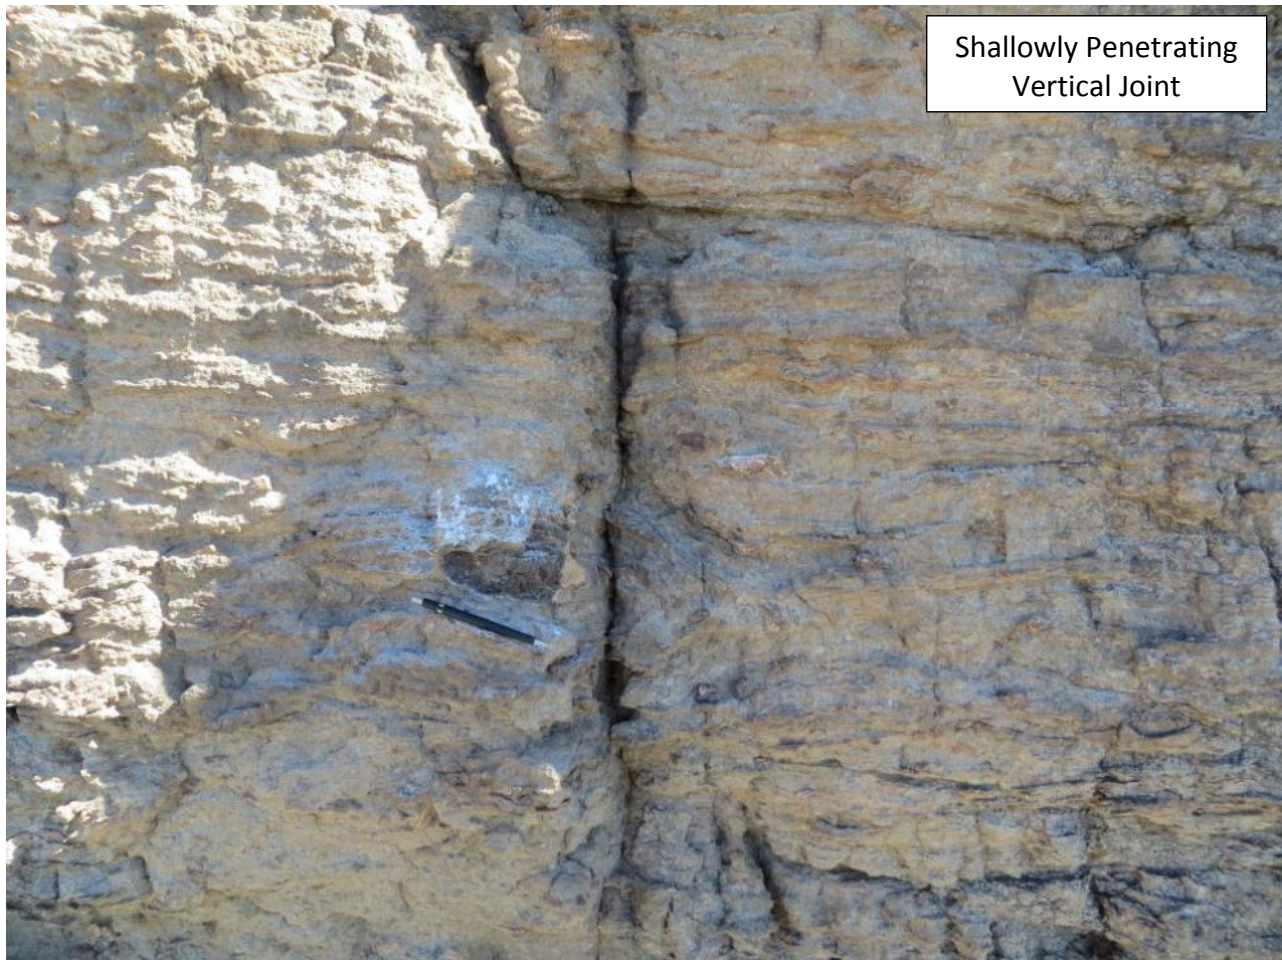
### PRL22

Outcrop of sub-horizontally banded perlite. Perlite and pink microcrystalline bands of silica, differential weathering of glassy perlite bands, three vertical cracks in the exposure close off right below surface, massive.

Shallowly Penetrating  
Vertical Joint

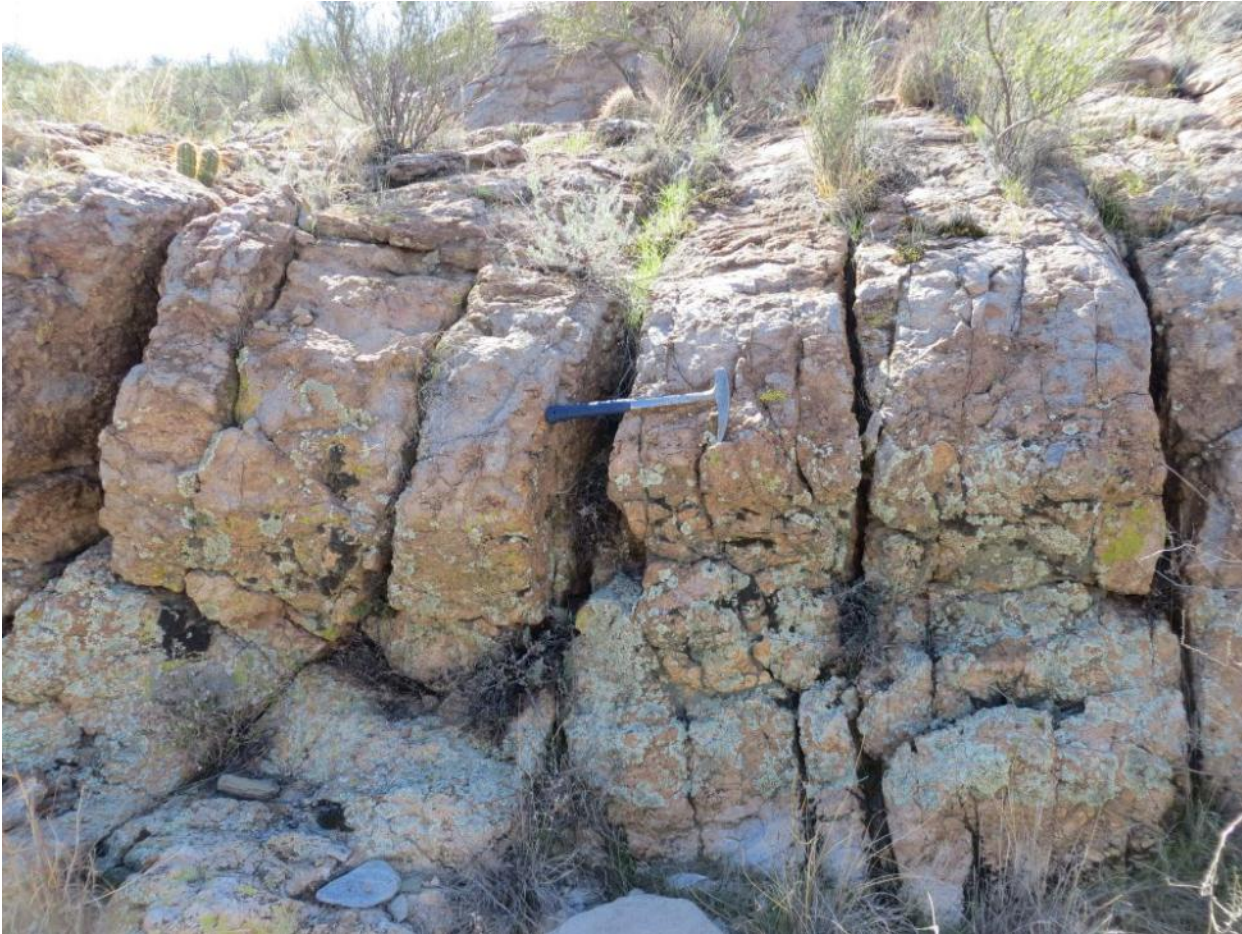
### PRL23

Perlite and rhyolite exposure. Fresh, R4 to R5, pink silica with perlite, “glassy” texture in perlite not well developed, joint spacing = 30 cm (*11.81 inches*), sub-vertical, wide range of joint aperture at surface from closed to ~ 20 cm (*7.87 inches*), maximum depth of measured joint penetration into outcrop = 100 cm (*39.37 inches*), stepped and rough joint surfaces, silty sand or no infill.

Orientation of joint set: 187/90

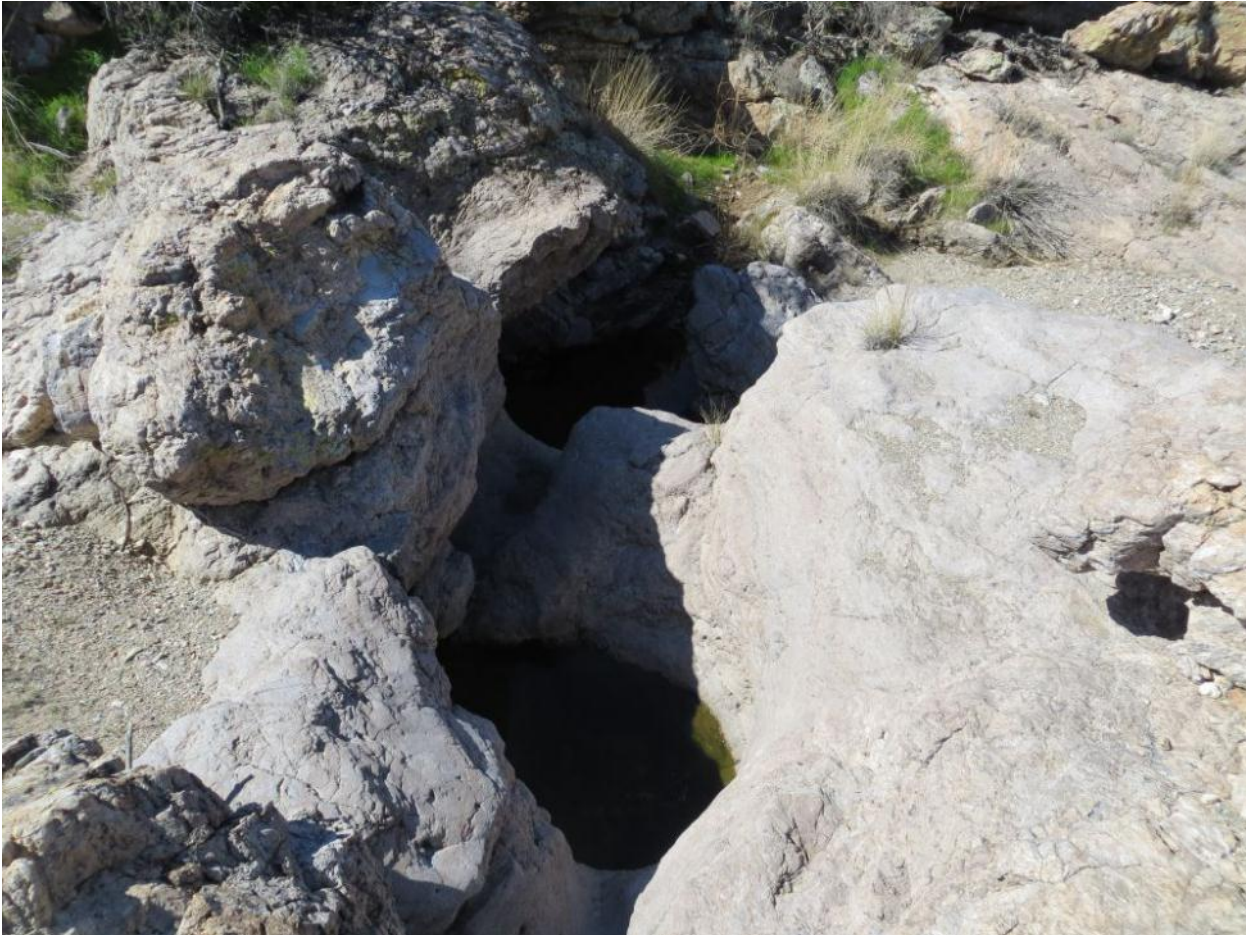
**PRL25**

Jagged outcrops of perlite. Fresh, R3, strong sub-horizontal parallel layering (banding) with evidence of folding, banding spaced at mm scale, differential weathering between bands, some hard grey siliceous bands, few vertical closed fractures.

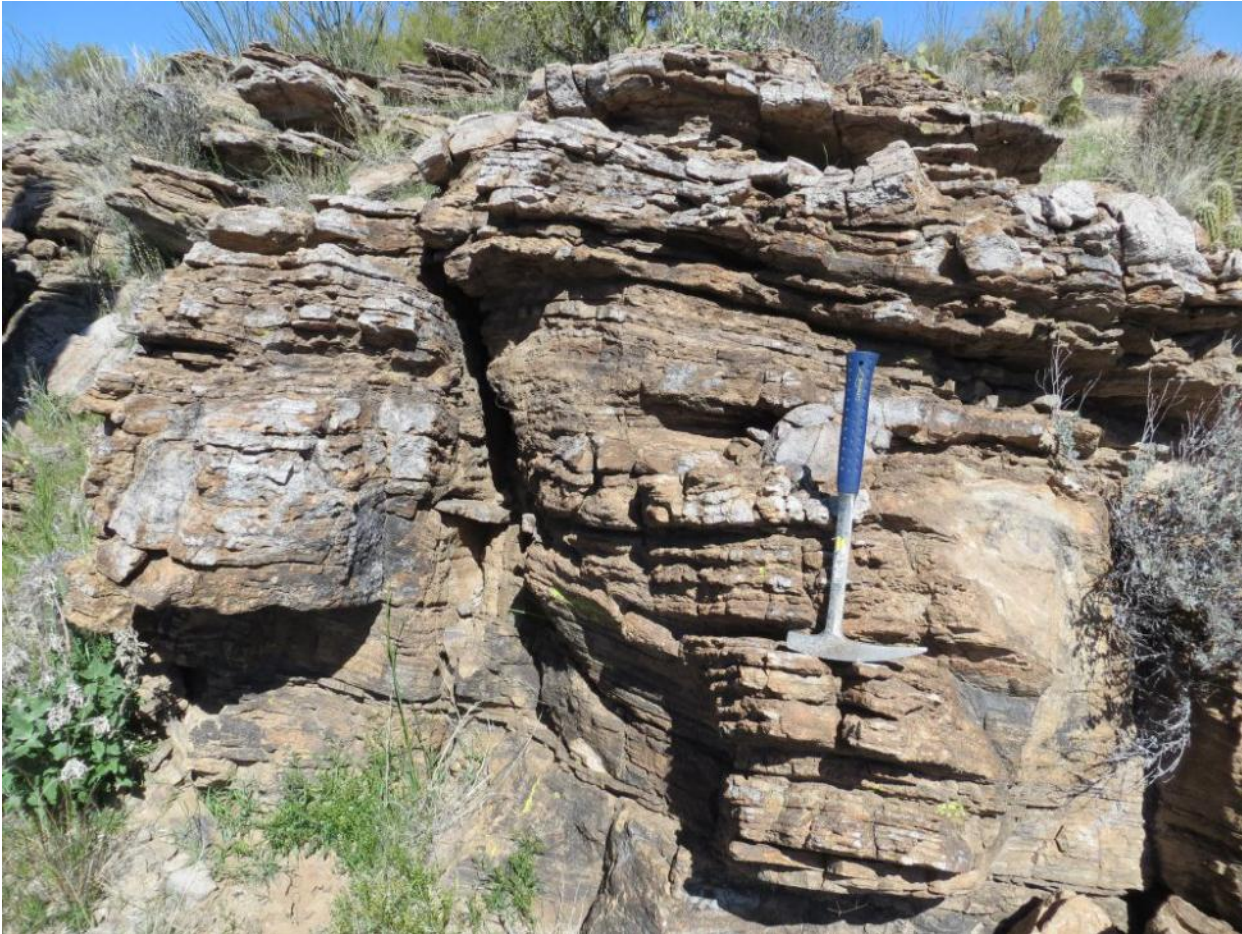
### PRL26

Banded perlite and pinkish grey silica with silica geodes (thunder eggs), silica bands much more weathering resistant. Fresh, R3 to R4, poorly developed “glassy” texture in perlite, some closed vertical cracks cutting across height of the outcrop, rock near the top of the outcrop displays vertical jointing but they close off at depth.

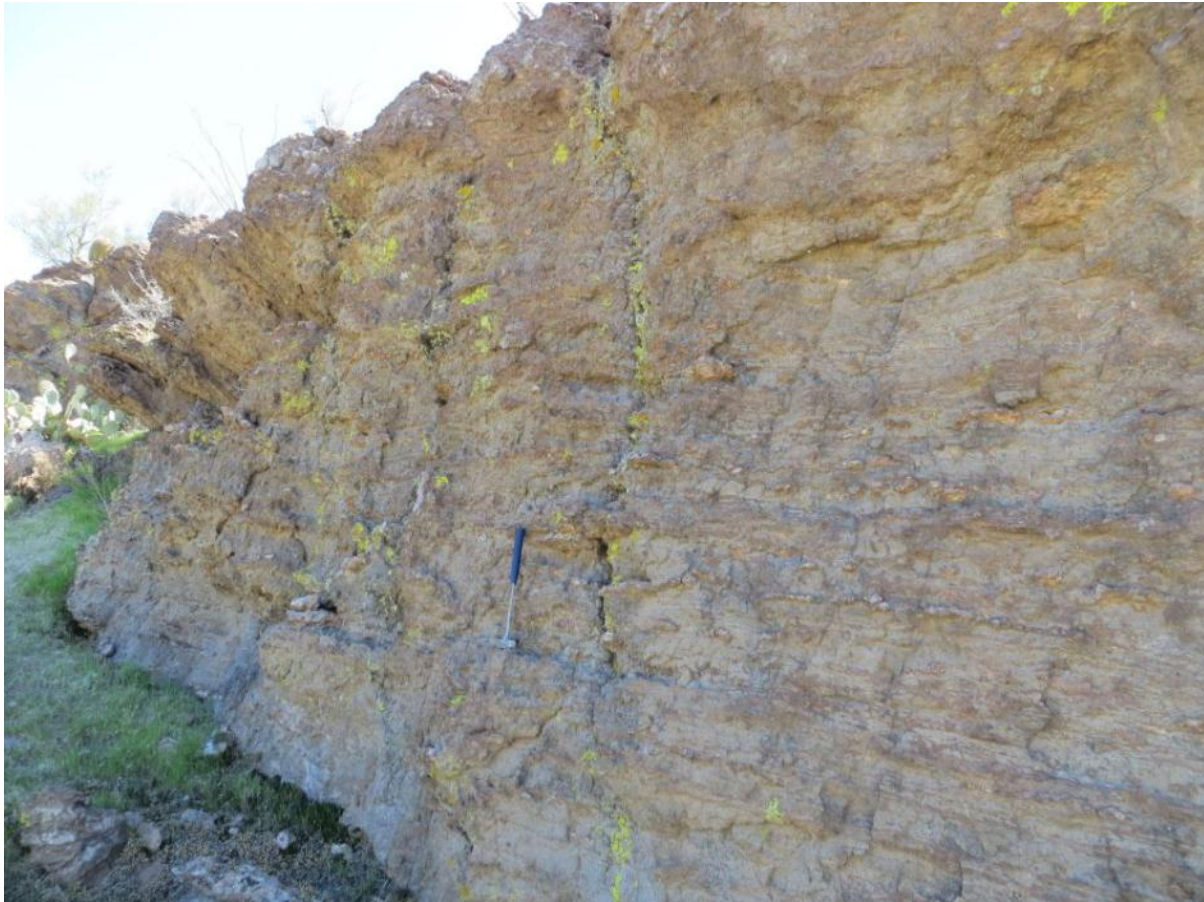
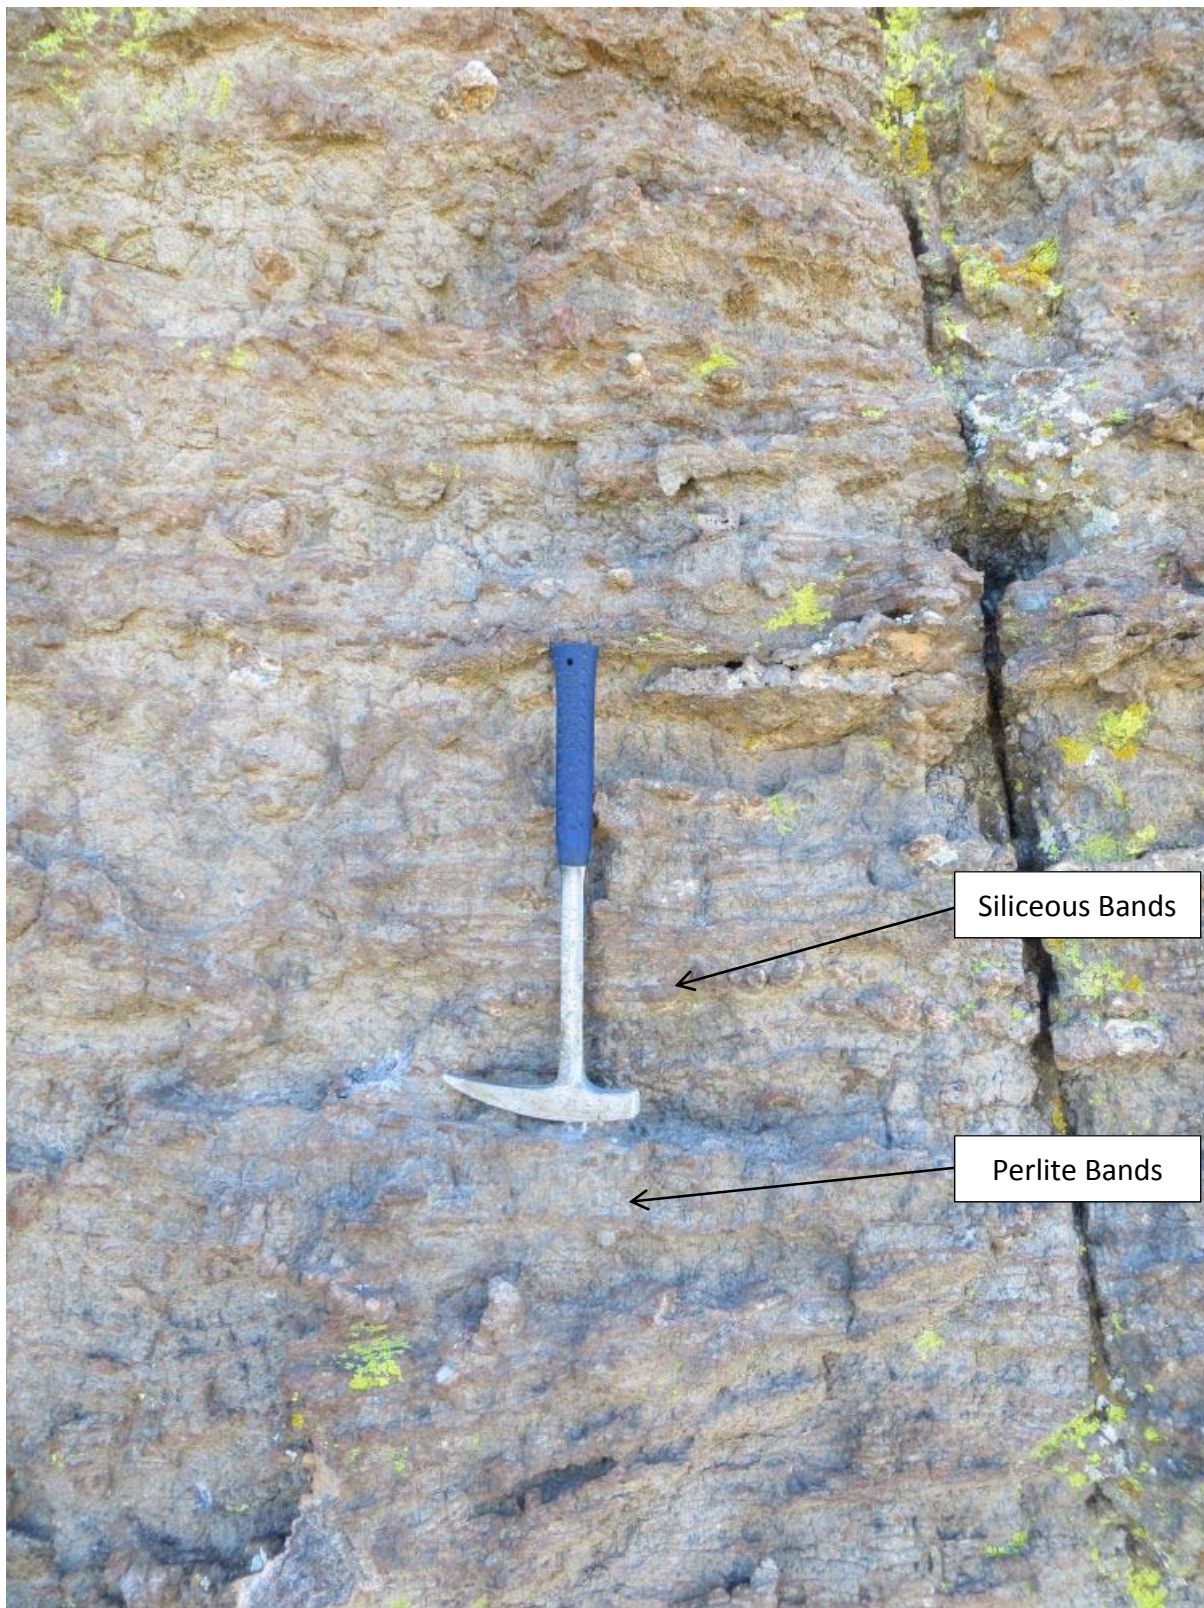
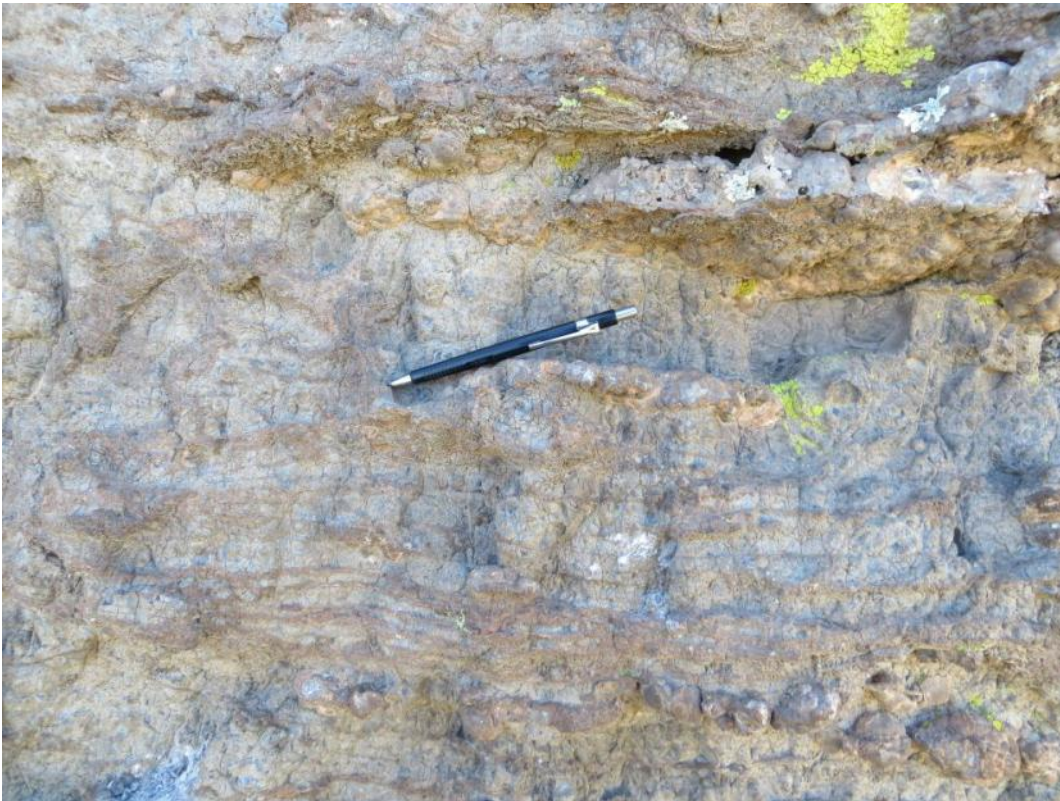
Vertical joints in  
upturned “blocks” at  
surface close off quickly  
at depth

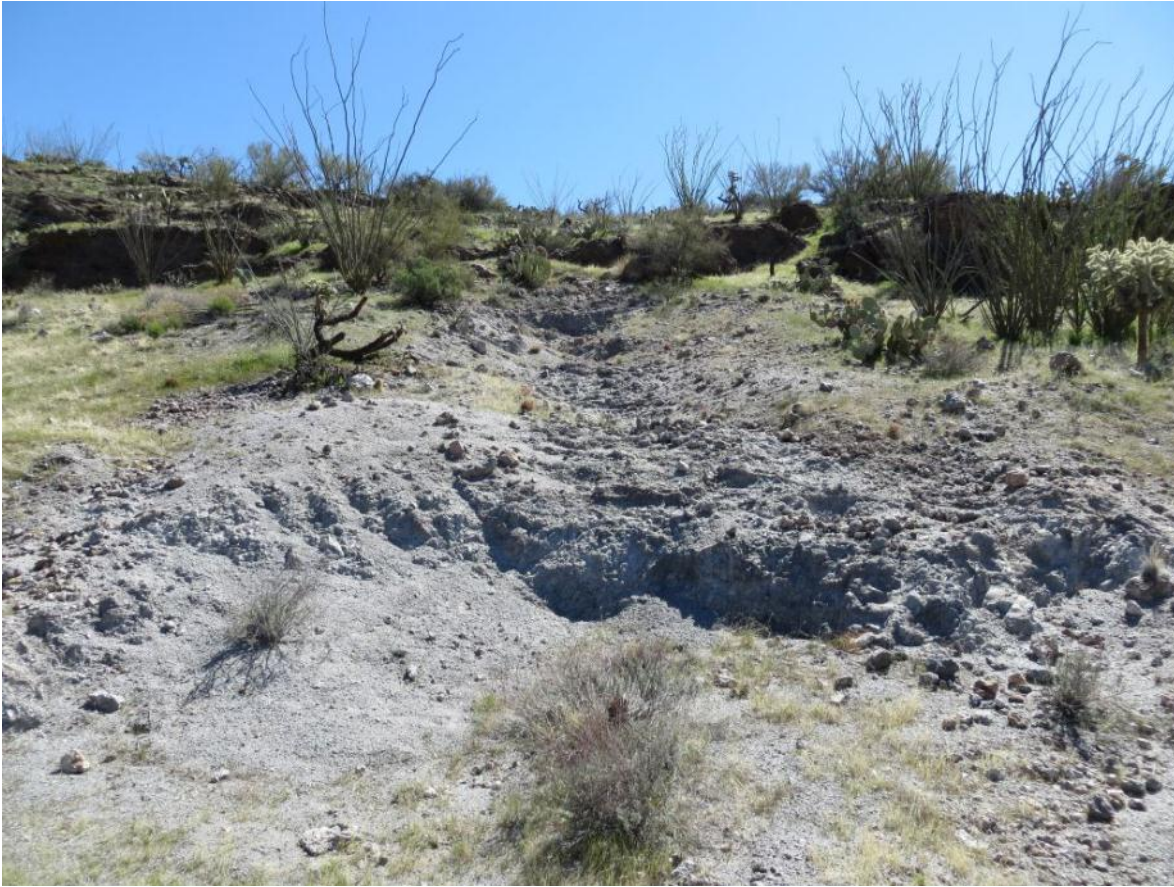
**PRL27**

Outcrop of perlite with well developed “glassy” texture. No microcrystalline silica banding.

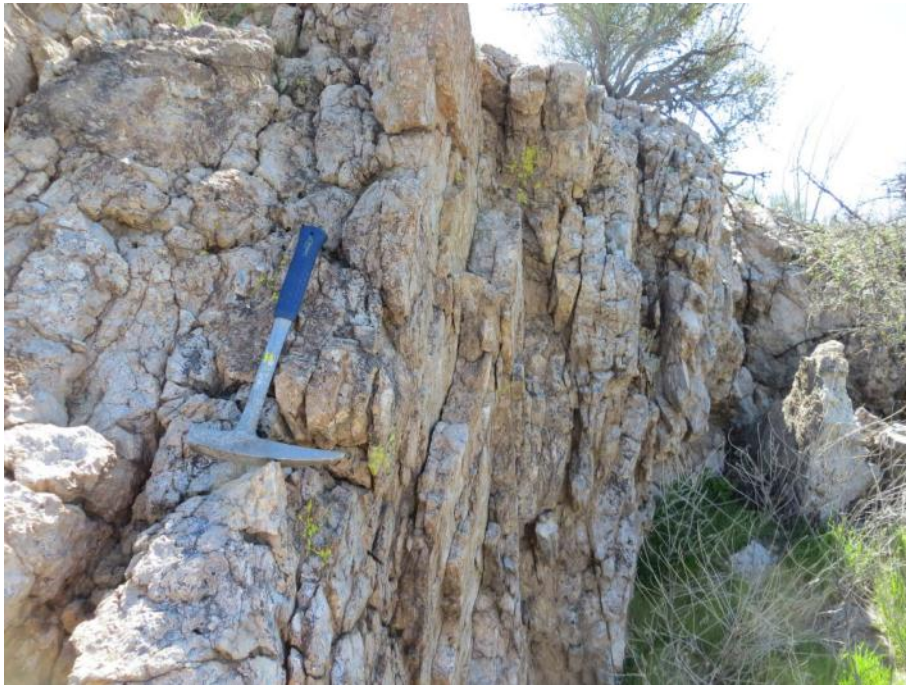
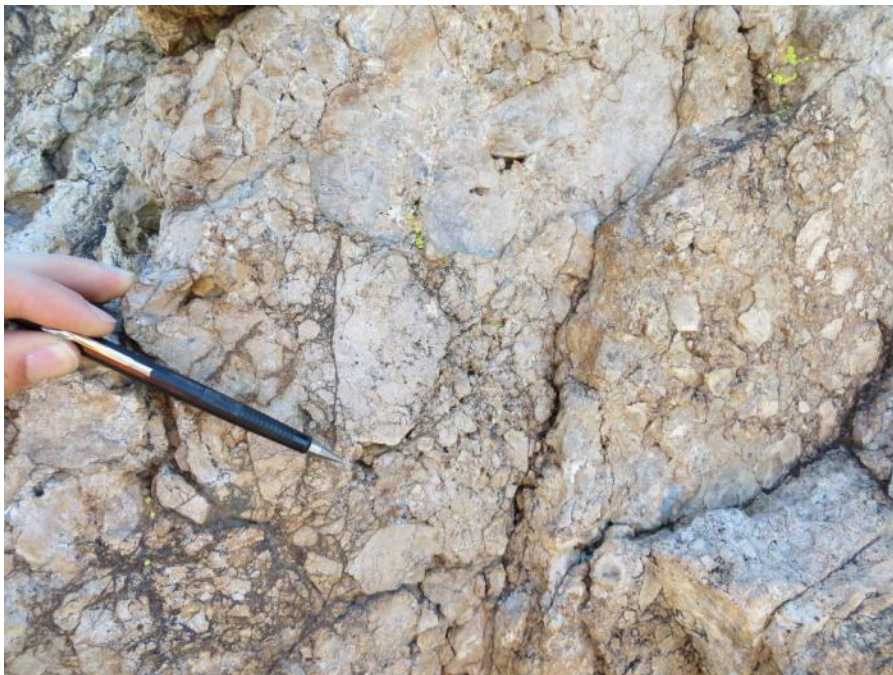
**PRL28**

Outcrop of white fine grained siliceous rock. Fresh, R4 to R5, tight spaced sub-vertical joints with spacing of 1 cm to 6 cm (*0.40 inches to 2.36 inches*), joints closed to moderately wide (max. 3 mm (*0.12 inches*)), stepped and rough surfaces, no infill, brecciated texture exposed on some joint faces.

Orientation of joint set: 350/83

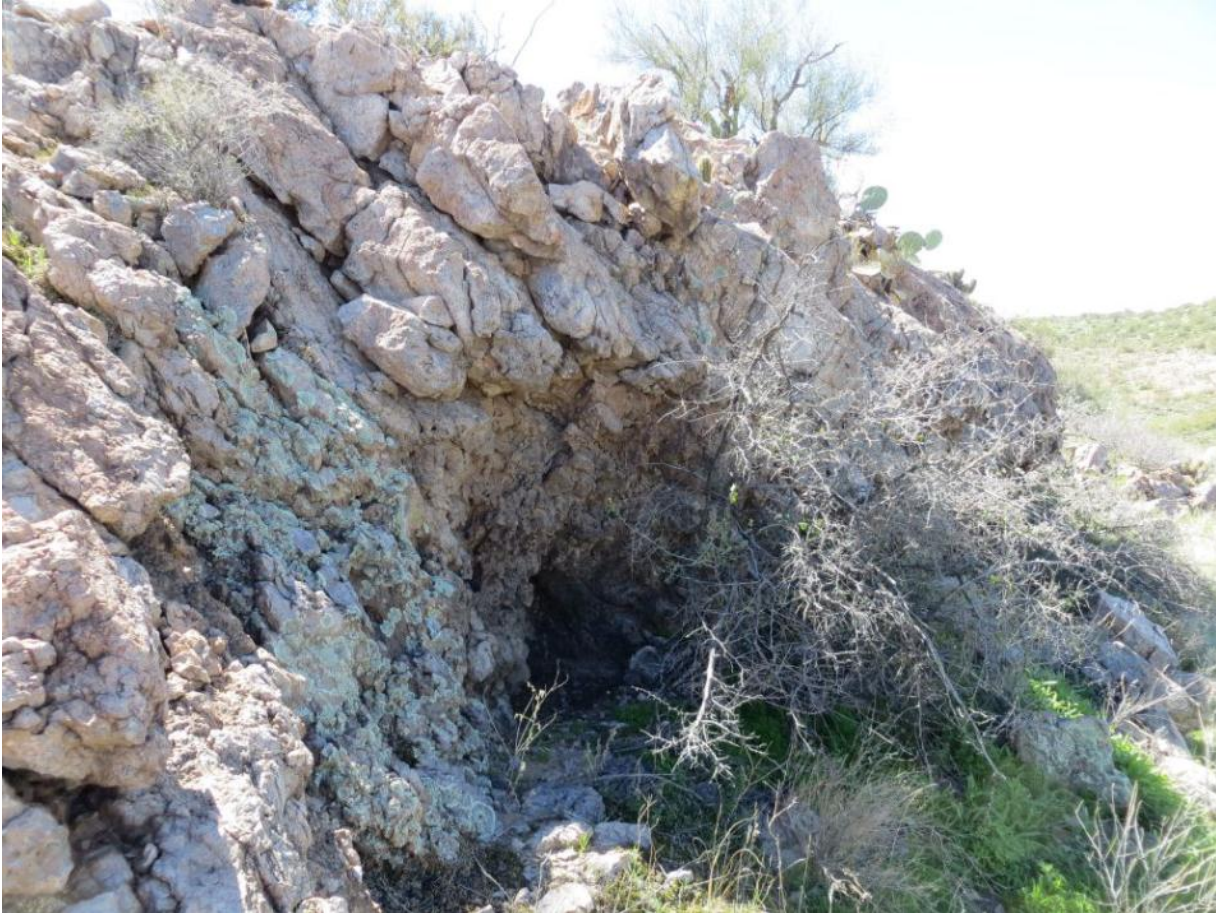
**PRL29**

White jointed siliceous rock forms a 2 m (6.6 ft) thick “cap” over banded silica/perlite (as PRL26) below.
