## APPENDIX I-E

### Traverse #5

PROJECT  
RESOLUTION PROJECT  
2013 NEAR WEST SITE INVESTIGATION

TITLE  
CREEK TRAVERSE #5

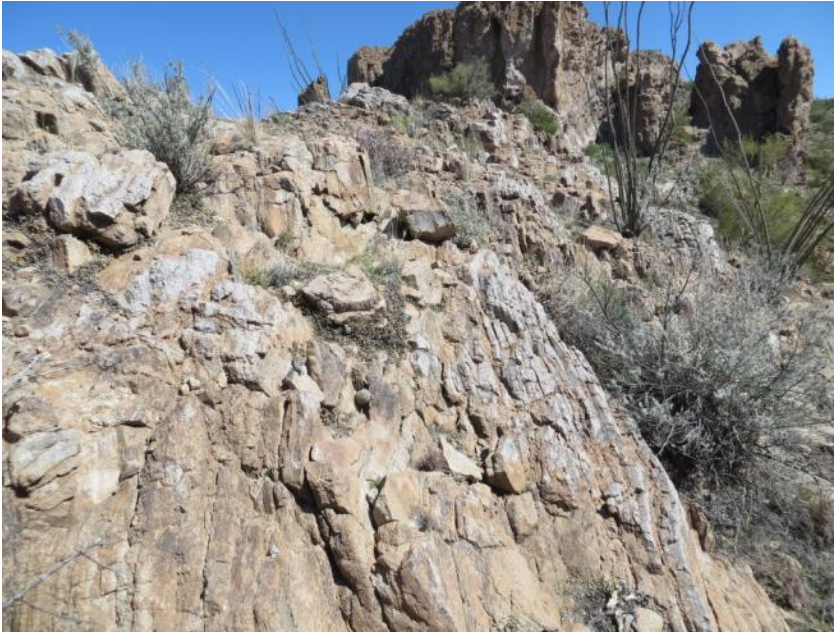
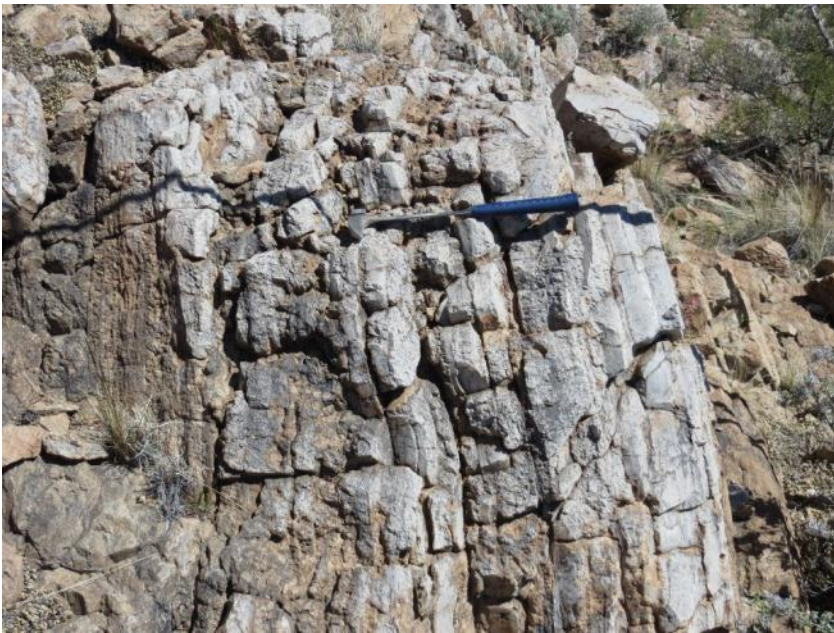
### PRL30

Outcrop of perlite at the top of a hill. Fresh, R3, well developed “glassy” texture, strong sub-vertical gently folded parallel layers, parallel laminations seen in fresh perlite, average spacing between layers = 3 cm (*1.18 inches*), layer interfaces open at surface but fresh exposures are closed, stepped and rough planes, other randomly oriented fractures and joints cutting across layers.

Orientation of layers: **078/73**

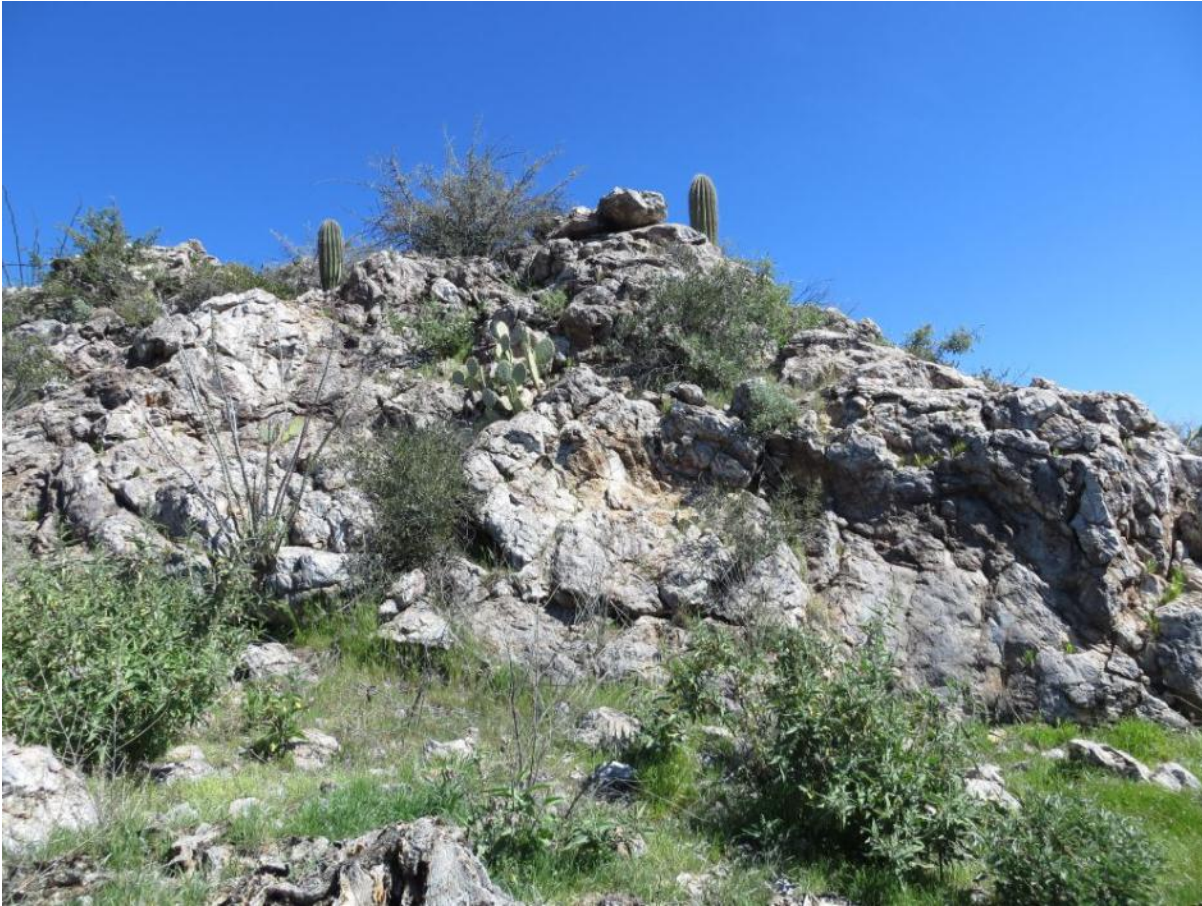
**PRL31**

Exposure of white to grey siliceous rock, similar to PRL29. Massive with no joint sets/discontinuities.

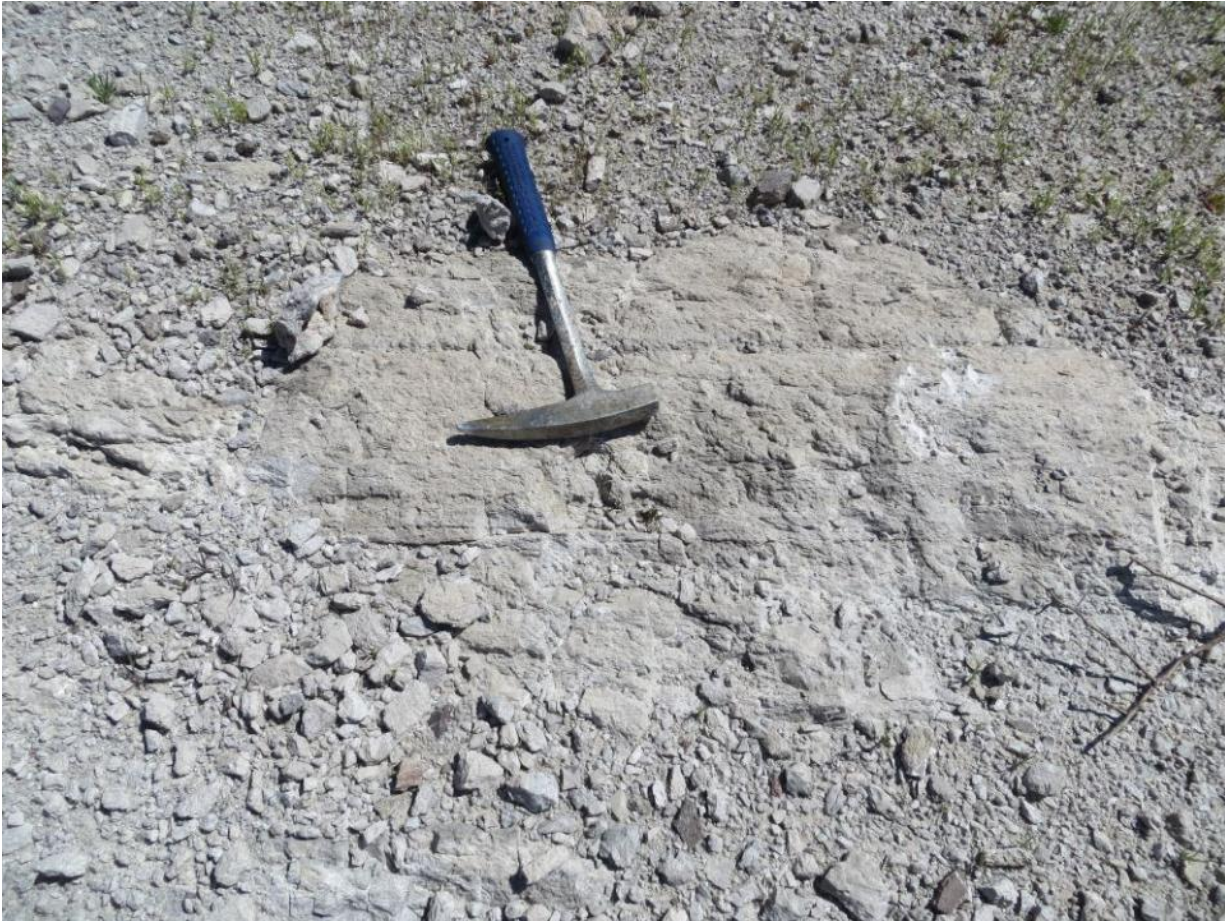
**PRL32**

Perlite with well developed “glassy” texture exposed in road surface right below PRL31.

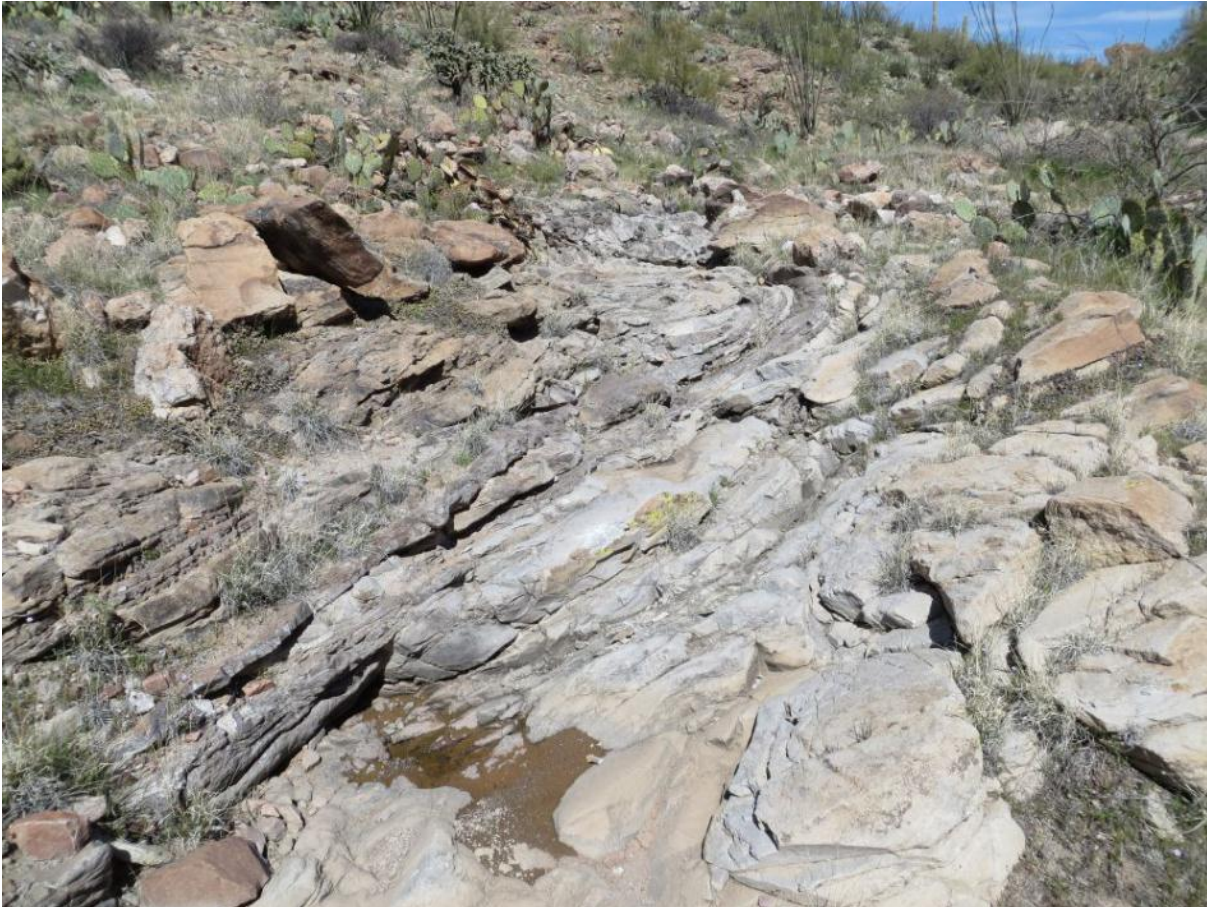
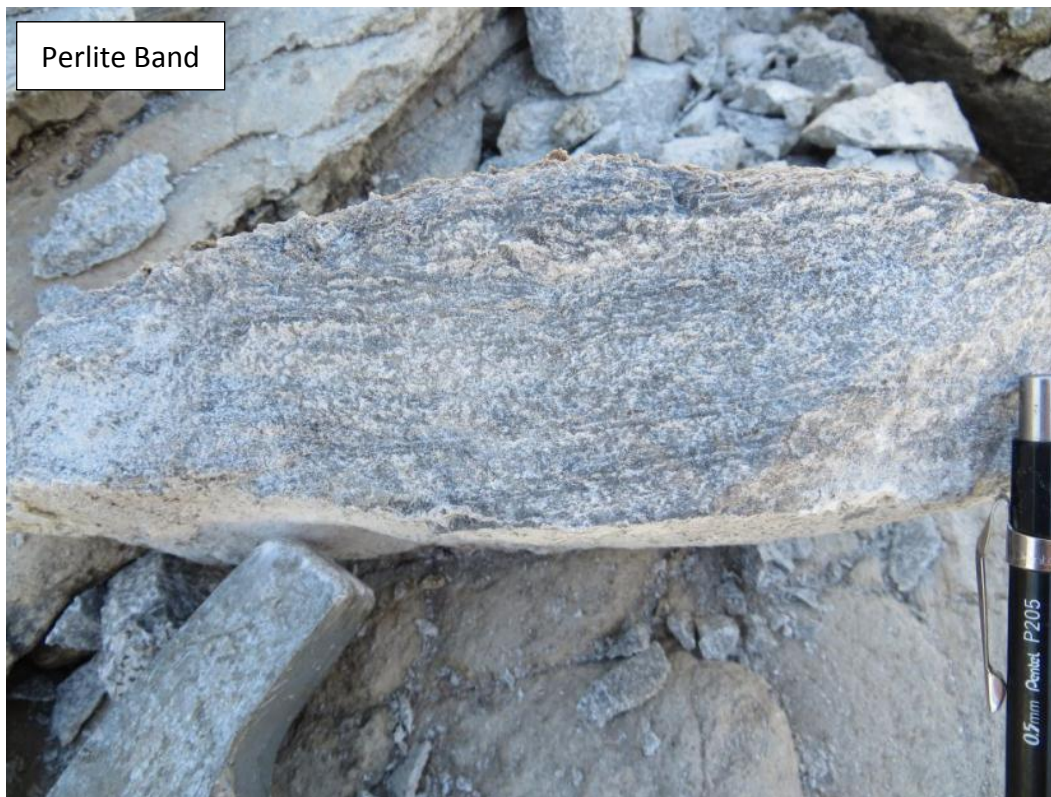
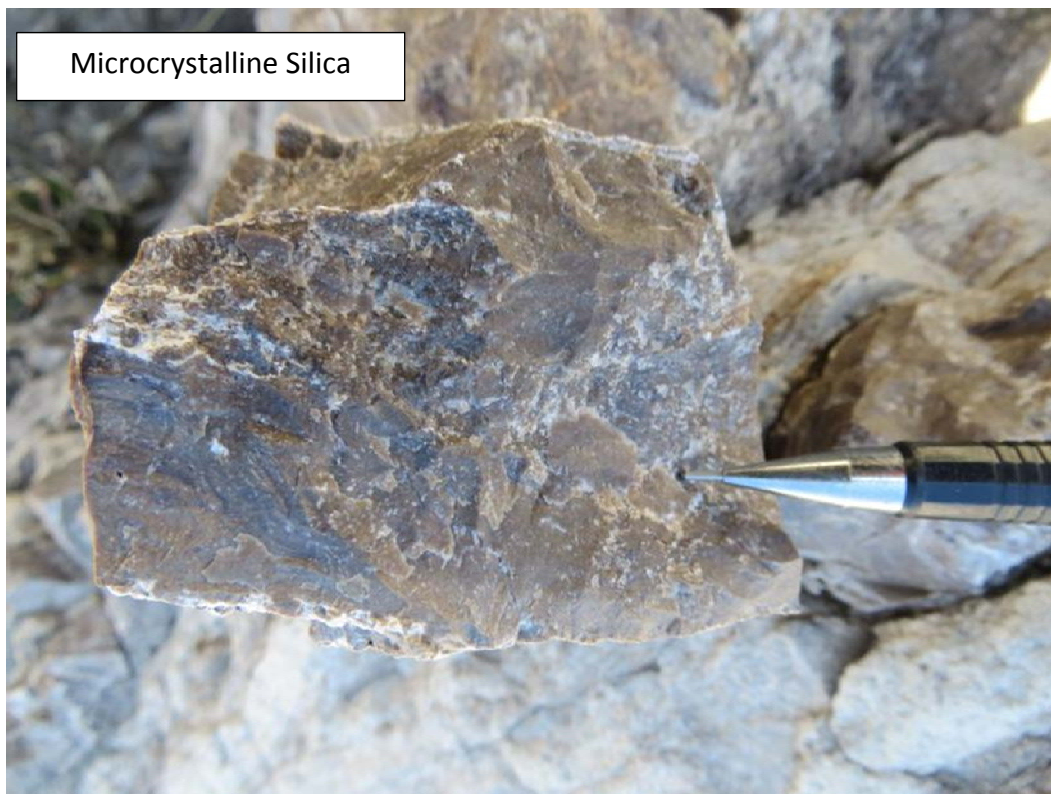
**PRL33**

Banded perlite (glassy perlite with hard purplish grey microcrystalline silica) exposed in channel invert. Fresh, R4, bands on mm to cm scale (up to 30 cm (*11.81 inches*)), evidence of folding, some randomly oriented closed fractures perpendicular to bands, water ponding on surface.

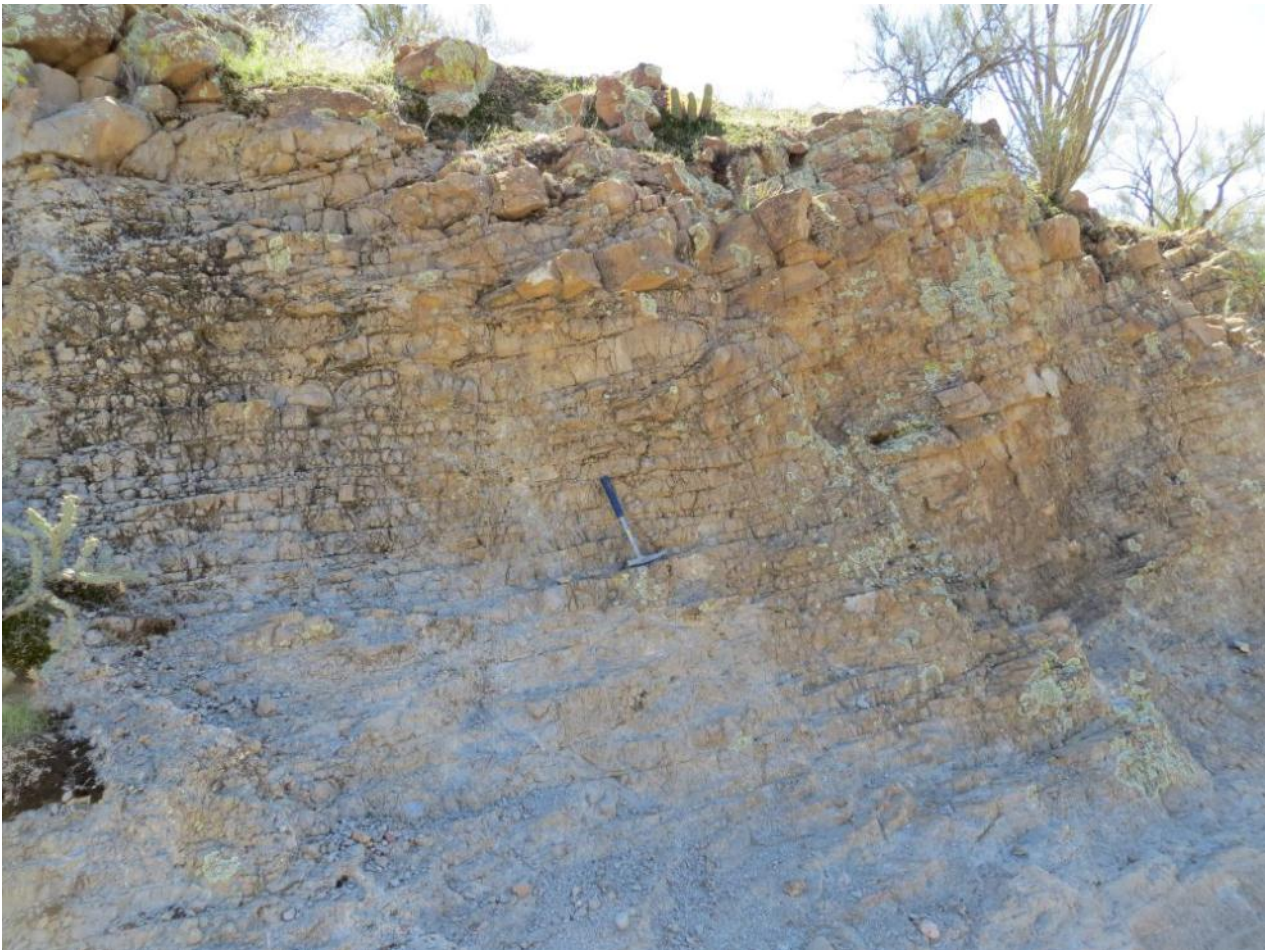
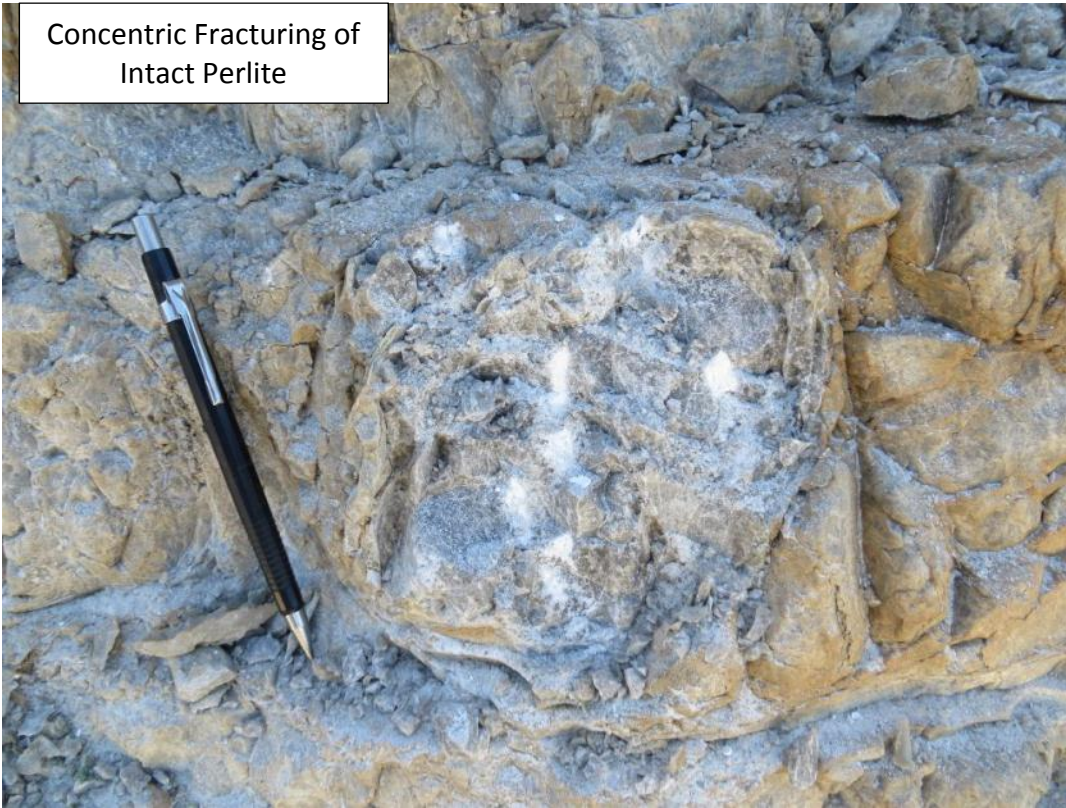
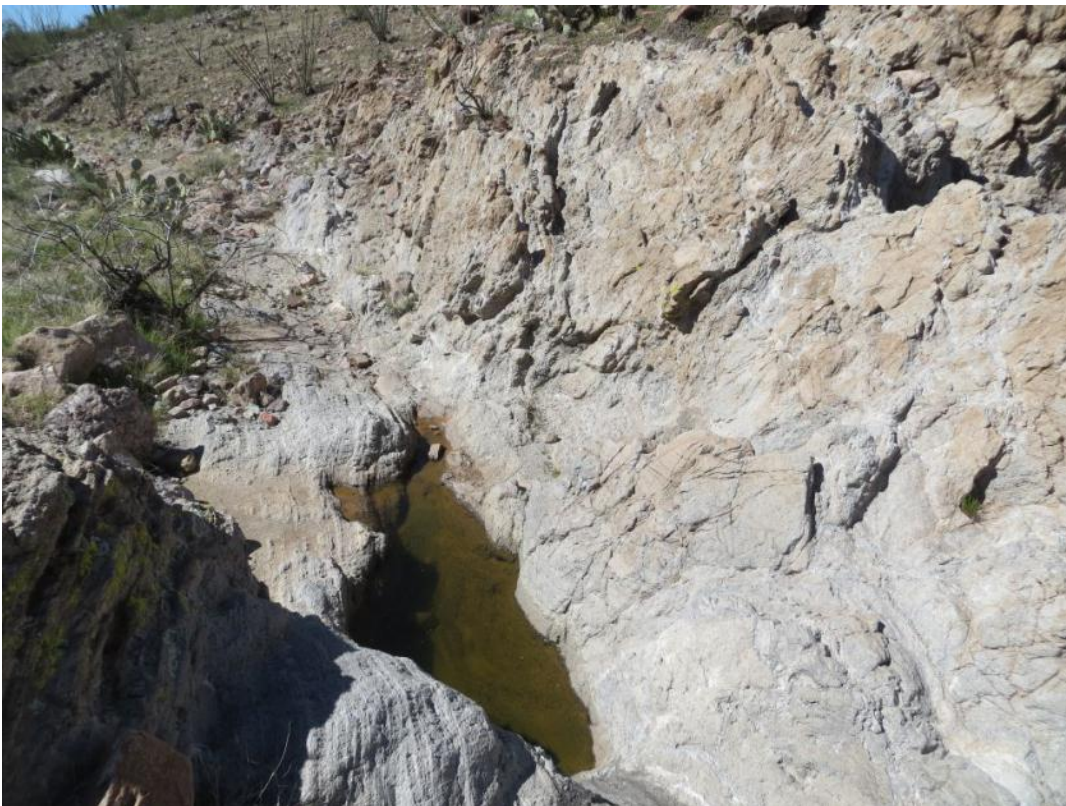
#### PRL34

Perlite exposure in channel invert and banks with well developed “glassy” texture. Fresh, R2 to R3 (weaker when chipped with pick), strong layering spaced 3 mm to 15 cm (*0.12 inches to 5.91 inches*) apart, sub-horizontal, smooth, planar layer interfaces, numerous fractures perpendicular to layering, concentric fracturing in intact perlite along smooth glassy planes. Water ponding in channel invert of exposed perlite.

Concentric Fracturing of  
Intact Perlite
