## Monitoring and Mitigation Plan for Groundwater Dependent Ecosystems and Water Wells

Resolution Copper, LLC.

Montgomery & Associates

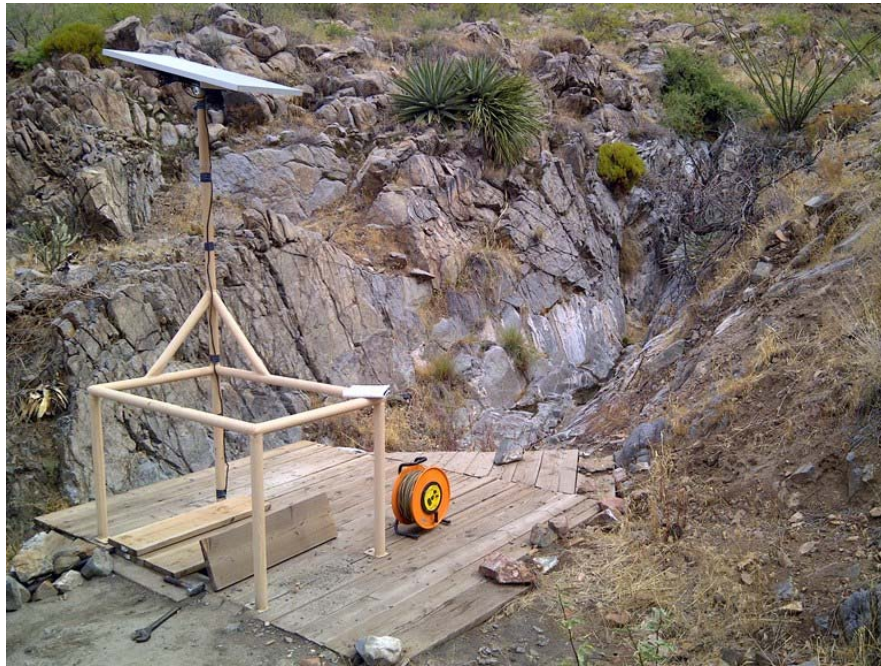
A covered, hand-dug sump is located within the channel, approximately 800 feet downstream from the spring source. A solar-powered submersible pump is installed in the sump and water is pumped to a steel holding tank, which provides water to a cement stock trough. The spring and infrastructure are maintained by a local rancher.

Photograph A-1. Spring sump with solar panel powered pump

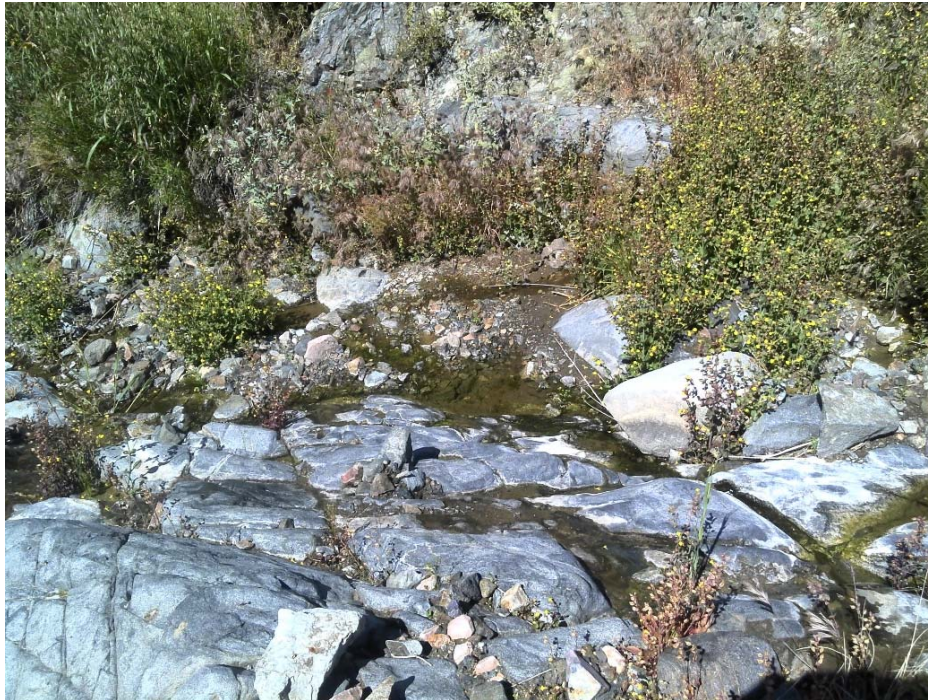
Photograph A-2. Bitter Spring, view of bedrock in streambed surrounded by herbaceous vegetation, May 2017

Periodic monitoring of flow and water quality parameters for Bitter Spring has occurred since August 2012 (M&A, 2018a). Flow observations are summarized in Table A-1; flow estimates range from 0 – 0.5 gpm. Although flow estimates are sparse, flow likely varies seasonally and may periodically comprise both groundwater discharge and surface water runoff.

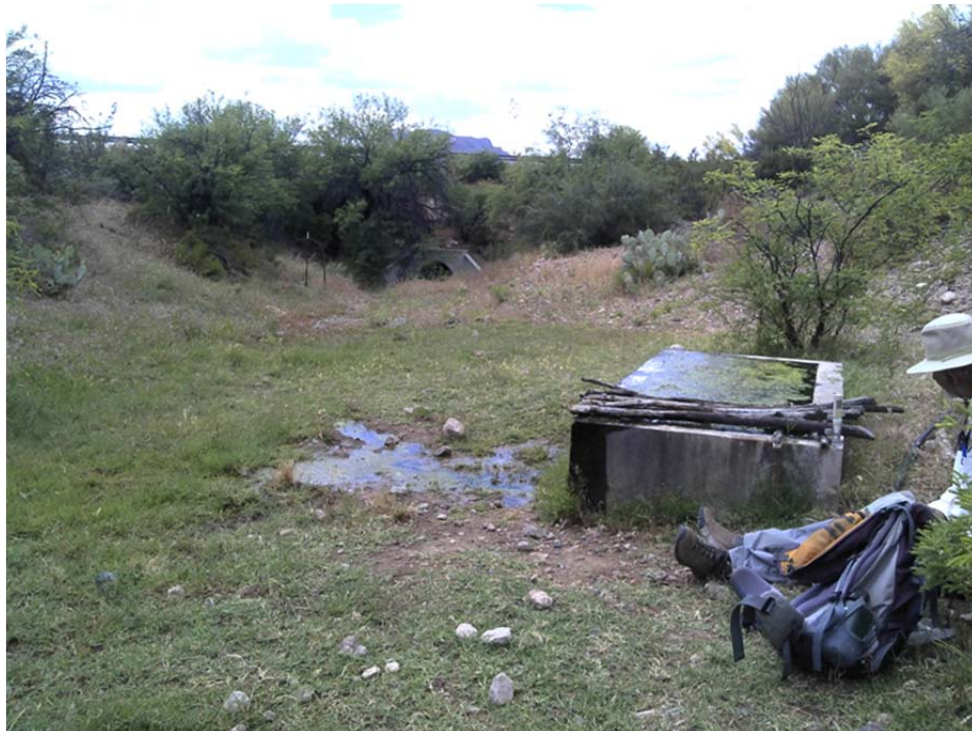
Bored Spring is an intermittent anthropogenic spring located in a small tributary of Pacific Canyon, immediately east of Arizona Highway 177 in the Queen Creek basin. Water seeps from the alluvium downslope from a diabase rock quarry. An area approximately 66 feet long by 16 feet wide is excavated below the seep, leading to a cement cattle trough that is plumbed into the spring. Historical records indicate that a well was drilled near this location and completed in diabase. Although this well has not been found, artesian flow from this well, or what remains of it, may represent a source of this spring.

Photograph A-3. Bored Spring view of cement trough and overflow.  
AZ Highway 177 visible in background, May 2017

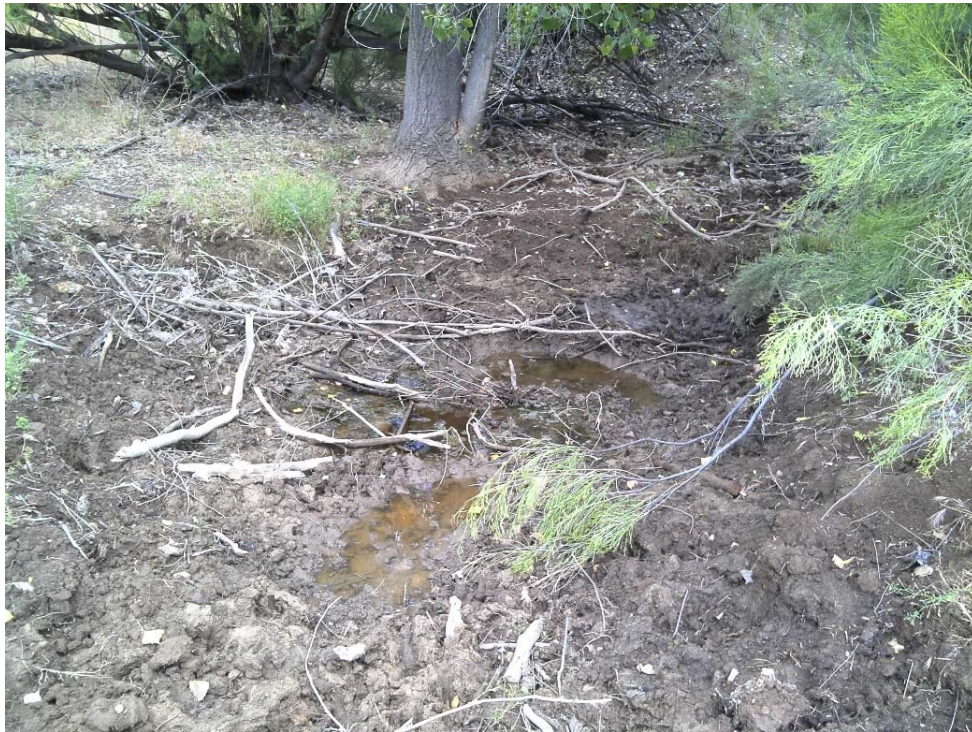
Photograph A-4. Bored spring discharge from excavated site below diabase rock quarry, 2017

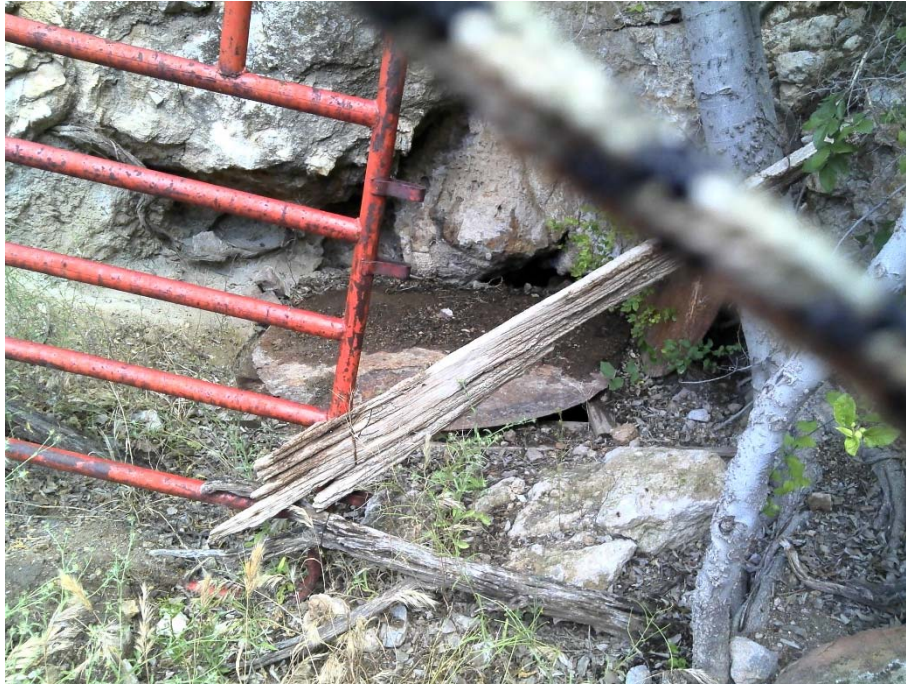
Hidden Spring is an intermittent rheocrene spring, located in an unnamed tributary to Arnett Creek, which is within the Queen Creek basin. The spring discharges from Paleozoic carbonates west of the Apache Leap escarpment. Travertine deposits are observed from active spring flow sites and former spring outlets. Spring water collects in an underground steel culvert and is plumbed to a drinker for stock and wildlife watering.

Photograph A-5. Hidden Spring, view of spring culvert with netleaf tree trunk in foreground, May 2017

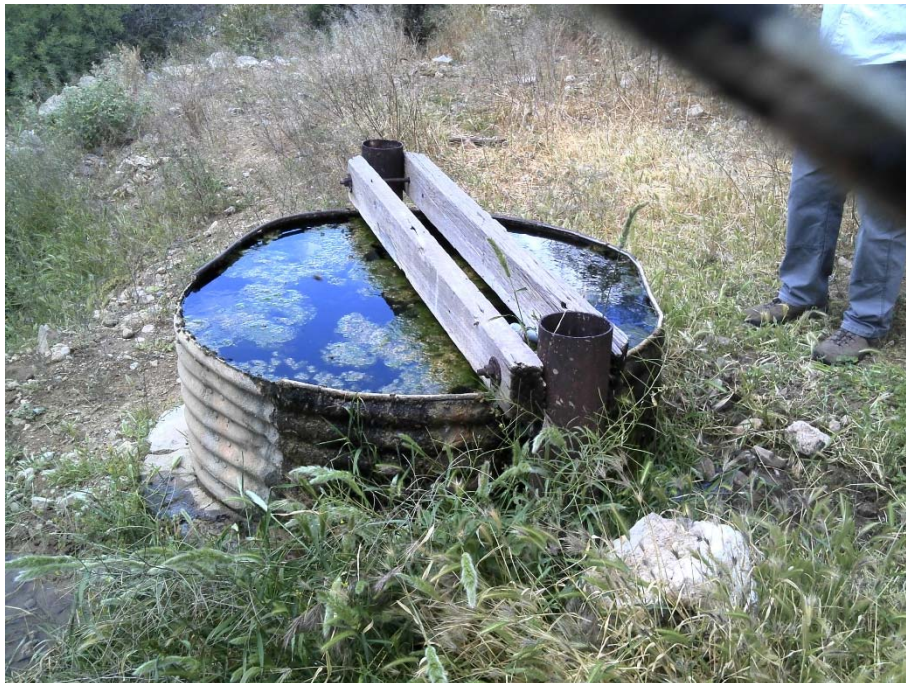
Photograph A-6. Hidden Spring, view of drinker with herbaceous vegetation including Rabbitsfoot grass, May 2017

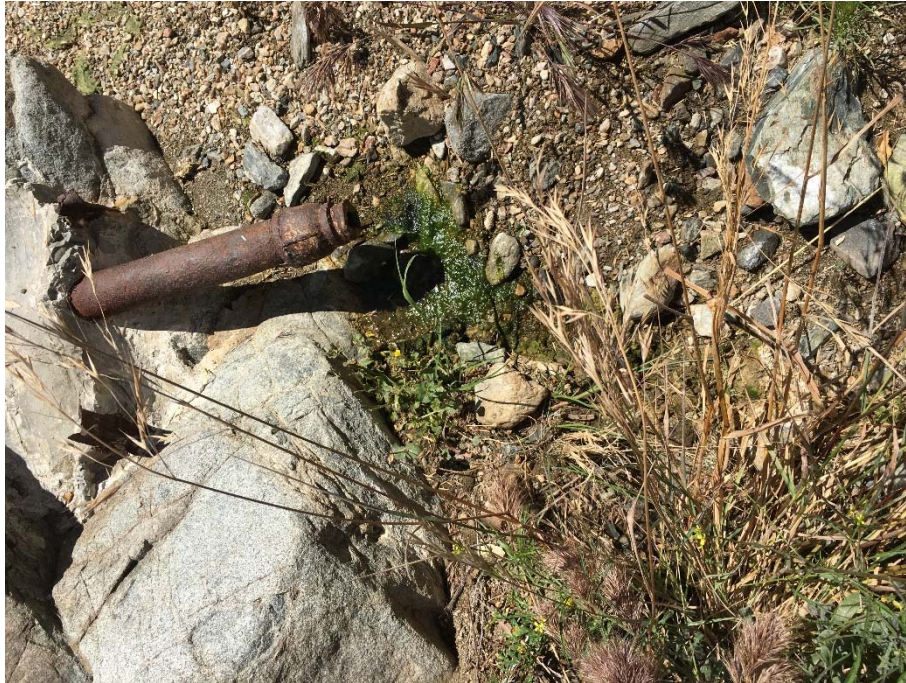
Iberri Spring is an intermittent rheocrene spring located in the channel of Peachville Wash, within the Queen Creek basin. The spring discharges as multiple seeps from the fractures in the Peachville quartz diorite downstream from a large deposit of alluvium. Horizontal steel piping is embedded into the bedrock at the upper end of the seeps. Downstream from the spring discharge there is a 5 feet wide by 1 foot high concrete dam, likely evidence of former spring development.

Photograph A-7. Iberri Spring, view of embedded pipe, near upper end of seeps.  
Herbaceous vegetation including yellow monkeyflower and oats, May 2017

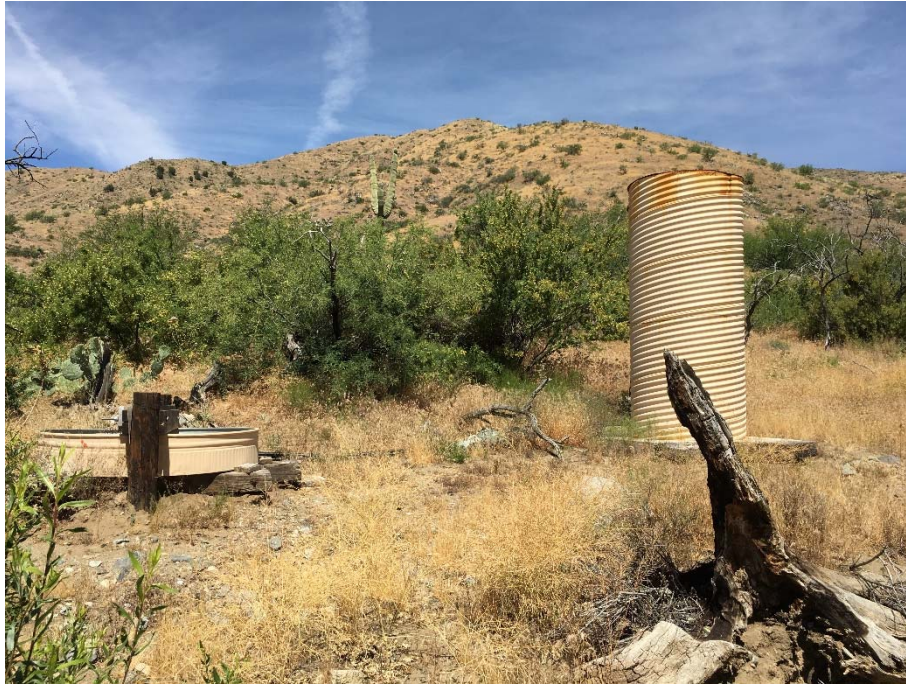
A shallow hand-dug well equipped with a solar pump is located upstream from the spring in Peachville Wash. This well likely taps shallow groundwater stored in the alluvial deposits. Plastic tubing leads upstream from the well to a storage tank and drinker.

Photograph A-8. Iberri Spring, view of container and drinker, May 2017

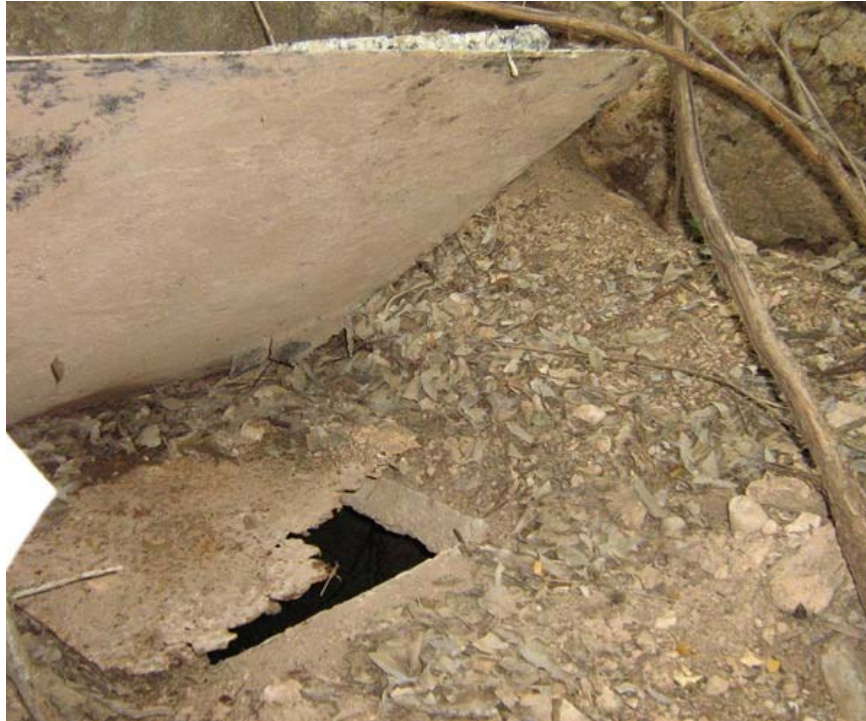
Kane Spring is an intermittent rheocrene spring located in the channel of an unnamed tributary of Arnett Creek in the Queen Creek basin. The spring discharges from bedding planes between strata of Paleozoic carbonates west of the Apache Leap escarpment. Spring flow is captured in several small tinajas and continues downstream where it disappears in alluvial deposits. A spring box and several generations of piping are evident near the source.

Photograph A-9. Kane Spring, spring box, July 2010

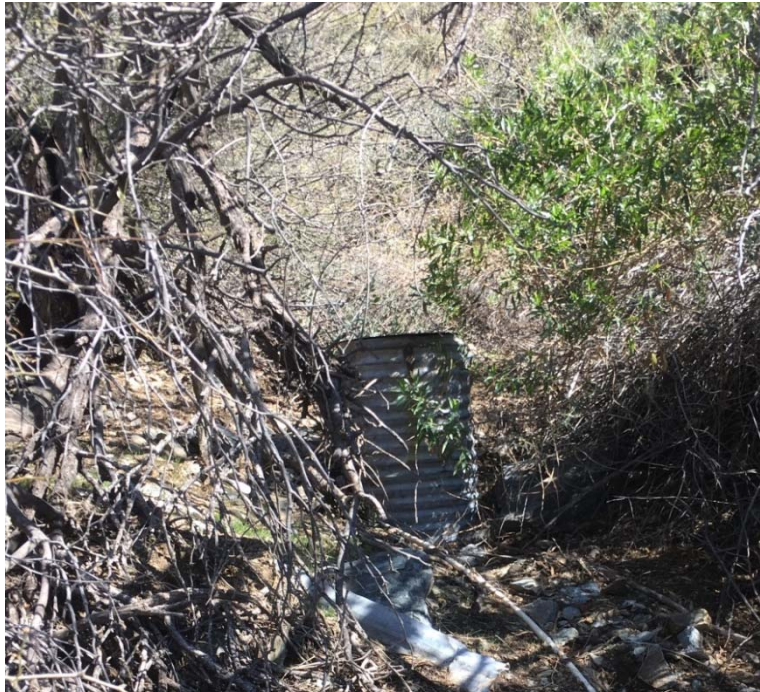
McGinnel Spring is a rheocrene spring of undetermined persistence located in the channel of an unnamed tributary of Whitford Canyon in the Queen Creek basin. The spring consists of a 3-foot diameter, 6.8-foot deep sump lined with a corrugated steel culvert which is plumbed to a cement cattle trough roughly 600 feet to the southwest. The feature appears to be mostly supported by runoff water stored in alluvial channel deposits, with potentially some contribution from weathered schist bedrock.

Photograph A-11. Culvert lined pit at McGinnel Spring, shaded by seepwillow, March 2018

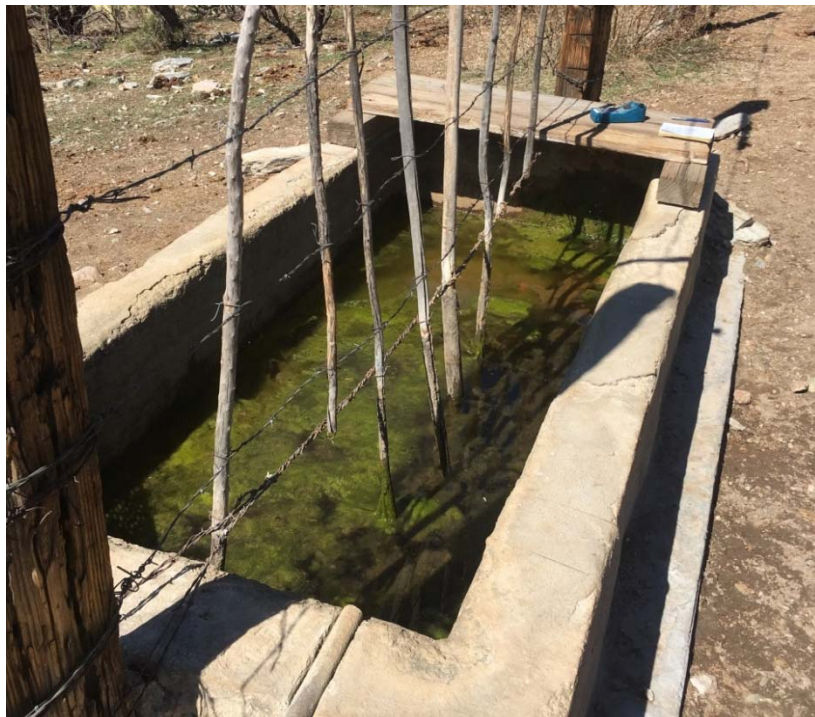
Photograph A-12. Cement trough plumbed to McGinnel Spring culvert, March 2018

McGinnel Spring has been surveyed on two occasions since 2018 (M&A, 2018a). Flow measurements are summarized on Table A-6. No flow has been observed at the spring source, however flow has been measured from the trough from 0 – 0.1 gpm.

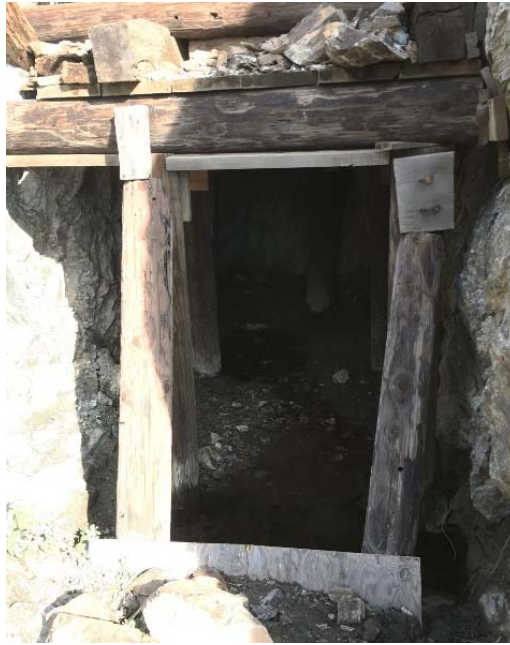
McGinnel Mine Spring is an intermittent anthropogenic spring located within an abandoned mine adit along FS Road 2389, approximately 1.5 miles from the Cottonwood Well in Whitford Canyon, Queen Creek basin. The mine adit is excavated in Pinal Schist on the western face of Peachville Mountain, more than 1,000 feet above the Whitford Canyon channel. The feature is likely supported by infiltration of stormwater runoff into the mine workings through the weathered schist surface. Standing water has been observed in the mine workings, retained by a 2 foot tall wooden dam. Water is intentionally captured and stored in the mine and conveyed via a black polyethylene tubing to a small earthen cattle tank near the Cottonwood Well.

Photograph A-13. McGinnel Mine Spring entrance, standing water present along floor, March 2018

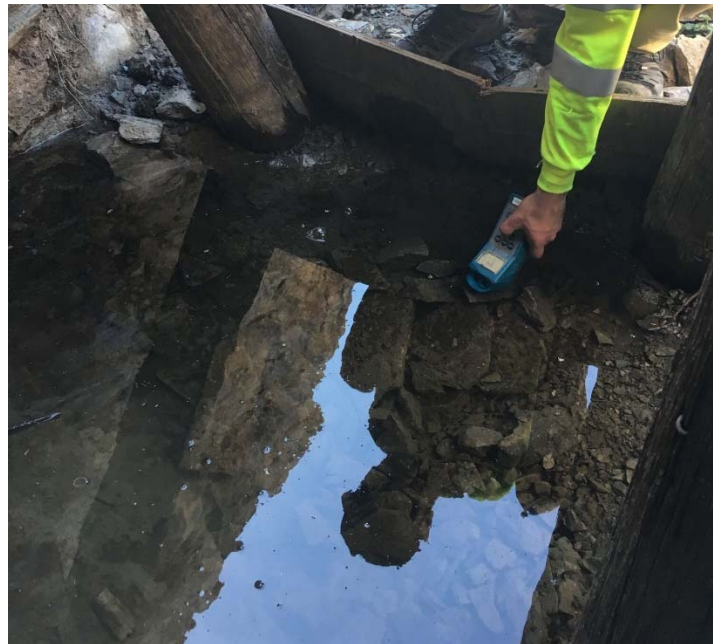
Photograph A-14. Water dammed near entrance to mine adit, March 2018

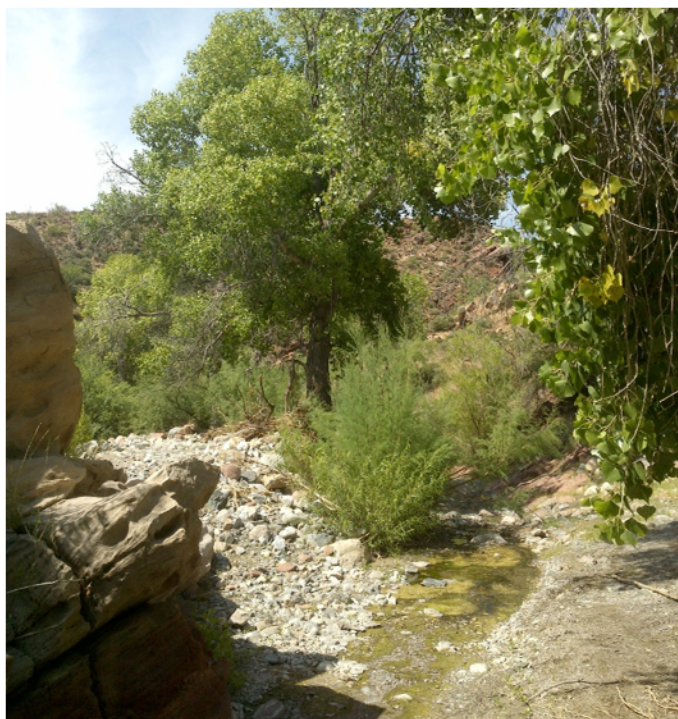
Photograph A-15. No Name Spring, beginning of flowing reach, riparian vegetation, June 2017

No Name Spring is an intermittent rheocrene spring located in the channel of Whitford Canyon in the Queen Creek basin. Several seeps occur at contacts between the Dripping Springs quartzite and Pioneer shale, with the shale acting as the perching geologic unit. Substantial alluvial deposits occur in the channel upstream from the spring. No evidence of anthropogenic controls have been noted at this location.

Periodic monitoring of flow and water quality parameters for No Name Spring has occurred since May 2017 (M&A, 2018a). Flow observations are summarized in Table A-8; flow has ranged from 0 – 3 gpm at this spring. Surface flow has been observed for more than 1,300 feet downstream from the spring before disappearing into the alluvial channel deposits.

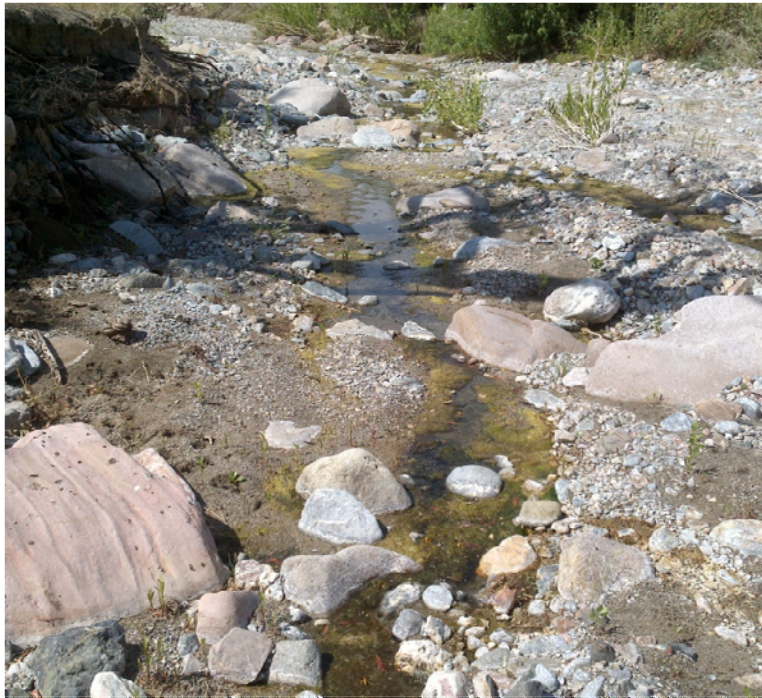
Photograph A-16. Flowing reach in alluvial channel downstream from No Name Spring, June 2017

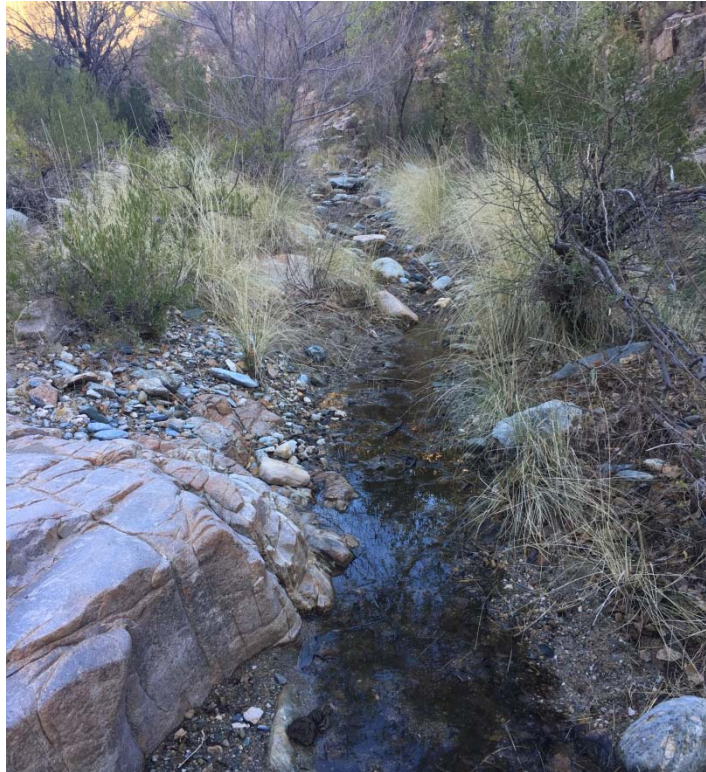
Photograph A-17. Rock Horizontal Spring, flowing through granitic slot canyon, March 2018

Rock Horizontal Spring is an intermittent rheocrene spring located in the channel of Reavis Trail Canyon, within the Queen Creek basin. The spring flow surfaces from the alluvium upon

entering a scoured granite narrows. Seepage has also been observed from joints in the granite canyon wall. Plastic hose and steel pipe downstream from the spring source are evidence of historical water source development at this spring location.

Rock Horizontal Spring has only been monitored on two occasions starting in March 2018 (M&A, 2018a); flow observations are given in Table A-9. Flow has been measured between 0.1 – 0.5 gpm.

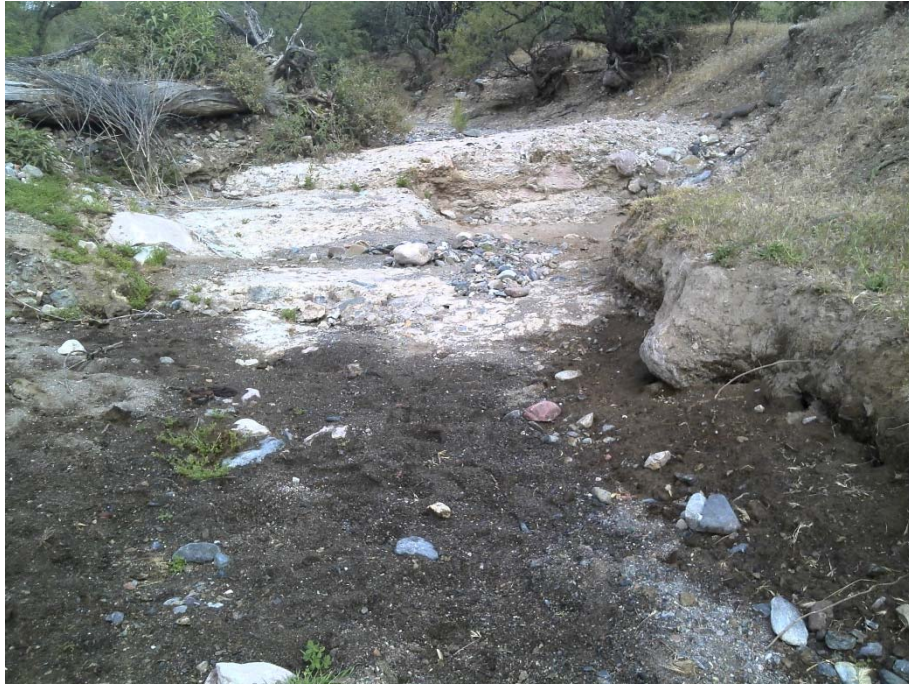
Walker Spring is an intermittent flowing, rheocrene spring located in Happy Camp Canyon, within the Queen Creek Basin. The spring discharges from the Gila conglomerate and alluvium along both banks of the stream. Cemented layers within the Gila conglomerate act as the perching geologic unit.

Photograph A-19. Walker Spring, view of conglomerate bedrock ledge across streambed, May 2017

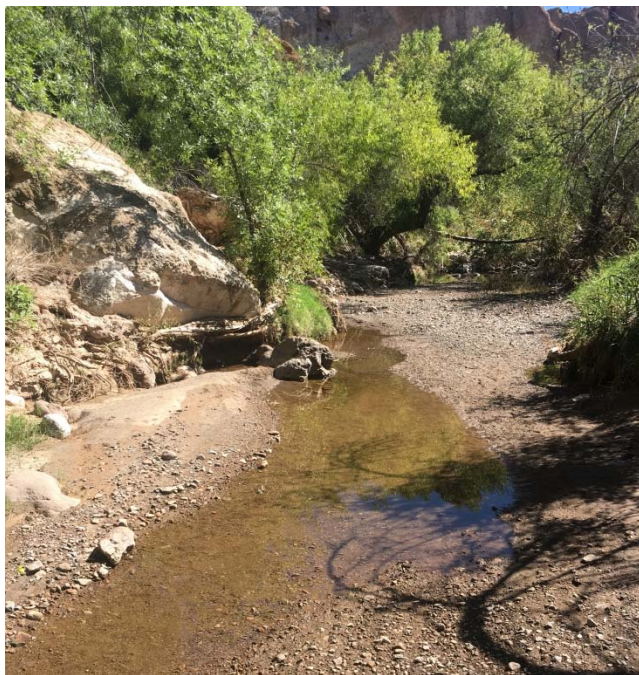
Photograph A-21. QC 17.39 to 15.55, view of perennial flowing reach, September 2018

QC 17.39 to 15.55, the perennial flowing reach of Queen Creek from the Town of Superior Waste Water Treatment Plant and the Harborlite perlite mine down to the Boyce Thompson Arboretum, is currently classified by the Arizona Department of Environmental Quality as effluent dependent. Flow in this reach is attributed primarily to discharge from these facilities; a stream camera and a transducer are installed in the Harborlite discharge canal to monitor dewatering schedule and estimate flow into Queen Creek. Seasonal storm water runoff also contributes to flow in this reach. Currently there is no evidence that this reach is supported by groundwater discharge from the regional aquifer (M&A 2017).

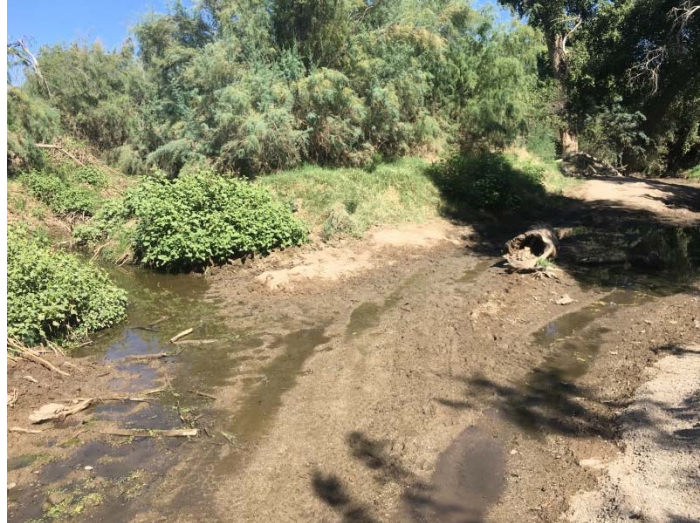
Photograph A-22. Whitlow Ranch Dam, view of saltcedar and Fremont's cottonwood, October 2017

Whitlow Ranch Dam is a flood control structure located on Queen Creek about 10 miles west from Superior (**Figures 1**). The compacted-earthfill dam was completed in 1960 by the USACE to protect agricultural lands and communities in downstream areas from large damaging floods such as the one that occurred in 1954 (U.S. Army Corps of Engineers, 1975). The dam is situated at a narrow bedrock canyon, and represents the discharge point for all surface water runoff and underflow from upper Queen Creek in the Superior Basin. Discharge of surface water (and groundwater) through the dam occurs via a 5.5-foot diameter culvert (M&A 2013).

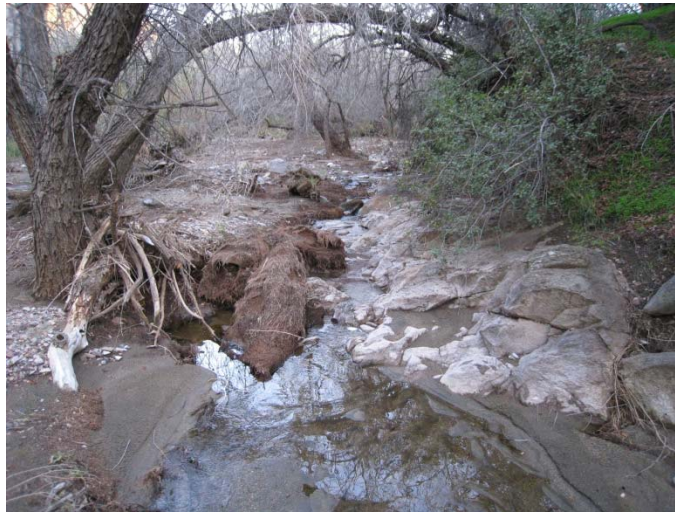
Photograph A-24. AC 12.49 to 12.38, flowing reach of Arnett Creek, looking upstream, February 2010

This perennial flowing reach occurs in Arnett Creek along the Arizona Highway 177 (Figure 1). The reach coincides with Blue Spring, which discharges from a detached block of Apache Leap Tuff. Water upwells to the surface as alluvial cover pinches out, and flows perennially for 361 feet. There is no instrumentation installed in this reach to monitor surface flow.

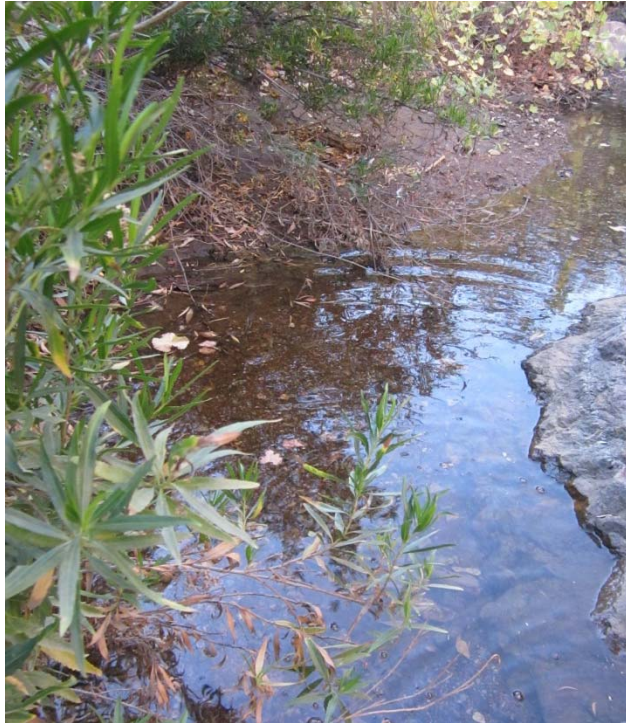
Photograph A-26. TC 1.06 to 1.01, flowing reach along volcanic outcrop and Nerium oleander, November 2012

Wetland plant species observed at this location include: canyon grape, seepwillow, and nerium oldeander. Very dense vegetative cover result in major phreatophytic variations of surface water quantity and flow within this reach of the canyon.

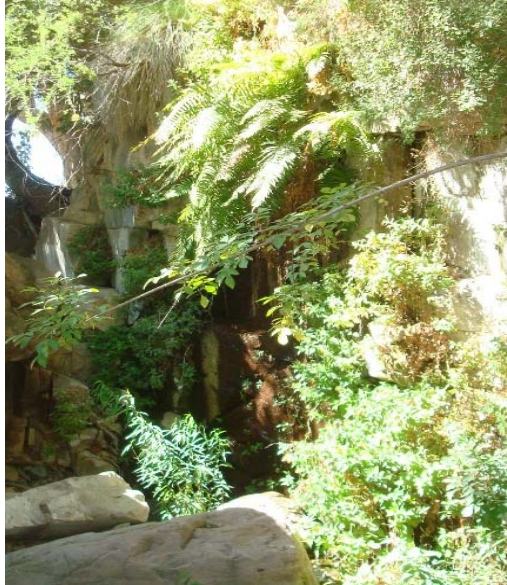
DC 4.1E is a perennial hanging garden spring complex located in the lower reach of Devils Canyon. The springs discharge from the Apache Leap Tuff on the eastern wall of the canyon. Vertical fins in the cliff face suggest fracture control on spring discharge.

Photograph A-27. View of hanging garden at DC 4.1E spring with vegetation growing from canyon wall, May 2011

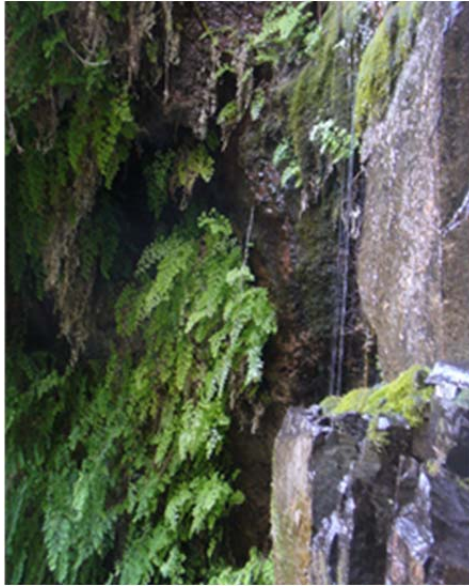
Photograph A-29. DC 6.1E, view of hanging garden spring seeping from canyon wall, June 2009

DC 6.1E is an intermittent hanging garden spring that occurs on the east wall of Devils Canyon adjacent to the bottom pool of the “Crater Tanks.” The spring discharges from the Apache Leap Tuff on the east wall of the canyon. Water seeps from the megaspherulite zone of the tuff, which occurs above the vitrophyre subunit.

Periodic monitoring of flow and water quality parameters for Spring DC6.1E has occurred since November 2002 (M&A, 2018a). Flow observations are summarized in Table A-12 flow

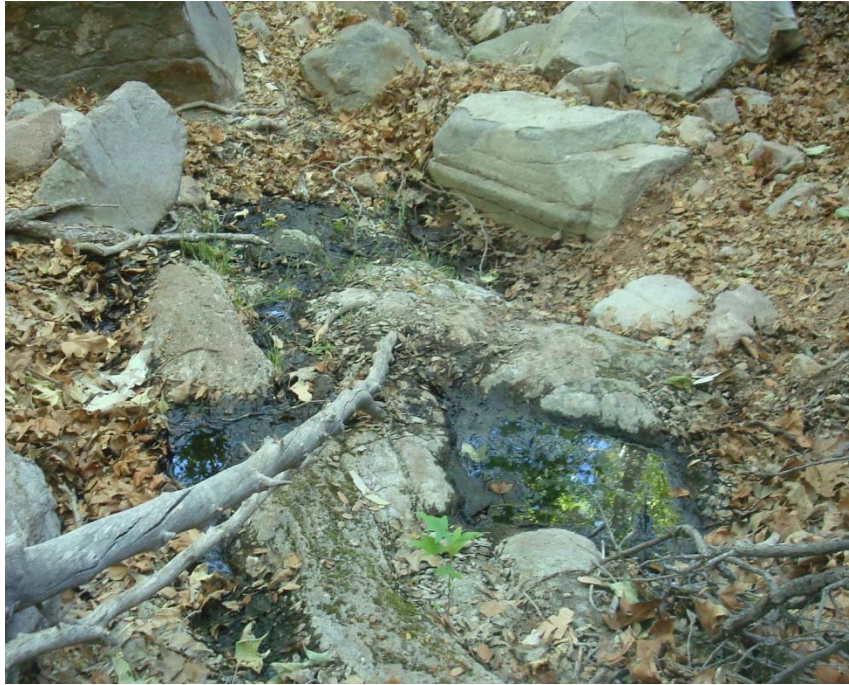
Photograph A-31. DC 6.6W, view of pool along surface water flowing reach, May 2011

DC 6.6W is an intermittent rheocrene spring located in a small unnamed tributary to Devils Canyon, approximately 656 feet above the main channel of Devils Canyon. The spring discharges from the Apache Leap Tuff at the contact with the underlying Whitetail Conglomerate.

Periodic monitoring of flow and water quality parameters for Spring DC6.6W has occurred since October 2002 (M&A, 2018a). Flow observations are summarized in Table A-13; flows generally range from 0.5 - 2 gpm, with higher flows noted during storm water runoff events.

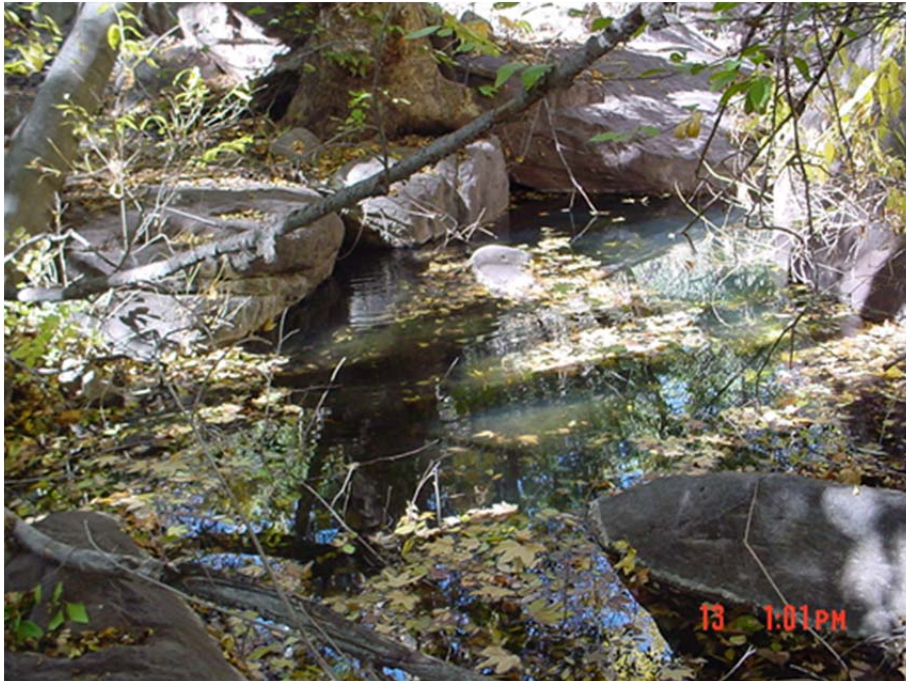
Photograph A-33. DC 8.2W, view spring discharge pool near main channel, October 2002

DC 8.2W is a perennial hillslope spring complex, located on the west side of Devils Canyon between Hackberry and Oak Canyons. DC 8.2W is the largest spring complex noted in Devils Canyon. There are two springs at this location approximately 66 feet apart, with flow connection to the main channel.

Periodic monitoring of flow and water quality parameters for Spring DC8.2W has occurred since October 2002 (M&A, 2018a). Flow observations are summarized in Table A-14; flow measurements range from 1 – 15 gpm. Groundwater discharges through fracturing in the Apache Leap Tuff, and emerges from under a large boulder and pools in several areas.

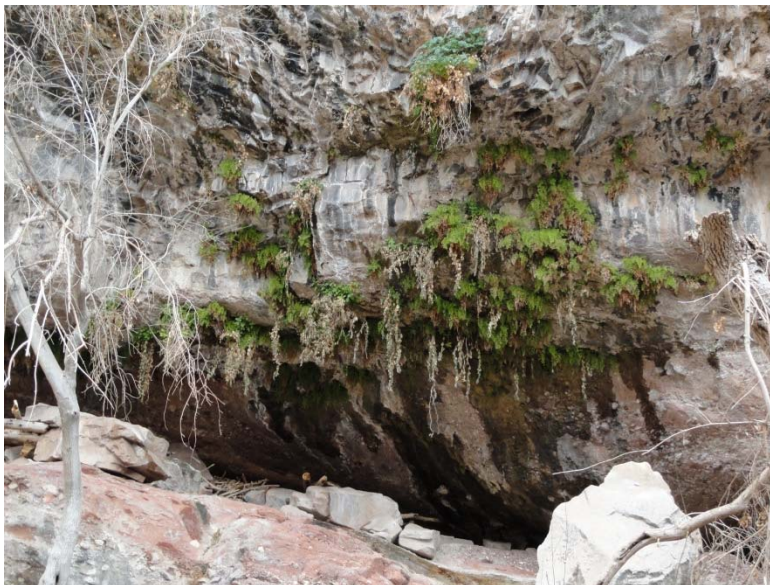
Photograph A-35. Hanging garden spring DC 6.1E, start of Devils Canyon lower reach, February 2011

This perennial flowing reach occurs in Devils Canyon below the lower Crater Tank (Golder Associates, 2003). The reach begins at the hanging garden spring DC 6.1E at the contact of the megaspherelyte and vitrophyre units of the ALT with the Whitetail conglomerate (Tw). ALT water that is perched above the less permeable vitrophyre and the conglomerate discharges into the canyon from the eastern wall. Surface flow continues through the channel to the 5.44 kilometer mark where it disappears into alluvial cover.

Surface water occurrence surveys have been conducted in the Devils Canyon study area starting in November 2002. Average discharge measured at DC 5.5C datasonde ranges from 0 to 0.204 cubic feet per second (cfs) per year since 2003 (M&A 2017).

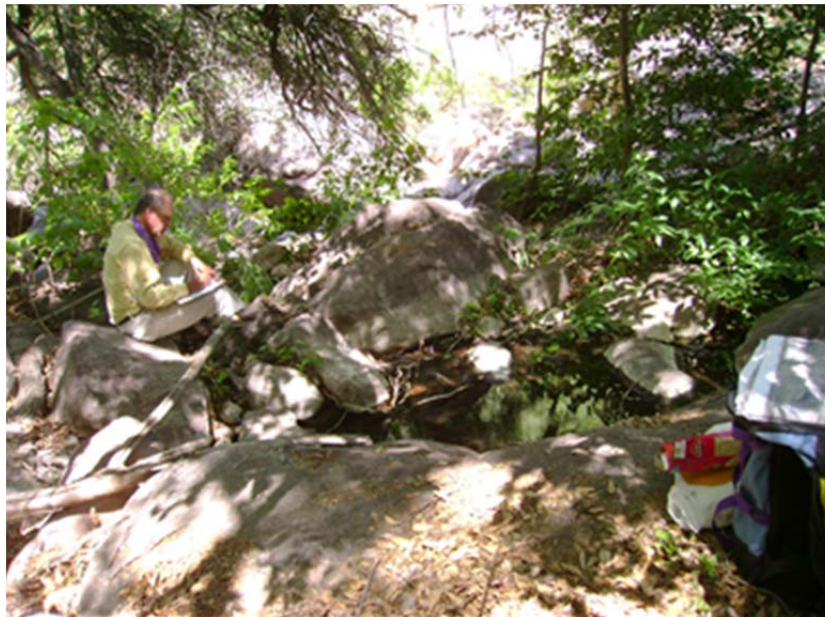
Photograph A-36. DC 9.14 to 7.53, Riparian vegetation includes Arizona alder, Bonpland's willow and western poison ivy, May 2011

This stretch of perennial flowing water in Devils Canyon begins just below the confluence with Rancho Rio Canyon. This perennial reach is believed to be structurally controlled by faulting along the southeast boundary of the Resolution graben. Water upwells from the ALT aquifer along the southwest-northeast striking fault that runs perpendicular to Devils Canyon. In addition to groundwater, streamflow is supported by surface water runoff from Upper Devils Canyon, as well as contributing side drainages: Rancho Rio Canyon, Hackberry Canyon, and Oak Canyon.

Surface water occurrence surveys have been conducted in the Devils Canyon study area starting in November 2002. Surface flow was quantified using the November seven-day low flow statistic, which is calculated as the minimum of the seven-day moving average streamflow, calculated during November. Average streamflow measured at DC 8.1C datasonde ranges from 0.002 to 0.051 cfs since 2011, and from 0.024 to 0.688 cfs per year at DC 8.8 since 2002 (M&A 2017).

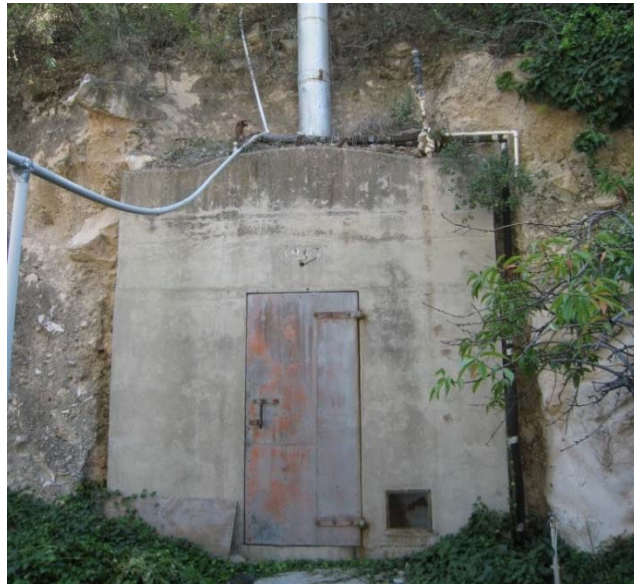
Photograph A-37. Entrance to the Government Springs vault, September 2008

Government Spring is a perennial rheocrene spring located in Mineral Creek, above the confluence with Lyon's Fork. Several springs discharge from a brecciated outcrop of Apache Leap Tuff along the edge of the Mineral Creek floodplain. The main spring is contained in a large covered spring box in a horizontal tunnel excavated into the slope. Several other small spring boxes occur in the area. The spring supplies water for potable and irrigation supply for the Government Springs Ranch.

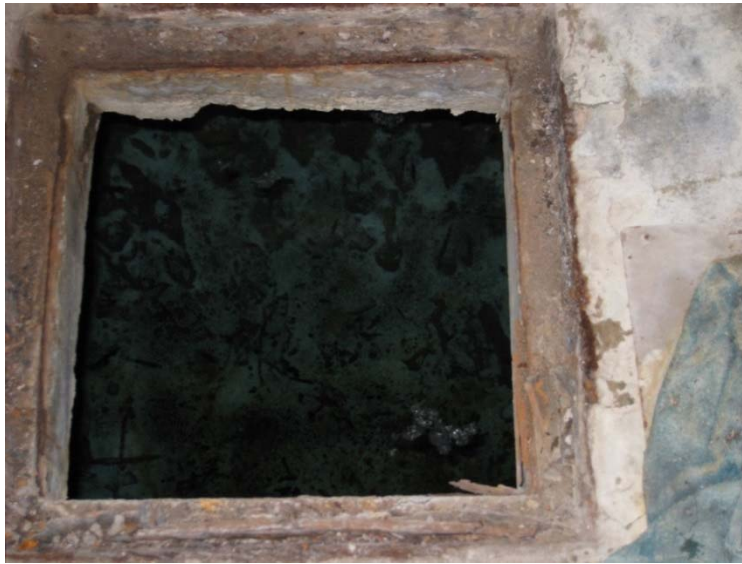
Photograph A-38. Government Spring, developed and covered pit located in vault, September 2008

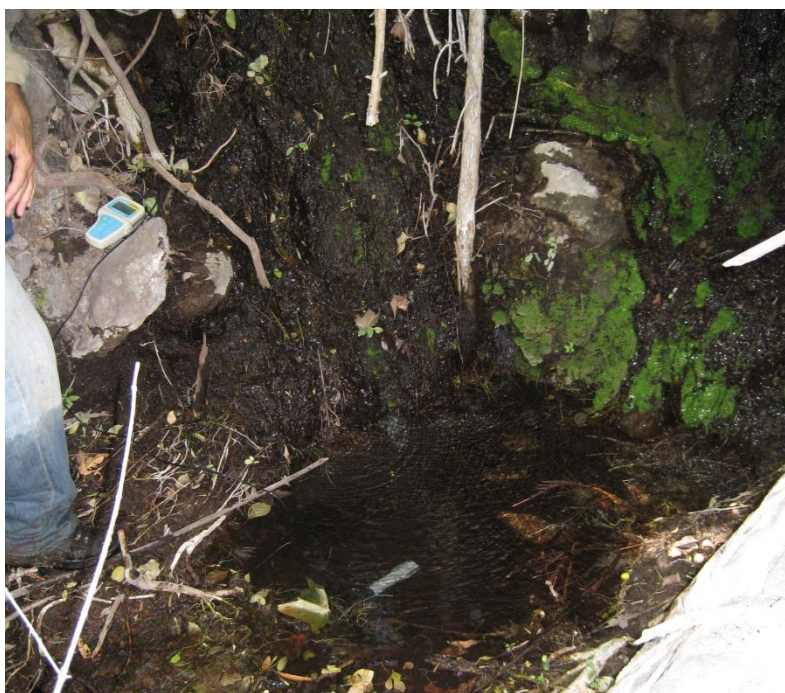
Photograph A-39. MC 3.4W, water seeping from TAL on western side of Mineral Creek, September 2008

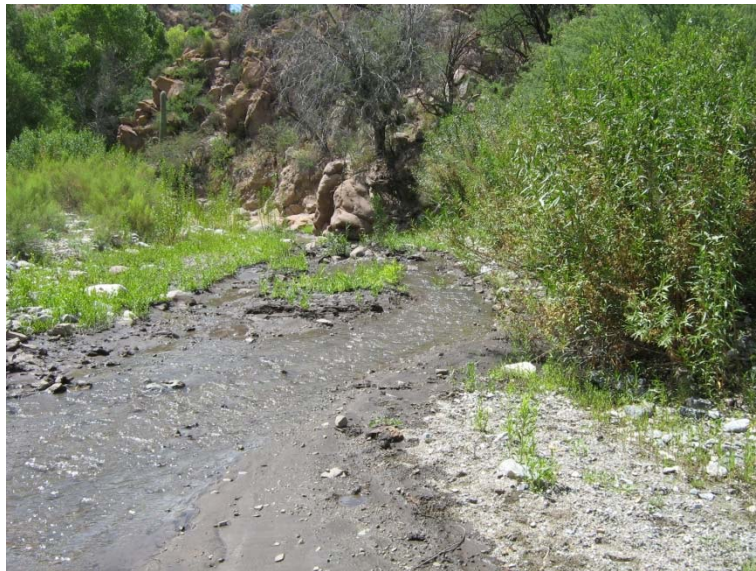
Photograph A-40. MC 8.4 to 7.8, water flowing in Mineral Creek after storm, July 2010

This perennial flowing reach begins below Government Springs Ranch and flows from 8.4 to 7.8 kilometers upstream of the confluence with Devils Canyon (Figure 1). The reach begins flowing from the alluvium where Apache Leap Tuff outcrops in the creek bed, and flows continually, or intermittently, for approximately 1,969 feet before seeping back into the channel alluvium. Sampling location MC 8.4C has been monitored since 2008 for surface water occurrence and surface water hydrochemistry.

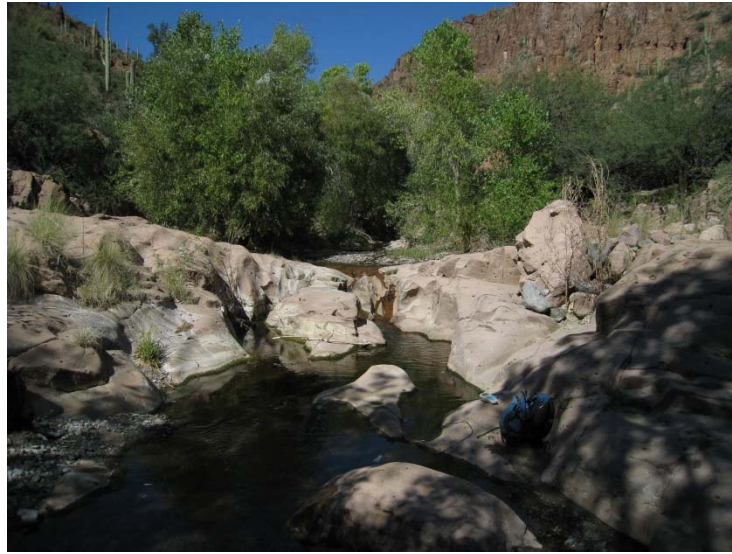
Photograph A-41. Designated location of Lower Mineral datasonde, September 2008
