FIELDNOTES

Volume 14 No. 2

THE "FLOODS" OF OCTOBER 1983

by H. Wesley Peirce
and Peter L. Kresan

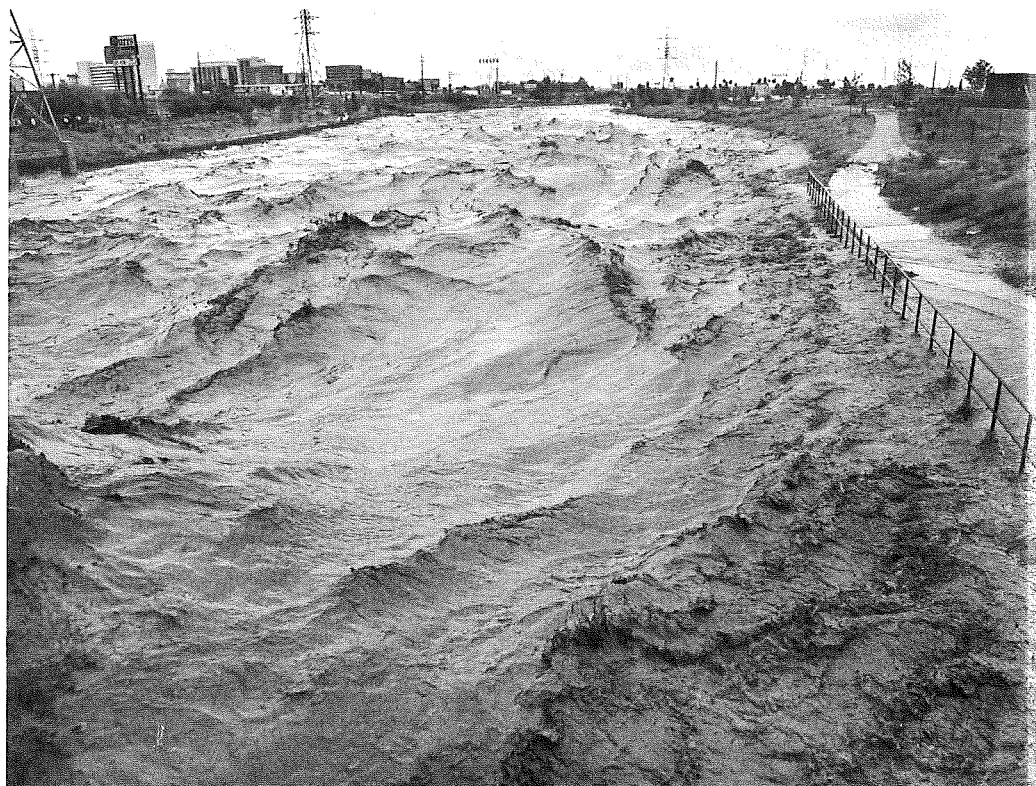
Figure 1. Raging waters of the brimful Santa Cruz River. Looking upstream to the south from St. Mary's Bridge. Photo taken on October 2, 1983 by Peter Kresan.

Those who witnessed one or more of the major drainages in action were reminded of the frightening power of rushing, roily water (Figure 1). A flow rate of 25,000 cubic-feet-per-second (estimated for Rillito Creek) is about equivalent to an 800-ton mass moving past a given point each second. (An 800-ton mass weighs more than two 747 Jumbo Jets, which weigh 775,000 pounds each.)

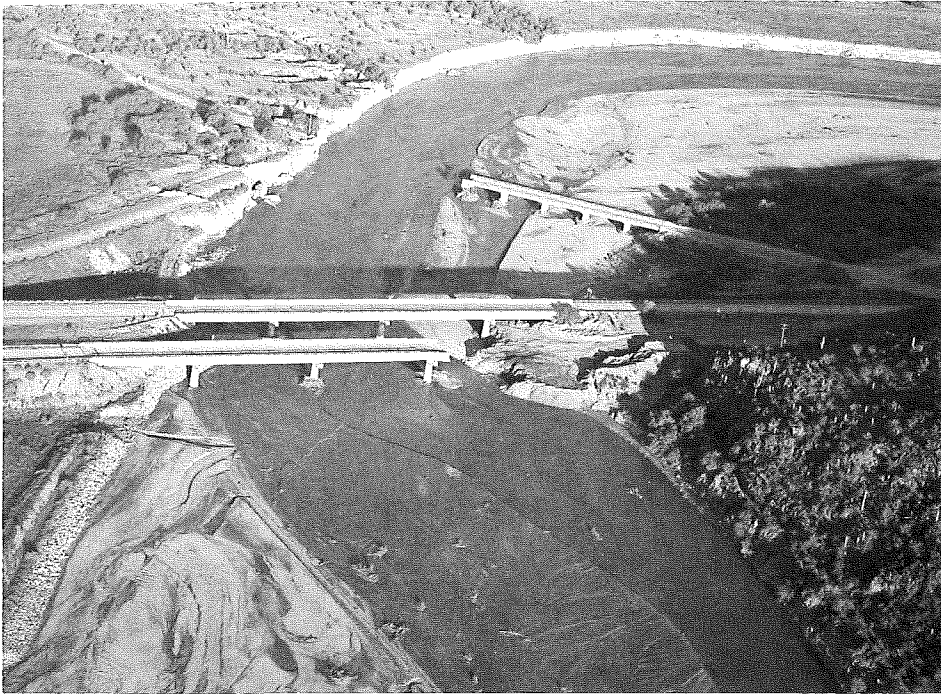
Figure 2a. Severe bank-cutting along the Santa Cruz River near I-19 and San Xavier Road. Looking northwest. Bridge segment nearest viewer collapsed when support washed out. Bridge in distance did *not* fail. Bank retreated from west end of bridge to present position. Distance between bank and midstream end of bridge is measure of amount of bank erosion that occurred. Photo taken on October 9, 1983 by Peter Kresan.

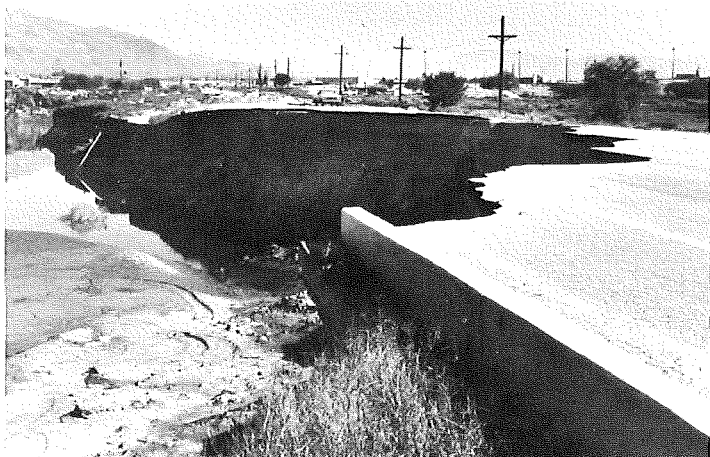
Figure 3a. Ina Road undercut by water from adjacent Santa Cruz River. Looking northeast. Photo by Ken Matesich.

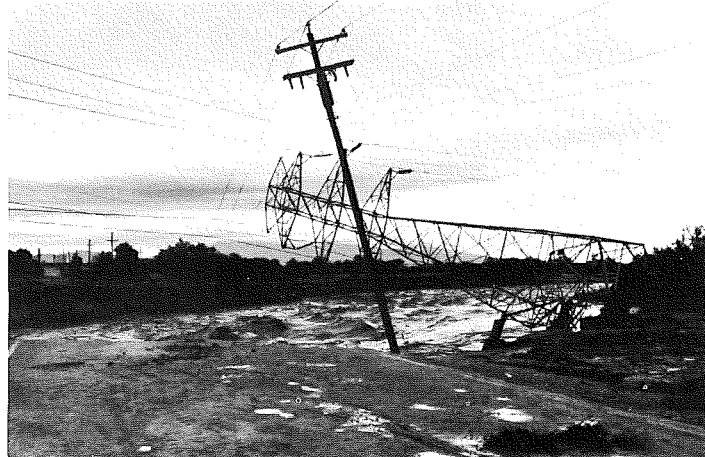
Figure 3b. Wipeout of bridge and utility tower at Sunset Road crossing of Santa Cruz River. Looking southeast. Photo taken on October 2, 1983 by Steve Reynolds.

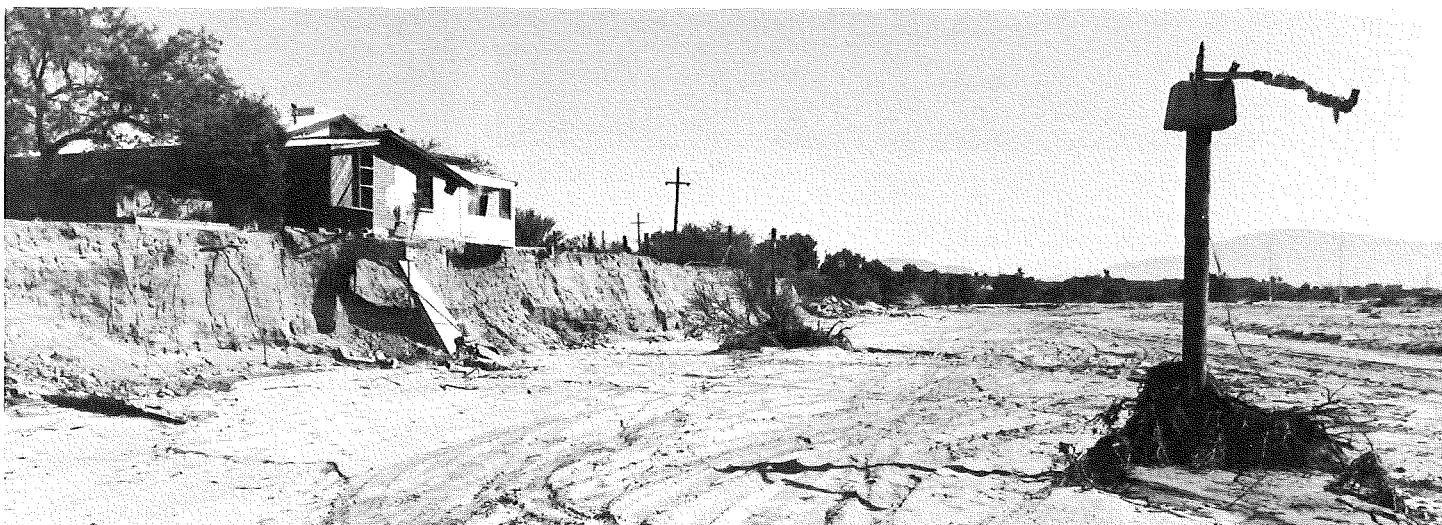
Figure 3c. Same area as Figure 2d. Looking upstream at water well that was on left side of bank before erosion. Photo by Ken Matesich.

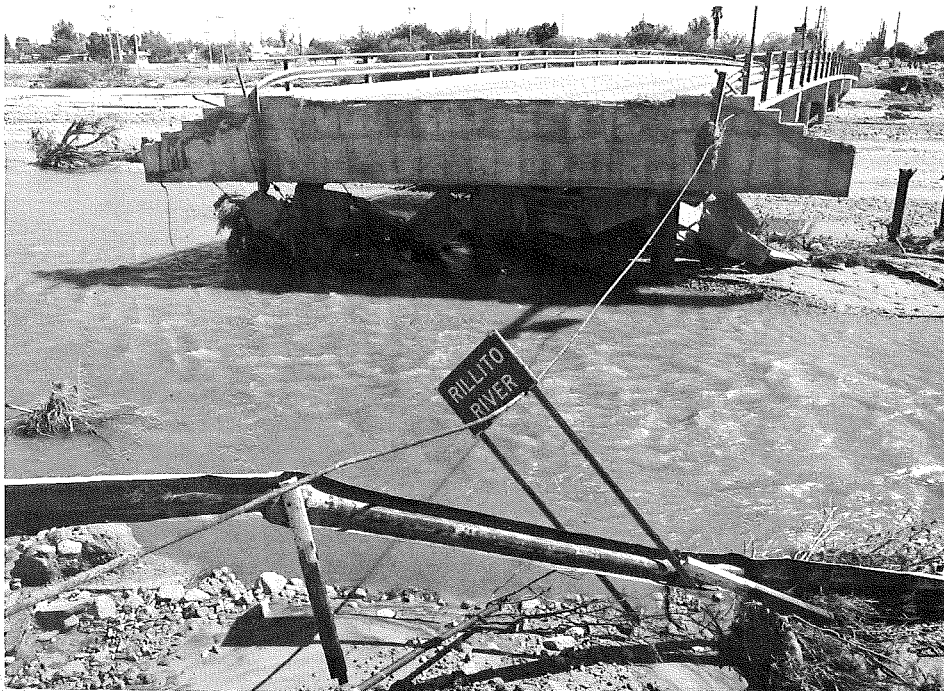
Figure 3d. Wipeout of northern approach to Dodge Boulevard Bridge over Rillito Creek. Looking south. Photo by Peter Kresan.

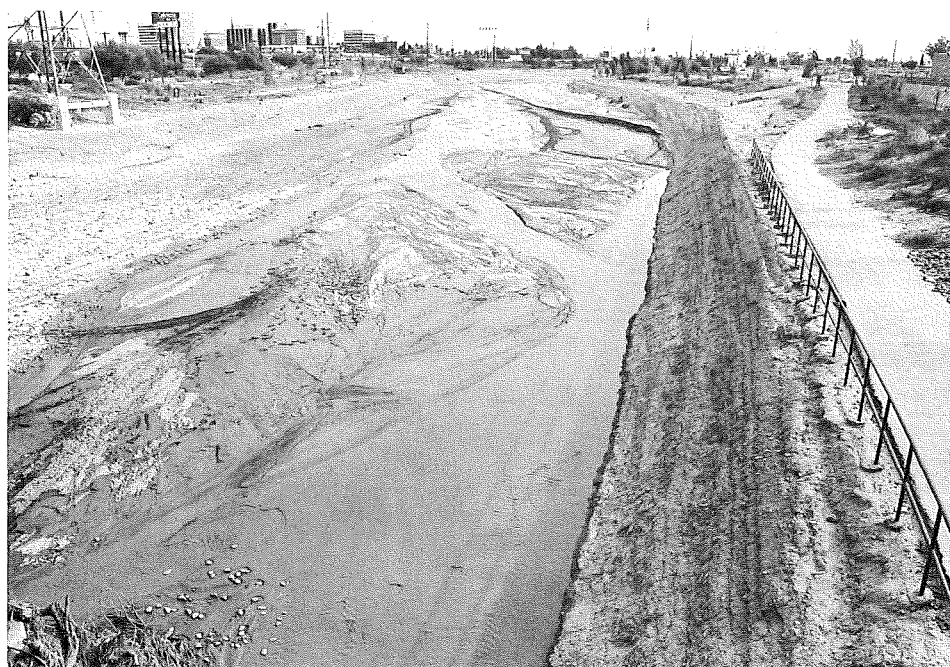
Figure 6a. Same area as Figure 1 after passage of major flow. Right bank with railing is undamaged soil cement. Photo by Peter Kresan.

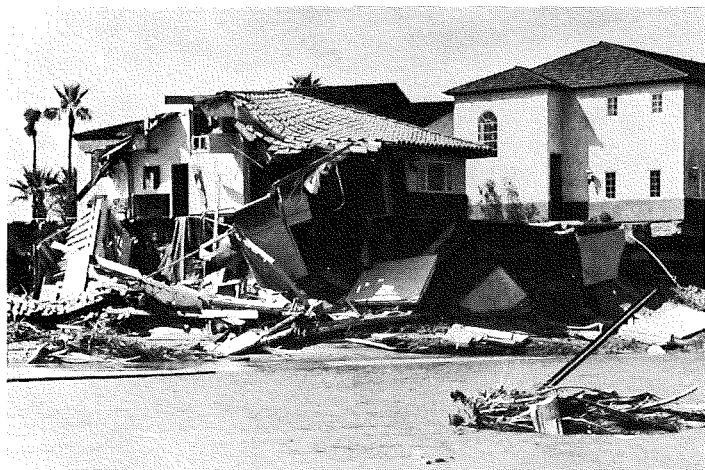
Figure 7a. Post in foreground marks position of bank-protection device prior to October 1983. South bank of Rillito Creek near N. 1st Avenue. Photo by Peter Kresan.

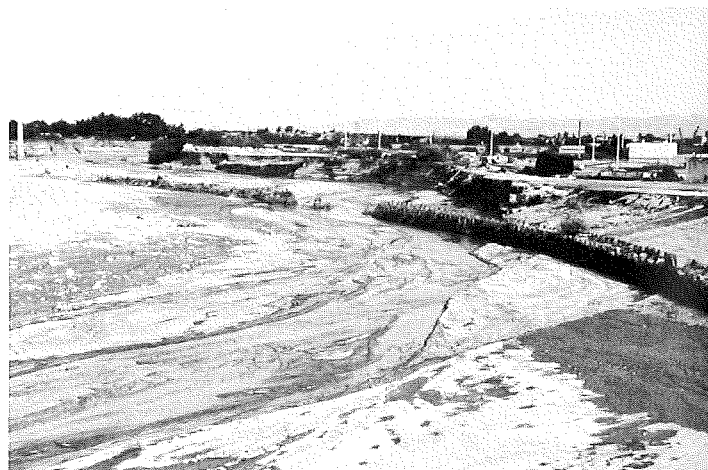
Figure 7b. Rock-and-wire-mesh bank-protection device breached and overtopped in October 1983. Looking north along Santa Cruz River from bridge at W. Grant Road. Photo by H. Wesley Peirce.

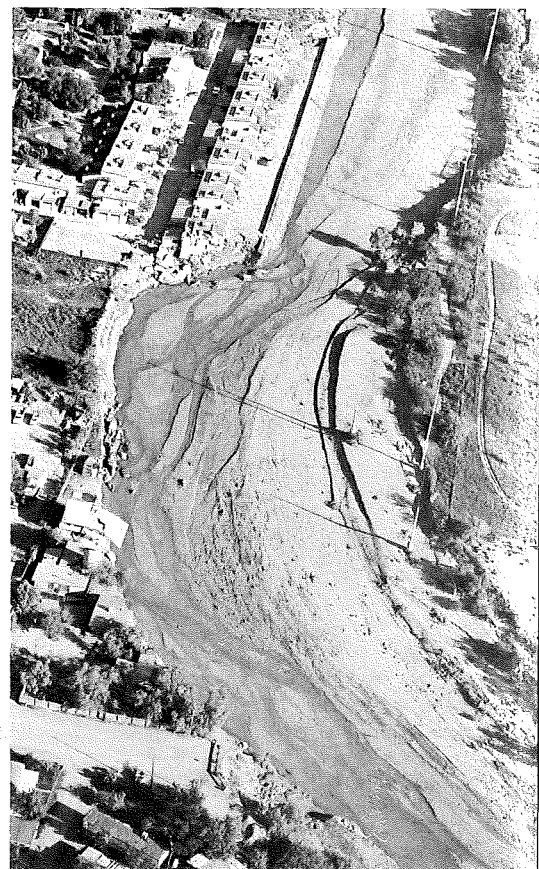
Figure 9. Bank collapse after Rillito Creek got behind upstream end of soil-cement protective device and undermined buildings. Flow is from bottom to top. There was no bank protection for buildings in lower left position. Near intersection of Prince and Country Club Roads. Photo taken on October 9, 1983 by Peter Kresan.
