Fundão Tailings Dam Review Panel

Report on the Immediate Causes of the Failure of the Fundão Dam

EXECUTIVE SUMMARY

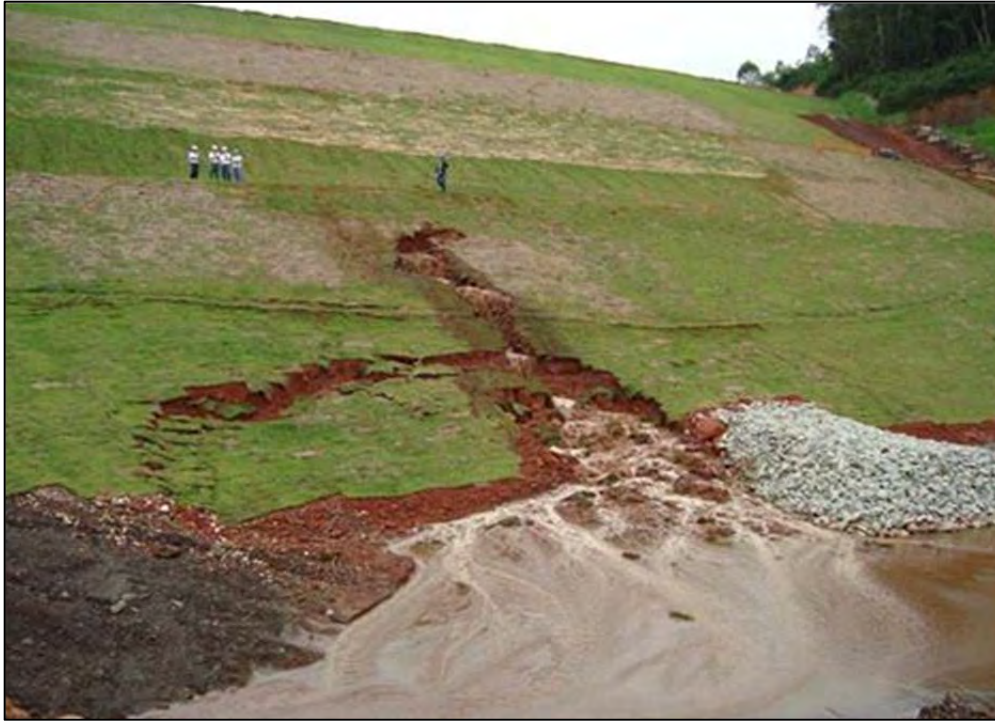
Figure 2-6 Internal erosion effects on downstream slope of Dike 1

Construction of the Dike 1 Starter Dam, with its requisite drains and galleries, was completed in October, 2008. Shortly after full-scale discharge of sand tailings began on April 13, 2009, large seepage flows carrying fines appeared on the downstream slope above the main underdrain as shown on Figure 2-6, conditions symptomatic of the process of *piping* or *internal erosion*.

An Emergency Action Plan in place for the dam at that time was immediately implemented. The reservoir was lowered, a berm was constructed over the affected portion of the dam slope, and provisions were made for holding the reservoir's remaining contents in the downstream Santarem Dam should failure occur. Engineering investigations later revealed serious construction flaws in the base drain and its filters, including a portion of the drain's outlet that had never been completed. This allowed water pressure within it to build until causing the slope to erode and slump.

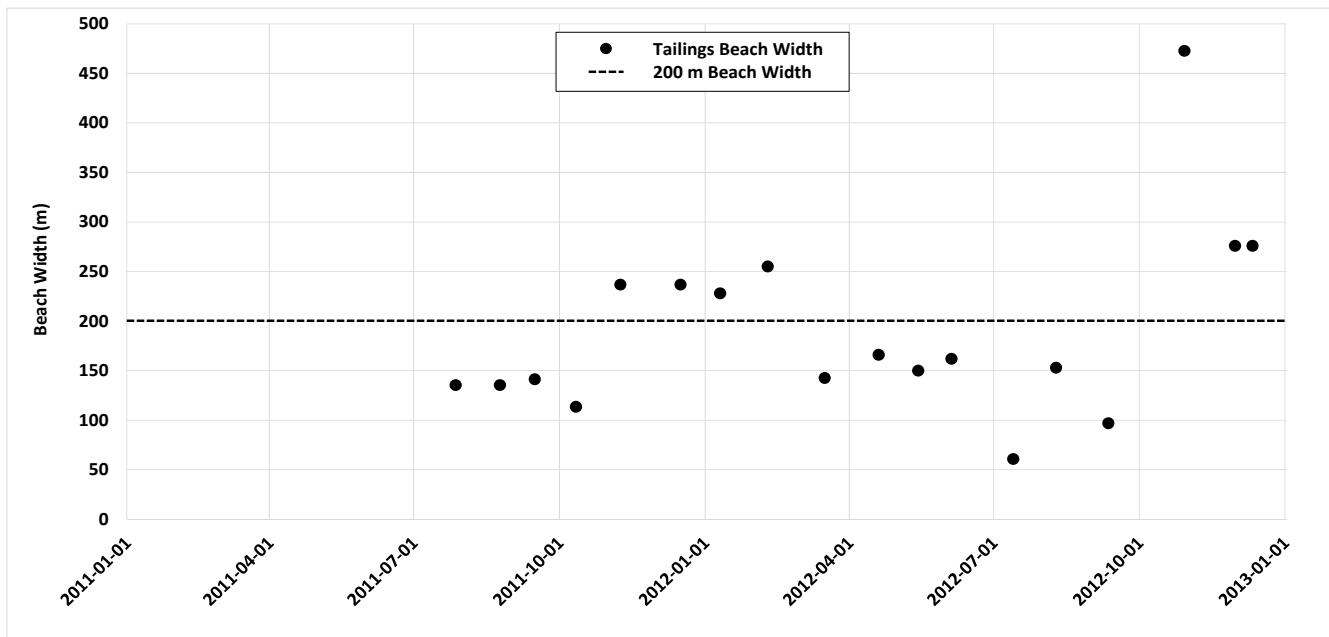
Figure 2-9 Monthly beach width measurements by Samarco, 2011-2012

But as operation proceeded, this beach-width criterion was not consistently achieved. As explained in greater detail in Section 5.1.3, a new Overflow Channel was conveying water and slimes from Dike 2 to the rear of the Dike 1 reservoir, making beach management more difficult. No longer were the sands and slimes physically separated; the interface between them could only be controlled by adjusting the amount of sand spigotted from the dam crest in relation to the amount of slimes-laden water being introduced. As plotted on Figure 2-9 and documented in Appendix B, during much of 2011 and 2012, beach widths violated the 200 m minimum more often than not, at times encroaching to as little as 60 m from the crest.

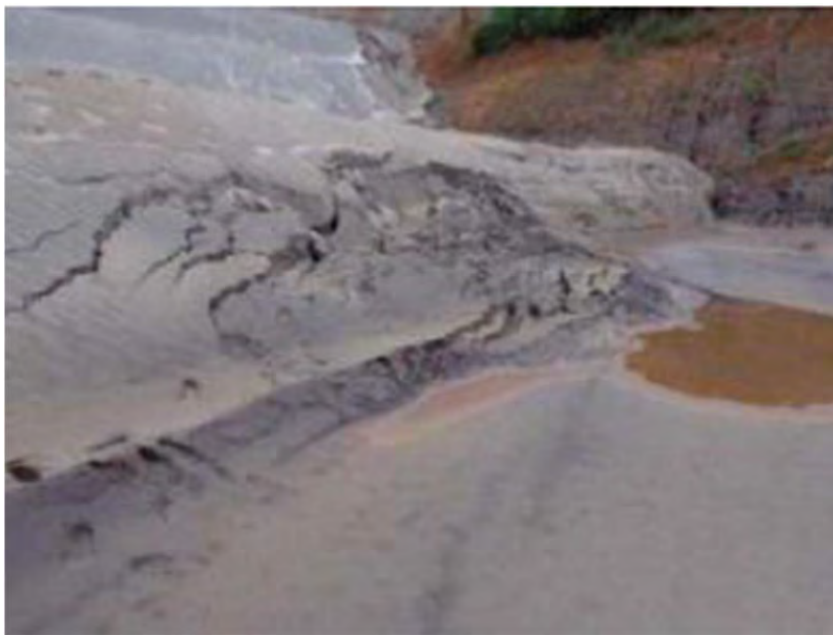
Figure 2-11 November, 2013 seepage, cracking, and slumping at left abutment El. 860 m

Filling of the Secondary Gallery was completed on August 22, 2013. Meanwhile, dam raising had continued, with seeps that began to appear at the left abutment as early as June 26, 2012, at El. 845 m. In February, 2013, three-dimensional seepage modeling of the 920 raise showed that additional drains would be needed at the abutments if seepage breakout were to be prevented. This analysis was borne out when seepage, saturation, and cracking began appearing at several locations at the left abutment during 2013. The first such incident occurred in March at El. 855 m, followed by another seep in June at El. 855 m. Both were treated by constructing a drain. A third seep on November 15 appeared at El. 860 m and was accompanied by slumping of the slope shown on Figure 2-11. Another drain was provided to address this condition. On December 26, seepage occurred at El. 860 m and there was cracking on the left abutment crest at El. 875 m.

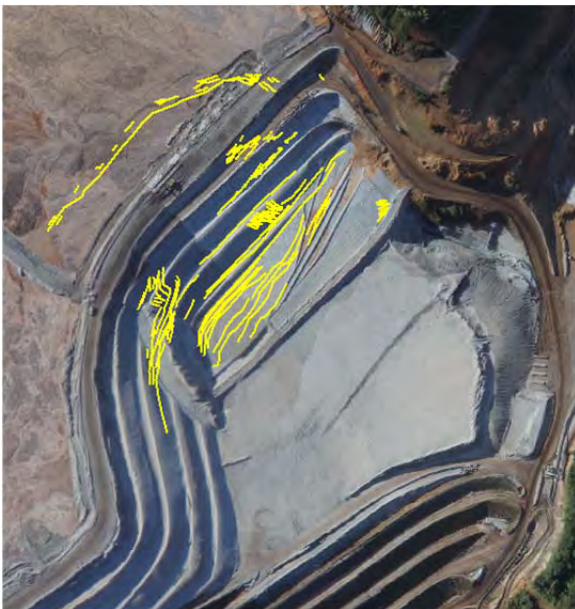
Figure 2-14 August 27, 2014 cracking at left abutment setback

Just after sunrise on August 27, 2014 a series of cracks much more extensive than anything that had occurred the previous year were discovered that extended behind the dam crest, emerged at the toe, and encompassed most of the slope as shown on Figure 2-14. Accompanying the cracking was shallow saturation at the toe, as shown on Figure 2-15.

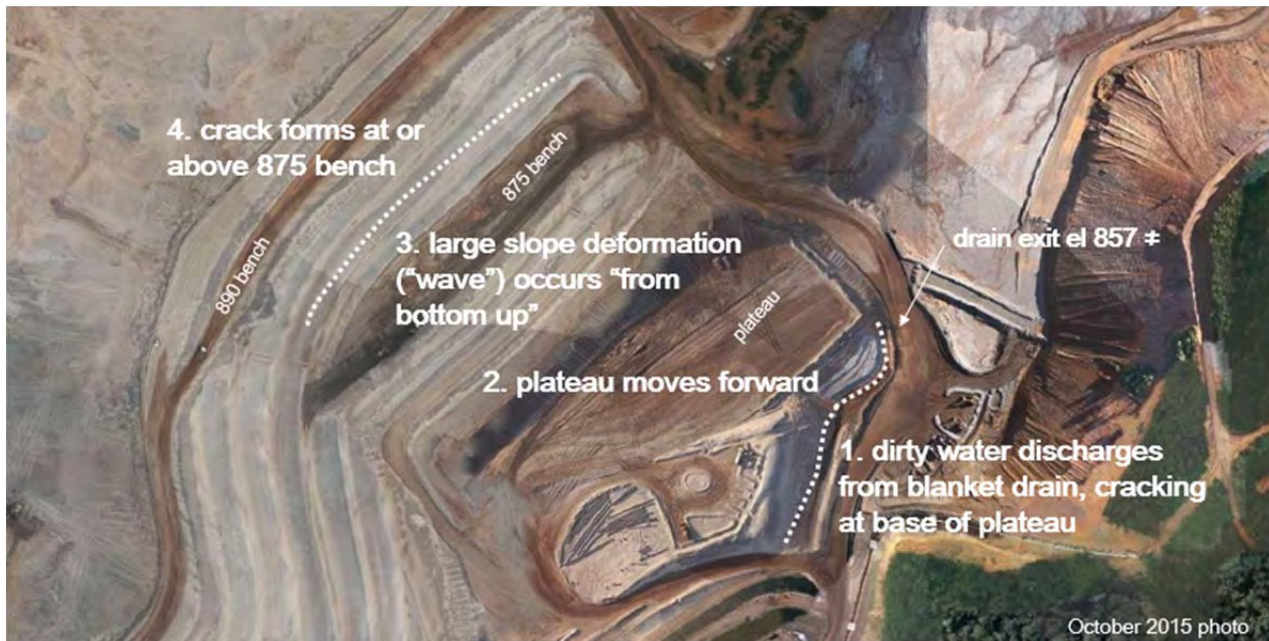
Figure 2-18 Failure initiation sequence

Next to move was the lower slope of the setback. Eyewitnesses at 2, 3, and 5 describe slope movement having propagated “from the bottom up” on the lower benches, not from the crest down, placing the seat of movement at lower elevations. A worker at 3 observed a small bulldozer on the El. 875 m bench moving or being pushed outward, placing the head of the incipient failure at or above this elevation. At first, the lower slope progressed slowly forward “like a snake.” Remaining intact and moving as a unit, it then bulged, becoming grossly distorted as movement accelerated, coming down “like a wave,” or as if it were “melting”. Subsequently, a witness at 3 characterized the violent turbulence of the fluidized mass as “going in somersaults” downstream.

By the time the events on Figure 2-18 had occurred, the growing failure would have become apparent to the observers on the crest at locations 4, 5, and 6 as it progressed back behind the crest and into the reservoir. Only then did the central and right sides of the dam begin to disintegrate.

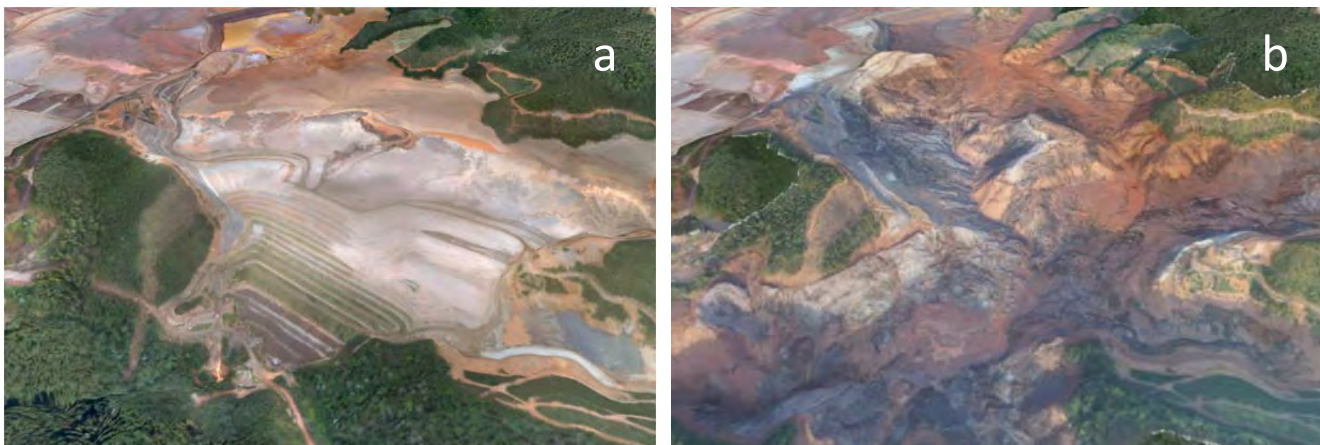
Figure 2-19 Fundão damsite and reservoir (a) before, (b) after failure

A conveyor crossing the Fundão stream channel about 1300 m downstream from the offset crest stopped functioning at 3:49PM, four minutes after failure is reported to have begun at 3:45PM. From this, it is ascertained that the flowslide was moving at about 11 m/s by the time it reached the conveyor. It is calculated that 32 million m³ of tailings was lost, representing 61% of the impoundment contents—an unusually high proportion in relation to tailings dam failure statistics. In a matter of hours, the Fundão Dam was gone, and what once had been Figure 2-19(a) became Figure 2-19(b).

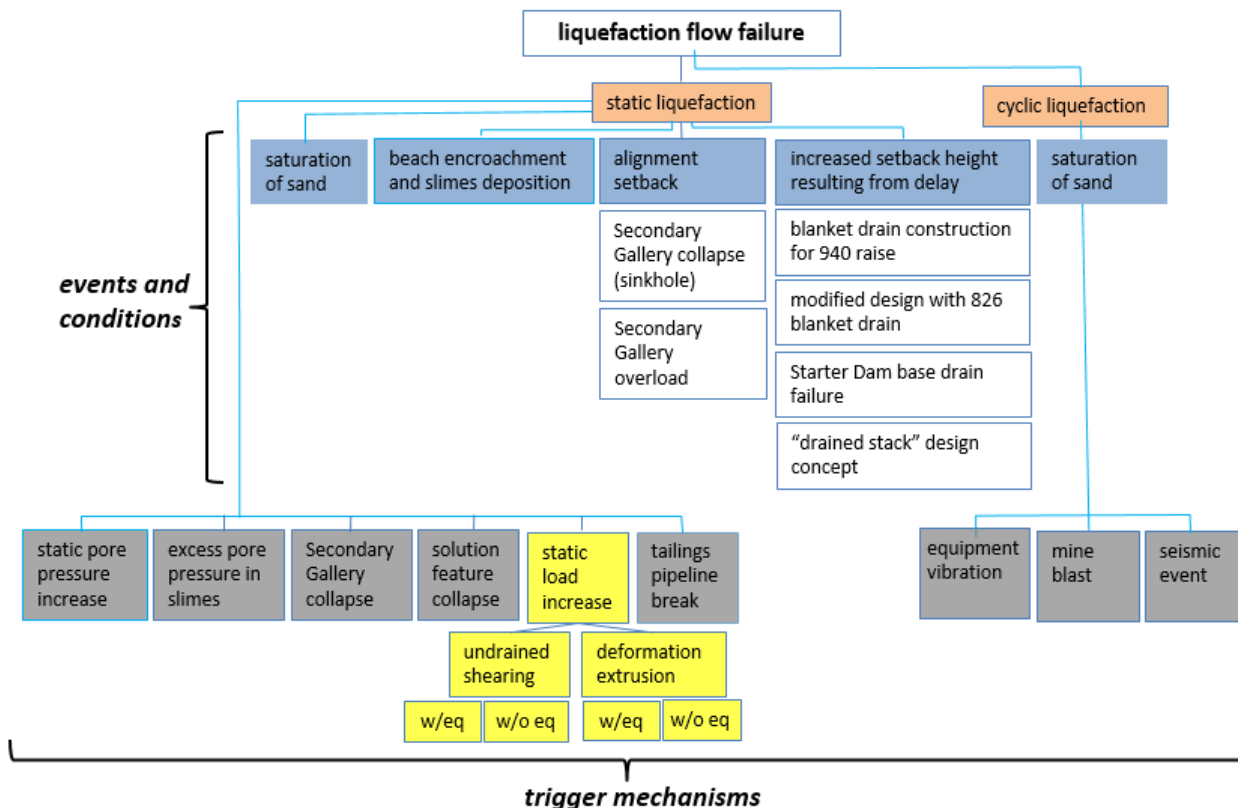
Figure 3-1 Fault tree for liquefaction triggering

The top event on Figure 3-1 is liquefaction flow failure. The next tier of events represents the two fundamental liquefaction processes: static and cyclic, either of which might have been operative. In this representation, cyclic-induced liquefaction flow failure is distinct from cyclic pore pressure contribution to static liquefaction.

The surviving liquefaction trigger mechanism is static load increase, shown in yellow on Figure 3-1 with its two subsidiary processes: undrained shearing and deformation-related extrusion. Both of these might be operative either with or without cyclic pore pressure contribution from the November 5, 2015 earthquake series.

Also important on Figure 3-1 are the antecedent events and conditions shaded in blue that allowed or promoted static liquefaction at the left abutment. These are: (1) saturation of the sand; (2) water encroachment that allowed slimes deposition on the tailings beach; (3) the alignment setback; and (4) the increased height of the setback resulting from continued raising of the dam.

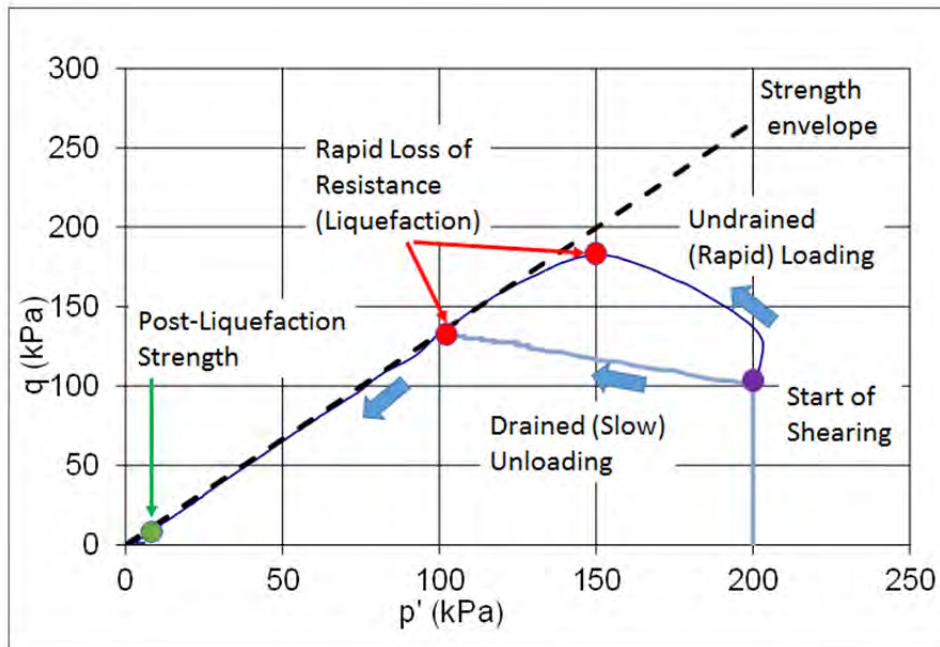
Figure 4-1 Stress paths for undrained loading and drained unloading of sand, Fundão test data

In the first test, conventional undrained loading is applied to simulate rapid shearing. When the stress path reaches the strength envelope it reaches a condition of liquefaction. As shearing resistance reduces due to changes in pore pressure, it progresses downward along the envelope and strength rapidly diminishes until arriving at a very low *post-liquefaction* strength.

The second test represents a different stress path central to understanding the Fundão failure. Instead of being loaded, the sample is laterally unloaded to simulate horizontal spreading. In addition, the unloading process is conducted slowly under drained conditions. As seen on Figure 4-1, the behavior on reaching the strength envelope is the same as before: liquefaction occurs, strength rapidly decreases, and the same *post-liquefaction* value results. In both tests, the loss of strength accompanying liquefaction is dramatic and nearly instantaneous, so much so that this behavior is sometimes referred to as *collapse*. The parallels between this kind of behavior in the laboratory and that which occurred during the Fundão failure are evident.

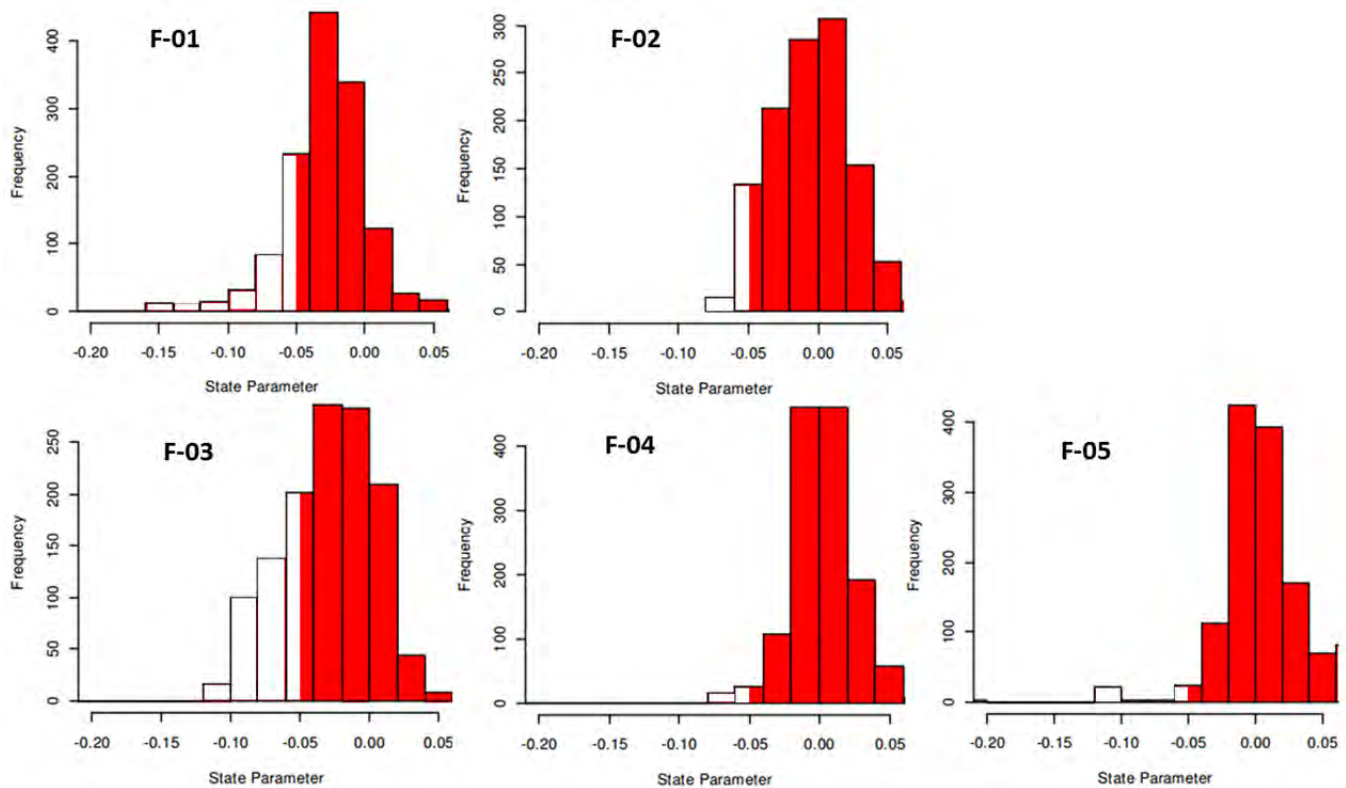
These principles are applied to the Fundão tailings sand on Figure 4-4 that provides a statistical summary from Appendix C of CPT data on sand tailings obtained by Samarco prior to the failure in early 2015. The five CPTs were located along two transects on the Fundão tailings beach, one behind the left abutment setback and another in the central portion. While in theory contractive materials are those having $\psi > 0$, in practice $\psi > -0.05$ is often adopted as the boundary (Shuttle and Cuning 2007).

Shaded areas on Figure 4-4 indicate relative proportions of contractive material. Upper and lower histograms are for the left abutment and central transects, respectively, at locations given in Appendix C.

On this basis, approximately 70% to 80% of the sand tailings within 75 m of the dam crest are indicated to have been contractive, and 95% or more at greater distance up to 180 m. This demonstrates that the majority of hydraulically-discharged Fundão sand tailings satisfied the contractiveness requirement for liquefaction flowsliding. This is confirmed by CPT-based liquefaction criteria developed by Robertson (2010) on Figure 4-5 that supplements state parameter with liquefaction field case histories. These include flow liquefaction of the Nerlerk offshore berm for the encircled point labeled 19, 20, and 21, a case that figures prominently in the Fundão assessment as subsequently explained in Section 6.

Figure 4-4 Histograms of state parameter for Fundão sand tailings

The second campaign from September, 2014 to March, 2015 has the most data in the region of interest. CPTs F-01 to F-05, which explore from El. 854 m to El. 889 m, all reveal contractant characteristics of beach material, consistent with the existence of potential collapse behavior. Relevant data has previously been summarized on Figure 4-4.

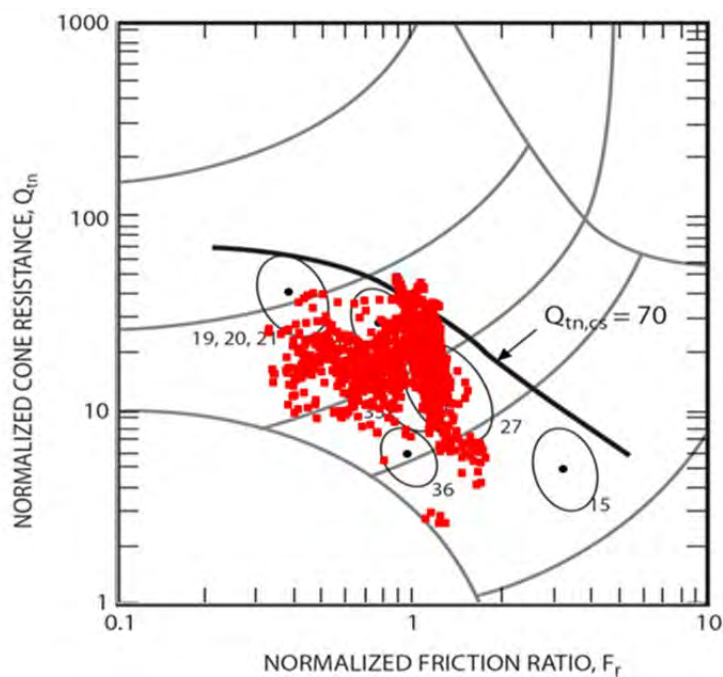
Figure 4-5 Robertson (2010) liquefaction criterion for Fundão CPT F-02 data

With respect to the CPT profiles, the Panel has utilized the Robertson (2010) procedure previously shown on Figure 4-5 for evaluating the contractant/dilatant behavior of the deposits, primarily because it incorporates liquefaction failures of tailings dams and other deposits for immediate comparison. All CPT interpretations are available in Appendix C.

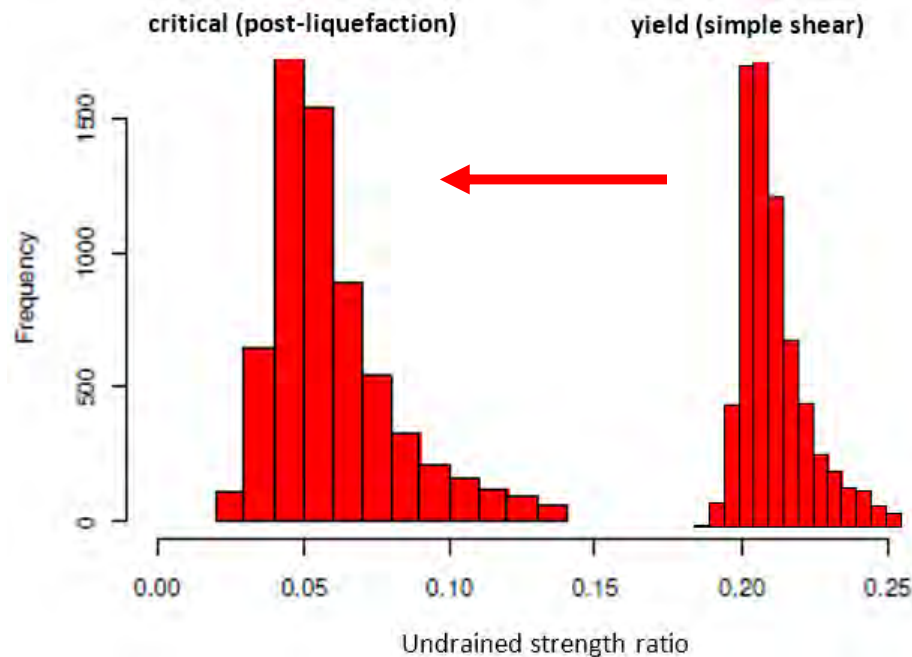
Figure 4-6 shows that mean undrained strength ratio dropped from 0.21 before the flowslide to 0.07 during it, demonstrating that the Fundão sand tailings were susceptible to significant loss of strength.

Figure 4-6 Yield (pre-flowslide) and critical (post-flowslide) undrained strengths for aggregated 2015 Fundão CPT data

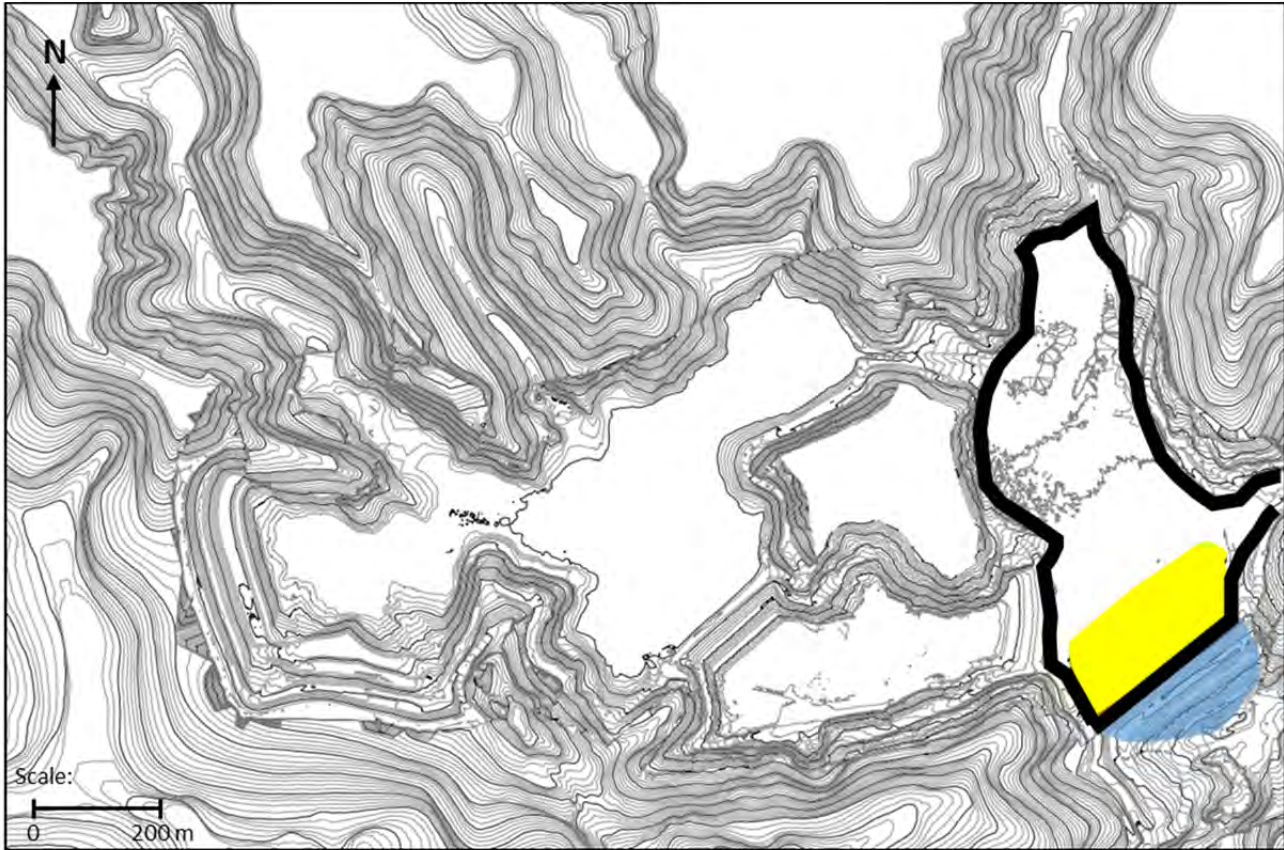
The progression of conditions that promoted saturation is best illustrated by the following series of figures that integrates this information. Figure 4-7 shows the blanket drain in July, 2011, shortly after its completion the previous November. At that time the drain spanned the entire width of the Starter Dam. In this early configuration—which most closely resembled the original drained-stack concept—the impoundment size was limited and the drain was beneath the discharged tailings where it could intercept downward drainage to maximum effect.

Figure 4-7 July, 2011 configuration showing El. 826 m blanket drain (yellow), Starter Dam embankment (blue) and impoundment outline

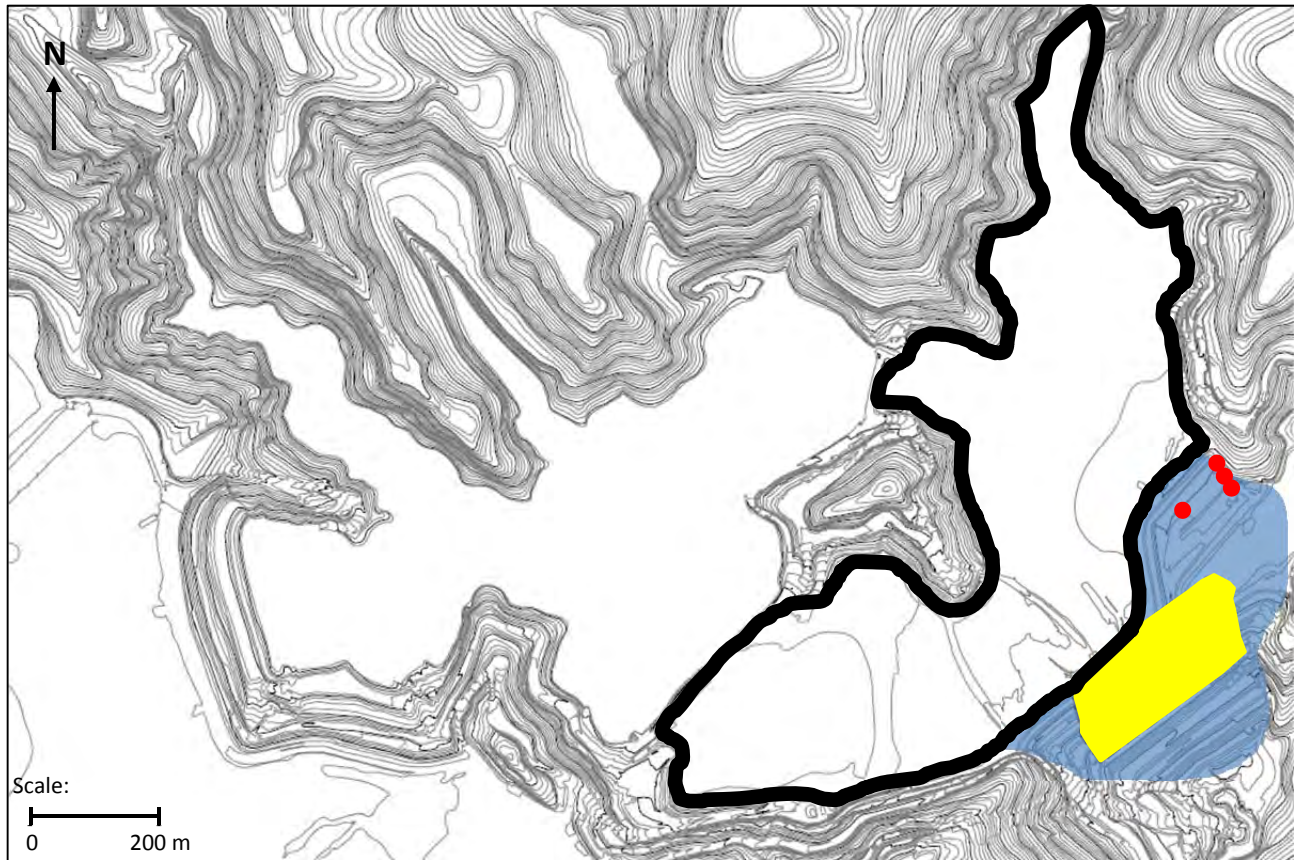
Figure 4-8 August, 2013 configuration showing El. 826 m blanket drain, raised dam, impoundment outline, and left abutment seeps (red dots)

Figure 4-8 shows that by August, 2013 both the embankment and impoundment had widened considerably as the dam grew higher, expanding beyond the limits of the drain on both sides. This had the effect of funneling seepage flow into the much narrower drain, and in the process raising the saturation level in the tailings. At the same time, the impoundment was moving upstream and becoming more distant from the drain as upstream dam raising progressed, also increasing the volume of saturated tailings.

With the left abutment setback by then in place, seeps appeared at El. 855 m in March and June, 2013 as the rising saturation reached the tailings surface, and again in November and December at El. 860 m. This shows that the saturation level at the surface of the left abutment rose some 5 m in elevation during the course of 2013. Localized drains constructed to treat these seeps had mostly near-surface effects, preventing further seepage breakout on the embankment face but not significantly reducing saturation in the tailings mass behind them.

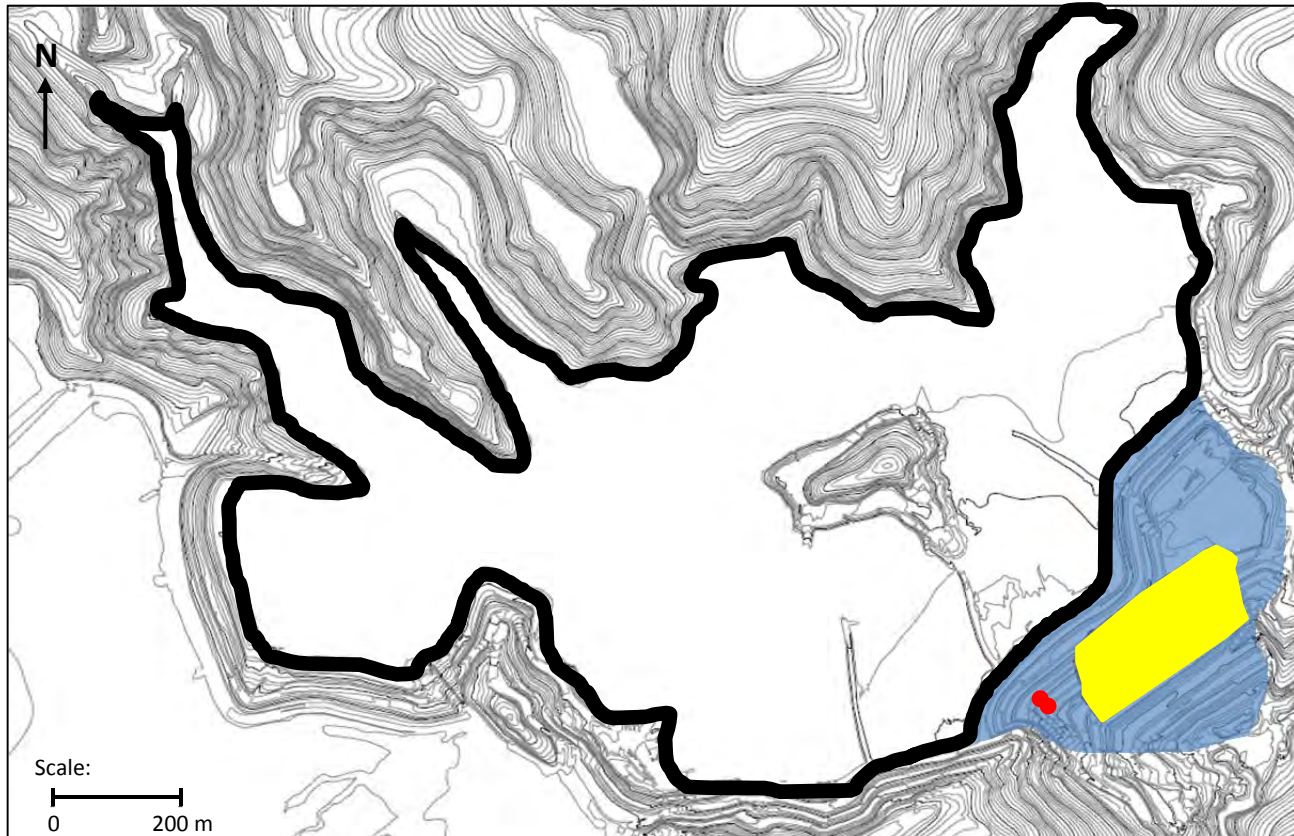
Figure 4-9 shows that by August, 2014 the impoundment had nearly doubled in size, principally on the right side. With this enlargement came a seep on the right abutment at El. 855 m in July, followed by another in January the next year. As upstream raising continued, the impoundment became even further removed from the drain, expanding the volume of saturated tailings behind it still further.

Figure 4-9 August, 2014 configuration showing El. 826 m blanket drain, raised dam, impoundment outline, and right abutment seeps (red dots)

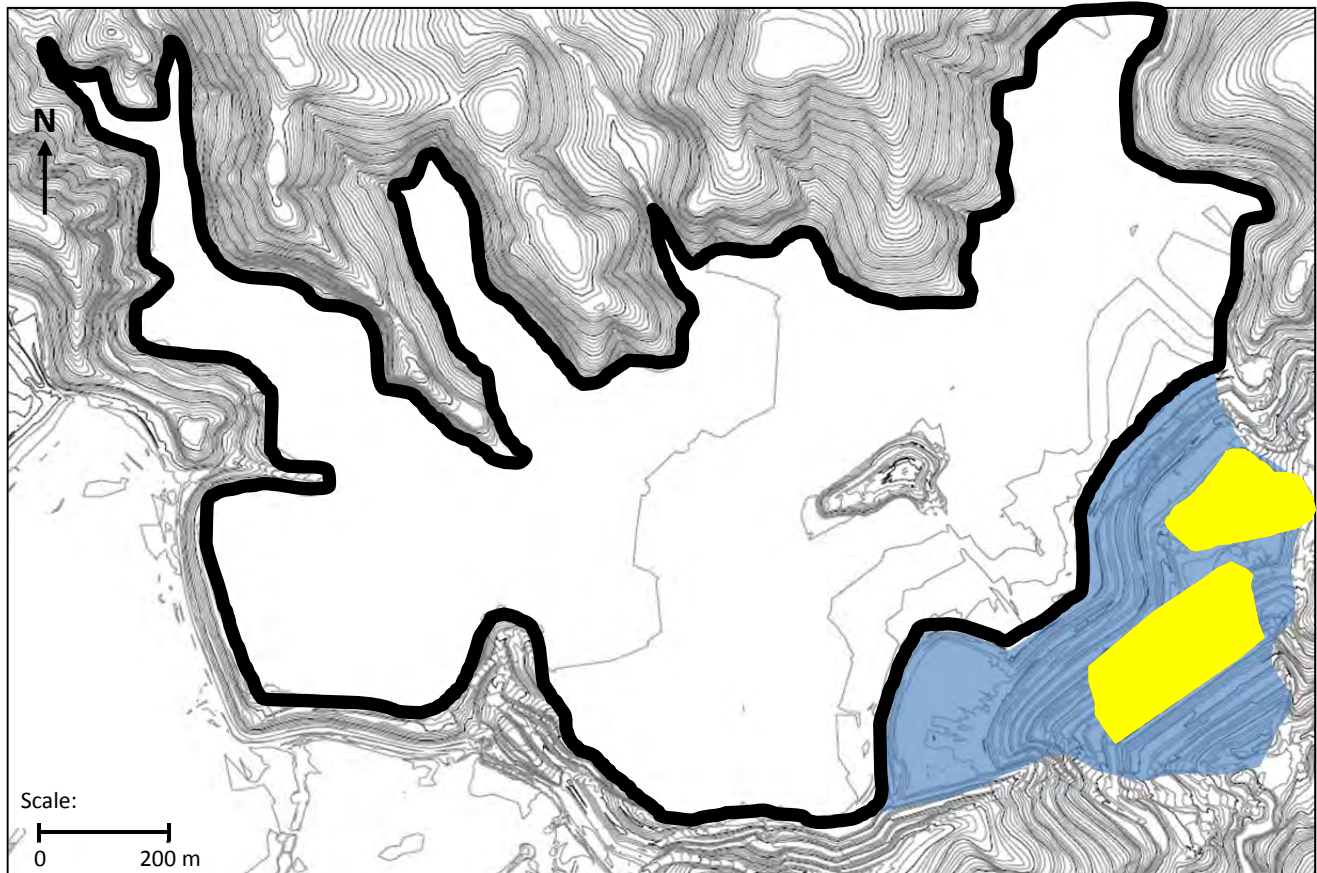
Figure 4-11 shows the drain configuration in November, 2015 with the ever-expanding impoundment. In preparation for the new 940 raise, the new blanket drain at El. 860 m had been completed at the left abutment setback and a companion drain at the right abutment was under construction. Had failure not intervened and had the dam alignment been restored, both of these new drains would have underlain the tailings much as the El. 826 m blanket drain once did. But as it was, neither had any effect on the tailings saturation that had already developed.

Figure 4-11 November, 2015 configuration showing El. 826 m and El. 860 m blanket drains, raised dam, and impoundment outline

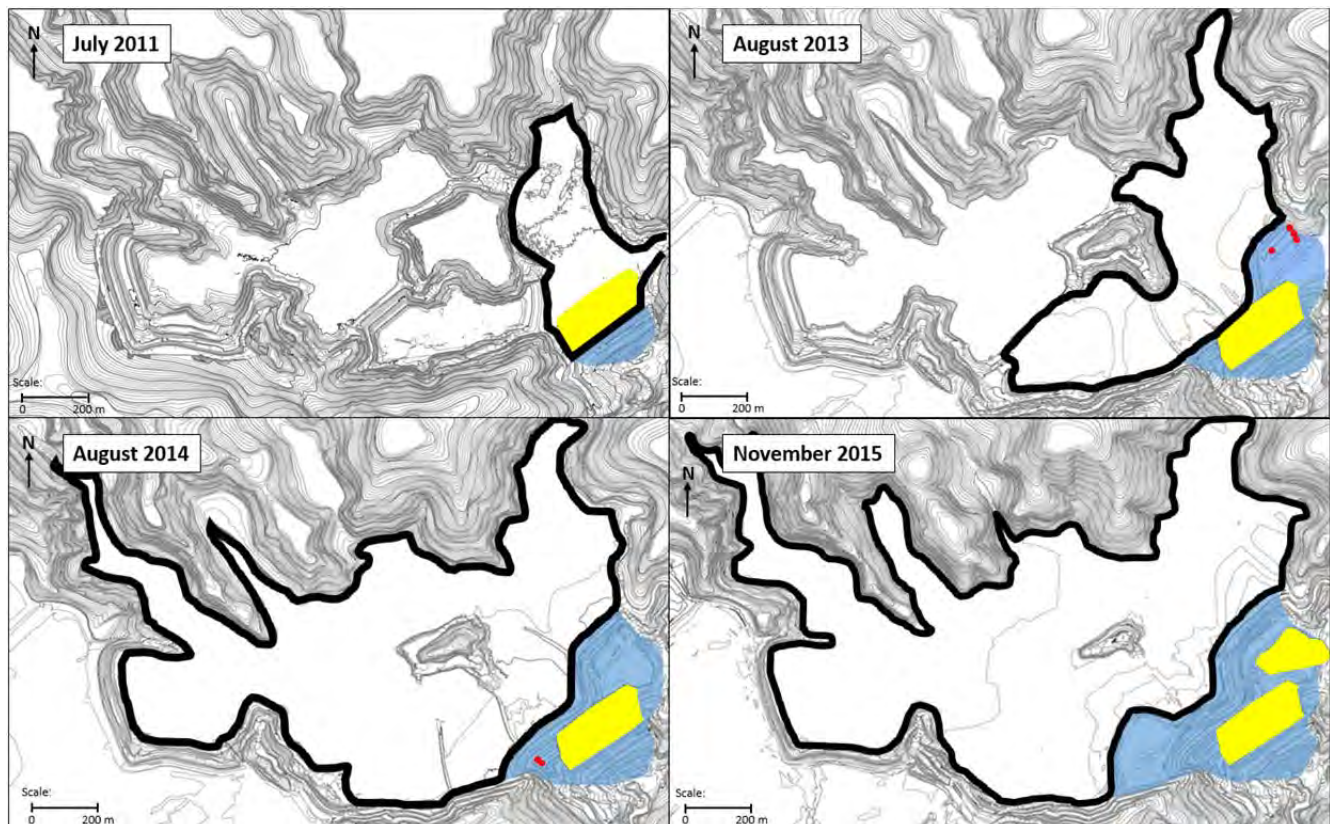
Figure 4-12 summarizes the time-sequence of these impoundment drainage provisions. As upstream raising continued and the impoundment expanded, the El. 826 m blanket drain became increasingly more distant from the tailings it was intended to drain and eventually could no longer keep pace with rising saturation levels. With this, the saturated conditions necessary for liquefaction flowsliding were satisfied.

Figure 4-12 Progression of impoundment and drainage provisions with time

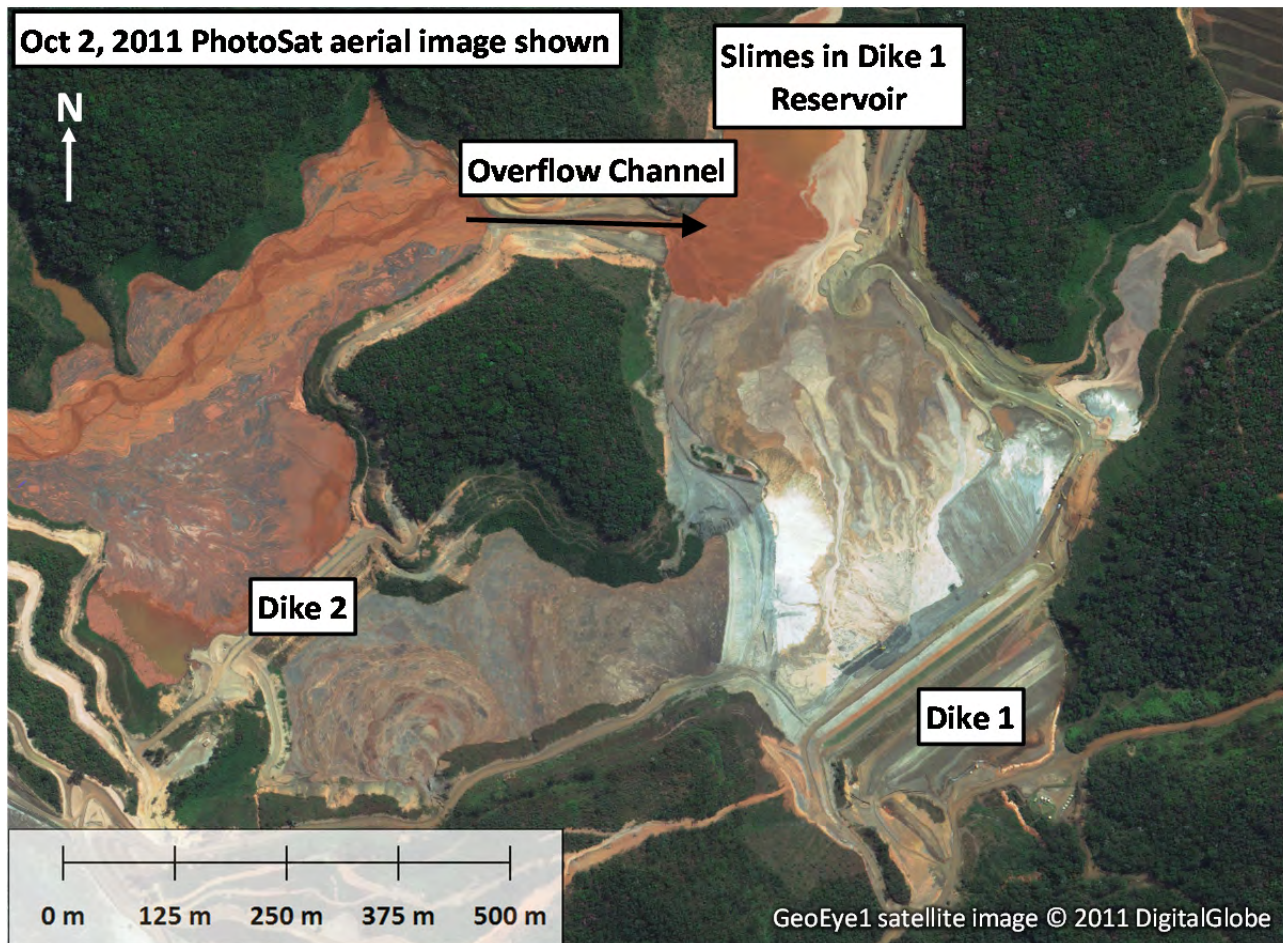
Section 2.2 described how this concept was abandoned after the Dike 1 Starter Dam was seriously damaged by piping and internal erosion. In addition, subsequent structural problems with the Main and Secondary Galleries made it necessary to re-route water and slimes from the Dike 2 impoundment into Dike 1. These problems happened during 2011 and 2012 when tailings that would later underlie the left abutment setback were being deposited. The aerial image in Figure 5-5 shows that an Overflow Channel was constructed from the Dike 2 slimes reservoir to the Dike 1 reservoir from January, 2011 to July, 2012. This Overflow Channel introduced slimes into the Dike 1 reservoir.

Figure 5-5 Slimes Overflow Channel from Dike 2 reservoir to Dike 1 reservoir

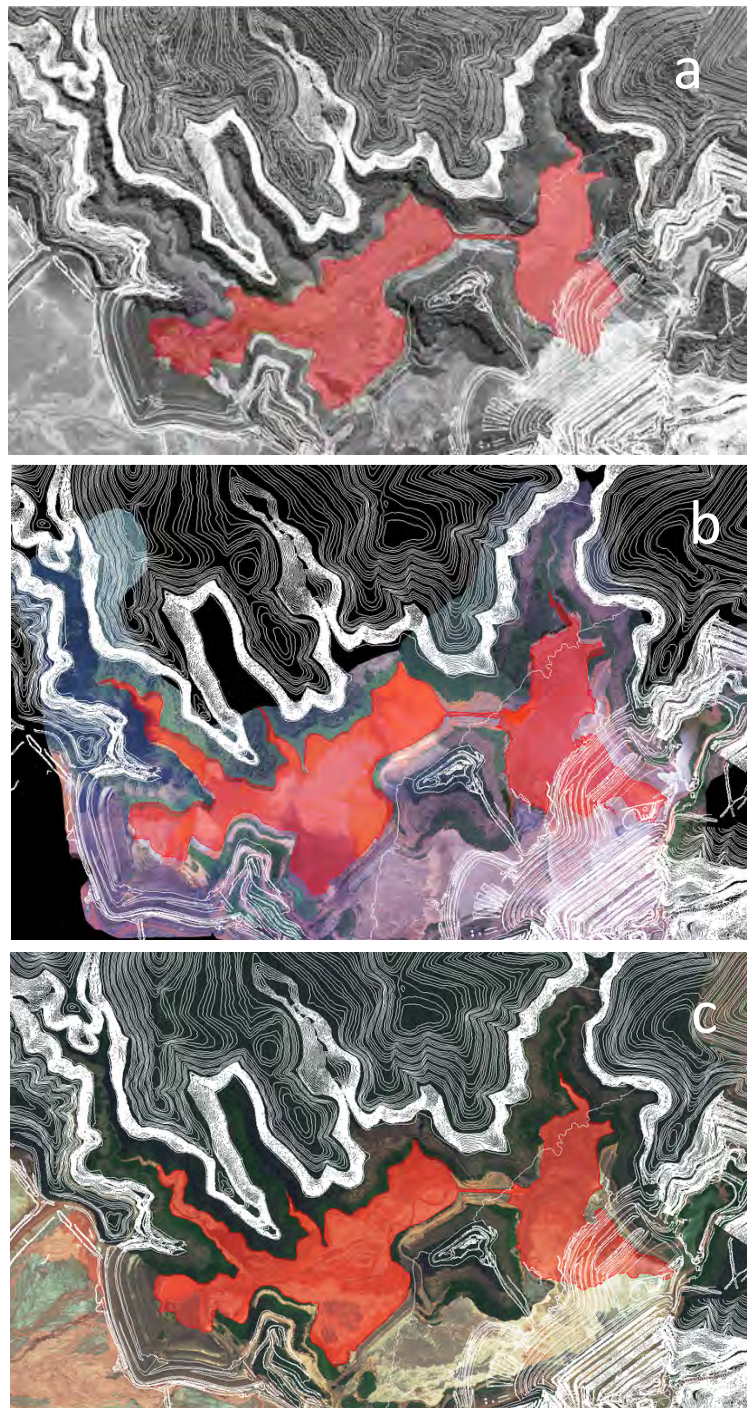
The Overflow Channel was closed in August, 2012 but not before slimes were deposited between El. 824 m and El. 850 m. Operation of the Overflow Channel and resulting slimes deposition is illustrated by imagery at selected dates during late 2011 and early 2012 on Figure 5-6.

Figure 5-6 Slimes deposition (a) September 20, 2011; (b) January 21, 2012; (c) March 3, 2012. Slimes highlighted in red; final embankment contours in white

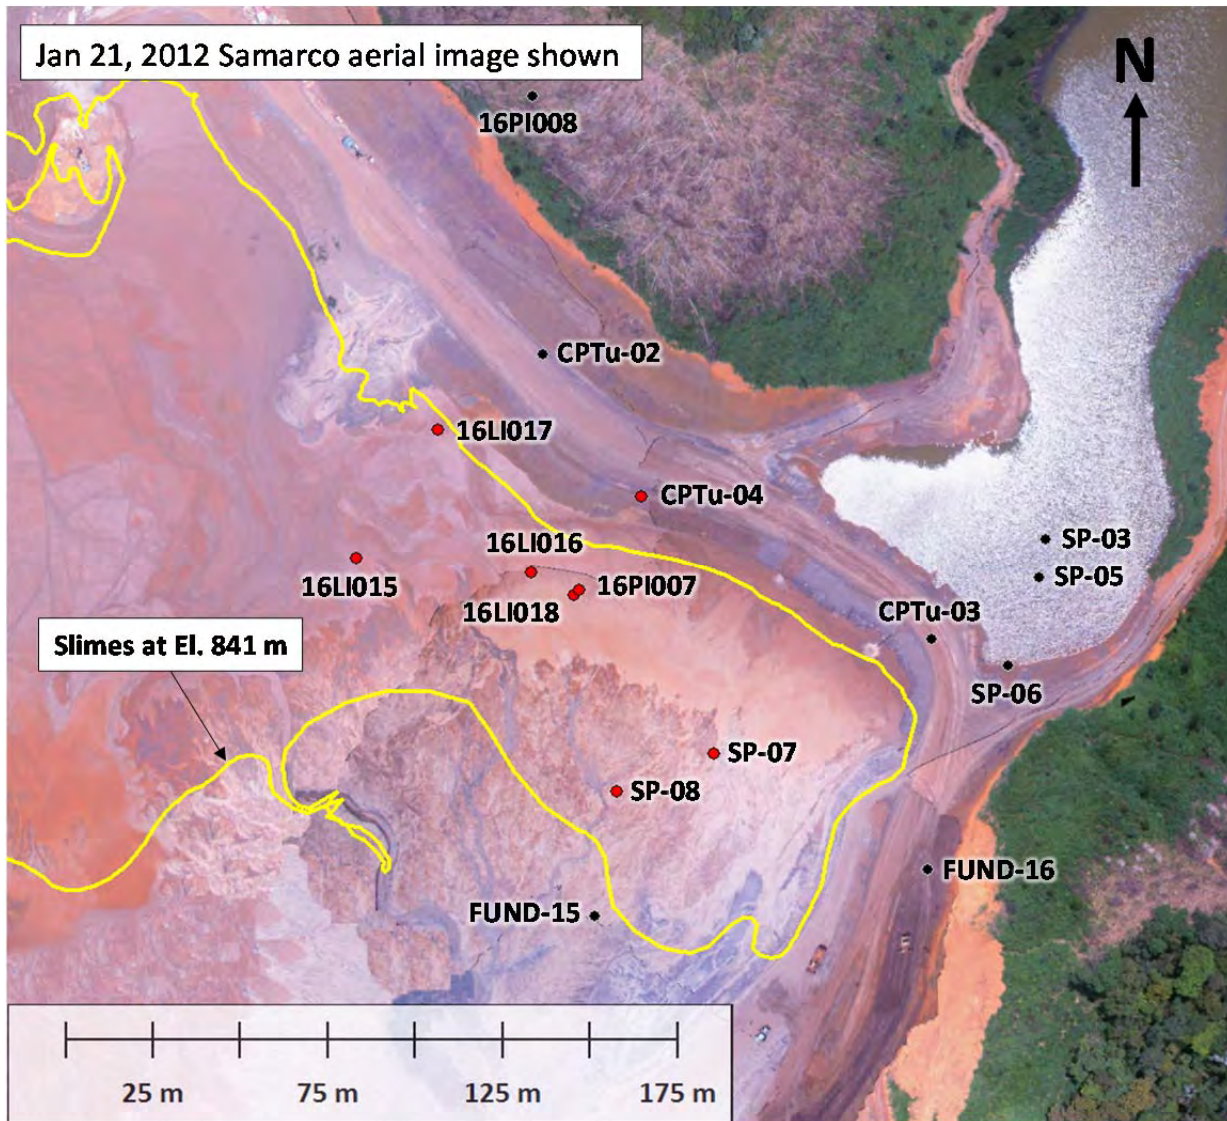
The locations of slimes inferred from mapping can be compared to logs of drill holes through the left abutment tailings. Figure 5-7 shows borings and CPTs that penetrated a target interval of El. 830 m to El. 850 m. These holes were drilled at different times and surface elevations, but for reference they are superimposed on imagery from January, 2012. Also on Figure 5-7 for comparison are the outlines of slimes mapped at El. 841 m on that date that also appear on Figure 5-6b.

Figure 5-7 Left Abutment Drill Holes. Red circles indicate slimes within target interval of El. 830 m to El. 850 m.

brown in color, as opposed to grey for sands, often noting the presence of clay in varying amounts. Slimes were taken in CPTs as materials having apparent fines content of 100% that are not associated with road fill or other introduced materials. On this basis, Figure 5-7 shows holes indicating the presence of slimes within the target elevation interval in red and holes with no such indications in black. It can be seen that the drill hole information corresponds to the area of mapped slimes. A number of other holes not shown on Figure 5-7 were drilled over the Secondary Gallery for purposes of investigating its foundation conditions. With a surface elevation at or near El. 835 m, they mostly penetrated tailings below the target interval.

Within those holes where slimes were identified, their distribution is more difficult to determine because the tailings were not continuously sampled. However, SP-07 is notable in having distinguished two discrete clay layers corresponding to slimes: a 2 m thick layer at El. 836.36 m and a deeper 2 m layer at El. 828.36 m. Also, CPTu-04 penetrated slimes layers up to several centimeters thick. It is reasonable then from the drill holes to categorize discrete layers of slimes as ranging from a few centimeters to a few meters in thickness, with the remainder of the slimes material intermixed with sand in varying proportions. This characterization is consistent with the zone of interlayering and intermixing portrayed on Figure 5-4.

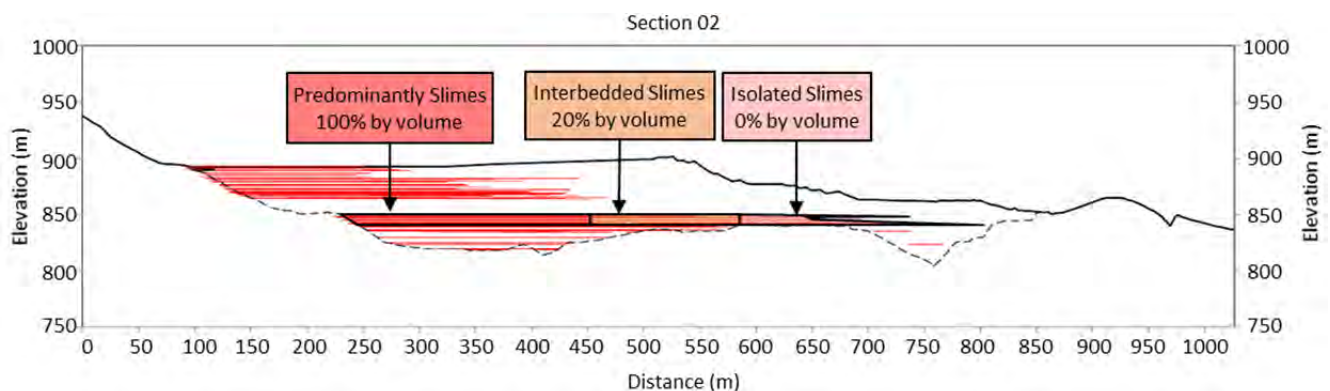
Figure 5-8 Distribution of slimes at left abutment

The mass balance provides a measure of the volumetric proportion of constituent slimes and slimes layers within a specified zone. Figure 5-8 portrays the results in cross section. Here, the region designated *predominantly slimes* is nearly 100% slimes, *interbedded slimes* is estimated to contain 20% or more slimes overall, and the zone of *isolated slimes* less than this amount. Although distinct boundaries are shown between these regions, actual conditions are transitional in character.

The preceding discussions have shown that slimes were present at the left abutment, in particular between El. 830 m and El. 850 m, and that their concentration increased with distance behind the dam. How these conditions influenced the embankment requires accounting for the setback.
