Fundão Tailings Dam Review Panel

Report on the Immediate Causes of the Failure of the Fundão Dam

EXECUTIVE SUMMARY

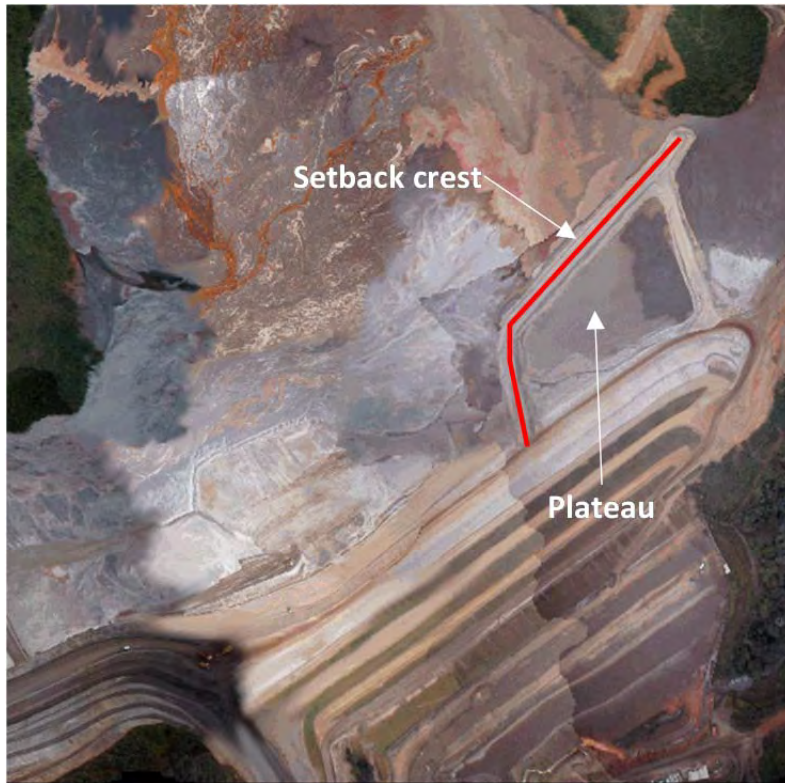
Figure 5-9 Aerial photograph of the setback alignment in October, 2012

The setback was initiated when the plateau was at approximately El. 855 m. By the end of 2013, the crest had risen to El. 877 m, or about 22 m high.

The setback had significant effects. Moving the embankment back toward the impoundment caused it to be raised over the slimes deposited in 2011 and 2012. In addition to influencing foundation conditions, these slimes also changed the seepage regime, elevating the phreatic surface on the left abutment.

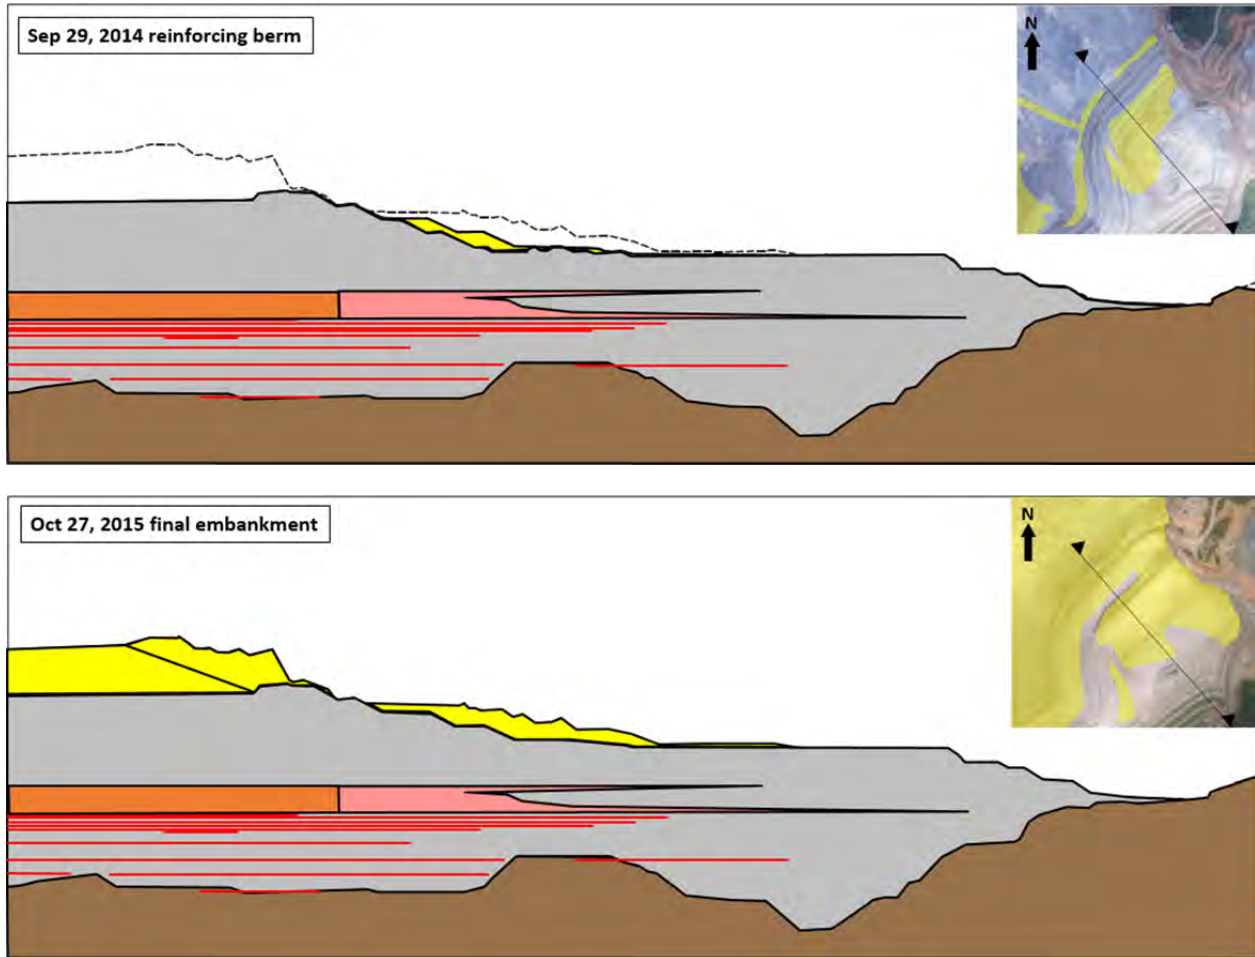
Figure 5-10 Sequential raising of setback embankment over slimes

Figure 5-10 shows that the alignment setback caused all or most of the embankment to be constructed over slimes. In addition, as the embankment became higher and its crest moved upstream, more of the embankment slope became underlain by the higher proportion of slimes in the interbedded region.

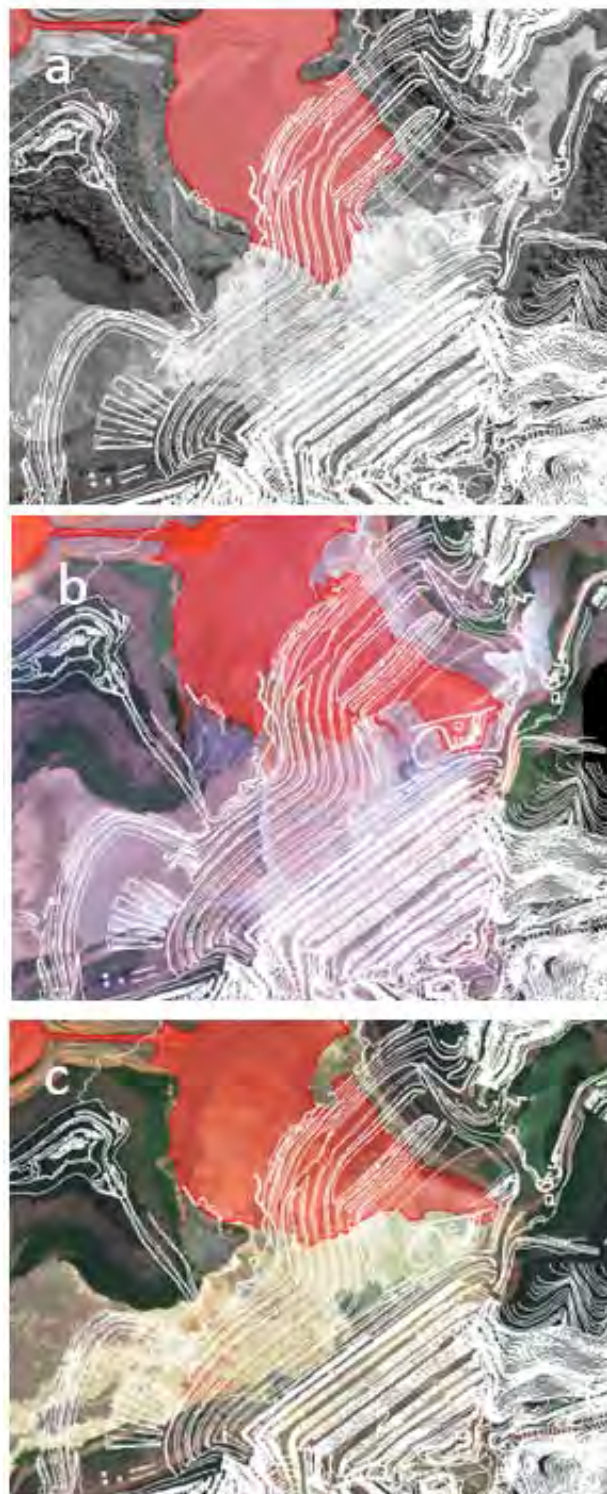
Figure 5-11 Slimes beneath final embankment: (a) September 20, 2011; (b) January 21, 2012; (c) March 3, 2012. Slimes highlighted in red; final embankment contours in white

The areal extent of the slimes depicted on Figure 5-10 deposited in 2011 and 2012 beneath the left abutment setback is shown on Figure 5-11, where again it can be seen that by the time the embankment reached its final height, slimes would be present beneath the entire setback slope and much of the plateau area.

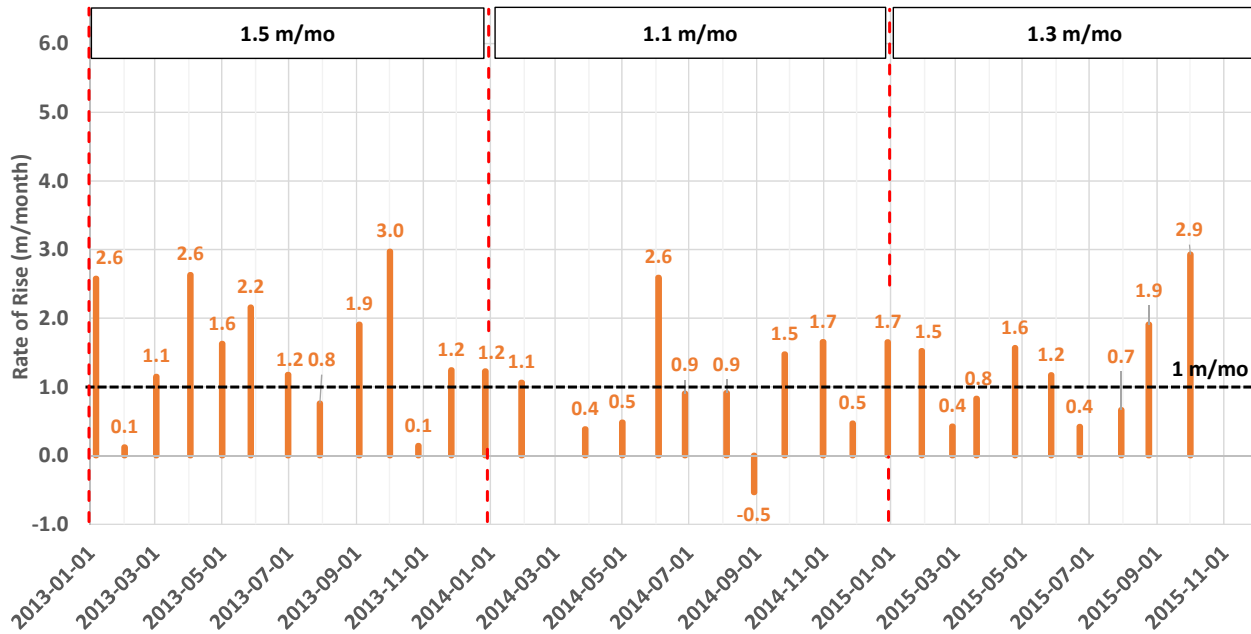
Figure 5-12 Rate of dam crest rise at left abutment setback

As indicated on Figure 5-12, the rate of rise of the dam crest at the left abutment varied during the life of the setback. The average 1.3 m/mo during 2015, or an annualized rate of 15.7 m/yr, was intermediate between rates experienced during 2013 and 2014. Also during 2015 in the months immediately prior to failure, raising accelerated from as low as 0.4 m to 2.9 m. The small negative rate of rise in September, 2014 was produced by regrading related to construction of the reinforcing berm and is not consequential to the overall trend.

In addition to the stresses applied, the loading due to embankment raising must also be considered. This was based on actual survey data, as illustrated in Appendix B. As previously shown on Figure 5-12, the rate of rise at the left abutment reached a value of 2.9 m/month. There is no evidence that this rate had a material effect on the sands, but it could certainly induce an increment of undrained loading on the underlying slimes.

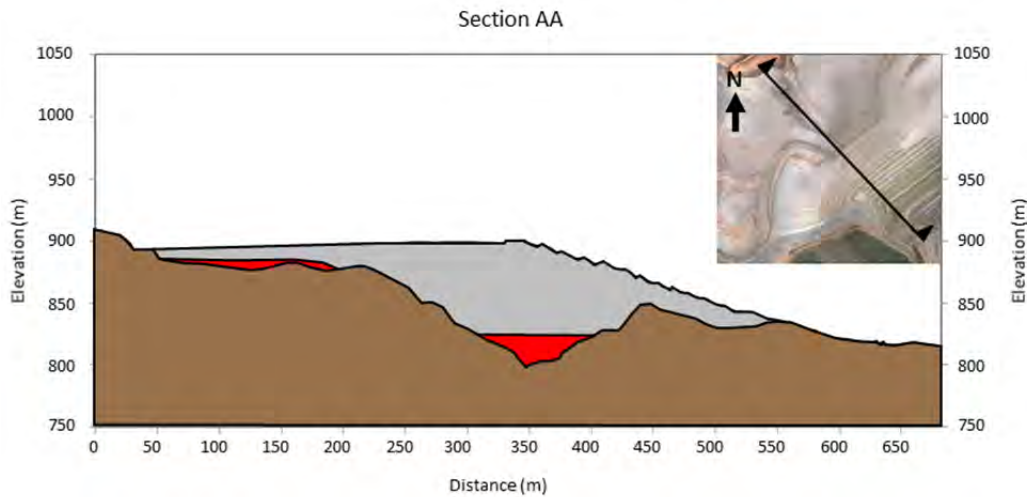
Figure 5-13 Slimes at right abutment Section AA

Figure 5-13 shows Section AA at the right abutment and its internal composition based on mapping as described in Section 5.1.3. The distinguishing feature of the right abutment compared to the left is the nearly complete absence of slimes beneath the embankment slope. The only region of slimes lies below El. 825 m where it is confined both upstream and downstream by natural ground. This is in sharp contrast to the left abutment on Figure 5-8 where slimes can be seen to extend beneath virtually the entire length of the slope.

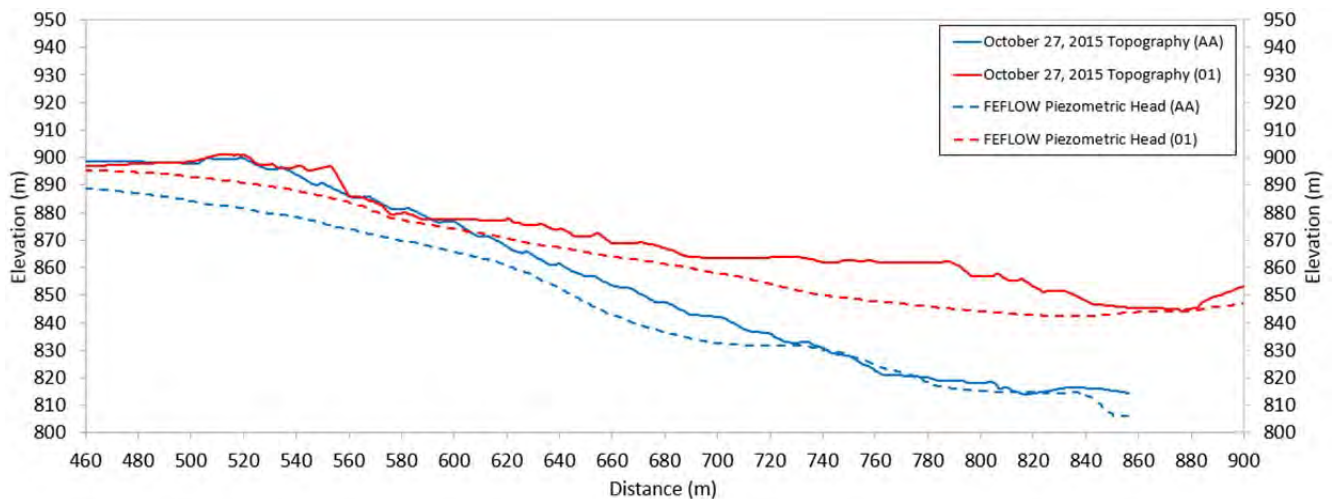
Figure 5-14 Geometry and piezometric comparison of left and right abutments

The left and right abutments can be compared more directly by overlaying the respective sections. Figure 5-14 provides an overlay of Section 01 at the left abutment and right abutment Section AA, coincident at the respective dam crests. Geometrically, the greater overall steepness and extended length of the 3.0H:1.0V right abutment slope stands out.

Also depicted on Figure 5-14 is the difference between the piezometric surface at the two locations, with generally higher conditions on the left that reflect the influence of slimes. This is illustrated in more detail on Figure 5-15.

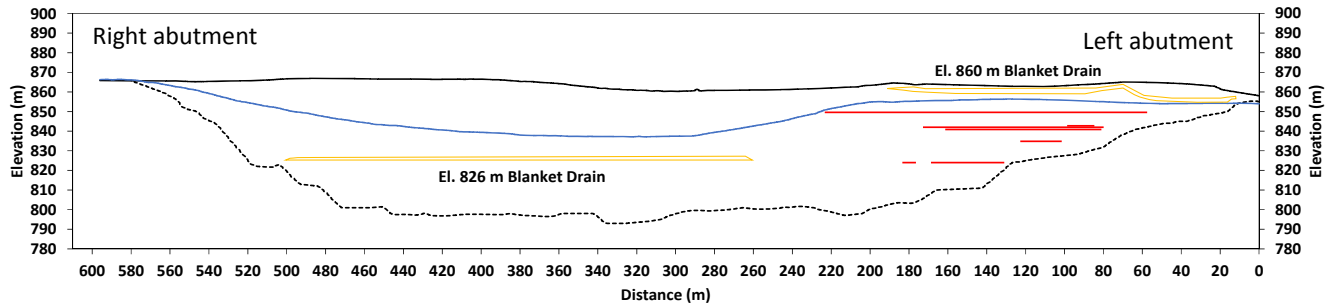
Figure 5-15 Longitudinal section from FEFLOW, view looking upstream. Phreatic surface shown in blue, El. 826 m blanket drain in yellow, slimes in red.

Figure 5-15 is based on results of a 3D steady state and transient seepage analysis of the tailings impoundment performed as part of the Investigation and described in Appendix G. The estimated phreatic surface from this modeling is shown on the longitudinal section. On the left abutment, inflows from Grota da Vale together with the slimes maintain the phreatic surface at a higher elevation. In contrast to the right abutment, the slimes on the left extend outward toward the El. 826 m blanket drain and limit the lateral extent of its influence.

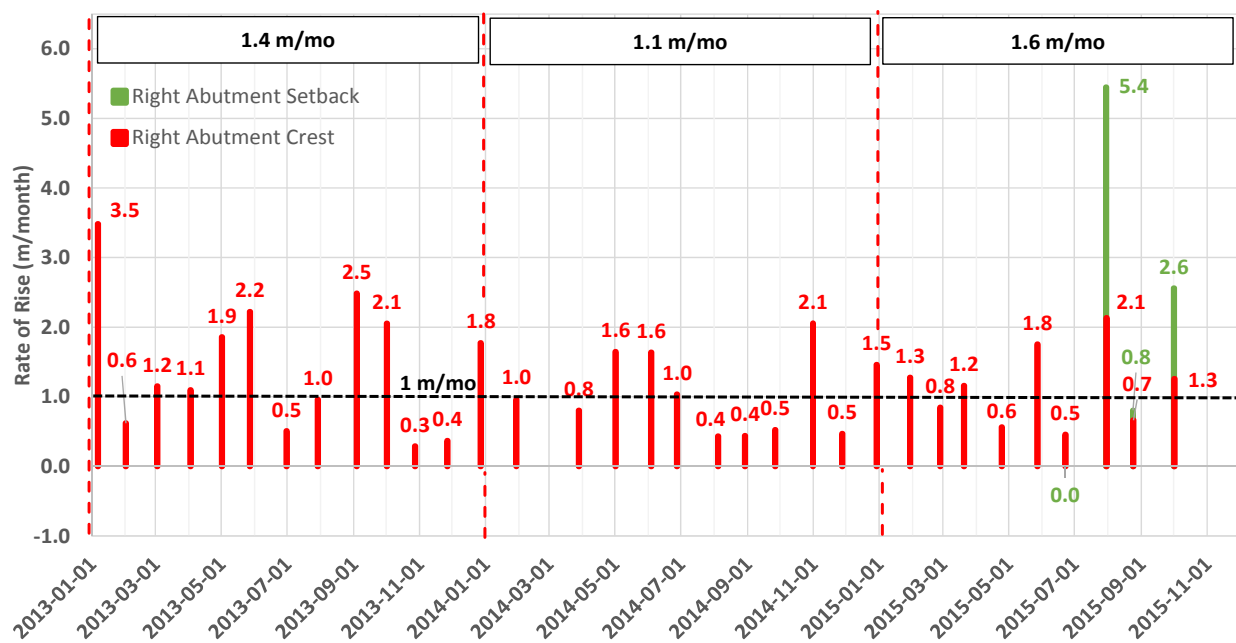
Figure 5-16 Rate of rise at right abutment

The rate of rise of the embankment crest at the right abutment is shown on Figure 5-16, which can be compared to conditions at the left from Figure 5-12. Average annual rates are generally similar except during 2015 when the right abutment was raised at a higher rate of 1.6 m/mo compared to 1.3 m/mo on the left. The right abutment experienced an unusually high rate of rise of 5.4 m/mo in August, 2015 on a newly-initiated realignment of the crest that was set back from the former location to allow for drain construction depicted on Figure 2-12.

Conditions conducive to failure at the right abutment therefore include greater slope steepness and higher rate of rise than the left abutment, although these are mitigated somewhat by the lower piezometric conditions. The net effect can be evaluated by means of stability analysis.

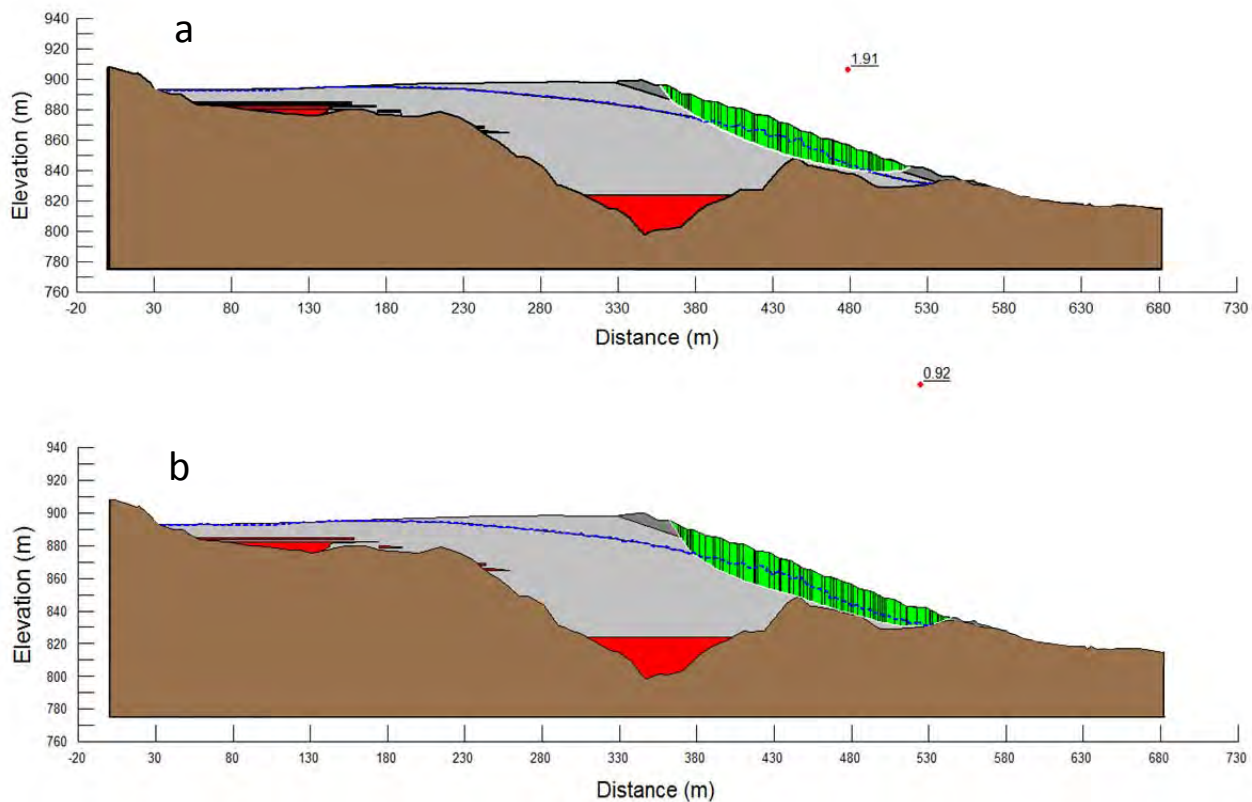
Figure 5-17 Stability analyses at right abutment Section AA; (a) effective stress (ESA); (b) undrained strength (USA)

Stability analyses for the right abutment Section AA on November 5, 2015 are shown on Figure 5-17 for both ESA and USA, where a calculated factor of safety (FS) less than 1.0 indicates failure. The ESA adopts a friction angle of 35 degrees and 5 kPa for compacted tailings fill and 33 degrees and zero kPa for hydraulically-discharged tailings, while the USA uses an undrained strength ratio in compression of 0.25 for tailings below the piezometric surface.

Figure 5-17 shows $FS = 1.91$ for ESA conditions and $FS = 0.92$ for USA. Hence, with a USA factor of safety less than 1.0, rapid failure and associated flowsliding should have initiated at the right abutment if undrained conditions had been operative. The fact that failure did not initiate there means that undrained strength was not fully mobilized and that drained conditions represented by the ESA prevailed at the right abutment. It is equally apparent that the rate of embankment rise at the right abutment was not itself sufficient to mobilize undrained strength in the sand tailings.

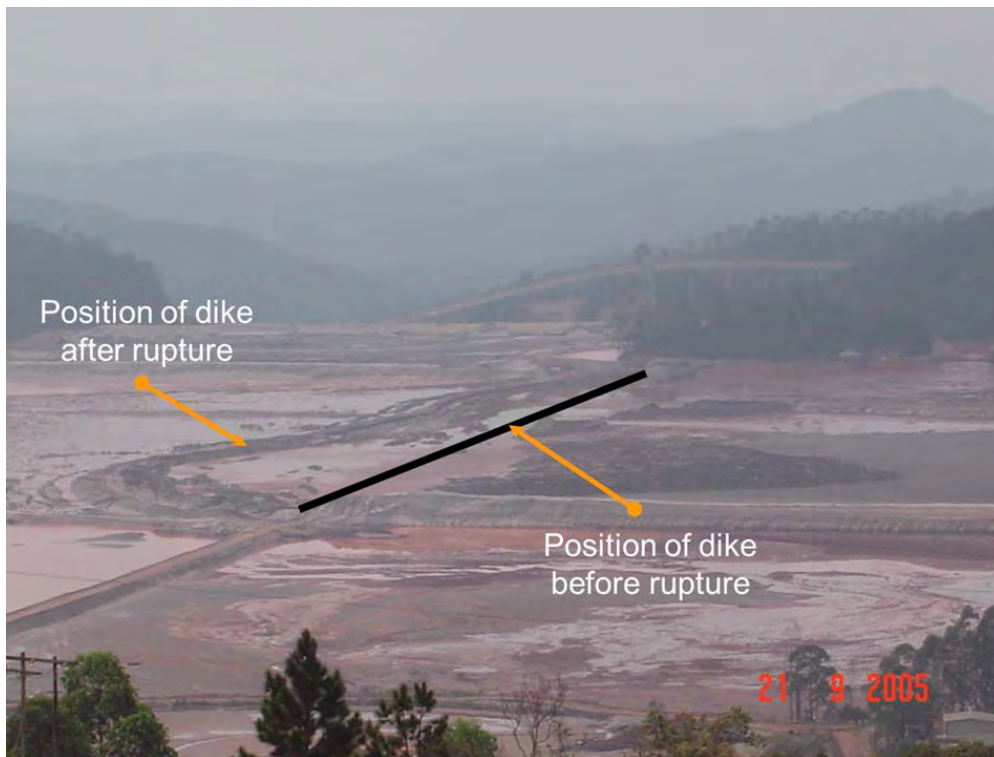
Figure 6-1 2005 Baia 4 static liquefaction failure

An important case of static liquefaction occurred at the Germano Complex itself in 2005. As shown in Figure 6-1, a low dike being raised over interlayered and intermixed slimes in the Baia 4 area experienced a sudden, high-mobility failure that moved rapidly over a distance of 80 m. The Baia 4 failure was attributed to liquefaction.

The Baia 4 failure provided the basis for determining parameters for slimes-rich layers used in modeling of the Fundão failure. Specifically, parameters relating to the peak undrained shear strength of these layers and the reduction in strength at large deformations were derived by back calculation from pre-failure and post-failure conditions. In these respects, the Baia 4 failure provided an important link between the theoretical studies conducted by the Panel and actual experience at the Germano Complex itself (see Appendix C for details).

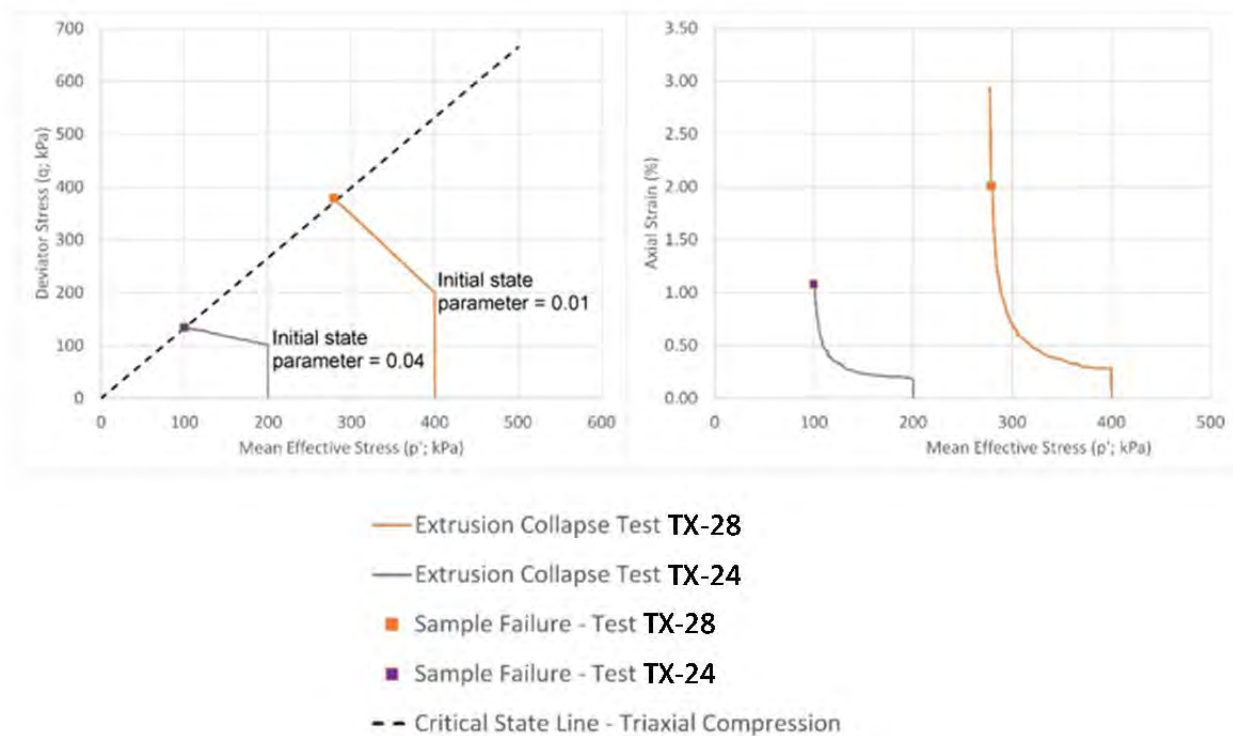
Figure 6-3 Extrusion collapse tests on Fundão sand

The Panel has experimentally demonstrated the lateral extrusion mechanism leading to collapse by conducting drained triaxial compression tests that adopt a specially-designed stress path. Designated *extrusion collapse* tests, they simulate the reduction in horizontal stress in the sand due to slimes extrusion while keeping the vertical stresses constant. Details of the test procedures and data obtained are provided in Appendix D, which includes the results from the tests that were performed. The results of two tests are shown on Figure 6-3, one on a contractive specimen with an initial state parameter $\Psi = +0.01$ and another with $\Psi = +0.04$. These values are on the contractive side of CPT data previously shown on Figure 4-4 and as such tend to bracket the characteristic state in the field. In both cases, as the shear stress along this loading path approaches the ultimate friction line, collapse occurs in an abrupt and sudden manner after only small deformations in the sand. This testing provides both a qualitative demonstration and a quantitative reference for collapse of Fundão sand associated with the extrusion mechanism.

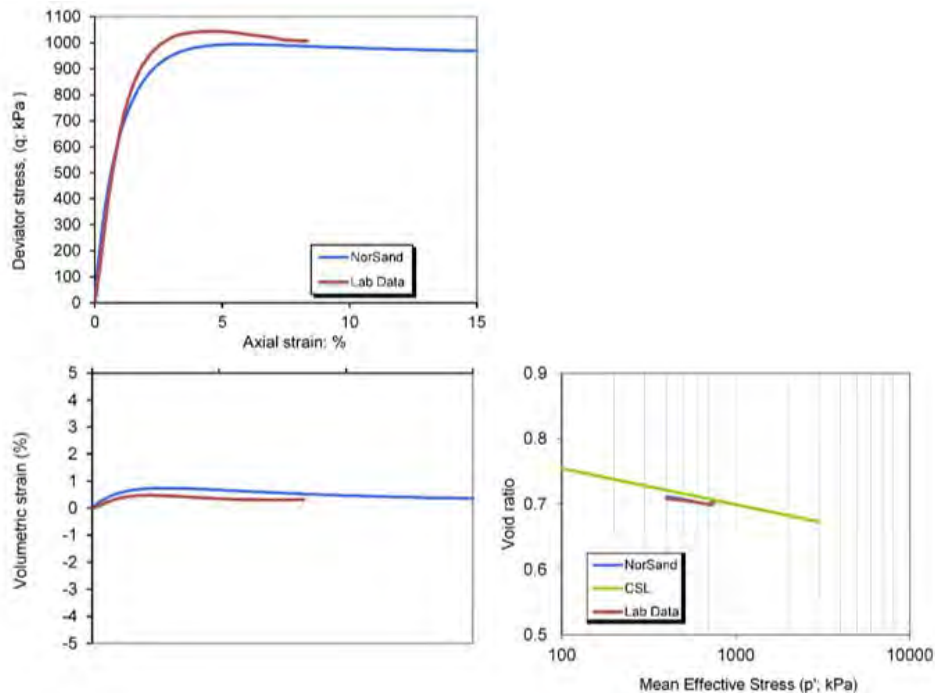
Figure 6-4 Simulated drained triaxial compression test (Test ID TX-12)

An important check on any complex numerical model is to replicate the experimental information that constitutes the building blocks of the comprehensive constitutive relationship needed to undertake more complex analysis. Figure 6-4 and Figure 6-5 show the results of a simulation of a drained triaxial compression test and an undrained stress-controlled triaxial compression test. The latter follows a stress path simulating the effect of the extrusion mechanism in the slimes on the overlying sand developed in Section 6.4.2 above. The correspondence between numerical simulation and experiment is encouraging. The model strength result is about 3% less than the experimental value and it will be used as a reference to assess proximity of the simulation to collapse.

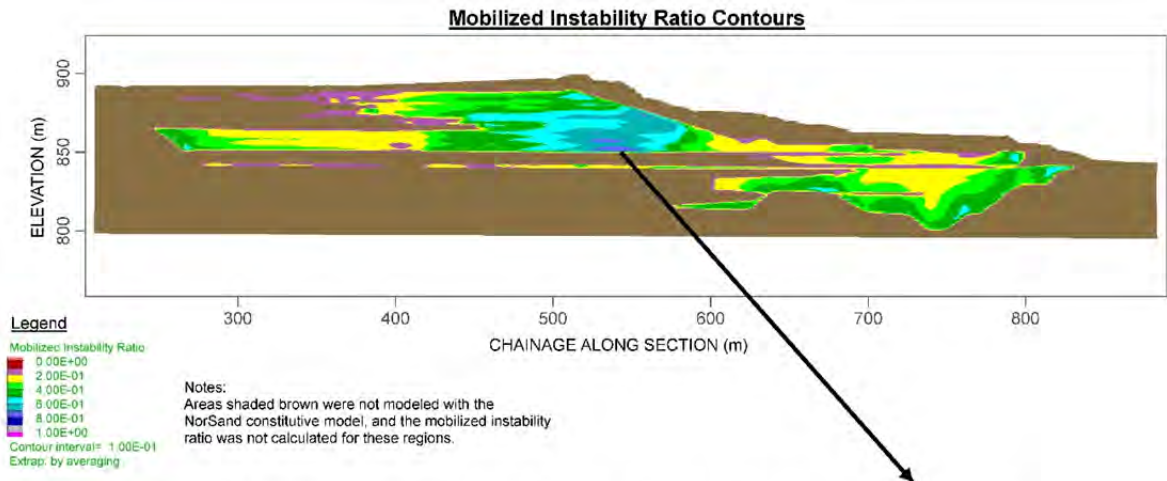
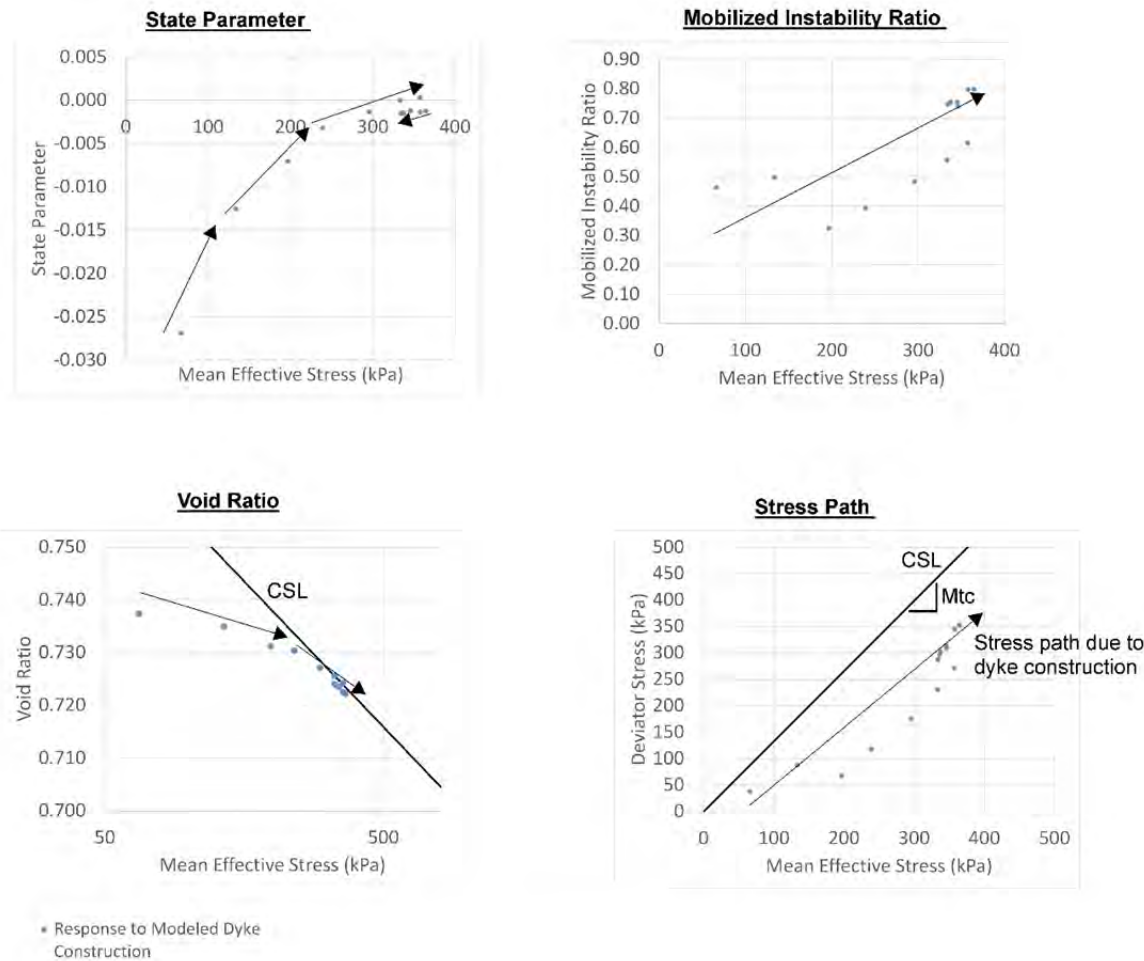
Figure 6-6 Mobilized Instability Ratio

The Mobilized Instability Ratio (MIR) is a criterion for the triggering of collapse. It is defined as the ratio of the deviator stress and mean effective stress to the ratio at the onset of collapse. The color zonation represents the MIR related to the collapse strength determined from laboratory tests. The maximum value computed is 80%. Numerical convergence limitations inhibit the modeling from progressing further. However, the information available from the simulation provides compelling support for the hypothesis that collapse was triggered by lateral extrusion of the slimes-rich deposits.

Figure 6-6 also plots the stress path calculated throughout construction of the Fundão Dam. Operation of the lateral extrusion mechanism is cumulative during construction as reflected by the results plotted. The stress path has been calculated at the base of the sand which is the location where collapse would be initiated. The calculation indicates that 80% of the available collapse resistance has been mobilized with the strength as prescribed in the analysis and determined by laboratory tests. Numerical instability, from a computational perspective, precluded advancing the calculations further.

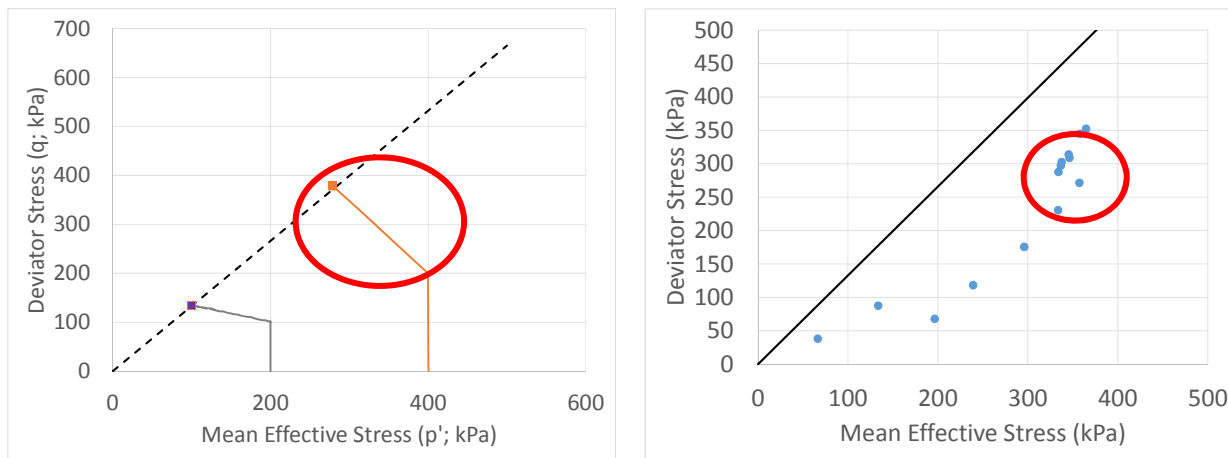
Figure 6-7 Comparison of laboratory and simulated field stress path

Figure 6-7 provides a comparison of laboratory data from Figure 6-5 with the simulated field stress path on Figure 6-6. It shows that the field stress path displays similarity to the controlled laboratory stress path and is migrating towards the ultimate strength line. As noted above, numerical convergence limitations preclude completing the analysis.

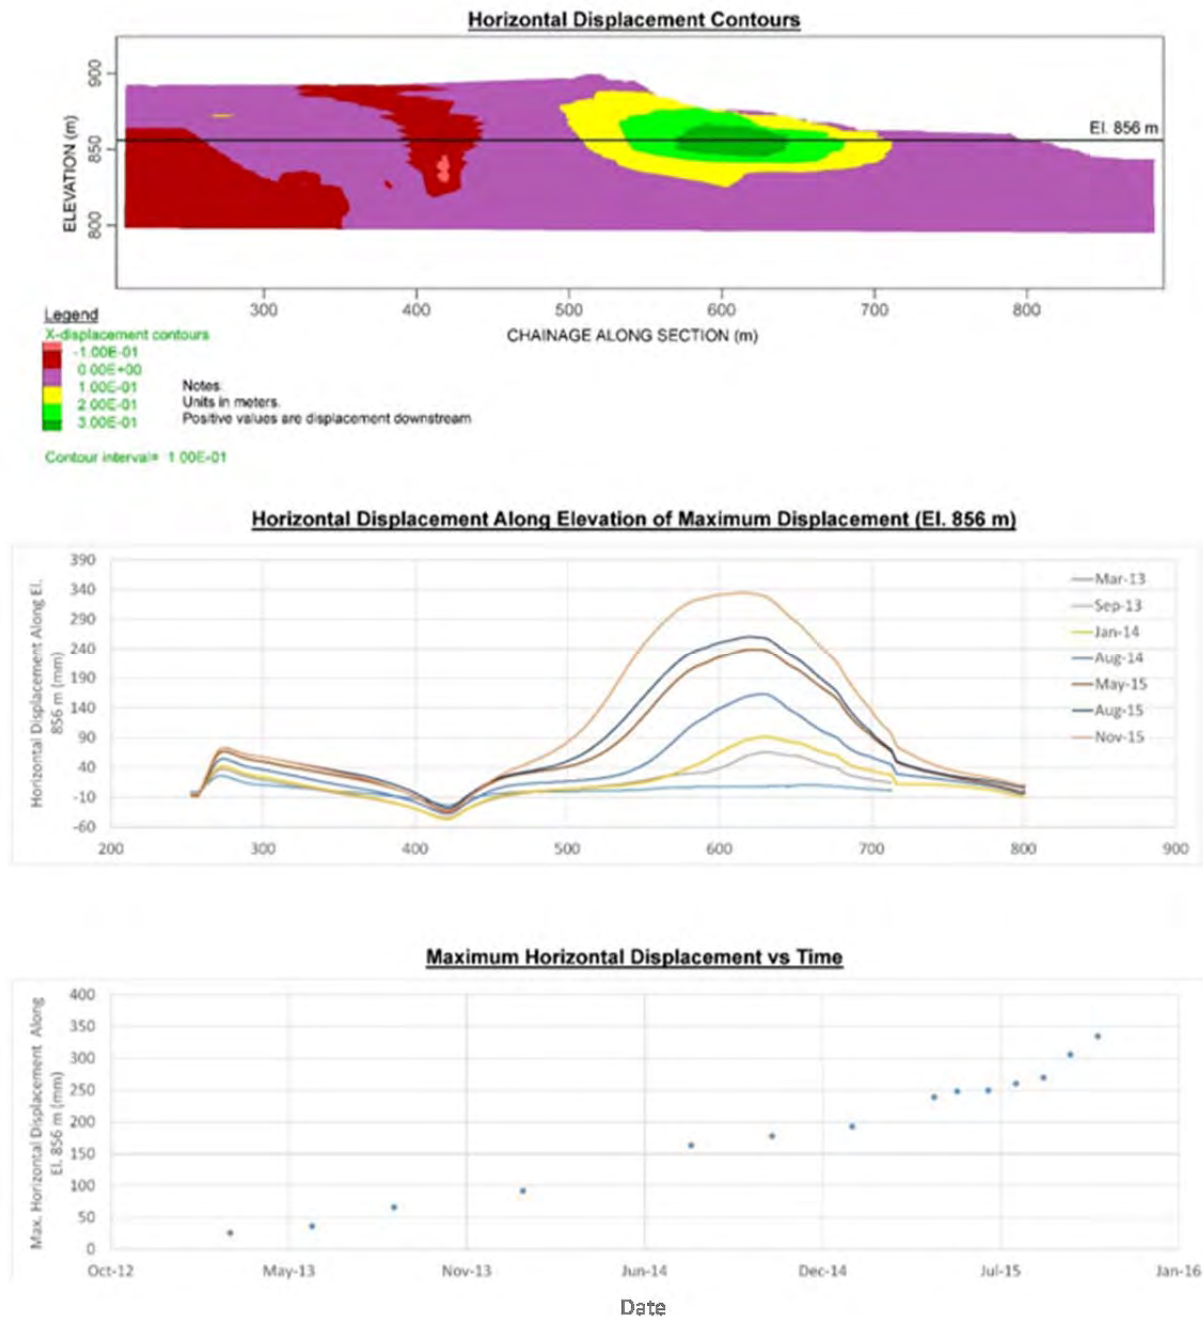
Figure 6-8 Horizontal displacements at sand/slimes interface

Figure 6-8 plots horizontal deformations along the slimes/sand interface at various stages of construction of the Fundão Dam. It illustrates that the largest lateral movements occur beneath the slope and downstream of the crest. This implies compressive straining in the downstream direction and extension straining in the upstream direction. Extension strains result in a reduction of horizontal confinement consistent with the lateral extrusion hypothesis.

It is also of interest to note that the maximum horizontal displacements beneath the lower part of the slope coincide with eyewitness reports of slope movement having initiated on the lower benches, as described in Section 2.7.

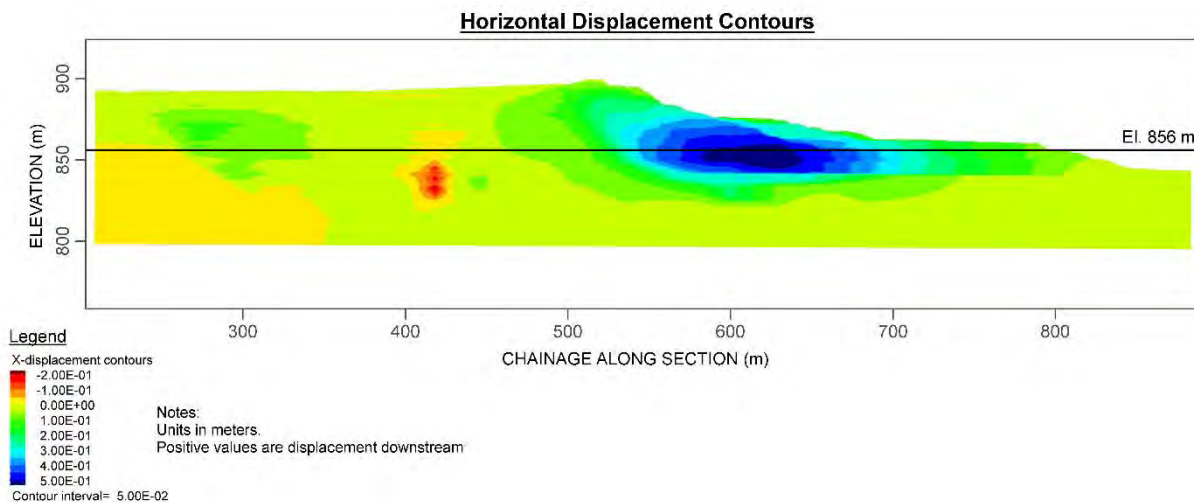
Figure 6-9 Horizontal displacements resulting from Mohr-Coulomb analysis approaching a factor of safety of unity

The pattern of displacements resulting in November, 2015 if a factor of safety of unity was approached is shown on Figure 6-9. The pattern of displacements is similar to that shown previously for the NorSand model analyses.

The deformation model used for failure analysis is equivalent to limit equilibrium analysis and hence provides a linkage between sliding displacement at failure and factor of safety. As discussed earlier in this section, a factor of safety of unity represents a trigger for the onset of liquefaction. The deformations associated with the onset of liquefaction with the shearing mechanism are much greater than those associated with the lateral extrusion mechanism. Therefore, liquefaction would be initiated by lateral extrusion prior to the development of shear failure.

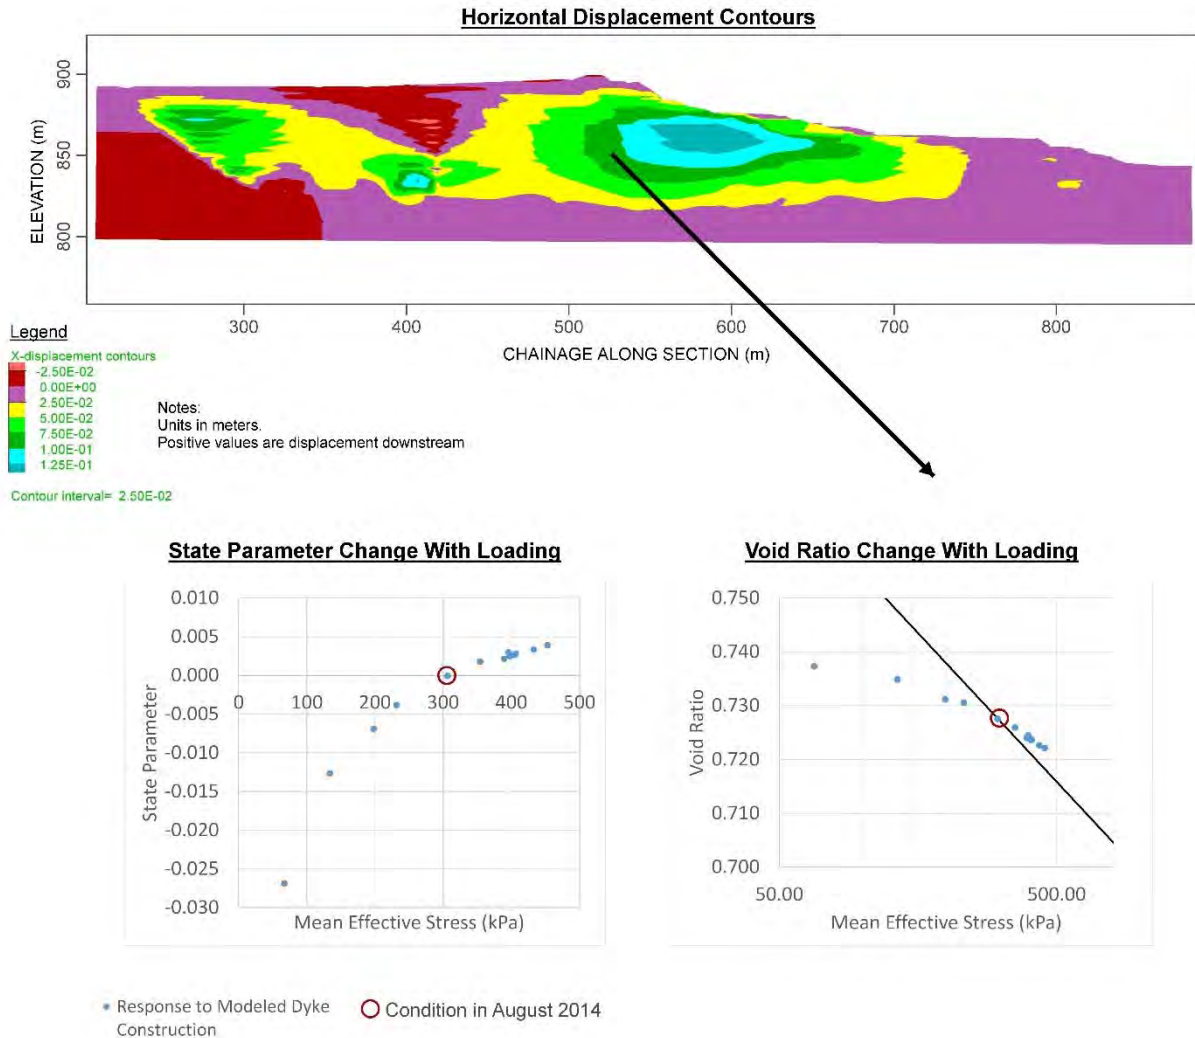
Figure 6-10 Example NorSand model output

The August, 2014 cracking incident did not display the mobility associated with flowsliding indicating that liquefaction did not occur. Figure 4-3 previously explained in principle how increased loading can cause a formerly dilatant material to become contractant. This effect is displayed in the NorSand model of conditions prevailing on or about August of 2014. As shown on Figure 6-10 on August, 2014 the sand is on or close to the CSL, which is a boundary between contractant and dilatant behavior. At this point the sand became loose enough to exhibit volume change and associated cracking but was not sufficiently loose to exhibit liquefaction. Also, Section 4.3 explained that a fundamental change in seepage patterns happened on or about the same time. Together these two changes, one in sand behavior and the other in saturation, produced the observed effects.

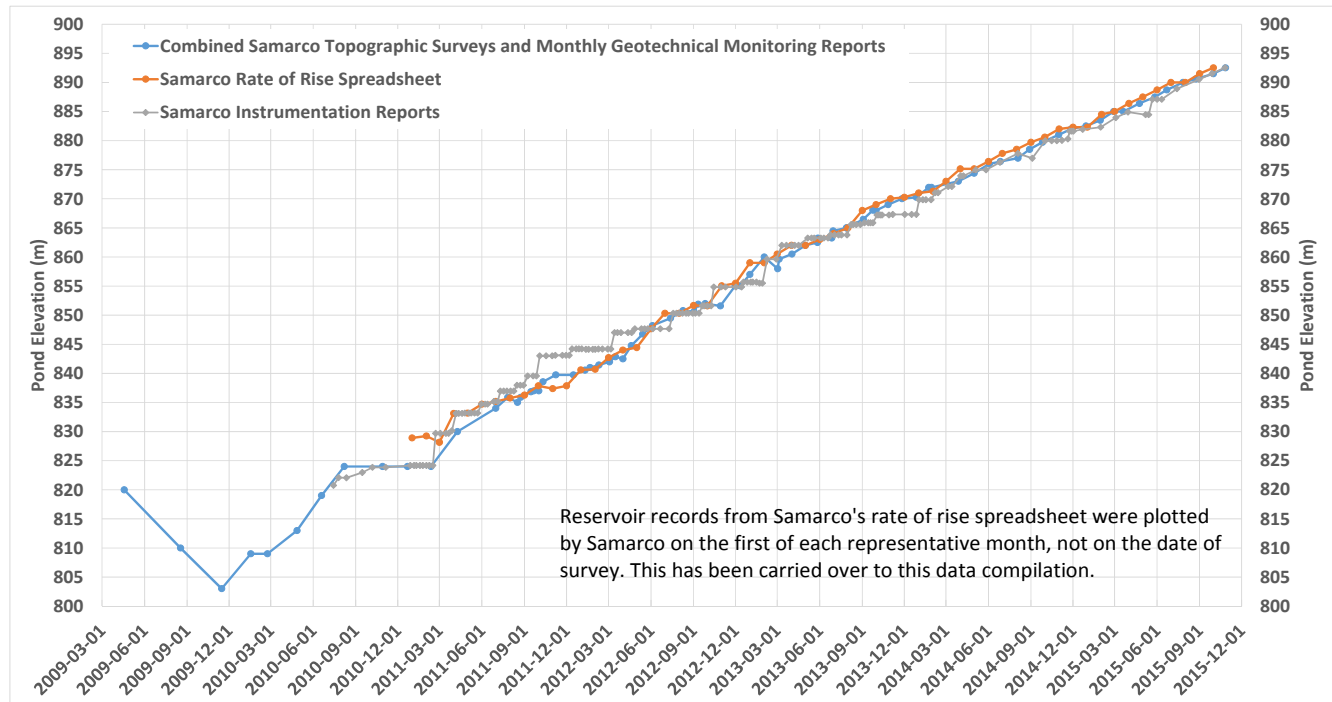
Figure B5-9 Comparison of pond elevations from monthly instrumentation reports, rate of rise spreadsheet and topographic surveys

- As seen on Figure B5-9, several steps up to 5 m in elevation at a time were noted in the instrumentation report data series.
 - ◆ A review of weekly reports shows most corresponded with activities at the intakes of the Secondary Gallery or Auxiliary Spillway. These include construction of temporary coffer dams and use of stoplogs to improve water quality downstream at Santarem.
- The instrumentation report data series shows periods of constant pond elevation prior to a step in the data series.
 - ◆ The constant pond elevation is not consistent with the dike being continuously raised. The pond elevation was likely not updated regularly in the instrumentation reports.
- The rate of rise data series generally follows the trend from the combined topography and monthly geotechnical monitoring reports series. However, the location and method of survey are not known.

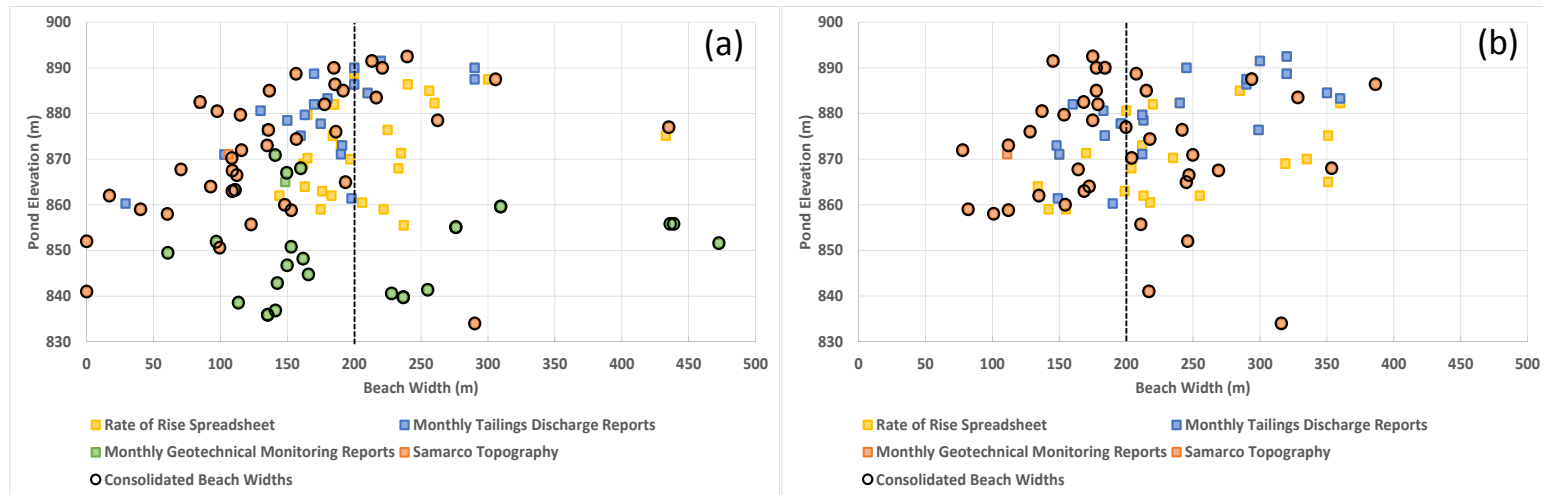
Figure B5-12 Beach width vs. pond elevation – left (a) and right (b) abutment

The minimum design beach width for Fundão was supposed to be 200 m^[1]. The consolidated beach width data set over time is shown on Figure B5-11. The operational requirement was not consistently met at both the left and right abutments as shown on Figure B5-12. The ingress of the pond to the dike crest occurred more frequently at the left abutment compared to the right during the critical period between El. 840 m and El. 850 m where the beach below water (and slimes incursion) lies below the embankment slope by November, 2015. This is shown on Figure B5-13.

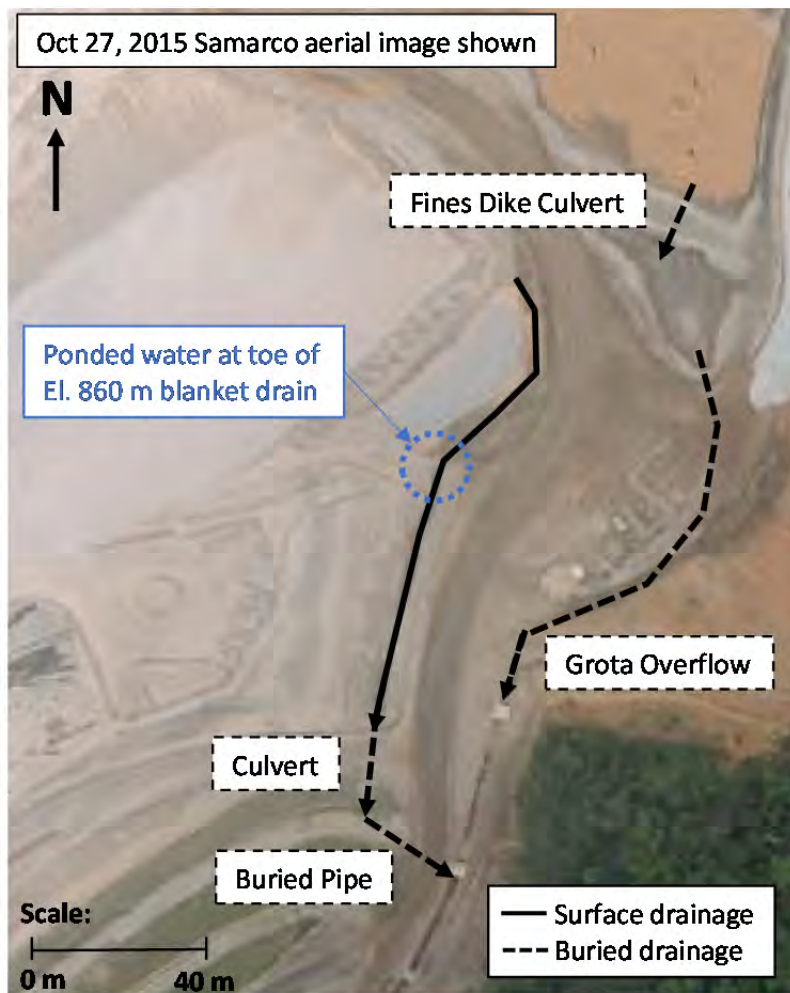
Figure B5-16 Drainage at left setback prior to failure

The surface drainage system at the left abutment setback was documented for the months leading up to failure to investigate how surface/groundwater was managed. Ponded water was observed at the toe of the El. 860 m blanket drain in many of the site photos (see dashed blue lines on site photos in Attachment B5). The first instance was noted in construction photos from the week of June 29, 2015. Ponded water is also visible on photos from the morning of November 5, 2015, prior to the failure.

The surface water pathway and outlet for this ponded water is as shown on Figure B5-16. The history of water routing on the setback platform is expanded further in Section B8 as part of the documentation of drains installed at the setback in response to seepage incidents. From this review, there appears to be a surface drainage system in place to convey water away from the left abutment setback.

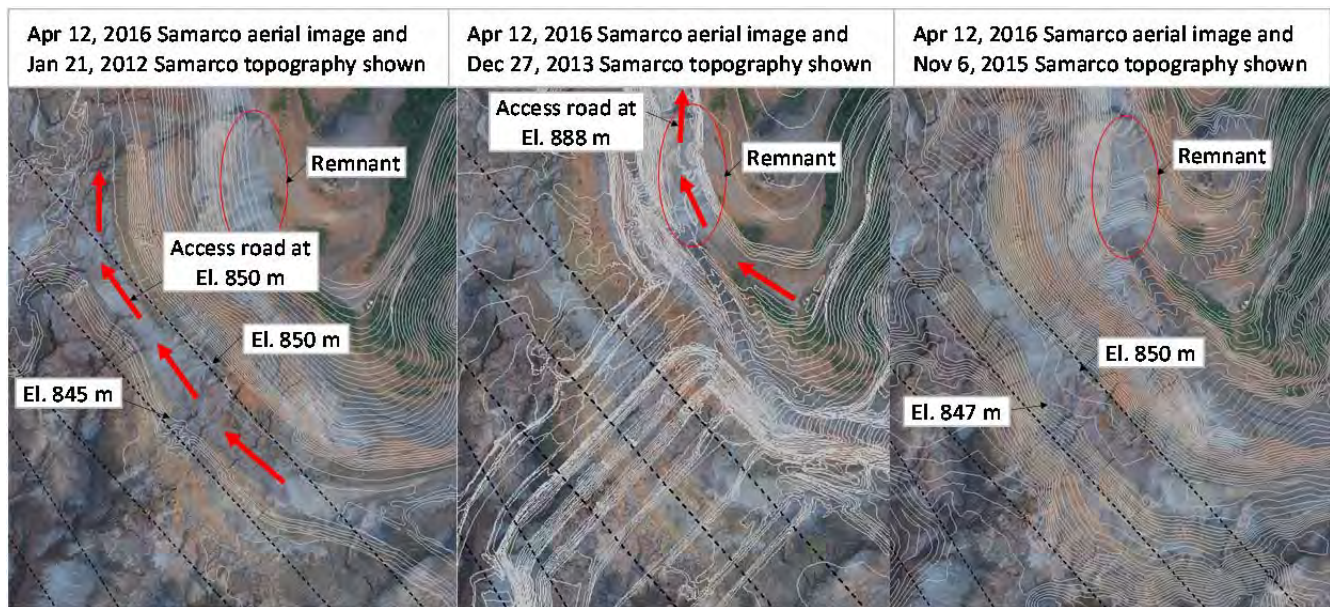
Figure B5-17 April 12, 2016 aerial image with January, 2012, January, 2014 and immediate post-failure topography

Photos from a drone flight in the area of the left abutment on April 12, 2016 show remnants of the left abutment. When overlaid with contours from January, 2012 and 2014, it appears the post-failure surface coincides with a historical access road under the tailings in two locations: one under the remnants of the left abutment and another several meters below the remnants on a lower bench. This is shown on Figure B5-17.
