Fundão Tailings Dam Review Panel

Report on the Immediate Causes of the Failure of the Fundão Dam

EXECUTIVE SUMMARY

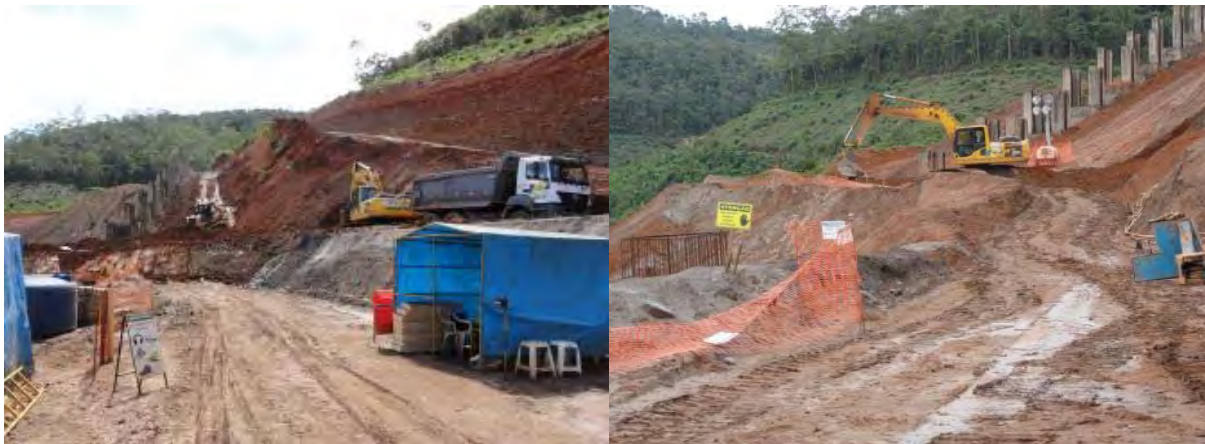
Figure B5-18 Photos of access to the Secondary Gallery tulipas from weekly reports on week of April 9-15, 2012 (left) and April 30-May 6, 2012 (right)

- It is unknown if the natural ground was consistently stripped back to phyllite during periods of access road construction. Figure B5-18 shows what looks like colluvium remaining on the stripped slopes in the area of the access road at El. 850 m.
- Oversized material was placed on the access roads in other locations around the facility for traffic purposes, as seen on Figure B5-19.
- Figure B5-20 shows one instance when, the ground against which the left abutment was being raised was stripped to remove loose material prior to raising. In addition, the oversized material on the roads was removed and the area smoothed in preparation for the raise. However, it is unknown whether this practice was consistently applied or extended further upstream to access roads underlying the non-compacted tailings. Figure B5-20 shows the stripped slope to consist of a mix of phyllite and colluvium.

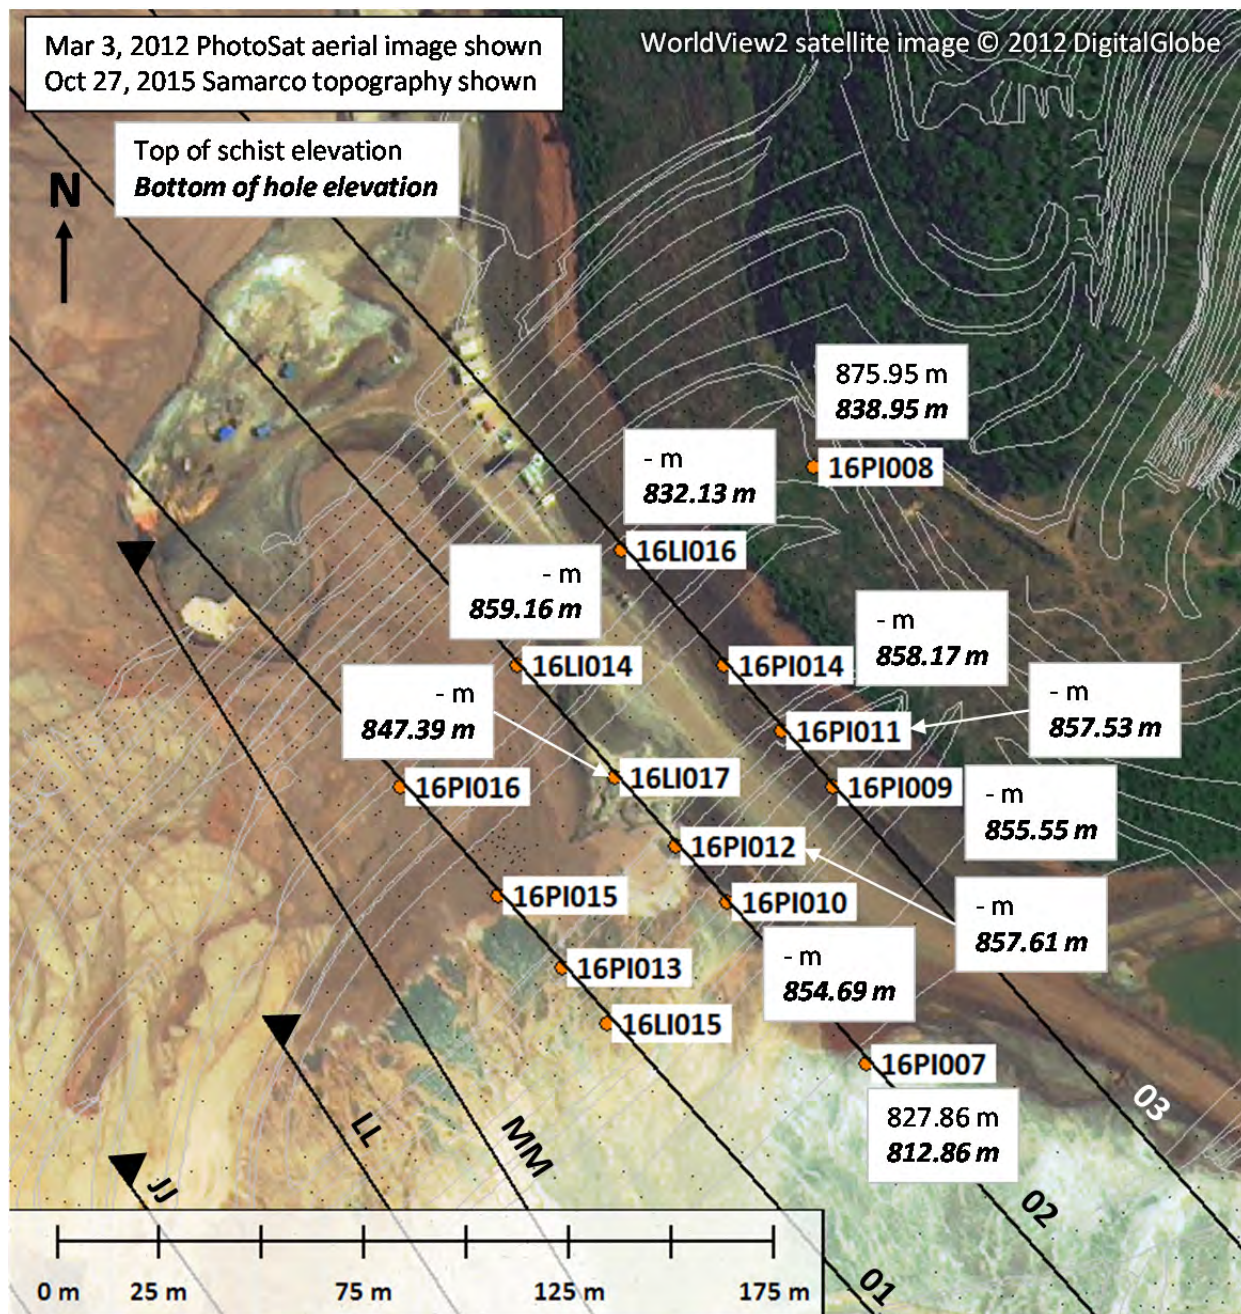
Figure B5-21 Left abutment drill hole review for oversized material

Ten of the standard penetration test (SPT) logs from the installation of the piezometers on the setback were reviewed to see if oversized material was encountered. These locations were chosen given their proximity to the road at El. 850 m. The review showed:

- Of the ten, two encountered schist at the elevations shown on Figure B5-21 and did not encounter oversized material.
- Most of the holes were not deep enough to reach the road at El. 850 m and did not encounter oversized material.

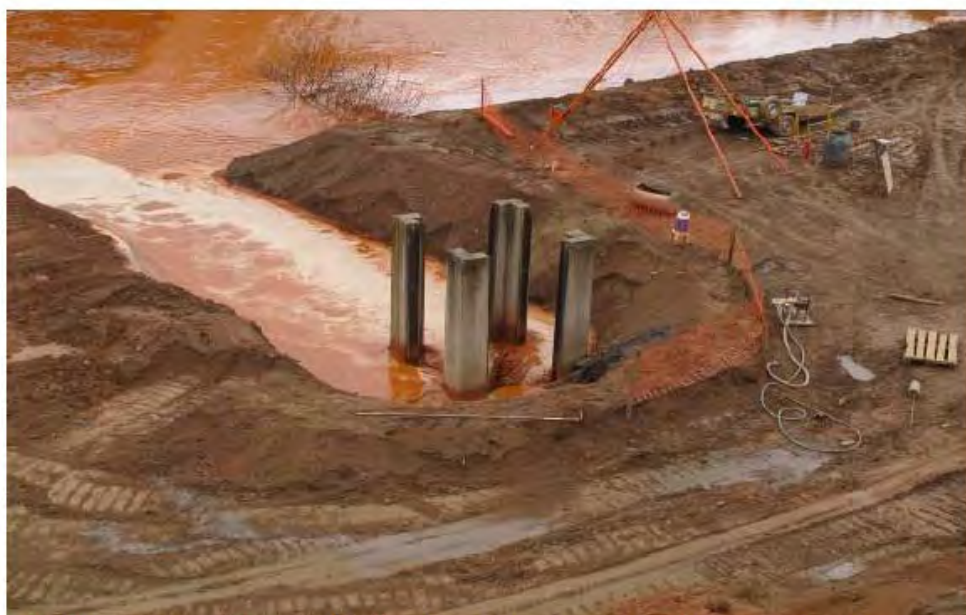
Photo 3 – Secondary Gallery intake without grillage to prevent debris entry or provide personnel safety

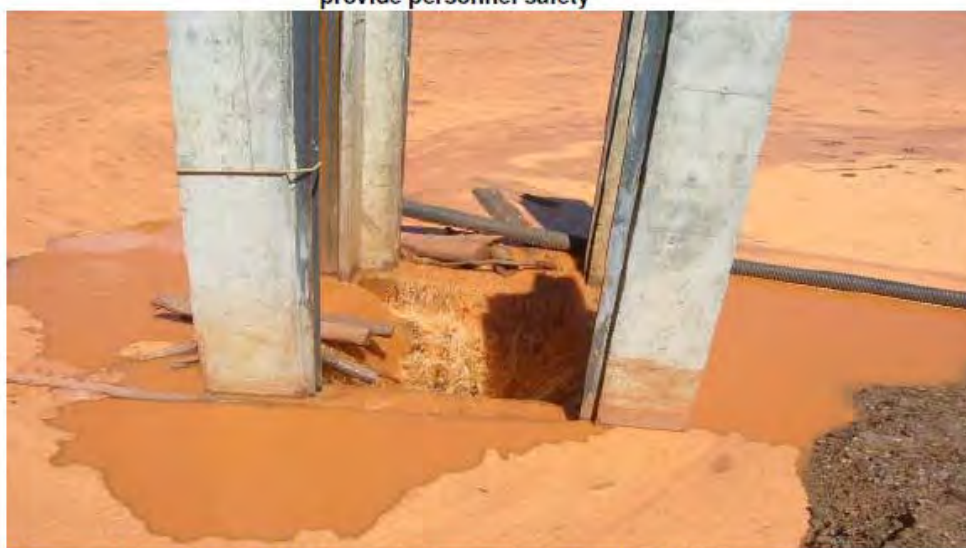
Photo 4 - Intake (from prior inspection) showing debris entry

Figure B6-6 Secondary Gallery intake showing presence of slimes, photo from October, 2011 ITRB report

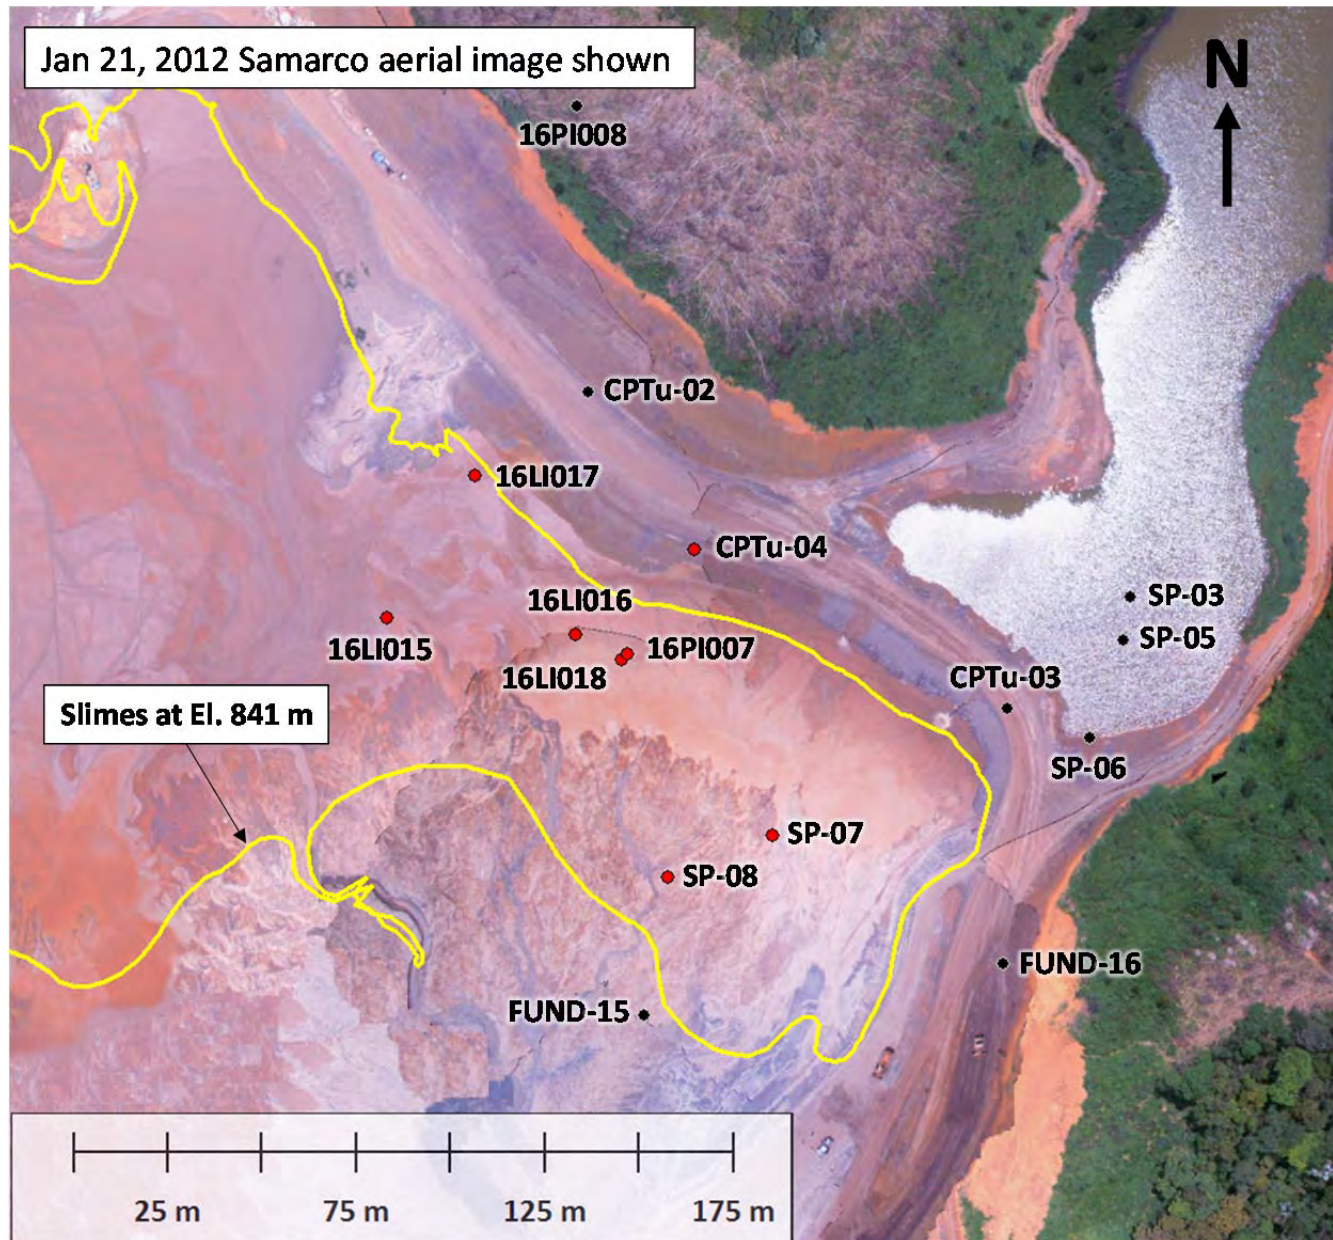
Figure B6-9 Drill hole review for slimes at left abutment

Of the 110 drill holes reviewed at the left abutment, 17 contained data between El. 840 m and El. 850 m, of which 8 encountered slimes as per the criteria set out in Table B6-6. These 8 drill holes are in the immediate vicinity of the left abutment (Figure B6-9) and encounter material that underlies the November, 2015 embankment slope (Figure B6-10). A summary table of drill holes is given in Table B6-7.

Black dots indicate drill holes with data in elevation range 840 m to 850 m that do not indicate presence of slimes. Red dots indicate drill holes with data in elevation range 840 m to 850 m that do indicate presence of slimes.

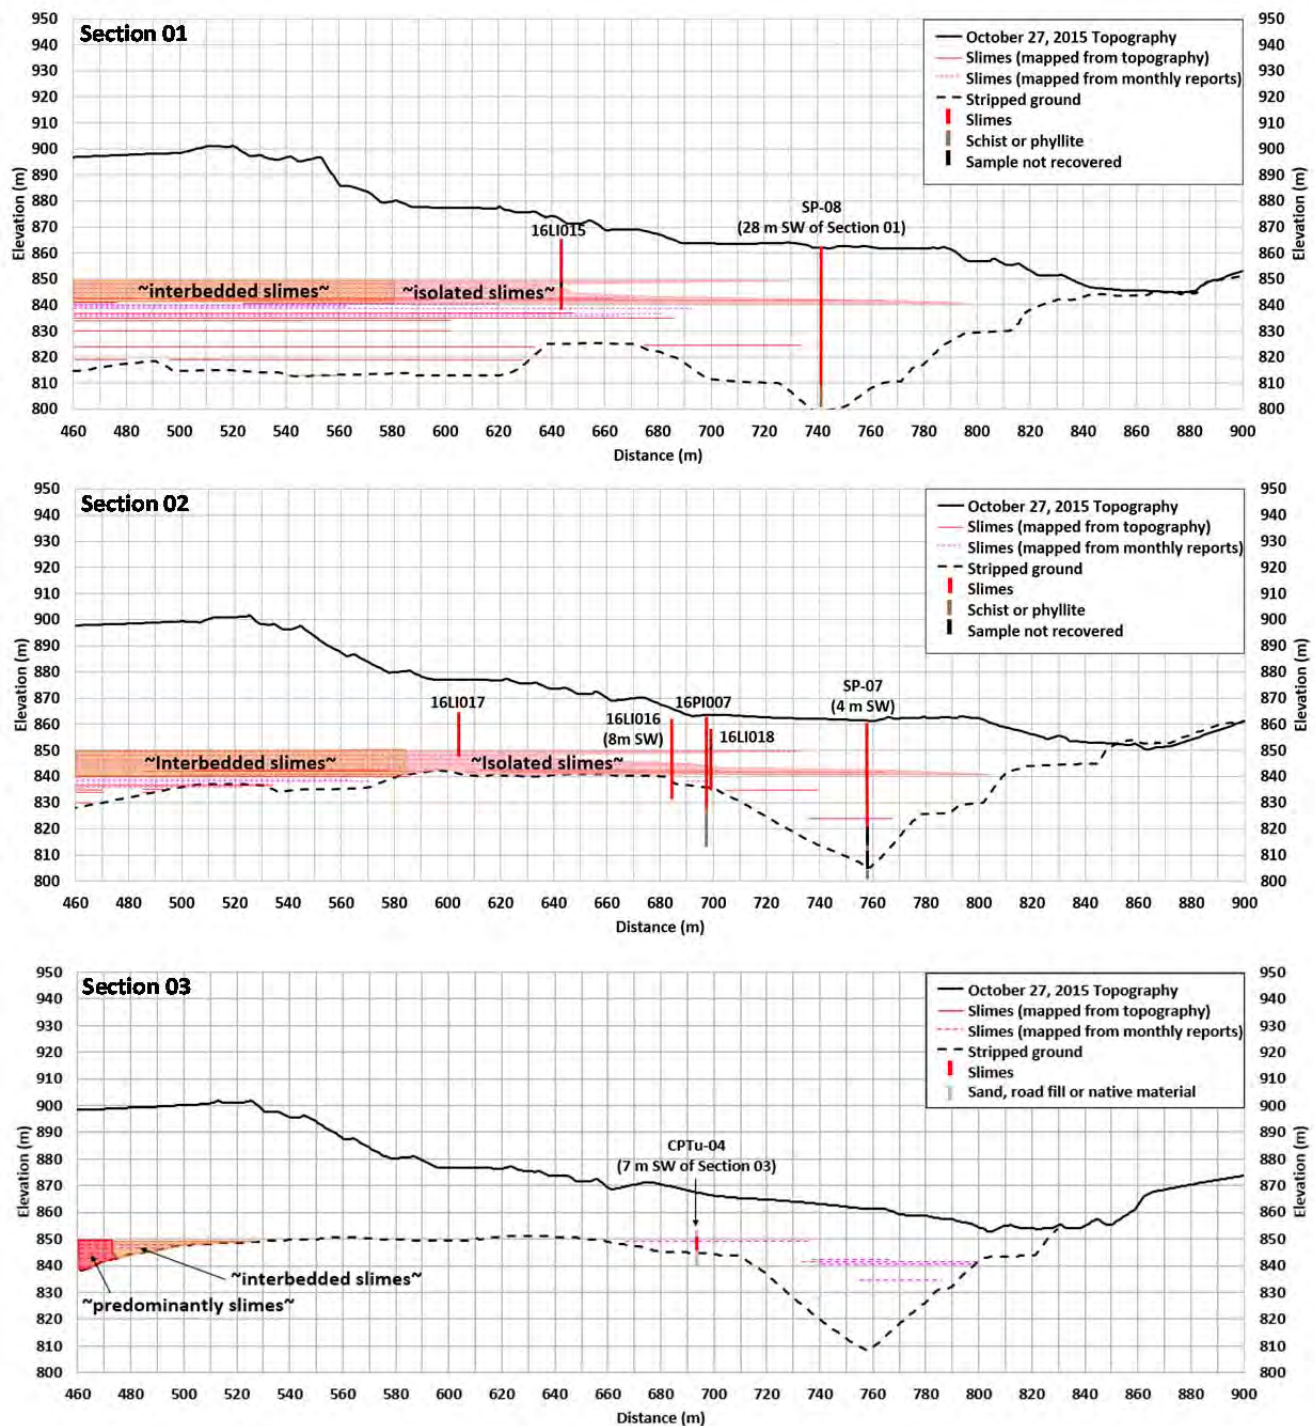
Figure B6-10 Drill hole lithology shown on Sections 01, 02, 03

Within the eight holes where slimes were identified, their distribution is more difficult to determine because the tailings were not continuously sampled. However, SP-07 is notable in having distinguished two discrete clay layers corresponding to slimes: a 2 m thick layer at El. 836.36 m and a

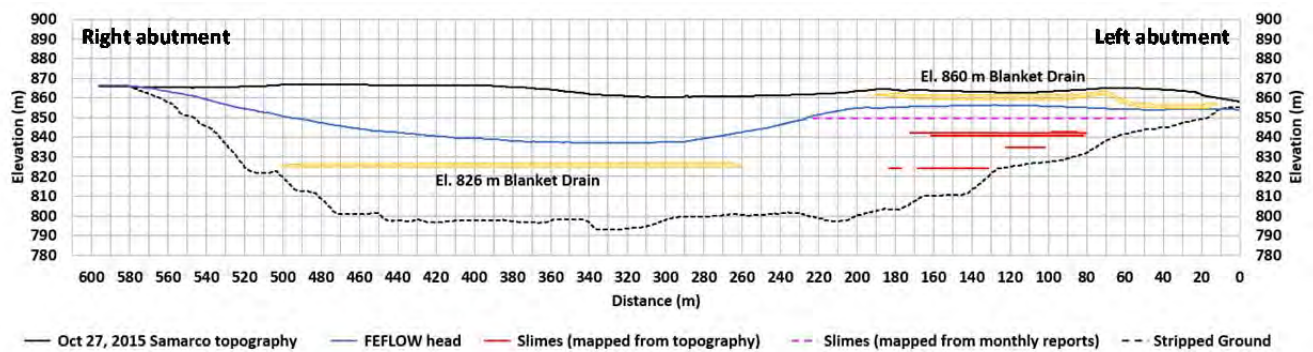
Figure B6-12 Longitudinal section from left to right abutment

There appears to be a perched water table in the left abutment area. The piezometric readings from the piezometers at the left setback are presented in the following section.

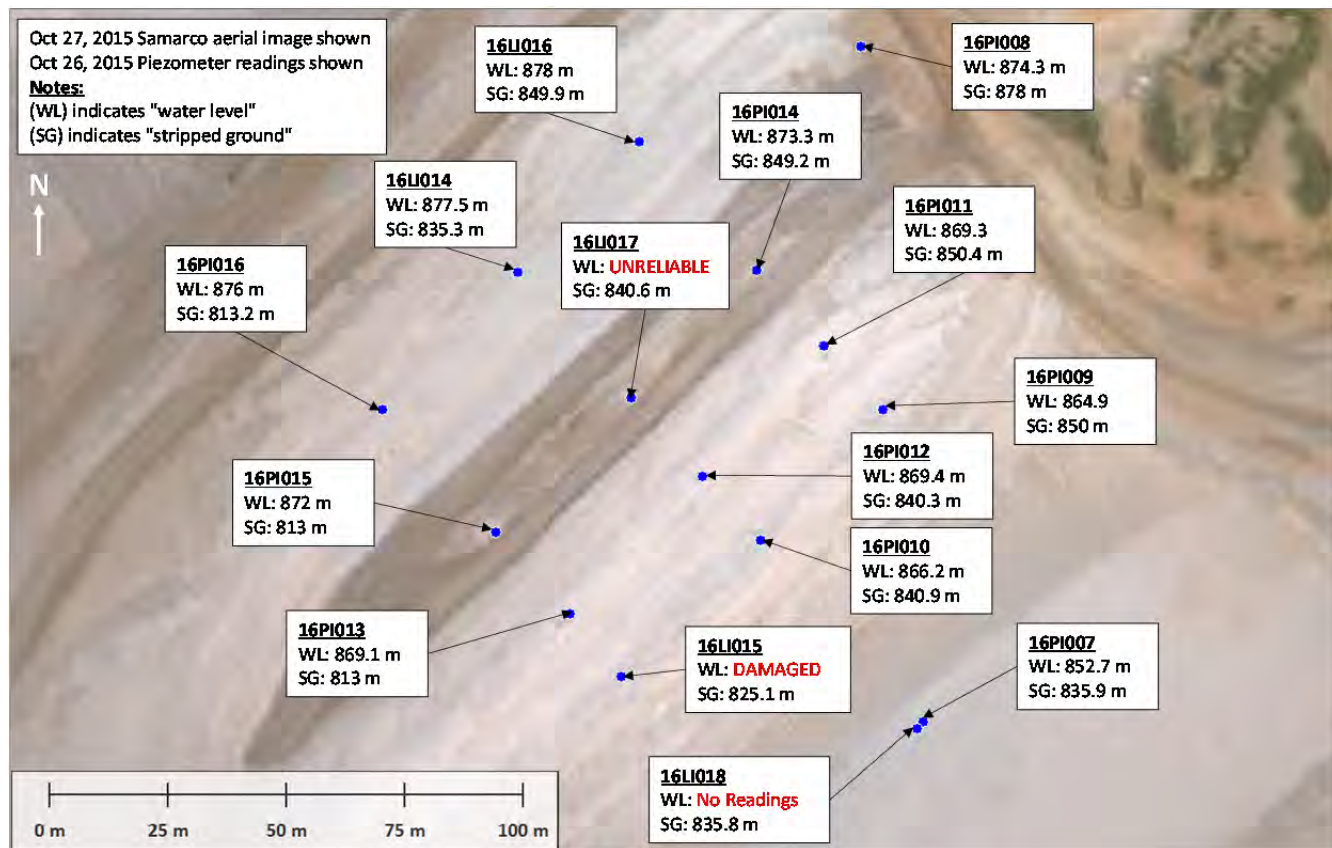
Figure B6-13 Piezometric readings and stripped ground elevation at setback in October, 2015

Despite a steeply sloped stripped ground surface moving away from the left abutment, the piezometric records denote a relatively flat water table. This again implies there is an impedance to downward drainage to the El. 826 m blanket drain below the left setback. The presence of an elevated phreatic surface at the left abutment supports the presence of slimes below the dike fill, resulting in a waterfall effect at the end of the slimes extents. It is also noted in Appendix G that flow from Grota da Vale elevates the piezometric surface on the left abutment.

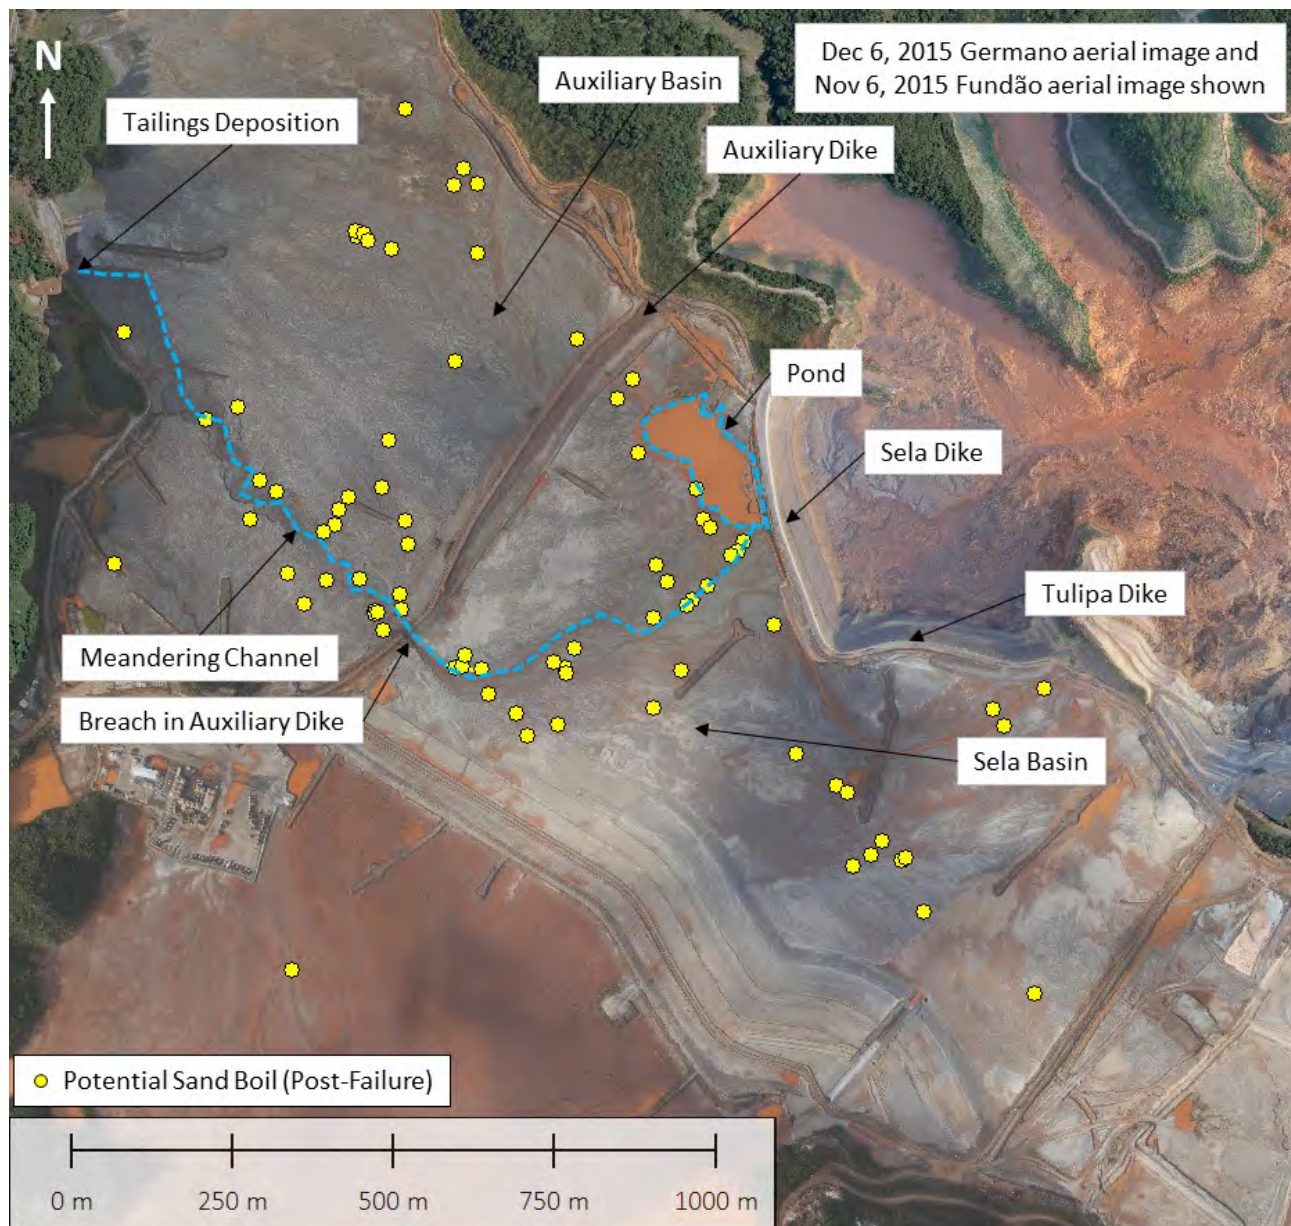
Figure B9-7 Location of features identified in the Germano facility

The approximate ground locations of the mapped features are shown in yellow on Figure B9-7. Lineations and clusters of features were found at several locations (see Figure B9-1). As shown on Figure B9-7, the majority of features were mapped in the Auxiliary and Sela basins with some upstream of the Tulipa Dike.

The October 27, 2015 and July 16, 2015 aerial images show tailings deposition at the northwest end of the Auxiliary basin. Local erosion has formed a meandering channel that flows from the pipeline outlet across the Auxiliary basin to a breach in the Auxiliary Dike and towards the Sela Dike. As shown on Figure B9-7, the majority of the mapped features in Germano are localized around the meandering channel and near the small pond bordering the Sela Dike (see example feature on Figure B9-4). These areas have the highest degree of saturation from the tailings stream which demonstrates a correlation between formation of the features and areas of active tailings deposition.

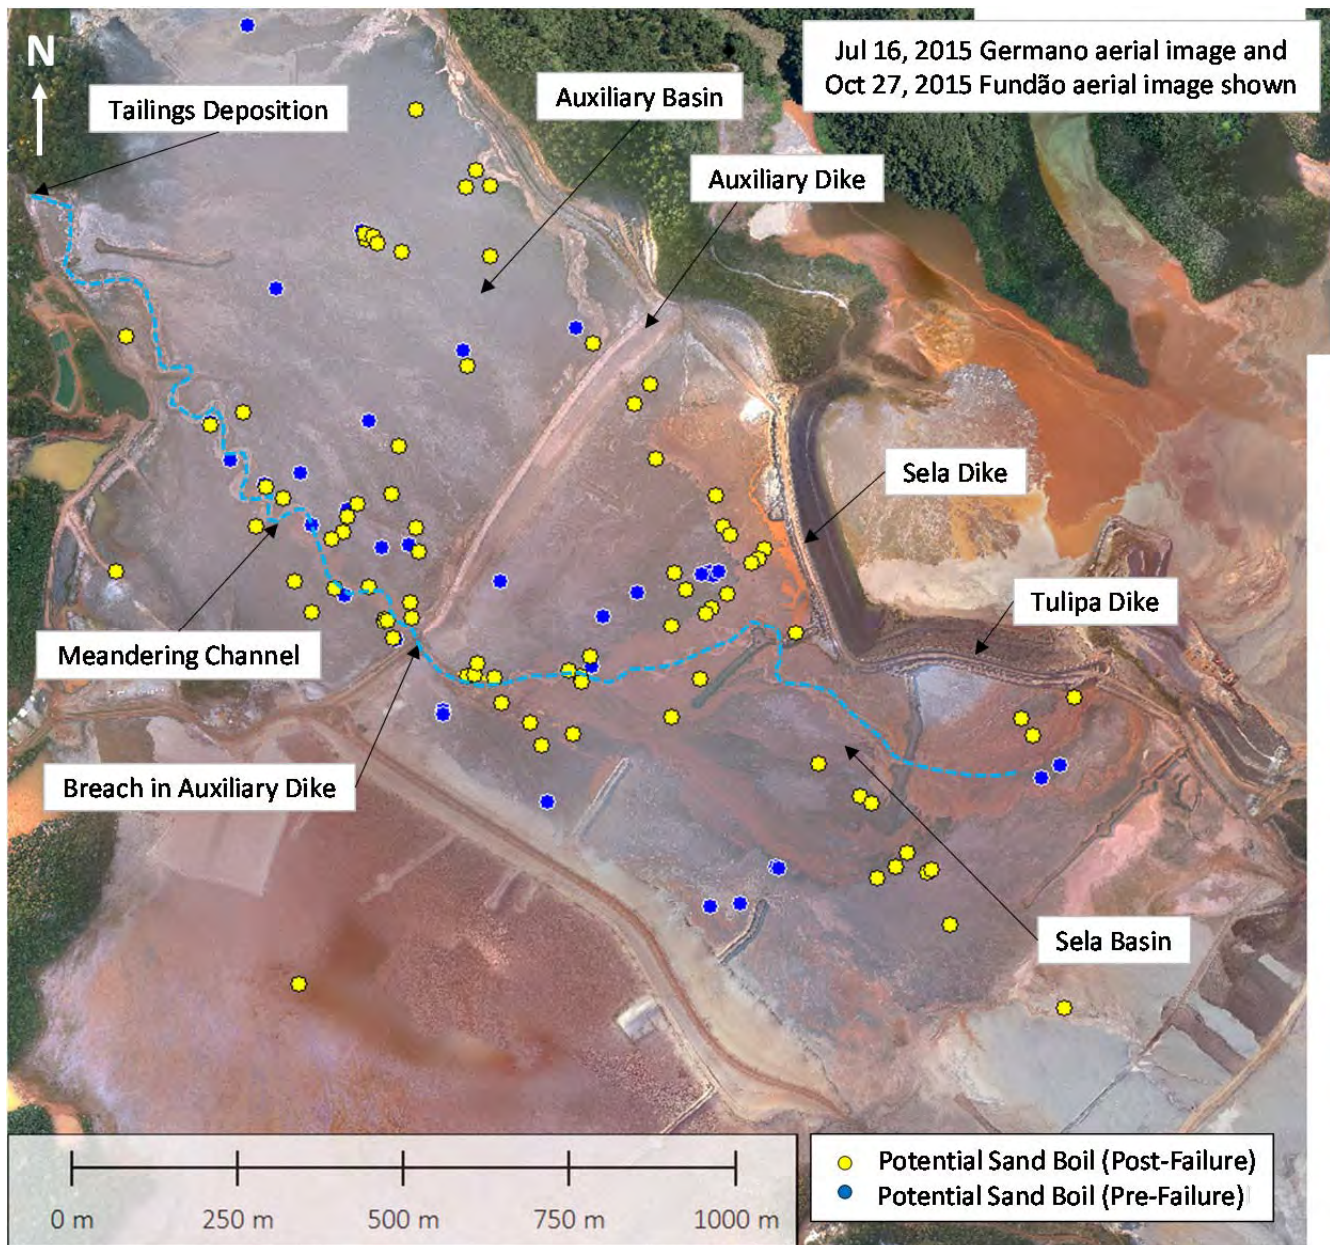
Figure B9-10 Location of features mapped pre- and post-failure

It is unlikely that any of the features seen in the pre- and post-failure images are the same given that this was an active tailings deposition area during the fall of 2015. However, Figure B9-10 shows that the pre-failure features also plot in the locally saturated areas.

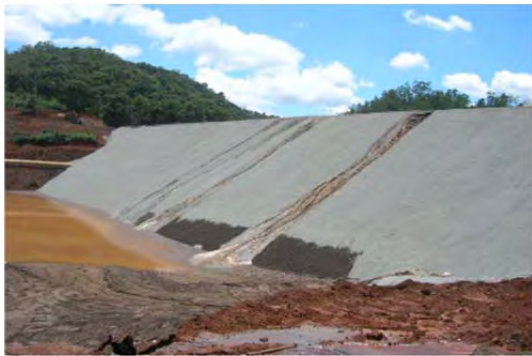
<p>Photo 32 – Upstream face of FD 1 covered with blanket drain that has been eroded</p> <p>December, 2008 Andrew Robertson audit photo taken during site inspection showing the upstream drainage blanket heavily eroded to sand tailings discharge in the Dike 1 reservoir.</p> </div> <div style="text-align: center;">

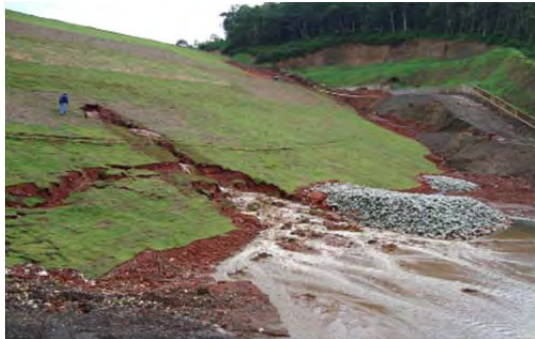
<p>Photo 2 – Initial Seepage flow – April 13, 2009</p> <p>May, 2009 Andrew Robertson audit photo showing the downstream slope of Dike 1 during the April, 2009 piping incident.</p> </div> </div>

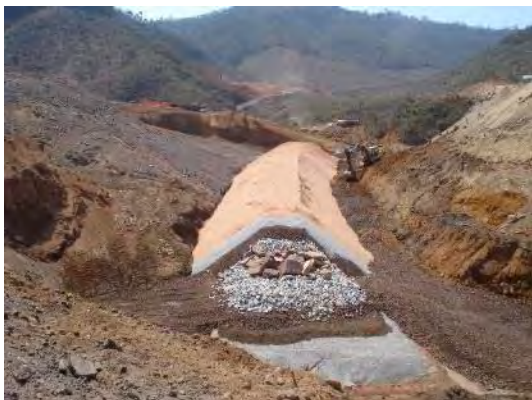
<p>October, 2007 construction photo of partially completed Principal Foundation Drain.</p> </div> <div style="text-align: center;">

<p>April, 2009 photo of exposed Principal (Main) and Auxiliary (Secondary) Foundation Drains during plugging.</p> </div> </div>
Noted incidents	Clogging of drain due to lack of protection over exposed drains prior to tailings placement. Other noted construction-related deficiencies.
Notes	-

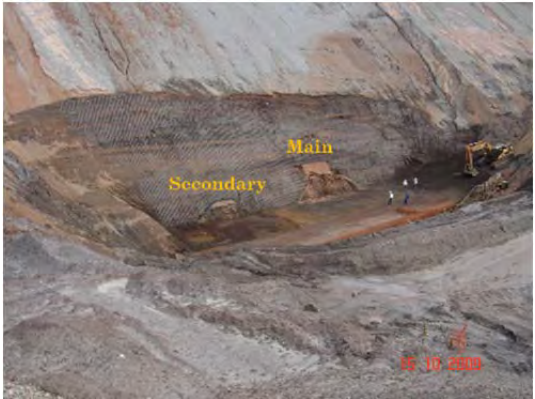
<p>April, 2009 photo of exposed Principal (Main) and Auxiliary (Secondary) Foundation Drains during plugging.</p> </div> </div>
Noted incidents	Clogging of drain due to lack of protection over exposed drains prior to tailings placement. Other noted construction-related deficiencies.
Notes	-

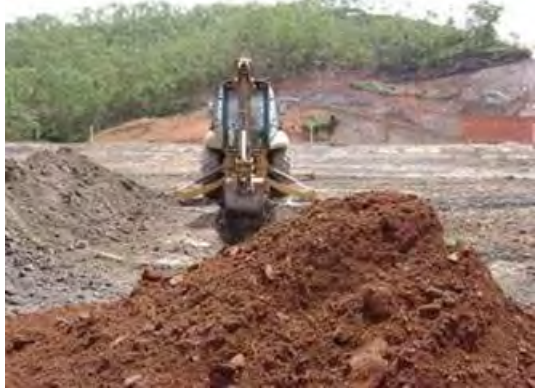
<p>January, 2008 construction photo of partially completed Vertical Chimney Drain and "future ore" material used (brown color).</p> </div>
Noted incidents	<p>From the August, 2009 Andrew Robertson engineering audit report where FD1 is Dike 1:</p> <p>The chimney drain in FD1 is of questionable reliability, as it was constructed using 'future ore' which is of questionable grading consistency and permeability. <i>The FD1 dam remediation should therefore assume that this drain will not function. A downstream Stabilization Berm, with a filter/drain layer at the dam interface is required to stabilize the resulting dam, as has been demonstrated by Pimenta (CL-3).</i></p>

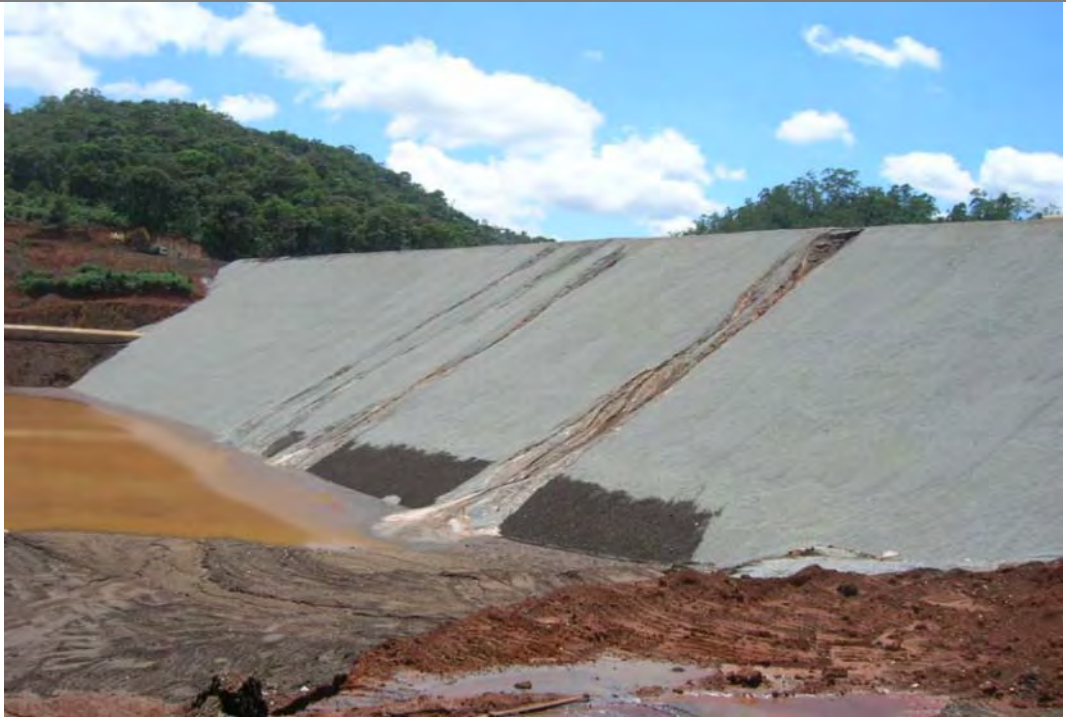
<p>December, 2008 Andrew Robertson site inspection photo showing the upstream face of Dike 1 covered with eroded drainage blanket.</p>
Noted incidents	Drainage blanket was not protected from erosion prior to placement of sand tailings. Structure was removed in its entirety during the April, 2009 remediation works.
Notes	-

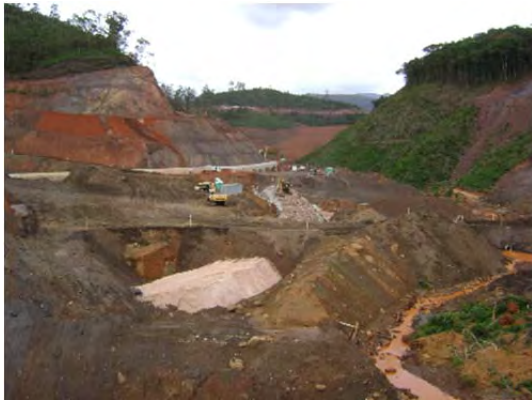
<p>February, 2008 construction photo showing partially completed Contingency Drain at left abutment with Secondary Gallery in the background.</p> </div> <div style="text-align: center;">

<p>Construction photo showing upstream end of Contingency Drain on right abutment during excavation in May, 2010.</p> </div> </div>
Noted incidents	Questionable construction quality, plugged prior to operation as part of Dike 1 remediation works.
Notes	-

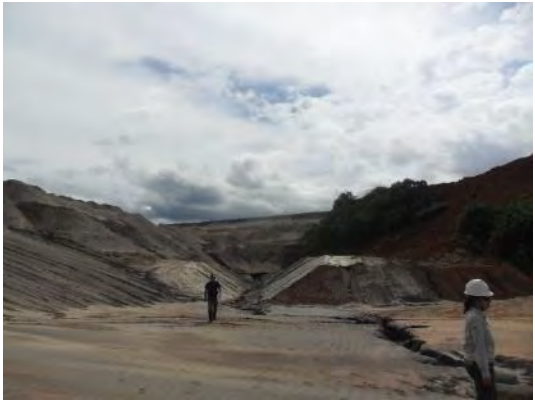
<p>March 27, 2014 VOGBR site inspection photo showing meandering erosion channel from end of open channel to Grota da Vale.</p> </div> </div>
Noted incidents	None
Notes	No engineering drawings or design reports available. The channel was implemented by Samarco's operations team to allow continued raising of the left setback without burying the rockfill trench which served as the outlet for the buried drains at El. 855 m and El. 860 m.

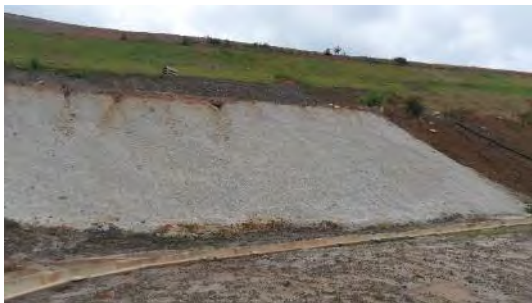
<p>July, 2014 VOGBR site inspection photo showing the initially placed inverted drain^[12].</p> </div> <div>

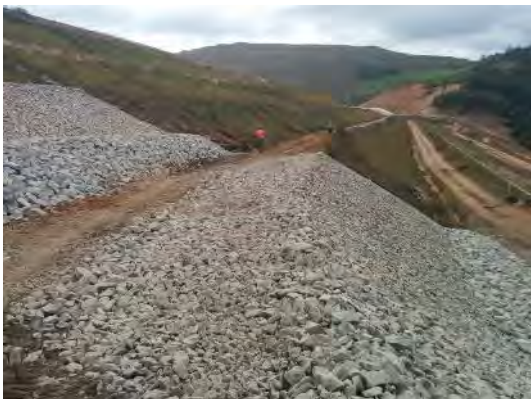
<p>July, 2015 VOGBR site inspection photo showing the remediated inverted drain^[13].</p> </div>
Noted incidents	None
Notes	Reported in [14]. This is at times referred to as the El. 850 m drain.

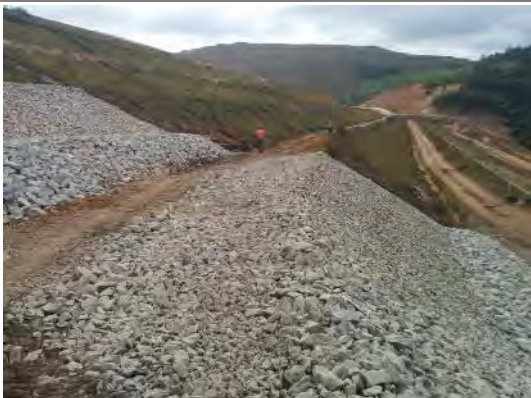
<p>July, 2015 VOGBR site inspection photo showing the remediated inverted drain on the upper bench^[13].</p> </div>
Noted incidents	None
Notes	Shown in [13]. This is at times referred to as the El. 855 m drain.

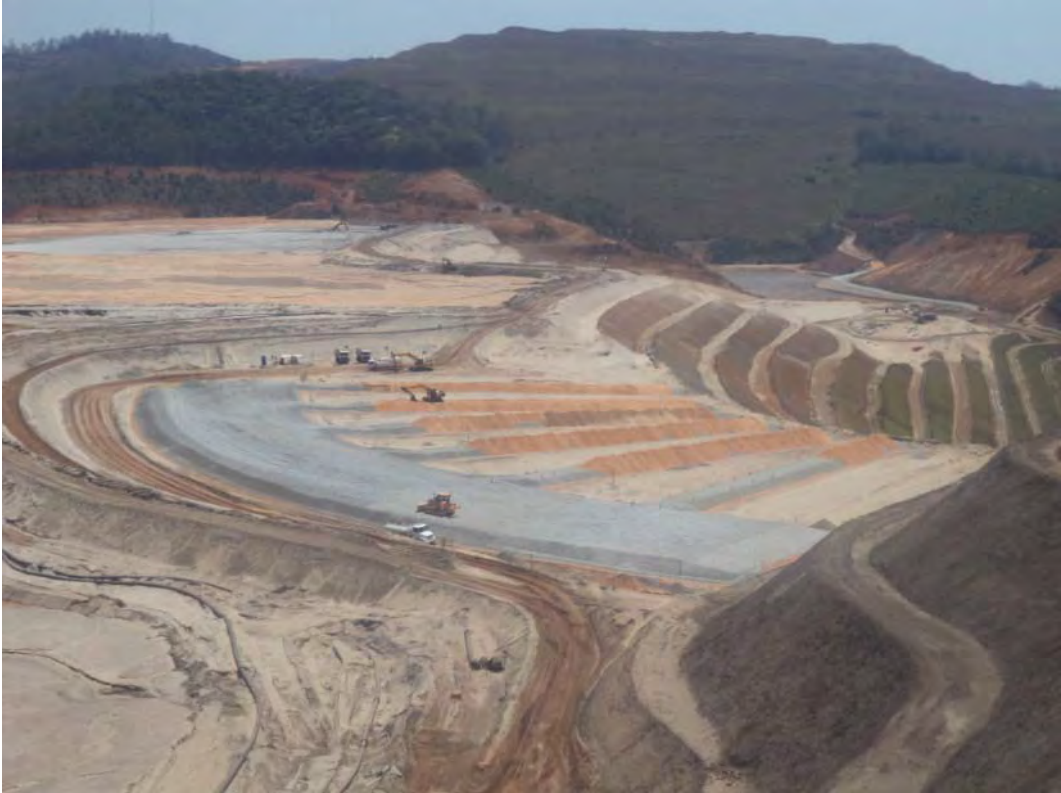
<p>November, 2015 construction photo showing partially completed Right Abutment El. 940 m Drain. Photo was taken from the right abutment looking towards the left with the Fabrica Nova Waste Pile in the background.</p>
Noted incidents	None
Notes	-

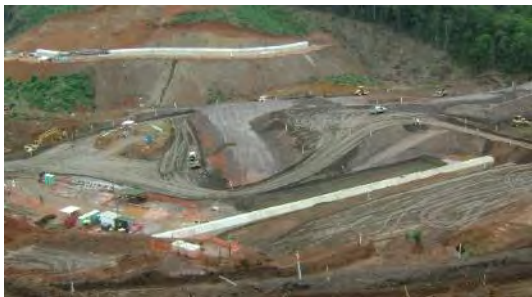
<p>November, 2007 construction of Main Gallery (bottom) and Secondary Gallery (top).</p> </div> <div style="text-align: center;">

<p>February, 2008 construction photo showing the Main Gallery next to a partially constructed Principal Foundation Drain. Photo was taken standing on the right abutment of Dike 2 looking towards Dike 1.</p> </div> </div>
Noted incidents	July, 2010 settlement which led to formation of a sinkhole at the top of the tailings. Multiple instances of cracks and operational defects.
Notes	As-built alignment documented in multiple surveys.

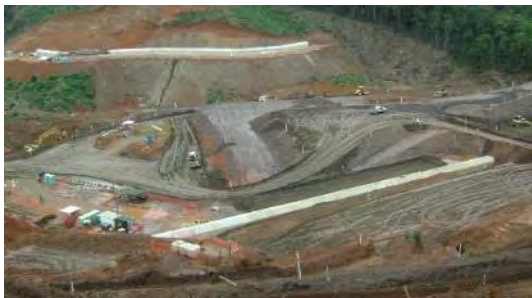
<p>November, 2007 construction of Main Gallery (bottom) and Secondary Gallery (top).</p> </div> <div>

<p>July, 2007 construction photo of completed Secondary Gallery tulipas (vertical riser intakes).</p> </div>
Noted incidents	Multiple instances of cracks and operational defects. Secondary Gallery sinkhole on November 25, 2012.
Notes	As-built alignment documented in multiple surveys.

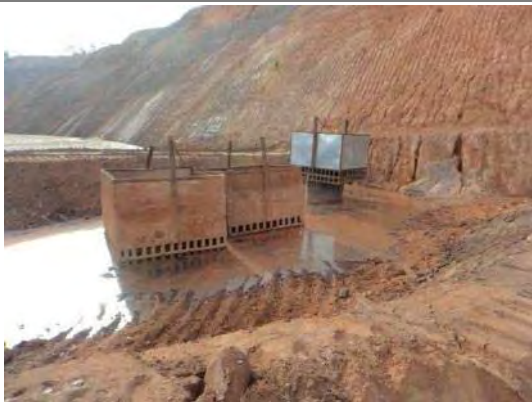
<p>Weekly report photo from week of November 17, 2014 showing screens around the 4th Spillway tulipas to protect from entry of debris to the decant system.</p> </div> <div>

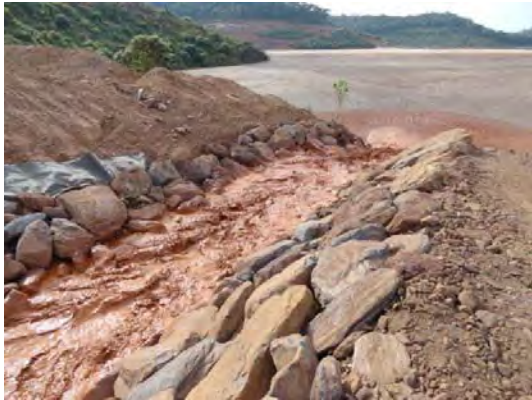
<p>Weekly report photo from week of July 15, 2013 showing the Overflow Channel in operation and decanting slimes from the Dike 2 reservoir into the Dike 1 reservoir.</p>
Noted incidents	None
Notes	-

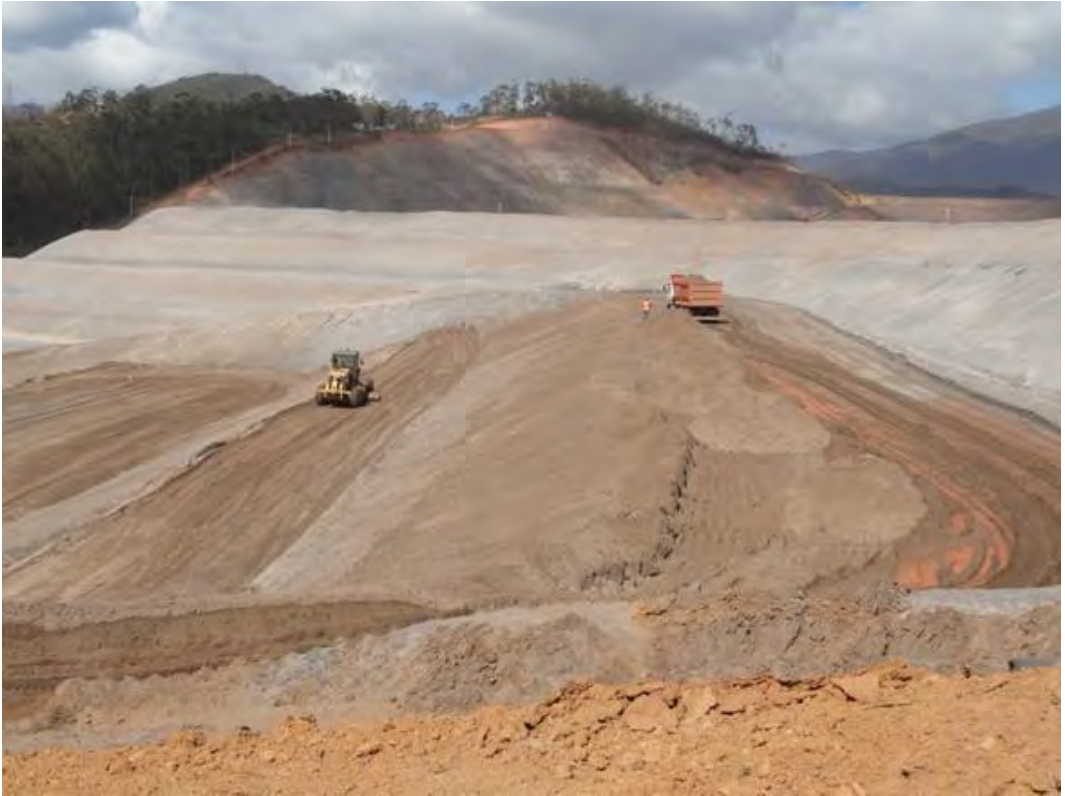
<p>Weekly report photo from week of September 8, 2014 showing completed Reinforcement Berm on left setback.</p>
Noted incidents	None
Notes	-

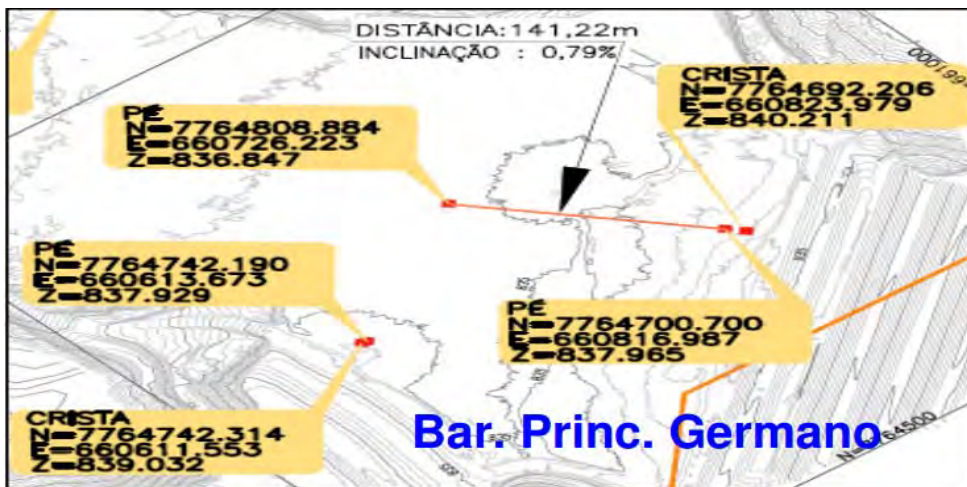
Dam was mislabeled as Germano in the September 2011 monitoring report.

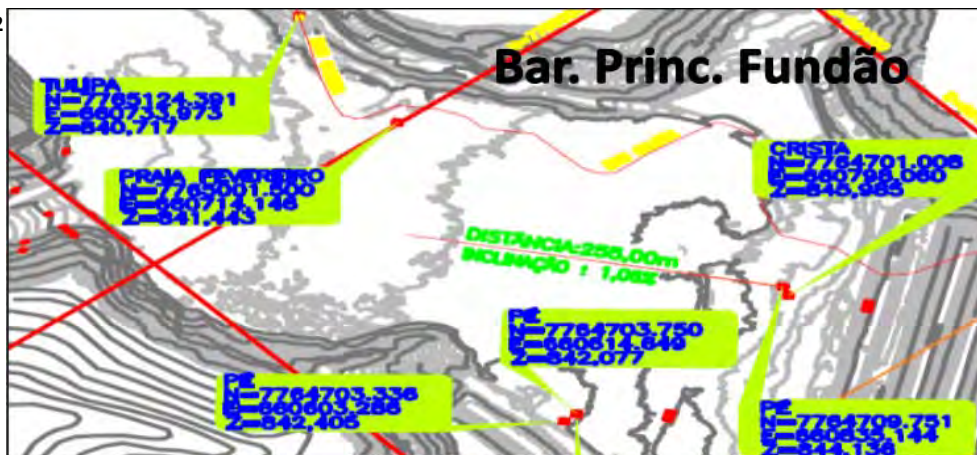
February 2012

The coordinates for the upstream toe of Dike 1 do not plot where it is shown in the monitoring report. The coordinates are assumed to be erroneous.

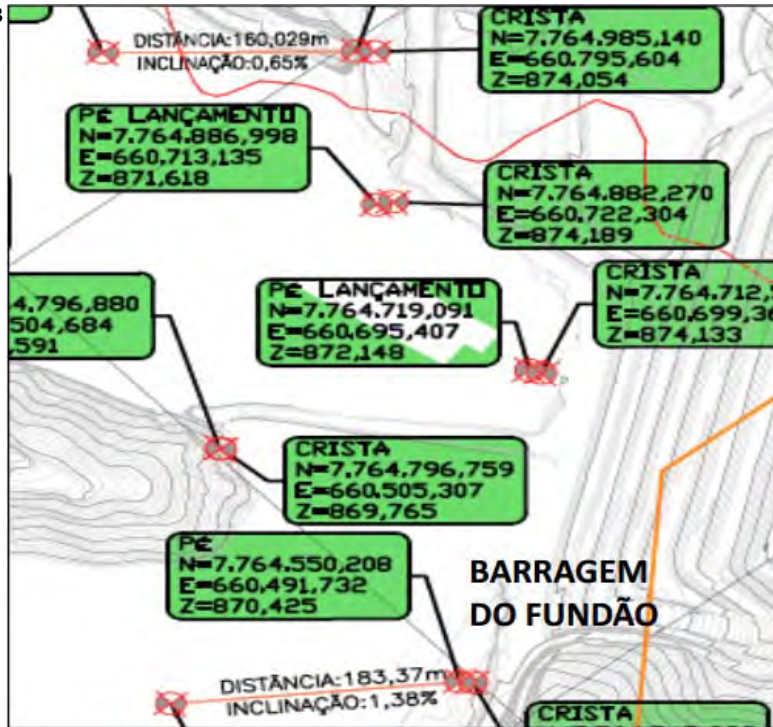
The survey date for the data shown in the December 2013 report is given as October 30, 2013 which is the same date as the one given in the October 2013 report. The measurements shown are discarded from the beach width data set.

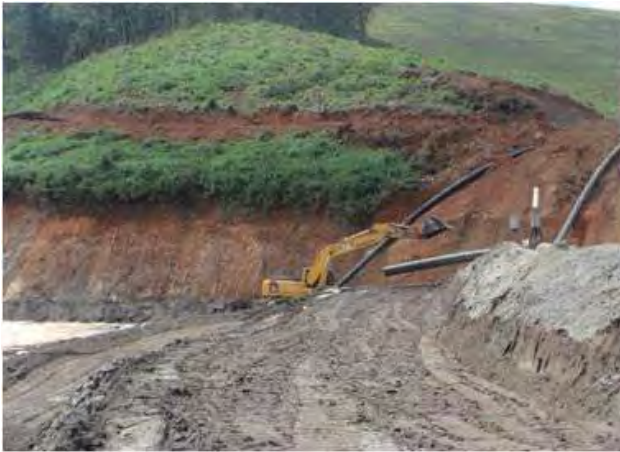
1-A: Photo from weekly report, week of May 3, 2015: "Elevation of the left-side abutment, phase 4."

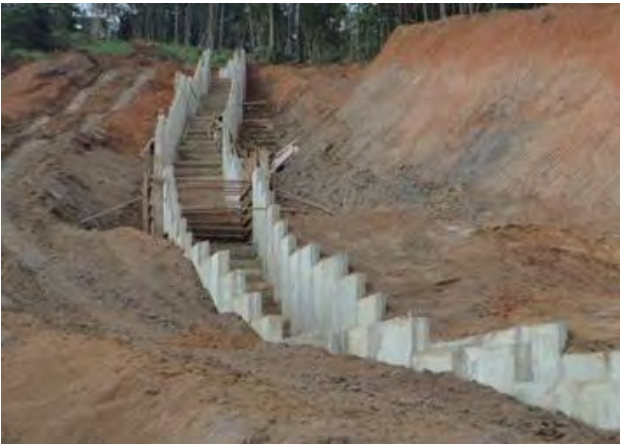
MISC-B: Photo from weekly report, week of May 17, 2015: "Construction of drainage chutes at the left-side abutment of Dike 1."

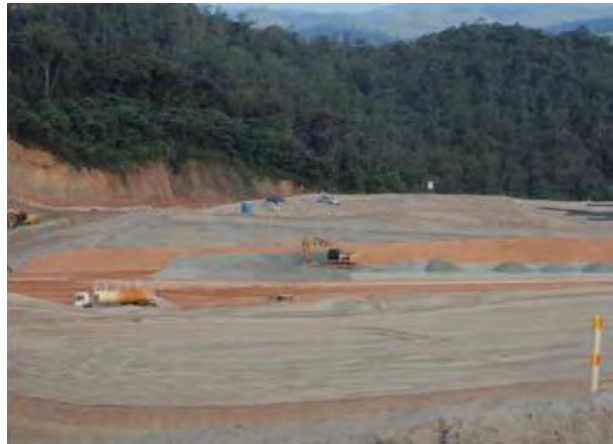
MISC-C: Photo from weekly report, week of May 24, 2015: "Continued construction of blanket drain at the left-side abutment of Dike 1."

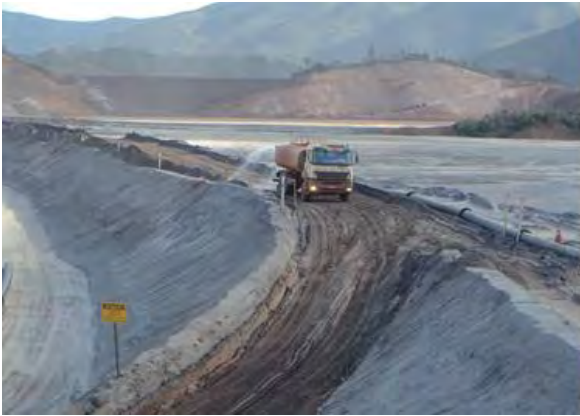
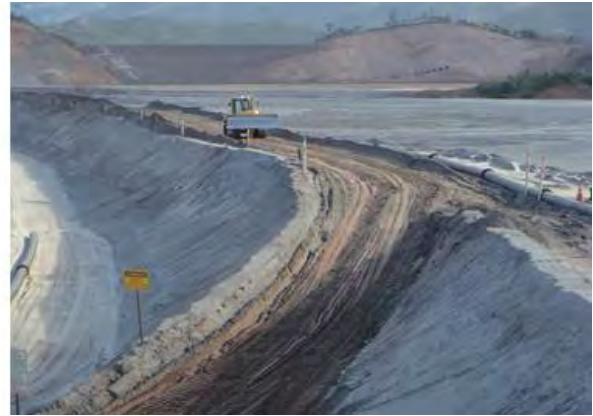
3-A: Photos from weekly report, week of May 31, 2015: "Construction begin of the 25.00 m plateau upstream at, to the 890 m elevation. At Dike 1."
