Fundão Tailings Dam Review Panel

Report on the Immediate Causes of the Failure of the Fundão Dam

EXECUTIVE SUMMARY

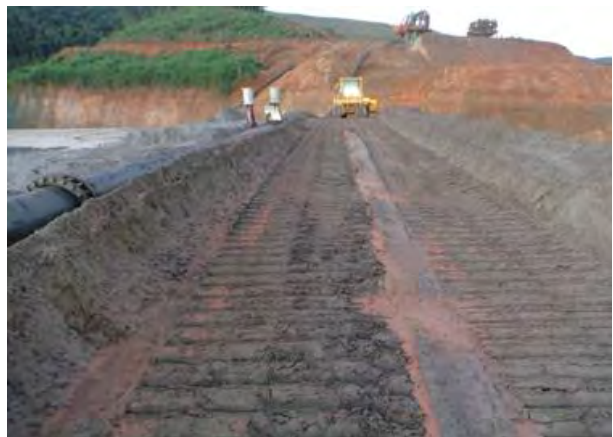
3-C: Photo from weekly report, week of June 7, 2015: "Spreading and compaction of the tailings on the left-side abutment."

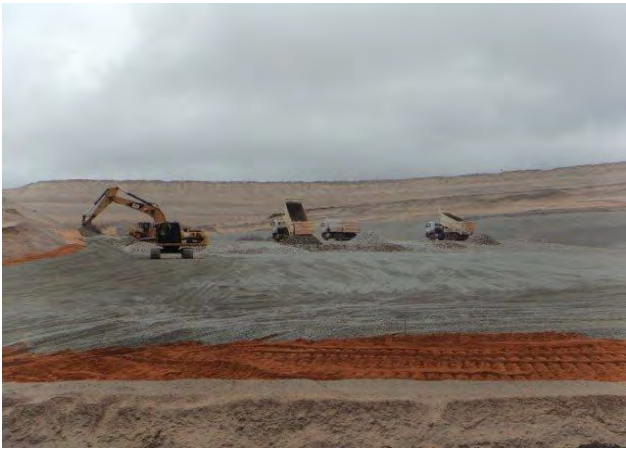
4-A: Photo from weekly report, week of June 14, 2015: "Construction of a drainage blanket on the left-side abutment of Dike 1."

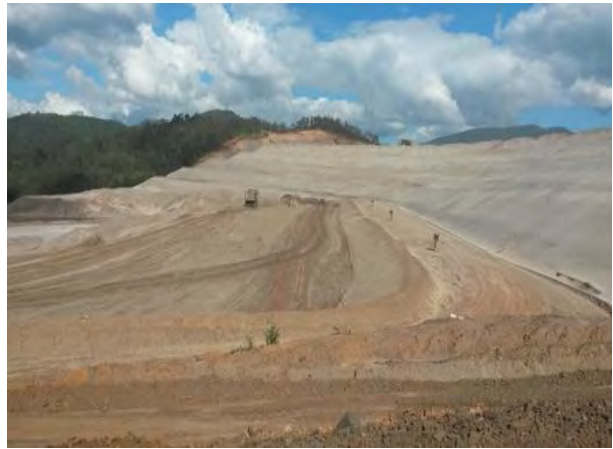
6-A: Photo from weekly report, week of June 7, 2015: "Landfill over the left-side abutment drain, to the 877.0 m elevation."

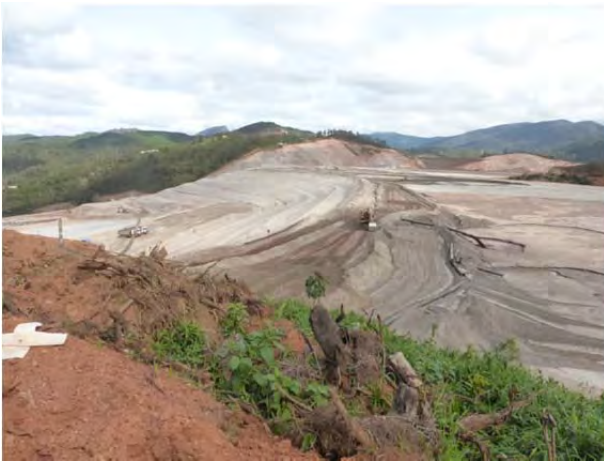
6-D: Photo from June 21, 2015 site visit by ITRB showing view of left abutment.

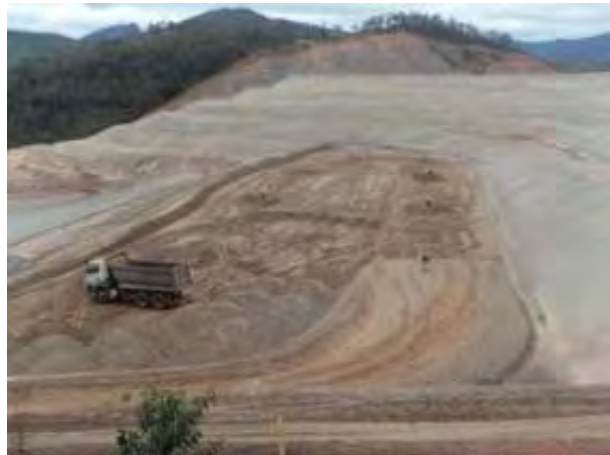
6-E: Photo from weekly report, week of June 21, 2015: "Elevation of the crest at the left-side abutment connection."

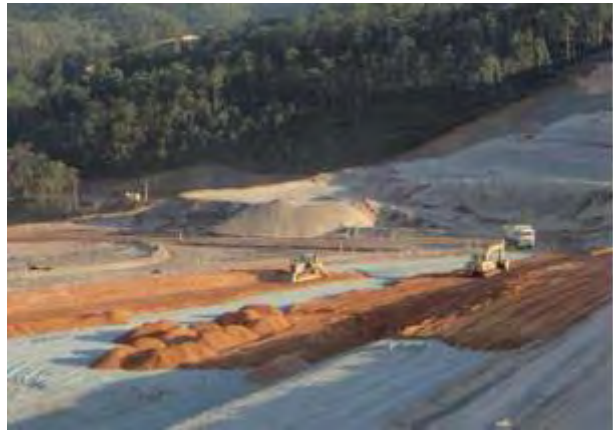
10-A: Photo from weekly report, week of June 28, 2015: "Construction of drain carpet on the left-side abutment of Dike 1."

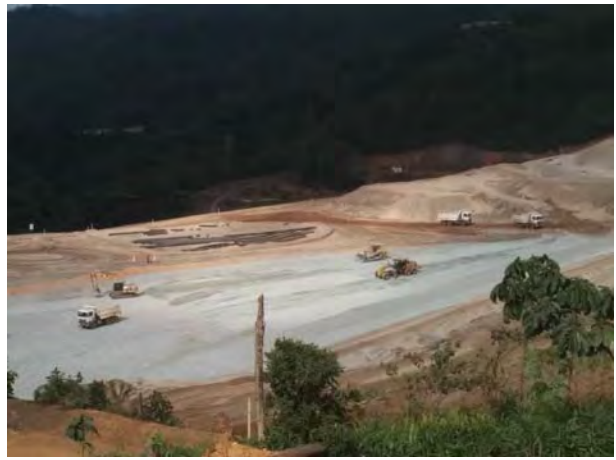
10-C: VOGBR photo from July 2, 2015^[18] showing drain rock placement on left setback.

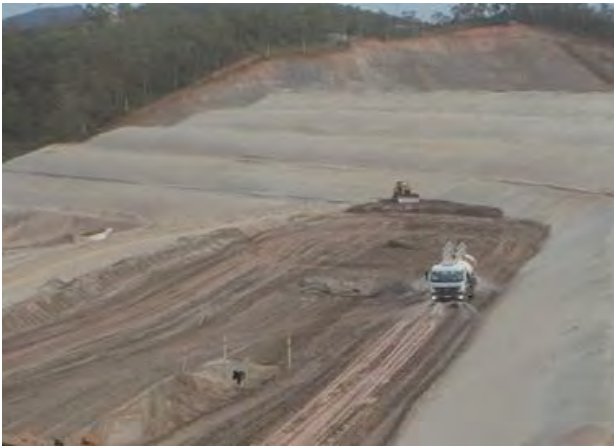
9-D: Photo from weekly report, week of July 5, 2015: "Tailings discharge to recover the original axis of Dike 1."

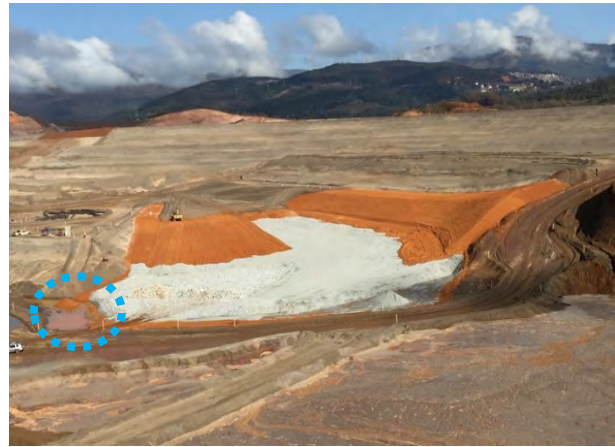
10-E: Photo from weekly report, week of July 5, 2015: "Construction of drain blanket on the left-side abutment of Dike 1." Dashed blue line around ponded water.

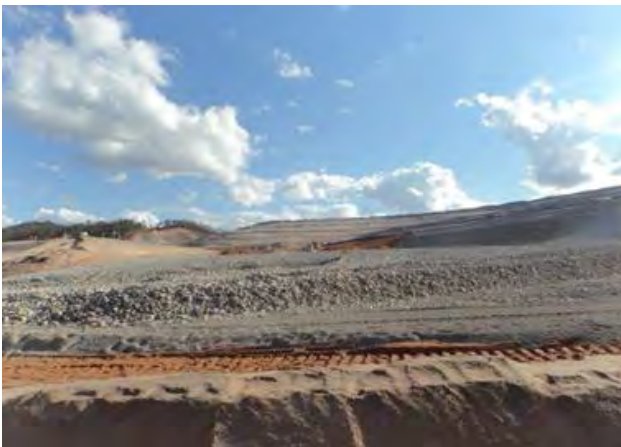
10-F: Photo from weekly report, week of July 5, 2015: "Construction of drain blanket on the left-side abutment of Dike 1."

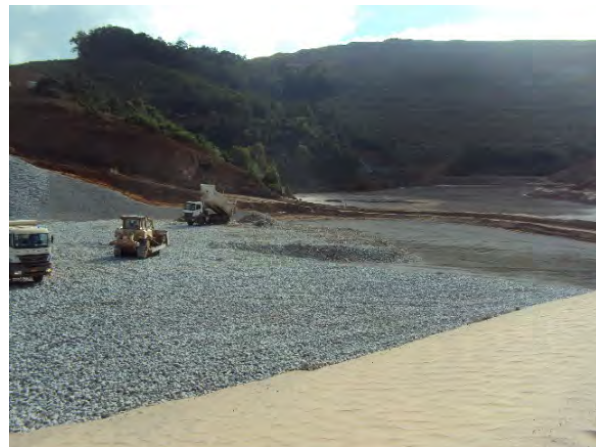
10-G: Photo from Technical Monitoring Photographic Report (2015-06-29 to 2015-07-03)^[19] showing drain rock placement on the left setback.

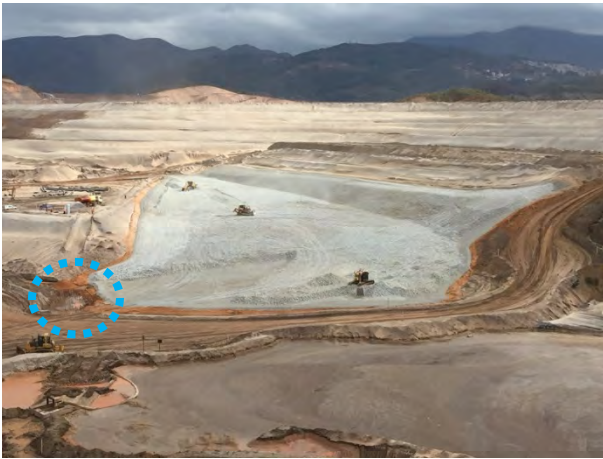
10-H: Photo from Technical Monitoring Photographic Report (2015-06-29 to 2015-07-03)^[19] showing left setback. Dashed blue line around ponded water.

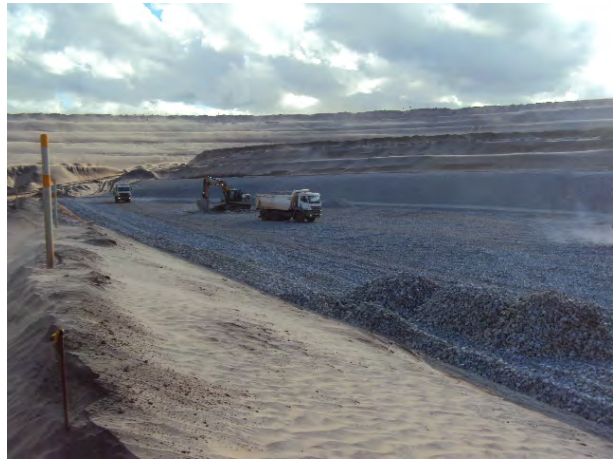
10-I: Photo from Technical Monitoring Photographic Report (2015-06-29 to 2015-07-03)^[19] showing drain rock placement on left setback.

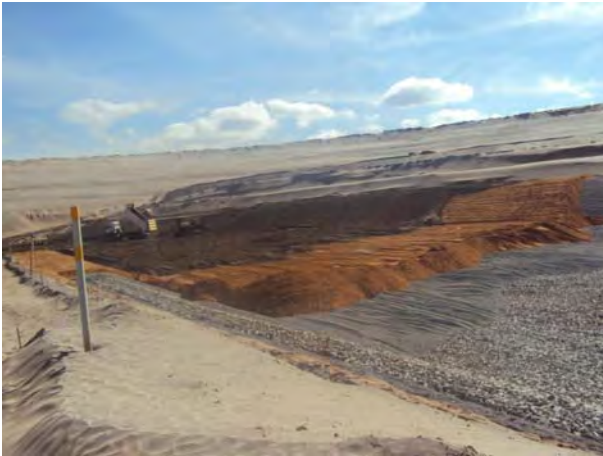
10-J: Photo from Technical Monitoring Photographic Report (2015-07-13 to 2015-07-17)^[20] showing sand placement.

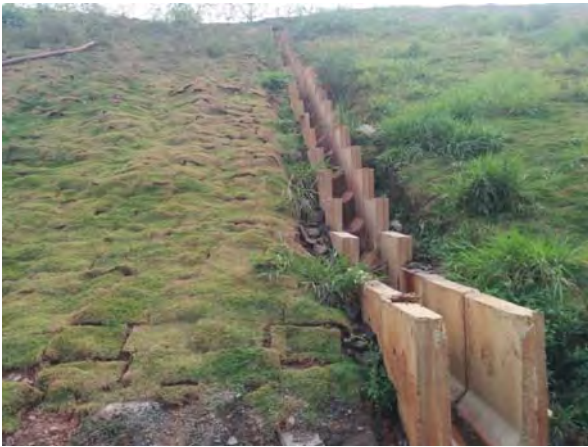
MISC-D: VOGBR photo from July 2, 2015^[18]: "Left Abutment - Saturation in the Slope - El. 826 m."

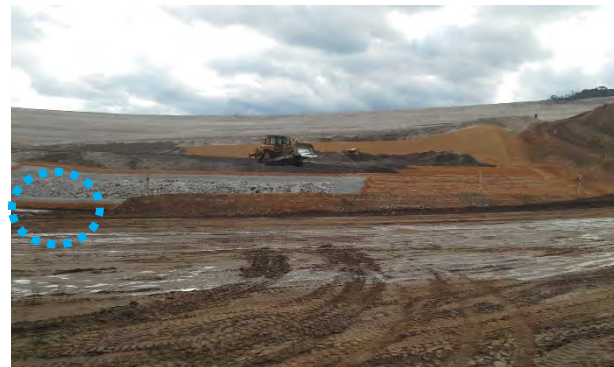
14-D: Samarco construction photo from August 14, 2015 showing drain construction on the left setback. Dashed blue line around ponded water.

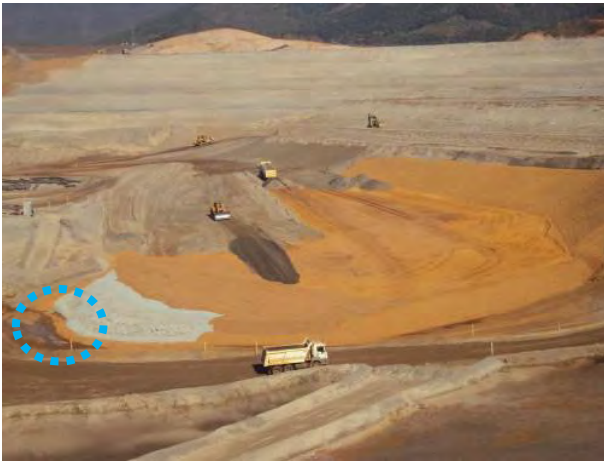
14-E: Photo from VOGBR report dated July 21, 2015 to August 20, 2015^[21] showing left setback. Dashed blue line around ponded water.

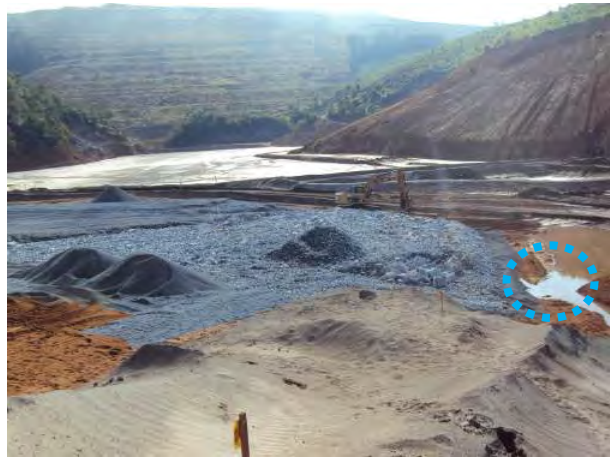
14-F: Photo from VOGBR report dated July 21, 2015 to August 20, 2015^[21]. Dashed blue line around ponded water.

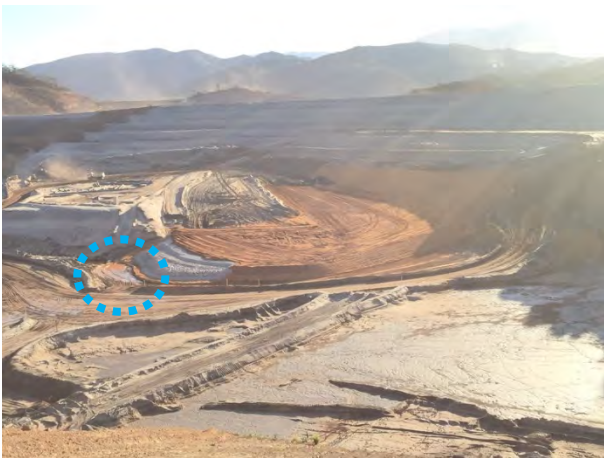
14-G: Samarco construction photo from August, 2015 (exact date unknown) showing left setback. Dashed blue line around ponded water.

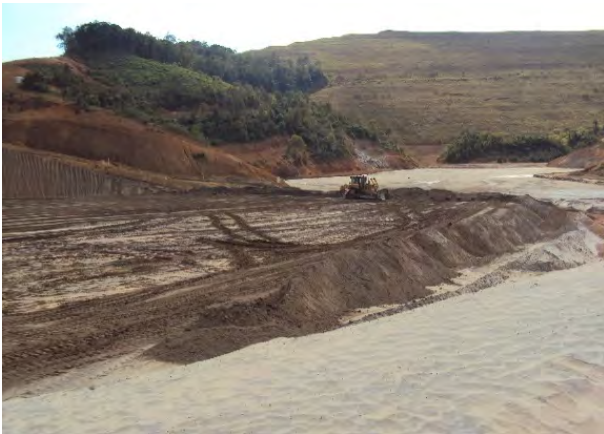
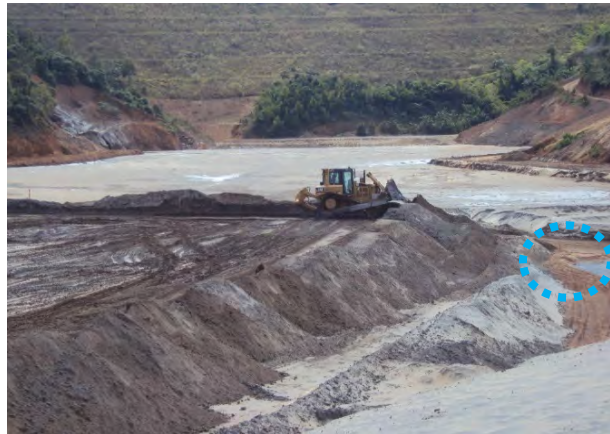
14-H, I: Photos from VOGBR report dated August 21, 2015 to August 28, 2105^[22]. Dashed blue line around ponded water.

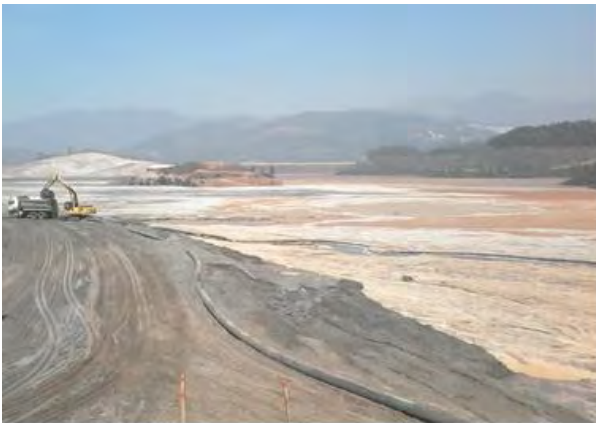
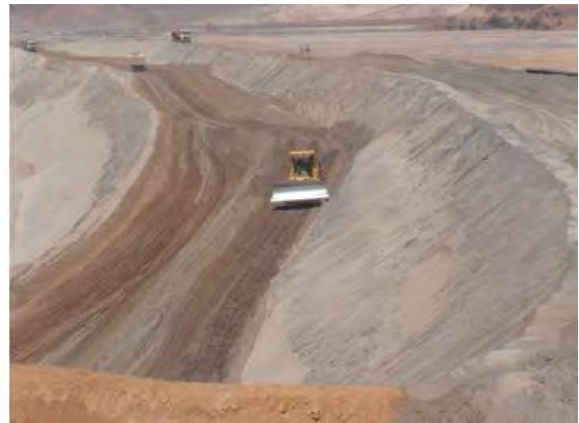
20-C, D: Photo from weekly report, week of October 11, 2015: "Heightening of the berm downstream from the left-side abutment, to ensure a safe height (5.00 m) between banks 895/900 m, allowing the heightening to proceed."

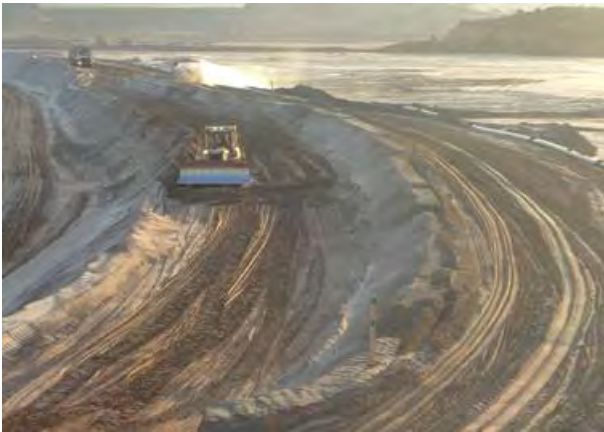
20-E: Photo from weekly report, week of October 11, 2015: "Heightening of the crest, downstream, to elevation 899.00 m, left-side abutment."

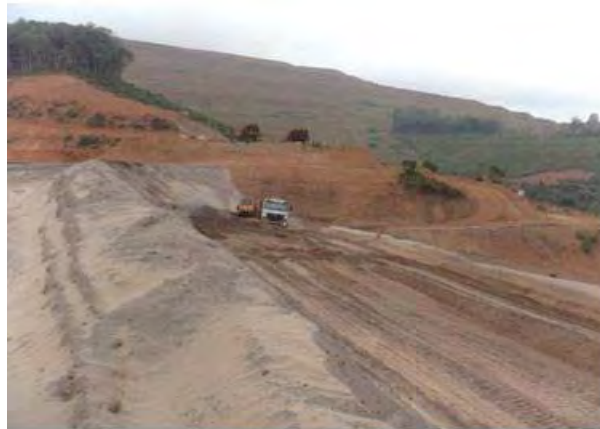
20-F: Photo from weekly report, week of October 24, 2015: "Construction of a reinforcement berm downstream from the 895/900 m bank, on the left-side abutment."

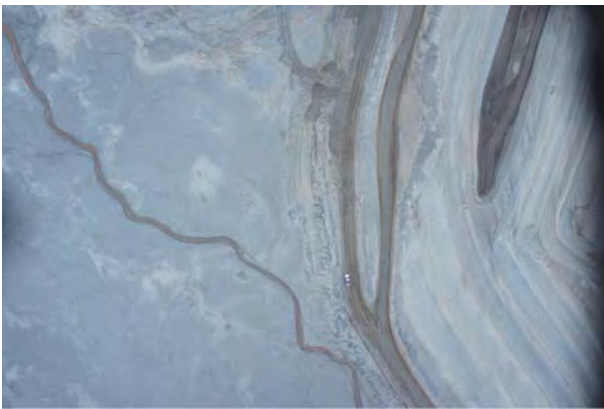
20-G: Raw drone photo showing greater detail of the "pullout" from October 28, 2015.

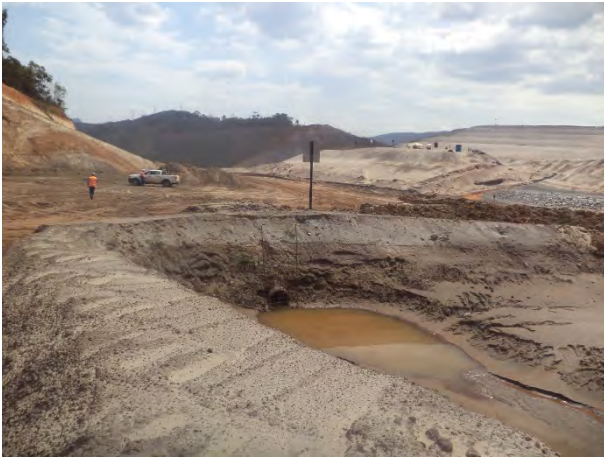
MISC-G: Photo from morning on day of failure from eyewitness report, November 5, 2015, showing toe of El. 860 m blanket drain.

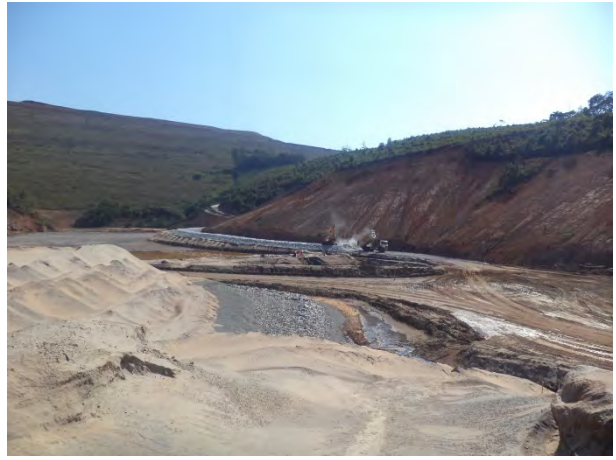
MISC-H: Photo from morning on day of failure from eyewitness report, November 5, 2015, showing toe of El. 860 m blanket drain.

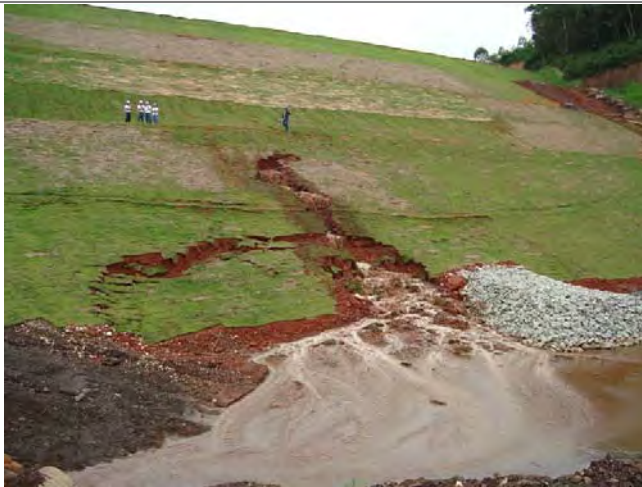
- A leak on the downstream face of Dike 1 above the Principal Foundation Drain developed.
- A berm was placed immediately on top of the leak, but this did not stop the flow.

April 13, 2009 site inspection photo^[23] showing piping on the downstream face of Dike 1. The Principal Foundation Drain can be seen to the right of the spring.

- Tailings deposition was diverted from Fundão, the Dike 1 reservoir drained, and the Principal and Auxiliary Foundation Drains excavated on the upstream and downstream side of Dike 1 for inspection. Both drains were noted to have defects such as erosion of the filter layers and clogging of drain material with fines.

- The base drains were replaced with one blanket drain at El. 826 m with 27 Kananet® pipes.
- Old Dike 1A was constructed to allow continued deposition of tailings in Fundão while the El. 826 m blanket drain was constructed.

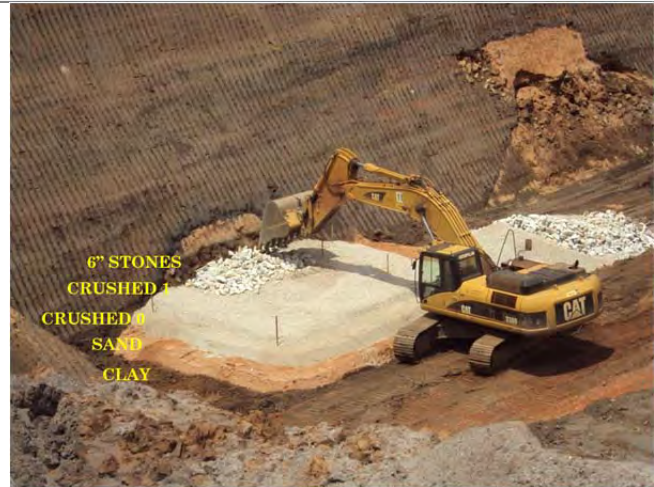
October, 2010 construction photo showing plugging of the Auxiliary Foundation Drain to the left with the excavated Principal Foundation Drain to the right.

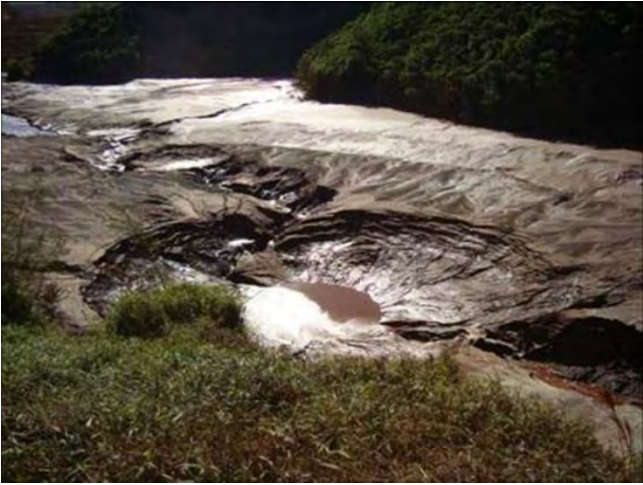
July 9, 2010 Main Gallery Settlement	
<u>Description</u>	
<ul style="list-style-type: none"> ▪ The module between Joint 26 and 27 experienced settlement which manifested as a vortex at the surface of the tailings. ▪ Tailings deposition in this area was suspended and an inspection showed tailings entering the Gallery through a large crack. ▪ New Dike 1A was built to shield this area from tailings deposition while jet grouting was completed on the foundation of the Gallery. 	
<u>Photos</u>

<p>July, 2010 site inspection photo^[25] showing the vortex that formed at the surface of the tailings above the settlement.</p>

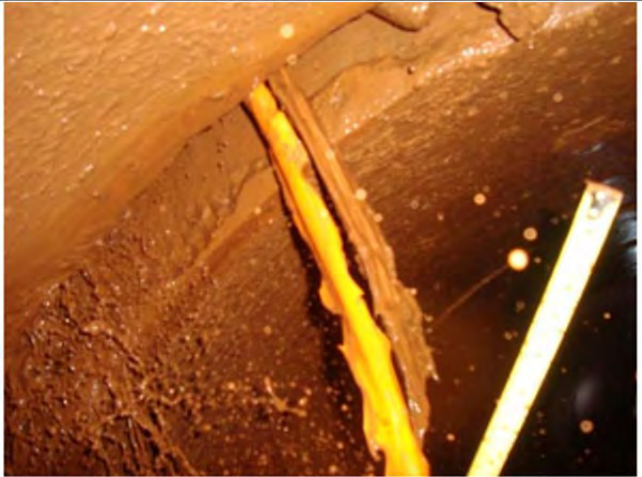
<p>Foto 05: Junta Fungenband danificada. Detalhe de desnível do concreto.</p> <p>July, 2010 inspection photo from GMAIA^[26] showing the inflow of tailings to the Gallery.</p>
<u>References</u>	<u>Conflicting references</u>
Samarco 2010 presentation ^[27] , Samarco 2010 presentation ^[28] , GMAIA 2010 inspection ^[26]	Joint references differ between sources, the second most common being the leak having occurred between Joints 22 and 23 instead of 26 and 27. This is due to different stationing having been used on drawings over time.

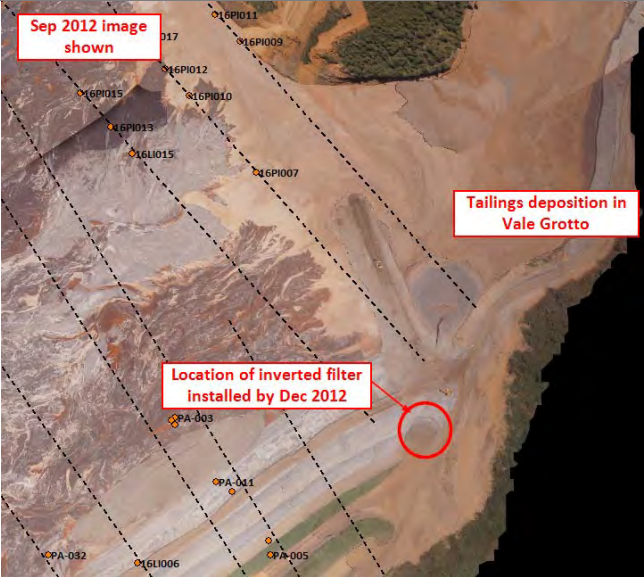
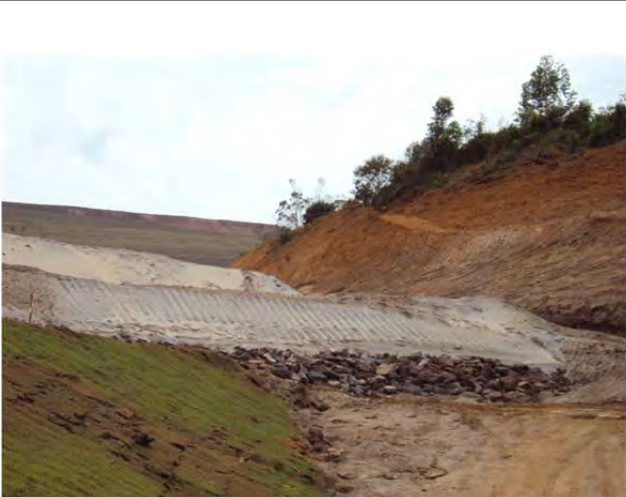
Figure 5.4 ~ Performance of an inverted drain ~ Dike 1 heightening, left abutment.

- Seepage was noted at El. 845 m on the non-setback part of the dike crest at the left abutment. VOGBR attributed this to the damming of water in the Grota da Vale which was upstream of the seepage location.
- The saturated upstream raise material was excavated and a drain installed. The drain consisted of a geotextile, granular material and coarse rockfill.
- No formal drain exit was installed until around May, 2015 in the form of a concrete channel that discharged into a buried pipe crossing the left abutment access road to the left abutment concrete channel.
- Flow records for this drain were not available.

Photo from VOGBR 2013 report^[29].

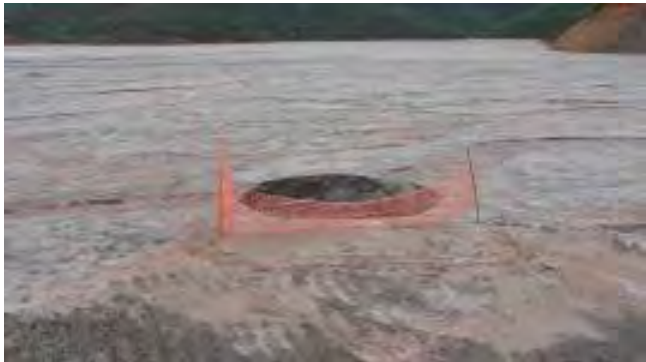
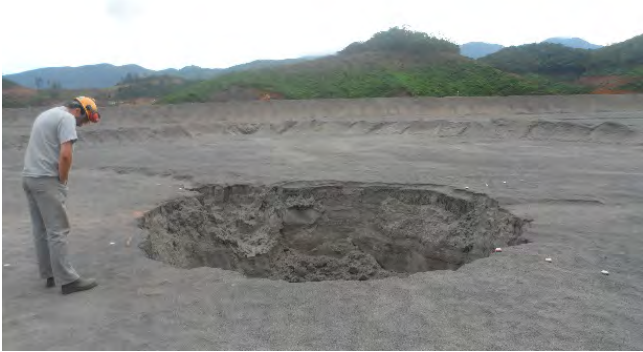
November 25, 2012 Secondary Gallery Sinkhole	
<u>Description</u>	
<ul style="list-style-type: none">▪ Sinkhole discovered on the El. 855 m bench at the setback portion of Dike 1 at the left abutment. This sinkhole was located above the Secondary Gallery at Joint 18.▪ An inspection revealed slug discharge of tailings and water from the tailings side of the Secondary Gallery.▪ Joint 18 was grouted internally.	
<u>Photos</u>

November 25, 2012 inspection photo ^[30] showing the sinkhole.	December 14, 2012 inspection photo ^[30] showing evolution of the sinkhole since November 25.
<u>References</u>	<u>Conflicting references</u>
Samarco 2012 inspection ^[30]	None

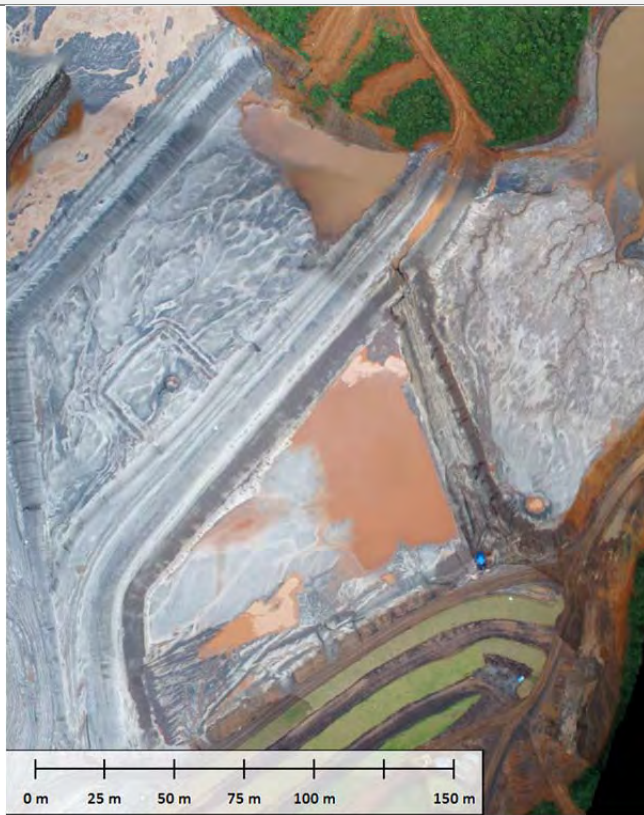
- The weekly report from the week of March 25, 2013 notes a saturated region at the left abutment.
- After a review of aerial images, part of the reason for saturation and ponding could be lack of surface drainage control on the left abutment roads above the dam. Topography shows this area to be ~El. 855 m.
- A buried drain (Drain 1) was put in, leading to a geotextile-wrapped rockfill trench (Drain 2) on the left setback. The buried drain was an inverted trapezoid, geotextile-wrapped rockfill drain.
- The geotextile-wrapped rockfill trench (Drain 2) eventually became a large open channel on the setback platform as the dam was raised around it. Details on the evolution of this drain are given on the last fact sheet of this section.

March 2, 2013 Samarco aerial image showing the Secondary Gallery sinkhole to the left and a region of saturation and ponding to the right at the dam's contact with the left abutment.

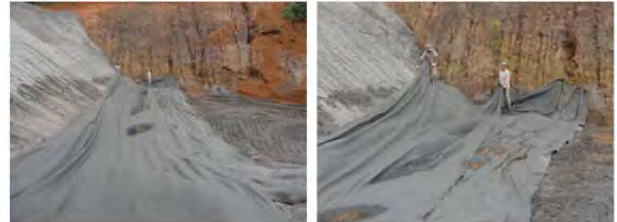
Installation of Bidim in the saturated region in the left abutment, (an inverted drain will be built later).

Weekly report from week of March 25, 2013.

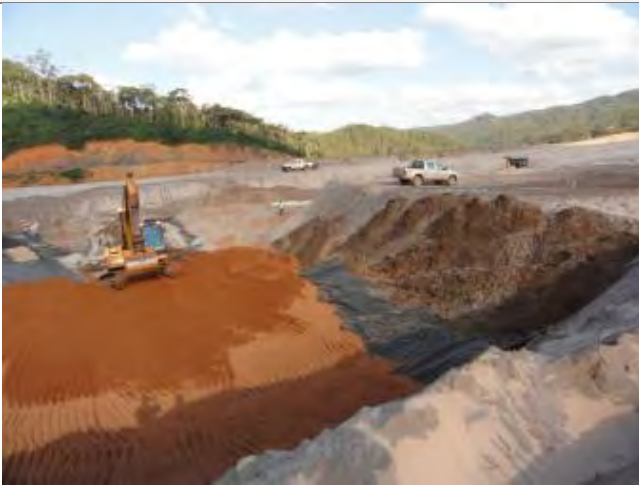
Construction photo from June 17-23, 2013 weekly report showing the geotextile and sand placement, with the beginnings of the rockfill trench to the left.

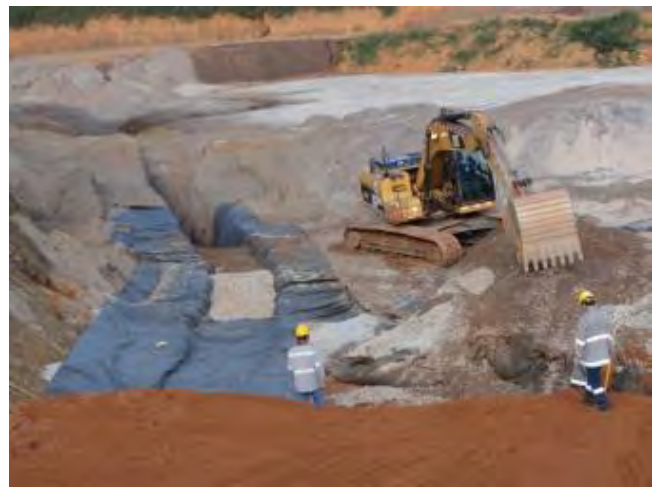
Construction photo from June 17-23, 2013 weekly report showing the beginnings of the rockfill trench.

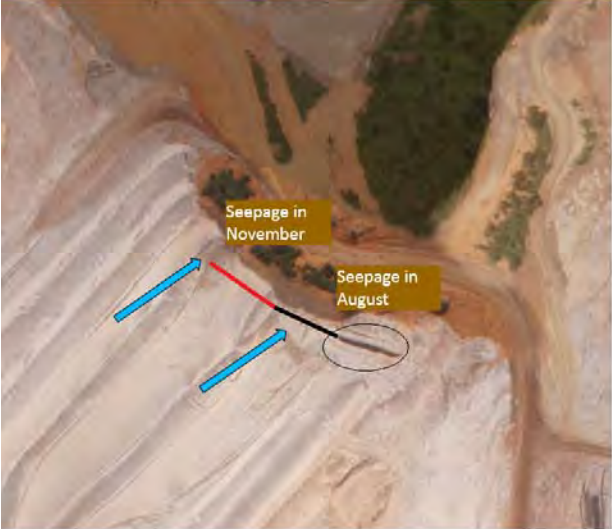
Seepage at D1 Left Abutment

As can be seen in the drawing on the left, there was an emergence of longitudinal cracks, which facilitated the collapse. The cracks located at the upper bank have the characteristics of being due to dryness.

— Drain constructed at El. 855 with crushed rock and sand enveloped by Bidim geotextile

— Drain constructed to connect the seepage at El. 860 to the drain constructed at 855. Composed only of sand enveloped by Bidim geotextile.

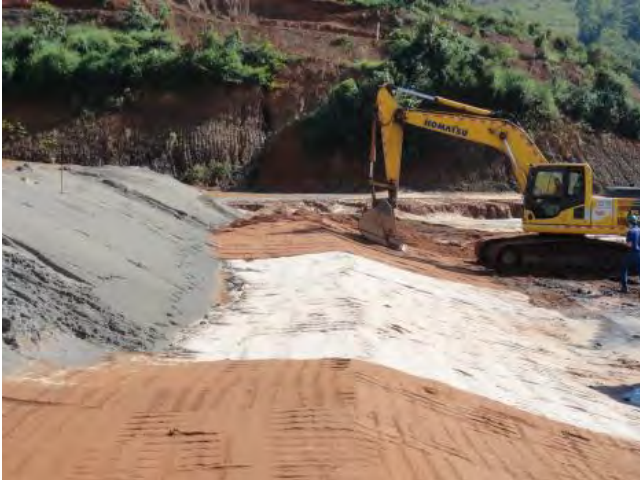
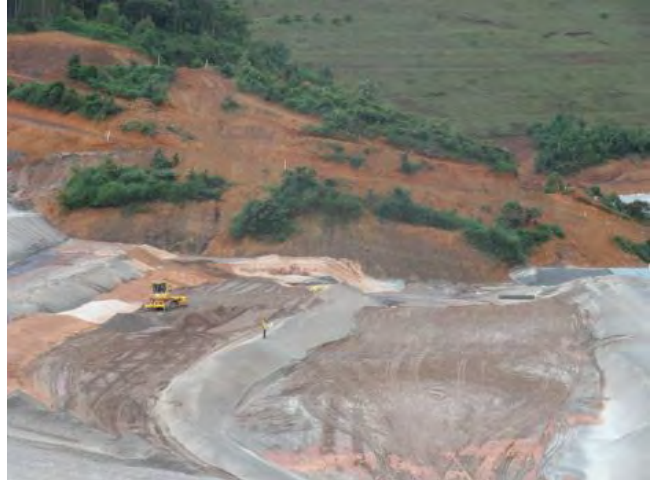
- 1 m of sand was placed on the slope face to retain fines. Setback was raised following the sand placement.
- Cracks were noted to be approximately 10 mm wide and 60 m long along the crest.

Photo from December 23-29, 2013 weekly report showing placement of sand over area of upwelling.

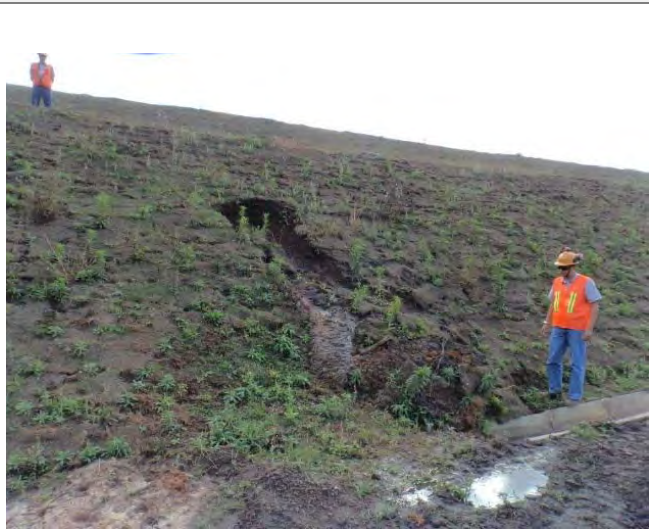
- The incident was discussed in detail by Samarco^[14] which concluded:
 - The interface between the soil backfill and sand tailings as part of the Auxiliary Spillway construction works has become a preferred seepage path.
 - The closest piezometer to the seepage incident is approximately 50 m away on Section AA. This piezometer (16LI011) showed the water level to be below the point of seepage.
- The saturated slope was excavated and replaced with a sand and gravel drain which can be seen in the drone aerial image taken on August 4, 2014. During a site visit in April 2015, VOGBR noted saturation of the bench downstream of the drain and recommended replacing the drain with one of VOGBR’s design. This was done in May, 2015.
- Flow from this drain was regularly monitored and reported in instrumentation and weekly reports.

July, 2014 inspection photo showing seepage outbreak on the downstream face of Dike 1.

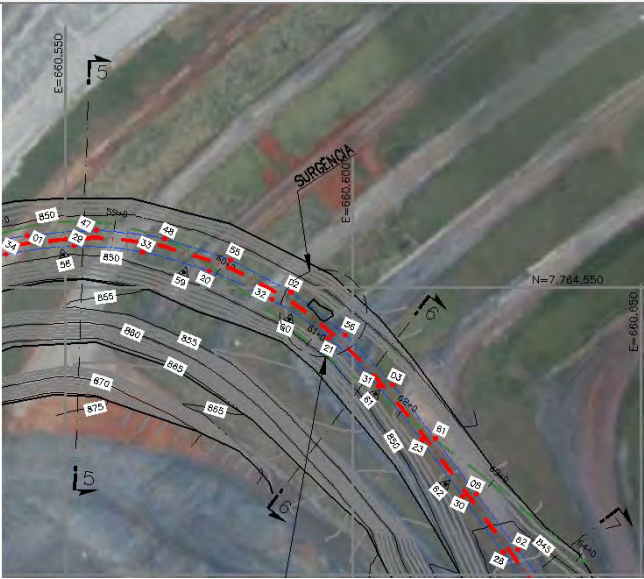
Location plan showing the seepage outbreak in relation to the earthworks extent for the Auxiliary Spillway.

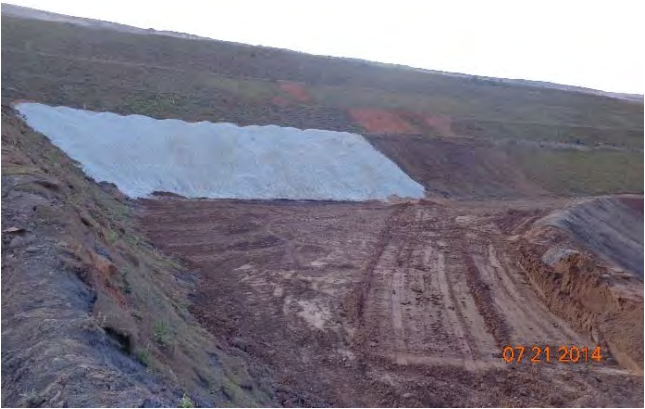
<p>July, 2014 inspection photo showing the sand and gravel drain placed.</p>

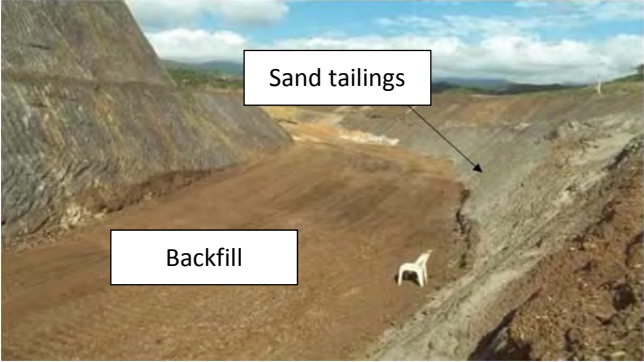
<p>Marked up photo from the Auxiliary Spillway construction period showing the interface between the backfill and sand tailings.</p>
References	Conflicting references
Samarco 2014 inspection ^[14] , VOGBR ^[13]	Dates and elevation as listed in the “Description” section.

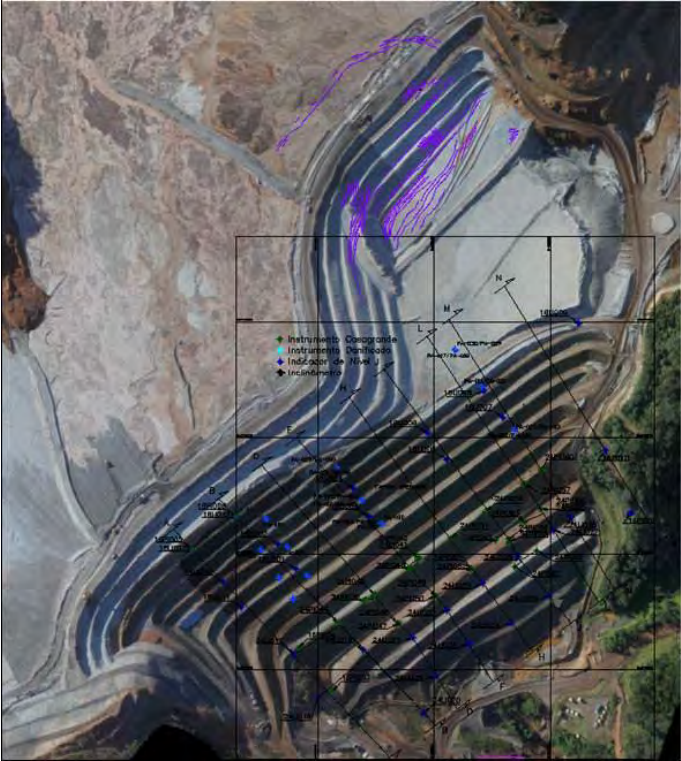
- At 6:00 AM on August 27, 2014, cracks were observed on the upstream beach, dam crest and downstream slope of the setback. The cracks showed differential thicknesses, some on crest ~6 cm, reaching up to 3x as thick on the upstream bench.
- Uplift at the toe of the El. 865 m bench was noted by the ITRB.
- Water was not observed on the upstream beach and crest, only normal saturation of sand tailings. At the toe of the El. 865 m bench, saturation was noted.
- Samarco designed and implemented a Reinforcement Berm. Piezometers and survey monuments were also installed.

Location plan showing the mapped cracks.

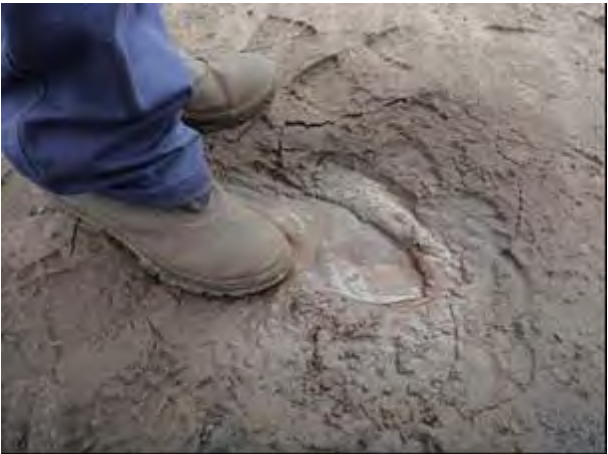
September 2014 inspection photo showing saturation of material at the toe of the El 865 m bench.

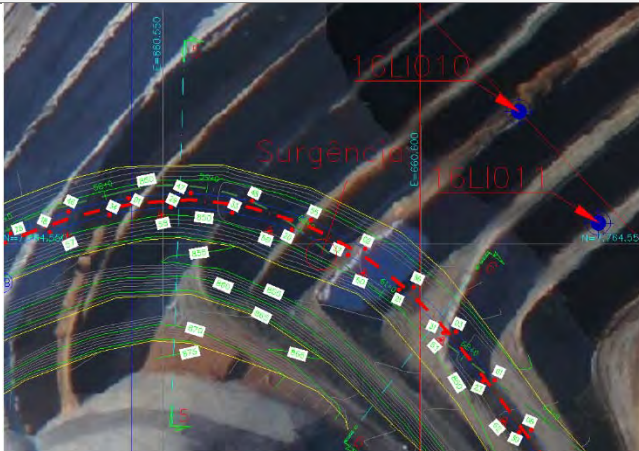
- According to topography, this incident occurred on the downstream face of the El. 860 m bench at El 858 m. This is one bench above the incident that occurred in July, 2014.
- Incident discussed in detail by Samarco^[35] which concluded:
 - The interface between the soil backfill and sand tailings as part of the Auxiliary Spillway construction works has become a preferred seepage path.
 - The closest piezometer to the seepage incident is approximately 50 m away on Section AA. This piezometer (16LI010) showed the water level to be below the point of seepage.
- The saturated slope was excavated and replaced with a sand and gravel drain. During a site visit in April, 2015, VOGBR recommended replacing the drain with one of VOGBR's design. This was done in May, 2015.
- Flow from this drain was regularly monitored and reported in instrumentation and weekly reports.

Location plan showing the seepage outbreak in relation to the earthworks extent for the Auxiliary Spillway.

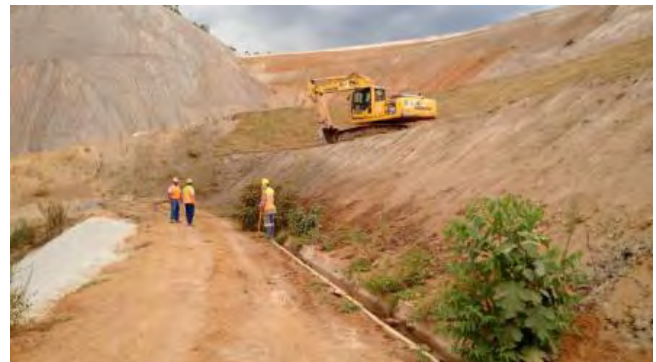
January, 2015 construction photo showing the beginning of stripping for placement of drain material on the slope^[35].

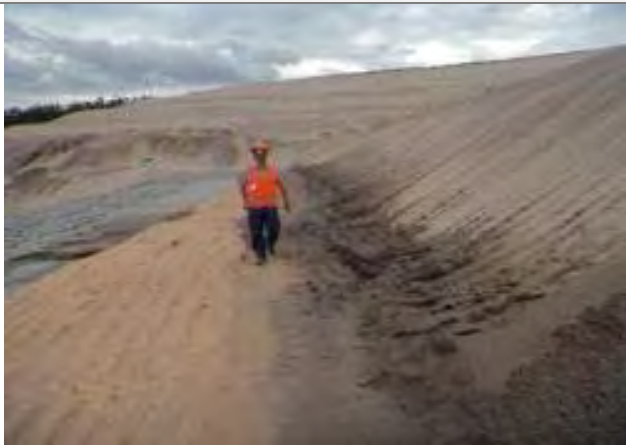
- Saturation above and below the El. 860 m blanket drain was noted by Samarco in the monthly geotechnical report. A photograph shows saturation at El. 867 m just above the on-going construction of the El. 860 m blanket drain.
- Drone aerial images from February 27, 2015 to April 24, 2015 show saturation at the location of the monthly report photograph.

Photo from monthly geotechnical report showing saturation at the toe of the slope above the El. 860 m blanket drain.

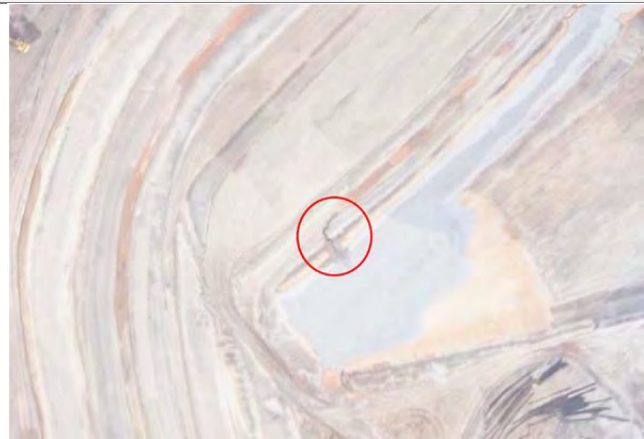
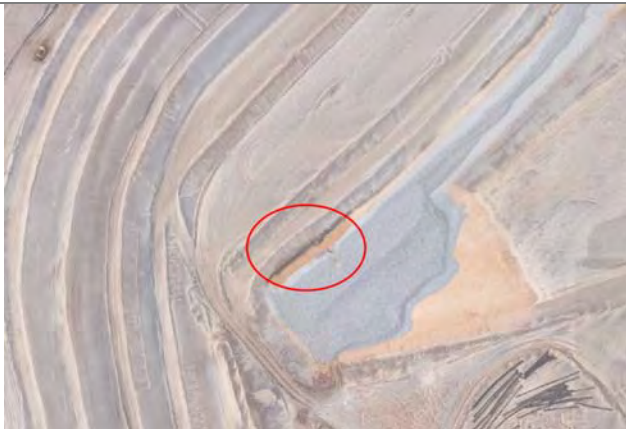
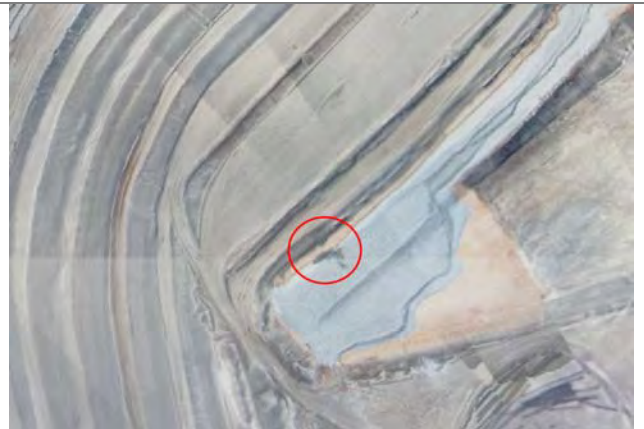
February 27, 2015 aerial image.

March 20, 2015 aerial image.

April 24, 2015 aerial image.

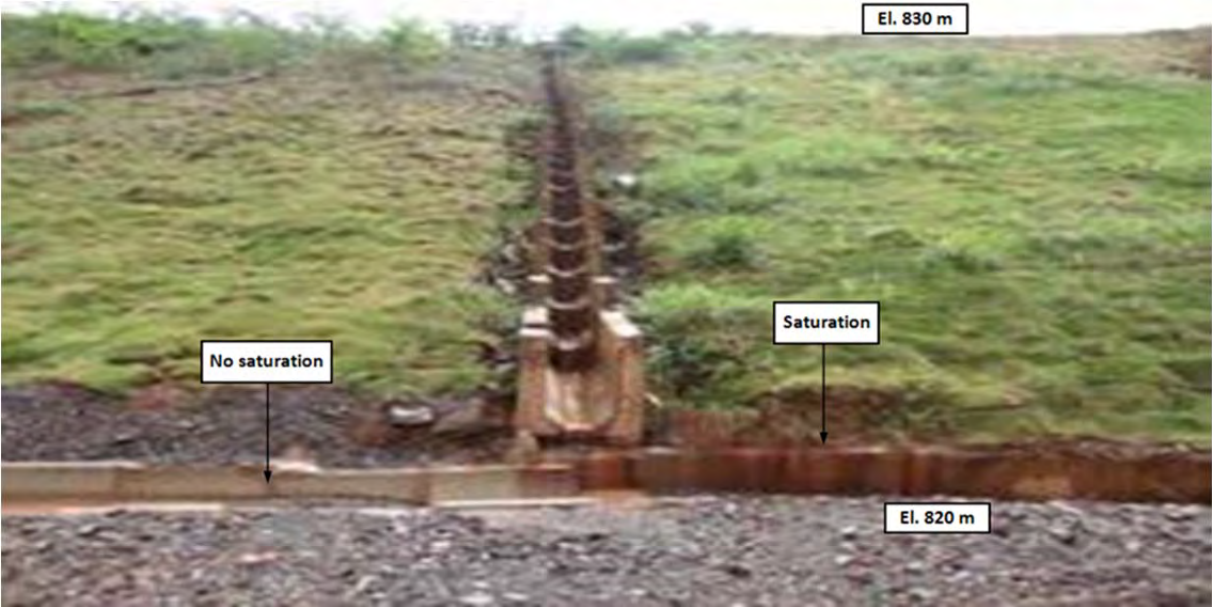
- Saturation of slope was noted by Samarco in the monthly geotechnical inspection report.

Marked up May, 2015 inspection photo from the Samarco geotechnical inspection report showing saturation of the slope left of the concrete channel.

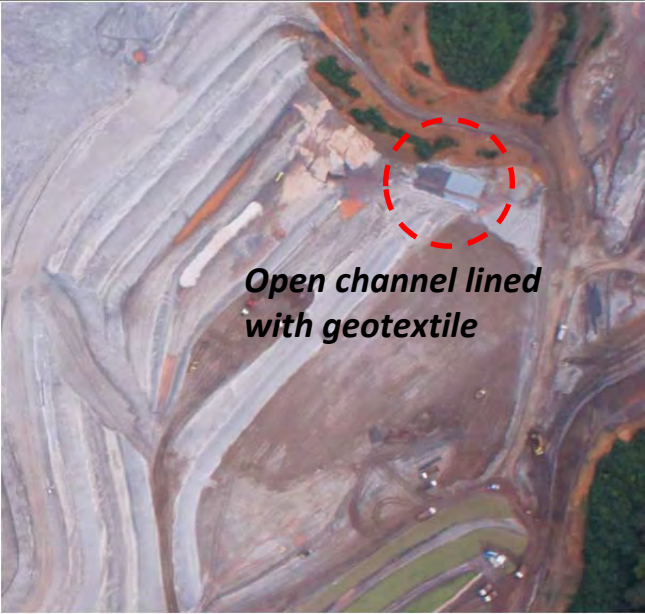
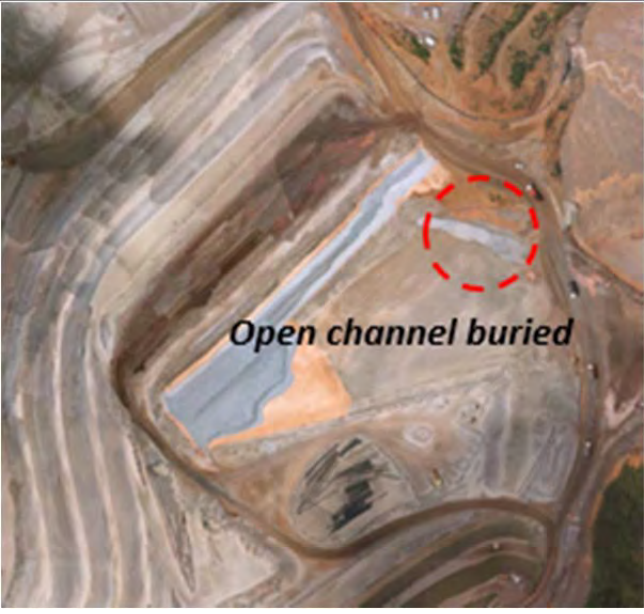
Evolution of the Left Abutment Rockfill Trench (Drain 2)	
<u>Description</u>	
<ul style="list-style-type: none">▪ The rockfill trench (Drain 2) was initially put in as part of June, 2013 seepage incident and receives water from the El. 855 m buried drain (Drain 1) and the El. 860 m drain (Drain 3 installed in November, 2013).▪ Water from this drain was permitted to sheet flow across the setback plateau and access road to Grota da Vale.▪ As the setback was raised around this trench, it became a large open channel lined with geotextile. This can be seen in the drone aerial image taken on December 27, 2013. By January 29, 2015, the aerial image shows the open channel having been buried with a light grey material. It is unclear whether this is drain rock or dry tailings sand.▪ During a May interview with a Samarco employee, the buried open channel was recounted to have an outlet in the form of a buried pipe. The alignment of this pipe is unknown to the Panel, but based on site photographs and aerial images, it is likely at the exposed toe of the El. 860 m blanket drain. Ponded water is consistently noted at this location.▪ VOGBR completed a drain design in May, 2014 to convey water from the buried El. 855 m drain (Drain 1) to the left abutment concrete channel. No records were found of this design having been implemented. However, as part of the design process, VOGBR conducted a site visit and took photographs of the open channel as it existed in March, 2014.

<p><i>Open channel lined with geotextile</i></p>

<p><i>Open channel buried</i></p>
Marked up drone aerial image taken December 27, 2013.	Marked up drone aerial image taken January 29, 2015.

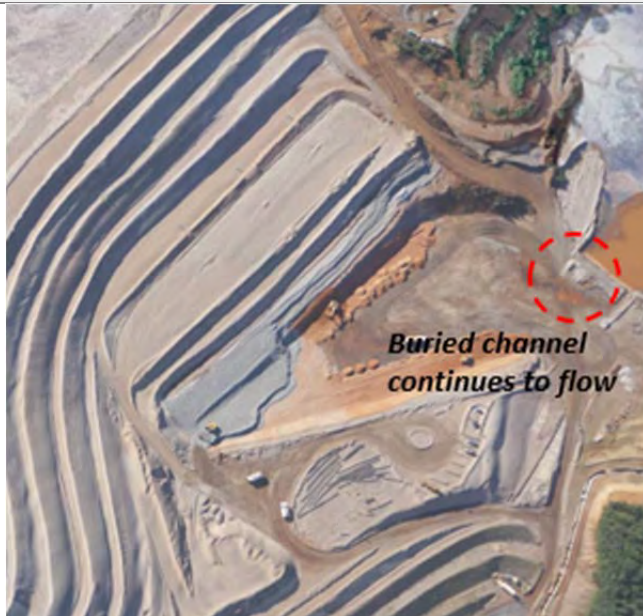
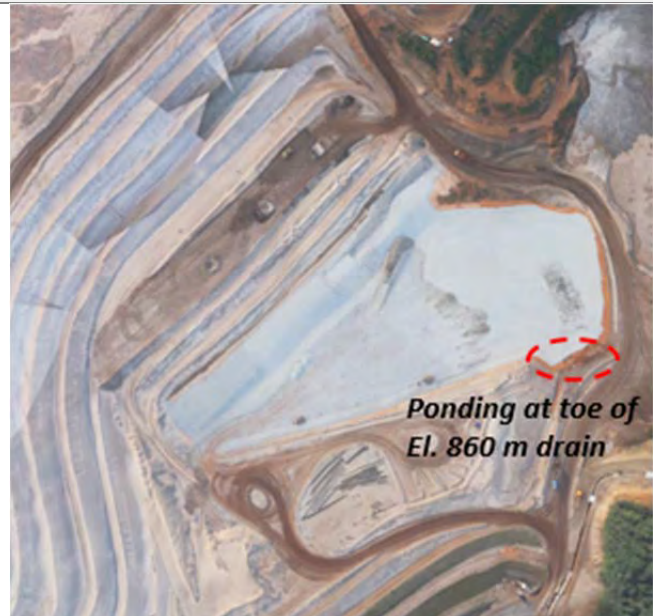
Marked up drone aerial image taken May 27, 2015.

Marked up drone aerial image taken June 22, 2015.

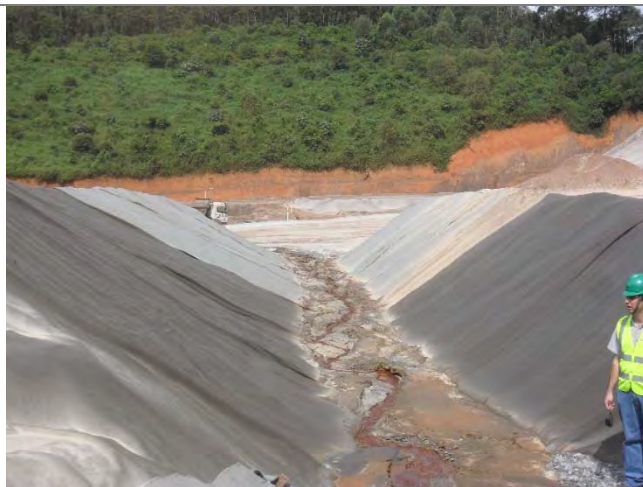
March 27, 2014 site visit photo from VOGBR showing the open channel looking down the slope of the dam toward the plateau of the left setback.
