Fundão Tailings Dam Review Panel

Report on the Immediate Causes of the Failure of the Fundão Dam

EXECUTIVE SUMMARY

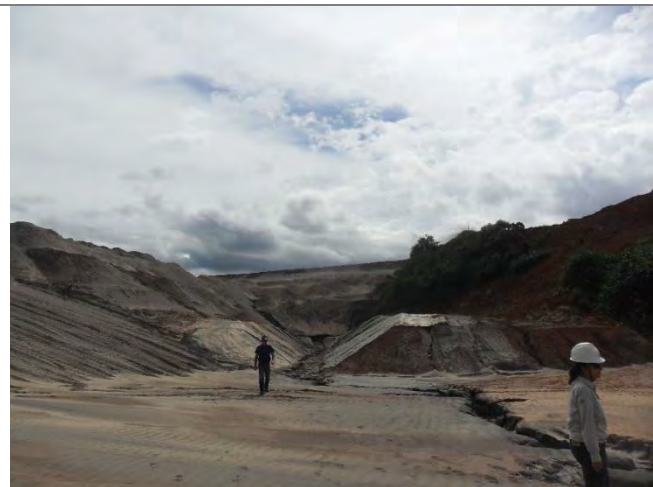
March 27, 2014 site visit photo from VOGBR showing the open channel looking upslope towards the dam crest. The erosion on the setback plateau can be seen to the right of the photo.

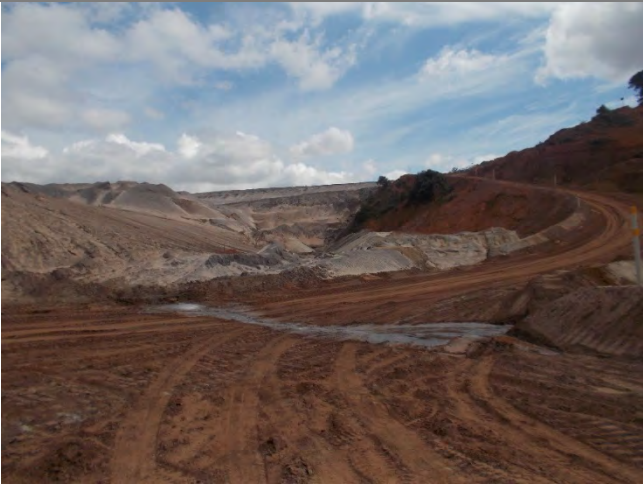
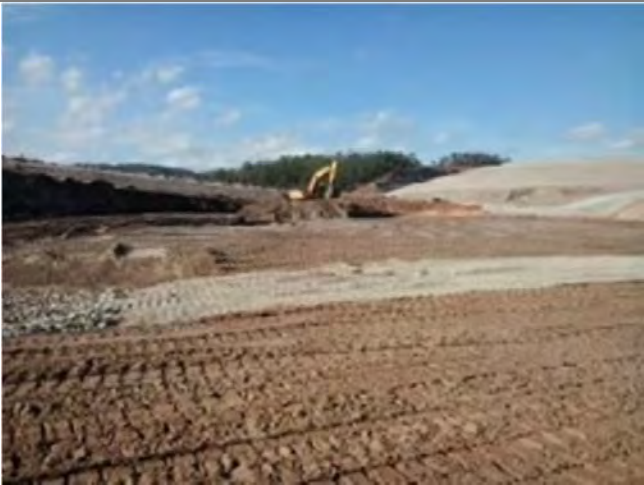
Evolution of the Left Abutment Rockfill Trench (Drain 2)	
Photos

July 10, 2014 site visit photo from VOGBR showing a pipe conveying water from the open channel through the access road berm. The water then sheet flows across the access road to Grota da Vale which is to the right of the photo.	January 16, 2015 construction photo showing the buried open channel with light grey material.
References	Conflicting references
VOGBR 2014 ^[11]	None

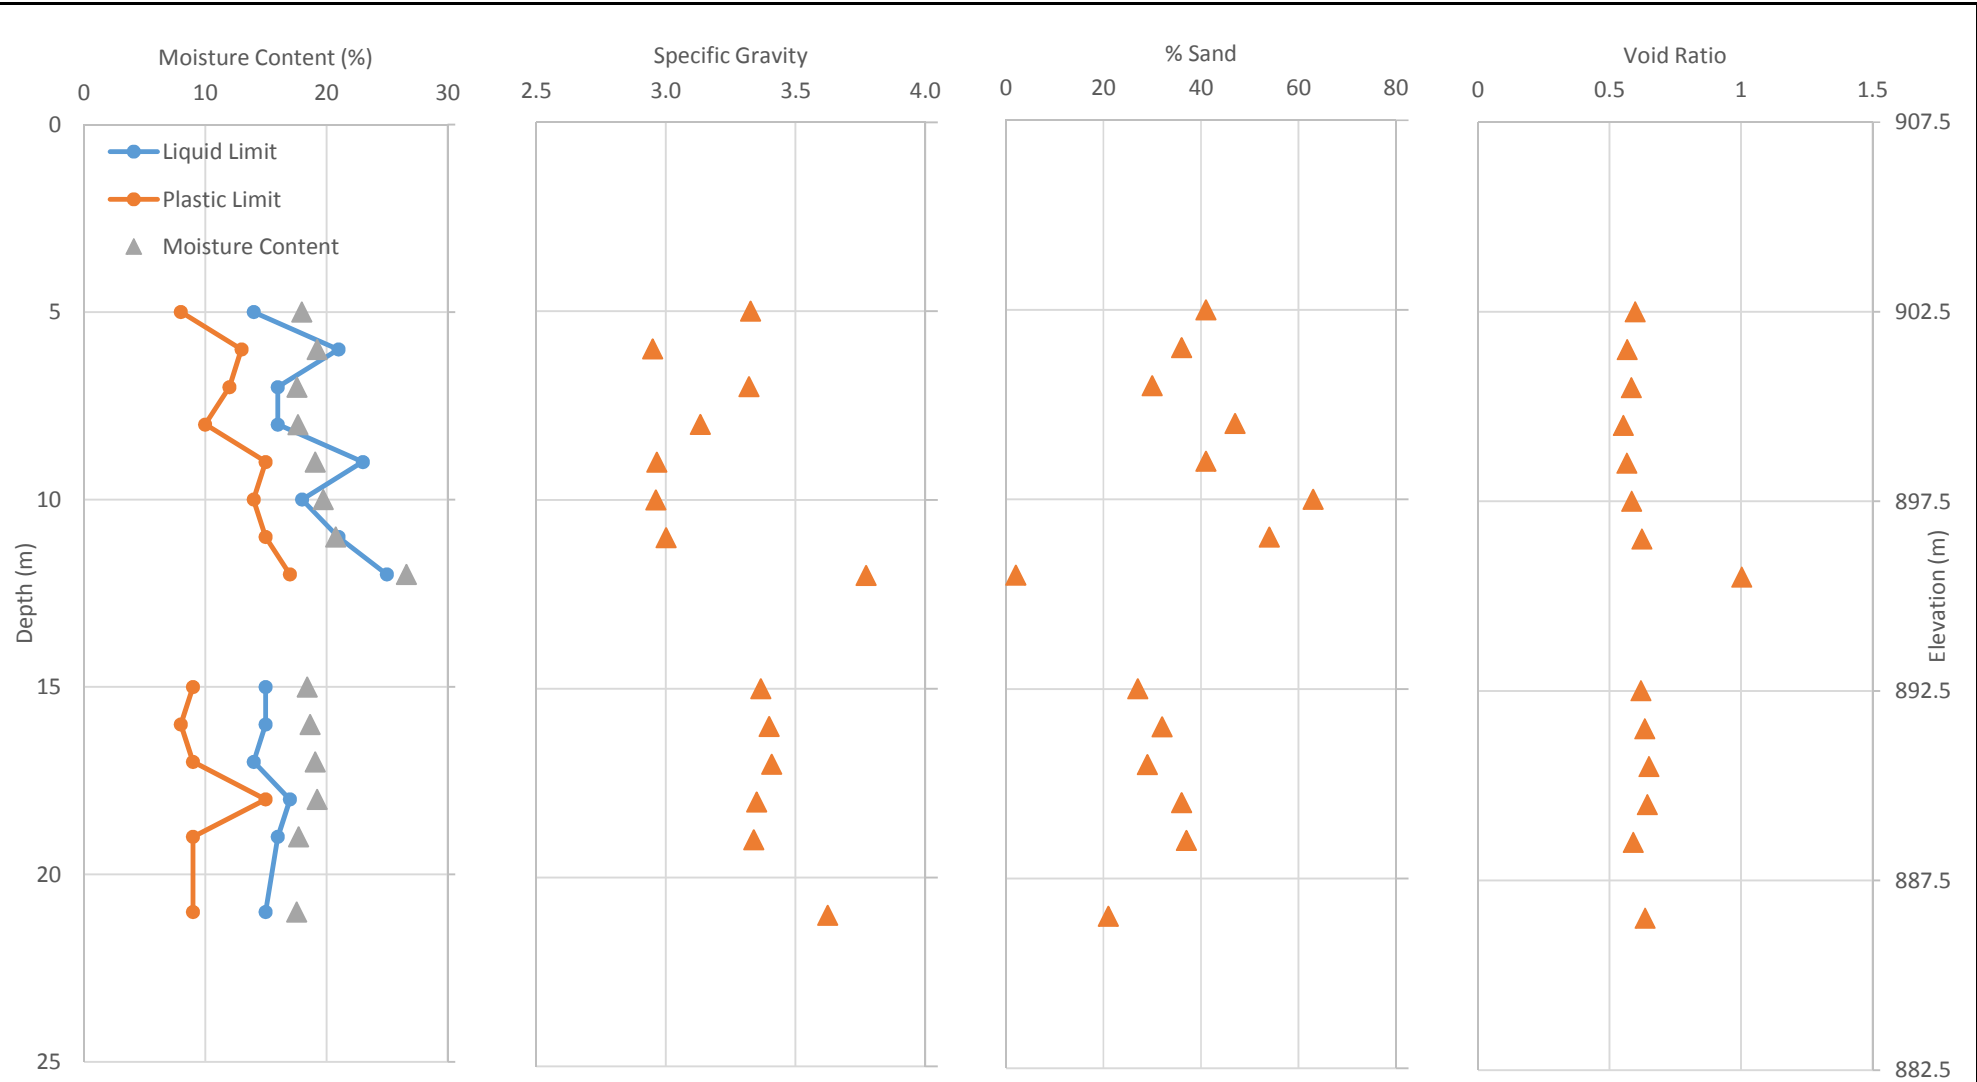
PROJECT	Fundão Tailings Dam Review Panel
	TITLE	Baia 4 Failure Laboratory Index Tests
	FIG. No.	C.C8-1

The Federal University of Ouro Preto (UFOP) completed a back-analysis of the failure in 2006^[38]. As part of the analysis, the University conducted a field investigation in Baia 4 and the adjacent Baia 5. The field investigation comprised SPTs, CPTu's, field vane tests and collection of Shelby tube samples to ascertain the undrained shear strength and the variation of pore pressure within the dike and foundation materials. Laboratory index testing was undertaken on the samples collected including moisture content, Atterberg limits and specific gravity. A review of the in situ testing and laboratory test results was undertaken by KCB and is reproduced on Figure C.C8.1 in Attachment C8.

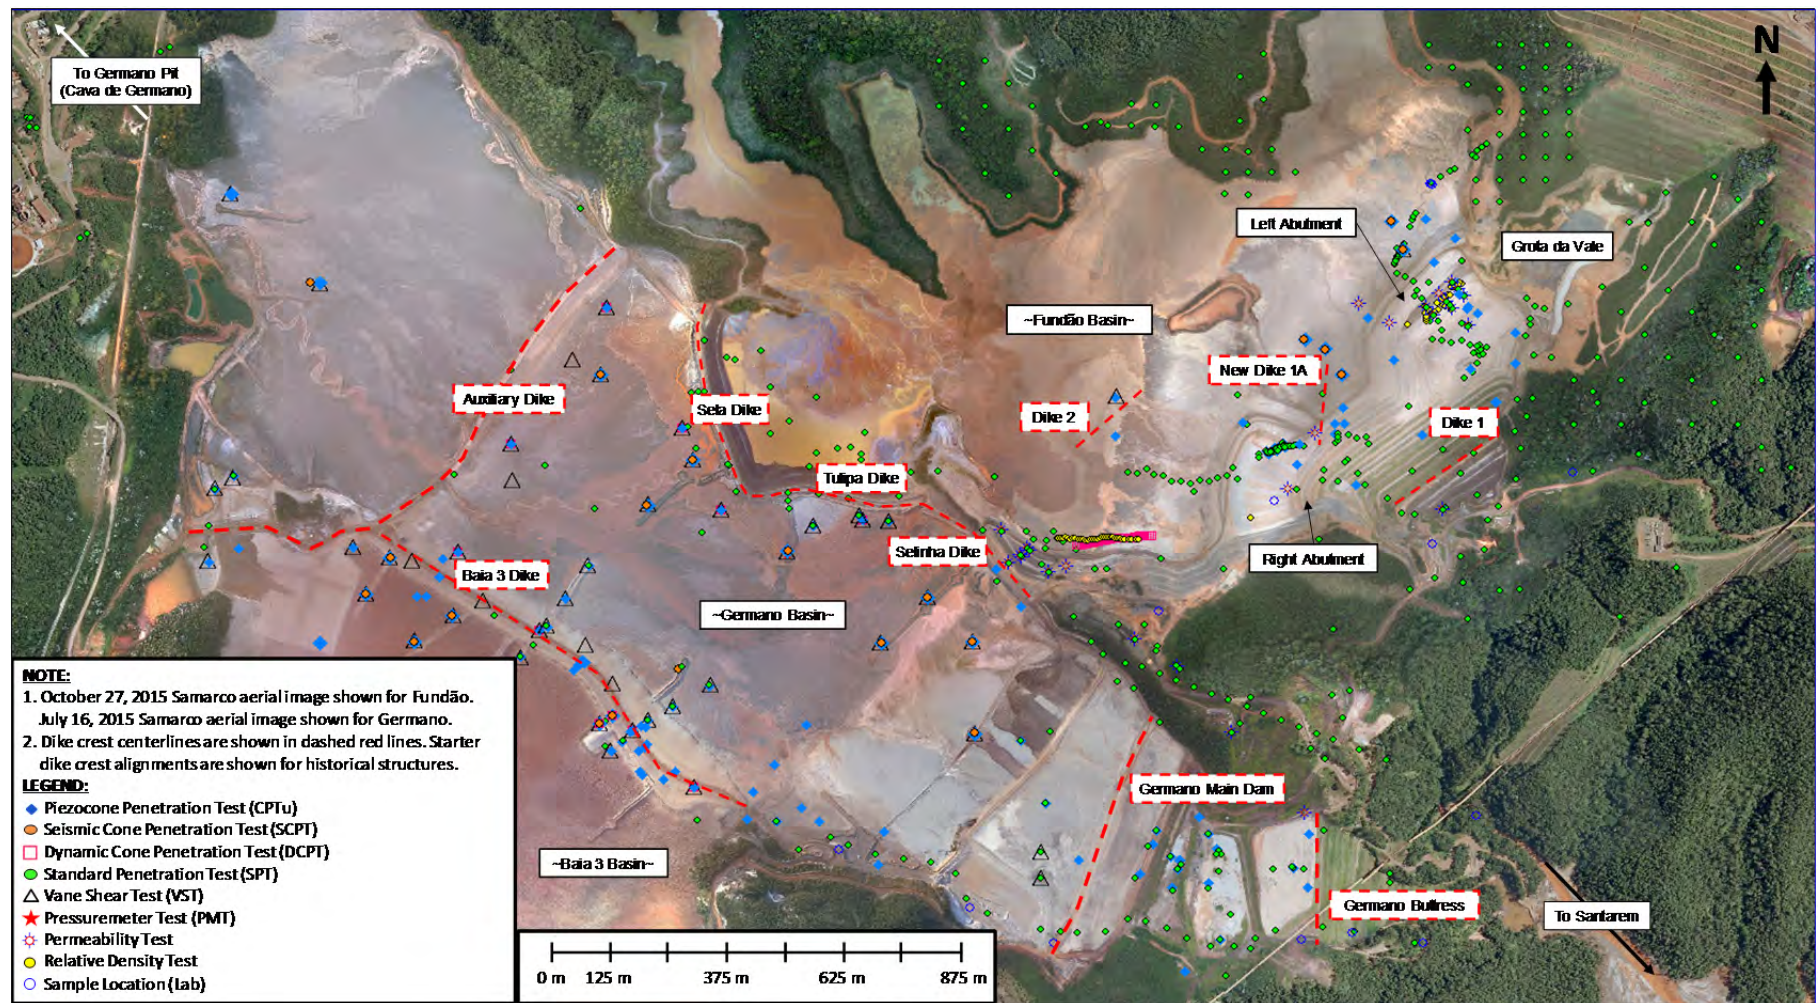
Figure C2-1 Pre-failure geotechnical investigation location plan

The numerous pre-failure field investigation programs are compiled and listed in Table C2-1 below. Figure C2-1 shows the locations of selected past drill holes and CPT locations by Samarco. Past investigation programs were first filtered by keyword from the master spreadsheet of available Samarco reports and data sources; primarily in Portuguese. After translation into English, the coordinates and elevations of the data were confirmed. Then the field data was evaluated and tabulated.

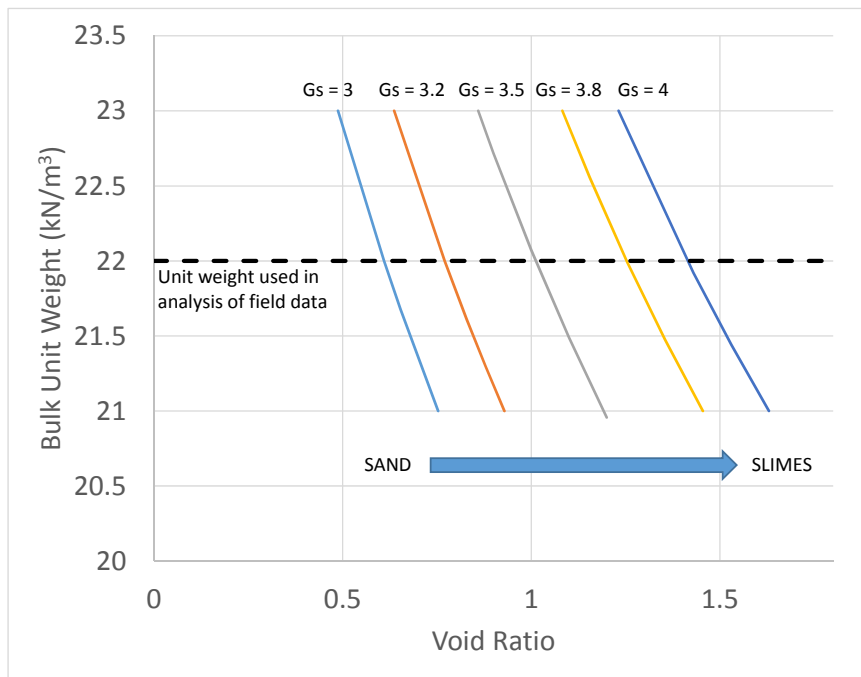
Figure C2-2 Void ratio/unit weight relationship

Where raw data was available from the pre-failure programs, the data was processed using standard methods to establish a common format for interpretation. In light of the expected range of specific gravity and void ratio for the sand and slimes, a single bulk unit weight of 22 kN/m³ was applied to all materials in our interpretation. The variation of saturated bulk unit weight with specific gravity and void ratio is calculated using the following formula: $\gamma = \frac{G_s + e}{1 + e} \gamma_w$, and is illustrated on Figure C2-2.

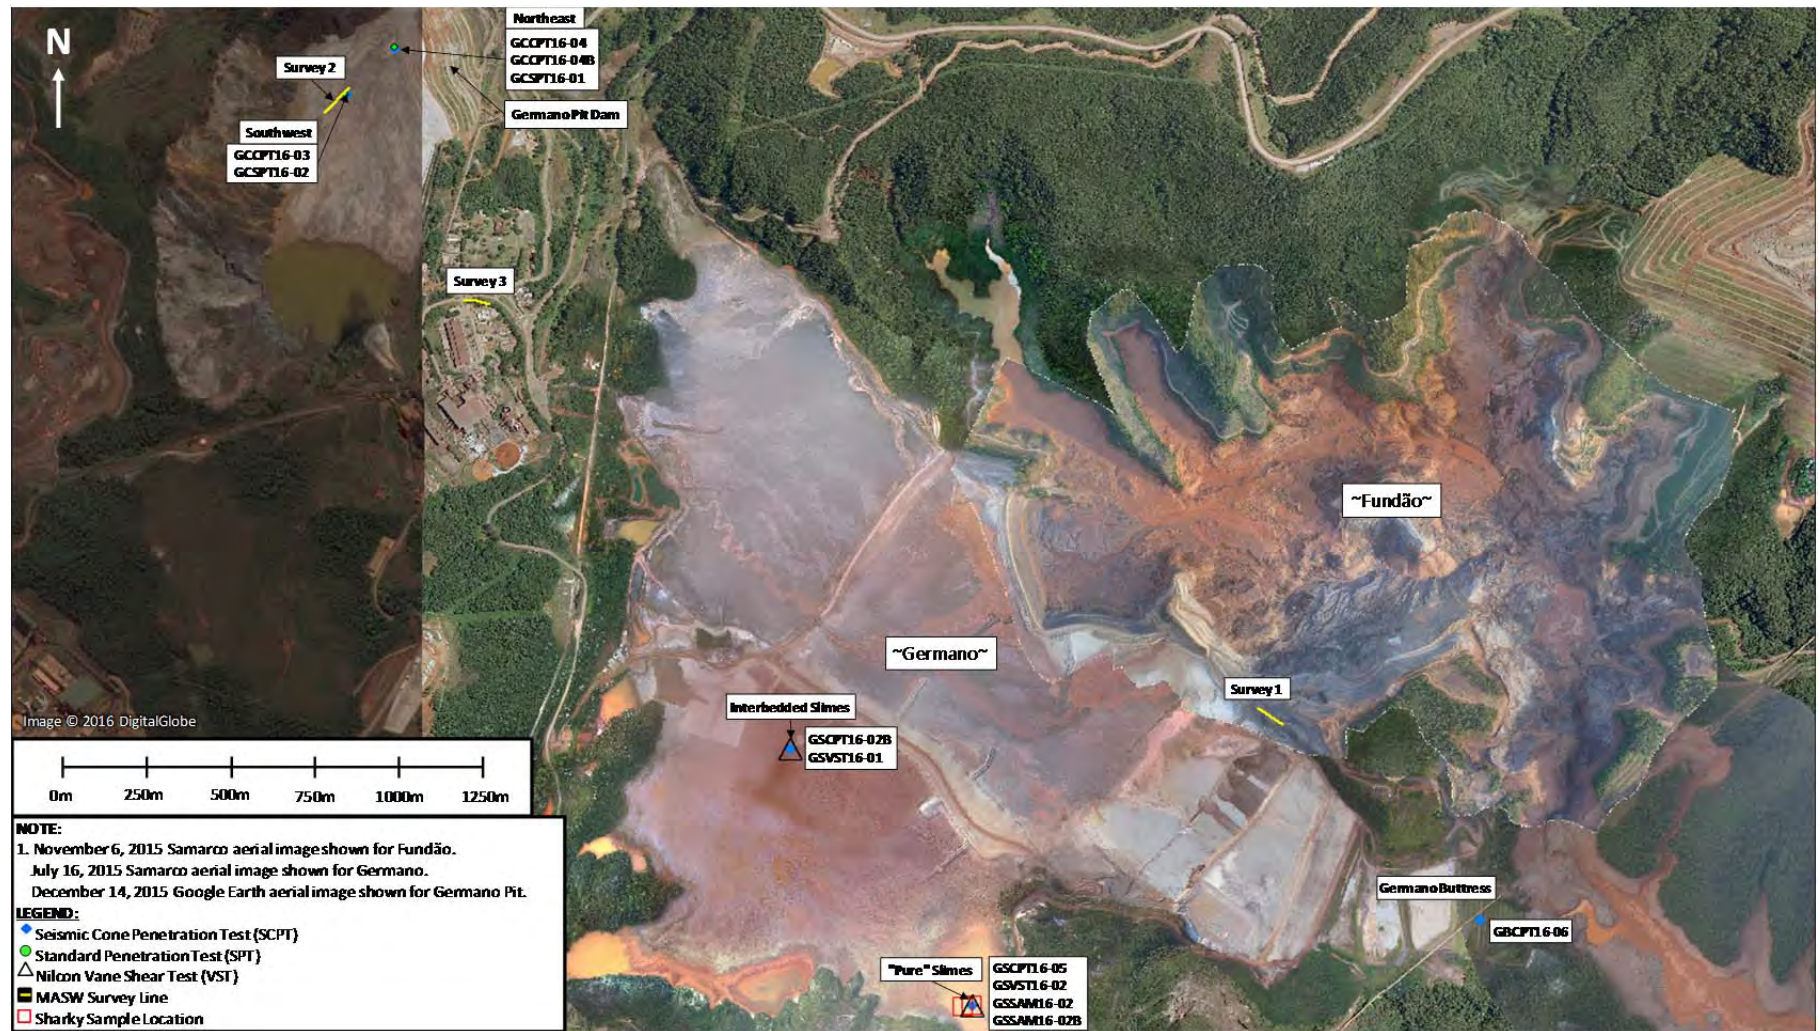
Figure C3-1 2016 geotechnical investigation location plan

Germano Pit Dam is constructed entirely of spigotted sand tailings with no direct slimes deposition in any part of the impoundment. The location of the impoundment relative to Germano Buttress is shown on Figure C3-1. There is a foundation finger drain beneath the impoundment whose intent is to maintain an unsaturated downstream slope. Gradation testing was done on surface samples prior to drilling which showed that the gradation of the sand tailings at Fundão Dam and Germano Pit Dam are virtually identical.

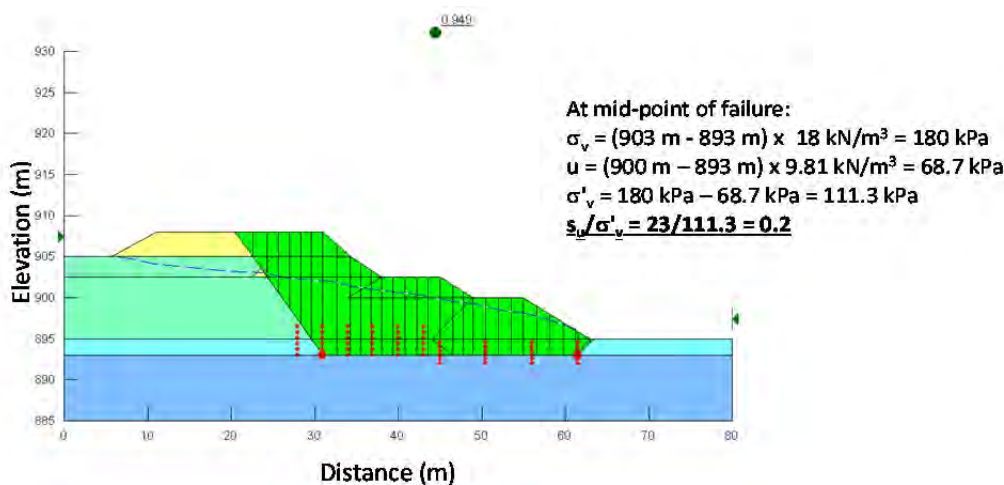
**Figure C4-1 Back analysis of the Baia 4 failure completed by UFOP^[38]**

UFOP derived geotechnical parameters from their field investigation as shown on Table C4-2. Stability analyses were performed by the University for both drained and undrained conditions. The undrained back analysis for an average embankment height of 10 m gave an undrained strength (s_u) of 23 kPa for the silty-clay layer at a Factor of Safety of 1.0 (see Figure C4-1). This s_u is equivalent to an undrained strength ratio of approximately 0.2. KCB checked whether the results of this analysis would differ if a higher unit weight of 22 kN/m³ was used, consistent with the assumptions used in the interpretation of field data throughout this appendix, and arrived at very similar results to those of UFOP (0.22). Based on these results, an undrained strength ratio of 0.2 to 0.22 is considered to represent the peak (or yield) strength of the interbedded sand and slimes.

KCB ran slope stability analyses to calculate the large-strain undrained shear strength ratio using the post-failure geometry. Observations of the failure at Baia 4 indicate the run-out of the rupture was approximately 70 m, so a slip surface length equivalent to the total observed run-out was used in back analysis. The height of the dike and the undrained strength was varied to produce a factor of safety equal to 1.0.

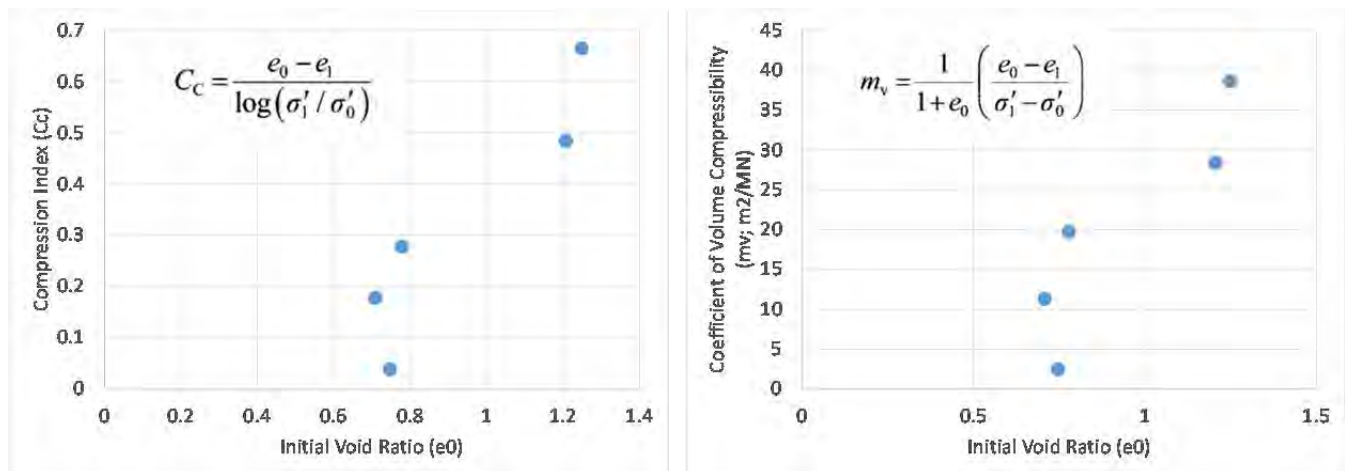
Figure C4-3 Slimes compressibility characteristics back calculated 2008 test fill

Following completion of the trial, the embankment was excavated and sampling was performed on the original ground to a depth of approximately 2 m^[4]. Basic laboratory index testing was undertaken on the samples including moisture content (w), specific gravity (G_s) and particle size distribution. A review of laboratory test results by KCB indicates that the void ratio of the slimes (referenced as “chocolate”) decreased following the trial. This calculated void ratio (e) decrease was made by assuming full saturation below the stated water table, and calculating $e = wG_s$ using the index testing before and after the trial. With an estimate of the load from the embankment, and the calculated change in void ratio, it was possible to calculate compression characteristics to supplement the 1D consolidation, as shown in Figure C4-3.

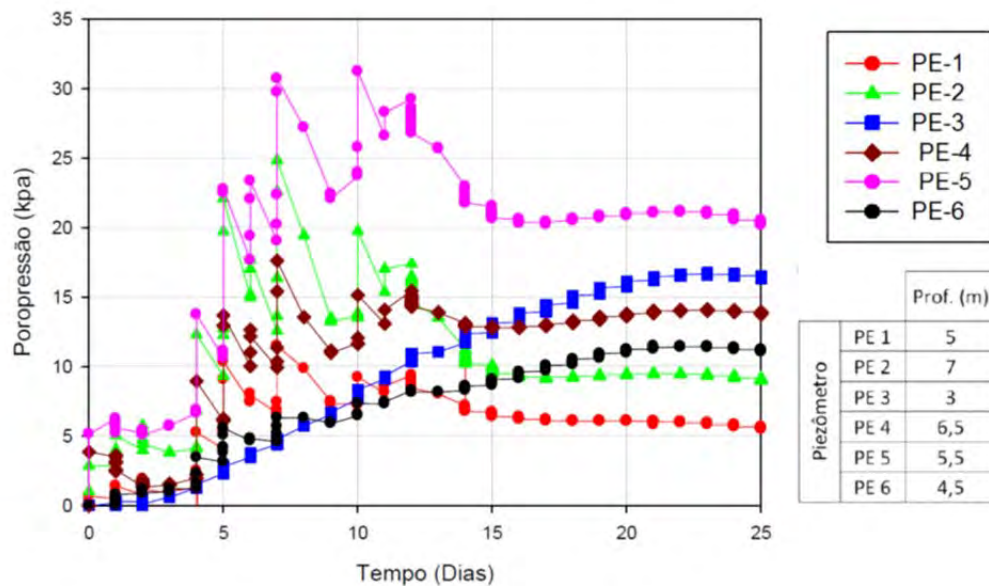
Figure C4-4 Pore pressure response to 2013 test fill

During the trial the pore pressure response to construction of the embankment recorded a maximum pore pressure response ($\Delta u / \Delta \sigma$) of 0.74 at depths of 5.5 m and 7 m below the embankment. A maximum settlement of 0.47 m was recorded beneath the maximum embankment height of 6 m^[39].

The results of the 2013 trial were similar to the 2008 trial. Pore pressures beneath the embankment dissipated rapidly (see Figure C4-4 for example response at various depths), and settlements in the range of approximately 78 mm per 1 m of embankment load were recorded compared to 74 mm per 1 m load recorded during the 2008 trial.

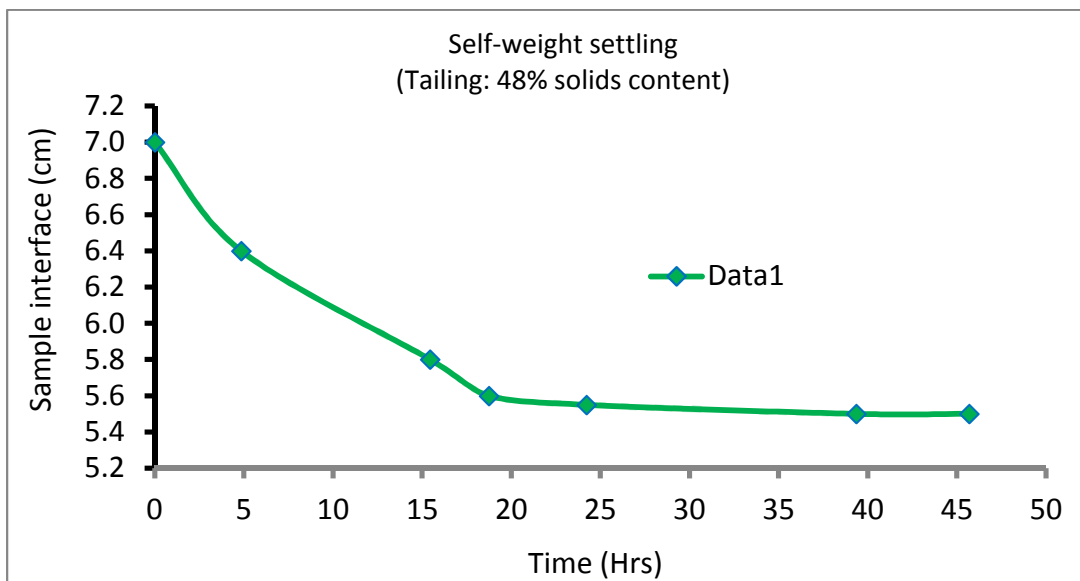
Figure 1. Interface settlement measured with time during settlement.

Figures 1 and 2 show the change of sample interface (sample height) and dissipation of excess pore pressure measured with time. It is noted that Figure 2 shows immediate decrease in excess pore pressure with settlement of the interface. As the excess pore pressure fully dissipates the sample has also settled completely. **Consolidation is defined as dissipation of excess pore pressure, therefore this is a settling process not a sedimentation process.**

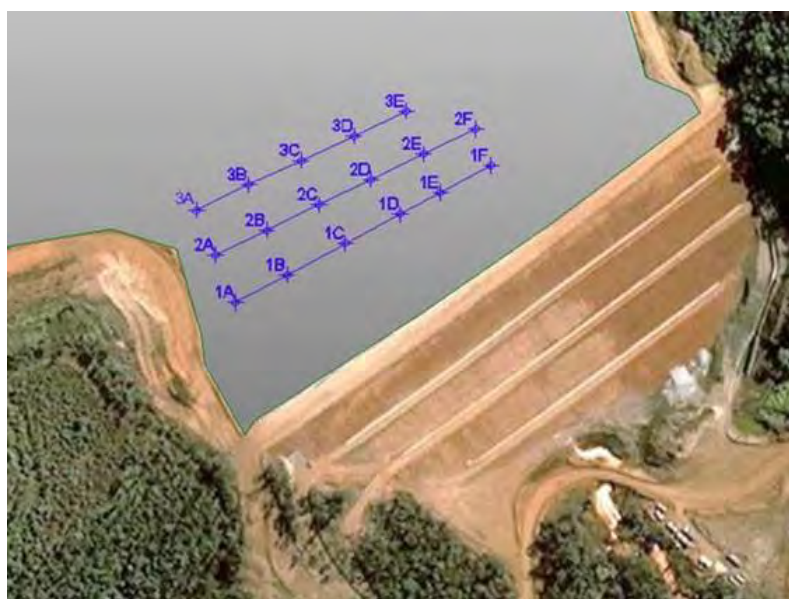
**Figure D2-1 Approximate location of sample collections for Campaign 1 at Dike 1 (Figure 3.3, page 41 of thesis)**

The first campaign took samples from the tailings beach in 2009 when the beach was at El. 812 m 5 months after the start of tailings deposition. The Starter Dam was at El. 830 m at the time. Subsequently, the tailings at the sampling location were removed to repair the underdrains in the Starter Dam. The sampling locations are shown on Figure D2-1, which is Figure 3.3 in the thesis.

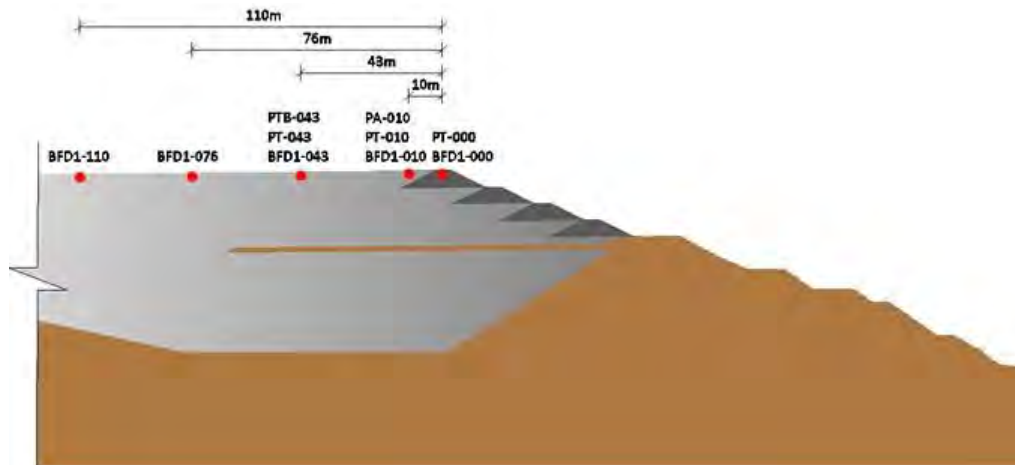
**Figure D2-2 Location of the survey 3 assays in Fundão Dam (Figure 3.12, page 54 of thesis)**

Approximately 20 samples were collected from the tailings beach between El. 845 m and El. 855 m. The sampling locations in section are shown on Figure D2-2.

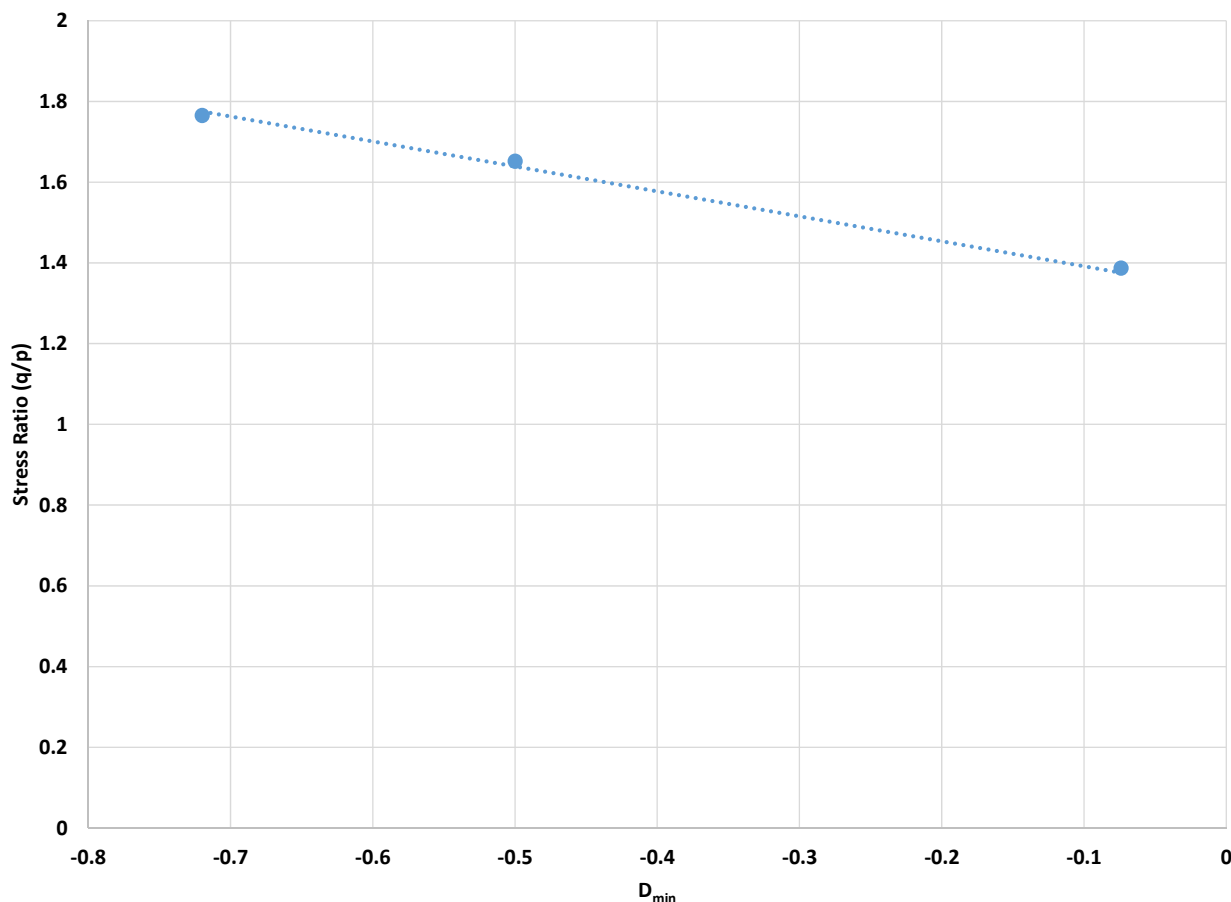
Figure D8-1 Dilatancy – stress ratio relationship for sand tailings

The stress dilatancy plot on Figure D8-1 was used to determine the volumetric coupling parameter, N . The slope of the line on Figure D8-1 is equal to $(1-N)$, giving a value of $N=0.38$.

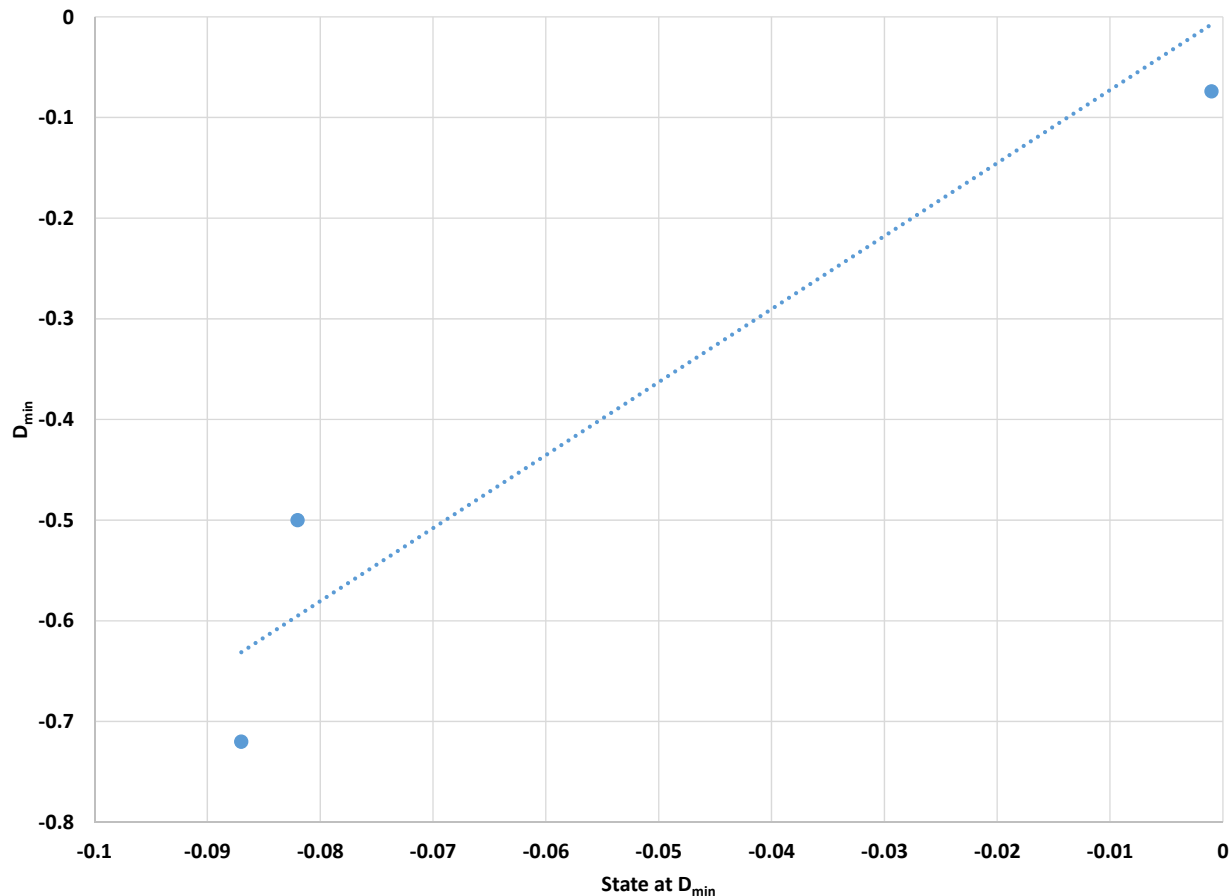
Figure D8-2 Dilatancy – state parameter relationship for sand tailings

The parameter χ_{tc} is the slope of the trend line for minimum dilatancy (equal to the dilatancy at peak stress ratio) versus the state parameter at peak stress ratio. Figure D8-2 indicates a results of $\chi = 7.3$.

The χ_{tc} value for this material is quite high when compared with the typical range (2.5-4.5), and would typically be associated with angular shaped particles.

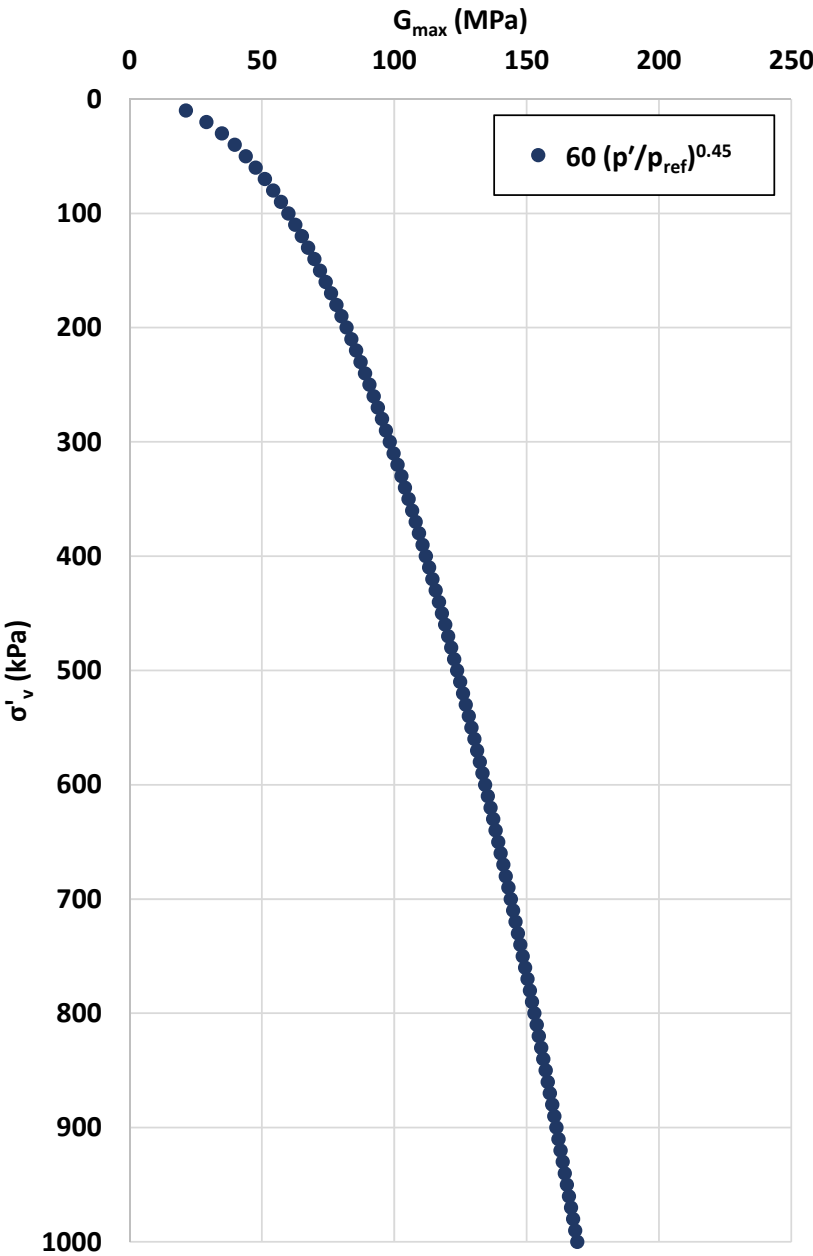
Figure D8-3 G_{\max} relationship for sand tailings from field testing program

All of the G_{\max} results were plotted against their associated mean effective stress and a trend was fitted through all of the data. A reasonable trend was found using the following relationship (see Figure D8-3):

$$G_{\max} = 60 \left(\frac{p'}{p_{\text{ref}}} \right)^{0.45}, \text{ where } p_{\text{ref}} = 100 \text{ kPa}$$

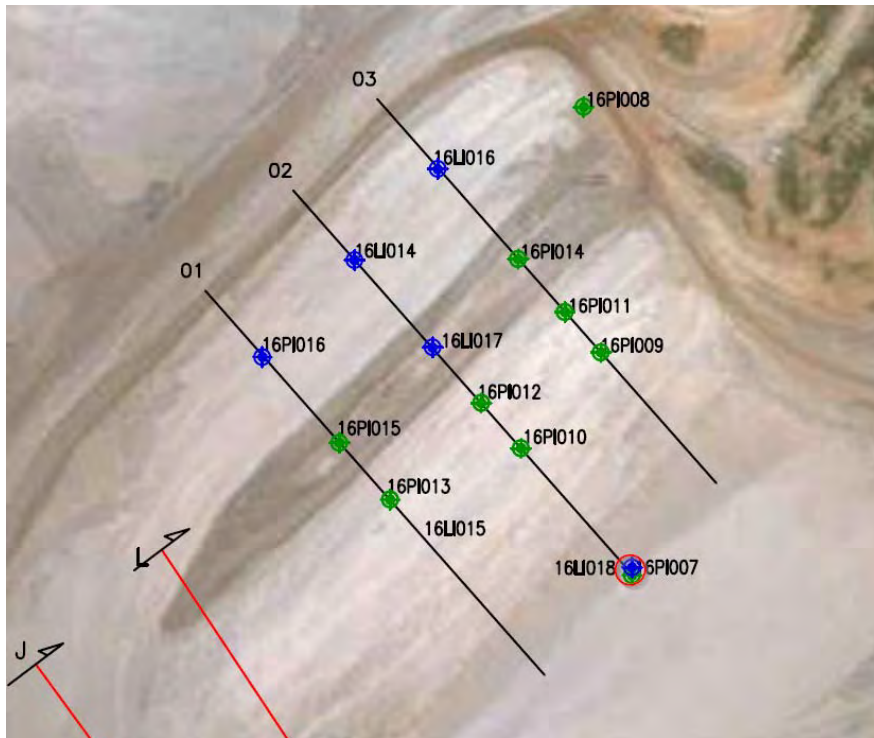
Figure E2-1 Zoom of Samarco instrumentation plan showing 16LI018

Water level indicator 16LI018, located on Section 02, appears in Samarco’s instrumentation plan^[42]. This instrument is not shown in plan or section in the November, 2015 instrumentation report for the left abutment and does not have readings in this document or in the Instrument Measurement Spreadsheet (described in Section E2.3). This instrument is located beside the functioning Casagrande piezometer 16PI007. The lack of records from 16LI018 does not influence the Panel’s analysis. The instrument is circled below on Figure E2-1.

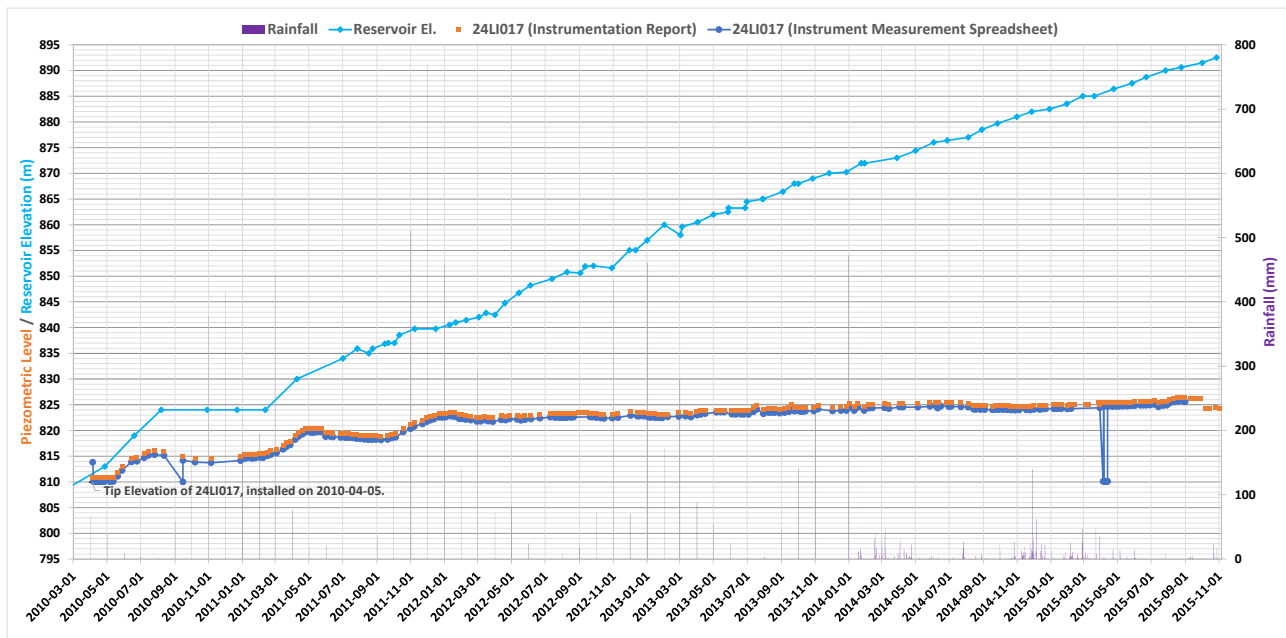
**Figure E2-2** Piezometer data comparison for 24LI017

The Panel plotted data from three of the overlapping data sets. The comparison plots are shown below. The general trend and number of data points for the overlapping period were the same. There was a constant vertical offset in the plots for two of the three locations (24LI017 and 16LI003) that is attributed to a different top of pipe elevation in the two data sources. The data from the Instrument Measurement Spreadsheet includes some errant points as seen in the plots for 24LI017 and 24LI020. The Panel therefore chose to use the data from the instrumentation reports. The remainder of the overlapping data from the Instrument Measurement Spreadsheet is not presented as part of this appendix.

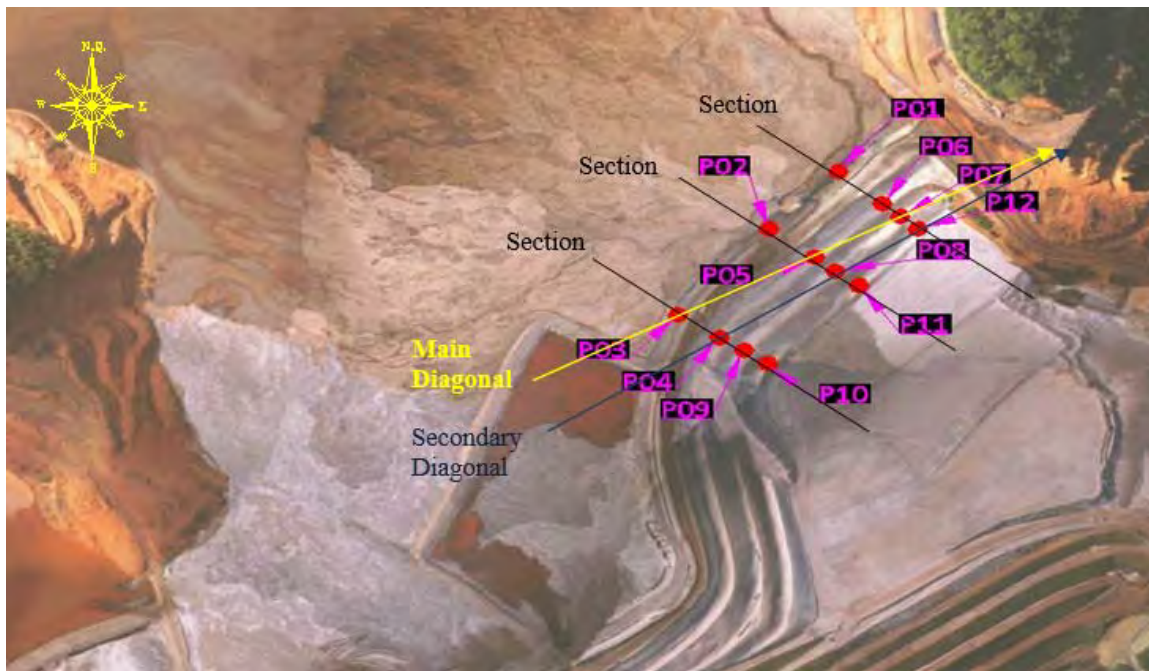
Figure E4-3 Location of survey monuments from Samarco's August, 2014 incident report^[52]

Figure E4-3 is an exact replica of a Samarco drawing^[52]. Their interpretation is that the direction of movement was towards the SE. This is different than the displacement seen in the December, 2014 to August, 2015 records, which is away from the left abutment and in the downslope direction of the stripped ground surface.

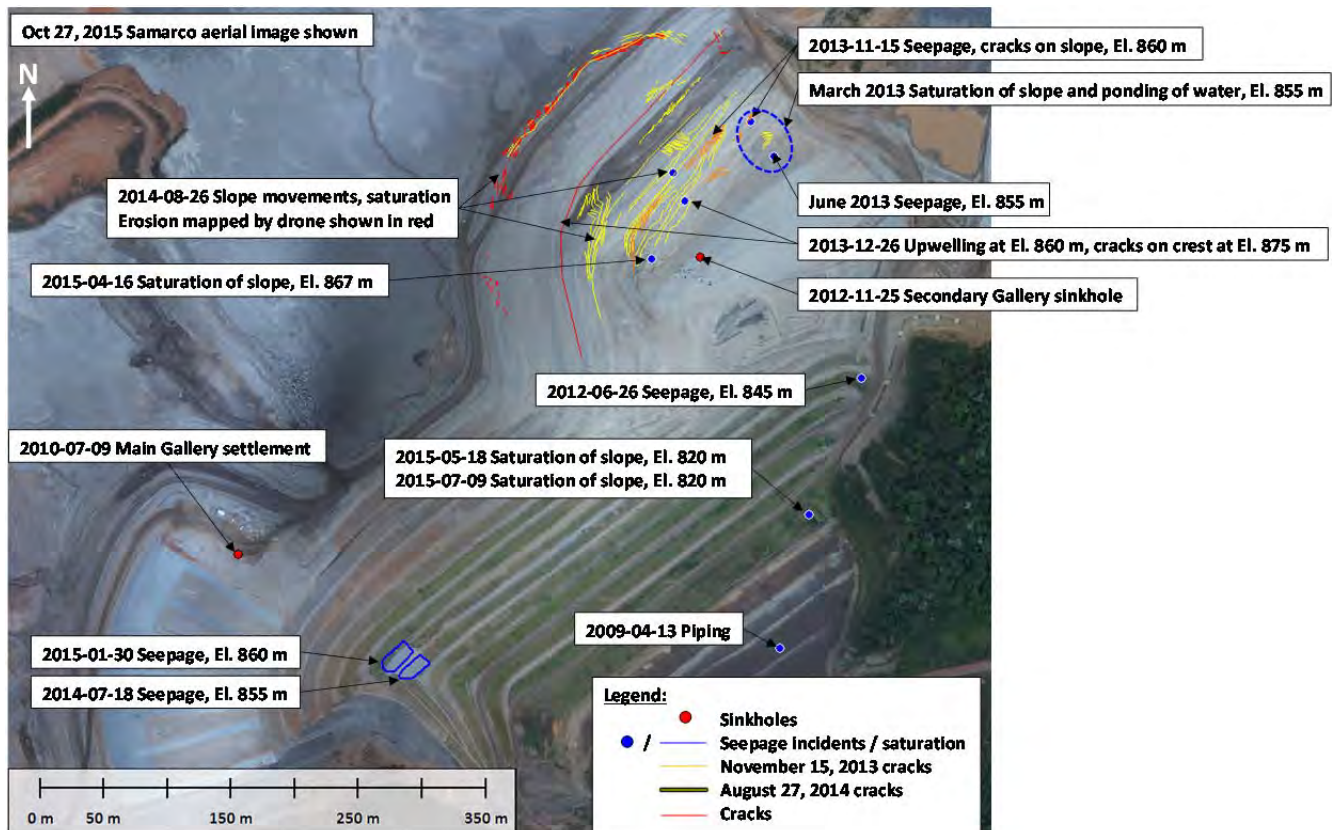
An additional observation of the steady state model is that the results predicted emergent seepage (~5.7 L/s) under steady state conditions at two locations on the left and right abutments. These locations are each coincident with 2015 seepage observations, as shown on Figure G3-11 (from Appendix B Attachment B8). This predicted seepage breakout is an indication of sound translation of the conceptual setting into the numerical environment.

Figure G3-11 Event map showing recorded seepage and failure related incidents

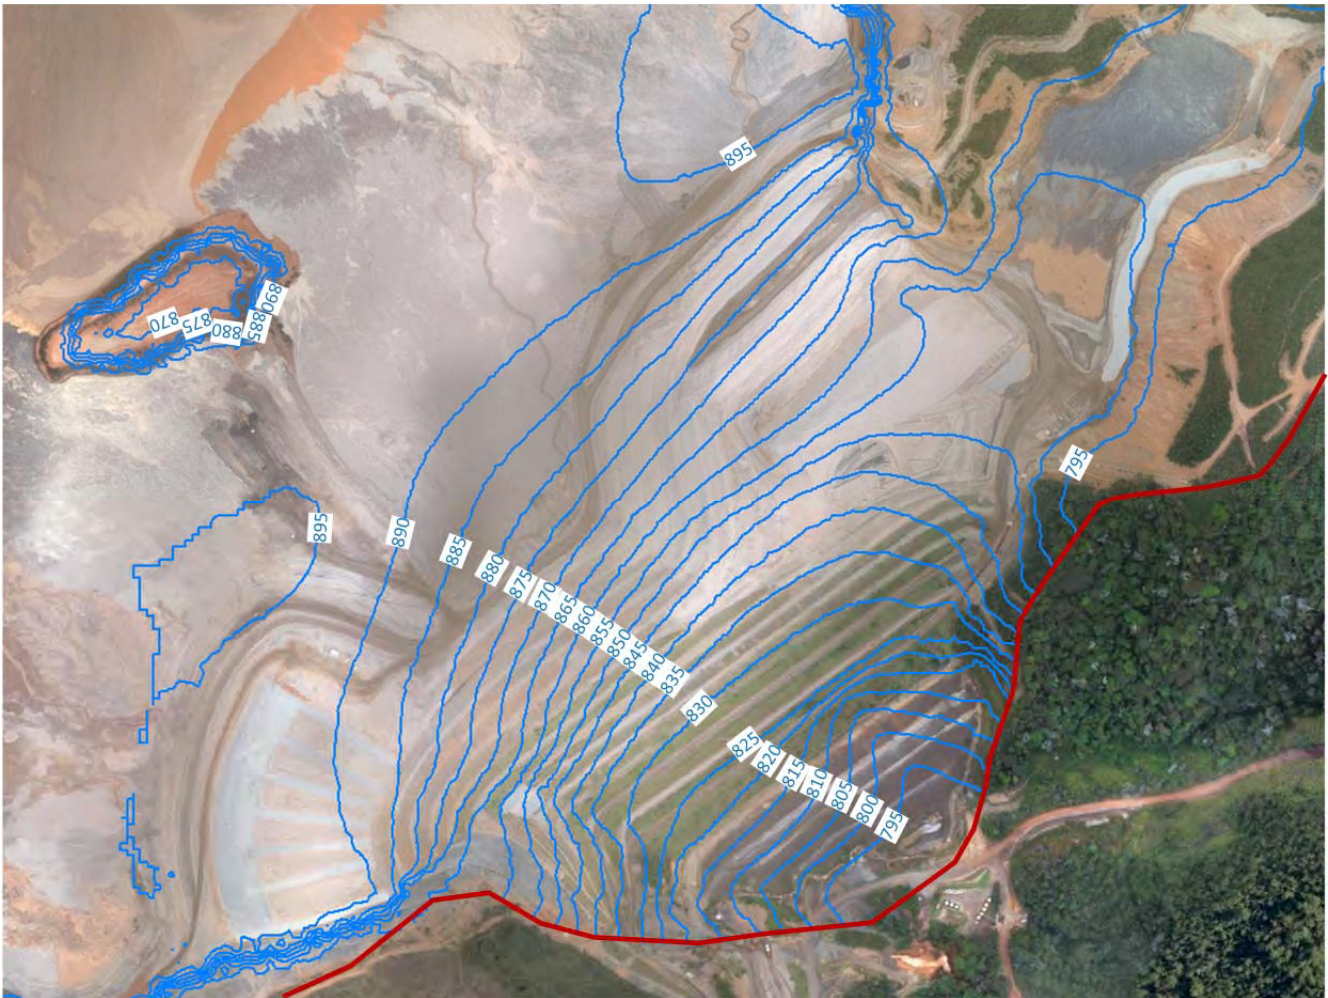
Figure G3-19 Transient model phreatic conditions, November, 2015

The process of transient calibration has shown good predictive quality of the model in presenting phreatic conditions. Key elements of the model results apparent on Figure G3-19 include:

- At the toe of the dam, contours wrap around the remnants of the Principal Foundation Drain and the Auxiliary Drain. This distortion of the phreatic conditions was apparent in the piezometric records from before the construction of the El. 826 m blanket drain.
- The phreatic surface “flattens” between the El. 825 m and El. 830 m contours, a direct response to the effect of the El. 826 m blanket.
- Conditions on the left abutment setback are more complicated, with effects from the left abutment drain (connected to the El. 860 m blanket drain) evident, and generally lower hydraulic gradients in the area between the downstream extent of the El. 860 m blanket drain and Grota da Vale (pond constant head ~El. 860 m).
