Fundão Tailings Dam Review Panel

Report on the Immediate Causes of the Failure of the Fundão Dam

EXECUTIVE SUMMARY

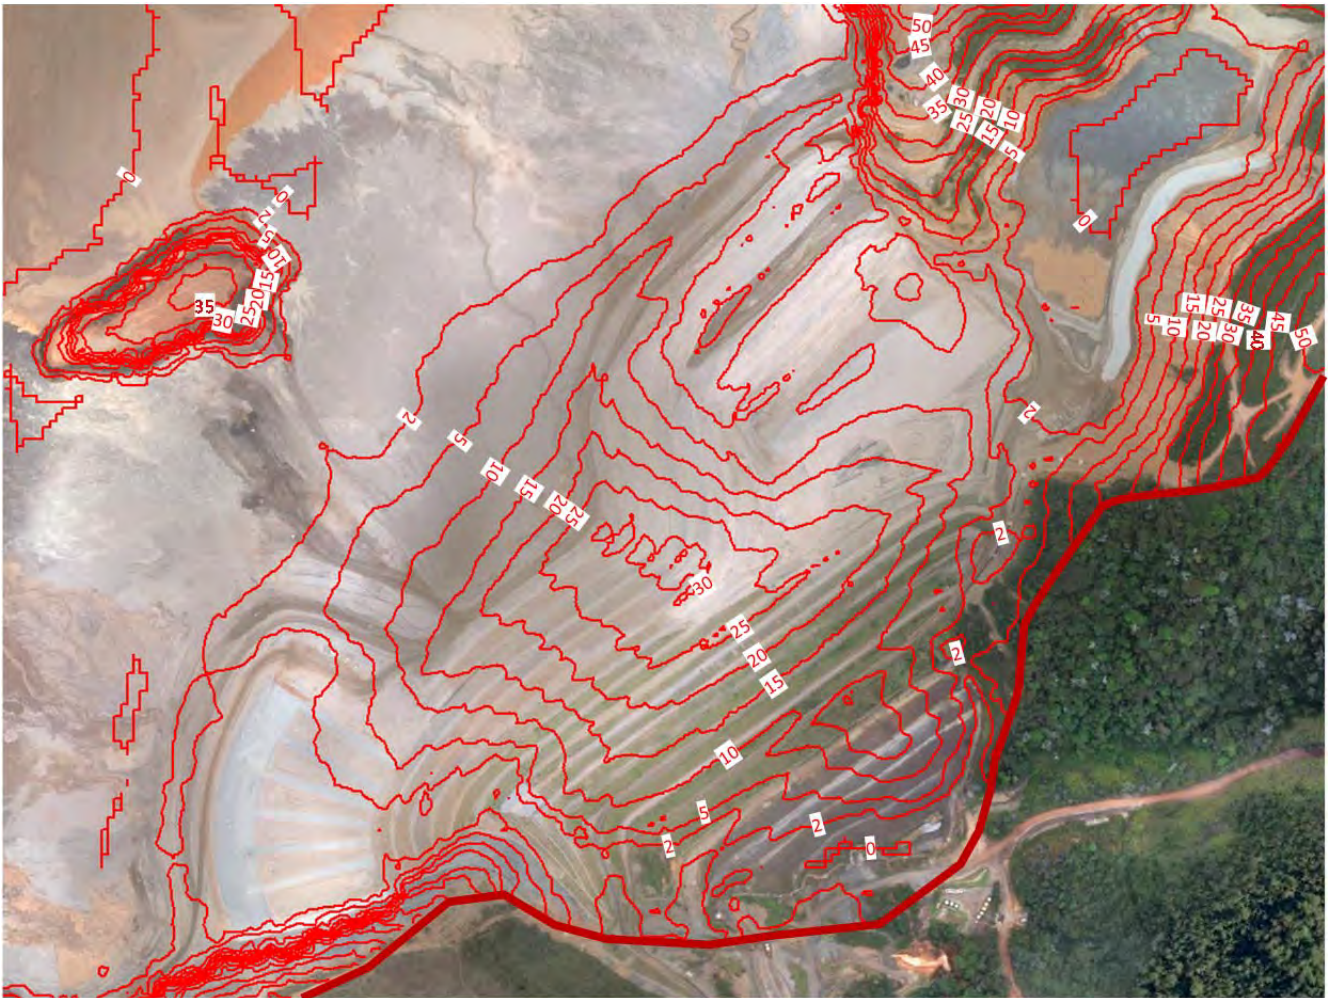
Figure G3-20 Transient model unsaturated isopach map, November, 2015

The unsaturated isopach (Figure G3-20) provides an indication of areas of limited unsaturated thickness, or areas where emergent seepage is predicted to occur. Of note from these results, there are four zones of <5 m unsaturated thickness:

- Seepage is predicted by the model at the toe of the dam near the exit point of the Principal Foundation Drain.
- Shallow unsaturated conditions are predicted on the right abutment (Figure G3-11). This area also had seepage in October of 2015, as reported in Samarco routine reporting.
- On the left abutment abutting foundation material in the area of the left abutment rock fill trench (Appendix B).
- Within the area of the setback and over the El. 860 m blanket drain near the toe of the left abutment reinforcement berm.

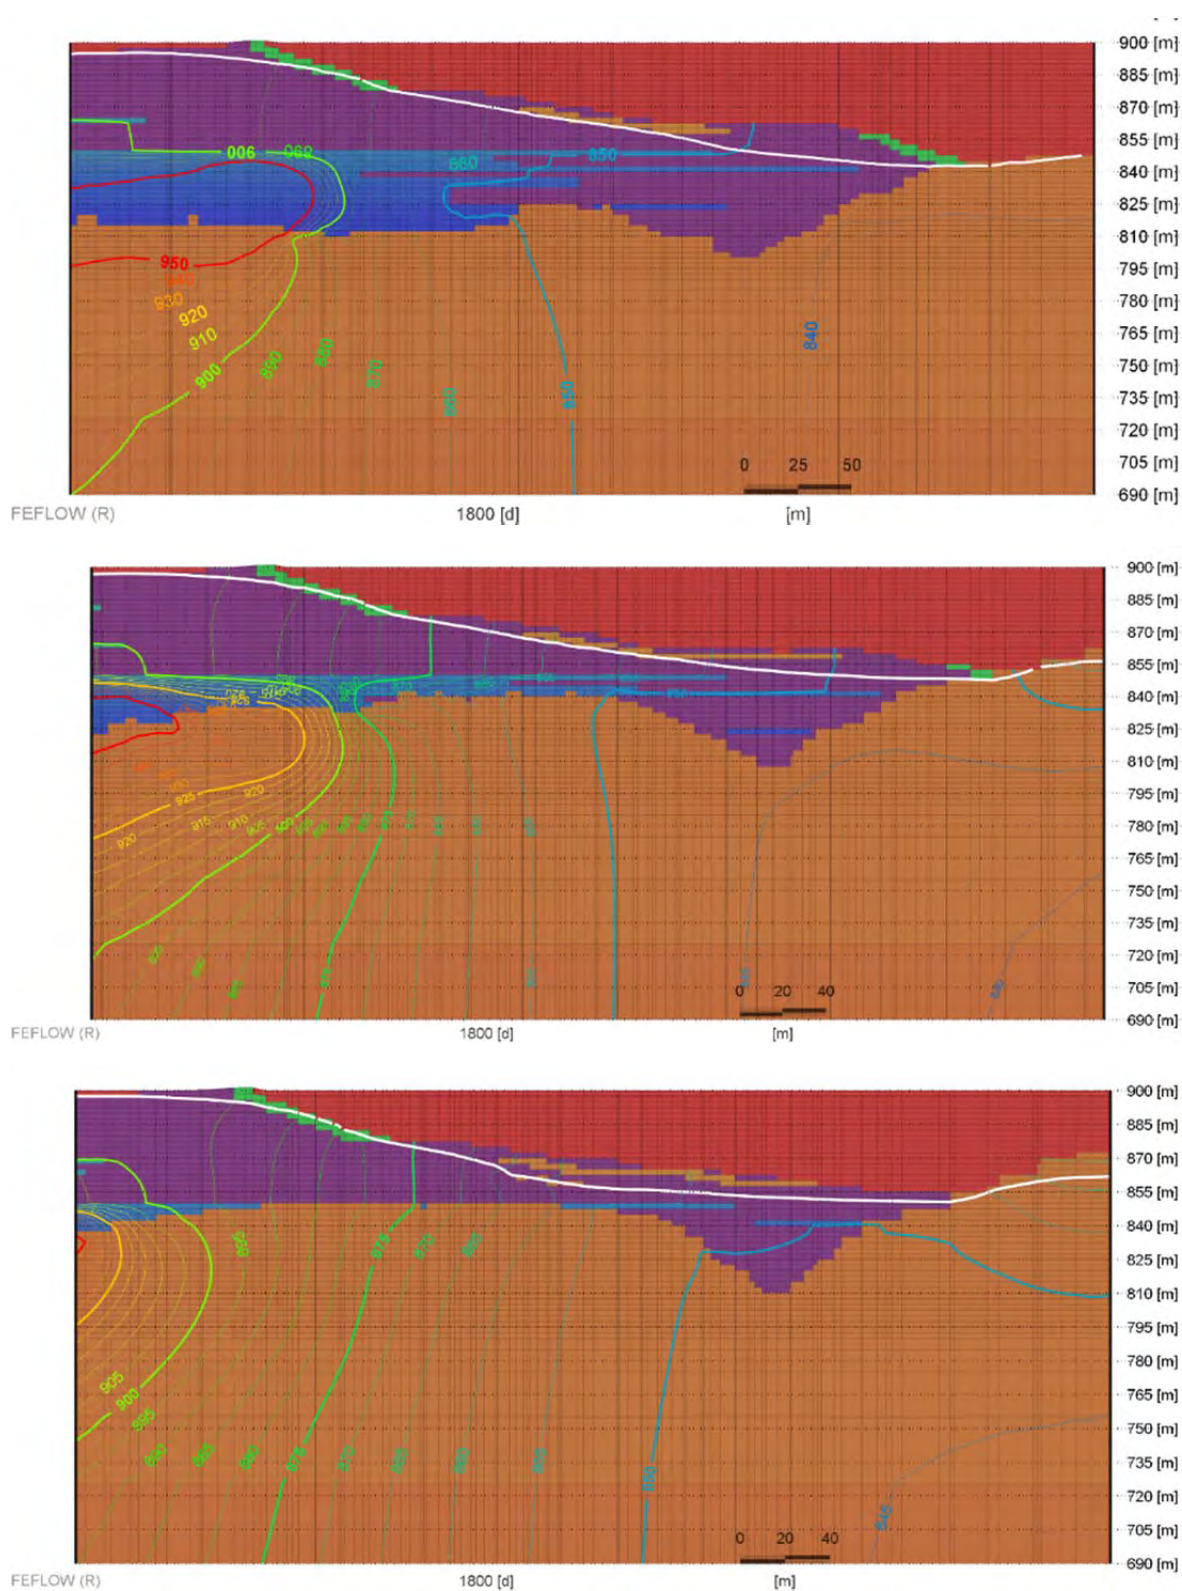
Figure G3-22 shows model predicted conditions for time 1800 days (November, 2015) through left abutment Sections 01, 02 and 03. Slimes, drains and compacted sands are color differentiated in the sections:

- The slimes still impose influence on the phreatic condition, holding the phreatic surface above their lateral location in section. Sands below these slimes are indicating downward vertical gradients, which are interpreted to occur as a result of the locally flattened gradients, reduced recharge, completed consolidation processes and increased distance from spigotting locations. The effects of the El. 826 blanket drain may also be influencing these conditions.

Section 02 is located parallel to Section 01. Similar conditions to those of Section 01 are apparent, although the pressure anomaly beneath the dam crest has significantly diminished. Slimes profiles are very similar to Section 01, and although the drain extends in length, most of the sand beneath is not in saturated contact with the drain. The effects of the El. 826 m blanket drain may be becoming more prominent and are starting to steepen the gradient between the two drainage blankets.

Section 03 has a similar profile, although it is noted that the model predicts phreatic conditions beneath the El. 860 m blanket drain to further lower, likely in response to steepening flow gradients towards the El. 826 m blanket drain which is now physically closer.

Figure G3-22 Left abutment water table and head contours Sections 01, 02 and 03, t=1800 days

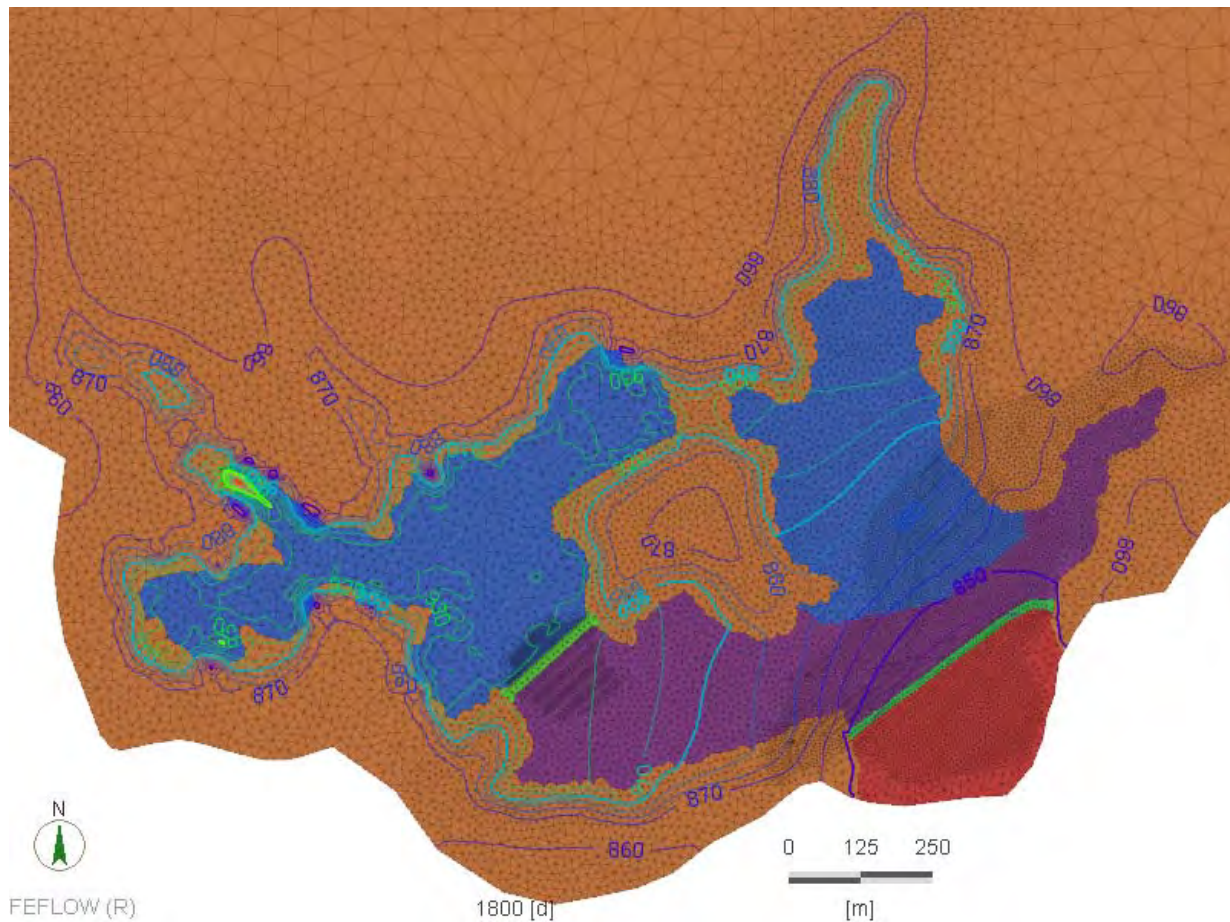
Figure G3-23 provides a plan layout of head conditions for El. 850 m at time 1800 days, which slice horizontally through the approximate upper contact with the main body of slimes (shown as blue). This section also lies between the drainage blanket elevations of El. 826 m and El. 860 m.

Of note is the differing hydraulic gradients apparent between the left abutment and the right abutment. On the left abutment the phreatic surface grades about 10 m over 250 m between Grota da Vale and the eastern area of the El. 826 m blanket drain. On the right abutment, gradients are much steeper, around 30 m over 125 m of distance, toward the western area of the drain. The gentle arc of the 850 m contour has a moderate skew toward the left abutment, which serves to reduce these gradients, and by consequence they are likely to result in slower groundwater velocities.

Figure G3-23 Facility head conditions for model layer El. 850 m

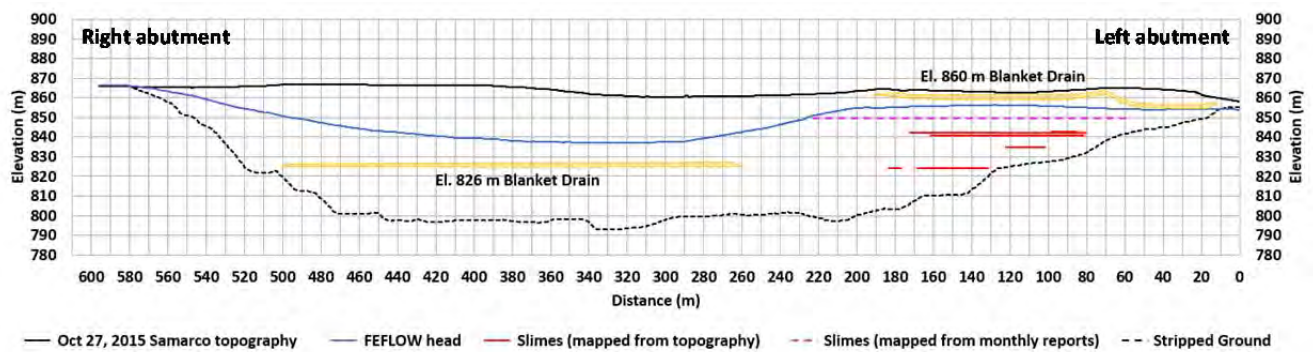
The Longitudinal Section starts on the left abutment, crosses the El. 860 m blanket drain, and rotates around the setback to then cross over the El. 826 m blanket drain and meet the right abutment (Figure G3-24). Three features of the phreatic surface are prominent in this section:

- On the left abutment, the hydraulic gradient is relatively flat, and heads are raised to be in contact with the drain, perched atop the upper sequence of slimes;
- On the right abutment, without this slimes perching effect, the phreatic surface is drawn toward the drain with steeper gradients from the right abutment and behind the drain.
- Between these two zones, the phreatic surface grades from ~El. 852 m to ~El. 838 m (~14 m decline) over 80 m of section. This is not a gentle grade but a sharp change in conditions from those where the slimes exist.

This indicates that the El. 826 m blanket drain does have influence on phreatic conditions toward the left abutment, but only after the extent of the slimes is passed. Further east, the slimes dominate the phreatic surface, with heightened and “plateaued” phreatic conditions and more sluggish lateral gradients.

Figure G3-24 Facility head conditions, Longitudinal Section, looking upstream

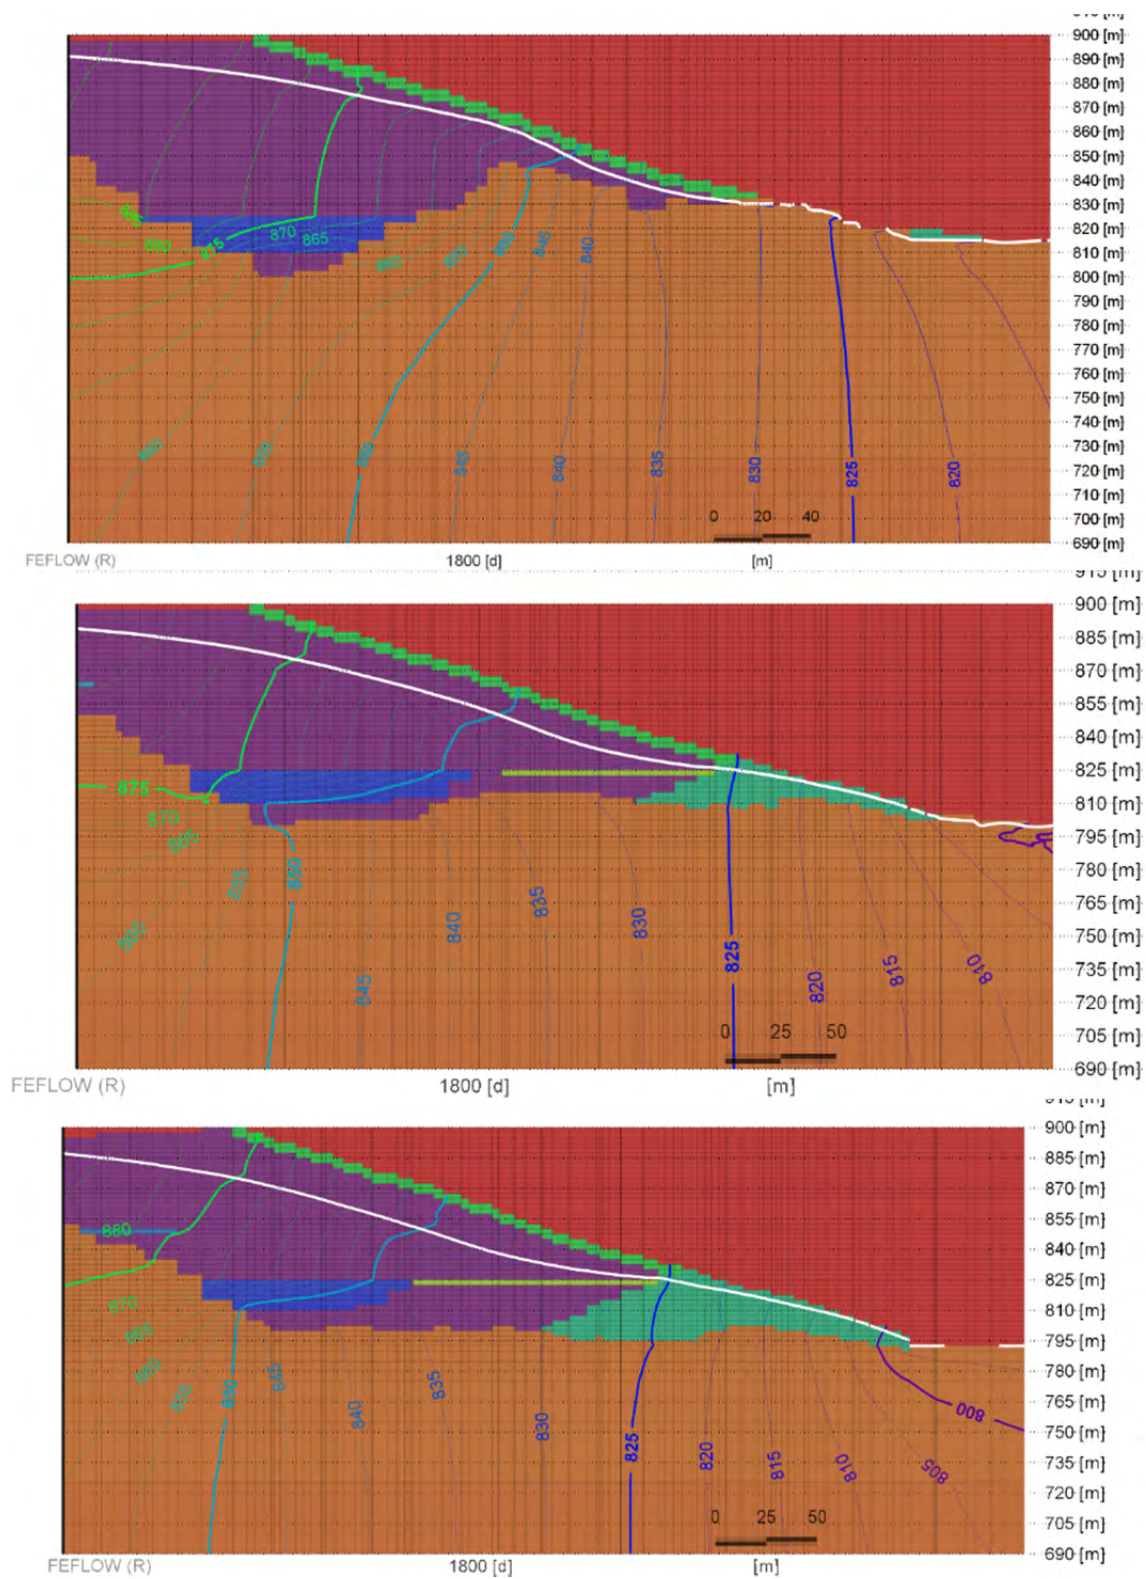
Figure G3-25 shows model predicted conditions for time 1800 days (November, 2015) through right abutment sections AA, BB and DD. Slimes, drains and compacted sands are color differentiated in the sections.

Section AA is located adjacent to but does not intersect the El. 826 m blanket drain. There are slimes at depth deposited in the valley low point. Phreatic conditions close to the abutment are heightened and appear compressed between the basement high and the face of the dam. Model predictions indicate low amounts of seepage at the dam face at about El. 860 m, which coincides with this basement high.

Section BB crosses the start of the El. 826 m blanket drain and extends through the Starter Dam. Slimes are located behind the dam in the basement depression, with an upper elevation of about El. 825 m, close to that of the blanket drain. Phreatic conditions reduce across the drain, with minor perching effects from the slimes possibly occurring above the slimes (the gradient appears to steepen mildly once it crosses the slimes). Over the blanket the effect of the drain is prominent, and effective in controlling phreatic conditions below the dam face.

Section DD shows a similar response to that of Section BB, with the drain becoming the more prominent feature affecting phreatic conditions. Slimes effects, although far more moderate than those of the left abutment, are weakly apparent, extinguishing behind and across the area where their presence ends.

**Figure G3-25 Right abutment water table and head contours sections AA, BB and DD, t=1800 days**

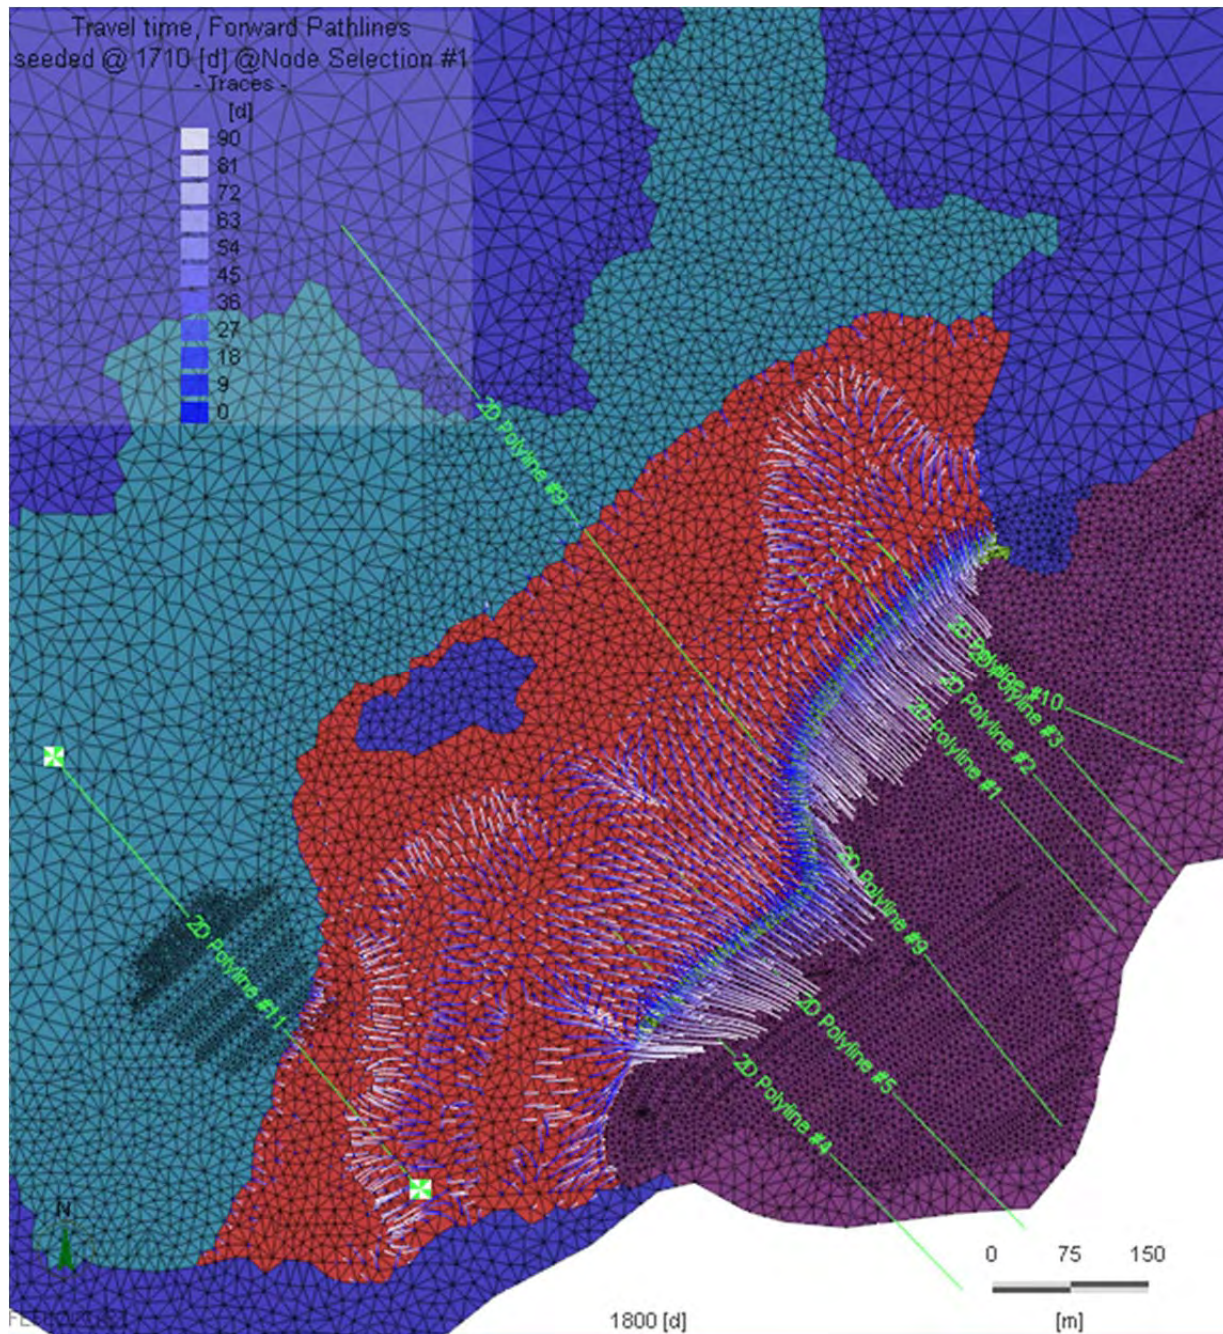
Figure G3-27 further explores the detail of groundwater movement with more focus on the period leading up to the failure event in November, 2015. This image is time constrained and shows particle paths from seeds placed on tailings sand 3 months before the failure event. Observations include:

- On the left abutment, groundwater flow is clearly toward the El. 860 m blanket drain, with longest pathways apparent from downstream of the dam crest. This is consistent with intersection of flow with the upper tiers of this drain, falling under steep gradient within high permeability material. The longer pathways occur along most of the drain, shorting in the area of the setback and where phreatic conditions begin to fall under the influence of flow toward the El. 826 m blanket drain.

- On the right abutment, flow vectors are most apparent adjacent to the construction activity for the drain construction and behind the El. 826 m blanket drain. This is consistent with the condition that the seeds placed behind the active construction activity are furthest from the drain and are experiencing flatter hydraulic gradients, resulting in shorter travel distances. Seeds placed closer to the dam crest and the drain fall under the steeper gradients directly toward the blanket.

Figure G3-27 Particle tacking, 90-day travel (day 1710 to 1800), seed placement upper tailings sand

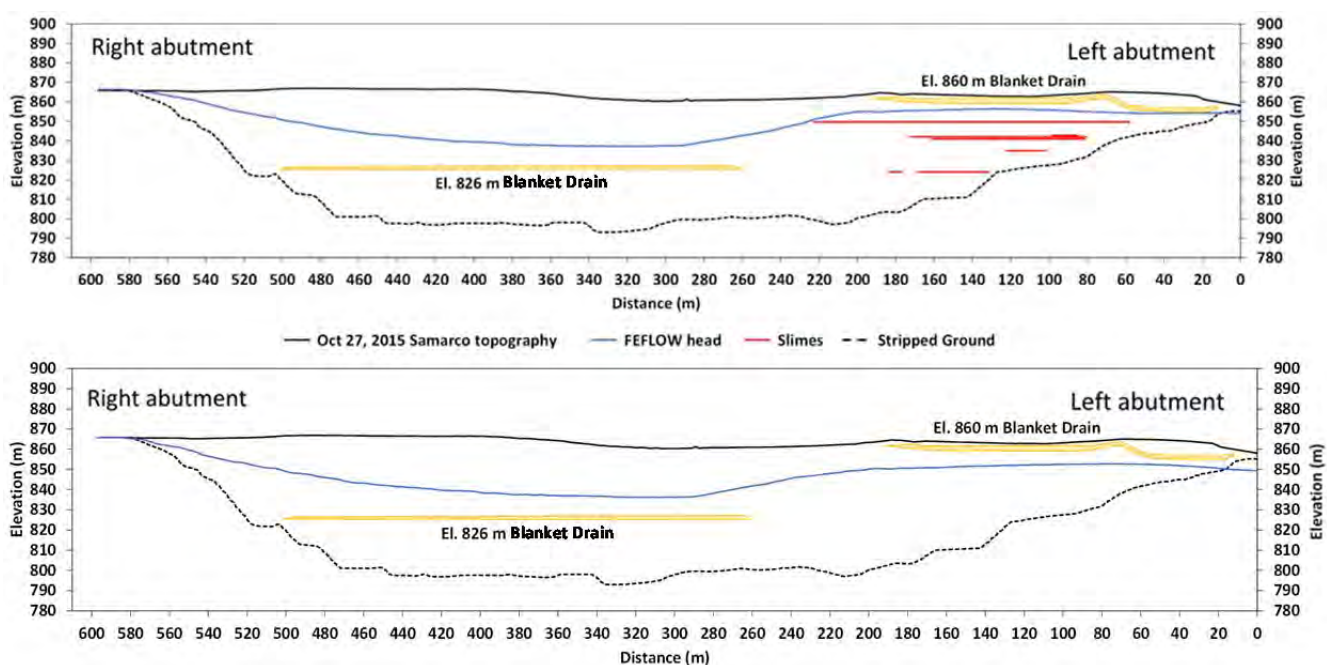
No other elements of the model were changed. The model was run under transient conditions to the same schedule as the calibrated model, with end of model water balance and head and pressure conditions reviewed. A comparison of the calibrated and scenario model using predicted phreatic conditions is provided on Figure G3-28 along the longitudinal section.

Figure G3-28 Longitudinal Section with water table from calibrated model (upper), Scenario 1 (lower), t=1800 Days

The differences are subtle but the left abutment phreatic condition is predicted to be lower in the scenario simulation (no slimes) than conditions predicted in the Ph1 calibrated model. The phreatic surface in the scenario simulation does not meet the El. 860 m blanket drain along this section, and the hydraulic gradient toward the El. 826 m blanket drain is a less abrupt feature. In the calibrated model, however, the phreatic surface is predicted to intersect the El. 860 m blanket drain in this transect.

Conditions over the El. 826 m blanket drain remain largely unchanged in both simulations.

- The slimes on the left abutment appear to be perching phreatic conditions and plateauing heads in the lower area of the El. 860 m blanket drain. Scenario 1 was conducted to test this theory and confirmed phreatic conditions on the left abutment to be predicted as lower if the slimes “tongues” were not present beneath the dam.

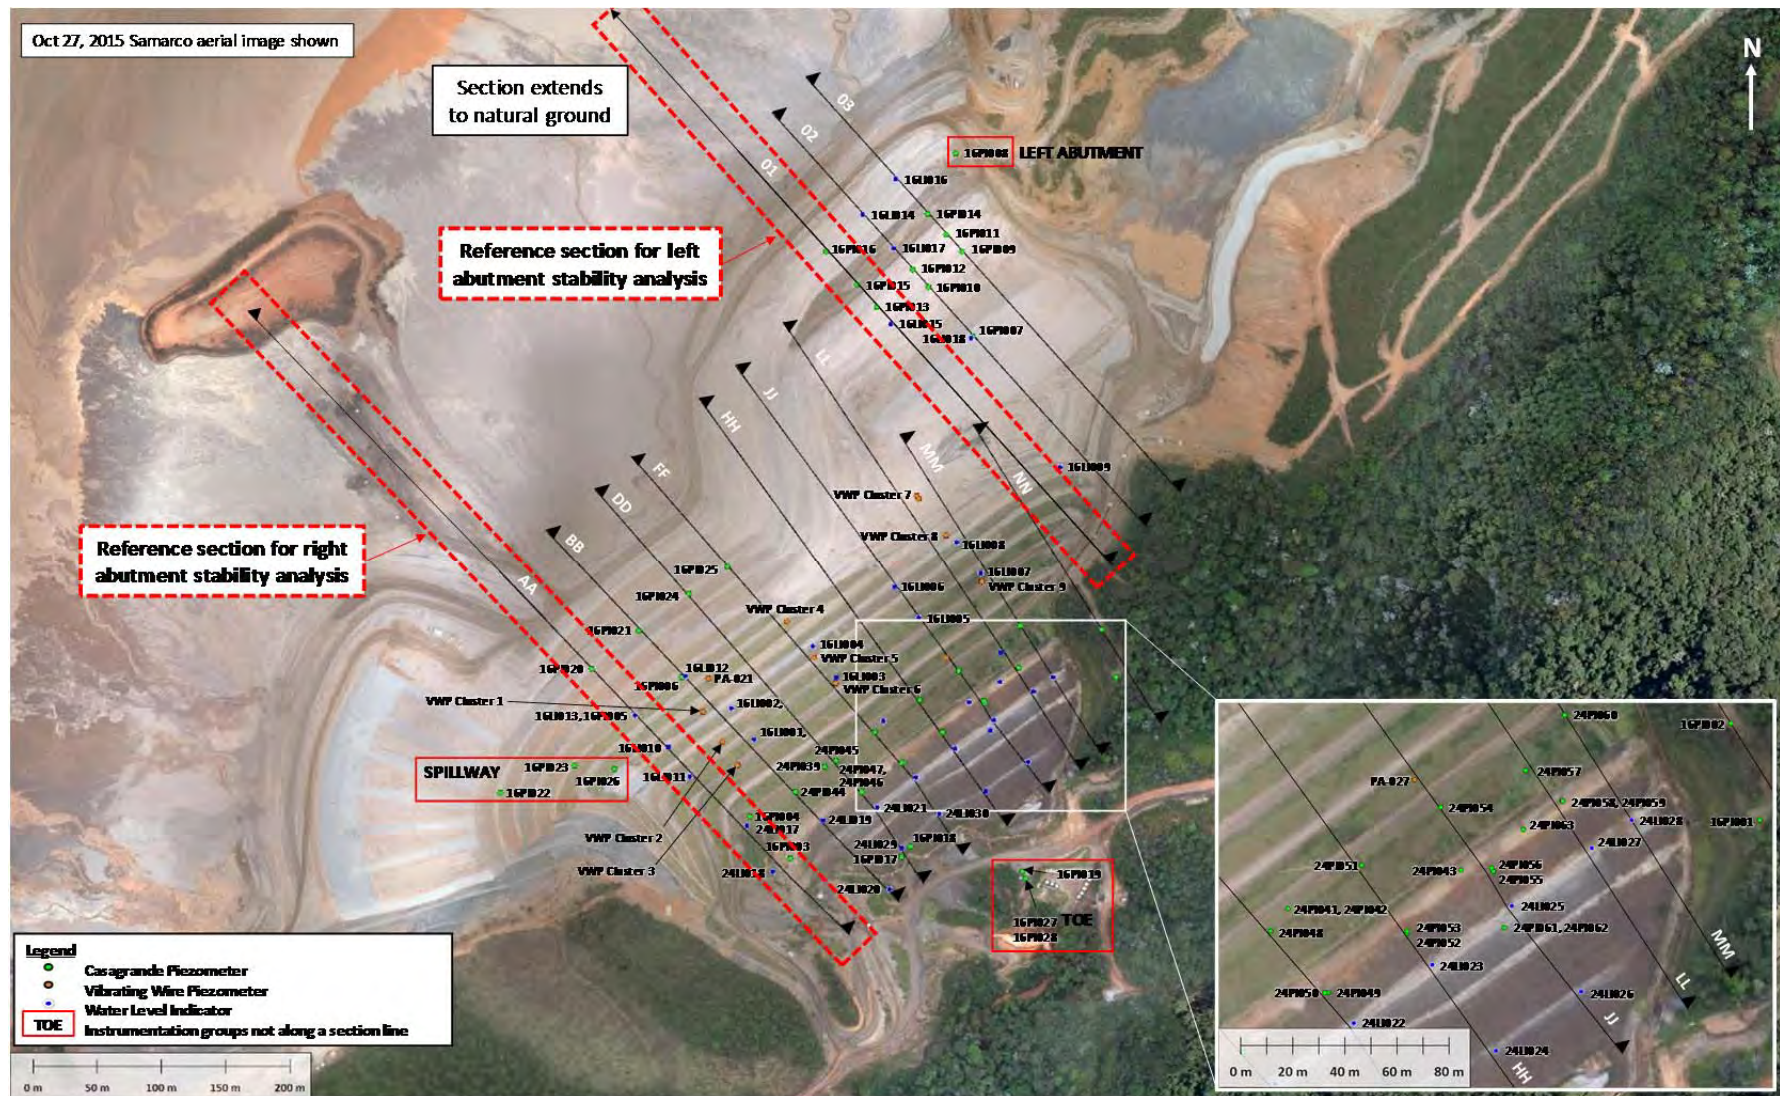
Figure H1-1 Stability sections location plan

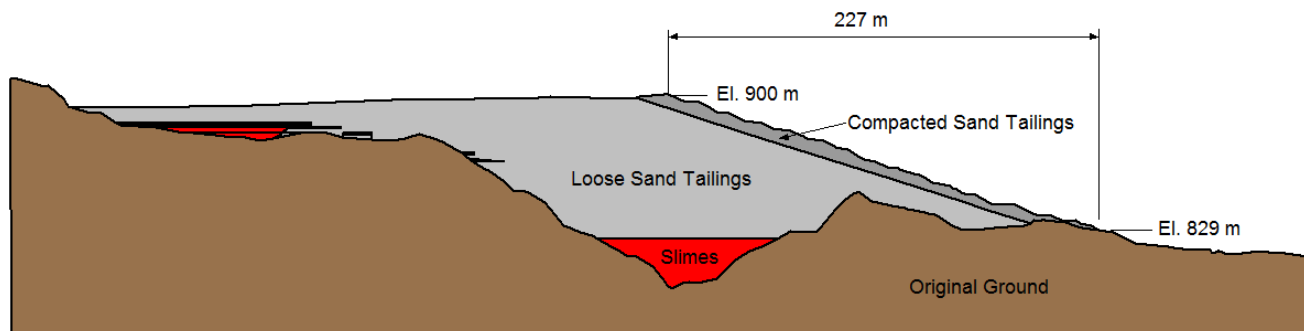
Figure H4-1 Right abutment model geometry

As shown on Figure H4-1, there is thin compacted shell of sand tailings on the upstream face. This zone was assumed to be 20 m wide and assigned a higher friction angle, 35° versus 33°, than the looser beach tailings.

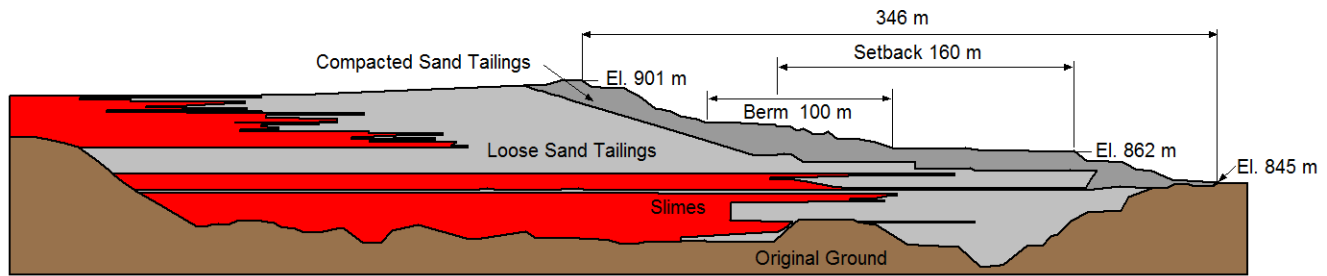
Figure H5-1 Left abutment model geometry – November, 2015

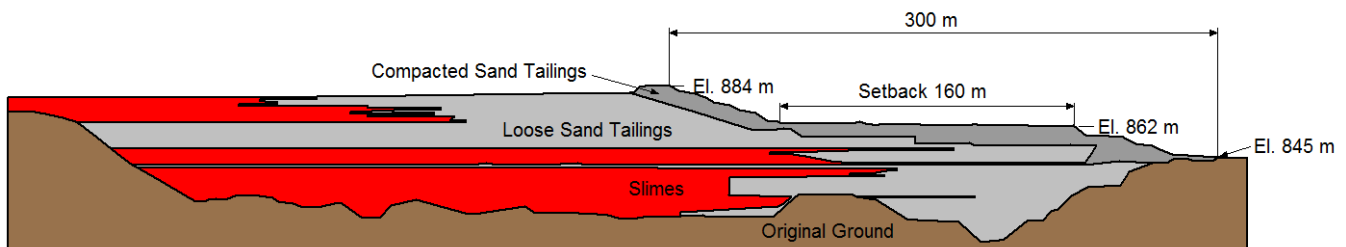
Figure H5-2 Left abutment model geometry – August, 2014

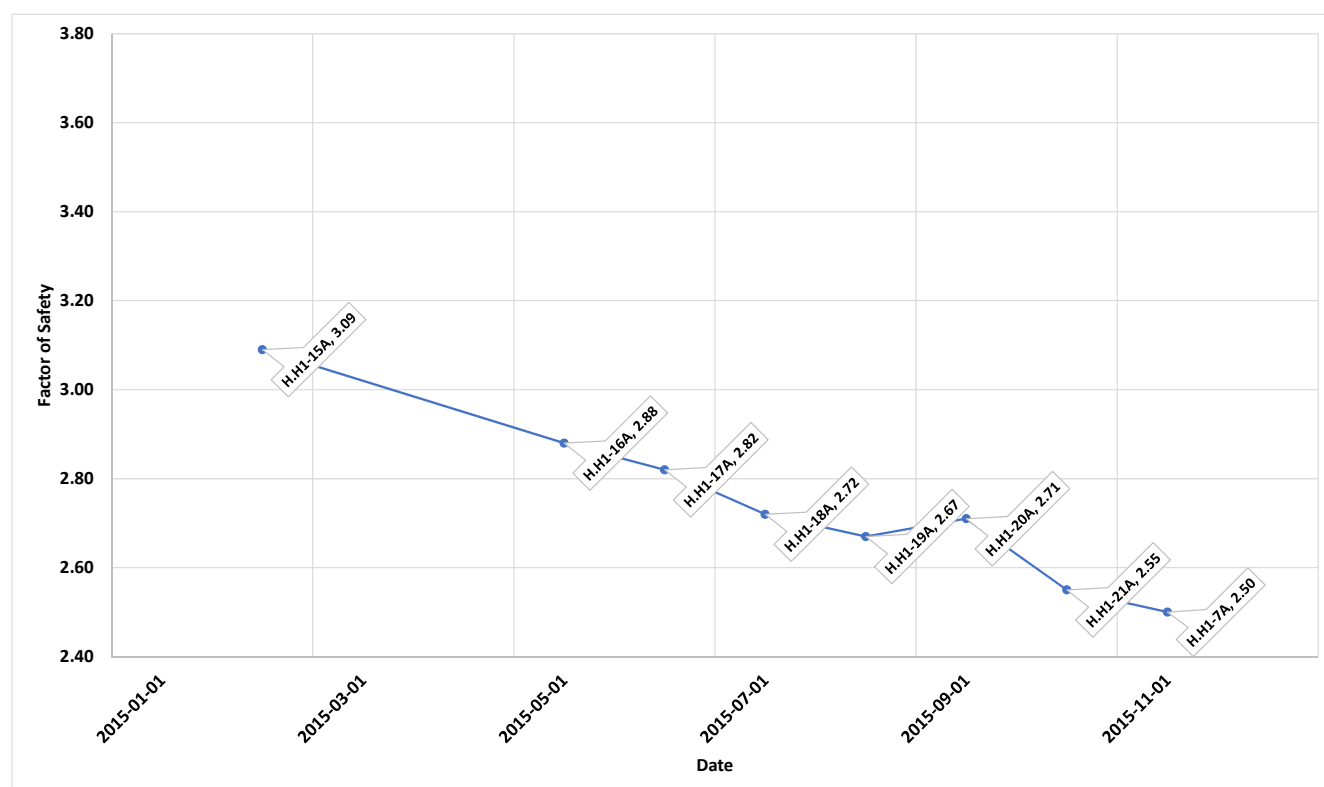
**Figure H5-3 2D limit equilibrium results (Section 01) – field data ESA FOS tracking (February, 2015 to November, 2015)**

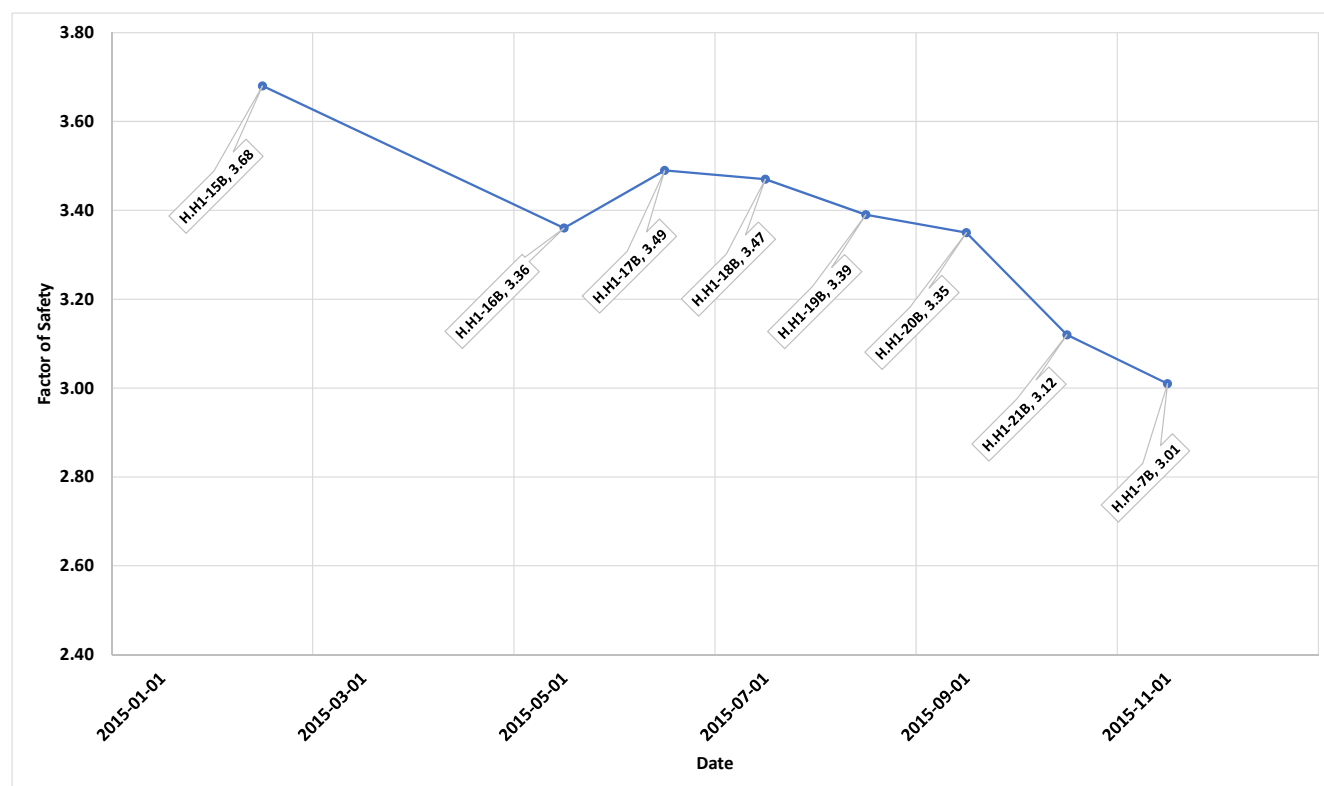
Figure H5-4 2D limit equilibrium results (Section 01) – FEFLOW data ESA FOS tracking (February, 2015 to November, 2015)

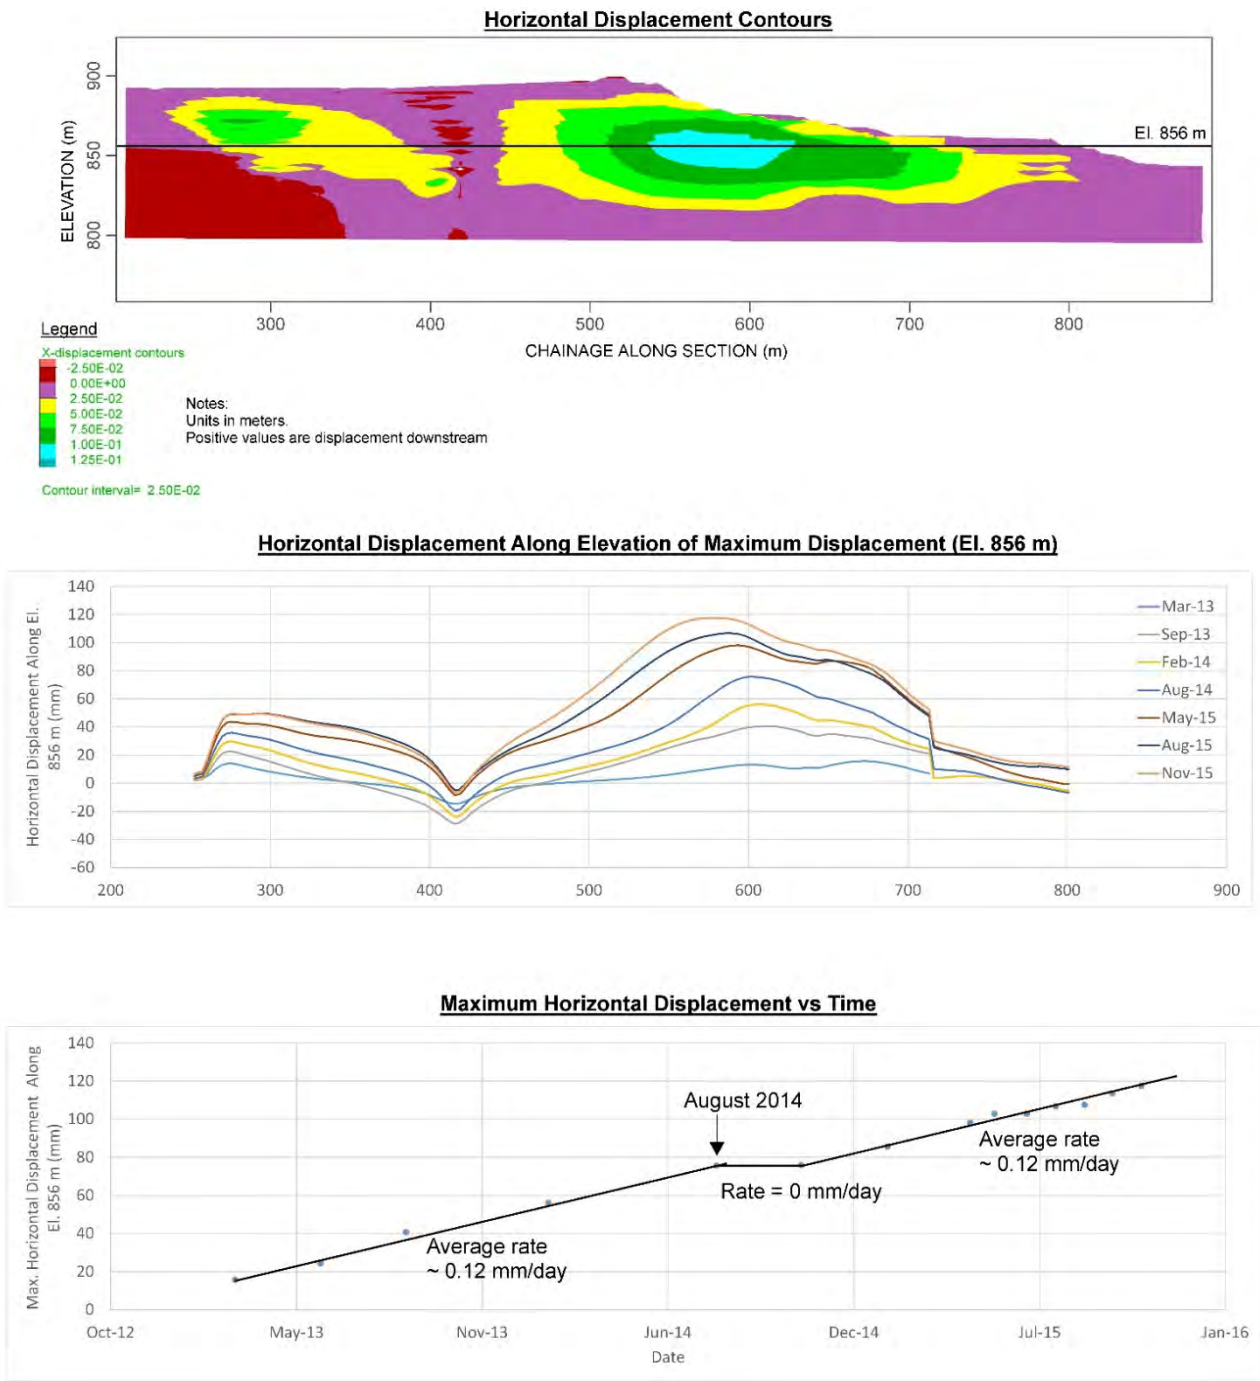
Figure I3-6 Horizontal displacement results – elastic analysis

Contours of horizontal displacement are shown on Figure I3-6, together with graphs showing the distribution and magnitude of displacements at stages throughout the model construction. These results show two main regions of horizontal displacement. One zone is located towards the upstream end of the model and the second is located beneath the slope. The upstream zone is a result of material settling above the highly compressible zone of predominantly slimes shown on Figure I3-7, and sliding along the interface with the bedrock. The downstream zone is a result of the dam's geometry. The abrupt break between these zones is a result of material immediately downstream of the predominantly slimes region being affected by displacement upstream due to the settlement of this layer. This is serving to offset the displacements in the downstream direction and leads to a zone of roughly zero horizontal displacement immediately downstream of the predominantly slimes region.

The largest horizontal displacements occur in the downstream region and concentrate in a zone that is downstream of the dike crest and centered along roughly El. 856 m. This implies compressive straining in the downstream direction and extension straining in the upstream direction. Extension strains result in a reduction of horizontal confinement consistent with a potential for liquefaction triggering from a lateral extrusion process.

The maximum horizontal displacement is shown throughout the dam construction on Figure I3-6. This shows a consistent response to loading throughout the majority of construction. An exception to this is between August and October, 2014 when zero displacement is shown in the model. This corresponds to a time period when a berm was built on the slope and the crest was raised by only 1 m following the cracking incident in August, 2014.

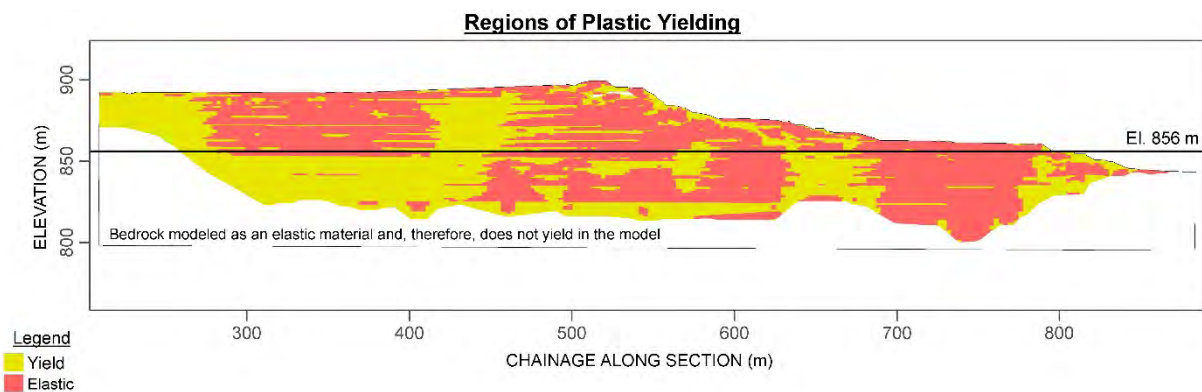
Figure I3-9 Regions of plastic yielding – Mohr-Coulomb analysis

Zones of yielding are shown as yellow shading on Figure I3-9. Pink shading indicates regions that have not reached the yield surface at any stage in the analysis. This figure shows that the areas experiencing the most significant yielding are those adjacent to the region of predominantly slimes material, and material at the toes of the left abutment setback and plateau.

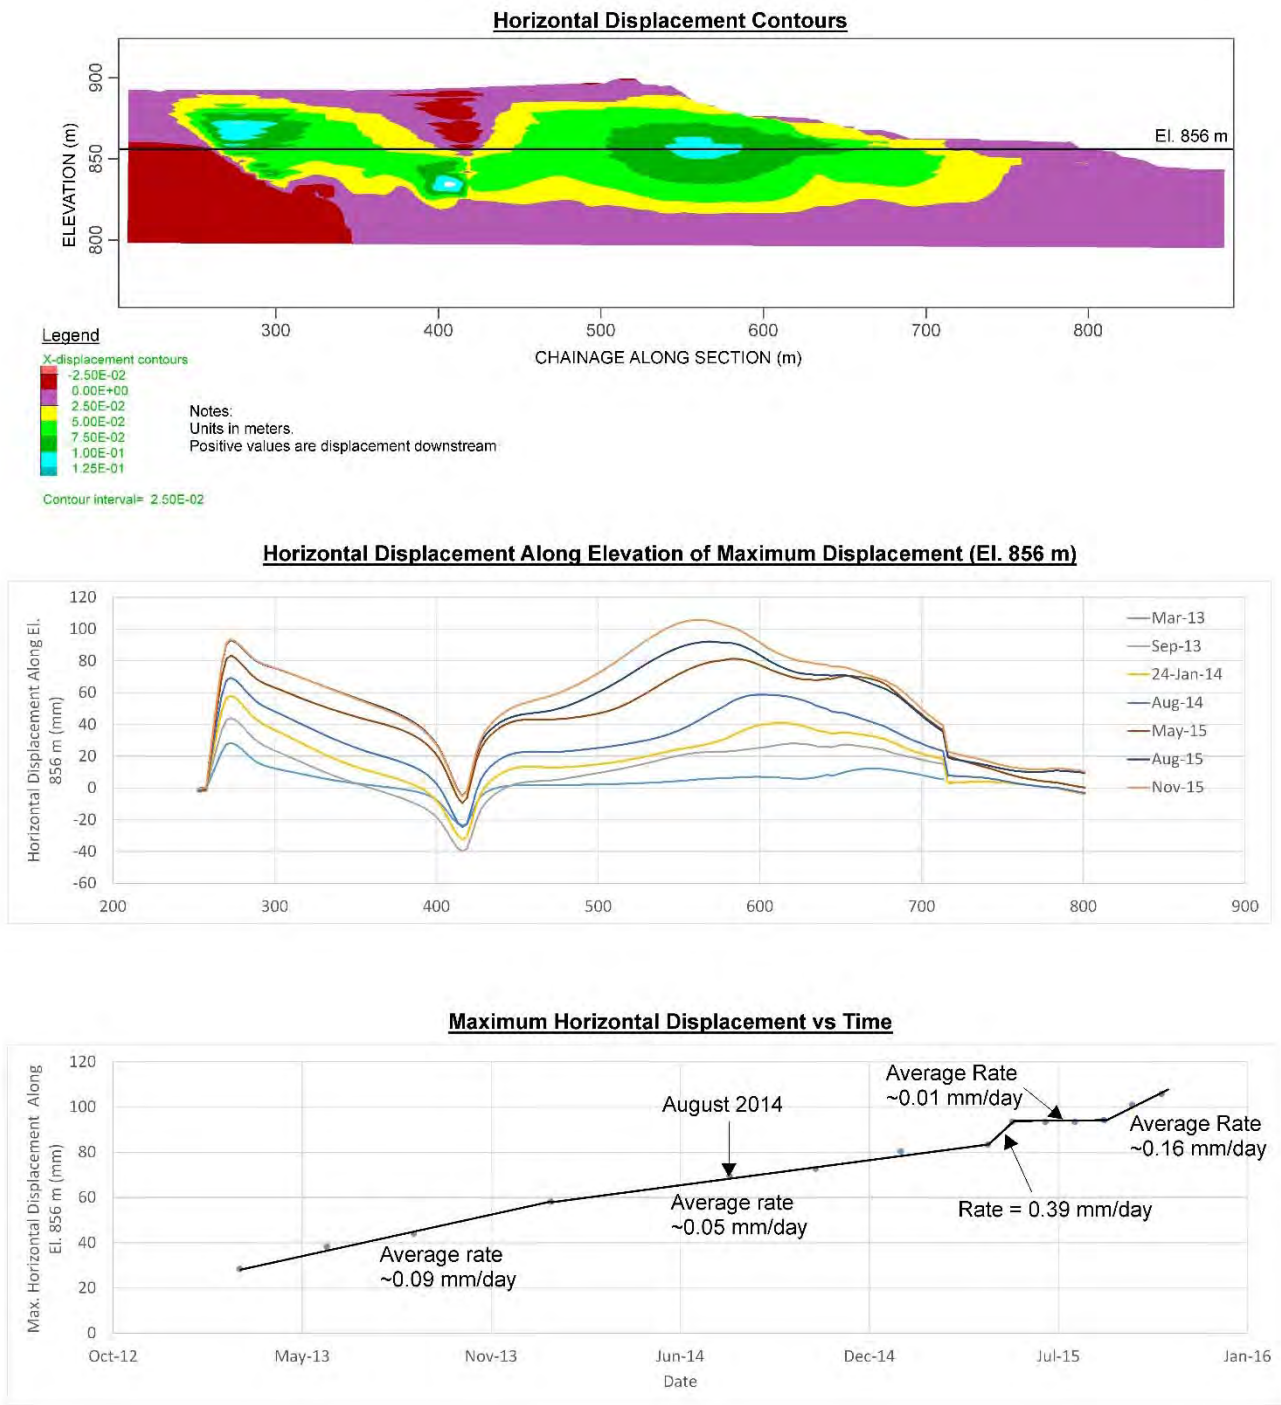
Figure I3-10 Horizontal displacement results – Mohr-Coulomb analysis

The effect on the yielding within the model can be seen by comparing Figure I3-10 with Figure I3-6. From such a comparison, it is apparent that the patterns of displacement are broadly similar, in that there are two main zones of displacement in the two models, which are in roughly the same location. However, it is apparent that there is additional displacement in an upstream direction towards the predominantly slimes material in the Mohr-Coulomb analysis. This is in line with expectations given the extent of yielding in that part of the model, which is in response to the settlement associated with the highly compressible slimes. The net effect of this additional upstream displacement is to slightly reduce the maximum displacements in a downstream direction. The maximum horizontal displacement at the November, 2015 stage of this model was 106 mm, compared with 118 mm in the elastic analysis.
