Fundão Tailings Dam Review Panel

Report on the Immediate Causes of the Failure of the Fundão Dam

EXECUTIVE SUMMARY

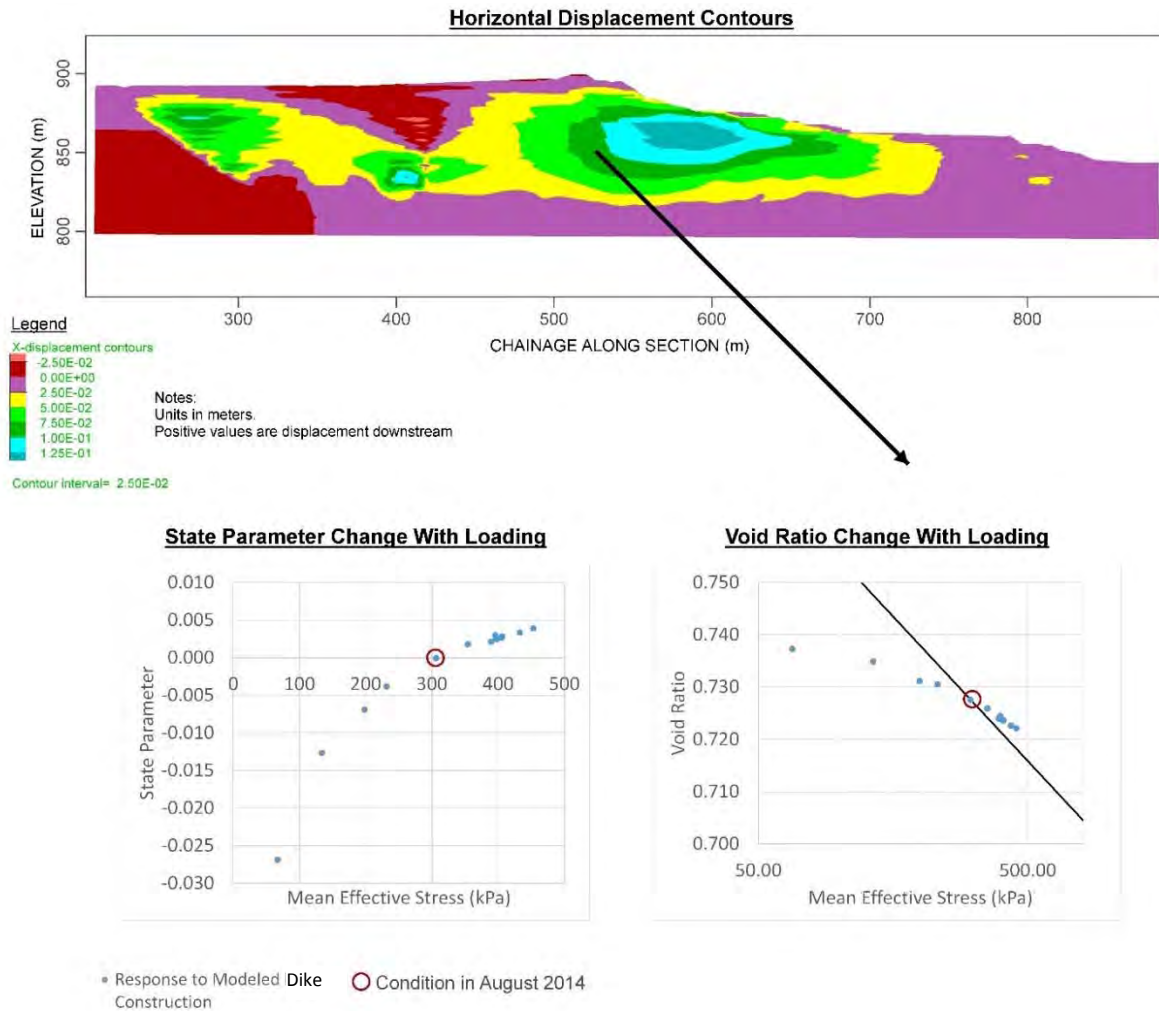
Figure I3-14 Horizontal displacement results – base case NorSand analysis

The observed reversal of the displacement trend from being lower than the Mohr-Coulomb model to being larger than that model at the August, 2014 model stage provides insight into a feature of the tailings behavior that may have contributed to the cracking incident occurring at that time and not sooner. To understand this trend, it is necessary to review the volumetric response of the tailings sand to loading. The variation of void ratio for an element of tailings sand located beneath the dam crest, above one of the slimes layers, is illustrated on Figure I3-14. This figure shows that as the dam is constructed, the void ratio is reducing at a lower gradient in e -log p' space than the critical state line. This is having the effect of making the tailings sand increasingly contractive (increasing the state parameter). As a result, this displacement trend is understandable if the change of stress-strain behavior with state parameter, illustrated on Figure I2-6, is considered. The explanation for this trend is that the tailings sand is initially slightly dilatant, causing the tailings to behave in a manner that is

stiffer than assumed in the Mohr-Coulomb analysis. At around August, 2014, the tailings become sufficiently contractive to produce a more ductile response to loading, which leads to a consequent increase in displacements. These displacements are moderated temporarily by the construction of the reinforcement berm following the August, 2014 incident, but then continue to increase with additional dike construction up until the November, 2015 failure.

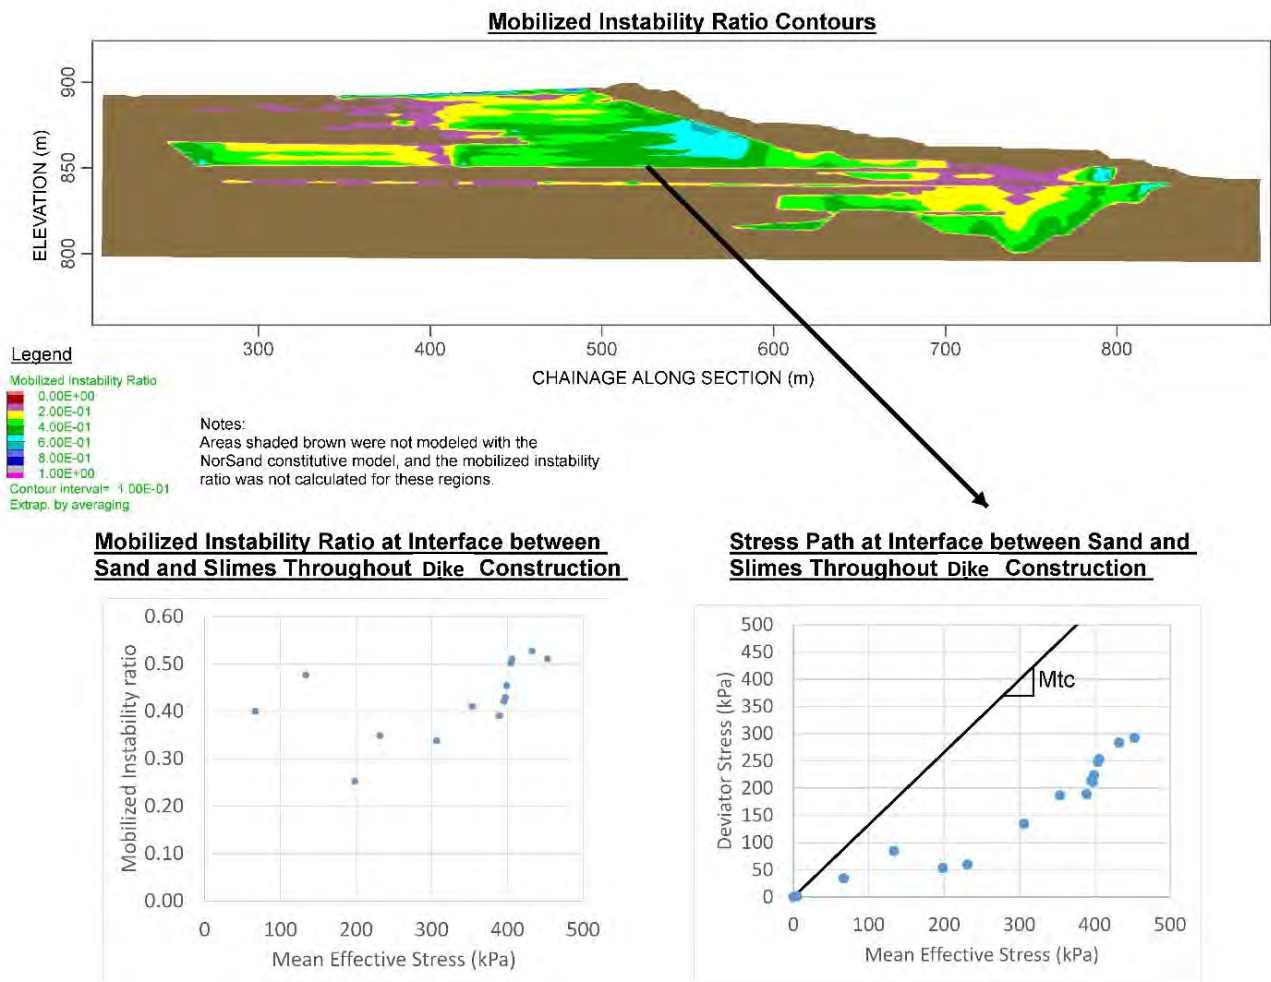
Figure I3-16 Mobilized instability ratio and stress path

Contours of mobilized instability ratio are shown, together with the variation of this parameter throughout the dike construction for a sand element located beneath the November, 2015 dam crest, at the sand-slimes interface, on Figure I3-16. This figure shows that the maximum mobilized instability ratios developed within this base case NorSand model, that included peak strengths assigned to the slimes, are roughly 0.5. These values are distant from the conditions at which rapid instability occurred in our laboratory tests, and suggest that drained deformations would be unlikely to lead to rapid instability under this model scenario. This model has formed the base for examining the effect of additional displacements within the slimes that may develop under conditions of more continuous slimes, or post-peak strength mobilization in the slimes, which are discussed in the following sections.

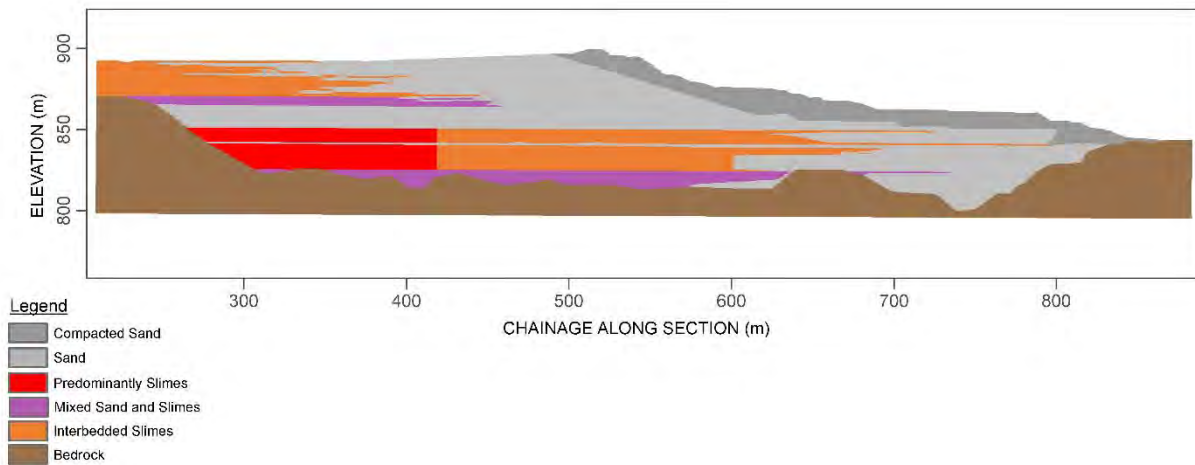
The model adjustment made for this analysis was to assume that the region designated as isolated slimes in the base case model was actually composed of interbedded slimes. The isolated slimes unit was merged with the interbedded slimes unit located farther upstream, leading to the model setup shown on Figure I3-18.

Figure I3-18 Updated model geometry incorporating continuous interbedded slimes

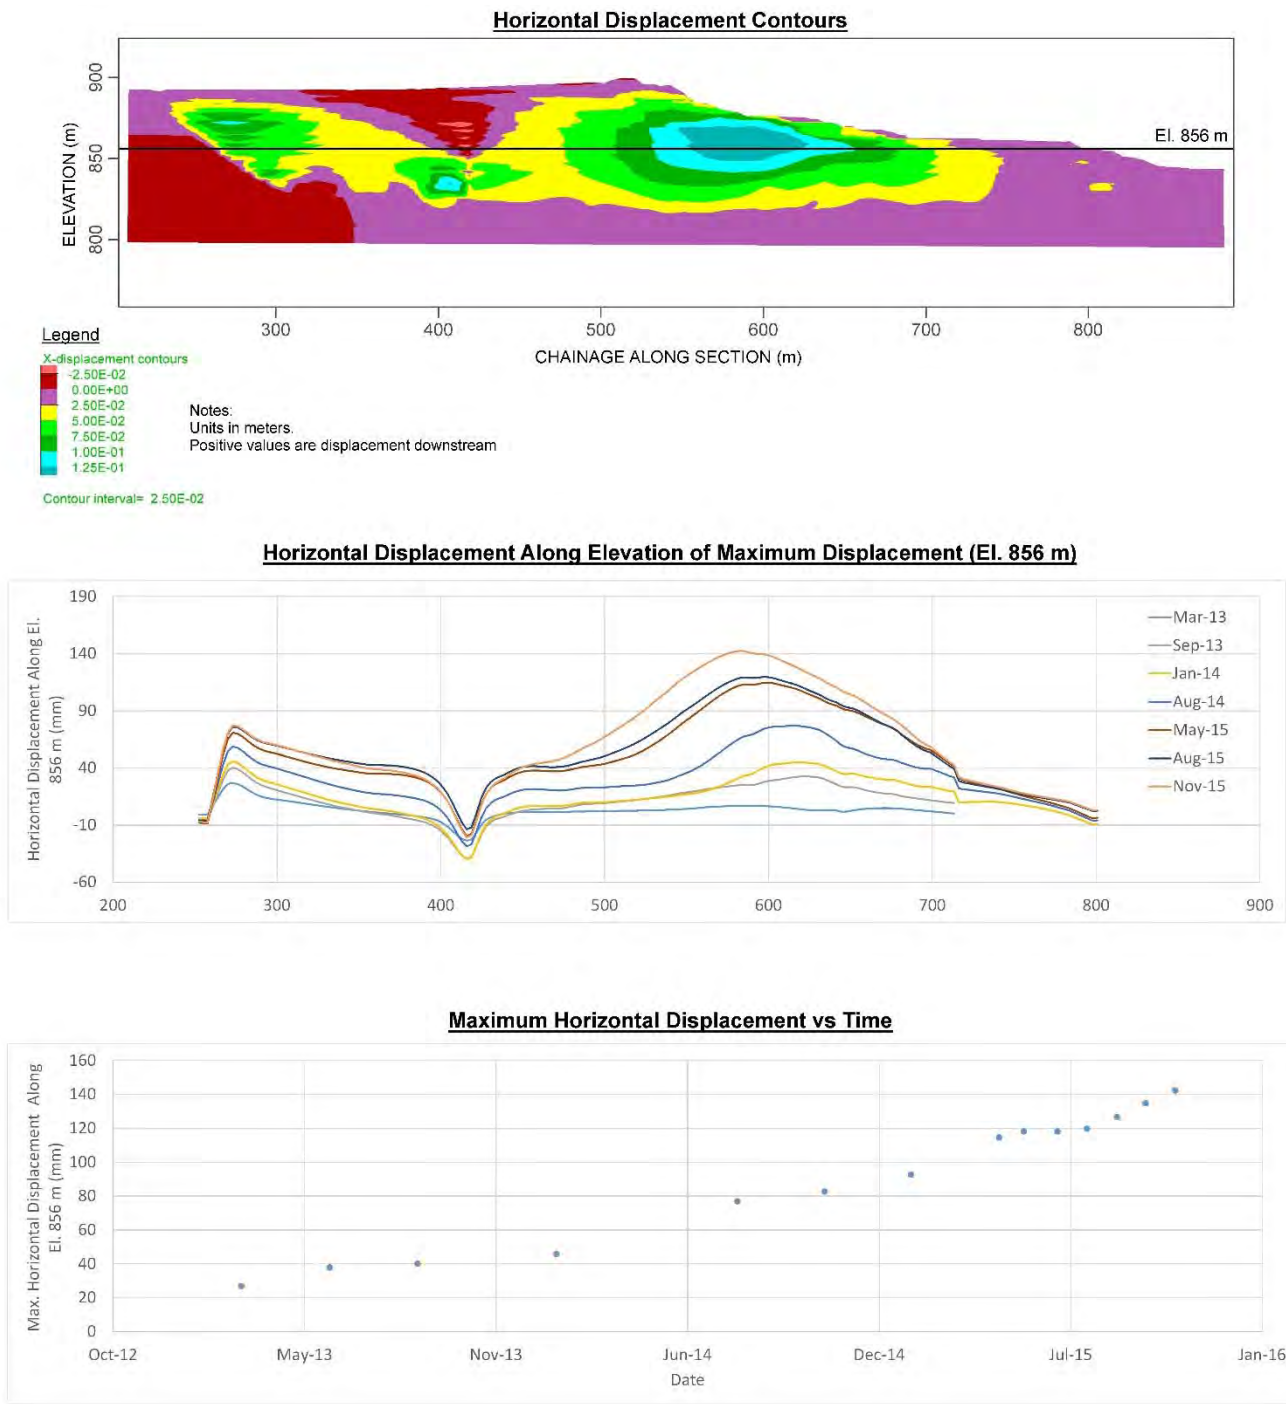
As shown on Figure I3-19 to Figure I3-21, assuming that the interbedded slimes are continuous in the downstream direction does not change the horizontal displacement or stress state results significantly from those of the base case. The outcome of this sensitivity analysis was to increase the horizontal displacements at the November, 2015 model stage by 7 mm, from 135 mm in the base case to 142 mm. The peak instability ratio of this model was similar to that of the base case, with both models resulting in a value of roughly 0.5. Therefore, these results suggest that the presence of a relatively discontinuous mixture of sand and slimes represented by the blended sand/slimes parameter sets would not bring the stress state of the tailings to an unstable condition, and would not account for the flow failure observed on November 5, 2015. The following sections of this appendix examine whether the presence of weaker, horizontally continuous, slimes-rich layers within the interbedded slimes region, which could mobilize a much lower strength than the blended parameters, could account for the November 5, 2015 flow failure.

Figure I3-19 Horizontal displacement results – continuous interbedded slimes model

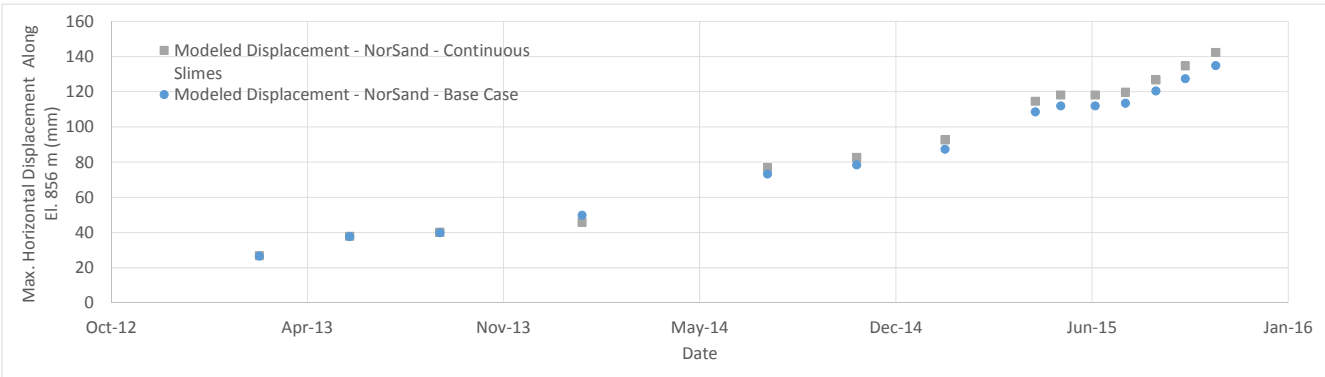
Figure I3-20 Comparison of displacements from NorSand base case with those from the continuous interbedded slimes sensitivity analysis

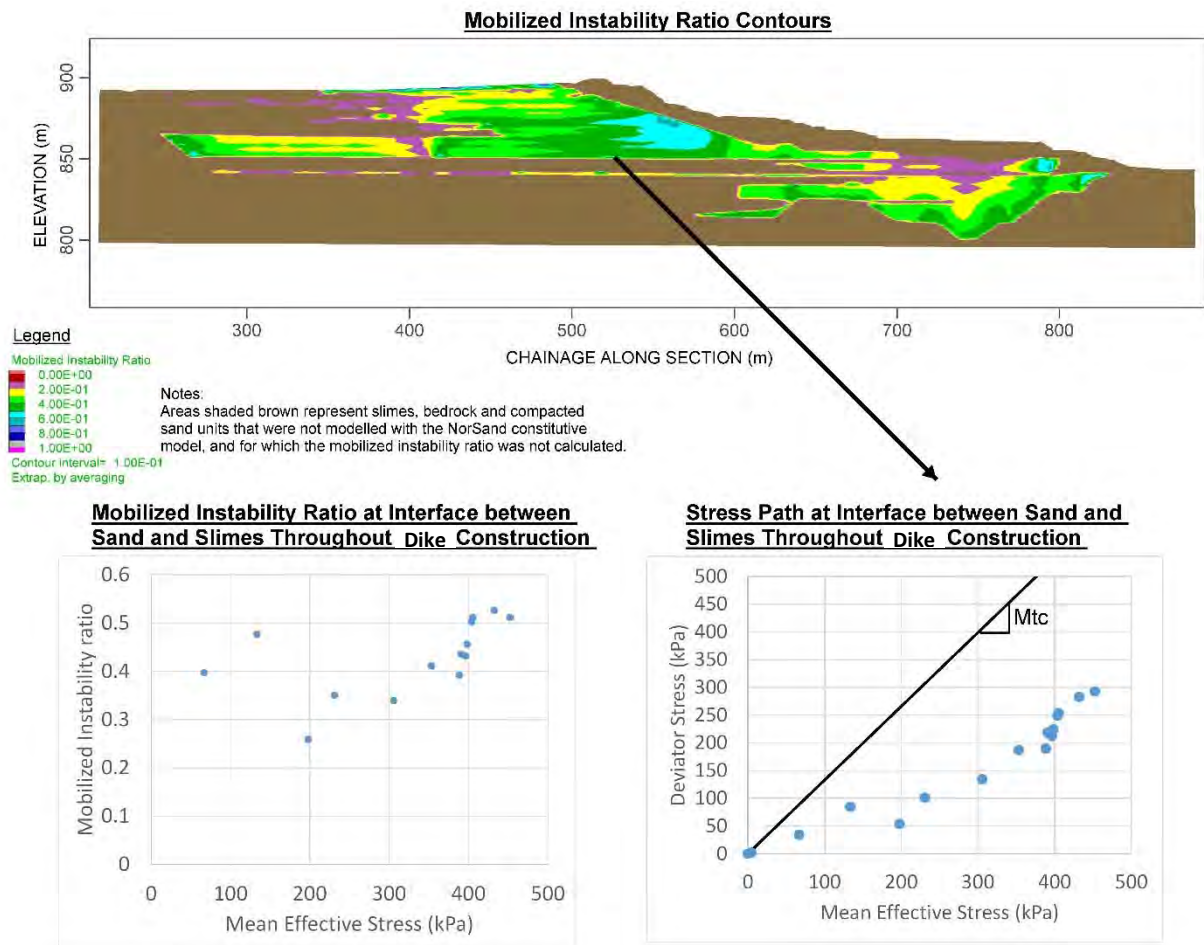
Figure I3-21 Mobilized instability ratio and stress path – continuous interbedded slimes model

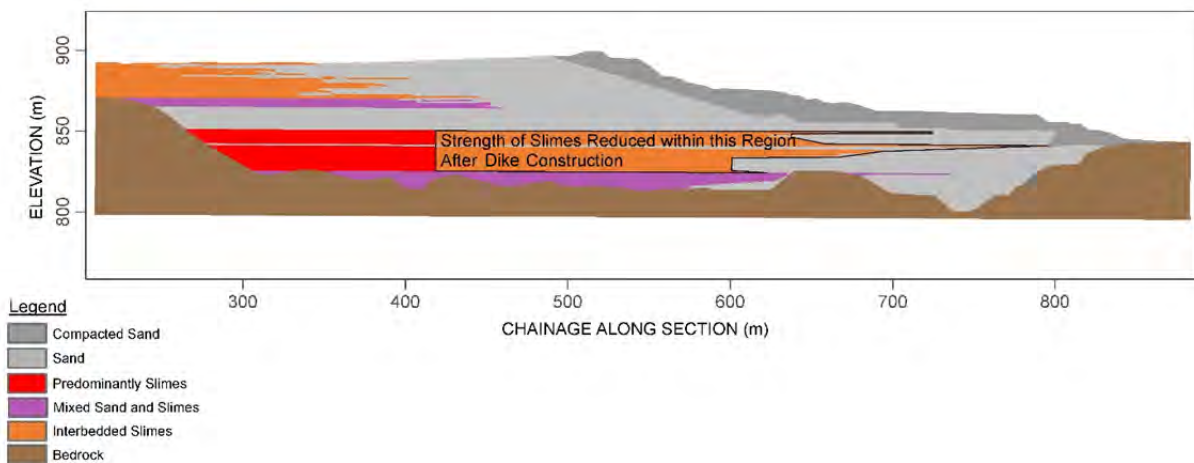
Having constructed the continuous interbedded slimes model to the November, 2015 model stage, this model was then used for a subsequent sensitivity analysis to assess how the strength of the slimes assigned to the interbedded slimes region was affecting the stress state of the overlying tailings sand. This analysis was completed as a separate stage to the previous model by incrementally reducing the strength of the slimes in the region shown on Figure I3-22 and then examining the stresses and deformations within the model. As noted previously, this reflects the sensitivity of the slimes.

Figure I3-22 Illustration of zone of slimes strength reduction

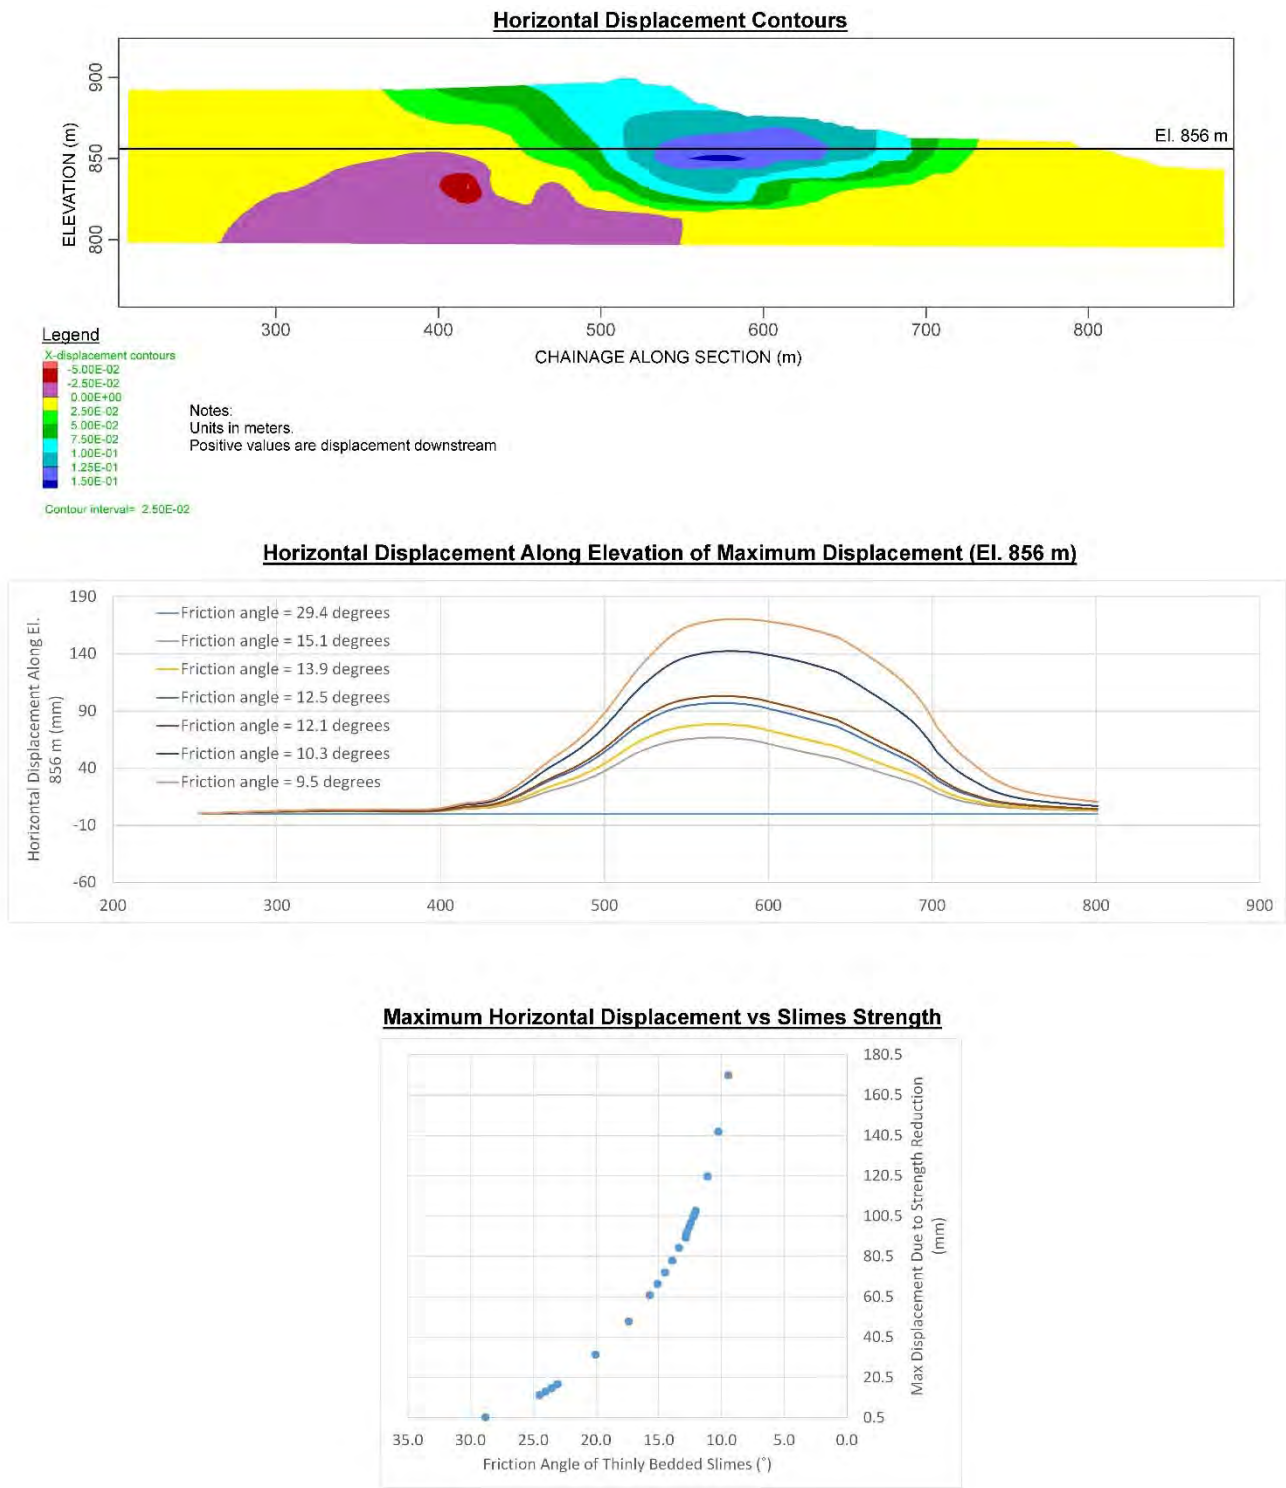
It was possible to reduce the strength of the slimes in this region to a friction angle of 9.5° before numerical convergence issues prevented the model from proceeding. The results shown on Figure I3-23 illustrate how this strength reduction led to 170 mm of additional displacement (lateral extrusion) downstream of the dike crest. Figure I3-24 shows that this lateral extrusion movement within the slimes has an effect of reducing the stress in the overlying tailings sand in a manner that is very similar to the stress path followed during the stress controlled extrusion-collapse laboratory tests (see Figure I3-5). The maximum mobilized instability ratio calculated during this analysis was approximately 0.8, compared with 0.5 calculated in the earlier analyses. This reduced slimes strength is within the range of parameters initially considered as reasonable for the predominantly slimes layers; therefore, it would not be unreasonable to think that this strength could be mobilized anywhere within the slimes mass, should sufficient continuity exist.

Figure I3-23 Displacements due to slimes strength reduction

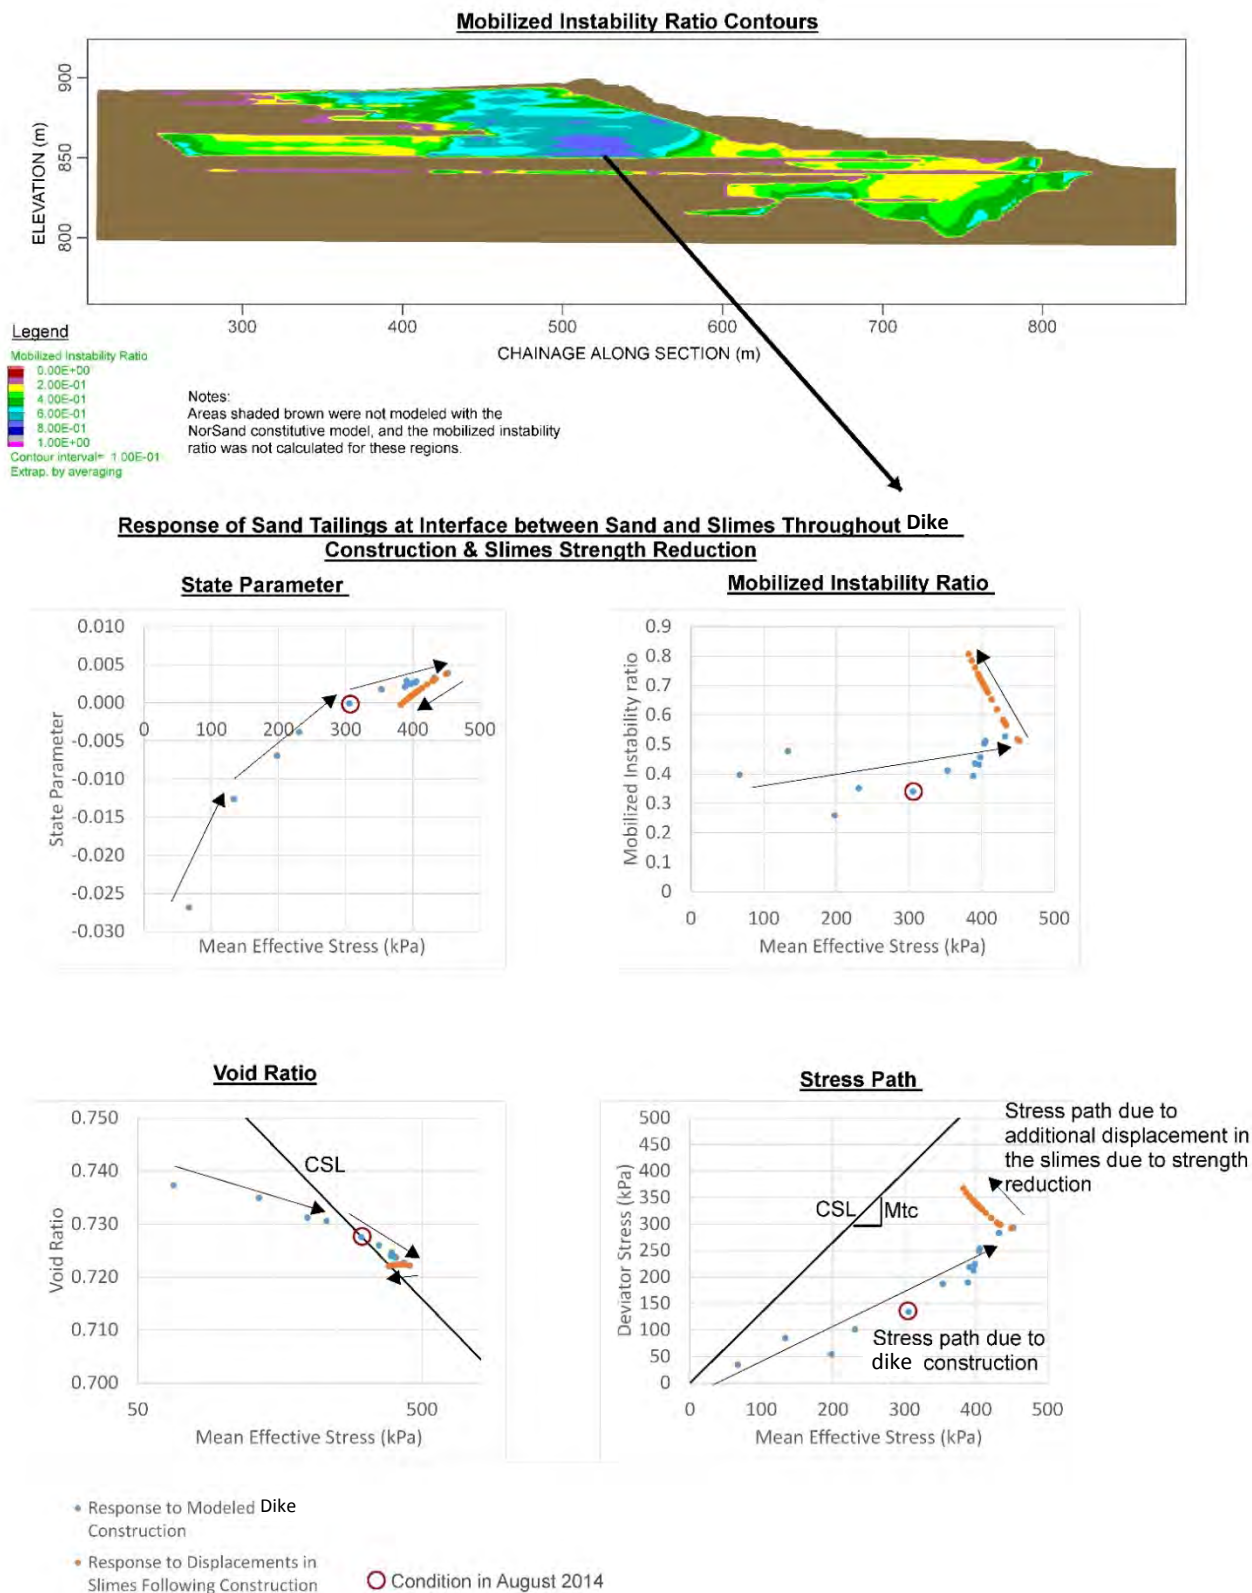
Figure I3-24 Mobilized instability ratio and stress path due to slimes strength reduction

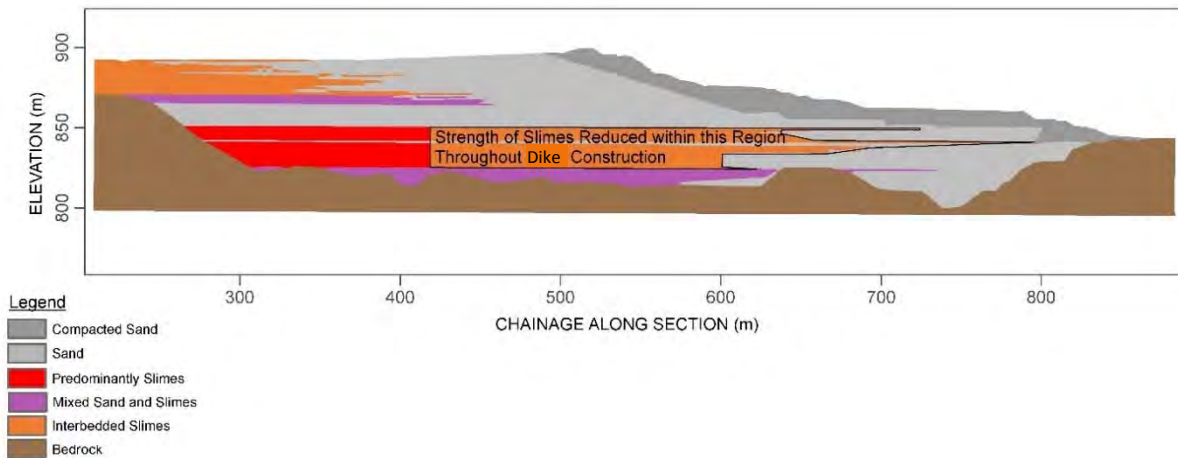
Having identified a slimes strength that leads to a stress state in the overlying sand approaching that at which rapid instability was observed in the laboratory tests, an additional sensitivity analysis was completed to identify how the response of the dike would differ if this strength was operative throughout the entire dam construction sequence, as shown on Figure I3-25.

Figure I3-25 Updated model geometry incorporating continuous interbedded slimes with reduced strength

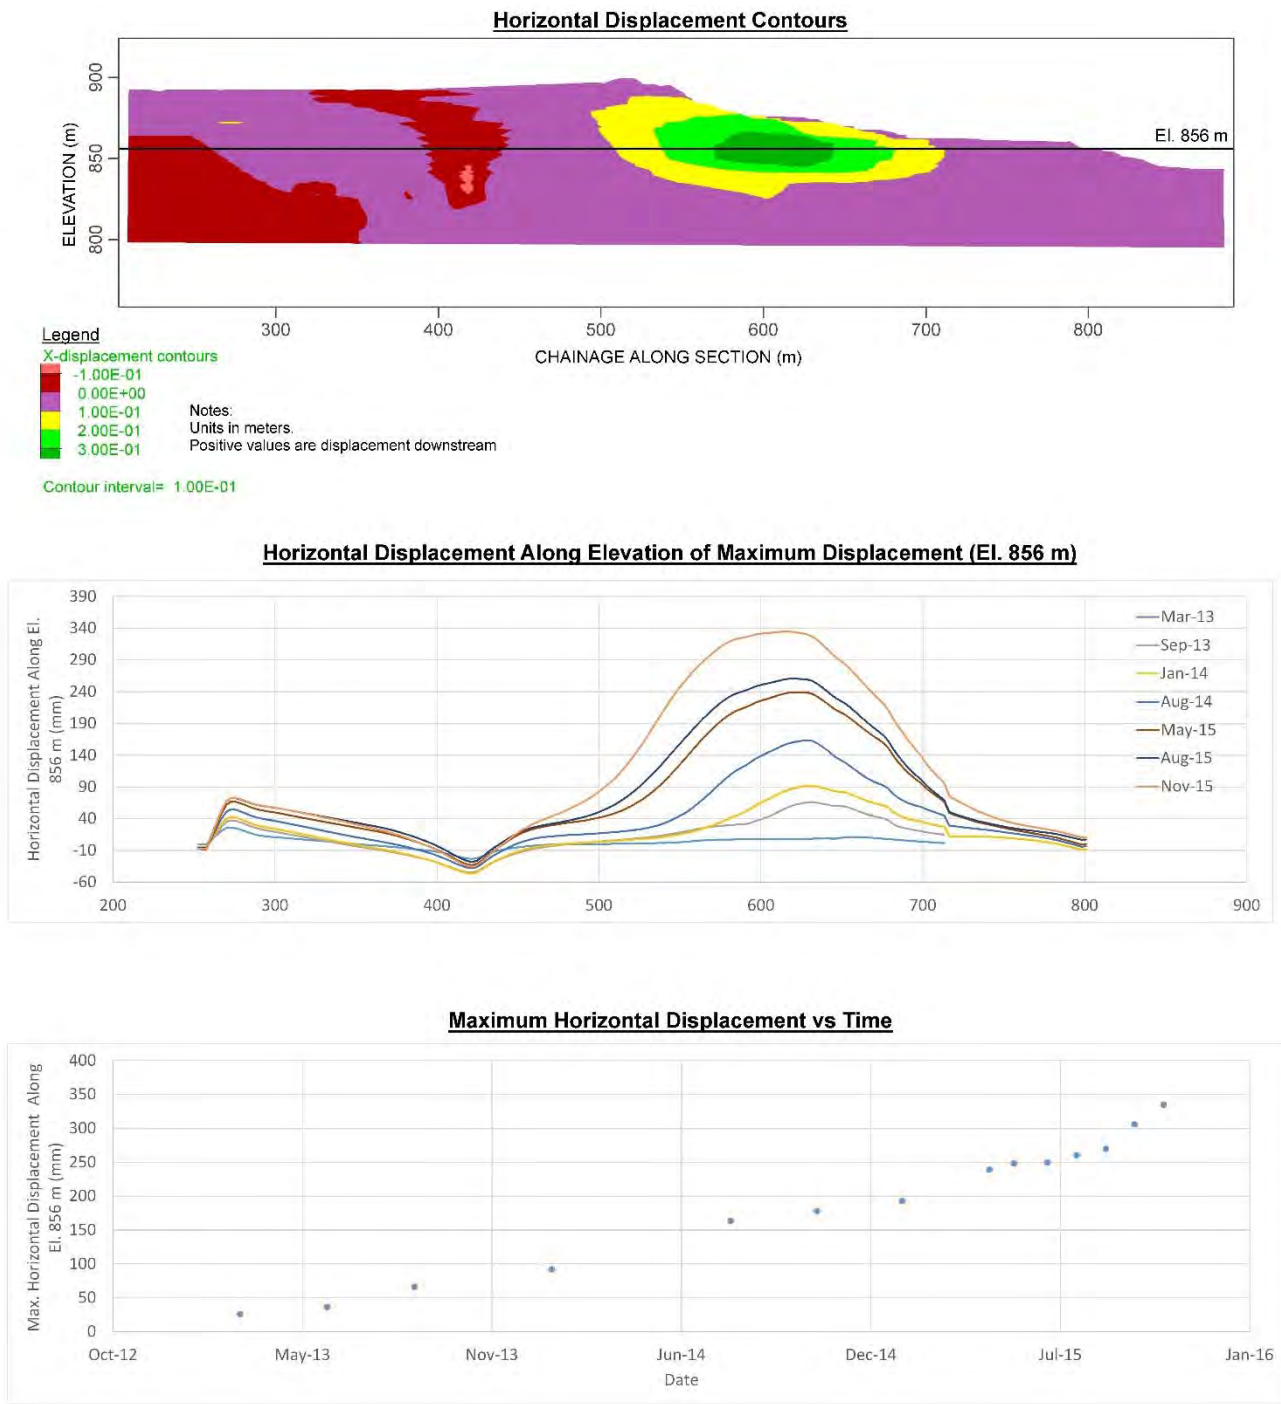
Figure I3-26 shows that imposing a friction angle of 9.5° on the interbedded slimes region beneath and downstream of the dike crest would, as expected, lead to a marked increase in displacements downstream of the dike crest at the November, 2015 model stage compared with earlier models. The maximum horizontal displacement from this analysis was 335 mm, compared with 142 mm in the analysis with base case strength parameters. This value is similar to the cumulative displacement of the analysis in which the strength of the slimes is reduced at the end of construction: $142 \text{ mm} + 170 \text{ mm} = 312 \text{ mm}$, versus 335 mm in this analysis. The overall pattern of displacement is similar to that observed in earlier model iterations in that the maximum displacements are concentrating in the same location downstream of the crest.

Figure I3-26 Horizontal displacement results – reduced strength continuous interbedded slimes model

It is of interest to note from Figure I3-26 and Figure I3-27 that if this slimes strength was operative throughout the dike construction history, the model suggests that an increase in displacement rate would be expected prior to the August, 2014 event, leading to a cumulative displacement of roughly 163 mm. However, even with this magnitude of movement, the lateral extrusion process would still not be sufficiently advanced to place the sand tailings in an unstable stress state at this stage in the dam's construction history. This, and observations from model variants discussed previously, may provide an explanation for a contributing feature to the timing of the August, 2014 event and the absence of a flowslide resulting from this incident.

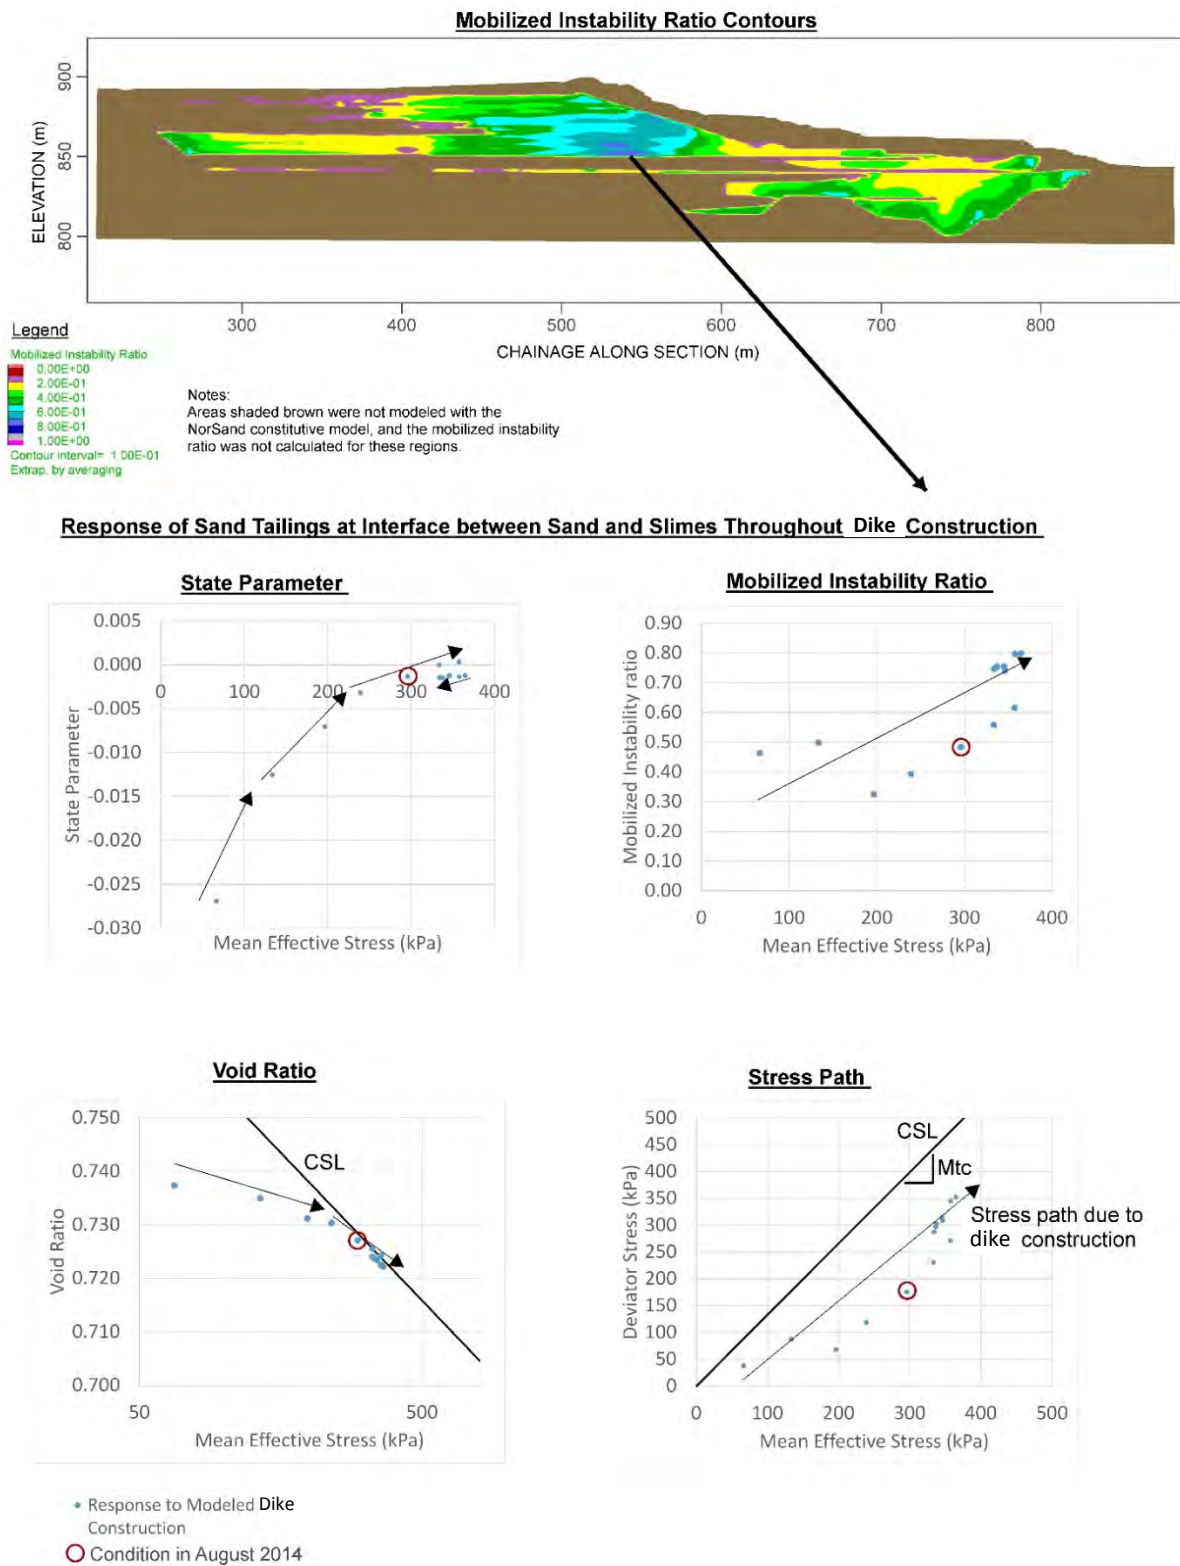
Figure I3-27 shows that the additional displacements due to the reduced slimes strength throughout the dike construction would lead the stress state of the tailings sand overlying the slimes to a similar mobilized instability ratio, as was observed when the slimes strength was reduced at the end of the dike construction (0.8). This implies that whether extrusion through the slimes was occurring continuously or in isolated incidents, the effect would be to drive the stress state of the sand into a potentially unstable condition.

If the volumetric response of the sand is reviewed using the e - $\log p'$ plot on Figure I3-27, it can be seen that the model suggests a relatively consistent trend of incremental volumetric strain throughout the dike construction. Unlike the collapse tests in the published literature completed by Skopek et al. (1994), no sudden change of volumetric behavior was observed in the simulation. Therefore, the assumptions of sustained drained conditions in the sand within the analysis is supported.

Figure I3-27 Mobilized instability ratio and stress path – reduced strength continuous interbedded slimes model

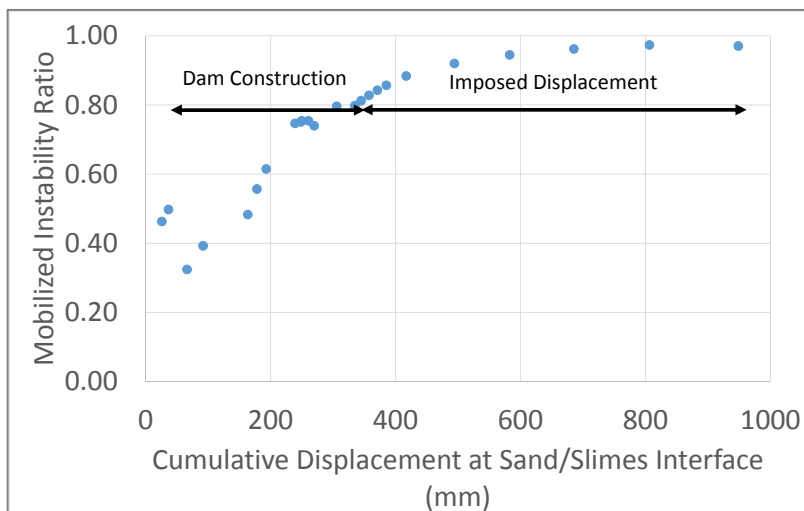
The results shown on Figure I3-28 and Figure I3-29 show that additional extrusion within the slimes layer would ultimately lead the stress state of the overlying tailings to a similar condition as that at which rapid failure was observed in our laboratory tests. These figures show that a mobilized instability ratio of approximately 1 would be approached at roughly 600 mm of cumulative horizontal displacement. Therefore, this is the magnitude of displacement required to trigger liquefaction due to lateral extrusion.

Figure I3-28 Mobilized instability ratio development with displacement at the sand/slimes interface

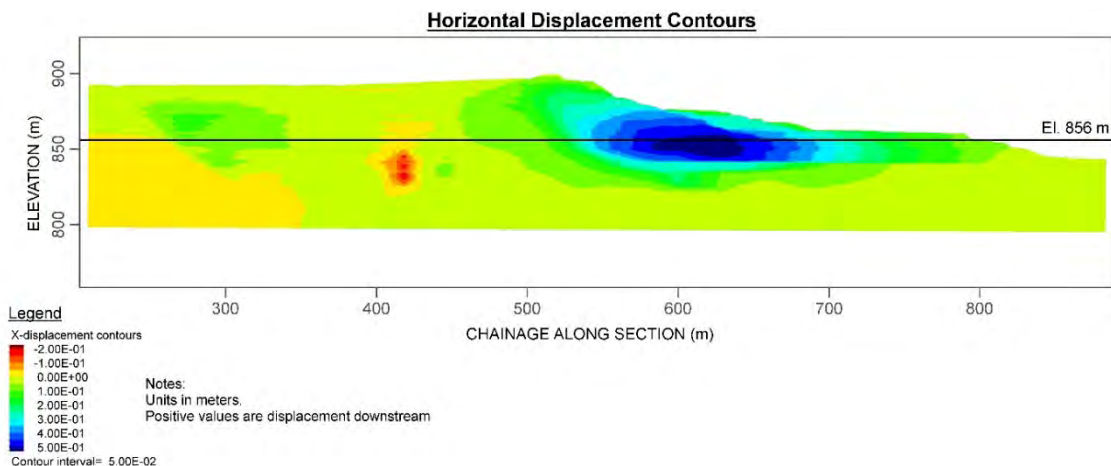
The pattern of displacements resulting in November, 2015 if an undrained strength ratio of 0.13 (equivalent friction angle 7.5°) was mobilized in the slimes is shown on Figure I3-30. The pattern of displacements is similar to that shown previously for the NorSand model analyses.

Figure I3-30 Horizontal displacements resulting from Mohr-Coulomb analysis with mobilized shear strength ratio of 0.13 (equivalent friction angle of 7.5°)

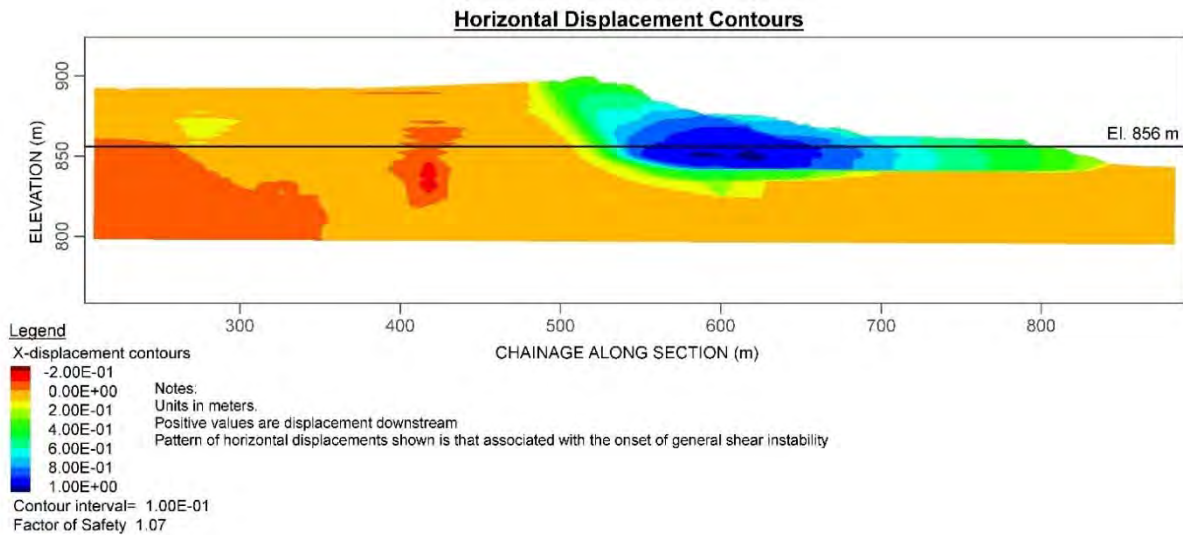
The factor of safety calculated using FLAC with an undrained strength ratio of 0.13 assigned to the slimes-rich layers is 1.07, as shown on Figure I3-31.

Figure I3-31 Factor of safety results calculated using FLAC with mobilized shear strength ratio of 0.13 (equivalent friction angle of 7.5°)

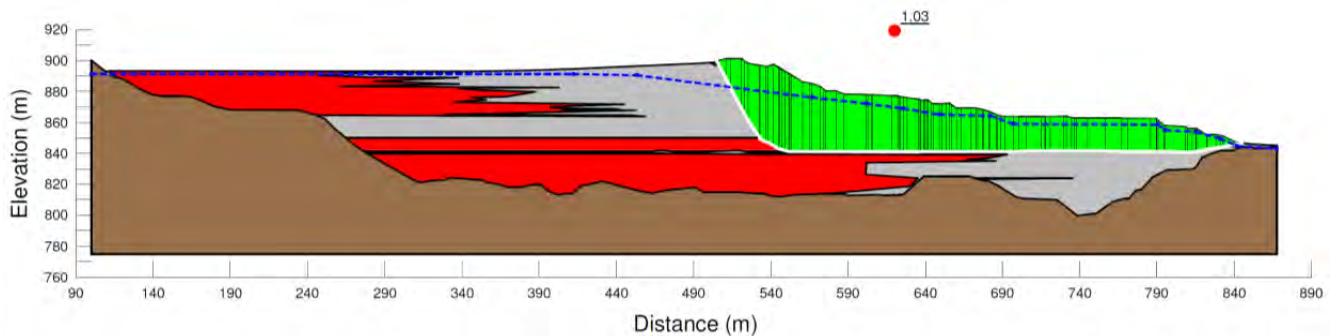
The factor of safety calculated using FLAC is similar to that calculated using limit equilibrium methods (see Figure I3-32).

Figure I3-32 Limit equilibrium analysis for comparison with FLAC analysis

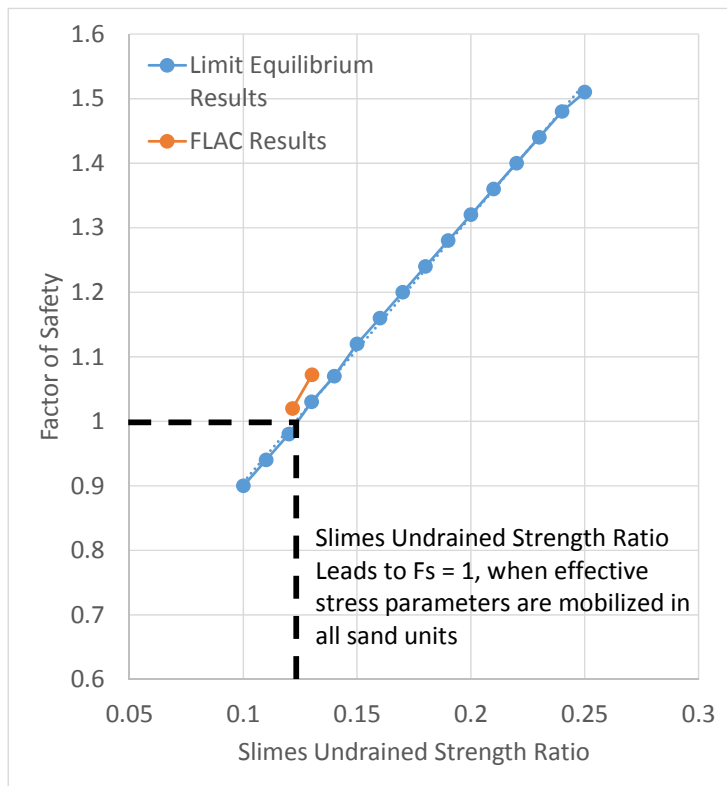
The equivalence between the FLAC and limit equilibrium analyses was also checked with an undrained strength ratio of 0.12, with both methods indicating that a factor of safety of 1 would be reached at this strength (see Figure I3-33).

Figure I3-33 Comparison of trends in FLAC and limit equilibrium factor of safety analysis results

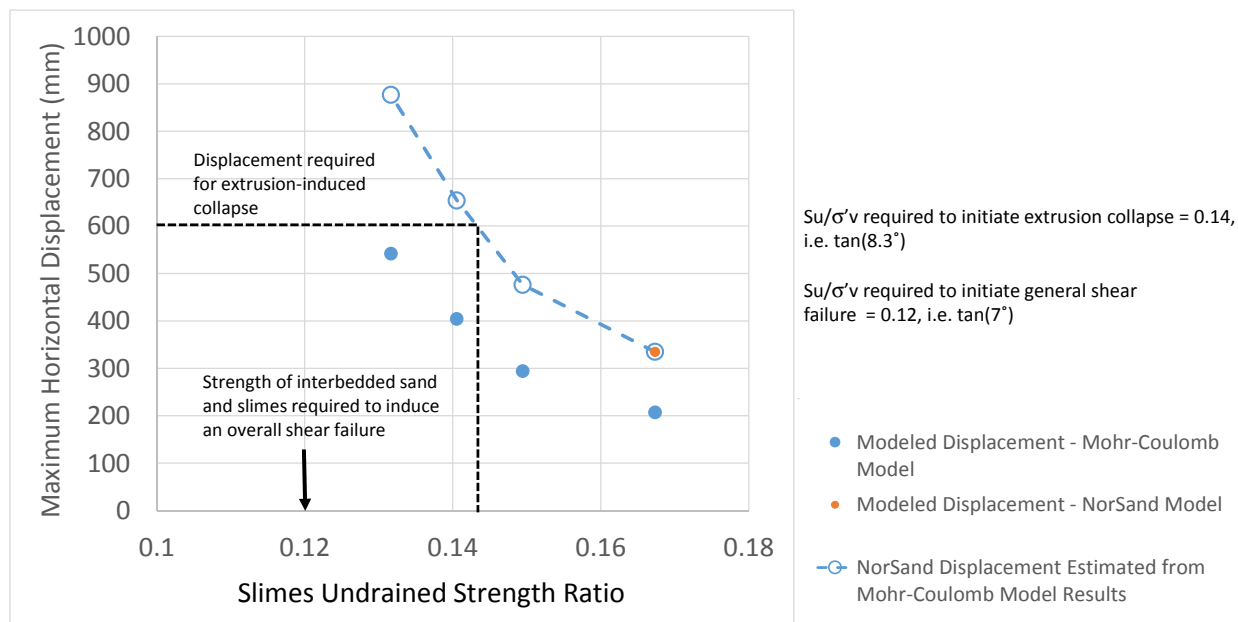
The trend of displacements associated with the various levels of strength mobilization in the slimes-rich deposits considered in the deformation analyses are shown for comparison with the displacements required to initiate extrusion-induced collapse on Figure I3-34. As discussed previously (Section I3.2.2), the Mohr-Coulomb analysis underestimates the displacements calculated by the NorSand model due to the increased ductility of the sand assumed within the NorSand formulation. Therefore, to estimate the levels of deformation that would result from the NorSand analysis with continued reduction in slimes strength below the limiting strength ratio value (0.17 – equivalent friction angle of 9.5°) reached in the NorSand analysis, the results of the Mohr-Coulomb analysis have been factored in accordance with the ratio of Mohr-Coulomb and NorSand-based results at a common undrained strength ratio of 0.17.

Figure I3-34 Comparison of displacements necessary to initiate extrusion-induced collapse and those associated with the onset of general shear failure

The outcome of this comparison between the conditions needed to generate liquefaction from lateral extrusion of the slimes-rich layers versus those needed to initiate general shear failure, illustrated on Figure I3-34, show that liquefaction would be more likely to occur due to lateral extrusion than general shear. The estimated undrained strength ratio of the slimes-rich layers required to develop the displacements necessary to trigger liquefaction due to the lateral extrusion mechanism is approximately 0.14. It is of interest to note that our estimate of the large-strain strength of the slimes-rich layers at the 2005 Baía 4 failure at Germano Dam was also approximately 0.14 (see Appendix C).
