Fundão Tailings Dam Review Panel

Report on the Immediate Causes of the Failure of the Fundão Dam

EXECUTIVE SUMMARY

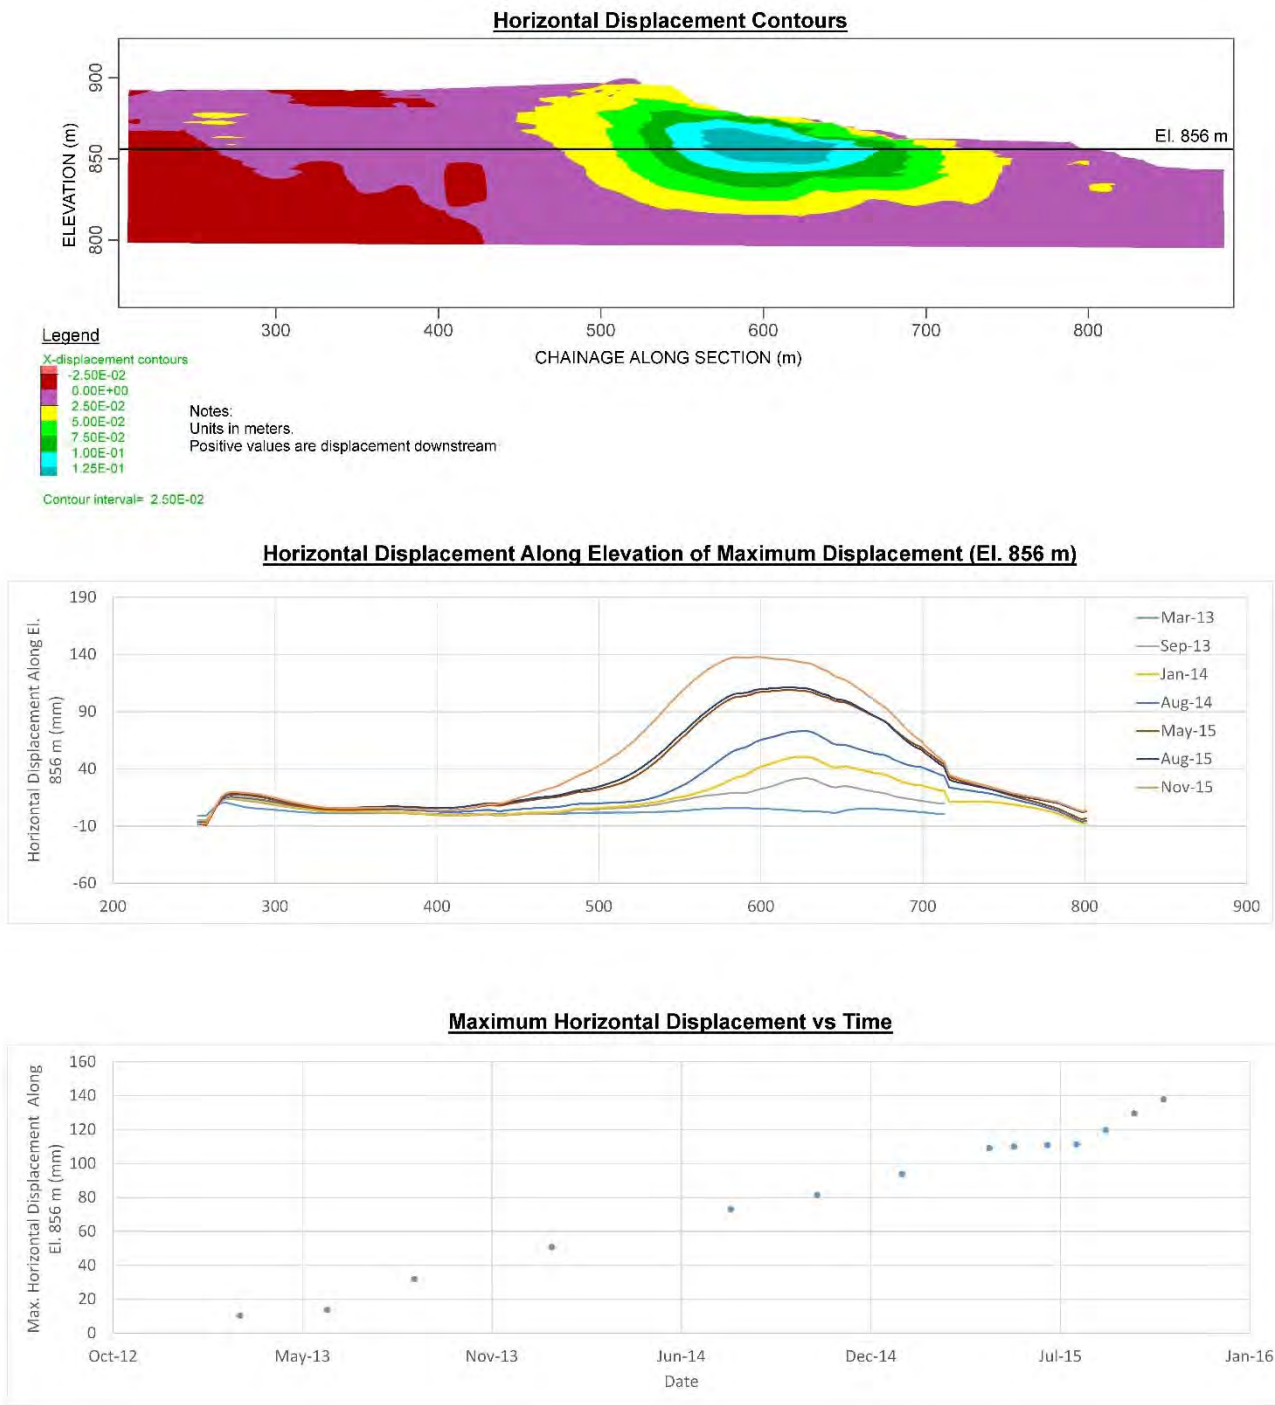
The results of this analysis shown on Figure I3-35 and Figure I3-36 illustrate how the response of the dam would be similar to that discussed earlier for the base case NorSand analysis if slimes did not exist within the left abutment region. As a result, the mobilized instability ratio of the model without slimes included in the left abutment would be in the order of 0.5, insufficient to trigger liquefaction.

Figure I3-35 Horizontal displacement results – no slimes model

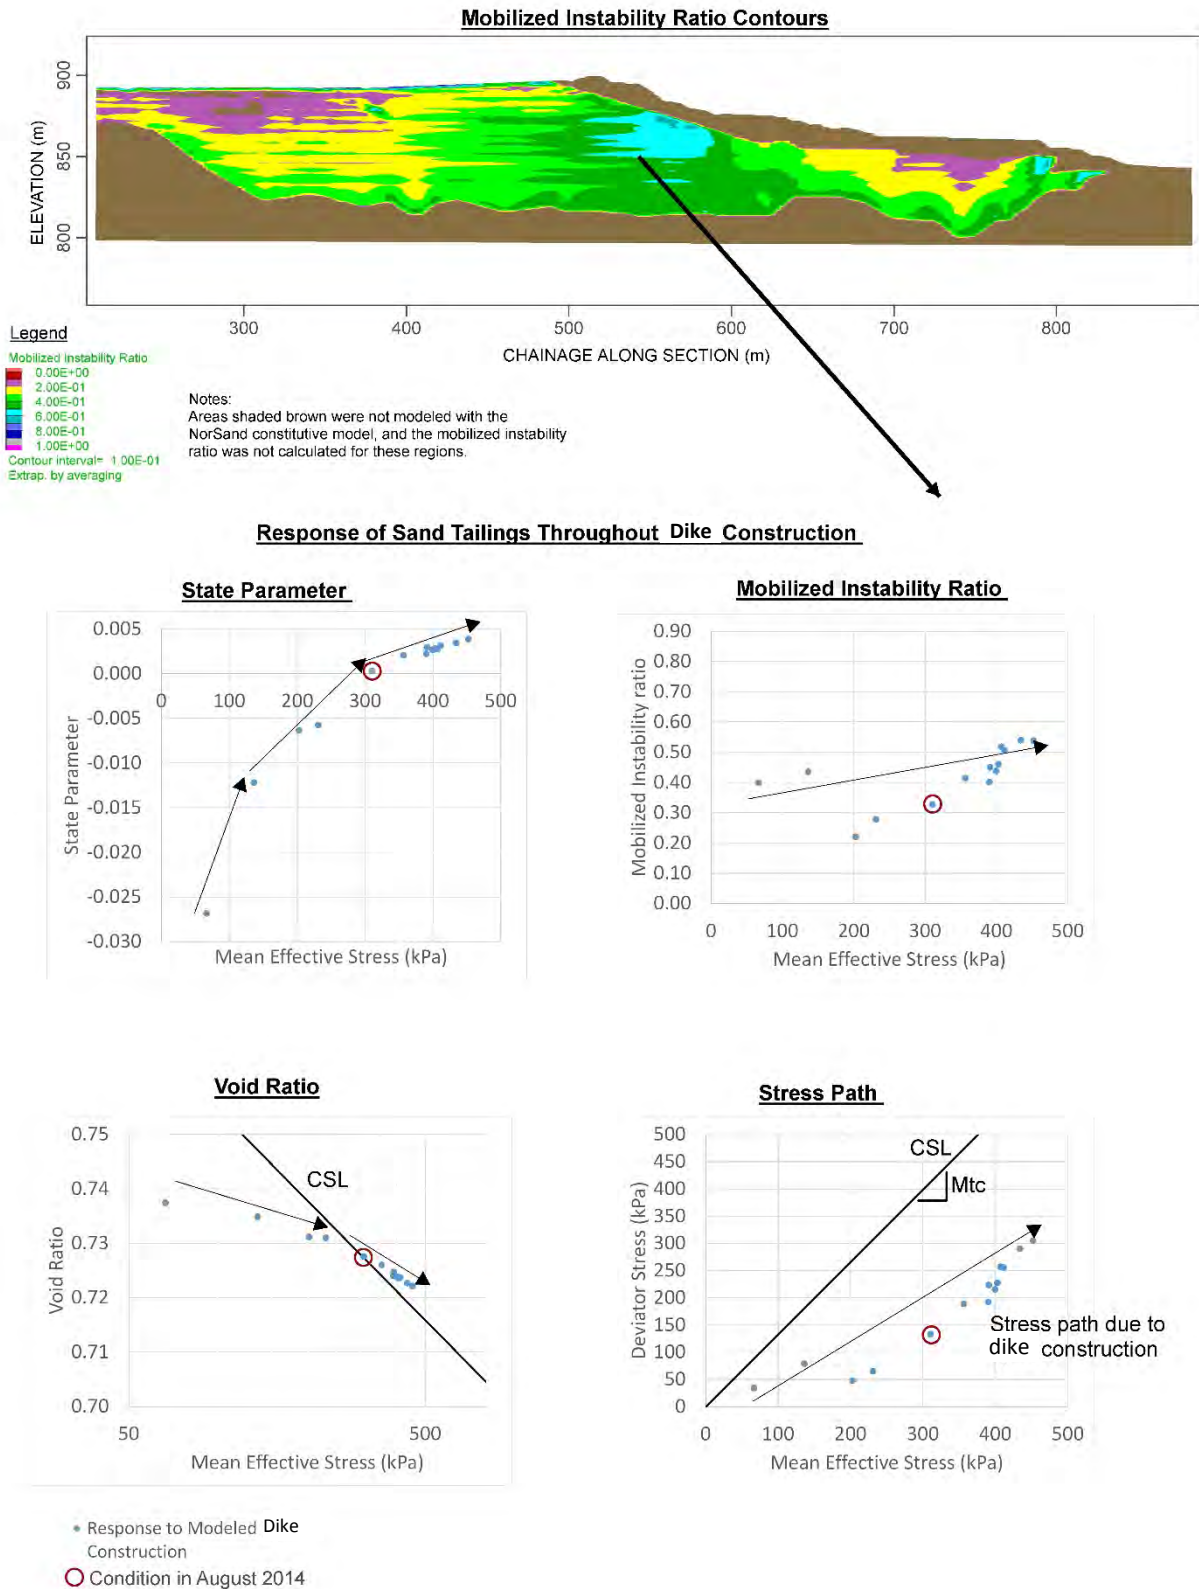
Figure I3-36 Mobilized instability ratio and stress path – no slimes model

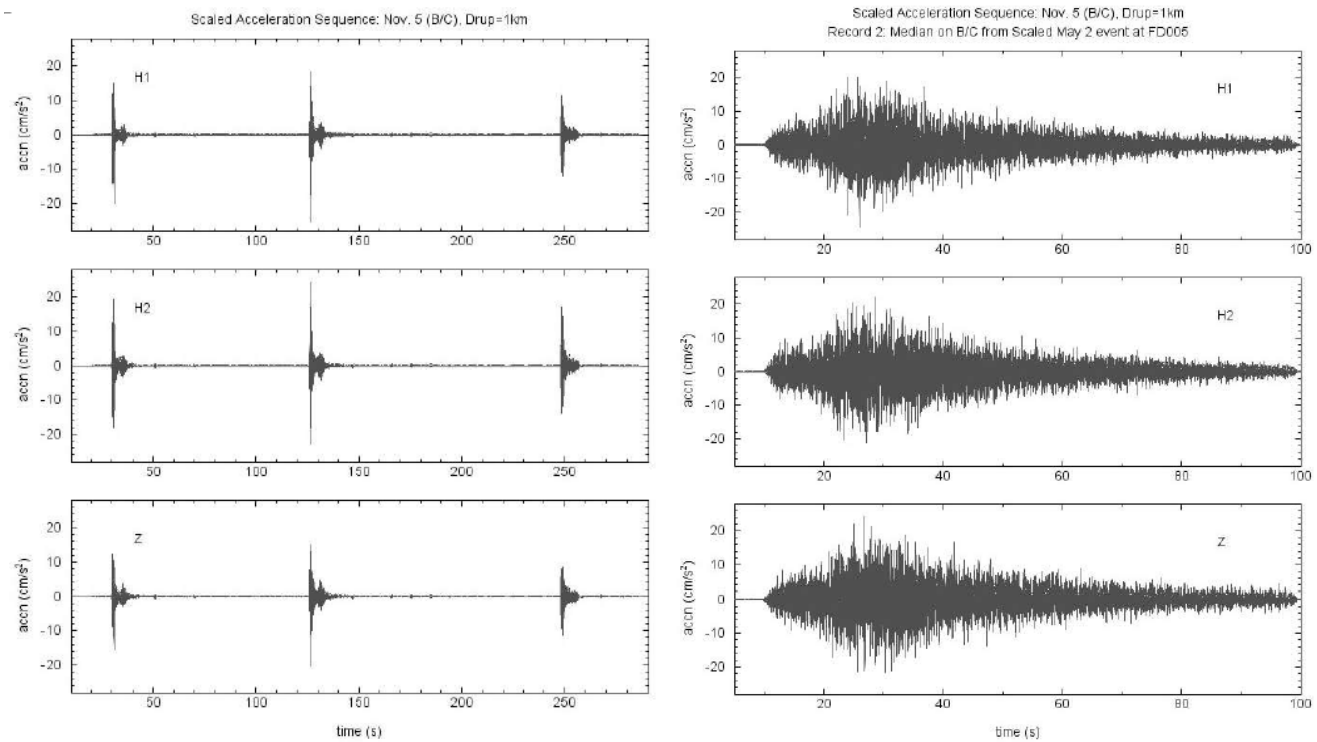
Figure J2-1 shows the two sets of median-level time histories provided by Atkinson (2016). The BC1 time histories contained the estimated foreshock, mainshock and aftershock sequence of November 5, 2015, whereas the alternative BC2 time histories were scaled up from a M3 earthquake that occurred about 70 km west of Samarco on May 2, 2016, and was recorded on the Nanometrics local array. Note the very long duration of the BC2 ground motion due to its original recording at 70 km distance from Samarco. As noted by Atkinson (2016), the BC2 time history sequence was intended to represent a composite of the foreshock-mainshock-aftershock events of November 5. Even so, the duration of the BC2 record is expected to be longer than the combined duration expected of the November 5, 2015 earthquake sequence.

Figure J2-1 Estimated time histories of November 5, 2015 earthquakes from Atkinson (2016). (BC1 median-level motions on left; BC2 median-level motions on right)

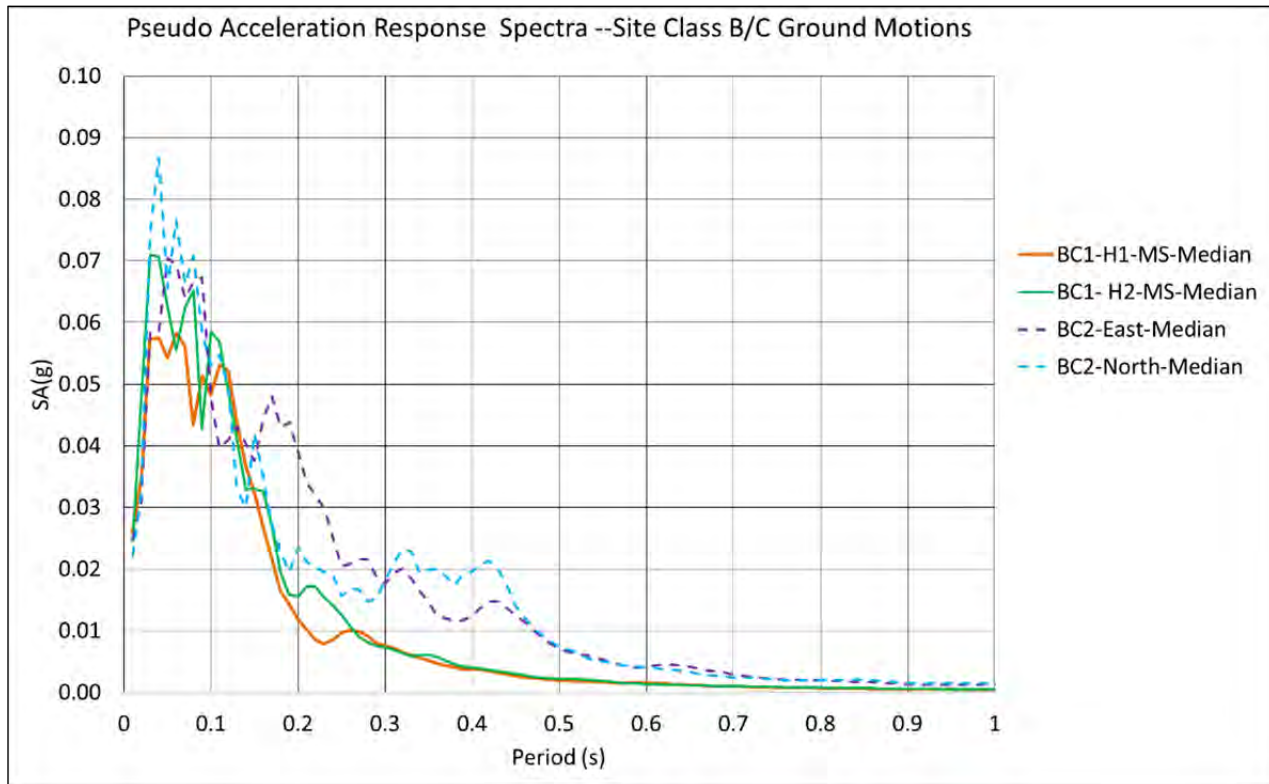
Figure J2-2 shows the response spectra of the BC1 (mainshock) and alternative BC2 median ground motions, for both horizontal components. As shown, the BC2 records are generally larger in amplitudes across most of the periods of interest (or frequencies) than the BC1 records.

Figure J2-2 Response spectra of BC1 (mainshock) and BC2 ground motions provided by Atkinson (2016)

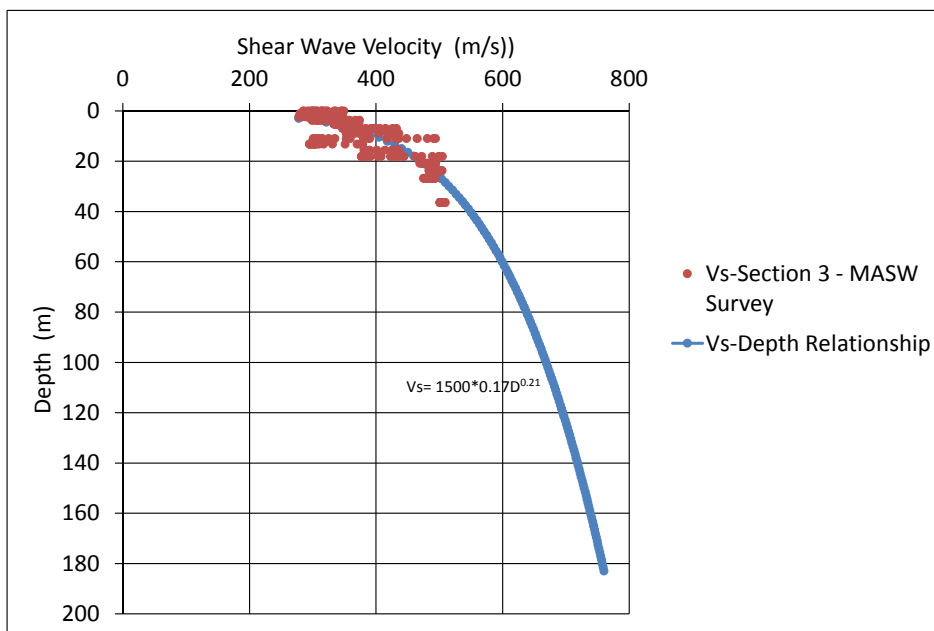
Figure J3-2 shows our estimated shear wave velocity (v_s) profile for the residual soil/weathered phyllite rock at the Samarco office. The v_s profile was estimated based on v_s measurements in the top 36 m depth from a geophysical survey (MASW survey conducted by AFC Geofisica Ltda., see June, 2016 report in Appendix C Attachment C3) and extrapolated to 180 m depth by gradually increasing v_s to a value of 760 m/s, based on a typical weathered rock profile in California for which extensive v_s measurements were available. The v_s value of 760 m/s at the base of the model corresponds to site class B/C soft rock conditions, for which the November 5, 2015 earthquake ground motions were developed by Atkinson (2016). The v_s value of the top 30 m (v_{s30}) of the weathered rock profile is about 350 m/s, which corresponds to site class C/D stiff soil condition near the surface.

Figure J3-2 Shear wave velocity data in weathered phyllite at Samarco office site

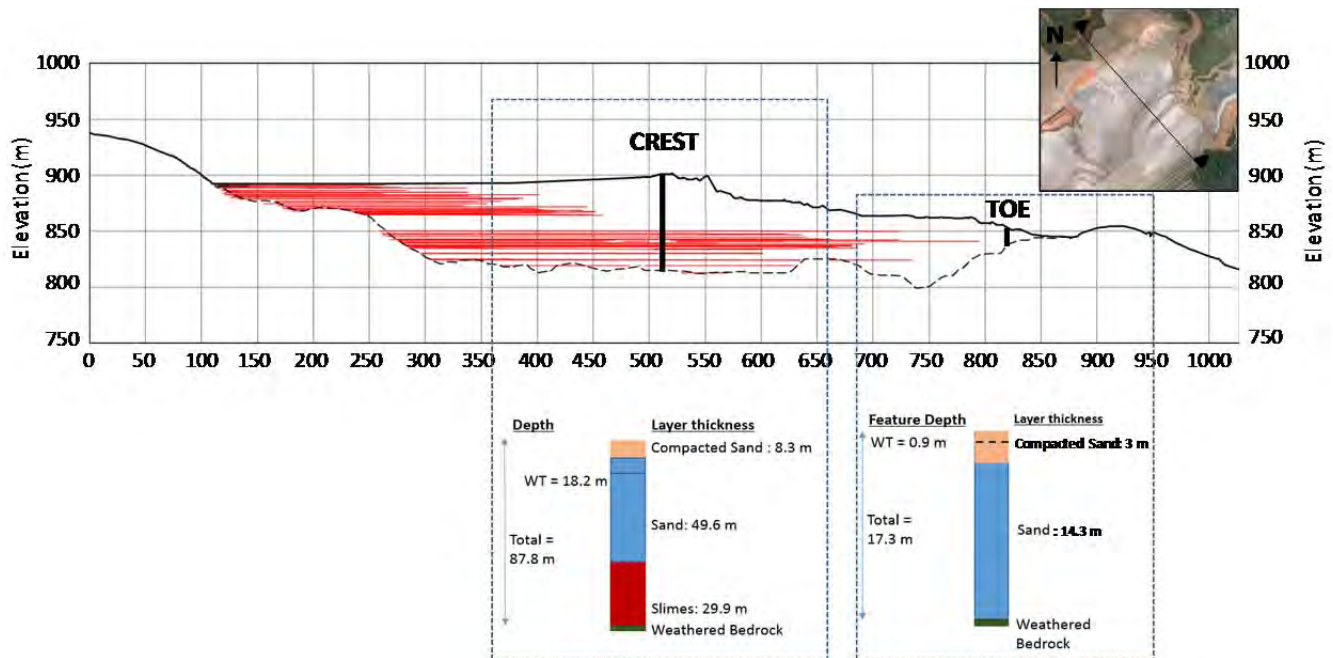
At the Fundão tailings dam, we modeled a typical soil profile at the crest of the dam and one at the toe. Figure J3-3 illustrates these two soil columns relative to a cross-section of the dam. The crest soil column is 88 m deep, consisting of a surface layer of compacted sand, overlying uncompacted tailings sands and slimes. The toe soil column is 17 m deep and comprises compacted sand overlying only sand tailings. Both soil columns overlie weathered phyllite (C/D soft rock condition) at the original ground surface.

Figure J3-3 Selected soil columns at Fundão Dam for 1D site response analysis

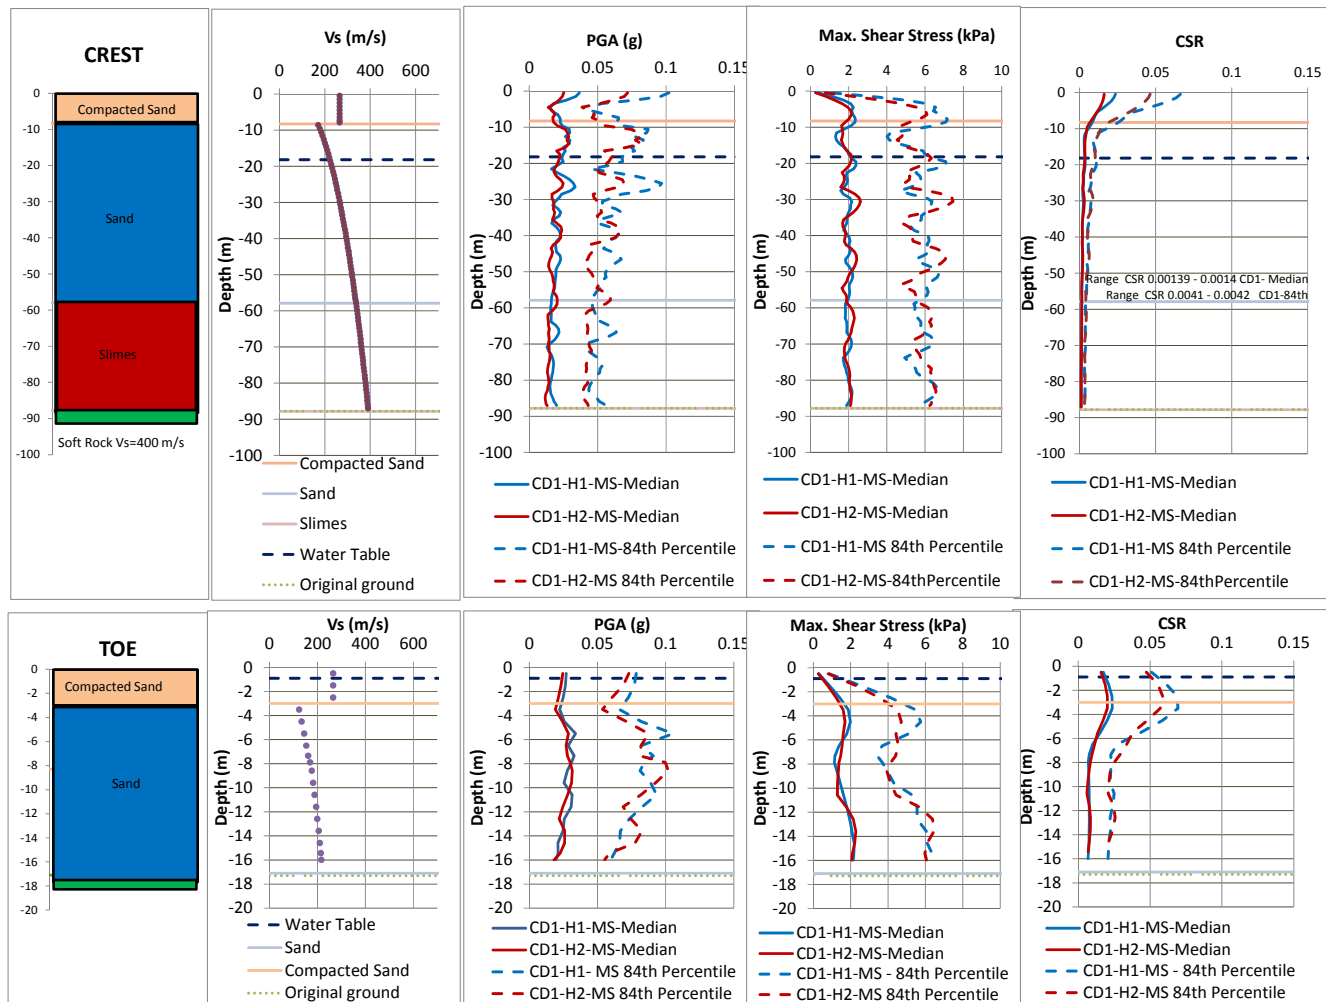
Figure J4-3 Results of SHAKE analyses for crest and toe soil columns at Fundão Dam

As shown on Figure J4-3 for the crest soil column, the estimated CSR in the sand near the top of the slimes deposit at 58 m depth is about 0.0014 for the median ground motion and 0.004 for the 84th percentile ground motion. The estimated number of equivalent uniform cycles of the irregular shear stress time histories extracted at the sand-slimes interface is about 6 to 8. This information was used for the laboratory cyclic testing described in Appendix D, and discussed further in Section J5.

The higher cyclic loads calculated close to the surface occur (Figure J4-3) in compacted material that would not be susceptible to liquefaction.

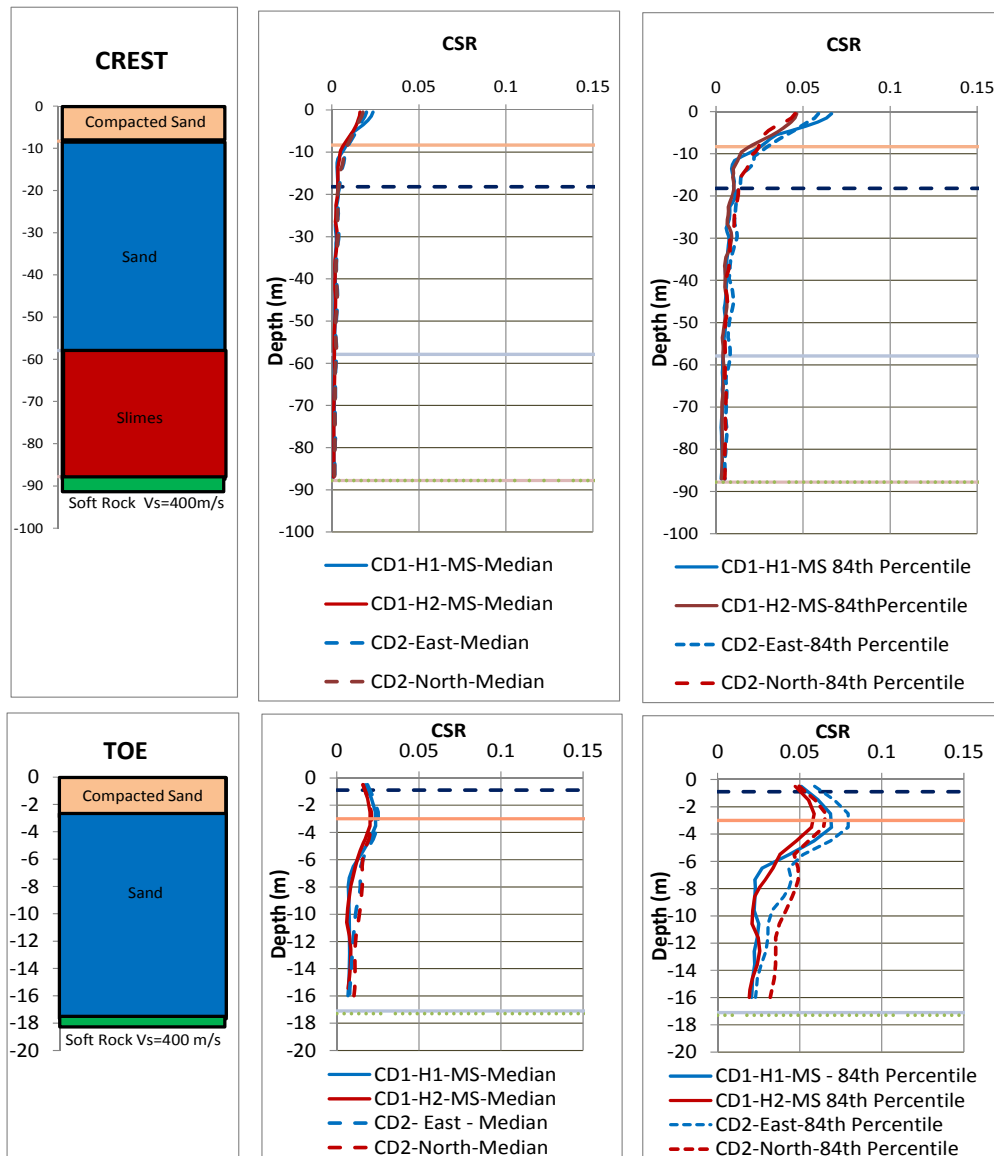
Figure J4-4 Comparison of cyclic stress ratios induced by CD1 and CD2 ground motions

For the crest and toe soil columns at Fundão Dam, we also ran SHAKE2000 analyses using the alternative CD2 input ground motions. The cyclic stress ratios induced by the CD2 time histories are compared to those from the CD1 time histories on Figure J4-4, for both median and 84th percentile horizontal ground motions. In general, the higher-amplitude alternative CD2 ground motions generated CSRs about 40% higher than those of the CD1 ground motions. Also, the earthquake-induced cyclic stresses at the toe soil column are higher than at the crest soil column, due to amplification of ground motions.

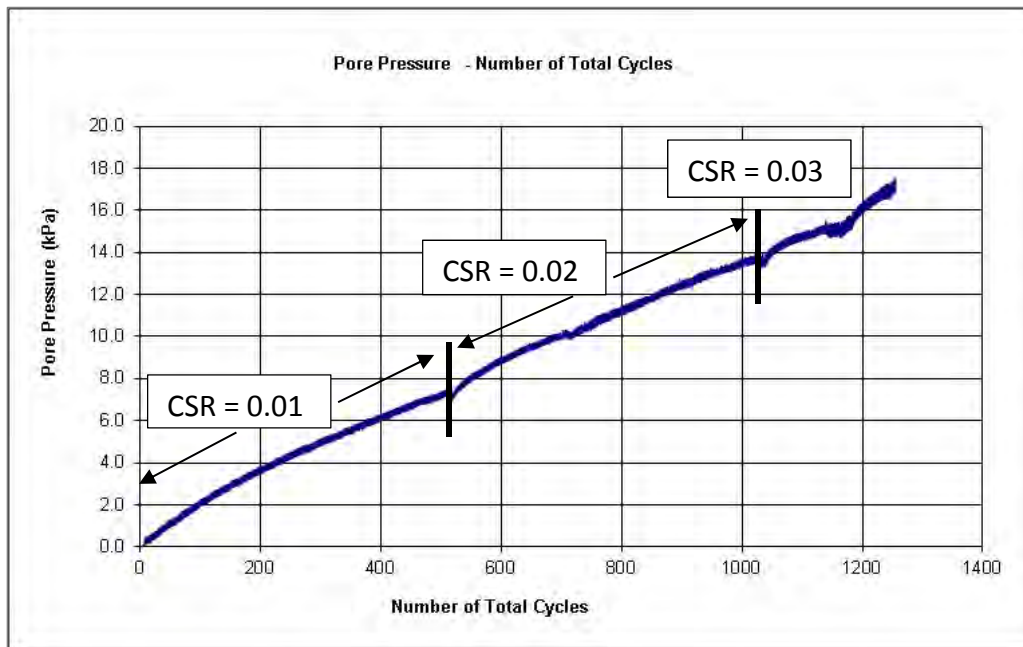
Figure J5-1 Pore pressure development in laboratory test following lateral extrusion mechanism and then cyclic loading (test ID TX-31) – very loose sample ($\psi=+0.05$)

The calculated ground motions are not sufficient to trigger seismic liquefaction under ordinary conditions; however, in light of the collapse behavior observed in the laboratory tests (see Appendix D), and the likelihood of similar stress conditions having developed in the field (see Appendix I), it was deemed necessary to assess whether these motions could induce collapse in an already fragile sample. This was investigated by completing an additional stress controlled extrusion collapse triaxial test. In this test (TX-31), a very loose sample ($\psi=+0.05$) was brought to a condition of incipient failure, identified by the axial strain response to an increment of unloading, before closing the drainage valves and then subjecting the sample to cyclic loading. We intended to apply the CSR

calculated at the sand/slimes interface beneath the crest, since that is the region of the dam cross section where the lateral extrusion mechanism would initiate static liquefaction. The cyclic loading calculated for the sand/slimes interface beneath the crest is a CSR of 0.001 to 0.004. It was not practical to apply such a low load in the laboratory testing; therefore, a CSR of 0.01 was applied. The sample did not fail under this load after applying 525 cycles. The load was increased to a CSR of 0.02 and cycled for a further 521 cycles. The sample still did not fail, so the CSR was increased to 0.03 and the sample failed after a further 209 cycles. Very little pore pressure was developed during the cyclic loading. This shows that the loading from the earthquake would be insufficient to induce liquefaction in even a very fragile sample. The results from this test are shown on Figure J5-1 and Figure J5-2. Refer to the cyclic direct simple shear tests shown in Appendix D for further examples of the insignificant effect that this level of shaking would have on pore pressure development in other samples of sand tested along an alternate stress path.

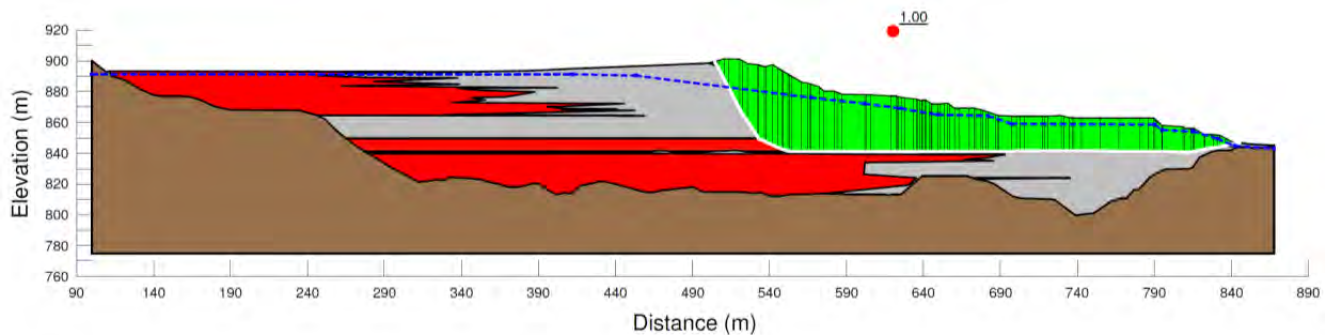
Figure J6-1 Calculation of yield acceleration for Newmark-type displacement analysis

The yield acceleration was calculated in this analysis for the cross section used in the deformation and stability analyses (Section 01 - see Appendices H and I) assuming that the dam was on the verge of collapse due to lateral extrusion. Consistent with this assumption, an s_u/σ'_v strength ratio of 0.14 was used in the calculations because this is the mobilized strength necessary to initiate liquefaction due to lateral extrusion (see Appendix I). The a_y value calculated in this analysis was 0.01 g.

Strengths: Slimes-Rich Layers = s_u/σ'_v (0.13); Sand = $\phi' = 33^\circ$; Compacted Sand = $\phi' = 35^\circ$ & $c' = 5$ kPa
Horizontal seismic coefficient = 0.01 g

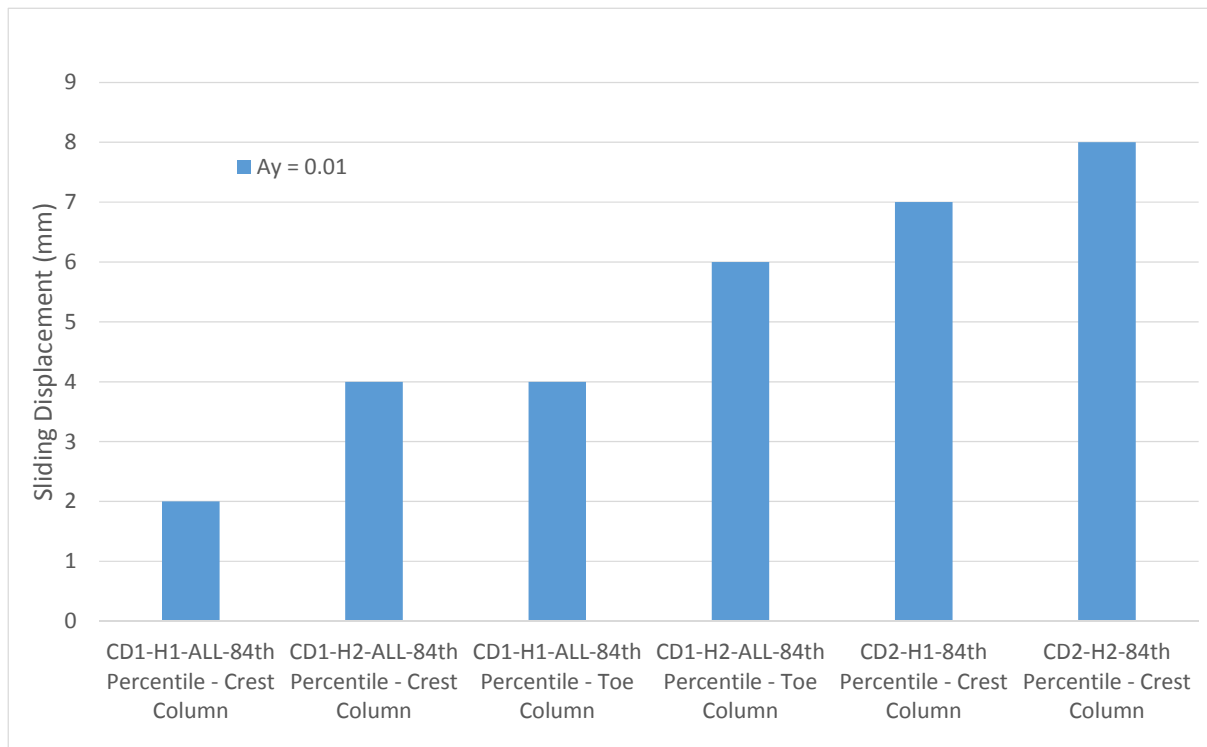
**Figure J6-2 Estimated displacements**

The results shown on Figure J6-2 indicate small displacements, ranging from 2 mm to 8 mm, with an average of 5 mm.

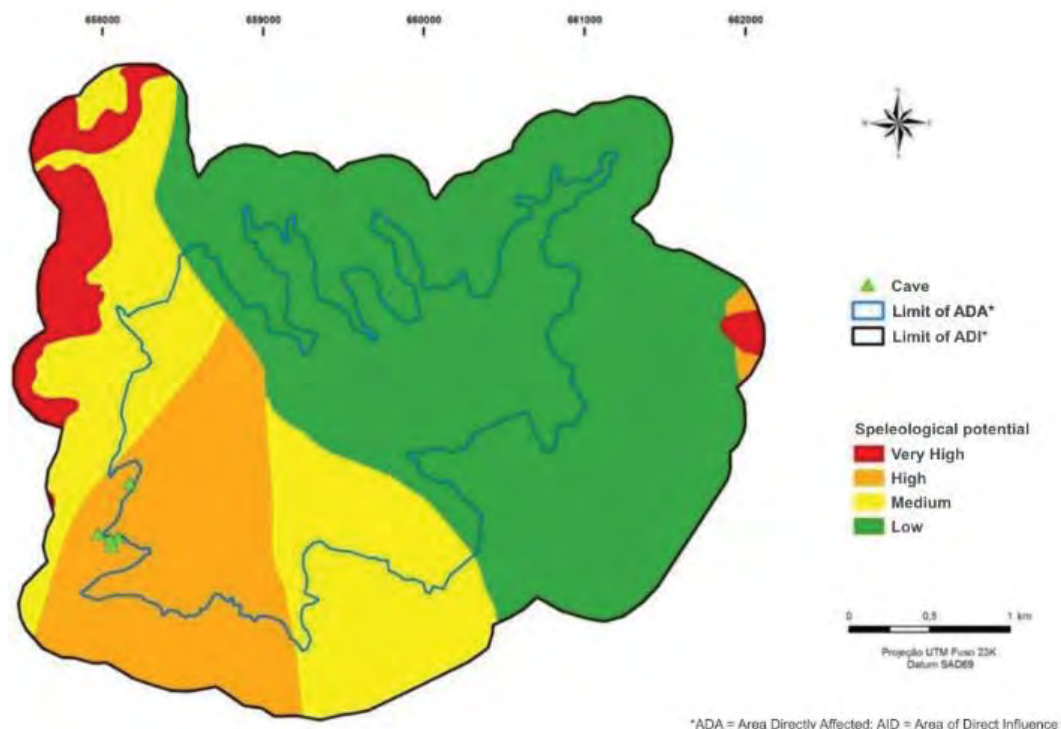
Figure 13 – Map of the prospected area around the Germano and Fundão Dams reflecting speleological potential. Source: Carste (2013-a).

Thus, Carste (2013-a) defined each lithotypes' speleological potential, divided by class and coverage area. In the very high potential speleological class are the iron formation and ferricrete, corresponding to 5% of the area directly affected. In the high potential speleological class is a mapped unit consisting of an association of quartzite with lenses of conglomerate and phyllites, relative to 18% of the area. In the middle potential speleological class are phyllites and conglomerates, with subordinate dolomites, quartzite and banded iron formation lenses. The lowest potential speleological class includes the metavolcanic rocks, schists and phyllites (**Figure 13**).

The region where the Fundão Dam is inserted was defined as of low speleologic potential. In the study, during the satellite images analysis stage, features of the defect types or structures with propensity to cavity formation were not identified in the lithotypes of the area (phyllites, shales, quartzites, among others).

In field survey phase, five caverns were identified in the southwestern part of the Germano Dam reservoir, above its maximum level. This corresponds to a high-potential area for karstic features, determined by the occurrence of quartzite rocks of the Itacolomi Group.

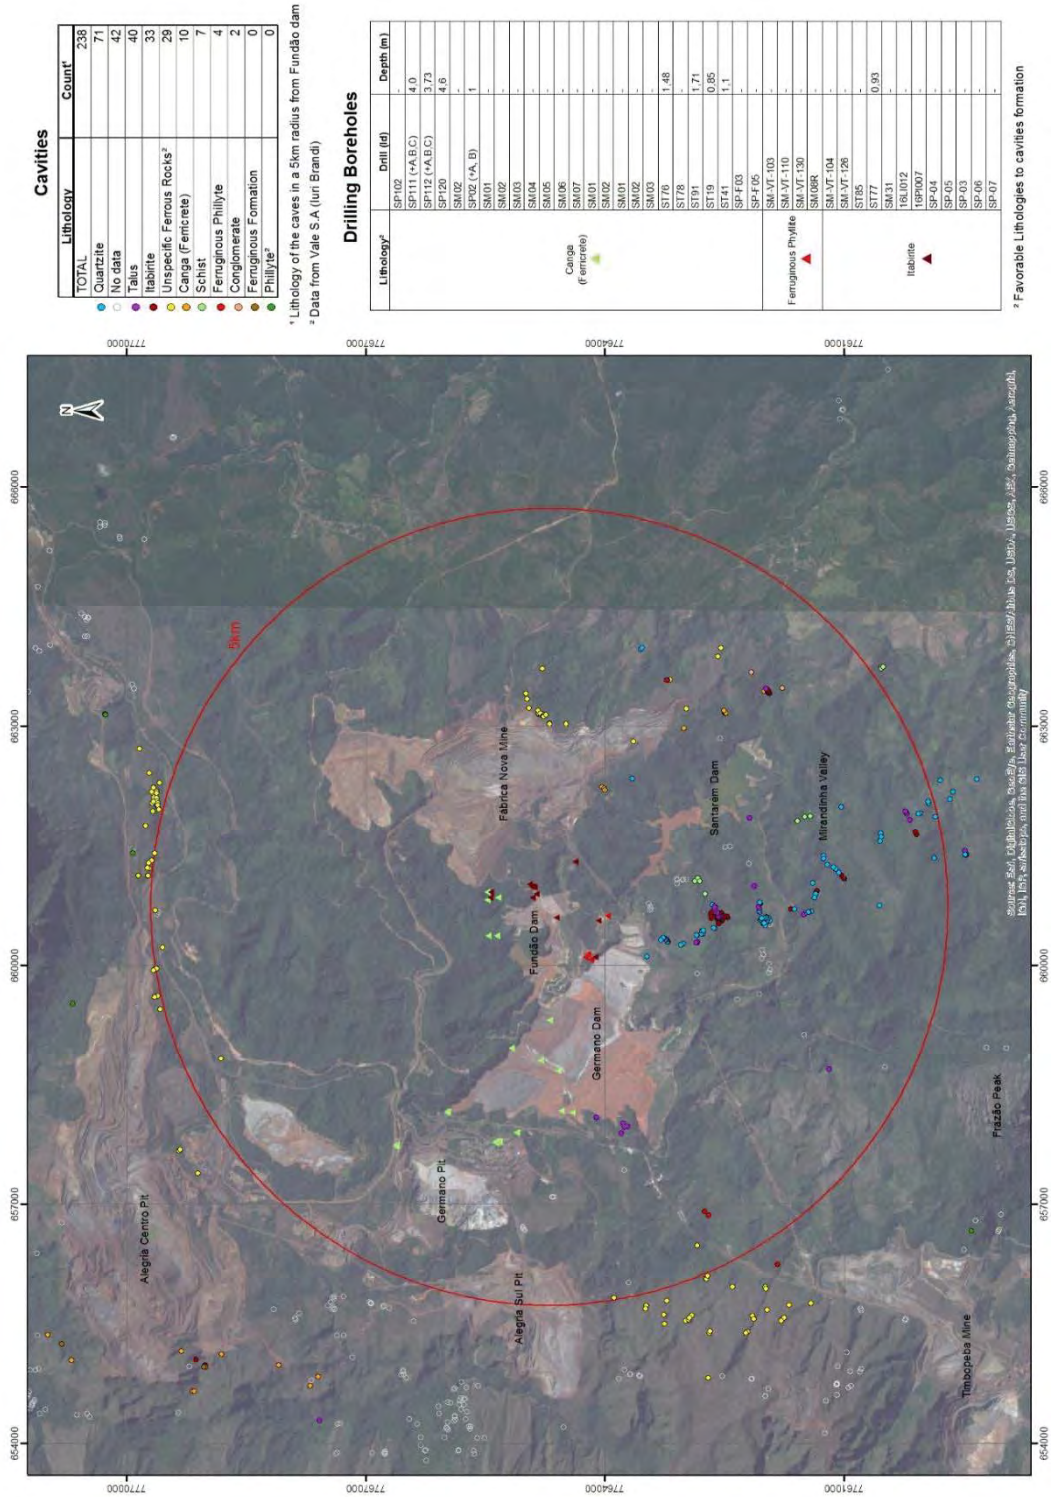
A consolidated research on this available database revealed the existence of 238 cavities within a 5 km radius of the Fundão Dam (**Figure 14**). This influence area includes the site of the Fábrica Nova Mine and part of the Alegria Mine, discussed previously in Chapter 4.

Figure 14 – Known cavities and drilling boreholes within a 5 km radius of the Fundão Dam.

It should be noted that only one of the almost 240 listed cavities has been characterized as developed in phyllitic rocks, approximately 1 km to the southwest of the Germano Dam reservoir's upper level, confirming previous assumptions that this lithotype presents a low speleological potential. This proportion is in accordance with regional data compiled for the entire Vale's area inside Iron Quadrangle, that identified only 57 cavities within phyllites, none of which appears in the 5 km radius of Fundão Dam (Brandi, 2016).

Therefore, based on the low speleological potential and in the absence of evidence, the likelihood of cavities in the area where the Fundão Dam was built can be dismissed, thus excluding the possibility of a cavity collapse as a trigger to the dam failure.

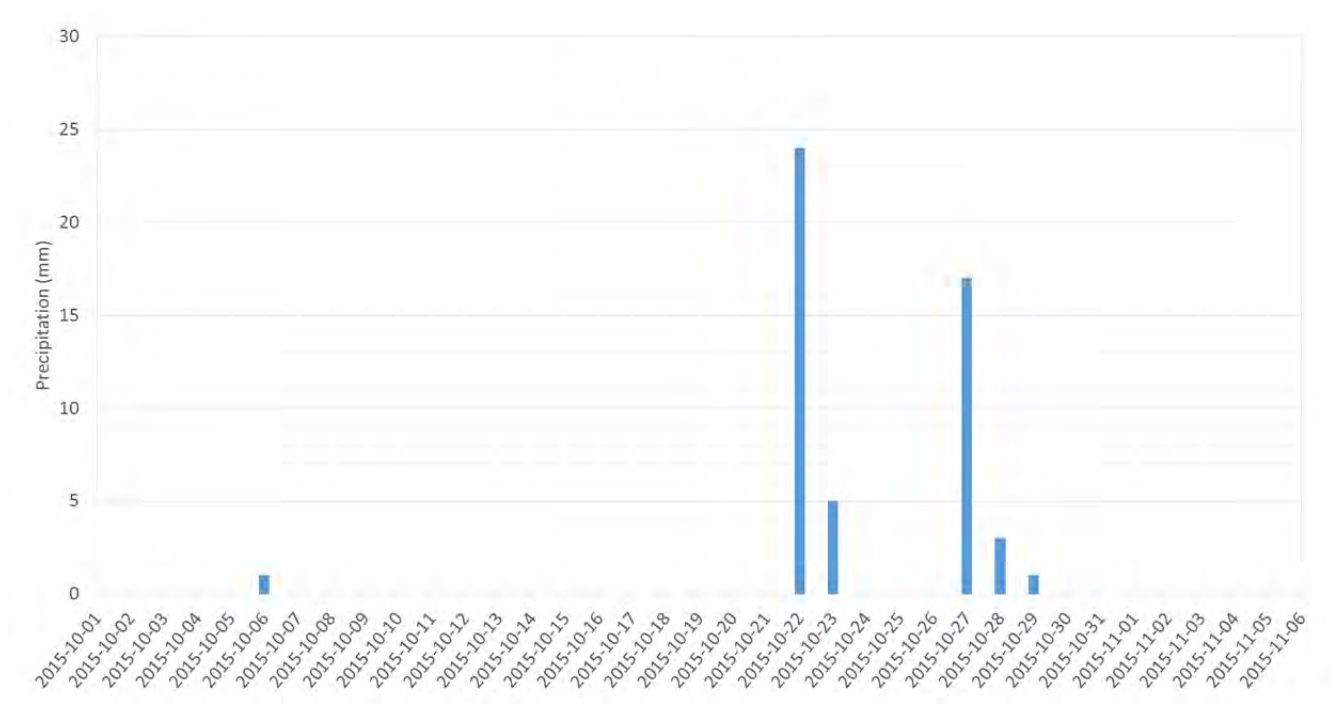
Figure K1-1 provides daily precipitation recorded at the Germano Dam station from October 1, 2015 through the date of failure on November 5, 2015. The last significant precipitation event occurred on October 27, nine days prior to failure. Flood overtopping as a causative failure mode can be ruled out on this basis.

Figure K1-1 Pre-failure daily precipitation

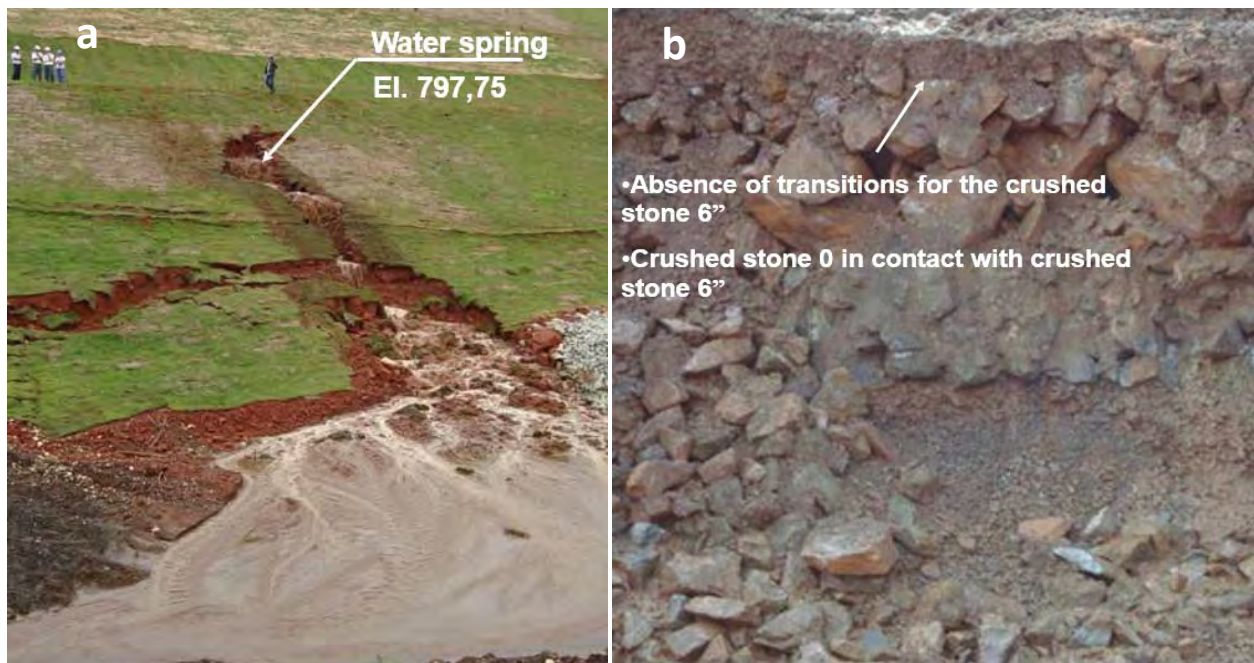
Internal erosion was manifested in the Fundão starter dam during the 2009 piping incident, as evidenced by the deposit of transported material and filter defects visible on Figure K1-2. In addition, the ITRB reported that cavities within the Starter Dam were indicated by geophysical investigations following the incident.

Figure K1-2 Internal erosion in 2009 Fundão starter dam. (a) Delta of transported material on downstream slope^[23]. (b) Defective filter^[23].

During the initial stages of failure, two eyewitnesses at the toe of the dam not far from the location of Figure K1-2(a) reported a dark or reddish coloration to water ponded there. However, they also reported that the Starter Dam remained intact even while tailings released from above were cascading down on their vehicle. These observations indicate that internal erosion within the Starter Dam did not initiate failure.

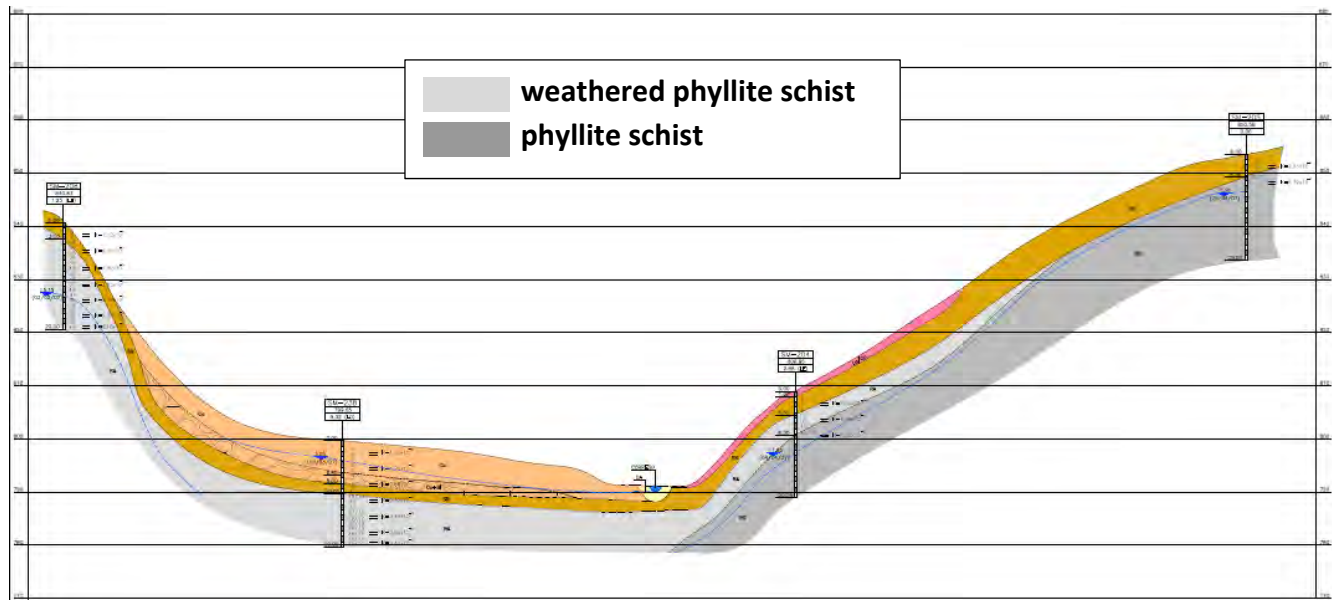
Failure by foundation sliding would have been manifested in the Starter Dam and would require the presence or development of shear surfaces within the natural foundation materials. This concerns in particular the phyllite schist and weathered phyllite schist, since overlying residual soils were removed from beneath the Starter Dam prior to construction. A pre-construction geologic profile through the Starter Dam foundation on Figure K1-3 indicates the location and extent of these materials.

Figure K1-3 Geologic profile beneath Starter Dam^[66]

Again, the same eyewitnesses at the toe of the Starter Dam reported that it did not move during failure initiation, ruling out foundation failure as the causative mechanism. The same is true of sliding within embankment fill materials of the Starter Dam.

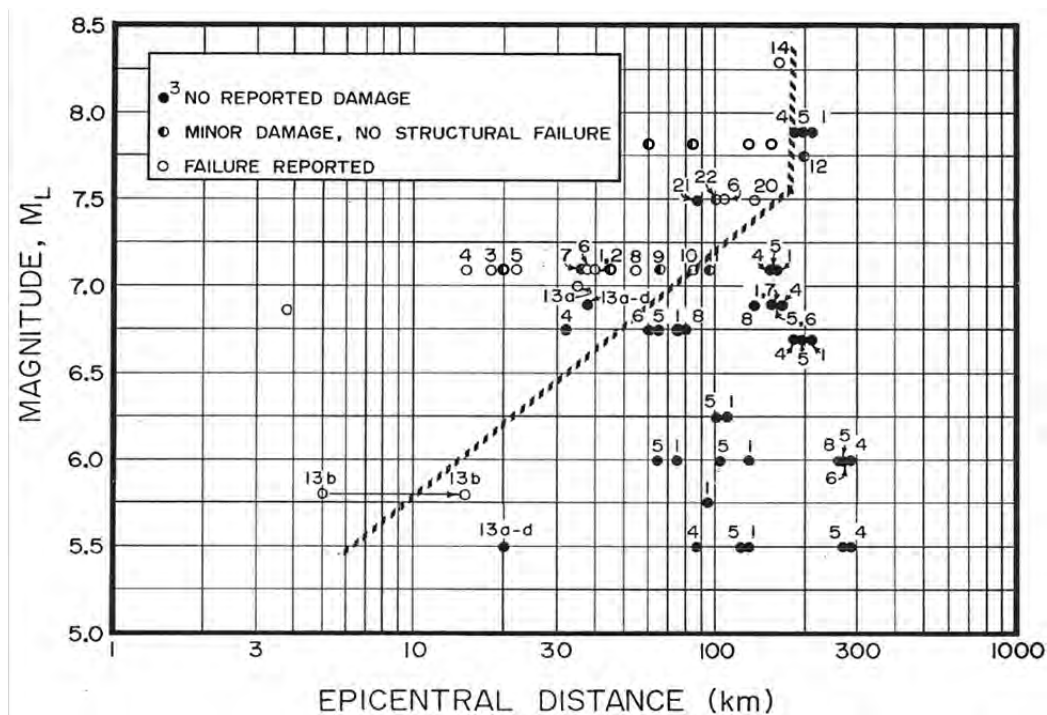
Figure K2-2 Seismic performance of operating tailings dams (after Conlin 1987; Lo et al. 1988)

From Figure K2-2, it is significant that no failure of an upstream tailings dam has been reported for magnitude less than 5.5 despite the large number of such dams exposed to smaller earthquakes, especially but not exclusively in highly-seismic areas.

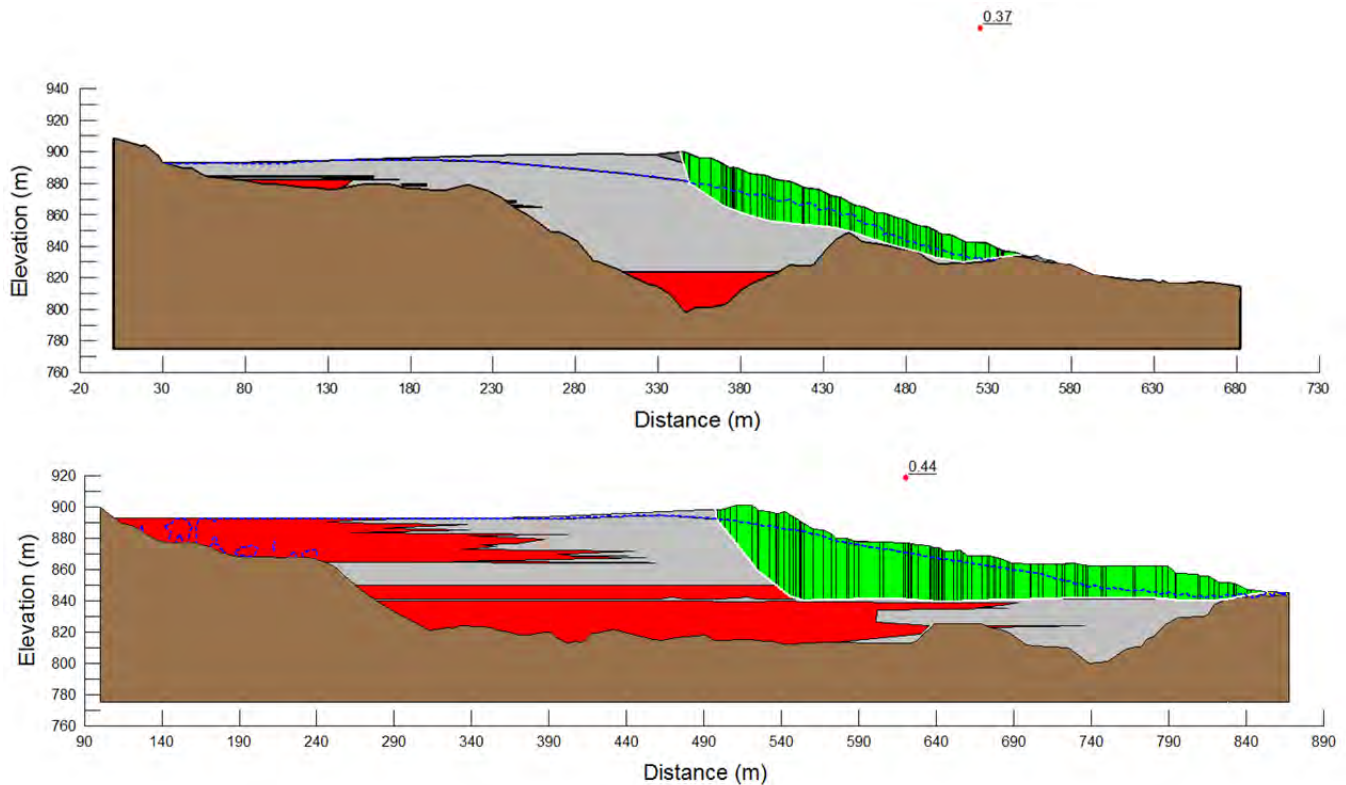
The process of cyclic liquefaction reduces initial undrained strength to some much lower post-liquefaction strength. Figure K2-3 shows stability analyses performed by the Panel that assign a post-liquefaction undrained strength ratio of 0.07 to saturated tailings for right and left abutment sections. The resulting factor of safety at the steeper right abutment (0.37) is lower than the left (0.44). Hence, had cyclic loading triggered liquefaction, the right abutment would have failed before the left, the opposite of what actually occurred.

Figure K2-3 Post-liquefaction comparison of right (top) and left (bottom) abutment sections

On the basis of this evidence, cyclic liquefaction alone, in and of itself, is ruled out as the operative trigger mechanism. However, this does not preclude some contribution of cyclic loading to other mechanisms, as subsequently explained.
