Fundão Tailings Dam Review Panel

Report on the Immediate Causes of the Failure of the Fundão Dam

EXECUTIVE SUMMARY

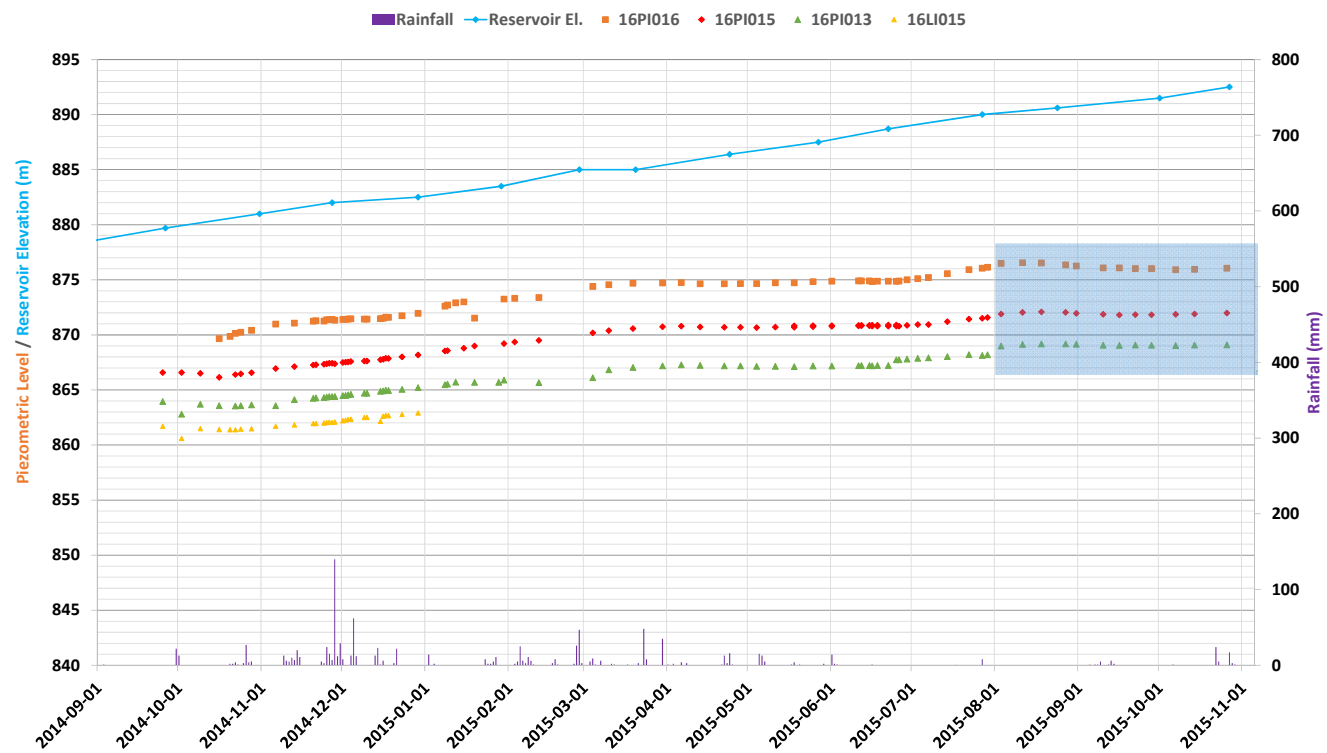
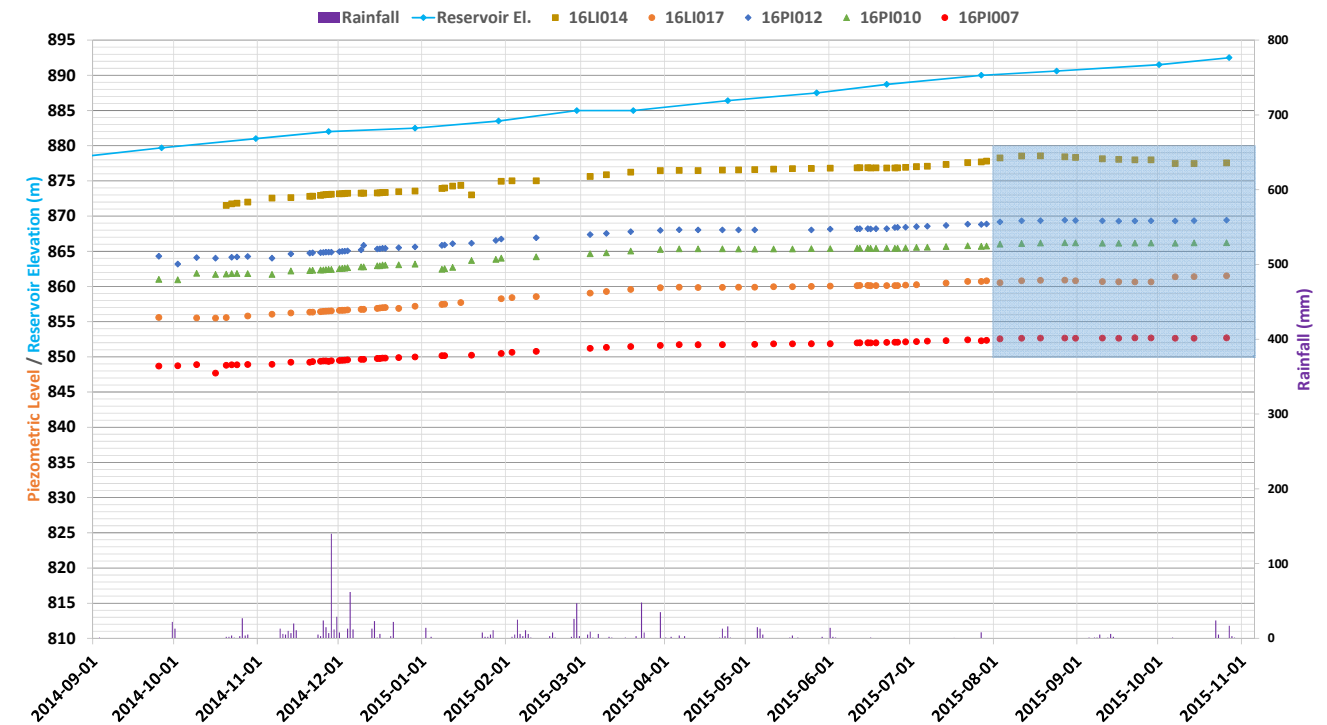
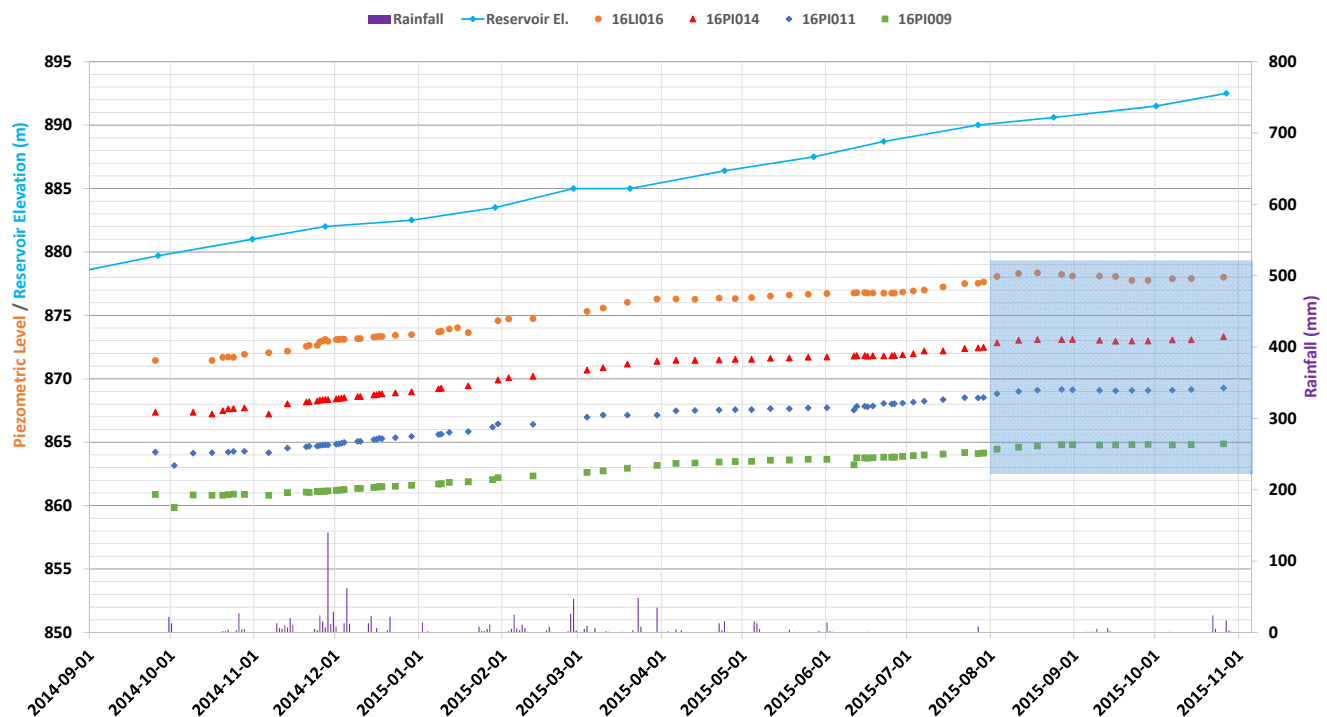
Figure K2-5 Piezometer readings, Section 01

Figure K2-6 Piezometer readings, Section 02

Figure K2-7 Piezometer readings, Section 03

Piezometric behavior prior to failure is similar at all three sections. Despite the continuing increase in reservoir level indicated by the upper blue line in the figures, the readings peak shortly after the beginning of August, 2015, then either remain constant or decline slightly. This effect is attributed to the influence of the newly-constructed left abutment blanket drain at El. 860 m when it intercepted and arrested the rise of the piezometric surface at a time coinciding with the peak readings.

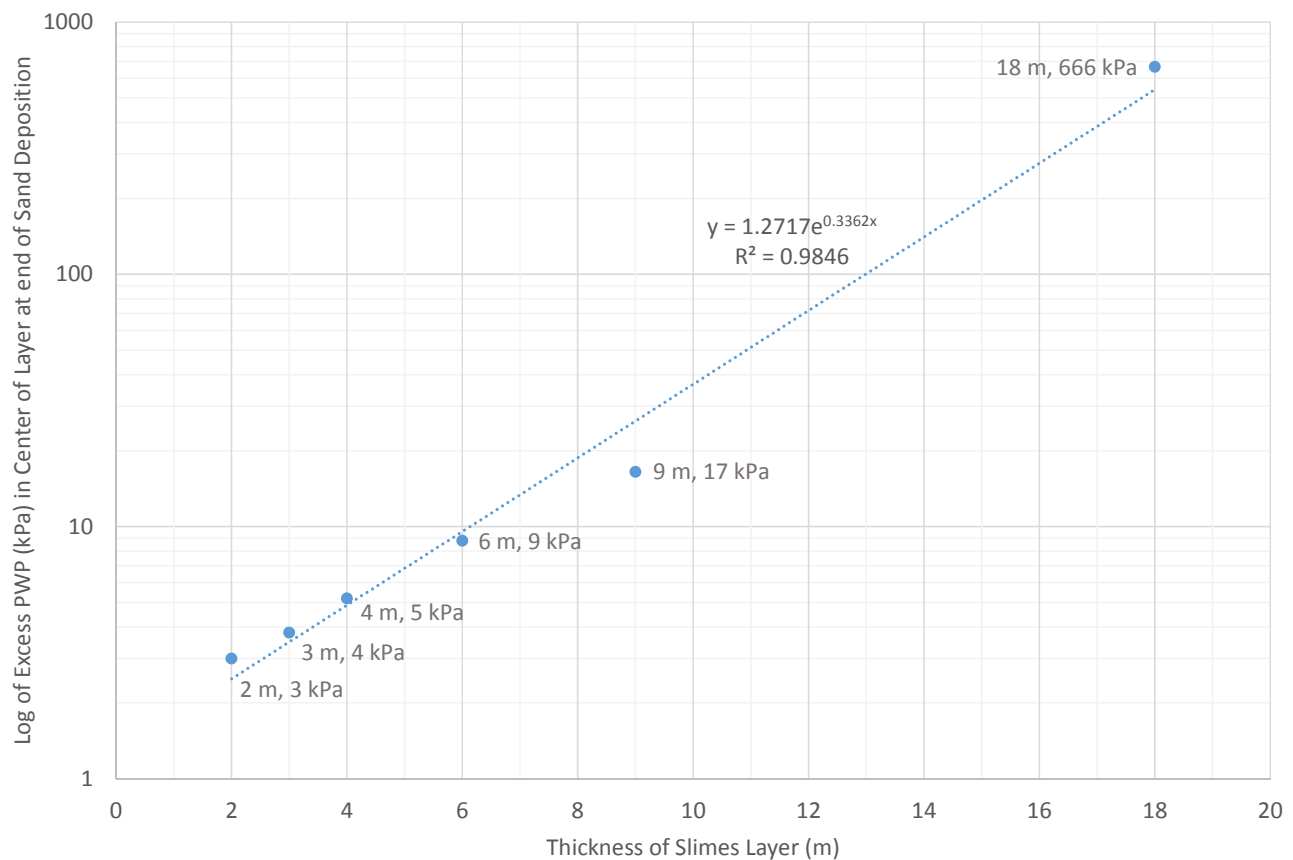
Figure K2-8 Slimes excess pore pressures

Appendices B and C show that the greatest documented discrete slimes layer thickness beneath the embankment is approximately 2 m at boring SP-07. Figure K2-8 shows that corresponding excess pore pressures in such a layer beneath the embankment at El. 840 m to El. 850 m would be less than 1% of the effective overburden stress, an insignificant amount. On this basis, excess pore pressure in slimes layers is not a candidate trigger for static liquefaction.

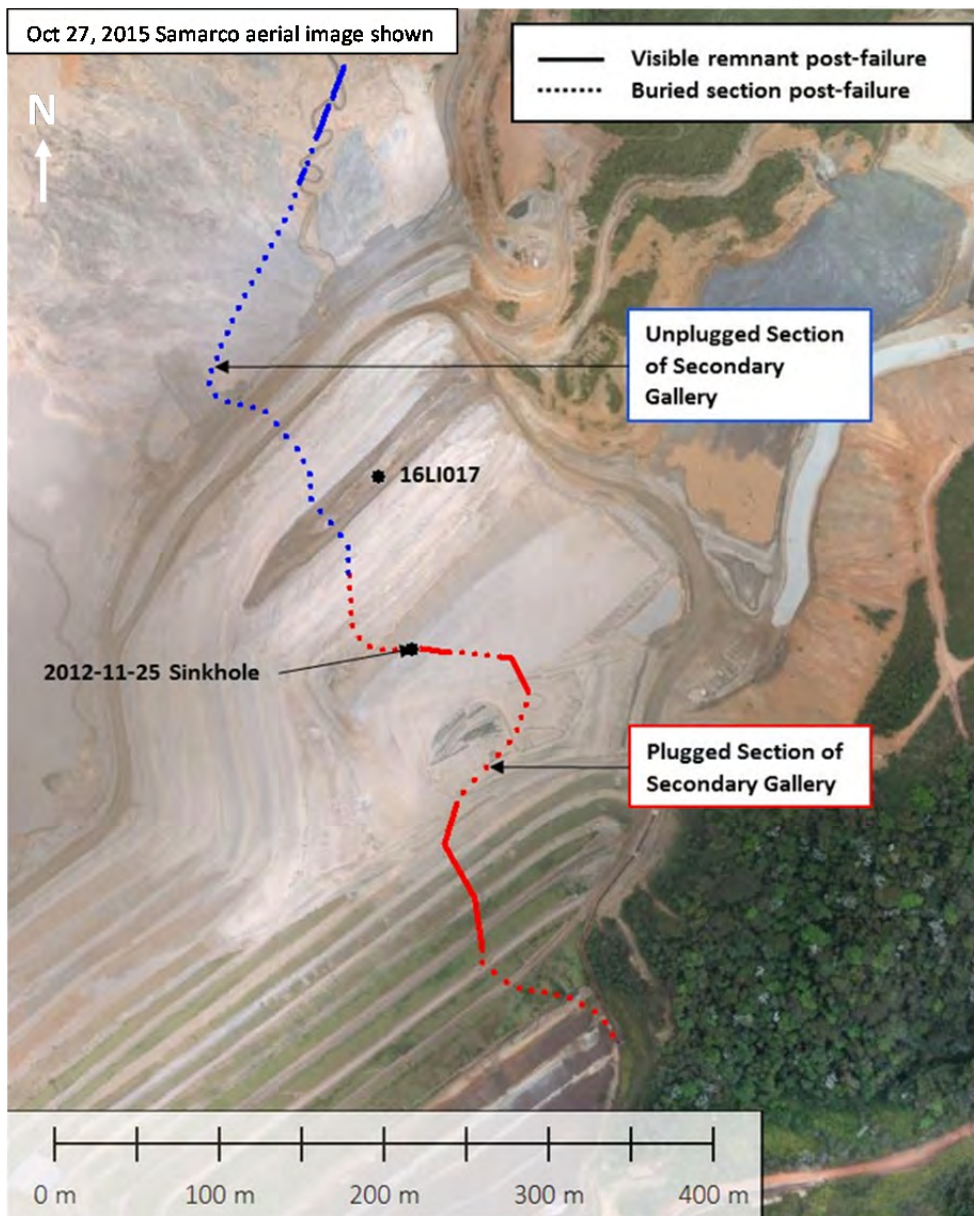
Figure K2-9 Secondary Gallery alignment beneath left abutment setback

Several events and conditions are relevant to this potential trigger mechanism. As shown on the figure, the downstream portion of the gallery is reported to have been filled with concrete to enable it to resist the stresses that would be imposed by raising the overlying embankment to its maximum design height at El. 920 m. However, the setback of the El. 920 m dam crest was not accounted for in establishing the terminus of this concrete-filled section, which resulted in the embankment being as much as 60 m above the open, unfilled portion of the gallery.

Another factor is the break in the Secondary Gallery that occurred on November 25, 2012 at the location indicated on Figure K2-9. The sinkhole itself is shown on Figure K2-10, illustrating the upward propagation of the resulting void to the surface of the overlying tailings.

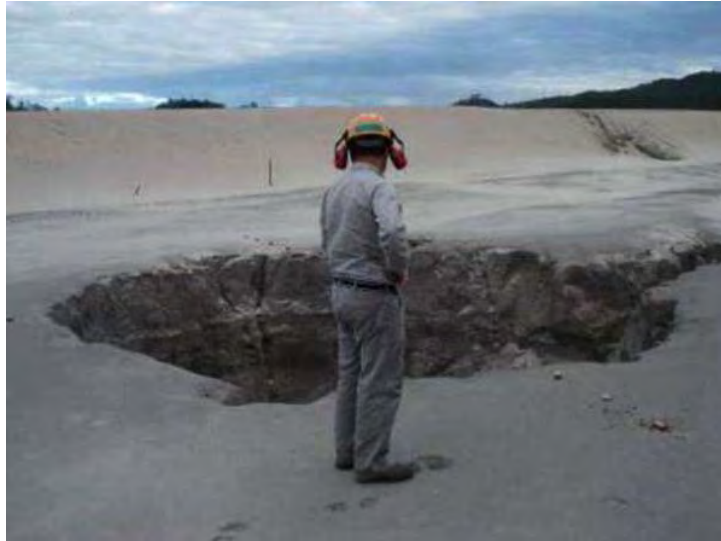
Figure K2-10 Sinkhole over Secondary Gallery, November 25, 2012 from April, 2013 ITRB report

4. *Previous behavior.* The behavior of the tailings during two previous gallery events provides insight into the propensity of such events to trigger widespread liquefaction. One such break in the Secondary Gallery shown on Figure K2-10 resulted in void formation that propagated to the surface by upward stoping, but did not produce a more generalized void redistribution that triggered liquefaction in the saturated tailings at greater depth. The second case was a collapse of the Main Gallery on July 9, 2010 that allowed tailings entry and produced a vortex in the water above. The feature that remained is shown on Figure K2-12. It is apparent that tailings flow into the Gallery left a conical depression but did not disturb the surrounding tailings or produce more generalized liquefaction beyond the limits of the material that flowed.

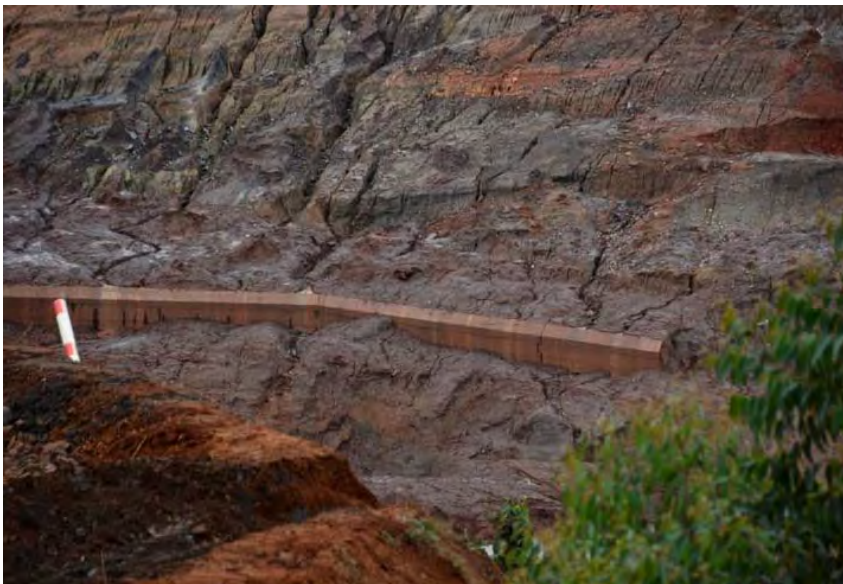
1. *Secondary Gallery remnants.* Several exposed segments of the Secondary Gallery remained intact after the failure at the locations on Figure K2-9, one of which is shown on Figure K2-11. These intact sections demonstrate that gallery collapse did not occur—and therefore that the related liquefaction trigger could not have been operative—at these particular locations.

Figure K2-11 Post failure remnant of Secondary Gallery (March 1, 2016 photo)

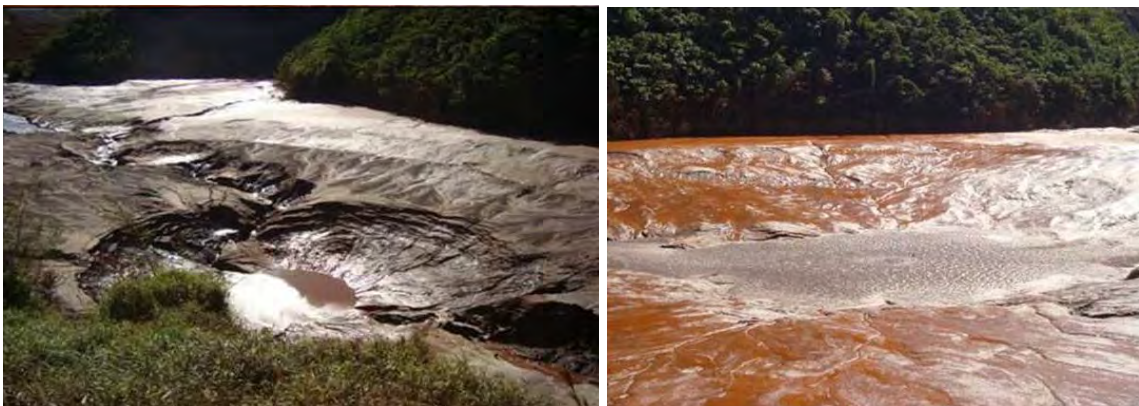
Figure K2-12 Tailings depression resulting from break in Main Gallery^[25]

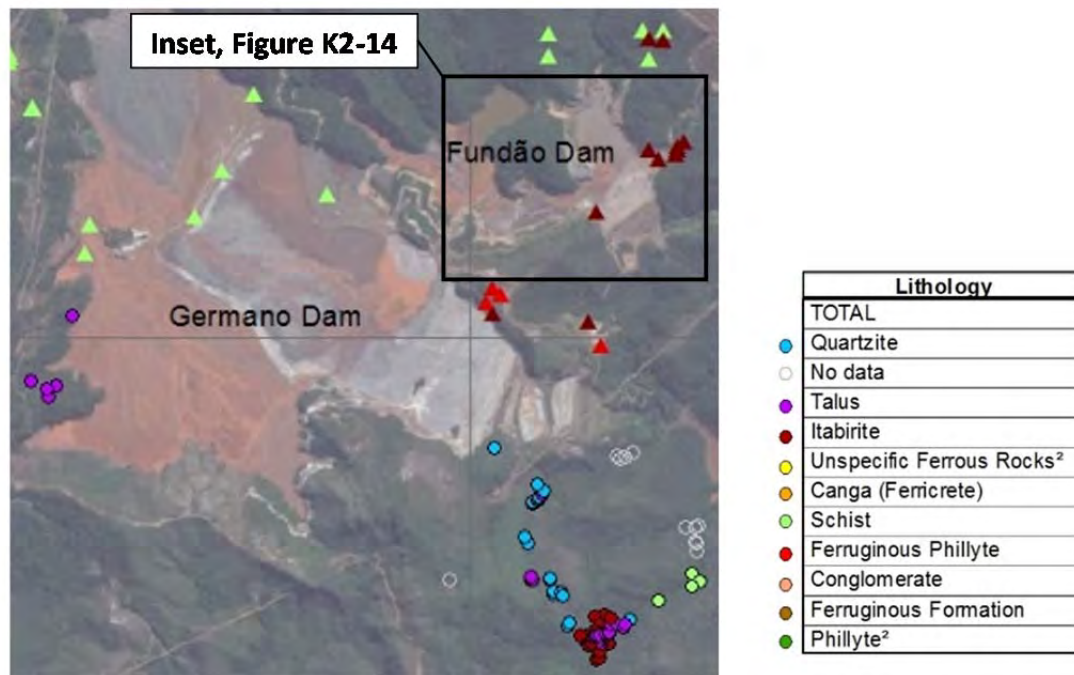
There are 238 mapped cavities within a 5 km radius of Fundão Dam. The closest of these are shown on Figure K2-13.

Figure K2-13 Mapped cavities (circles) and associated lithologies in the Fundão vicinity

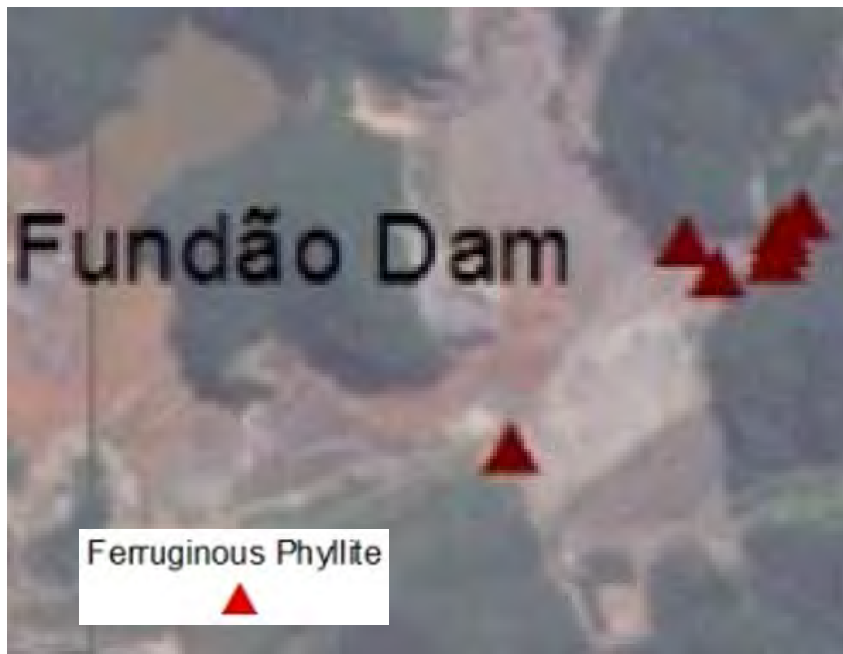
Figure K2-14 Location of ferruginous phyllite in the immediate Fundão vicinity (see inset Figure K2-13)

In the immediate Fundão vicinity, Figure K2-14 shows that iron-rich ferruginous phyllites that could provide a more favorable host for solution cavities are found mainly in the Grota da Vale area. To further investigate cavity presence, more than 300 drill holes were analyzed. From these, there were 41 cores with lithologies favorable to the formation of cavities, but none were beneath the Fundão Dam or tailings. No evidence of cavities was found in boreholes drilled for the Fundão Dam or in speleological studies performed in the area.

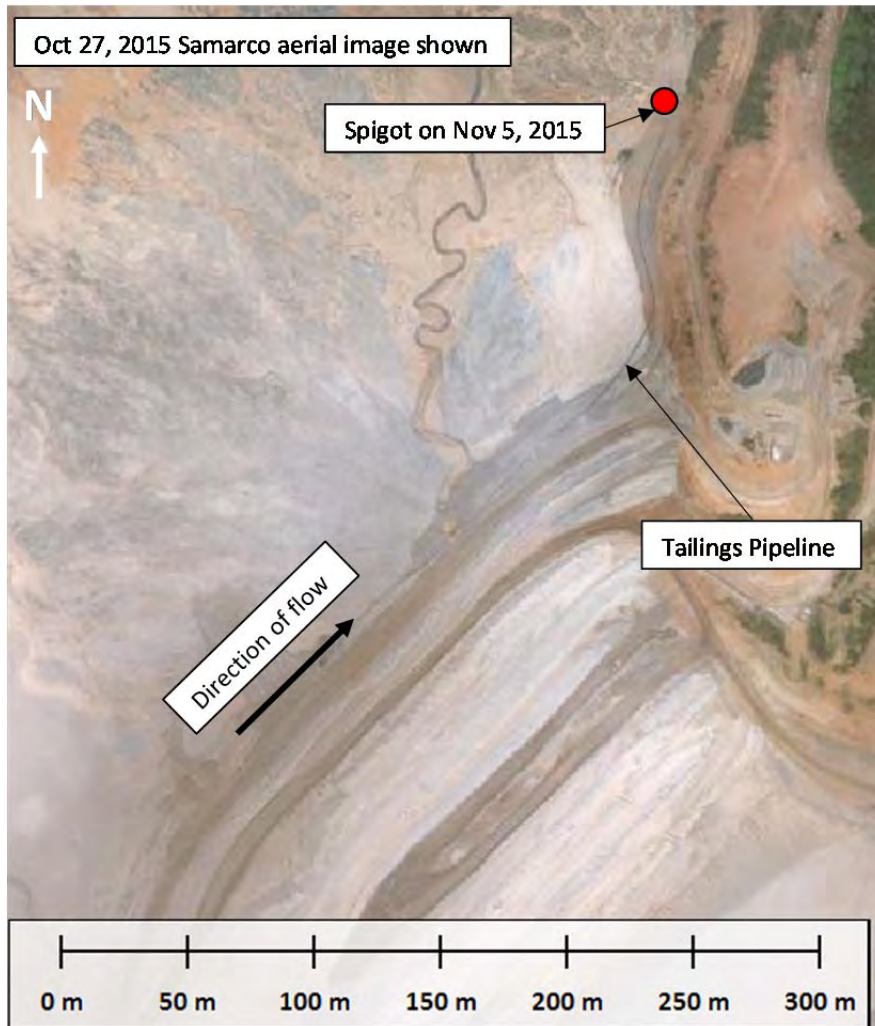
Figure K2-15 Tailings pipeline location

Figure K2-15 shows that tailings were being discharged at the left abutment prior to failure from a tailings pipeline located on the tailings beach at the upstream edge of the dam crest.

At the time of failure, the piezometric surface was at least 15 m below the pipeline, so erosion would have to extend to this depth and more before reaching and releasing saturated tailings. This would have taken considerable time, allowing ample opportunity to be seen. Of the many observers on the dam, none reported an erosional breach on the crest. To the contrary, it was consistently reported that the failure started “from the bottom up,” beginning at the lower benches rather than on the crest where erosional breach from a pipeline break would have initiated. On this basis, it is concluded that pipeline rupture did not trigger liquefaction.

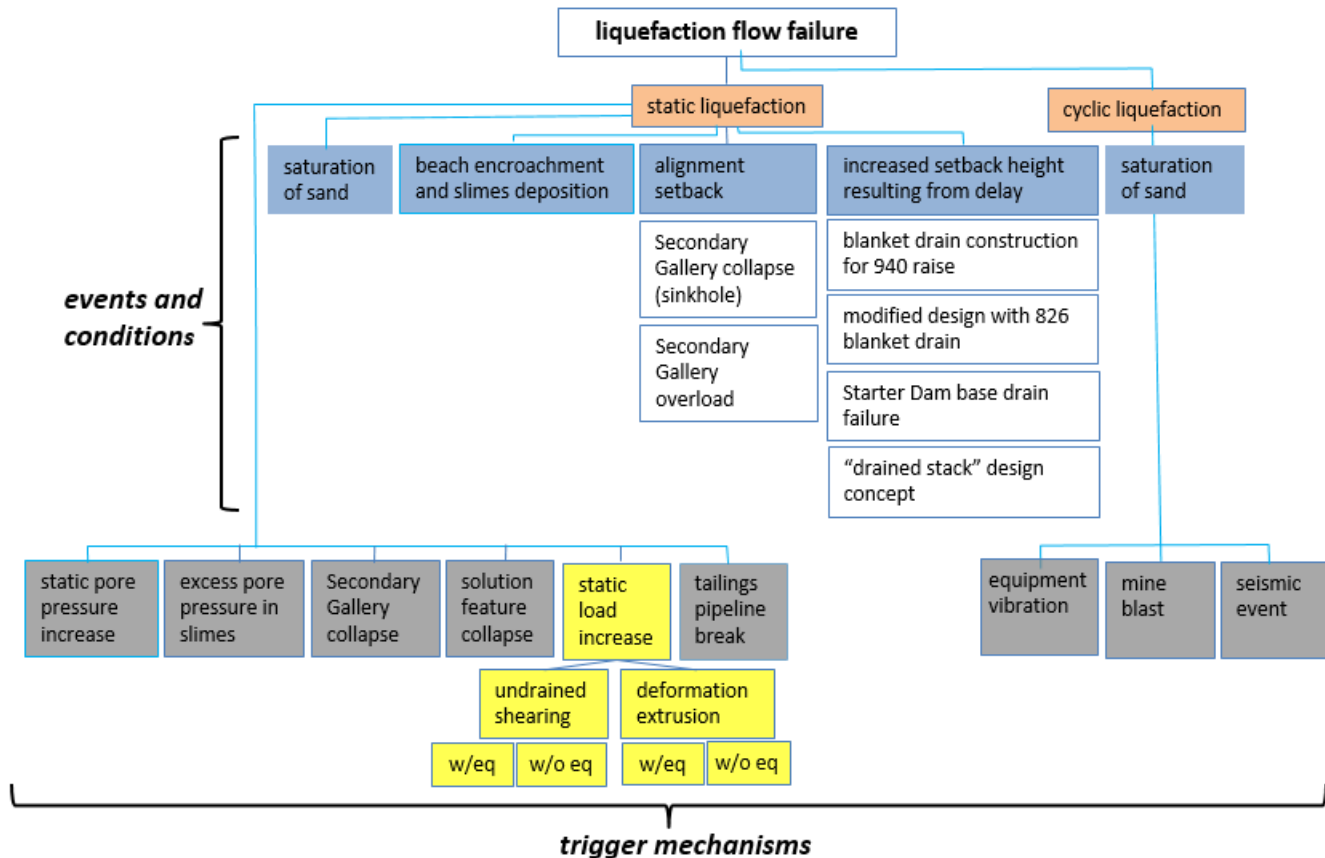
Figure K2-16 Surviving liquefaction triggers (yellow)

It is useful to revisit the fault tree of Figure K2-1 reproduced below as Figure K2-16 in order to review the status of the various candidate liquefaction trigger mechanisms. All of the potential triggers shaded in gray have been considered and rejected for cause per the preceding discussions, with the candidate triggers that have survived the process of elimination shaded in yellow.

The sole surviving trigger on Figure K2-16 derives from static (as distinct from dynamic) load increase, and it can be subdivided into two forms. One is simple undrained shearing, whereby the loading imposed by embankment raising increased until exceeding the undrained shearing strength of the tailings. The other, termed *extrusion* (Jefferies and Been 2016), is a deformation process whereby load-induced strains triggered liquefaction. To the extent that strength and deformation are inextricably linked, these two mechanisms are complementary and not mutually exclusive. Both are carried forward in the text of this report. Figure K2-16 also shows that both of these mechanisms may or may not have been significantly influenced by the earthquake sequence described in Table K2-1, and this assessment is carried forward as well.
