# MOUNT POLLEY MINING CORPORATION POST-EVENT ENVIRONMENTAL IMPACT ASSESSMENT REPORT – KEY FINDINGS REPORT

JUNE 5, 2015

Golder Associates Ltd.  
Suite 200 - 2920 Virtual Way,  
Vancouver, BC, V5M 0C4

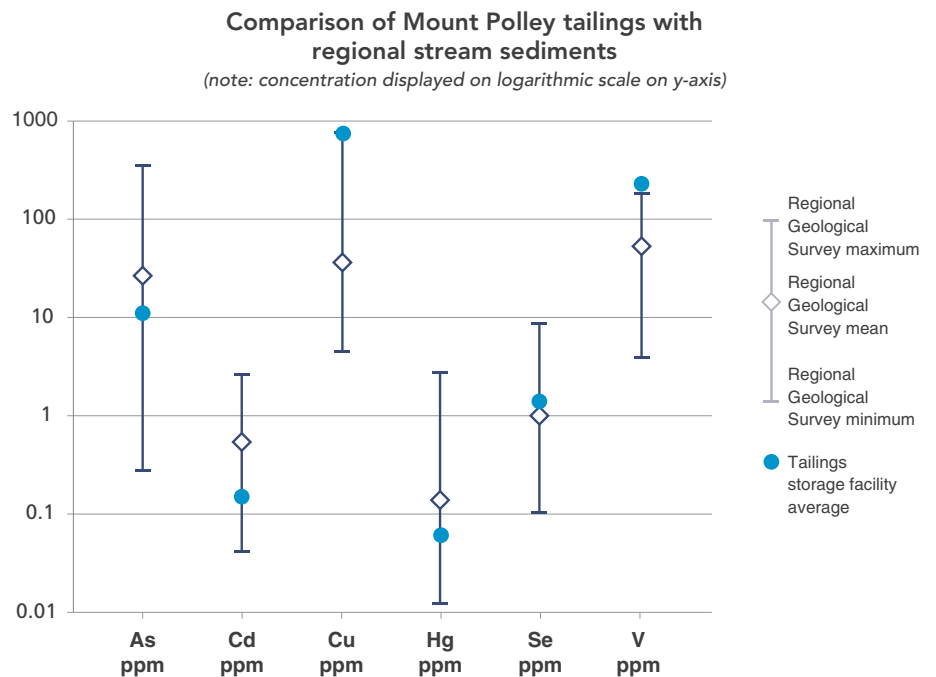
Figure 2: Comparison of Mount Polley tailings with regional stream sediments

A regional survey of the chemistry of stream sediments in the area was conducted by the Geological Survey of Canada in 1980 (seventeen years before the mine started operation) and found enriched concentrations of many metals in the sediments in the area. The copper concentrations in the tailings are higher than

copper in almost all streams in the area, but the concentrations of many other metals in these stream sediments are similar to the MPMC tailings (Figure 2).

Looking closer to home tells the same story. A rock collected in Likely, BC, shows similar or higher concentrations of many metals compared to their concentrations in the MPMC tailings, except for copper. It is this strong natural enrichment of copper at Mount Polley that is the reason it is a copper mine, but the tailings are not enriched in many other metals when compared to other rocks and sediments in the area.

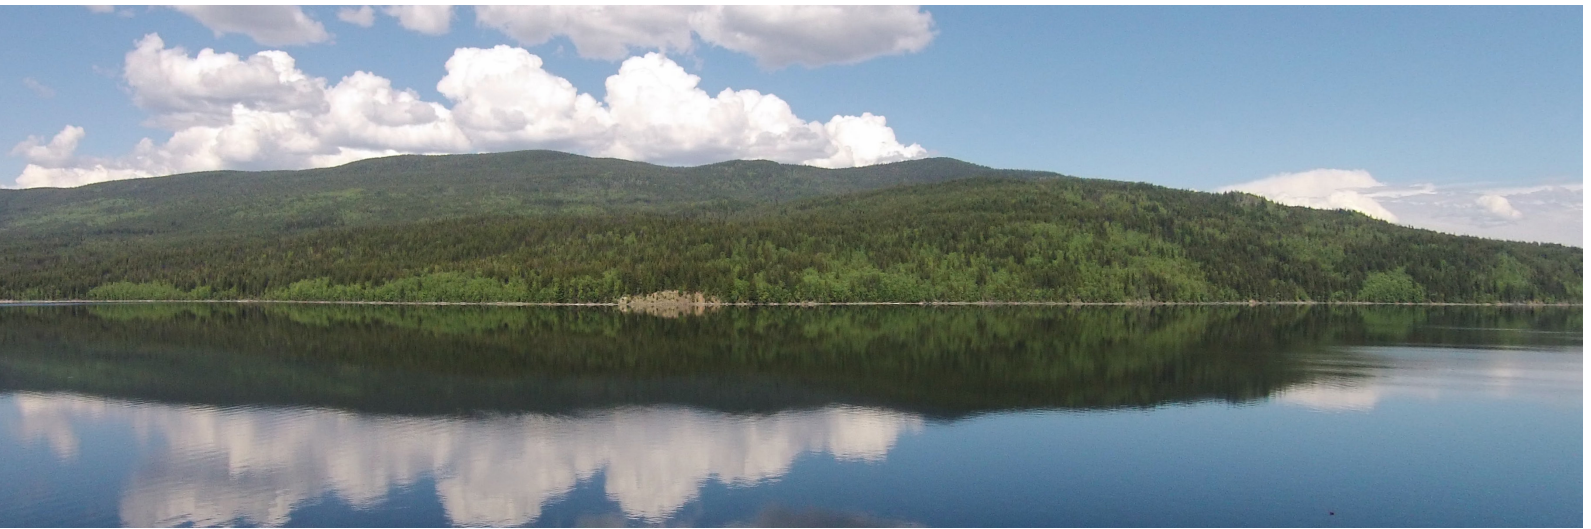
Quesnel Lake as viewed from the air, at the mouth of Hazeltine Creek, May 20, 2015

The water in Hazeltine Creek is now running clear and the turbidity of the main body of Quesnel Lake is in the range of pre-event conditions. There is still a slight increase in turbidity near the bottom of Quesnel Lake and that is expected to clear, but the main body of the lake has returned to normal conditions and is expected to stay that way into the future.

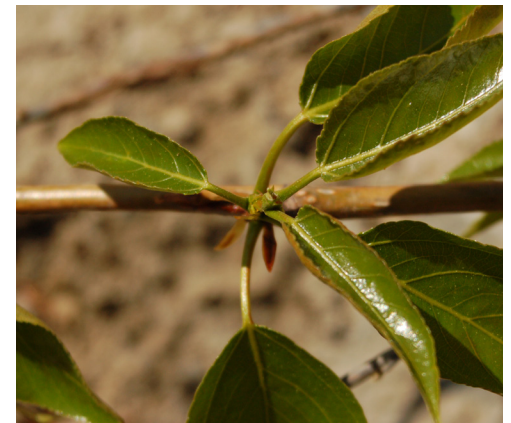
Vegetation planted in lower Hazeltine Creek shows early signs of successful growth

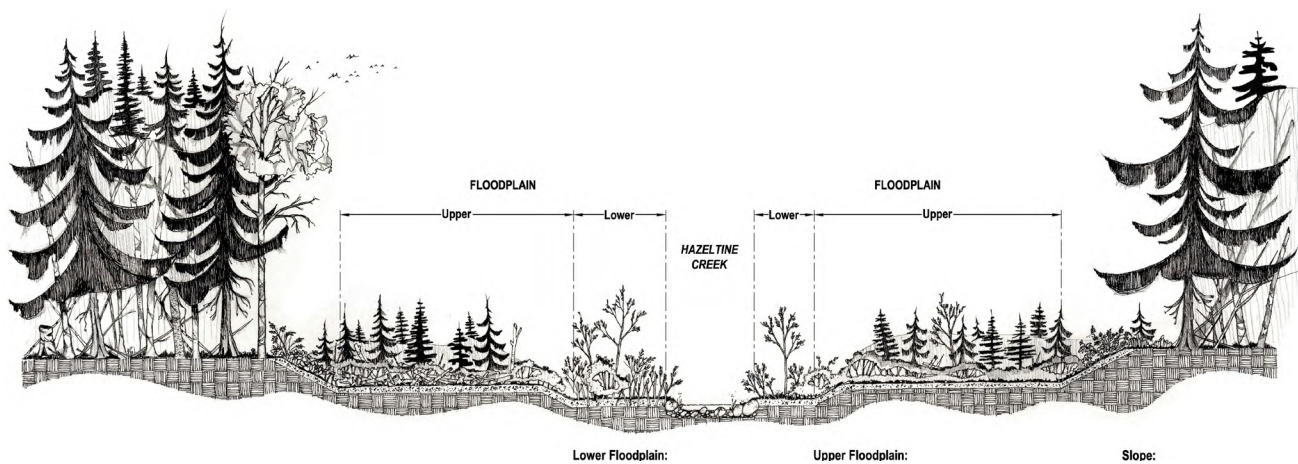
Figure 19: Conceptual channel cross section after five years (Envirowest, 2015)

With this in mind, the engineering design of Hazeltine Creek included a number of key steps. First, a landscape assessment was conducted to evaluate the natural slopes and physical characteristics of the original creek and provide guidance for the channel reconstruction and design. Next, an assessment of water flow volumes was conducted so that the high and low flows of the creek could be accommodated. These elements were put together so that the design will accommodate water flow during peak flows, but maintain sufficient water for trout and other wildlife during low flows. A cross section of the final Hazeltine Creek conceptual habitat design (shown five years after completion) is shown below.

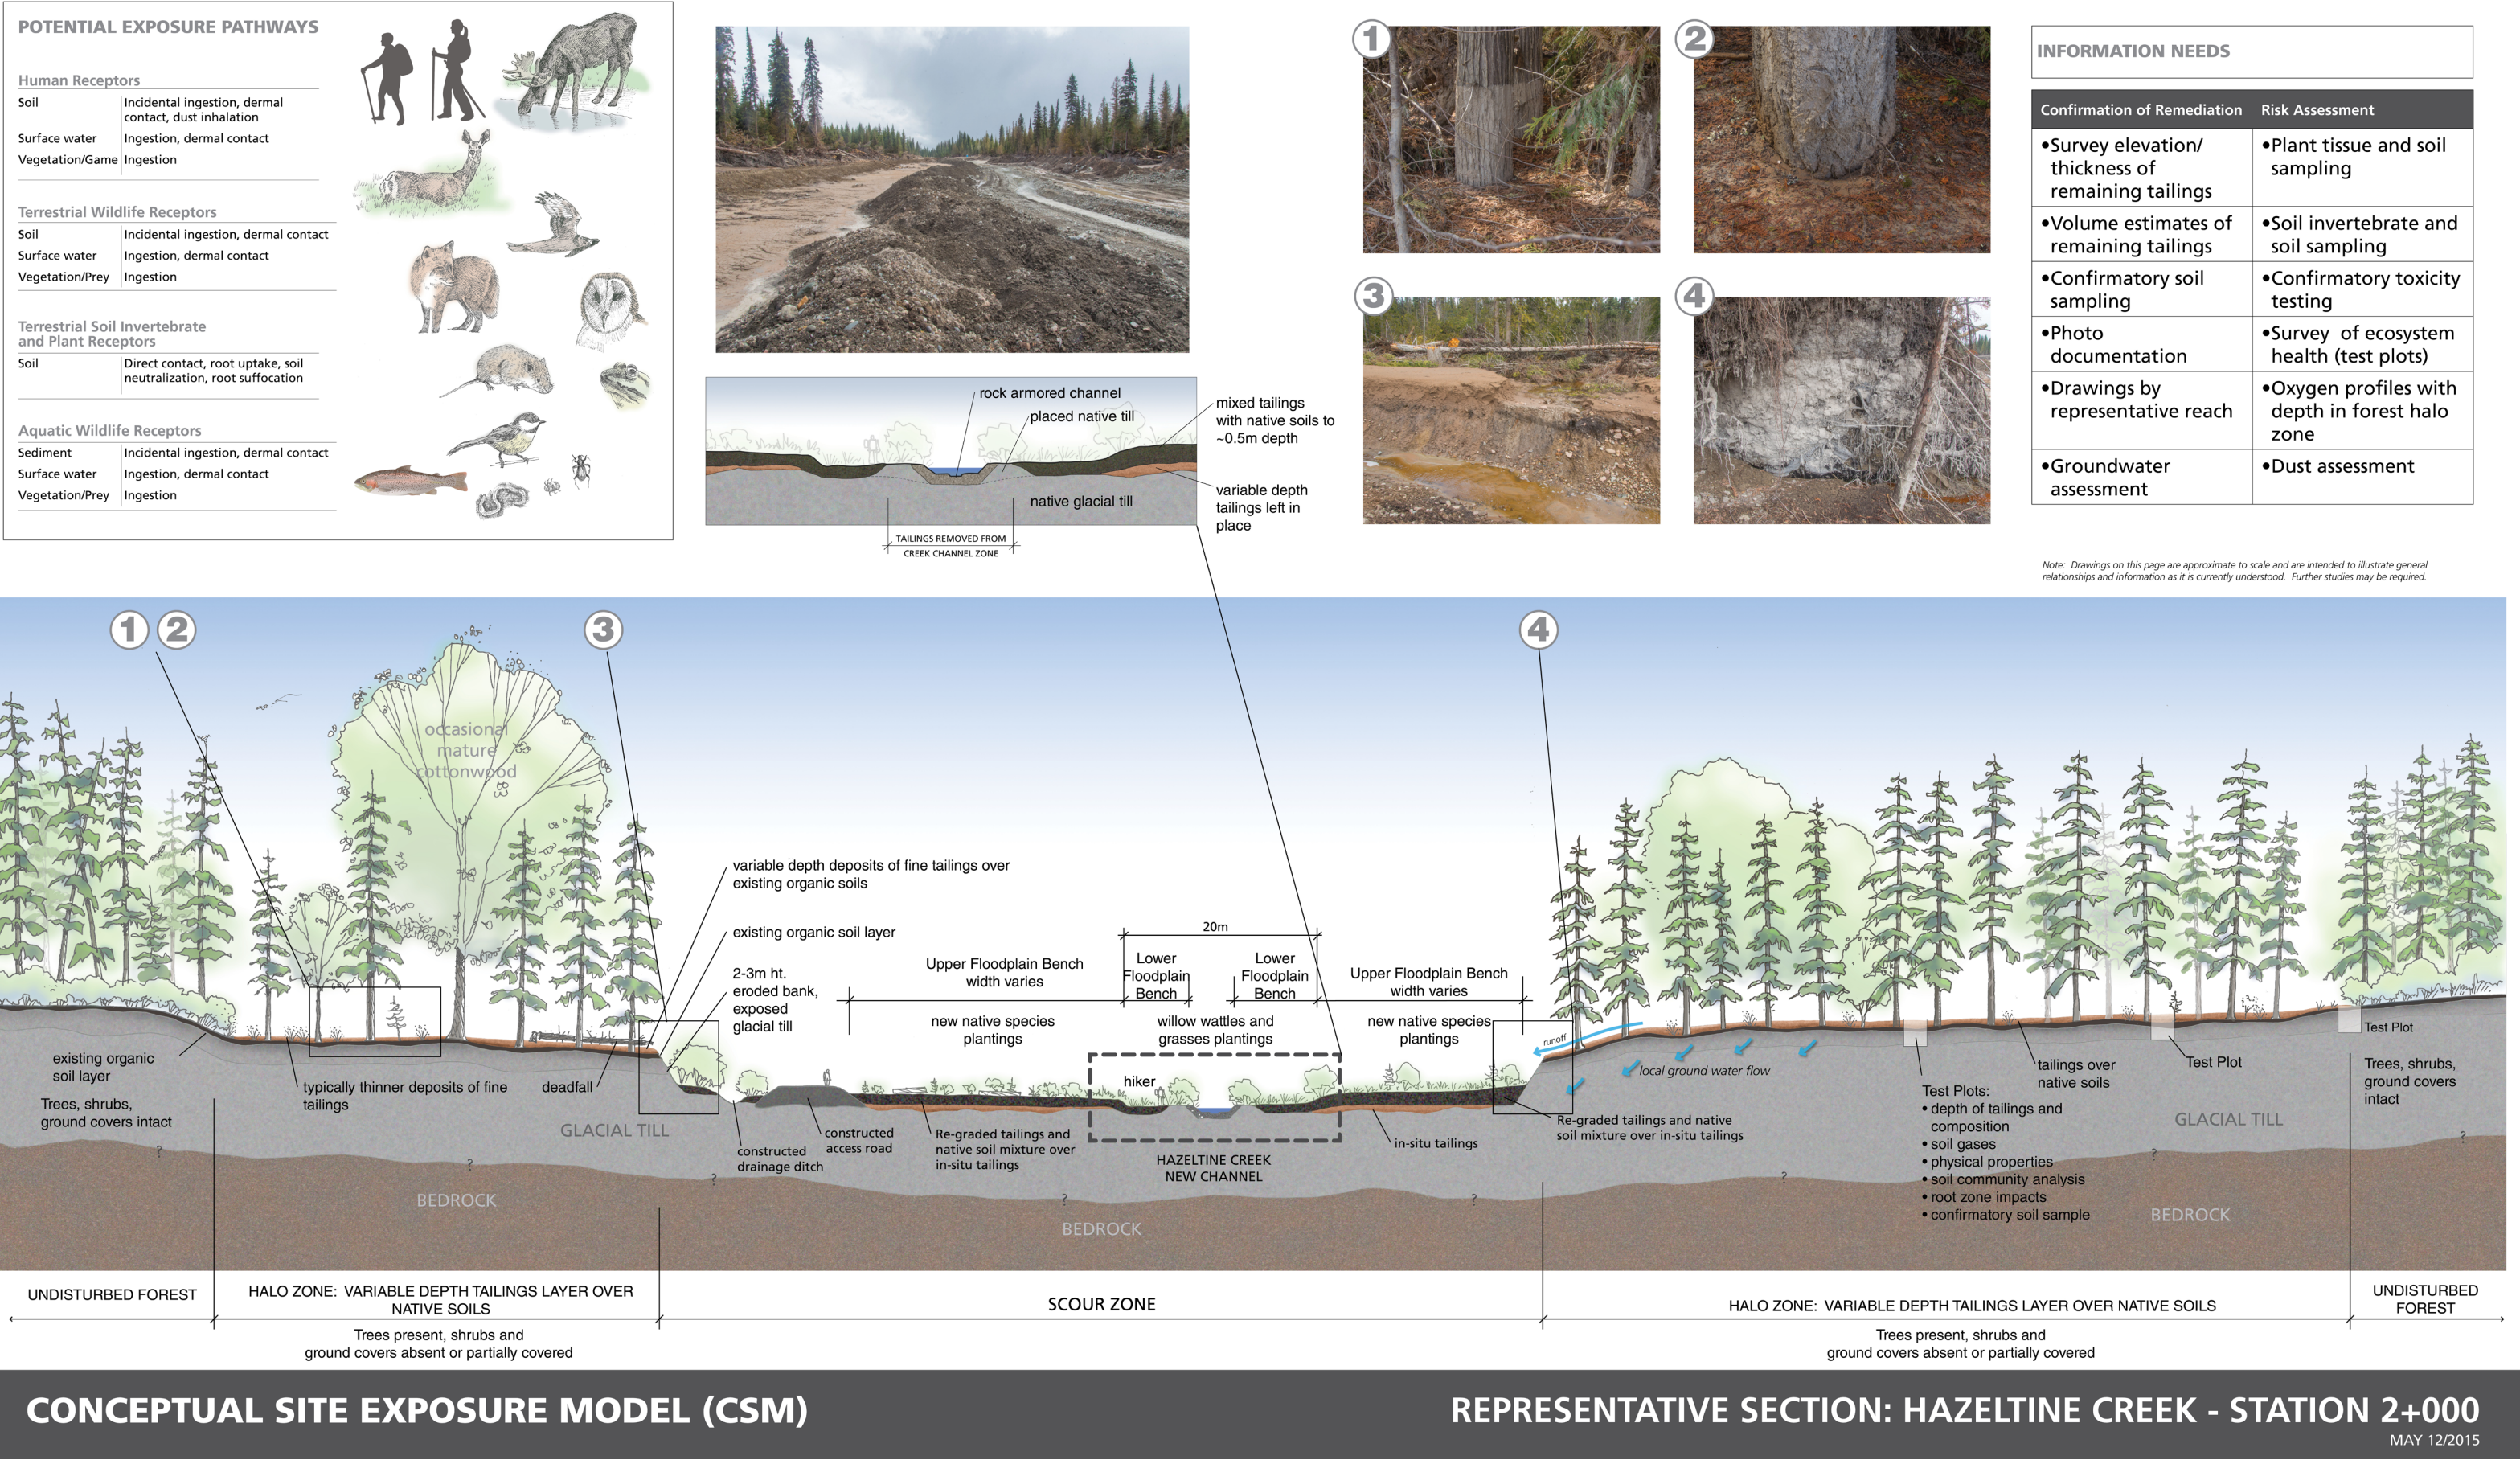
Figure 20: Conceptual Site Exposure Model (CSM) - Representative Section: Hazeltine Creek Station 2+000

This process has been started and is reflected in the Conceptual Site Exposure Model (Figure 20). A sampling and analysis plan to obtain the data needed to understand contaminant exposure and potential effects has been started. The results from the long term tests, for example, the geochemistry test results that we not yet available at the time of writing the PEEIAR, will be incorporated into the risk assessment. Essentially, the Human Health and Ecological Risk Assessment will pick up from where the PEEIAR left off, adding data to support a longer term assessment of risk to both people and the environment.
