MOUNT POLLEY MINE **TAILINGS STORAGE** **FACILITY BREACH**

August 4, 2014

Investigation Report
of the Chief Inspector of Mines

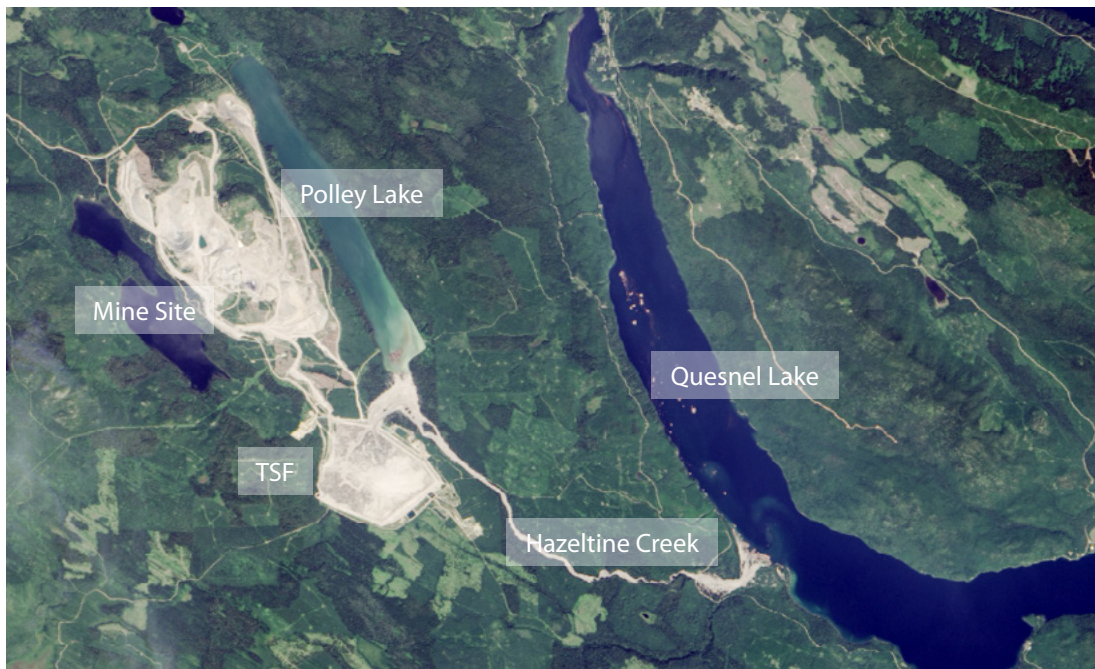
Figure 1.1 *Immediate Aftermath of Breach on Hazeltine Creek, Quesnel Lake, Polley Lake*
NASA high-altitude imagery (August 5, 2014)

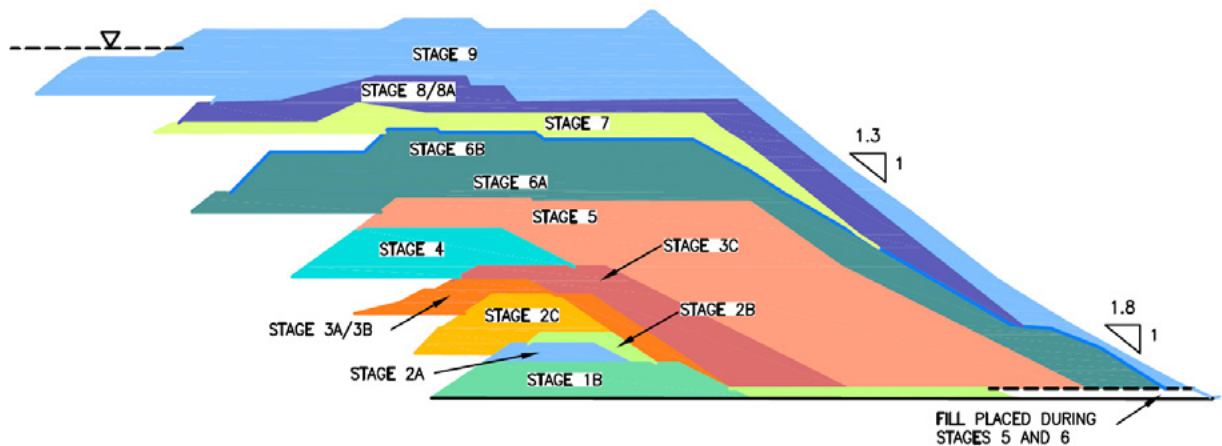
The design profile of the PE at the close of Stage 9 (at the time of the failure) is shown in Figure 1.2. The elevation of the crest is 970 m; the height of the embankment at its highest point (where the breach occurred) is approximately 40 m, and the downstream slope is at 1.3H:1.0V.

Figure 1.2 Embankment Stages Appendix 3, Fig. 2.6

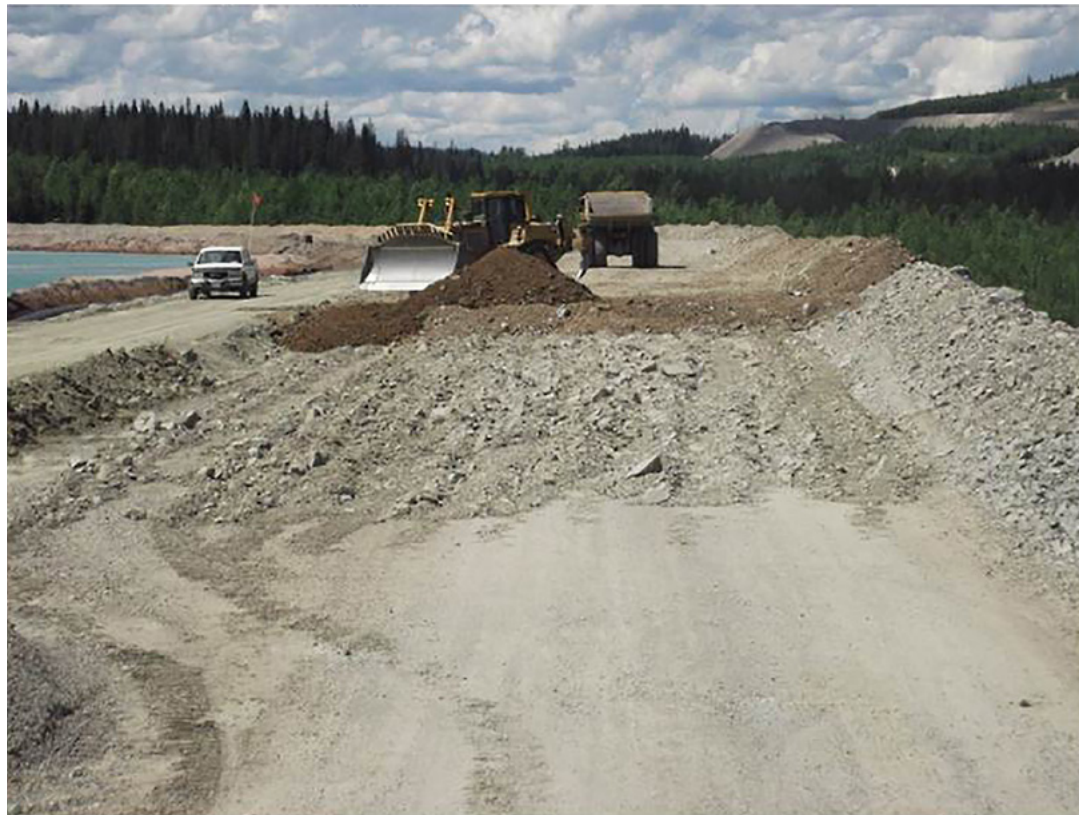
Figure 4.3 Placement of Zone C Rock near the area of the breach, June 26, 2014, Mount Poilley Mining Corporation (2014c)

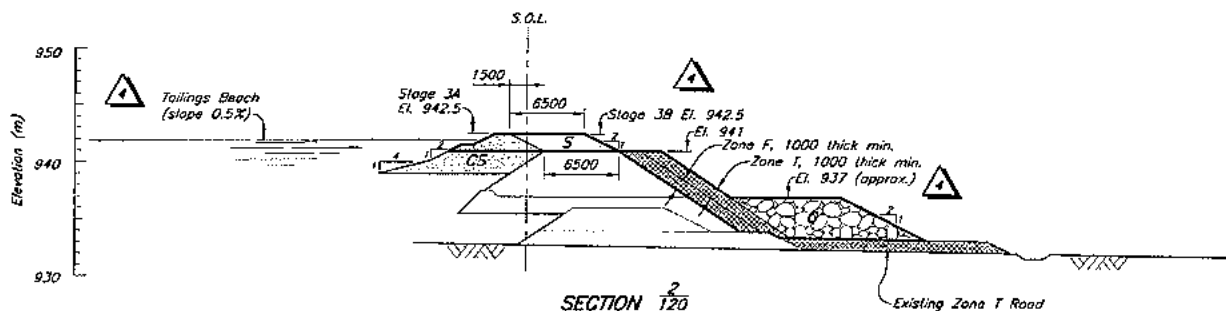
Figure 6.5 Typical As-Built PE Section
Knight Piésold (2001) Dwg. 11162-13-125

No section drawings of the Stage 3 as-built PE were made at the critical section (the location of the breach). Figure 6.5 depicts a section of the PE to the southeast of the breach area, similar to the area of interest, though somewhat lower in overall height. Documentation presented an embankment built in general accordance with the approved design.

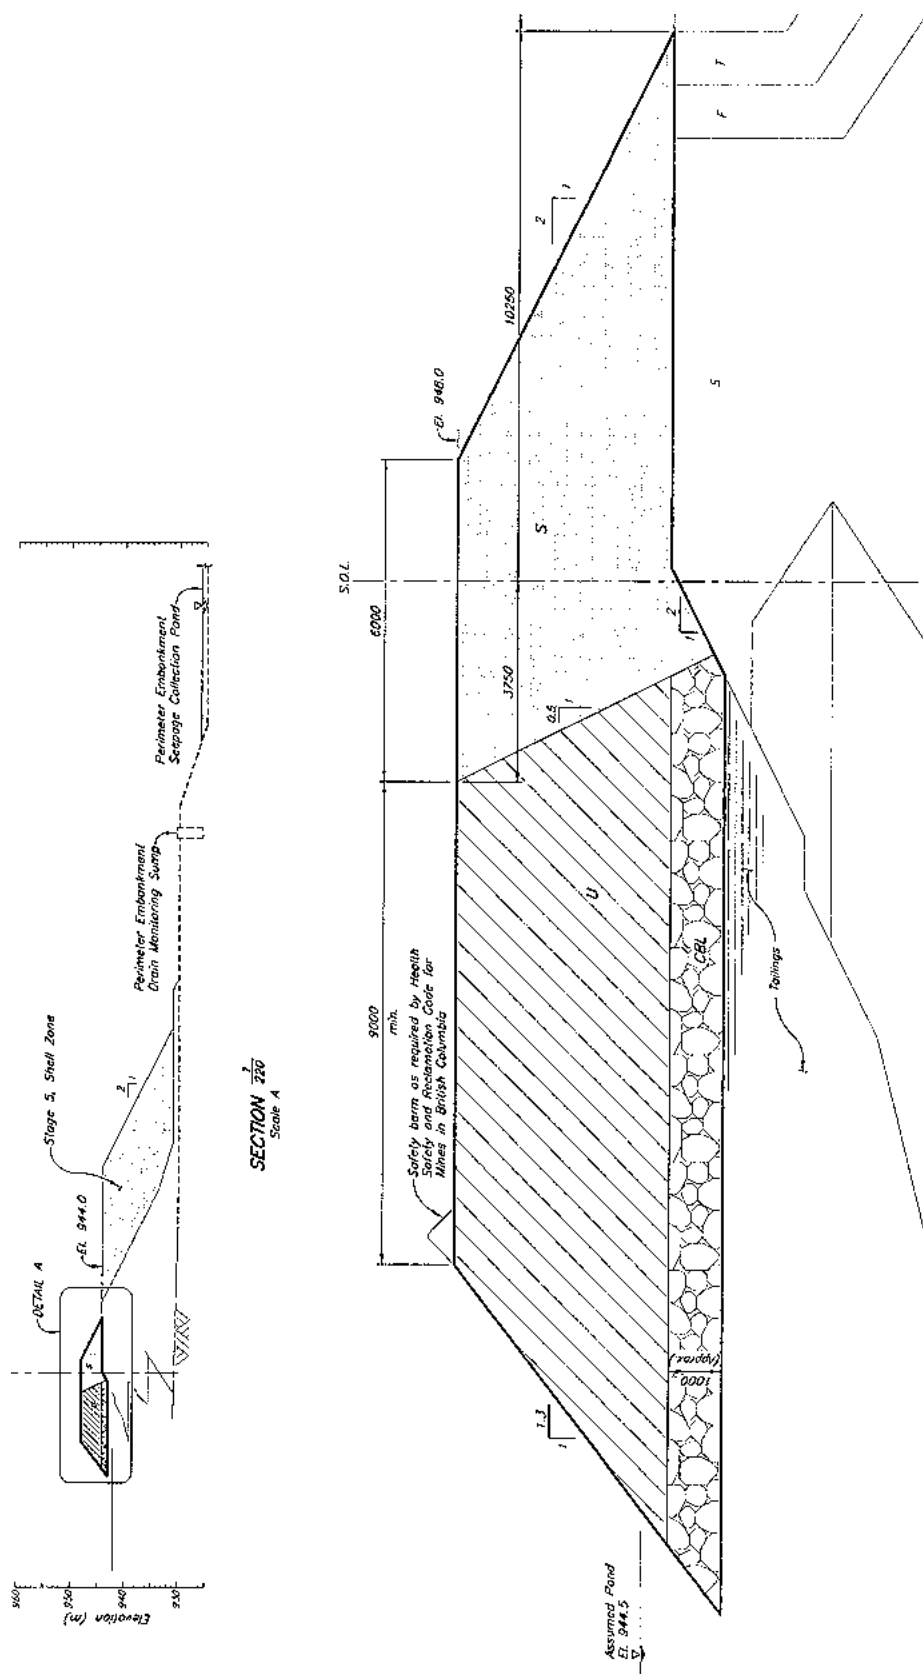
The Stage 4 construction program involving a 4 m cap raise using a modified centerline design commenced in May 2005 and was completed the first week of October 2006, with placement of the Zone C downstream shell planned for April 2006.⁵³ However, no Zone C shell rock was placed during Stage 4 (see Figure 6.6); expansion of Zone C was delayed until Stage 5 instead.

Figure 6.6 Stage 4 PE Section, As-Built
Knight Piésold (2007a) Dwg. 10-225 Rev. 1

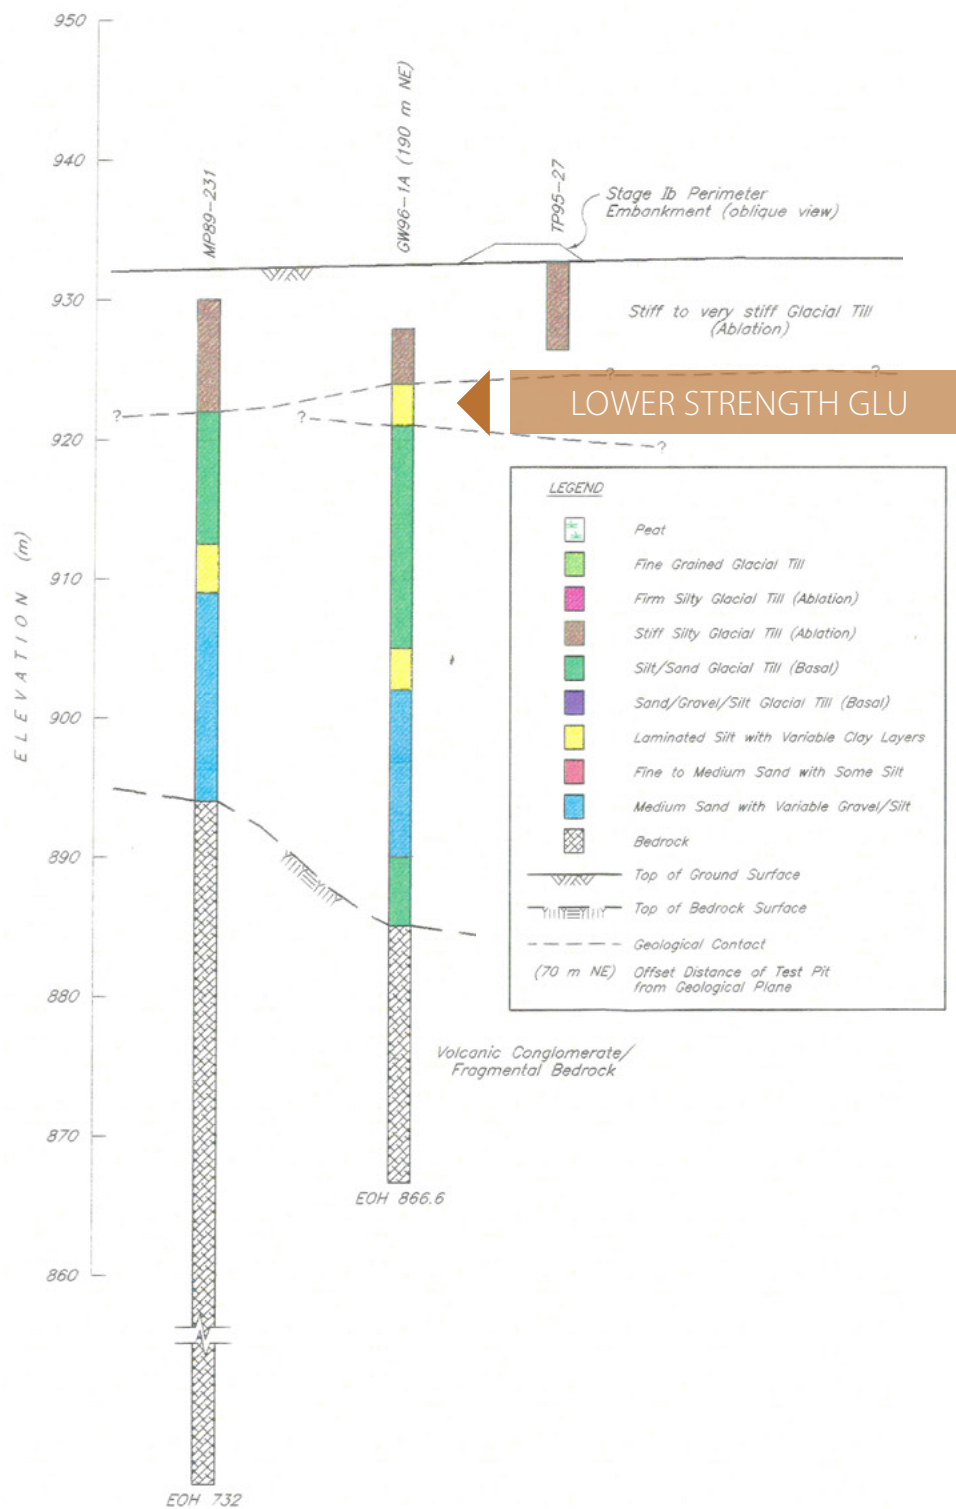
The test holes located in the vicinity of the area of the breach included: MP89-231 (condemnation drill hole), and GW96-1A (groundwater monitoring well), which are shown in plan on Fig 6.7 and in section on Fig. 6.8. The highlighted section represents a lower-strength clay unit.

Figure 6.8 Profile of Drillholes MP89-231 and GW96-1A
Knight Piésold (1997d) Dwg 1627.011

A response letter from Les GALBRAITH, P.Eng., and Ken BROUWER, P.Eng. stated, “the glaciolacustrine deposit encountered in GW96-1A and shown on cross-sections 9 and 10 consists of glaciolacustrine layers (silt, some clay) with lesser fine-grained glaciofluvial layers (sand). The material was described as firm based on an SPT N value of 6. The glaciolacustrine unit encountered within the TSF basin is a continuous unit near the Main Embankment, *but is only present as thin, discontinuous layers within the glacial till unit to the northeast near the Perimeter Embankment.* This was investigated during development of the original borrow area during the initial Stage 1 construction program which involved excavating approximately 50 testpits and drilling approximately 22 hollow and solid stem auger holes on a 50m grid pattern. The location of the original borrow area is illustrated on Drawing 1627.001. The borrow area was also inspected during Stage 2 construction. These investigations confirm that the glaciolacustrine deposit encountered in GW96-1A is a discontinuous unit and will not adversely affect the dam stability (italics added).”⁵⁹

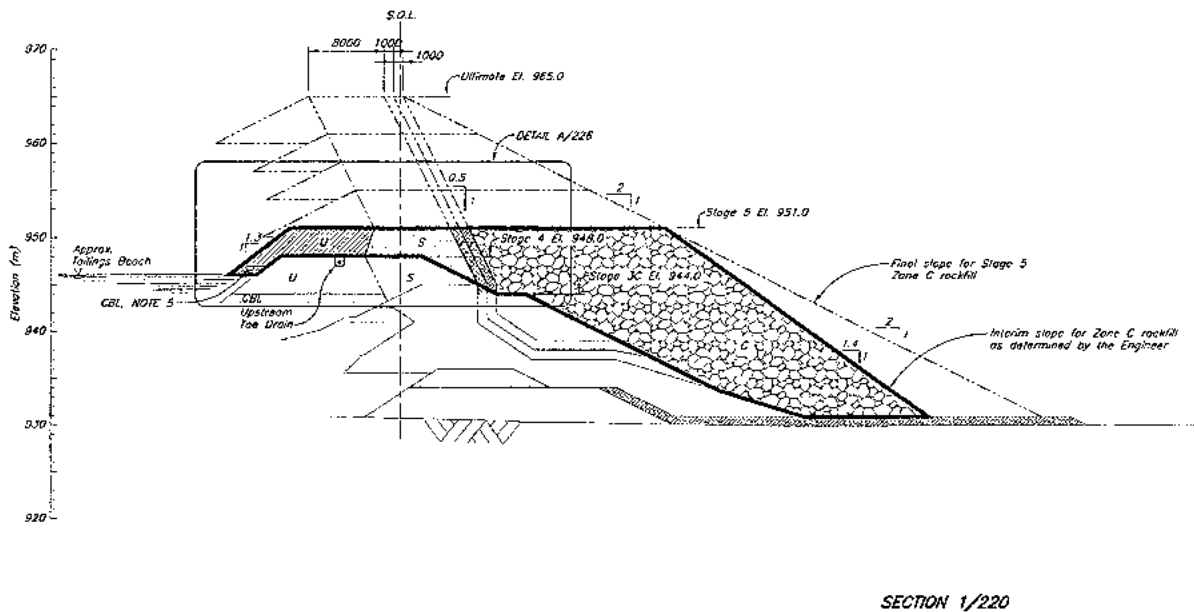
Figure 6.9 Stage 5 PE Section, Planned
Knight Piésold (2006a) Dwg. 12-225 Rev. 0

Construction of Stage 5 was an uninterrupted continuation of Stage 4 expansion, and was completed in November 2007. The crest of the PE was significantly widened (see Figure 6.9) resulting in a considerable expansion of the volume of Zone C rockfill. The planned upstream toe drain was added during this stage with an elevation of 946.3 m. The drain provided seepage control within the embankment, as well as draining and consolidating the tailings mass near the embankment.⁷⁰

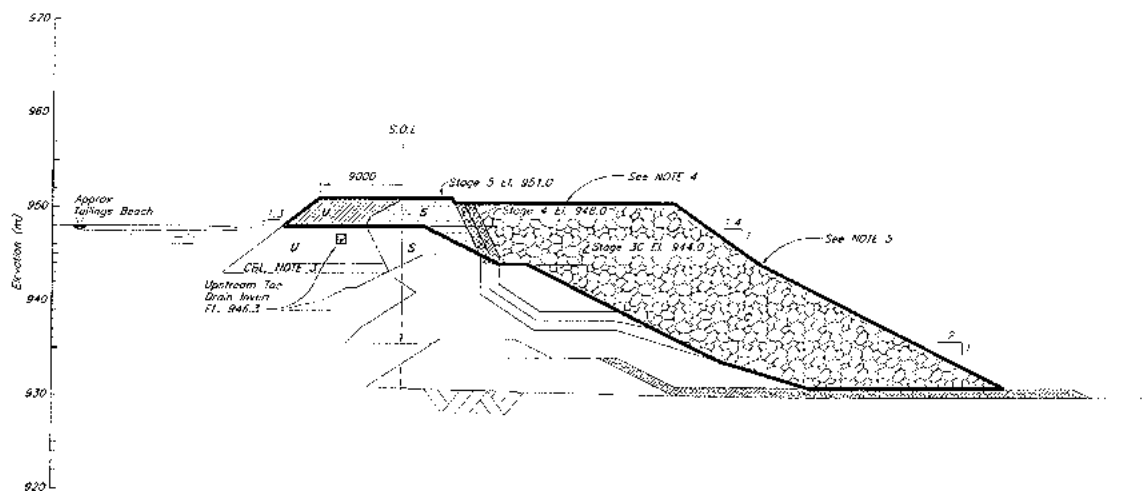
Figure 6.10 Stage 5 PE Section, As-Built, with Interim Slope
Knight Piésold (2008a) Dwg. 225

The as-built report (shown in Figure 6.10) indicates that the upper portion of the slope was an interim slope and the lower slope was 2H:1V.⁷¹

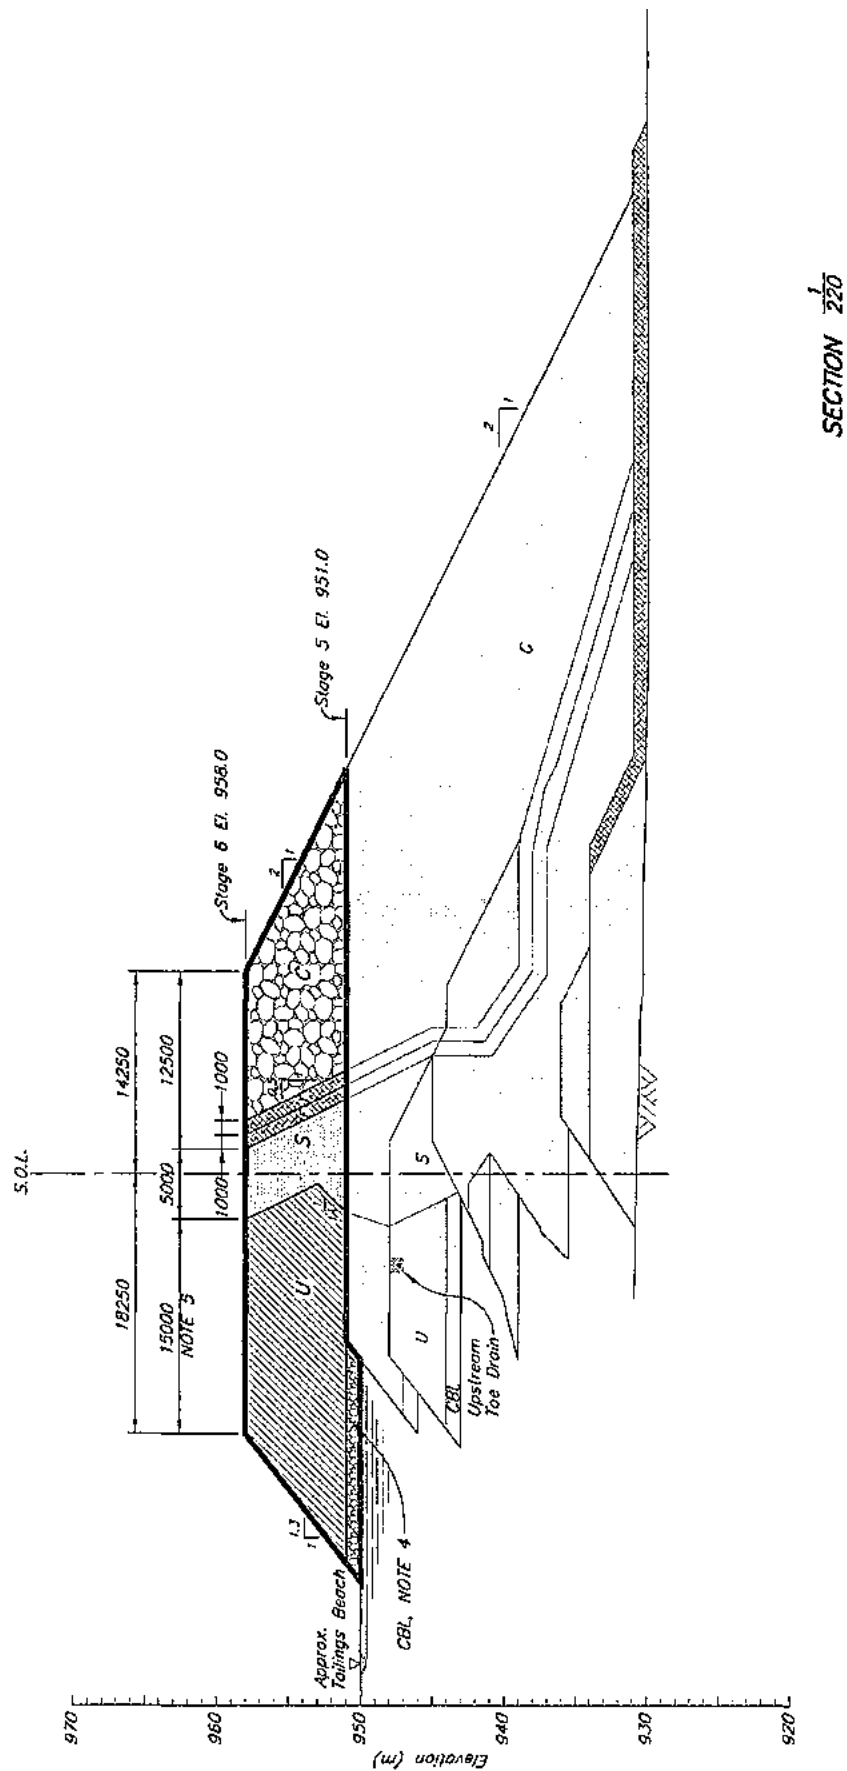
Figure 6.11 Stage 6 PE Section, Planned, without Interim Slope Knight Piésold (2007b) Dwg. 18-225 rev. 0

Design of Stage 6 was intended to accommodate a 7 m raise to an elevation of 958 m, sufficient to provide two years' storage to the TSF (see Figure 6.11). The design reflected the findings of the DSR conducted by AMEC (at that time, a third party firm) in October 2006. Additional design modifications included a reduction of the core width (Zone S) from 8 to 5 m based on improved performance of the dam's toe drains, and constructing a buttress at the ME. The design was also reflective of the mining plan that increased the total resource at the mine from 85 to 100 million tonnes, which would translate to an eventual height of 970 m for the TSF; and to an average daily throughput of 20,000 tonnes.⁷⁴

The DSR questioned the level of preshearing in the GLU and its effect on strength. As highlighted in the DSR, KP reviewed the issue of foundation soils: "laboratory testwork on the foundation soils indicates that the materials have adequate shear strength to ensure foundation stability of the embankments. The lacustrine unit at the Main Embankment is being investigated further and samples have been collected for direct shear testing to confirm the shear strength of this material."⁷⁵ No concerns were registered regarding foundation soils on the perimeter.

Stability analyses, conducted for the planned construction stage dam configuration, were also completed "to identify the buttress requirements at the Main Embankment *should a weak layer exist in the lacustrine material* (italics added)."⁷⁷ The stability analysis for the PE indicated a factor of safety of 1.7.

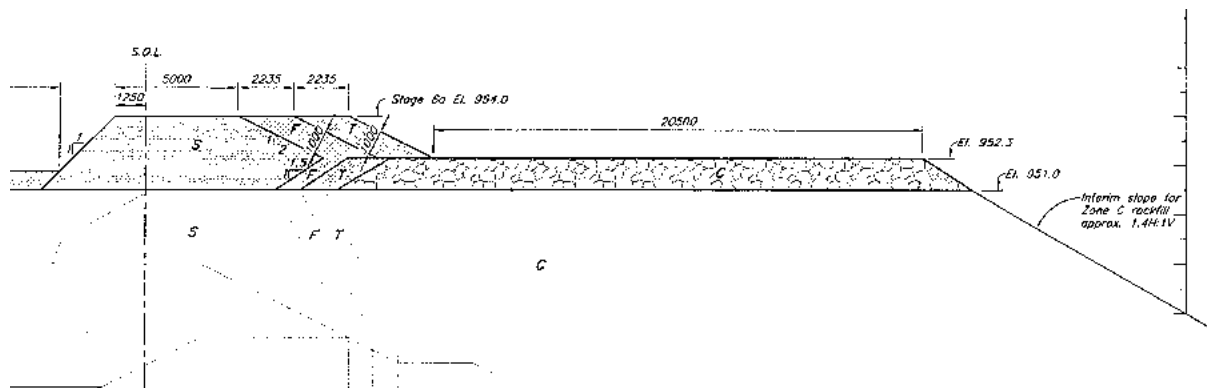
Figure 6.12 Stage 6A PE Section, As-Built: Detail Reflecting an Interim Slope of 1.4H:1V
Knight Piésold (2009b) Dwg. 225

Construction to an elevation of 954 m was completed in October 2008. Five new piezometers⁷⁸ were installed, for a total of 68 – 12 of which were foundation piezometers. Zones F, T, and C used screened, crushed waste rock from mine operations. At the request of MPMC, the design specifications for the slope of Zones S, F, and T were flattened to “facilitate the placement of the filter materials.”⁷⁹ As in the previous stage the upper portion of the embankment slope was 1.4H:1V and the lower portion was 2.0H:1V (see Figure 6.12; the full embankment section is shown in Figure 6.13).

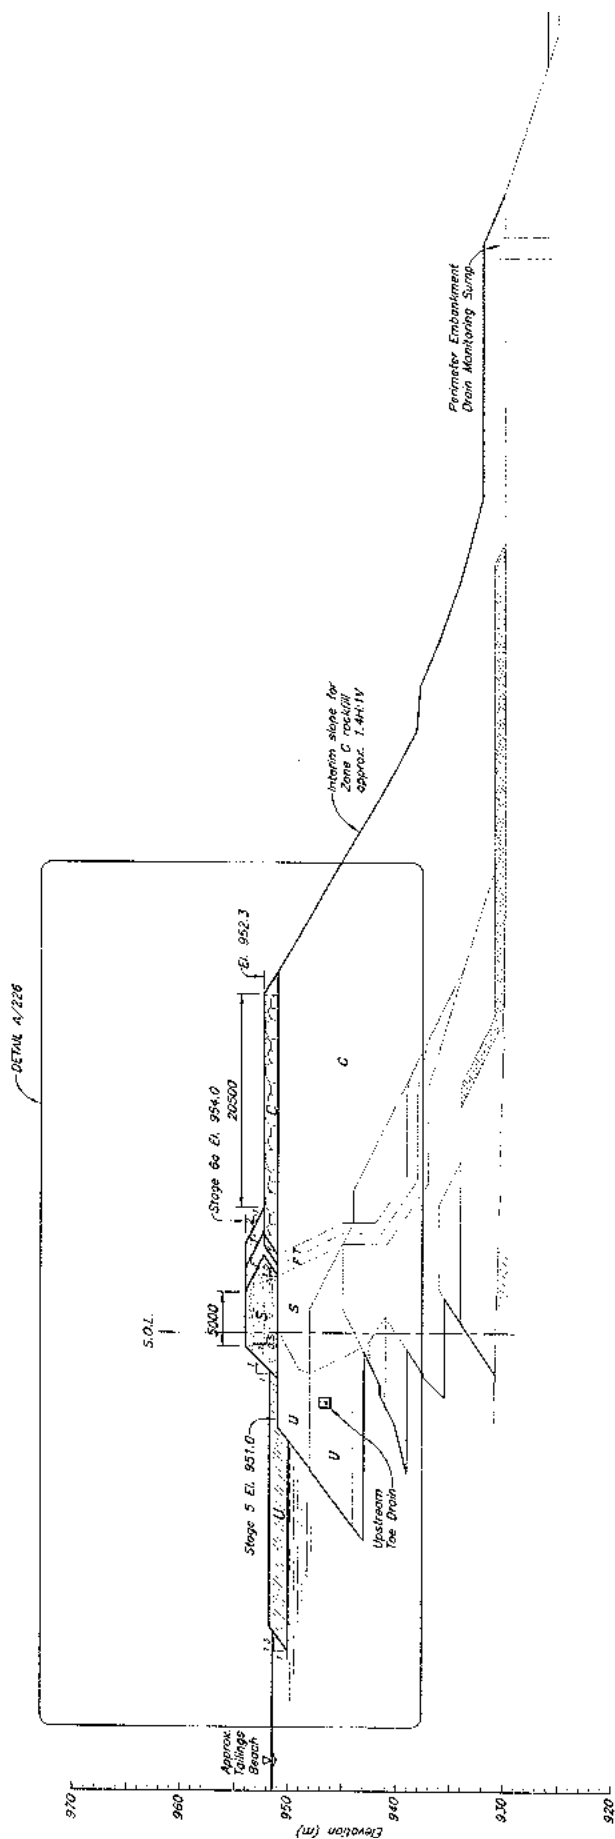
Figure 6.13 Stage 6A PE Section, As-Built
Knight Piésold (2009b)
Dwg. 225

During the 2008 construction season, a series of 11 sonic boreholes were drilled into a potential borrow area downstream of the PE (southwest of the breach area). Drilling to depths of 11 - 24 m, the drillholes exposed some lacustrine sediments, which “typically occur as poorly sorted fine sands and silts with trace clay. They have low to moderate plasticity and are typically moist to wet, very dense and massive. The lacustrine sediments occurred as thin lenses within the till units, or as thick deposits underlying the till.”⁸⁰ No laboratory testing results were reported on these samples.

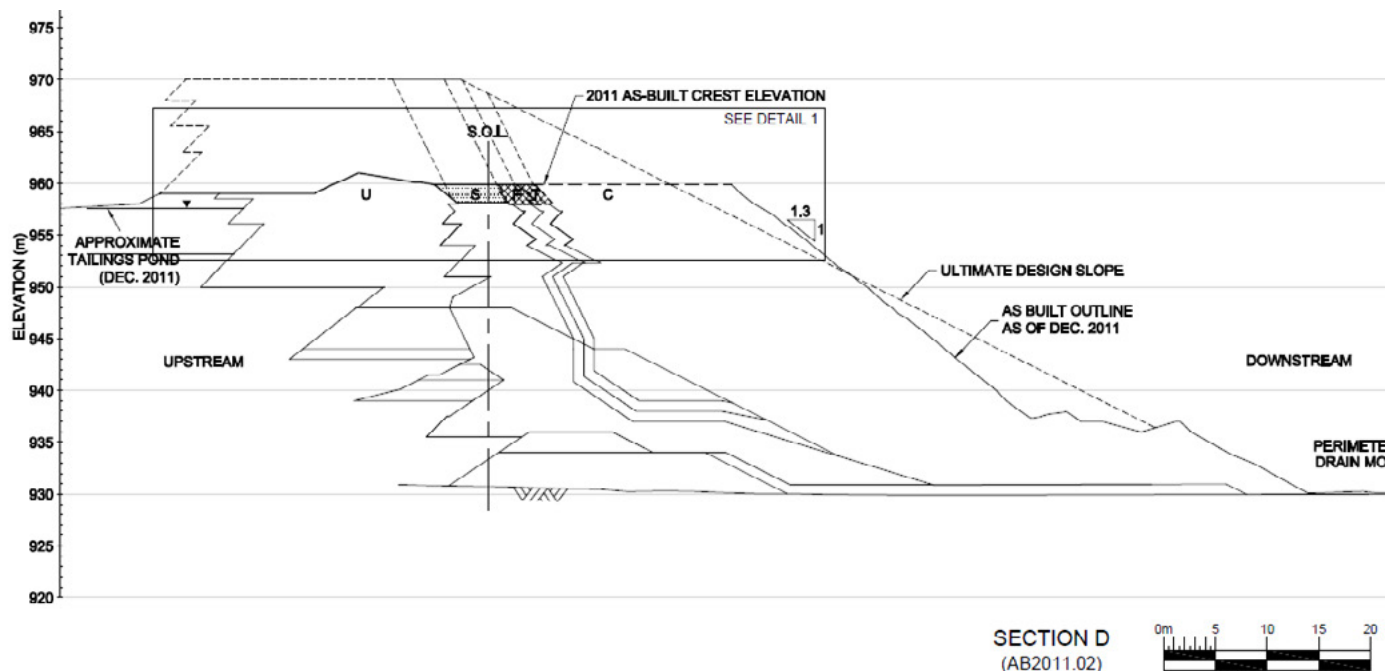
Figure 6.16 Stage 7 PE Section, As-Built, Reflecting an interim Slope of 1.3H:1V
AMEC Earth & Environmental (2012) Fig. 2011AB.05

The 2.1 m raise in Stage 7 took place between June 13 and September 21, 2011.¹⁰¹ Stage 7 fill placement was conducted by Peterson Contracting Ltd (Zones S and F) and by MPMC (Zones U, T and C). According to AMEC’s overall assessment of Stage 7, the construction “achieved conformance with design intent.”¹⁰²

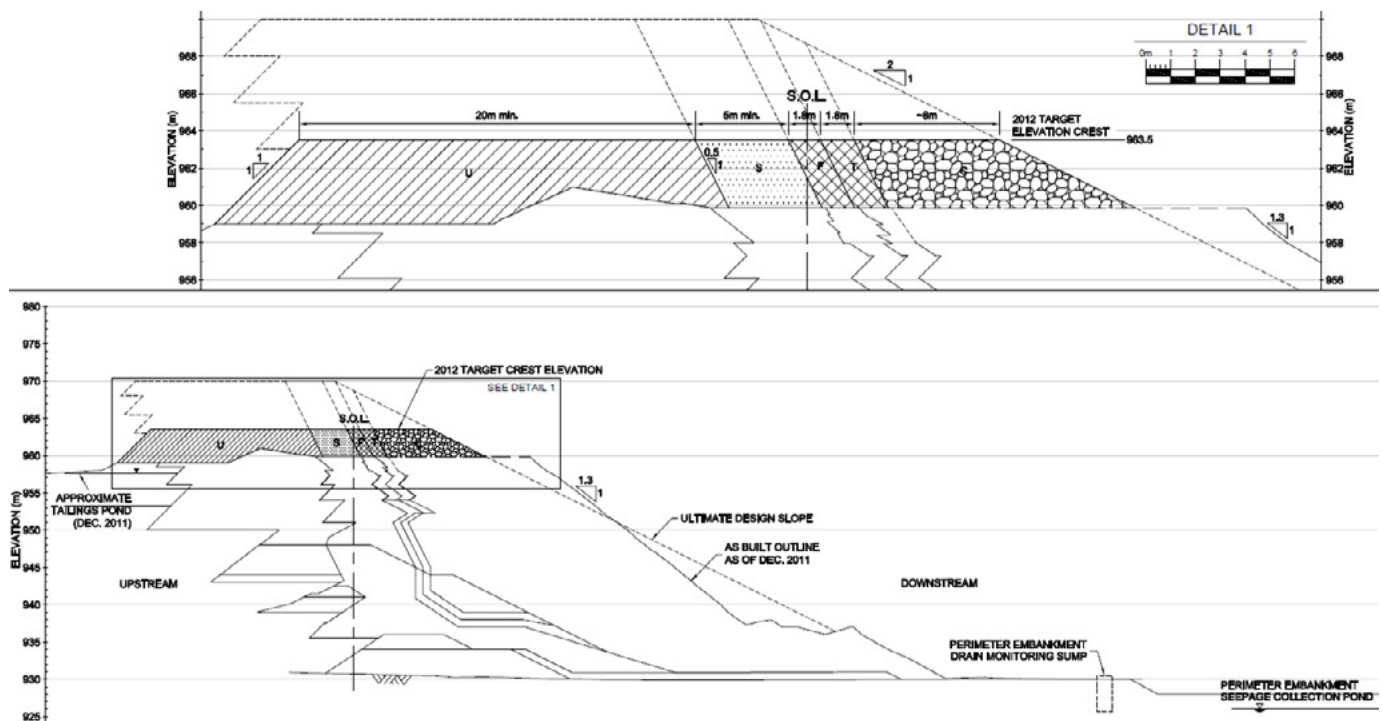
*Figure 6.17 Stage 8 PE Section, Planned, Reflecting an Initial Slope of 1.3H:1V
AMEC Environment and Infrastructure (2012a) Fig. 2012.05)*

Design of Stage 8 generally continued the design from Stage 7, with a raise of 3.0 to 3.4m following the modified centerline method, resulting in a narrowing of the dam crest. The PE downstream slope was again acknowledged at 1.3H:1V, with an “ultimate design slope” of 2H:1V (see Figure 6.17).

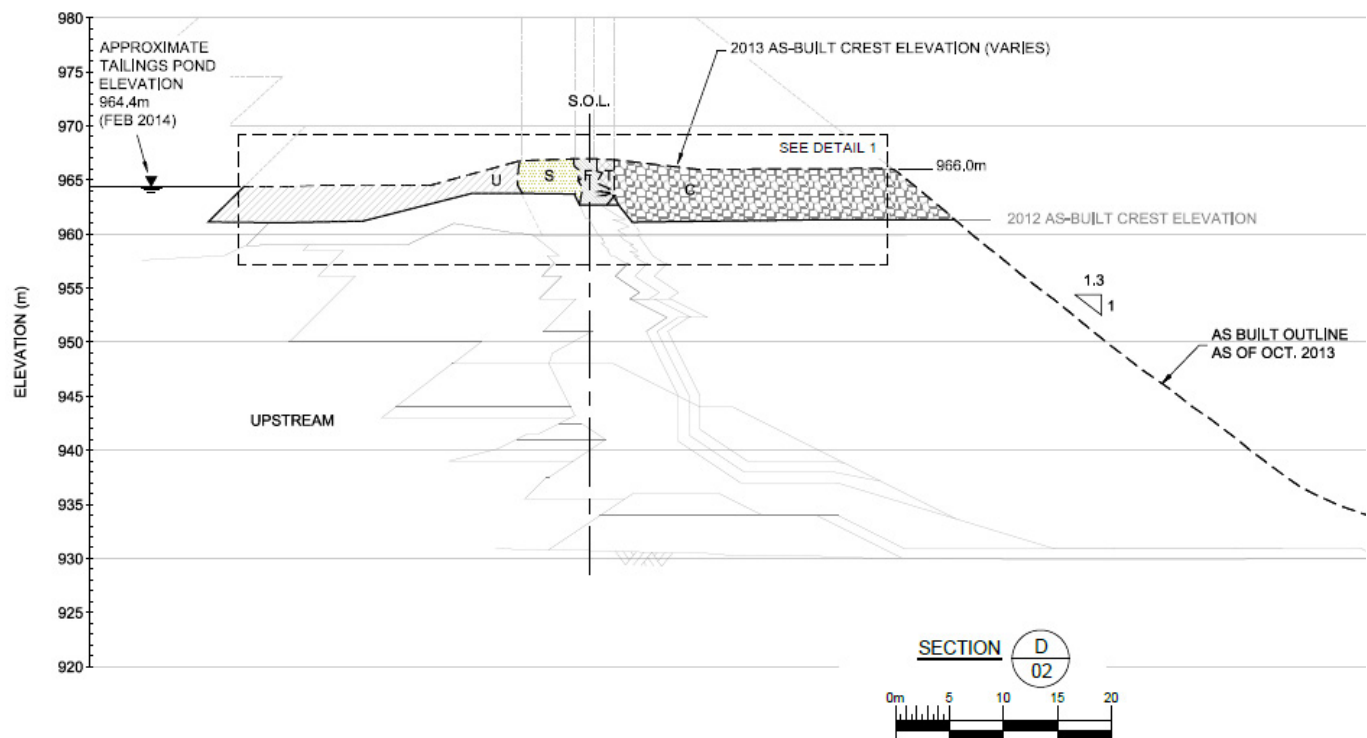
Figure 6.22 October 2013 PE Section, As-built, with Slope of 1.3H:1V
AMEC Environment and Infrastructure (2014a) Fig. 2013.AB04

At the end of the 2013 construction season, the PE was raised to 966 m (with a core elevation of approximately 966.5 m). The downstream slope of the PE remained at 1.3H:1V, and the maximum elevation of the dam was sketched in at 980 m (see Figure 6.22).

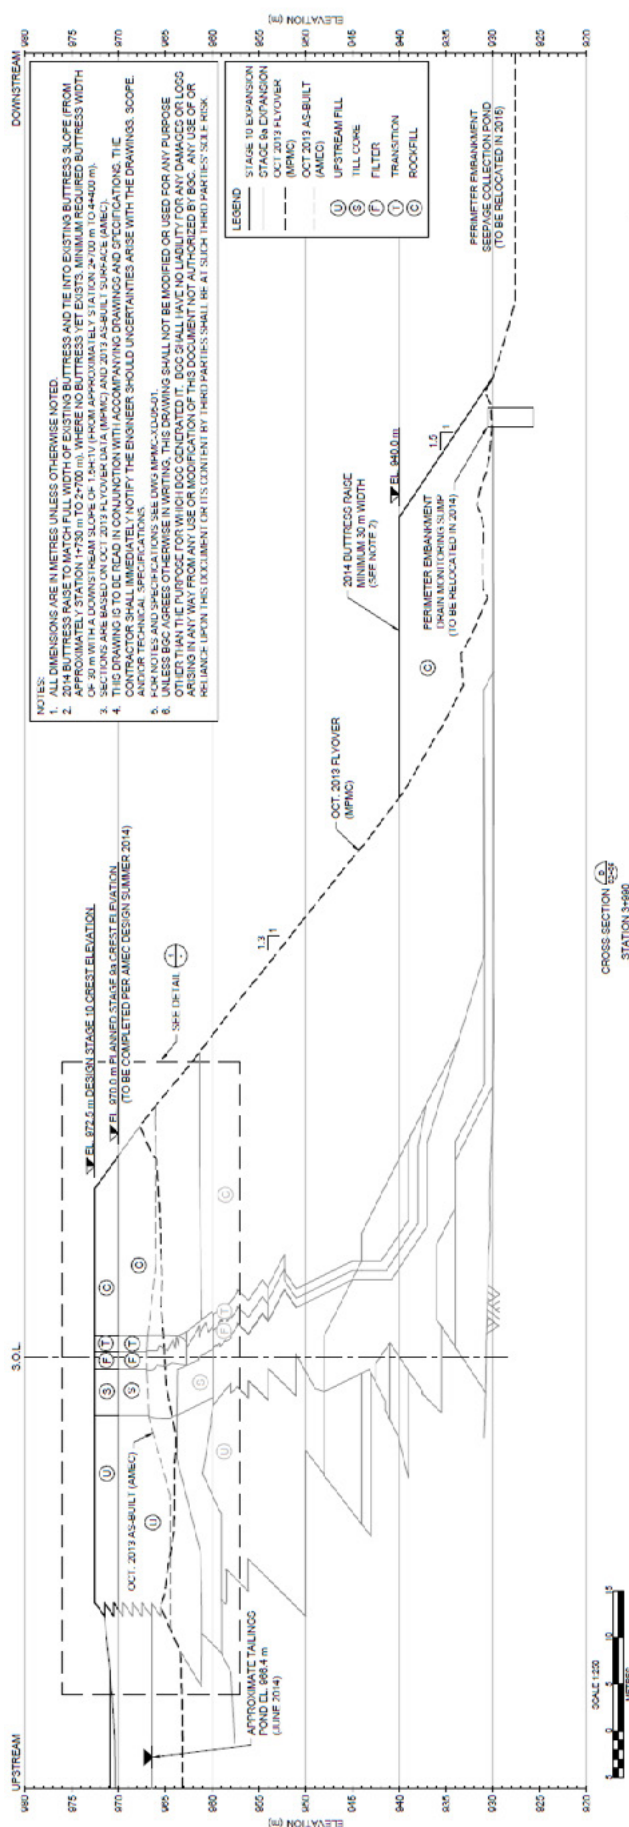
Figure 6.26 Stage 10 PE Section Plan
BGC Engineering Inc. (2014)
Dwg. MPMC-XD-03-02

The crest raise to 972 m “is expected to provide sufficient tailings, water storage, and flood storage freeboard until the end of September, 2015.”¹⁵⁰ Figure 6.26 shows both the construction lift at the dam crest and the development of a buttress to increase stability.

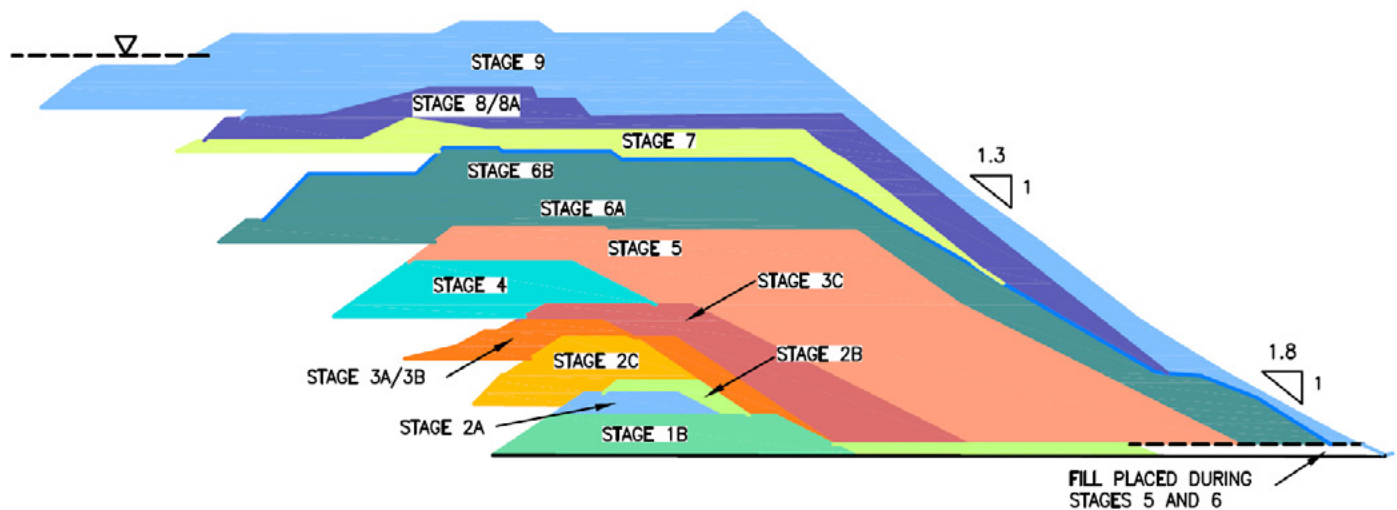
Figure 6.27 Embankment Stages Appendix 3, Fig. 2.6

The design profile of the PE at the close of Stage 9 (at the time of the failure) is shown in Figure 6.27. The elevation of the crest is 970 m; the height of the embankment at its highest point (where the breach occurred) is approximately 40 m, and the downstream slope is at 1.3H:1.0V.

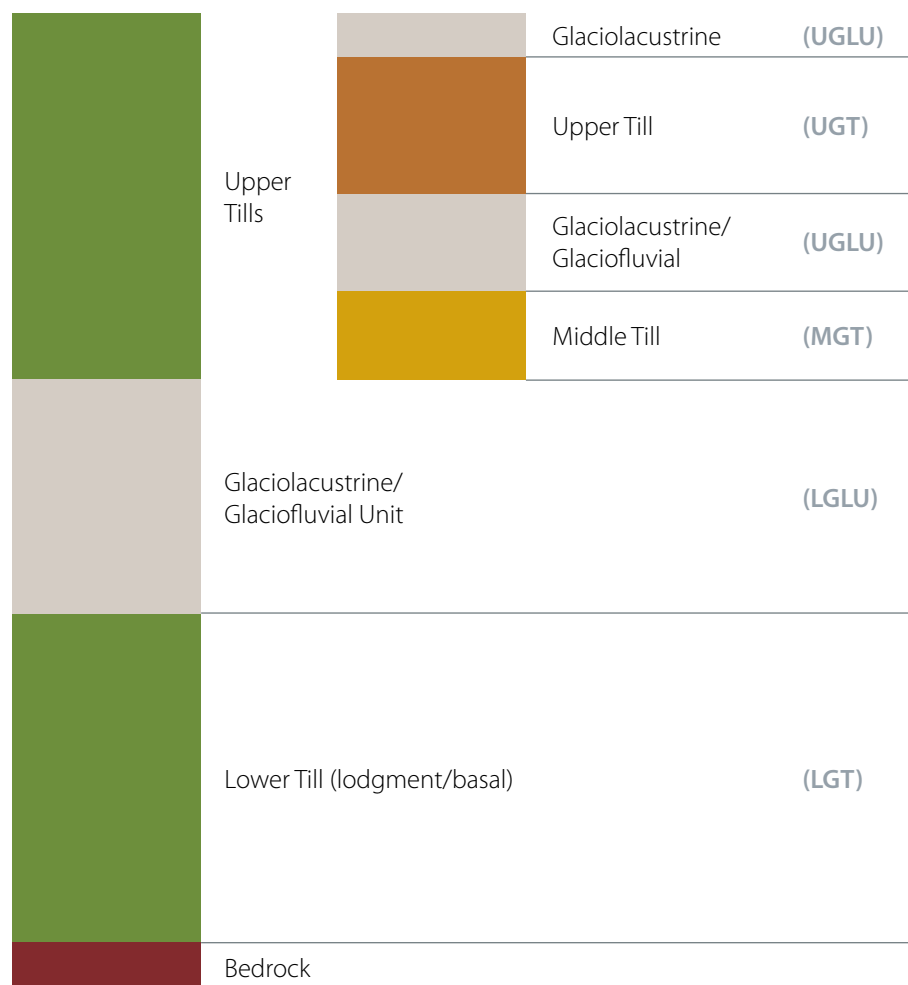
Figure 7.1 Schematic of Generalized Soil Units Appendix 3, p. 79

A simplified schematic illustrating the generalized soils units is presented in Figure 7.1. The left soil profile is the generalized summary of the foundation soils as known prior to the breach; the right side shows the additional detail gained from investigations following the breach.

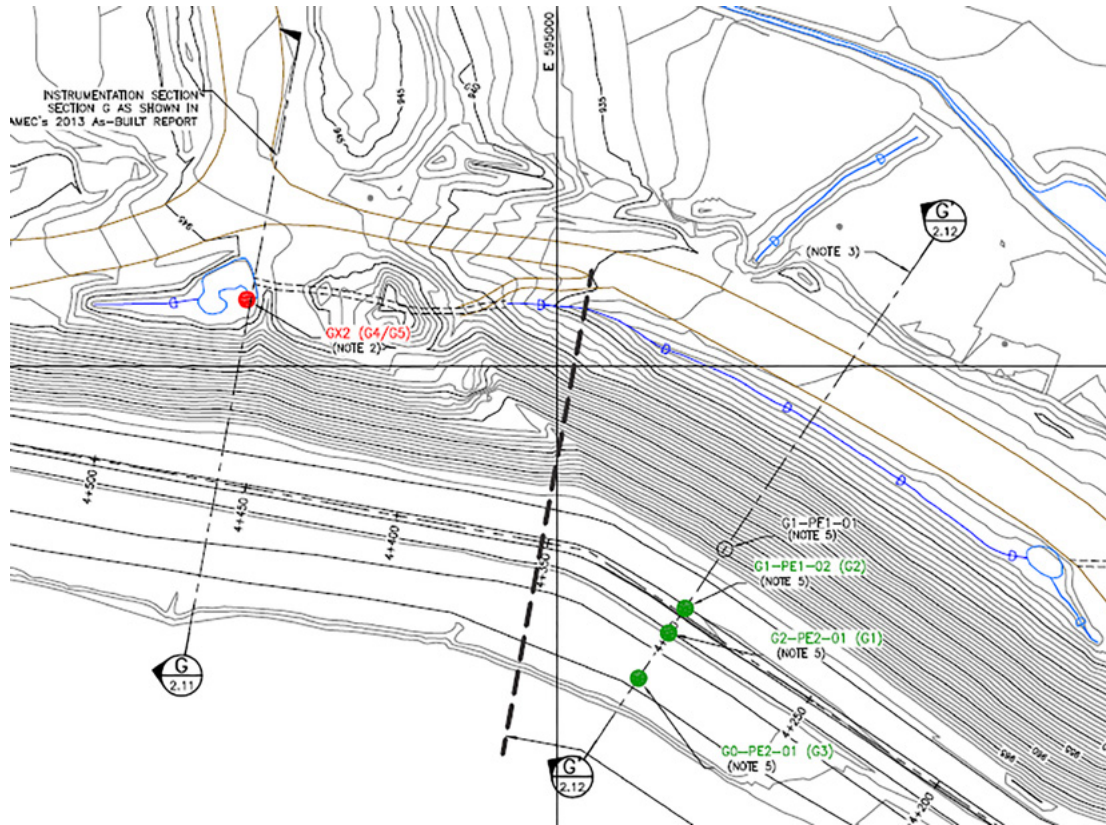
Figure 7.3 Instrumentation Plan at Section G and G' at Breach Site
Appendix 2, Fig 2.10

Figure 7.3 presents the pre-failure instrumentation plan at Corner 1 of the PE. Instrumentation includes: 17 vibrating wire piezometers, 2 slope inclinometers and flow measurements from the upstream toe drain. Reference information for the instrumentation is included in the *Failure Assessment*, Appendix 2.

The piezometers were either installed during construction within the tailings impoundment and fill materials, or installed in foundation soils during site investigations. In the area of the breach, piezometers were installed in the dam structure, but not in the foundation. 12 of the 17 vibrating wire piezometers at the PE were functioning in 2014. The functioning piezometers are located along three sections (2 are shown in Fig. 7.2; Section D is shown in Appendix 2, Figure 2.10:

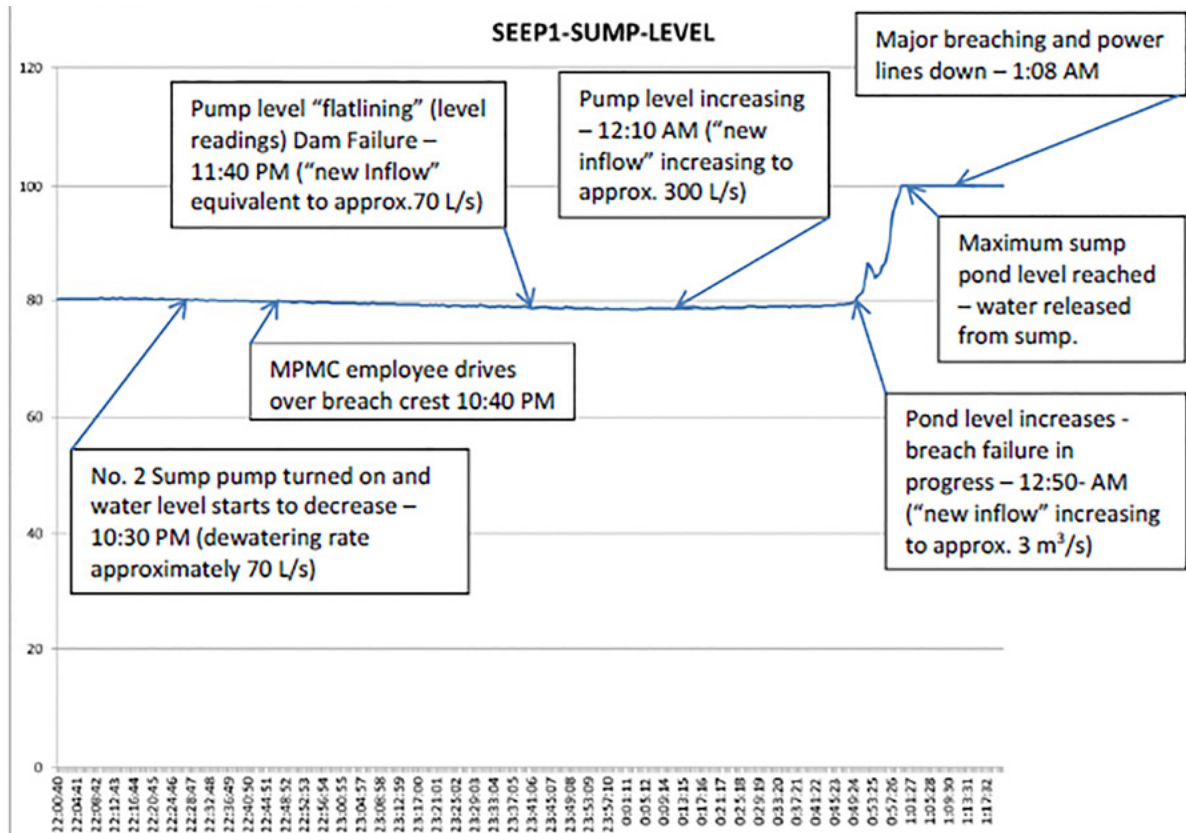
Figure 9.3 Perimeter Sump Volumes Appendix 3, Fig. 5-1

Following the structural failure of the dam, the breach increased progressively. While it is difficult to assign specific durations to each element of this sequence, flow records from the pump at the Perimeter Sump indicate the volume of water overtopping the dam at the times noted in Figure 9.3.

Overtopping flow rates began to increase at approximately 10:30 pm, and by 11:40 pm the rate was 70 L/s. By 12:10 am, the rate had increased to approximately 300 L/s. As the breach was in progress by 12:50 am, the flow level increased to 3 m³/s (or 3,000 L/s). The breach increased with sufficient flows to take down the power lines below the dam by 1:08 am.

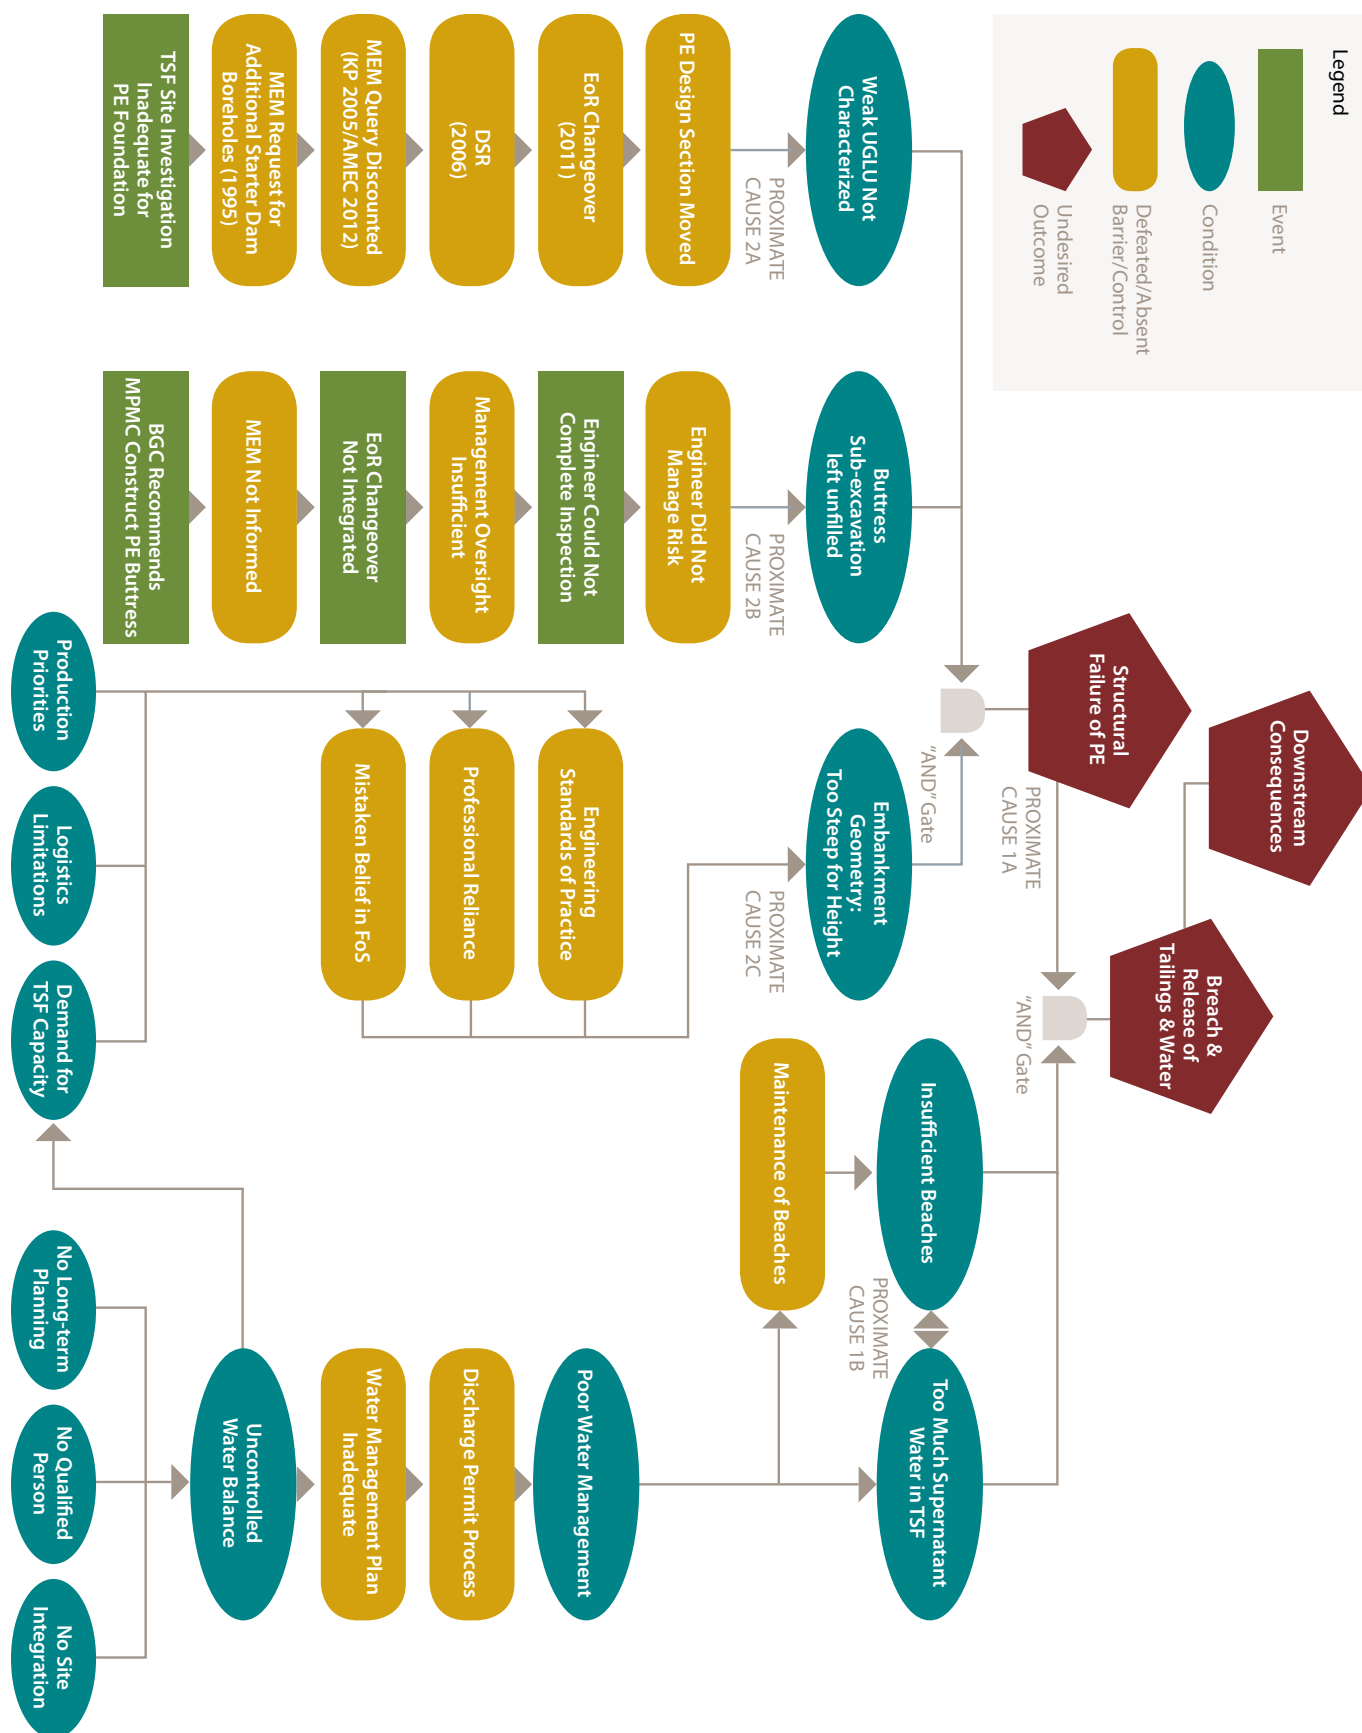
Figure 10.1 RCA Event and Causal Factor Tree - Summary Ministry of Energy and Mines (2015b)

This chapter presents the full analytical component of the RCA process undertaken by the investigation. The analysis is summarized in the ECFT in Figure 10.1.

Three proximate causes are associated with the structural failure of the PE: geometry of the embankment, an uncharacterized foundation glaciolacustrine unit, and an open sub-excavation at the embankment toe. The proximate causes are linked with an "and" gate, indicating that each of the three causes was necessary to produce the structural failure.
