MOUNT POLLEY MINE **TAILINGS STORAGE** **FACILITY BREACH**

August 4, 2014

Investigation Report
of the Chief Inspector of Mines

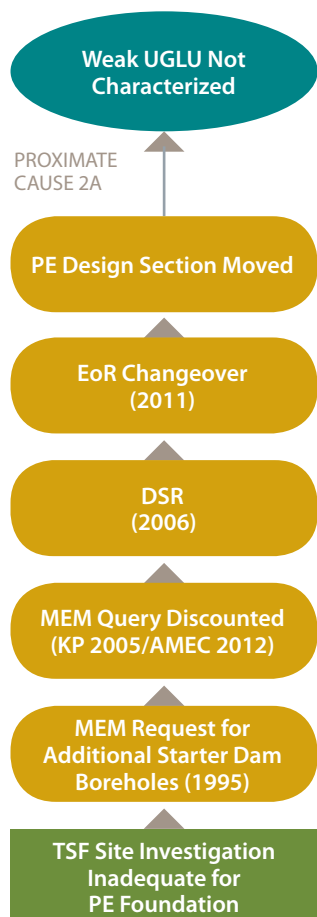
WEAK UGLU NOT CHARACTERIZED

- The glacial history of the dam foundation was not adequately understood.
- There was a disconnect between the level of understanding and an appreciation of uncertainty with respect to that understanding. The risk associated with the potential for weak UGLU was not appreciated, and never taken into account with stability analyses. There was limited effort to either conduct more soil exploration or to anticipate potentially unknown soils with a more conservative design. Either approach would have, in all likelihood, avoided the failure.

- Site investigations appeared to be focused on the initial starter dam (which was limited to the ME) or at most, the first two stages. Subsequent construction stages seemed to operate on the assumption that all necessary foundation studies had been completed during the initial design phase, and that test holes were mainly for installation of monitoring instrumentation.

the root cause associated with Proximate Cause 2A is that the site investigation conducted for the Perimeter Embankment was inadequate

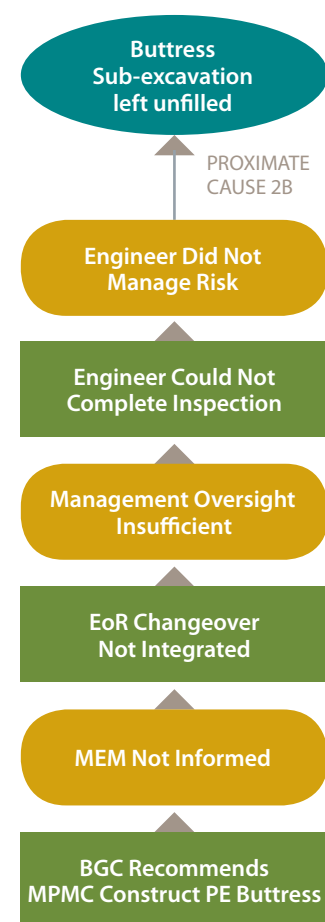
BUTTRESS SUB EXCAVATION LEFT UNFILLED

The design for the PE buttress, including detailed construction drawings, was submitted to MEM as part of the Stage 10 *Mines Act* permit amendment application prepared by BGC Engineering, and received by MEM on July 25, 2014 — 10 days before the breach event.

The root cause associated with Proximate Cause 2B is that an unapproved buttress subexcavation reduced the PE Factor of Safety

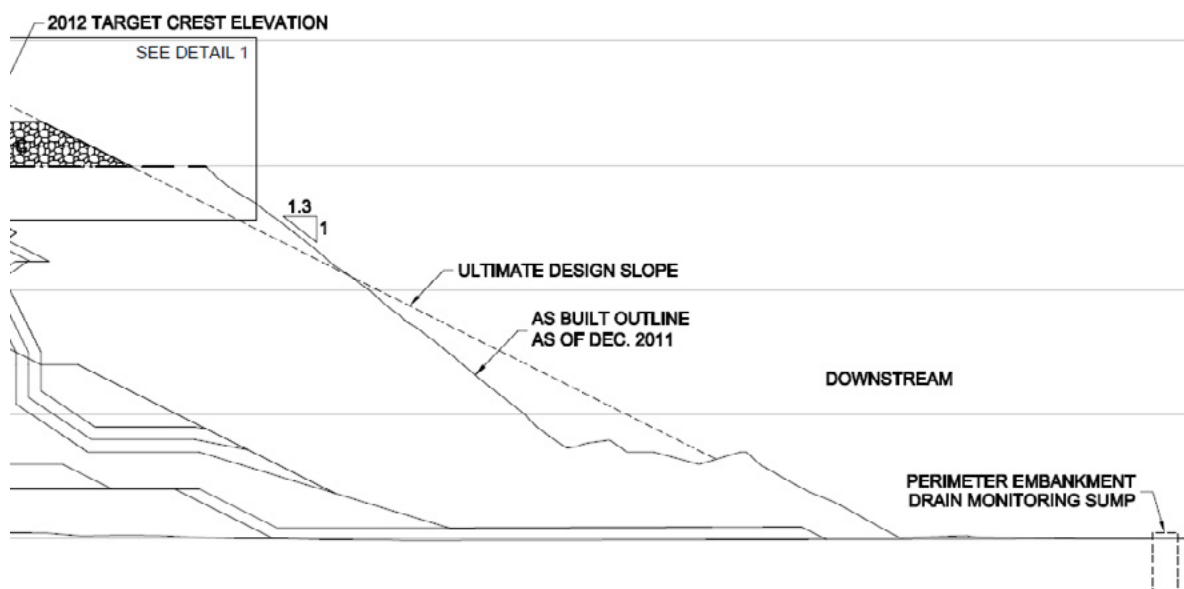
*Figure 10.4 PE Downstream Slopes. AMEC Environment and Infrastructure (2012c)
Dwg 2012.05*

The final proximate cause of the structural failure of the PE is embankment geometry: both steepness of the downstream slope and the height of the embankment (see Figure 10.4). A downstream rockfill shell with adequate slope represents a conventional engineered barrier: it is a completely passive, effective defense against failure of an embankment.

Mirroring the Stage 7 as-built report, the *Stage 8 (2012) Construction Manual* acknowledged an as-built slope of 1.3H:1V, with the drawing (see Figure 10.4) noting a 2H:1V slope as the “ultimate design slope,”⁴⁴ the slope that would remain after closure. Language referring to an “interim slope” no longer appeared in design documentation. The *Stage 8 As-Built and Annual Review Report* documented a 1.3H:1V slope as of October 2013 without comment on the as-built drawings.⁴⁵ The slope became accepted in Stage 9: the *Stage 9 Construction Manual* specified a 1.3H:1V downstream slope without comment.⁴⁶

The steepness of the downstream slope contributed to the initiation of the failure of the PE on August 4, 2014. The over-steepened slope and increased height of the dam led to stress concentration below the downstream slope of the dam within the UGLU, which ultimately induced undrained strength behavior, leading to progressive failure of the dam.

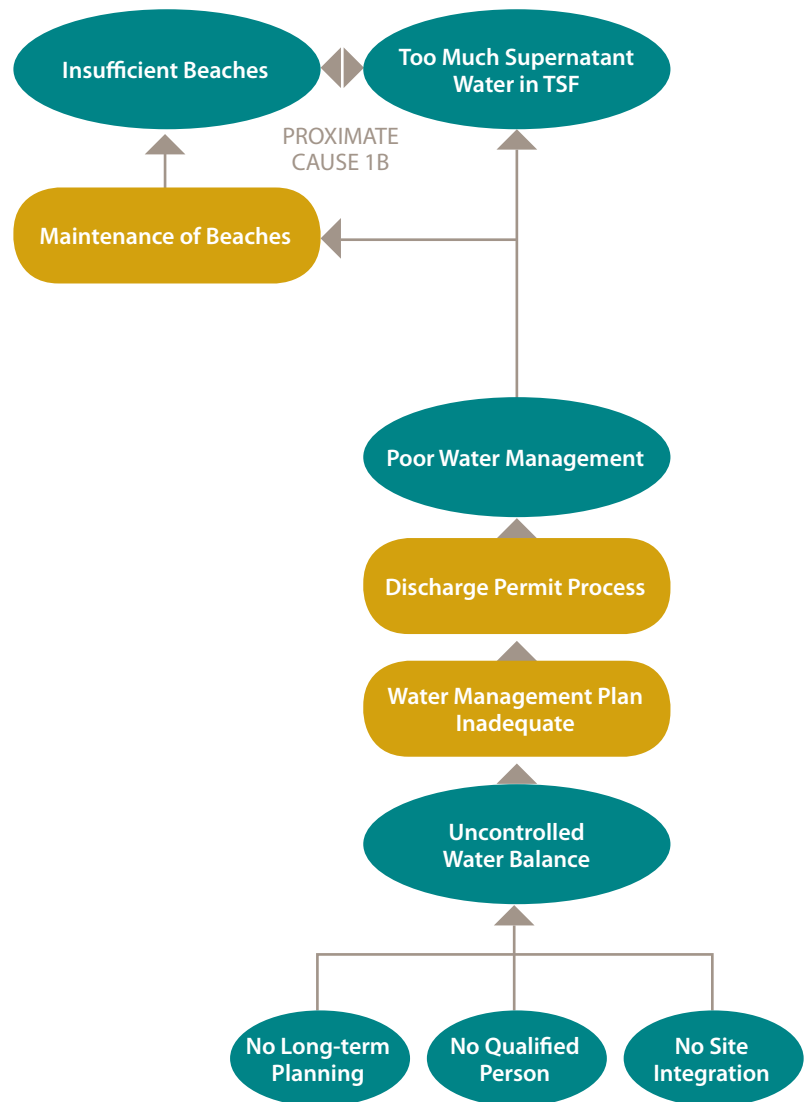
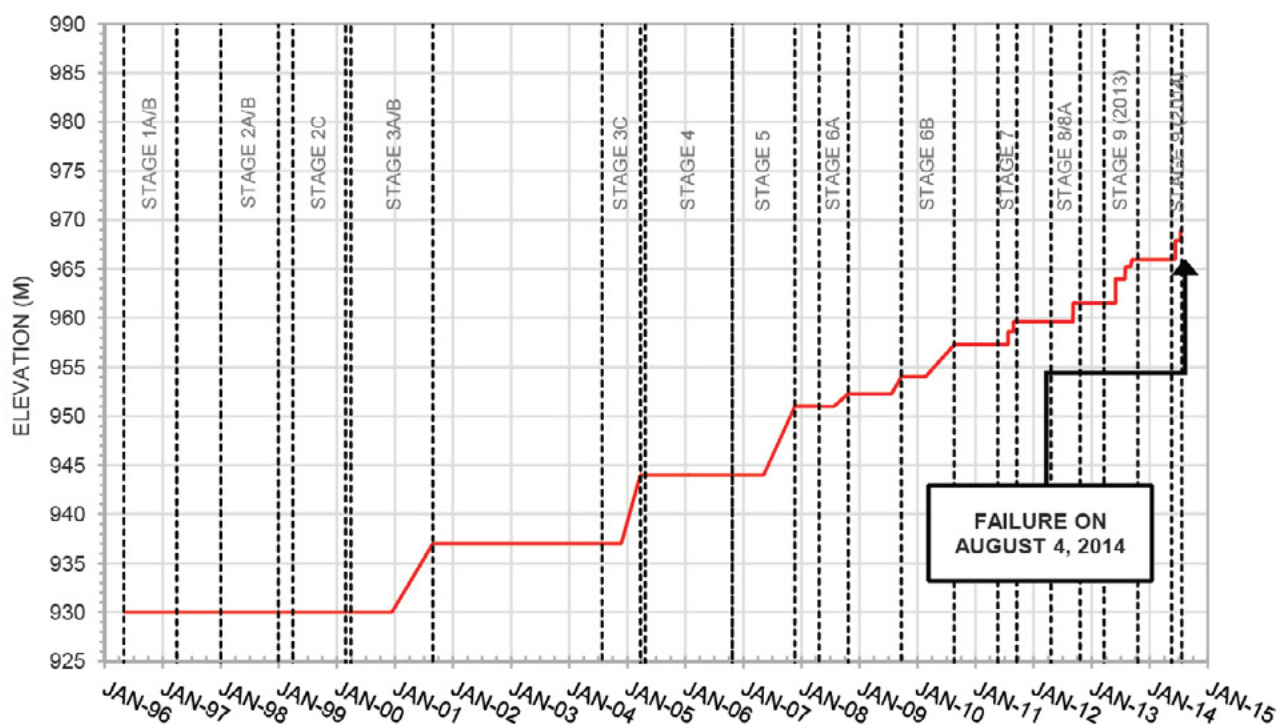
Water Levels. Both a tailings deposition model and an effective water balance are needed to assess if the tailings beach can be maintained throughout the operation of the TSF. Historical pond elevation and tailings beach levels are shown in Figure 10.6 below. The pond elevation immediately prior to failure was 966.8 m (freeboard was reported to be between 2.7 and 3.0 m) as reported in AMEC's daily report dated August 3, 2014. The beach elevation in the area of the breach at that time was estimated to be 966.3 m as inferred from the post-failure tailings contours outside the breach area, the observed submergence of the tailings beach and photographic records from August 2014.⁵⁴

Figure 10.6 Embankment Zone C Elevation Over Time
Independent Expert Engineering Investigation and Review Panel (2015), p. 5-5
