Report of the Expert Panel on the Technical Causes of the Failure of Feijão Dam I

December 12, 2019

EXECUTIVE SUMMARY

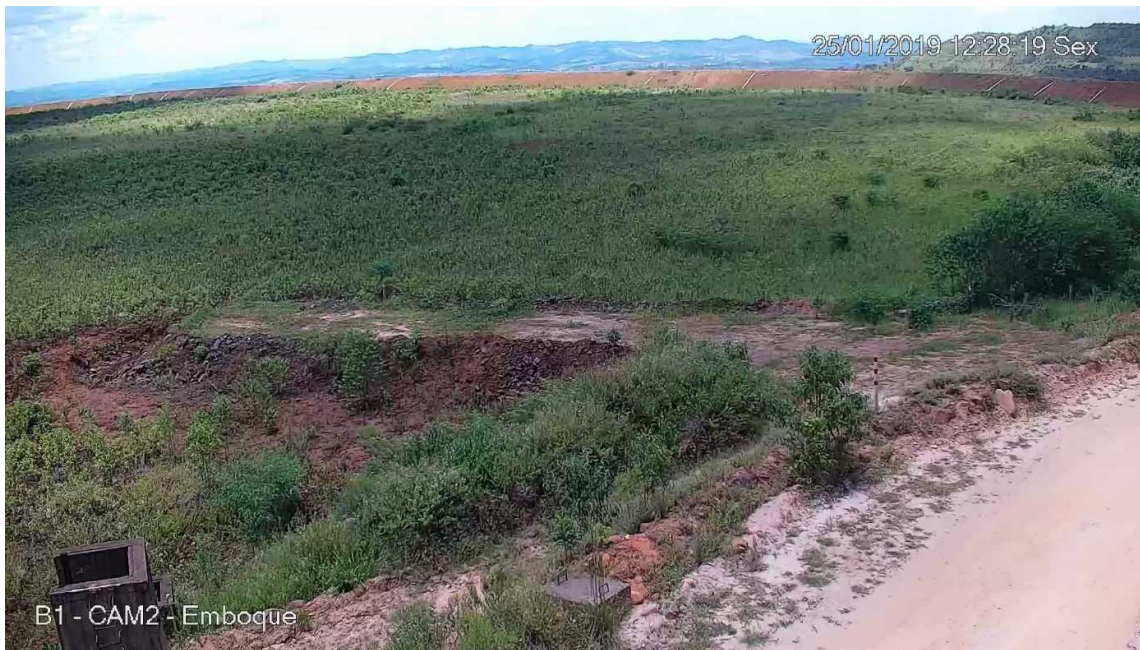
Figure 13: Just Prior to the First Observed Deformation, as Captured by CAM2

CAM2 confirmed that the initial failure was relatively shallow and started just behind the crest. CAM2 also clearly shows the regression of the failure into the stored tailings, eventually stopping close to natural ground, as seen in Figures 13 through 17. CAM2 also shows that after each failure slice, the failed material appears to become a heavy liquid.

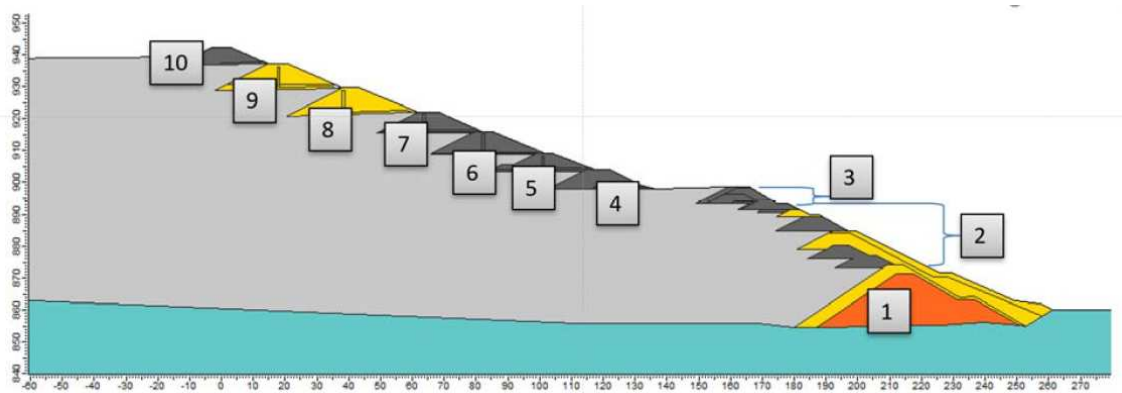
Figure 19: Dam I Cross-section, Showing Raisings and Stages of Construction⁸

Dam I was constructed over a 37-year period from 1976 to 2013 in 15 stages, corresponding to 10 raises. A summary of the history is shown in Table 1, and the raises and stages are illustrated schematically in the cross-section in Figure 19. As shown in Figure 19, the Fourth Raising was set back compared to the previous three raisings, resulting in the straightening and modification of the dam centerline. The setback reduced the overall slope of the dam but moved the upper portion of the dam over weaker, finer tailings and brought water closer to its face. Having water closer to the face also can limit surface drying of the deposited tailings from exposure to sun and wind. No new raisings were constructed after 2013, and the placement of tailings ceased in July 2016.

Upstream construction resulted in movement of the crest upstream over time, as illustrated in Figure 19. Using this method, the dam was constructed to a total height of 86 m (toe to crest), with a final crest elevation of 942 meters above mean sea level (m msl) and a crest length of 720 m. The height of each raising varied from 5 m to 18 m. The upstream and downstream slopes of the berms constructed in each raising varied from 1.5 horizontal to 1 vertical (1.5H:1V) to 2.5H:1V; however, slopes of 2H:1V were used in most cases.

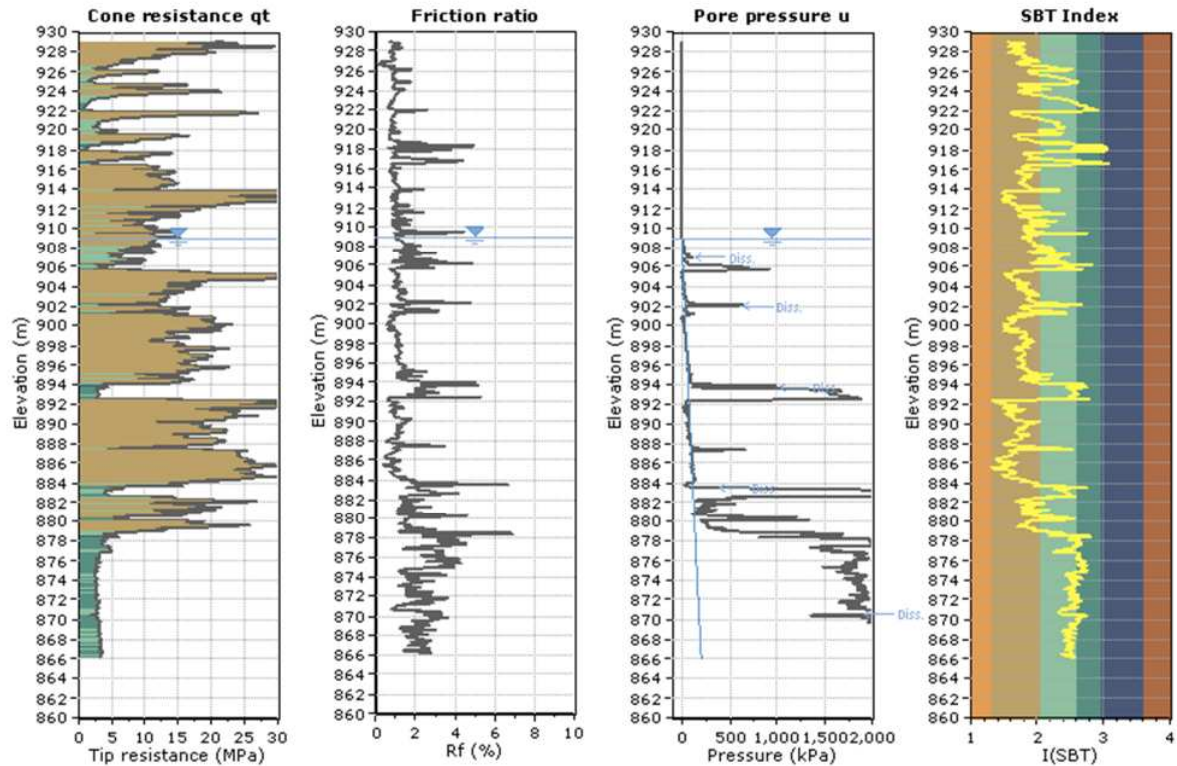
Figure 22: Example CPTu Profile for PZE-29-35

elevation of 872 m msl. The CPTu shown in Figure 22 illustrates the predominately coarse tailings with thin layers of fine tailings.

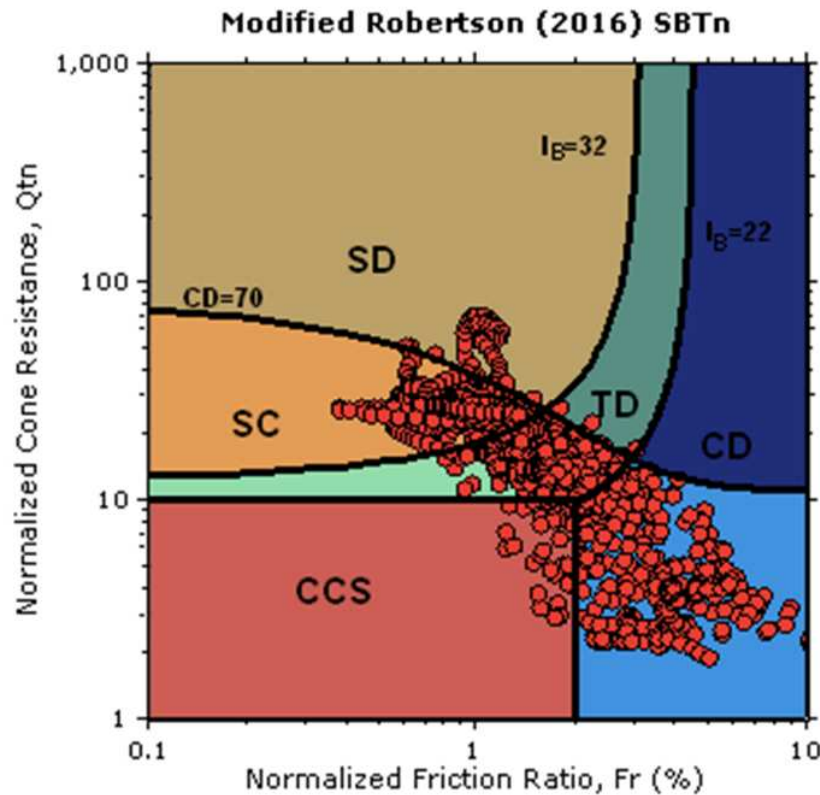
Figure 23: Example CPTu (PZE-29-35, from Elevation 910 m msl to 878 m msl)

The CPTu results indicate that the tailings are predominately loose and contractive at large strains, consistent with other hydraulically deposited tailings. Figure 23 shows an example CPTu (PZE-29-35) on the modified soil behavior type chart¹² to illustrate that the tailings below the water level (in this case, those collected between elevation 910 m msl to 878 m msl) are contractive at large strains. The CPTu data shown in Figure 23 were normalized using an appropriate high unit weight for the tailings and the measured downward piezometric gradient.

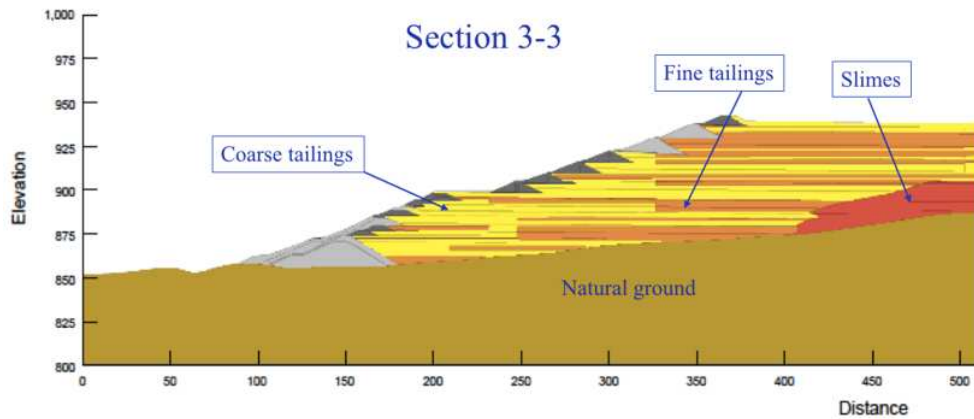
Figure 24: Recreated Cross-section 3-3 Based on Historical Data, Expanded to Show Details Under the Dam

Figure 24 shows an example of a recreated cross-section for the steepest and highest section of the dam (cross-section 3-3). Figure 24 shows that the predominate material under the dam was coarse tailings (shown in yellow) with thin layers of fine tailings (shown in orange). In general, the tailings become more fine-grained with depth, reflecting the increasing distance from past crest elevations during the upstream construction. The slimes (shown in red) are generally farthest from the Dam.

An example of a recreated cross-section (3-3) is shown in Figure 24 that illustrates a complex layering of coarse and fine tailings underlying the dam extending approximately 200 m upstream. Soil parameters were based on the available field and laboratory data, and were varied to calibrate the seepage model until the calculated water pressures matched the measured

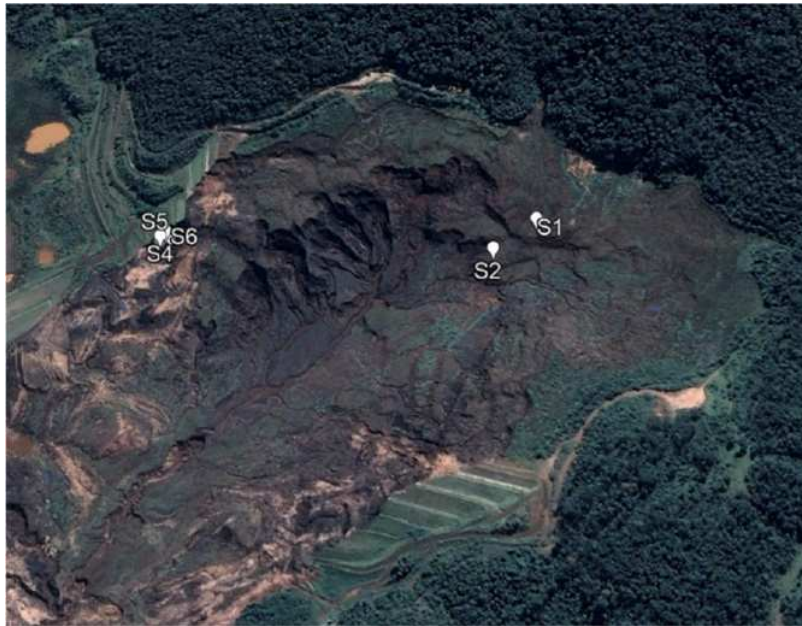
Figure 27: Sample Locations from June 2019 on Post-failure Image

The bulk samples of coarse tailings were taken from exposed surfaces of intact tailings that represent beach tailings from previous raises below the final dam, as shown on Figure 27. The samples were obtained from an exposure that was estimated to be below the Seventh Raising at the right abutment. Figure 28 shows the distinct thin layering in the coarse tailings sample locations.

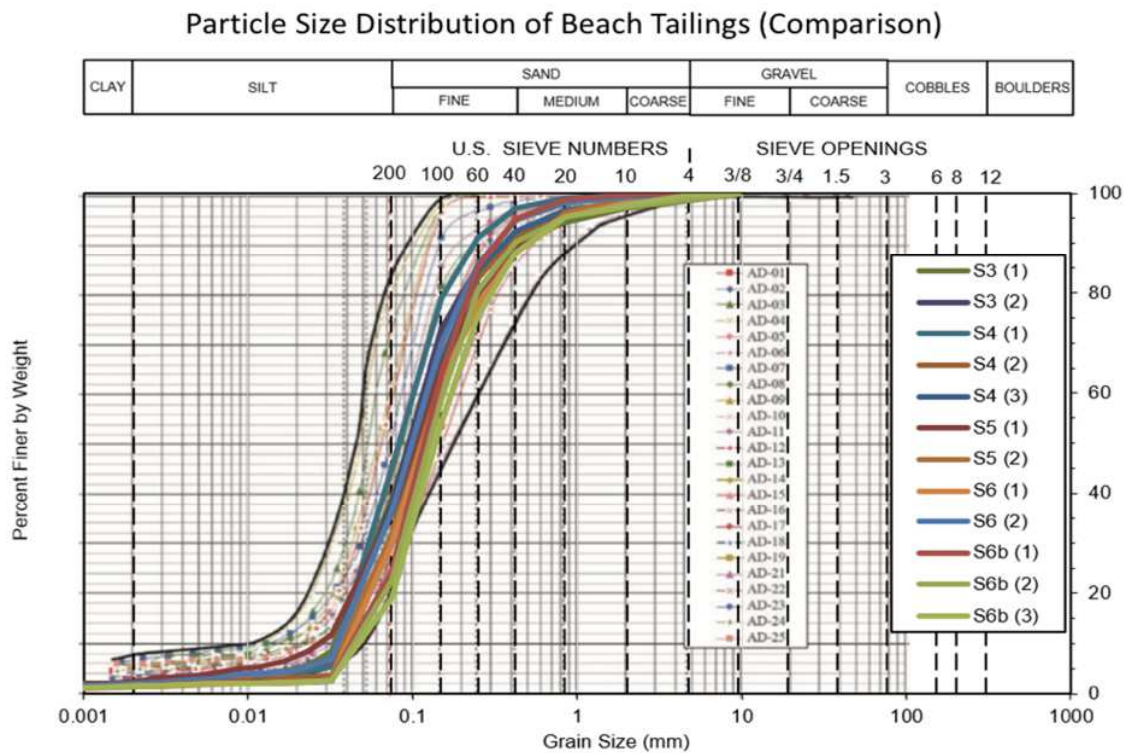
Figure 30: Comparison of Particle Size Distribution Curves from the 2019 Samples with Pre-failure Historical Data

The index testing confirmed that the coarse tailings are poorly graded and have a fines content (based on 0.075 mm sieve size) between 20% and 50%, and are non-plastic. The fine tailings under the dam have a fines content between 50% and 90%. The slimes are more well graded with essentially 100% fines content and PI of around 18%. Figure 30 shows a comparison between the coarse tailings particle size distribution curves collected in 2019 and some historical curves, and shows that the 2019 samples are similar to historical samples collected under the pre-failure dam.

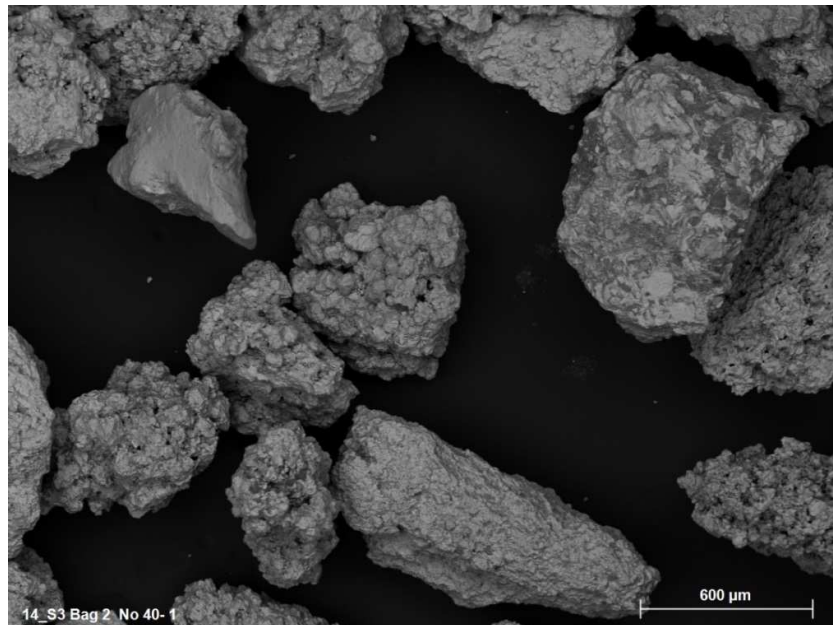
Figure 31: SEM Image of Sample 3 Bag 2 – Coarse Tailings

Scanning electron microscope (SEM) images were taken of samples of coarse tailings and slimes from the June 2019 field program to qualitatively assess particle structure, angularity, and other parameters at the microscopic level. Example images are shown in Figures 31 (coarse tailings) and 32 (slimes). The SEM images confirm the high iron content and show that the particle shape is similar for both materials and that the grains are typically sub-angular to angular with rough, often pitted surfaces. Additional SEM images were taken to study the interaction between particles and showed evidence of bonding between particles, shown in Figures 33 and 34. The nodules shown in Figure 33, and highlighted in Figure 34, are composed of iron oxide. The bonding appears to be derived from clay-size iron oxide. It appears that oxidation of the iron produces bonding between particles.

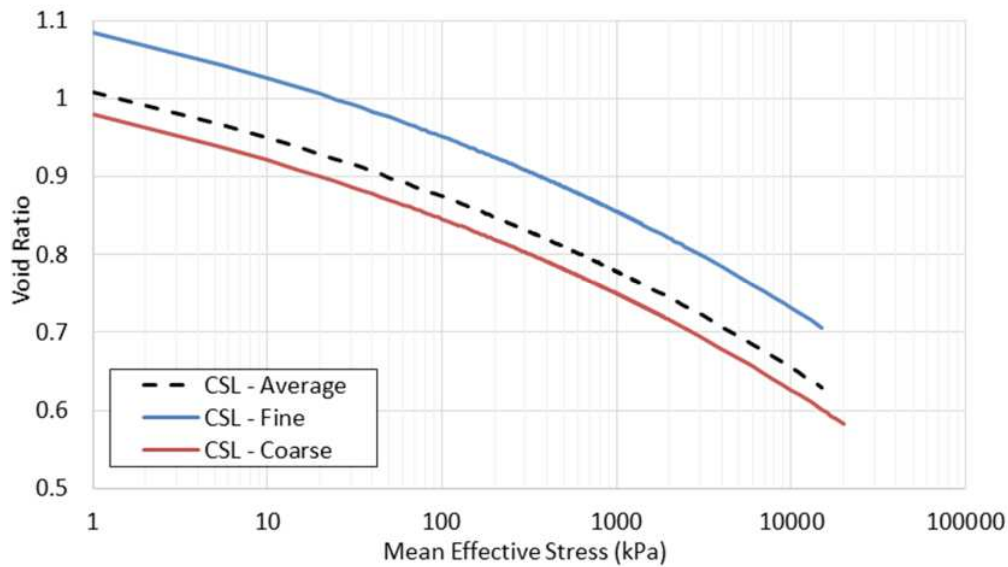
Figure 36: Comparison of CSLs for the Representative Tailings Tested

The shape and location of the CSLs, shown in Figure 36, are consistent with the similar grain characteristics (shape, angularity) and mineralogy of the tailings tested, even though the mean particle size varies. The ϕ'_{cs} for each gradation was also very similar with an average value of 34 degrees.

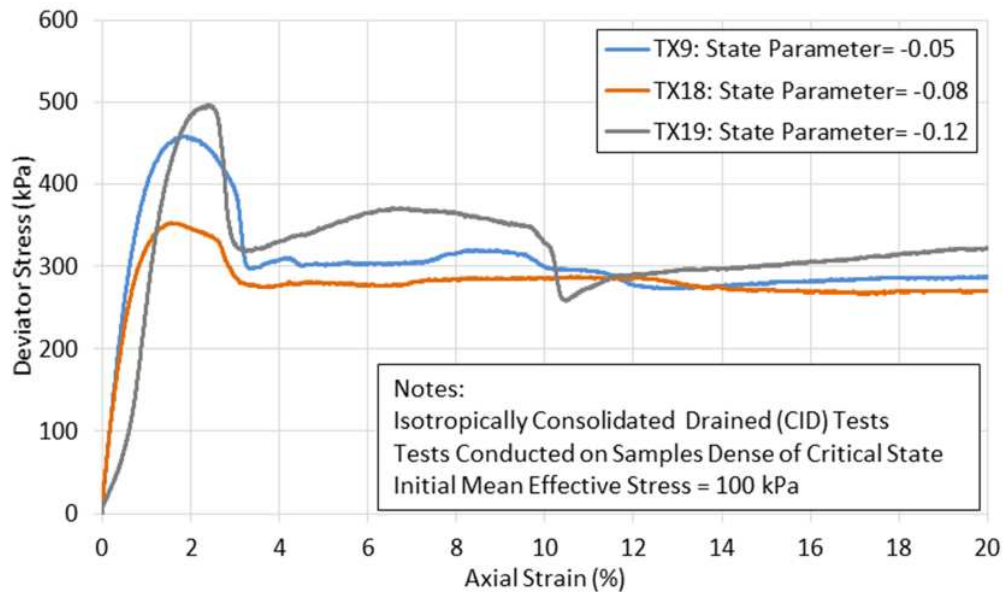
Figure 37: Comparison of Isotropically Consolidated Drained Triaxial Tests on Average Gradation Samples at Different State Parameters that are Dense of CS

Figure 37 compares the results of isotropically consolidated drained (CID) triaxial tests on average gradation samples consolidated to the same effective stress (100 kPa) but prepared to different state parameter (ψ) values (void ratio) that are dense of CS. The rapid strength loss and the peak strength is inconsistent with the state (void ratio) of the samples (e.g., the looser state ($\psi = -0.05$) has a similar peak strength as the densest state ($\psi = -0.12$)).

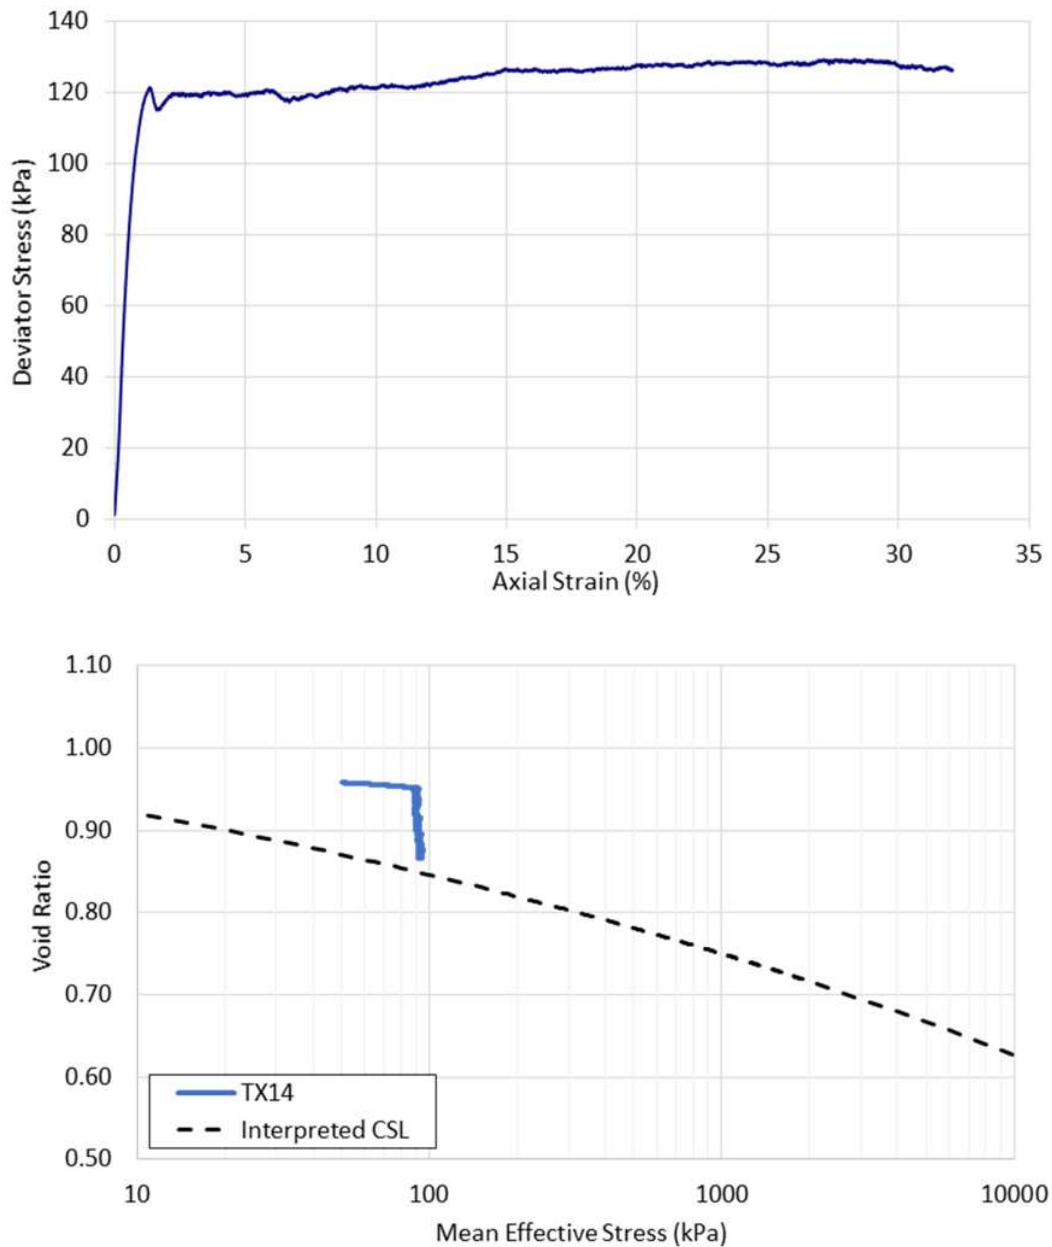
Figure 38: CID Triaxial Test Result on an Average Gradation Sample Consolidated to 50 kPa Prepared to a State Loose of CS ($\psi = +0.09$)

Figure 38 shows the test result of a CID triaxial test on an average gradation sample consolidated to 50 kPa and prepared to a state that is loose of CS ($\psi = +0.09$). For a sample that is loose of CS, the expected behavior would be for the sample to show a gradual increase in deviator stress (q) combined with a gradual decrease in volume to CS. However, this test showed a very stiff response to peak q at an axial strain of about 1%, followed by an abrupt reduction (collapse) in volume at a constant mean effective stress (p') and q .

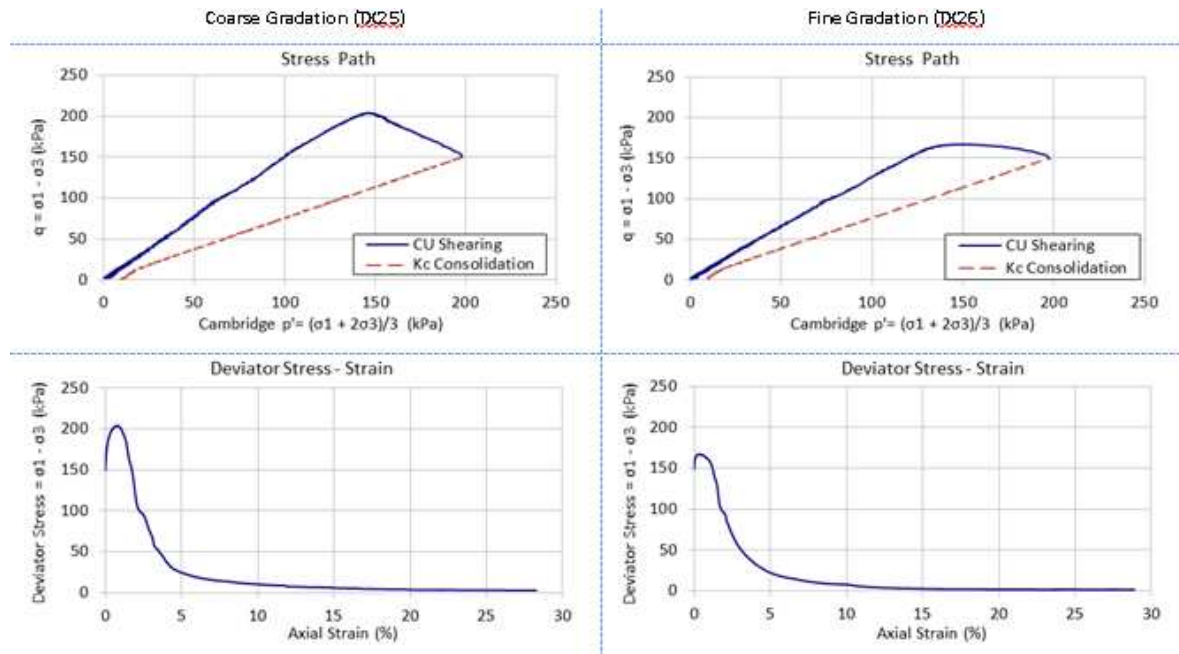
One anisotropically consolidated undrained (CAU) triaxial test was performed on fine and coarse gradations to assess the undrained response of a loose sample of these gradations to identify whether they are similar. Both samples were anisotropically consolidated to a mean effective stress of 200 kPa and a ratio of horizontal to vertical effective stress, K_0 , of 0.5 before starting the undrained loading. The fine and coarse samples were prepared to the same state parameter of $\psi = +0.07$. The results of these tests appear in Figure 39, which shows that both samples generated an extremely brittle response during the undrained loading. The samples failed at 0.3% and 0.8% axial strain for the fine and coarse gradations, respectively. The peak strength ratios ($S_{u(peak)}/p'$) for the fine and coarse gradation samples were 0.42 to 0.51, respectively (equivalent to $S_{u(peak)}/\sigma'_v = 0.26$ and 0.34). The residual strength ratios ($S_{u(residual)}/p'$) for the fine and coarse gradation samples were 0.005 to 0.01, respectively. These peak strength ratios are significantly higher than empirical estimates based on CPTu data, such as those of Olson and Stark (2002), and the residual (or liquefied) strength ratios are significantly lower than empirical estimates, such as those of Robertson (2010). The test results also confirmed that the fine and coarse gradations behave in a similar manner during undrained shear.

Figure 39: Results of CAU ($K_0 = 0.5$) Strain-controlled Triaxial Tests (Coarse and Fine Gradations)

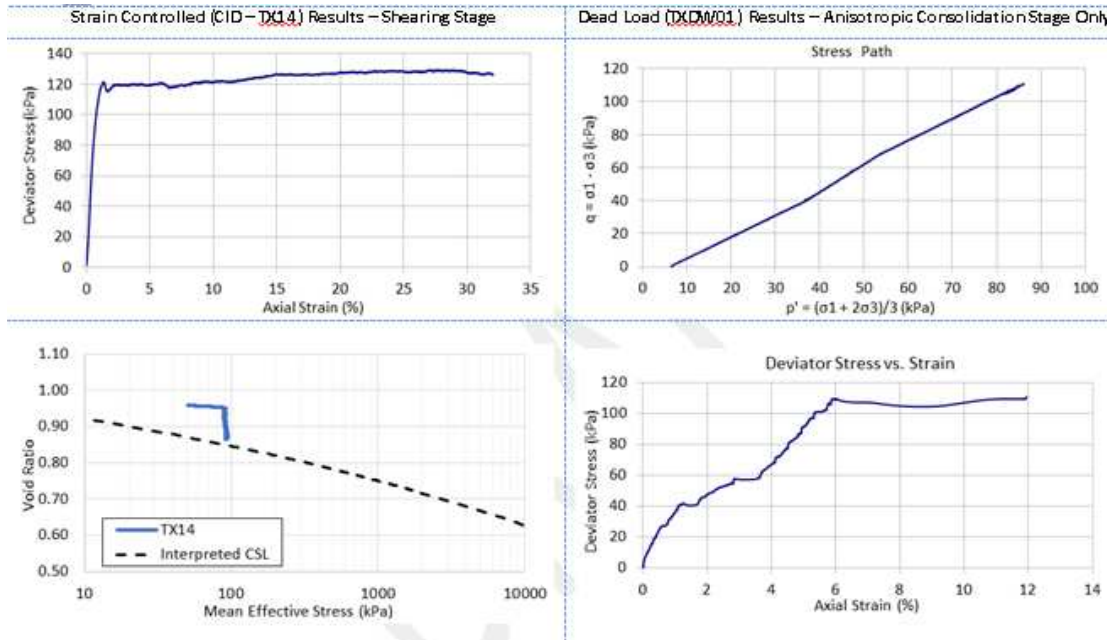
Two triaxial load-controlled tests using dead loads (TXDW) were completed for comparison with the strain-controlled tests. Both tests were completed on the coarse gradation sample. The first test (TXDW01) was completed as a drained test and was intended to replicate test TX14, which was a strain-controlled CID test carried out at an initial p' of 50 kPa and a state parameter of +0.09 (Figure 40). The CID test (TX14) showed an abrupt reduction in volume at around 1% strain, at a constant p' and q . The purpose of the equivalent load-controlled test (TXDW01) was to see if this volumetric reduction would lead to pore pressure generation and

strength loss under dead load conditions. The equivalent dead load test was anisotropically consolidated to stresses approaching those at which TX14 failed; however, the sample failed in a rapid manner at smaller stresses. The rapid nature of the failure indicates it occurred undrained. The load-controlled test also showed significant creep under constant q .

Figure 40: Comparison Between an Isotropically Consolidated Strain-controlled Test (CID-TX14) and Anisotropically Consolidated Load-controlled Test (TXDW01) with the Same State ($\psi = +0.09$) and Coarse Gradation

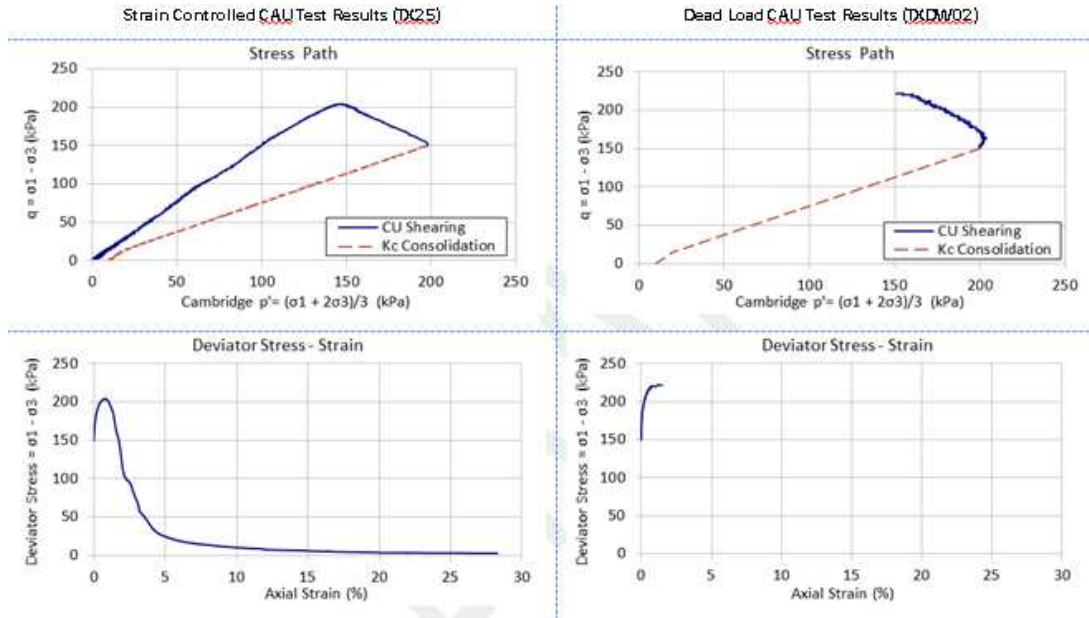
The second dead load test (TXDW02) was carried out for comparison with the anisotropically consolidated strain-controlled undrained (CAU) test (TX25) completed at an initial p' of 200 kPa and a K_0 of 0.5, as shown in Figure 41. Except for the dead weight load application, TXDW02 was completed in exactly the same manner as TX25. The load-controlled test (TXDW02) failed at an axial strain of 0.7% and a peak undrained shear strength ratio of 0.55. The residual (liquefied) strength ratio of this sample could not be measured because the failure occurred in a rapid manner and produced complete failure of the sample. The brittle response, peak undrained shear strength ratio, and small strain to peak were similar for both tests, illustrating general consistency across testing methods.

Figure 41: Comparison Between an Anisotropically Consolidated Strain-controlled (CAU-TX25) and Load-controlled Test (CAU-TXDW02) with Same State ($\psi = +0.09$) and Coarse Gradation

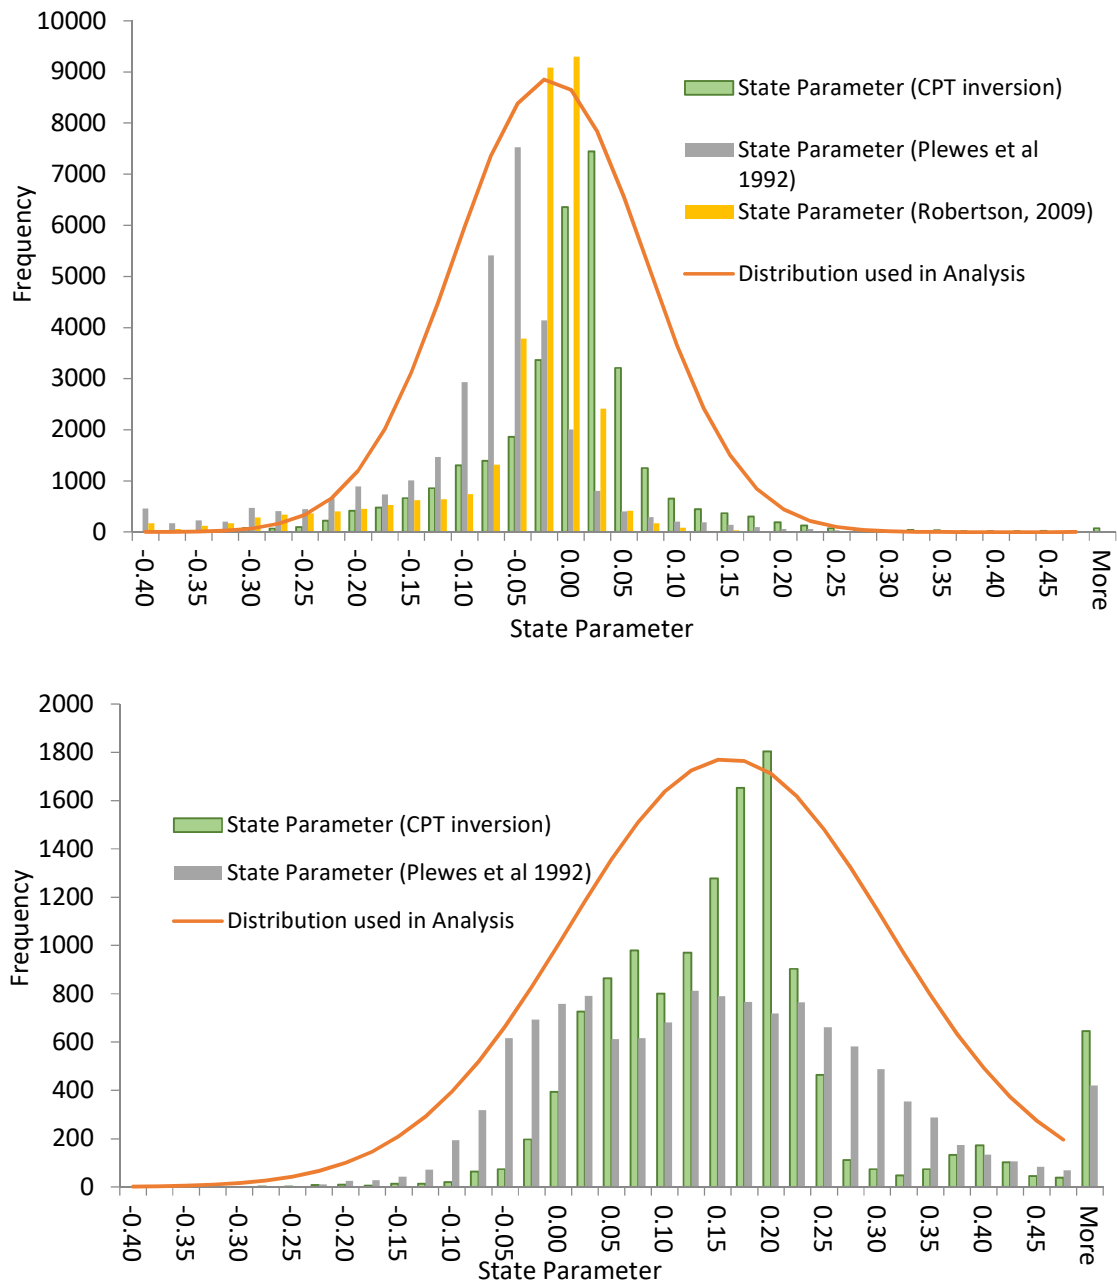
The estimation of *in situ* state followed four different approaches. Initial estimates were made using the empirical method suggested by Robertson (2010), but it was recognized that the unusual mineralogy of the tailings would likely make these estimates unreliable. A second approach was applied using the laboratory bender element (Vs) results combined with the field measured Vs values. However, this methodology was questionable due to the lack of sensitivity to variations in the *in situ* Vs measurements. A third approach was applied using the method suggested by Plewes et al. (1992), since this method allows input of the specific CSL parameters, which were available from the advanced laboratory testing. However, this too presents reliability issues since the mineralogy and other properties of the tailings are different than the historical data used to develop the relationships. The final approach applied was the full inversion of the CPTu results using CS parameters obtained from the advanced laboratory testing and applying the approach suggested by Jefferies and Been (2016). This involves using cavity expansion to obtain estimated state parameters from CPTu. This has the ability to account for the unique material behavior captured in the advanced laboratory testing. This final approach was considered to be the most reliable. A summary of the estimated state parameters for the coarse and fine gradations is shown in Figure 42, along with histograms used in the analysis. The resulting average state parameters are -0.02 for the coarse gradations and +0.16 for the fine gradations. All methods show that the fine tailings have a looser state than the coarse tailings.

Figure 42: Cumulative Distribution of State Parameters for Coarse and Fine Gradations

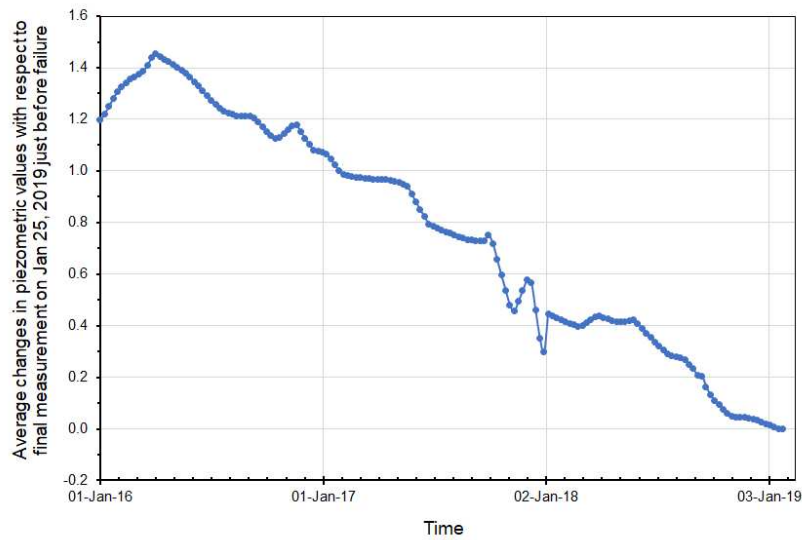
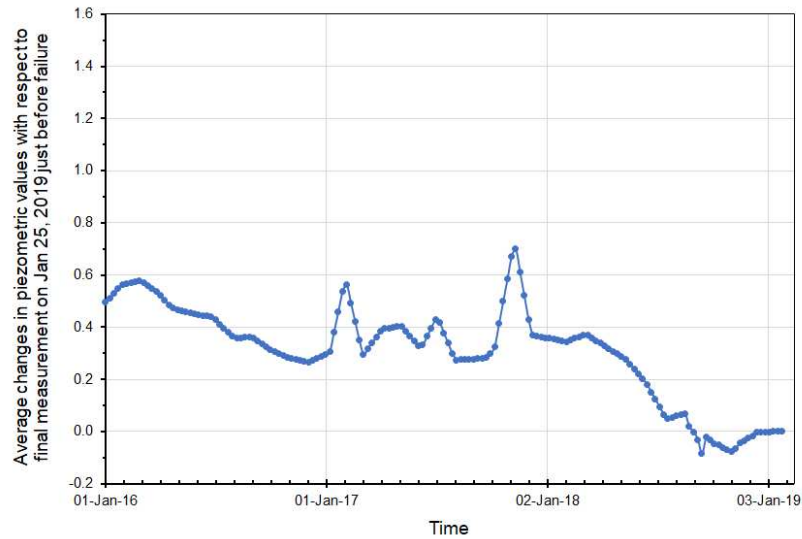
Figure 45: Mean Piezometric and Water Levels Relative to Final Measurements on January 25, 2019

Figure 45 shows that there was a gradual decline in the mean water level since 2016. The decline was about 1.4 m for the installations above the setback (900 m msl) and about 0.5 m for the installations on or below the setback. This observation is attributed to a slow net drawdown of water after tailings deposition ceased in 2016. The water appears to be draining from the upper portions of the dam toward the lower portions. The drawdown also creates an increasing unsaturated zone in the upper portions of the dam. Figure 45 also shows minor short-term increases in water level that appear to be linked to responses during the wet seasons.

a) Changes in Piezometers and Water Level Indicators Above 900 m msl

b) Changes in Piezometers and Water Level Indicators Below 900 m msl

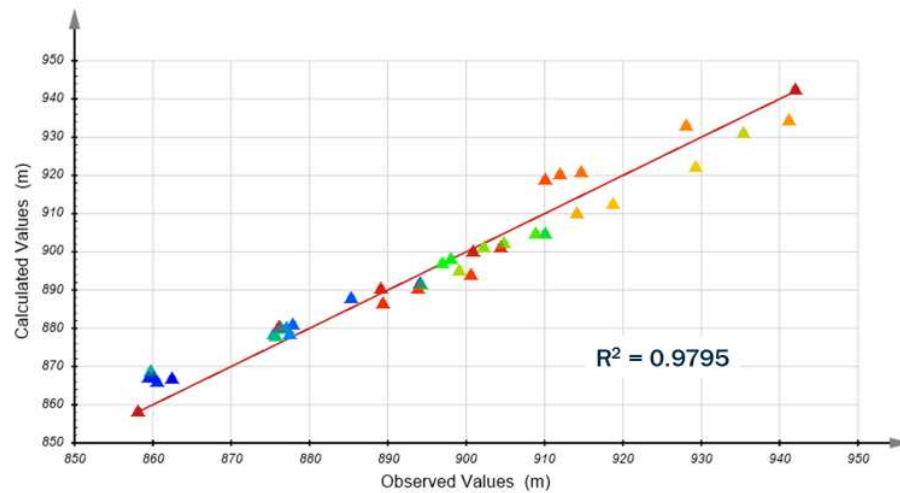
Figure 46: Calculated Versus Observed Piezometer Values for a 2D Seepage Model on Cross-section 3-3

A strong correlation was found between the measured and computed water levels that provides confidence in the accuracy of the 2D saturated/unsaturated seepage model.

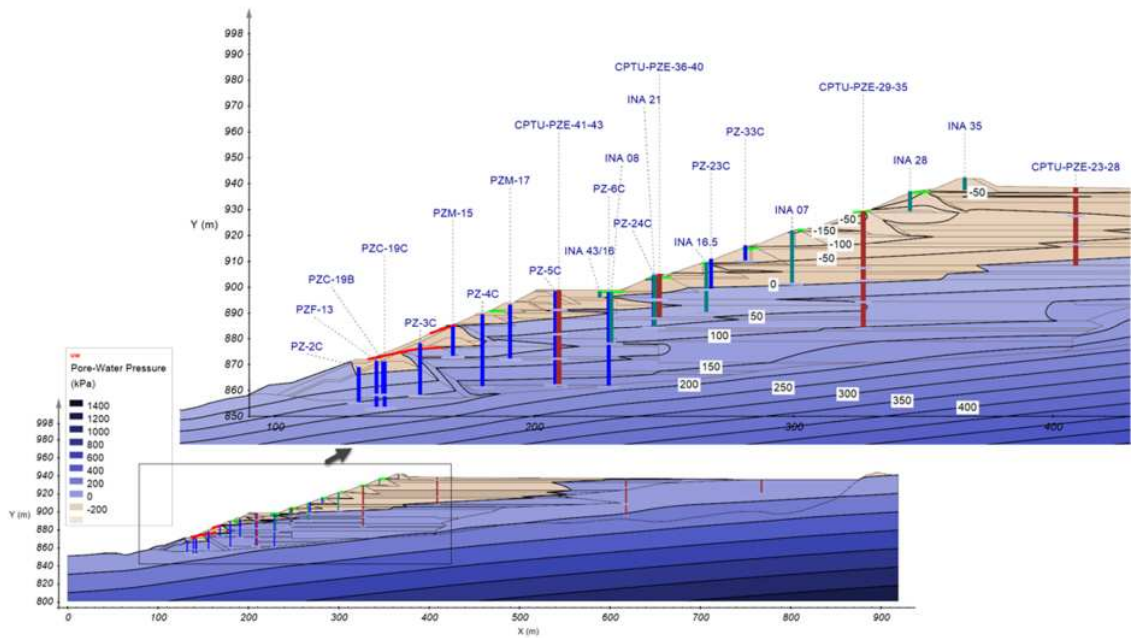
Figure 47: Computed Water Pressures from the 2D seepage model for Cross-section 3-3

The effect of poor downward drainage and restricted flow at the berms is clearly apparent in the results of the simulation presented in Figure 47. The water level shown in Figure 47, which matches the piezometer readings as well as the CPTu dissipation measurements, is high in the toe region of the dam and below the setback. The seepage analysis shows that a significant portion of the dam was saturated with a high water level, especially in the toe region.

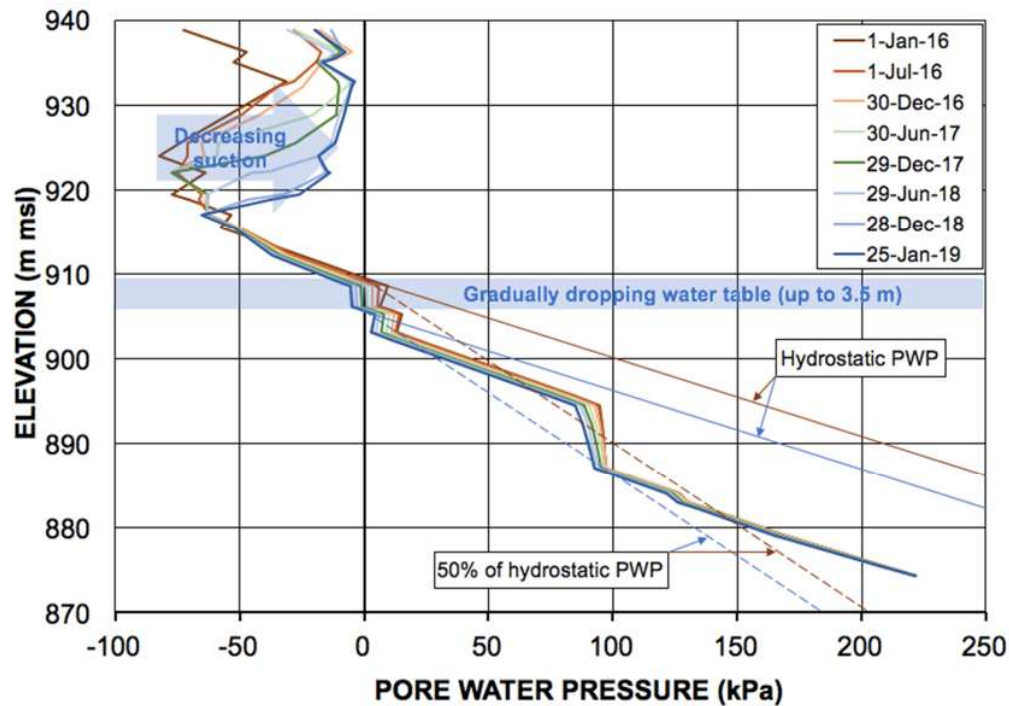
2D computer analyses, using rainfall data from January 2016 to January 2019, were carried out to evaluate changes in soil suctions above the water level. Figure 48 shows an example profile at a location near the crest of the dam at cross-section 3-3 and shows that the computed values of suctions in the unsaturated zone decrease significantly as rainfall infiltrates the unsaturated materials. The loss in suction associated with infiltration is in the order of 50 kPa, which in turn reduces the unsaturated shear strength in this zone by about 10 kPa to 15 kPa. The impact of this loss of strength in the unsaturated zone is discussed further in Section 8. Figure 48 also illustrates that the average water pressure below the water level can be approximated by a 50% hydrostatic pressure profile.

Figure 48: Pore-water Pressure Profile Beside Top Berm on Cross-section 3-3

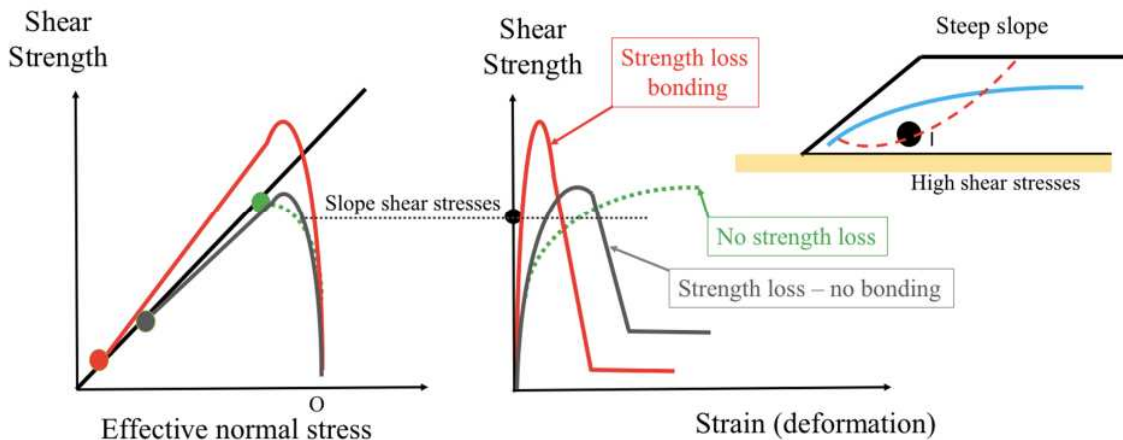
Figure 49 schematically shows the different approximate stress-strain and stress-path responses for soils that have no strength loss, strength loss with no bonding, and significant strength loss due to bonding. Materials that have no strength loss will typically show significant deformation prior to failure. Materials that have strength loss with no bonding show less deformation before failure compared to the materials with no strength loss. Materials that have significant strength loss due to bonding tend to show very little deformation before failure and require very little strain to trigger the strength loss.

Figure 49: Schematic Comparison in Behavior Between Soil that has No Strength Loss, Soil with Strength Loss, and Either No Bonding or with Bonding
