Floods from tailings dam failures

M. Rico^{a,*}, G. Benito^b, A. Díez-Herrero^c

Abstract

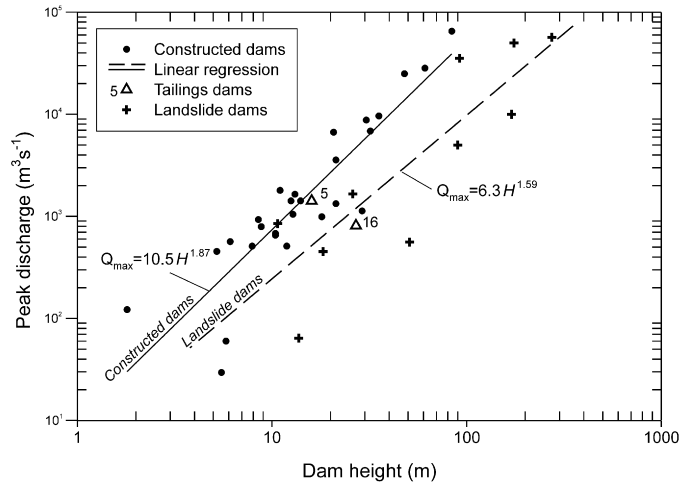
Fig. 5. Graph the dam height (H in meters) at time of failure, vs. peak discharge ($m^3 s^{-1}$) for constructed and landslide dams (dates from Costa [10]) and tailings dams (case 5: Buffalo Creek, USA; case 16: Los Frailes, Aznalcollar, Spain).

relationships obtained using dam height (H), water volume contained at the reservoir (V) and the resulting flood peak discharge (Q) when it failed (see Figs. 5 and 6). A major contribution of the Costa [10] paper is the analysis of floods from natural dams including ice dams (water impounded within or behind glacial ice), moraine dams, volcanic flow dams and landslide dams. Landslide dams typically involve large volumes of sediments producing wide abutments, which are partly eroded by water during dam overtopping and breaching [34]. According to Costa [10] this explains that flood peaks from failed landslide dams appear to be smaller than constructed dam failures with the same dam height and reservoir volume (Figs. 5 and 6).

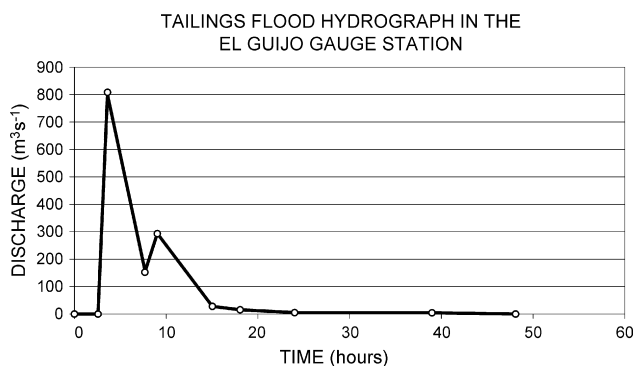
Fig. 7. Slurry flood hydrograph of the Los Frailes spill in the El Guijo gauge station, 11 km downstream of the Los Frailes tailings dam, in the Guadiamar River. The hydrograph comprises two peaks related to a first water pulse and a second tailings flow (after Ayala-Carcedo [32]).

Similarly, when a tailings dam is overtopped by runoff excess from the drainage basin, there is commonly large water content for tailings sediment before a full breach is developed which would be added to the tailings outflow volume. A tailings flood is commonly composed of water with high sediment concentration which provides a wide range of fluid behavior from debris flow to muddy floodwater. This wide range of flow behavior is reflected in the representation of the few available historical data points (Figs. 5 and 6), which corresponds to Buffalo Creek (case 5) and Los Frailes (case 16). On the one hand, Buffalo Creek dam incident plots on the regression line corresponding to water-storage dams due to a dam failure caused by flow overtopping in relation to extreme rainfall. The run-out flood contained a mixture of water and carbon residua with a turbulent flow behavior [2], which indeed plots on the regression line of incidents, related to constructed earthfill dams for water-storage. Regarding Los Frailes tailings dam incident, it was released a high viscous flow containing a large proportion of tailings. The mine waste flood discharge was recorded at a gauge station located 11 km downstream of the tailings dam. The hydrograph shape comprised two peaks, with the first one reaching $811 \text{ m}^3 \text{ s}^{-1}$ and a second one of $294 \text{ m}^3 \text{ s}^{-1}$, according to a rating curve calibrated for water flow, which probably overestimated the mine waste discharge due to its higher viscosity [32]. The first hydrograph peak was composed of a water-dominant flow, mainly from the upper water-laid layer at the reservoir, whereas the second contained a high tailings load in a high viscosity flow (Fig. 7). As shown in Fig. 5, Los Frailes tailings dam incident (case 16) plots on the regression line obtained from historical failures of landslide dams after Costa [10]. The discharge estimation from the landslide dam failure equation is $1189 \text{ m}^3 \text{ s}^{-1}$, which is a similar order of magnitude to the $811 \text{ m}^3 \text{ s}^{-1}$ recorded at the gauge station for the first hydrograph peak [32].
