CONCLUSIONS FROM EVALUATION OF TAILINGS DAM INCIDENTS

Clint Strachan, PE¹,
Breanna Van²

ABSTRACT

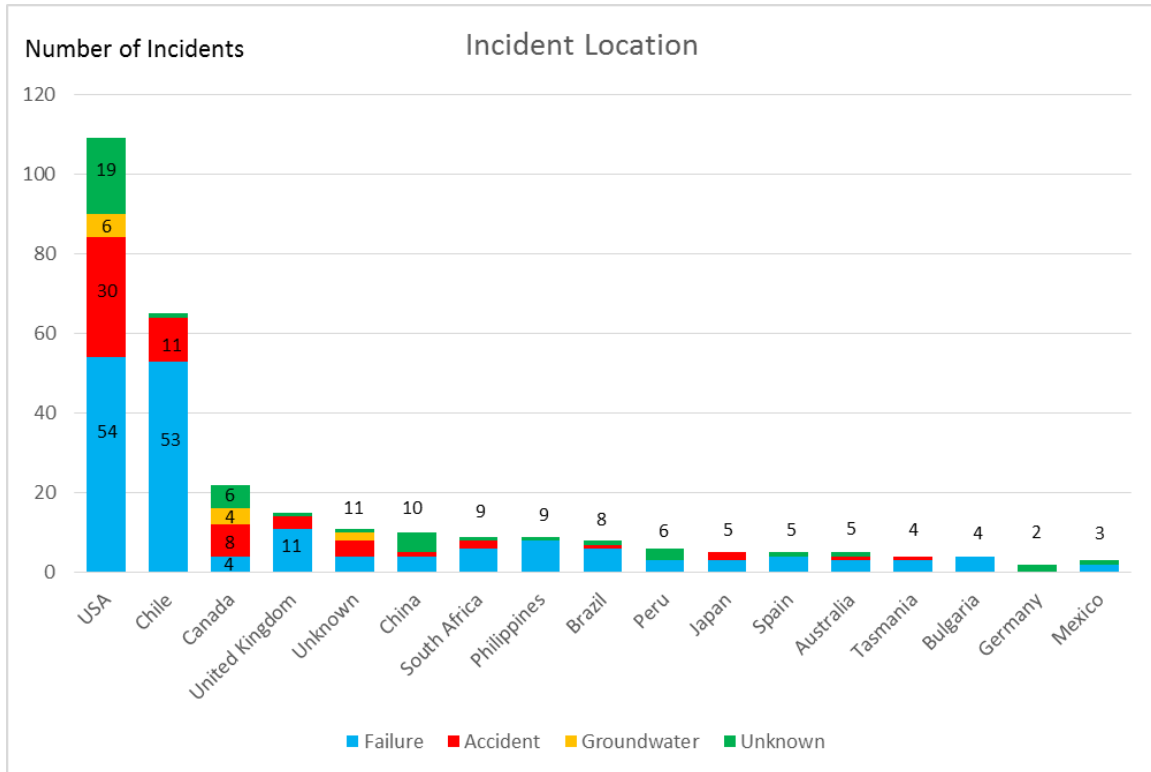
Figure 3 summarizes the incidents by country. The incidents are on continents and in countries where there has been significant mining activity. The relatively large number of incidents in the U.S. reflects the number of facilities in early operation and most likely more thorough incident reporting.

Figure 3. Incident type and location.

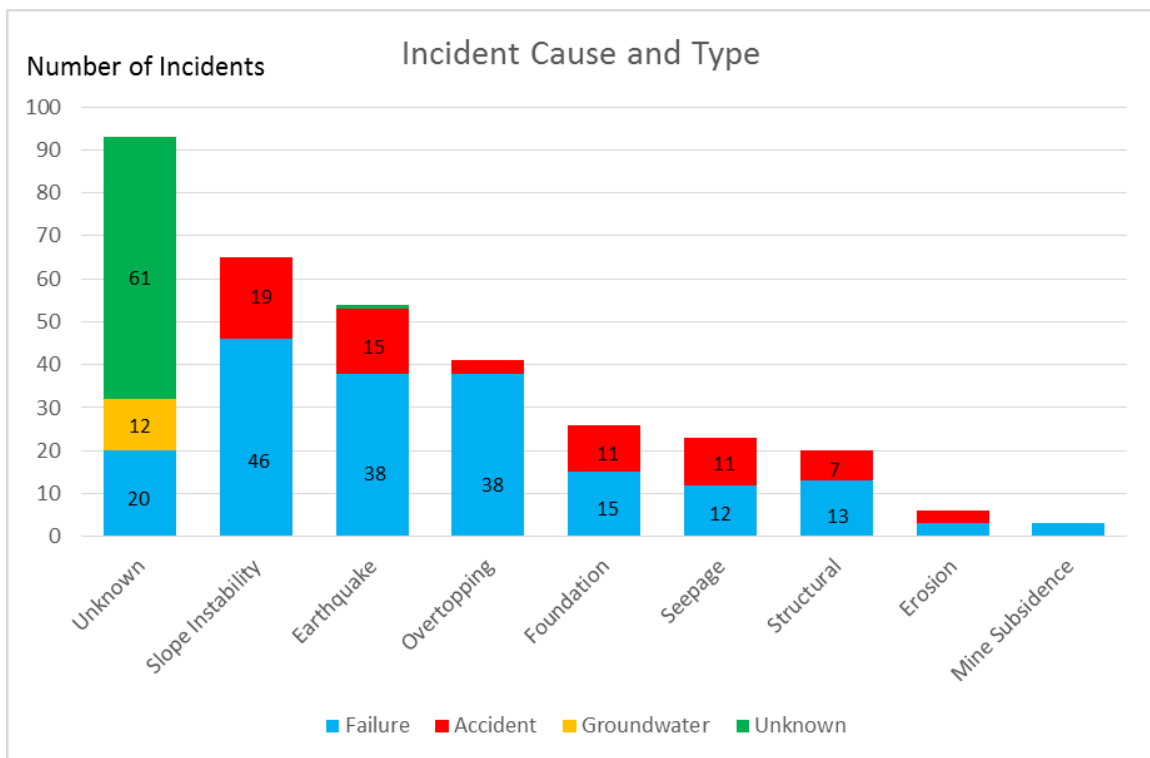
The reported incident cause is shown in Figure 6 with respect to the incident type. The incident causes are consistent with the causes reported in USCOLD (1988 and 1994), and are summarized below.

Figure 6. Incident cause and incident type.

For the incidents shown in Figure 6, slope instability, earthquake, and overtopping are the leading reported causes. Figure 6 also shows incidents where the cause is unknown.

From the data summarized in Figures 6 through 9, most of the reported incidents are associated with the water management aspects of the tailings dam, with incidents due to either water overtopping the dam or water seeping through the dam and affecting slope stability or causing erosion. Additional conclusions are summarized below.

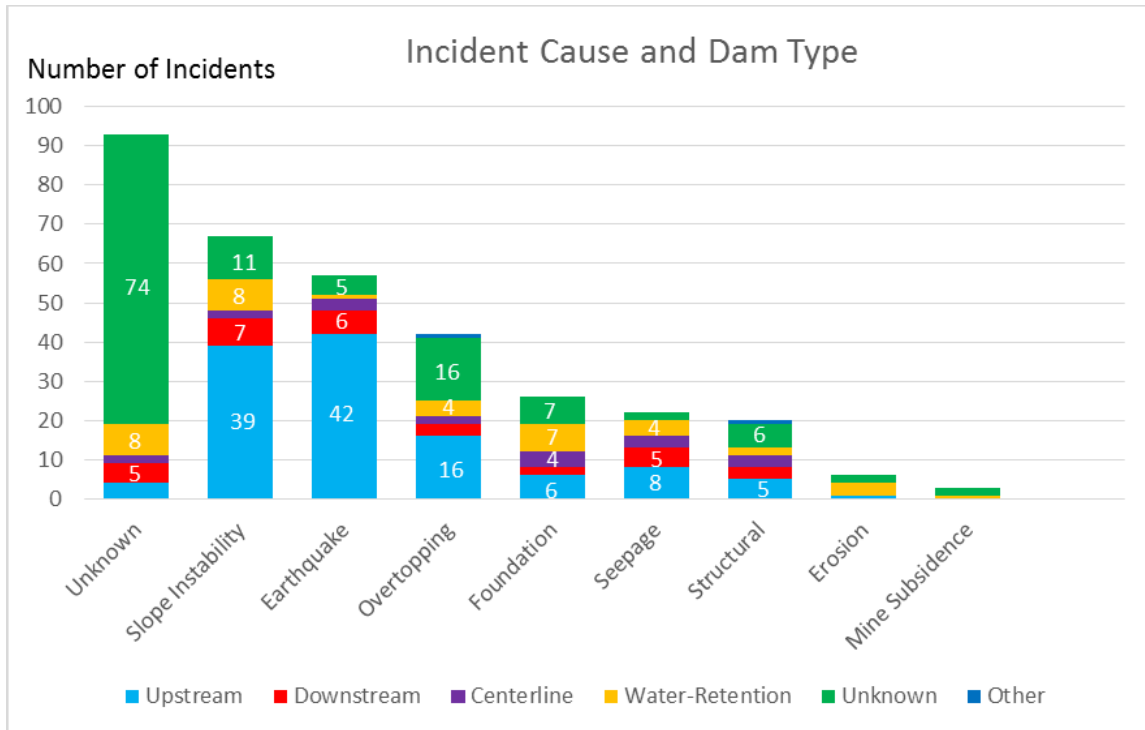
The incident cause information is shown in terms of dam type in Figure 8. Where reported, tailings dam types are separated into four categories: upstream, downstream, centerline, and water retention. These dam types are summarized below.

Figure 8. Incident cause and dam type.

The results of incidents with dam type in Figure 8 show that, while no dam type is immune from incidents, the majority of incidents are associated with upstream-constructed dams. This is due in part to the large number of upstream-constructed dams that have been in operation, and the fact that many of these dams were constructed in the early 20th century in by trial-and-error methods. Many of the dams in the unknown column in Figure 8 are most likely upstream-constructed dams.

However, the results in Figure 9 are similar to those in Figure 8. No dam type is immune from incidents, and the majority of incidents are associated with upstream-constructed dams. Many of the dams in the unknown column in Figure 8 are most likely upstream-constructed dams. The smaller number of incidents from earthquake and slope instability may reflect better geotechnical knowledge.

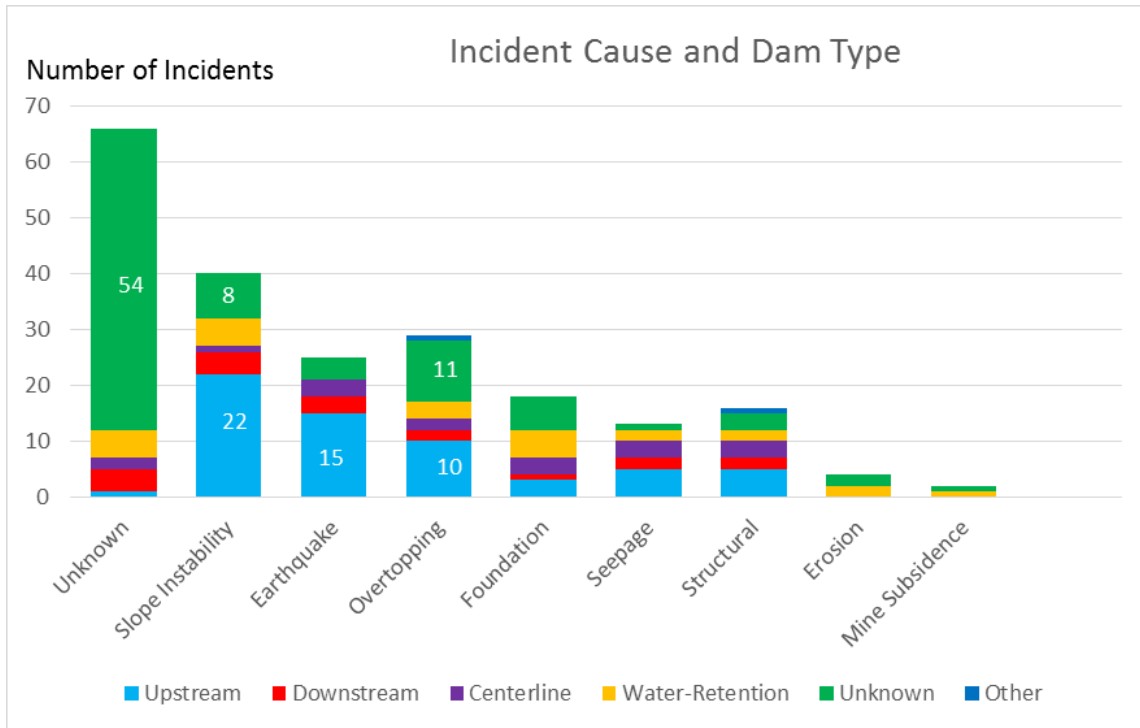
For comparison, Figure 9 shows incident cause and dam type for more recent conditions (1976 through 2017). This data set reflects the period to time with better knowledge of dam construction, larger earthmoving equipment, and use of slope stability analyses.

Figure 9. Incident cause and dam type, 1976-2017 time period.
