SEISMOTECTONIC INVESTIGATION FOR HORSESHOE AND BARTLETT DAMS-SALT RIVER PROJECT, ARIZONA Wong

# SEISMOTECTONIC REPORT 90-7

Seismotectonics and Geophysics Section Geology Branch Geotechnical Engineering and Geology Division Denver Office U.S. Bureau of Reclamation Denver, Colorado

August 1990

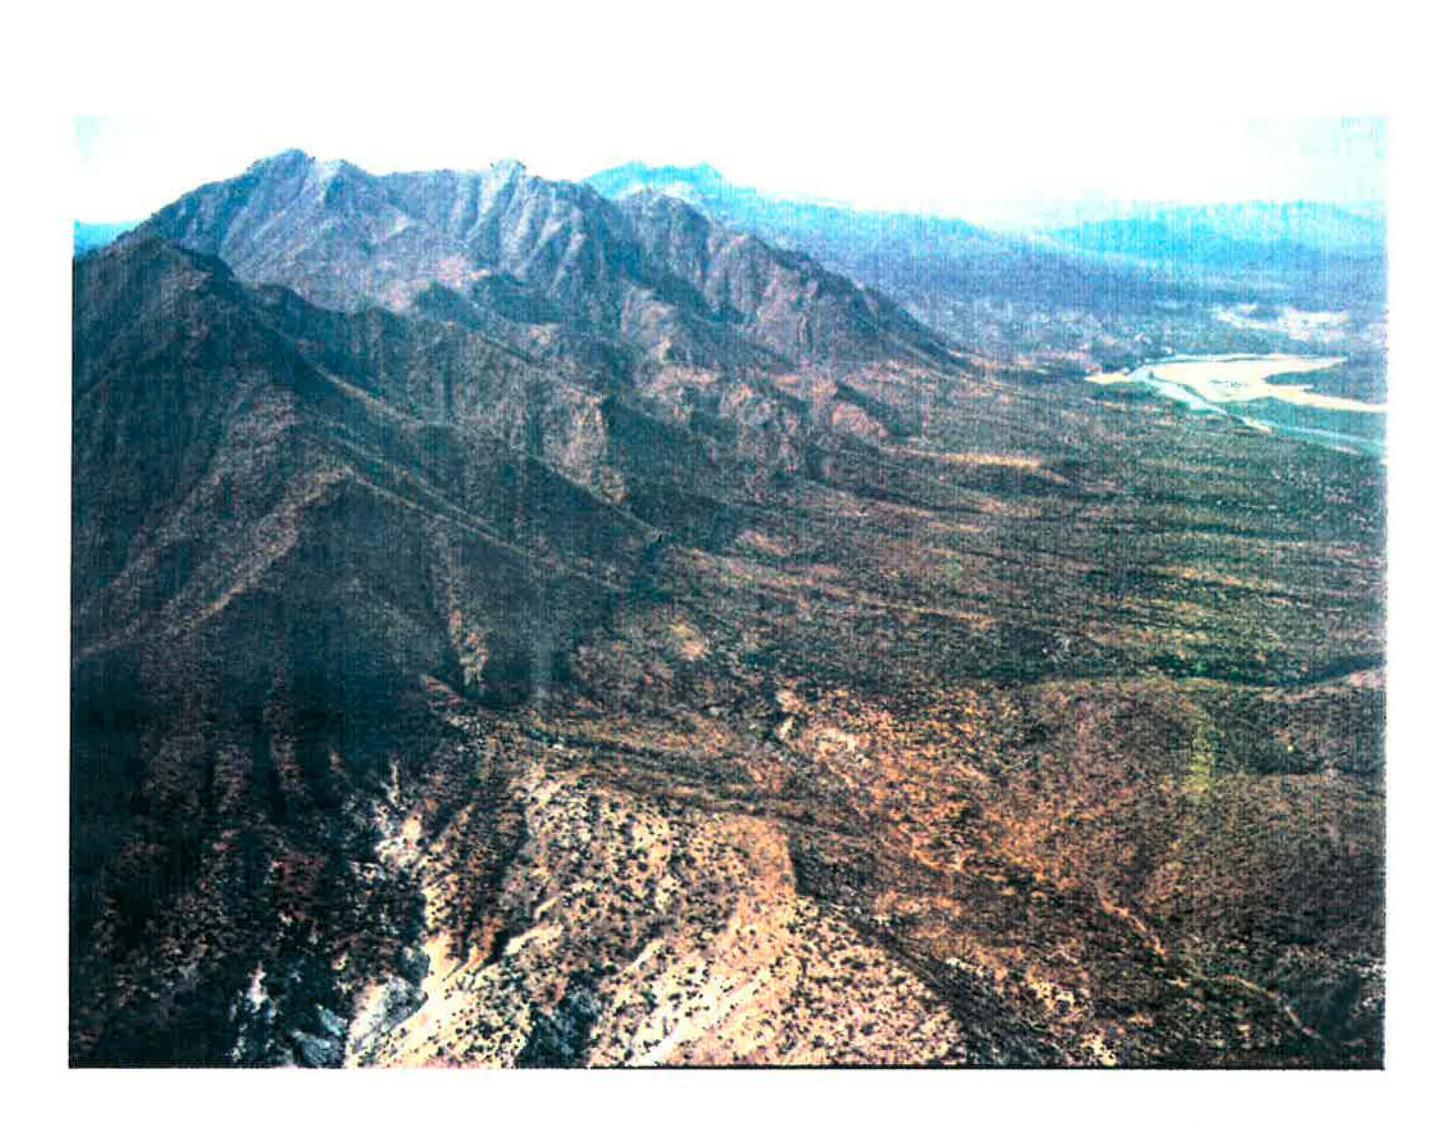
Figure 2-1. View of the Hell Canyon segment looking north from Lime Creek (plate 1). The white beds in foreground are Tertiary sediments (Ts); mountains on left are Precambrian granite. The Verde River and the upper part of Horseshoe Reservoir are visible in the background.

The Hell Canyon segment is marked by strong topographic, tonal, and vegetational lineaments (fig. 2-1). This basin-bounding fault, the result of the Basin and Range disturbance (Shafiqullah and others, 1980), juxtaposes Precambrian granitic rocks (on the west) against Tertiary basin-fill deposits (plate 1). Down-to-the-east scarps preserved on alluvial fans near the range front have a maximum height of 7.5 m and a maximum angle of 27° (appendix A). These parameters suggest a latest Pleistocene to early Holocene age for the most-recent surface-faulting event on this segment.

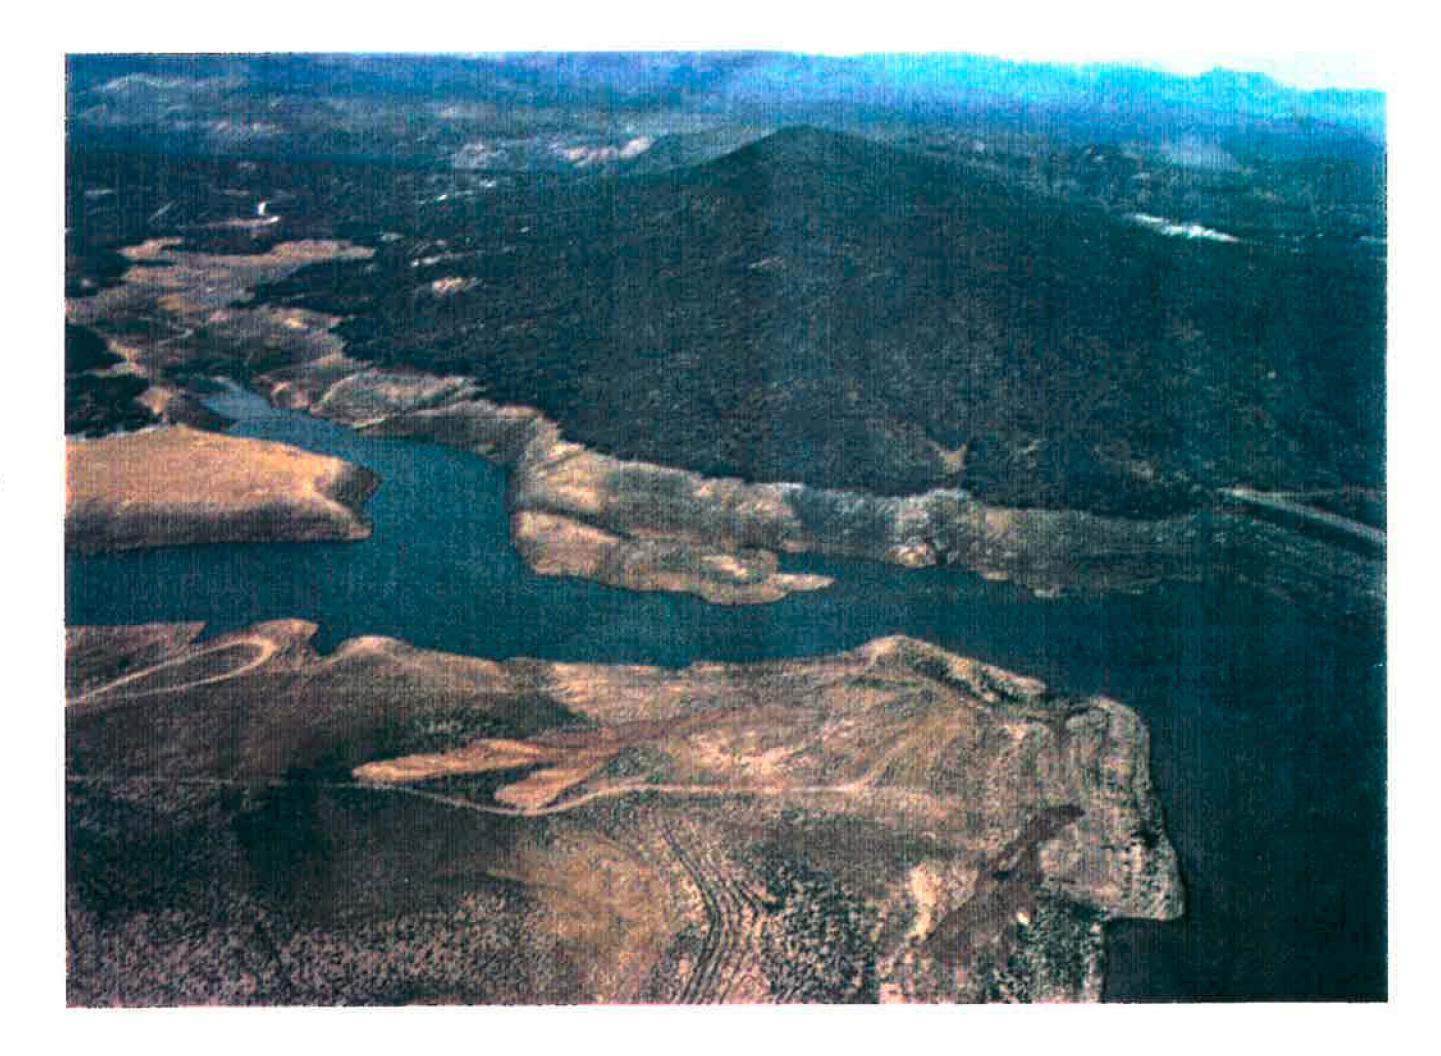
Figure 2-2. View looking east-southeast of the arcuate scarp on terrace t6 produced by the Horseshoe Reservoir fault segment (plate 1). The scarp is well delineated by cocklebur plants, which prefer the downthrown side of the fault. The trenches excavated across the Horseshoe Reservoir segment are visible on the terrace. Trench 1 is in the middle ground; Trench 2 is in the foreground. The fault continues across the slope in the background, where a resistant basalt bed on the right is juxtaposed against erodible Tertiary sediments on the left. Left abutment of Horseshoe Dam is at far right.

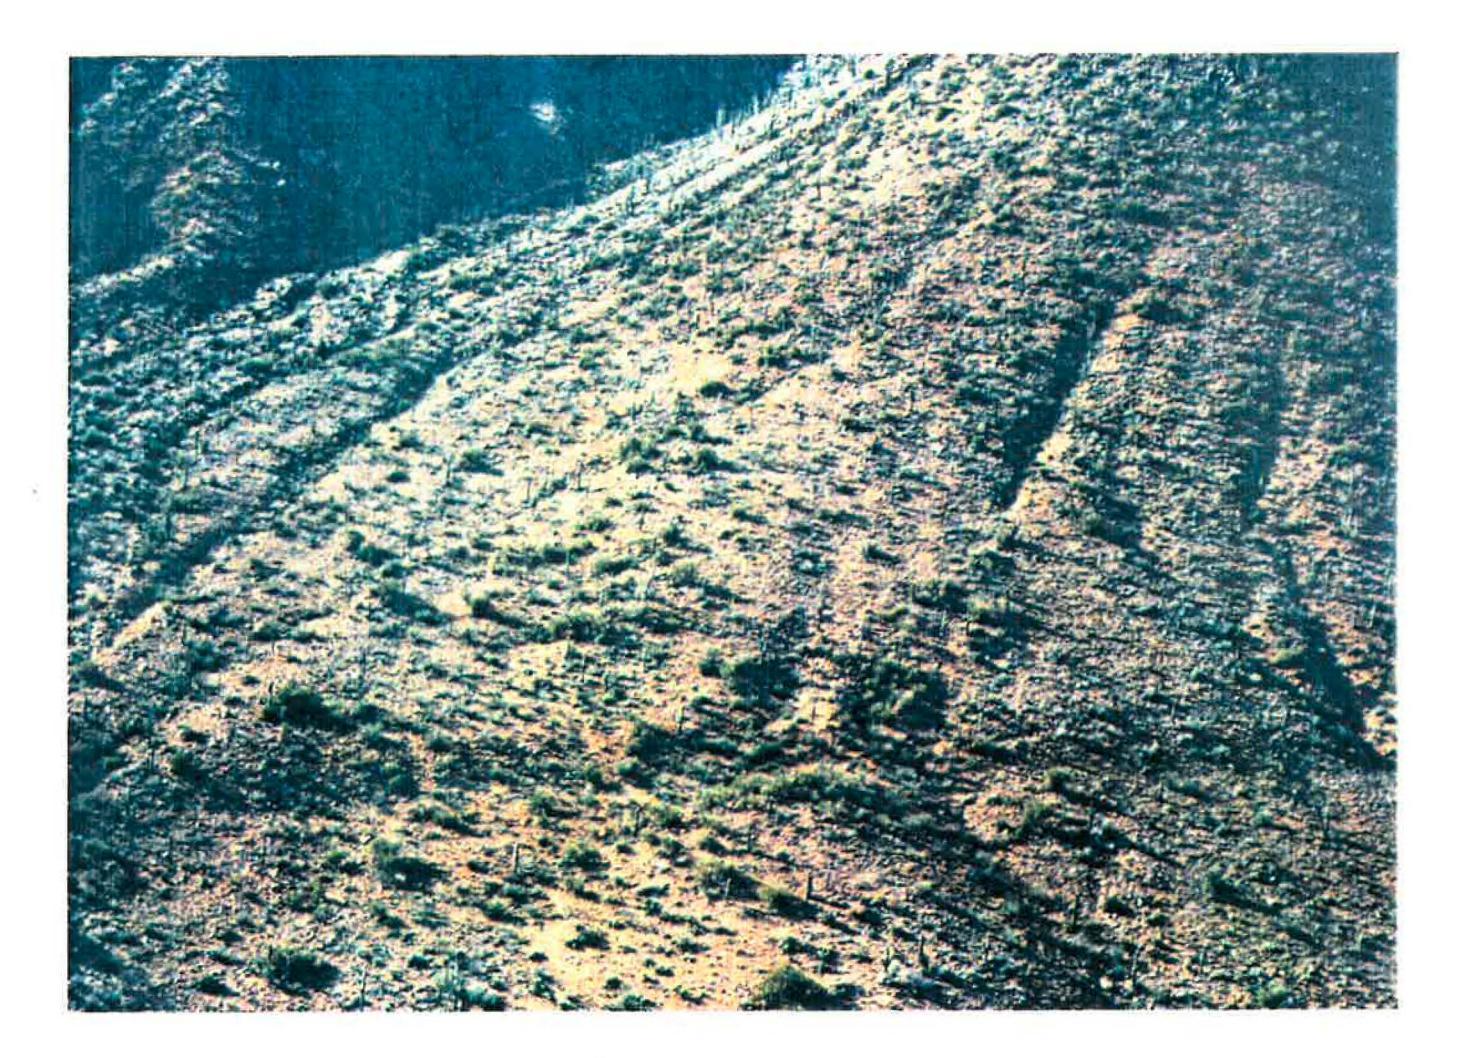
Figure 3-1. East-facing fault scarp at locality P3 along the Hell canyon segment (plate 1). At this locality between Lime Creek and Hell Canyon, the scarp height is 3.5 m, the vertical surface displacement is 2 m, and the maximum scarp angle is  $27^{\circ}$  (appendix A). The alluvial fan (f5) slopes about  $10^{\circ}$  to the east. View is to the west.

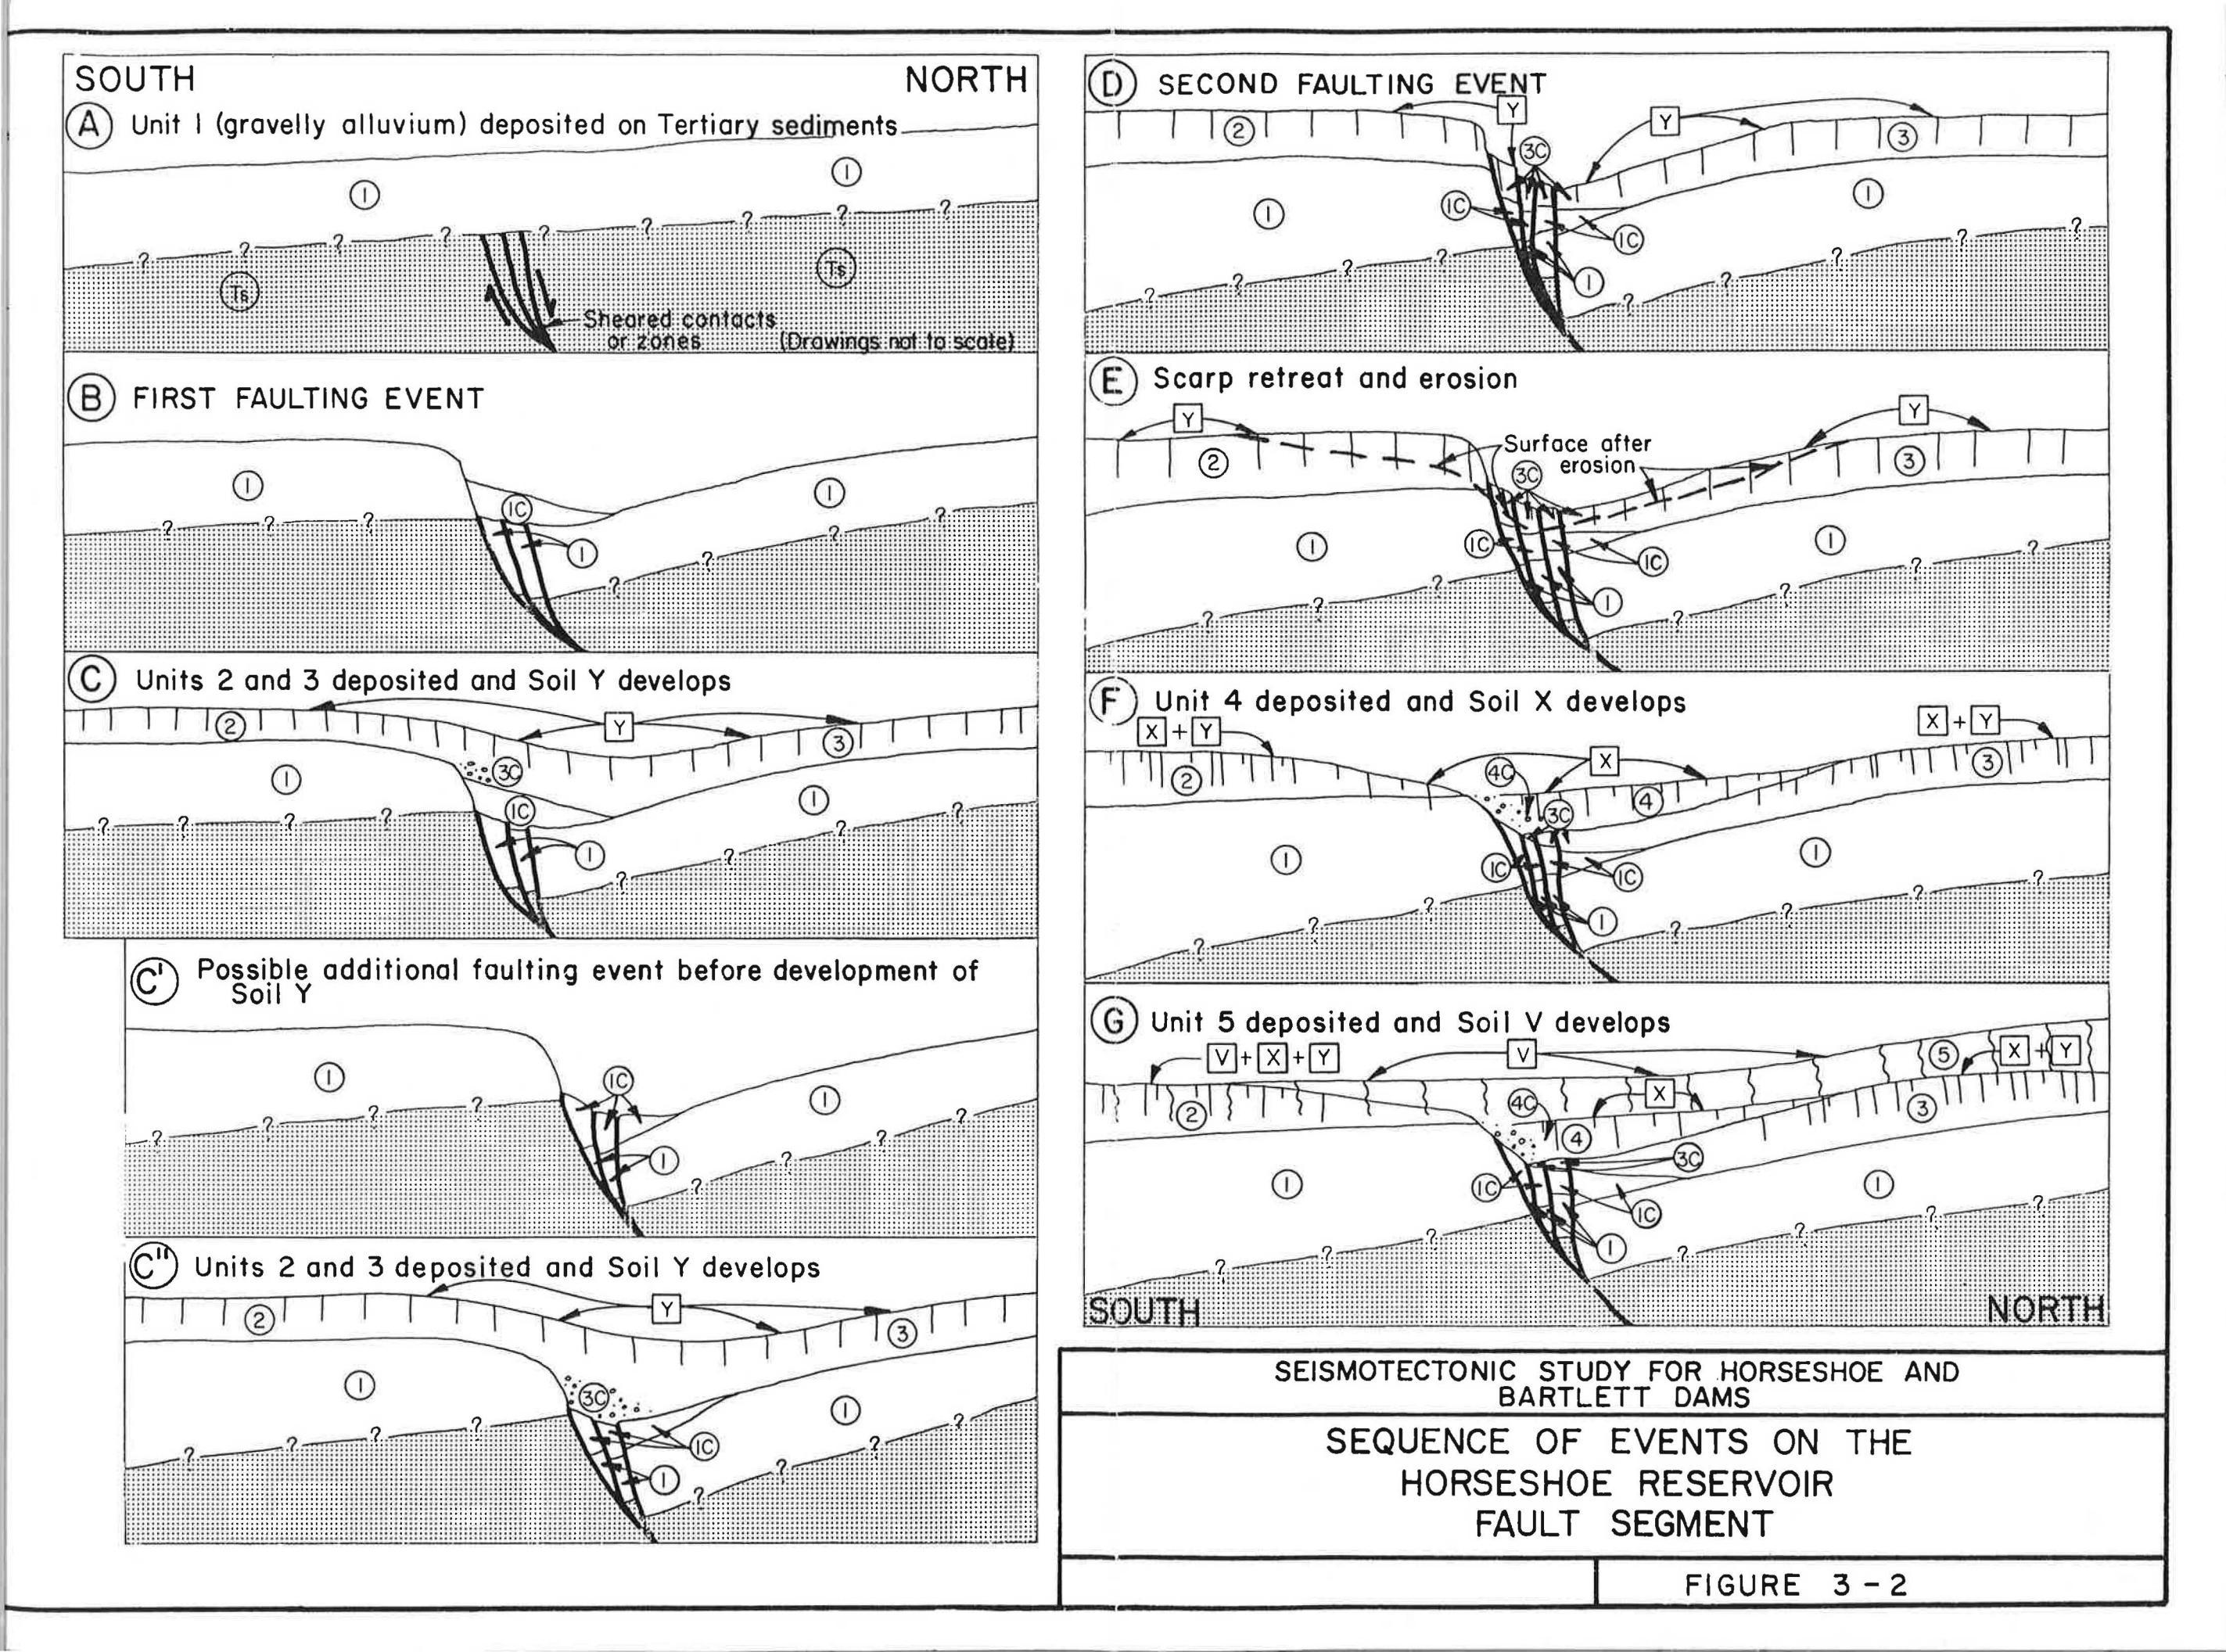
The following sequence of events is based on our interpretation of exposures in Trenches 1 and 2. Evidence for two ruptures during the last 300 000 years is clear; however, a third rupture could also be postulated. If this additional rupture occurred, events C' and C'' would replace event C in the sequence. Letters in circles indicate the events. Numbers in circles indicate depositional units exposed in Trench 1 (plate 2). Letters in boxes indicate soils described in Trench 1 (plate 2; appendix B).

Stratigraphic relationships exposed In Trench 1 suggest that at least two, but possibly three, surface ruptures have occurred on the Horseshoe Reservoir segment since deposition of gravelly alluvium of the t6 terrace (fig. 3-2). Three types of stratigraphic evidence indicate multiple surface ruptures: the number of deposits of possible fault colluvium, the evidence that colluvial deposits have been displaced subsequent to their deposition, and the different amounts of backtilting indicated by contacts and beds within units.

development, Soil V is estimated to have formed during the last 10 000 to 20 000 years. This gives a minimum age for Unit 5 because Soll V indicates the time when the surface of Unit 5 became stable. The length of time over which Unit 5 was deposited is not known. However, erosion of the upper part of Units 2 and 3 prior to deposition of Units 4 and 5, deposition of Unit 4, and development of Soil X suggest that Unit 5 was not deposited immediately following the youngest rupture; however, the length of this interval is not known. Thus, the minimum age for the youngest event is only constrained to >10 ka - 20 ka (fig. 3-2).

On the basis of the soil developed since deposition of the gravelly alluvium of the t6 terrace, Unit 1 is estimated to have been deposited by 300 ka to 400 ka. Because no soil is preserved in Unit 1, the time interval between deposition of Unit 1 and the oldest surface rupture recorded here is not known. The lack of soil development could indicate that the older rupture occurred shortly after Unit 1 was deposited. Alternately, a soil could have developed in Unit 1 and then been eroded. This would require that some time elapsed between the deposition of Unit 1 and the oldest rupture. We estimate that the maximum age of the older ruptures is about 300 ka (fig. 3-2).

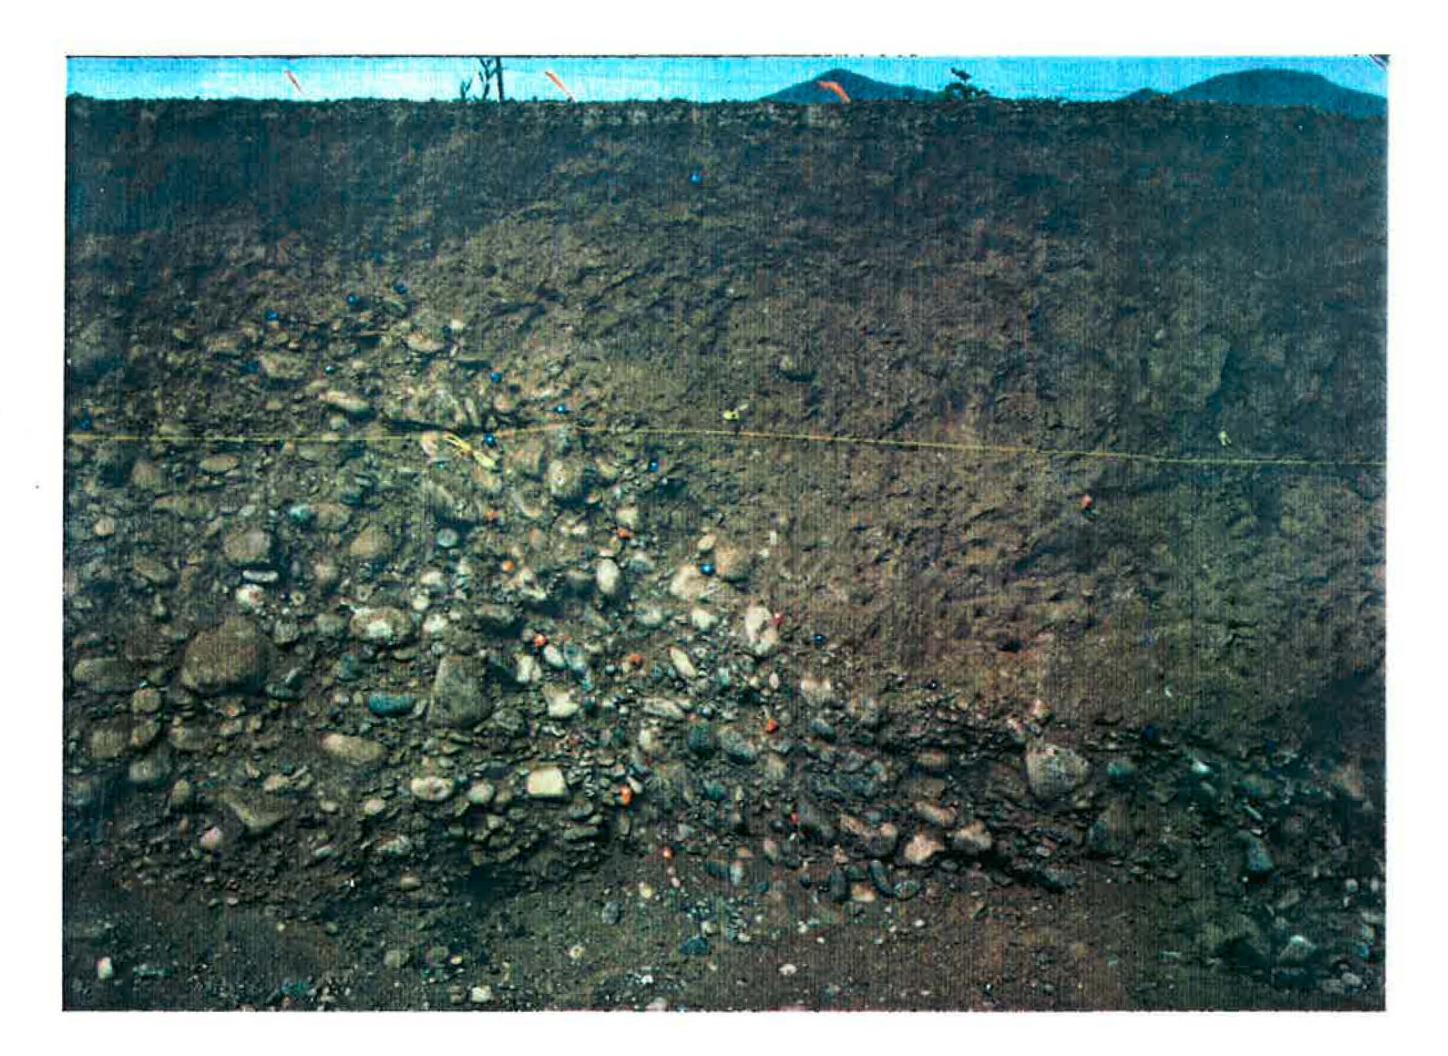
Figure 3-3. The Horseshoe Reservoir segment exposed in Trench 1 between stations 29 and 34 (plate 2). Note the rotated clasts that delineate the fault zone within the gravelly alluvium (Unit 1). Eolian and alluvial sand (Units 3, 4, and 5) overlie the gravelly alluvium. Pebbles are cobbles incorporated into the sandy units near the fault zone are interpreted as colluvium shed from the fault scarp.

Stratigraphic units exposed in Trench 1 consist of alluvial, colluvial, and eolian deposits (plate 2). Gravelly alluvium associated with the t6 terrace (Unit 1) contains 50 to 60 percent rounded to well-rounded boulders and cobbles. The alluvium was probably deposited by the Verde River but could also have been deposited, at least in part, by tributaries from the east (plate 1). The fault zone in Trench 1 is readily visible as a zone of rotated and aligned cobbles and pebbles within the gravelly alluvium. The fault zone strikes N60°E and is about 3.5 m wide. Individual shear zones, expressed as aligned cobbles and pebbles, dip about 70°NW (fig. 3-3).
