SURVEY OF SURFACE WATER FEATURES IN THE RESOLUTION PROJECT AREA AND VICINITY

Resolution Copper

102 Magma Heights – Superior, Arizona 85173 Project Number: 807.132 04 01 March 2018

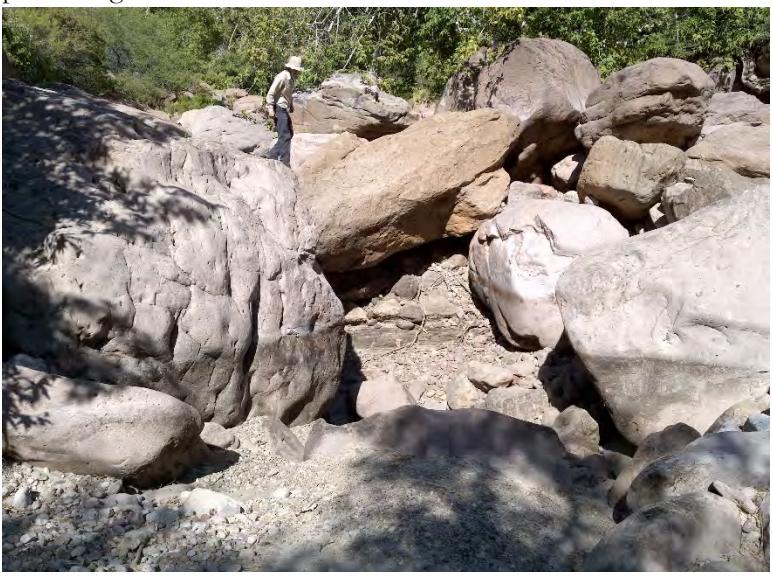
Photographs of Surface Water Features in Study Area **Photo 1.** East Plant Site and Vicinity: Boulder Hole, view of empty pool along channel

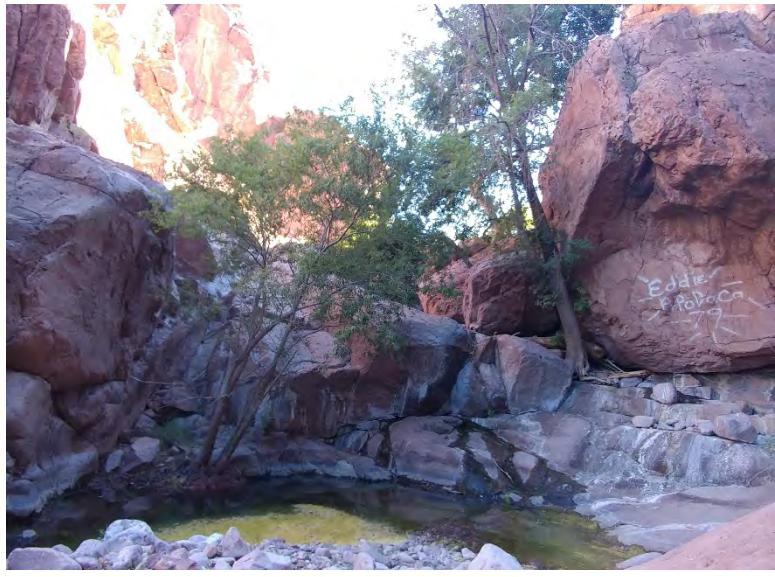
Eddie's Spring is a 5- by 5-meter pool in the south canyon wall of Queen Creek approximately 0.7 mile (1.1 km) upstream from the US 60 bridge (**Figure 2**). The pool is perched approximately two meters above the canyon floor and is ringed by bedrock and large boulders. At the time of the field visit, water was present in the pool and observed seeping into the pool from the surrounding bedrock. The bedrock substrate prevents much herbaceous vegetative growth but a Goodding's willow and velvet ash were present (**Appendix A, Photo 2**). Algae was present on the surface of the pool. No special-status, wetland or non-native plant species were observed. Water parameter measurements were not collected at this location as the instruments were not functioning correctly (**Table 1**).

Photo 2. East Plant Site and Vicinity: Eddie's Spring, view of pool in channel

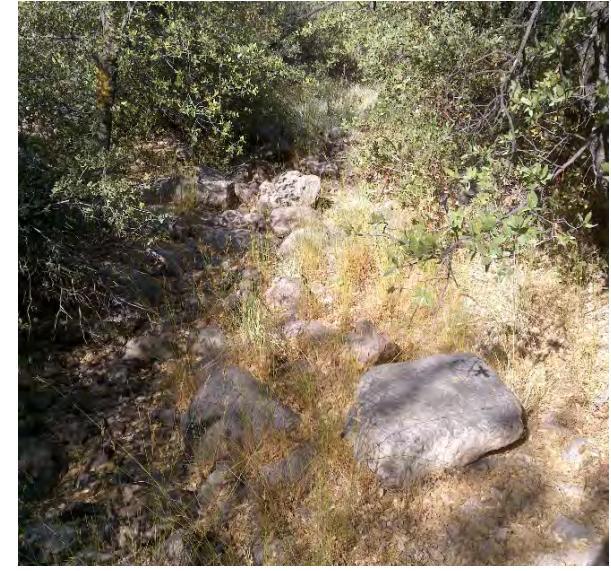
Gibson Well and Spring is located in Oak Flat Wash immediately upstream of the confluence with Queen Creek (**Figure 2**). The well is a hand-dug well in alluvial substrate, approximately 7 ft (2 m) in depth, and dry at the time of the field visit. The spring seeps from the banks on either side of the streambed just south of the well, but at the time of the field visit no surface water was present, only dampness. A high density of herbaceous wetland vegetation was observed (**Appendix A, Photo 3**) including Elliott's rush (*Juncus elliottii*), yellow monkeyflower (*Mimulus guttatus*), and pale spikerush (*Eleocharis macrostachya*). Other wetland species observed included coyote willow (*Salix exigua*), false indigobush (*Amorpha fruticosa*), and Arizona sycamore. No special-status plant species were observed.

Photo 3. East Plant Site and Vicinity: Gibson Well Spring, view of seepy area along streambed

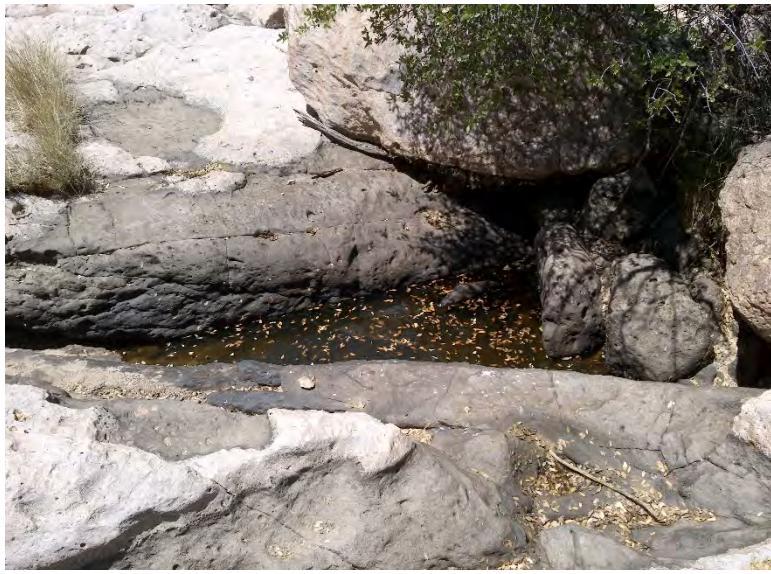
Number 9 Wash Tinajas are located in the channel of Number 9 Wash approximately 100 ft (30 m) from the confluence with Queen Creek (**Figure 2**). A series of three basins are present carved into bedrock ledges in the streambed. At the time of the field visit 0.25 cm of water remained in the three basins (**Appendix A, Photo 4**). Wetland species observed included grassleaf rush (*Juncus marginatus*) and Goodding's willow. No special-status or non-native plant species were observed. Water parameter measurements are provided in **Table 1**.

Photo 4. East Plant Site and Vicinity: Number 9 Wash Tinajas, view of surface water feature

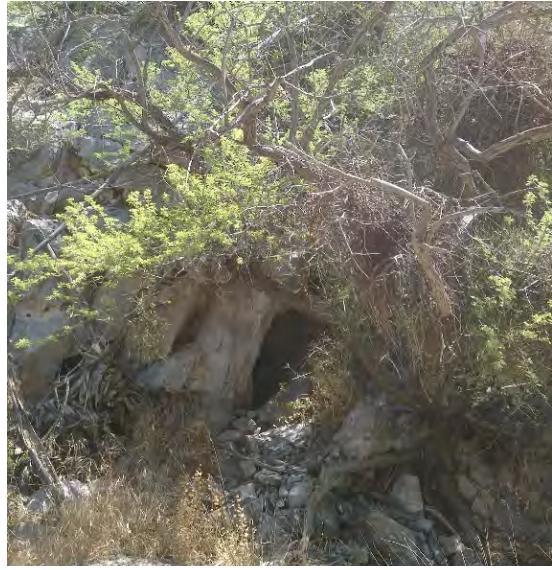
QC 22.6 E (Karst Spring) is located 200 ft (65 m) downstream of the US 60 bridge (Figure 2). A solution void in limestone is present on the east bank of Queen Creek about three meters east of the channel. At the time of the field visit there was no surface water observed, but water staining was present on the limestone above the stream channel, and surface water has been observed at this feature previously (Montgomery & Associates 2013). Wetland species observed included a small patch of yellow monkeyflower (Appendix A; Photo 5). No special-status or non-native plant species were observed. Water parameter measurements were not collected at this location as there was no surface water present (Table 1).

Photo 5. East Plant Site and Vicinity: QC 22.6E (Karst Spring), view of limestone void

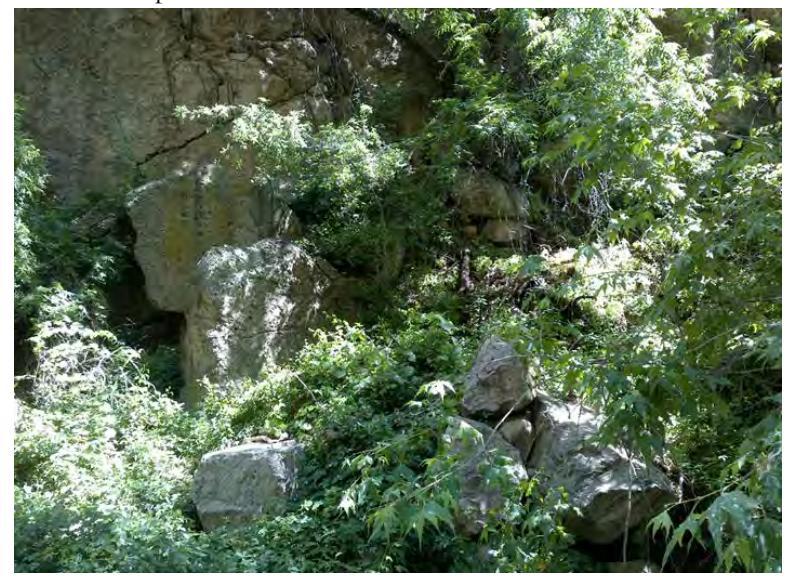
Queen Seeps is located on the south slope of Queen Creek Canyon, directly below Shaft No. 9 (**Figure 2**). No surface water is evident but an approximately 300-meter reach of soil on the slope is saturated, and supports a dense thicket of vegetation (**Appendix A, Photos 6-7**). Wetland plant species observed include coastal woodfern (*Dryopteris arguta*), Arizona sycamore, yellow monkey flower and wild heliotrope (*Phacelia distans*). No special-status plant species were observed. Non-native species observed included Himalayan blackberry (*Rubus* sp.). Water parameter measurements were not collected at this location as there was no surface water present (**Table 1**).

Photo 6. East Plant Site and Vicinity: Queen Seeps, view of thicket on south slope

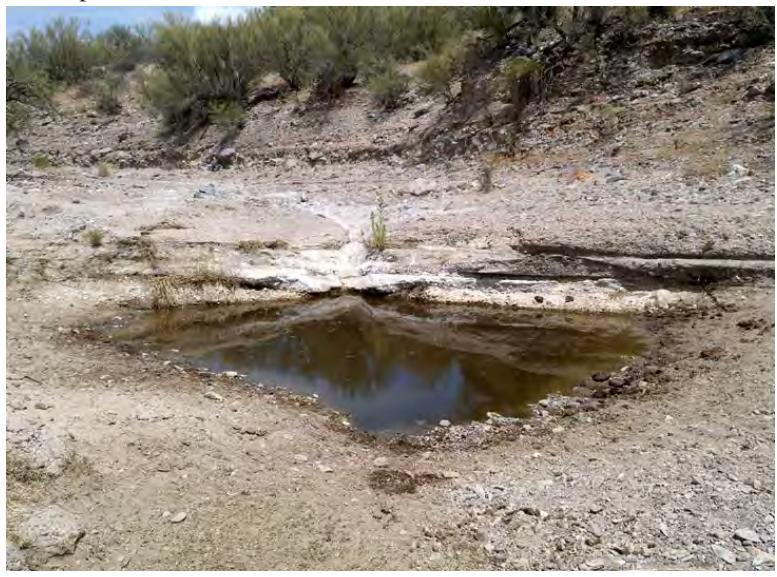
Photo 8. Tailings Area and Vicinity: Bear Tank: view of 10- by 10meter pool

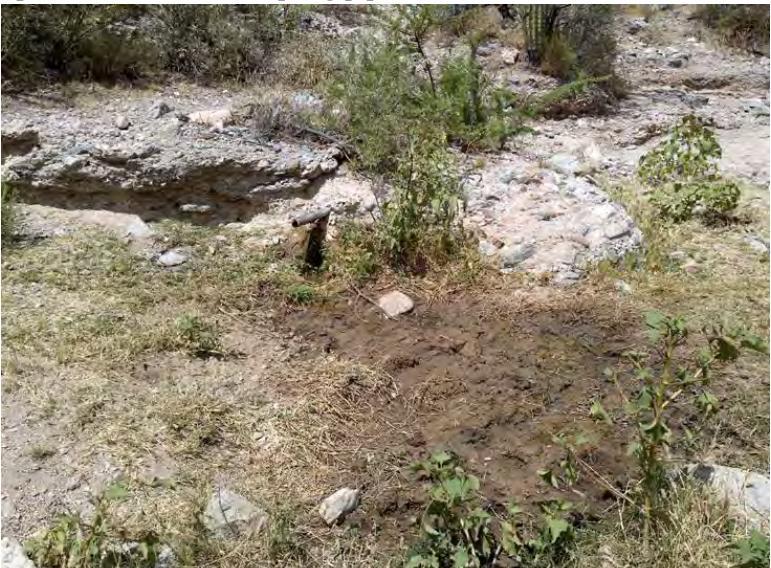
Photo 9. Tailings Area and Vicinity: Bear Tank: view of seep around open-ended horizontal spring pipe

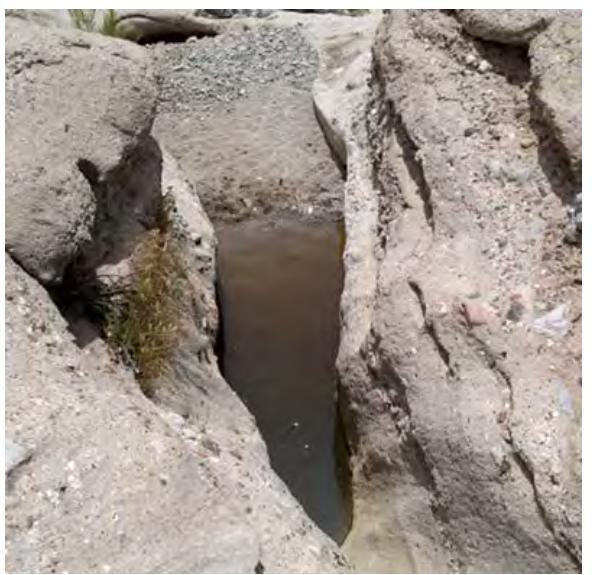
Photo 10. Tailings Area and Vicinity: Bear Tank Tinaja: view of basin in bedrock

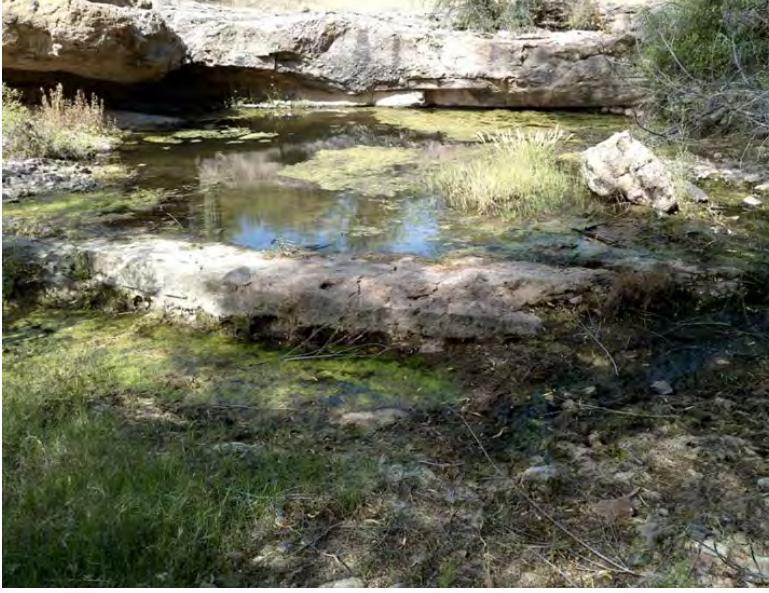
Benson Spring is located in the channel of Benson Spring Canyon 0.5 mile (0.8 km) upstream from the confluence with Queen Creek (**Figure 3**). The upper portion of the spring is a 20- by 20-meter tinaja in conglomerate bedrock that collects water from seeps that occur in the bedrock and from runoff events. Downstream of the tinaja, seeps occur in the loamy substrate and continue for approximately 50 meters, with several small pools along the flow (**Appendix A, Photos 11-12**). Wetland plants observed include yellow monkeyflower, speedwell (*Veronica anagallis-aquatica*), rabbitsfoot grass, pale spikerush, toad rush (*Juncus bufonius*) and Goodding's willow. No special-status plant species were observed. Non-native species observed included rabbitsfoot grass, Bermuda grass (*Cynodon dactylon*) and sowthistle (*Sonchus* sp.). Water parameter measurements are provided in **Table 1**.

Photo 11. Tailings Area and Vicinity: Benson Spring: view of tinaja

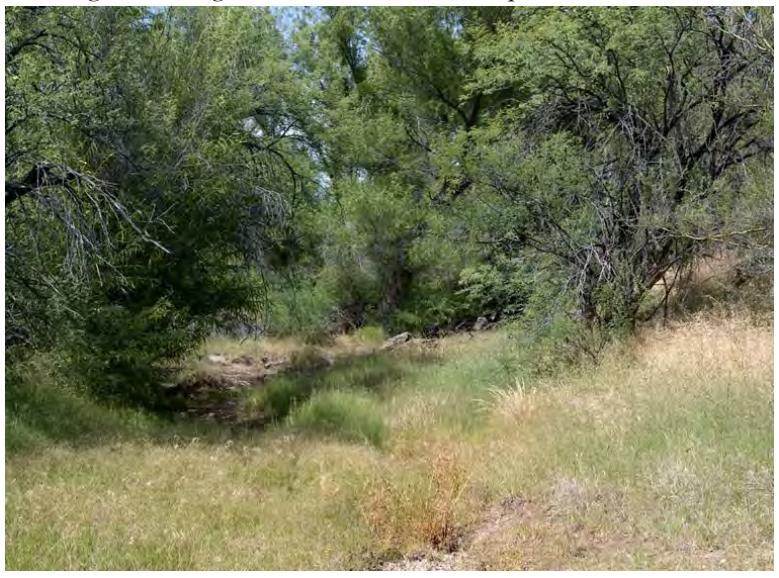
Photo 12. Tailings Area and Vicinity: Benson Spring: view upstream showing Goodding's willow and velvet mesquite

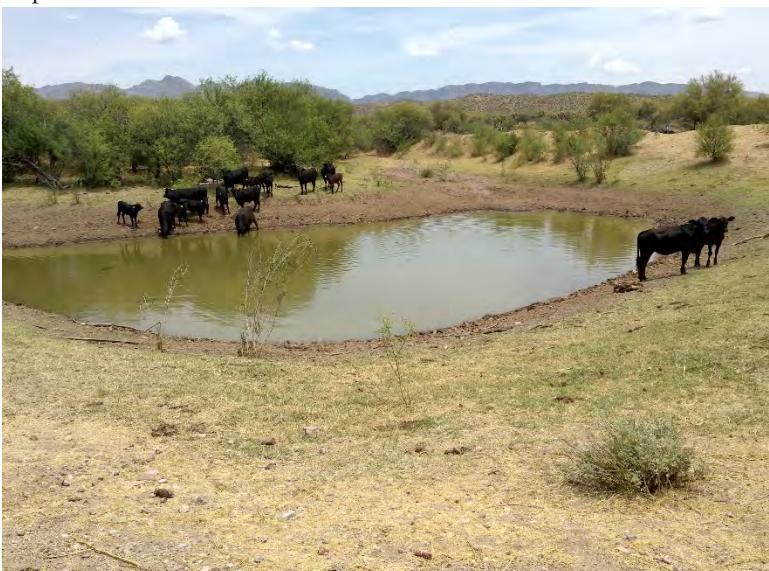
Benson Tank is located in the channel of Benson Spring Canyon 0.3 mile (0.5 km) upstream from Benson Spring (**Figure 3**). An earthen impoundment across the drainage captures runoff in a 50- by 100-meter depression in which surface water was present at the time of the field visit. Algae was present on the surface of the tank. Wetland plants observed include seepwillow (**Appendix A**, **Photo 13**). No special-status plant species were observed. Non-native species observed included rabbitsfoot grass and Bermuda grass. Water parameter measurements are provided in **Table 1**.

Photo 13. Tailings Area and Vicinity: Benson Tank, view of impoundment

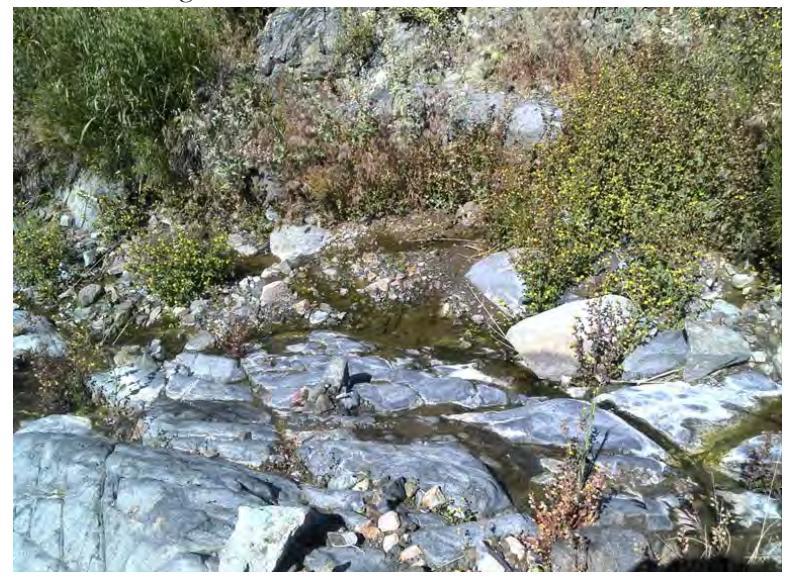
Bitter Spring is located in the channel of Peachville Wash approximately 1 mile (1.5 km) above the confluence with Silver King Wash (**Figure 3**). Within the incised channel, bedrock intrudes across the streambed and several seeps are present, which flow across bedrock and pool in several places. Dense patches of herbaceous vegetation line the stream, but there is no riparian vegetation overstory (**Appendix A, Photo 14**). Wetland plants observed include yellow monkeyflower and toad rush. No special-status plant species were observed. Non-native species observed included oats. Water parameter measurements are provided in **Table 1**.

Photo 14. Tailings Area and Vicinity: Bitter Spring, view of seeps and flows along bedrock in streambed

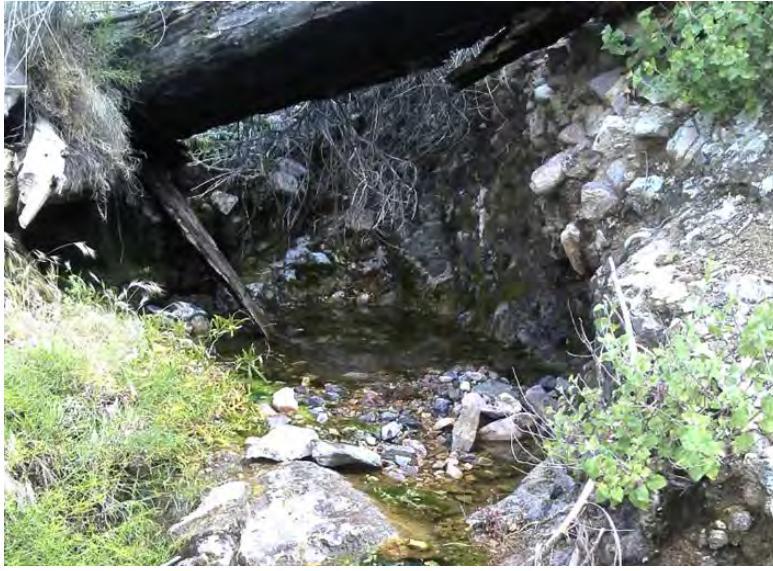
Conley Spring is located in the channel of Peachville Wash approximately 1 mile (1.5 km) above the confluence with Silver King Wash (**Figure 3**). Surface flow starts in a small pool underneath a dead Fremont cottonwood (**Appendix A, Photo 15**). The surface flow extends over bedrock substrate for over 100 meters, occasionally forming small pools. Algae is present along the flow. Flow ends where the bedrock channel turns into a sandy bottom. Wetland plants observed include watercress, yellow monkey flower,

Photo 15. Tailings Area and Vicinity: Conley Spring, view of pool under dead cottonwood at start of surface water flow

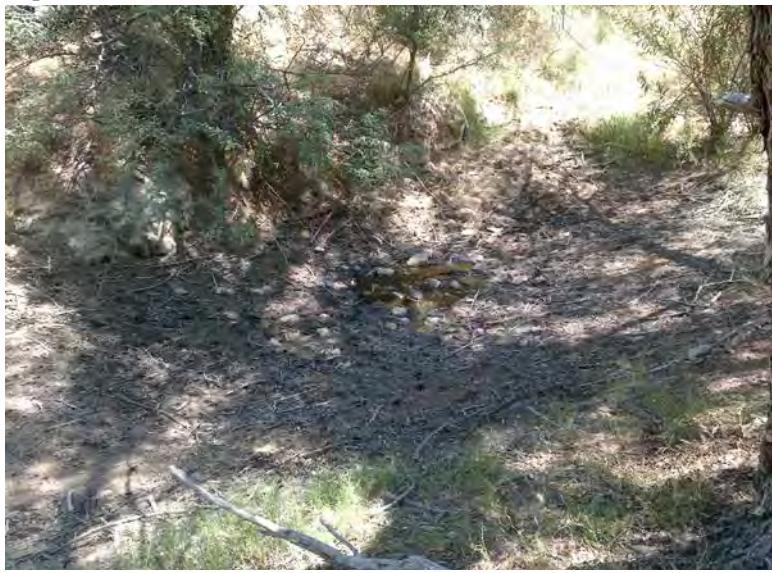
Government Tank is located on the east bank of Hewitt Wash, approximately 4.5 miles (7.25 km) above the confluence with Queen Creek (**Figure 3**). A two-meter deep depression is present at the base of a rock outcrop with signs of seepage. No stream channel enters the depression. At the time of the field visit, a one- by one-meter pool of muddy water was present at the bottom of the depression (**Appendix A, Photo 16**). Wetland plants observed include speedwell, rabbitsfoot grass, and Goodding's willow. No special-status plant species were observed. Non-native species observed included Bermuda grass, clover (*Melilotus* sp.), and rabbitsfoot grass. Water parameter measurements were not collected at this location due to safety concerns about being stung as the surface of the water was covered with wasps and bees (**Table 1**).

Photo 16. Tailings Area and Vicinity: Government Tank, view of depression

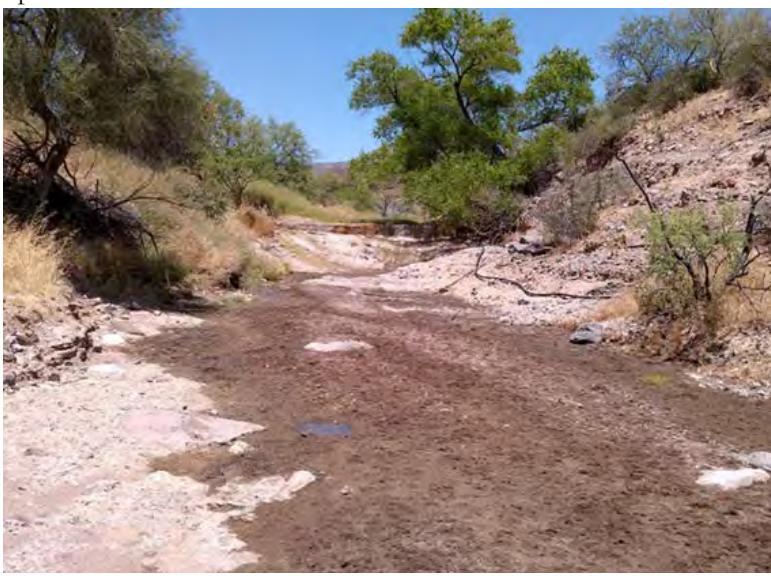
Happy Camp Spring is located in the channel of Happy Camp Canyon approximately 2.8 miles (4.5 km) above the confluence with Queen Creek (Figure 3). Flow starts in a dense patch of vegetation just downstream from a concrete dam (Appendix A, Photo 17), but areas of damp sand are present upstream from this. Flows from the stream banks converge into the stream bed and flow downstream for approximately 50 meters. Wetland plants observed include purple mat (*Nama demissa*), yellow monkeyflower, rabbitsfoot grass, toad rush, grassleaf rush, and Goodding's willow. No special-status plant species were observed. Non-native species observed included rabbitsfoot grass, Bermuda grass, and Malta star thistle (*Centaurea melitensis*). Water parameter measurements are provided in **Table 1**.

Photo 17. Tailings Area and Vicinity: Happy Camp Spring, view upstream of surface water flow and concrete dam

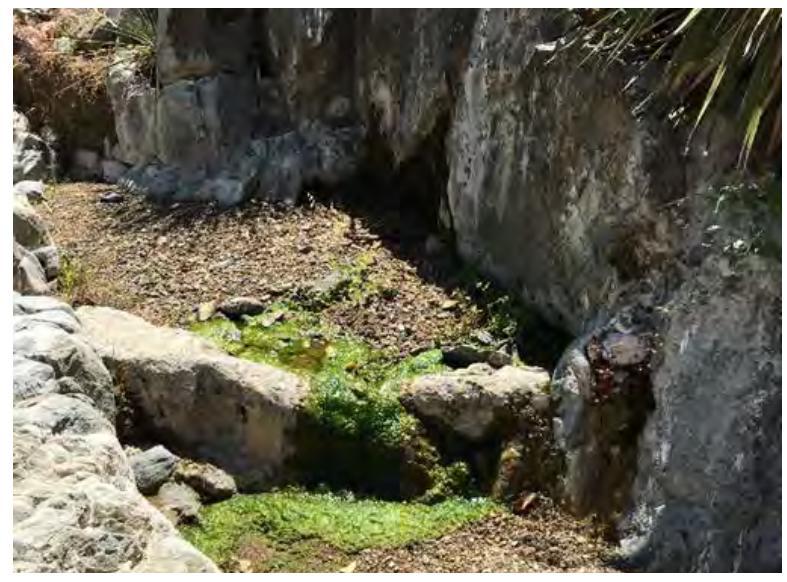
Photo 18. Tailings Area and Vicinity: I Berry Spring, view of bedrock intrusion across streambed and small concrete dam

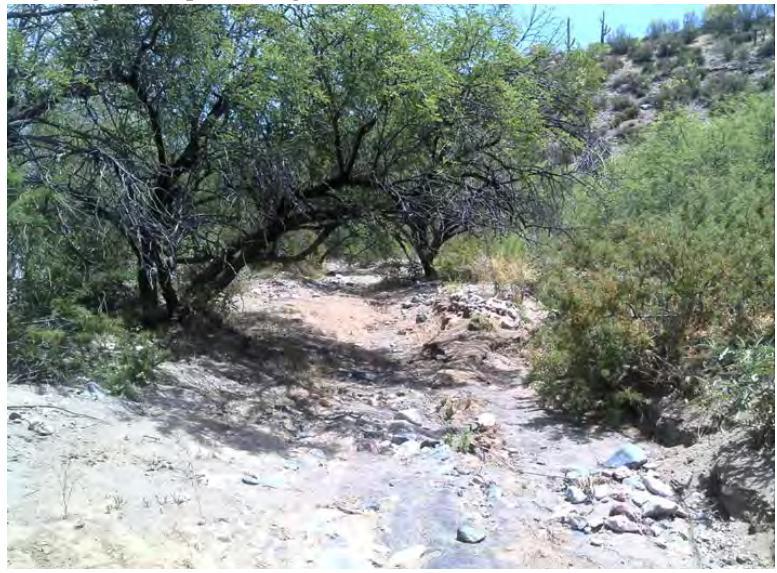
Lower Railroad Spring is located on the Picketpost Mountain USGS 7.5-minute quadrangle topographic map just north of where the MARRCO railroad crosses Happy Camp Canyon (Figure 3). However, at the time of this field visit, as in prior surveys (WestLand 2012a), there was no surface water or moisture evident, and no sign of this water feature. (Appendix A, Photo 19). No special-status or wetland plant species were observed. Non-native species observed included Bermuda grass.

Photo 19. Tailings Area and Vicinity: Lower Railroad Spring, view showing xero-riparian vegetation

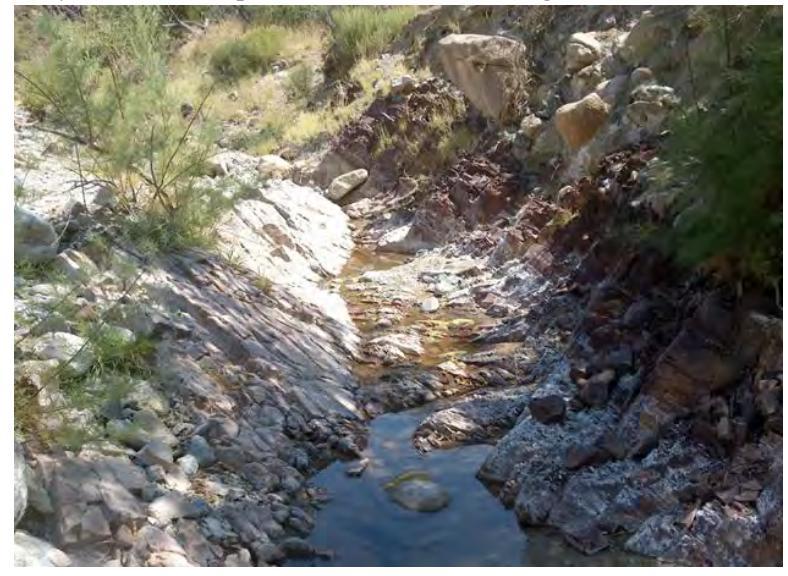
Photo 20. Tailings Area and Vicinity: No Name Spring in Whitford Canyon, view of seeps at bedrock contacts along the stream channel

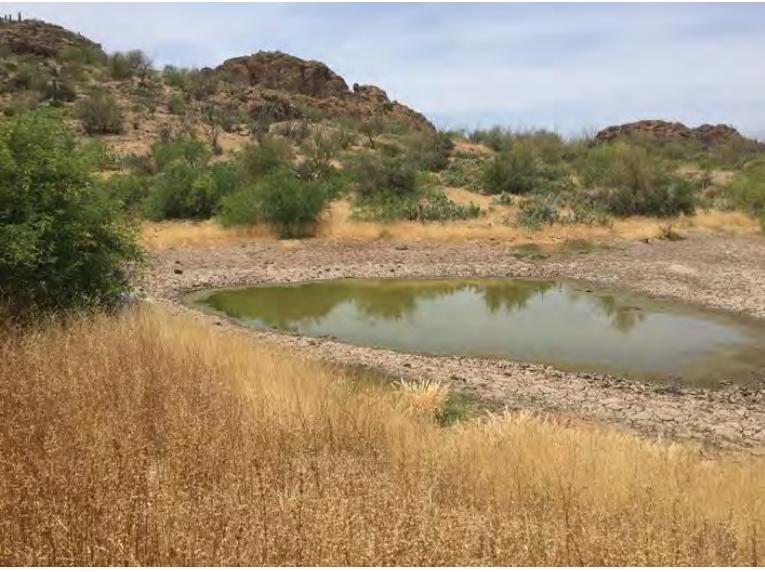
Perlite Spring is located in an unnamed canyon east of Bear Tank Canyon 1.8 miles (3 km) above the confluence with Bear Tank Canyon (**Figure 3**). At the time of the field visit, there was a pool of water approximately 15 by 20 meters and one meter deep at the base of a rock outcrop. An earthen impoundment is present upslope and northwest of Perlite Spring which was dry except for a small muddy pool (**Appendix A, Photos 21-22**). Wetland species present included yellow monkeyflower, rabbitsfoot grass and Goodding's willow. No special-status plant species were observed. Non-native species observed included Bermuda grass, canary grass (*Phalaris canariensis*), rabbitsfoot grass, red brome, stinkgrass (*Eragrostis cilianensis*), and Malta star thistle. Water parameter measurements were collected at the spring and are provided in **Table 1**.

Photo 21. Tailings Area and Vicinity: Perlite Spring, view of impoundment

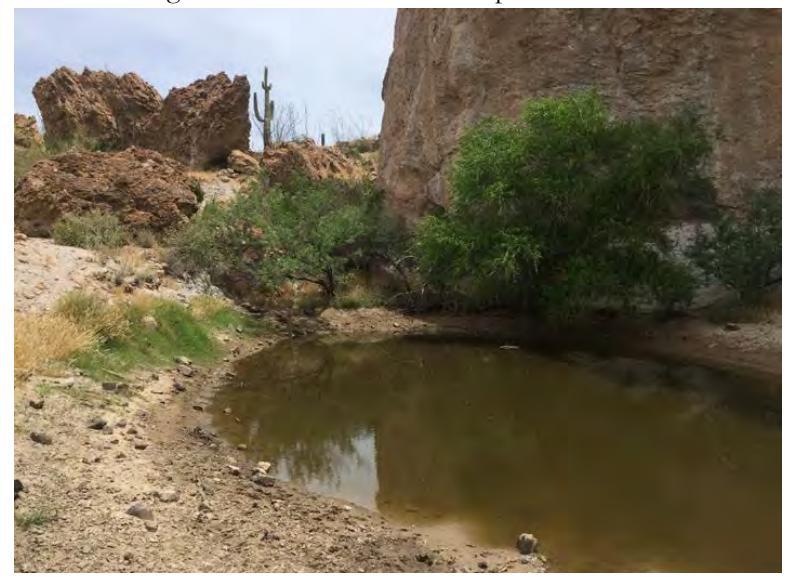
Photo 22. Tailings Area and Vicinity: Perlite Spring, view of pool and Goodding's willow below rock outcrop

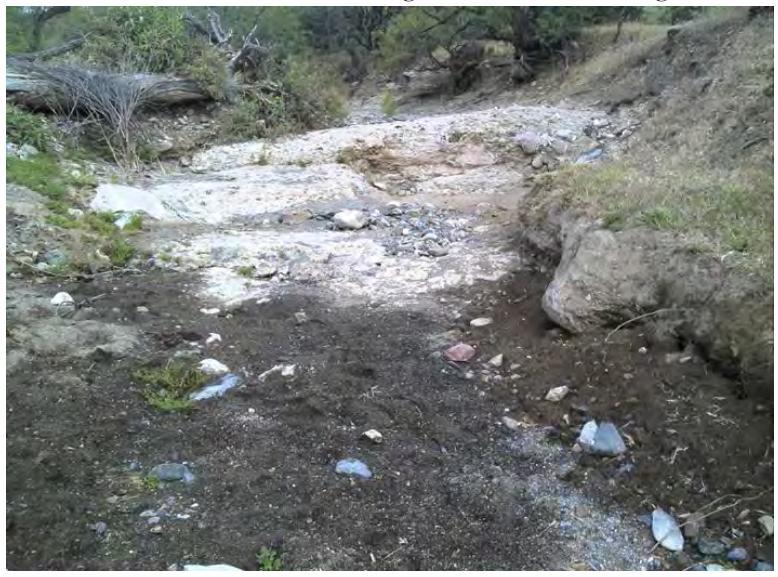
Walker Spring is located at the confluence of Happy Camp canyon and Silver King Wash (**Figure 3**). Surface water flow starts just below a conglomerate bedrock ledge in the streambed. Both sides of the stream banks are saturated and seeping. Seeps, flows, and pools are present for approximately 30 meters (**Appendix A, Photo 24**). Wetland species observed include purple mat, seepwillow, and speedwell. No special-status plant species were observed. Non-native species observed included red brome and clover. Water parameter measurements are provided in **Table 1**.

Photo 24. Tailings Area and Vicinity: Walker Spring, view of saturated streambed below the conglomerate bedrock ledge

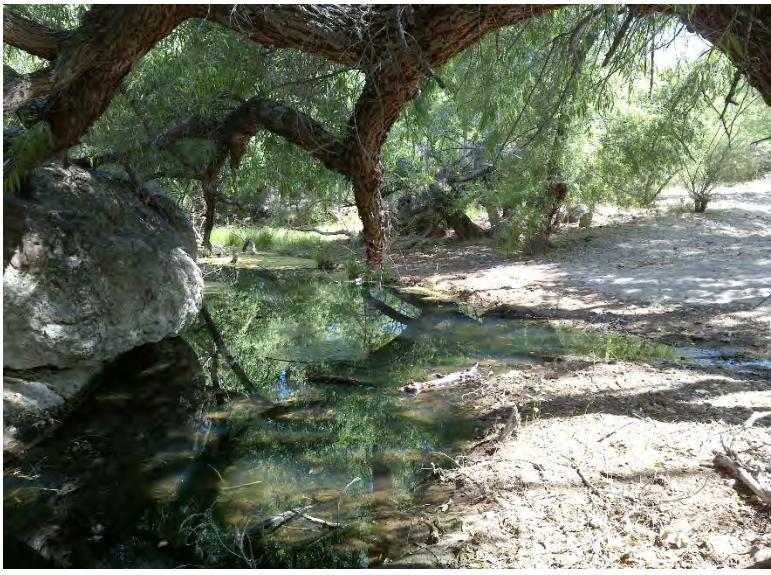
Photo 25. Queen Creek: Surface Water Reach, view of pool along reach

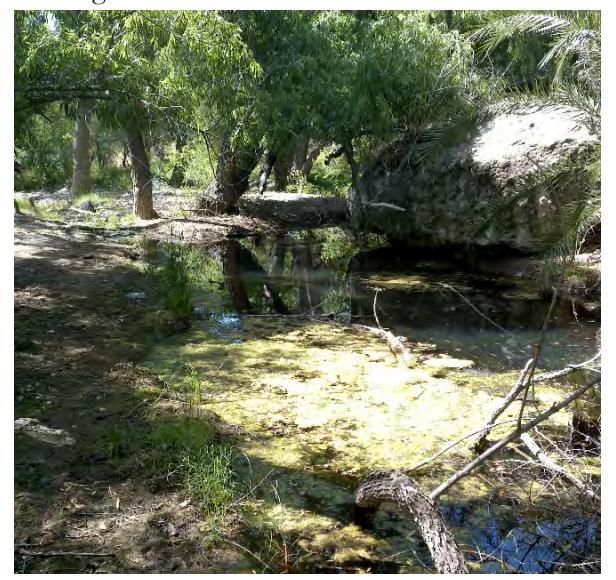
Photo 26. Queen Creek: Surface Water Reach, view of surface water and riparian vegetation

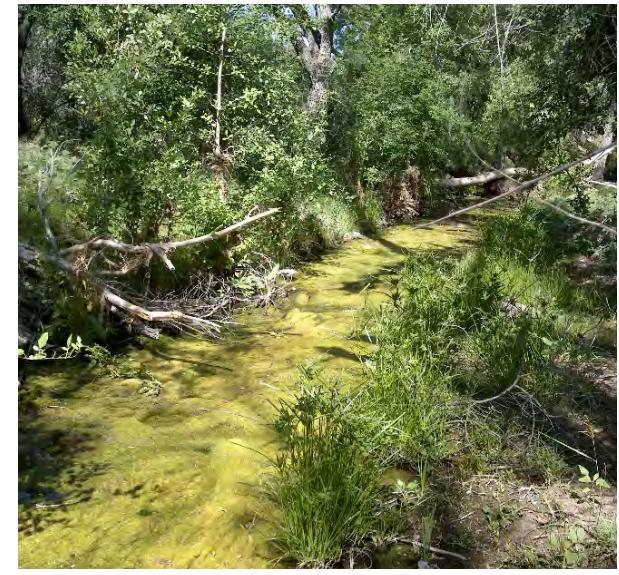
Photo 27. Queen Creek: Surface Water Reach, view of algae in surface water

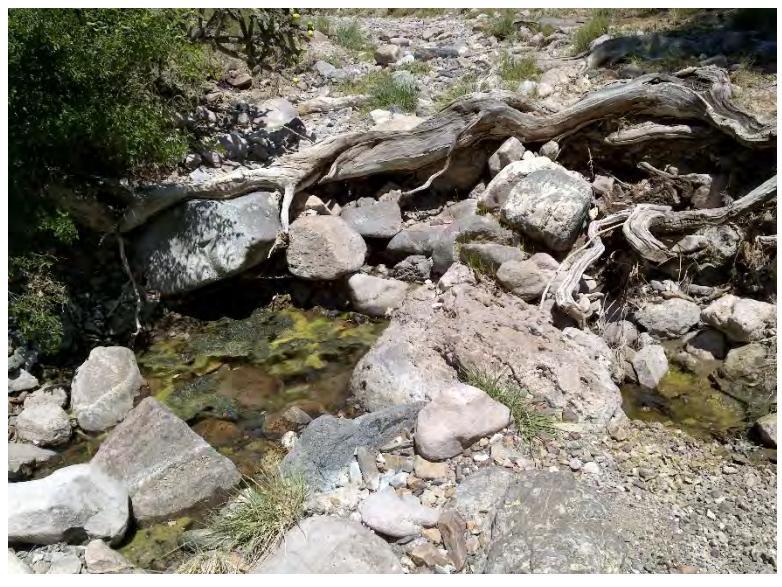
upstream observed water and the furthest downstream observed water (**Appendix A, Photos 28-29**), and are provided in **Table 1**. The most upstream water is the first of a string of five small pools along the stream channel. The most downstream surface water is a one by 10-meter rock tinaja.

Photo 28. Queen Creek: Pump Station Spring, view of pool along reach

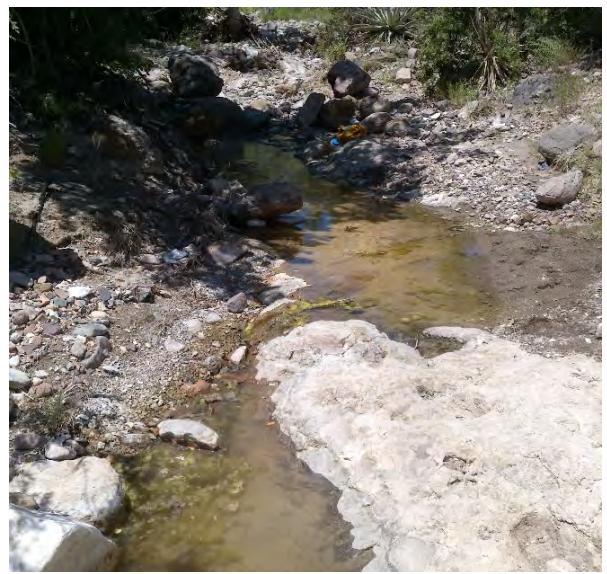
Photo 29. Queen Creek: Pump Station Spring, view of pool at end of reach

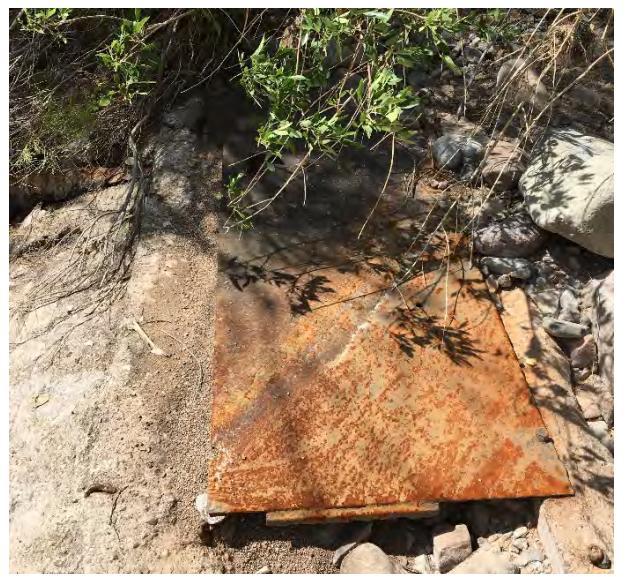
AC 1.8E is located in Arnett Creek 4.5 miles (7.5 km) upstream of the confluence with Queen Creek (**Figure 4**). A springbox with a locked steel lid and approximately six-inch-diameter corroded steel pipe are present within the stream channel (**Appendix A, Photo 30**). No water was observed in the springbox. Wetland species observed included seepwillow. No special-status or non-native plant species were observed. Water measurements were not collected at this location as there was no surface water present (**Table 1**).

Photo 30. Arnett Creek & Telegraph Canyon: AC 1.8E, view of spring box

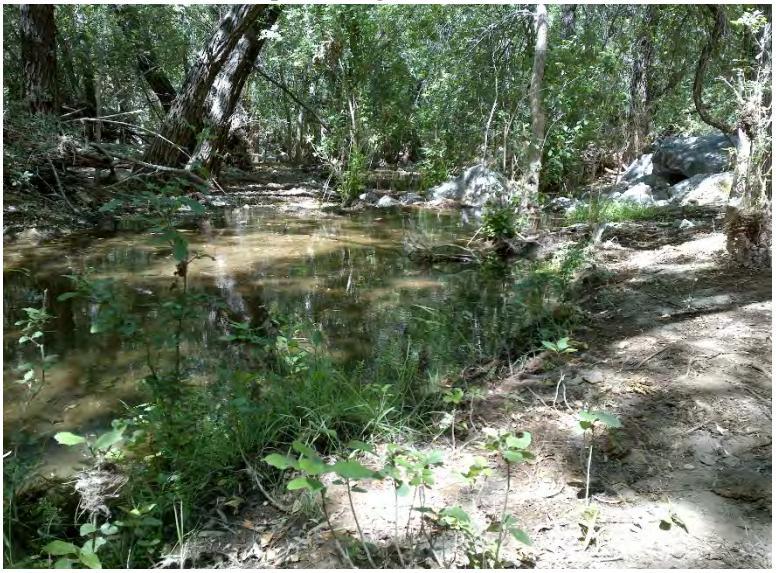
Arnett Creek Surface Water Reach begins just below the confluence with Telegraph Canyon (**Figure 4**) and is composed of a series of pools and flows over alluvial boulders, cobbles, and sand (**Appendix A, Photos 31-32**). The overstory is composed of velvet ash, Fremont cottonwood, velvet mesquite, and saltcedar. No special-status plant species were observed. Wetland species observed include algae, nutsedge (*Cyperus esculentus*), yellow monkeyflower, rabbitsfoot grass, pale spikerush, Elliott's rush, grassleaf rush, watercress, and Goodding's willow. Non-native species observed include Bermuda grass, oleander, stinkgrass, and saltcedar. Water parameter measurements were taken at three locations and are provided in **Table 1**.

Photo 31. Arnett Creek & Telegraph Canyon: Arnett Creek Surface Water Reach, view of riparian vegetation and flow

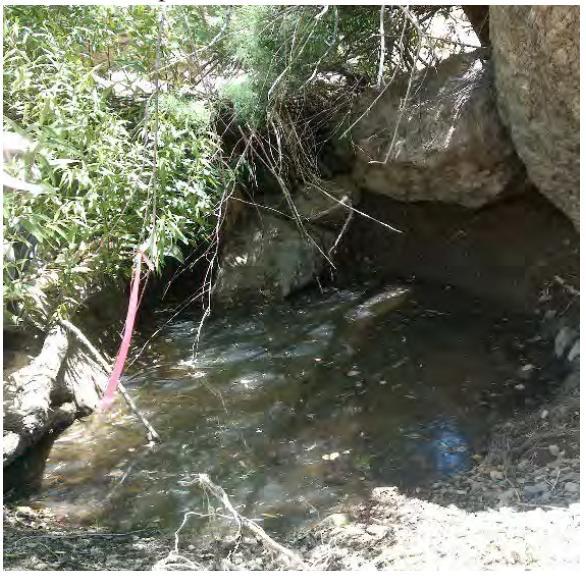
Photo 32. Arnett Creek & Telegraph Canyon: Arnett Creek Surface Water Reach, view of pool

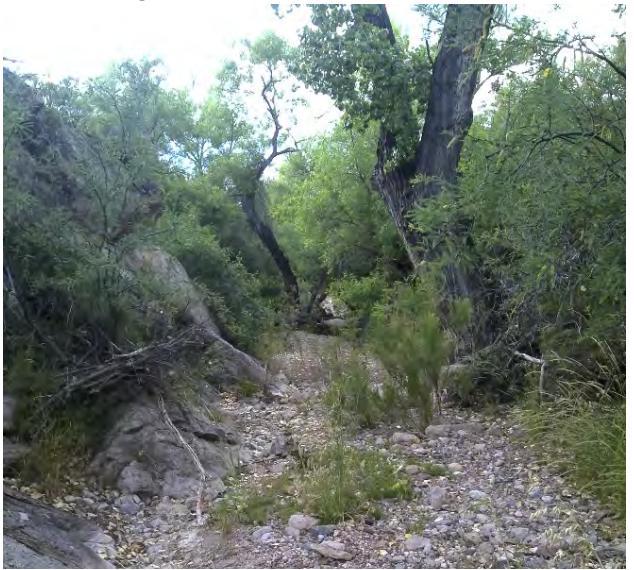
Blue Spring is located a short distance downstream from the Arnett Creek crossing of Arizona Highway 177 (Figure 4). Seeps over bedrock in the streambed support wetland plants including nutsedge, yellow monkeyflower, rabbitsfoot grass, seepwillow, and Goodding's willow (Appendix A, Photo 33). No special-status plant species were observed. Non-native species observed include Bermuda grass, oats, horehound, clover, rabbitsfoot grass and saltcedar. Water measurements were not collected at this location as there was no evident surface water present (Table 1).

Photo 33. Arnett Creek & Telegraph Canyon: Blue Spring, view of bedrock ledge in streambed

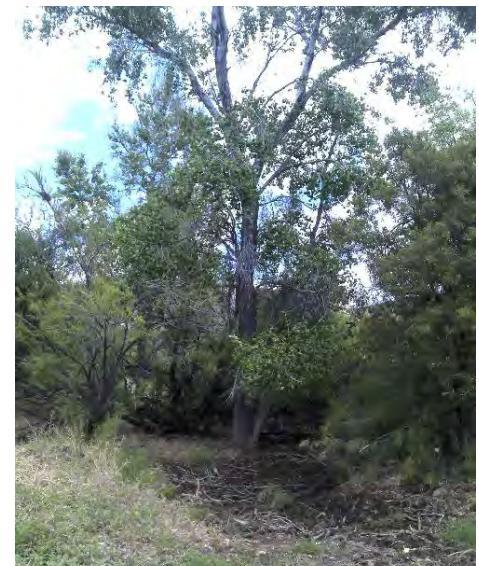
Photo 34. Arnett Creek & Telegraph Canyon: Bored Spring, view of muddy pool under Fremont cottonwood

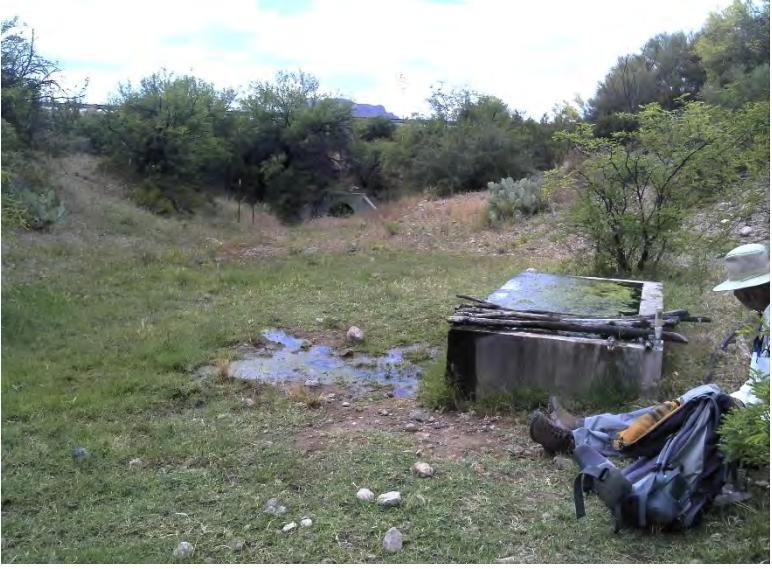
perimeter of the spring the herbaceous vegetation is composed of mostly non-native species including African sumac (*Rhus lanca*), saltcedar, Bermuda grass, fountain grass, red brome, and clover. Overflow from the trough supports wetland species yellow monkeyflower, and Goodding's willow. No special-status plant species were observed. Water parameter measurements were collected at the trough, and are provided in **Table 1**.

Photo 35. Arnett Creek & Telegraph Canyon: Bored Spring, view of trough downstream of spring

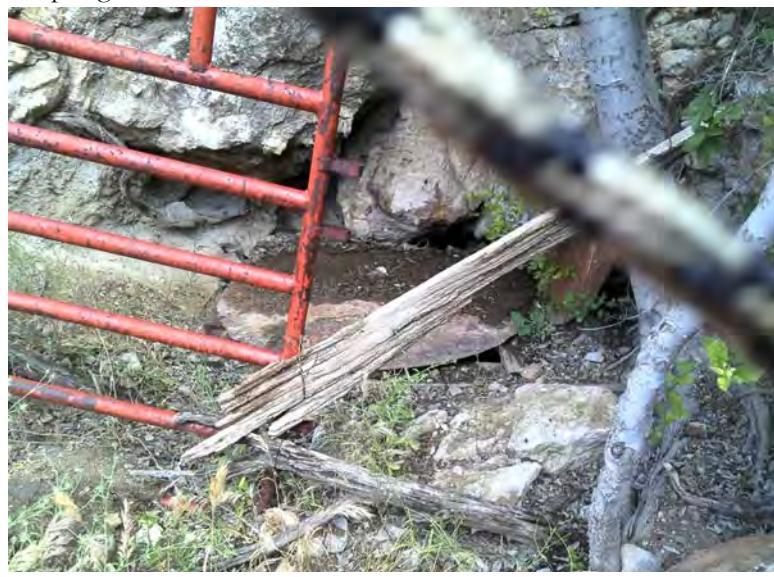
Hidden Spring is located in a narrow, limestone canyon east of Arizona Highway 177 (**Figure 4**) on bedrock substrate. A caisson made from a galvanized culvert encloses the spring which is piped to a trough (**Appendix A, Photos 36-37**). The trough has algae on the surface, overflows, and the flow supports a scattering of the wetland plants, yellow monkeyflower and rabbitsfoot grass. Non-native species observed include Malta star thistle, red brome, Johnson grass, and a patch of common garden iris (*Iris* sp.), probably a relict from when the area was homesteaded. A travertine cave on the slope across from the spring may have been the original spring but shows no evident moisture or seepage. No special-status plant species were observed. Water parameter measurements were collected at the trough, and are provided in **Table 1**.

Photo 36. Arnett Creek & Telegraph Canyon: Hidden Spring, view of spring

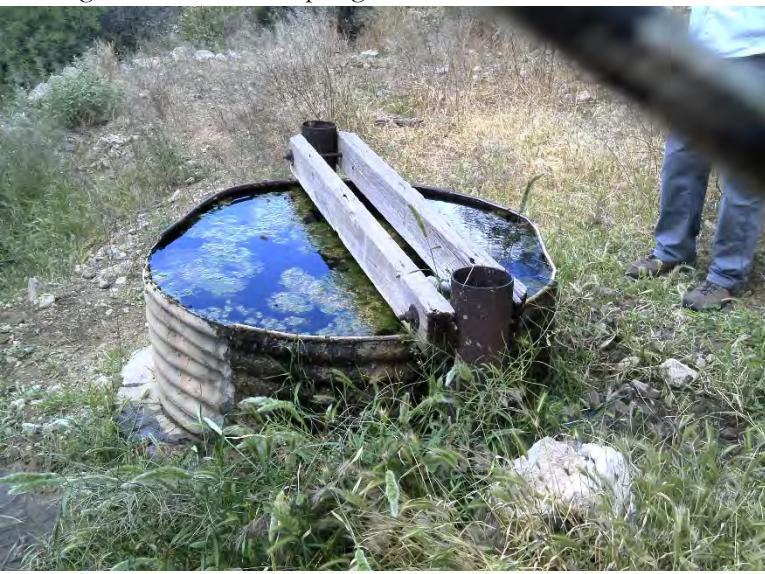
Photo 37. Arnett Creek & Telegraph Canyon: Hidden Spring, view of trough downstream of spring

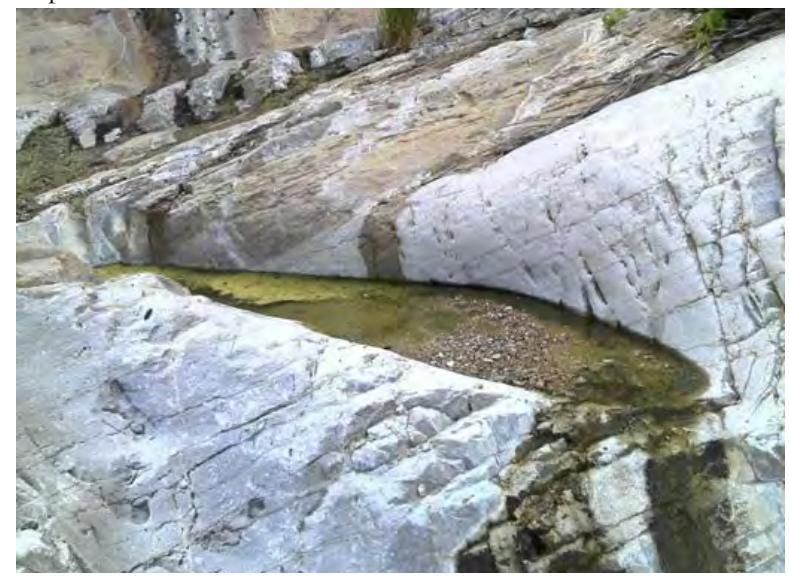
Kanes Spring is located in a narrow, limestone canyon east of Arizona Highway 177 that is tributary to Arnett Creek (**Figure 4**). Seeps occur between the limestone strata and the flows collect in small bedrock pools (**Appendix A, Photo 38**). A spring box with several generations of outlet piping is evident. Canyon grape (*Vitis arizonica*) and desert hackberry (*Celtis pallida*) form a thicket on the slope above and around the spring (**Appendix A, Photo 39**). Wetland plants observed include yellow monkeyflower, seepwillow, and grassleaf rush. No special-status plant species were observed. Water parameter measurements are provided in **Table 1**.

Photo 38. Arnett Creek & Telegraph Canyon: Kanes Spring, view of pools on bedrock

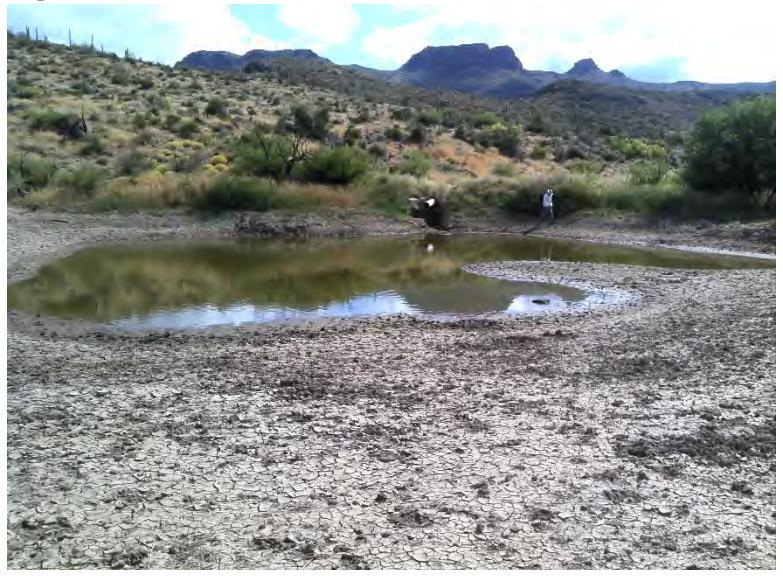
Lime Tank is located east of Arizona Highway 177 and is an earthen impoundment (Appendix A, Photo 40) along an ephemeral drainage in the next main drainage south of Kanes Spring (Figure 4). Around the perimeter of the approximately 32- by 32-meter earthen impoundment the vegetation is composed of mostly non-native species including oats, red brome, canary grass, rabbitsfoot grass, and saltcedar. Wetland species observed include rabbitsfoot grass. No special-status plant species were observed. Water parameter measurements are provided in Table 1.

Photo 40. Arnett Creek & Telegraph Canyon: Lime Tank, view of impoundment

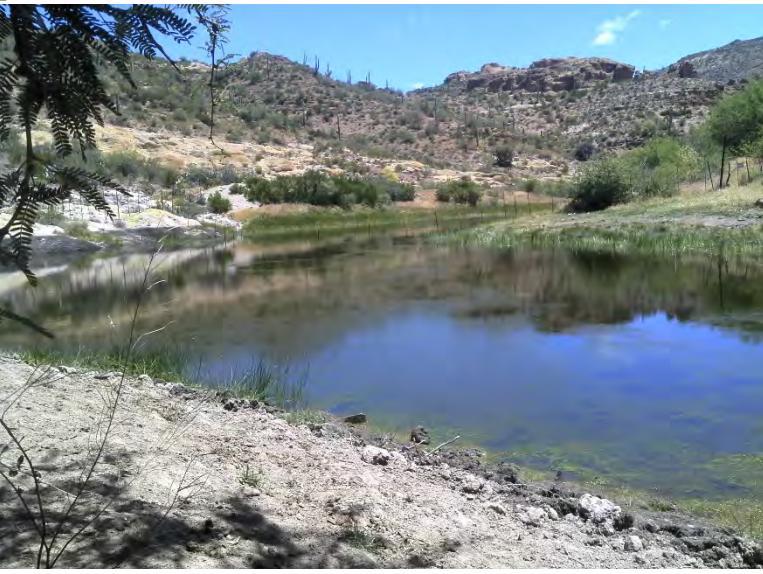
Rock Tank is located within an east side canyon of Telegraph Canyon (**Figure 4**). An earthen impoundment holds water approximately 50 meters long and up to 2 meters deep, with algae present on the surface of the water (**Appendix A, Photos 41-42**). Wetland plant species observed include seepwillow, pale spikerush, and rabbitsfoot grass. No special-status or invasive plant species were observed. Water parameter measurements are provided in **Table 1**.

Photo 41. Arnett Creek & Telegraph Canyon: Rock Tank, view of pool

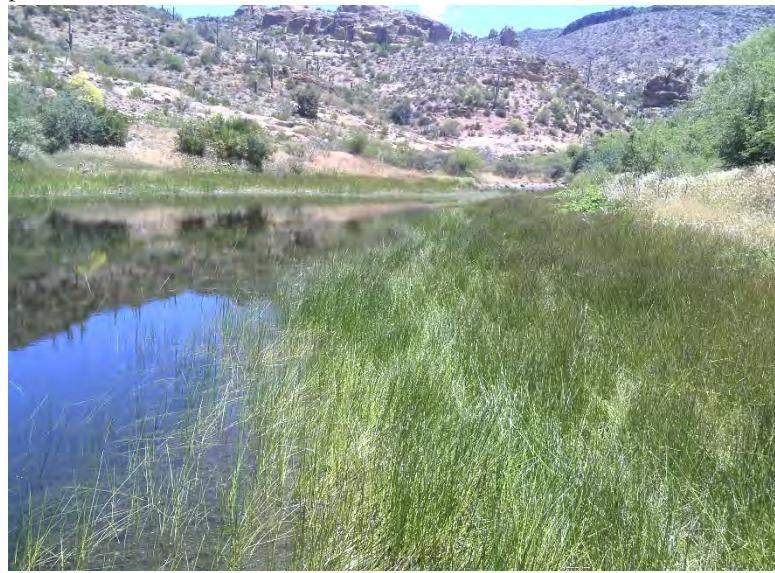
Photo 42. Arnett Creek & Telegraph Canyon: Rock Tank, view of pool

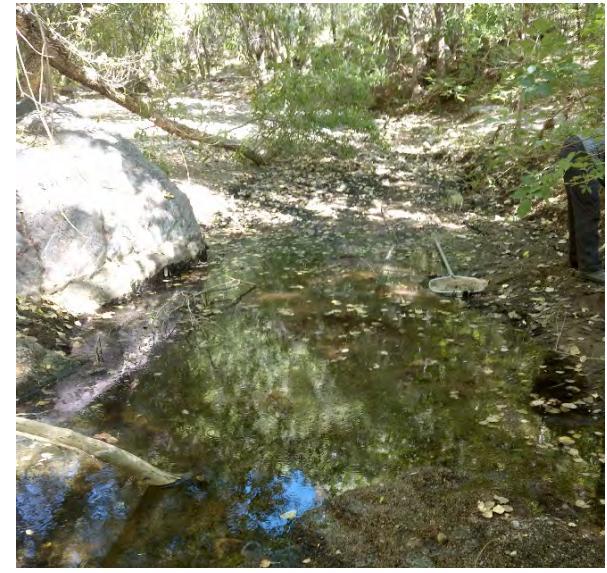
Thompson Spring is located in Arnett Creek at the confluence with Telegraph Canyon (**Figure 4**). The spring is located above the streambed on a steep rock face within an alcove under a rock overhang. The rock face seeps and flows to the stream channel and flows and pools downstream (**Appendix A**, **Photo 43**). No special-status plant species were observed. Wetland plant species observed include nutsedge, yellow monkeyflower, pale spikerush, and Goodding's willow. Non-native plant species observed include oleander and saltcedar. Water parameter measurements were collected at the pool, and are provided in **Table 1**.

Photo 43. Arnett Creek & Telegraph Canyon: Thompson Spring, view of start of surface water flow

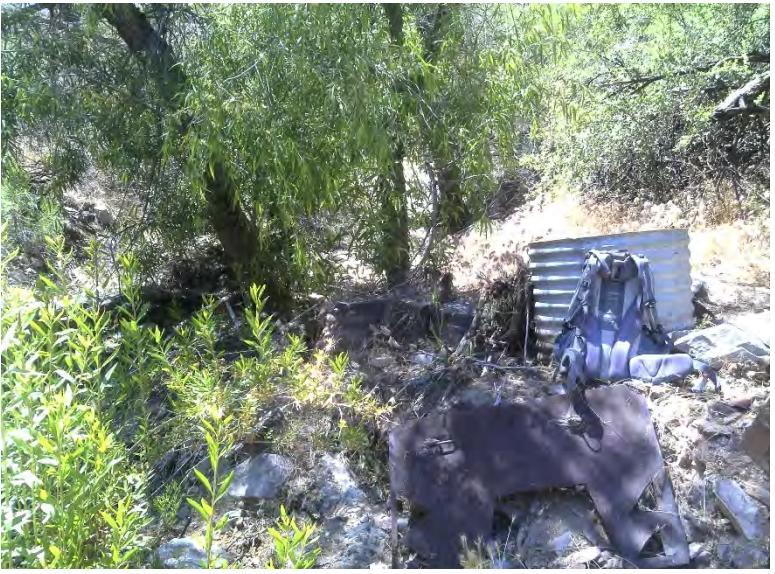
Trough Spring is located in a western tributary of Telegraph Canyon (**Figure 4**). Bedrock intrudes across the streambed and a small seep occurs under a Goodding's willow (**Appendix A, Photo 44**). A steel culvert holds approximately 16inches of water and is piped downstream to a trough, which was empty. Wetland species observed included Goodding's willow and seepwillow, while the non-native grasses oats and Bermuda grass were the herbaceous understory. No special-status plant species were observed. Water parameter measurements are provided in **Table 1**.

Photo 44. Arnett Creek & Telegraph Canyon: Trough Spring, view of culvert and seep under Goodding's willow
