SURVEY OF SURFACE WATER FEATURES IN THE RESOLUTION PROJECT AREA AND VICINITY

Resolution Copper

102 Magma Heights – Superior, Arizona 85173 Project Number: 807.132 04 01 March 2018

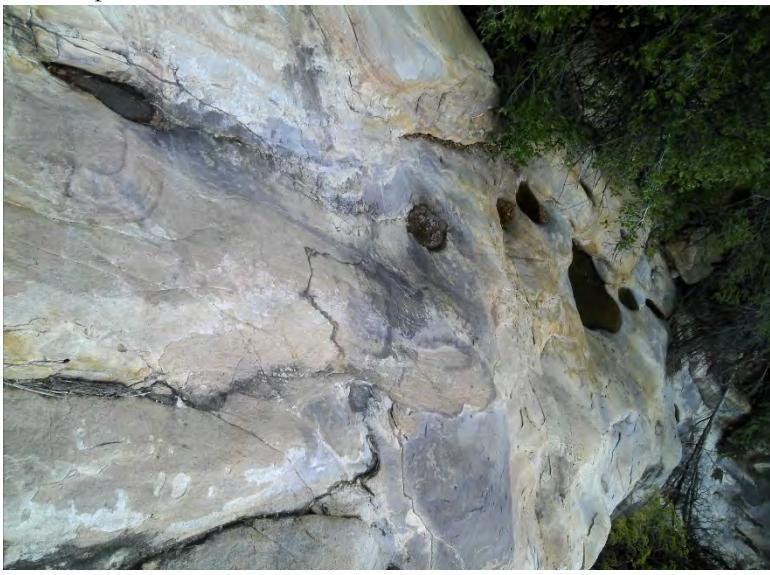
Wild Horse Spring is located east of Arizona Highway 177 along Oak Creek. (**Figure 4**). A bedrock ledge has several small rock basins which hold water (**Appendix A, Photo 45**). A pipe extended out of the bedrock at the upper end of a reach of fairly dense vegetation including velvet mesquite, catclaw acacia, sugar sumac (*Rhus ovata*), and Arizona rosewood (*Vauquelinia californica*) No special-status, wetland or invasive plant species were observed. Water parameter measurements are provided in **Table 1**.

Photo 45. Arnett Creek & Telegraph Canyon: Wild Horse Spring, view of pools on bedrock

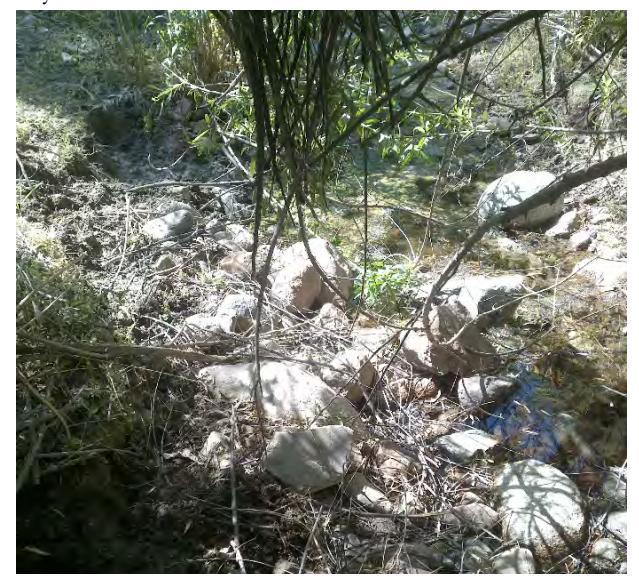
Photo 46. Mineral Creek: LF 0.2C, view of start of surface water flow in Lyon's Fork

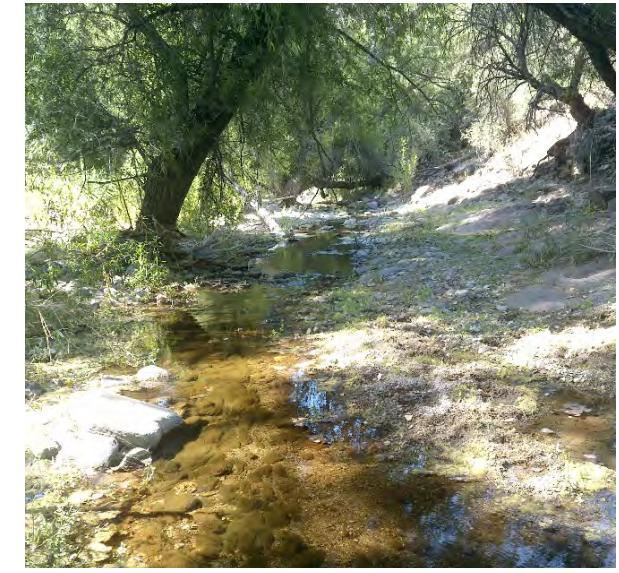
Photo 47. Mineral Creek Surface Water Reach, view of surface water flow

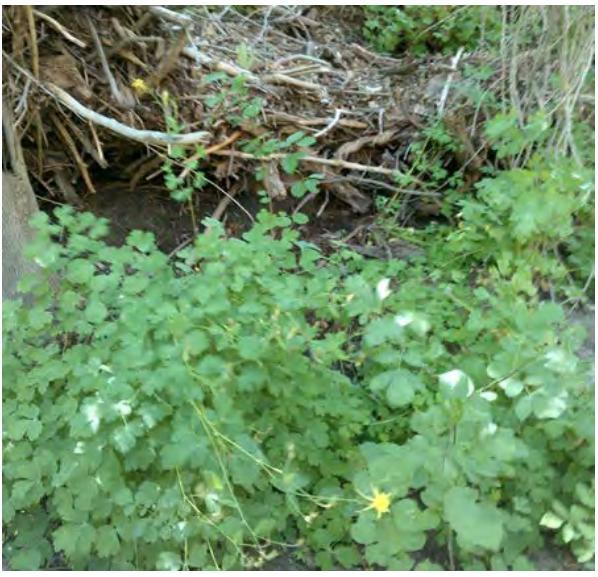
Photo 48. Mineral Creek Surface Water Reach, view of patch of golden columbine in saturated soil
